**SCAT Area Transition Report  
for A24**

Silvertip Pipeline Incident  
Laurel, Montana

October 22, 2011

Prepared for:  
ExxonMobil Pipeline Company

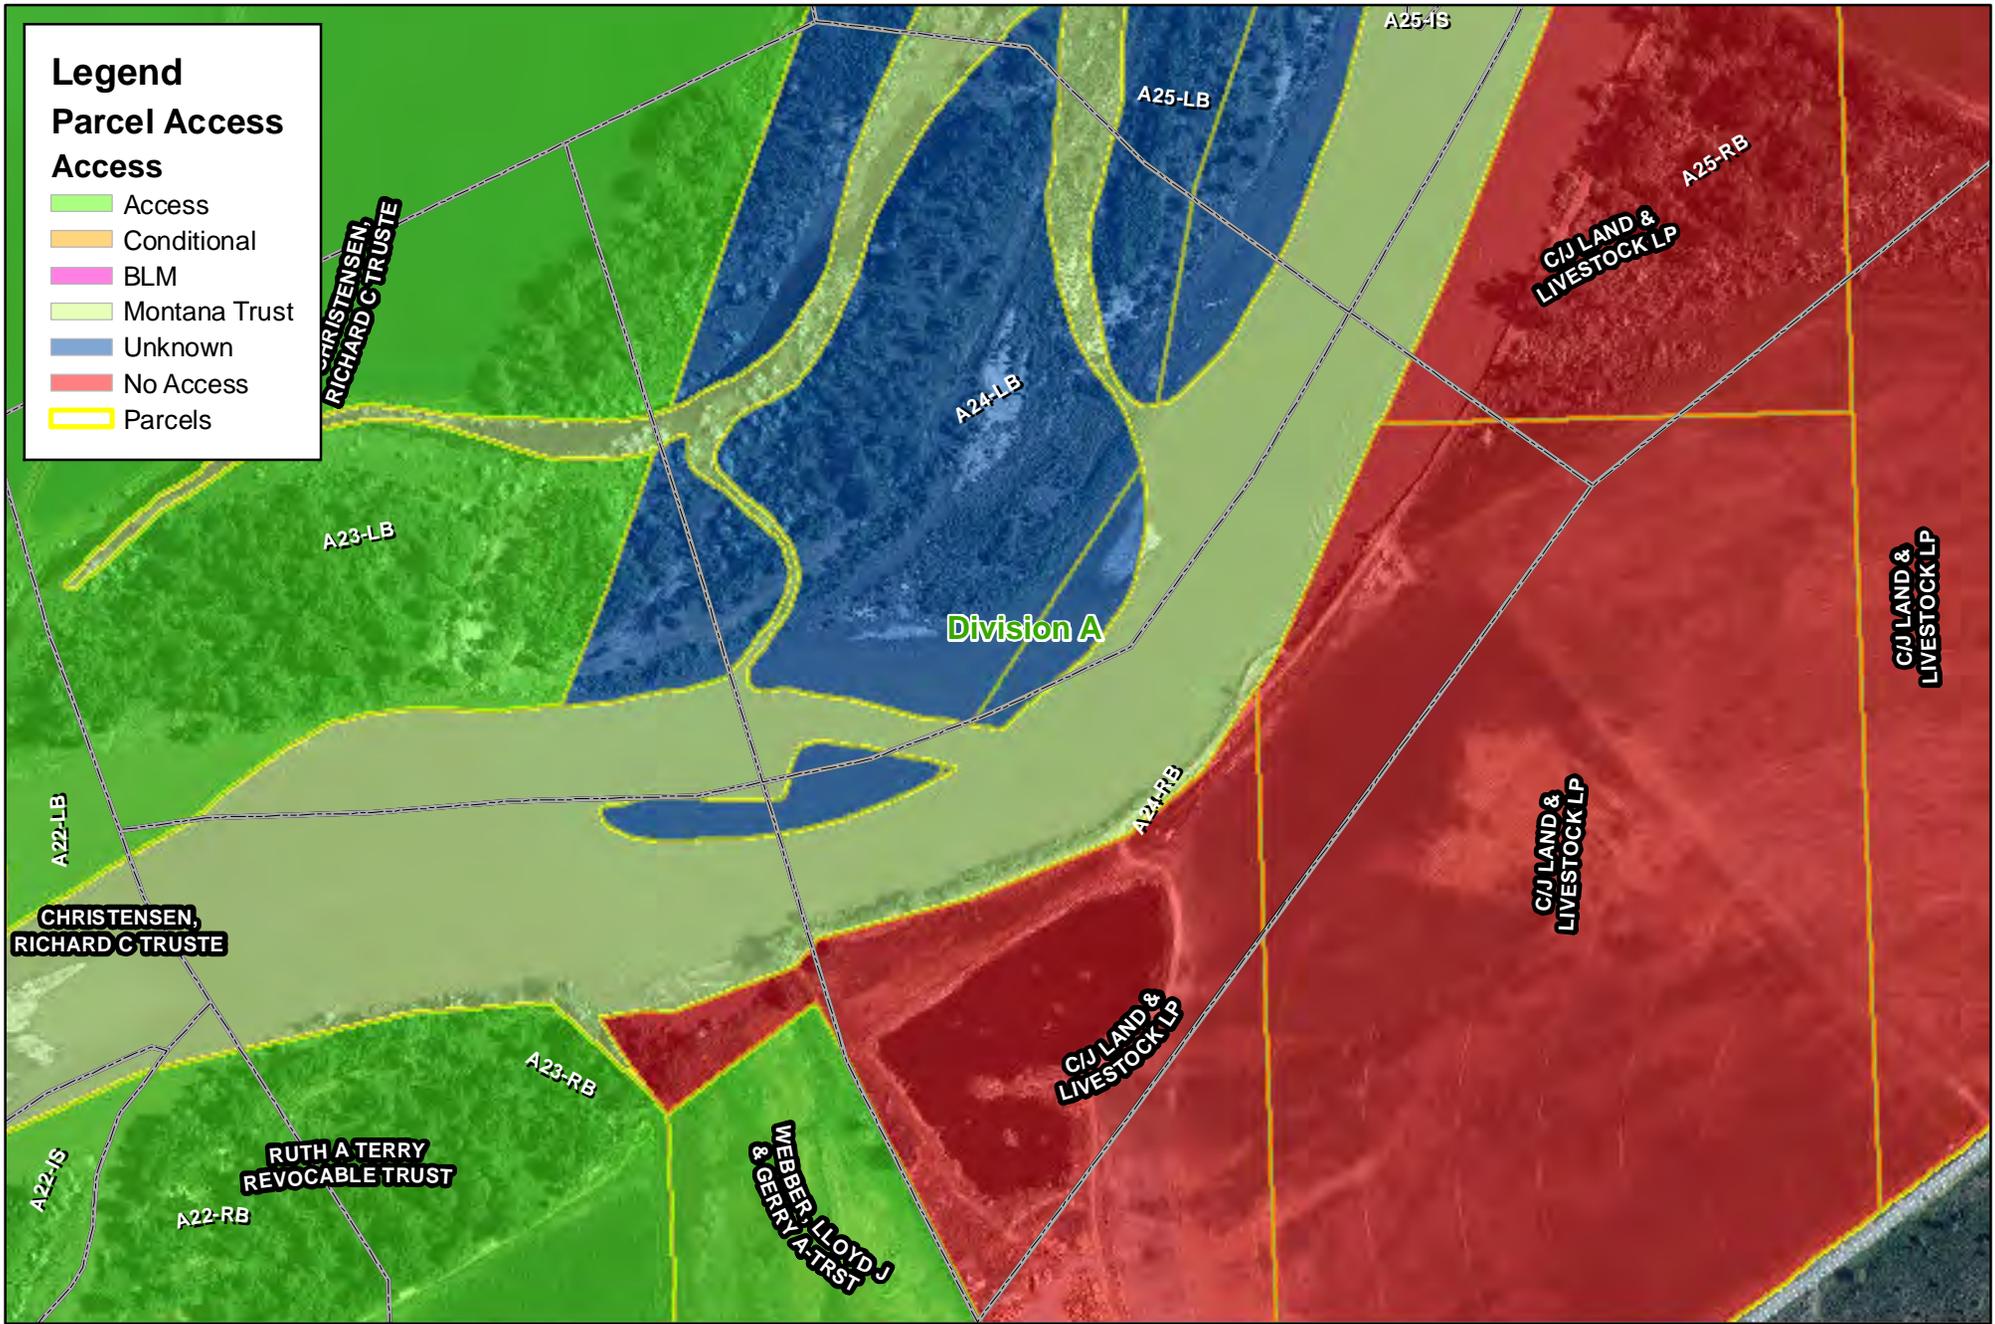
Figure 1 provides an aerial map of SCAT Area A24, along with the (a) SCAT Area boundary, (b) parcel boundaries and respective property owners, and (c) access constraints identified during the oil cleanup process. The acreage surveyed in Area A24 is 34.2. There were access issues for the right bank.

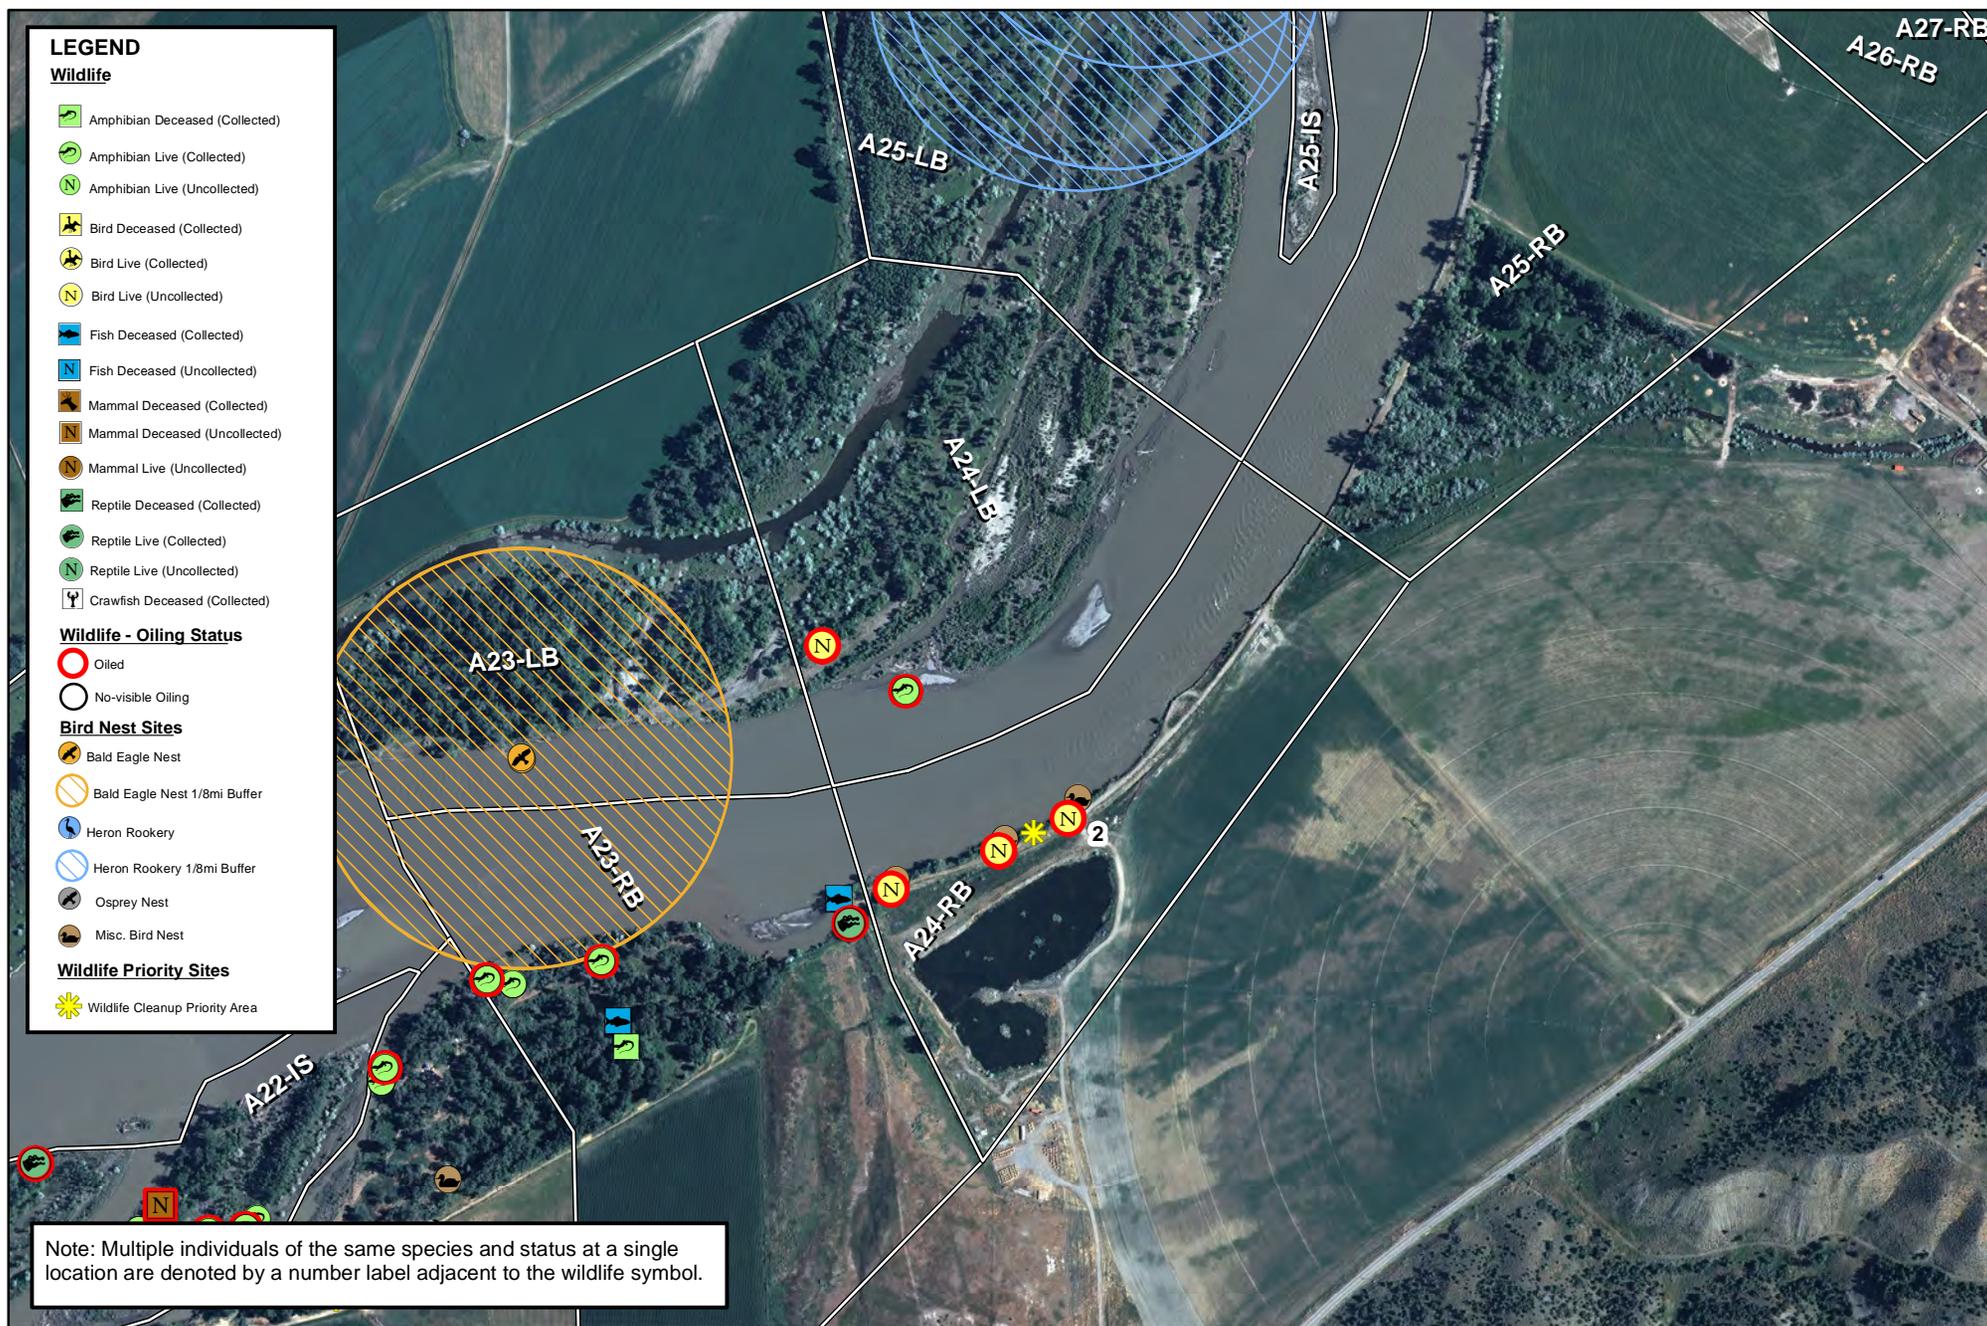
**Figure 2**  
**Wildlife Resources**

Figure 2 summarizes the natural resources identified in this segment. International Bird Rescue and Resource Advisors from U.S. Fish and Wildlife Service conducted regular inspections of Area A24. One oiled Woodhouse's toad (*Bufo woodhousii*) was captured, cleaned, and released. In addition, four oiled birds were noted: a nesting lightly oiled Downey woodpecker (*Picoides pubescens*); a lightly oiled pair of yellow warblers (*Dendroica petechia*); a lightly oiled nesting yellow warbler (*Dendroica petechia*), potentially one of the previously noted pair; and a lightly oiled northern shoveler (*Anas clypeata*). The figure with this section shows five oiled birds were observed (note the 2 by one of the symbols). None of these birds were captured for cleaning. One Wildlife Priority Cleanup Area (WPCA) was identified. The WPCA consisted of a band of heavy oiled vegetation along the river bank; the cleanup of this area was substantially delayed due to legal issues. The WPCA was treated to reduce the potential for wildlife oiling and is no longer considered a wildlife hazard. Three active migratory bird nests were identified in Area A24; two of the nests are noted above and the third belonged to a species that was not identified.

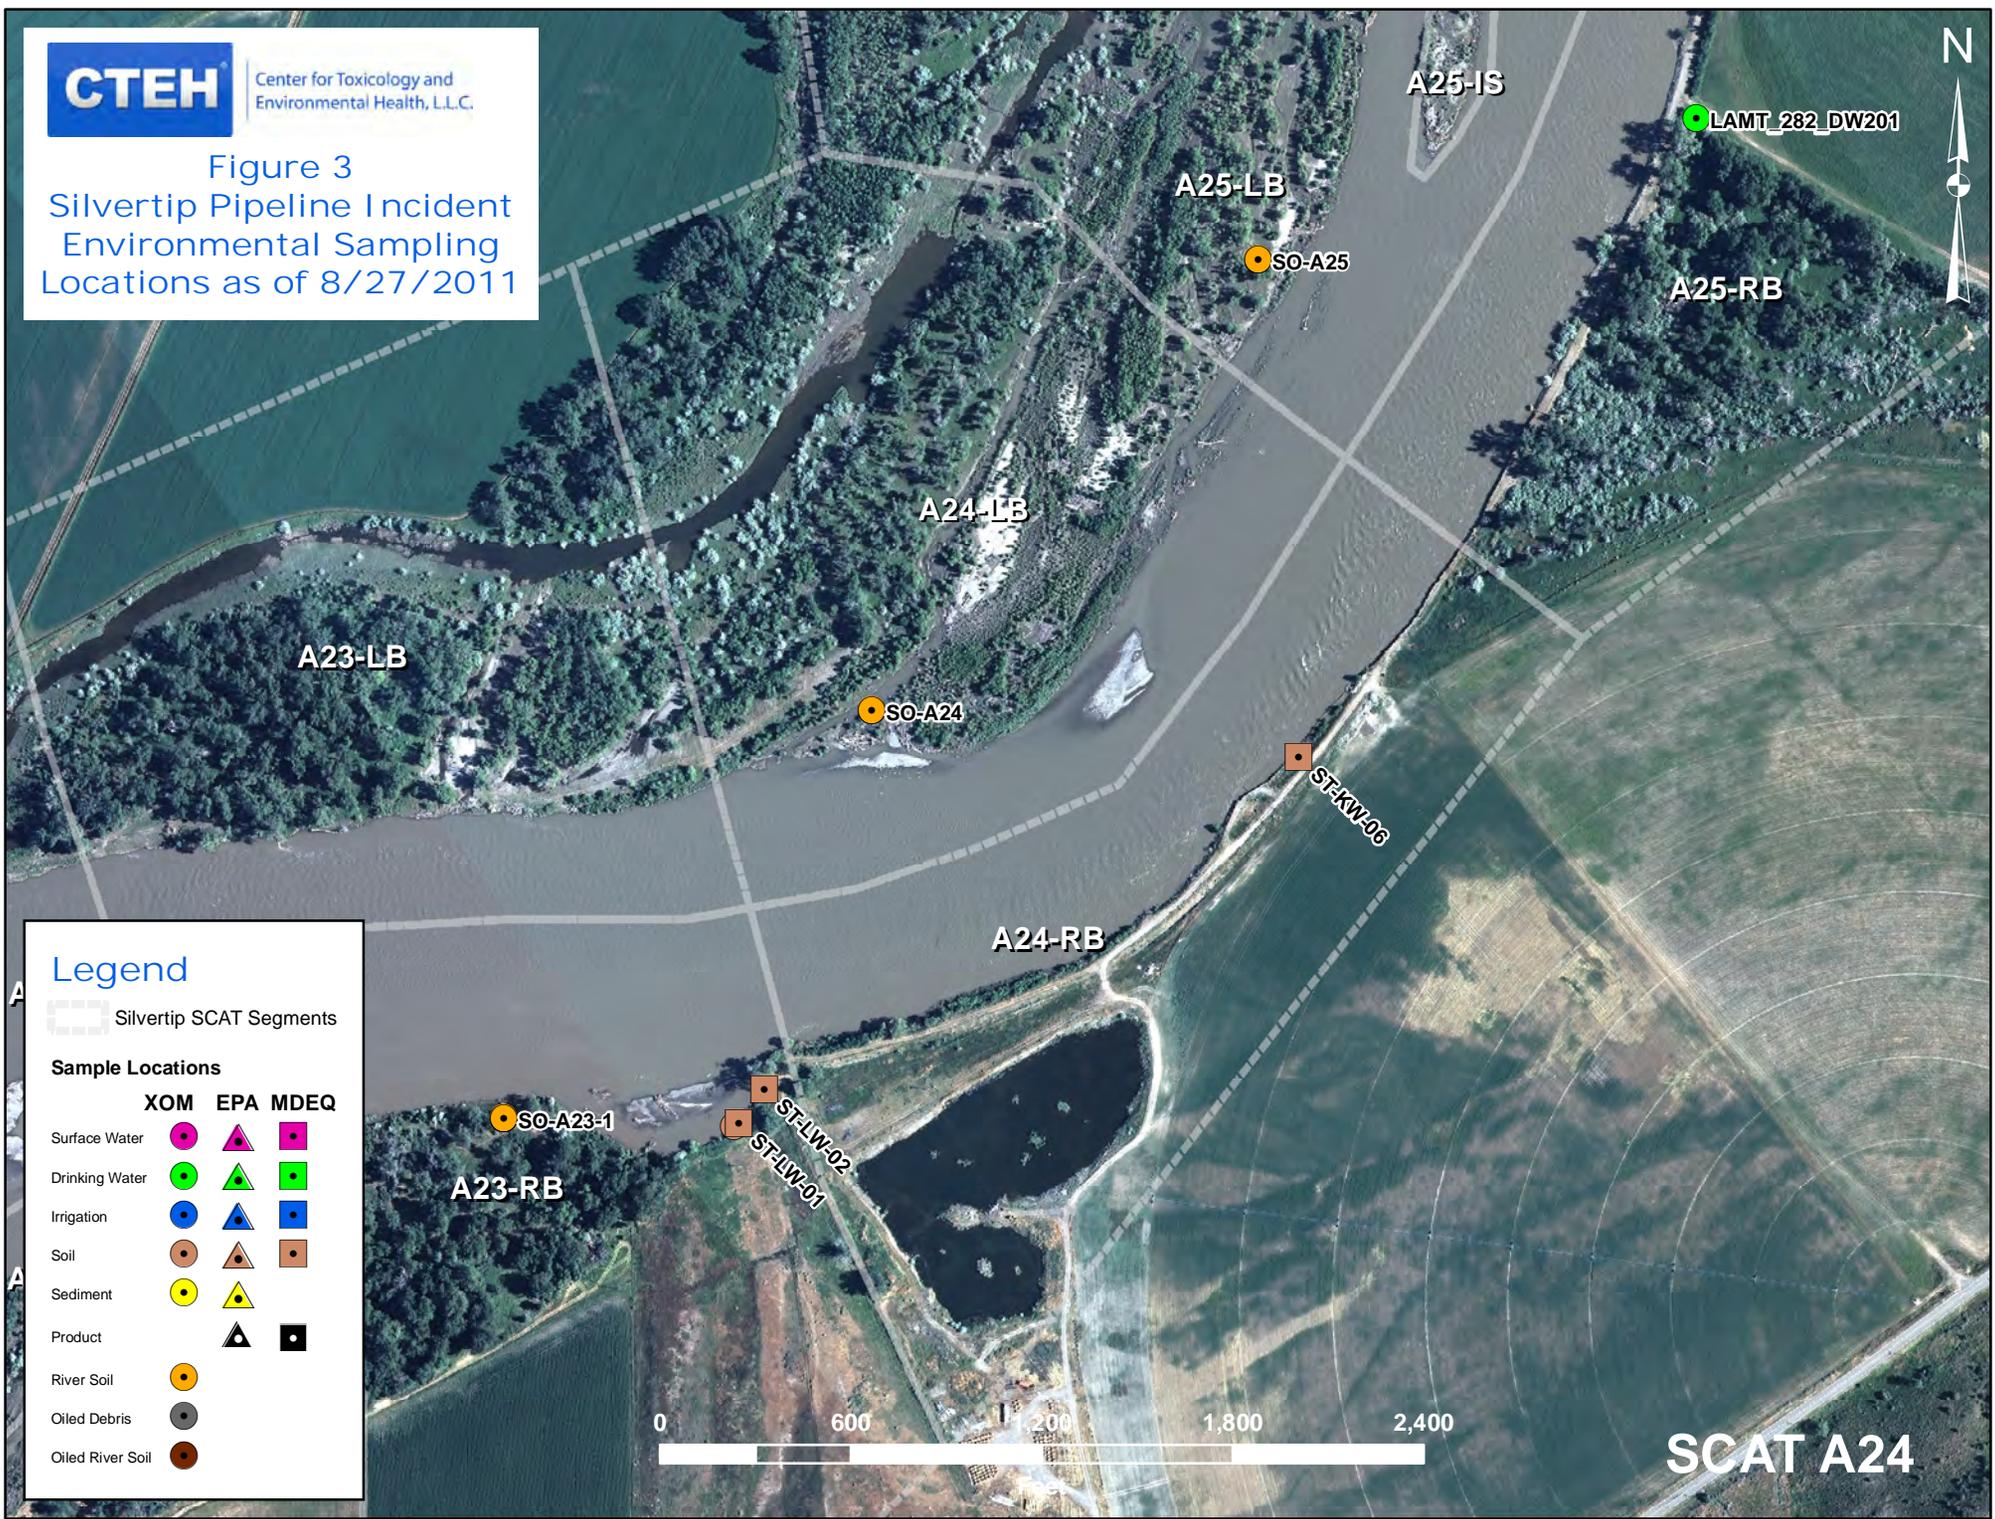
Figure 3  
Silvertip Pipeline Incident  
Environmental Sampling  
Locations as of 8/27/2011

Table 1 (below) summarizes samples collected within Area A24. The analytical results for the samples collected can be accessed through a publicly accessible database on the United States Environmental Protection Agency’s (USEPA’s) website. The approximate locations of samples collected within Area A24 are provided on Figure 3.

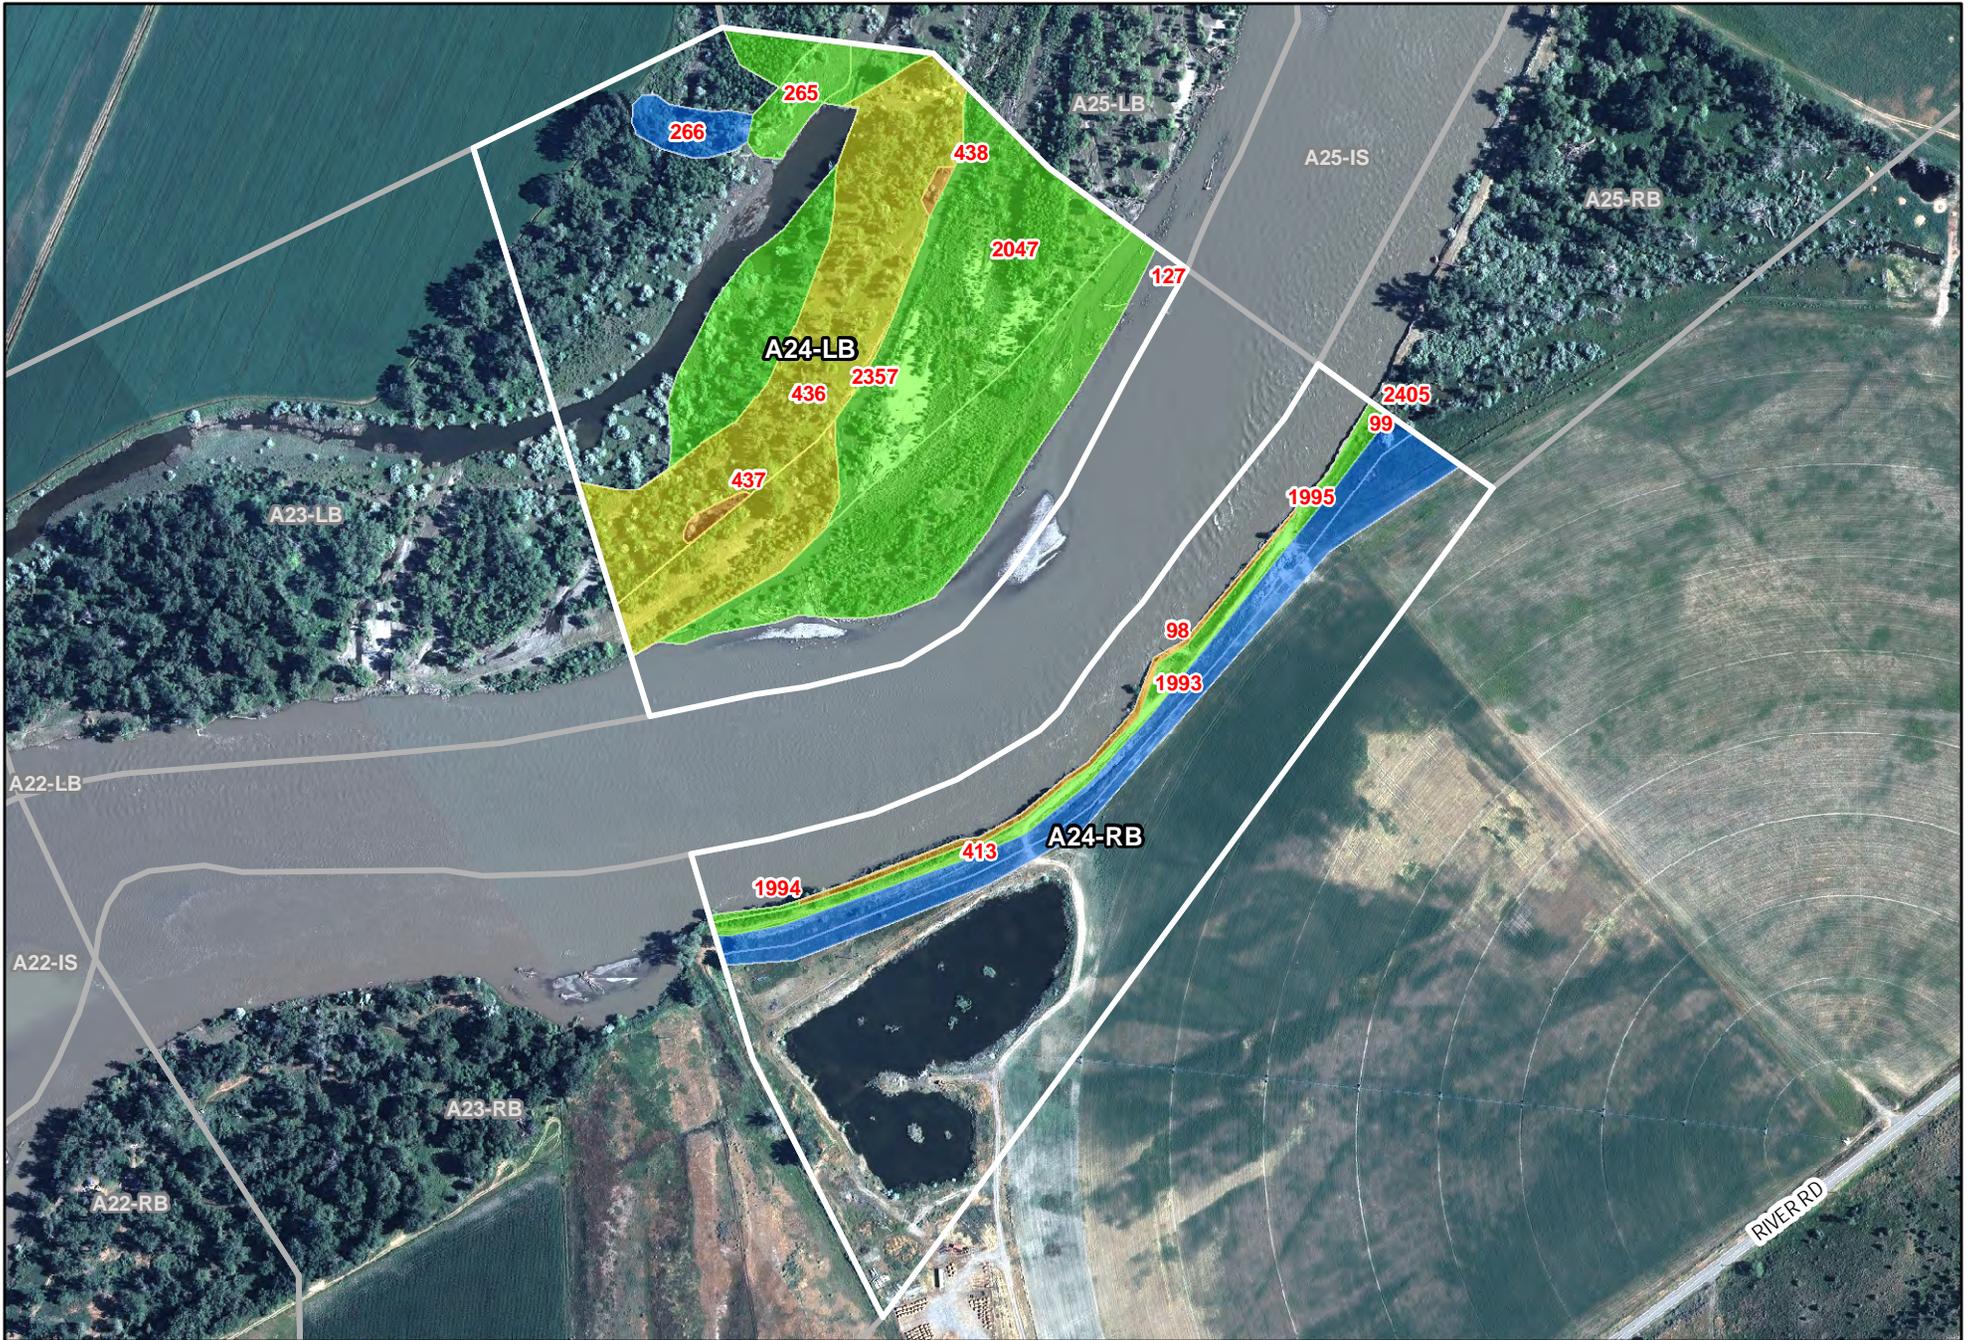
**Figure 4 - Maximum SCAT Observations For SCAT Area: A24**

The SCAT teams used systematic evaluation criteria and treatment method tables approved by the National Oceanic and Atmospheric Administration to provide a standard approach for data collection and conducting field surveys. The forms and sketches from the initial SCAT surveys performed along the river bank (water edge) and floodplain within Area A24 are included in Appendix B. Figure 4 provides the maximum oiling zones observed by the SCAT team during the initial surveys of Area A24.

The SCAT team developed compiled treatment recommendations (CTRs) providing approved treatment methods (ATMs) for each oiling zone identified during the initial SCAT surveys ([CTR No. 13](#) and [CTR No. 14](#)).

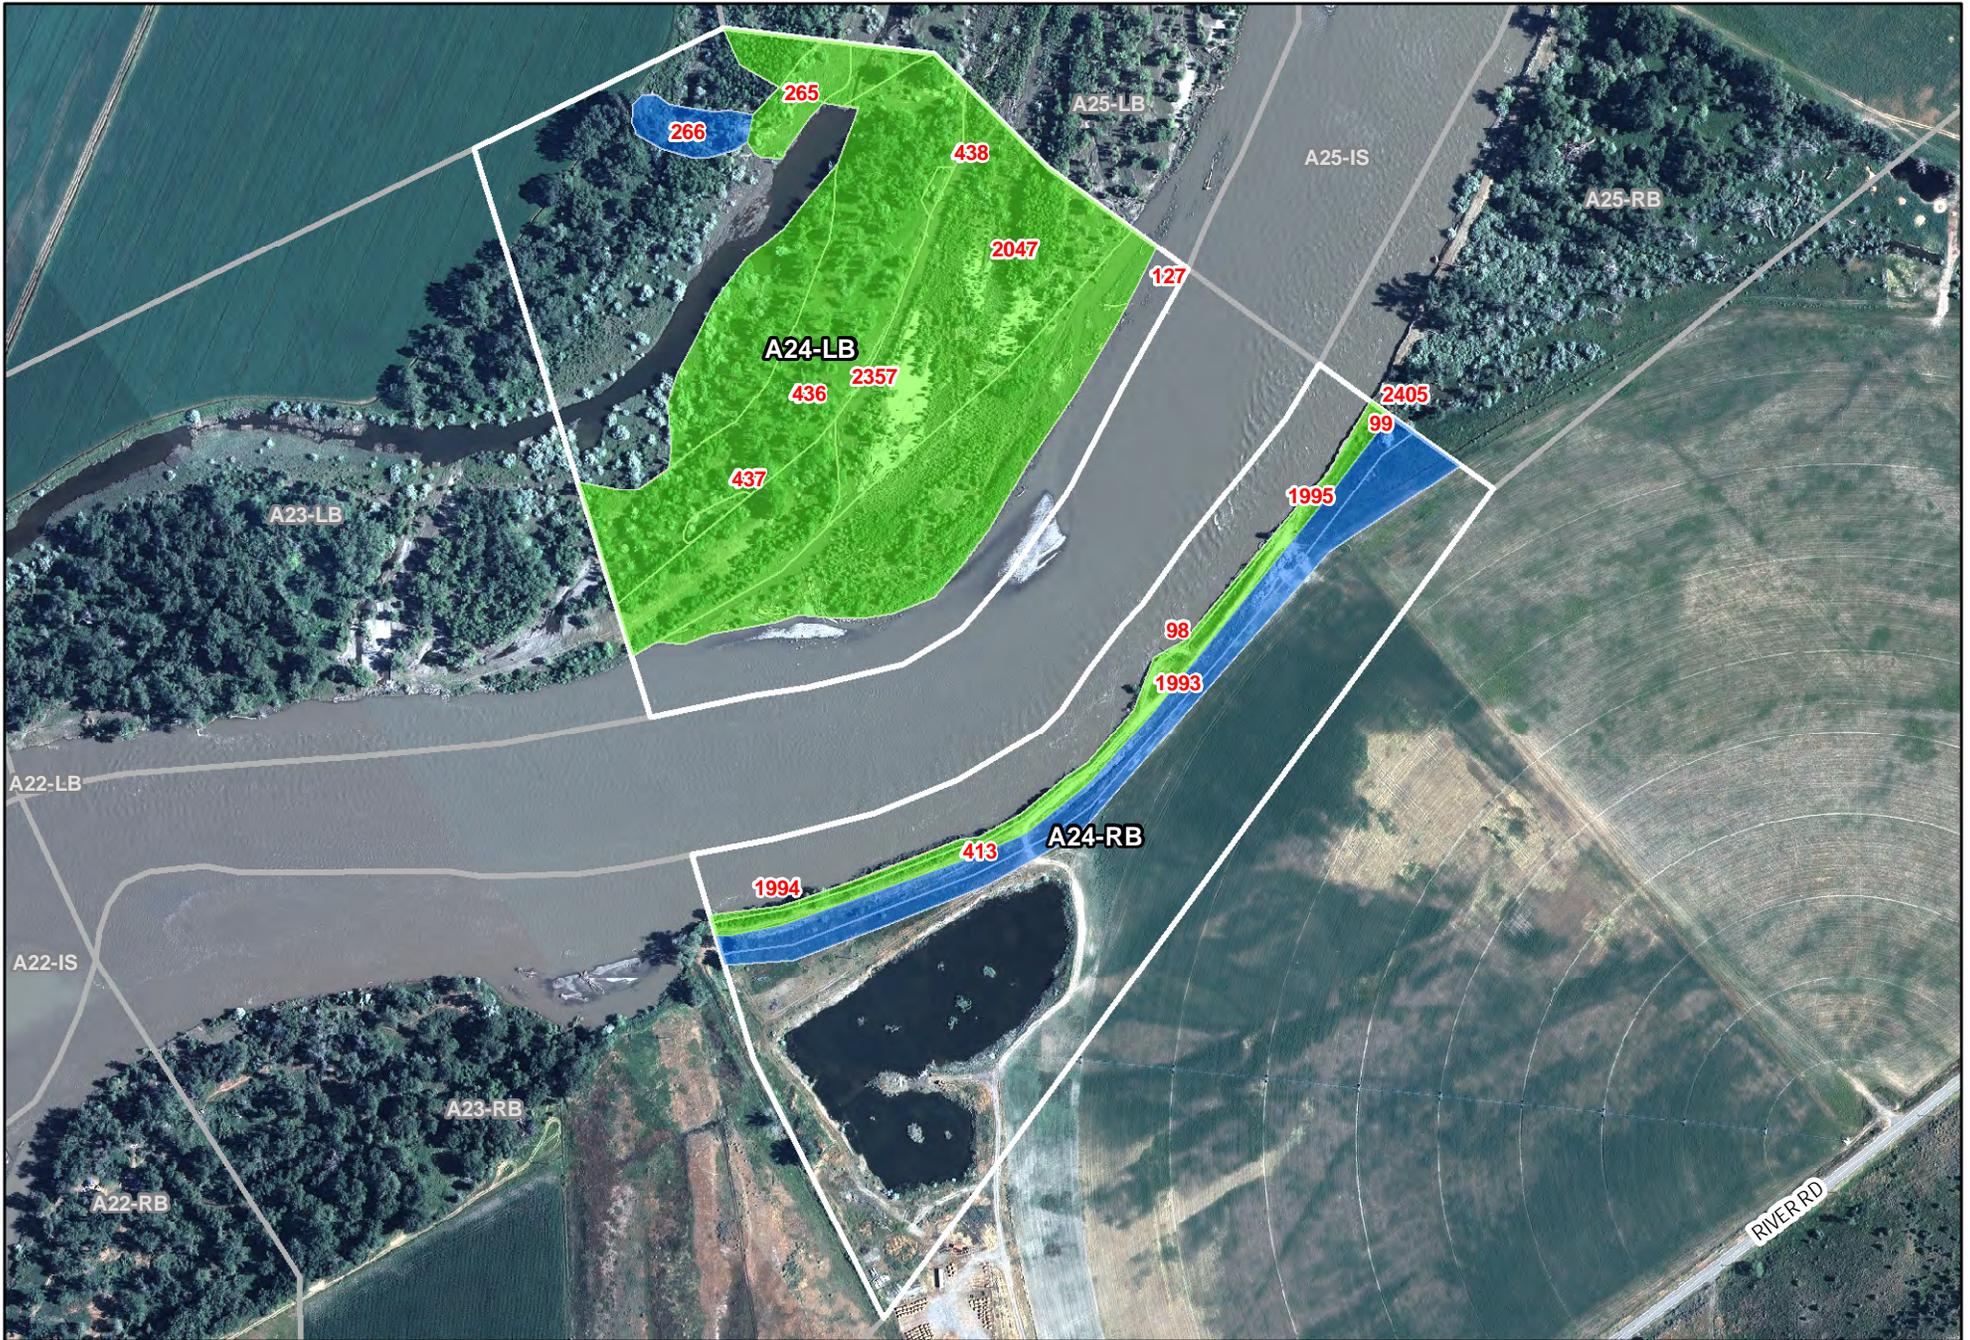
**Figure 5 - Final SCAT Observations  
For SCAT Area: A24**

Figure 5 shows the oiling conditions within Area A24 following completion of oil removal activities. The SCAT team performed final surveys of the left and right banks within SCAT Area A24 to confirm the agreed-upon cleanup endpoints identified in the applicable CTRs had been achieved. The final SCAT survey documentation is presented in Appendix E.

Based on the final SCAT surveys performed on the left and right banks within Area A24, no further treatment is recommended for these segments. SCAT Segment Sign-Off Forms are included as Appendix F.

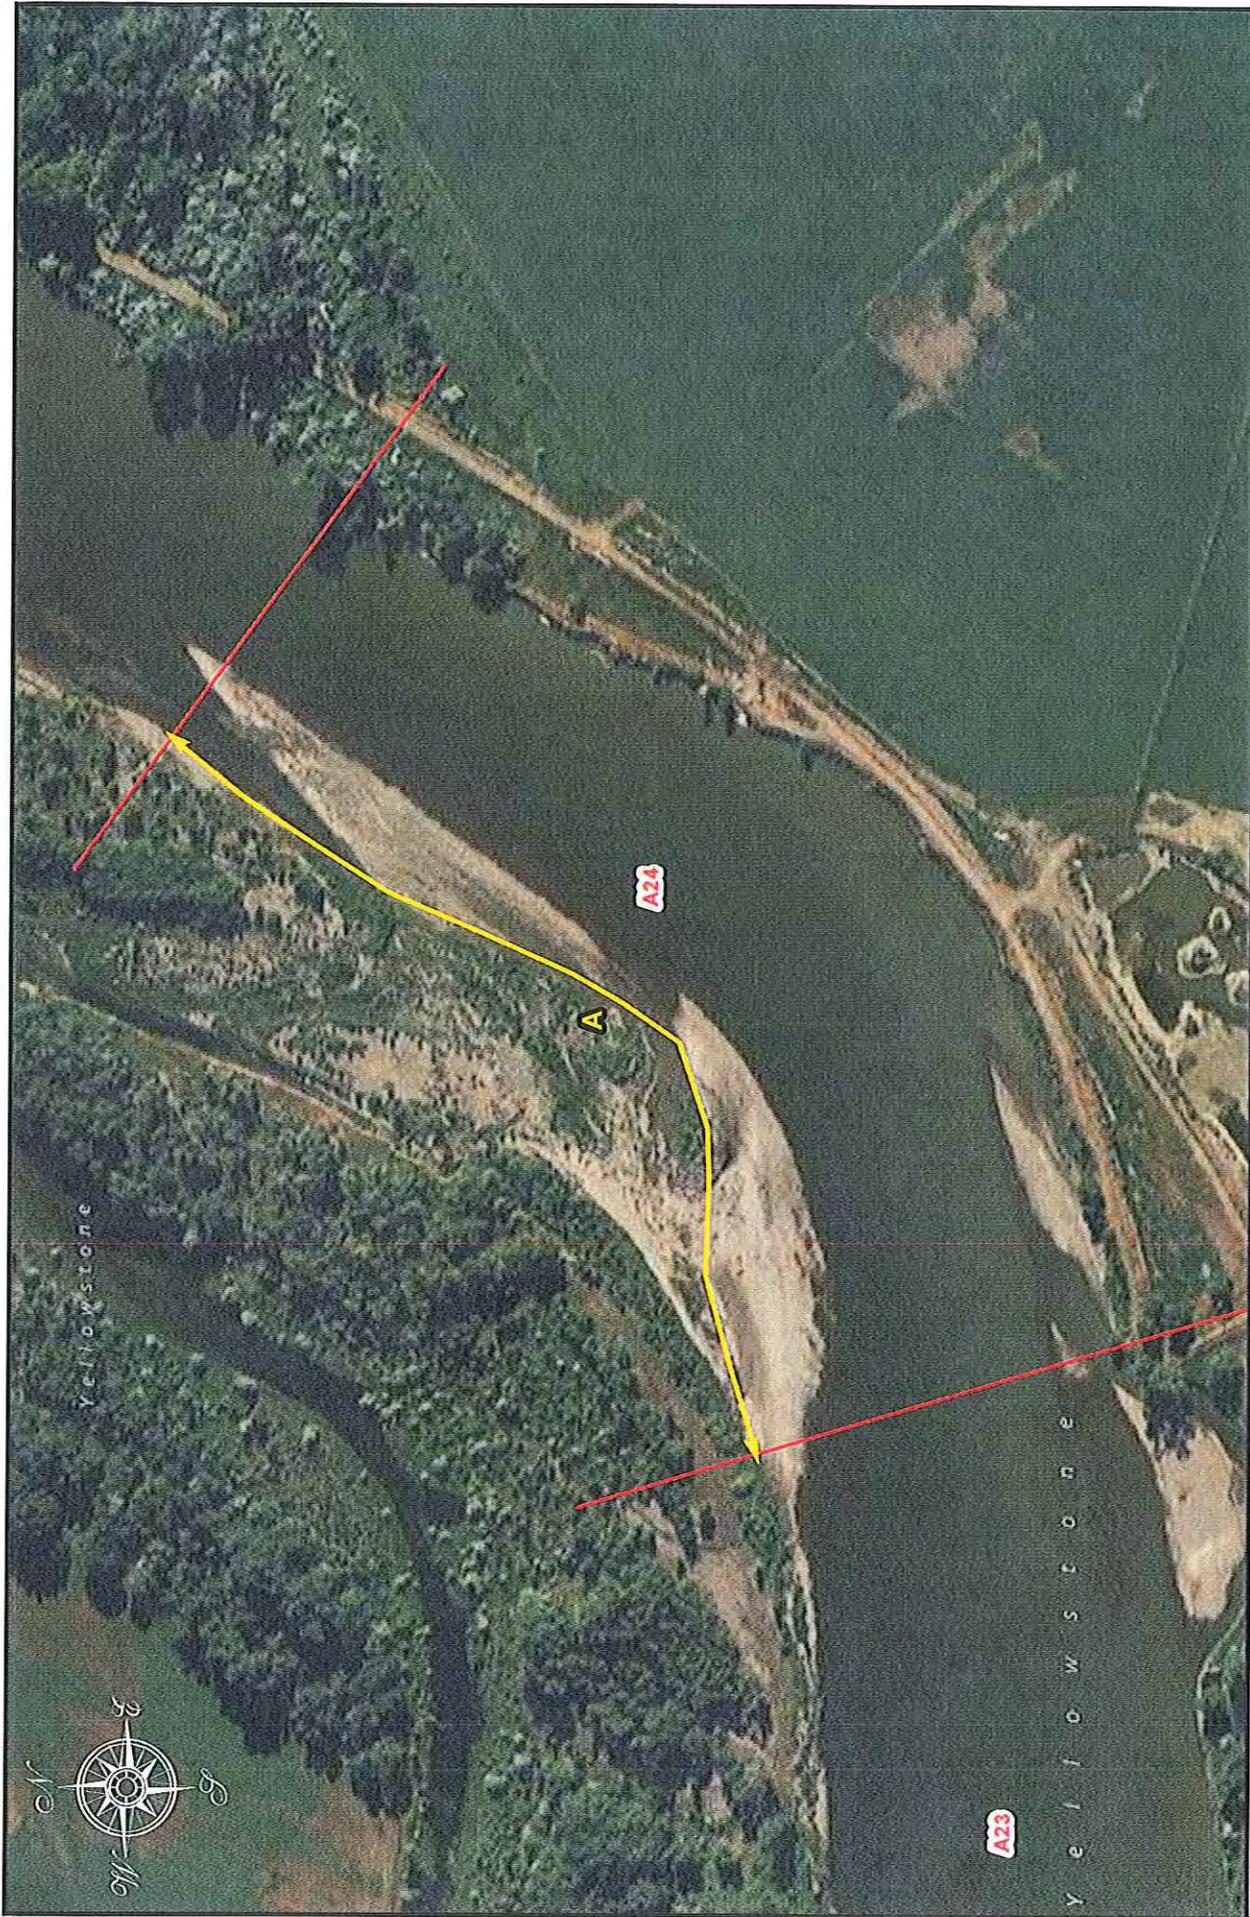
**SCAT Teams 2 & 4 Survey**  
Segment A24 Left Bank  
11-Jul-2011

OIL ZONE ID	RIVER BANK ZONE				OIL COVER			OIL THICKNESS					OIL CHARACTER								SUBST. TYPE(S)	
	MS	LB	UB	OB	Length m	Width m	Distrib. %	TO	CV	CT	ST	FL	FR	MS	TB	PT	TC	SR	AP	NO		
A			<u>X</u>	X	489	1	70			<u>X</u>	X		X									Grass, trees, debris

Oiled Band Heights: Zone A - 40cm

Due to survey platform (jet-drive boat) oil band width and heights are estimates. Unable to verify by foot.

Cleanup Recommendations: Trim oiled vegetation; wipe large oiled debris; remove small oiled debris; wipe oiled trees;

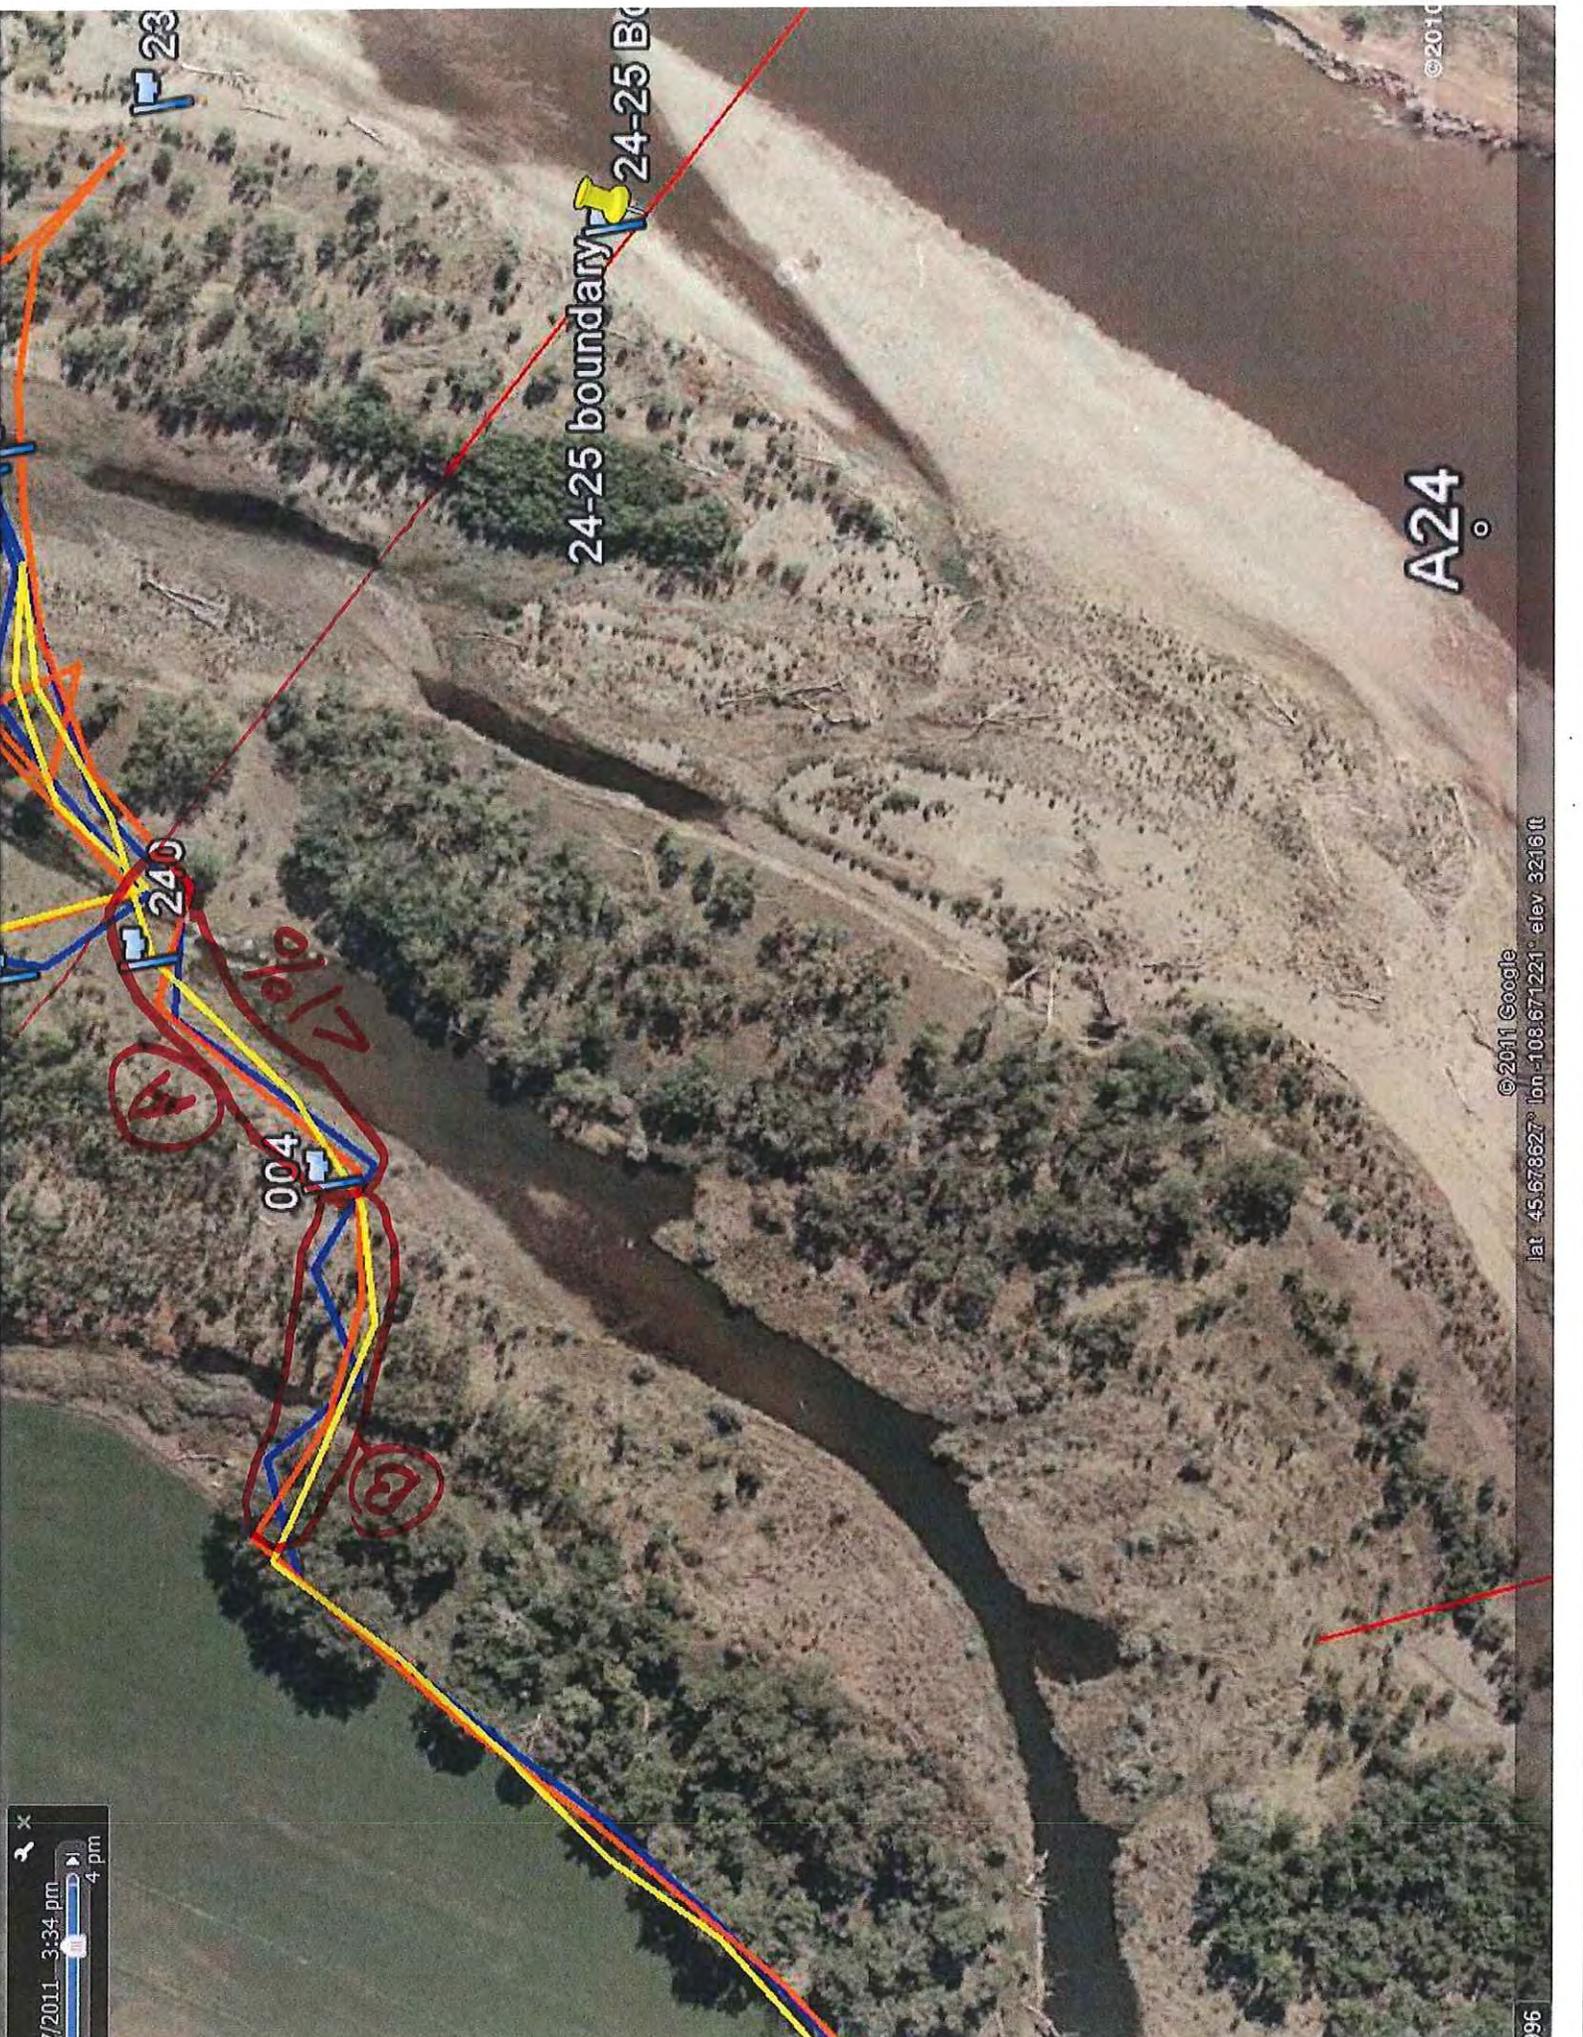
OIL ZONE ID	RIVER BANK ZONE				OIL COVER			OIL THICKNESS								OIL CHARACTER								SUBST. TYPE(S)
	MS	LB	UB	OB	Length m	Width m	Distrib. %	TO	CV	CT	ST	FL	FR	MS	TB	PT	TC	SR	AP	NO				
A				X	90	20	<1			X	X		X									veg		
B				X	100	20	0														X	veg

A - flood plain area with occasional oiled debris & small spots of oil on tree leaves/branches & grasses.

No treatment required.

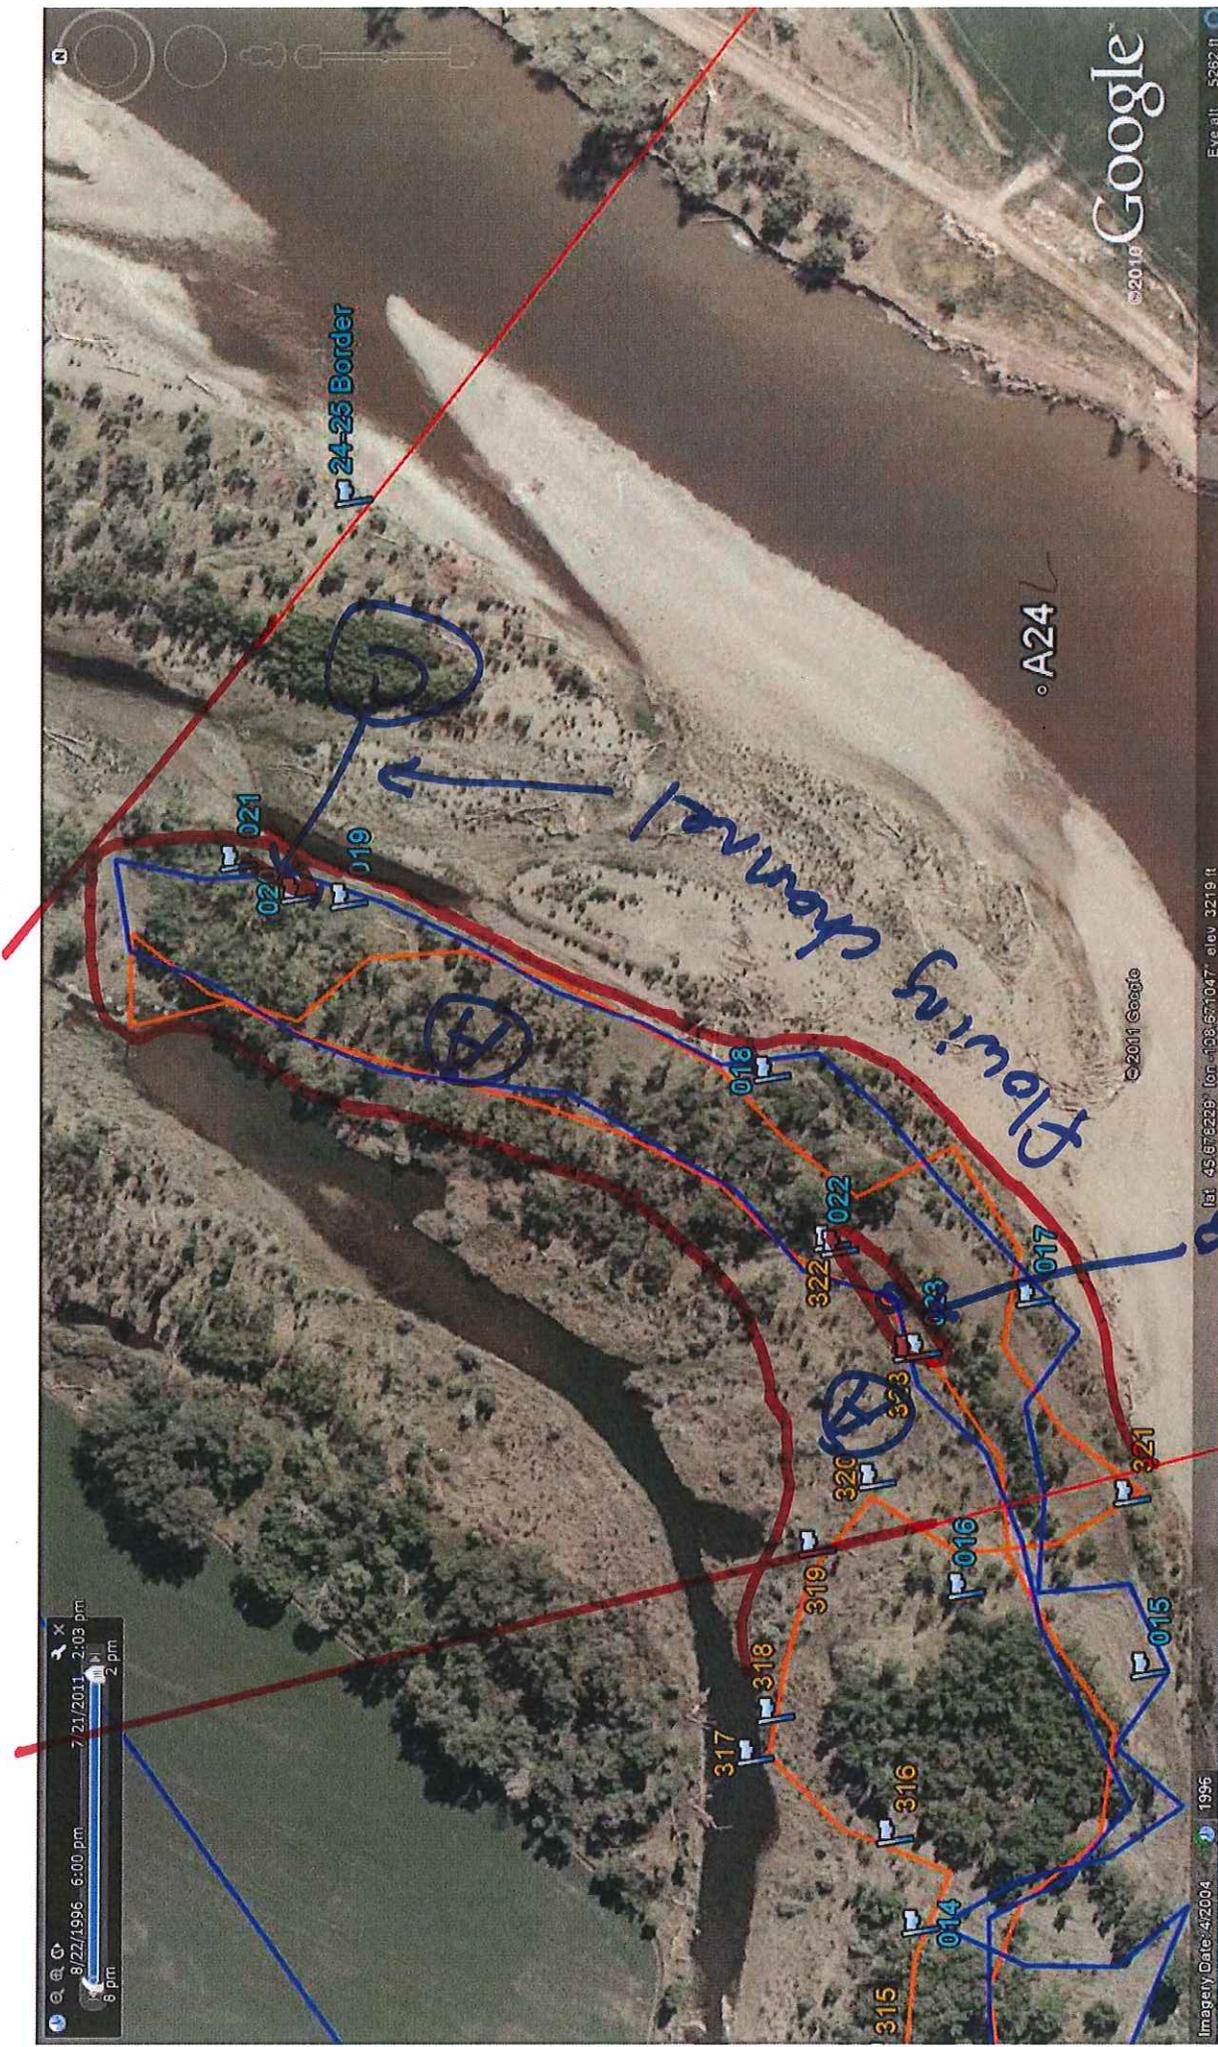
SCAT #3 A24L 21 July 2011

C - brown stain on grass to fatty coating in a small area on channel bank - (wp 20-21) - No treatment recommended
