**SCAT Area Transition Report  
for A24**

Silvertip Pipeline Incident  
Laurel, Montana

October 22, 2011

Prepared for:  
ExxonMobil Pipeline Company

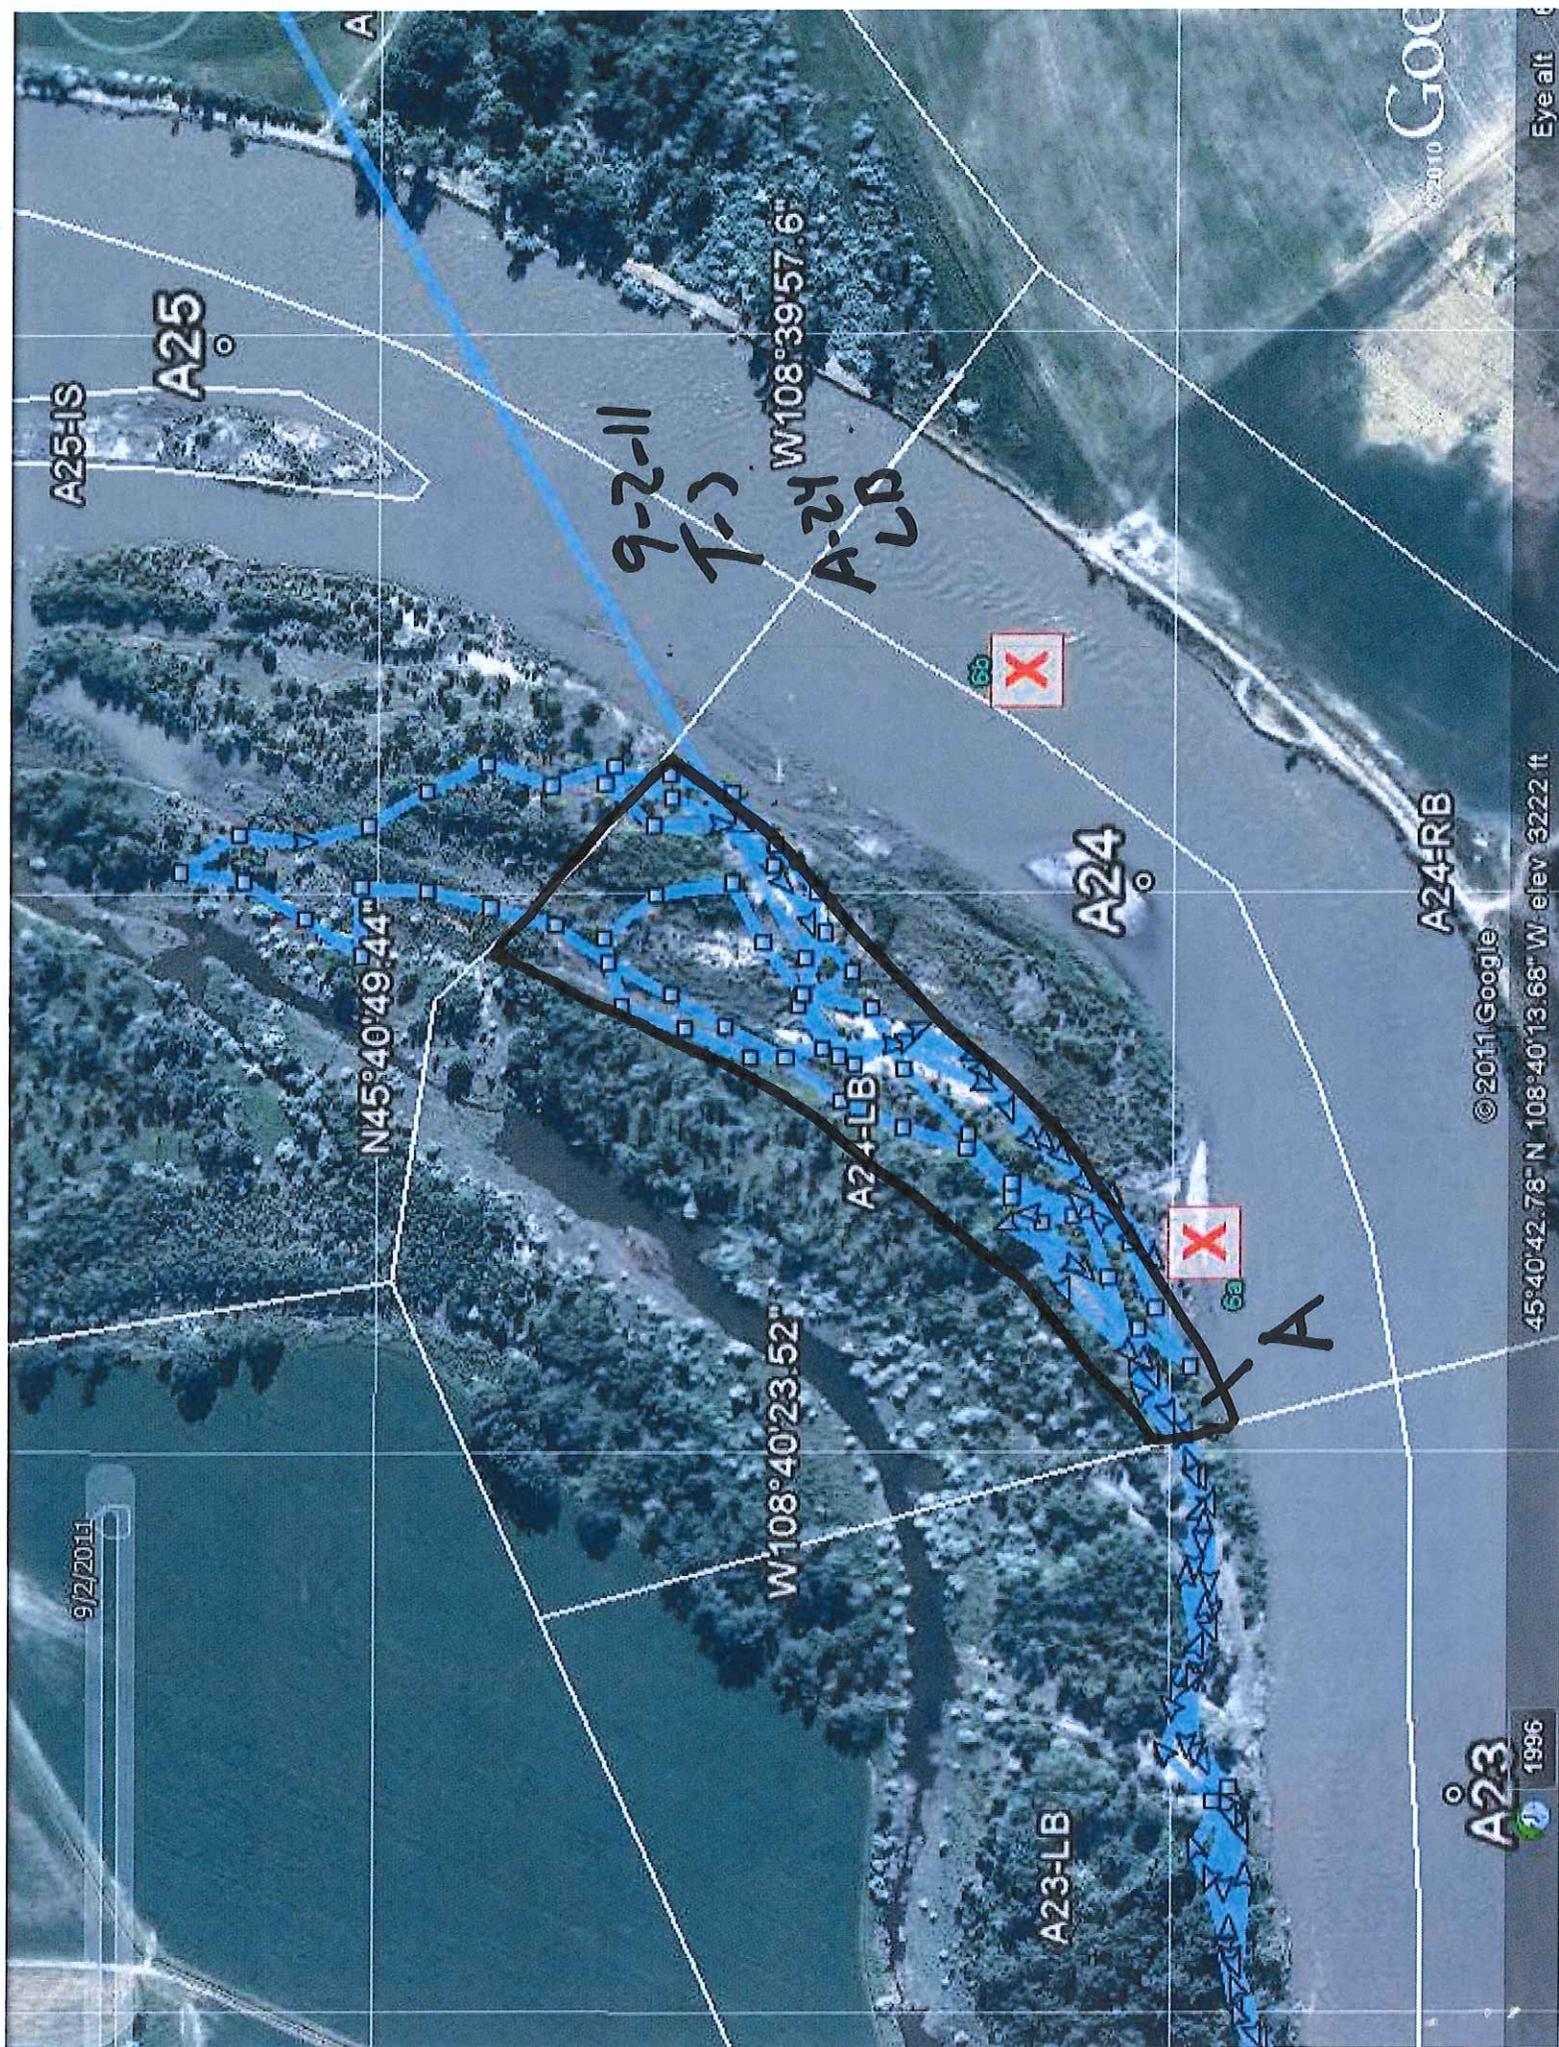
A-24  
LD

9-2-11  
T.S.

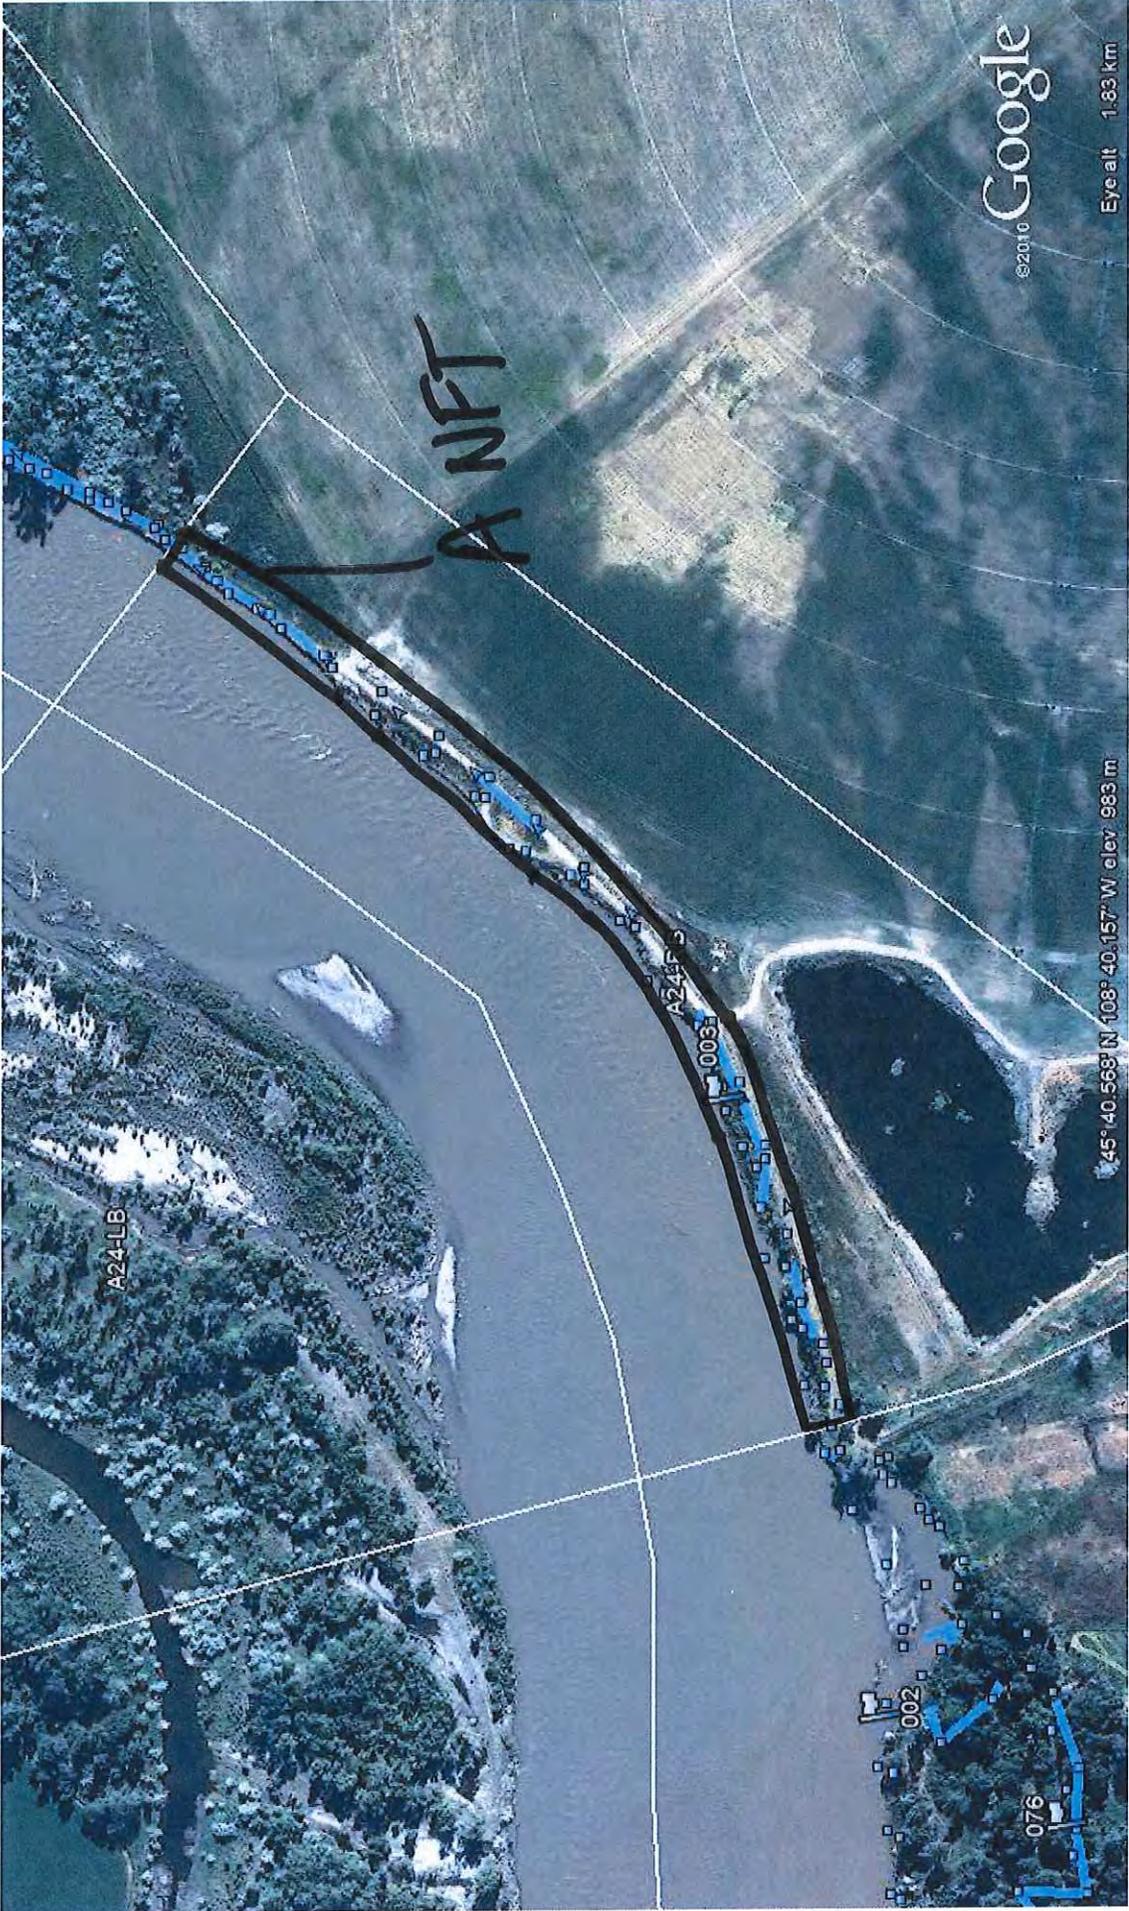
A24 RB  
T3 9/27/11

Treatment recommendations:  
 Zone A : Treated by Ops and Hot Shot crew ; No further  
 Zone : Treatment (NFT)
