**SCAT Area Transition Report  
for A26**

Silvertip Pipeline Incident  
Laurel, Montana

October 28, 2011

Prepared for:  
ExxonMobil Pipeline Company

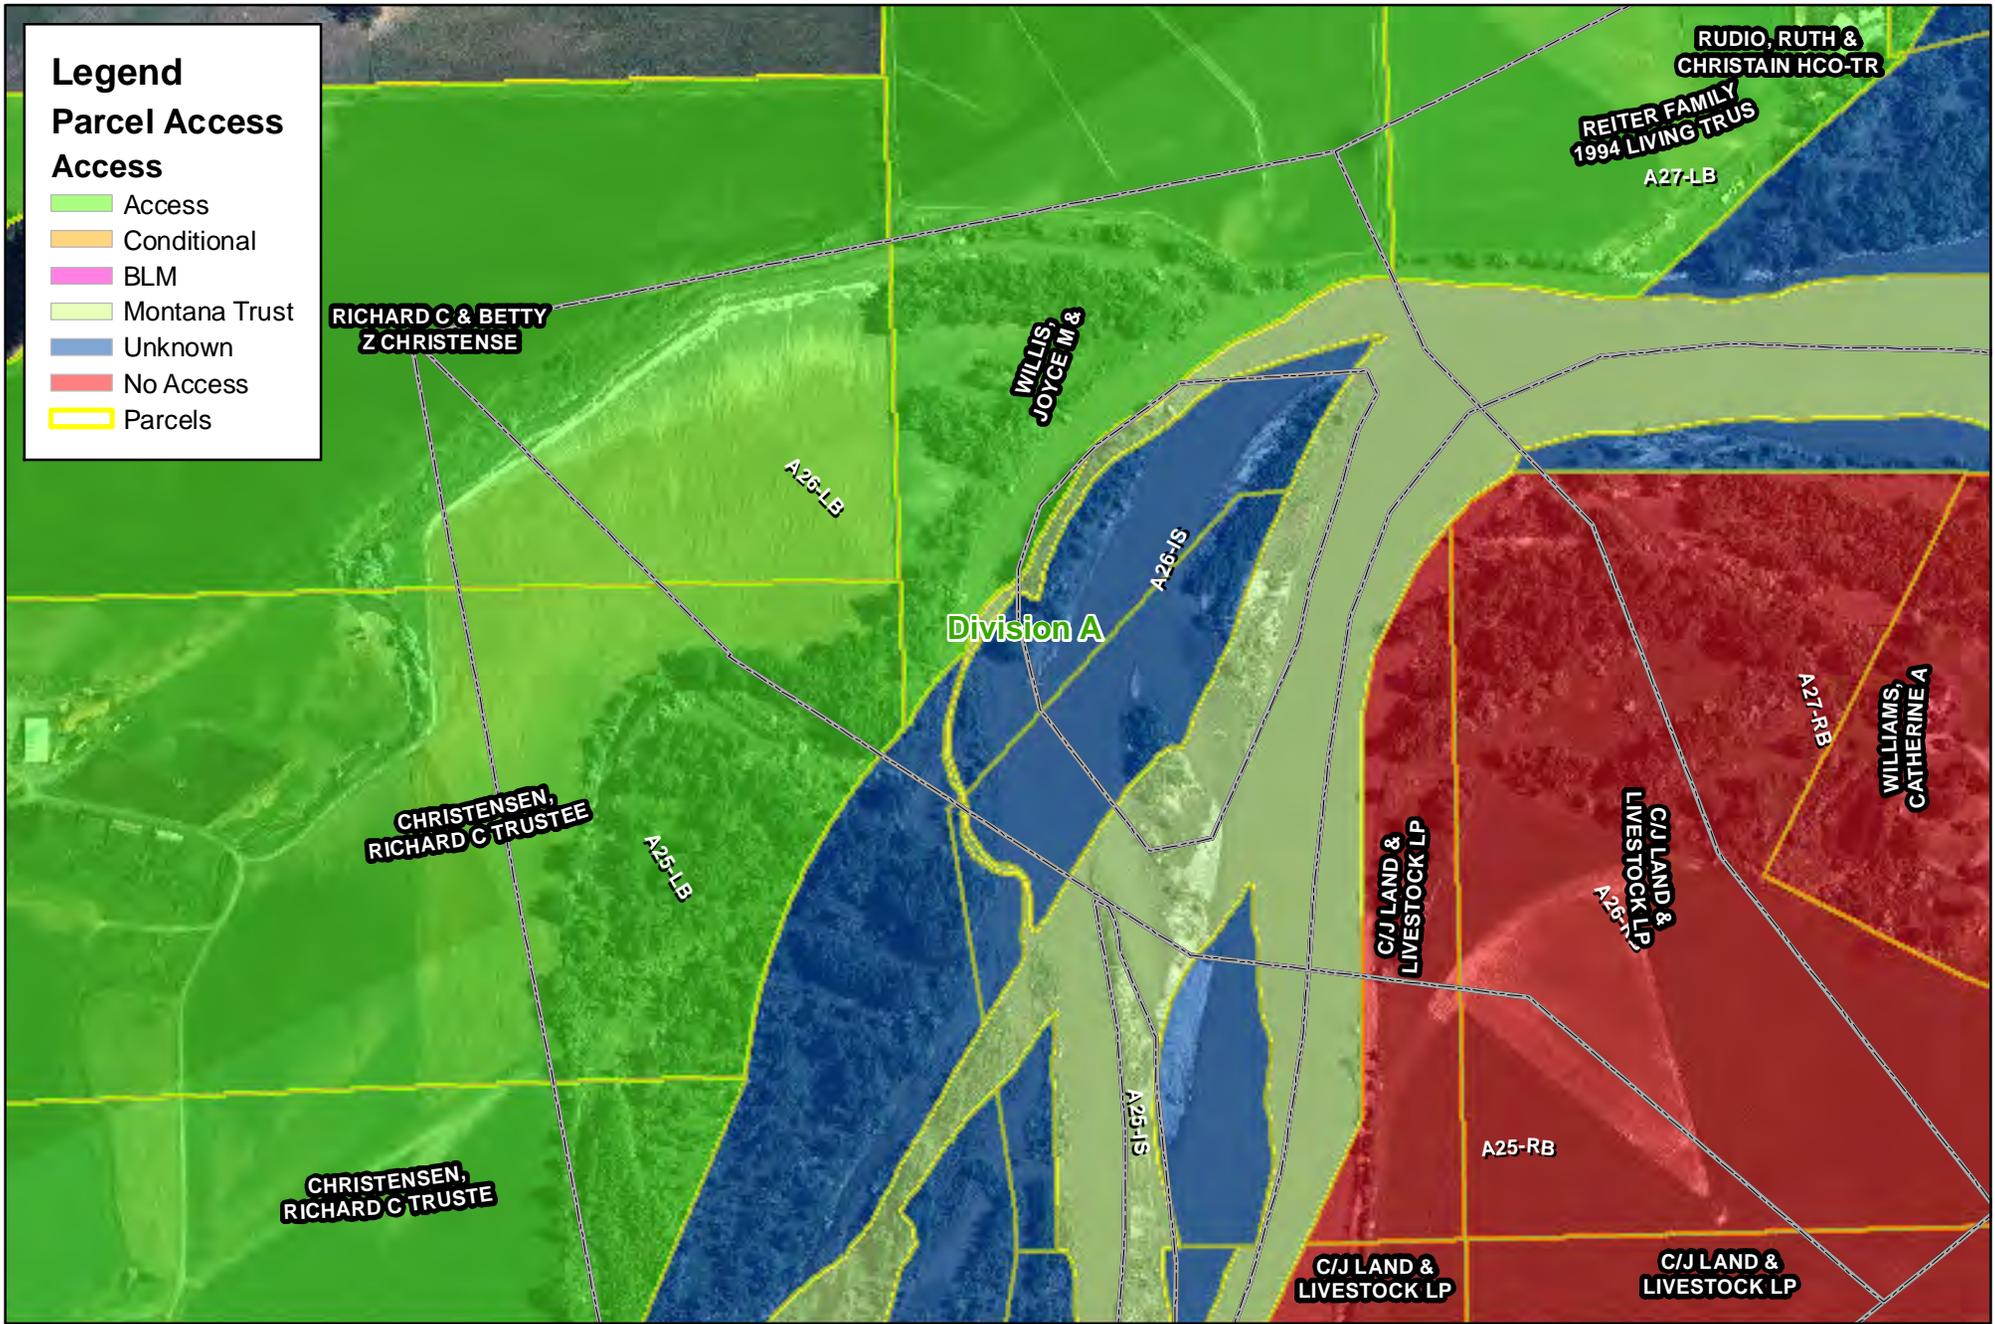
Figure 1 provides an aerial map of SCAT Area A26, along with the (a) SCAT Area boundary, (b) parcel boundaries and respective property owners, and (c) access constraints identified during the oil cleanup process. The acreage surveyed in Area A26 is 83.6. There was an access issue for the right bank but access was granted for SCAT, operations, and SCAT reassessment at scheduled times.

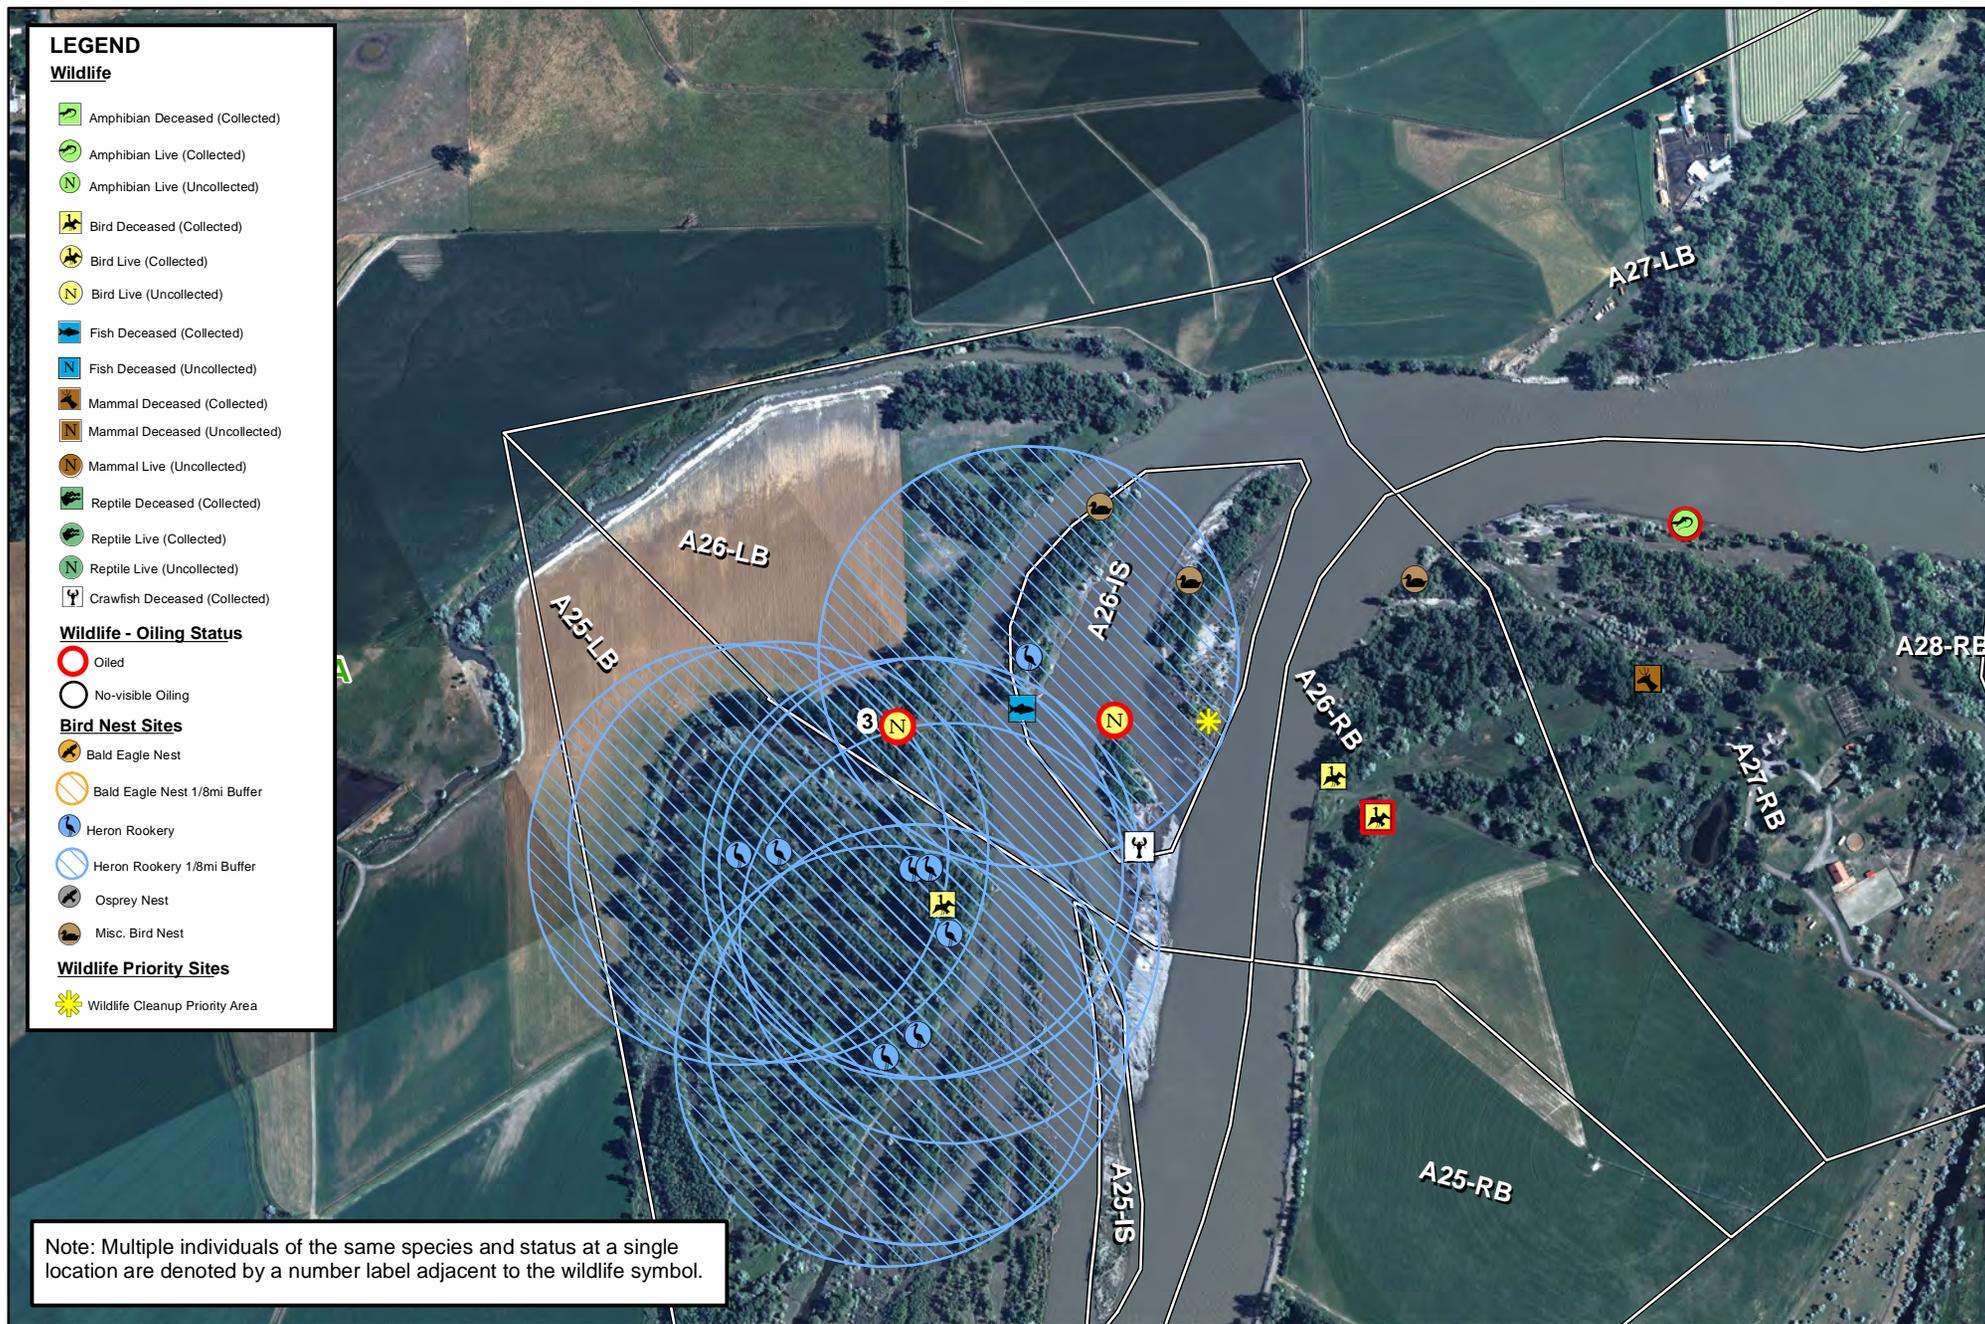
**Figure 2**  
**Wildlife Resources**

Figure 2 summarizes the natural resources identified in this segment. International Bird Rescue and Resource Advisors from U.S. Fish and Wildlife Service conducted regular inspections of Area A26. Three lightly oiled wood ducks (*Aix sponsa*) (a pair and a solitary male) and a lightly oiled Canada goose (*Branta canadensis*) were observed; none were captured and cleaned. A moderately oiled deceased wild turkey (*Meleagris gallopavo*) was identified and retained. Three deceased animals with no visible oiling were also identified and retained: a fish (unknown species), a crayfish, and a wild turkey. A Wildlife Priority Cleanup Area (WPCA) was identified in Area A26. The WPCA consisted of woody debris and vegetation with transferable oil. The WPCA was treated to reduce the potential for wildlife oiling and is no longer considered a wildlife hazard. A portion of a great blue heron (*Ardea herodias*) rookery is located in Area A26, and a  $\frac{1}{8}$ -mile buffer zone was provided to Operations to protect active nests.

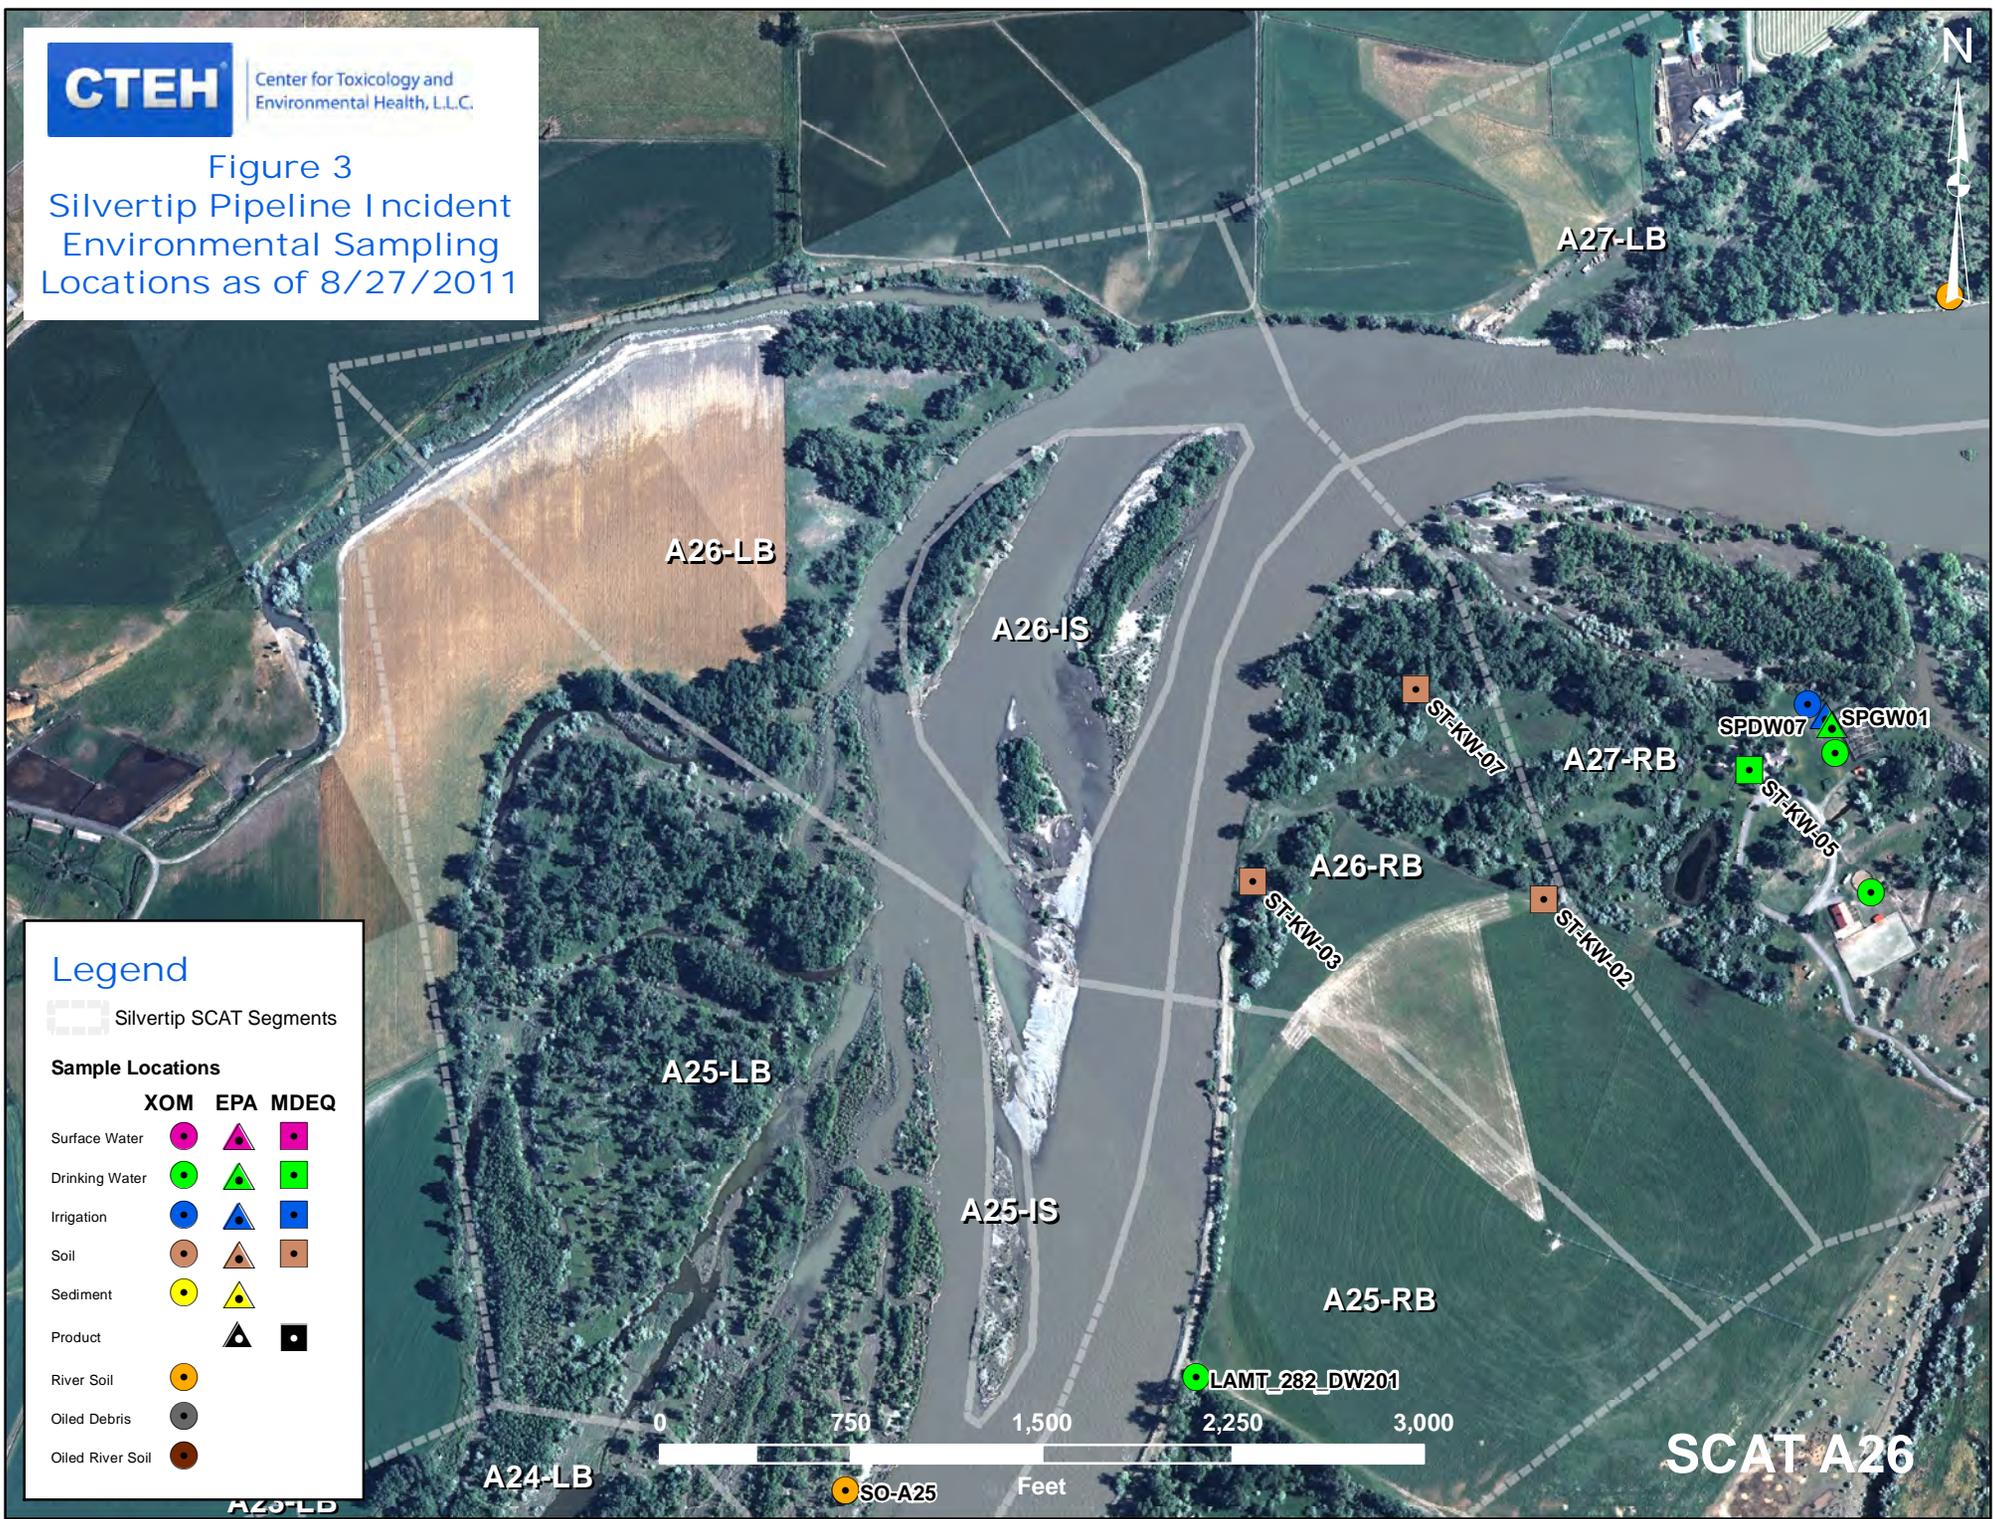
Figure 3  
 Silvertip Pipeline Incident  
 Environmental Sampling  
 Locations as of 8/27/2011

Table 1 (below) summarizes samples collected within Area A26. The analytical results for the samples collected can be accessed through a publicly accessible database on the United States Environmental Protection Agency’s (USEPA’s) website. The approximate locations of samples collected within Area A26 are provided on Figure 3.

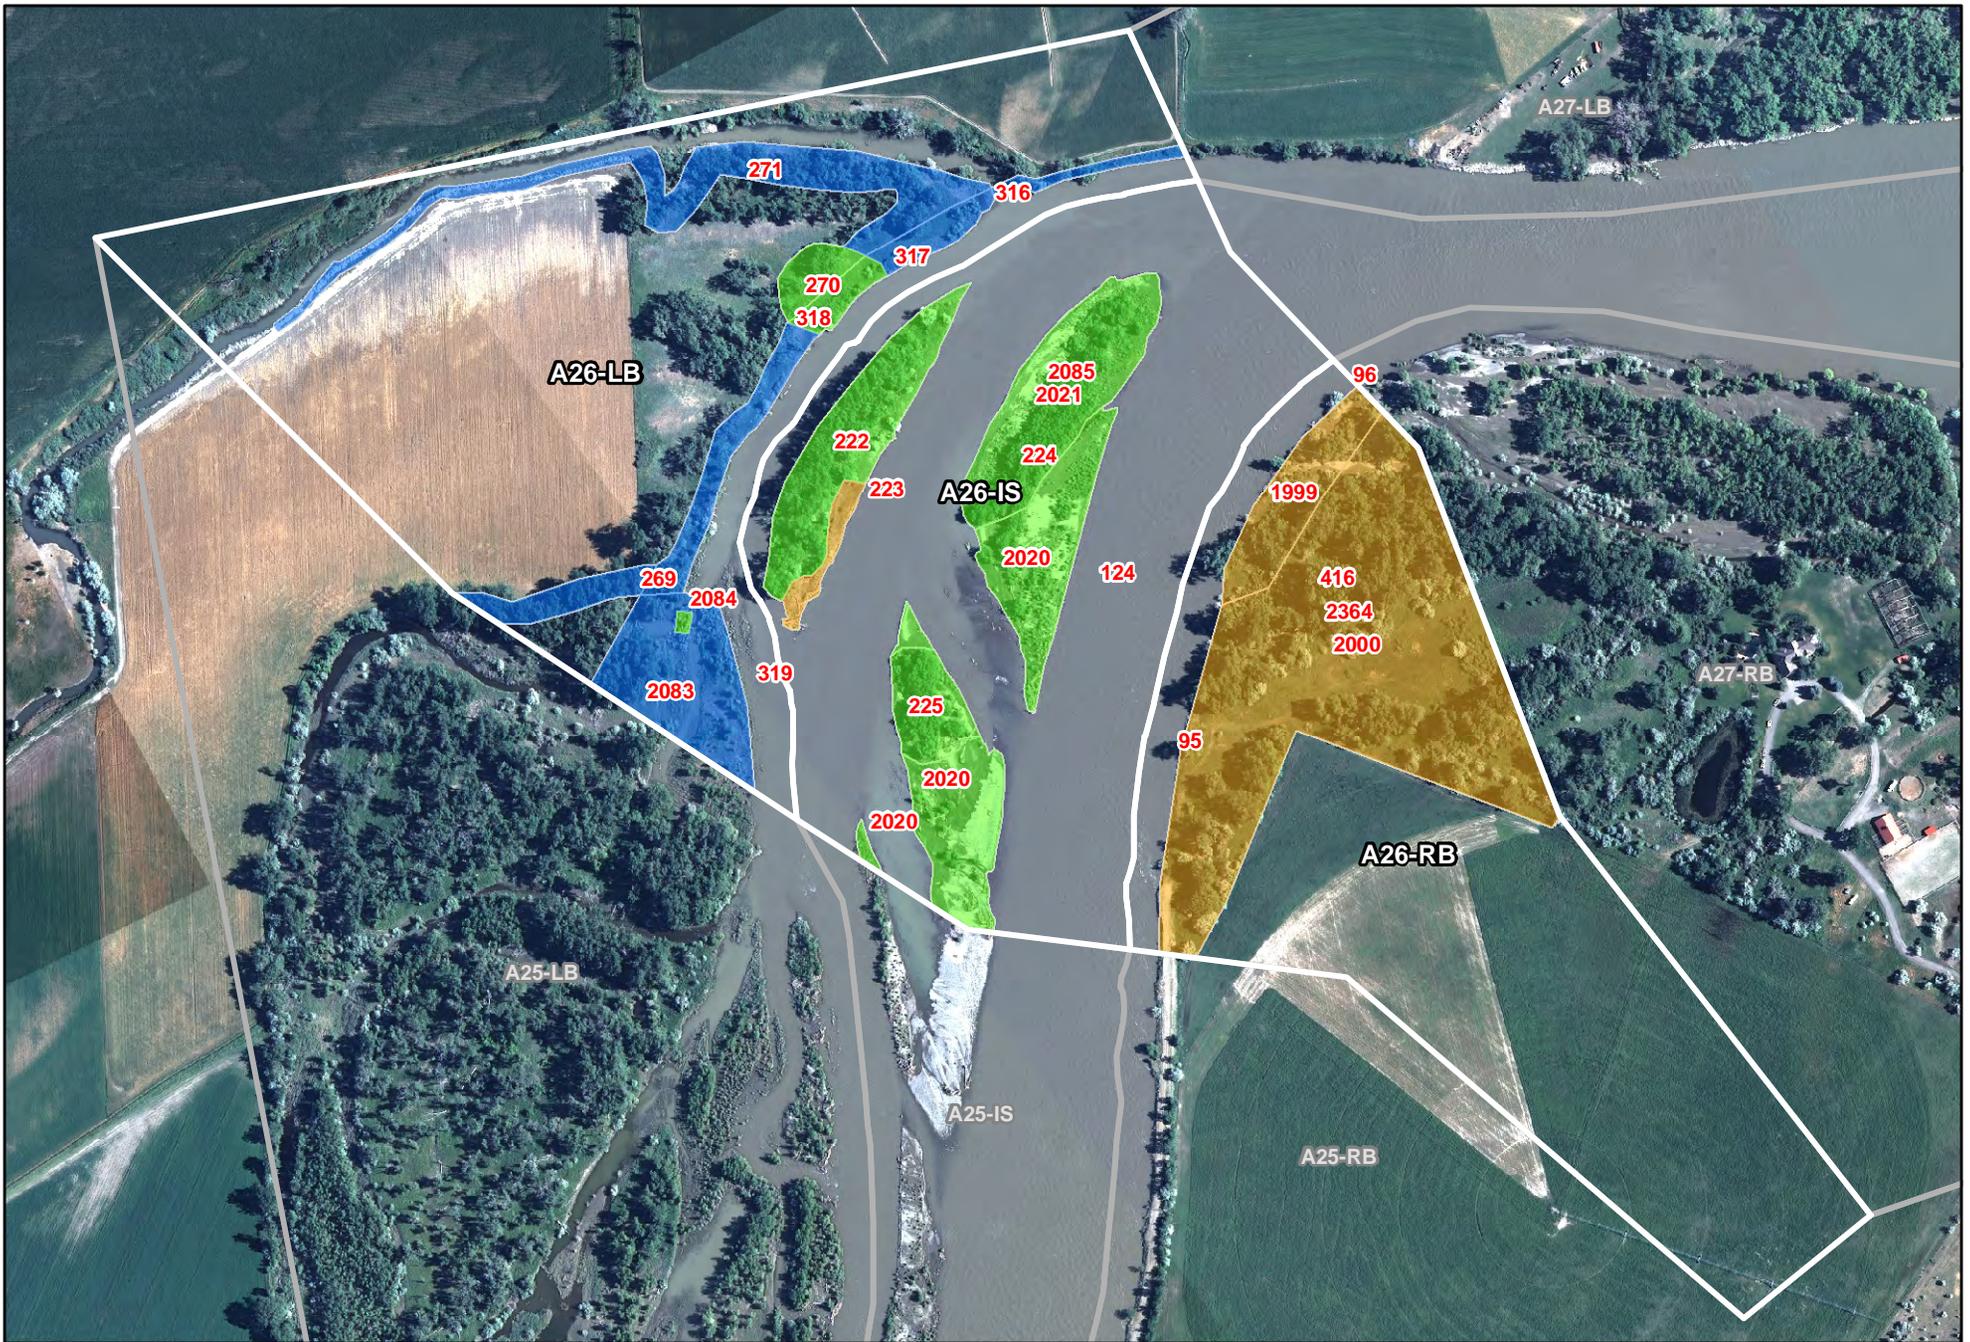
The SCAT teams used systematic evaluation criteria and treatment method tables approved by the National Oceanic and Atmospheric Administration to provide a standard approach for data collection and conducting field surveys. The forms and sketches from the initial SCAT surveys performed along the river bank (water edge) and floodplain within Area A26 are included in Appendix B. Figure 4 provides the maximum oiling zones observed by the SCAT team during the initial surveys of Area A26.

<p><b>9999</b> Oiling Zone ID  <b>Red</b> Heavy Oiling  <b>Yellow</b> Moderate Oiling</p>	<p><b>Light Green</b> Light Oiling  <b>Very Light Green</b> Very Light Oiling  <b>Blue</b> No Oil Observed</p>	<p><b>Figure 4 - Maximum SCAT Observations          For SCAT Area: <b>A26</b></b></p> <p>350 0 350 700          Feet</p>

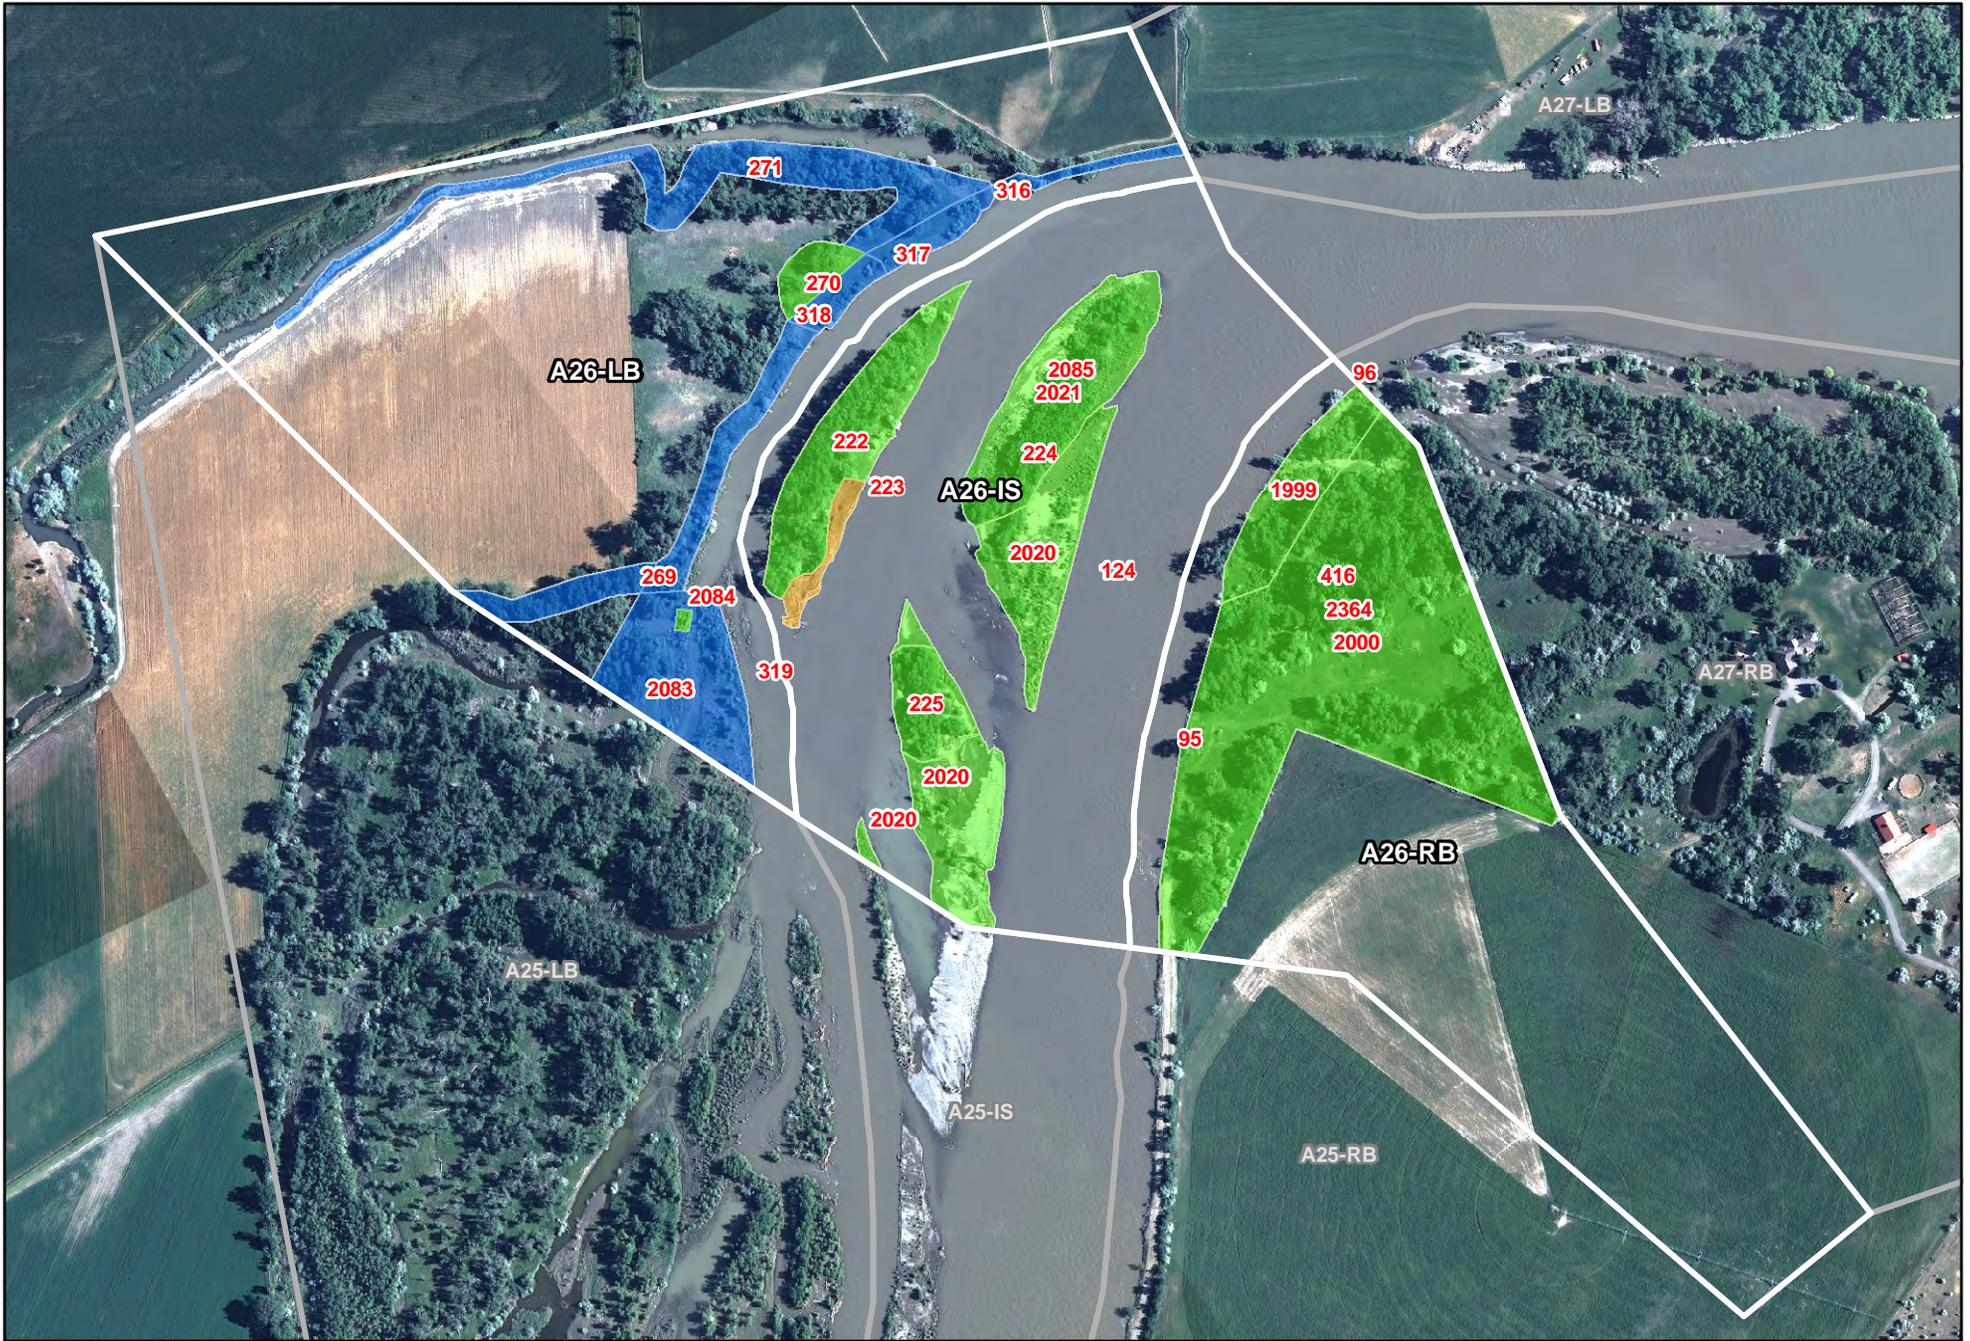
**Figure 5 - Final SCAT Observations  
For SCAT Area:**

Figure 5 shows the oiling conditions within Area A26 following completion of oil removal activities. The SCAT team performed final surveys of the islands, left bank, and right bank within SCAT Area A26 to confirm that the agreed-upon cleanup endpoints identified in the applicable CTRs had been achieved. The final SCAT survey documentation is presented in Appendix E.

Based on the final SCAT surveys performed on the islands, left bank, and right bank within Area A26, no further treatment is recommended for these segments. SCAT Segment Sign-Off Forms are included as Appendix F.

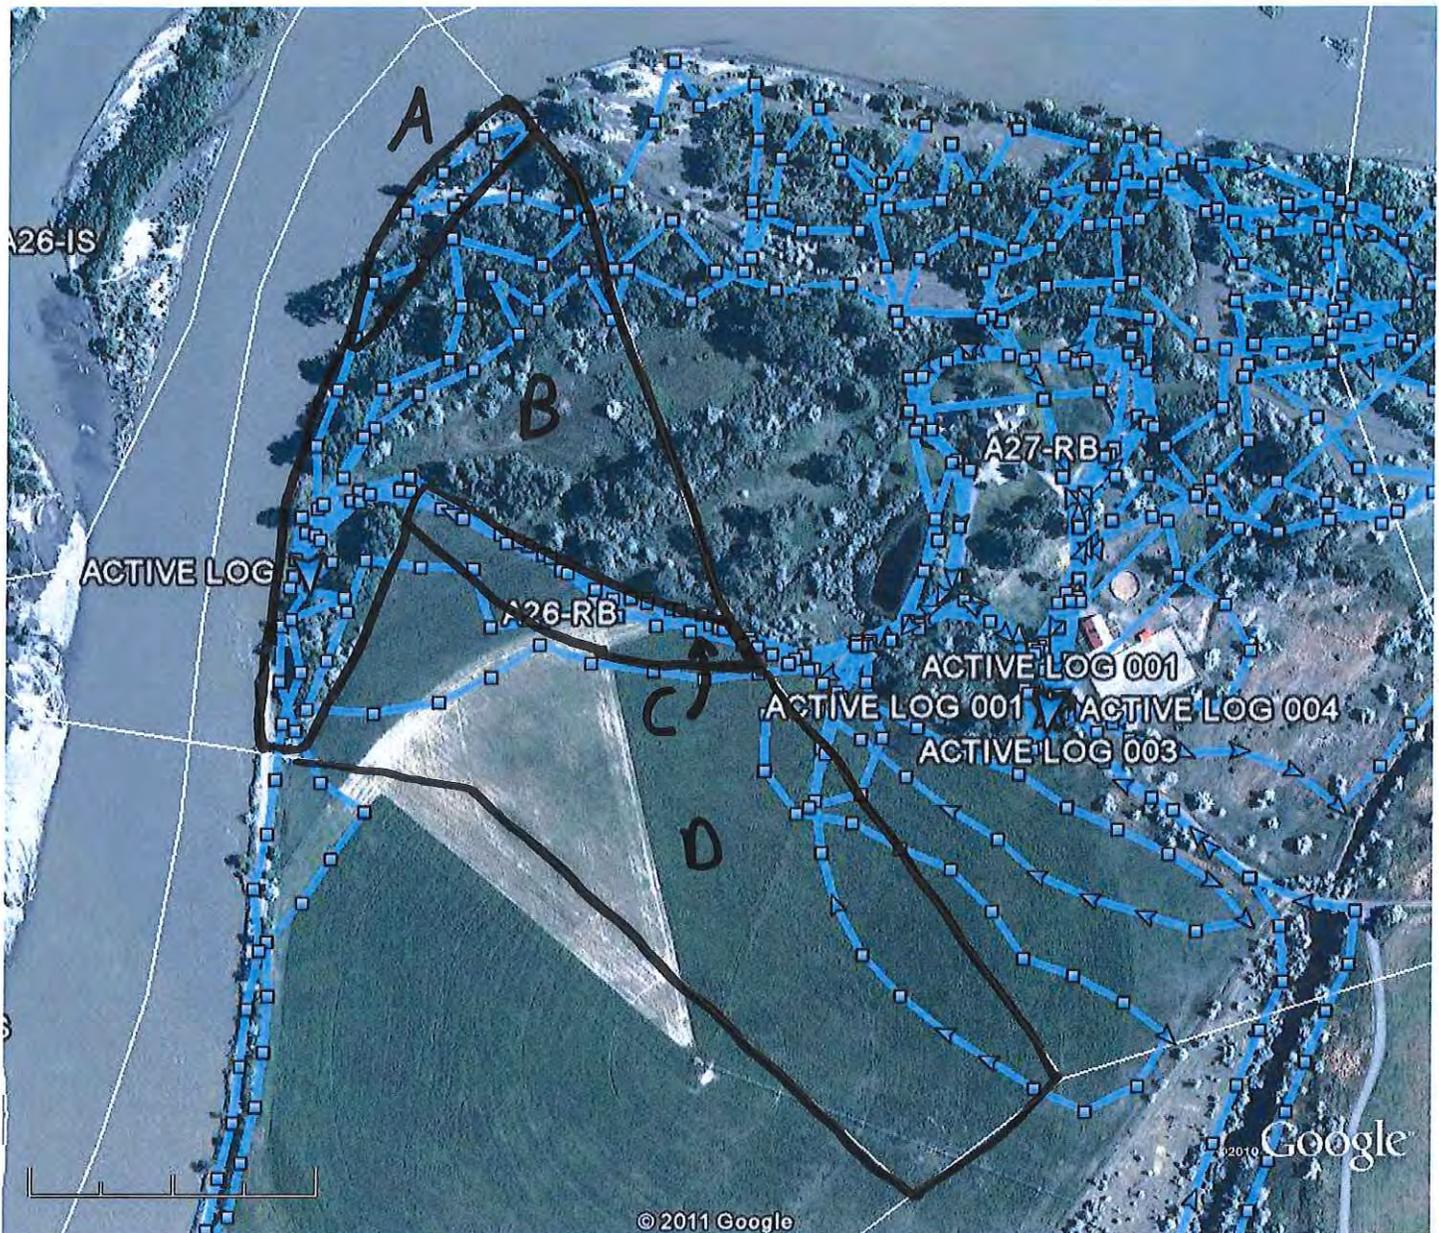
A26 RB  
9/1/11  
Team 2

Zone A: Area along bank with < 5% distribution of stains and coats, tar consistency, slightly transferable. ATM #1 and ATM #2

Zone B: Overbank area with 5 to 10% distribution of stains and coats, tar consistency, slightly transferable. ATM #1 and ATM #2.

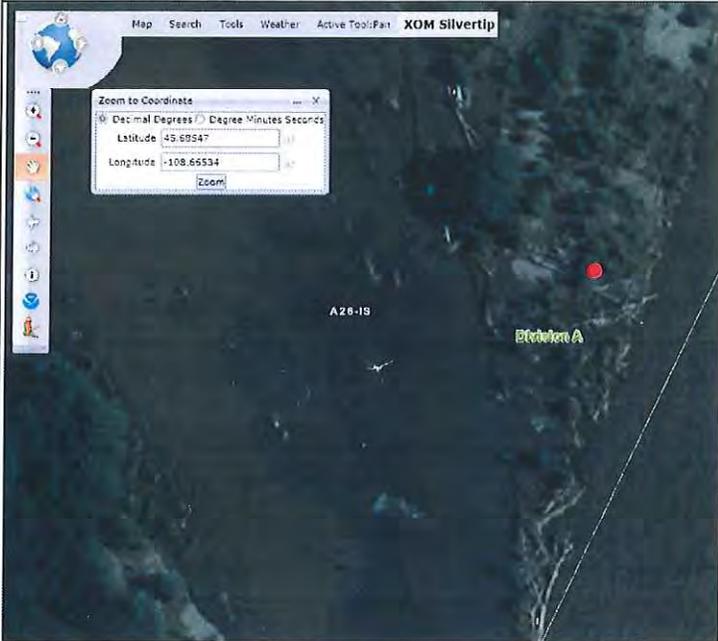
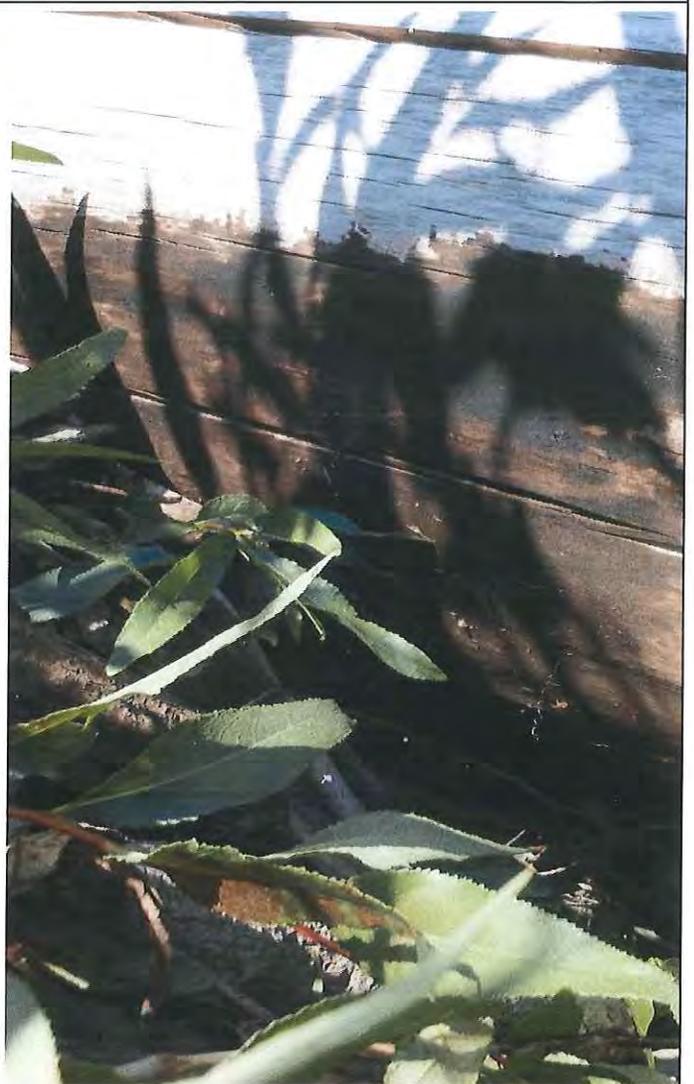
**MESSAGE:** International Bird Rescue and Resource Advisors with the USFWS identified a large fallen tree partially covered with oil. Concern for oil dripping into clay covered basin located underneath that may result in wildlife exposure after the next rain event. This segment has passed SCAT but requires further response to reduce wildlife exposure risks. This area is a moderate priority. The location of the tree is N45.68547 by W 108.66534. Also on this island, but listed a low priority, was a stand of approximately 20 trees that have oil rings that are still transferable. These trees appear to have been treated but not stabilized with "DUST." The location of the grove of trees is N 45.68678 by W 108. 66493. When crews are on this island they might want to check this area as well.

The Unified Command is aware of this area within SCAT Segment A-26 IS. ExxonMobil will coordinate any future remediation activities at this site with MTDEQ. In the meantime, this segment will be flagged and noted in the close-out segment report. If the work is not completed and signed off by the Wildlife Branch prior to closeout. Then this document will be included as an attachment to the Area Transition Report to document the need for additional work within this segment, and this report will be updated to document that the exception was addressed and no further follow-up will be needed.
