**SCAT Area Transition Report
for A27**

Silvertip Pipeline Incident
Laurel, Montana

October 19, 2011

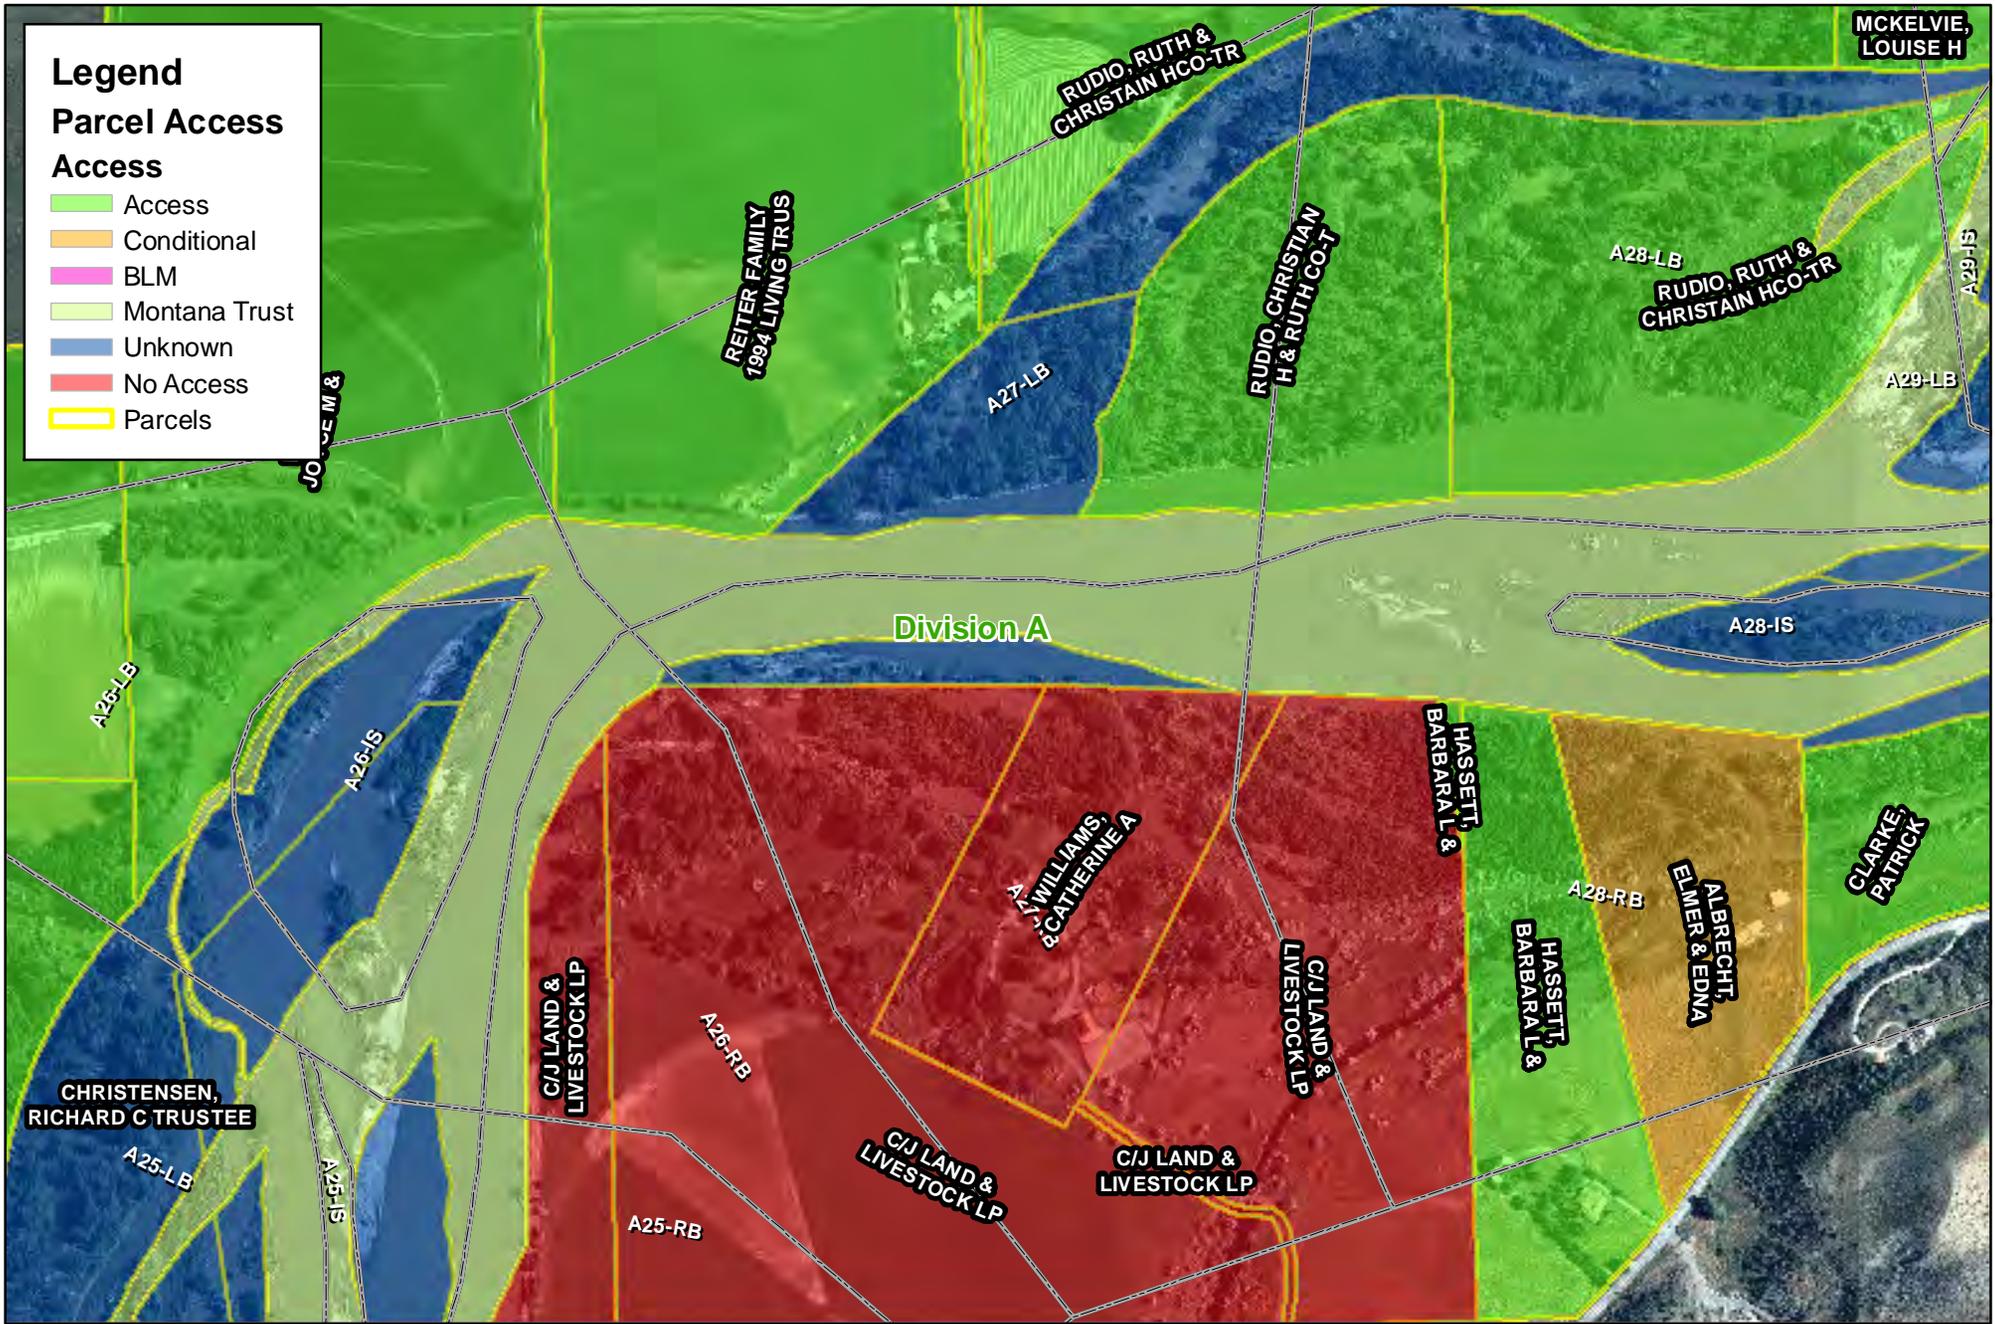
Figure 1 provides an aerial map of SCAT Area A27, along with the (a) SCAT Area boundary, (b) parcel boundaries and respective property owners, and (c) access constraints identified during the oil cleanup process. The acreage surveyed in Area A27 is 85.9. There were access issues for most of the right bank.

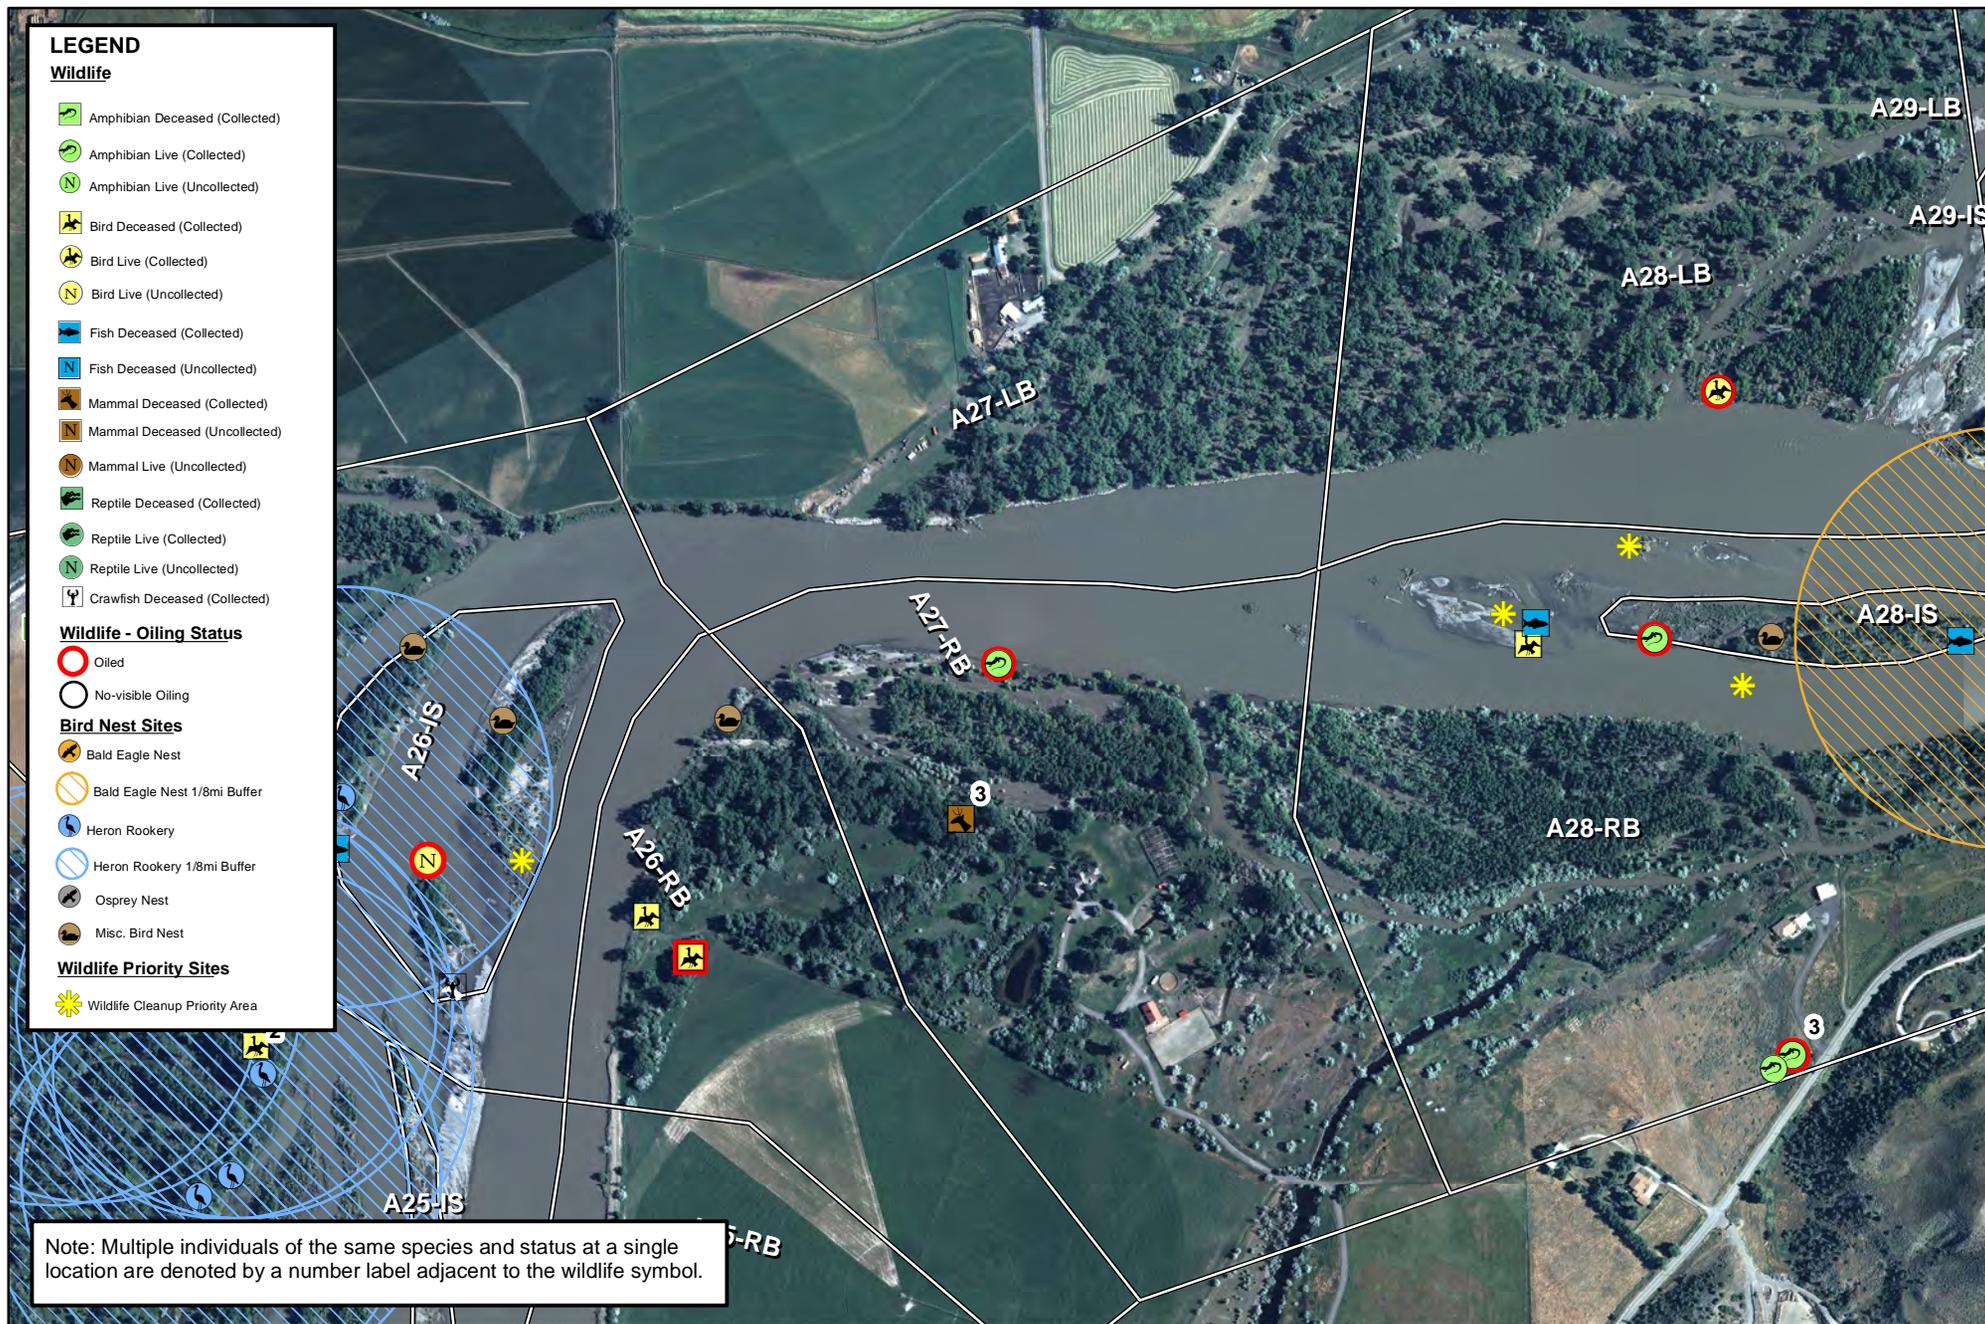
Figure 2
Wildlife Resources

Figure 2 summarizes the natural resources identified in this segment. International Bird Rescue and Resource Advisors from U.S. Fish and Wildlife Service conducted regular inspections of Area A27. A lightly oiled Leopard frog (*Rana pipiens*) was captured, cleaned, and released. Three deceased Red Fox squirrels (*Sciurus niger*) with no visible oiling were identified and retained. No Wildlife Priority Cleanup Areas were identified. No active migratory bird nests were identified in Area A27.

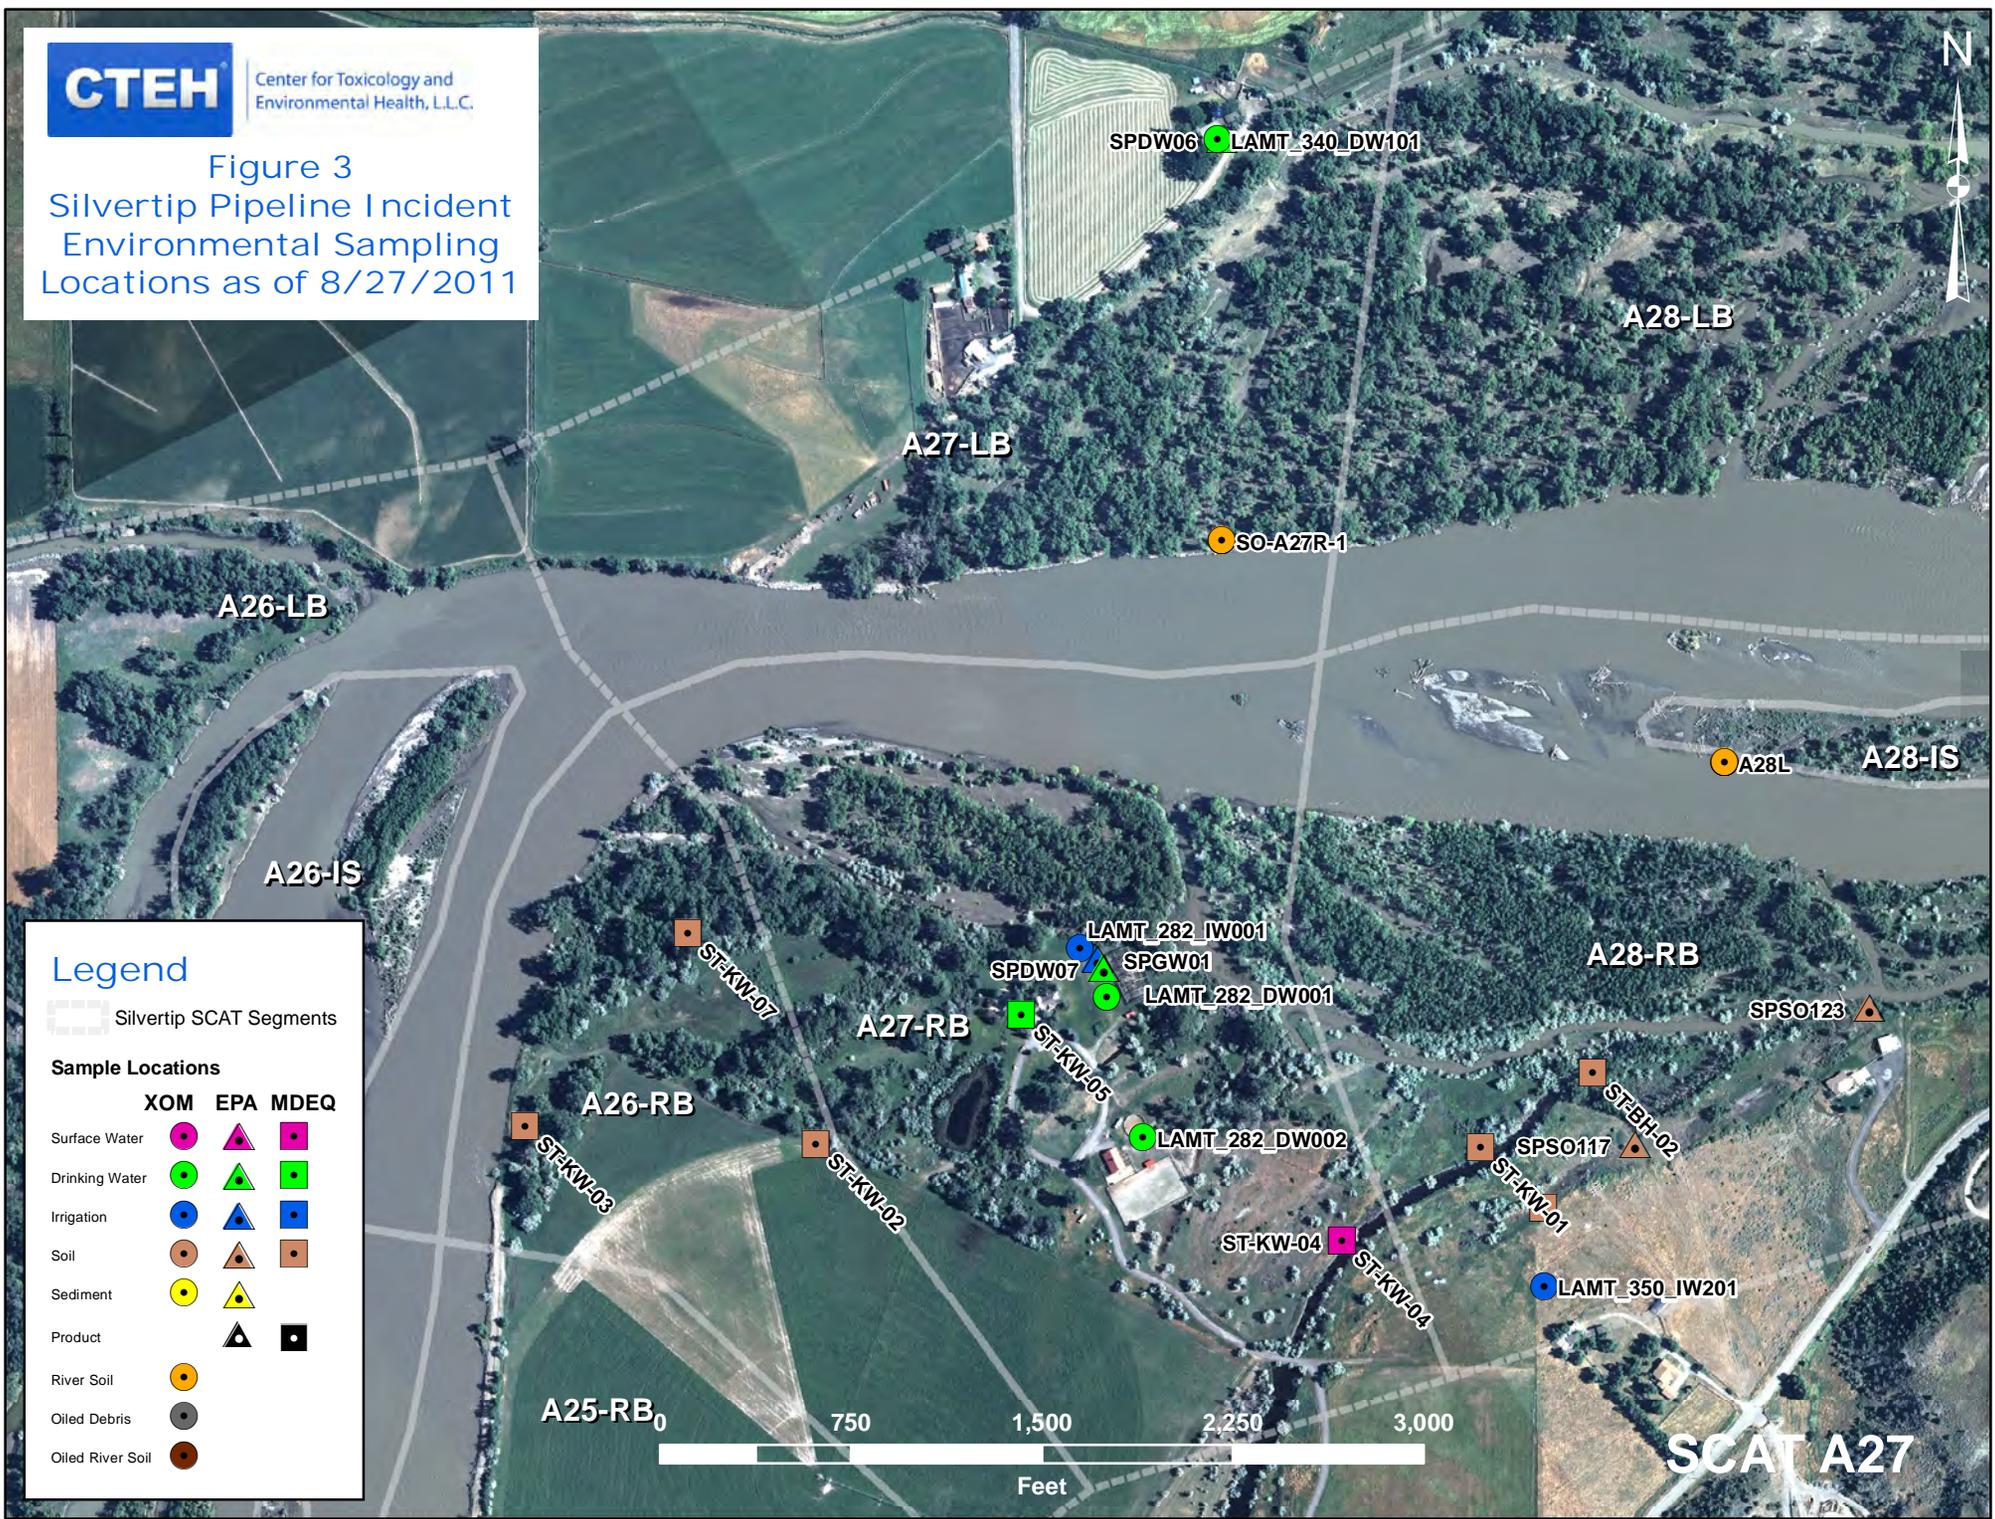
Figure 3
 Silvertip Pipeline Incident
 Environmental Sampling
 Locations as of 8/27/2011

Table 1 (below) summarizes samples collected within Area A27. The analytical results for the samples collected can be accessed through a publicly accessible database on the United States Environmental Protection Agency's (USEPA's) website. The approximate locations of samples collected within Area A27 are provided on Figure 3.

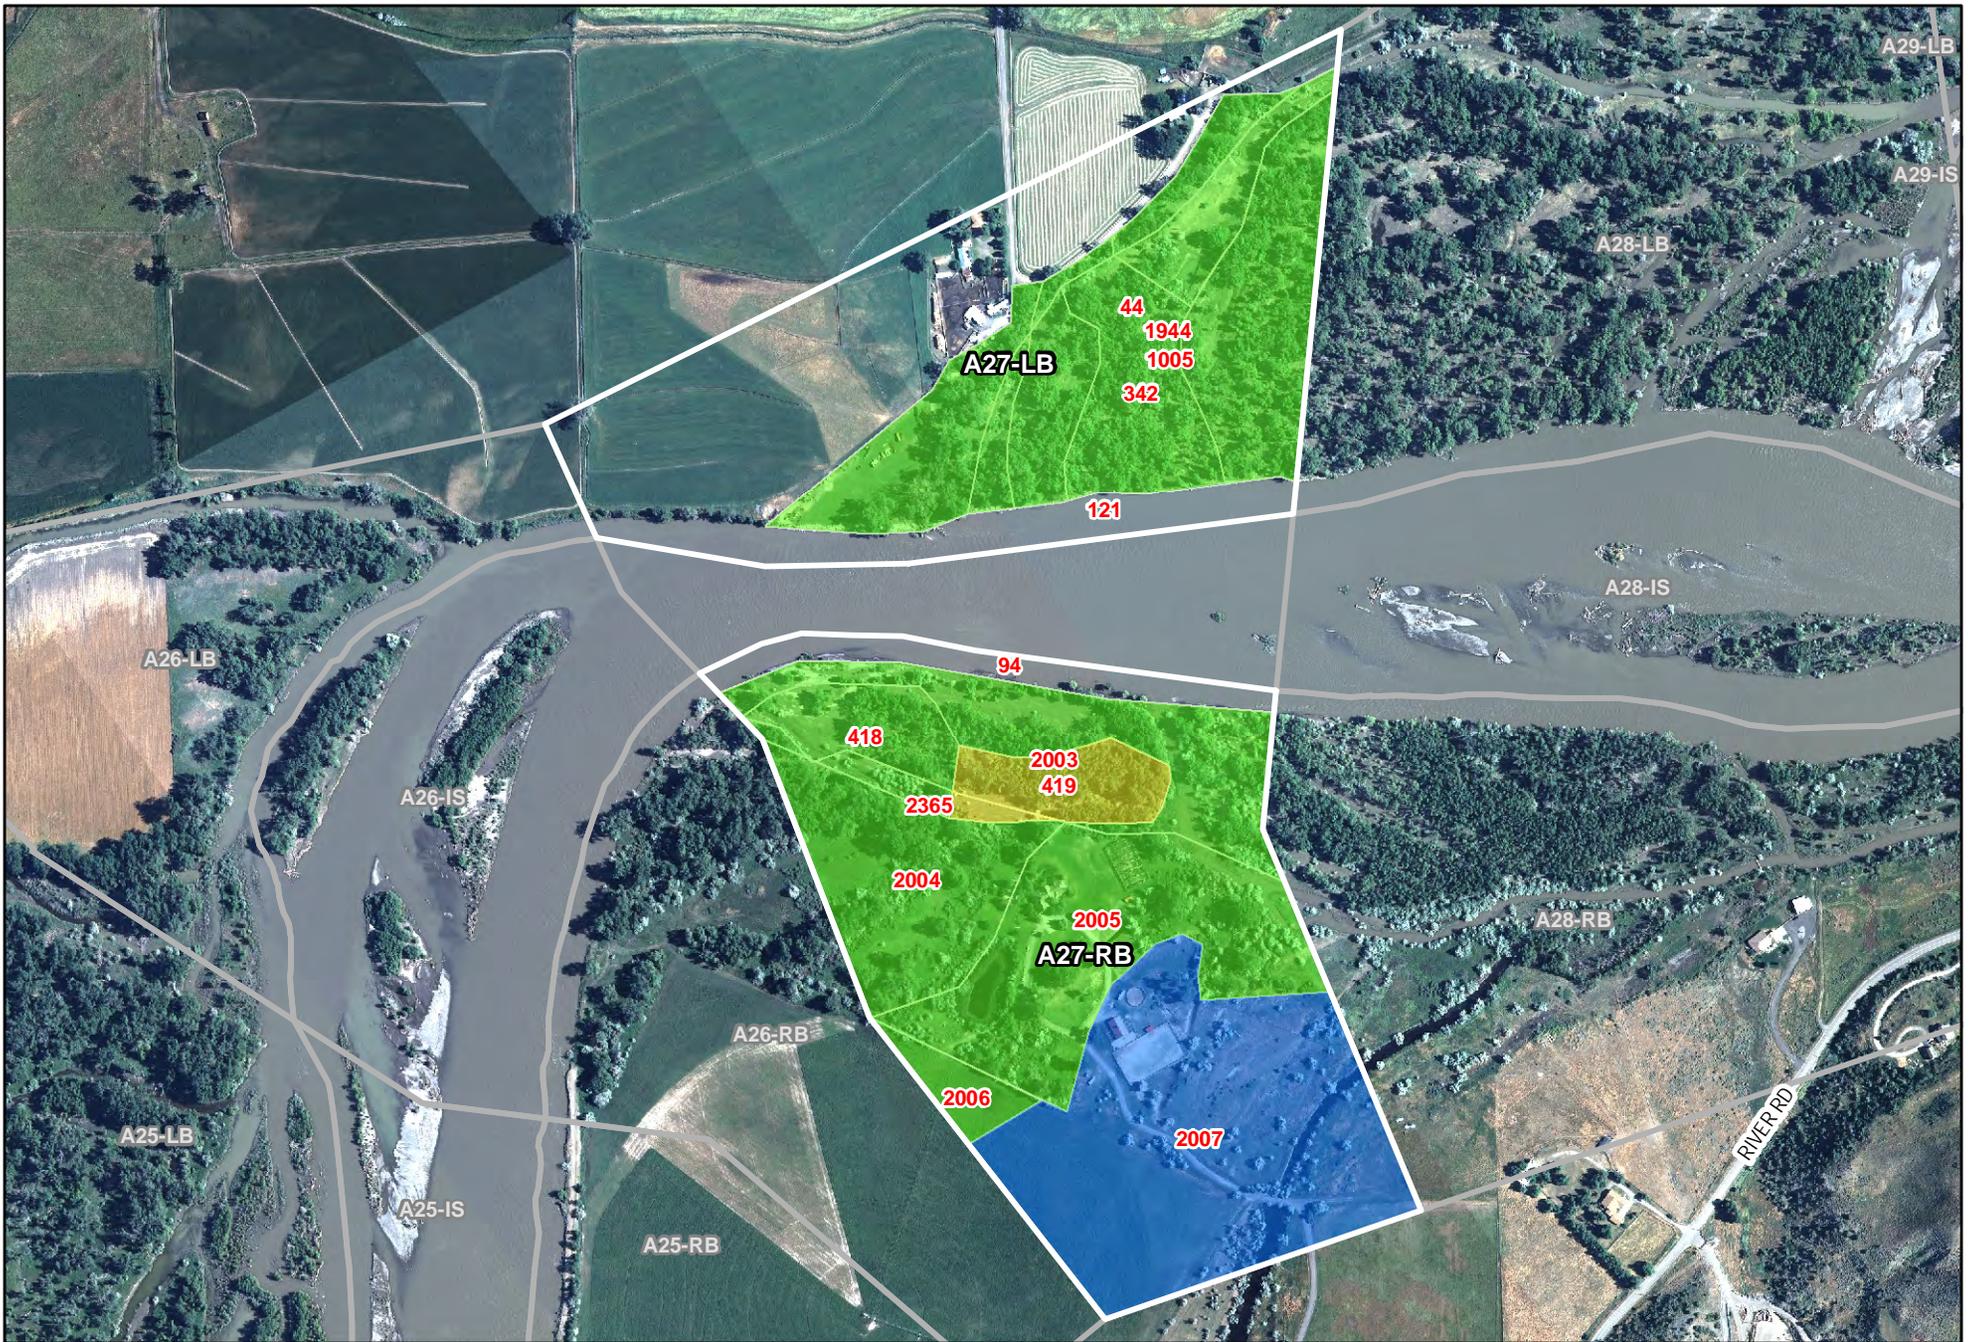
Figure 4 - Maximum SCAT Observations For SCAT Area: A27

The SCAT teams used systematic evaluation criteria and treatment method tables approved by the National Oceanic and Atmospheric Administration to provide a standard approach for data collection and conducting field surveys. The forms and sketches from the initial SCAT surveys performed along the river bank (water edge) and floodplain within Area A27 are included in Appendix B. Figure 4 provides the maximum oiling zones observed by the SCAT team during the initial surveys of Area A27.

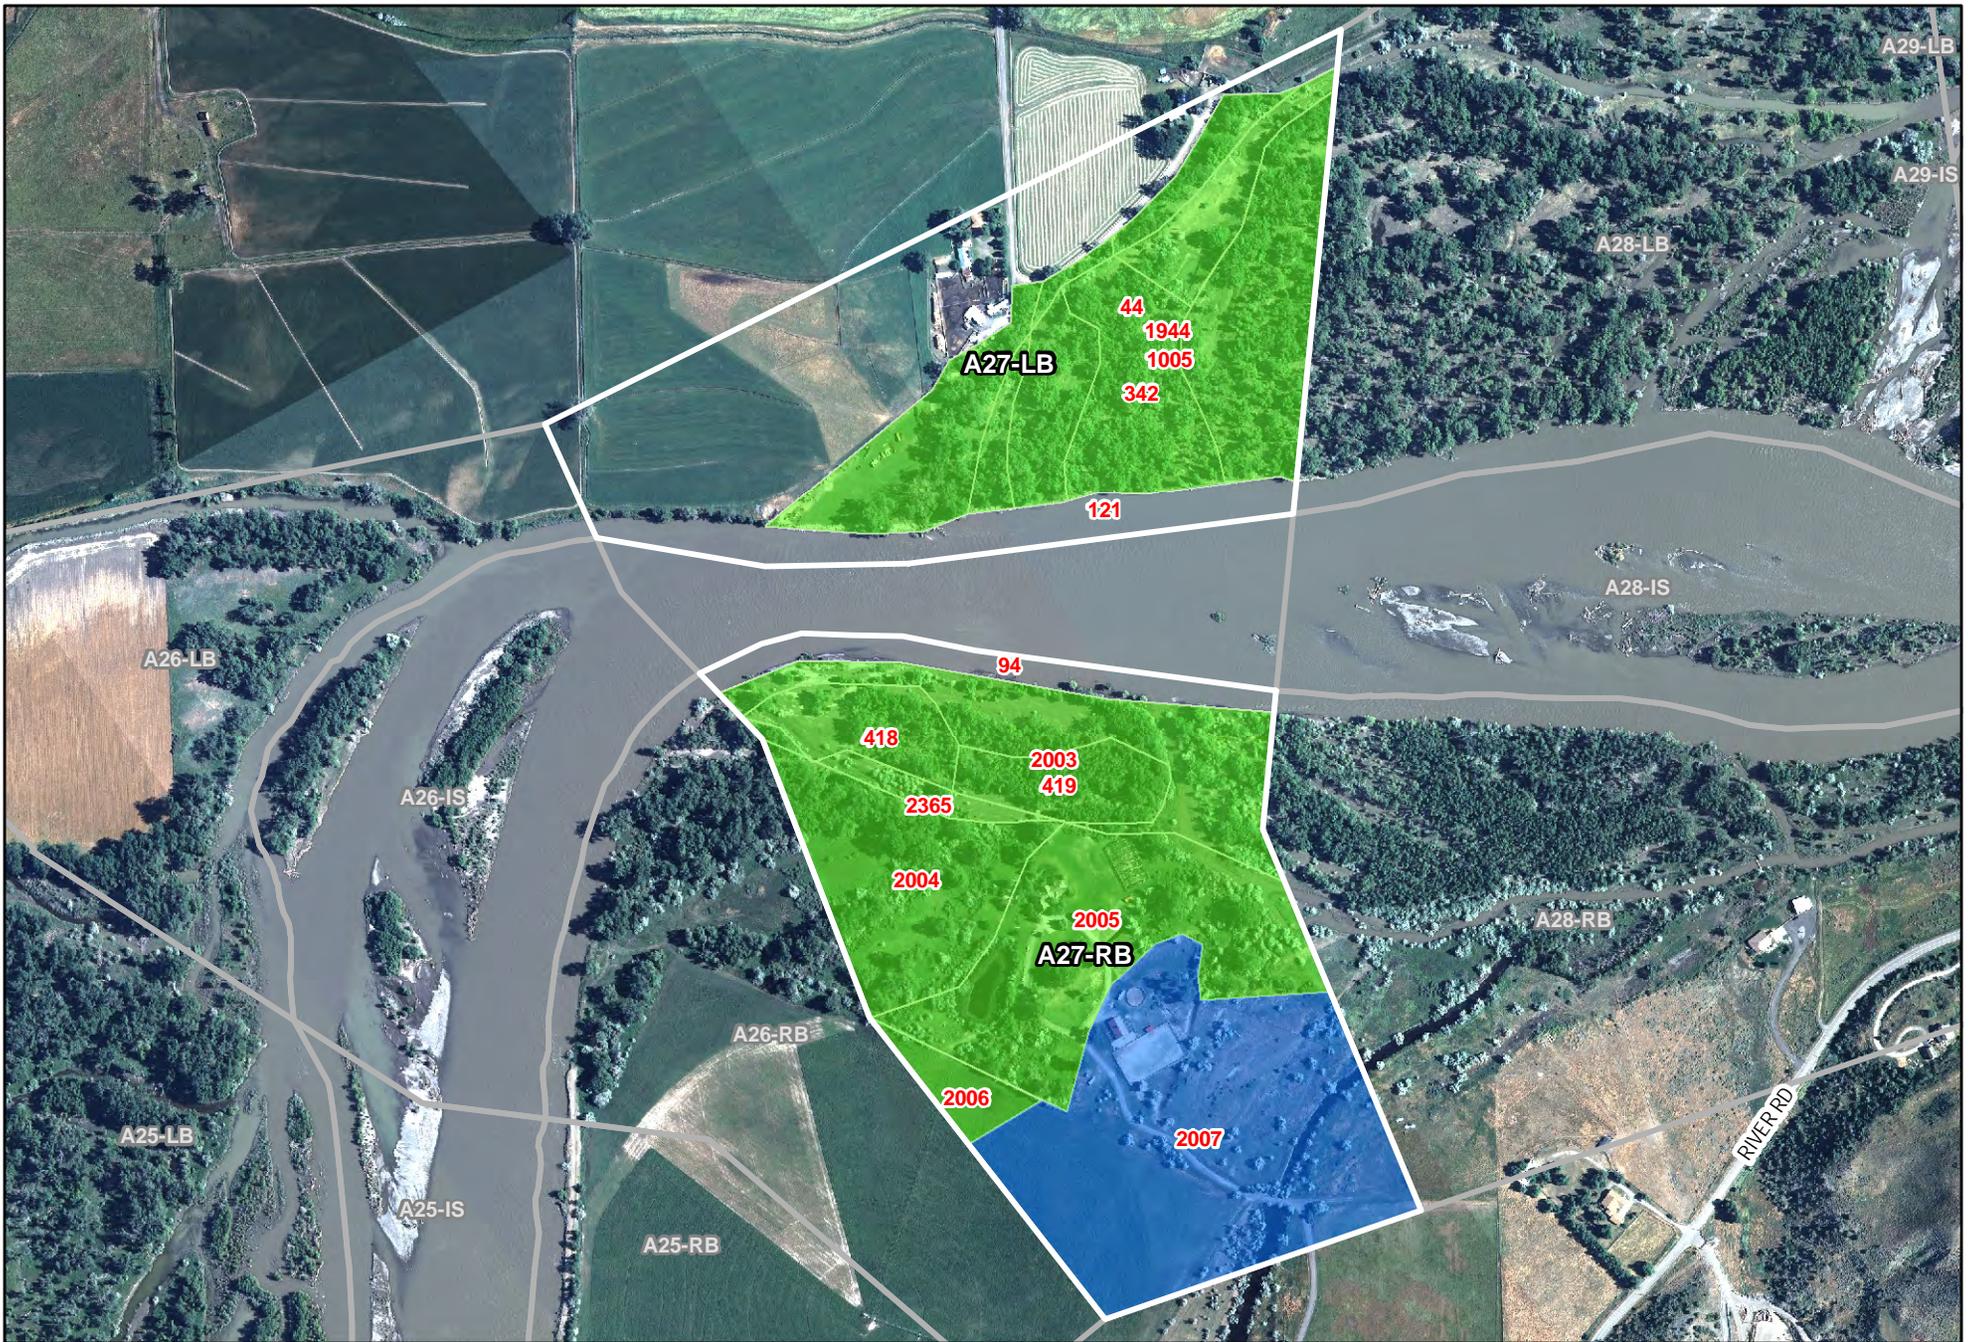
Figure 5 - Final SCAT Observations
For SCAT Area: A27

Figure 5 shows the oiling conditions within Area A27 following completion of oil removal activities. The SCAT team performed final surveys of the left and right banks within SCAT Area A27 to confirm the agreed-upon cleanup endpoints identified in the applicable CTRs had been achieved. The final SCAT survey documentation is presented in Appendix E.

Based on the final SCAT surveys performed on the left and right banks within Area A27, no further treatment is recommended for these segments. SCAT Segment Sign-Off Forms are included as Appendix F.

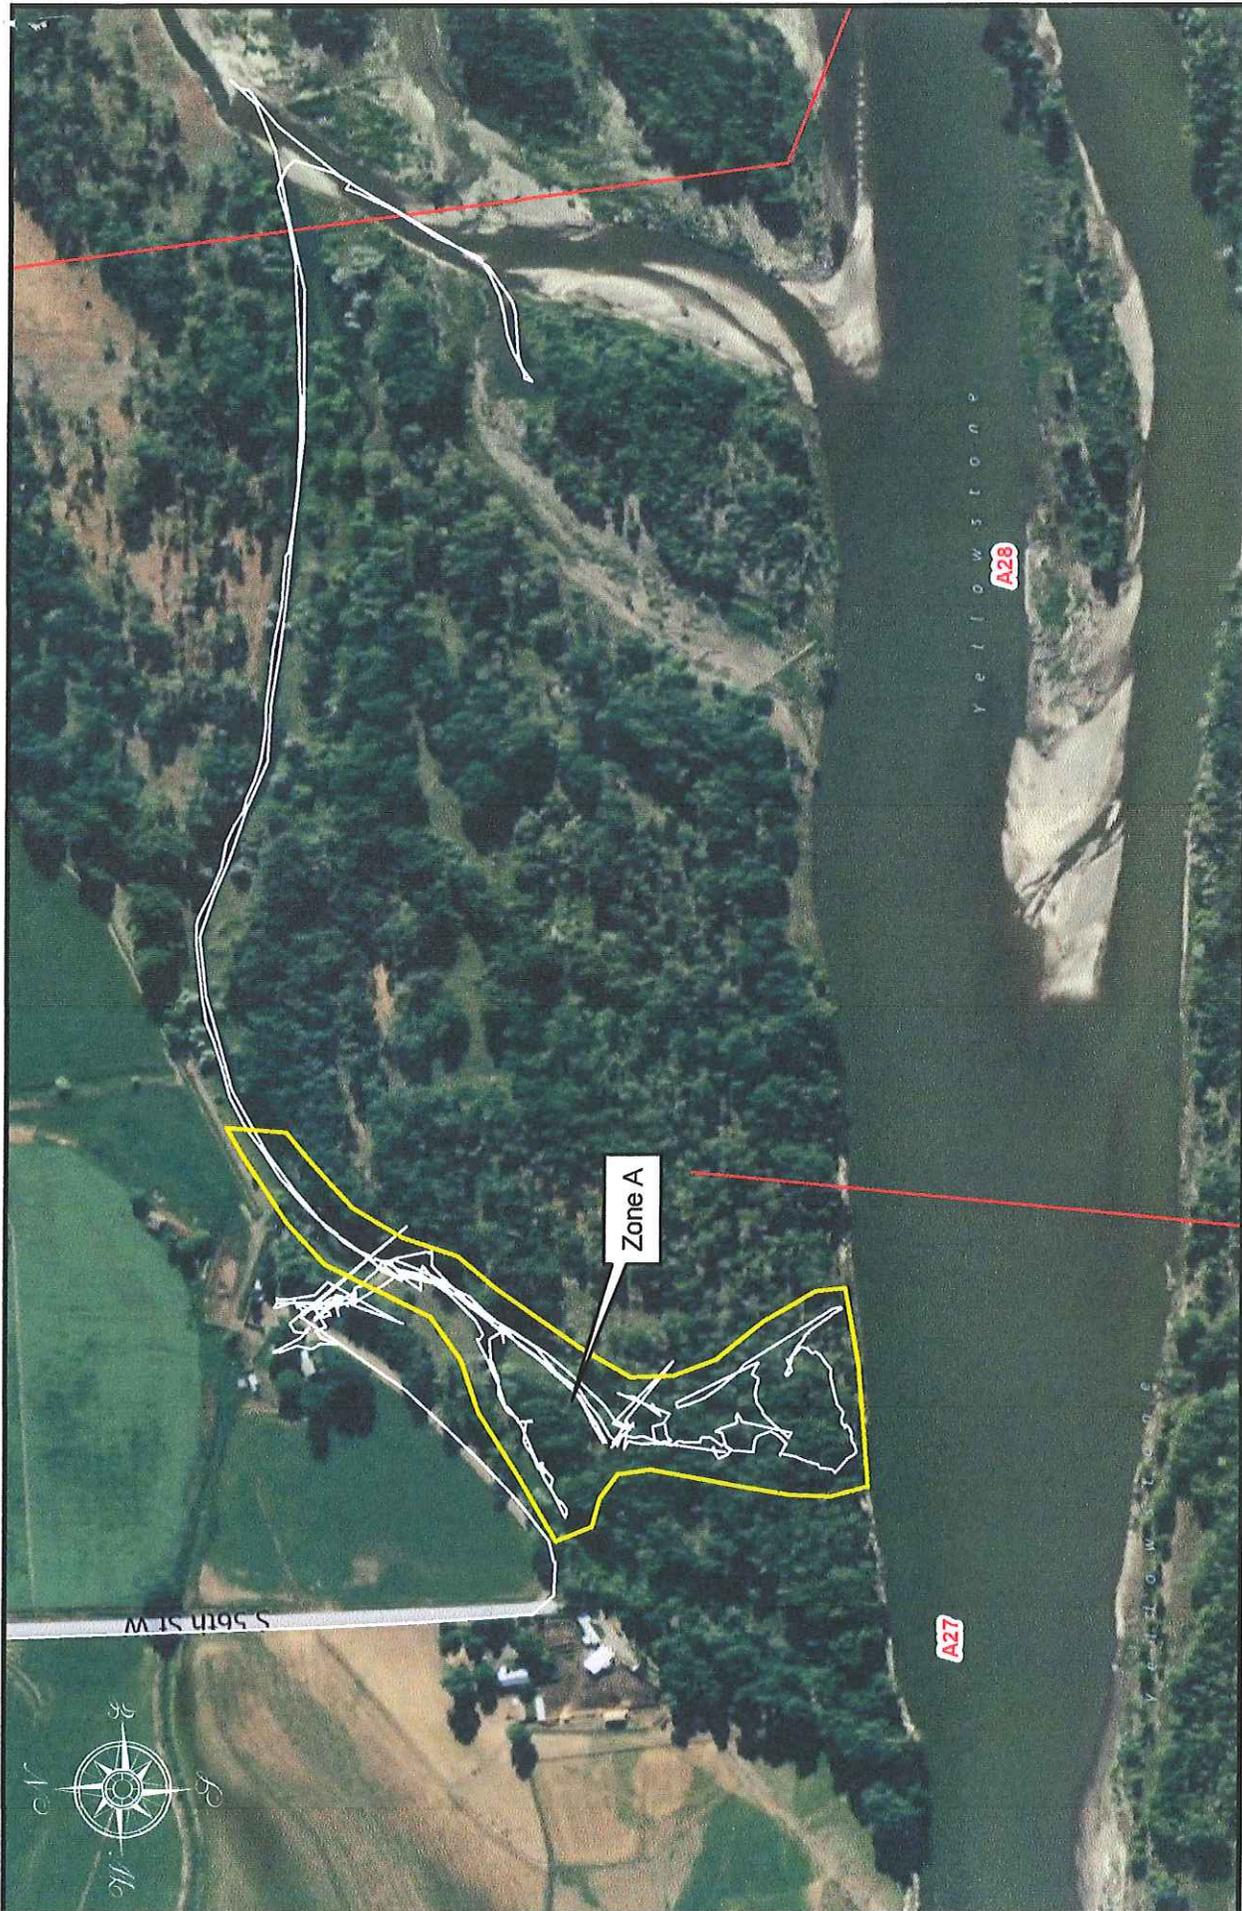
Segment A27

No oil observed.

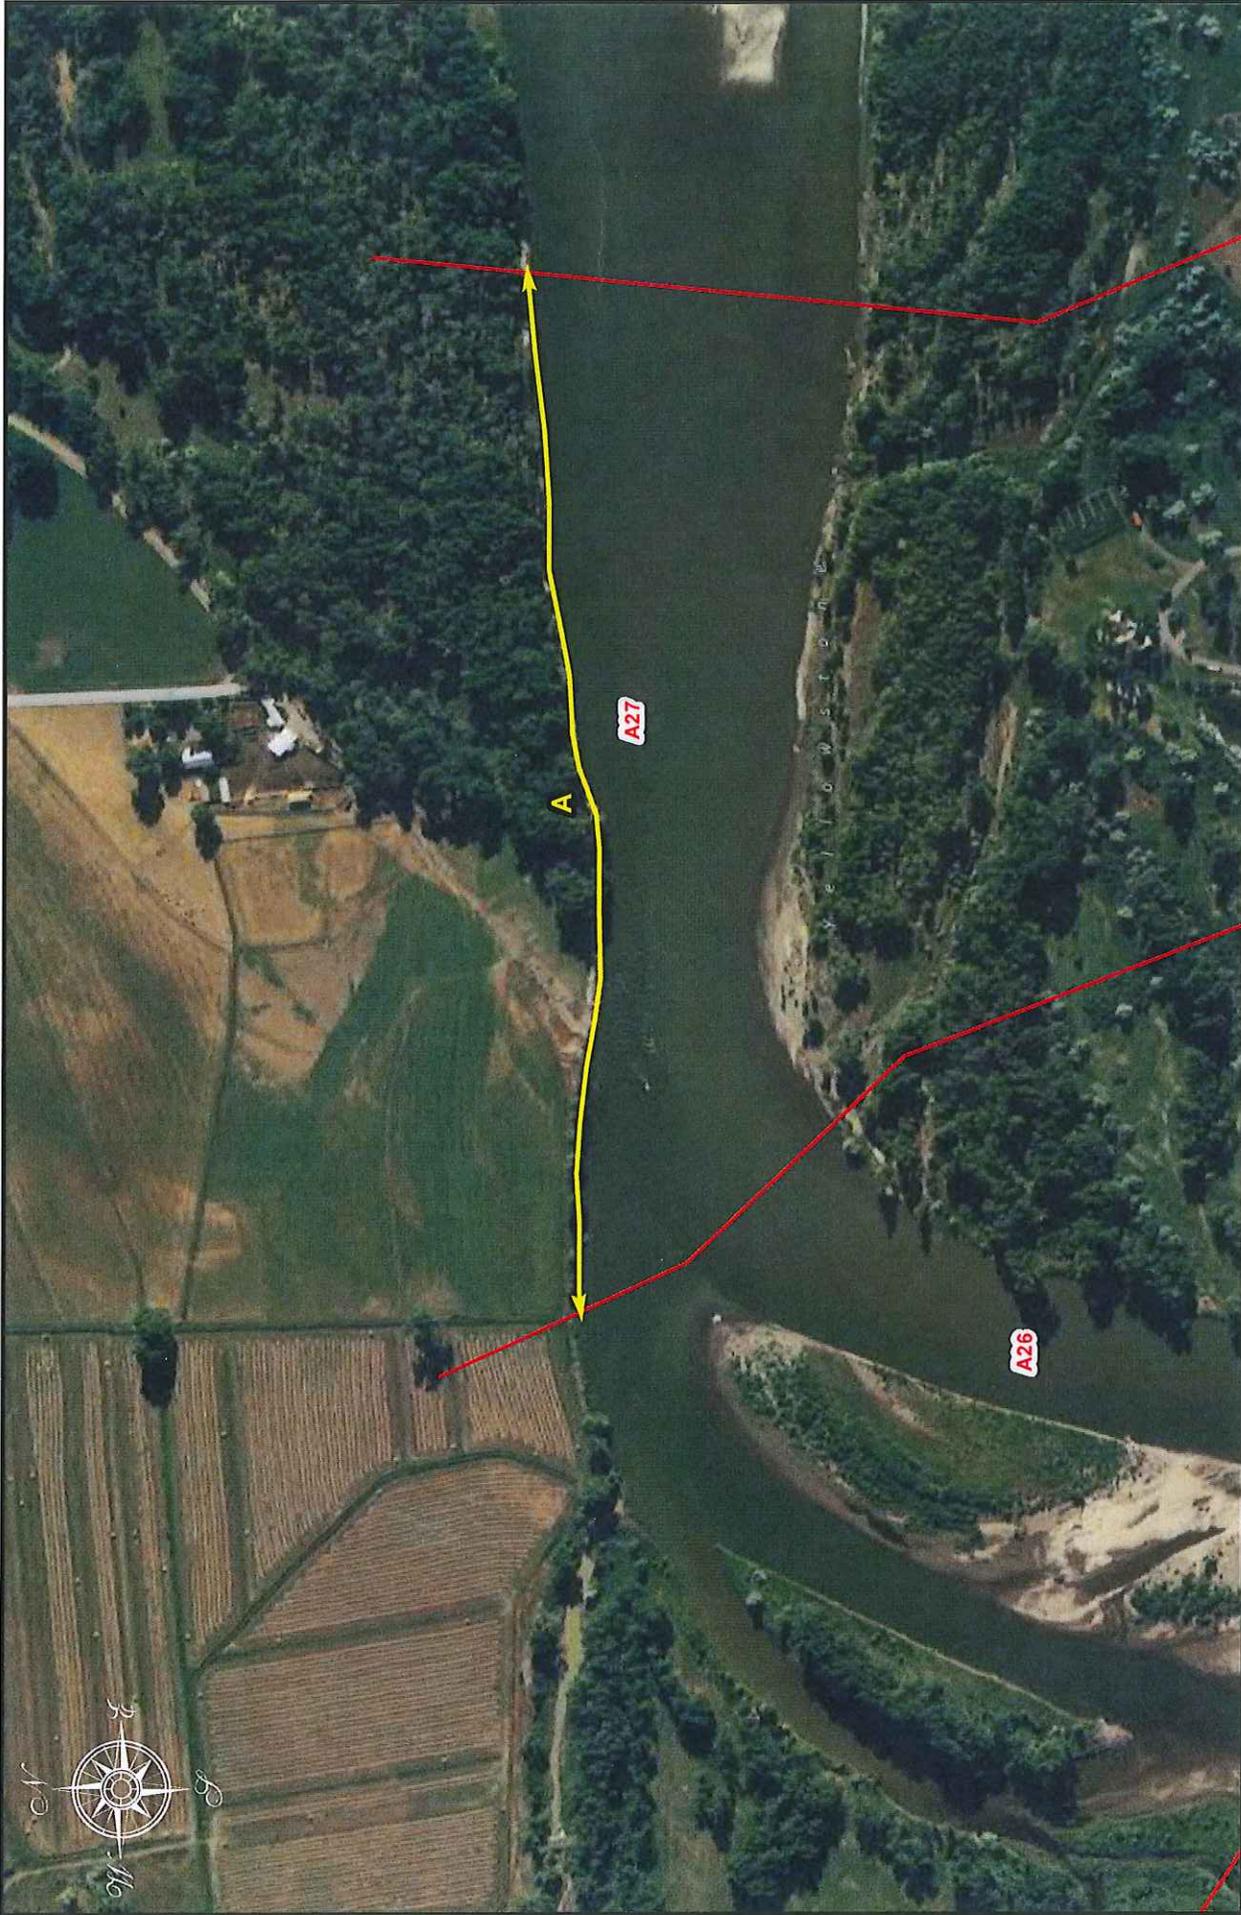
Segment A27 Left Bank

Cleanup Recommendations: No oil observed along river channel margin

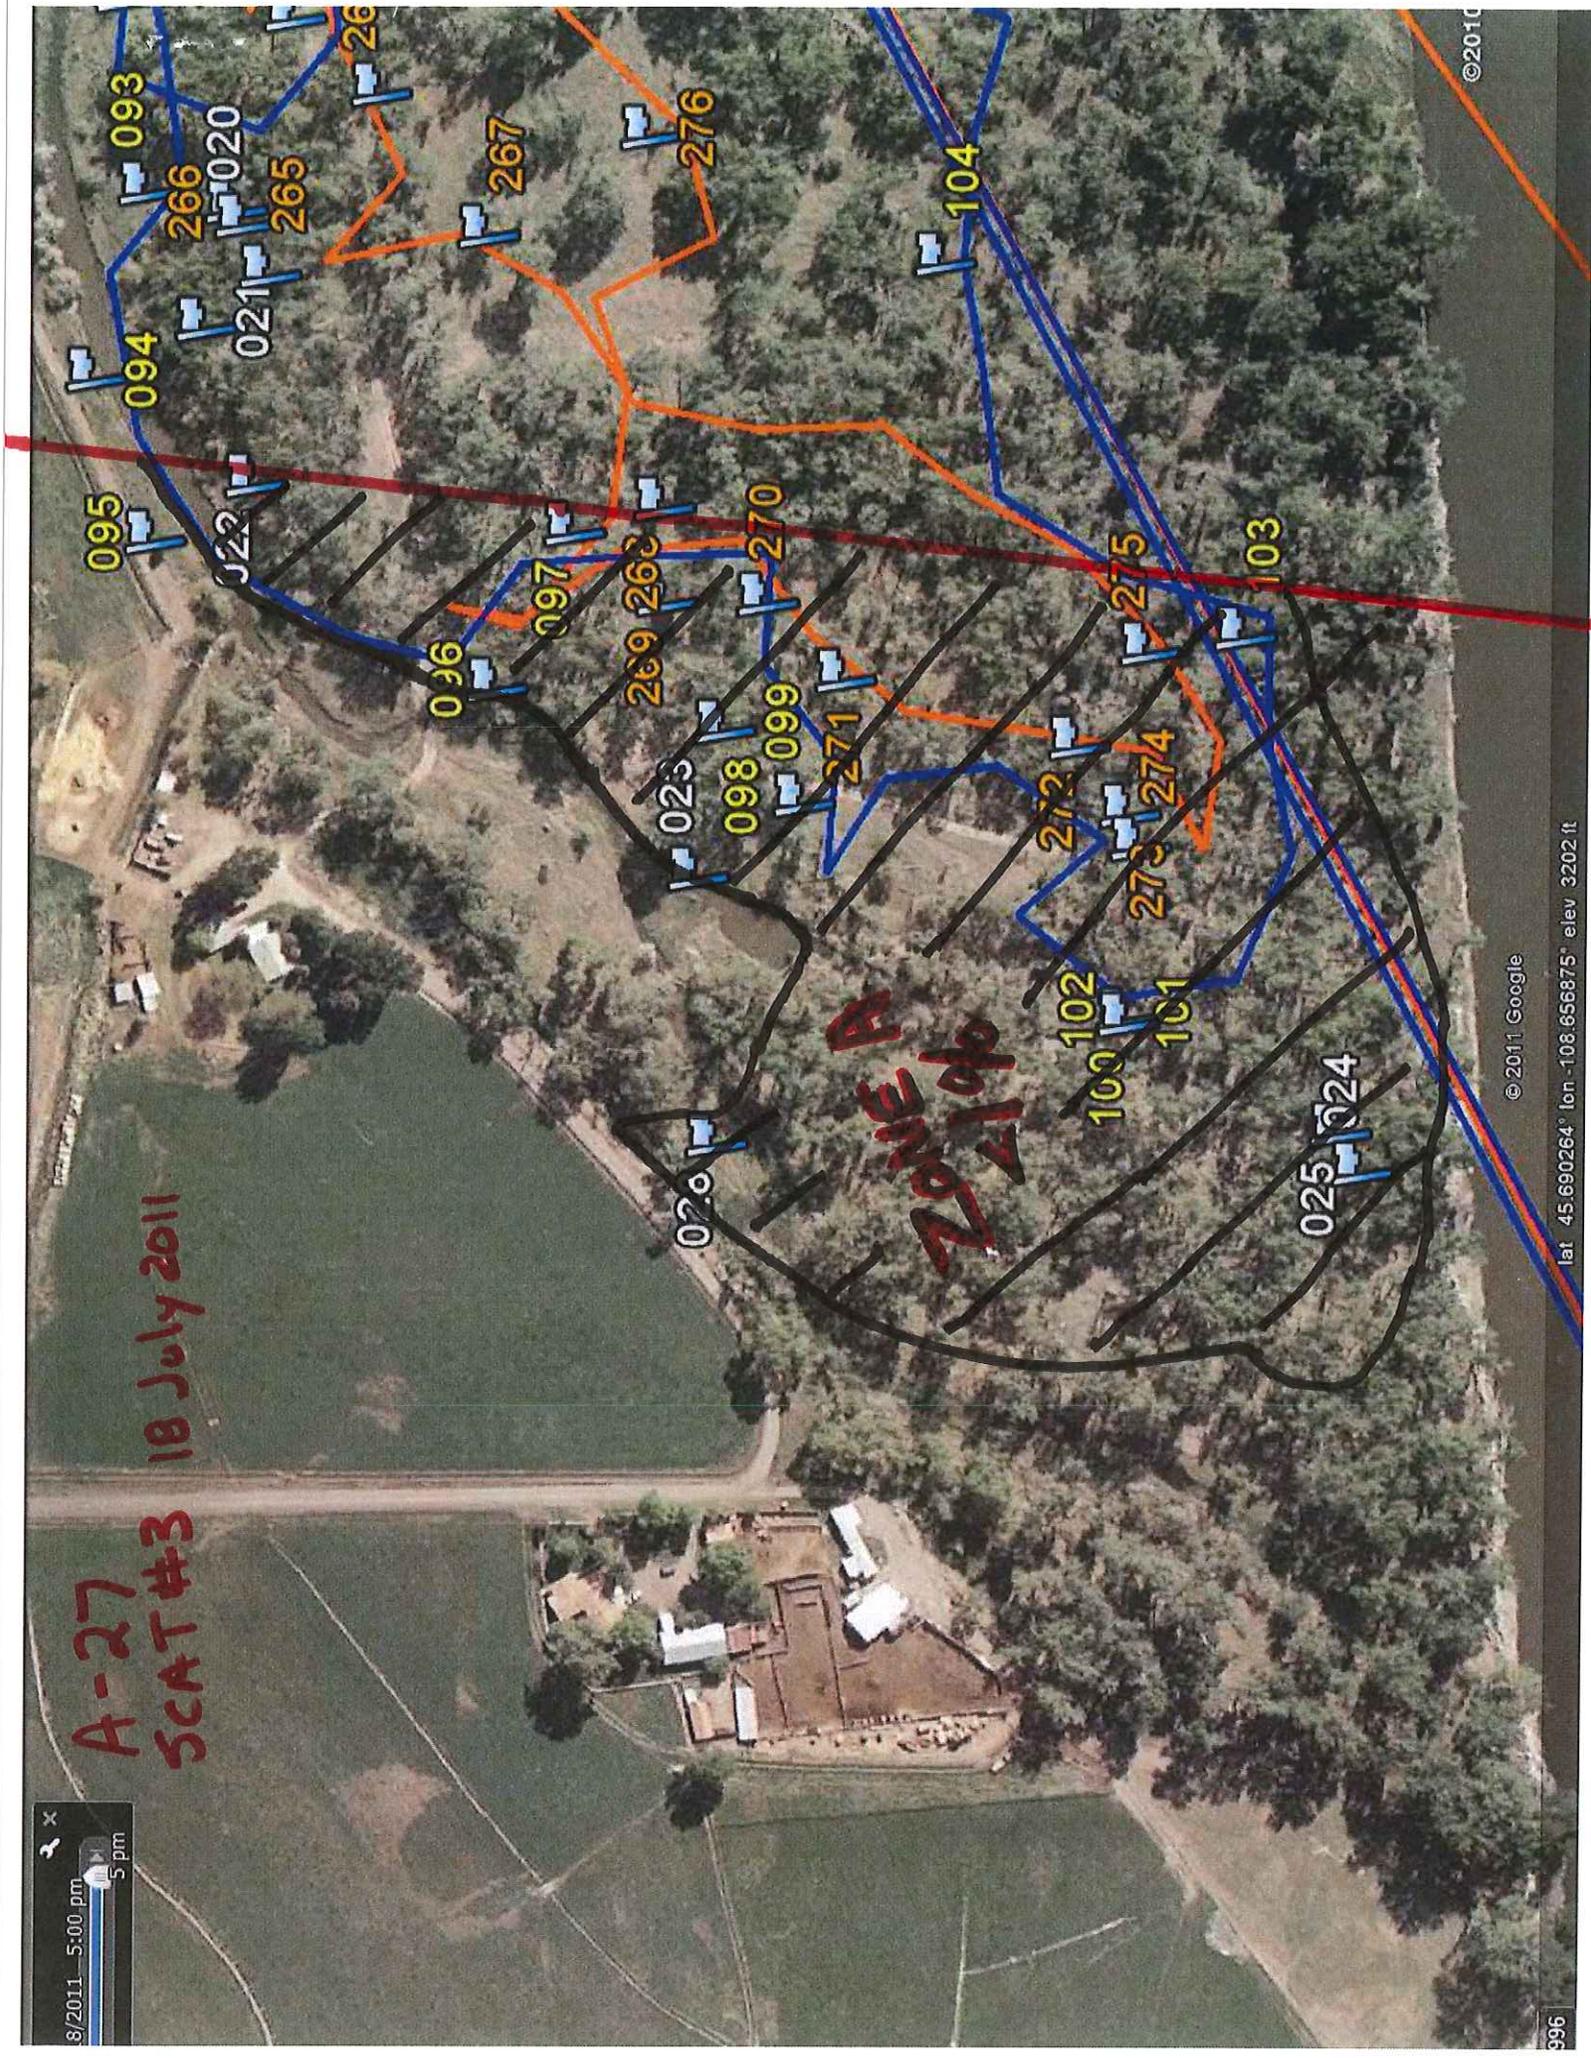
A-27
SCAT #3

A - Area had trace occasional oiled debris (mostly wooden), bath tub ring on several trees, and areas of tarry specs on grass (ave. 20-25 cm high on blade). Most oiled wood debris was associated with piles of drift logs and/or trapped under bushes. Very intermittent distribution primarily along edges of flood channel pathways. Size of oil patches range from 0.25 cm to ~50 cm. Bath tub ring from 0.5 cm to 5 cm wide. Evidence of landowner use throughout area
