**SCAT Area Transition Report
for A28**

Silvertip Pipeline Incident
Laurel, Montana

October 31, 2011

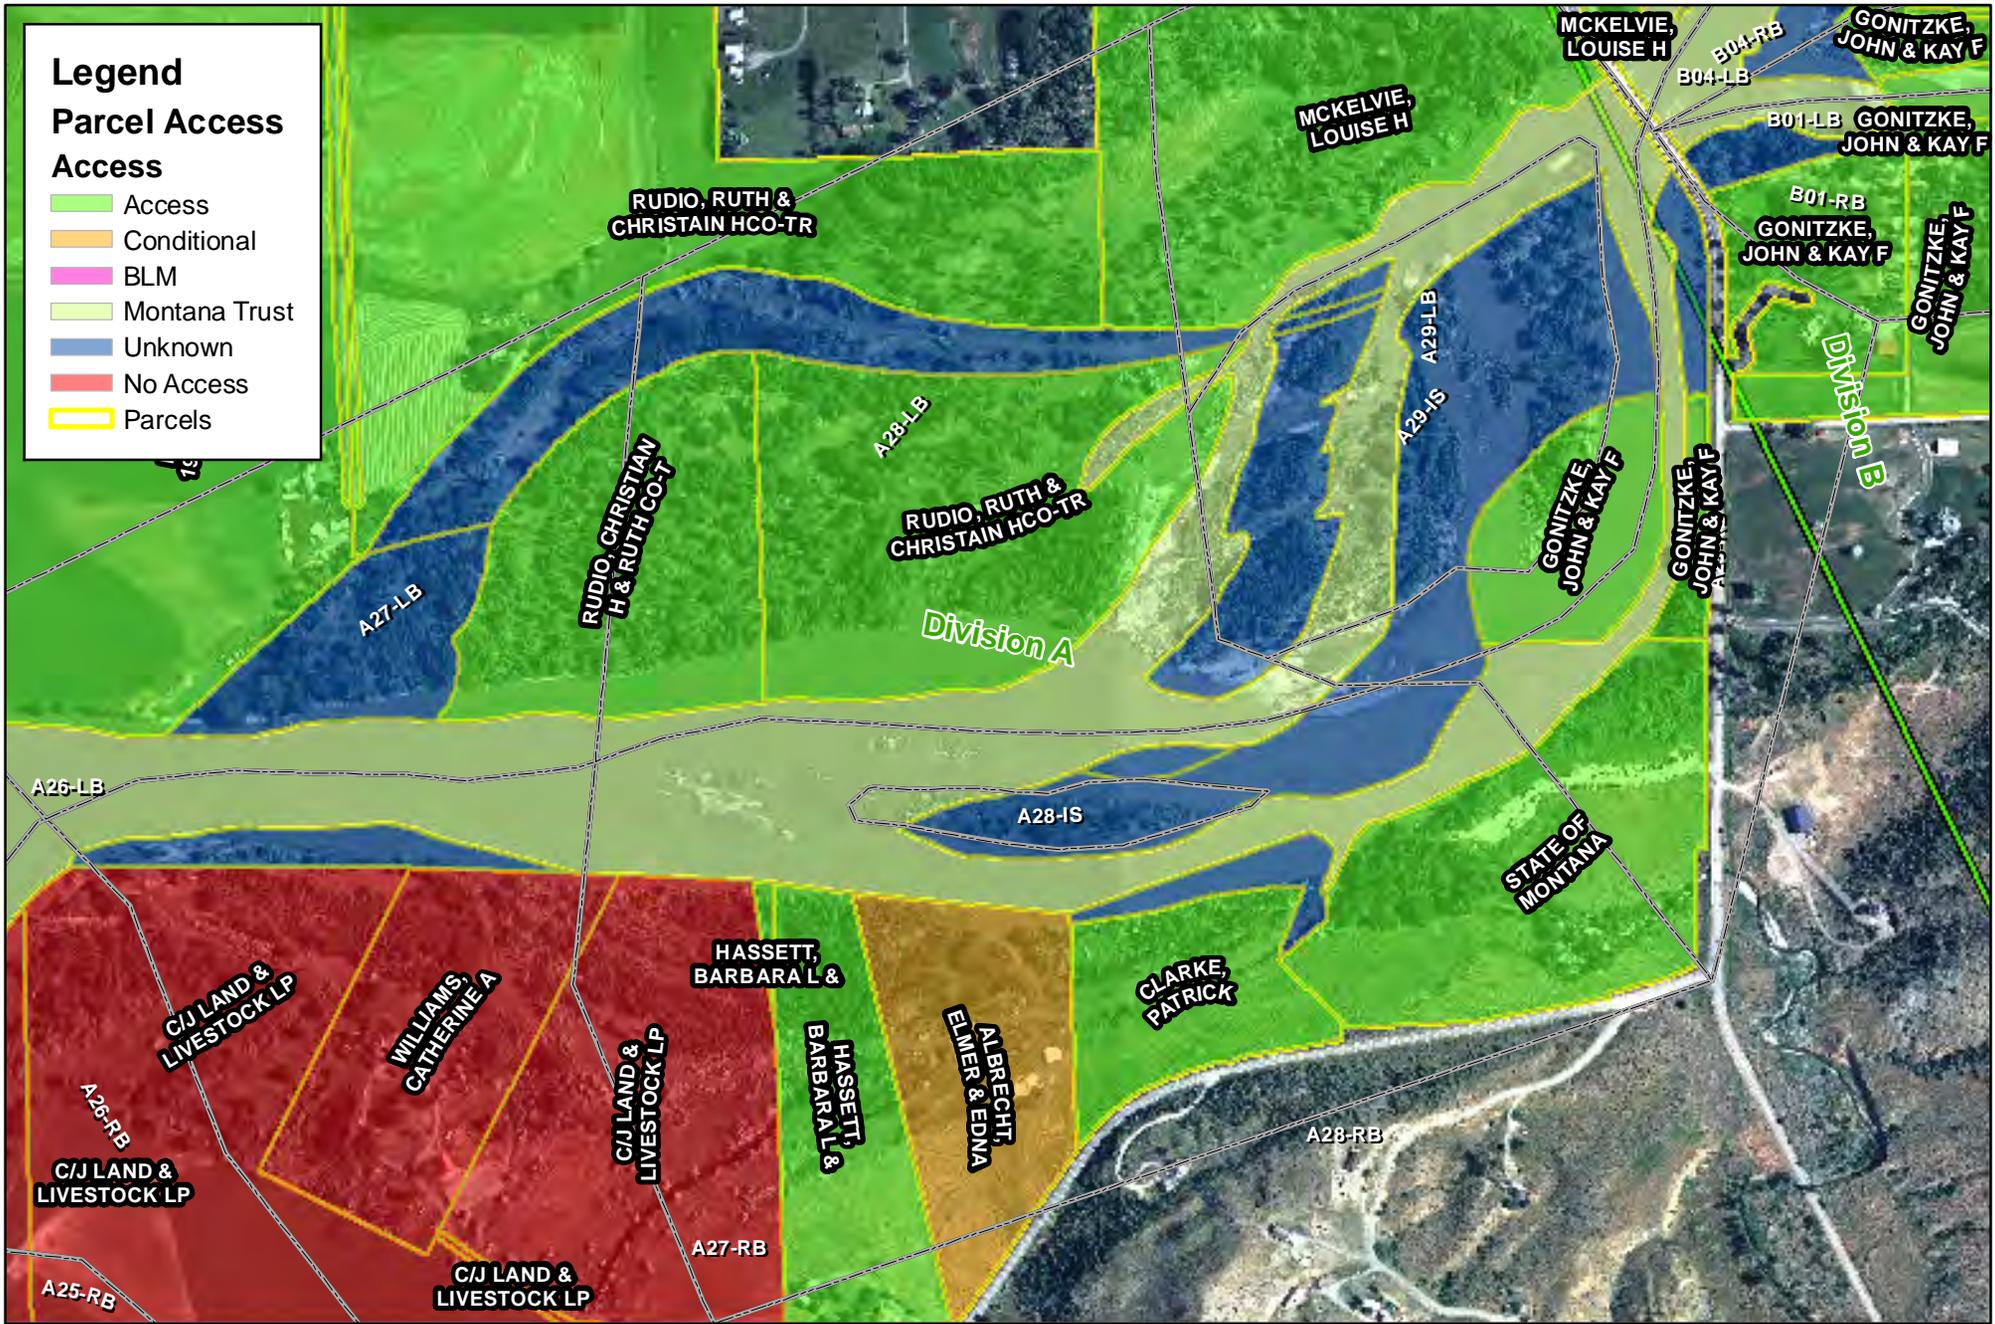
Figure 1 provides an aerial map of SCAT Area A28, along with the (a) SCAT Area boundary, (b) parcel boundaries and respective property owners, and (c) access constraints identified during the oil cleanup process. The acreage surveyed in Area A28 is 135.1. There were access issues associated with a portion of the right bank.

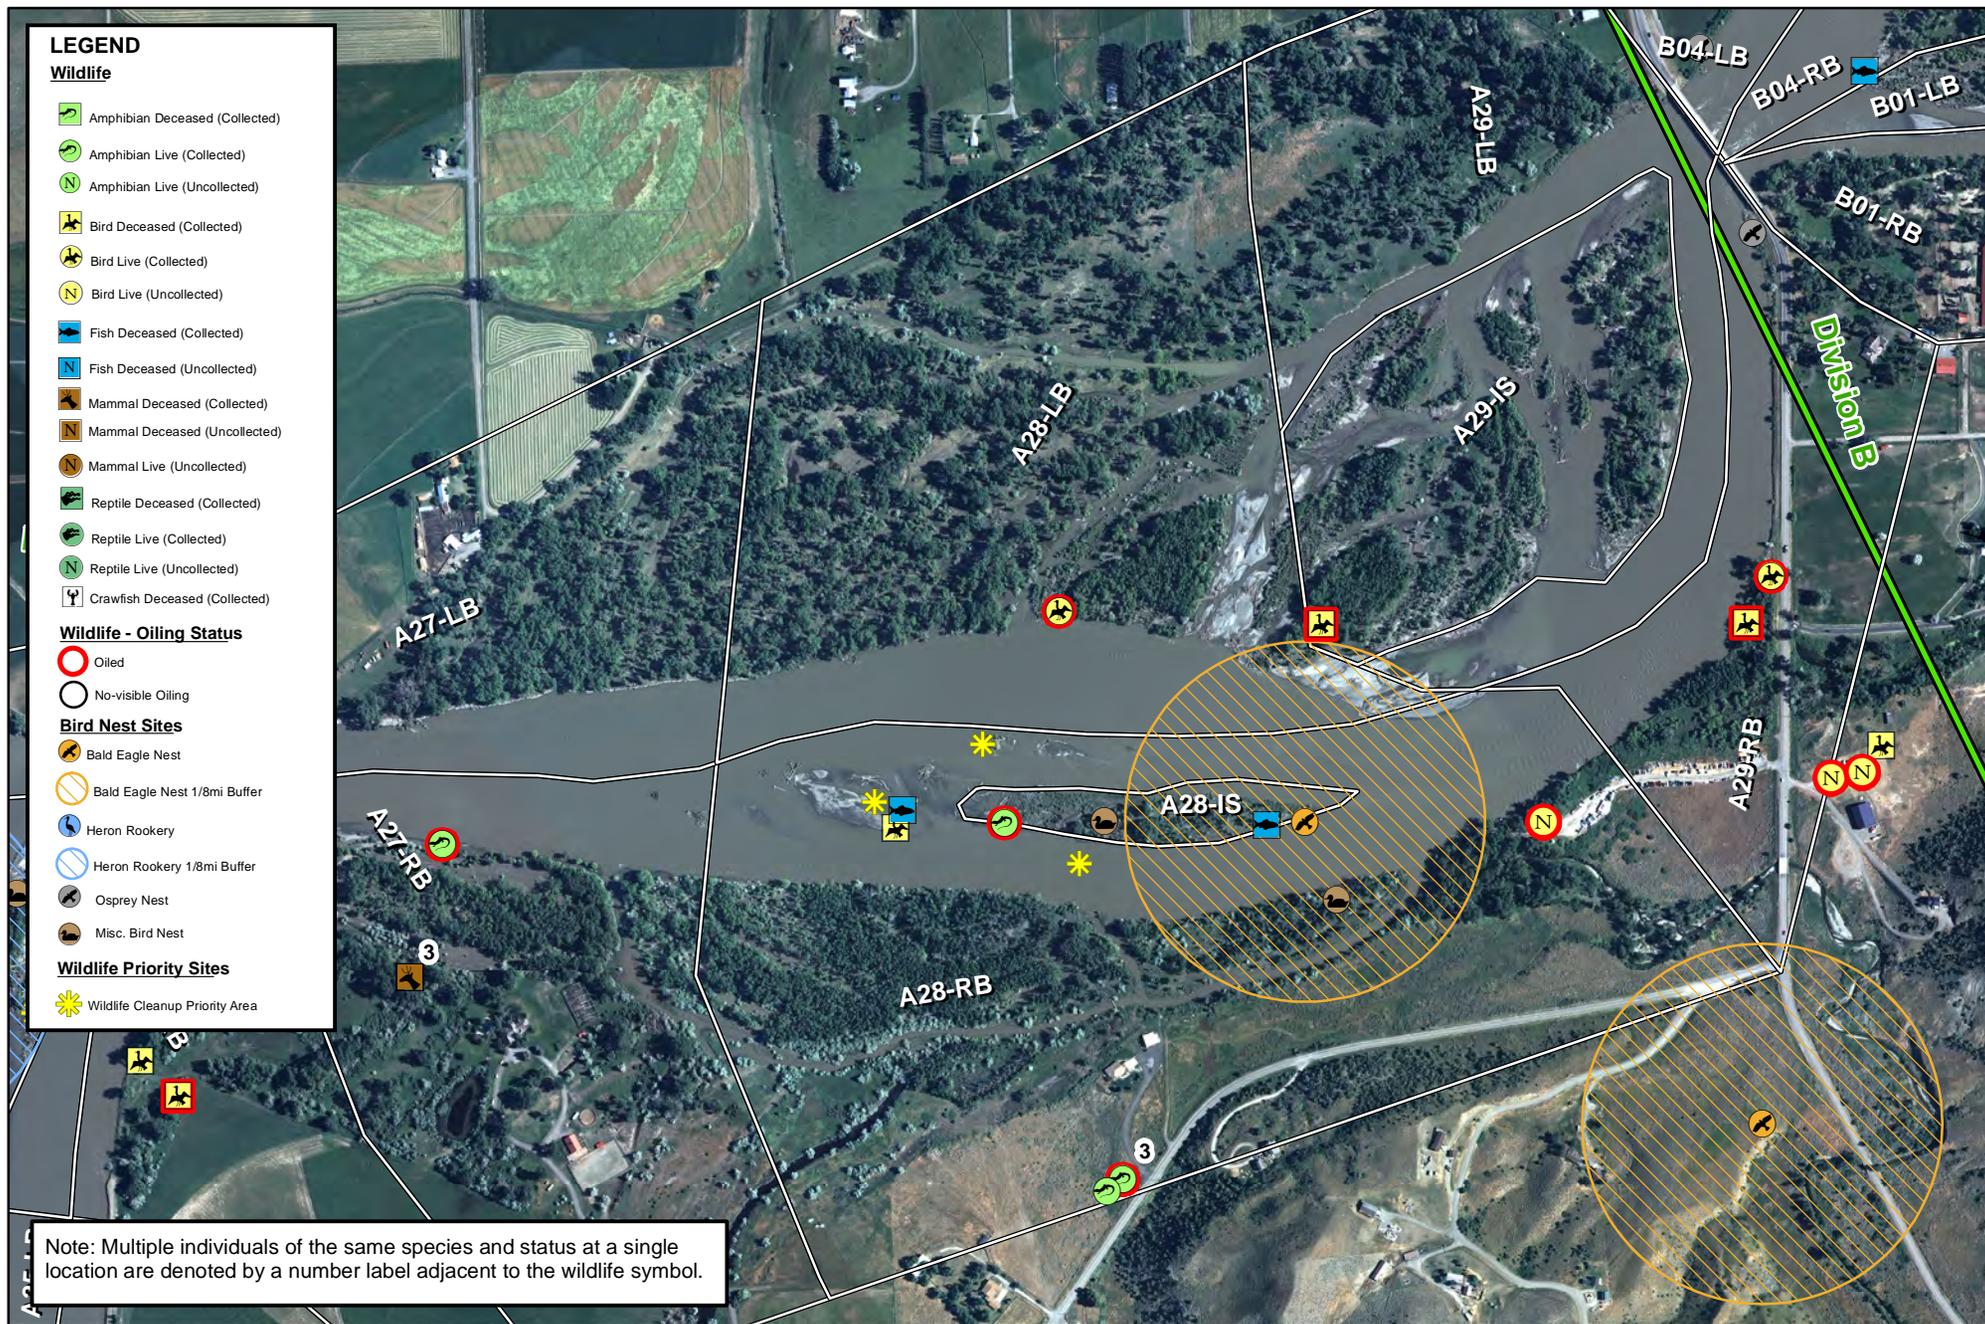
Figure 2
Wildlife Resources

Figure 2 summarizes the natural resources identified in this segment. International Bird Rescue and Resource Advisors from U.S. Fish and Wildlife Service conducted regular inspections of Area A28. Four oiled Woodhouse's toads (*Bufo woodhousii*) and a Copper's hawk (*Accipiter cooperii*) were captured, cleaned, and released. A lightly oiled red-tailed hawk (*Buteo jamaicensis*) was observed flying in this area. One Woodhouse's toad was captured and taken to the Wildlife Recovery Center for an oiling evaluation, determined to be un-oiled, and released. Two deceased fish (unknown species) and a bird (unknown species) with no visible oiling were collected and retained. A spotted sandpiper (*Actitis macularius*) nest and a bald eagle (*Haliaeetus leucocephalus*) nest were identified on the island portion of Area A28. The appropriate buffer zone for nesting bald eagles, depending on the type of activity, was maintained around the nest. In addition, four large stick nests that did not appear to be active were observed on the right bank; these nests were monitored for activity and to prevent damage during operations.

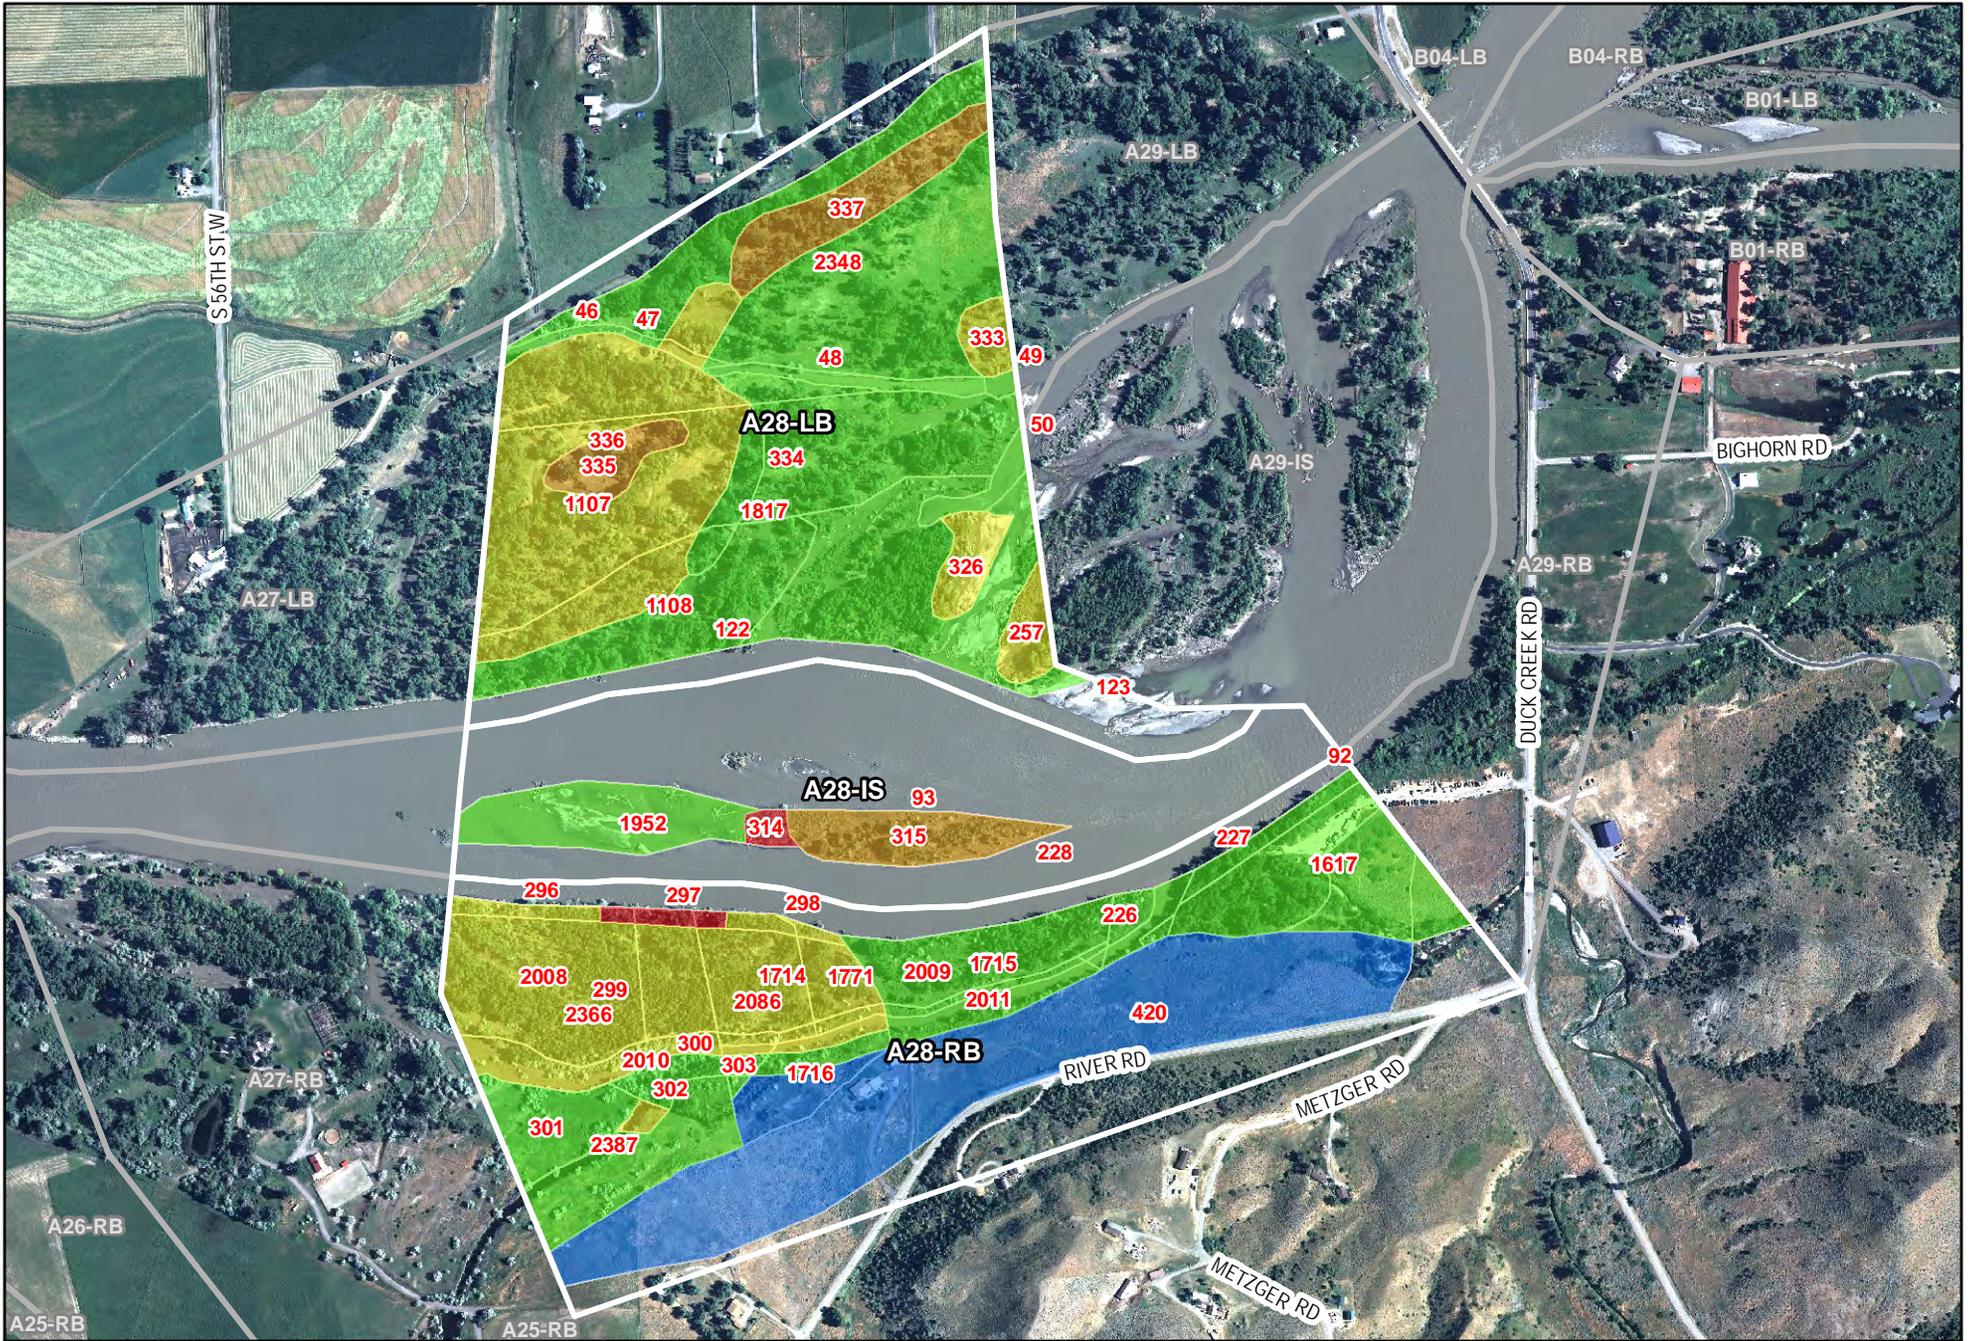
No Oil Observed</p>	<p>Figure 4 - Maximum SCAT Observations For SCAT Area: A28</p> <p>550 0 550 1,100 Feet</p>

maximum oiling zones observed by the SCAT team during the initial surveys of Area A28.

The SCAT team developed compiled treatment recommendations (CTRs) providing approved treatment methods (ATMs) for each oiling zone identified during the initial SCAT surveys of Area A28 ([CTR No. 15](#), [CTR No. 40](#), and [CTR No. 63](#)).

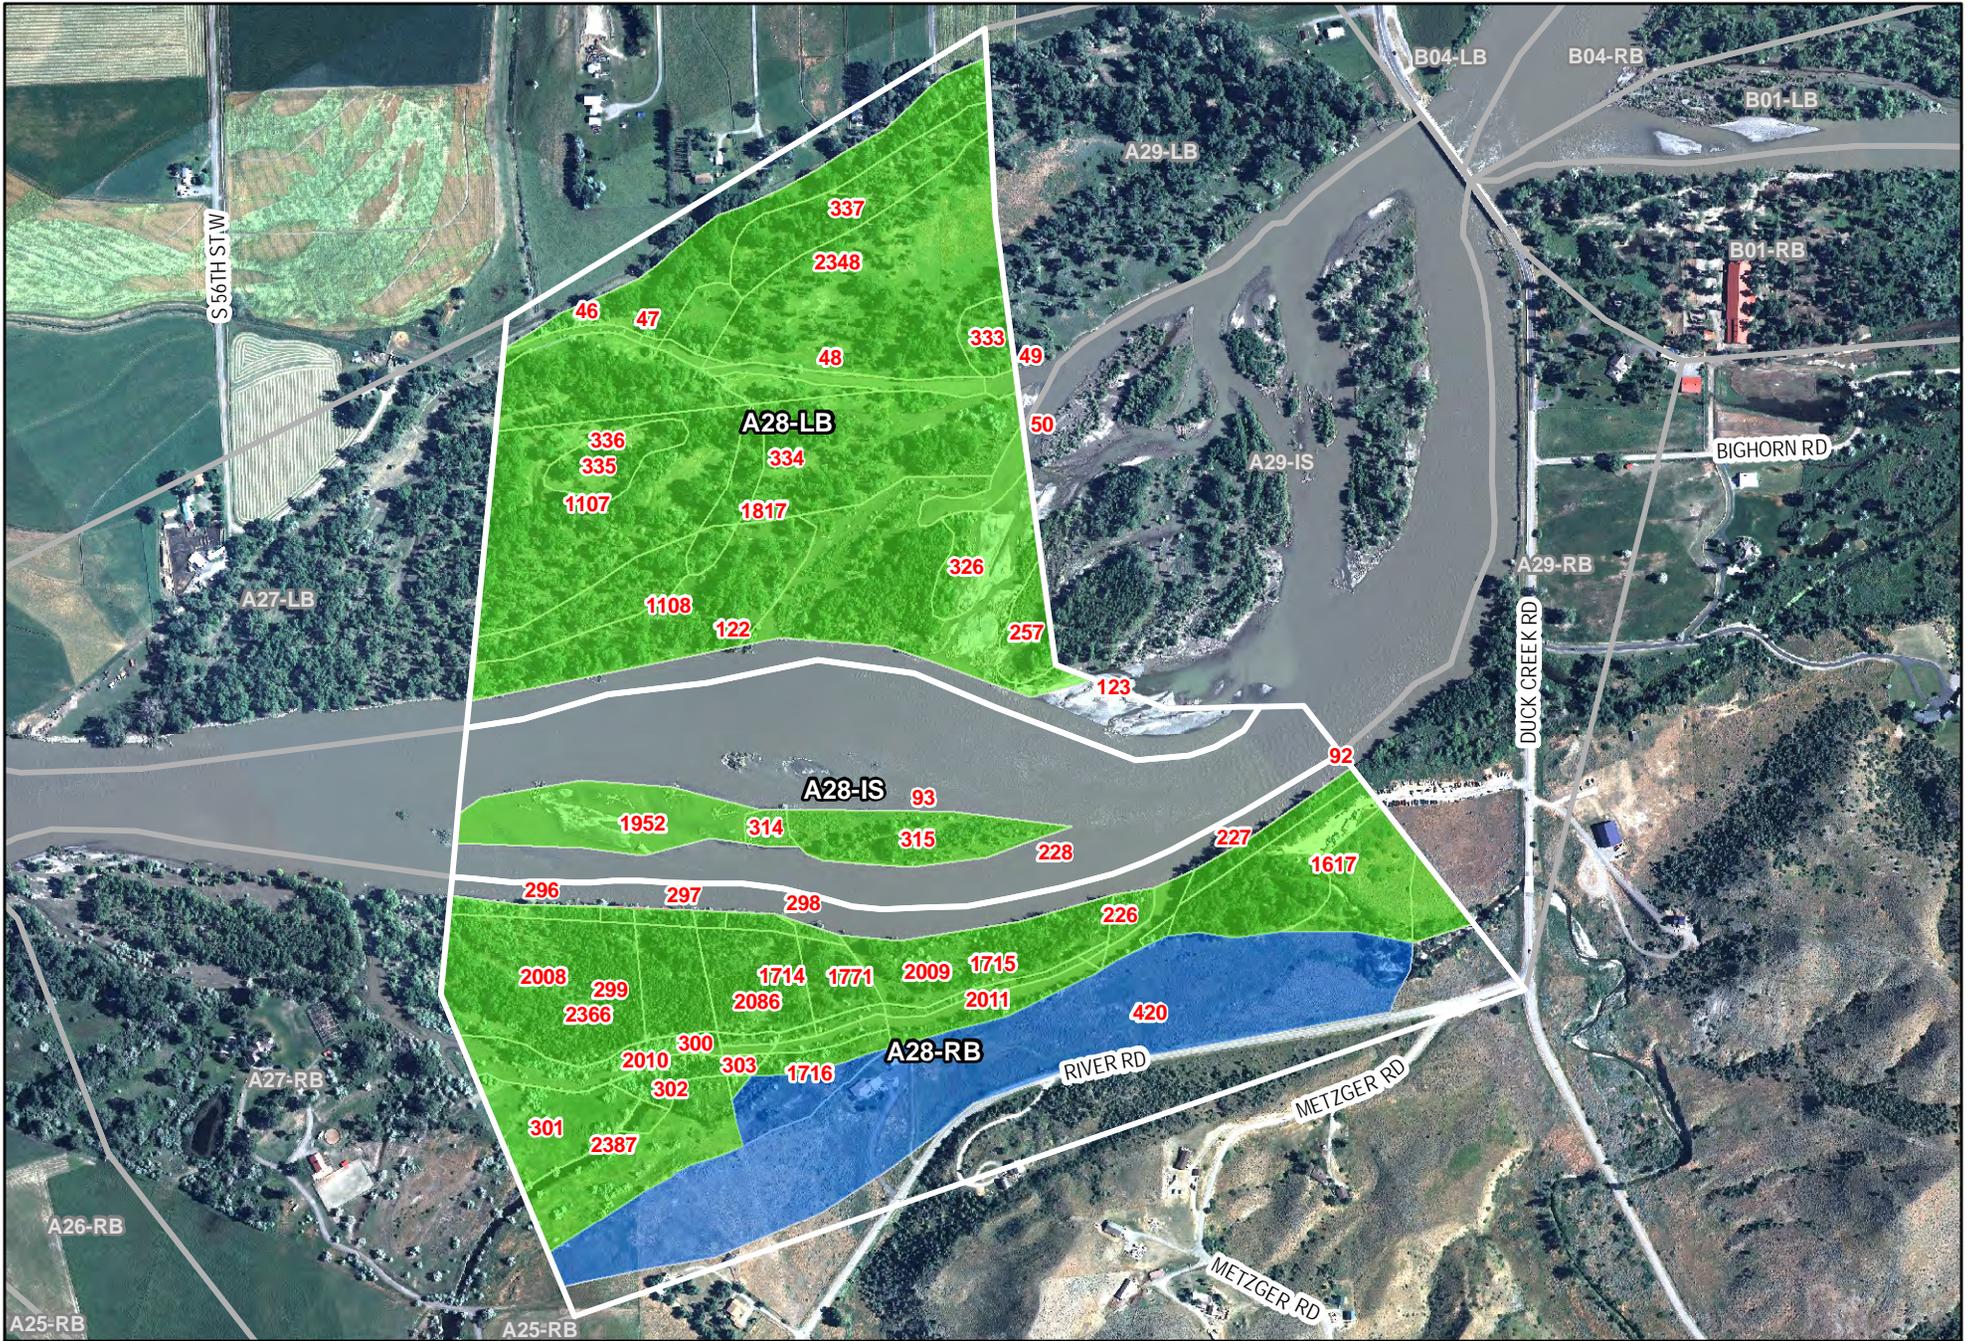
Figure 5 shows the oiling conditions within Area A28 following completion of oil removal activities. The SCAT team performed reassessments of the left bank, right bank, and island within SCAT Area A28 to confirm the agreed-upon cleanup endpoints identified in the applicable CTRs had been achieved. The SCAT reassessment documentation is presented in Appendix E.

Based on the initial SCAT survey performed on the right bank, no oil was observed on a portion of the segment. Based on the final SCAT surveys performed on the remainder of the right bank, left bank, and island within Area A28, no further treatment is recommended for these segments. SCAT Area Sign-Off Forms are included as Appendix F.

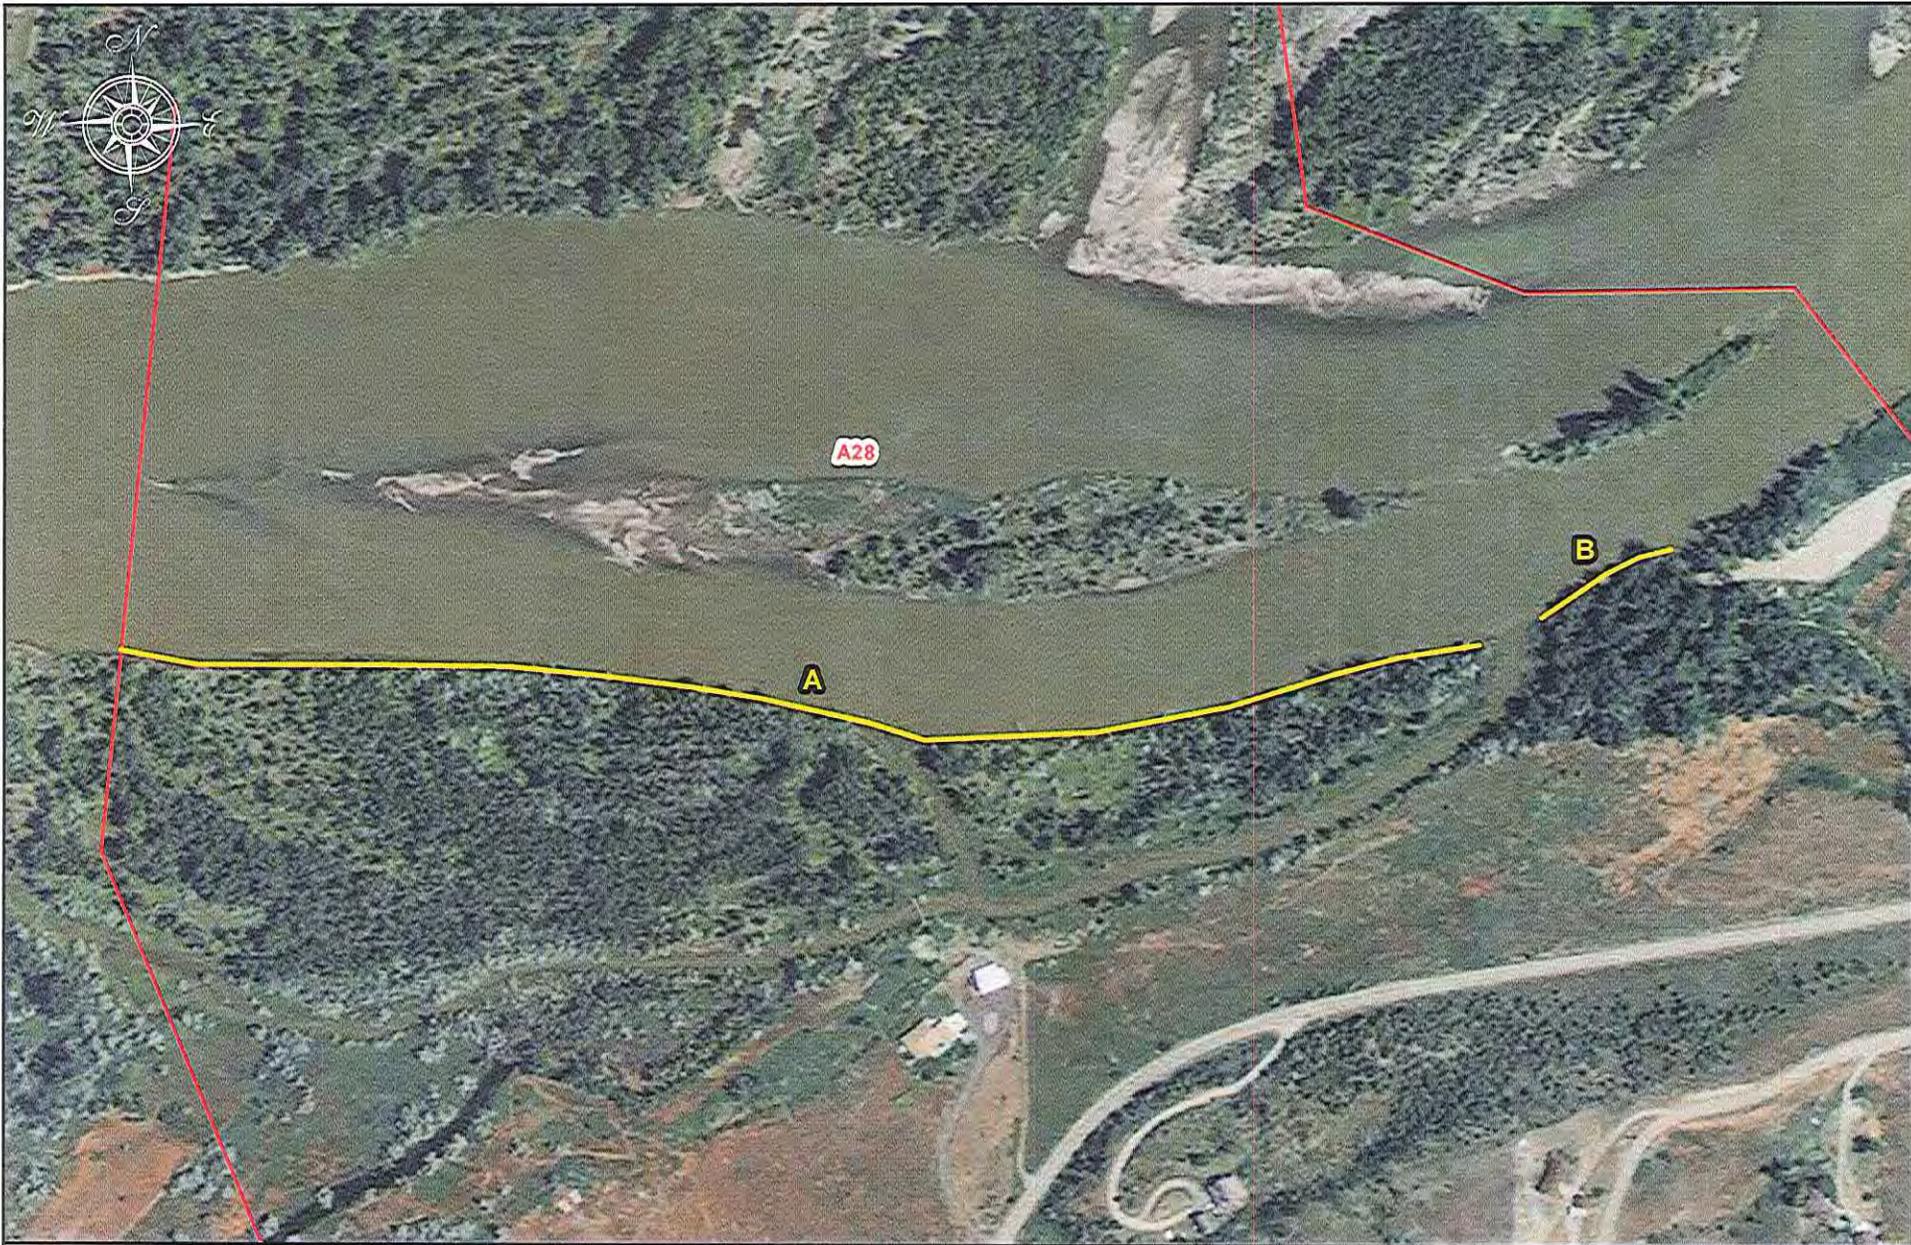
Segment A28 - Right Bank

Zone B Same Recommendations as Zone A. Hotspot ① 45.68644, 108.65320 - covered debris + grass - more dense than rest of zone.

Zone C Same recommendations as zone A - Hotspot ① 45.68623, 108.65115 oiled small debris + veg ~20'x20' area.

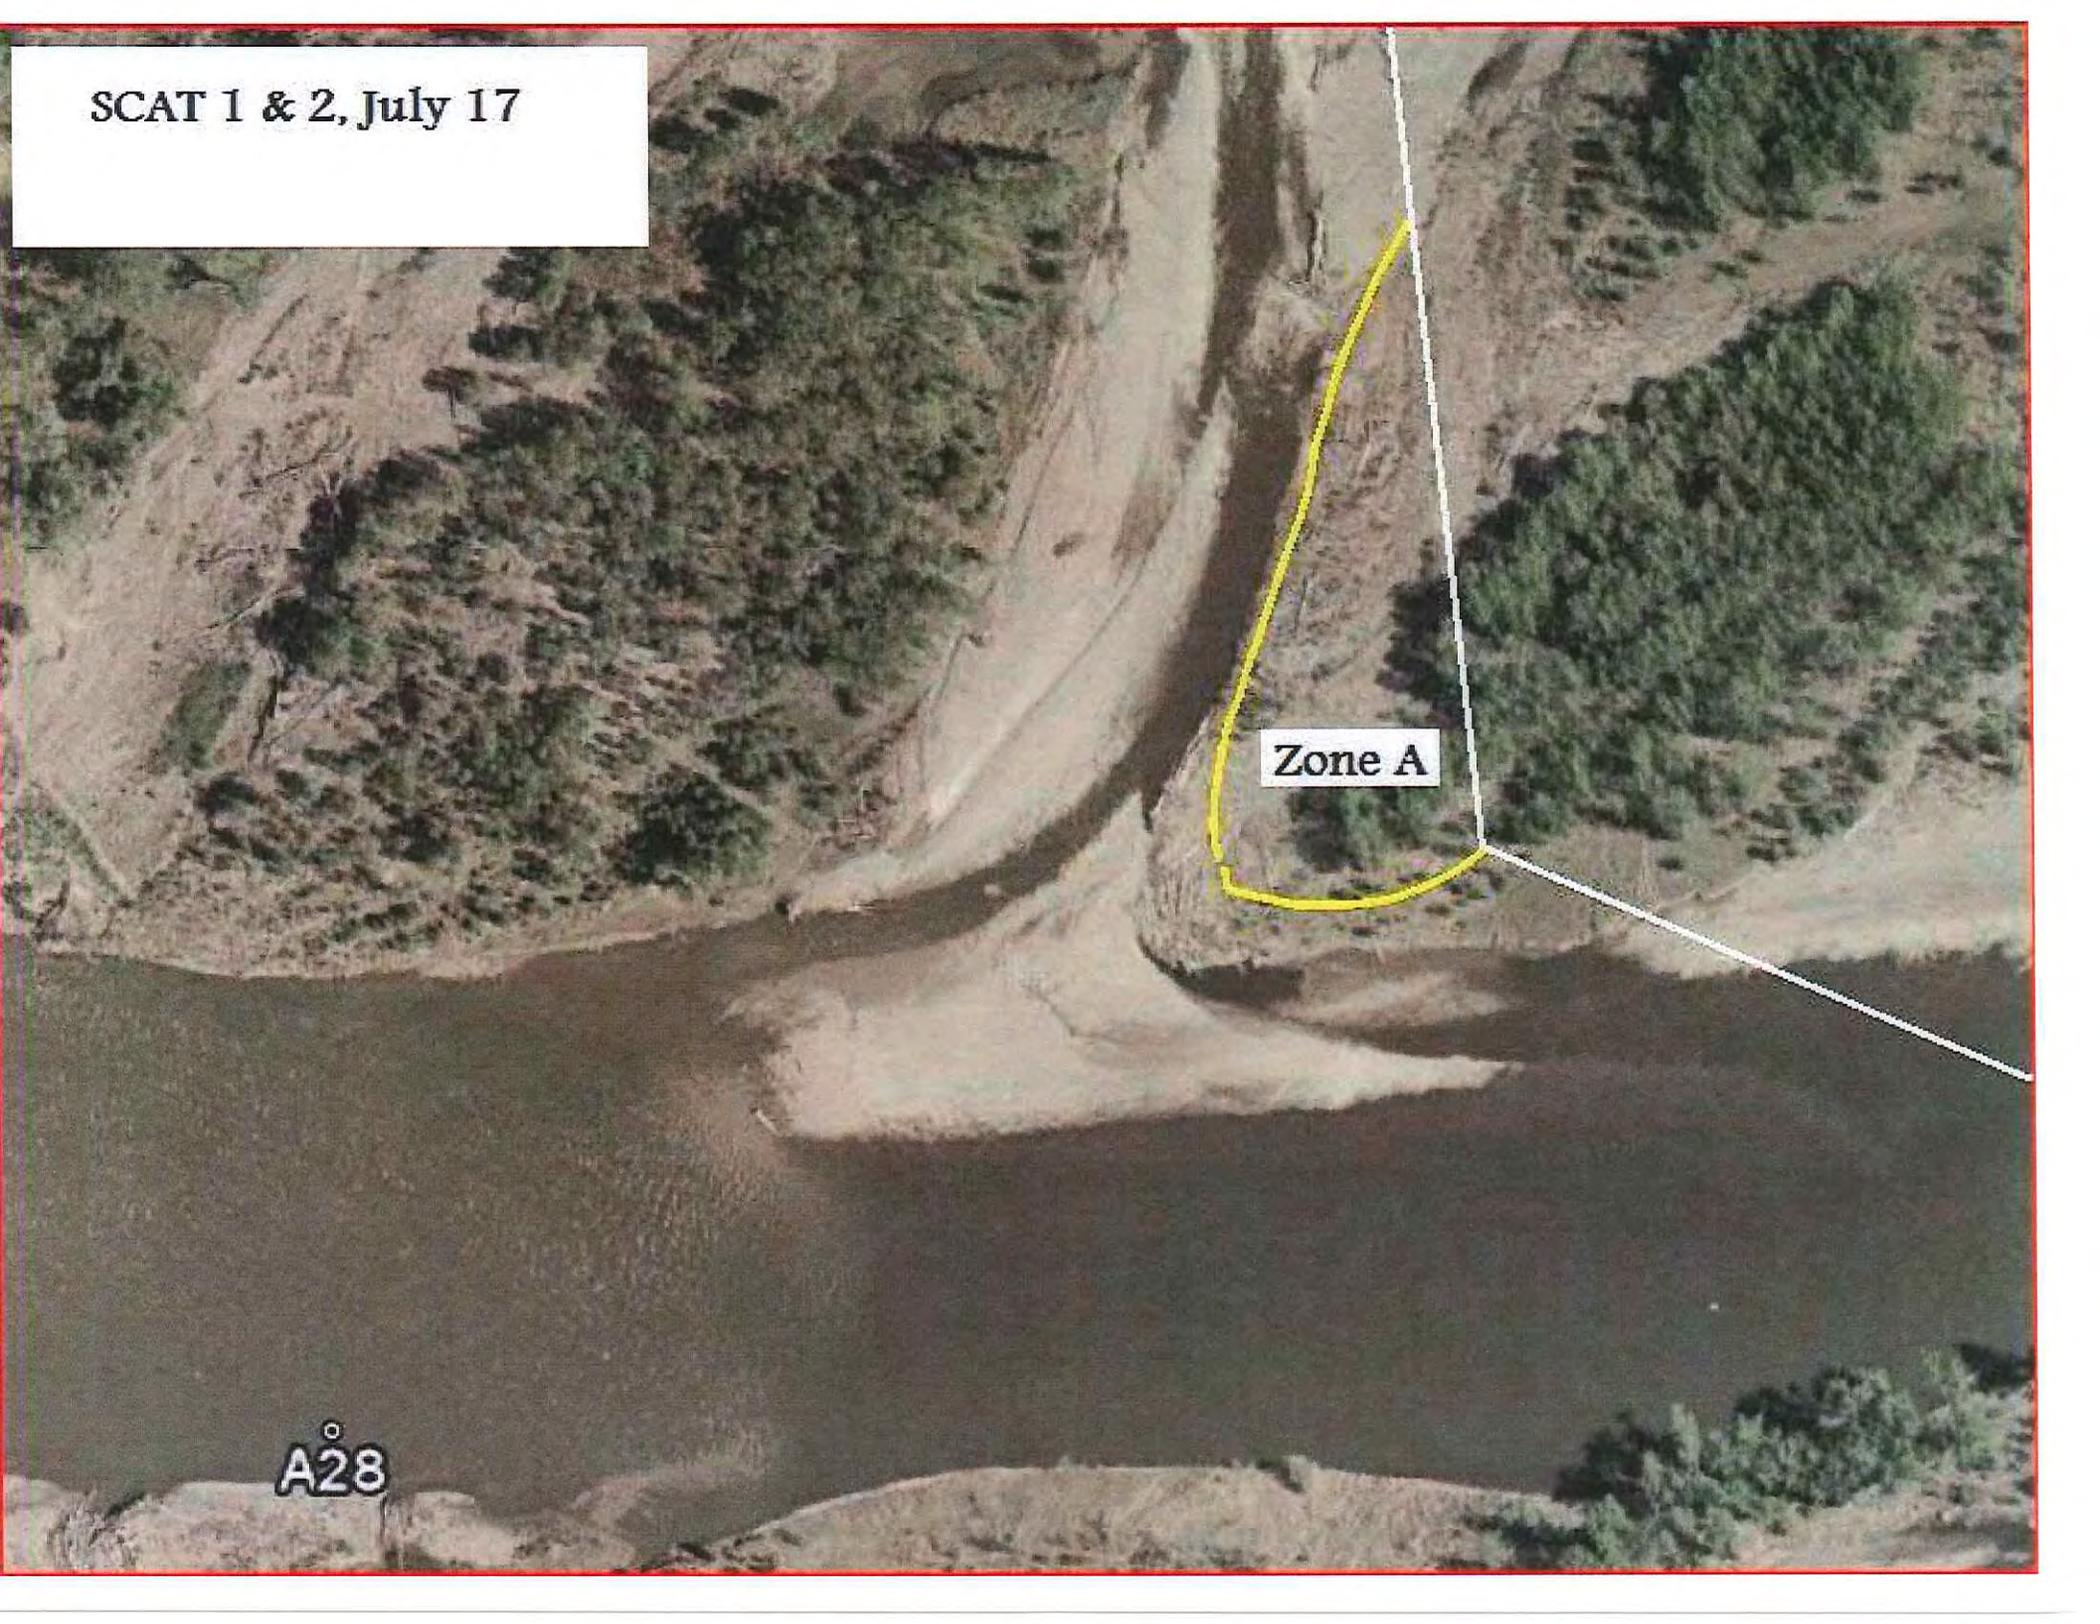
A28

6 SURFACE OILING CONDITIONS																				begin with "A" in the lowest tidal zone - circle the zone/s that correspond to primary shoreline type	
OIL ZONE ID	RIVER BANK ZONE				OIL COVER			OIL THICKNESS					OIL CHARACTER							SUBST. TYPE(S)	
	MS	LB	UB	OB	Length m	Width m	Distrib. %	TO	CV	CR	ST	FL	FR	MS	TB	PT	TC	SR	AP		NO
A				X			3			X	X			X							grass, debris, trees

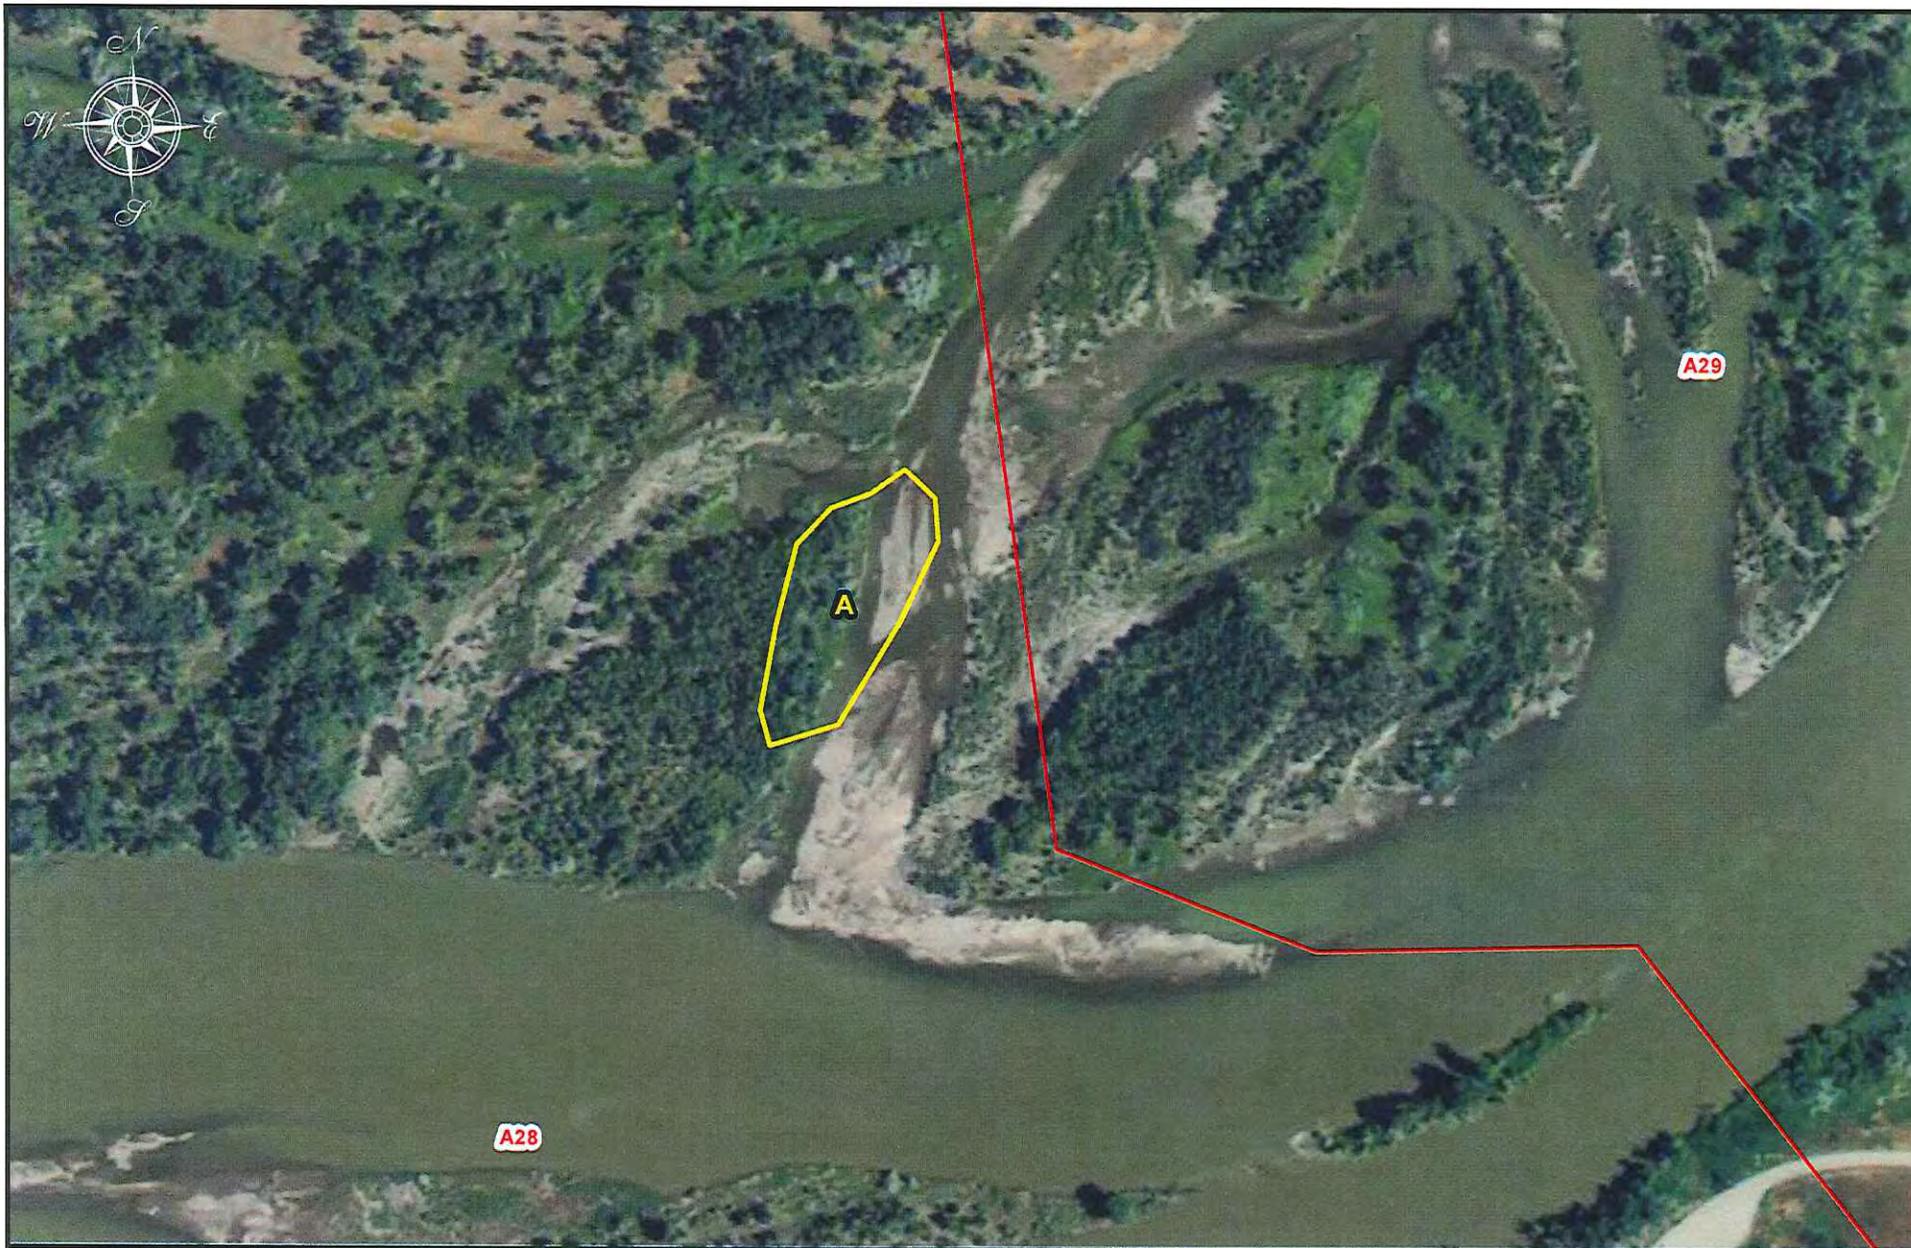
Segment A28 - Left Bank

A - area of trace oil on grass & woody debris to fence.
 B - no oil observed, very muddy, channels still flowing through area
 C - area of sporadic piles of woody debris, primarily around edges of channels at higher elevation that caught oiled debris & oil up 3m. Hand crew should go through & collect heavier oil. Three pads placed at WP# 276 to soak up pooled oil - need to collect.
 D - trace oil in grass & woody debris & on tree branches & trunks.

E - Area with discreet patches of oiled woody debris up to 2m in length.

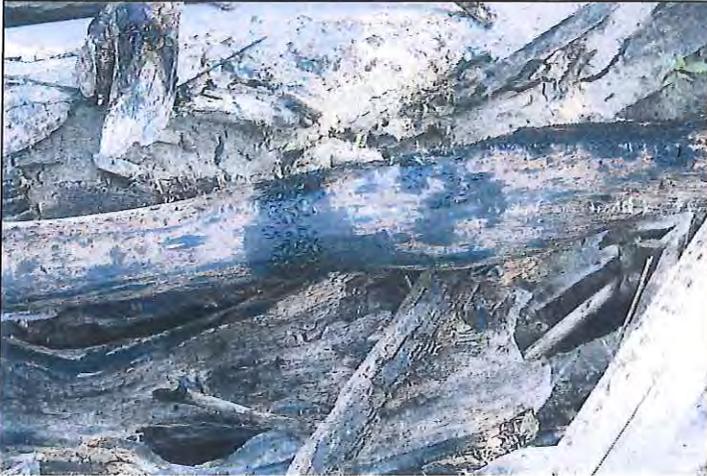
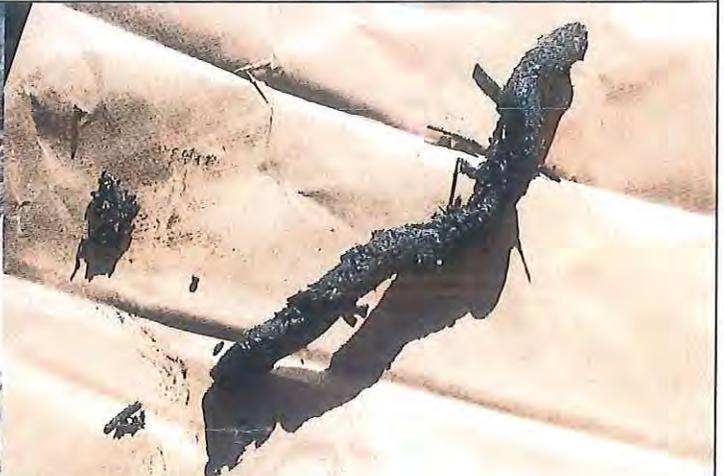
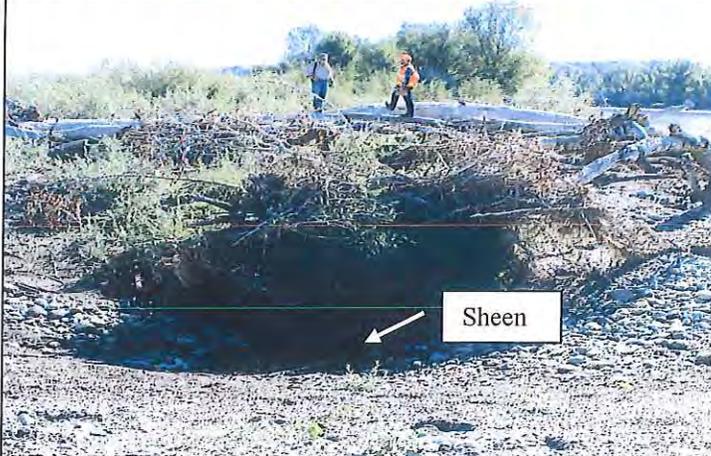
MESSAGE: International Bird Rescue and Resource Advisors from the U.S. Fish and Wildlife Service during the course of their work noted untreated oiled woody debris in approximately (6) debris piles on the western end of A08 Island. The debris piles are in close proximity to the active channel of the Yellowstone River, or situated over depressions that likely capture rain water and any oil that might be washed from the debris piles. Either situation is likely to result in sheen on surface waters, and a corresponding wildlife hazard. In the same portion of the island and generally associated with the debris piles are several small pools with sheen. These pools present an immediate risk to wildlife, especially migratory birds. A description of the area in need of treatment and general location information was provided to the Operation's Wildlife Quick Response Team to be added to their list Wildlife Priority Cleanup Areas.

per Nathan Cook
All operations - complete
completed on 9/13/11
[Signature]
J.R. Grawcek

REPLY:
The Unified Command is aware of the wildlife exception on the small emergent island adjacent to A28 Island. ExxonMobil will coordinate any future remediation activities at this site with MTDEQ. In the meantime, this segment will be flagged and noted in the close-out segment report. If the work is not completed and signed off by the Wildlife Branch prior to closeout. Then this document will be included as an attachment to the Area Transition Report to document the need for additional work within this segment, and this report will be updated to document that the exception was addressed and no further follow-up will be needed.

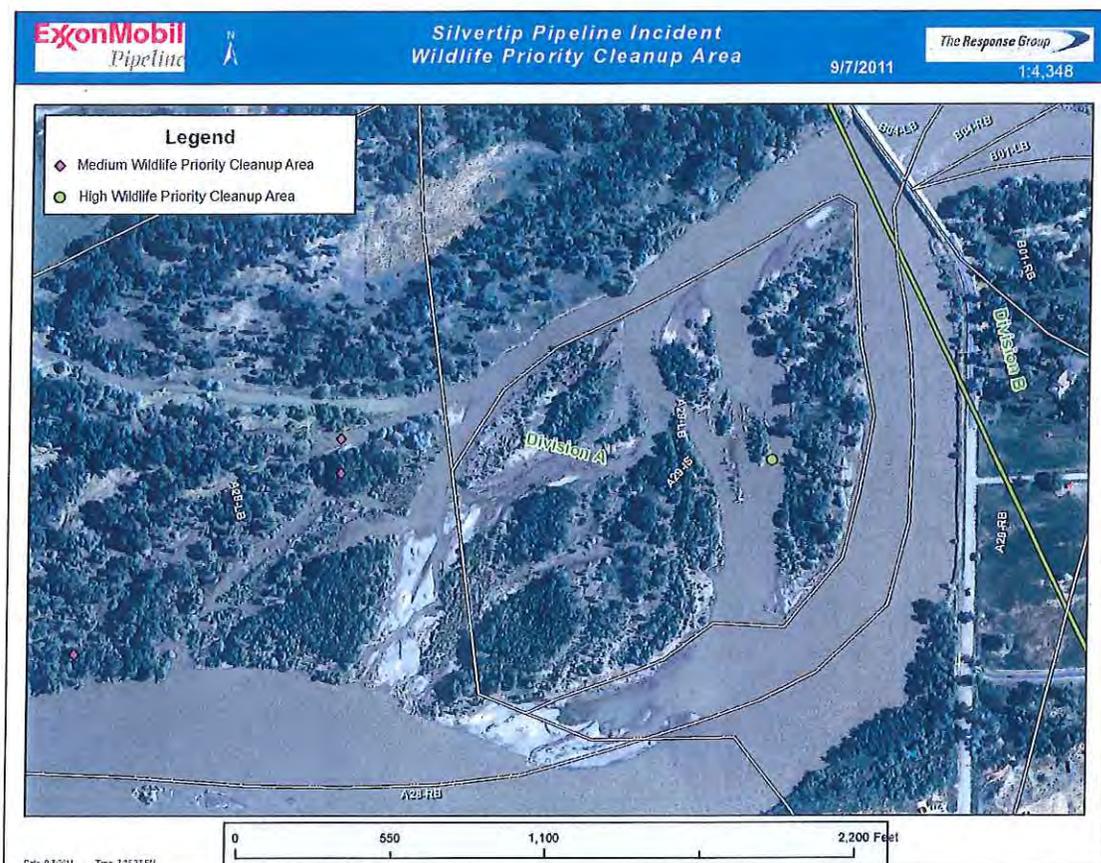
MESSAGE: International Bird Rescue and Resource Advisors with the USFWS identified four pools with sheen in scat sector A-28 and 29. This segment has passed SCAT but requires further response to reduce wildlife exposure risks. The four pools are identified on the map below. All pools had sheen on the water, passed the "stick test," the oil was transferable to a nitrile glove, and animal tracks were present. GPS coordinates of these pools are available and are listed on the Oiled Wildlife Risk Assessment Form maintained by the Wildlife Branch. A map of these areas is attached below, with a priority ranking associated with the locations. The size of the high priority area is 30 ft by 15 ft, the moderate priority areas are 50 ft by 20 ft, 100ft by 7 ft, and 30 ft by 10 ft.

An Exception Memo was drafted for sheen observed on several pools within Area 28. The Exception Memo was closed administratively after further investigation revealed that the sheen was not hydrocarbon or incident related.
