**SCAT Area Transition Report  
for A29**

Silvertip Pipeline Incident  
Laurel, Montana

Our Ref.:  
B0085883.1103

Date:  
October 22, 2011

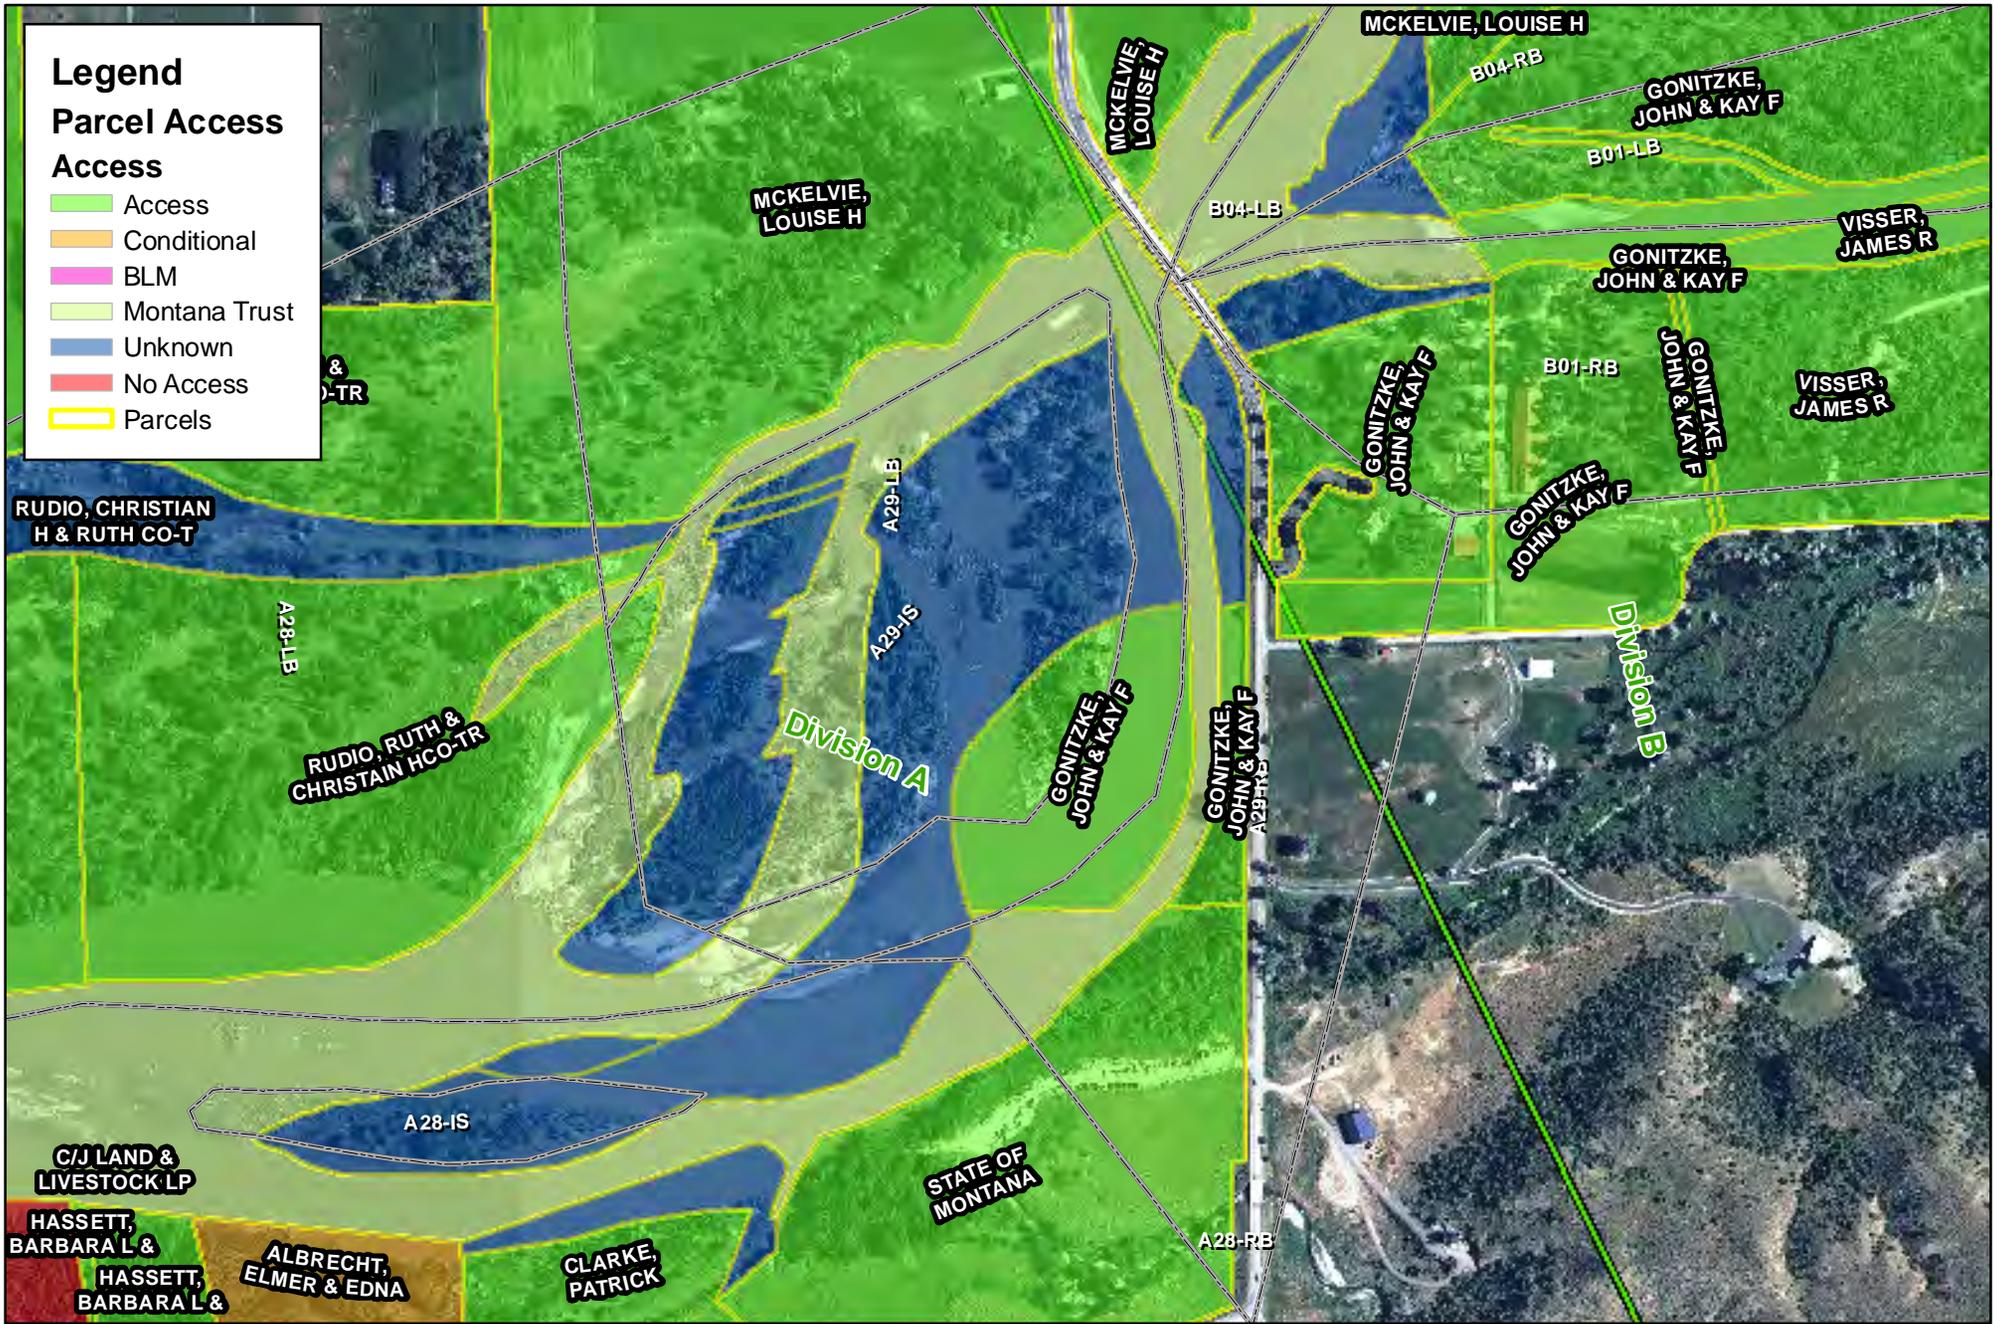
Figure 1 provides an aerial map of SCAT Area A29, along with the (a) SCAT Area boundary, (b) parcel boundaries and respective property owners, and (c) access constraints identified during the oil cleanup process. The acreage surveyed in Area A29 is 73.0. There were no access issues for this area.

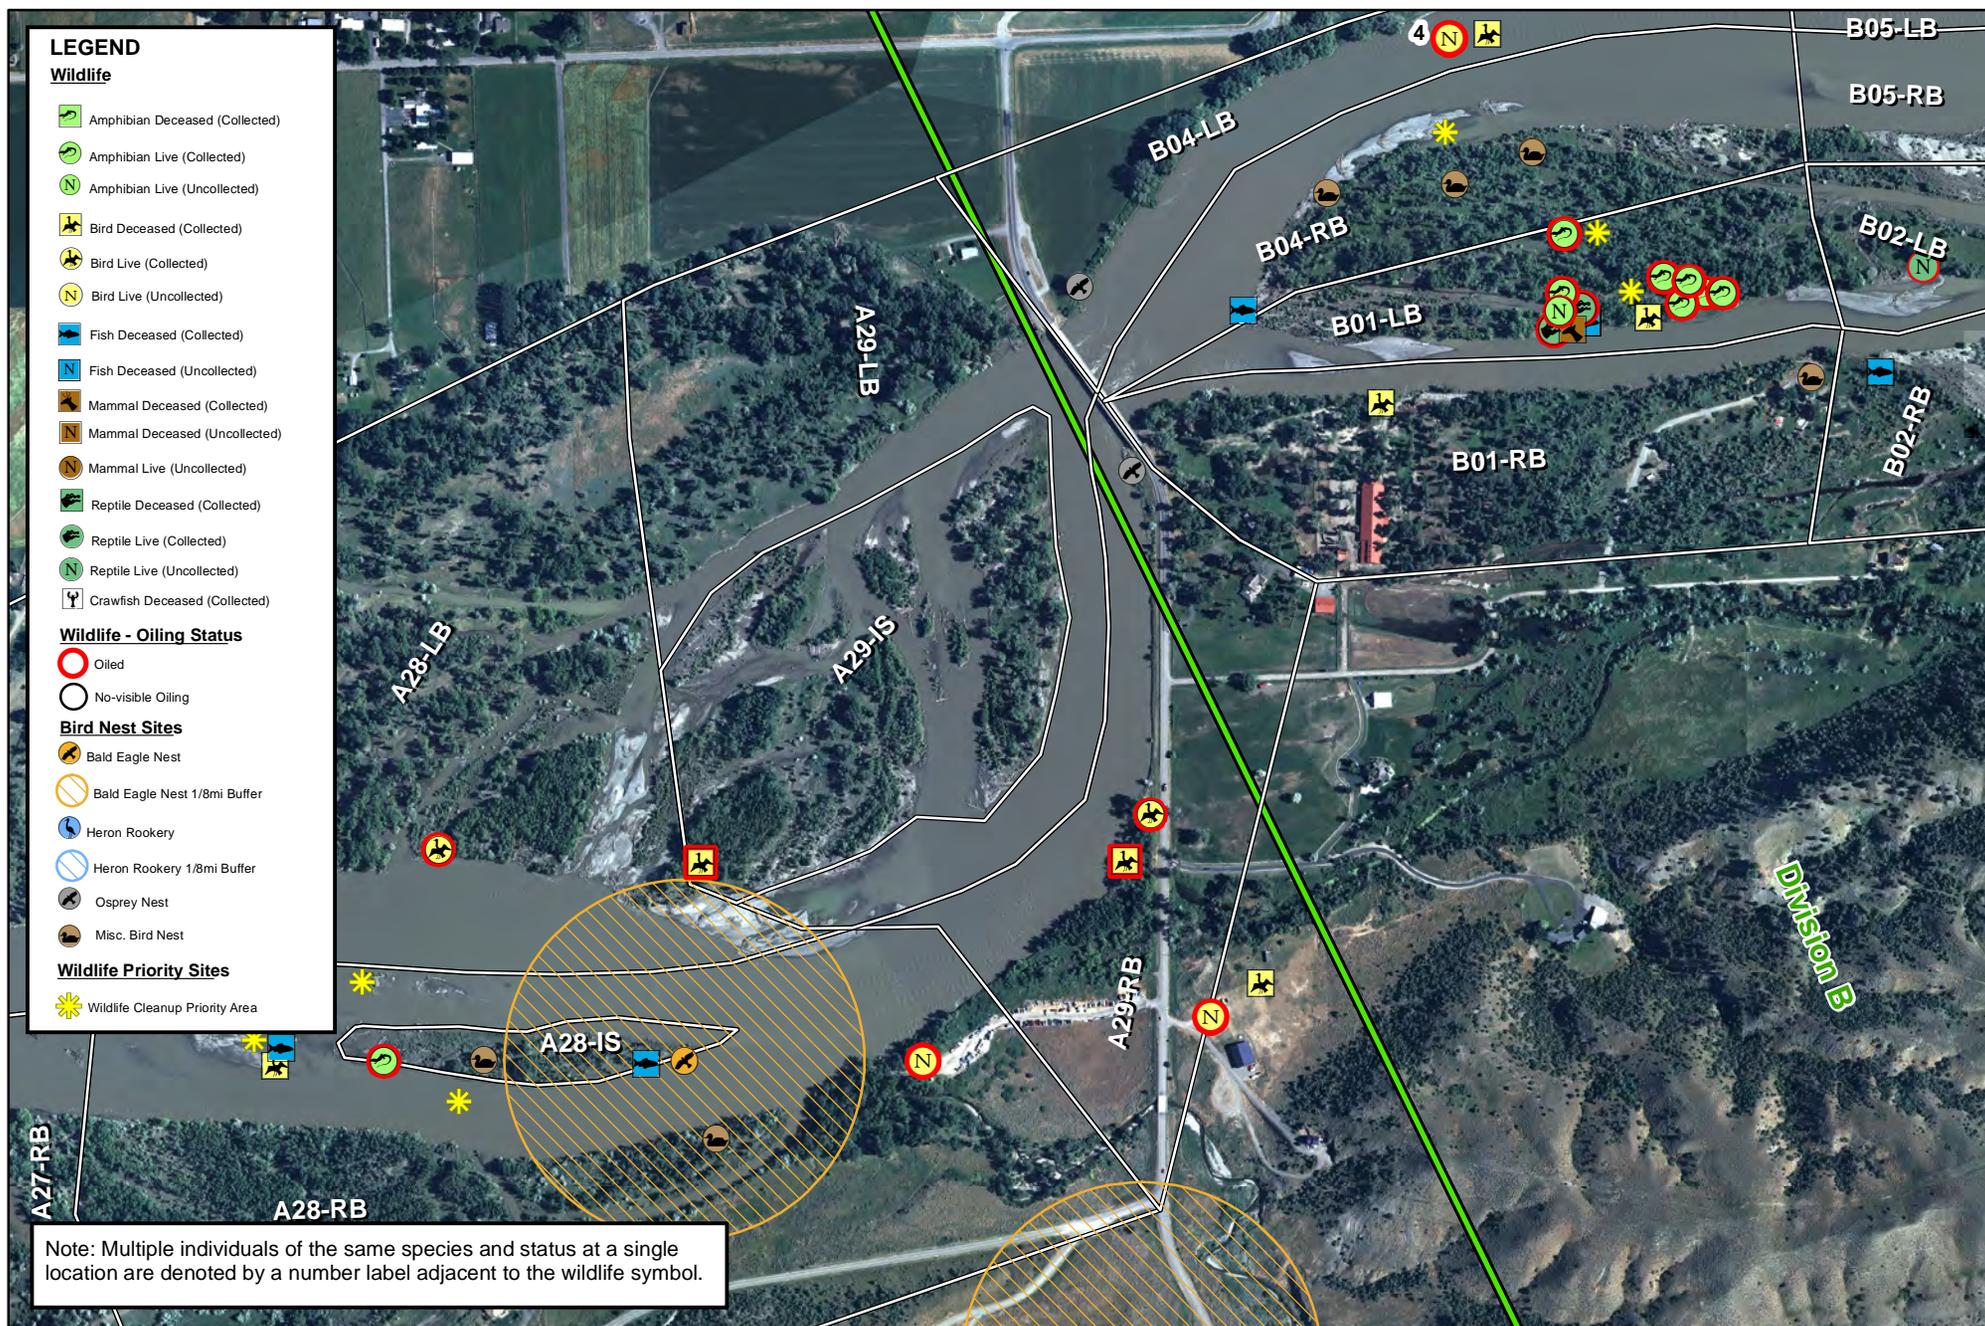
**Figure 2**  
**Wildlife Resources**

Figure 2 summarizes the natural resources identified in this area. International Bird Rescue and Resource Advisors from U.S. Fish and Wildlife Service conducted regular inspections of Area A29. One lightly oiled yellow warbler (*Dendroica petechia*) was captured, cleaned, and released. A lightly oiled red-tailed hawk (*Buteo jamaicensis*) was also observed; this is likely the same individual noted in the SATR for Area A28. One deceased moderately oiled mallard (*Anas platyrhynchos*) and one deceased lightly oiled great horned owl (*Bubo virginianus*) were collected and retained. No Wildlife Priority Cleanup Areas were identified. An Osprey (*Pandion haliaetus*) nest was identified in Area A29. In addition, a portion of a bald eagle (*Haliaeetus leucocephalus*) nesting buffer zone extended into Area A29 and was provided to Operations. An Exception Memo was drafted for sheen on several pools; the Exception Memo was closed administratively after further investigation revealed that the sheen was not hydrocarbon or incident related.

As described in Section 1.2, the Wildlife Branch identified pools with sheen and oiled woody debris in several areas of A29 after operations were complete. An Exception Memo was drafted for sheen on several pools; however, the Exception Memo was closed administratively after further investigation revealed that the sheen was not hydrocarbon or incident related. A copy of the closed Exception Memo is included in Appendix G.

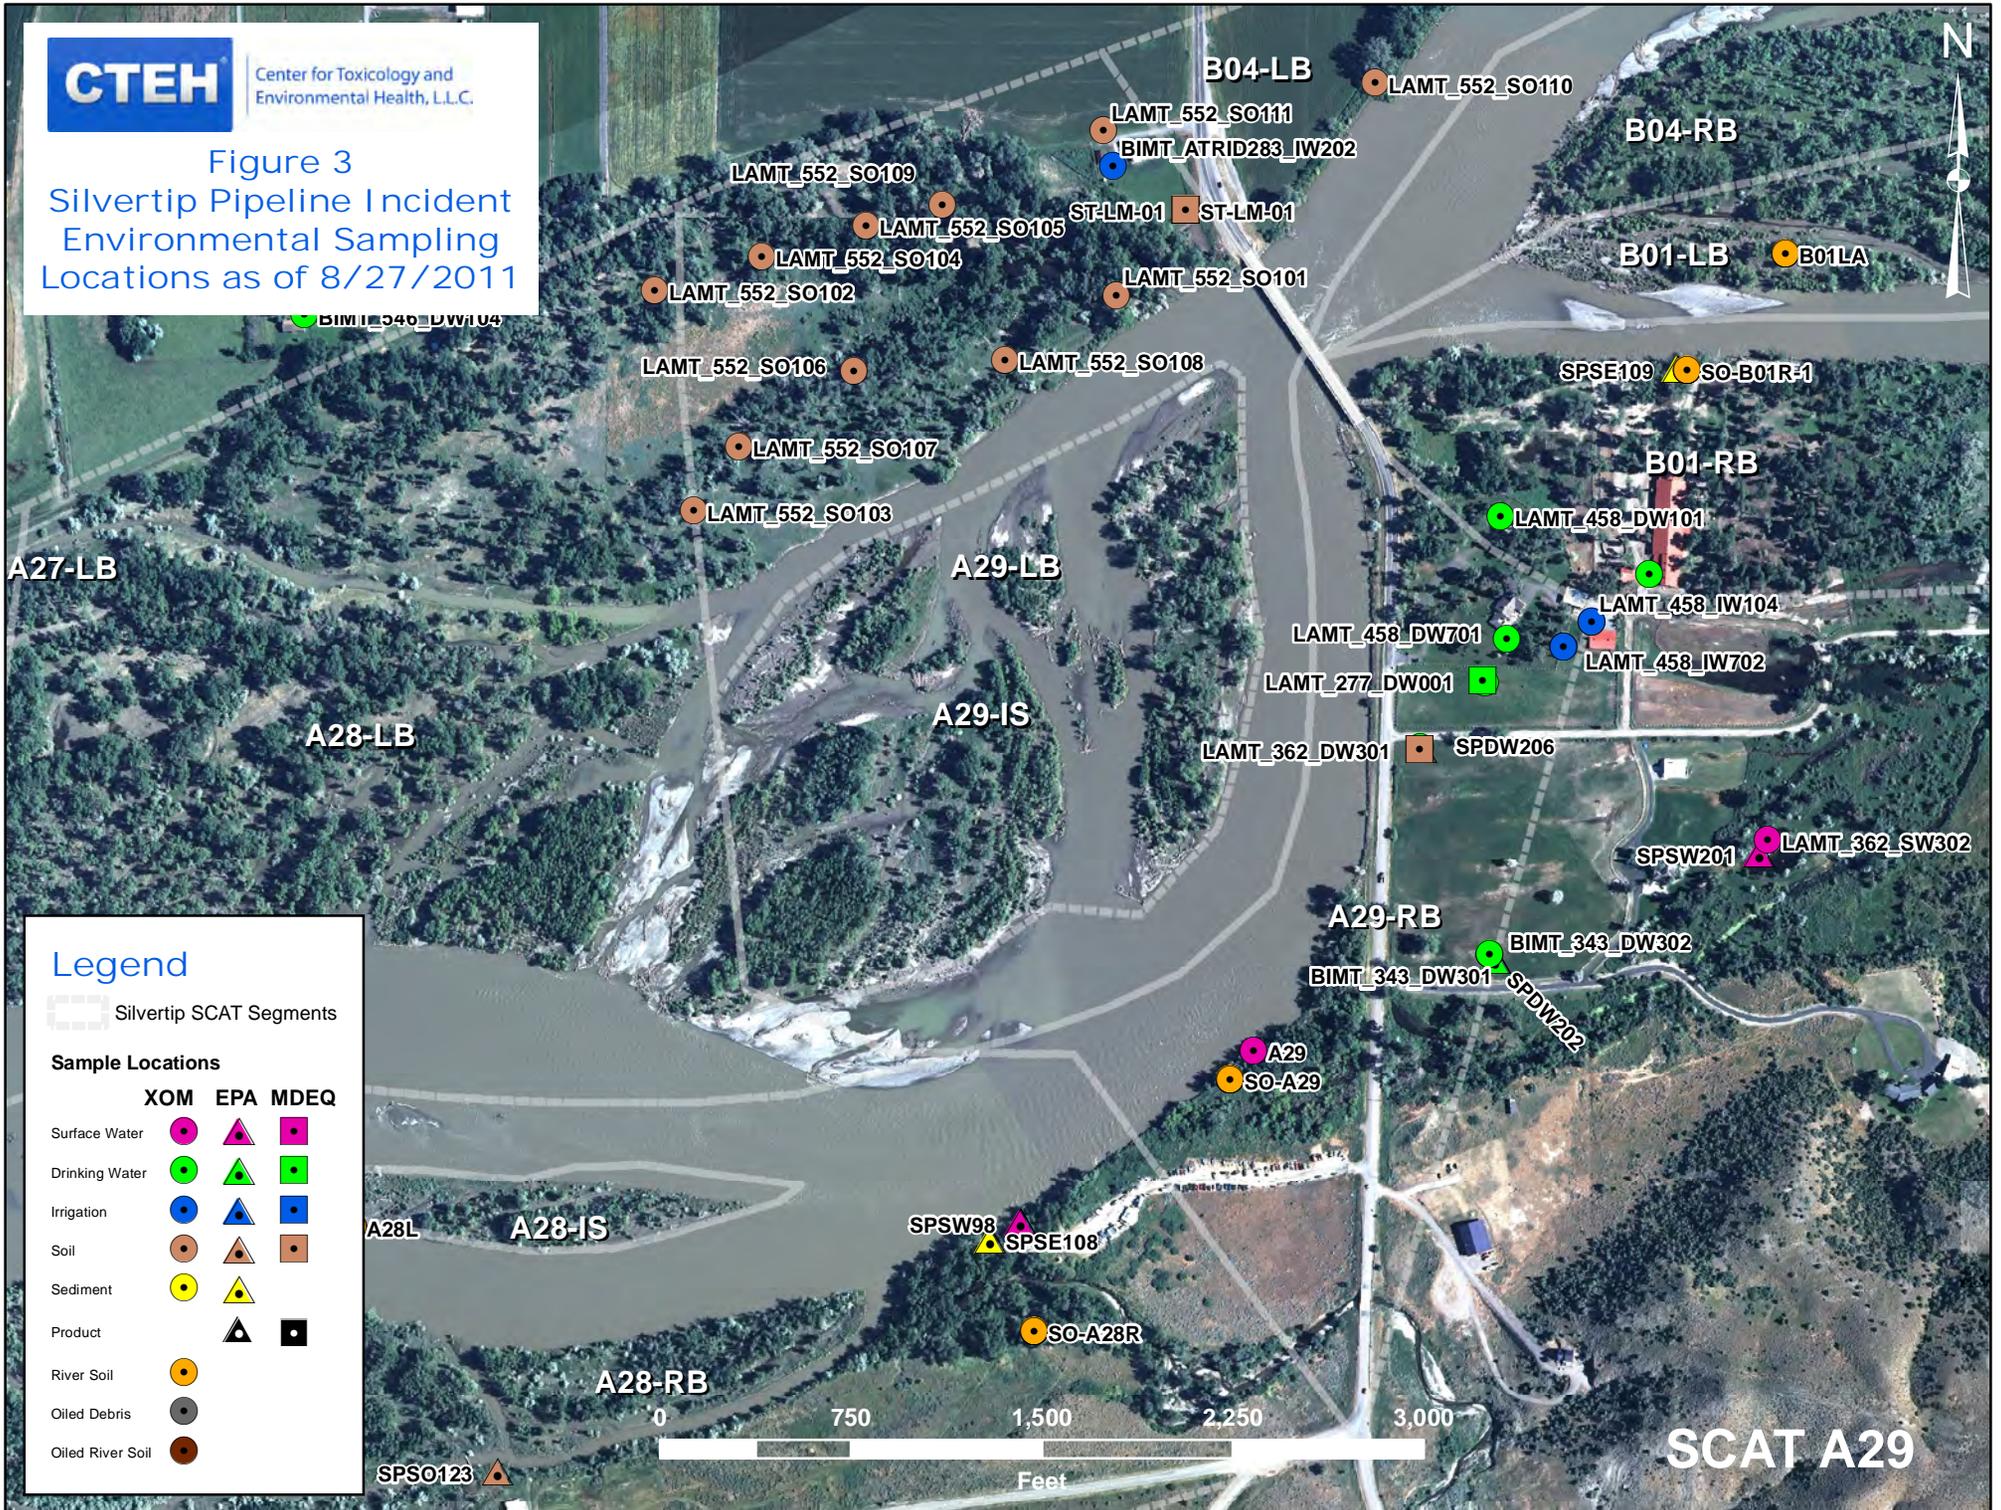
Figure 3  
Silvertip Pipeline Incident  
Environmental Sampling  
Locations as of 8/27/2011

Table 1 (below) summarizes samples collected within Area A29. The analytical results for the samples collected can be accessed through a publicly accessible database on the United States Environmental Protection Agency's (USEPA's) website. The approximate locations of samples collected within Area A29 are provided on Figure 3.

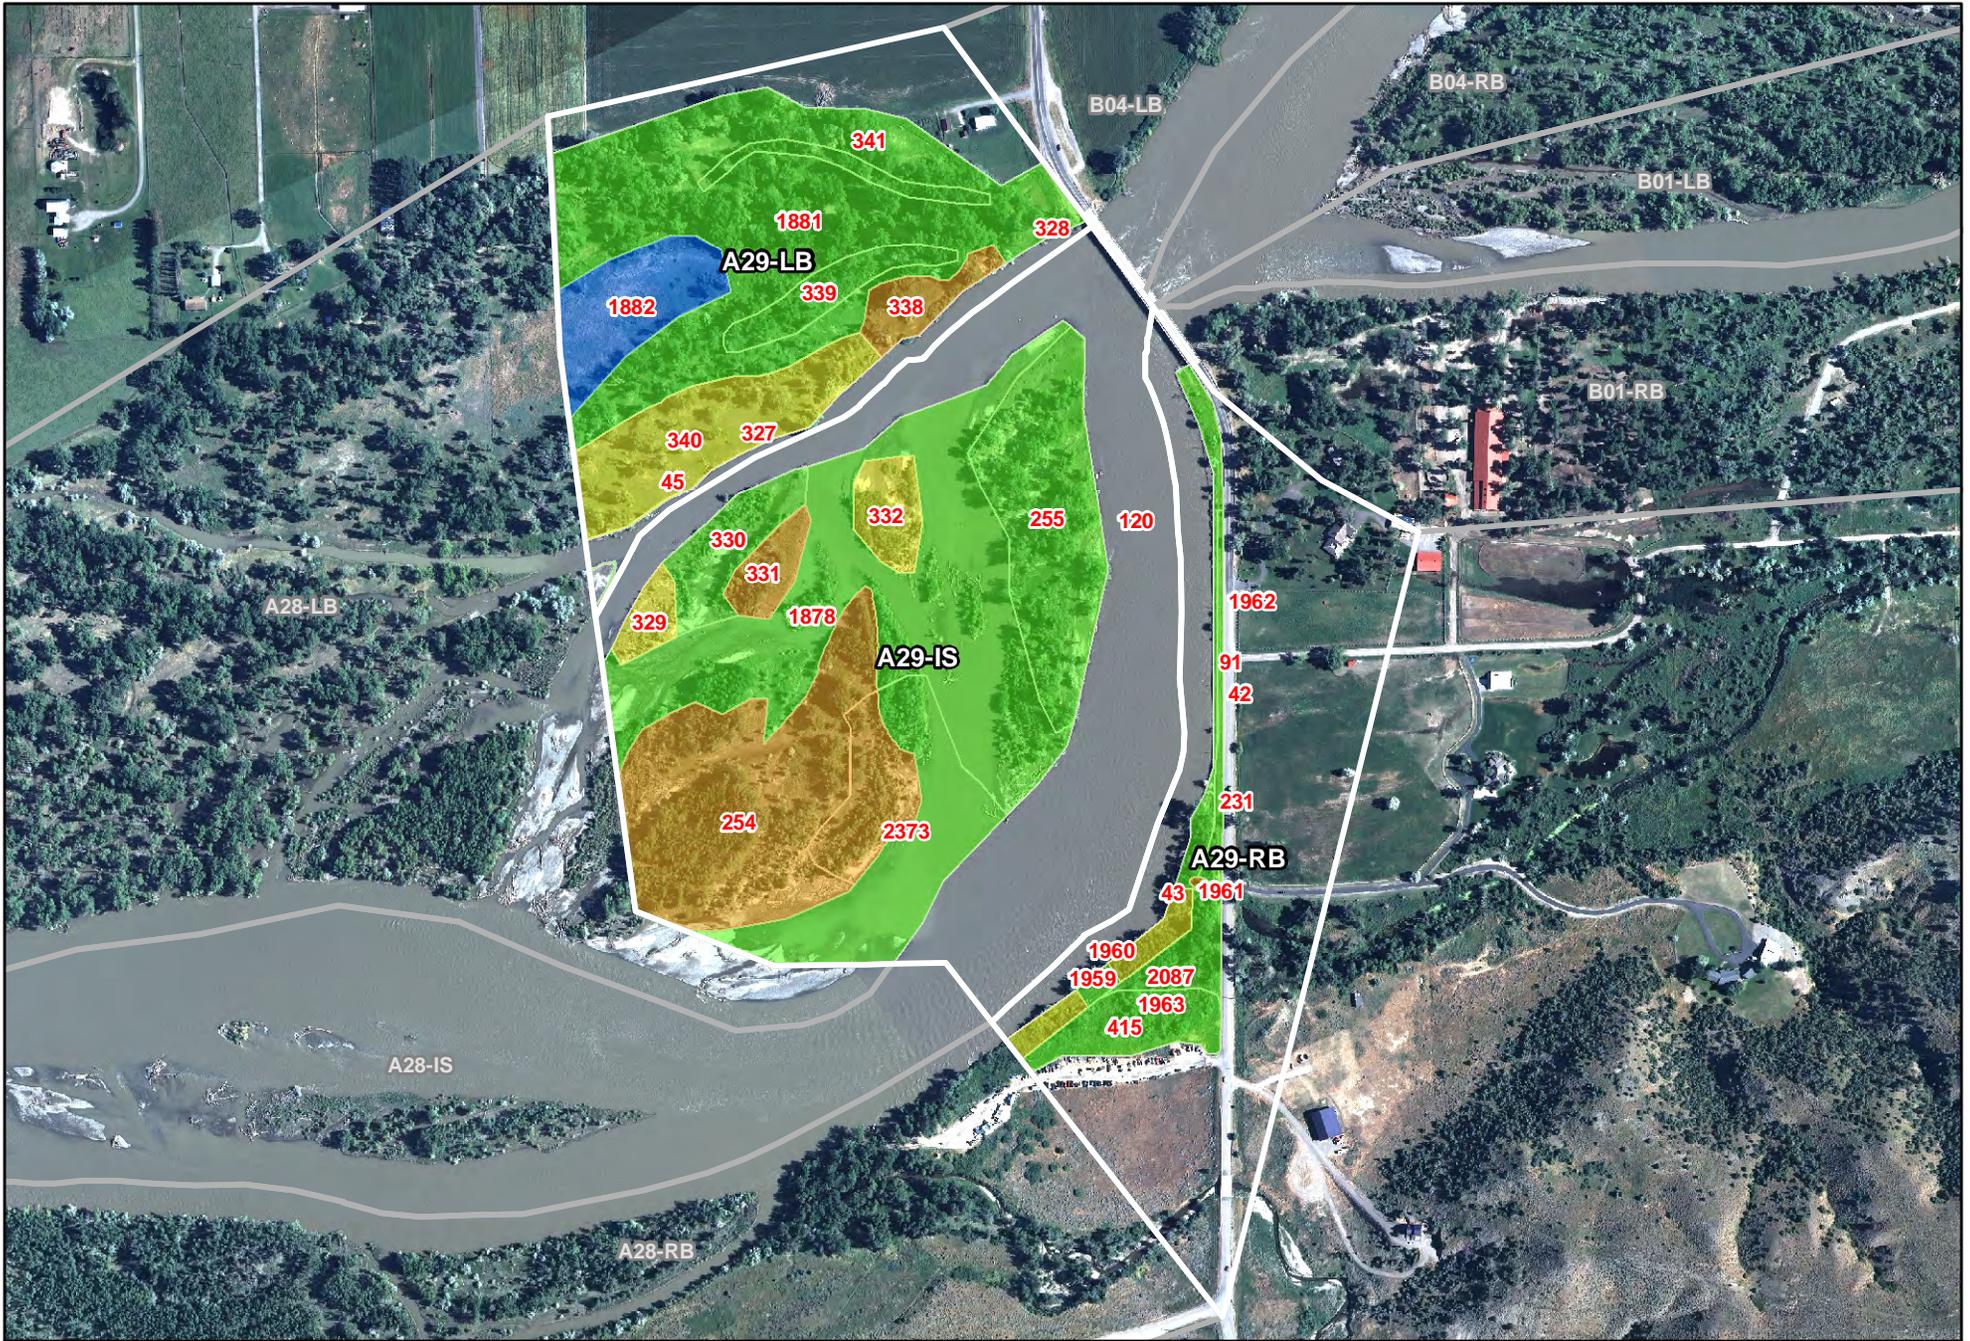
**Figure 4 - Maximum SCAT Observations For SCAT Area:**

The SCAT teams used systematic evaluation criteria and treatment method tables approved by the National Oceanic and Atmospheric Administration to provide a standard approach for data collection and conducting field surveys. The forms and sketches from the initial SCAT surveys performed along the river bank (water edge) and floodplain within Area A29 are included in Appendix B. Figure 4 provides the maximum oiling zones observed by the SCAT team during the initial surveys of Area A29.

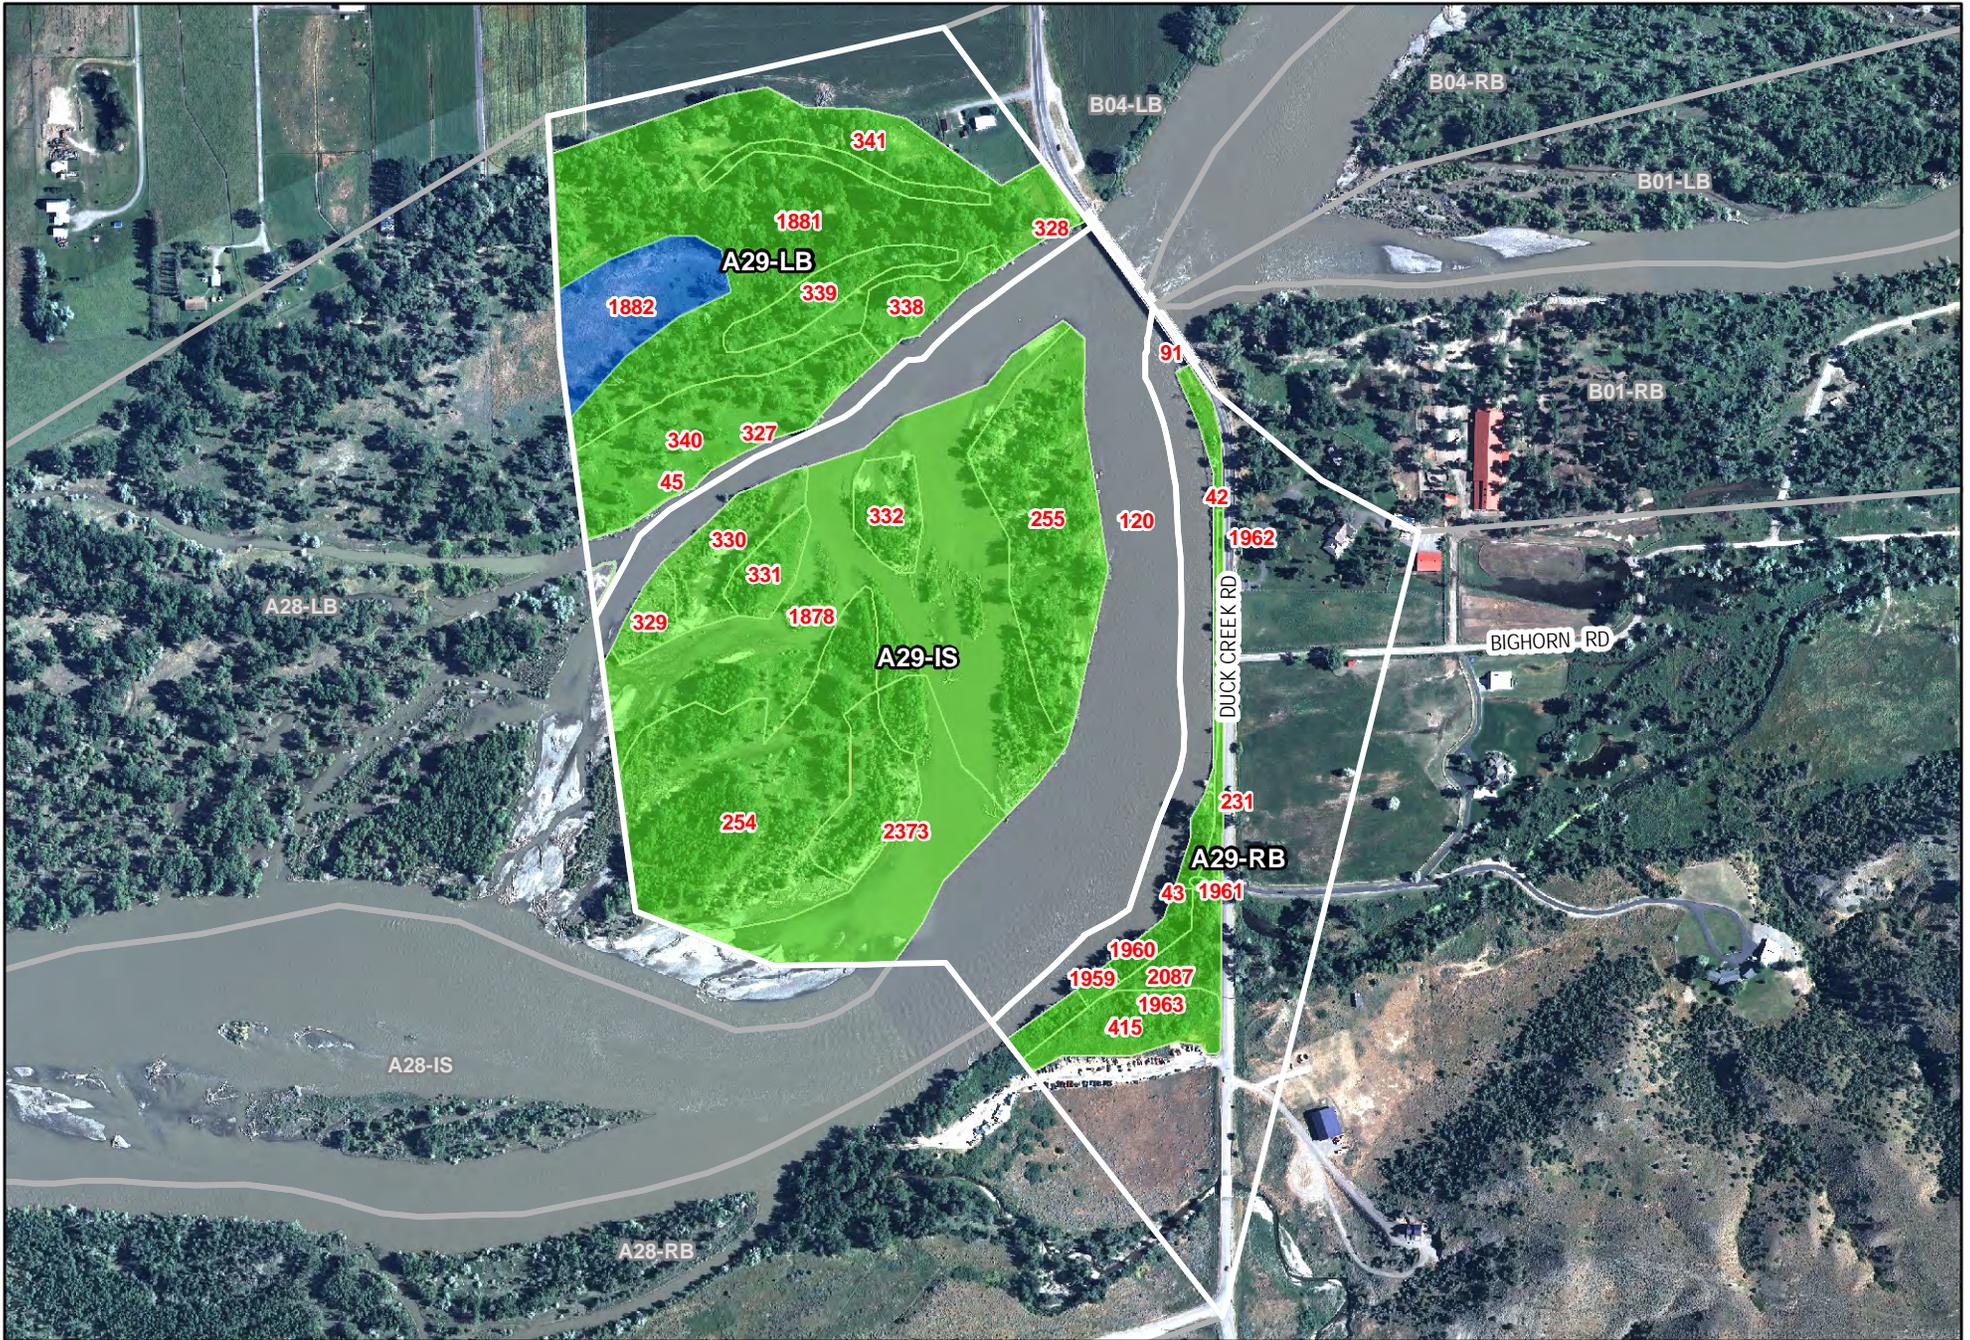
Figure 5 shows the oiling conditions within Area A29 following completion of oil removal activities. The SCAT team performed final surveys of the left and right banks and island within SCAT Area A29 to confirm the agreed-upon cleanup endpoints identified in the applicable CTRs had been achieved. The final SCAT survey documentation is presented in Appendix E.

Based on the final SCAT surveys performed on the left and right banks and island within Area A29, no further treatment is recommended for these areas. SCAT Segment Sign-Off Forms are included as Appendix F.

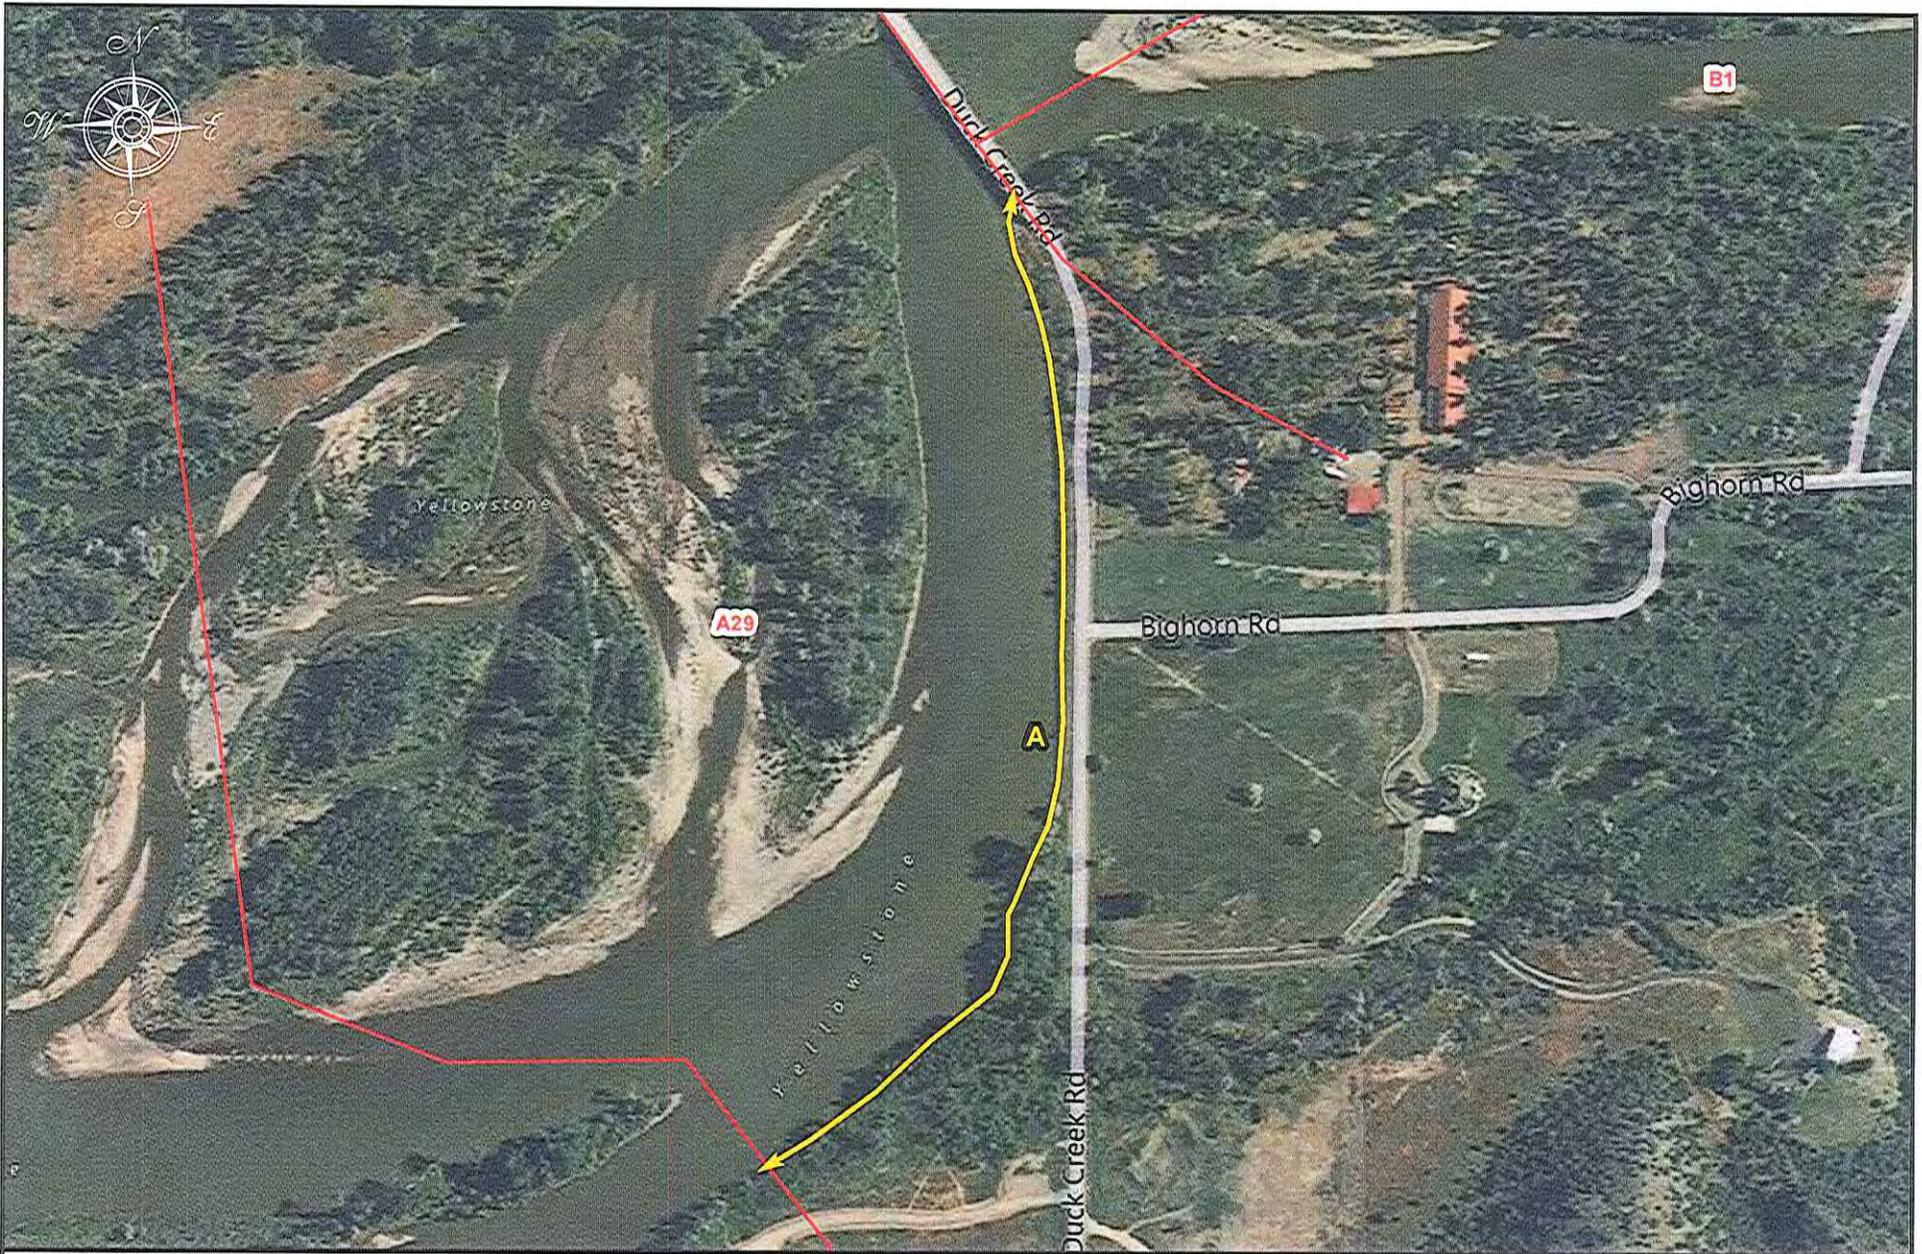
**SCAT Teams 2 & 4 Survey**

Segment A29 Right Bank

Diled veg detritus  
on ground  
intermittent through  
area

Collect & polish  
area by cutting, raking, collecting  
oiled veg.

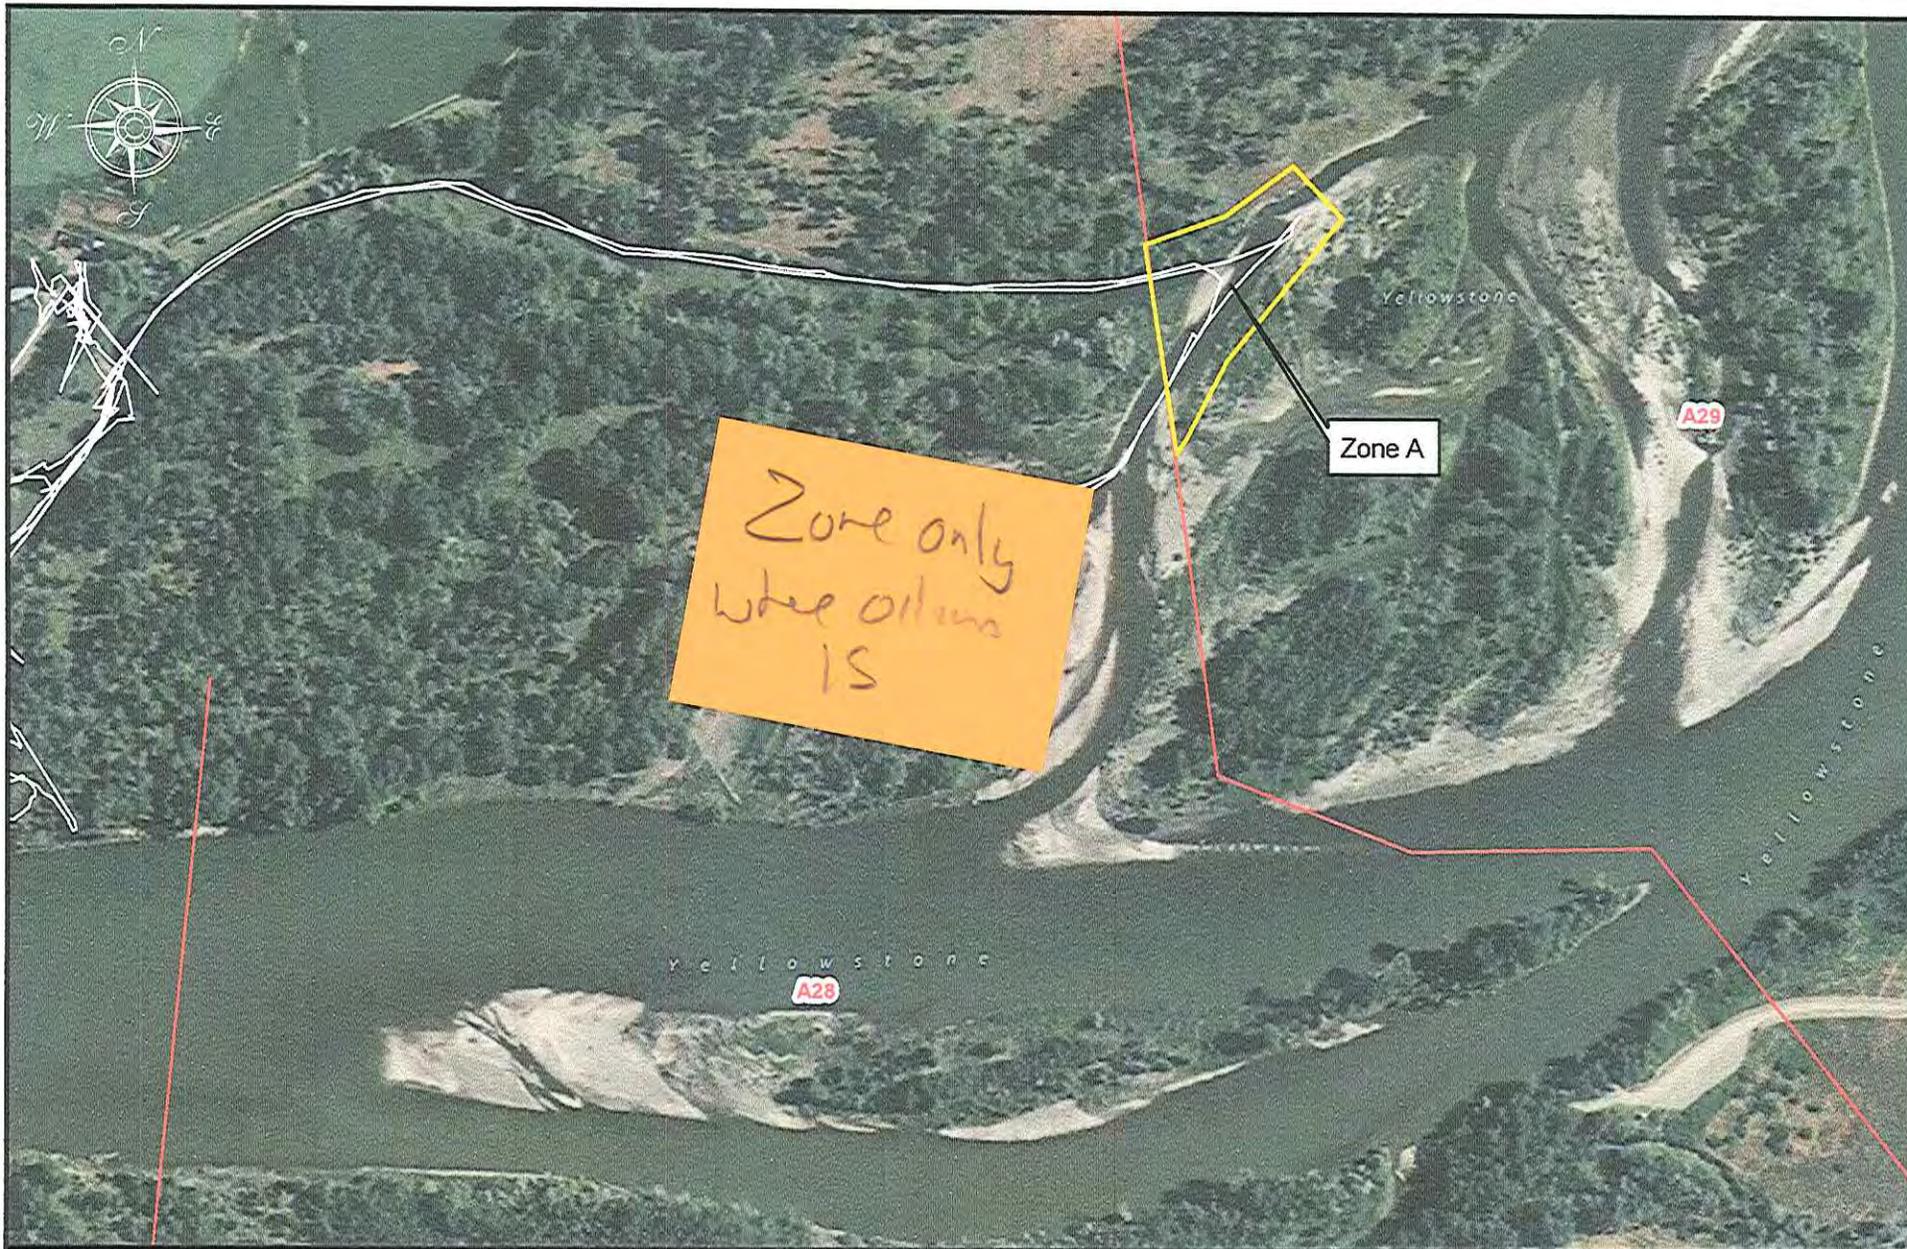
**SCAT Teams 2 & 4 Survey**

Segment A29

**Treatment Recommendations:**  
Zone A: Cut & remove oil coated vegetation smaller than 1" diameter. Wipe larger oil coated vegetation.

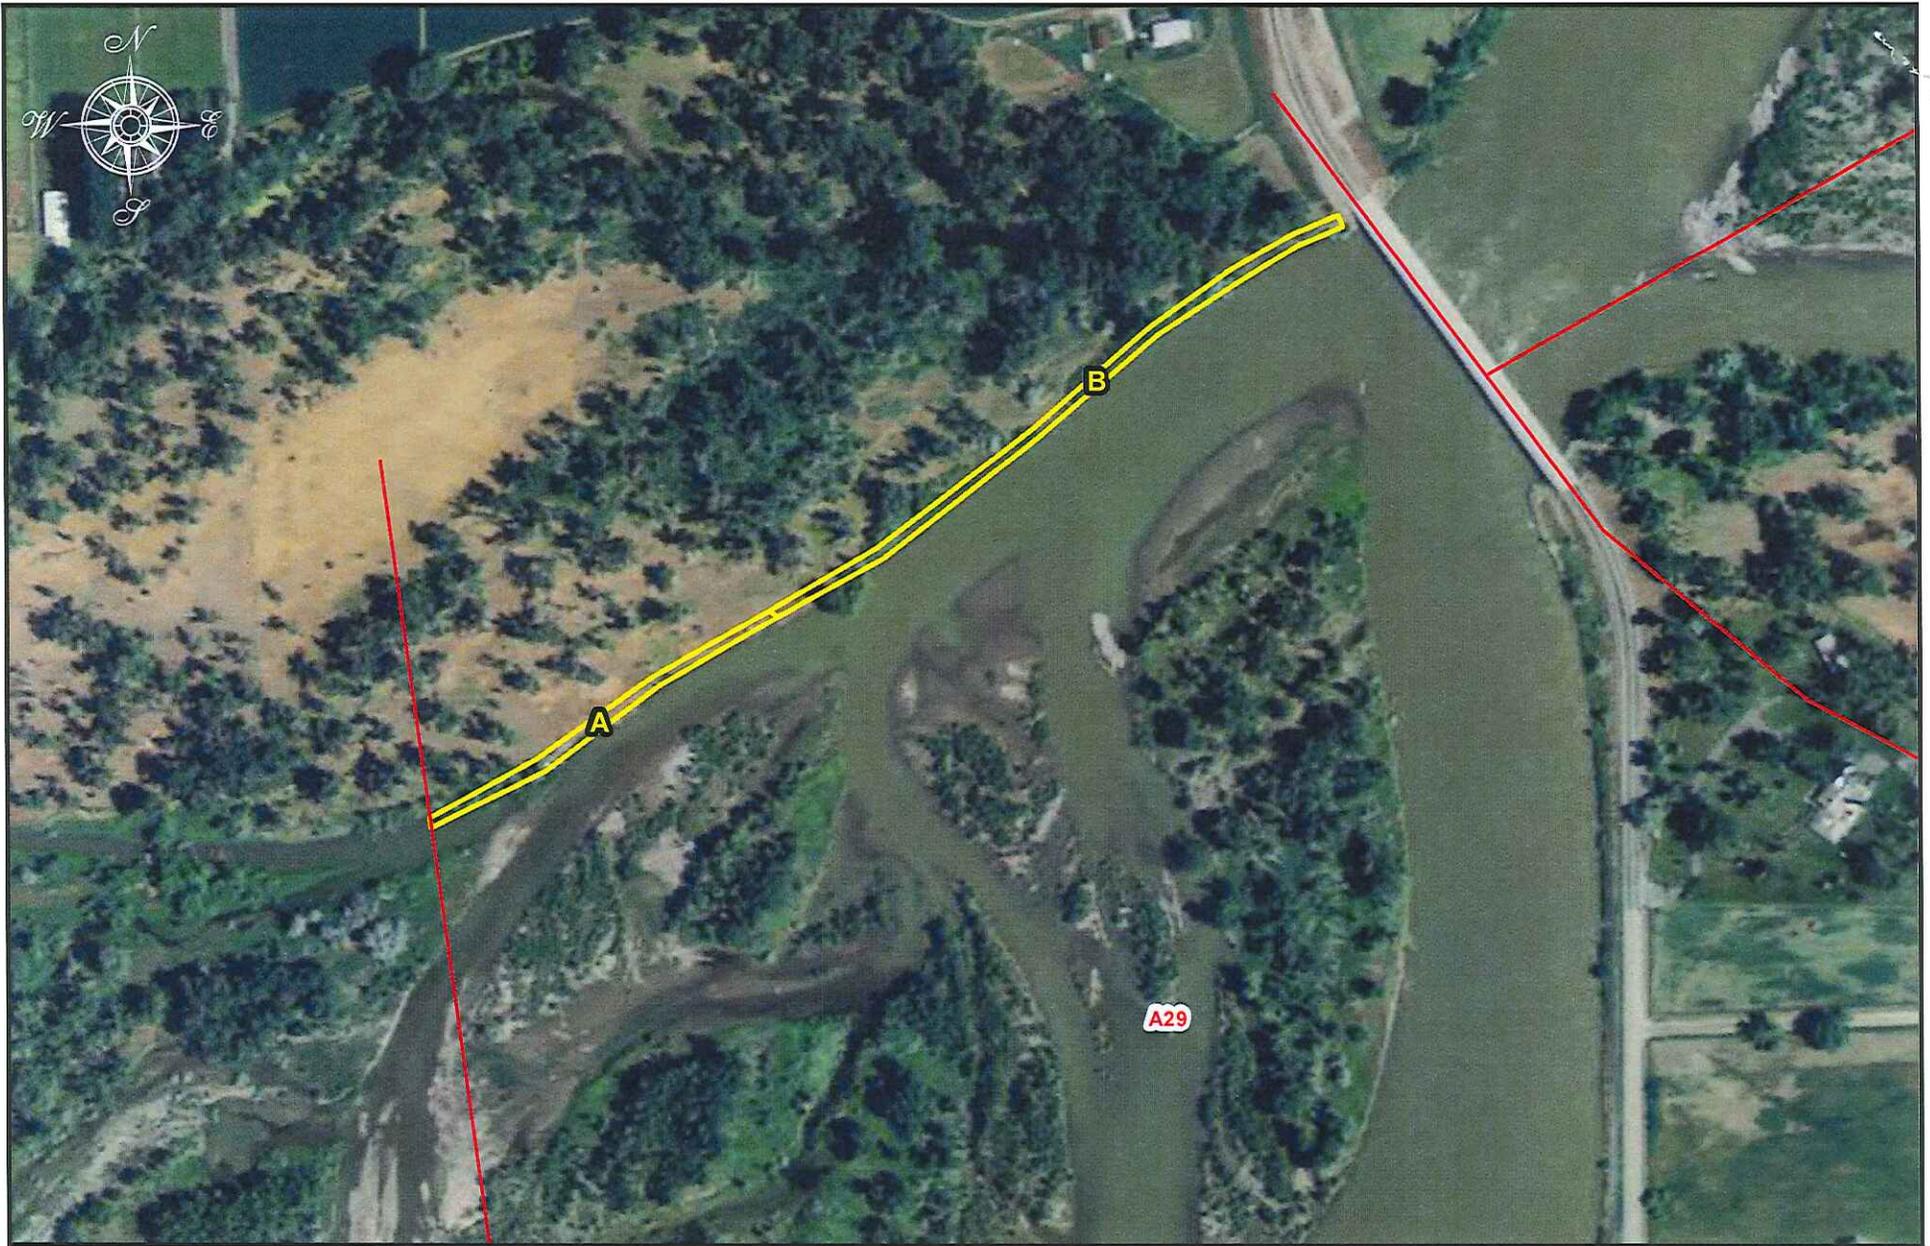
**SCAT Teams 1 & 2 Survey**

Segment A29 - Left Bank

B - no oil observed along drainage.

C - area of trace oiling on grasses & woody debris & tree branches. no treatment recommended

D - area of trace oiling on woody debris, & RB sheen noted on standing pools of oil throughout drainage - could be sampled for petroleum product & a more thorough SEAT survey.
