**SCAT Area Transition Report  
for A29**

Silvertip Pipeline Incident  
Laurel, Montana

Our Ref.:  
B0085883.1103

Date:  
October 22, 2011

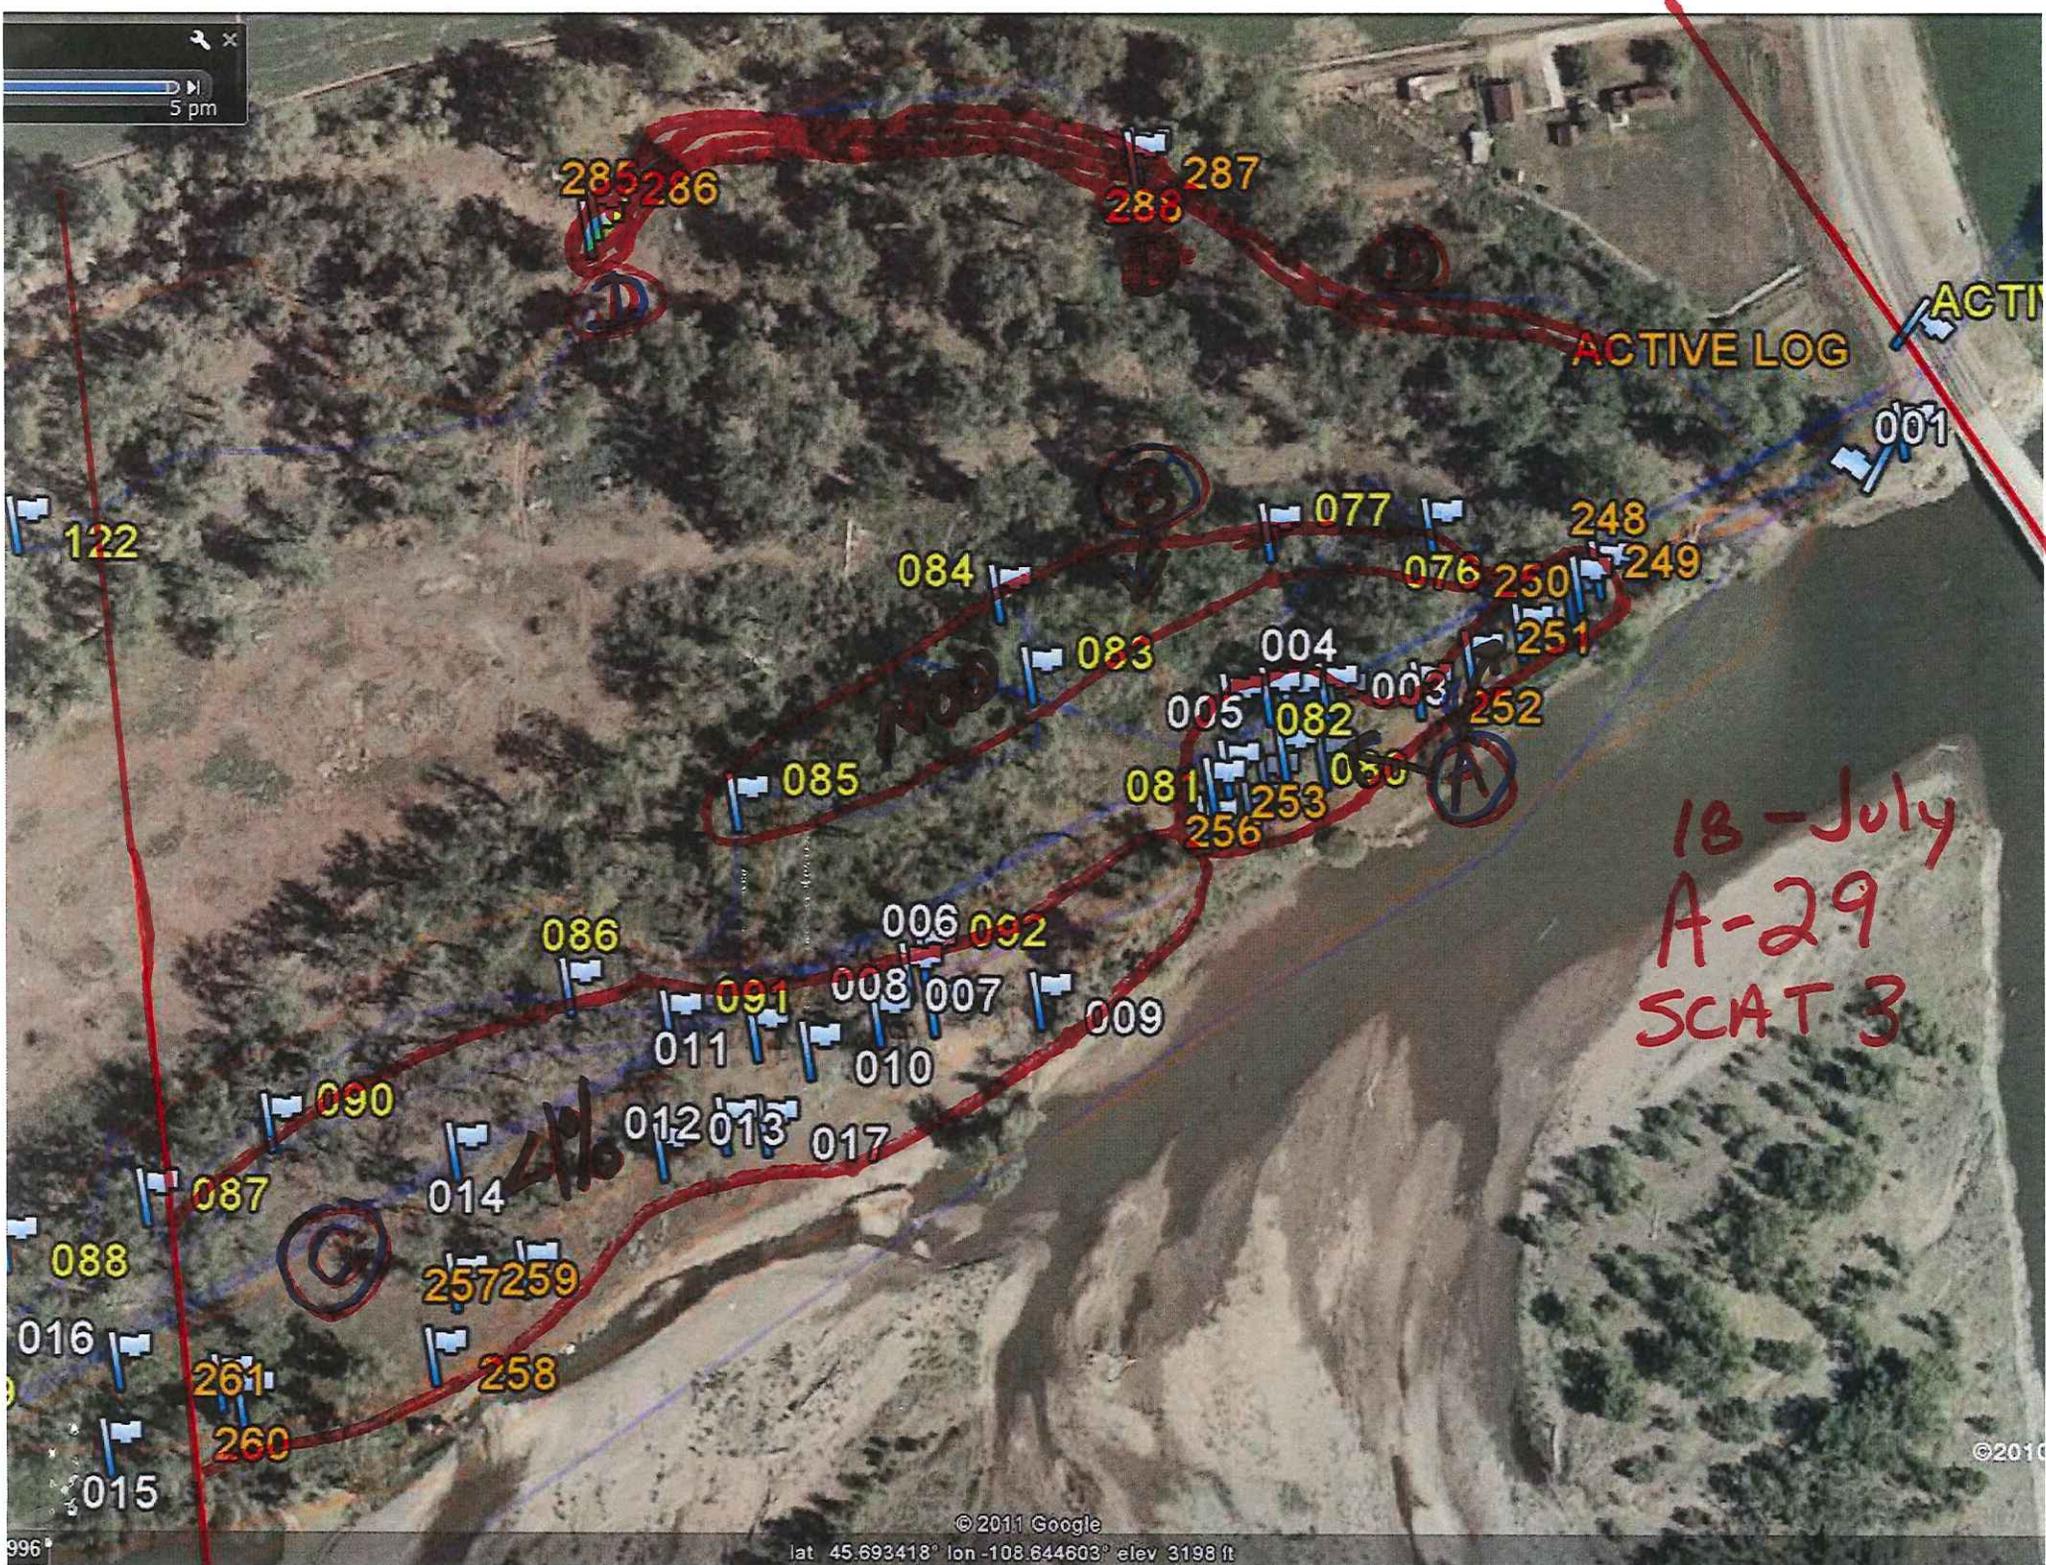
B - no oil observed along drainage.

C - area of trace oiling on grasses & woody debris & tree branches. no treatment recommended

D - area of trace oiling on woody debris, & RB sheen noted on standing pools of oil throughout drainage - could be sampled for petroleum product & a more thorough SEAT survey.

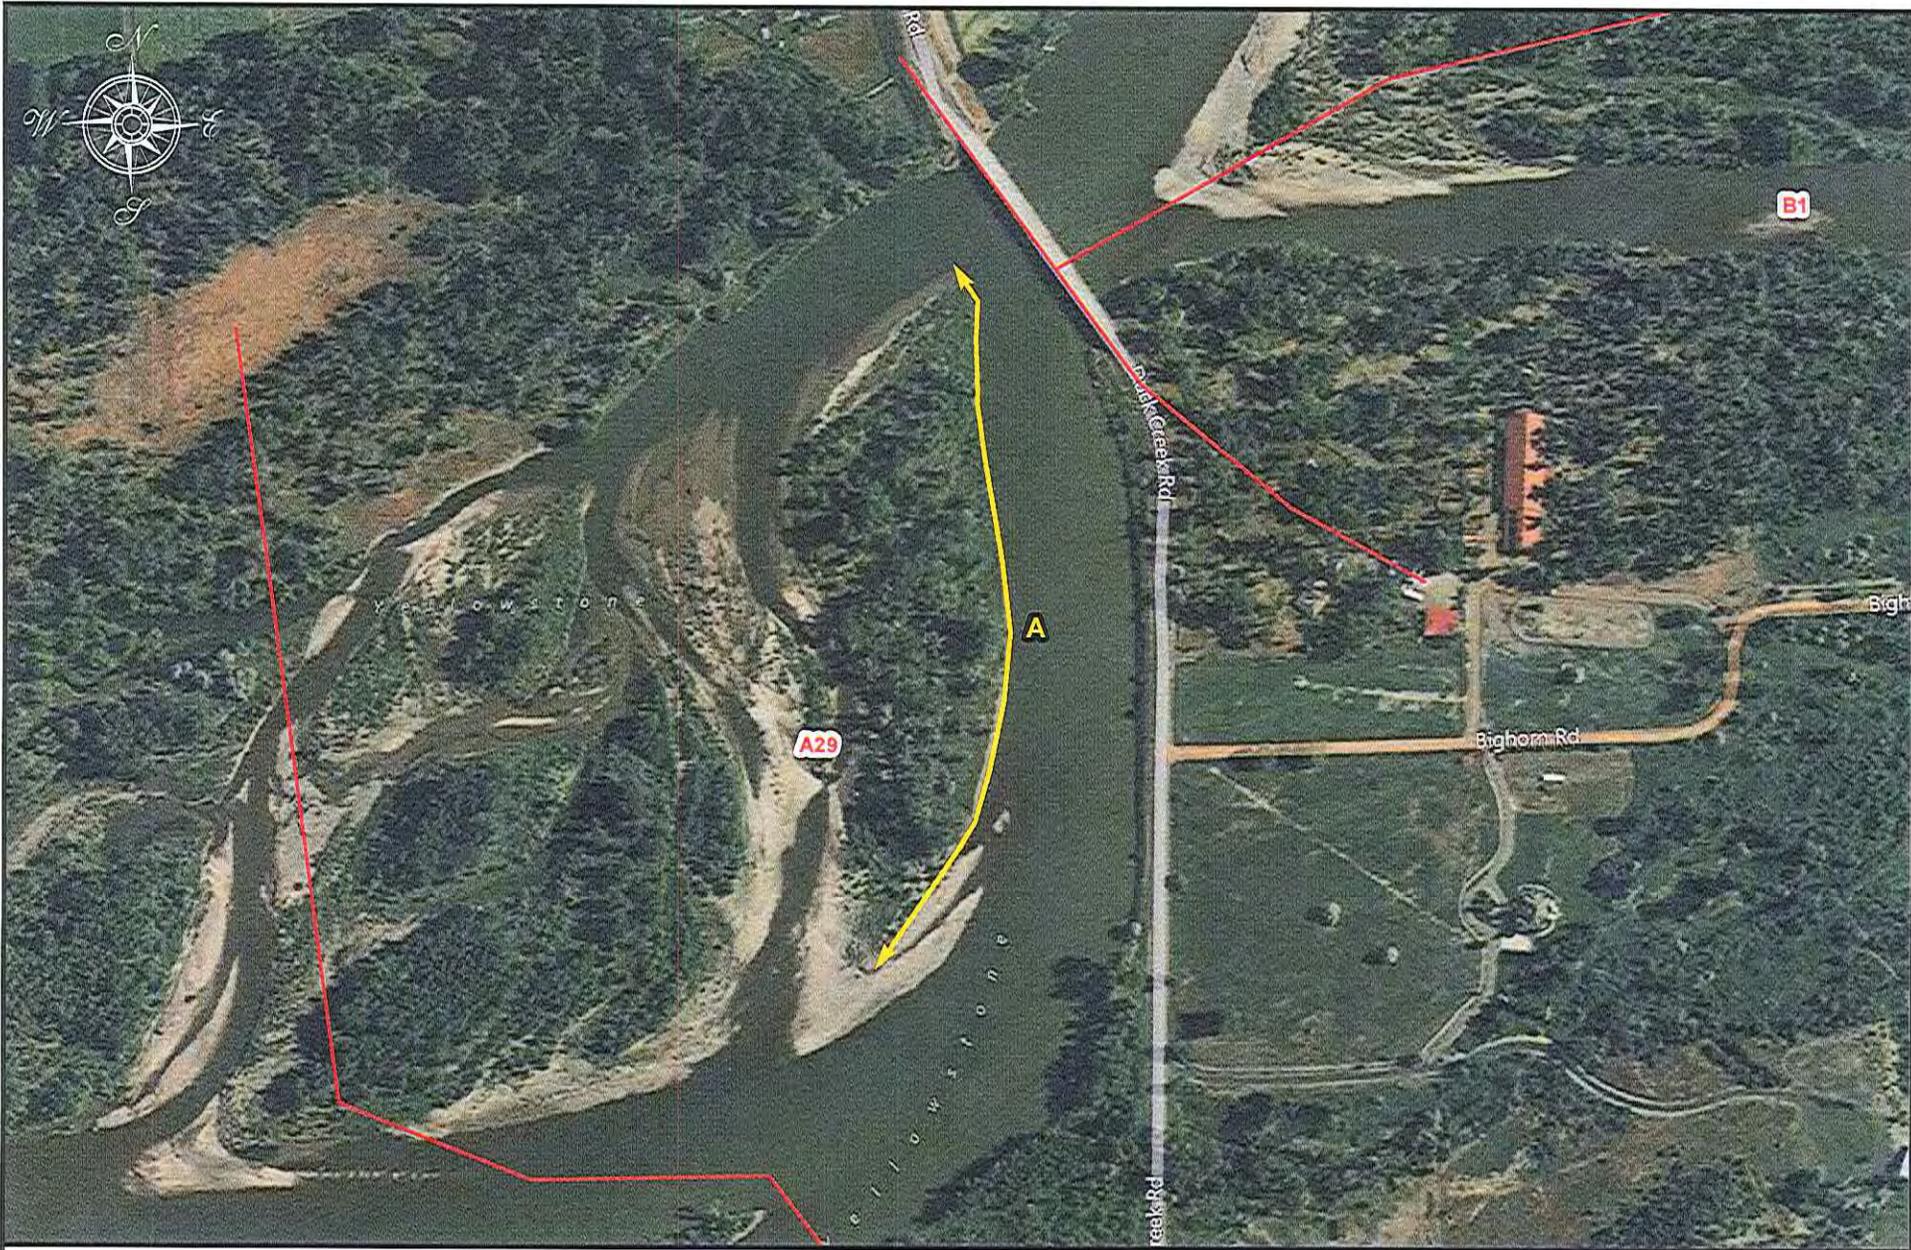
**SCAT Teams 2 & 4 Survey**

Segment A29 Left Bank

**Treatment Recommendations:**  
Zone A: Cut & remove oil coated vegetation smaller than 1" diameter. Remove oil coated debris smaller than 4" diameter. Wipe larger oil coated vegetation and debris. Remove pooled oil with sorbents. Due to the size and quantity of oil coated debris in this zone, alternative methods, such as burning, could be considered.

\*Refer to current approved treatment methods #1 (Cutting of Vegetation), #2 (Dead Vegetation and Small Debris), #3 (Large Woody Debris), #6 (Sorbent Use)

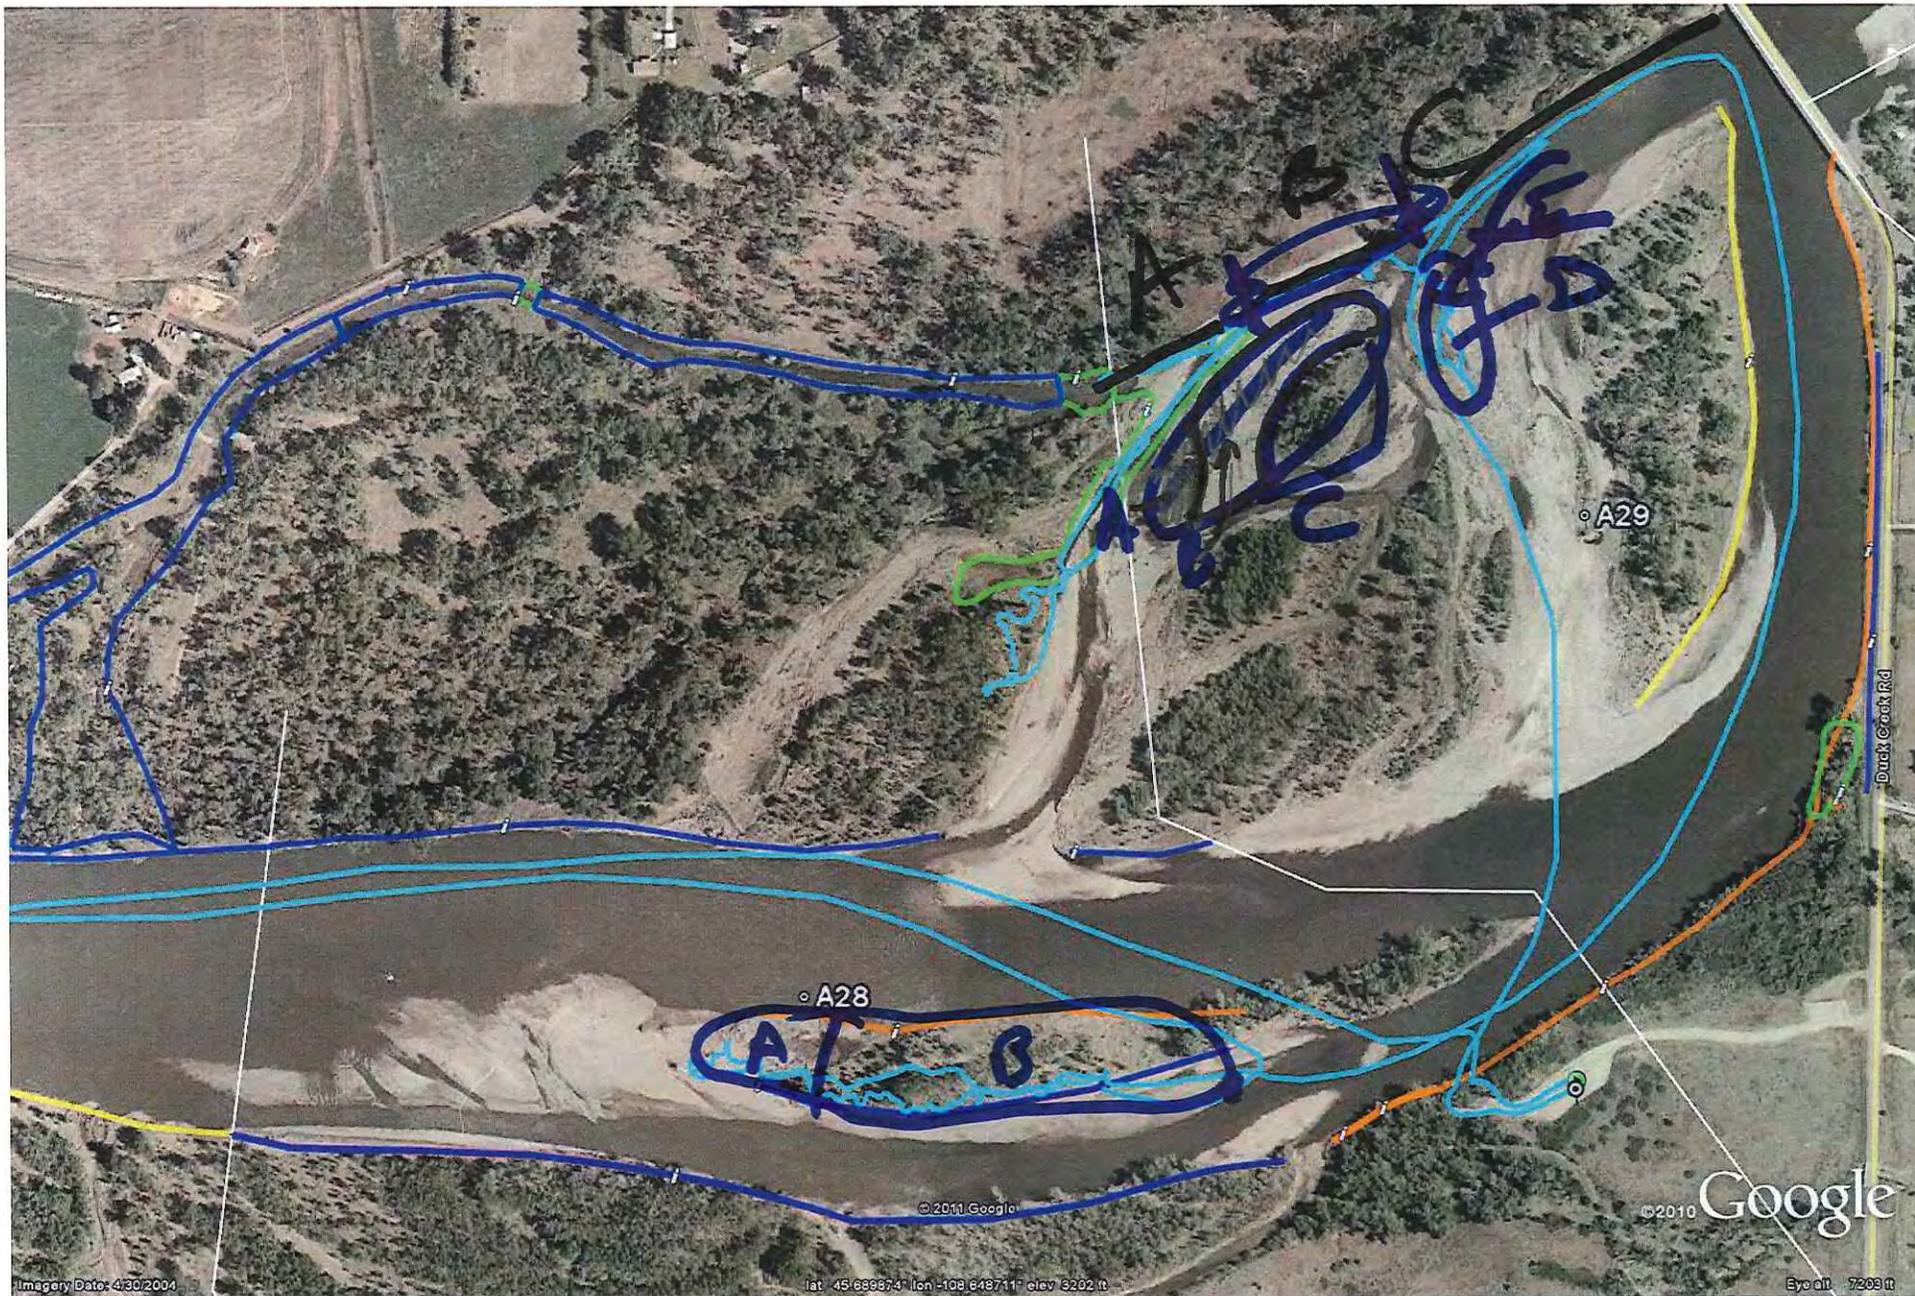
- A. Eastern end of segment is very steep riprap bank with oiled vegetation on sides.
- B. Middle section has oiled vegetation that requires removal

Due to presence of oiled buffalo berry bushes and grade of riprap it is recommended that Ops, Safety, Cultural representatives and DFWP meet on 29 to discuss best course of action for Eastern portion of segment.

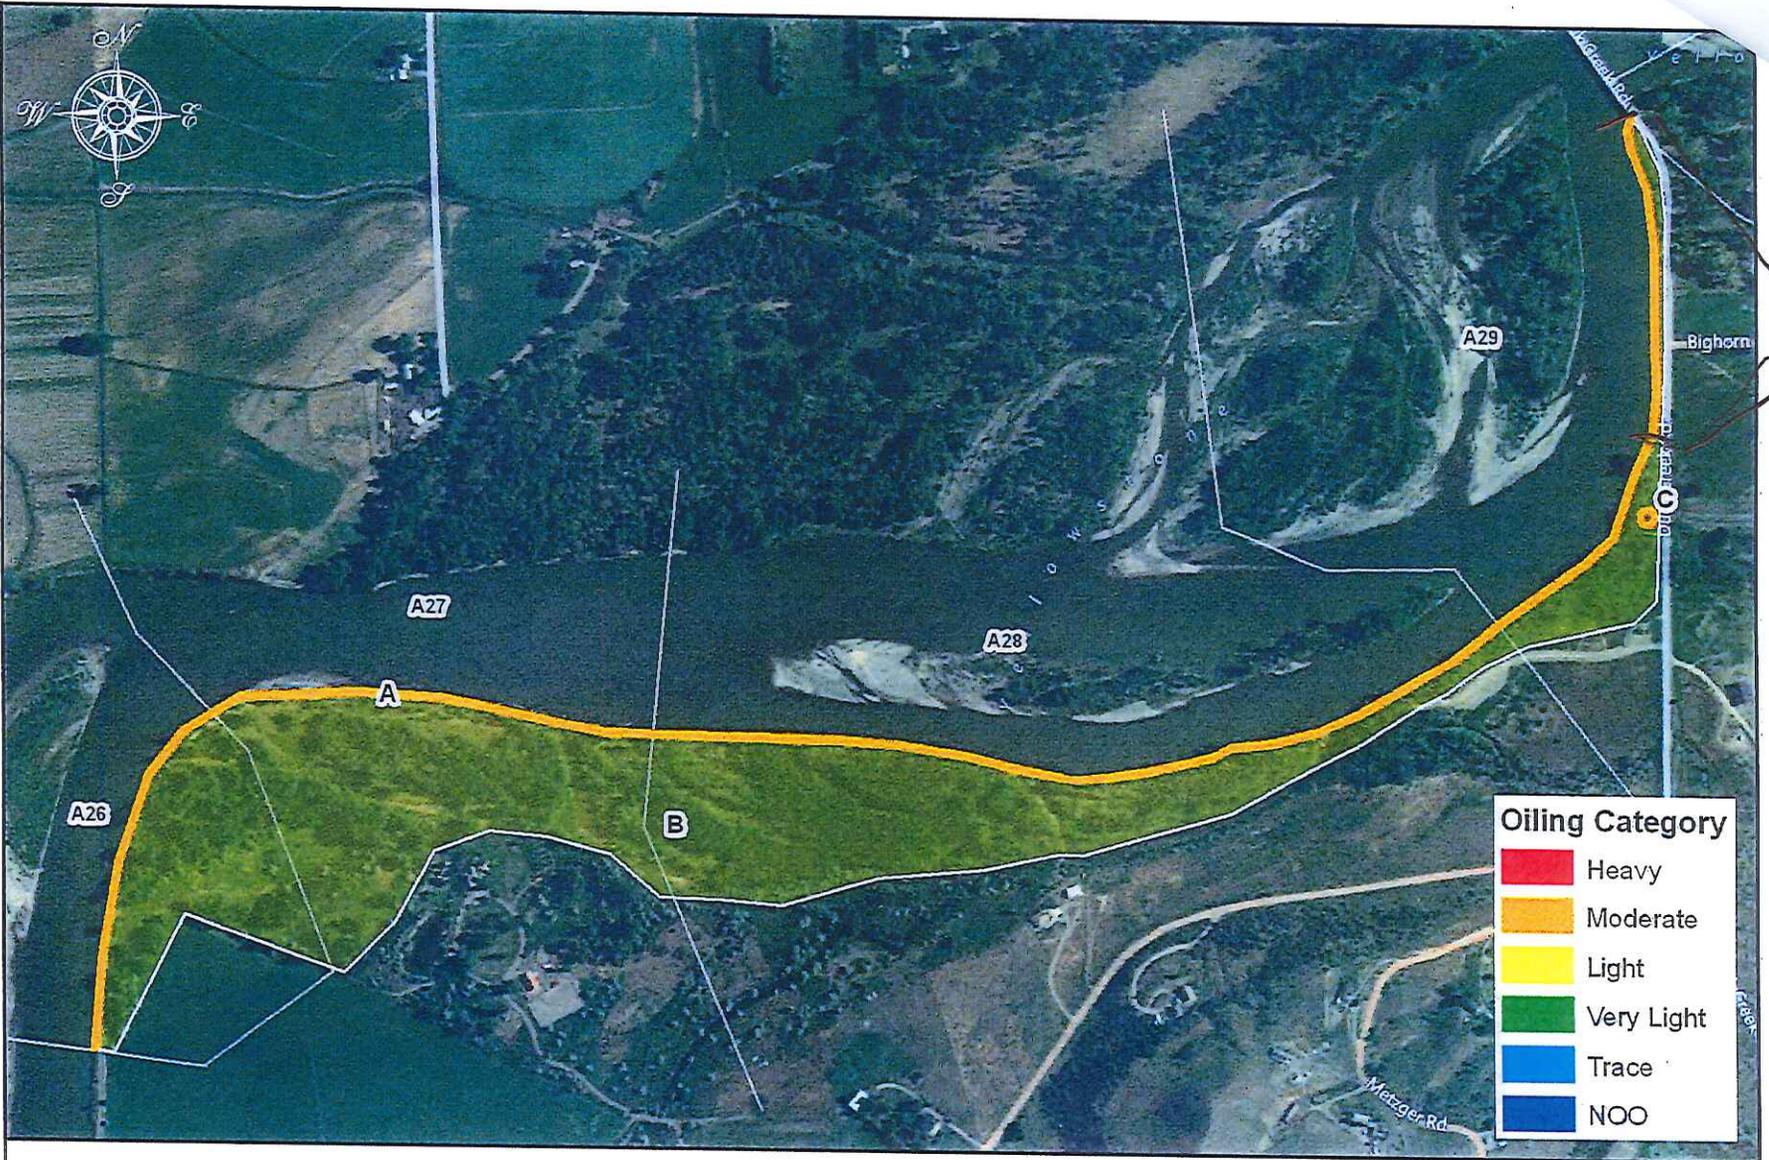
**Division A Segments 26-R through 29-R**

AREA OF CONCERN

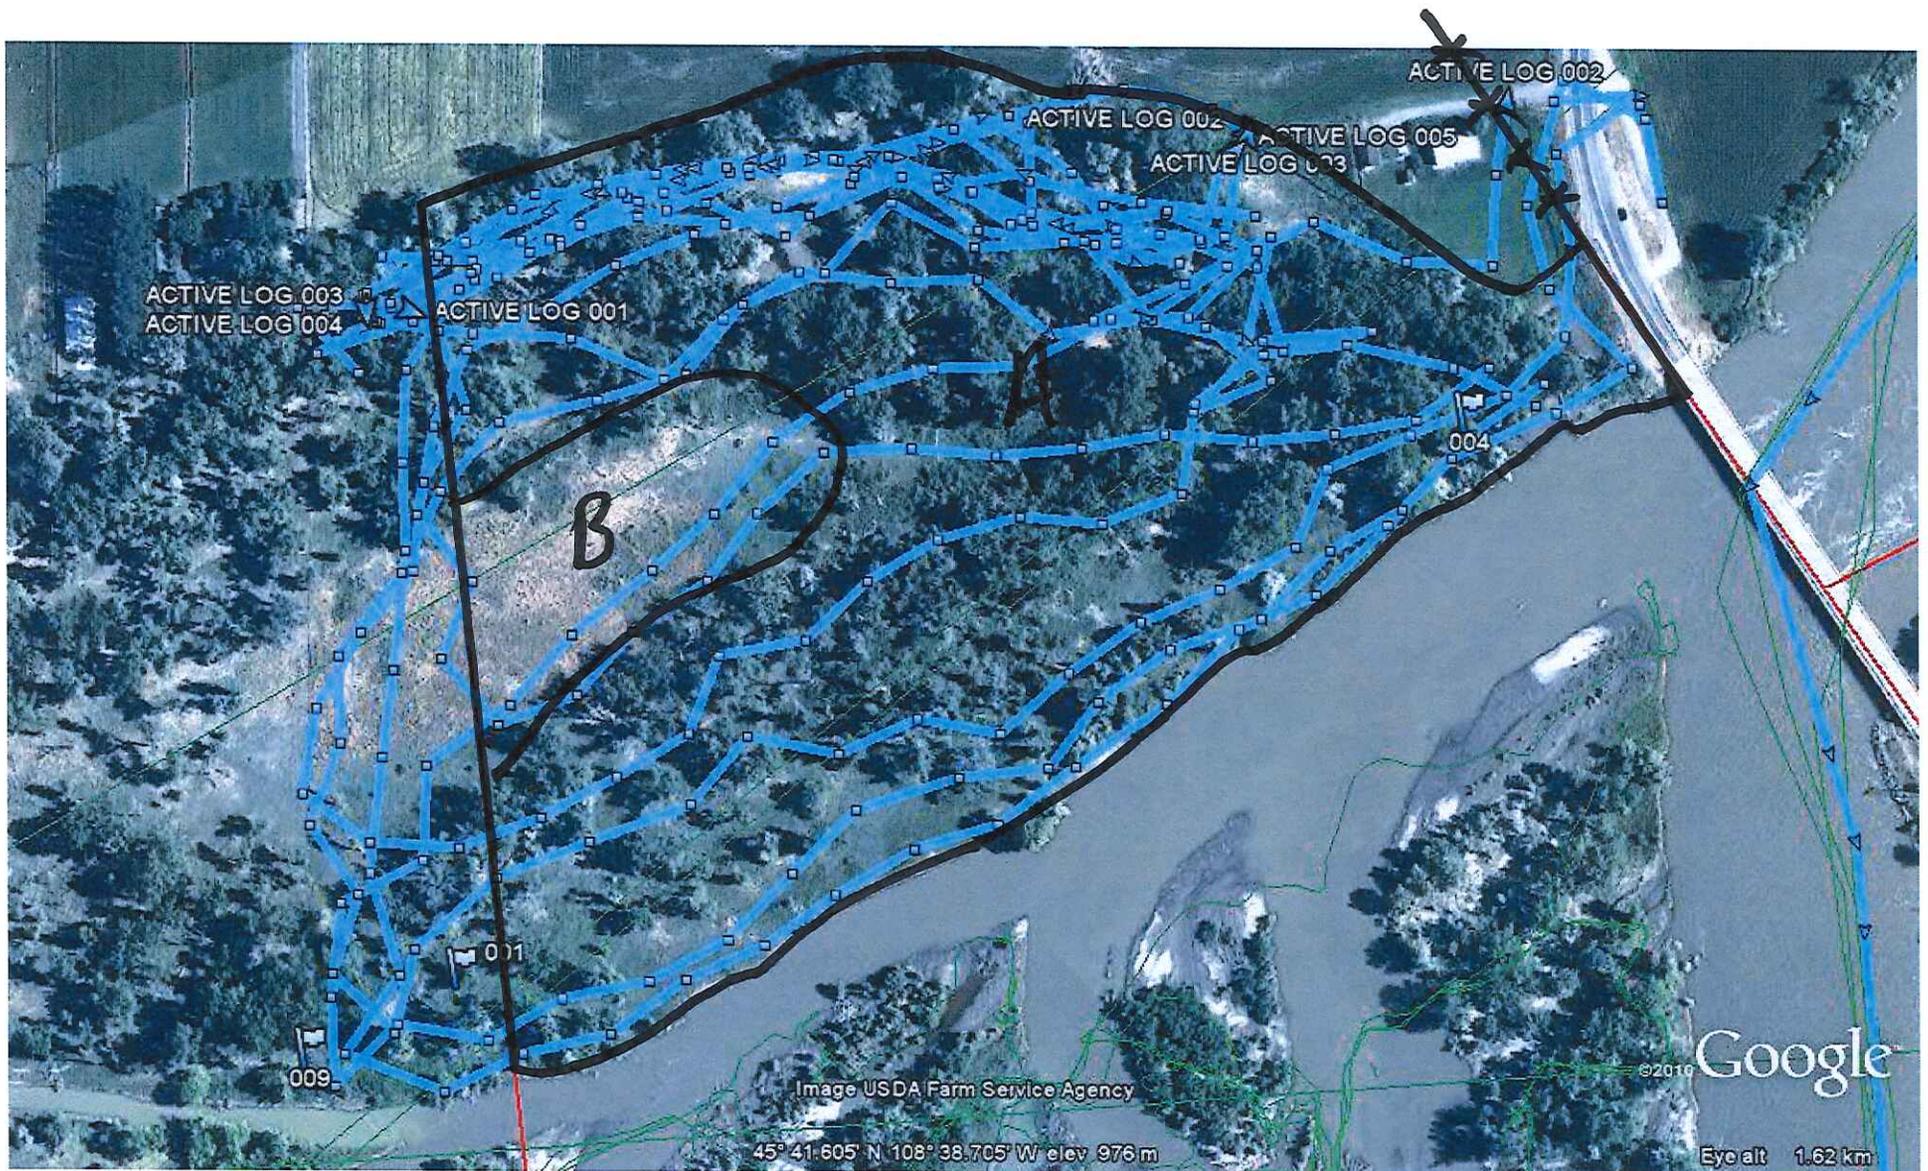
Segment 29LB  
August 26, 2011  
TEAM 4

A: Less than 1% - NPT  
B: NOO

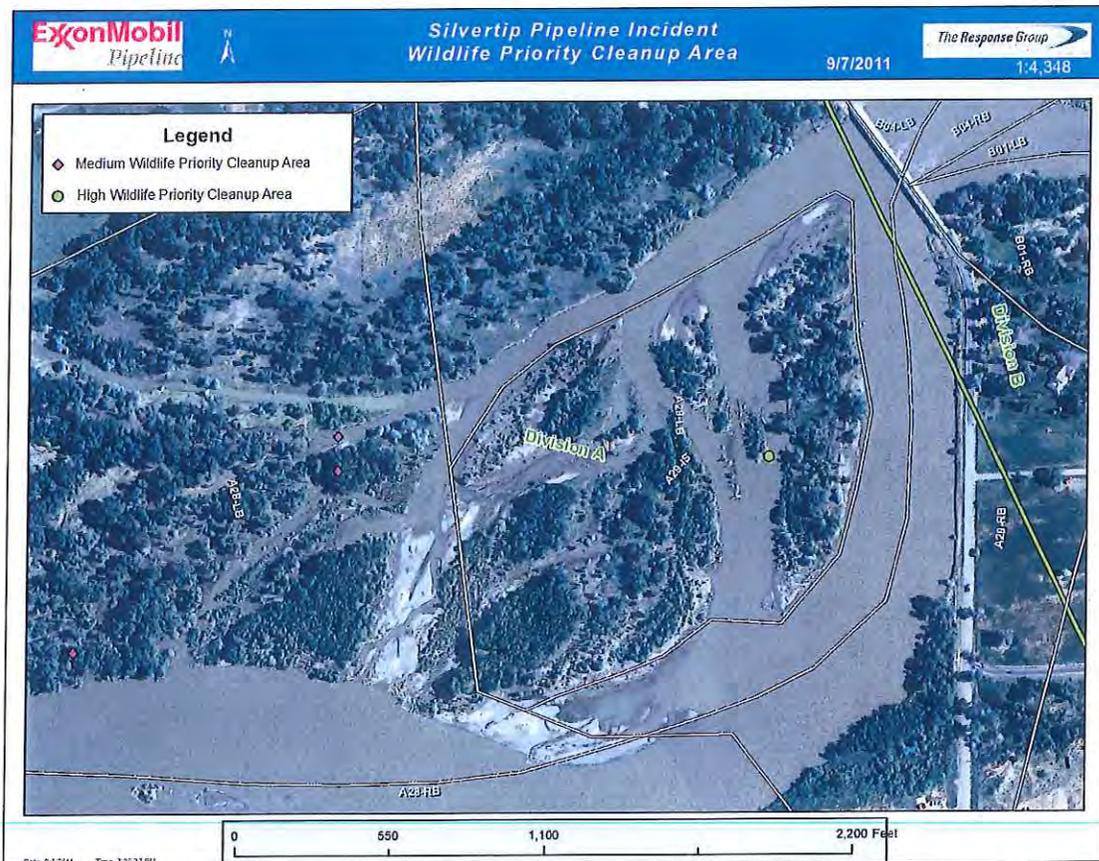
**MESSAGE:** International Bird Rescue and Resource Advisors with the USFWS identified four pools with sheen in scat sector A-28 and 29. This segment has passed SCAT but requires further response to reduce wildlife exposure risks. The four pools are identified on the map below. All pools had sheen on the water, passed the "stick test," the oil was transferable to a nitrile glove, and animal tracks were present. GPS coordinates of these pools are available and are listed on the Oiled Wildlife Risk Assessment Form maintained by the Wildlife Branch. A map of these areas is attached below, with a priority ranking associated with the locations. The size of the high priority area is 30 ft by 15 ft, the moderate priority areas are 50 ft by 20 ft, 100ft by 7 ft, and 30 ft by 10 ft.

The Unified Command is aware of this area within SCAT Segments A28 and A29 and understands that operations within these segments have been completed by operations and passed by Re-SCAT efforts. We agree with the recommended treatment proposed above for this area. ExxonMobil will coordinate any future remediation activities at this site with MTDEQ. In the meantime, this segment will be flagged as a "Wildlife Exception" and excised within GIS maps from the Re-SCAT report that will be produced to close-out the segment. This document will be included as an attachment to the Area Transition Report to document the need for additional work within this segment beyond Re-SCAT and a POST should be used to re-close the segment once these wildlife concerns are addressed by operations teams.

Pools contain sheen, after a field visit and research the sheen is likely not Hydrocarbon related and does not pose a hazard to wildlife
