**SCAT Area Transition Report
for B01**

Silvertip Pipeline Incident
Laurel, Montana

October 19, 2011

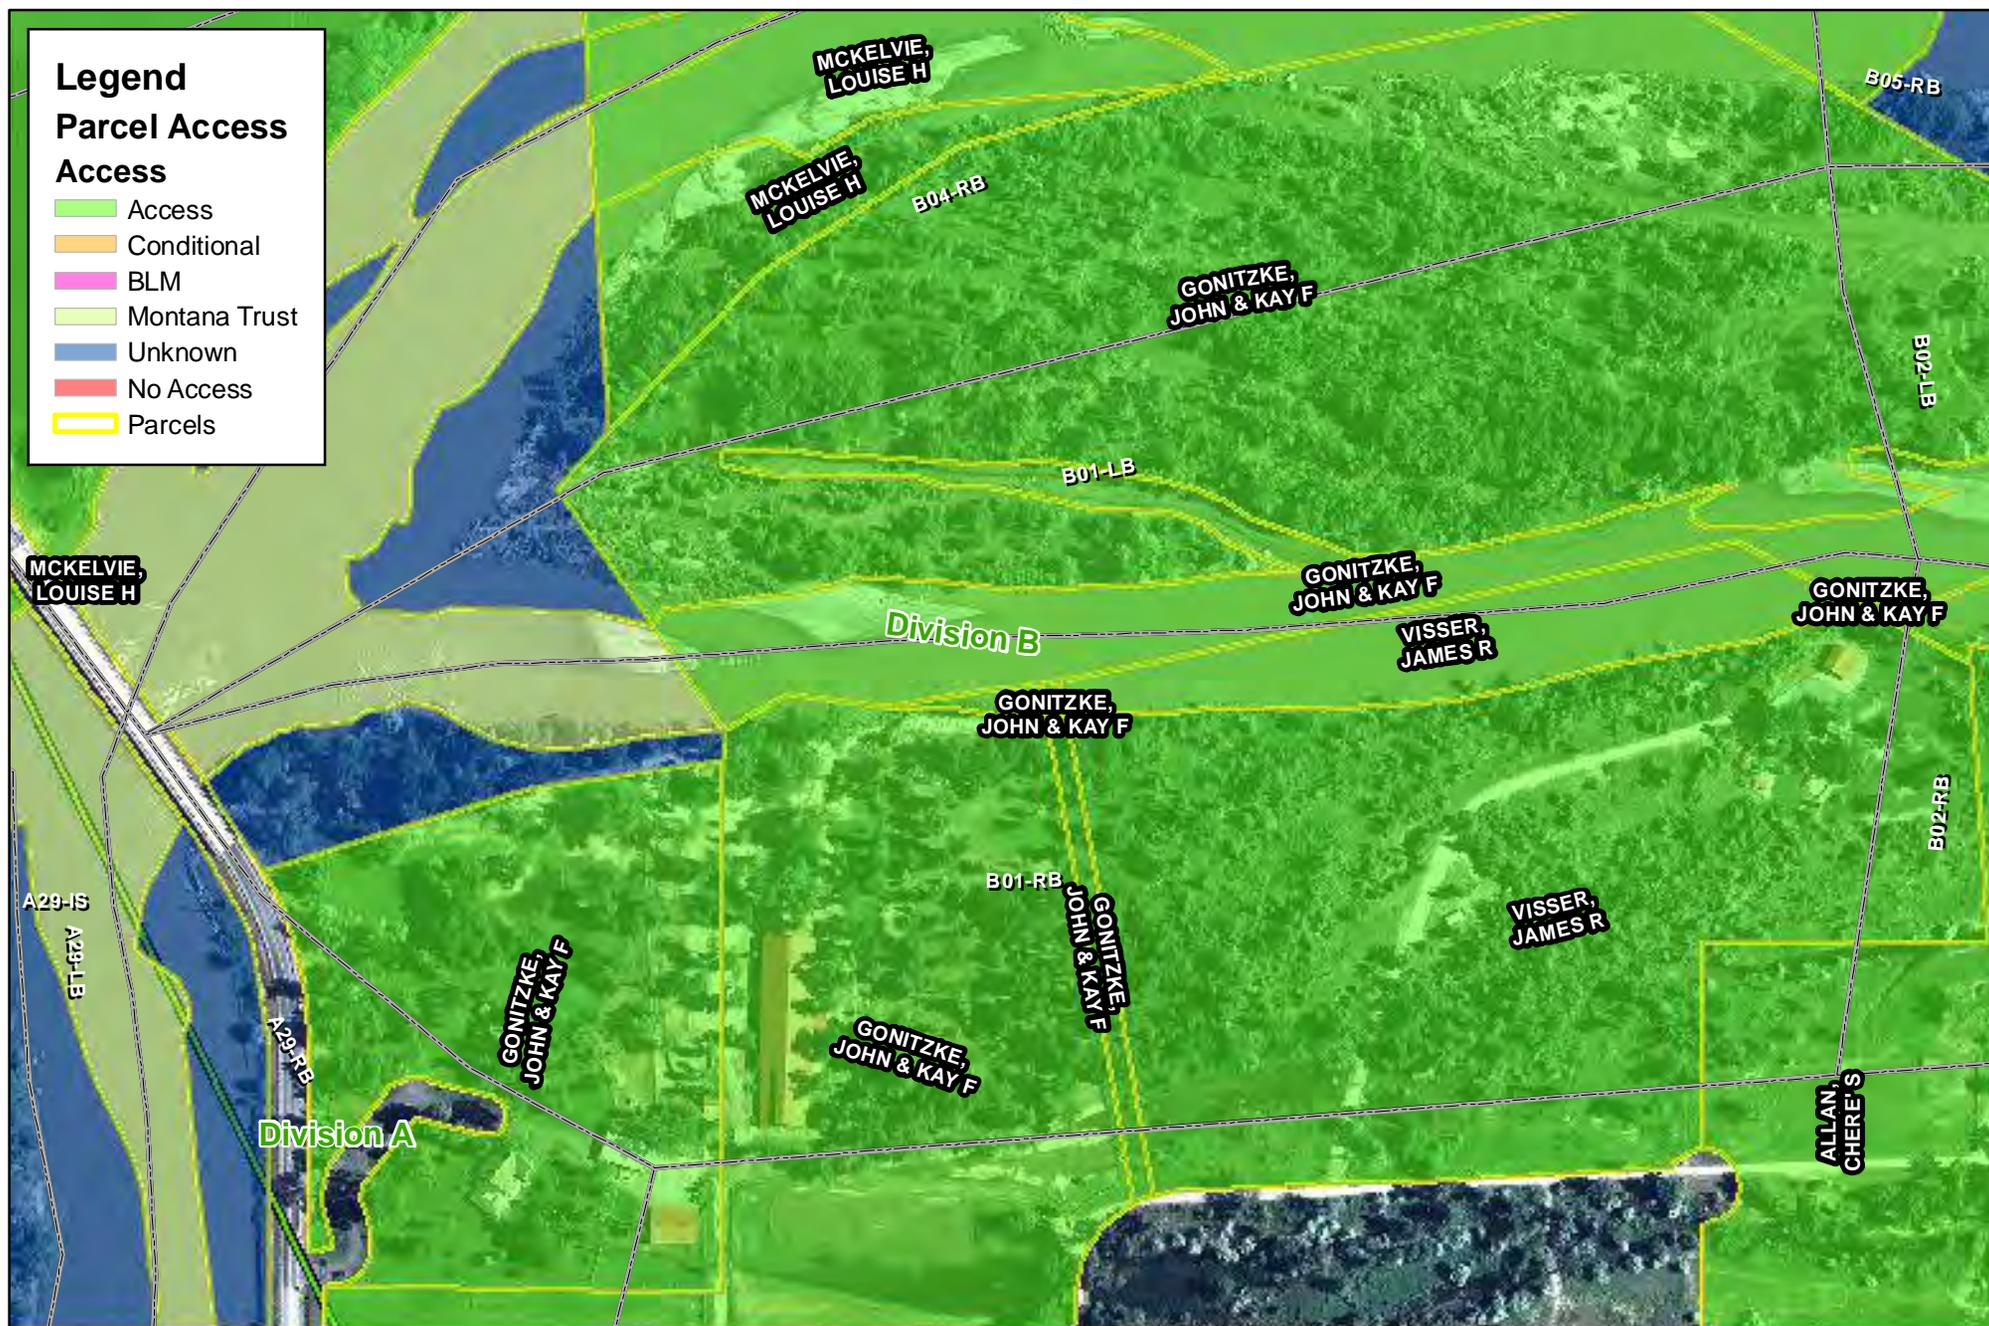
Figure 1 provides an aerial map of SCAT Area B01, along with the (a) SCAT Area boundary, (b) parcel boundaries and respective property owners, and (c) access constraints identified during the oil cleanup process. The acreage surveyed in Area B01 is 28.5. There were no access issues for the left or right banks.

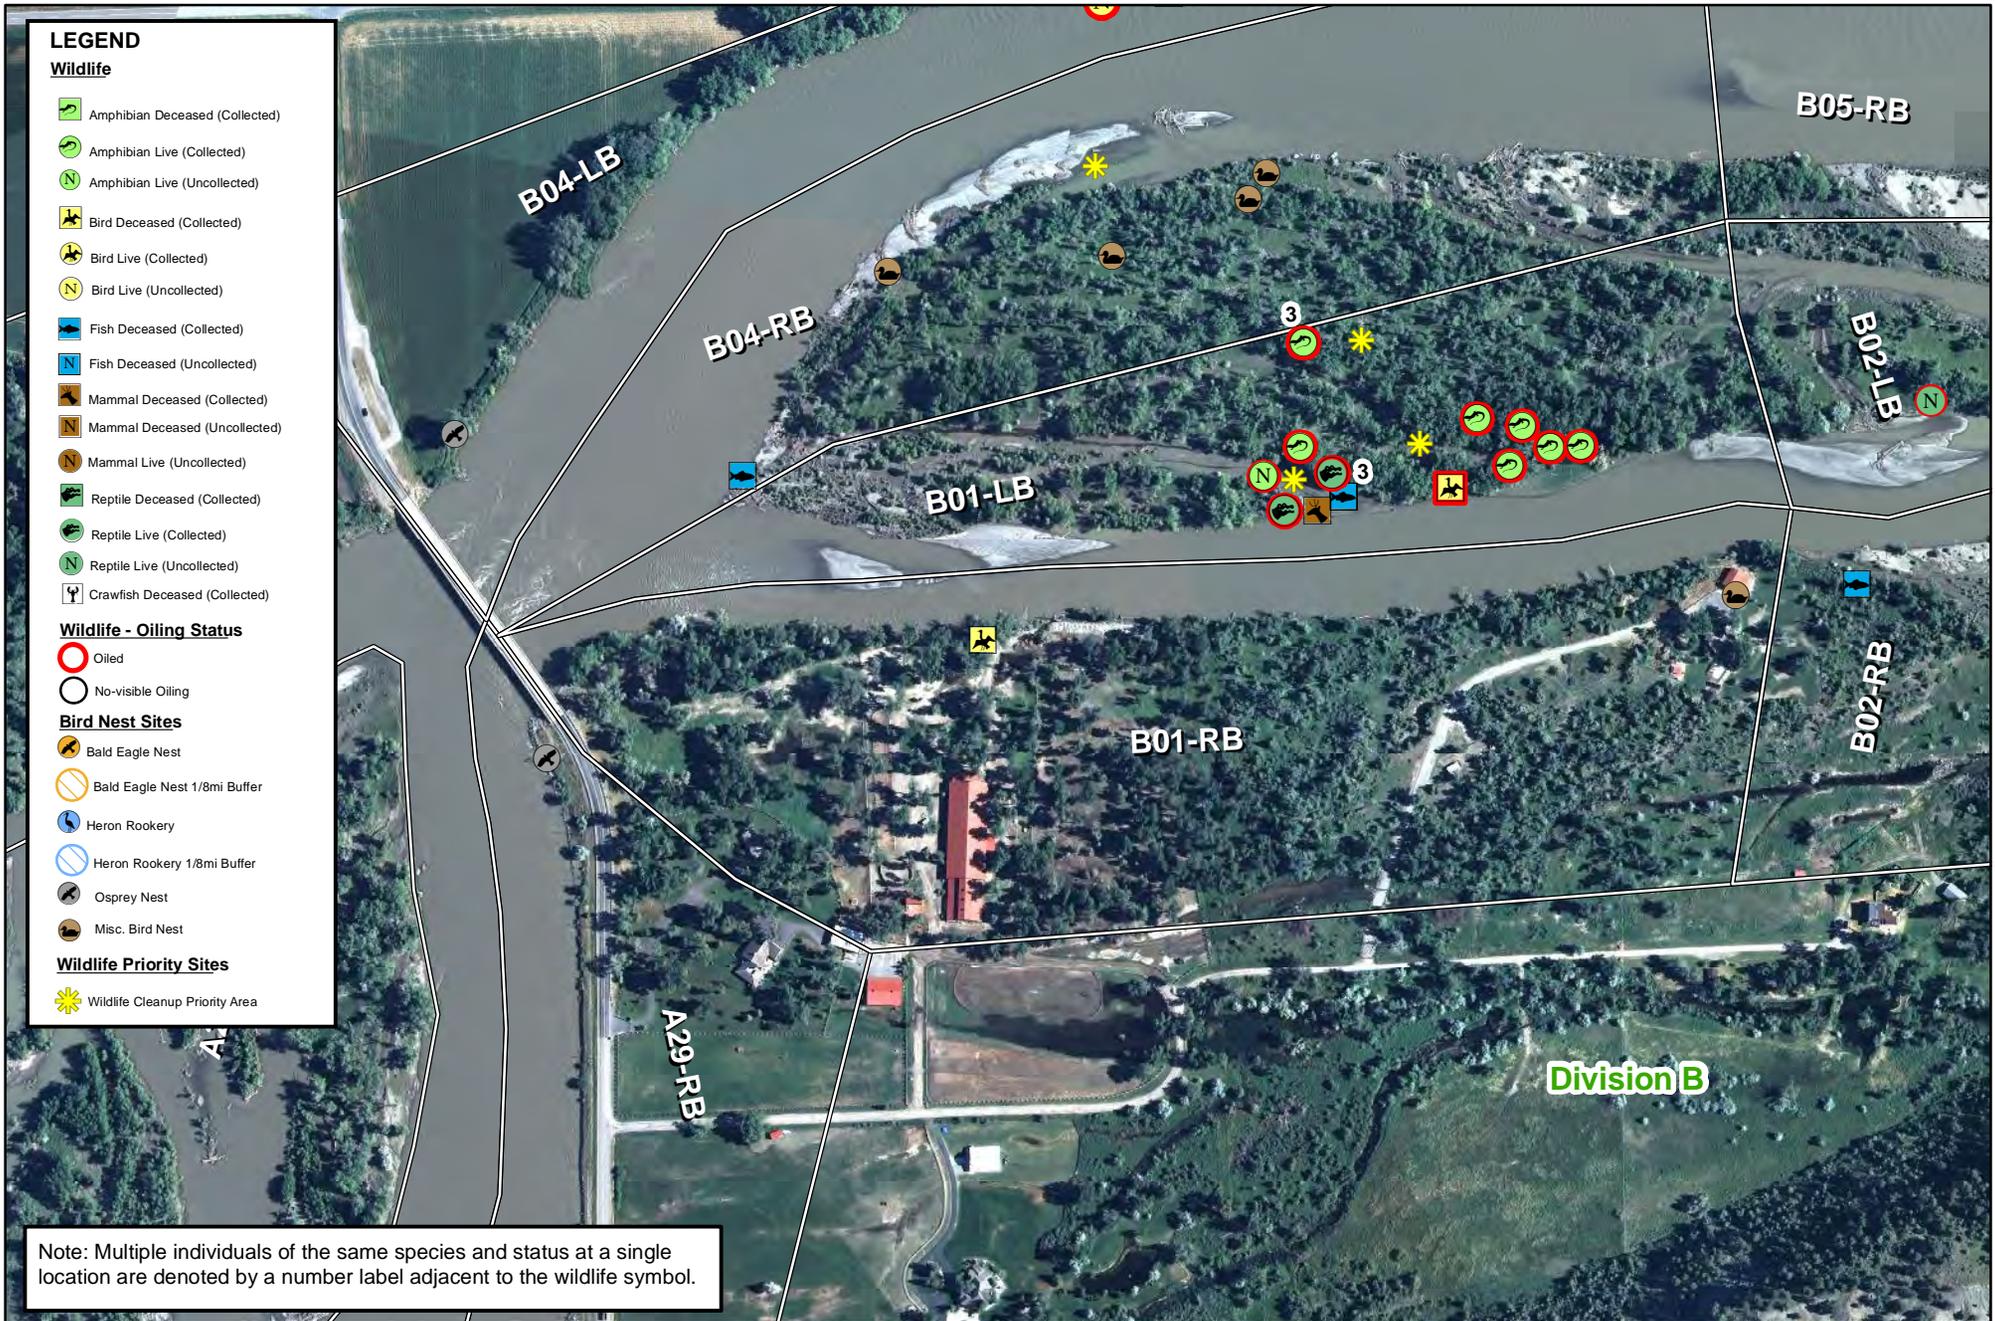
Figure 2
Wildlife Resources

Figure 2 summarizes the natural resources identified in this segment. International Bird Rescue and Resource Advisors from U.S. Fish and Wildlife Service conducted regular inspections of Area B01. Eight oiled Woodhouse's toads (*Bufo woodhousii*), two western terrestrial garter snakes (*Thamnophis elegans*), and a Leopard frog (*Rana pipiens*) were captured, cleaned, and released. An oiled bullfrog (*Rana catesbeiana*) was captured, cleaned, and transferred into the custody of the local zoo. In addition, one oiled Woodhouse's toad was captured but a record of its cleaning and release could not be found. One deceased lightly oiled red tailed hawk (*Buteo jamaicensis*) was identified and retained. One deceased beaver (*Castor canadensis*), a deceased American robin (*Turdus migratorius*), and three fish (unknown species) with no visible oiling were identified and retained. Three Wildlife Priority Cleanup Areas (WPCAs) were identified. Two of the WPCAs had pools with free product and sheen, one of which was associated with a debris pile. The third WPCA was a dense oiled debris pile that resulted in several oiled toads. The WPCAs were treated to reduce the potential for wildlife oiling and are no longer considered a wildlife hazard. A song sparrow (*Melospiza melodia*) nest was identified in Area B01.

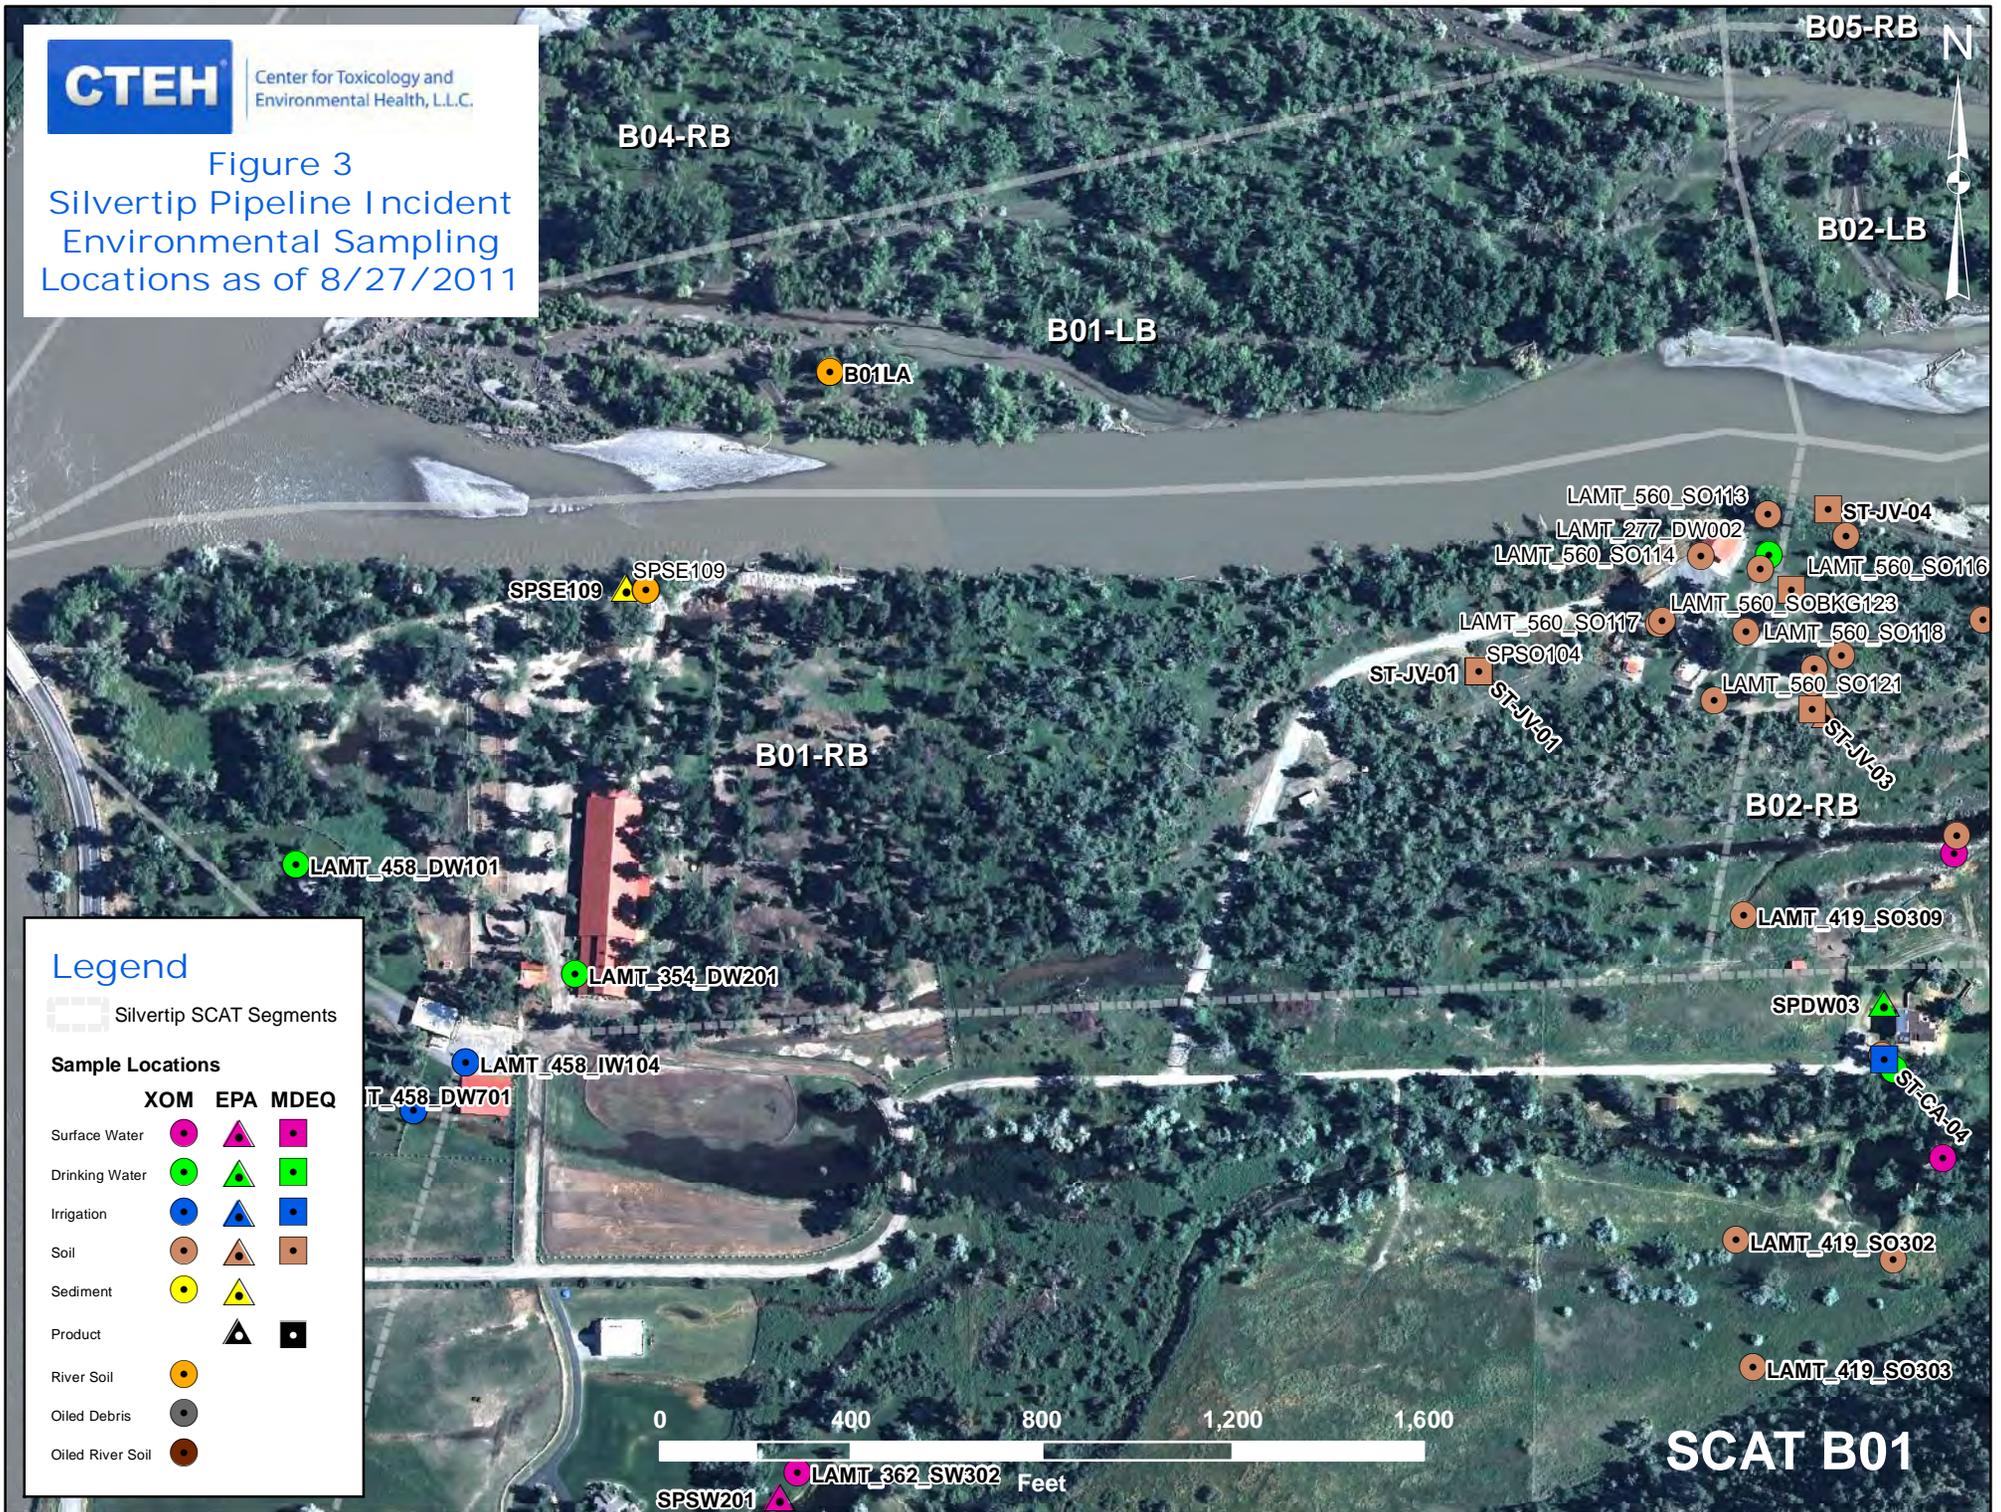
Figure 3
Silvertip Pipeline Incident
Environmental Sampling
Locations as of 8/27/2011

Table 1 (below) summarizes samples collected within Area B01. The analytical results for the samples collected can be accessed through a publicly accessible database on the United States Environmental Protection Agency's (USEPA's) website. The approximate locations of samples collected within Area B01 are provided on Figure 3.

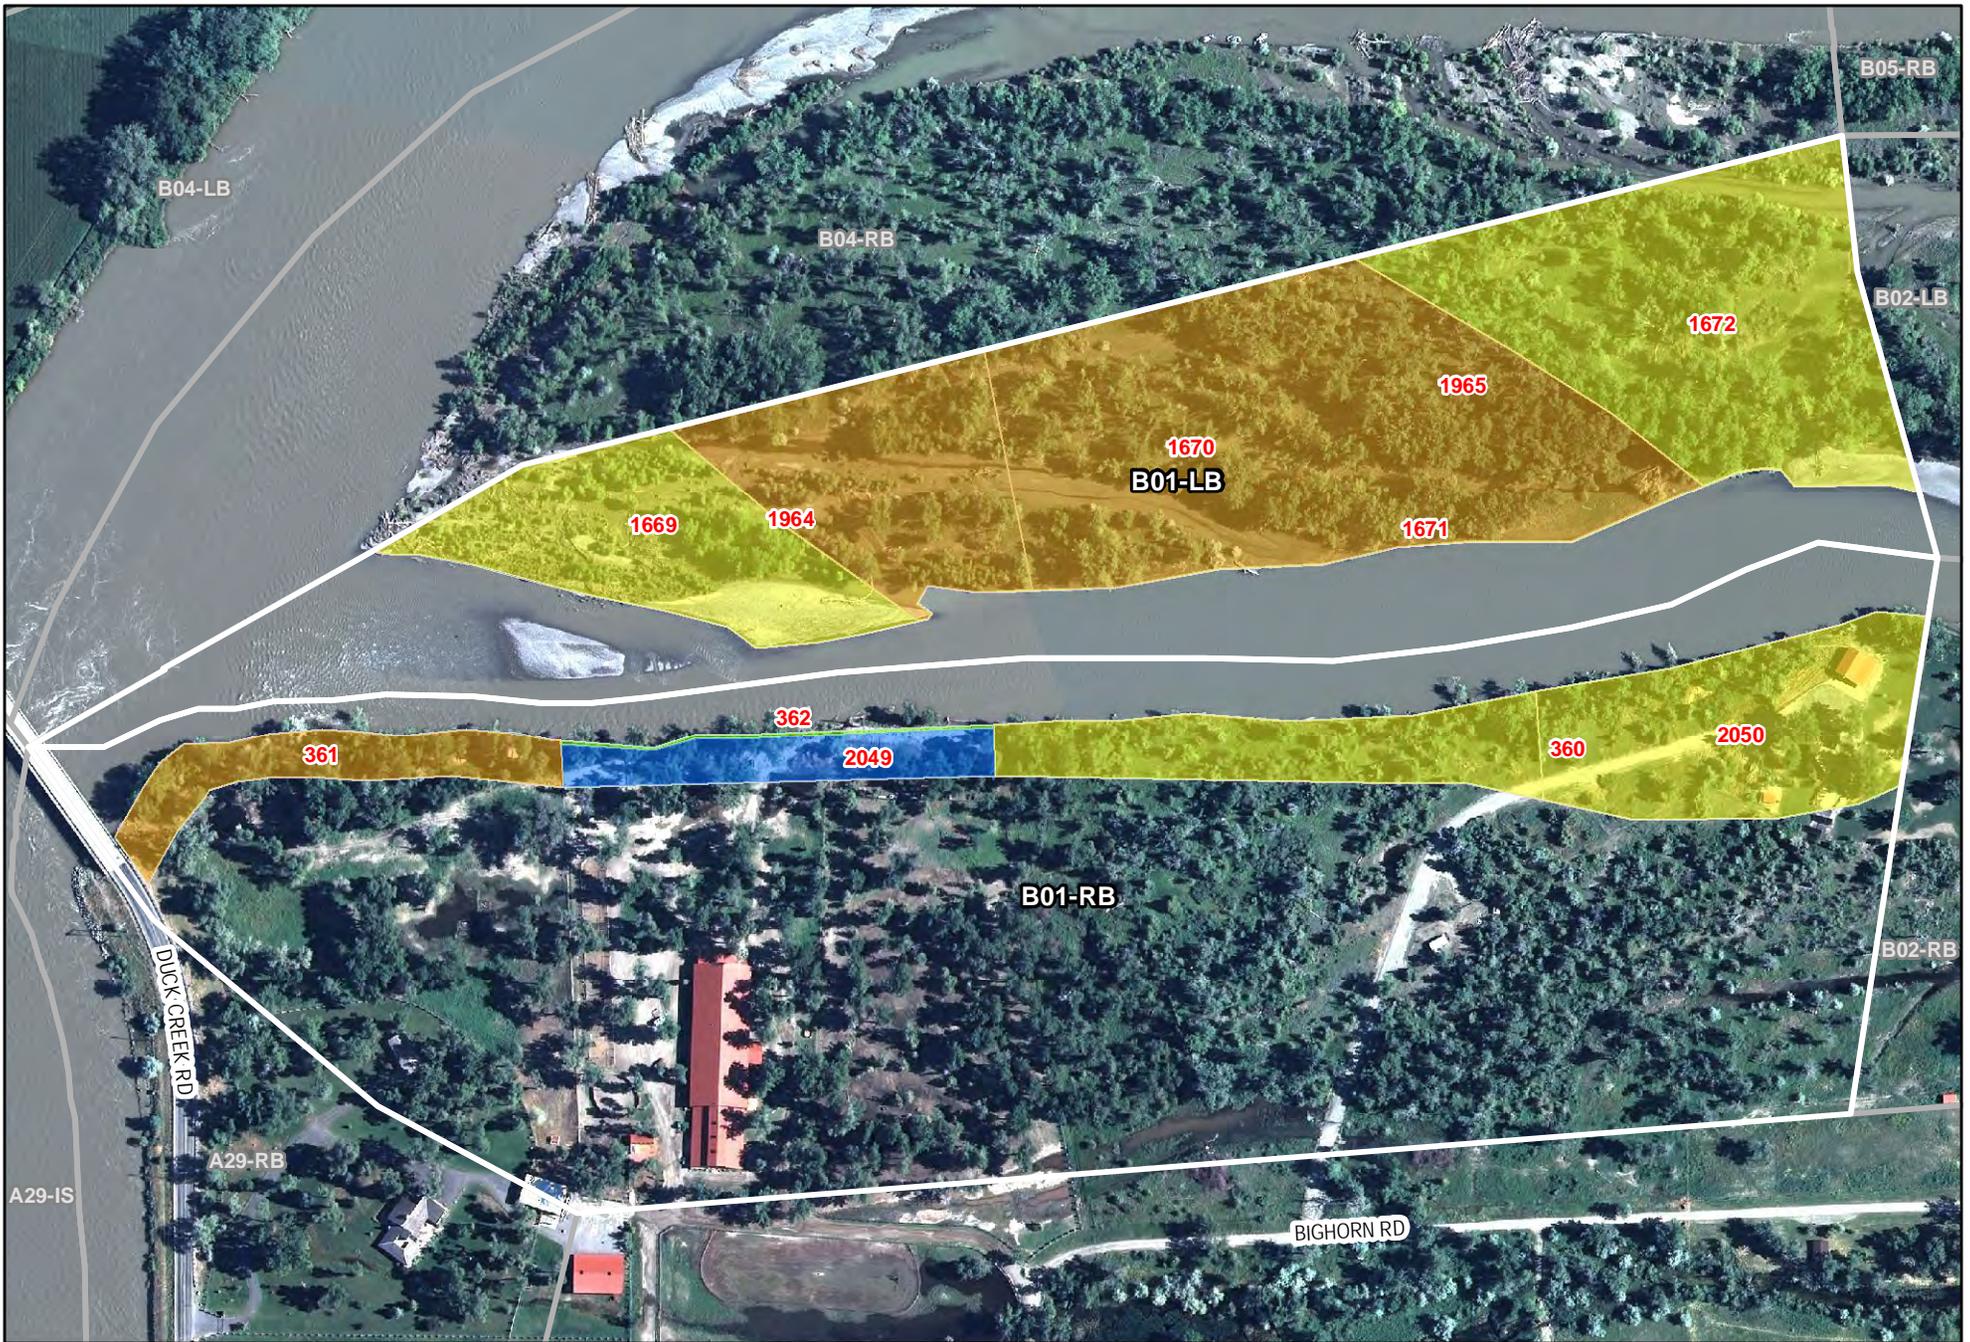
Figure 4 - Maximum SCAT Observations For SCAT Area: B01

The SCAT teams used systematic evaluation criteria and treatment method tables approved by the National Oceanic and Atmospheric Administration to provide a standard approach for data collection and conducting field surveys. The forms and sketches from the initial SCAT surveys performed along the river bank (water edge) and floodplain within Area B01 are included in Appendix B. Figure 4 provides the

maximum oiling zones observed by the SCAT team during the initial surveys of Area B01.

The SCAT team developed compiled treatment recommendations (CTRs) providing approved treatment methods (ATMs) for each oiling zone identified during the initial SCAT surveys ([CTR No. 9](#) and [CTR No. 20](#)).

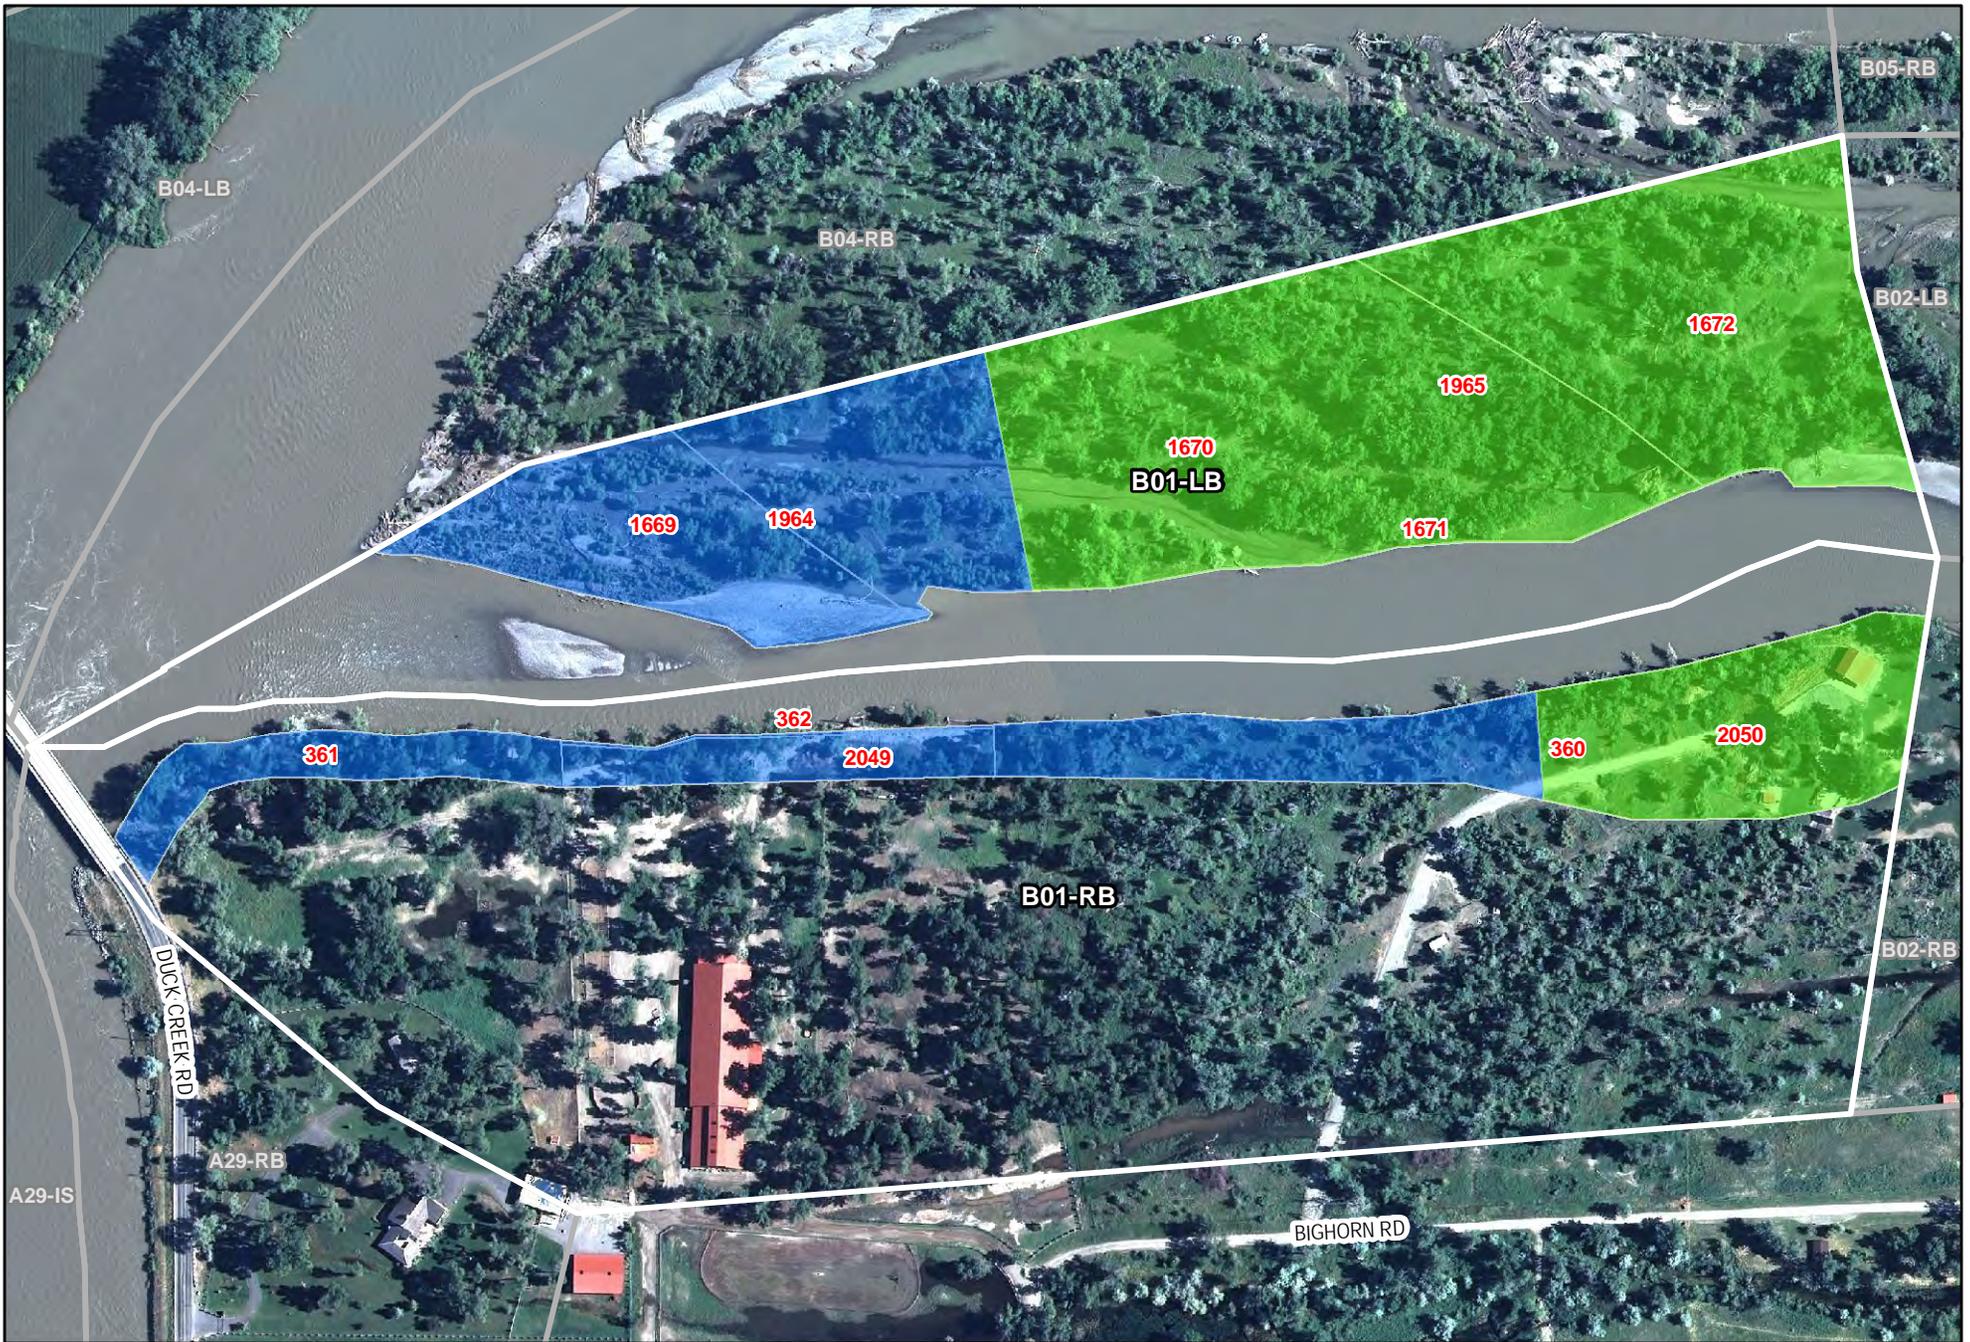
Figure 5 - Final SCAT Observations
For SCAT Area: B01

Figure 5 shows the oiling conditions within Area B01 following completion of oil removal activities. The SCAT team performed final surveys of the left and right banks within SCAT Area B01 to confirm the agreed-upon cleanup endpoints identified in the applicable CTRs had been achieved. The final SCAT survey documentation is presented in Appendix E.

Based on the final SCAT surveys performed on the right bank and the POST associated with the left bank within Area B01, no further treatment is recommended for these segments. SCAT Segment Sign-Off Forms are included as Appendix F.

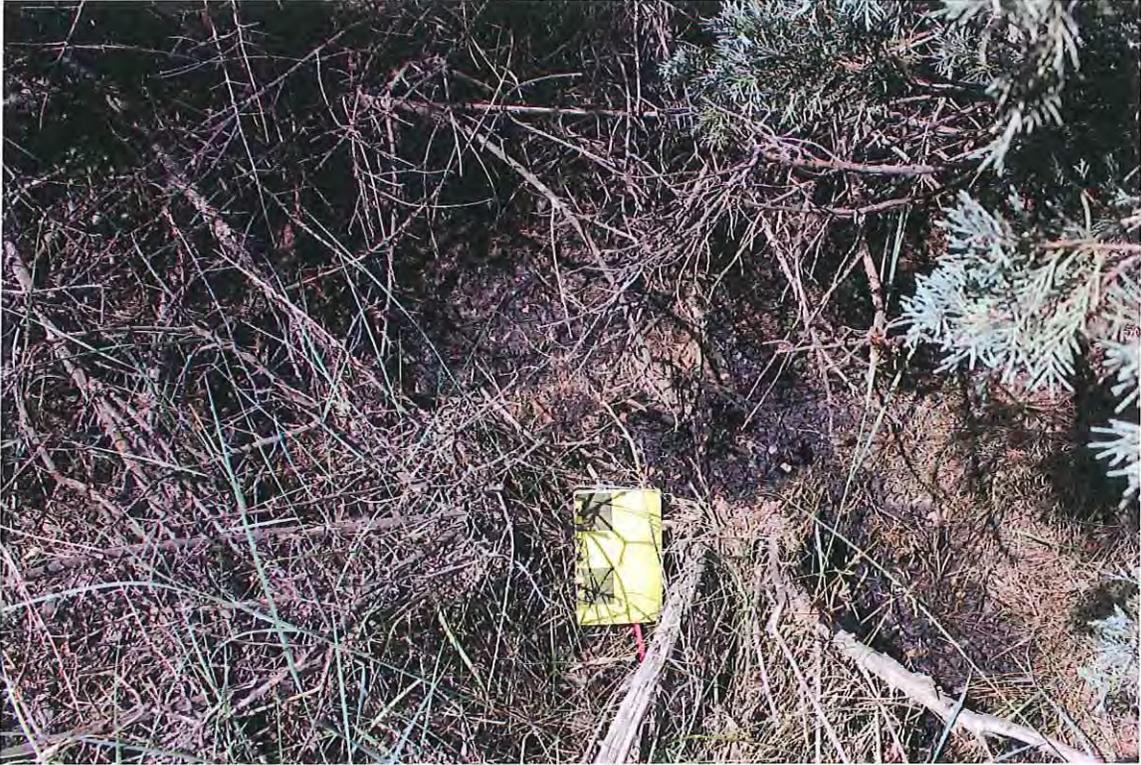
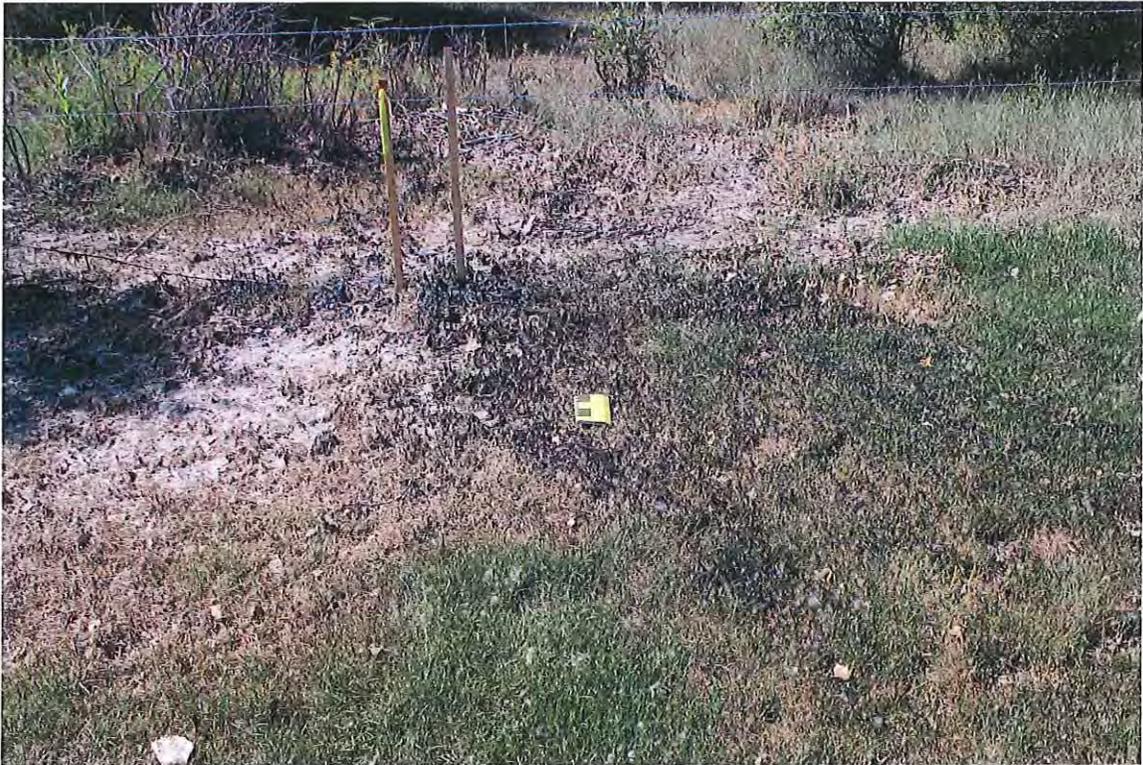
Segment B1, Zone A.

Oil band height: 8 cm

Zone A: Remove any remaining pooled oil with sorbents. Cut and remove oil coated vegetation smaller than 1" diameter. Remove oil coated debris smaller than 4" diameter. Wipe any larger oil coated vegetation and debris. Remove oil coated sediments with hand tools. Wipe oil coated cobble.

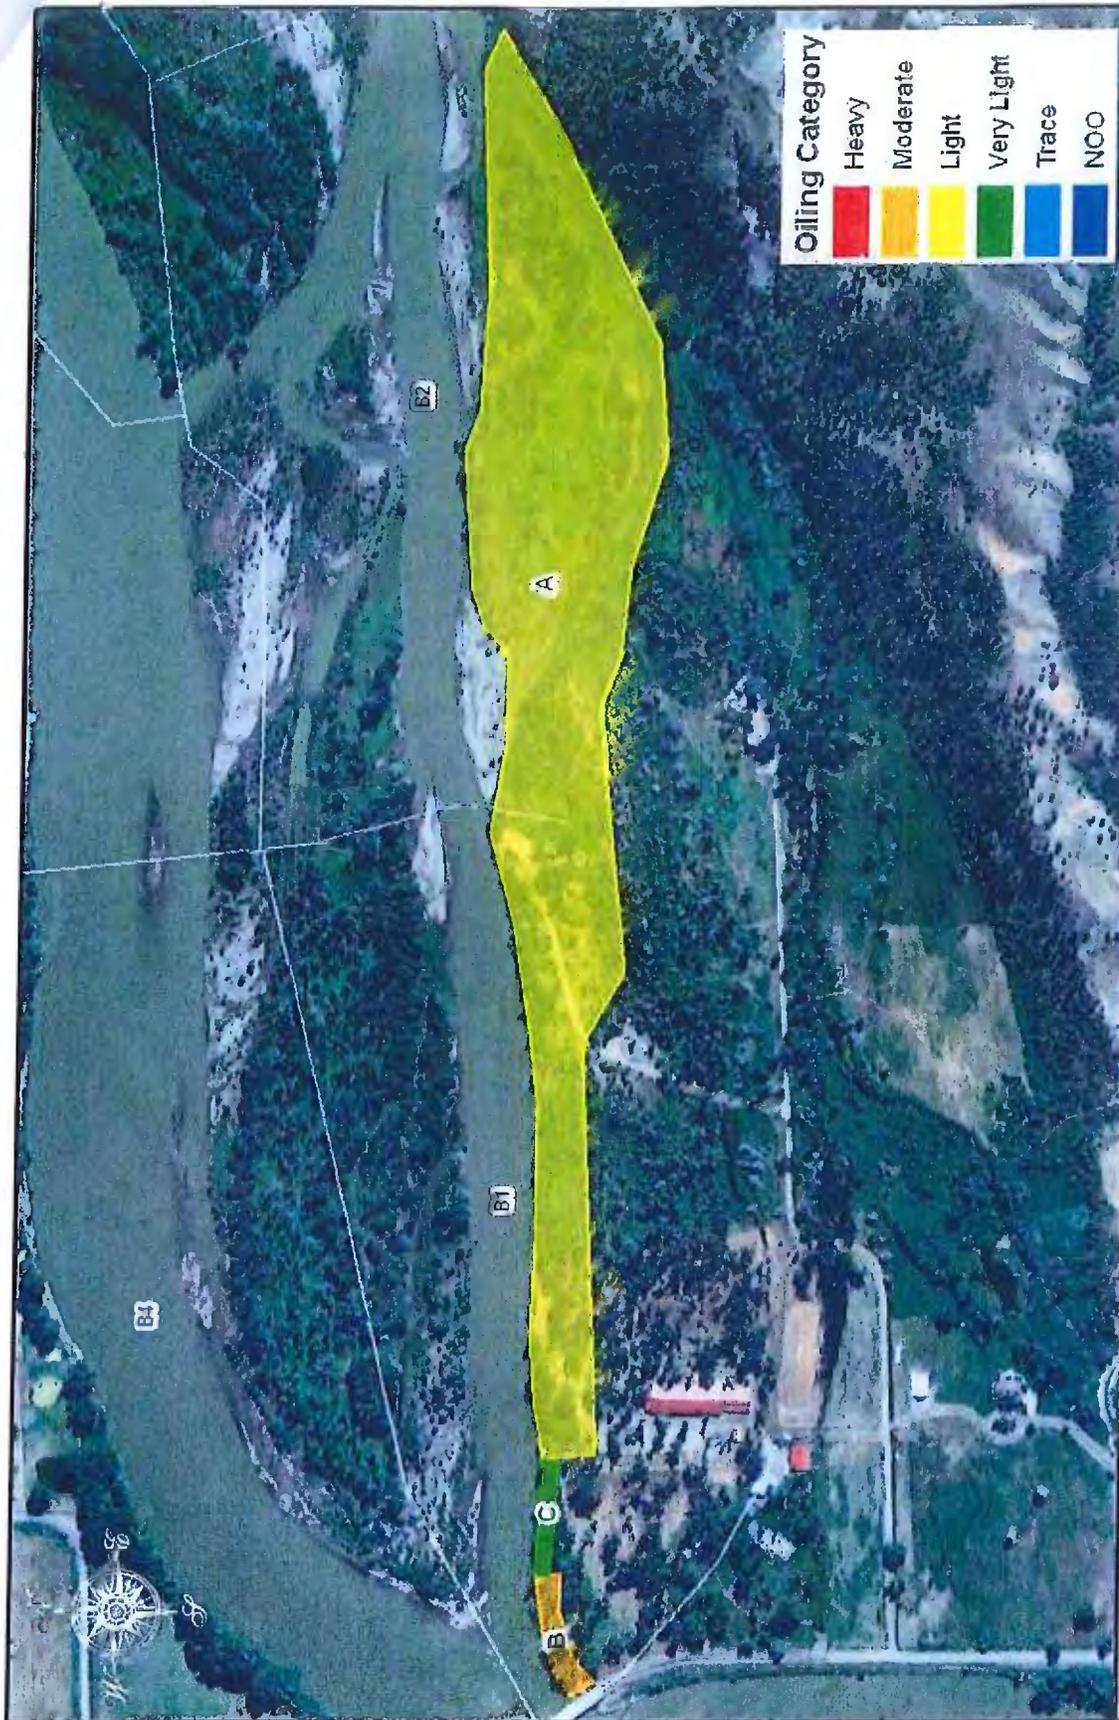
Division B Segments 01-R and 02-R.

Work specified in earlier visit was not completed. Contractor team completed required work site prior to departure of SCAT Liaison personnel.
