**SCAT Area Transition Report
for B12**

Silvertip Pipeline Incident
Laurel, Montana

October 19, 2011

Prepared by:
ARCADIS G&M of North Carolina, Inc.
11000 Regency Parkway
West Tower, Suite 205
Cary, North Carolina 27518-8518
Tel 919.469.1952
Fax 919.469.5676

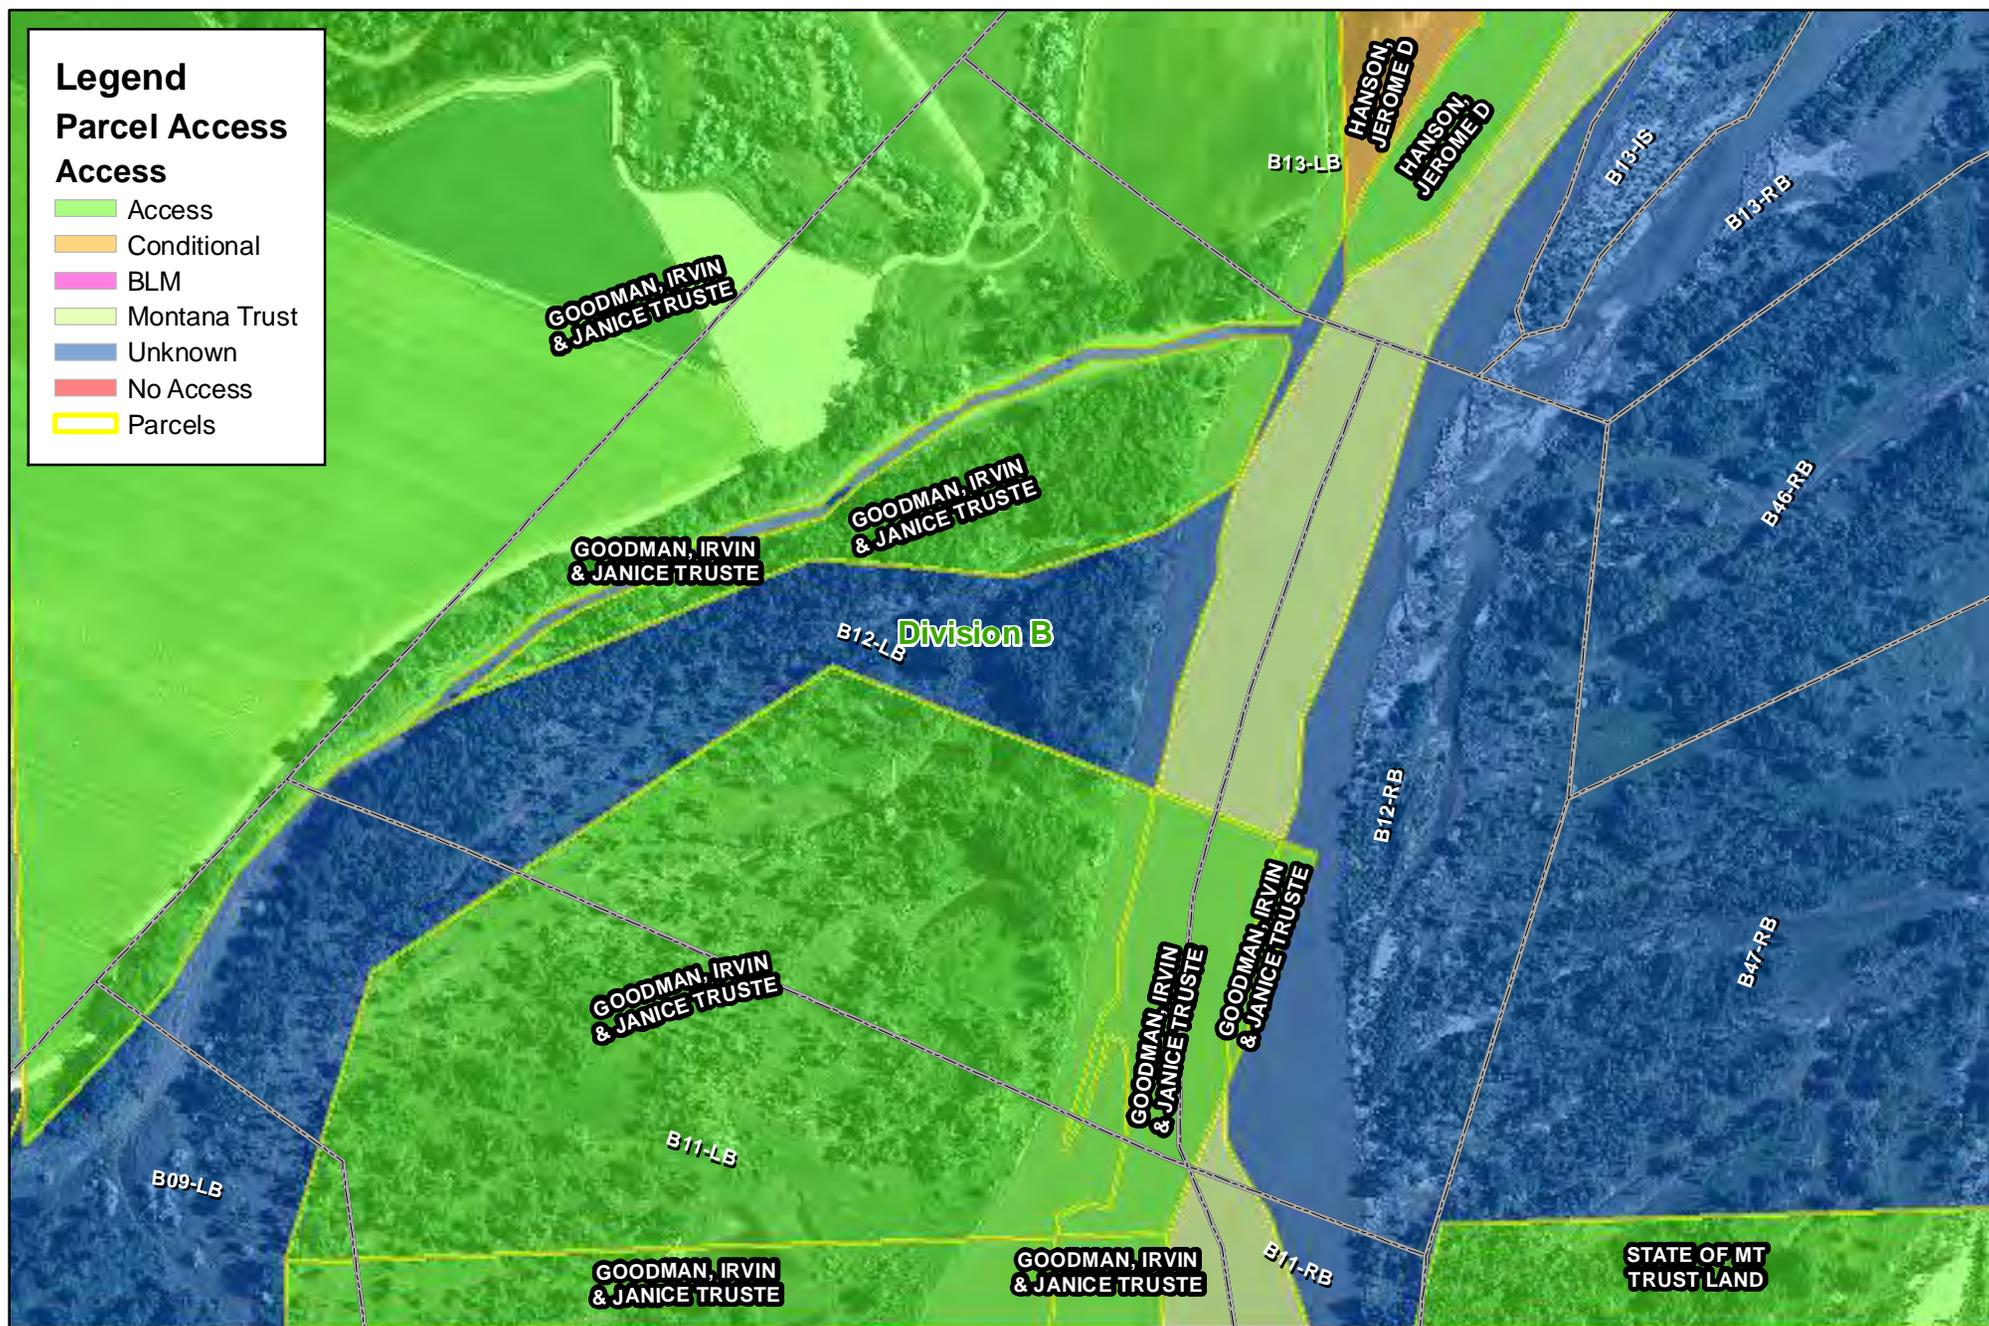
Figure 1 provides an aerial map of SCAT Area B12, along with the (a) SCAT Area boundary, (b) parcel boundaries and respective property owners, and (c) access constraints identified during the oil cleanup process. The acreage surveyed in Area B12 is 42.9. There were no access issues for this area.

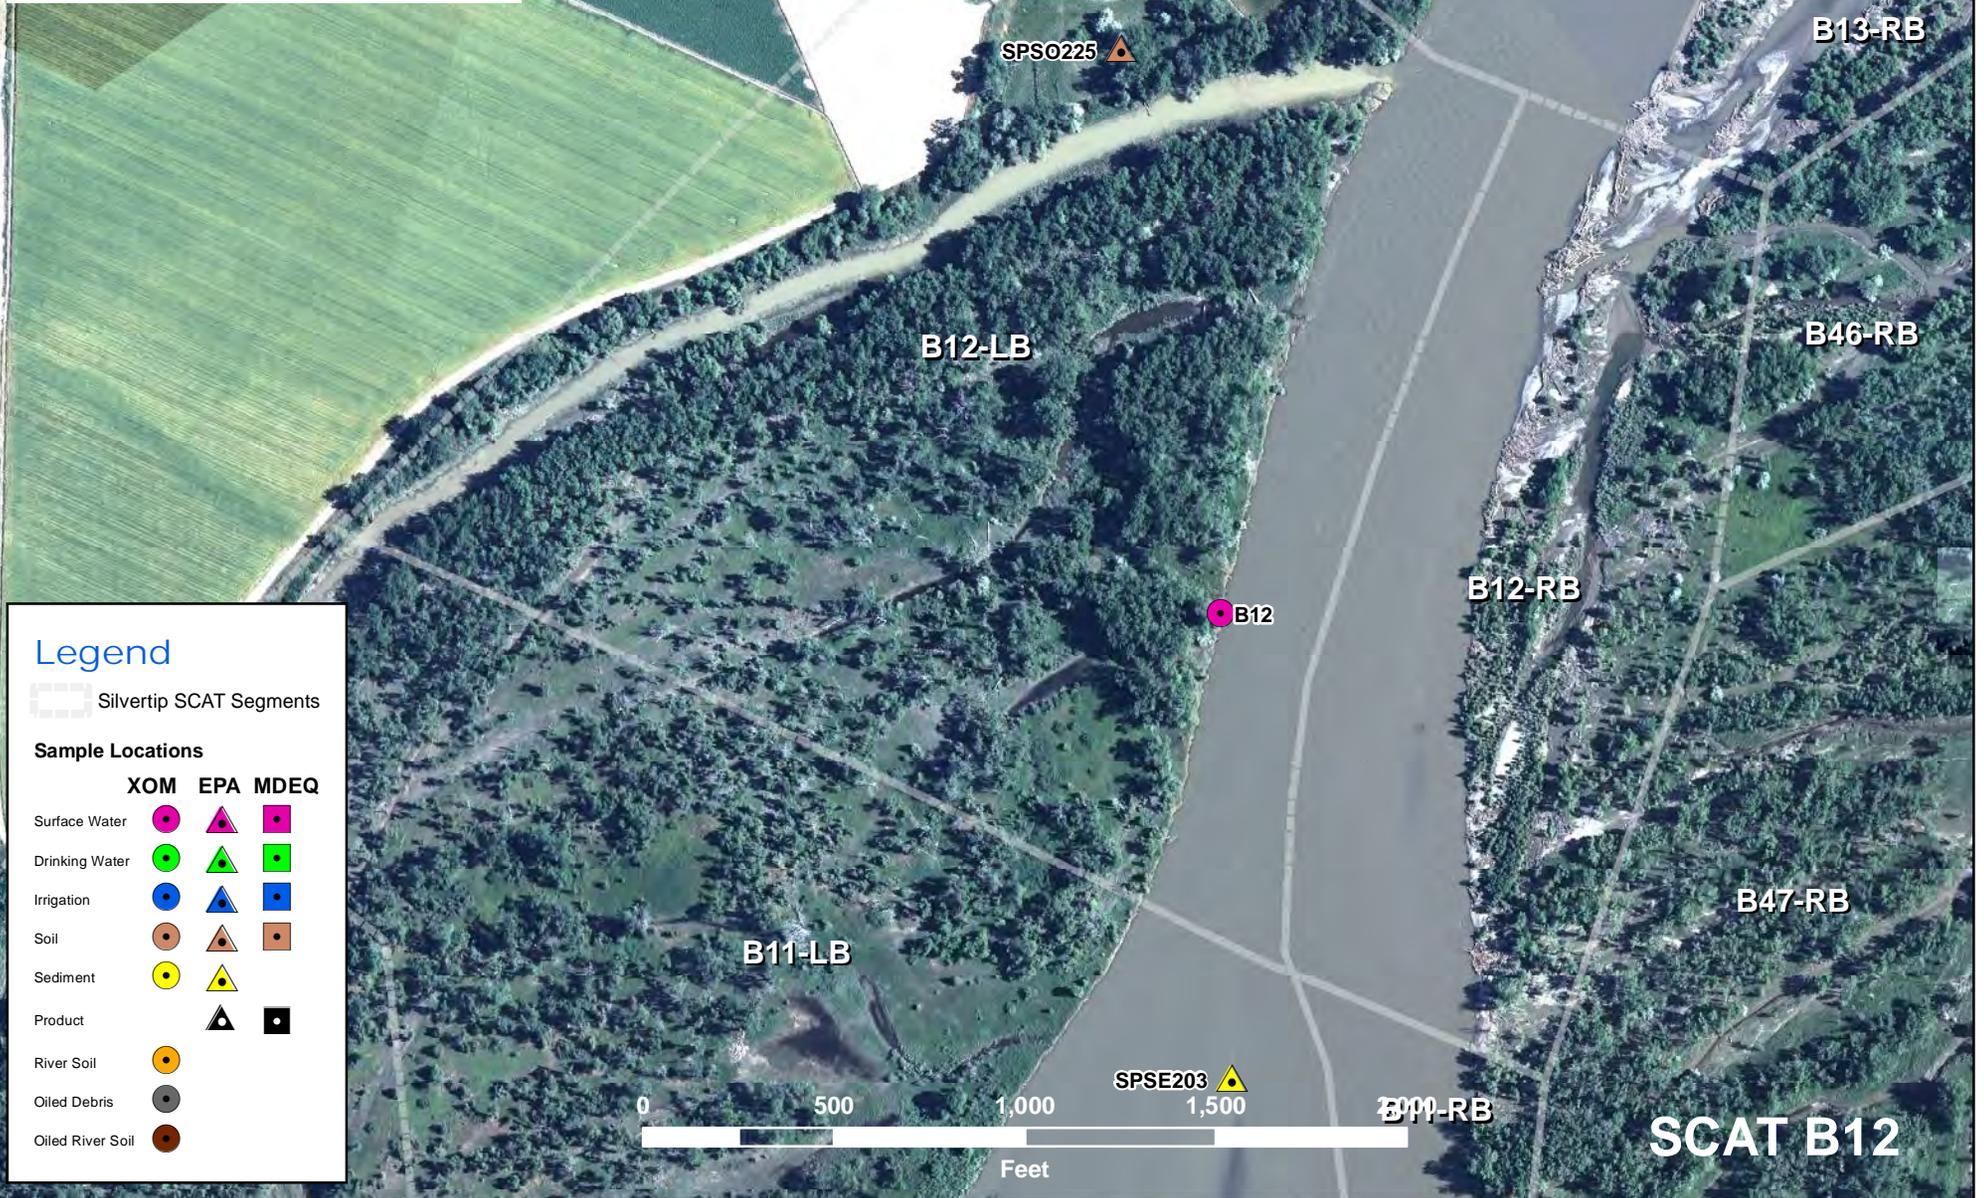
Figure 3
Silvertip Pipeline Incident
Environmental Sampling
Locations as of 8/27/2011

Table 1 (below) summarizes samples collected within Area B12. The analytical results for the samples collected can be accessed through a publicly accessible database on the United States Environmental Protection Agency’s (USEPA’s) website. The approximate locations of samples collected within Area B12 are provided on Figure 3.

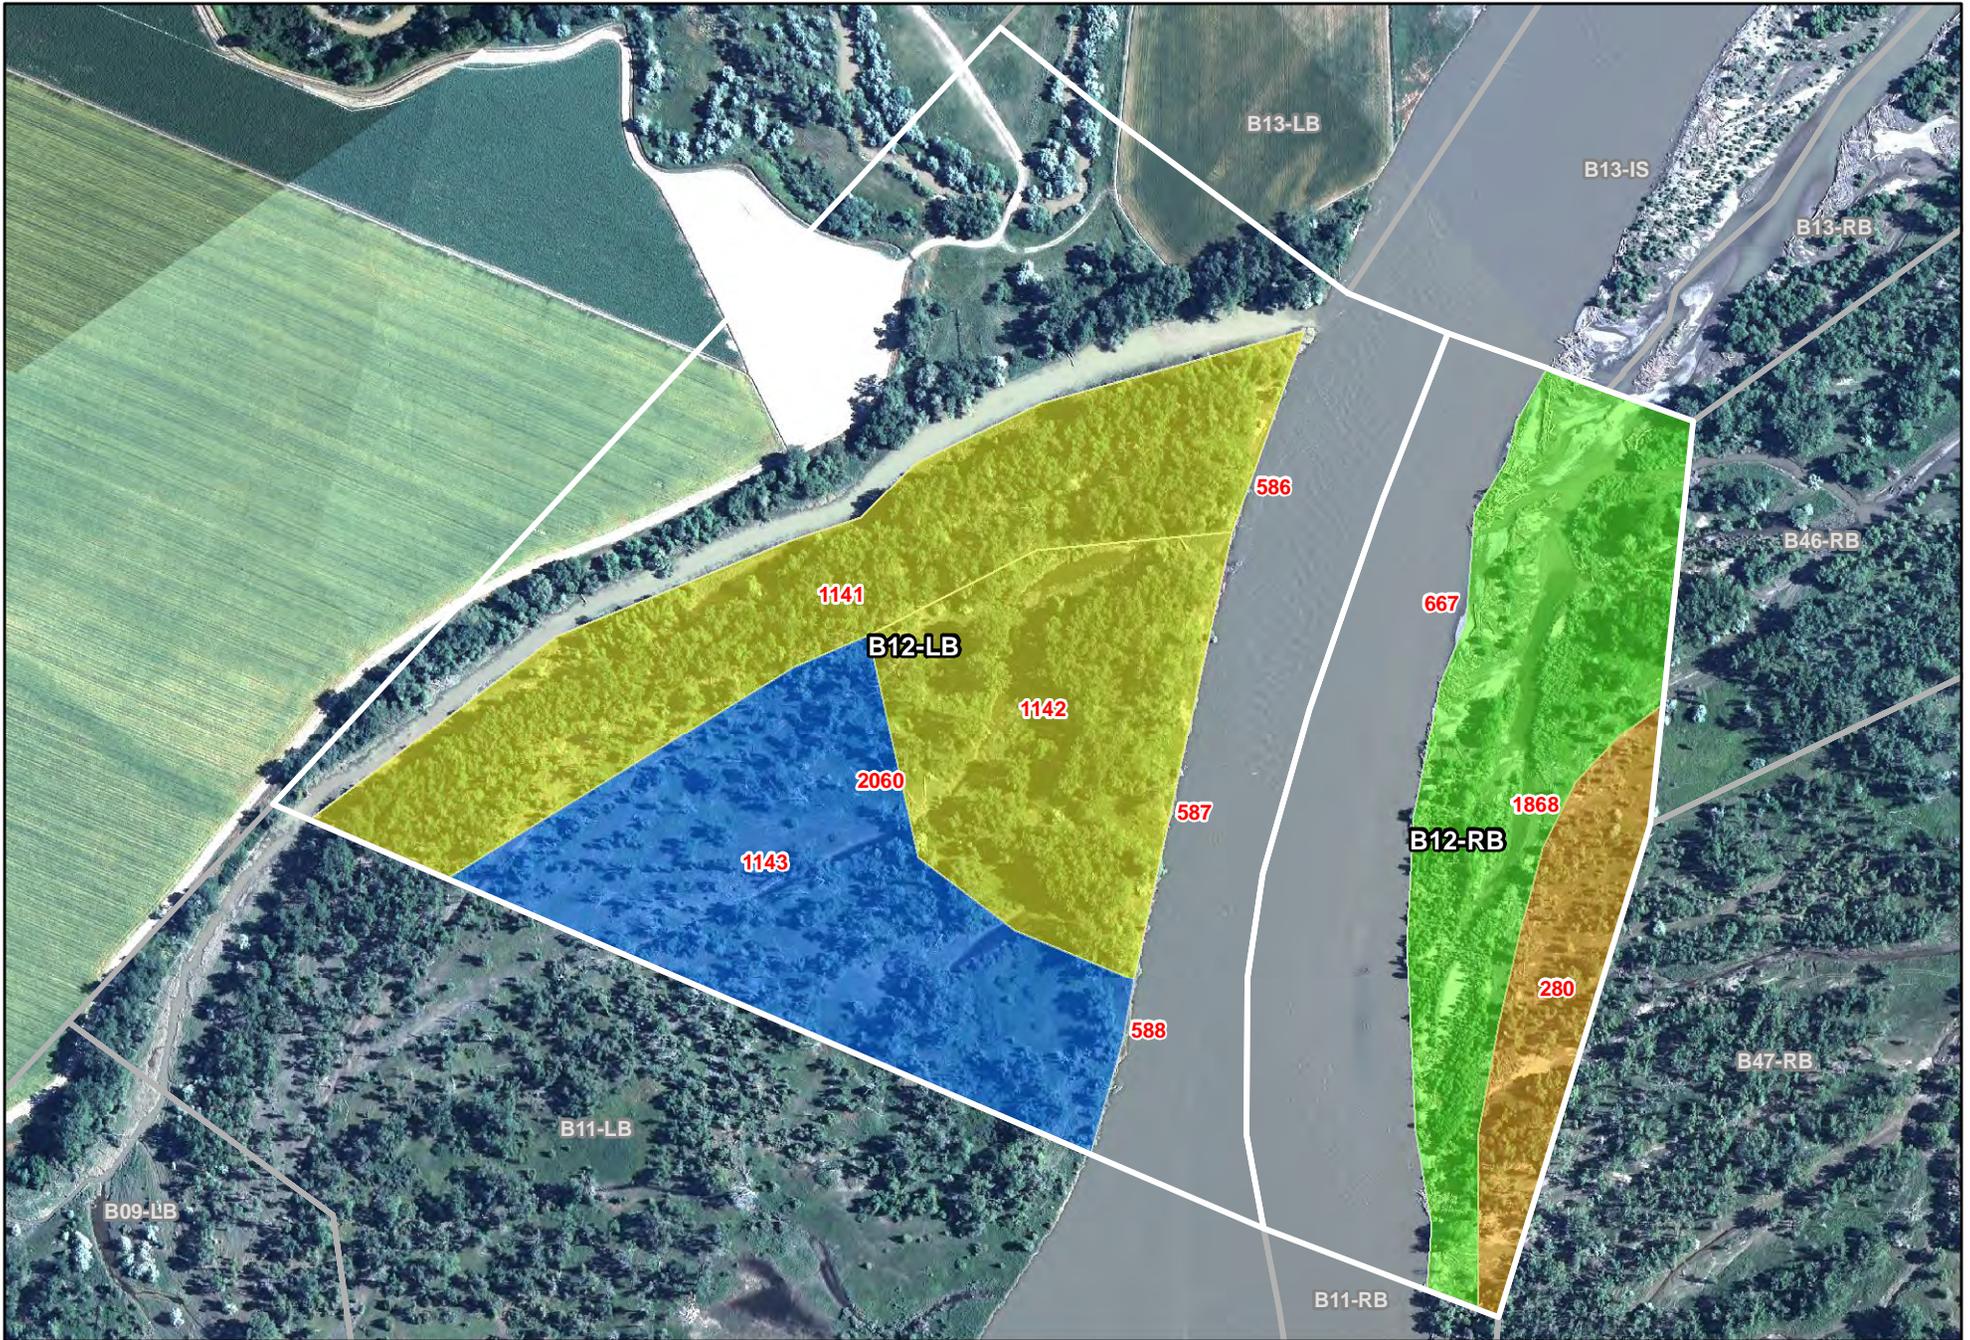
The SCAT teams used systematic evaluation criteria and treatment method tables approved by the National Oceanic and Atmospheric Administration to provide a standard approach for data collection and conducting field surveys. The forms and sketches from the initial SCAT surveys performed along the river bank (water edge) and floodplain within Area B12 are included in Appendix B. Figure 4 provides the maximum oiling zones observed by the SCAT team during the initial surveys of Area B12.

No Oil Observed</p>	<p>Figure 4 - Maximum SCAT Observations</p> <p>For SCAT Area: B12</p> <p>

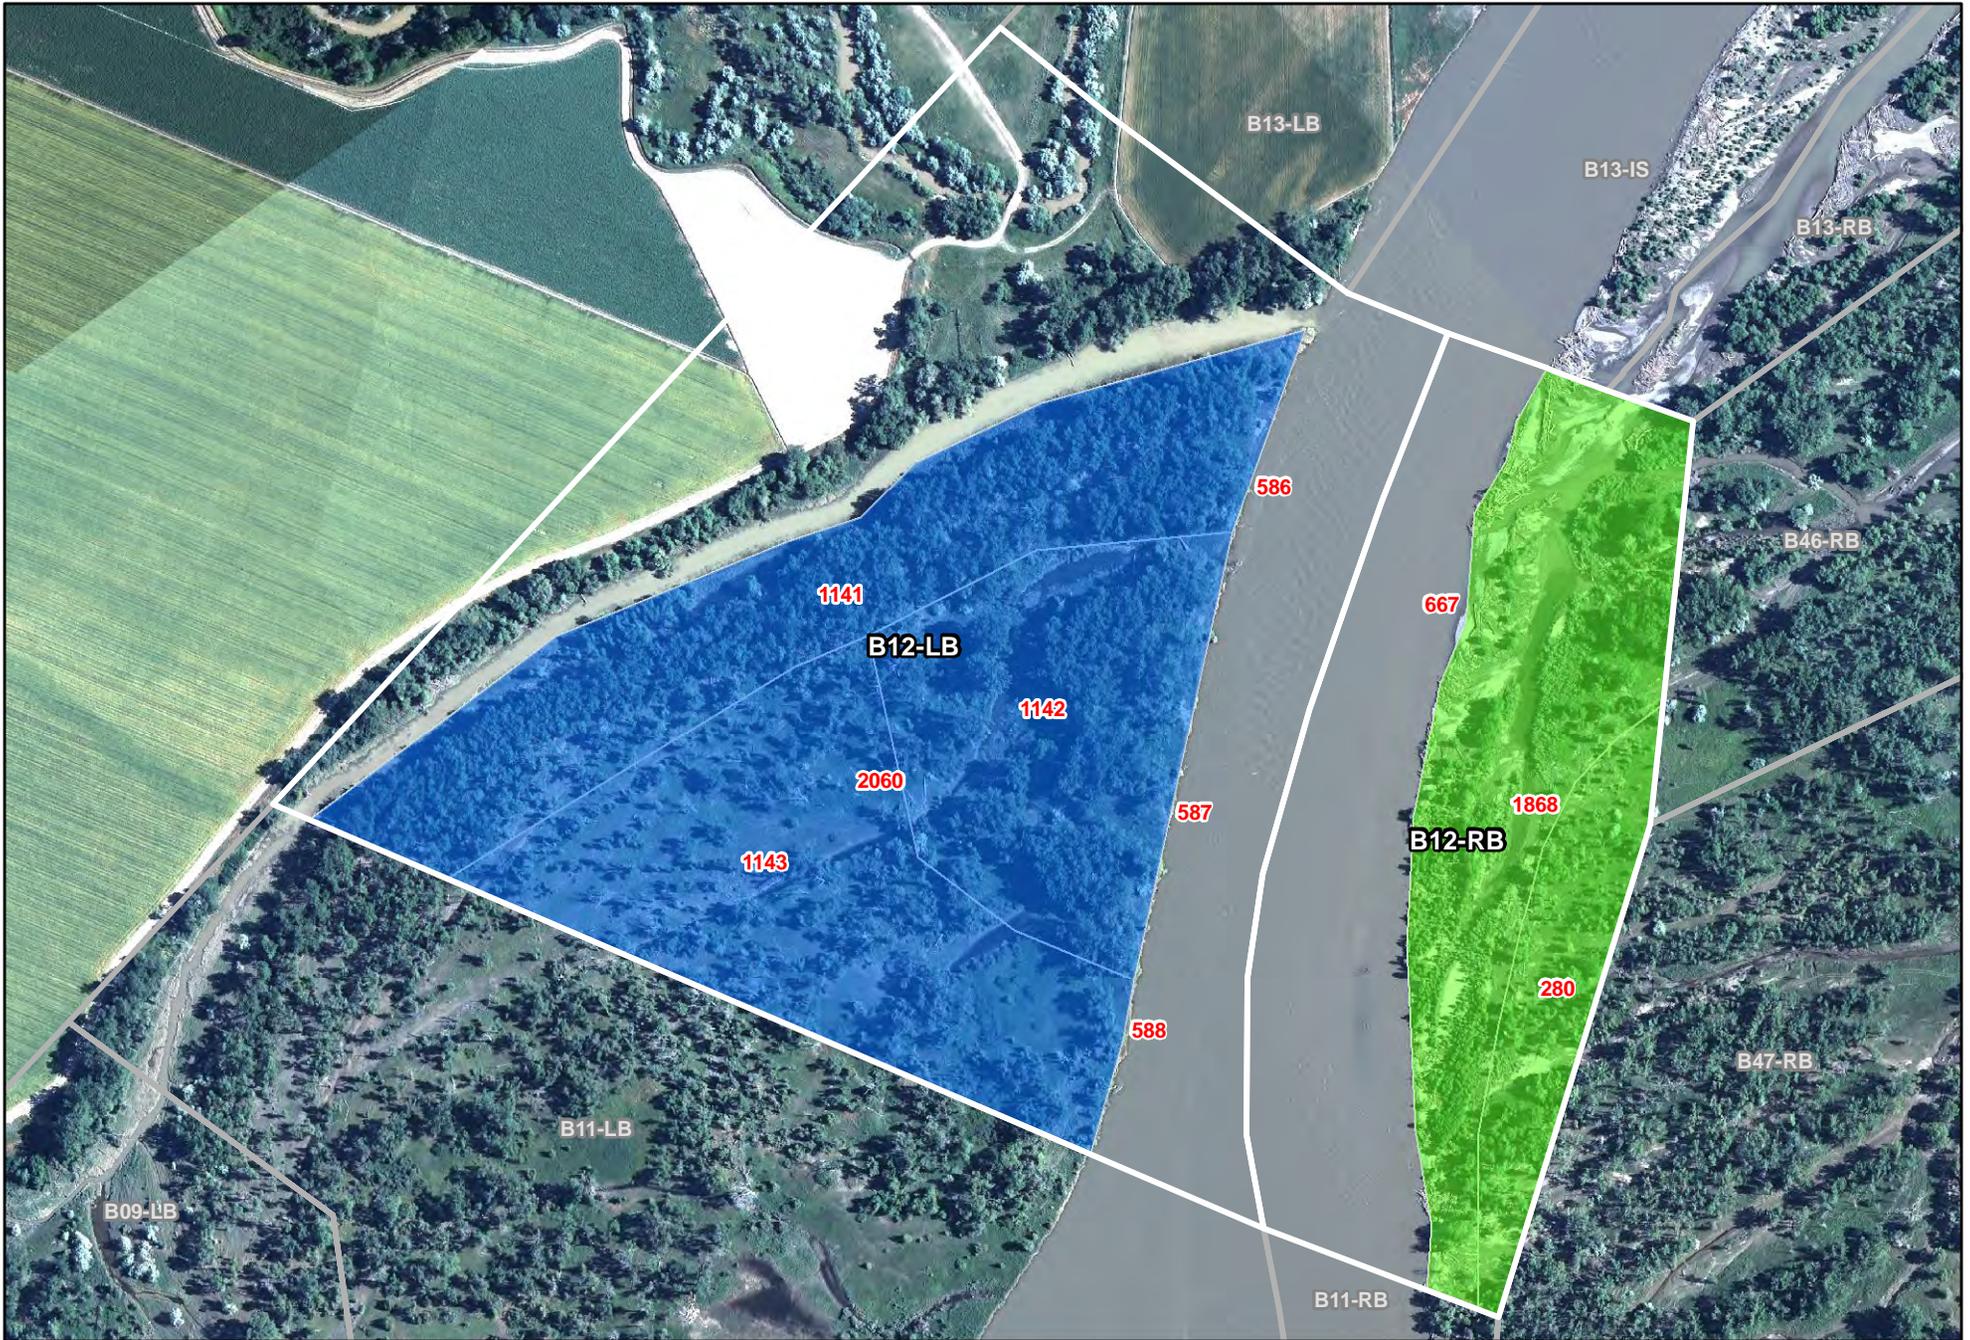
**Figure 5 - Final SCAT Observations
For SCAT Area: B12**

Figure 5 shows the oiling conditions within Area B12 following completion of oil removal activities. The SCAT team performed final surveys of the left and right banks within SCAT Area B12 to confirm the agreed-upon cleanup endpoints identified in the applicable CTRs had been achieved. The final SCAT survey documentation is presented in Appendix E.

Based on the final SCAT surveys performed on the left and right banks within Area B12, no further treatment is recommended for these segments. SCAT Segment Sign-Off Forms are included as Appendix F.

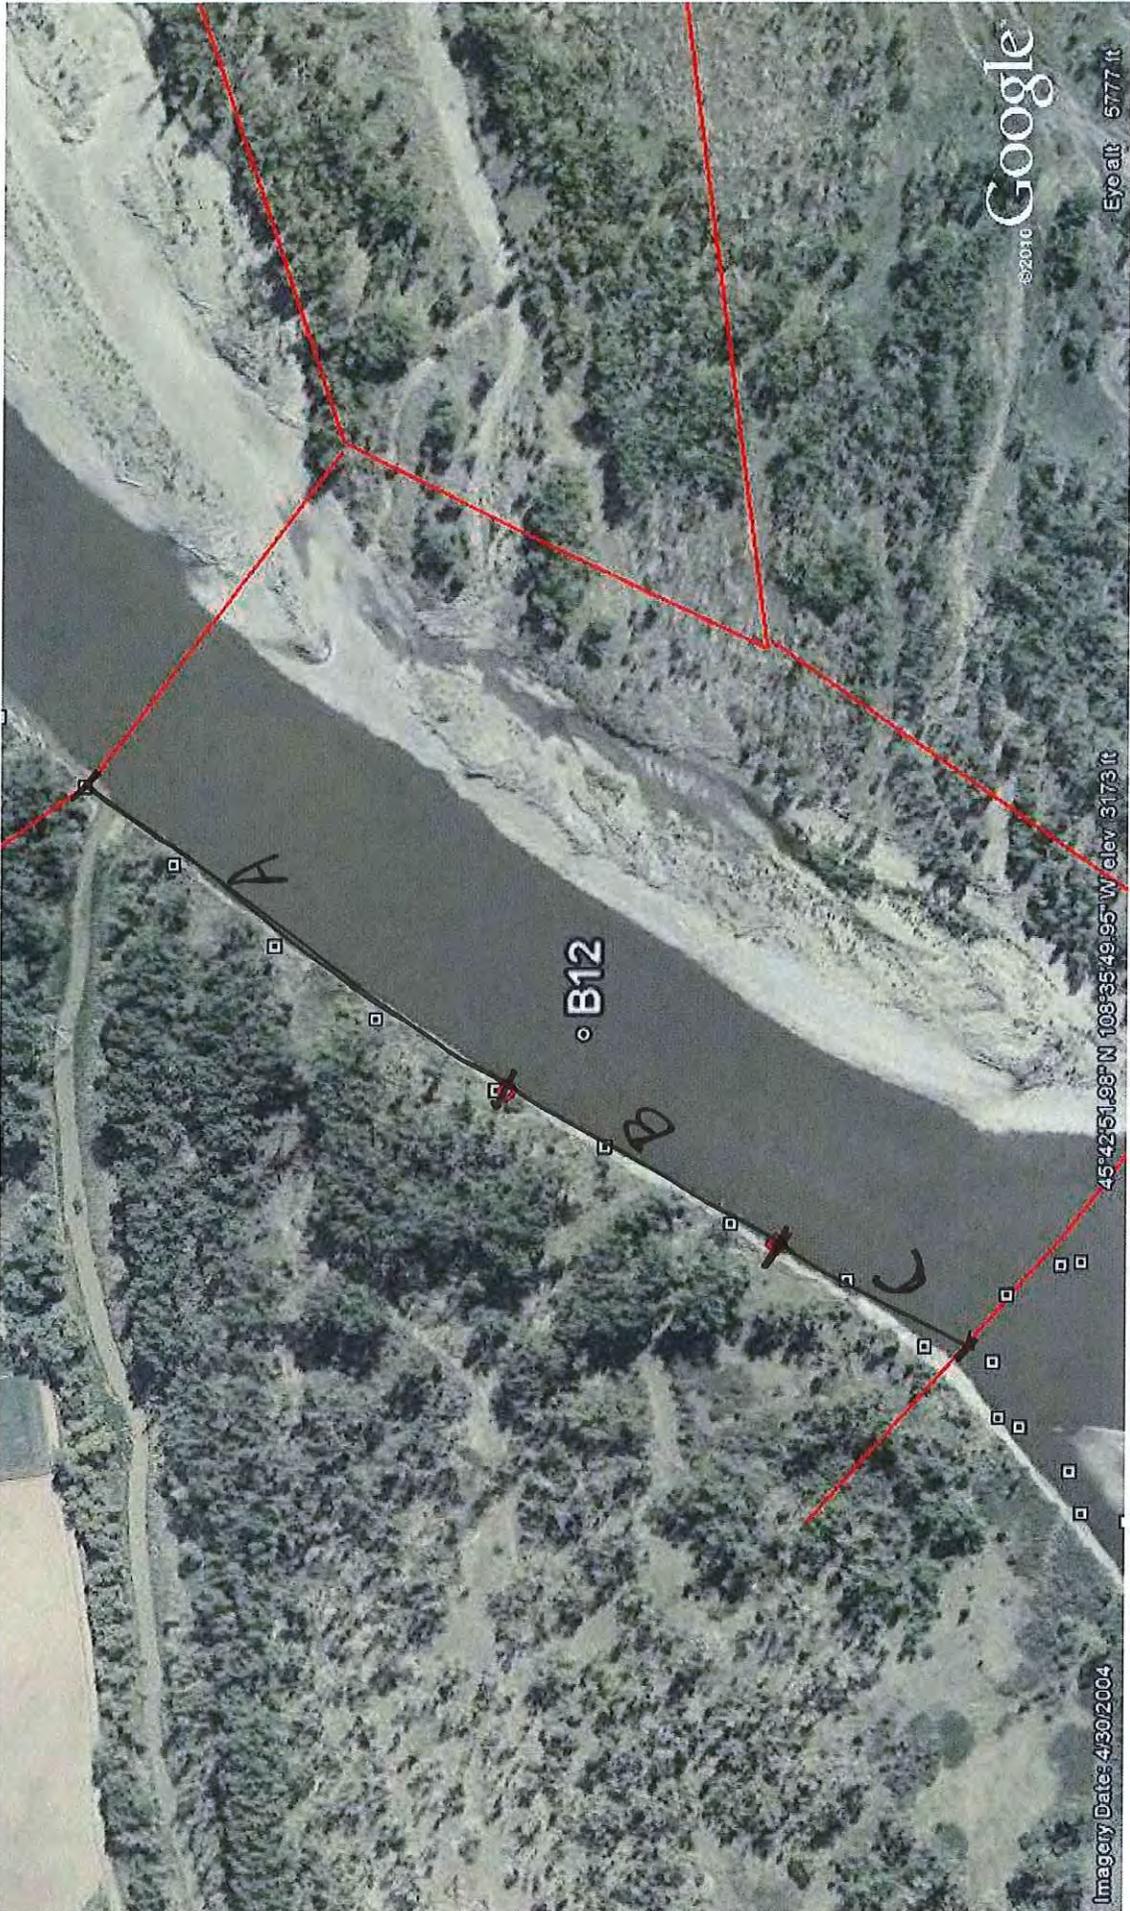
B12

Oil band heights: Zone B: 30 cm

Treatment Recommendations:
 Zone A, C: No oil observed; no treatment required.
 Zone B: Cut & remove oil coated vegetation smaller than 1" diameter. Wipe larger oil coated vegetation.

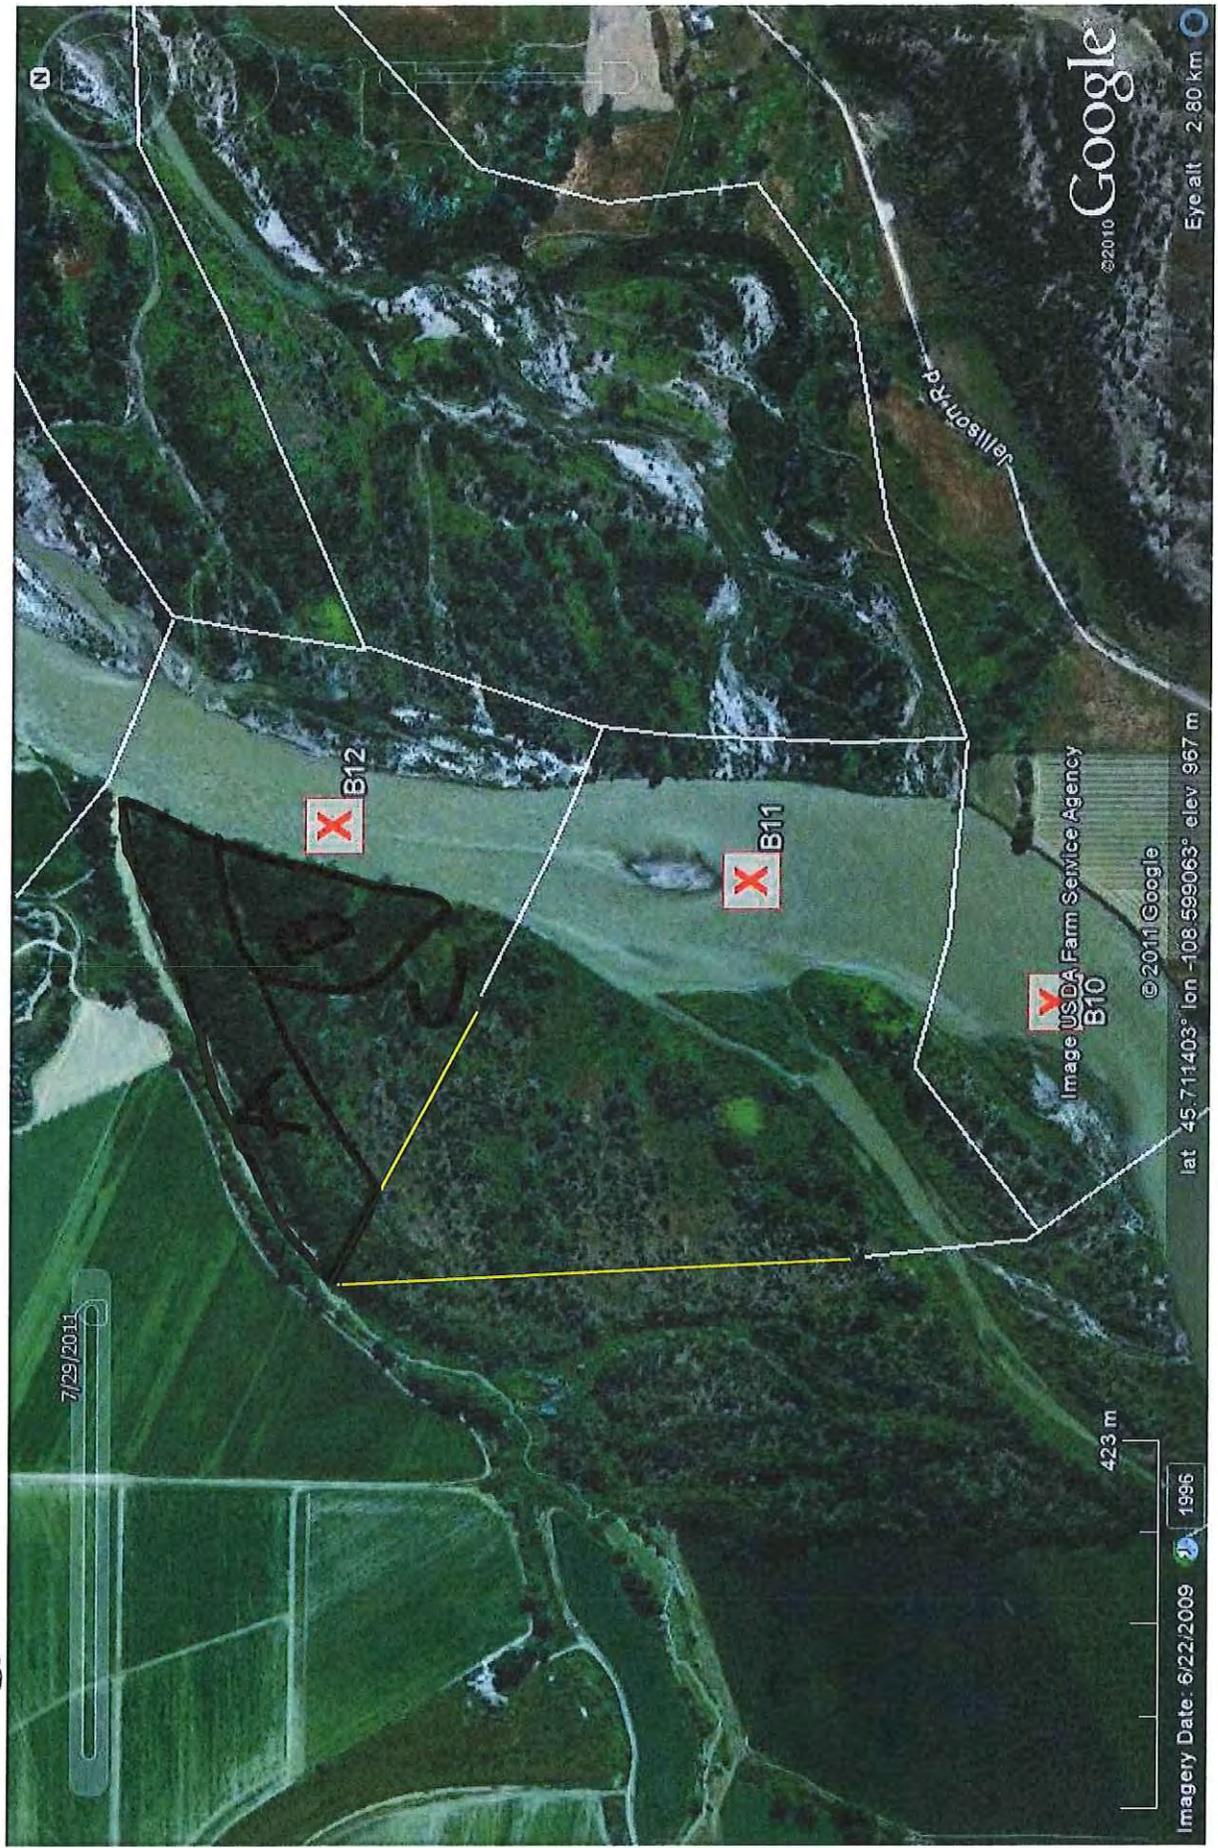
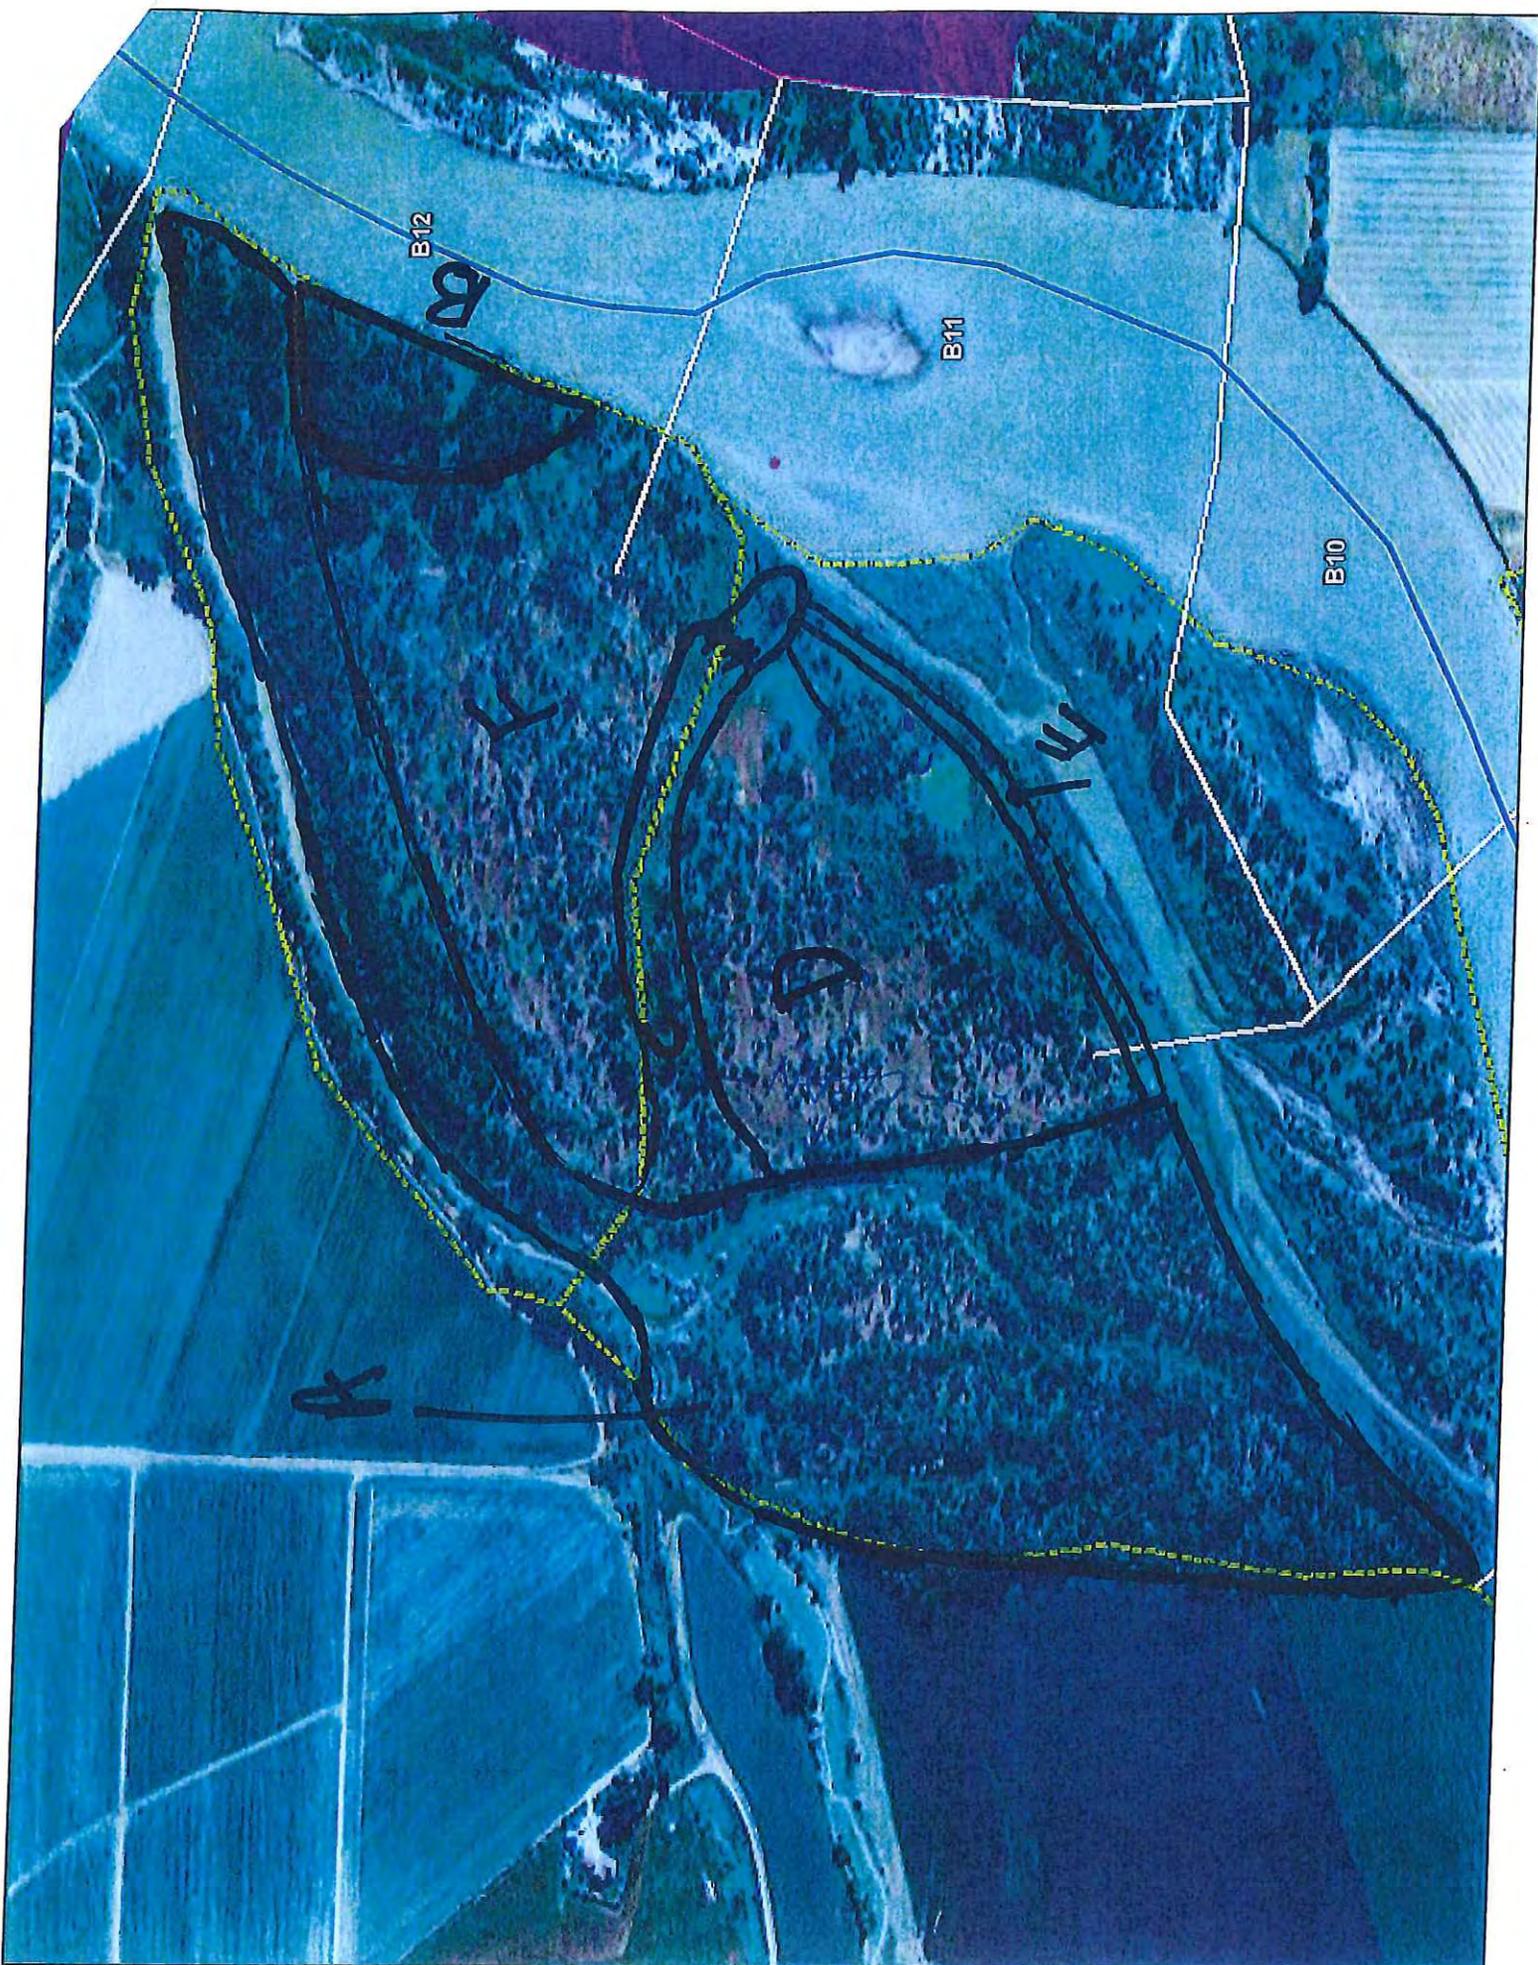
B12 L
Zones A, B, + C

NOTES: The B12 L survey dated July 27, 2011 (ATTACHED) included segments B9L, B10L, B11L, B12L. This cover sheet breaks out the zones listed on the July 27, 2011 form into their appropriate segment. Joe Bauer, July 29, 2011.

ZONE A, B. Cut and remove oiled grass, ^{debris} and oil coated vegetation smaller than 1" diameter - wipe larger coated vegetation.

C: no oil observed. no treatment required

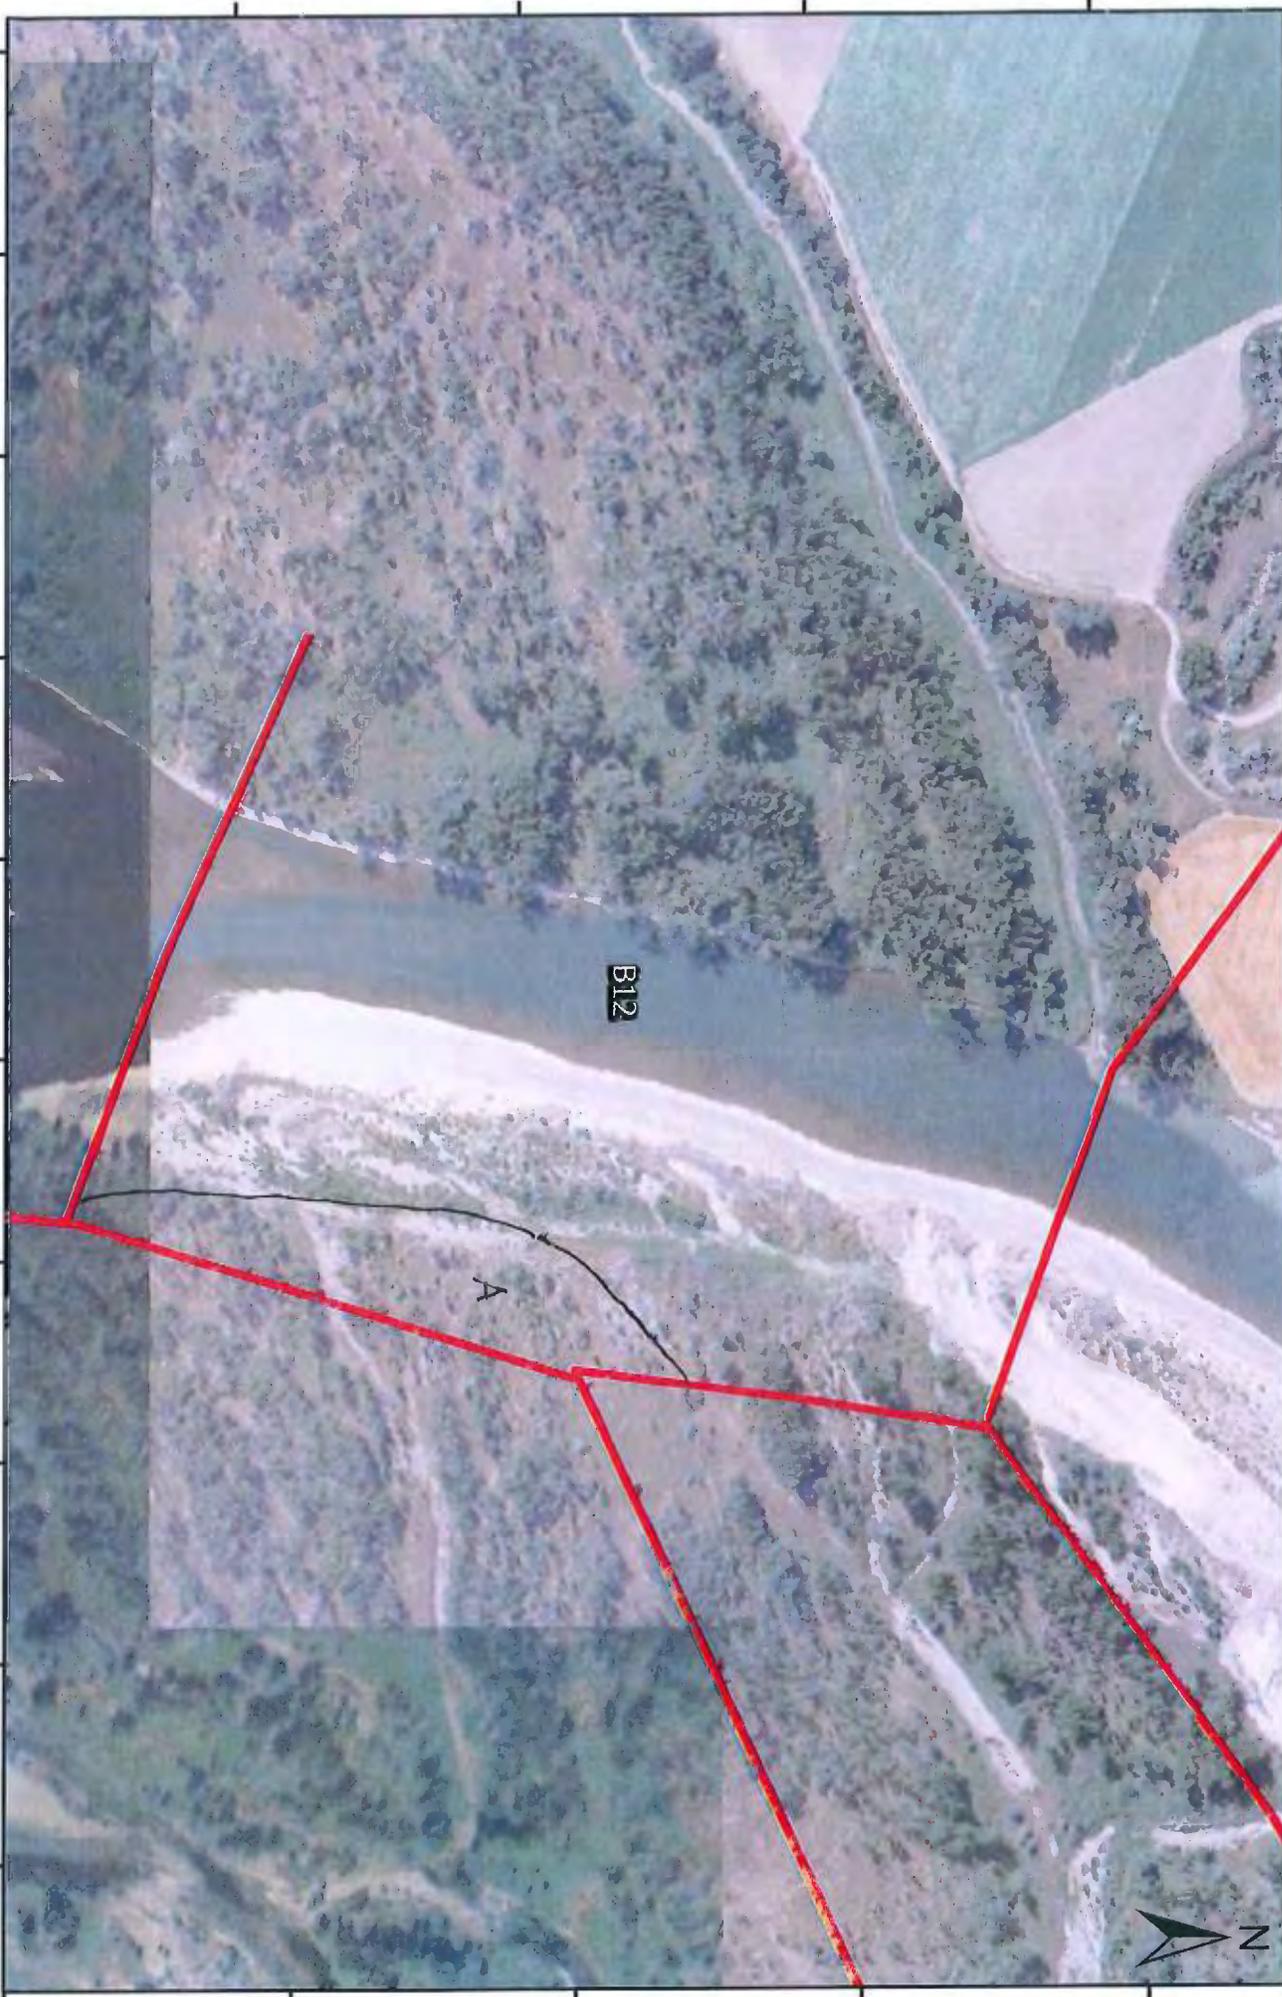
A- Most of this zone is productly covered with large piles of wooden debris that is coated. There is some strand vegetation, and small areas of pooled oil. Debris will need to cut and removed or surgically burned. Small pools need absorbent pads.
