**SCAT Area Transition Report
for B27**

Silvertip Pipeline Incident
Laurel, Montana

October 21, 2011

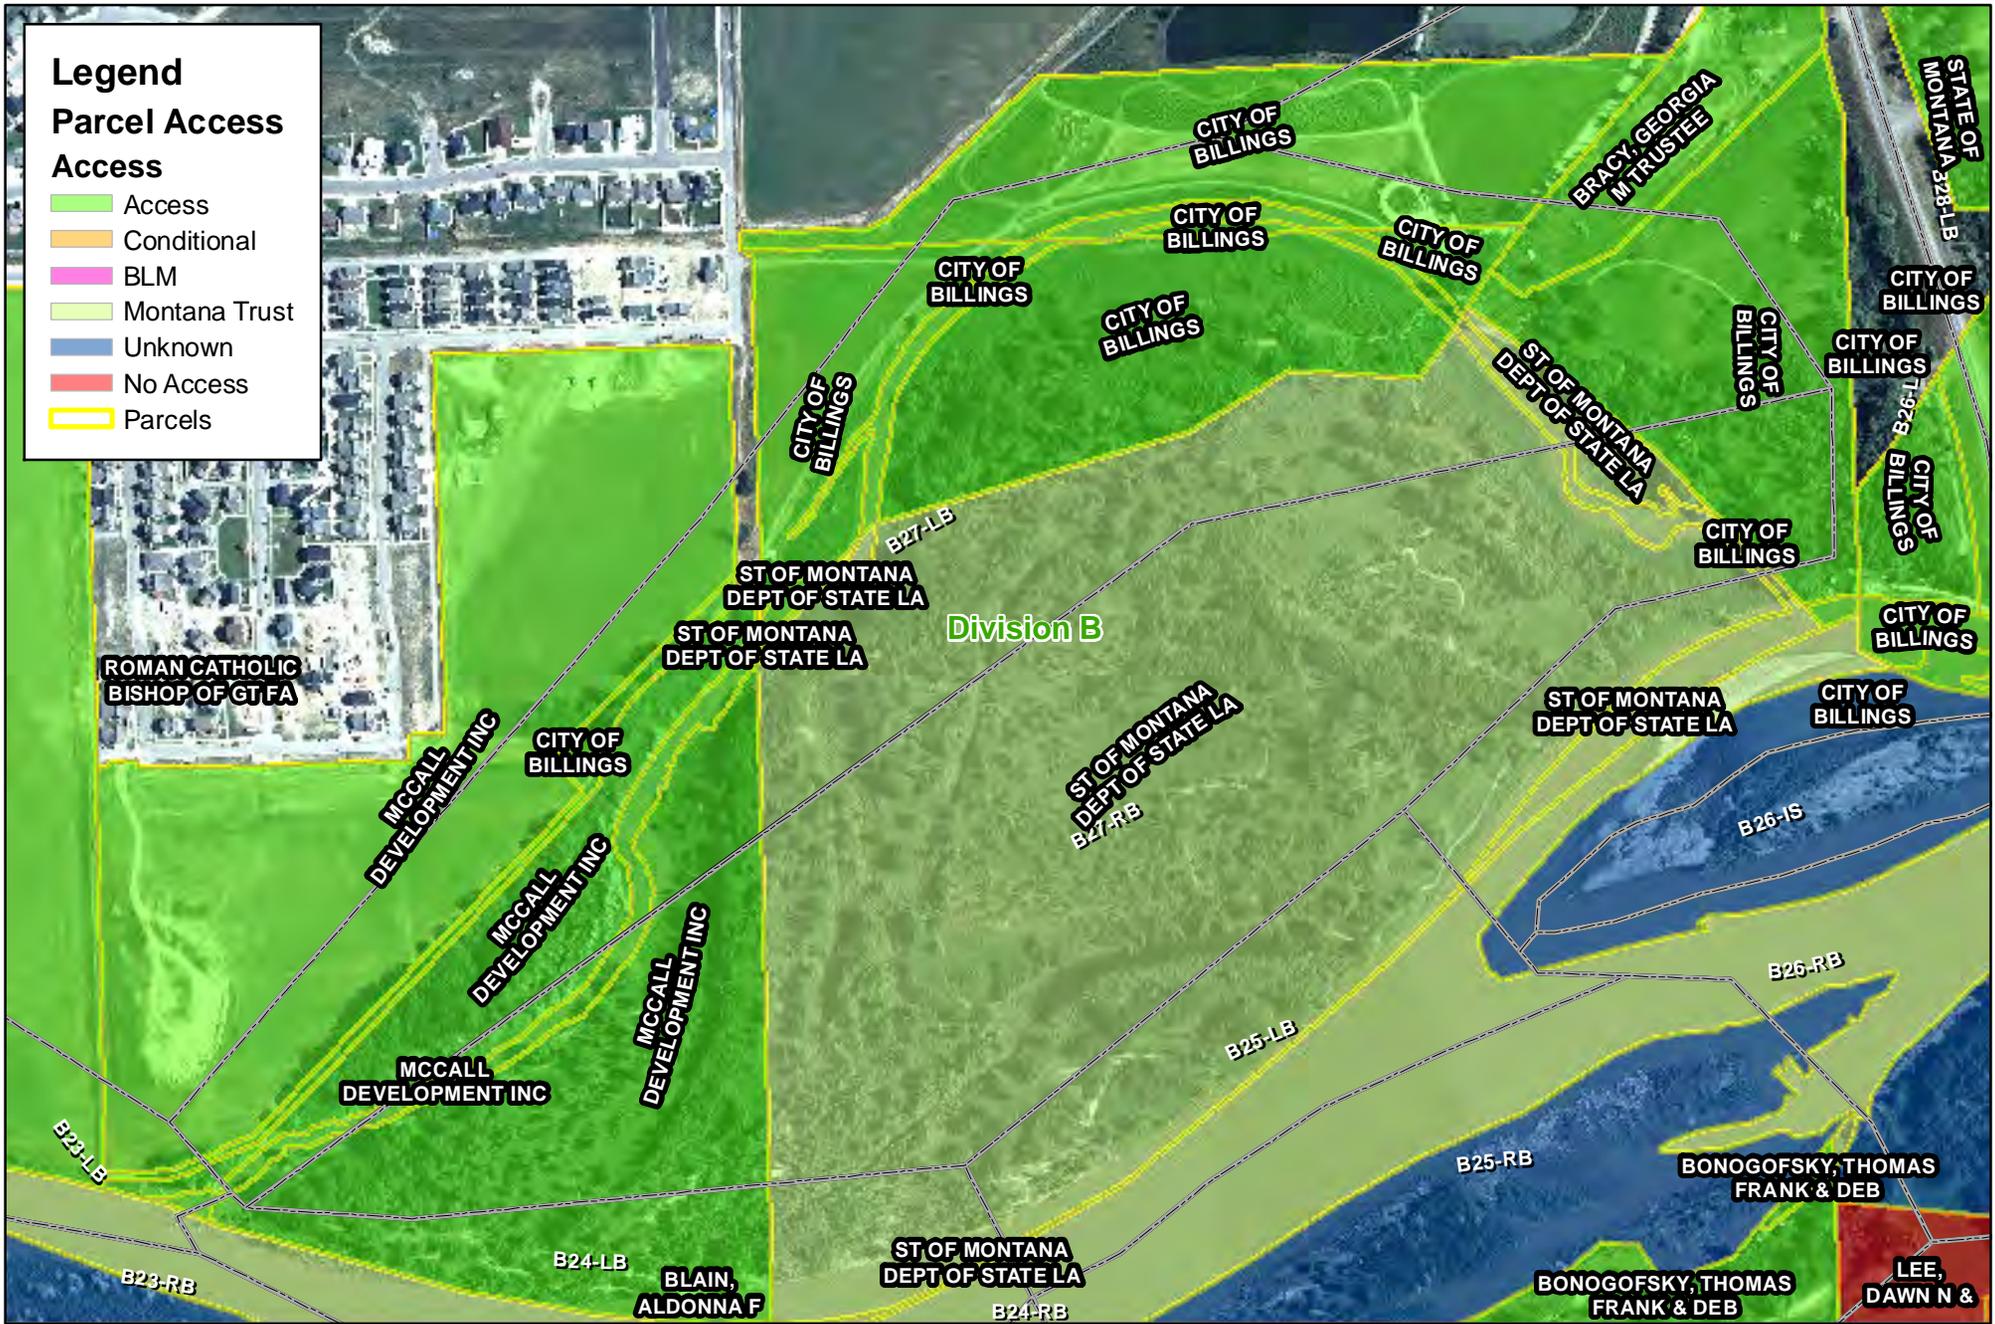
Figure 1 provides an aerial map of SCAT Area B27, along with the (a) SCAT Area boundary, (b) parcel boundaries and respective property owners, and (c) access constraints identified during the oil cleanup process. The acreage surveyed in Area B27 is 97.7. There were no access issues for this area.

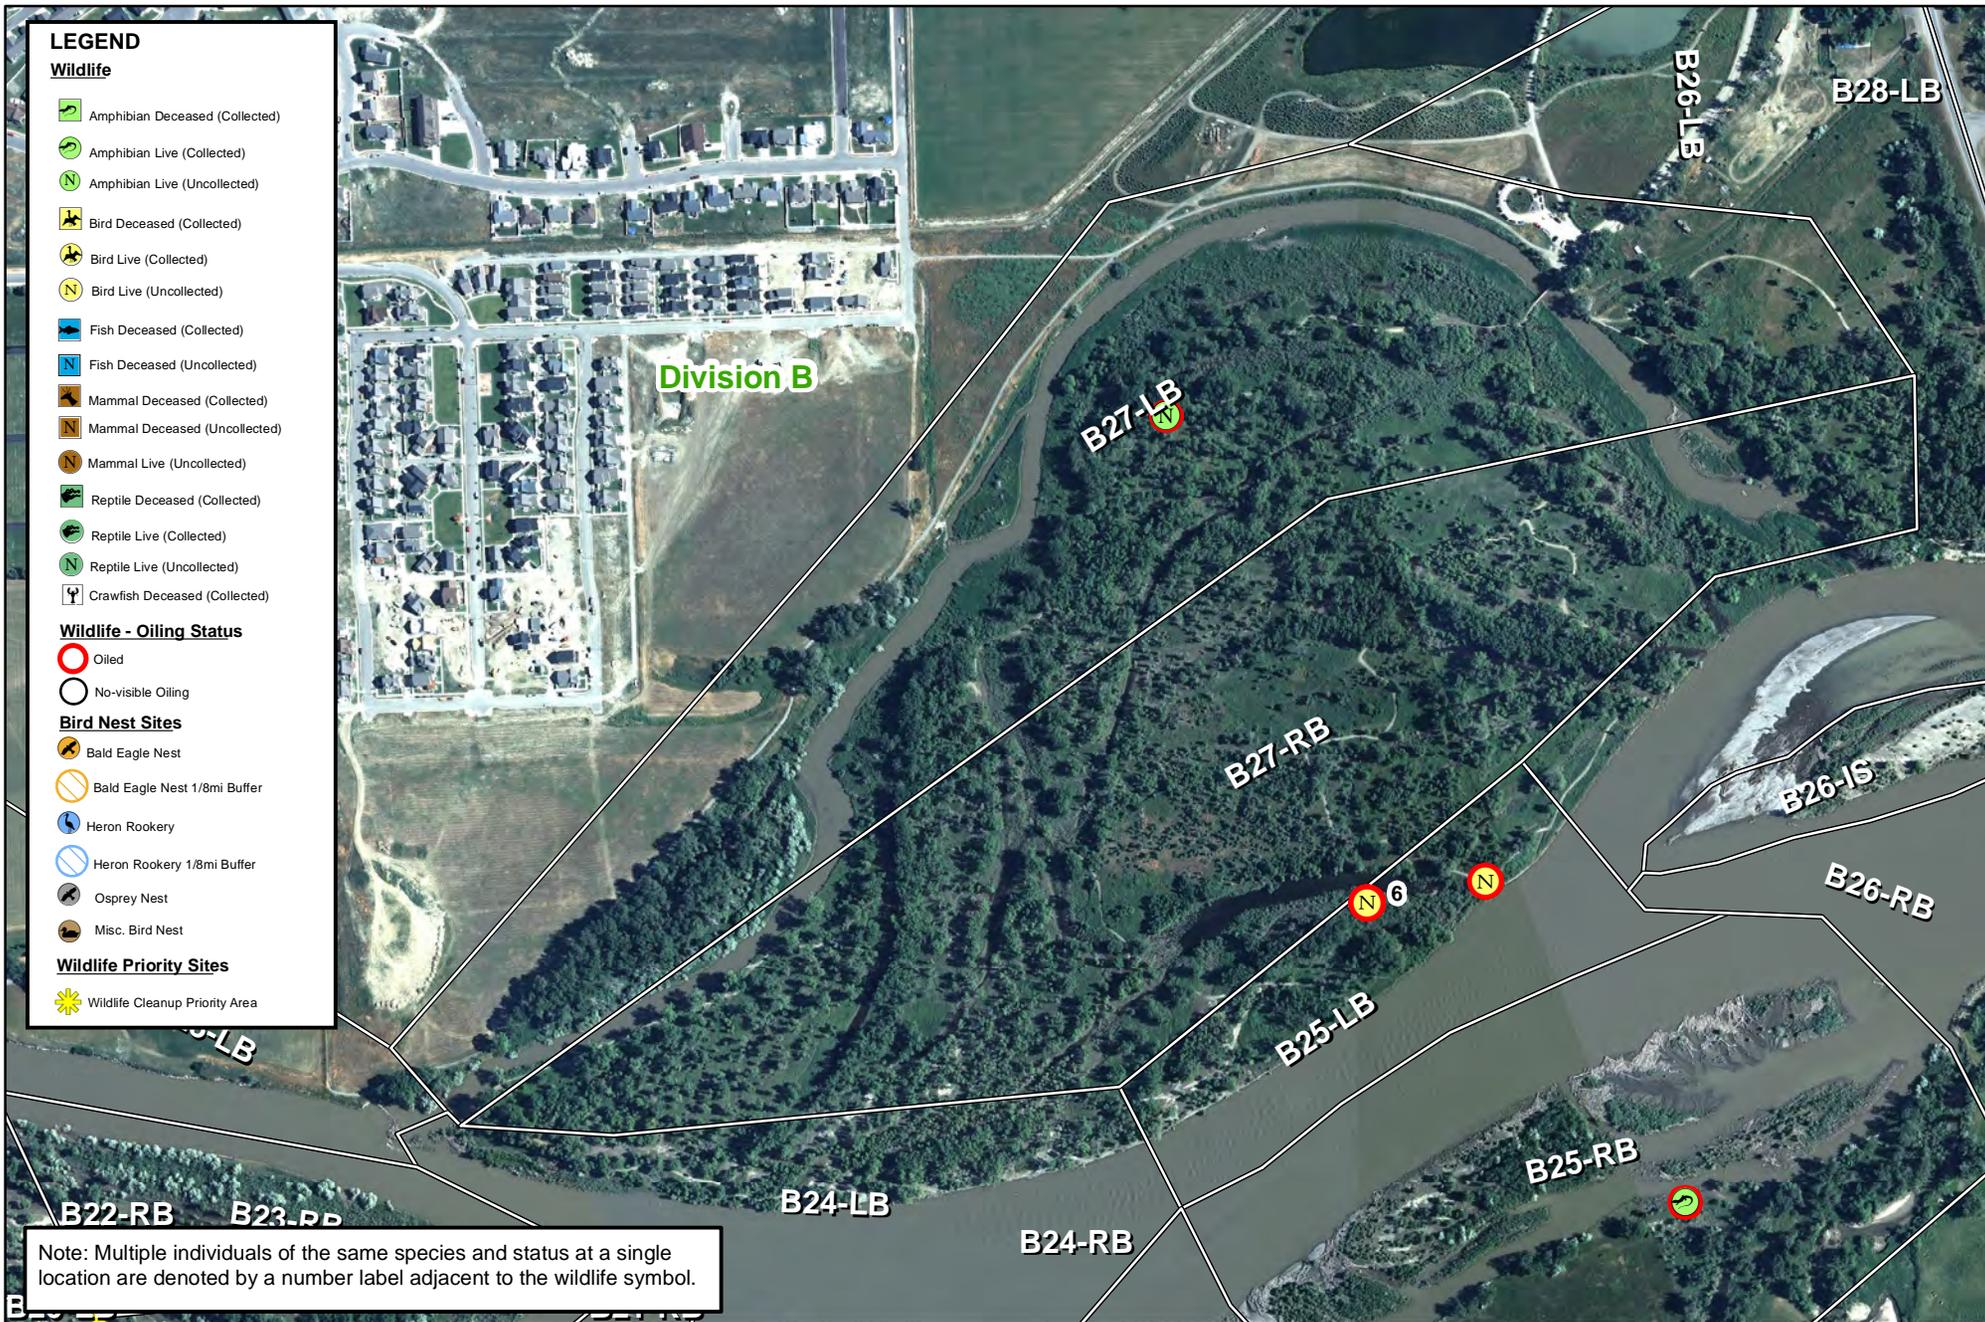
Figure 2
Wildlife Resources

Figure 2 summarizes the natural resources identified in this segment. International Bird Rescue and Resource Advisors from U.S. Fish and Wildlife Service conducted regular inspections of Area B27. One oiled Woodhouse's toad (*Bufo woodhousii*) was identified and photographed by a SCAT team but not captured or reported to the Wildlife Hotline. No Wildlife Priority Cleanup Areas were identified. No active migratory bird nests were identified in Area B27.

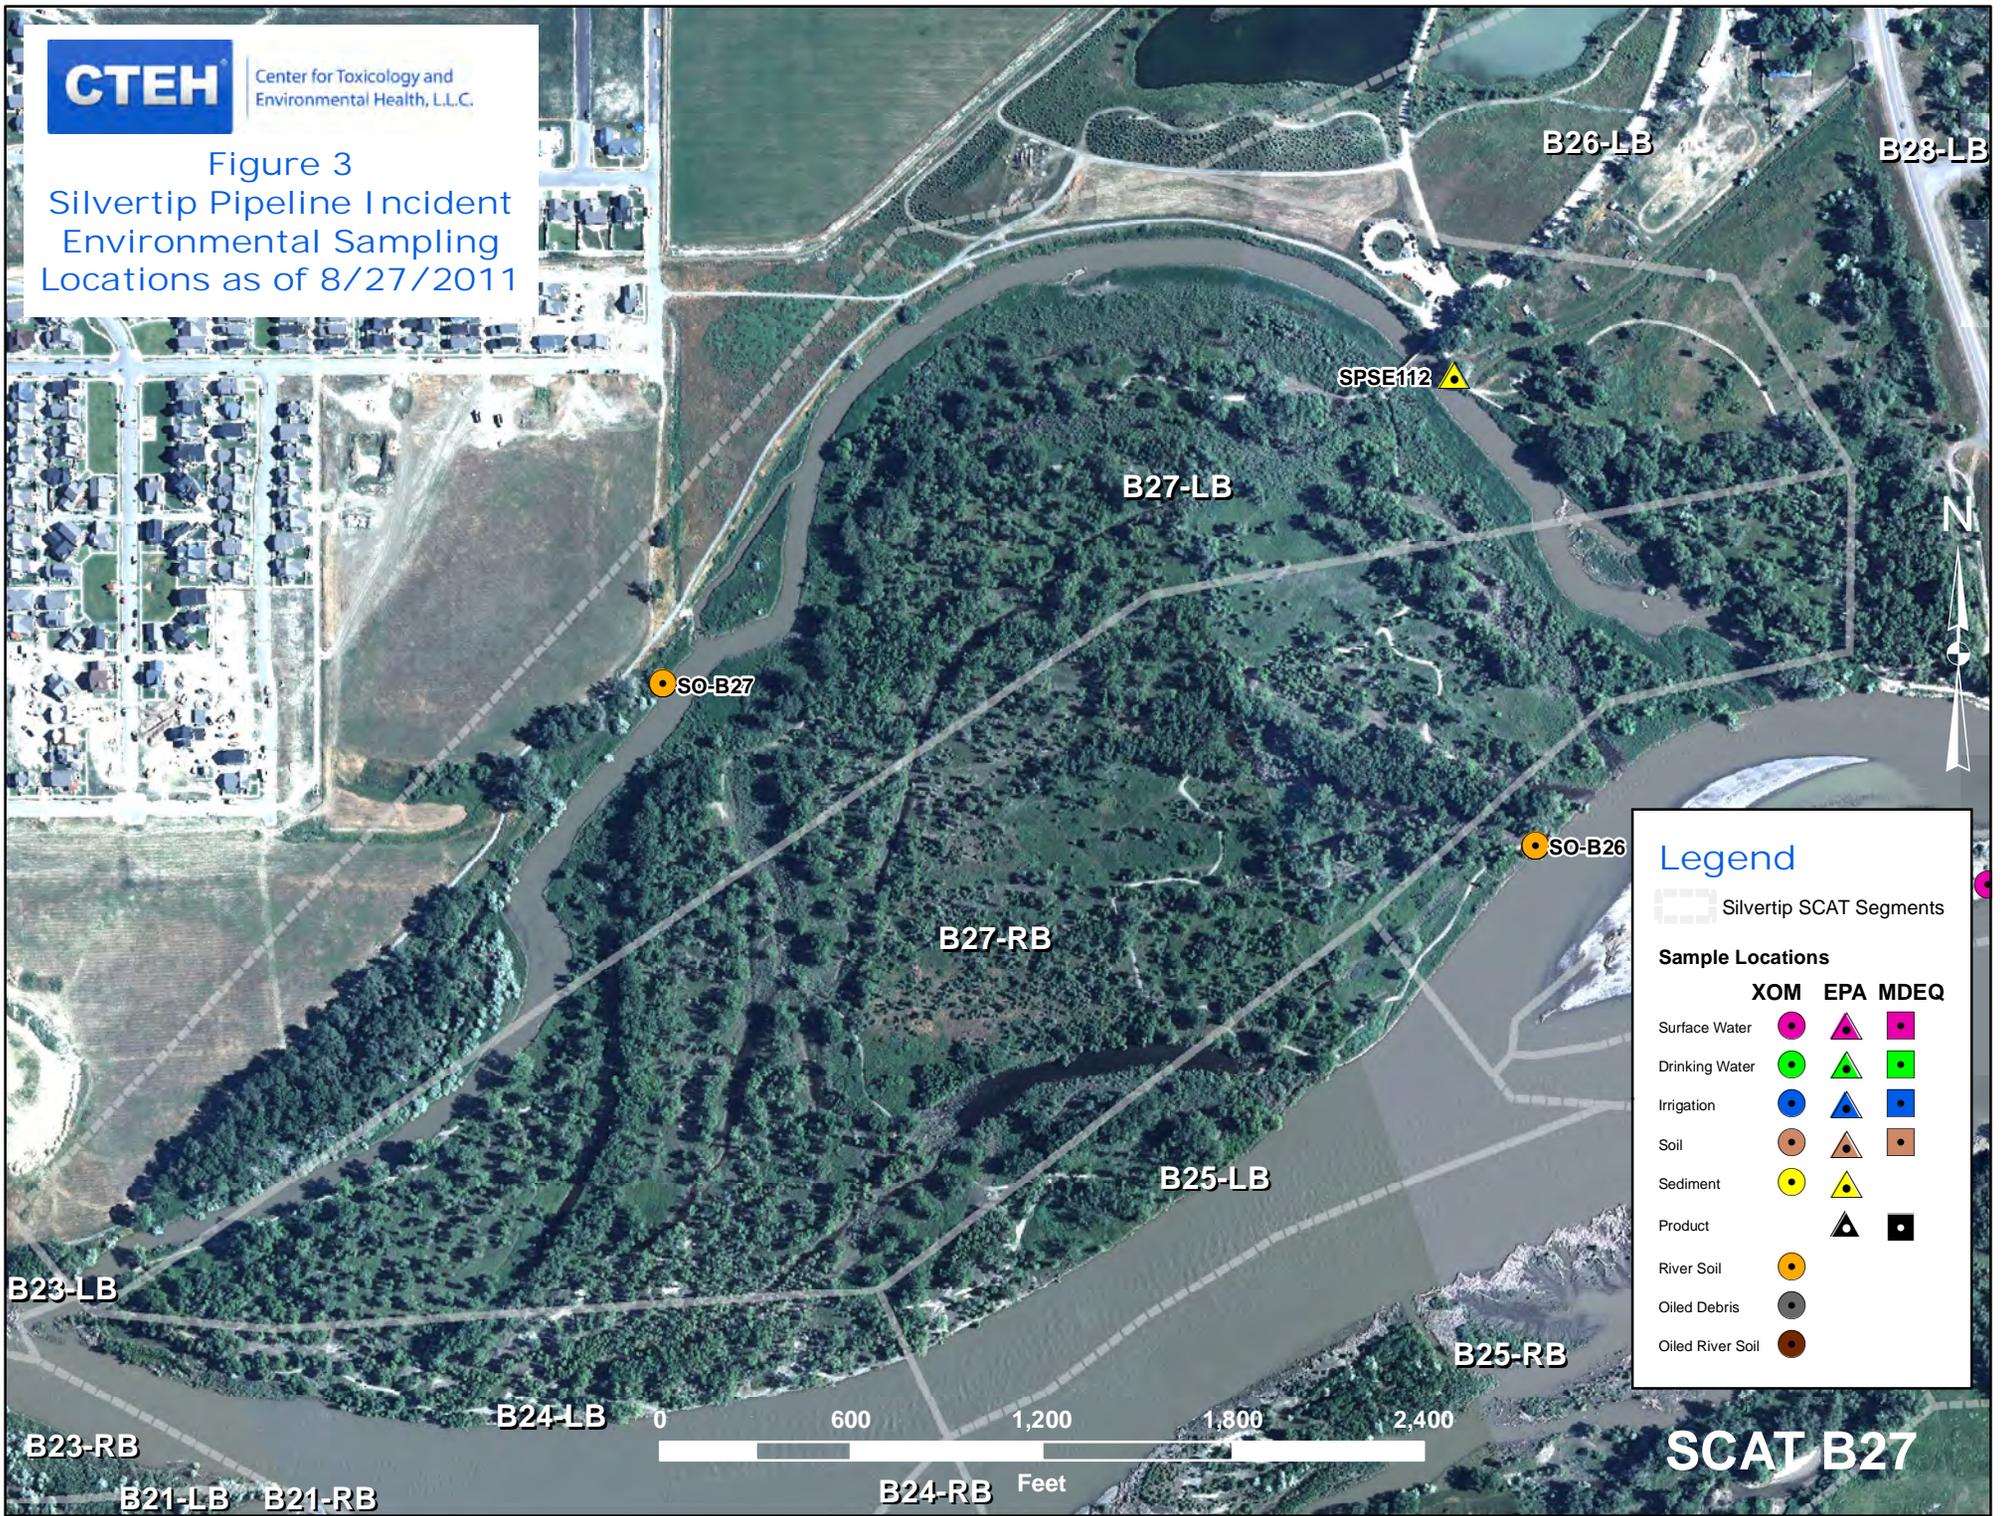
Figure 3
Silvertip Pipeline Incident
Environmental Sampling
Locations as of 8/27/2011

Table 1 (below) summarizes samples collected within Area B27. The analytical results for the samples collected can be accessed through a publicly accessible database on the United States Environmental Protection Agency's (USEPA's) website. The approximate locations of samples collected within Area B27 are provided on Figure 3.

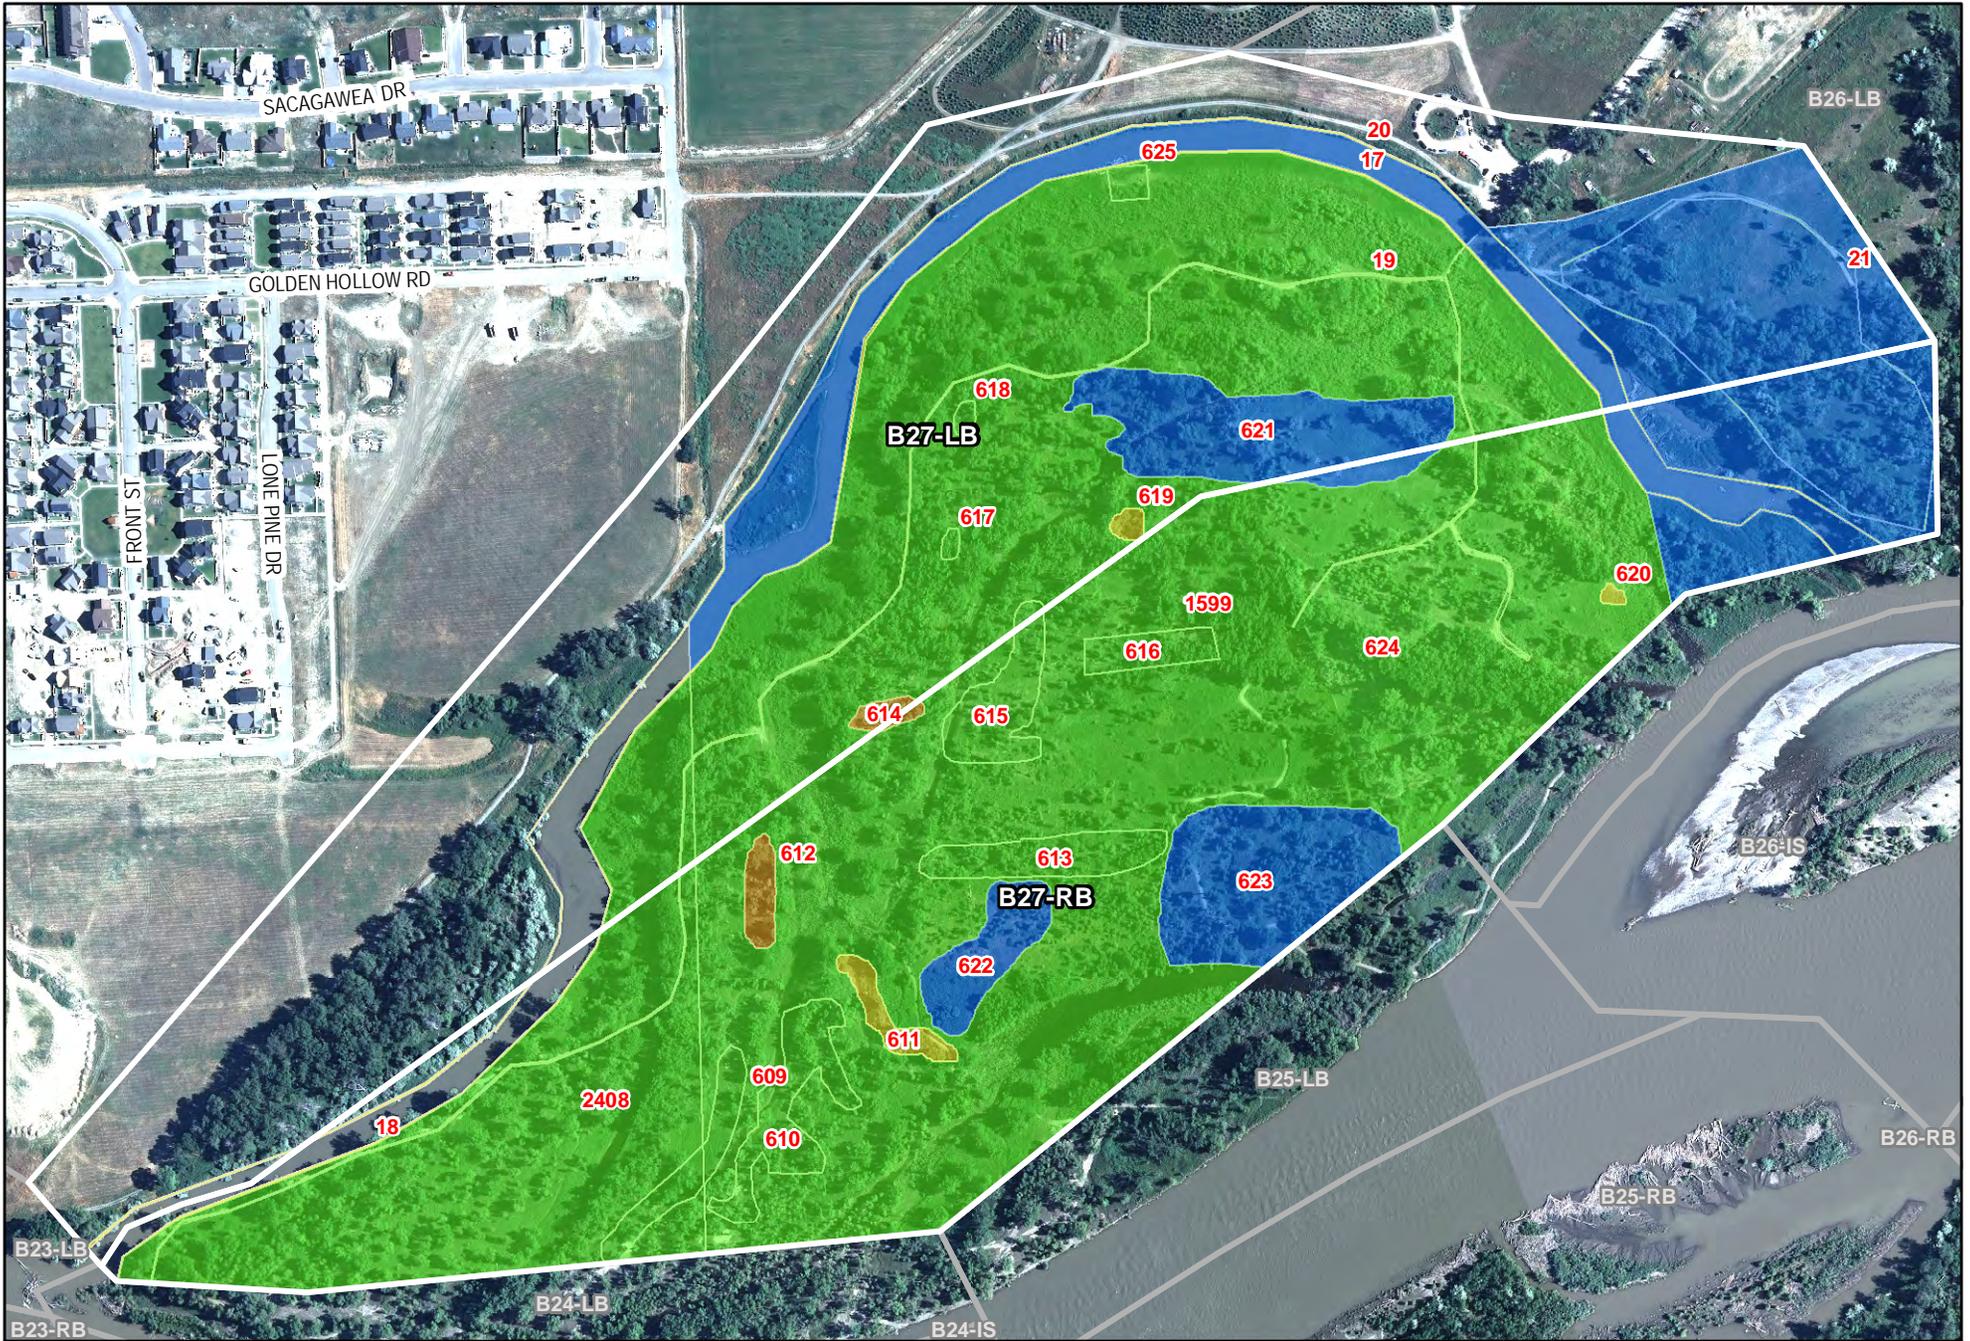
Figure 4 - Maximum SCAT Observations For SCAT Area: B27

The SCAT teams used systematic evaluation criteria and treatment method tables approved by the National Oceanic and Atmospheric Administration to provide a standard approach for data collection and conducting field surveys. The forms and sketches from the initial SCAT surveys performed along the river bank (water edge) and floodplain within Area B27 are included in Appendix B. Figure 4 provides the maximum oiling zones observed by the SCAT team during the initial surveys of Area B27.

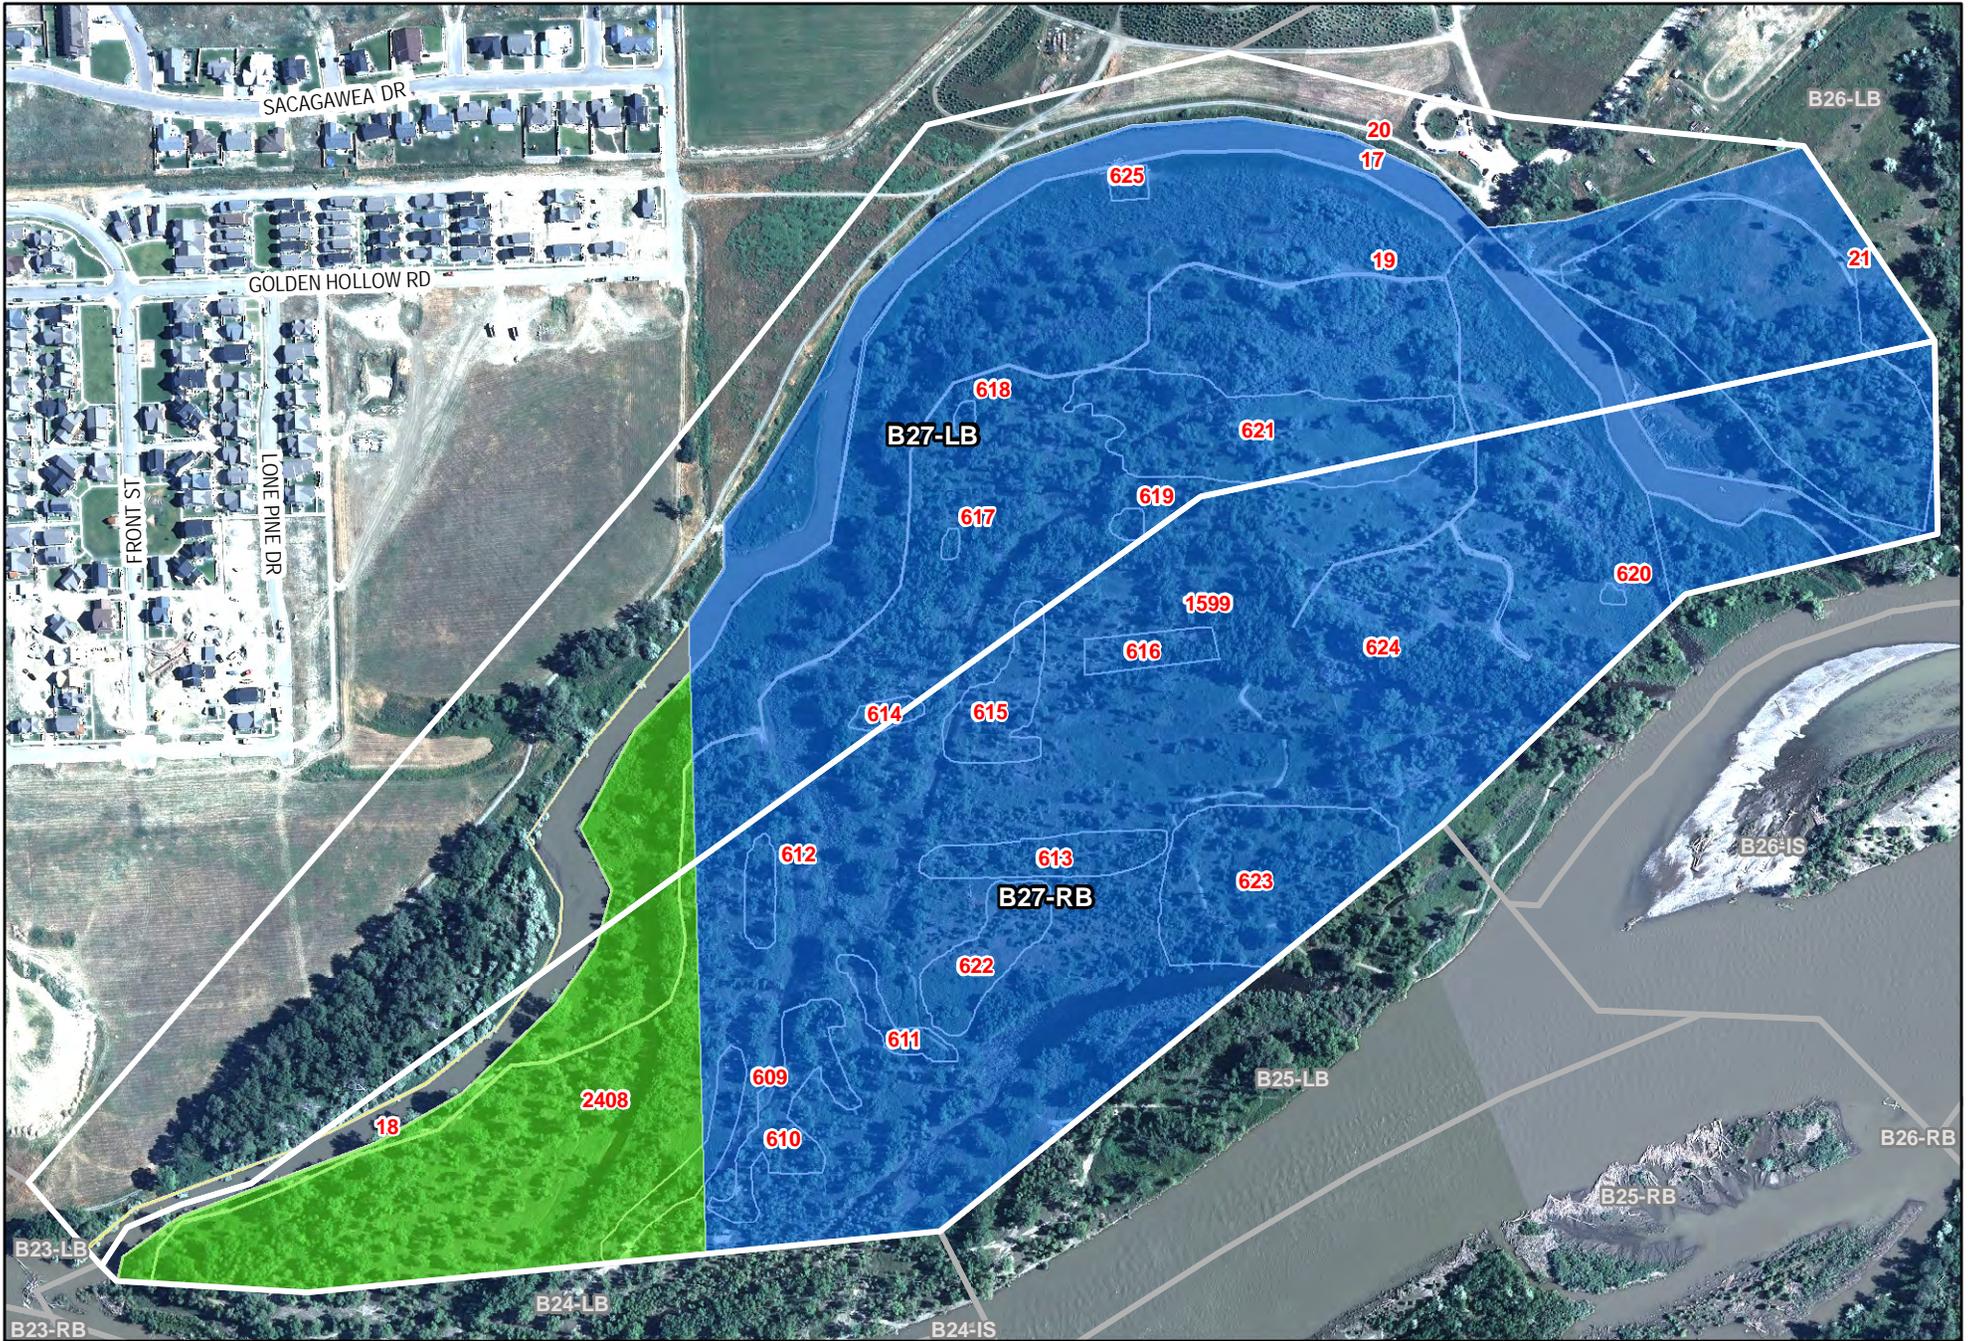
**Figure 5 - Final SCAT Observations
For SCAT Area: B27**

Figure 5 shows the oiling conditions within Area B27 following completion of oil removal activities. The SCAT team performed final surveys of the left and right banks within SCAT Area B27 to confirm the agreed-upon cleanup endpoints identified in the applicable CTRs had been achieved. The final SCAT survey documentation is presented in Appendix E.

Based on the final SCAT surveys performed on the left and right banks within Area B27, no further treatment is recommended for these segments. SCAT Segment Sign-Off Forms are included as Appendix F.

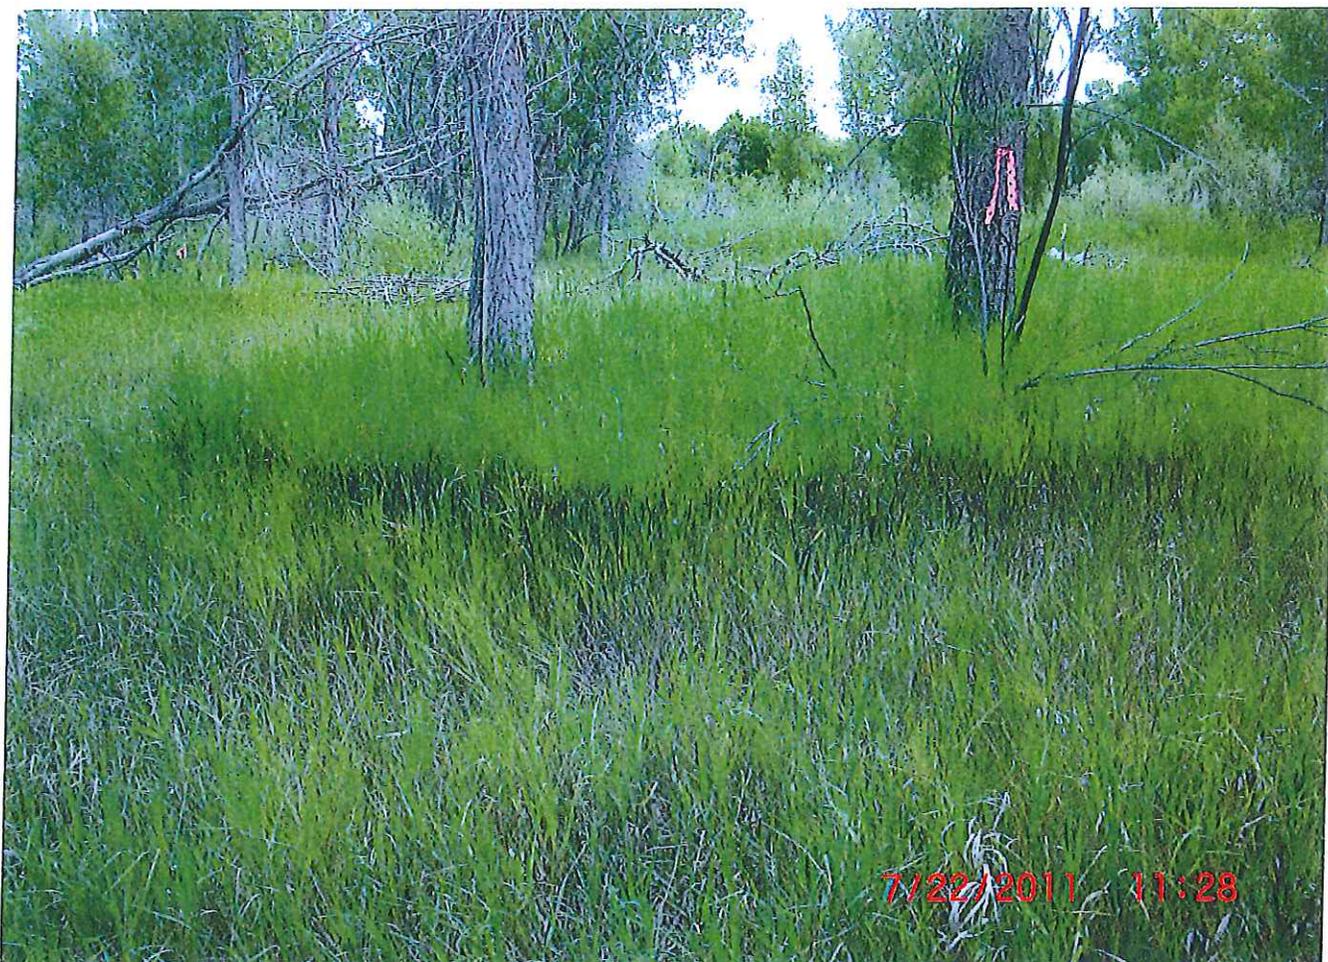
B27 L Example of areas flagged for collection

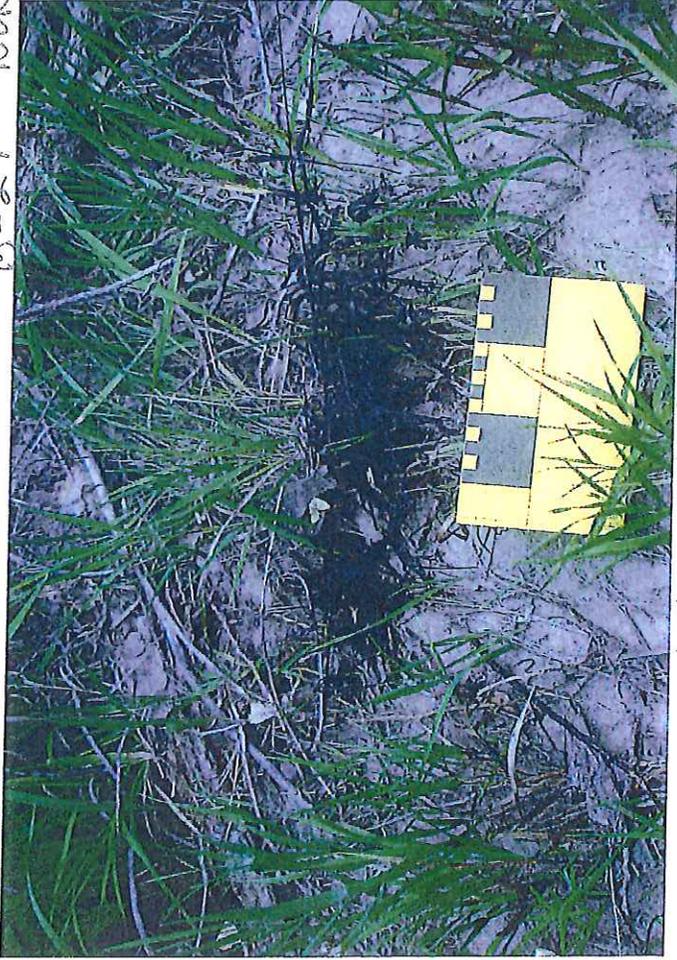
oiled wood debris ↓

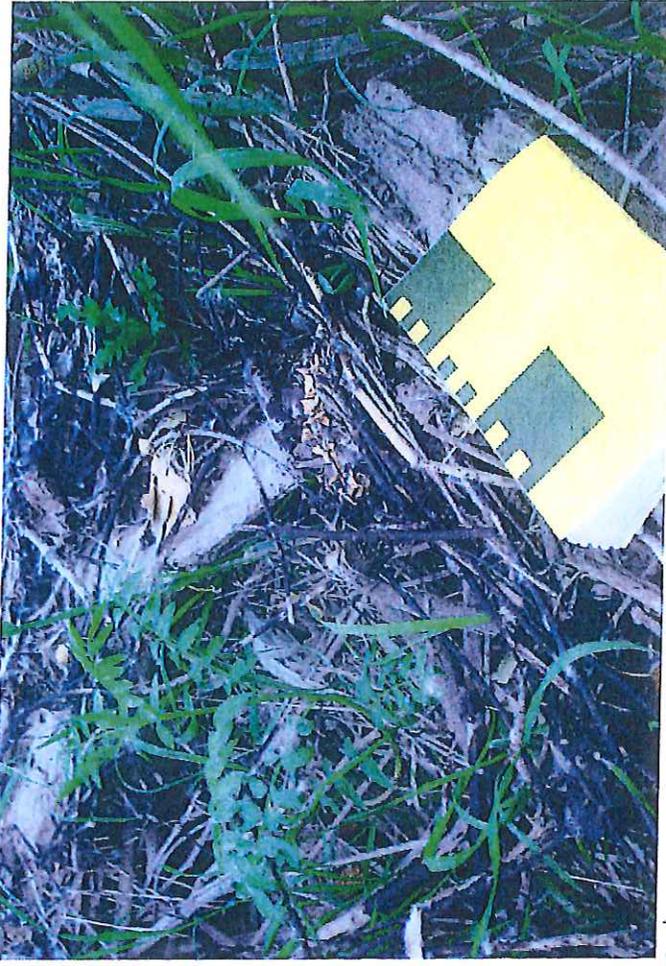
oiled grass →

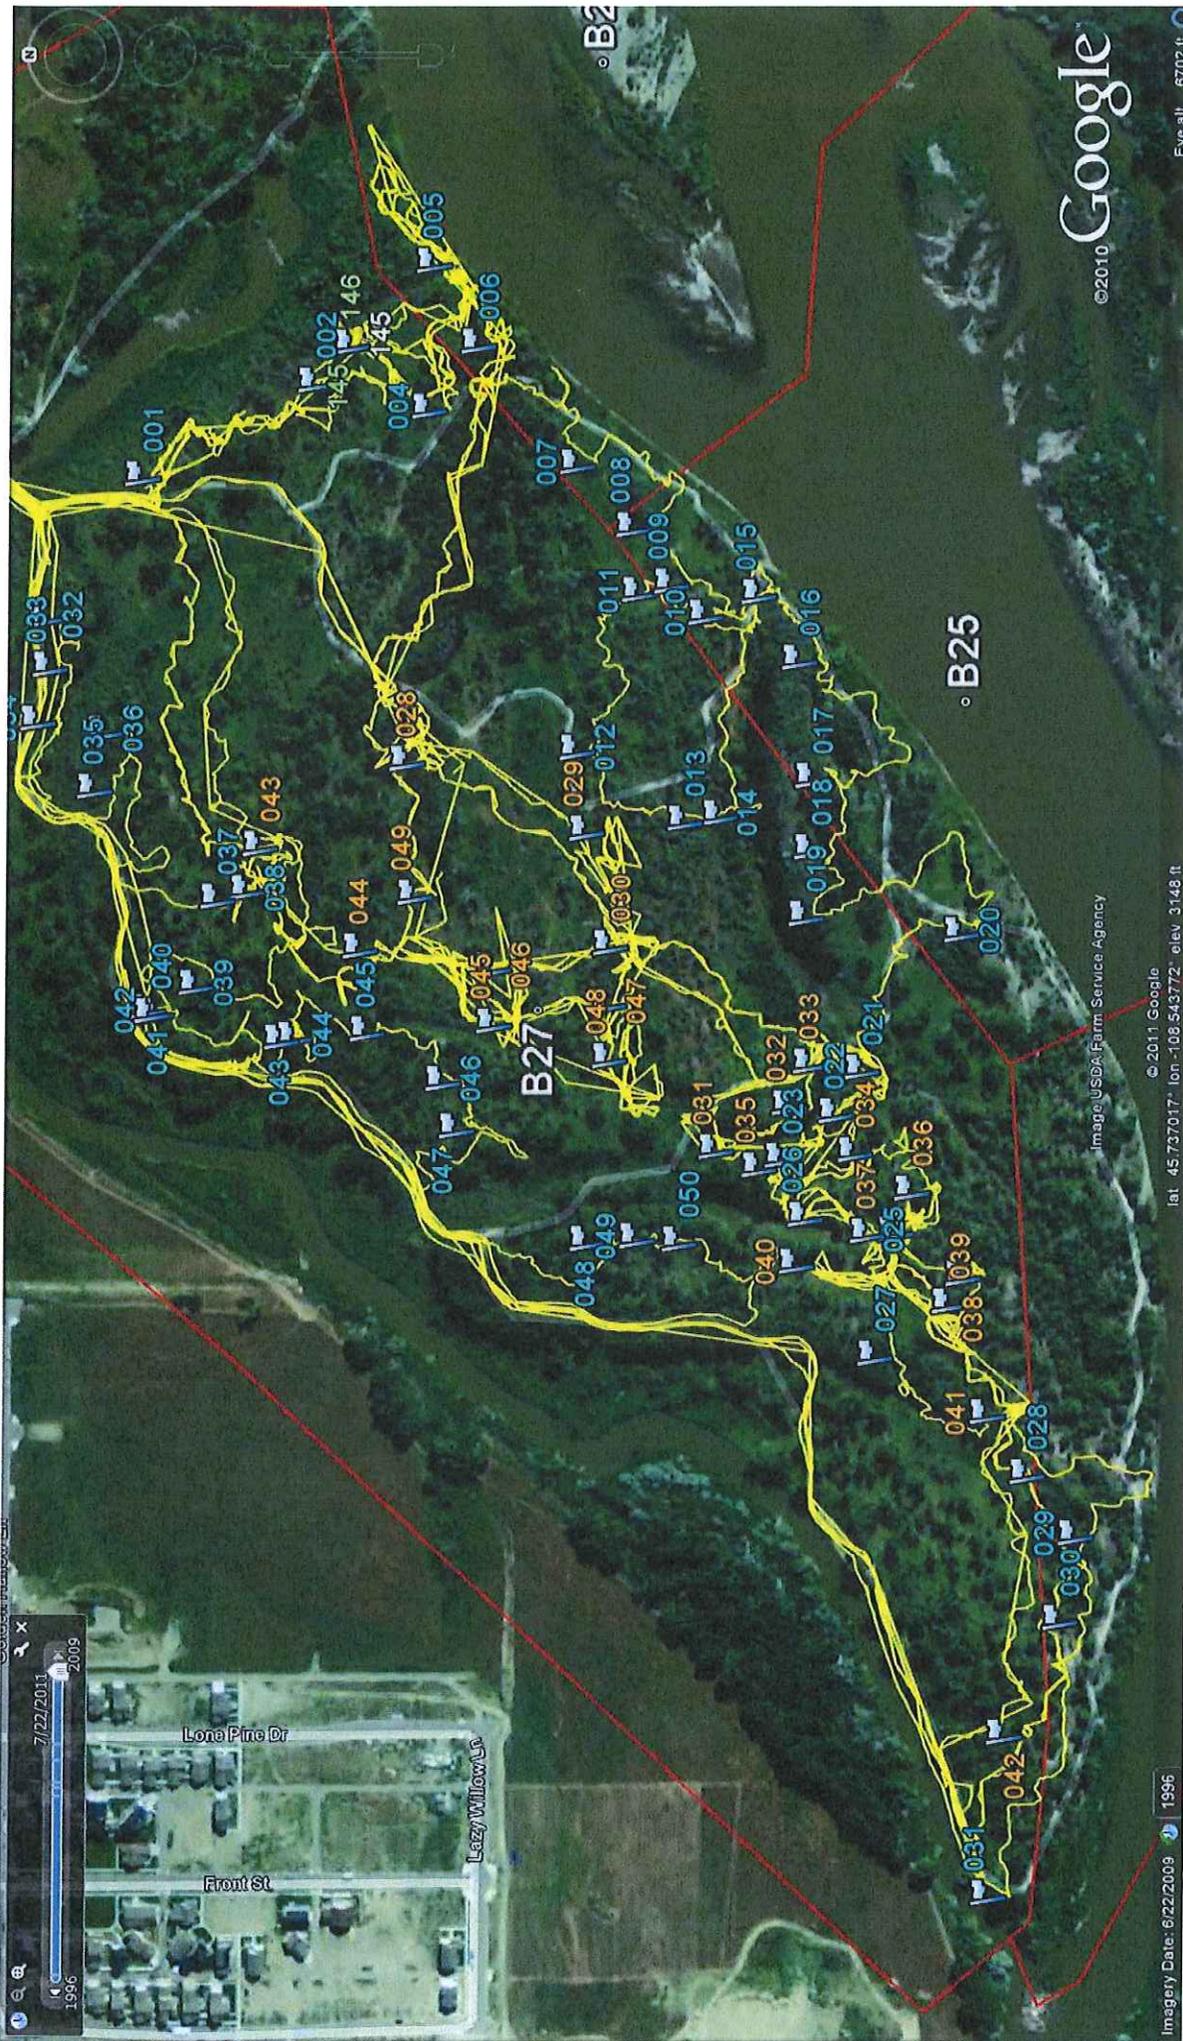
B27 SCAT #3
Norm's Island

Zones A to K have areas *flagged for collection using vegetation cuttings and oiled vegetation & small debris removal. Operations are already proceeding in this area. (* = flagged zone) and should continue to work through these areas (see attached maps). Oiling is found primarily in grass (scattered and as a "bathtub ring", in wood debris piles, and on overhanging branches at the high water mark along low lying drainage channels and above ponds of standing water.

Zones M, N, & O are NOD - higher elevation above high water mark.
