**SCAT Area Transition Report for  
B28**

Silvertip Pipeline Incident  
Laurel, Montana

Prepared for:  
ExxonMobil Pipeline Company

Prepared by:  
ARCADIS G&M of North Carolina, Inc.  
11000 Regency Parkway  
West Tower, Suite 205  
Cary, North Carolina 27518-8518  
Tel 919.469.1952  
Fax 919.469.5676

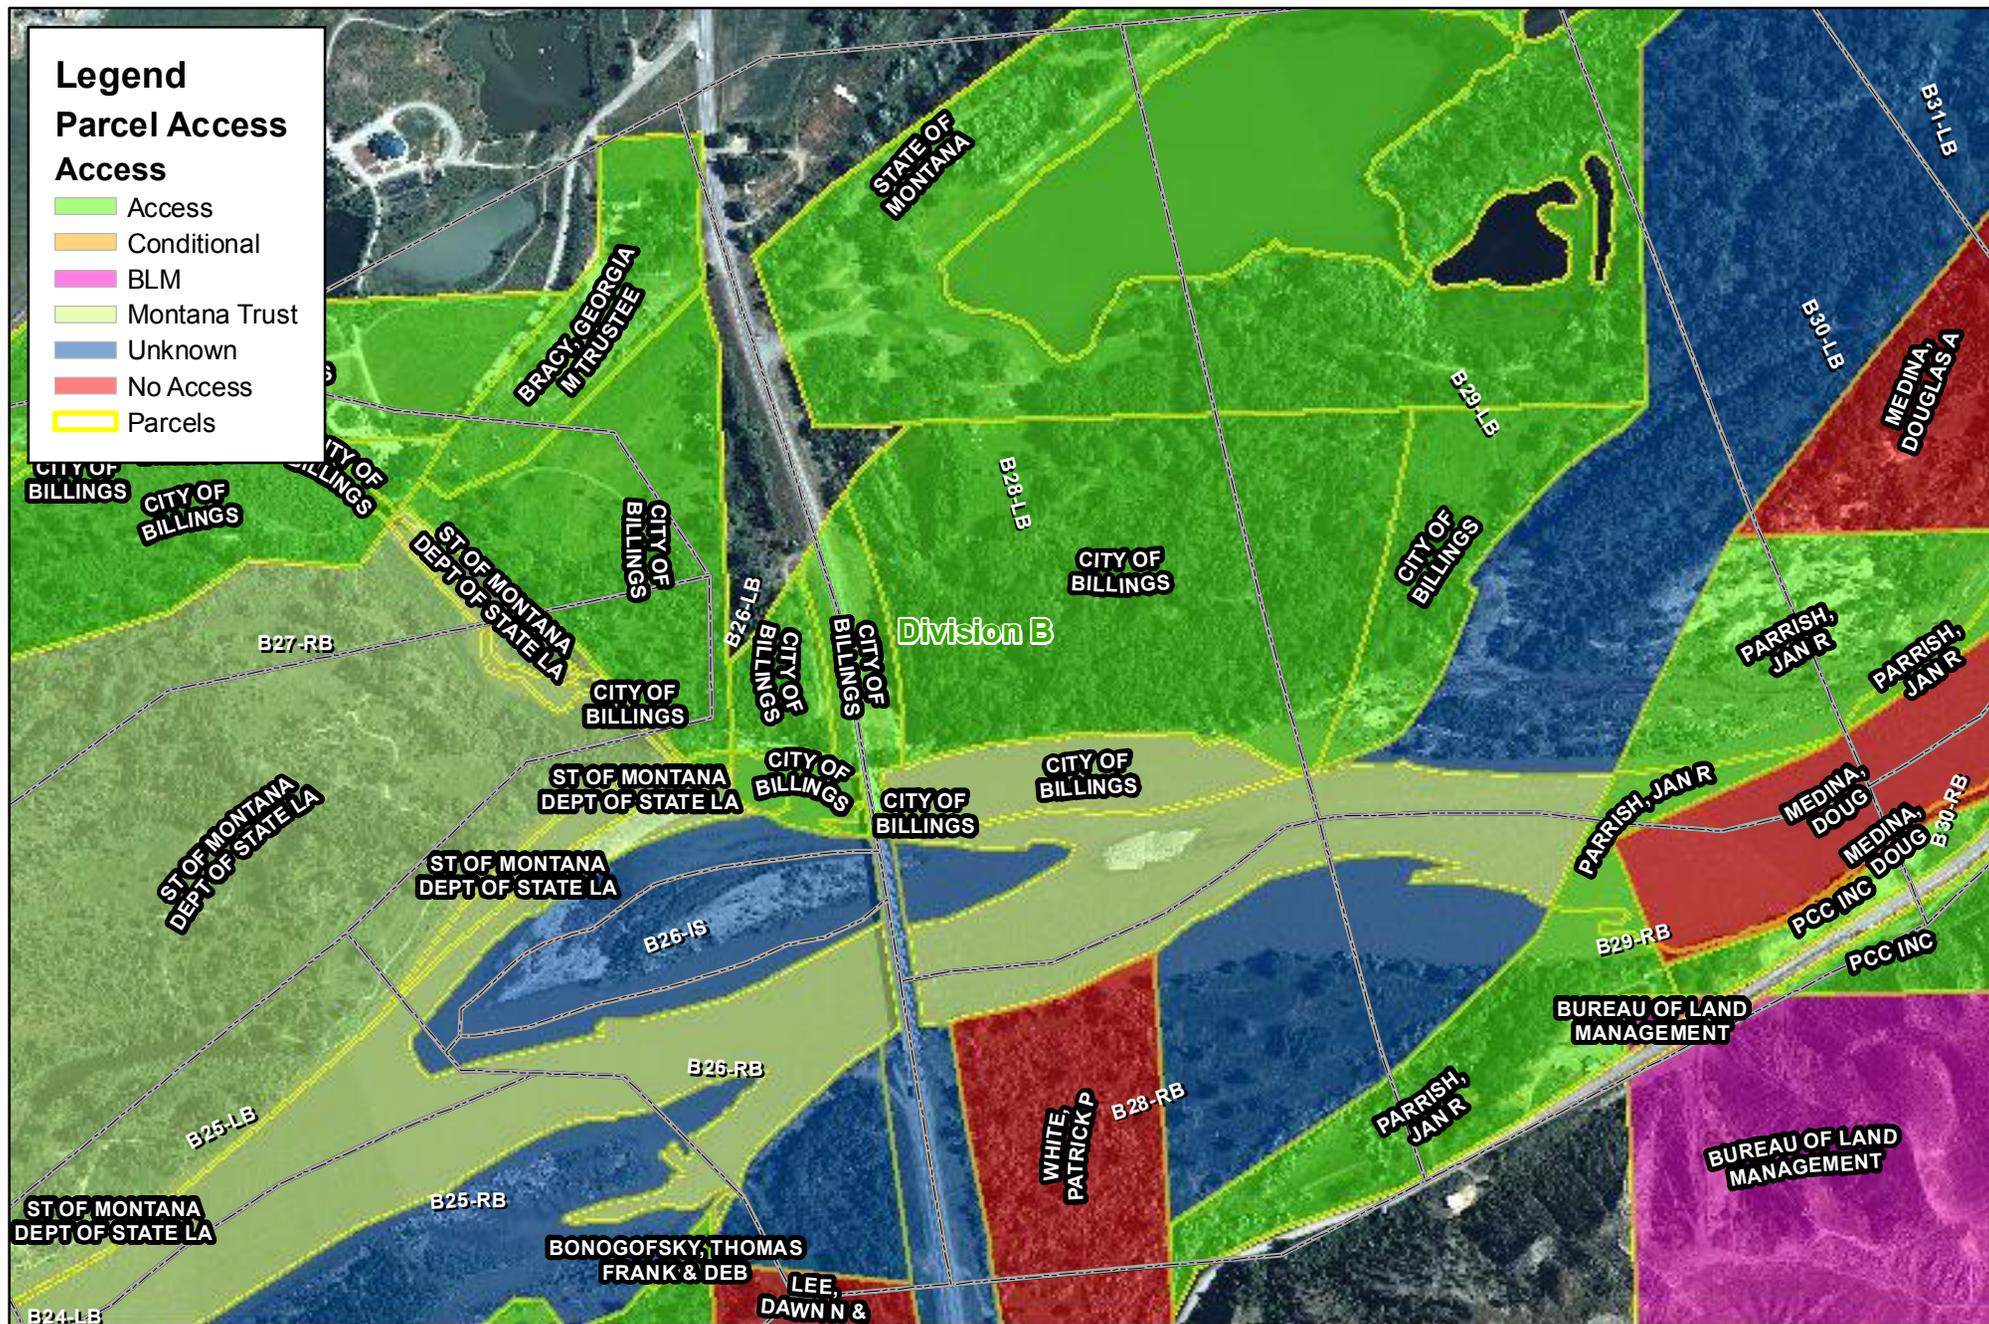
Figure 1 provides an aerial map of SCAT Area B28, along with the (a) SCAT Area boundary, (b) parcel boundaries and respective property owners, and (c) access constraints identified during the oil cleanup process. The acreage surveyed in Area B28 is 42.0. There were access issues associated with the right bank.

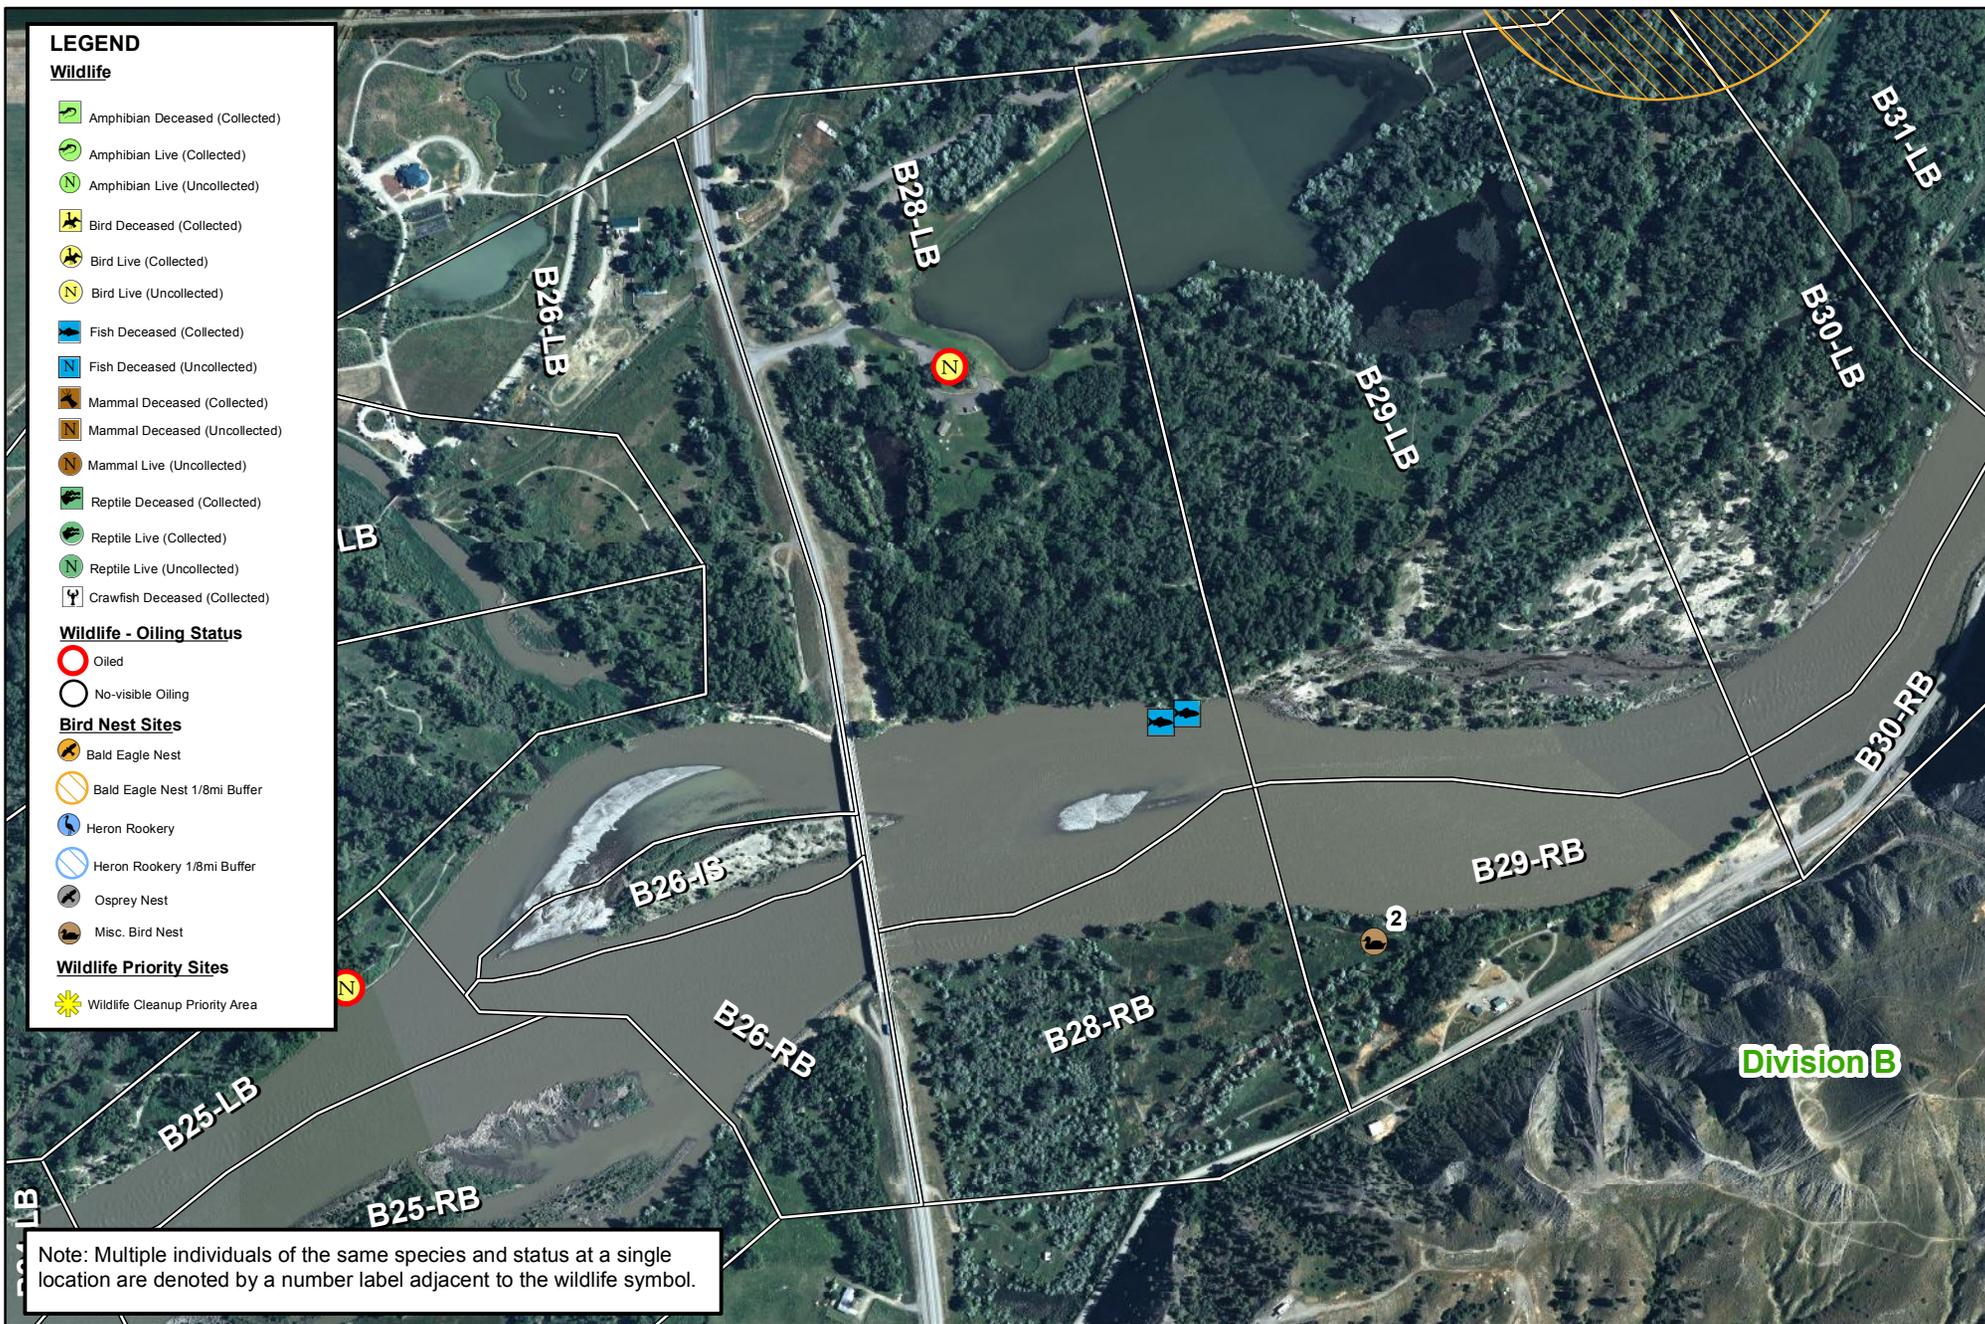
**Figure 2**  
**Wildlife Resources**

Figure 2 summarizes the natural resources identified in this segment. International Bird Rescue and Resource Advisors from U.S. Fish and Wildlife Service conducted regular inspections of Area B28. One light to moderately oiled Canada goose (*Branta canadensis*) was observed but not captured for cleaning. A deceased catfish (unknown species) and a deceased western silvery minnow (*Hybognathus argyritis*) with no visible oiling were identified and retained. No Wildlife Priority Cleanup Areas were identified. No active migratory bird nests were identified in Area B28.

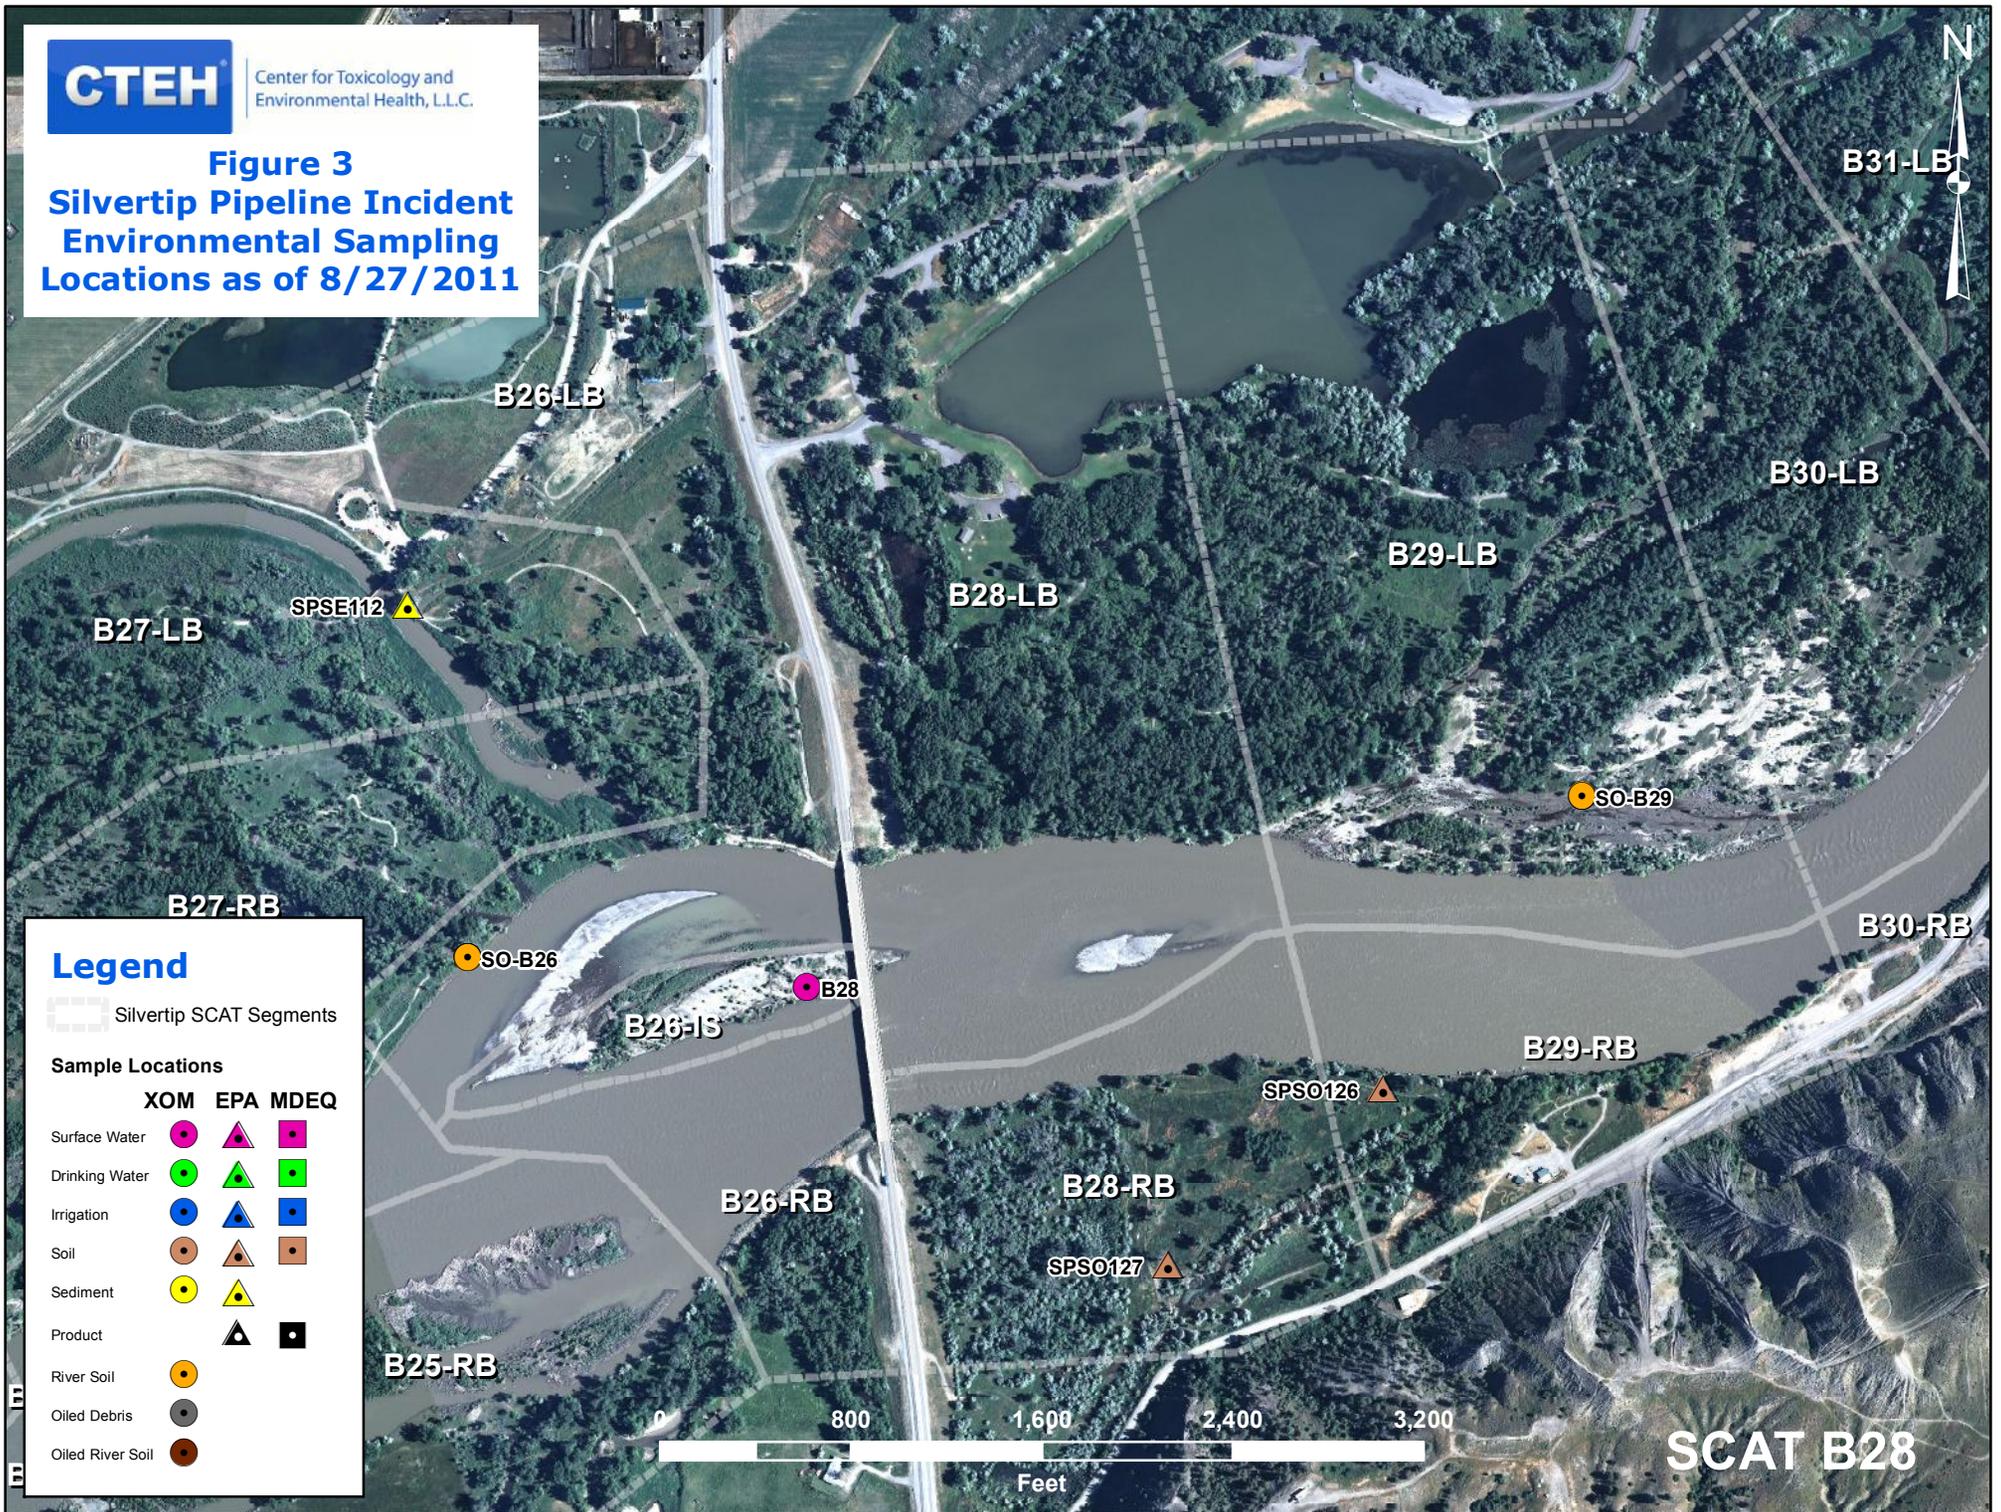
**Figure 3**  
**Silvertip Pipeline Incident**  
**Environmental Sampling**  
**Locations as of 8/27/2011**

Table 1 (below) summarizes samples collected within Area B28. The analytical results for the samples collected can be accessed through a publicly accessible database on the United States Environmental Protection Agency's (USEPA's) website. The approximate locations of samples collected within Area B28 are provided on Figure 3.

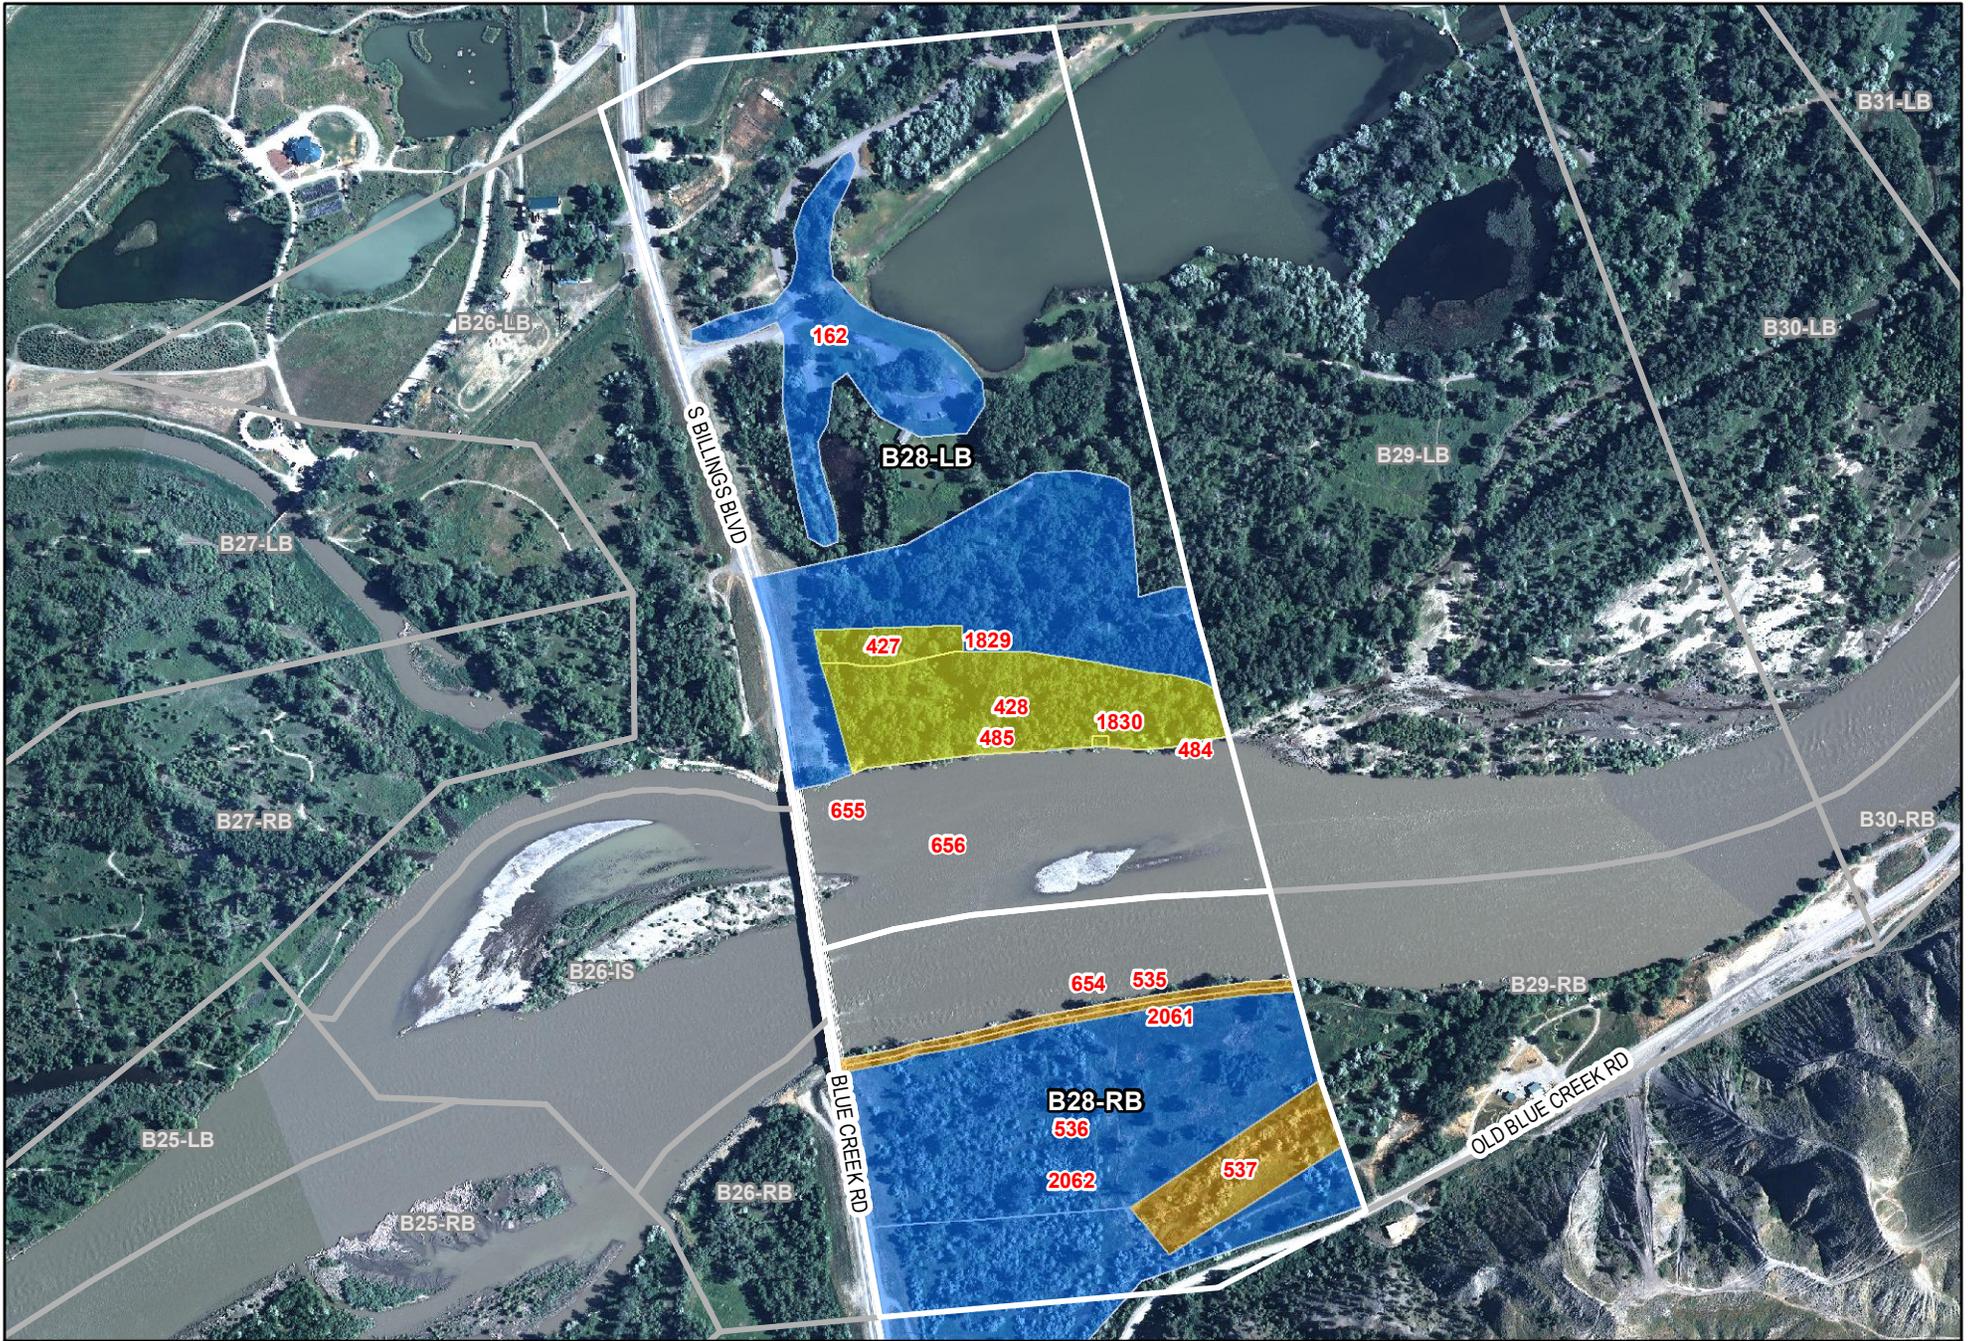
**Figure 4 - Maximum SCAT Observations For SCAT Area: B28**

The SCAT teams used systematic evaluation criteria and treatment method tables approved by the National Oceanic and Atmospheric Administration to provide a standard approach for data collection and conducting field surveys. The forms and sketches from the initial SCAT surveys performed along the river bank (water edge) and floodplain within Area B28 are included in Appendix B. Figure 4 provides the maximum oiling zones observed by the SCAT team during the initial surveys of Area B28.

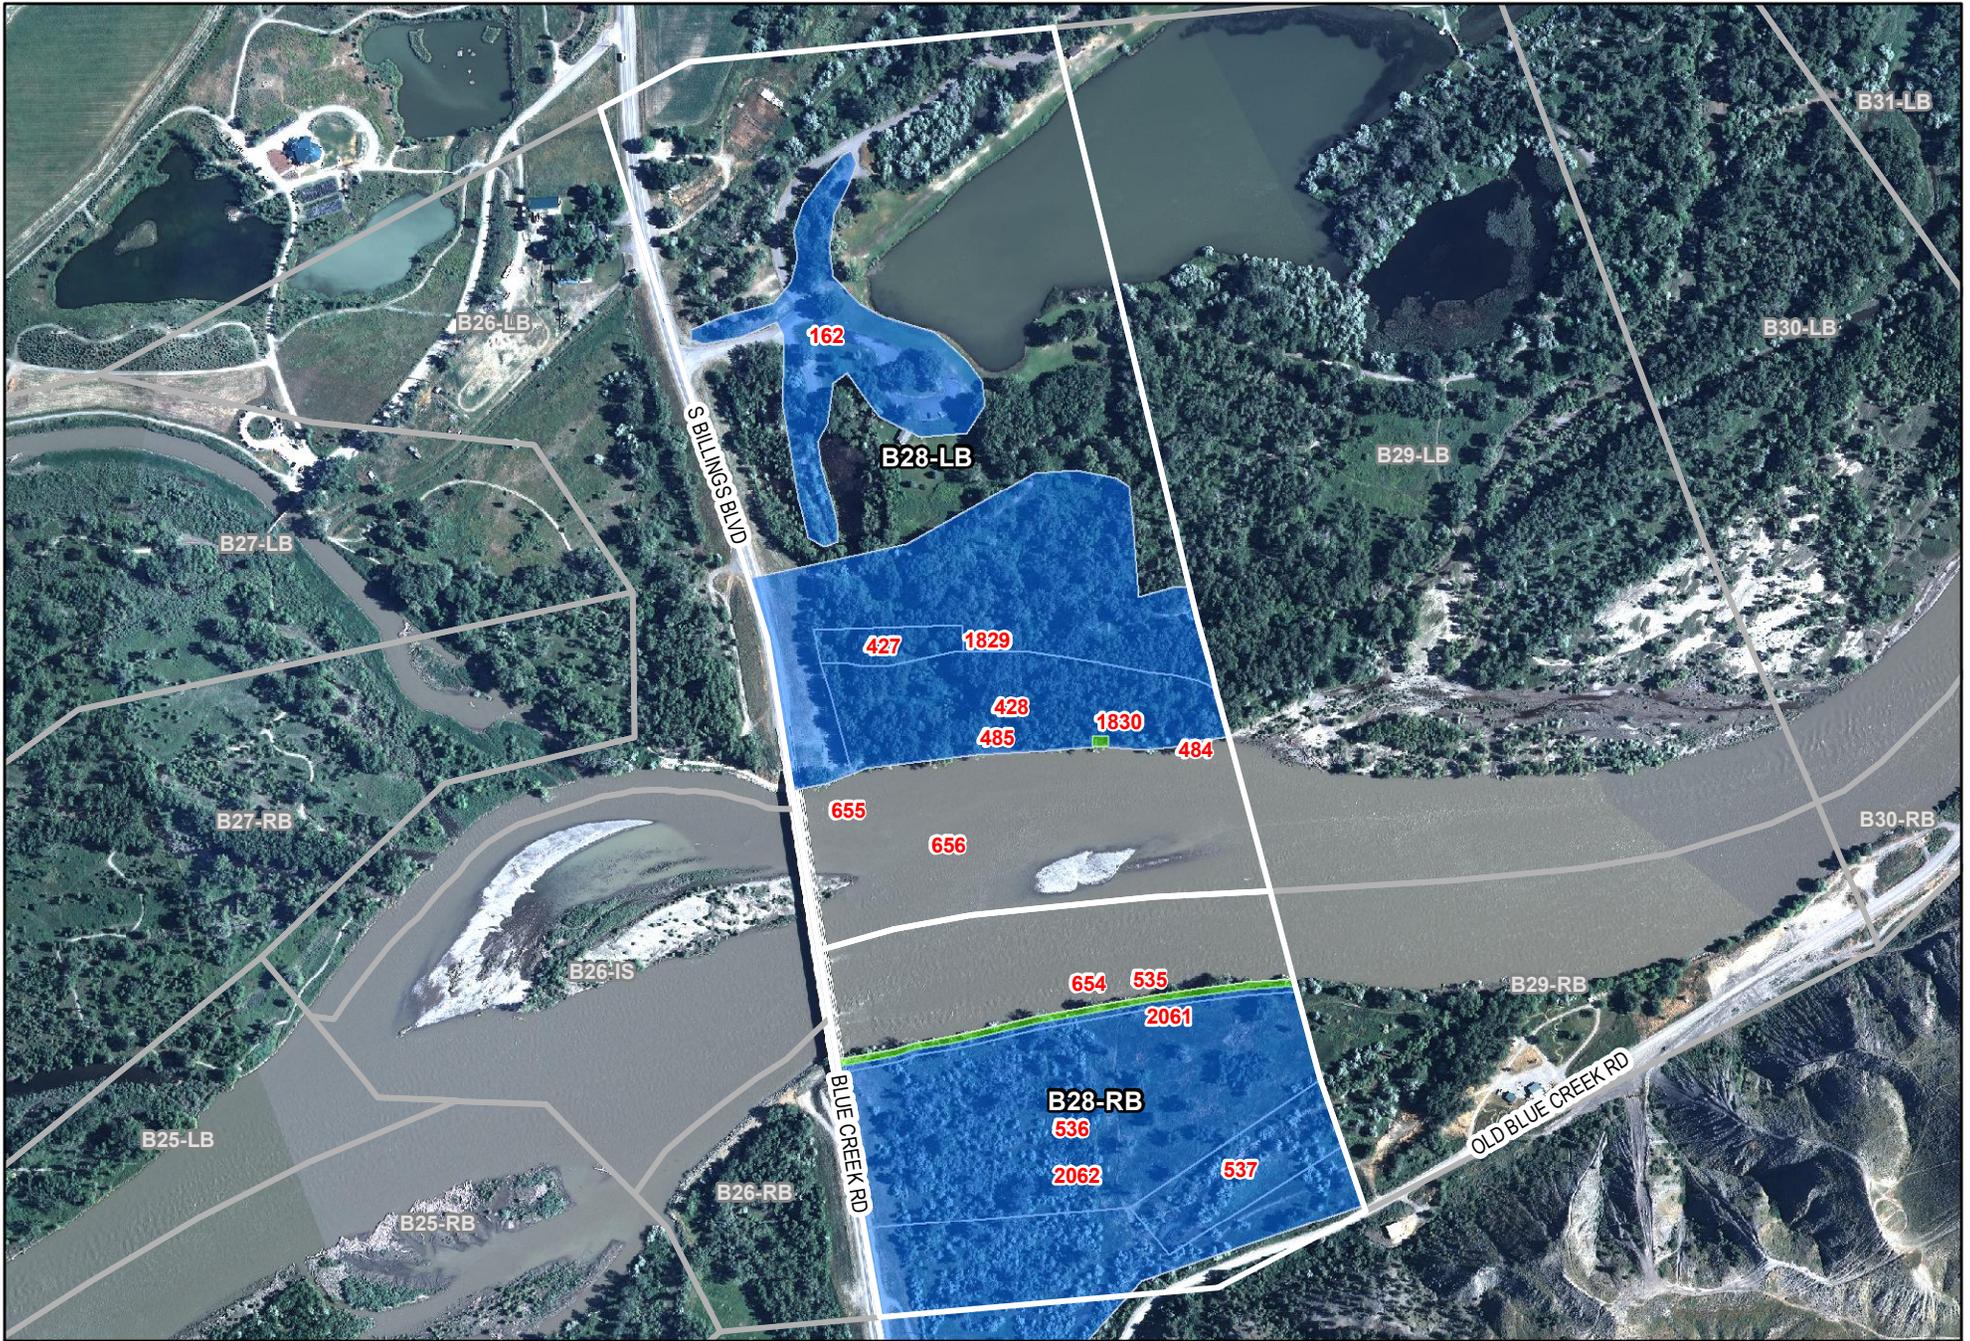
**Figure 5 - Final SCAT Observations  
For SCAT Area:**

Figure 5 shows the oiling conditions within Area B28 following completion of oil removal activities. The SCAT team performed final surveys of the right and left banks within SCAT Area B28 to confirm the agreed-upon cleanup endpoints identified in the applicable CTRs had been achieved. The final SCAT survey documentation is presented in Appendix E.

Based on the final SCAT surveys performed on the right and left banks within Area B28, no further treatment is recommended for this area. SCAT Segment Sign-Off Forms are included as Appendix F.

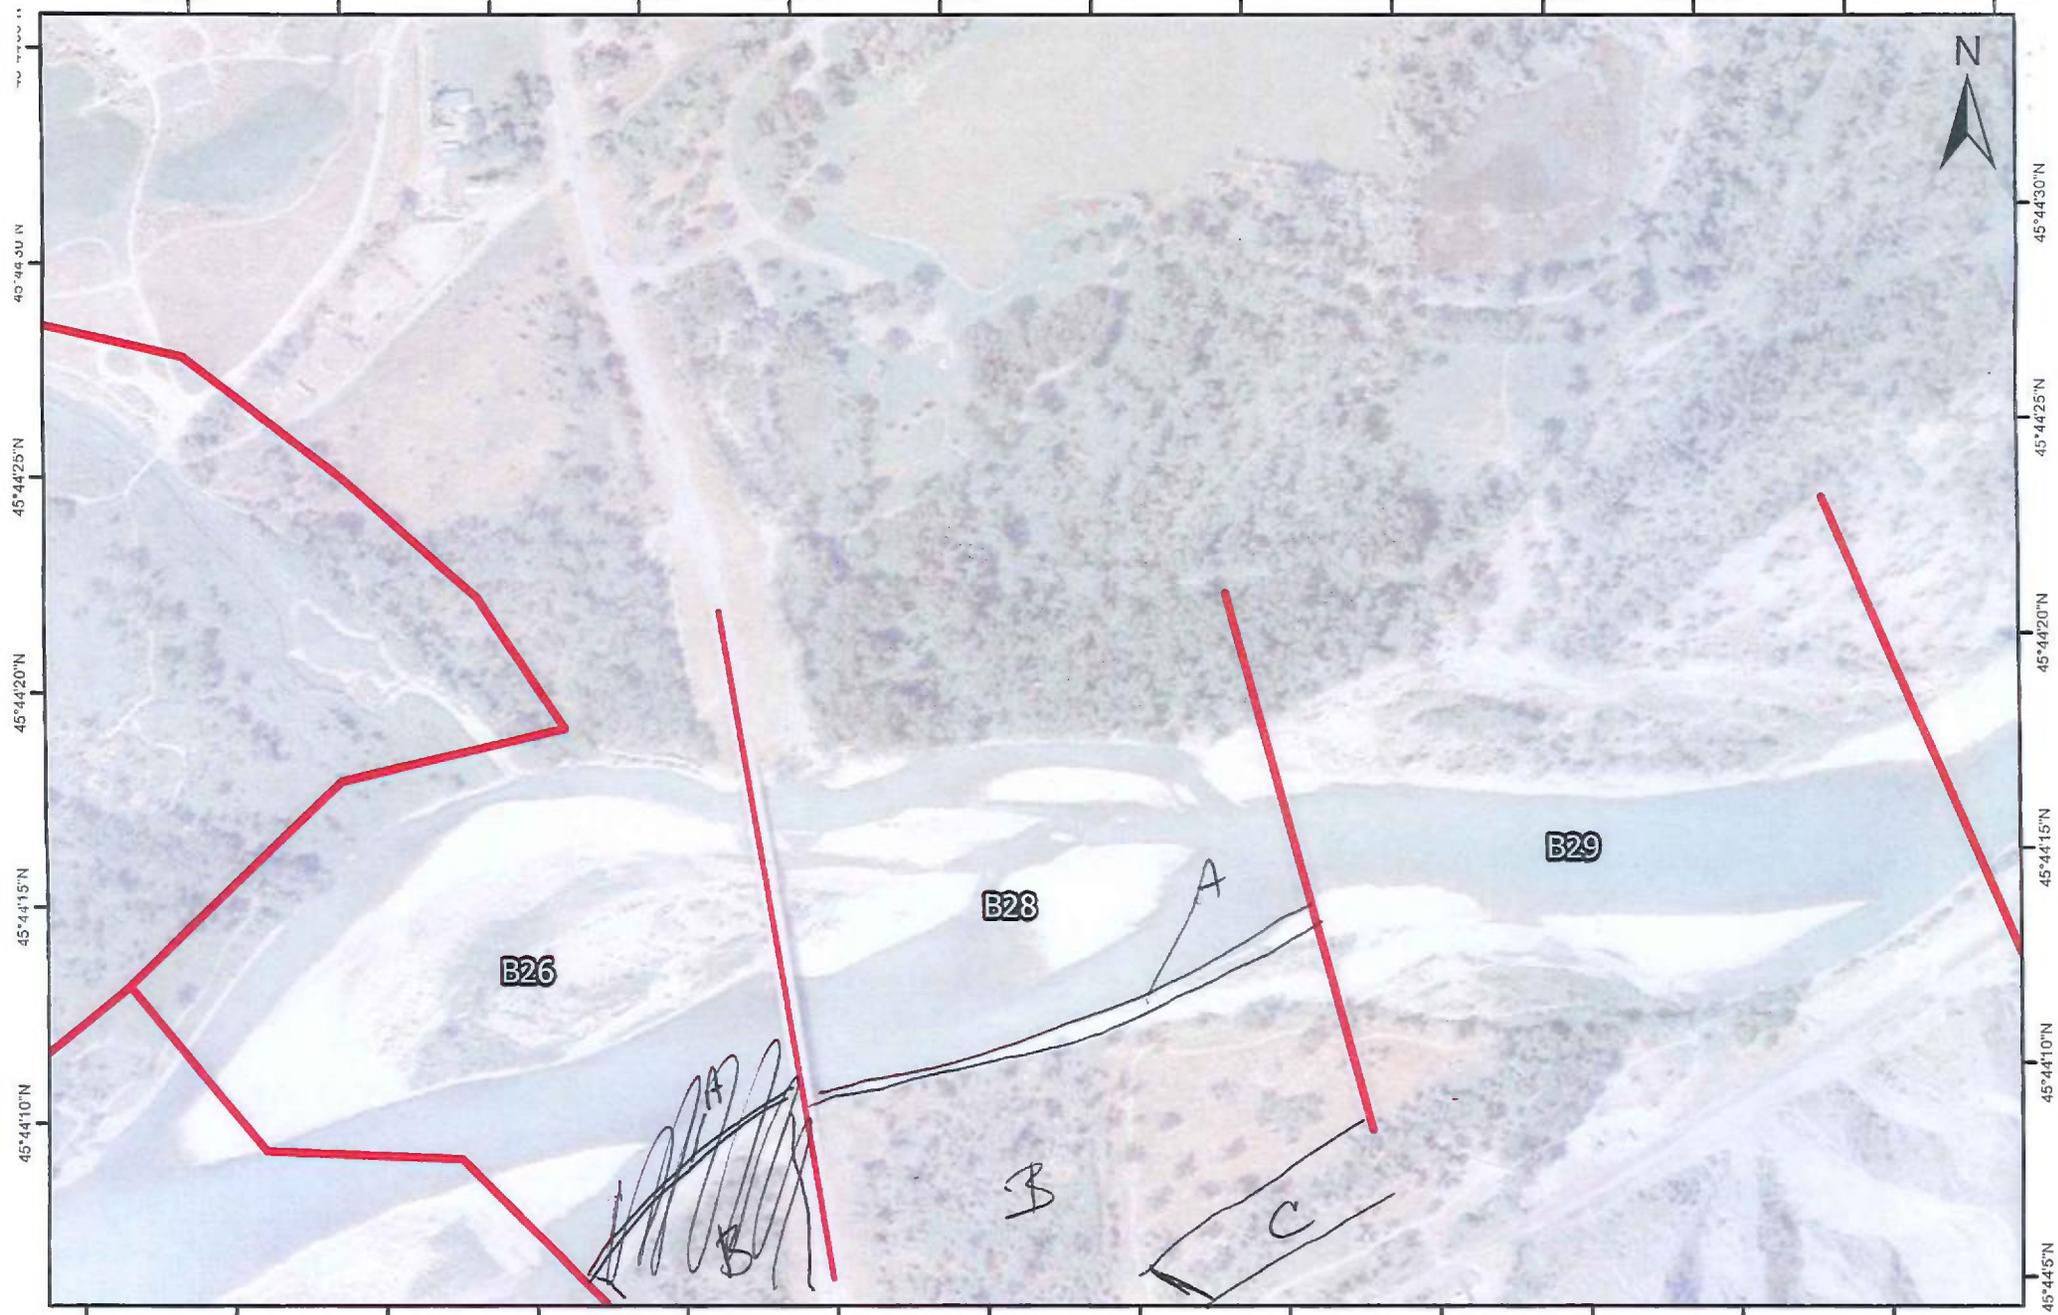
overbank survey required (P) overbank survey complete (P) shoreline survey complete (P)  
 Zone A: Recommend Low Priority Vegetation Cut & Removal Along shoreline  
 Zone B: No oil  
 Zone C: Slough area inundated with cut oil Recommend cut & removal of vegetation along edge of slough

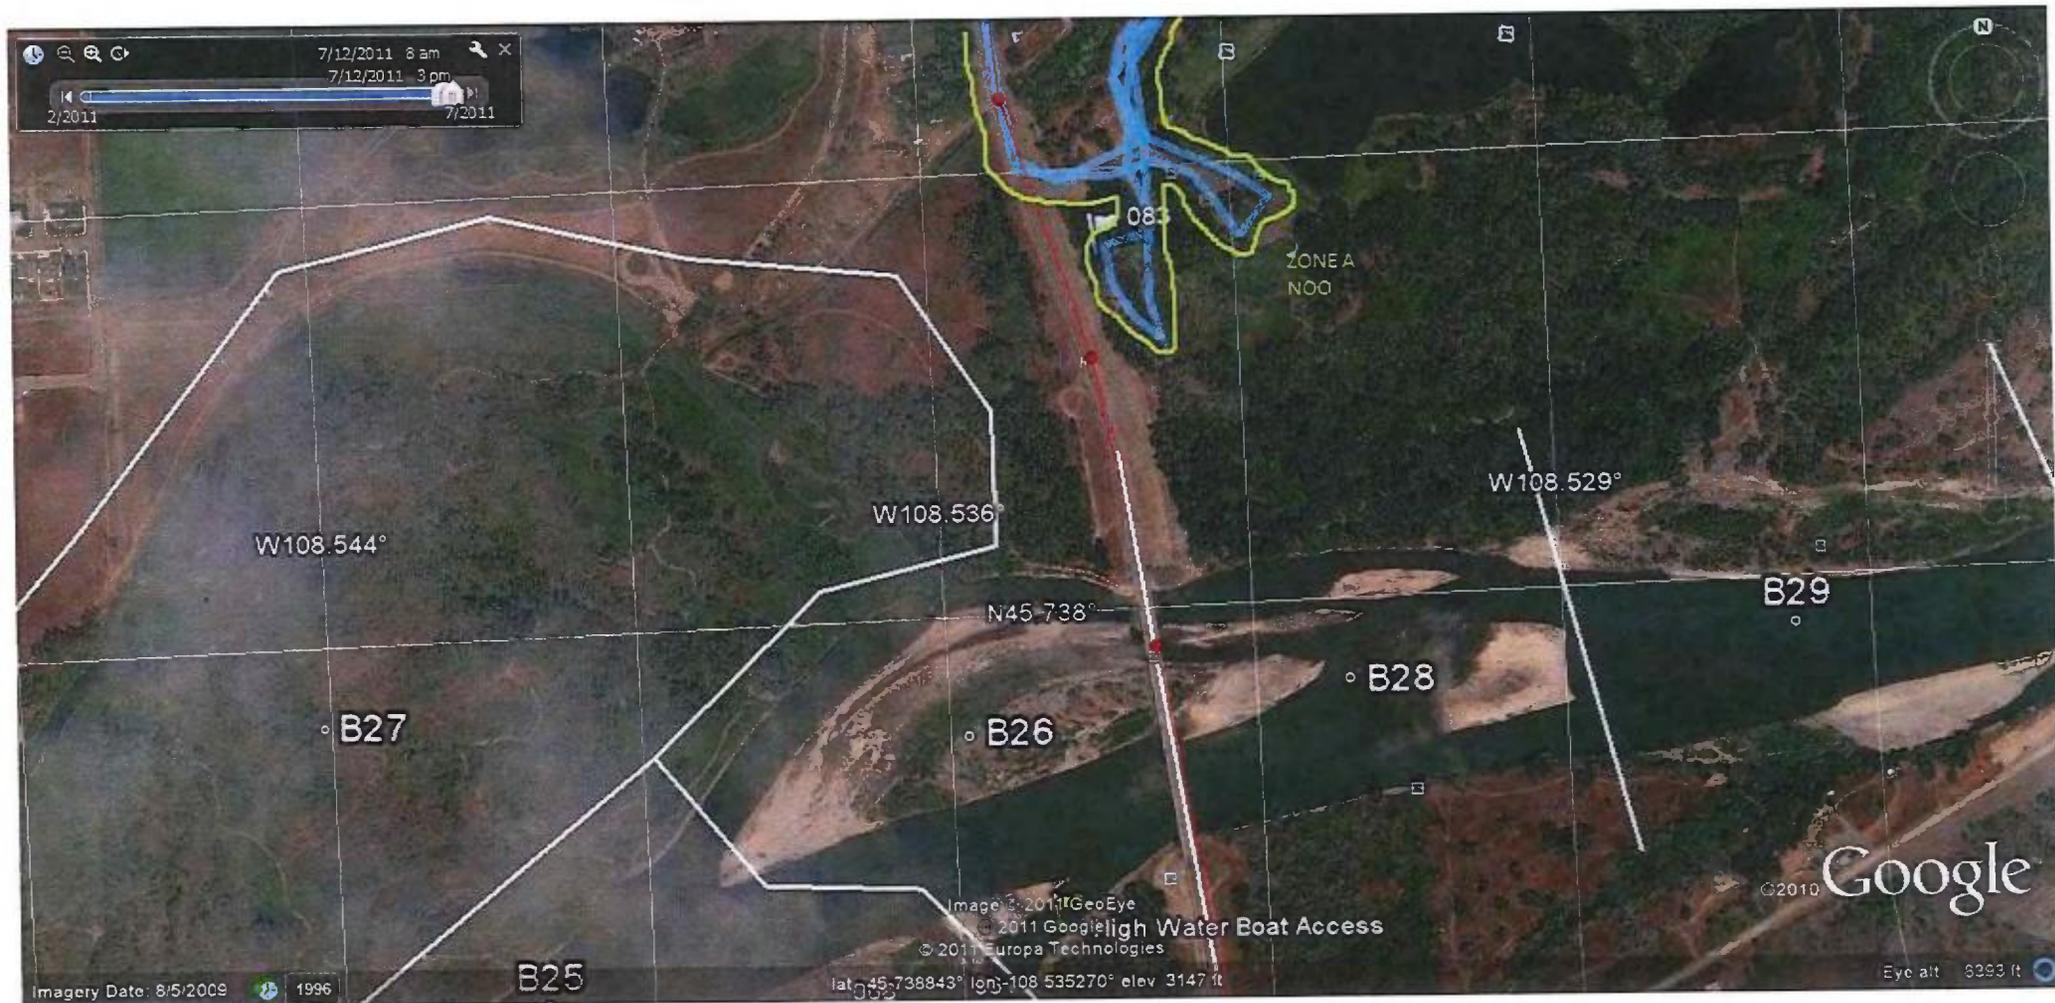
Sketch Map  
B28 Left Bank  
12 July 2011

Zone A is located in the overbank area in a region that has been flooded. No oil was observed on vegetation or on the water. Cleanup is not required.

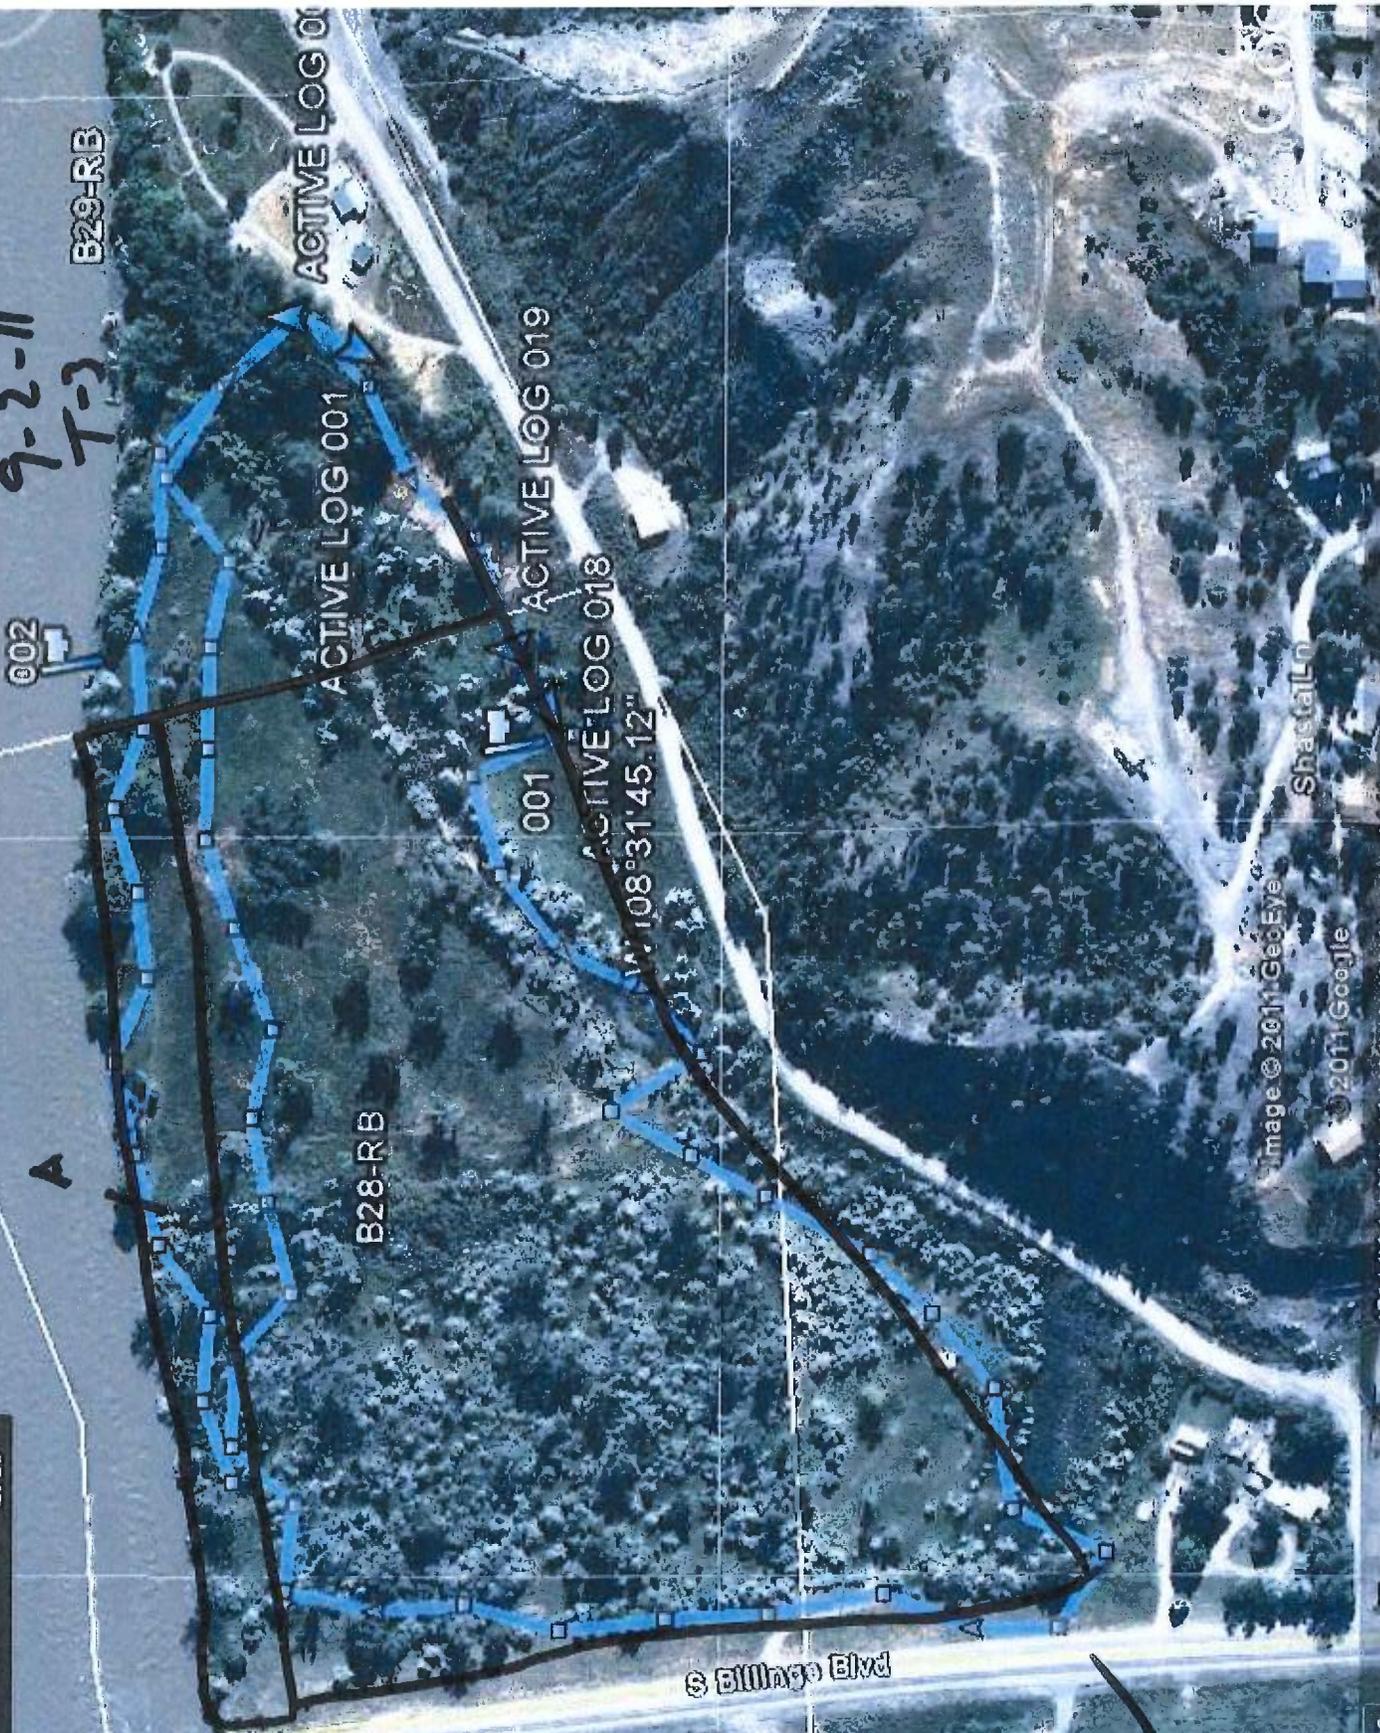
B28R  
9-2-11  
T-3

Zone B no oil ~~observed~~ observed
