**SCAT Area Transition Report for  
B28**

Silvertip Pipeline Incident  
Laurel, Montana

Prepared for:  
ExxonMobil Pipeline Company

Prepared by:  
ARCADIS G&M of North Carolina, Inc.  
11000 Regency Parkway  
West Tower, Suite 205  
Cary, North Carolina 27518-8518  
Tel 919.469.1952  
Fax 919.469.5676

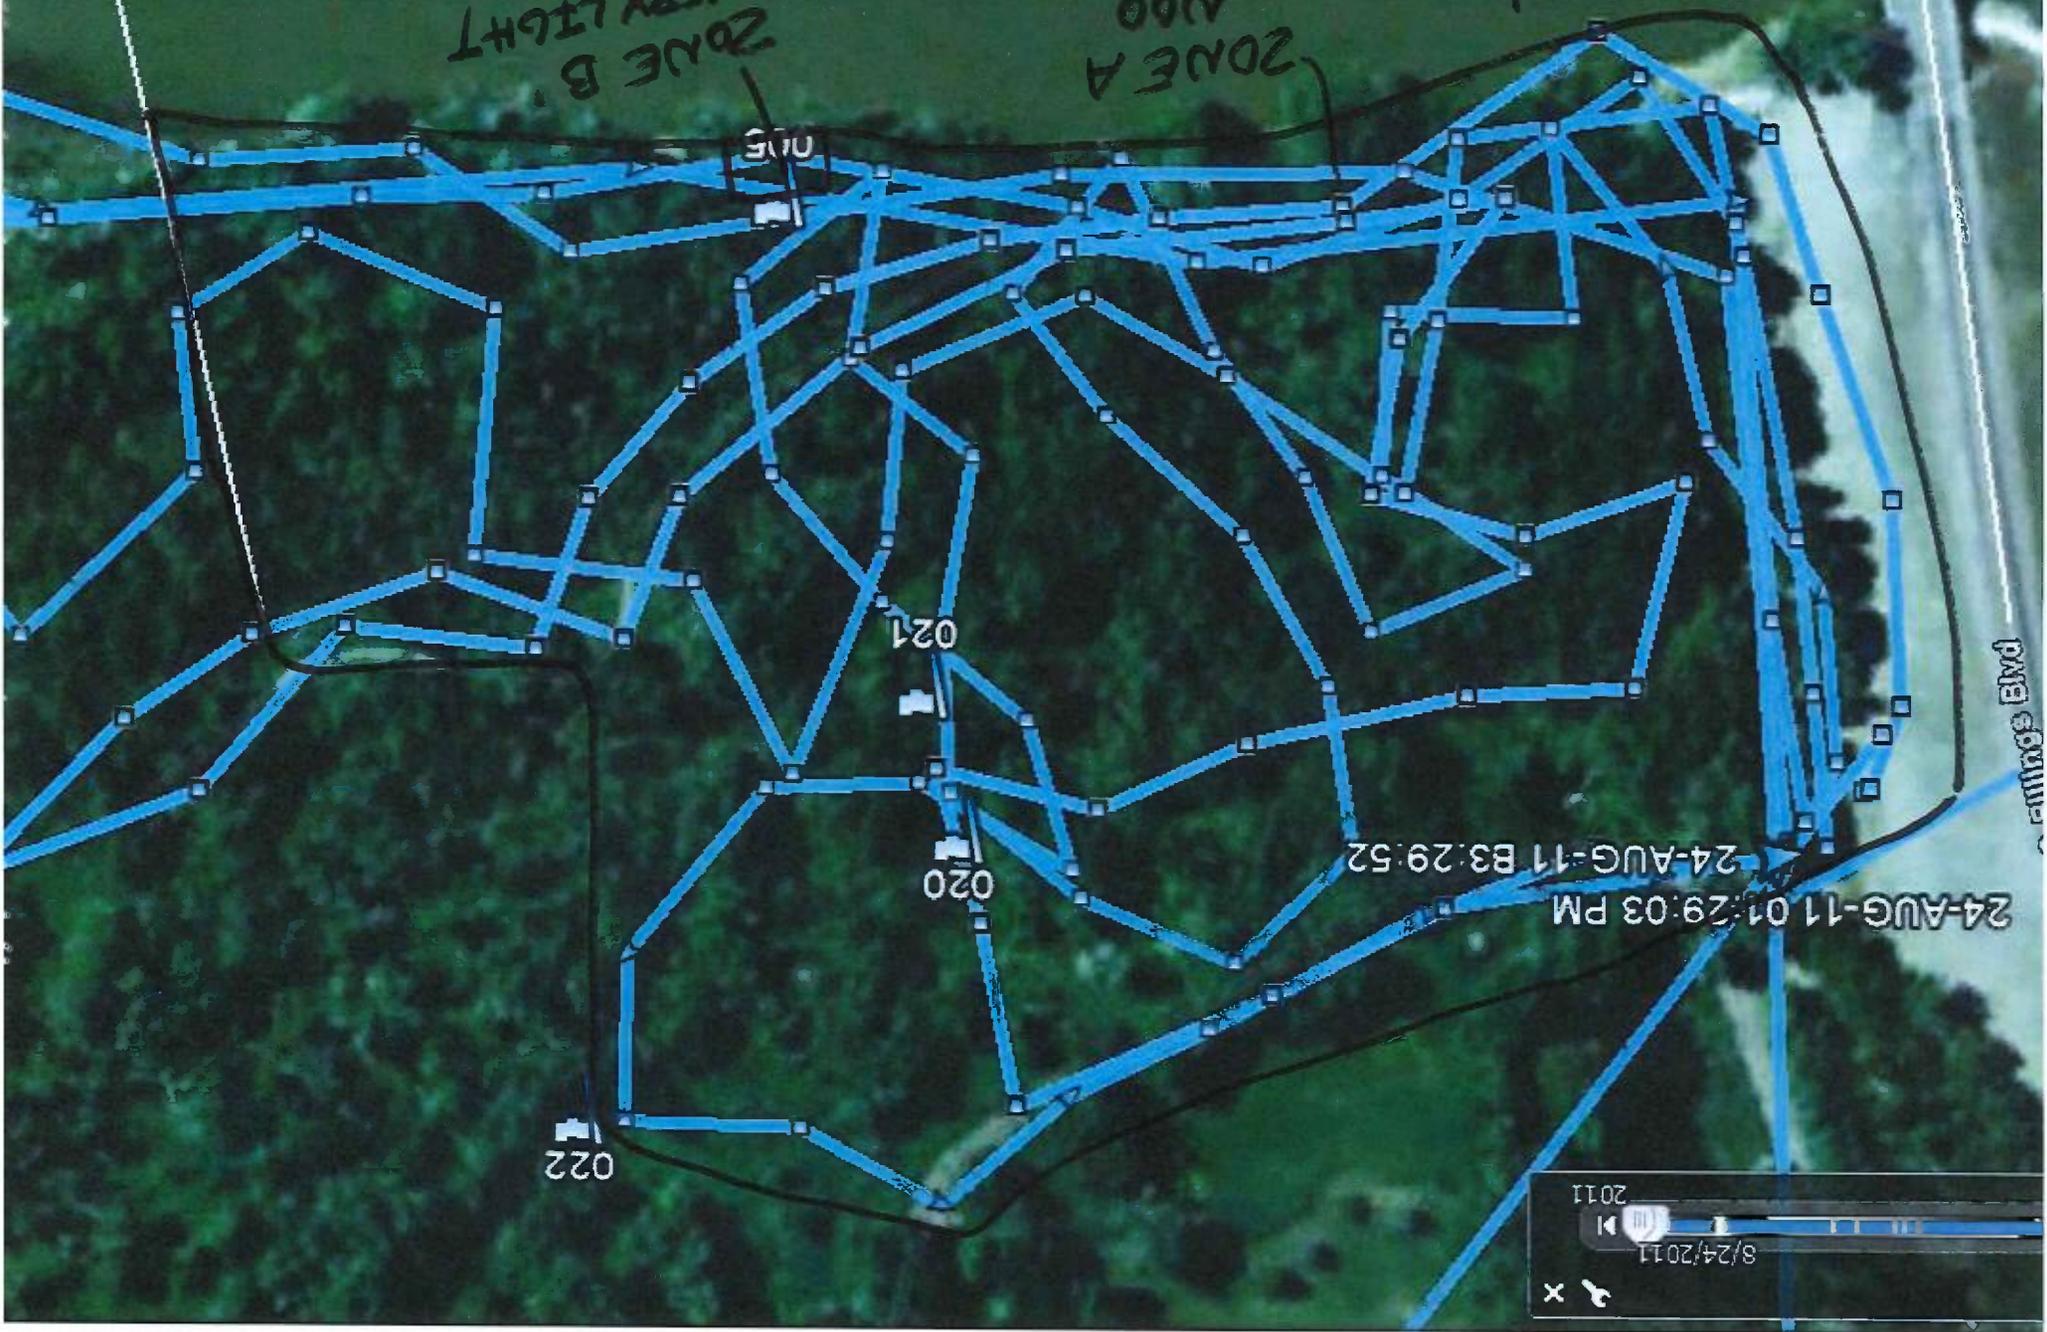
Small amount of oil visible. No cold vials or debris found

ZONE B  
VERY LIGHT  
NET

ZONE A  
M00
