**SCAT Area Transition Report for
B33**

Silvertip Pipeline Incident
Laurel, Montana

October 26, 2011

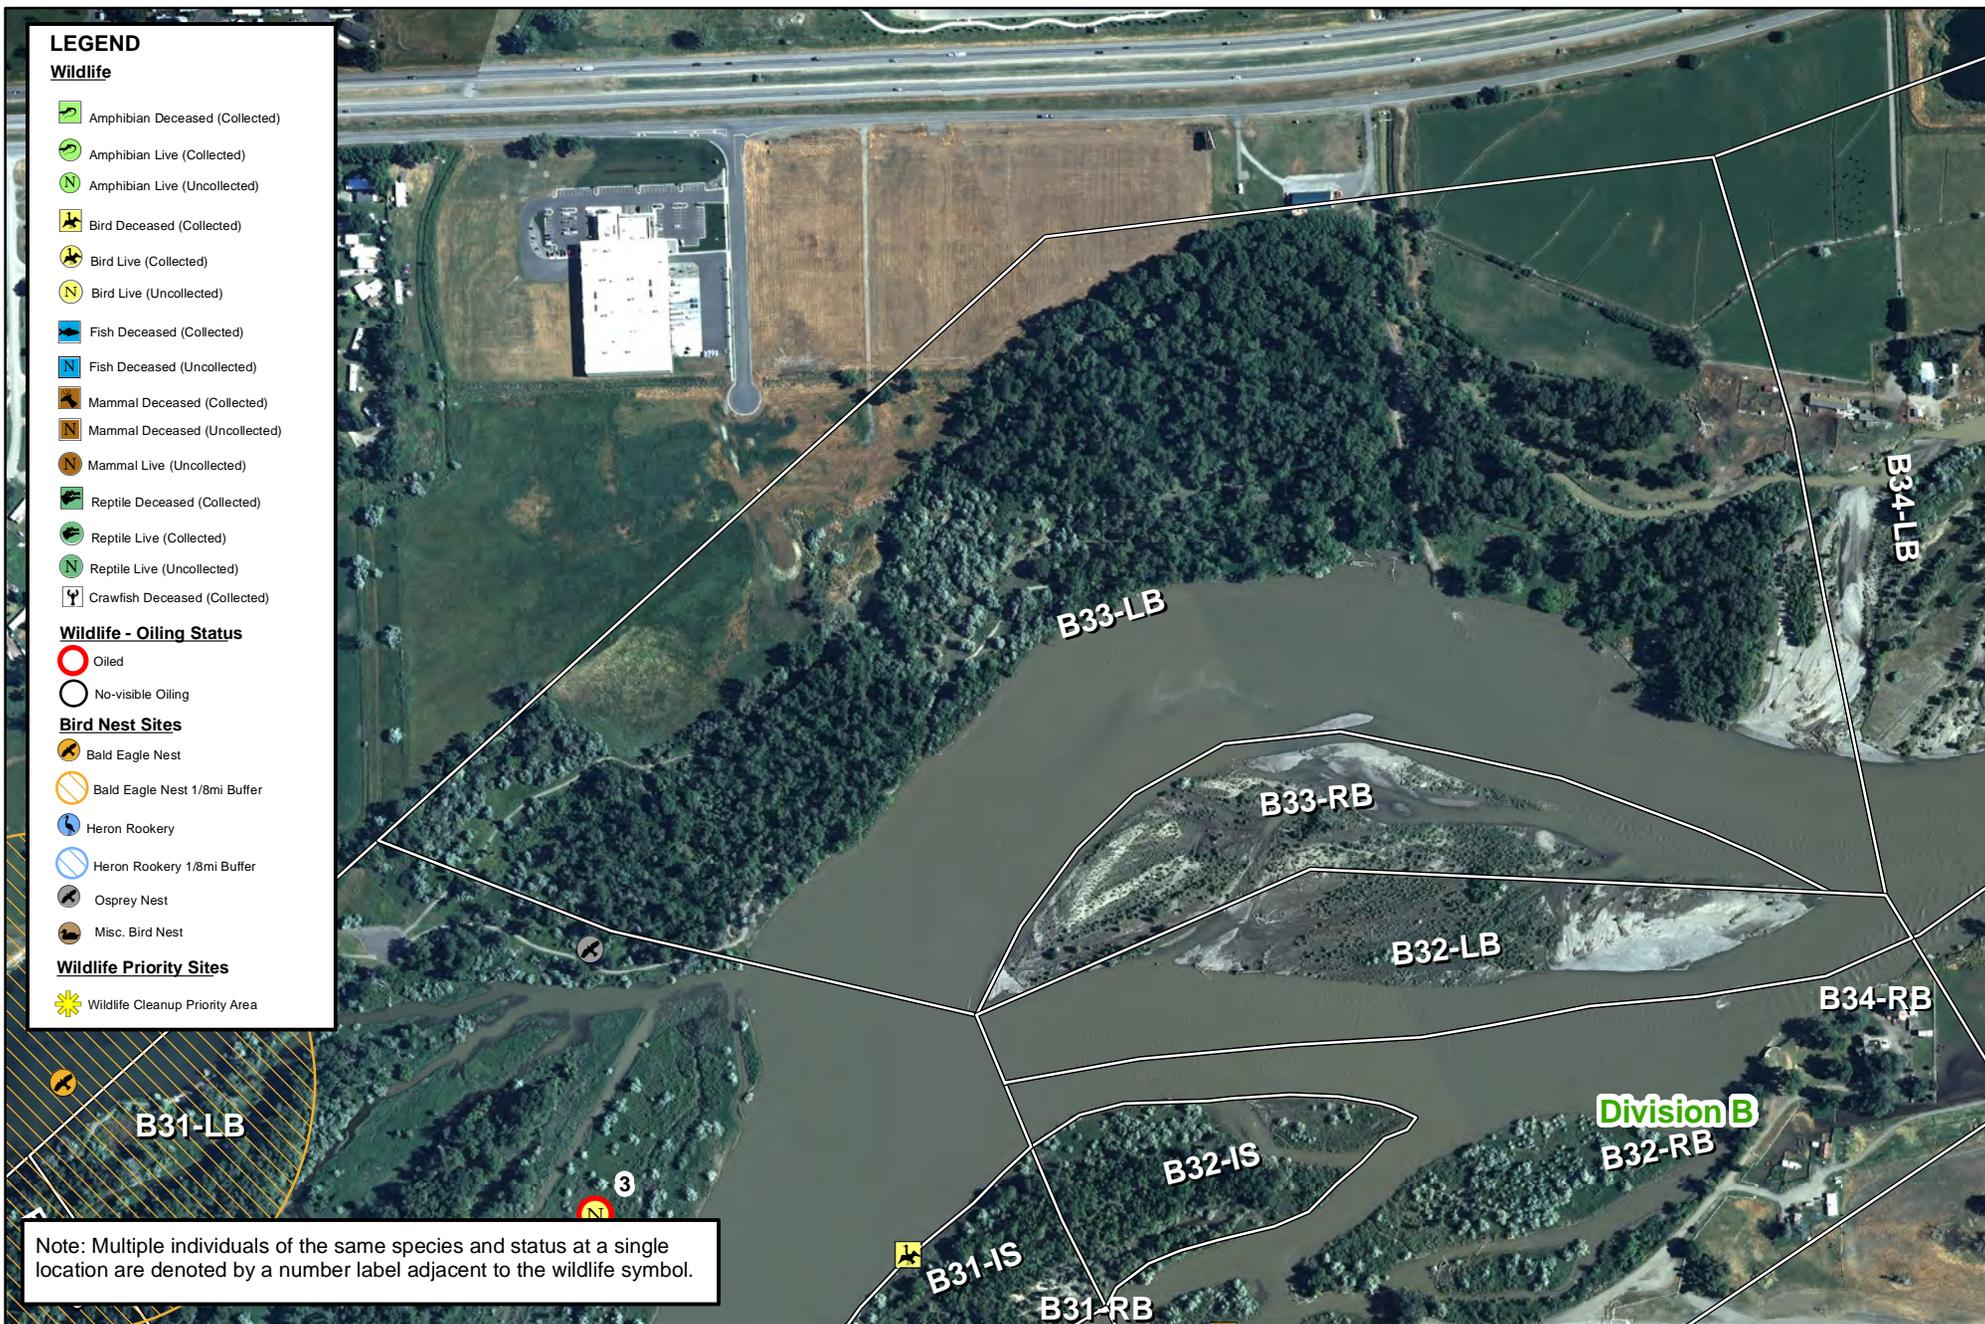
Figure 2
Wildlife Resources

Figure 2 summarizes the natural resources identified in this segment. International Bird Rescue and Resource Advisors from U.S. Fish and Wildlife Service conducted regular inspections of Area B33. No oiled wildlife was observed or recovered. No Wildlife Priority Cleanup Areas were identified. No active migratory bird nests were identified in Area B33.

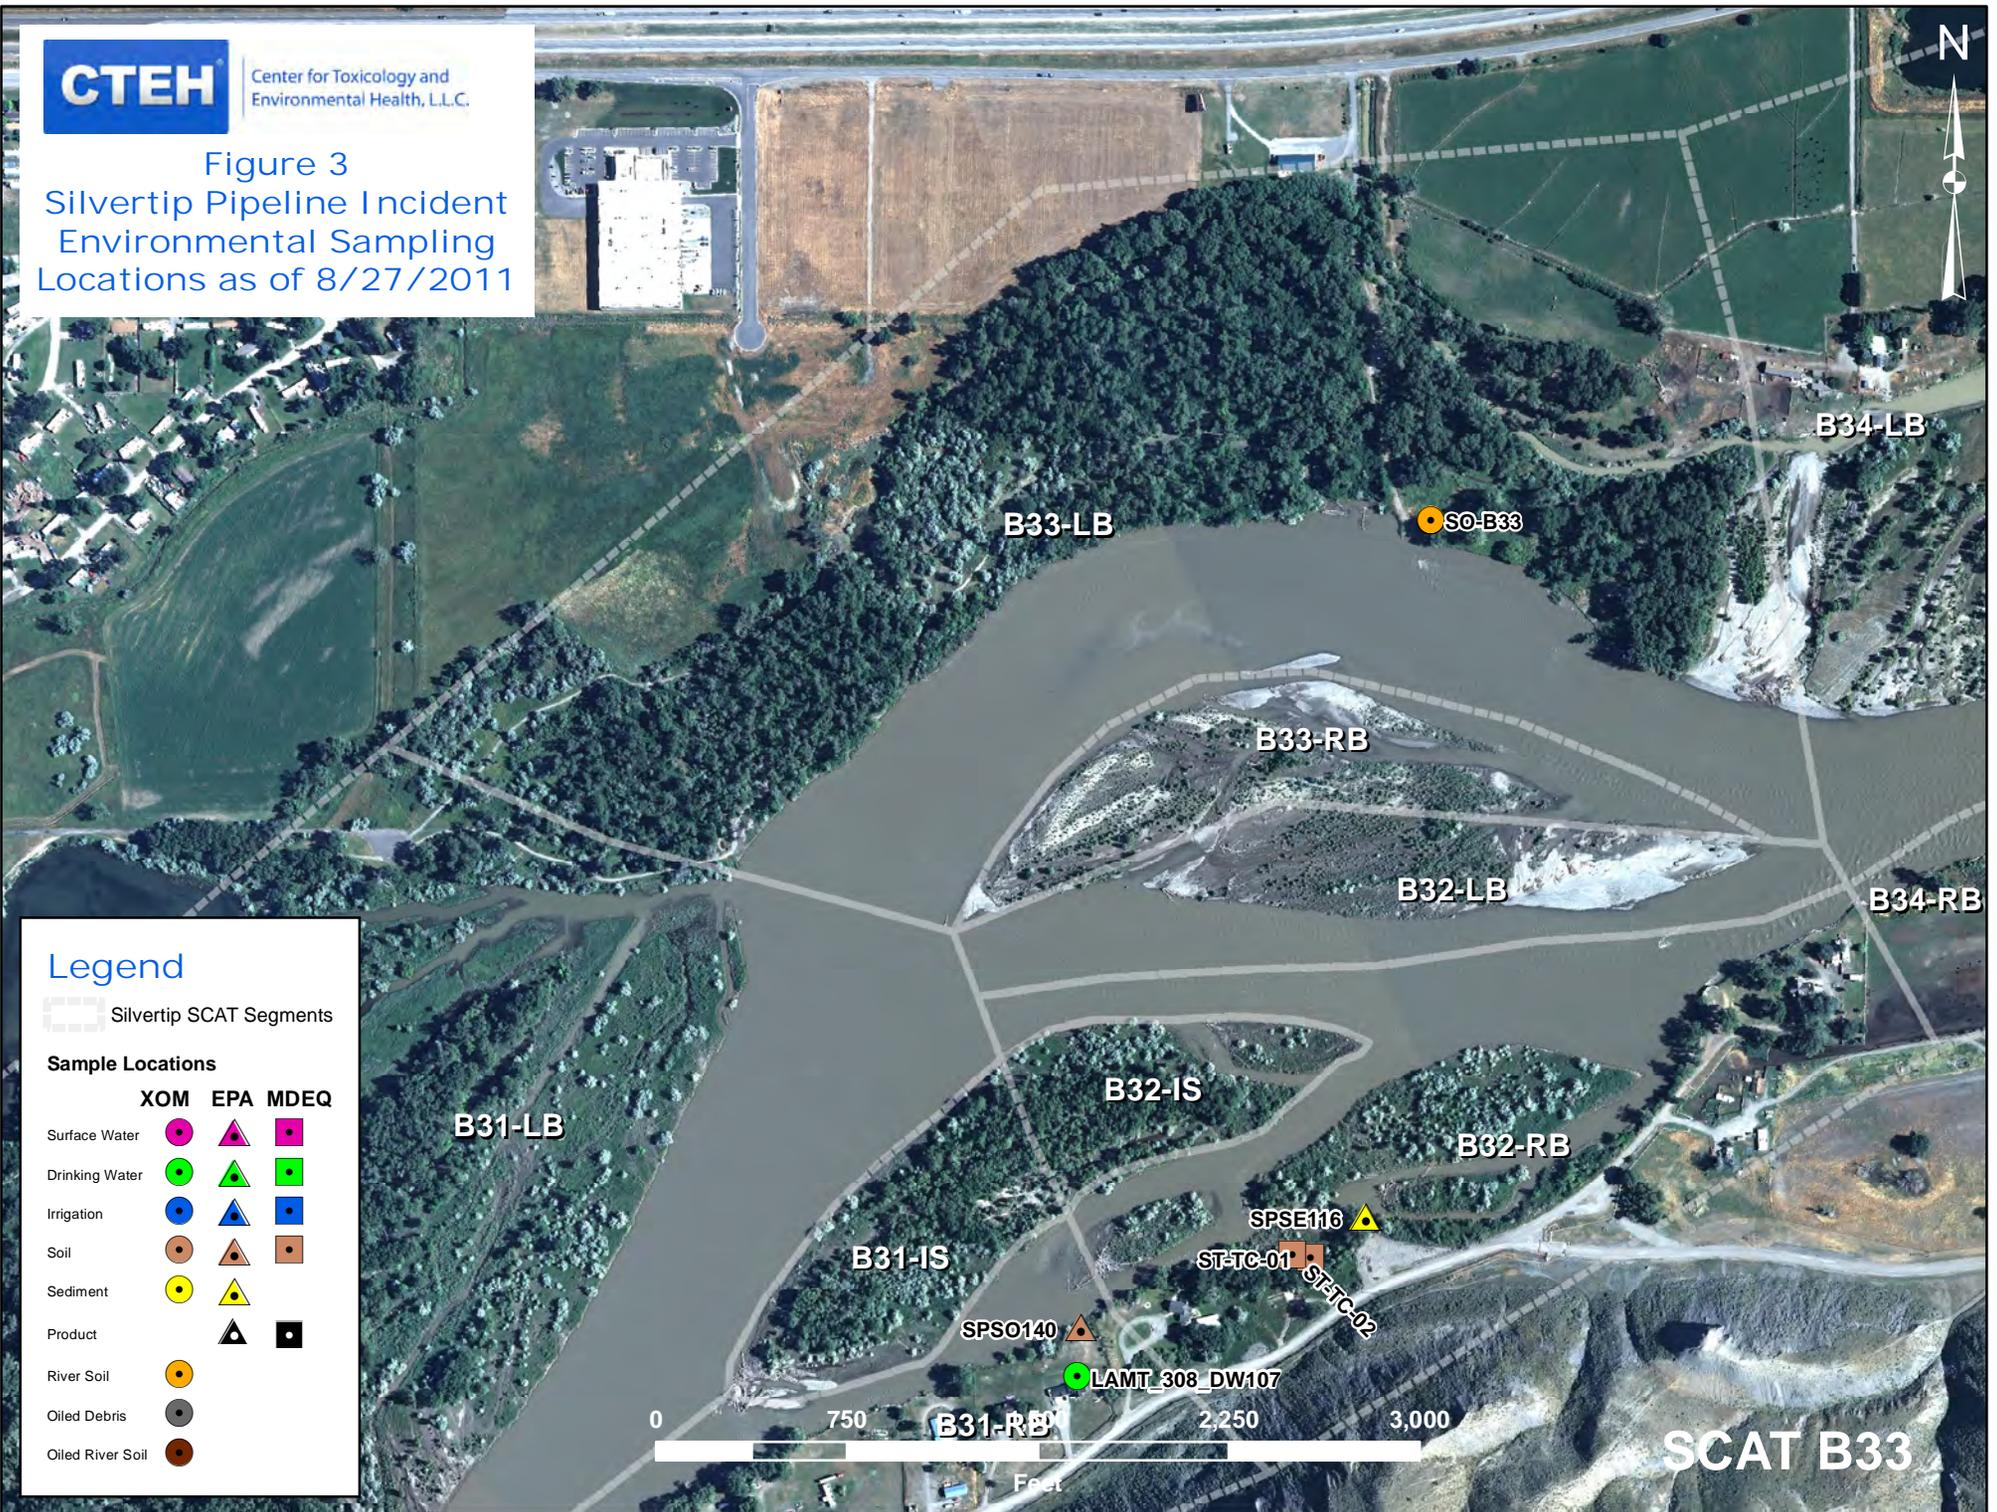
Figure 3
Silvertip Pipeline Incident
Environmental Sampling
Locations as of 8/27/2011

Table 1 (below) summarizes samples collected within Area B33. The analytical results for the samples collected can be accessed through a publicly accessible database on the United States Environmental Protection Agency's (USEPA's) website. The approximate locations of samples collected within Area B33 are provided on Figure 3.

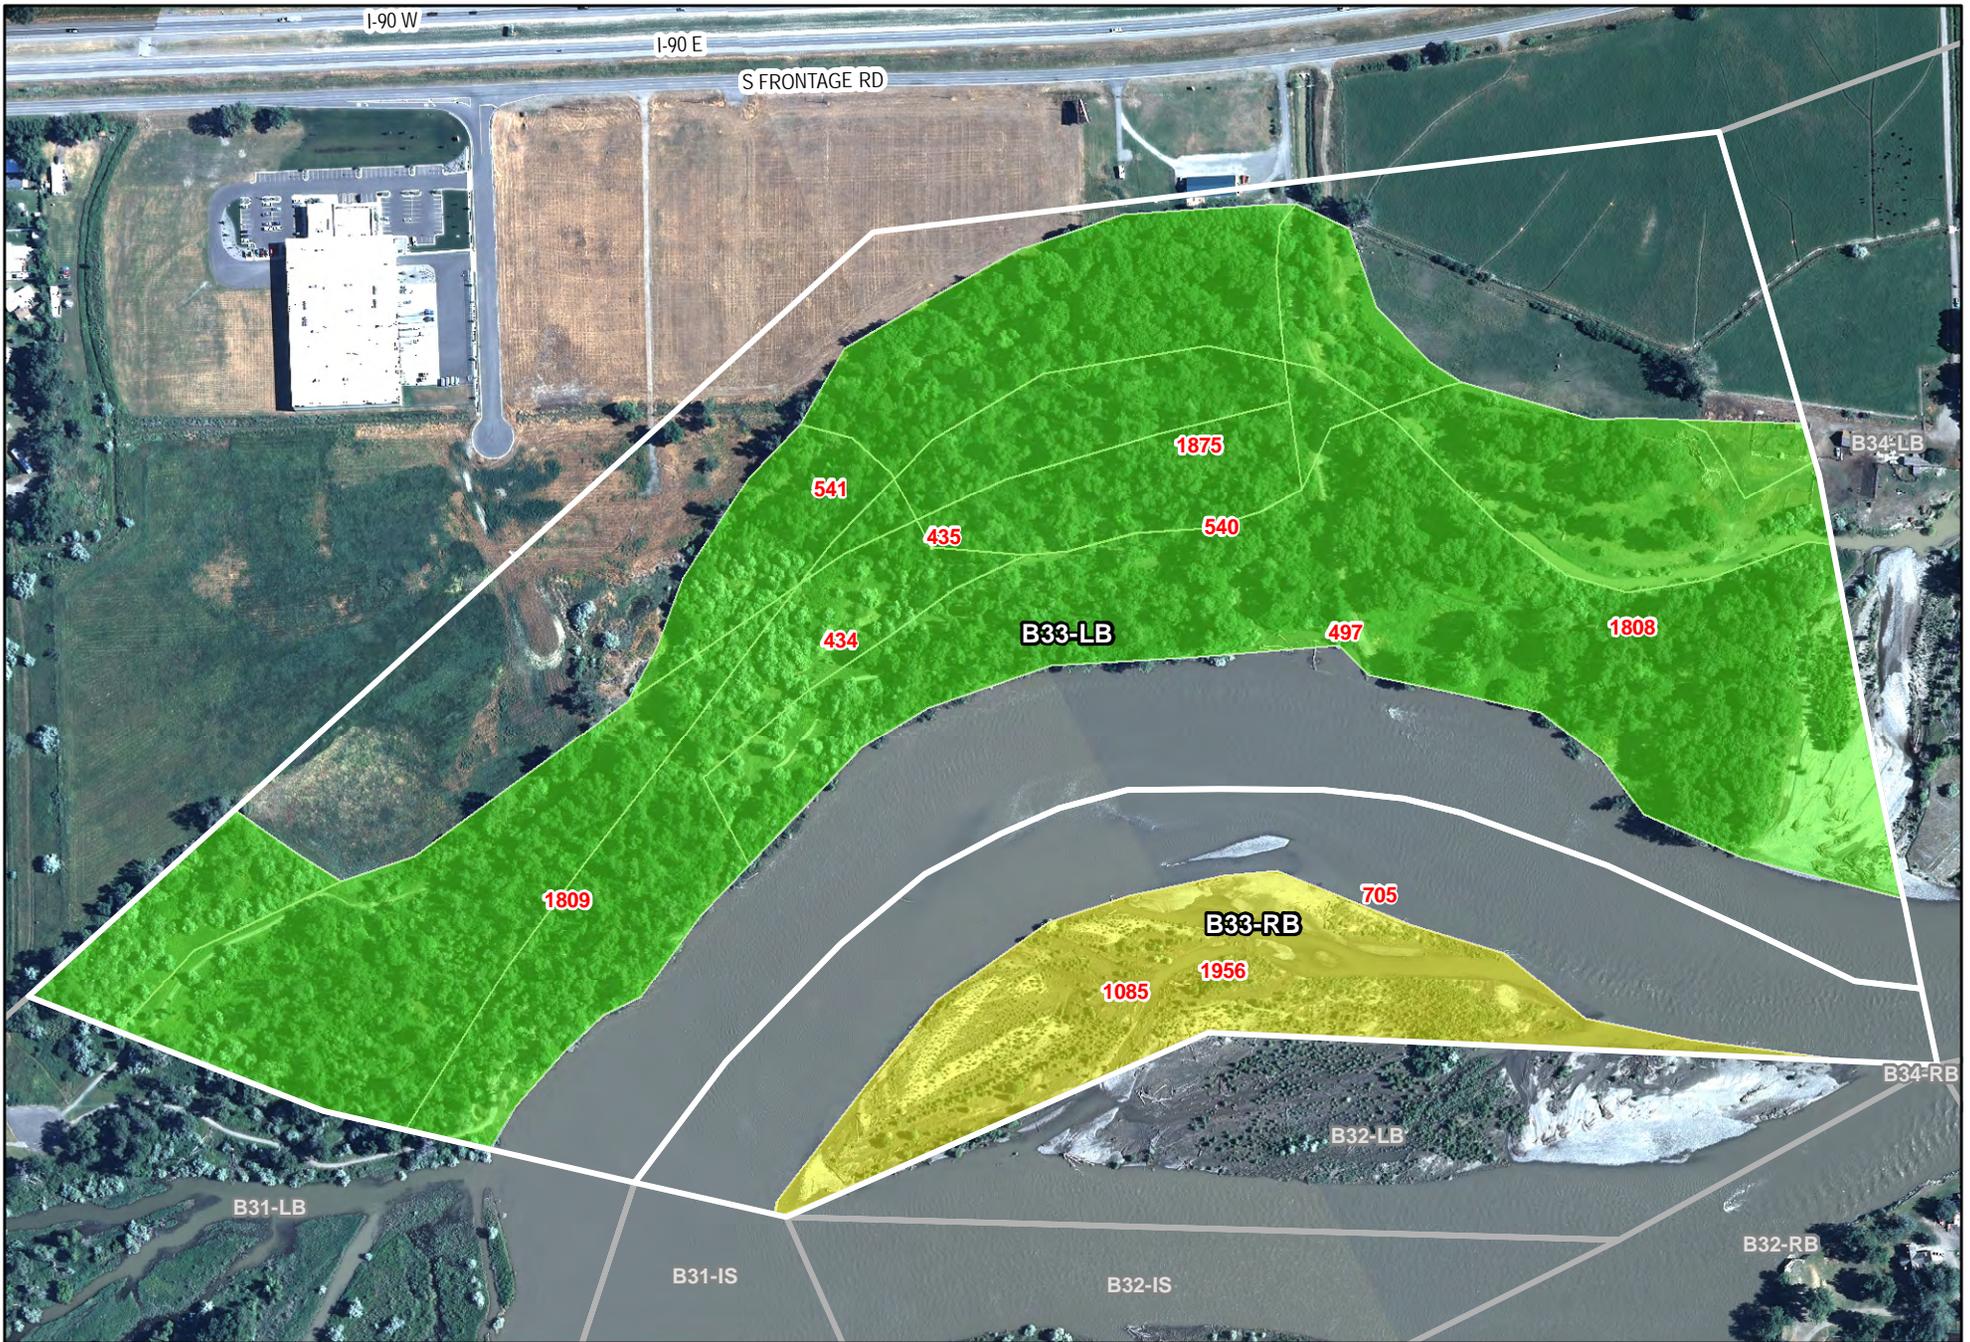
Figure 4 - Maximum SCAT Observations For SCAT Area:

The SCAT teams used systematic evaluation criteria and treatment method tables approved by the National Oceanic and Atmospheric Administration to provide a standard approach for data collection and conducting field surveys. The forms and sketches from the initial SCAT surveys performed along the river bank (water edge) and floodplain within Area B33 are included in Appendix B. Figure 4 provides the maximum oiling zones observed by the SCAT team during the initial surveys of Area B33.

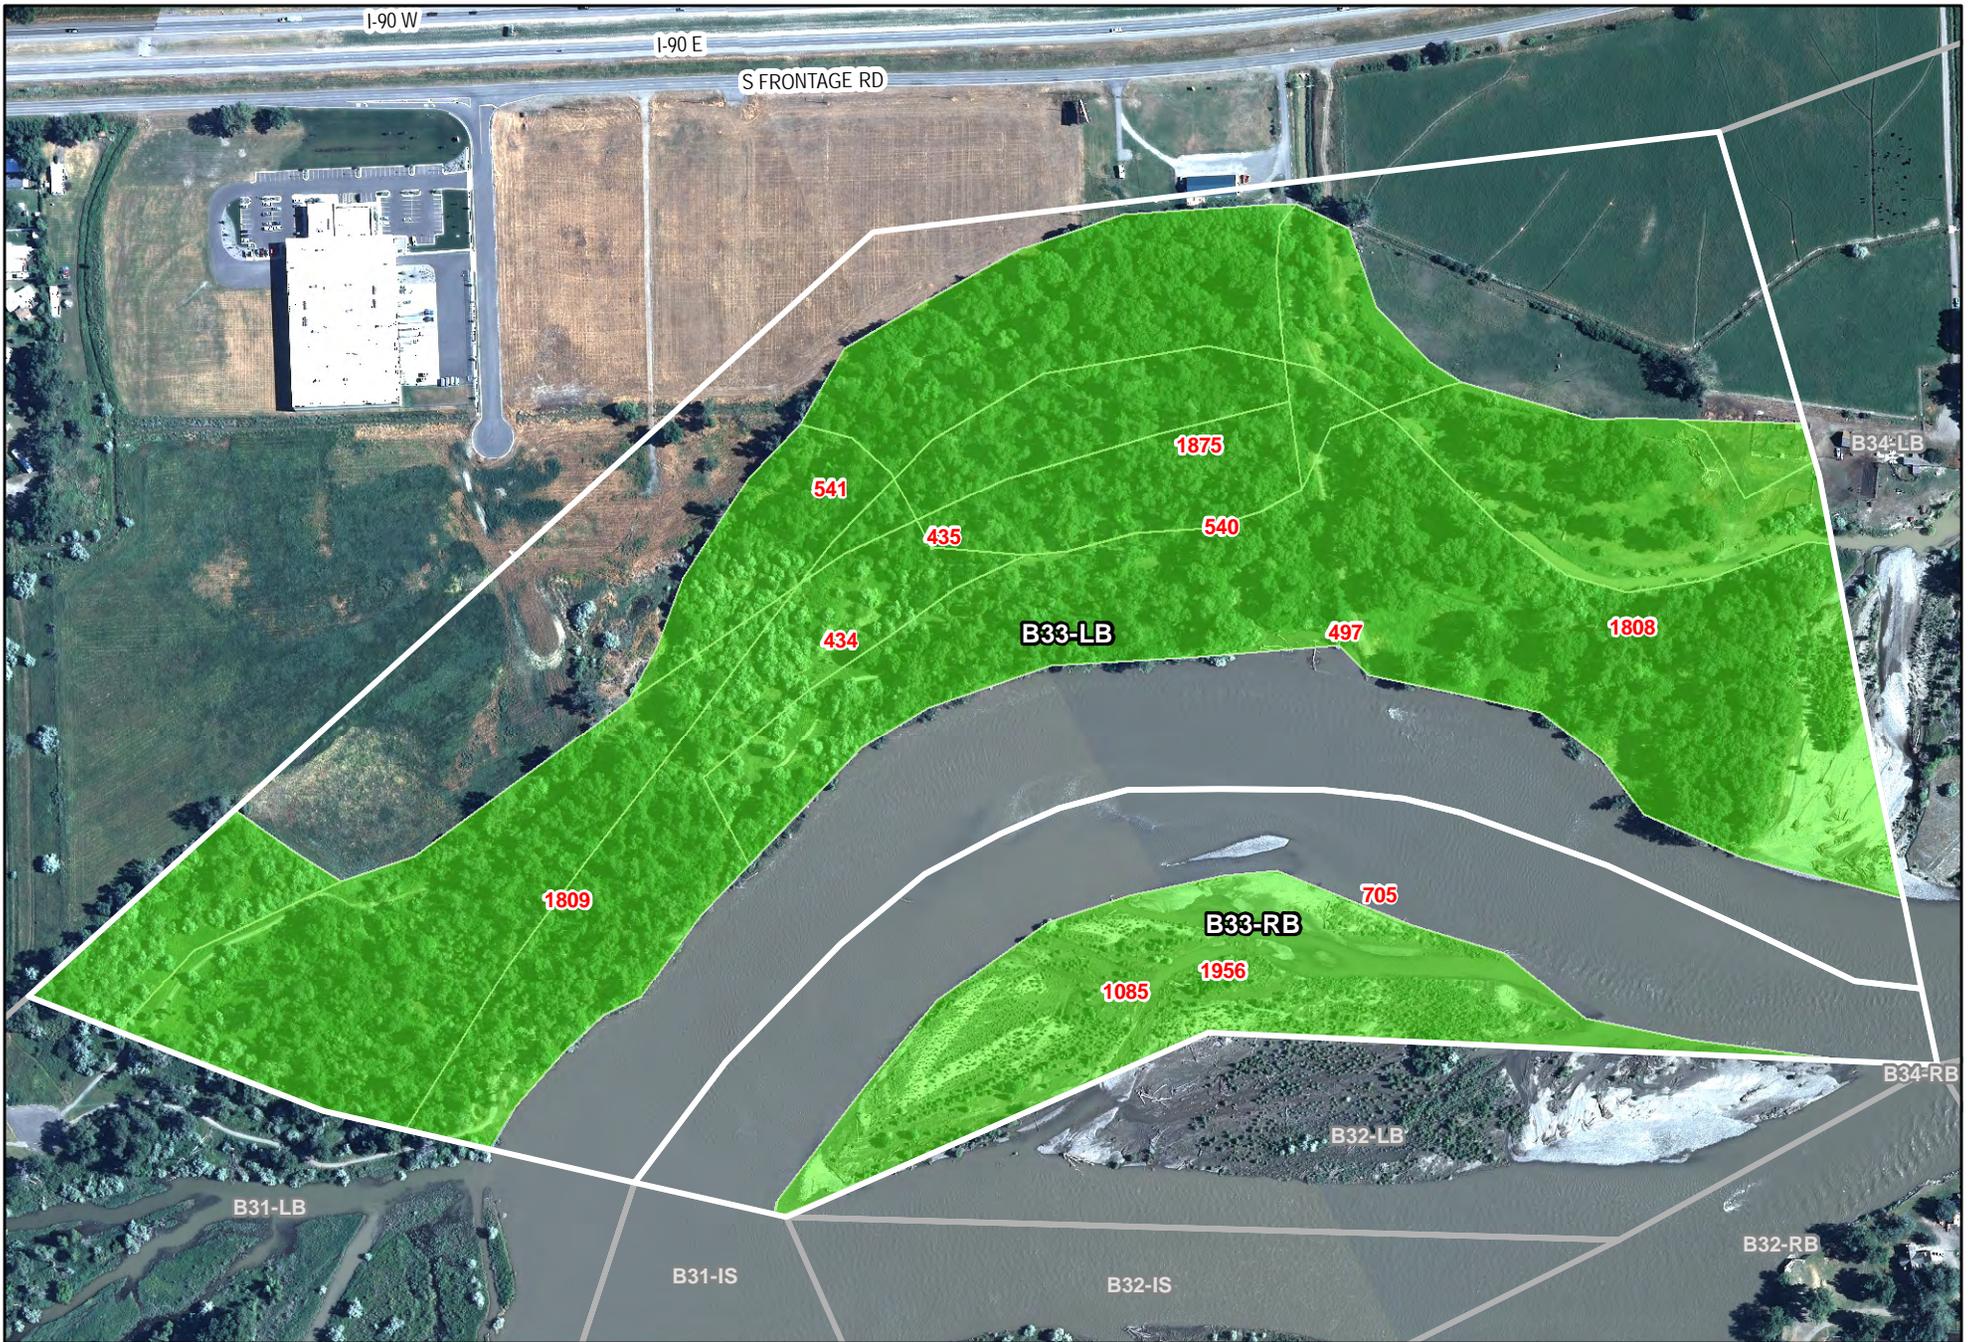
**Figure 5 - Final SCAT Observations
For SCAT Area:**

Figure 5 shows the oiling conditions within Area B33 following completion of oil removal activities. The SCAT team performed final surveys of the right and left banks within SCAT Area B33 to confirm the agreed-upon cleanup endpoints identified in the applicable CTRs had been achieved. The final SCAT survey documentation is presented in Appendix E.

Based on the final SCAT surveys performed on the right and left banks within Area B33, no further treatment is recommended for these segments. SCAT Segment Sign-Off Forms are included as Appendix F.

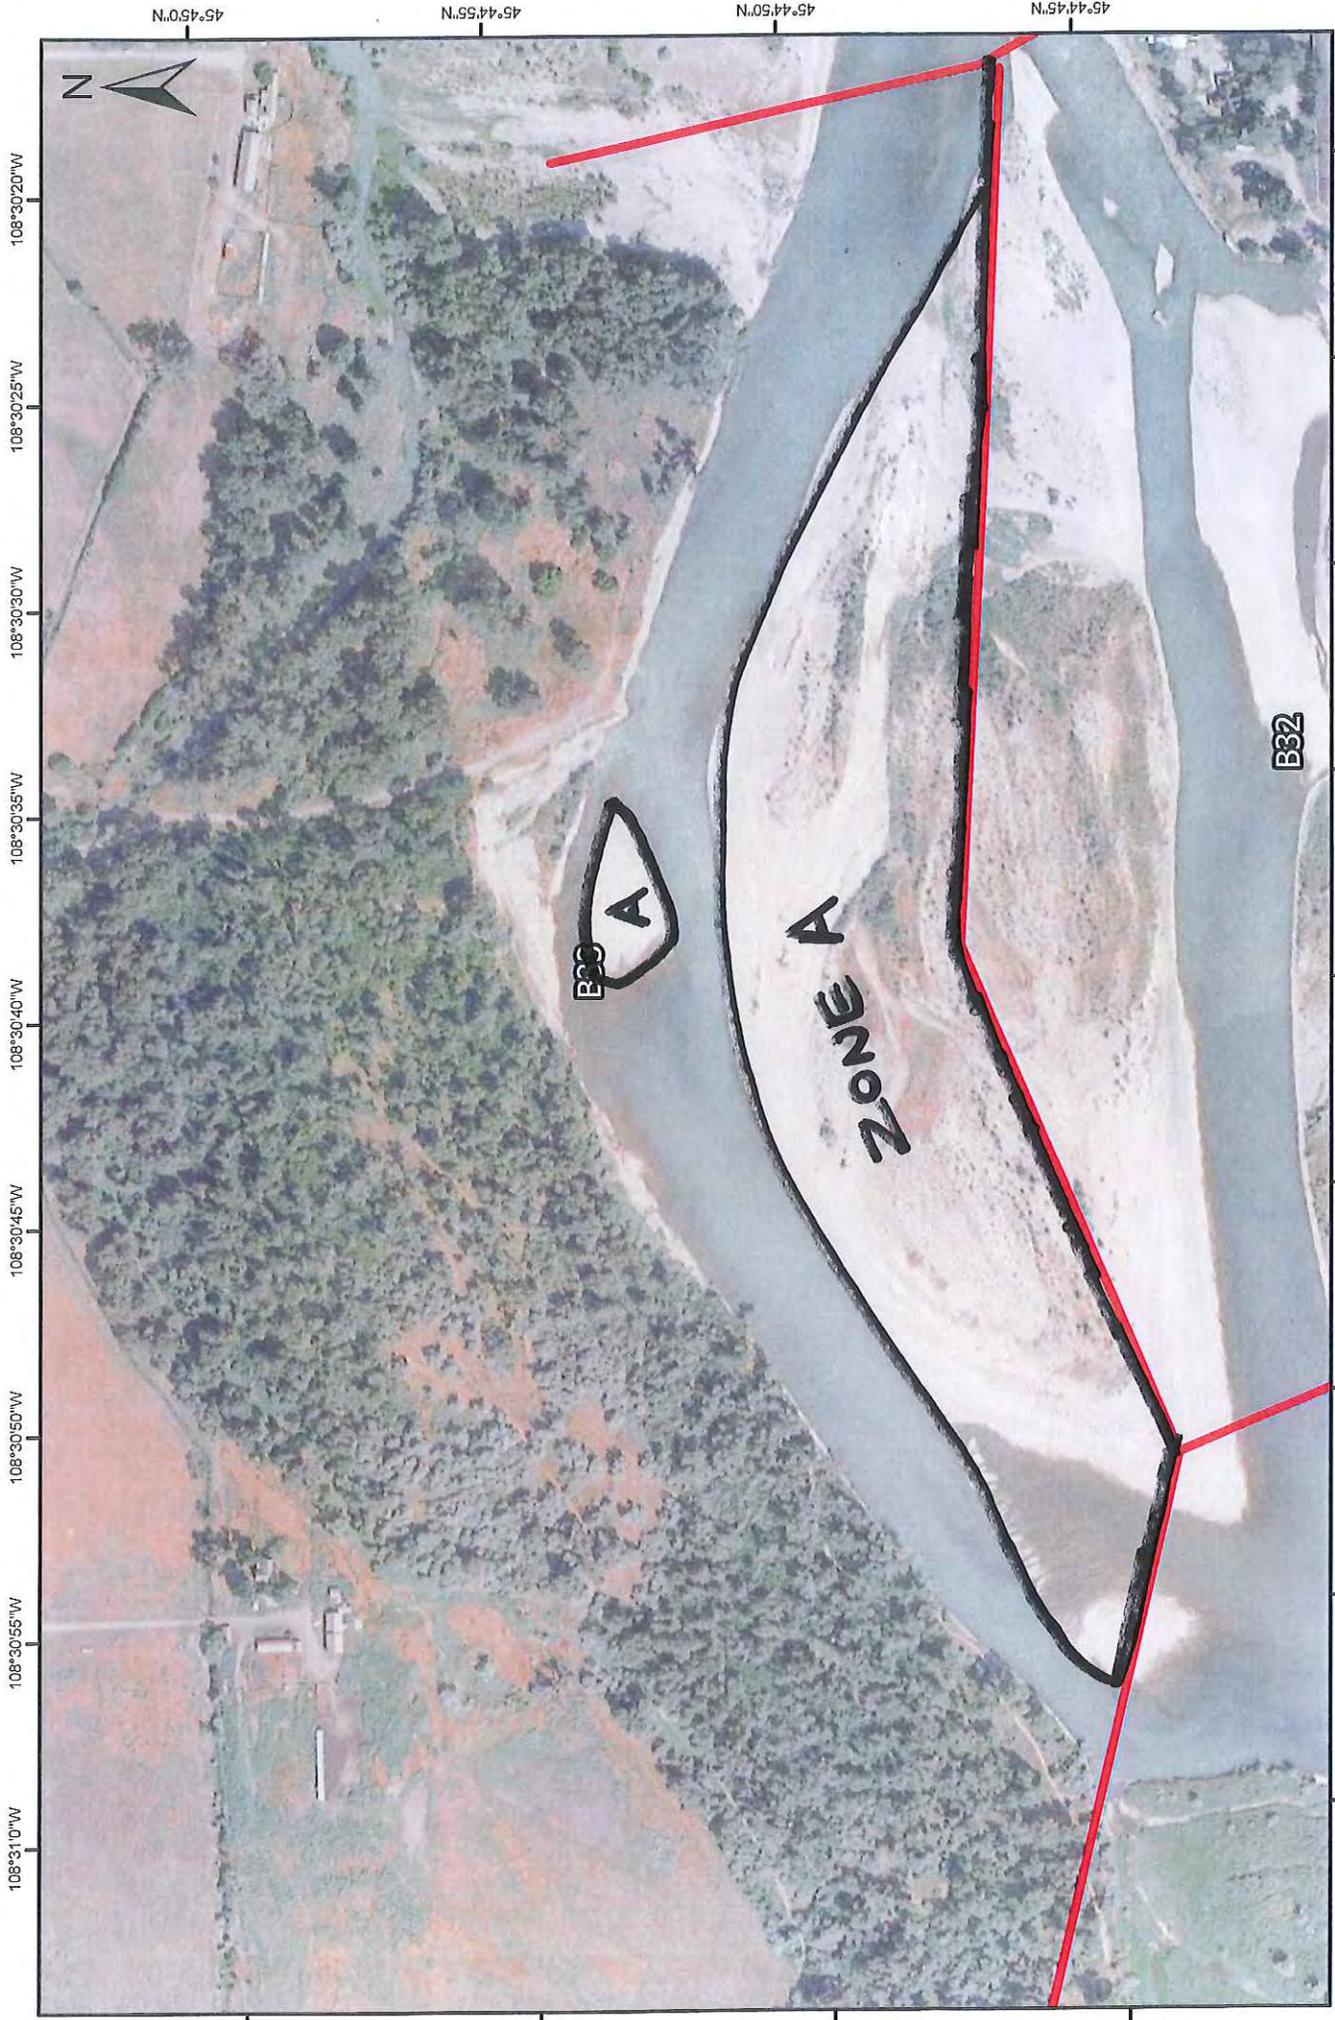
DATE: 28/07/11
TEAM: 2
Zone A
COMMENTS:

Seg 33, Zone A, Sporadic ST & CT. mainly stain on veg. nearshore, CT on trees & small debris piles inland. 2 hotspots flagged & photo'd & remove hotspots

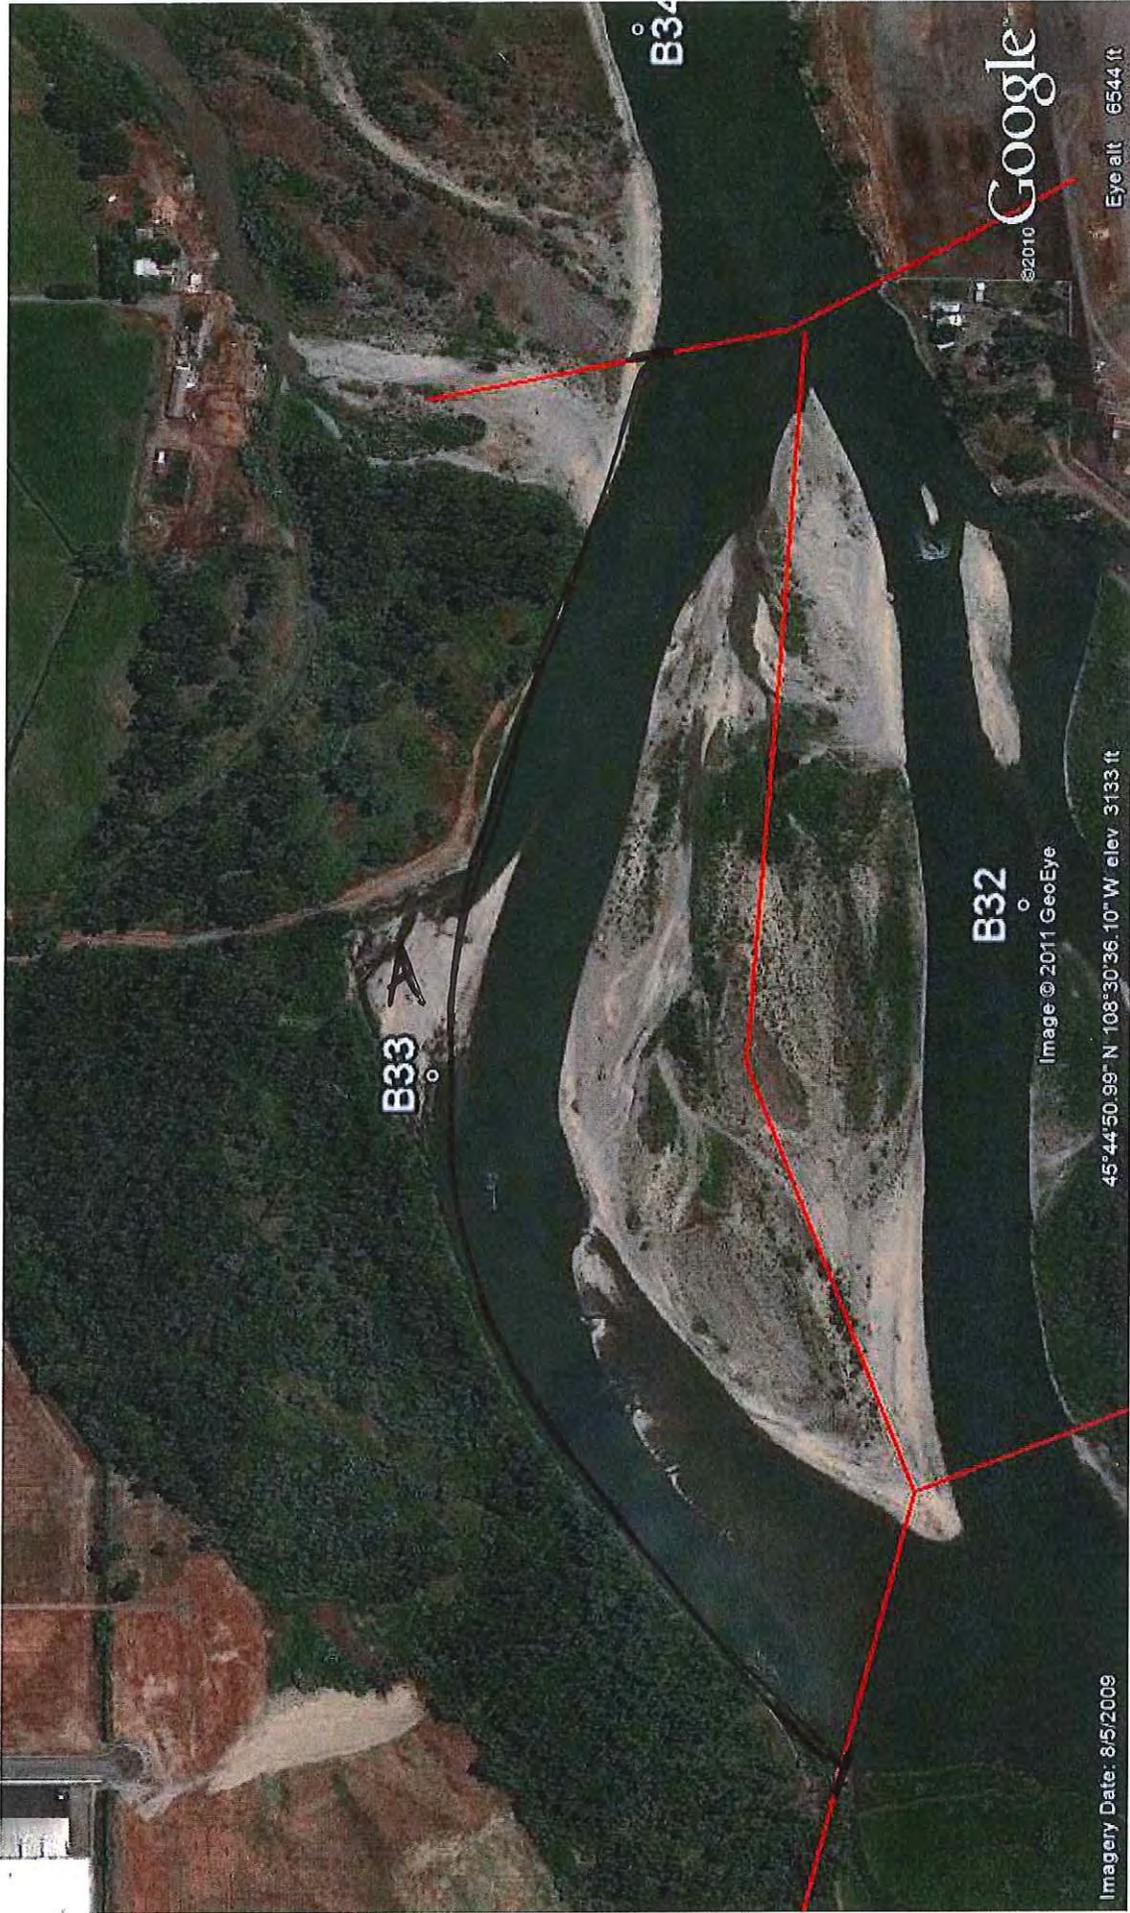
B33

Treatment Recommendations:
Zone A: No oil observed; no treatment required.

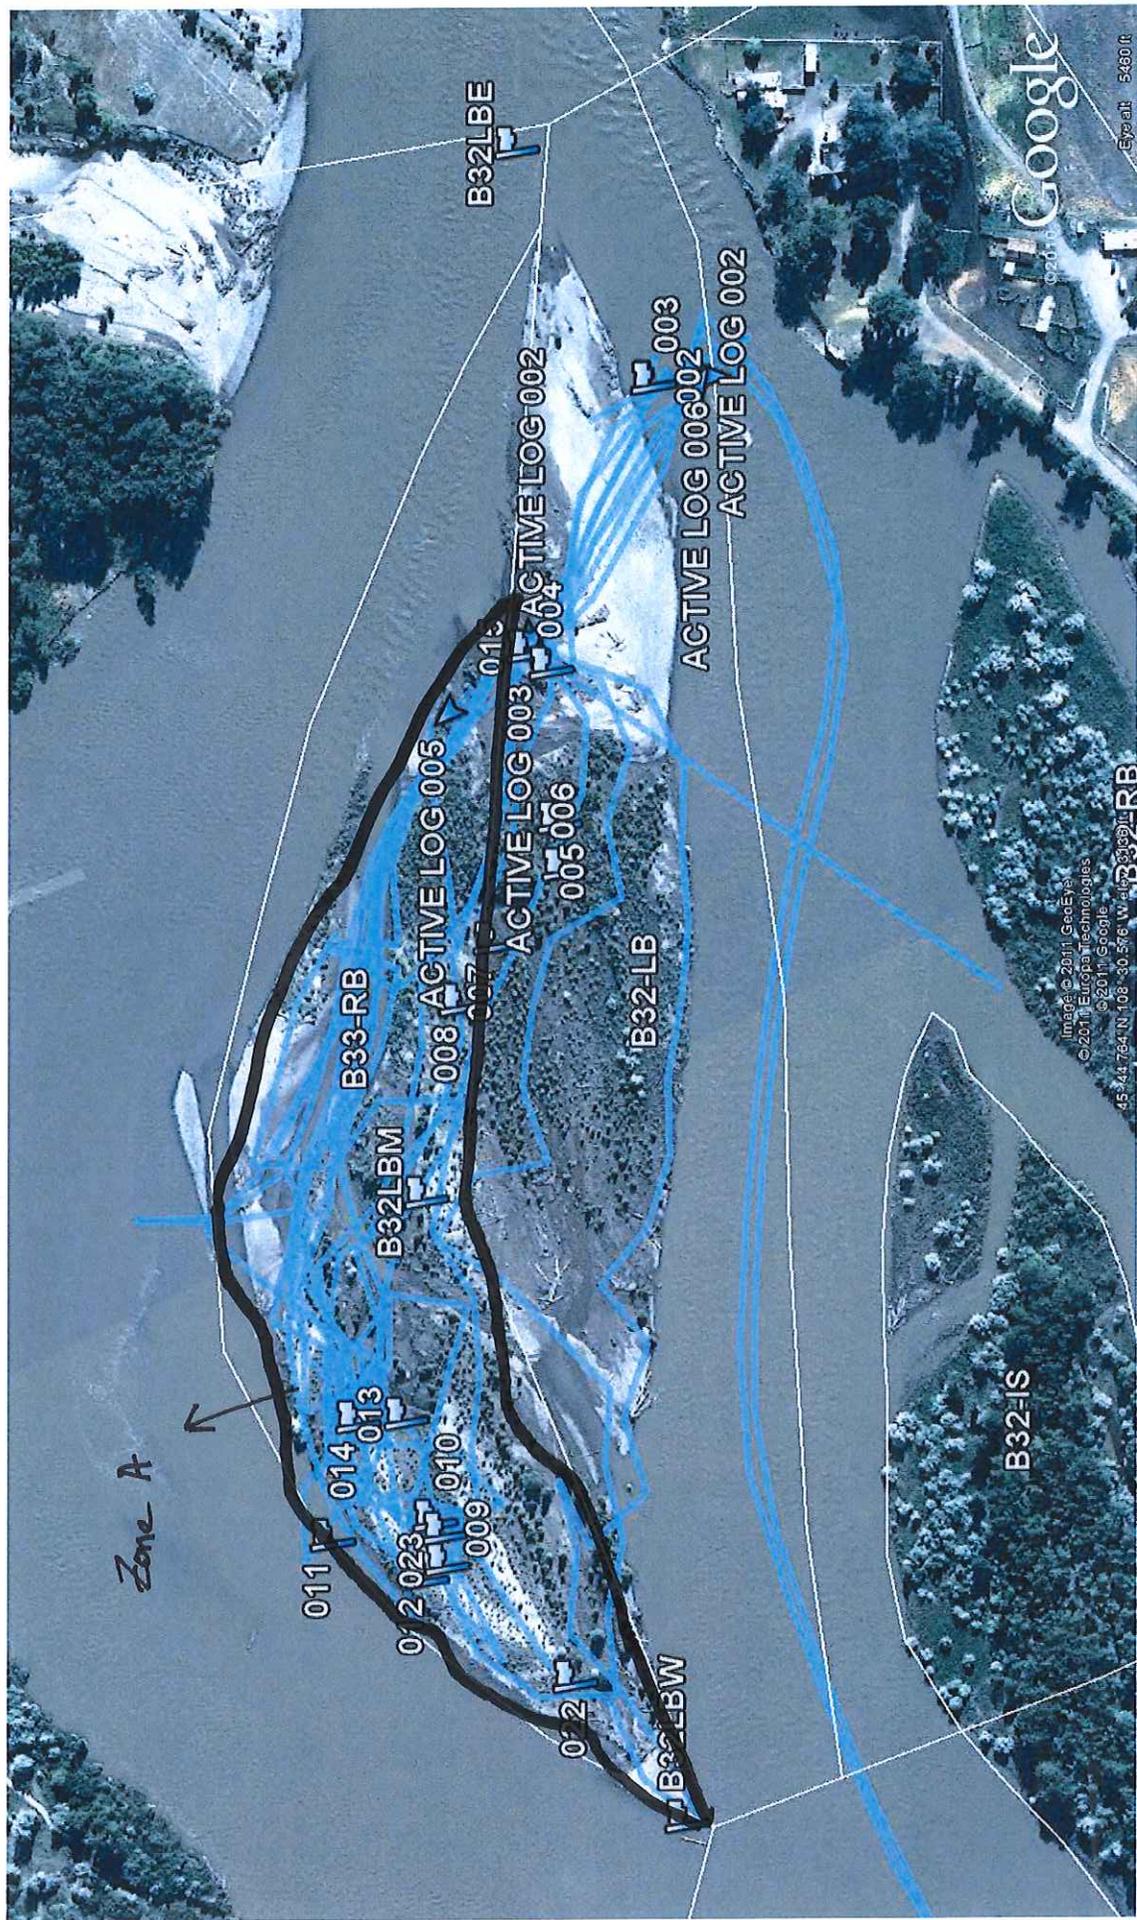
RIVER BANK OILING SUMMARY FORM for Silvertip Pipeline Incident

Zone A: trace destr oil coated / stained veg & debris. hotshot crew cleaned -> NFT

Zone B: ~~trace destr oil coated / stained~~
NO oil observed - NFT
