**SCAT Area Transition Report for
B38**

Silvertip Pipeline Incident
Laurel, Montana

October 20, 2011

Our Ref.:
B0085883.1103

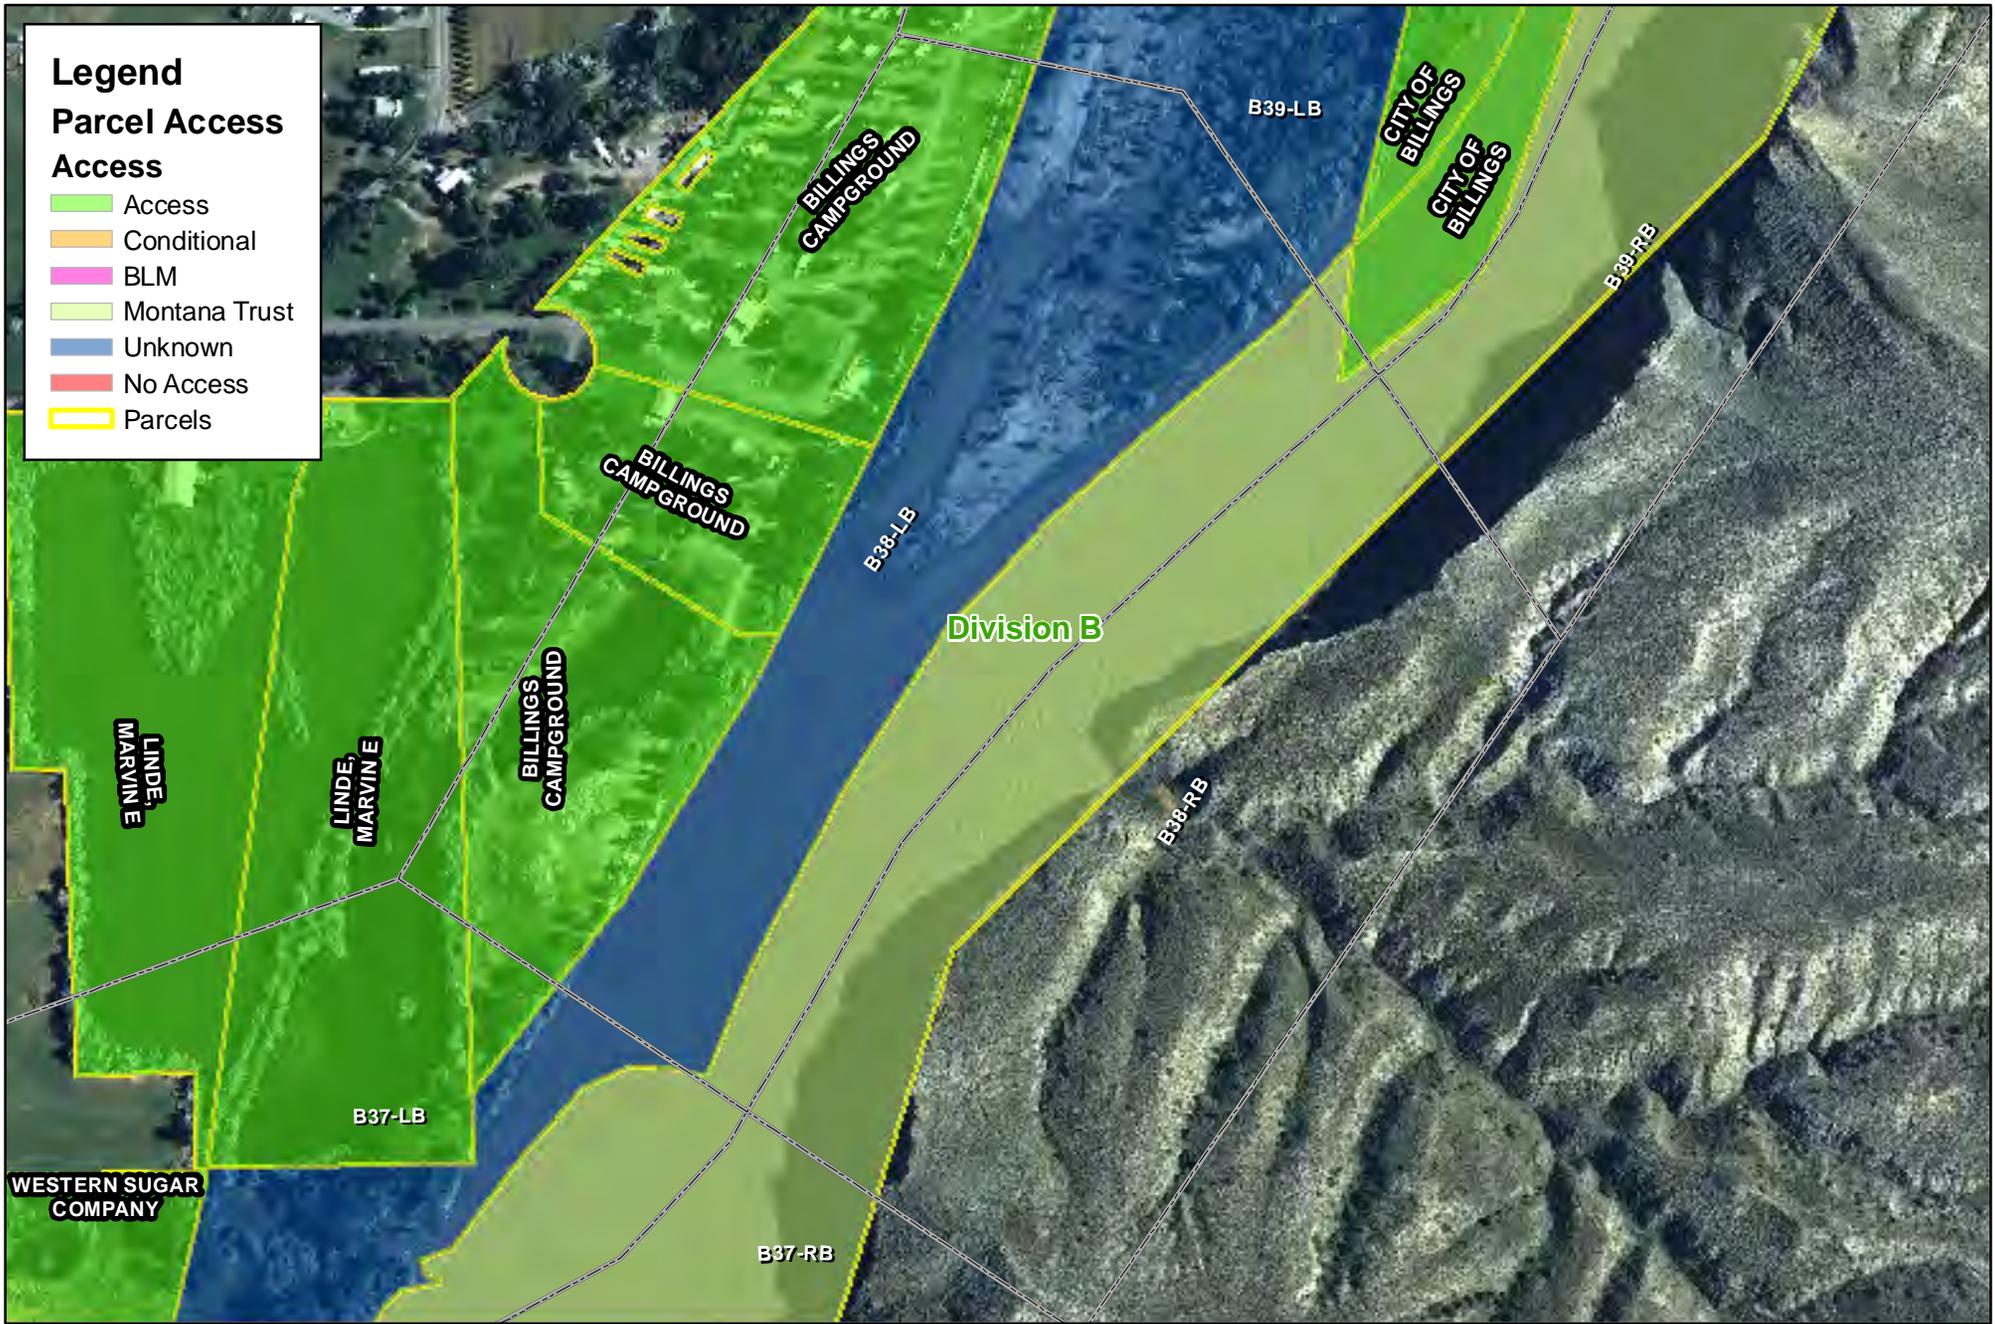
Figure 1 provides an aerial map of SCAT Area B38, along with the (a) SCAT Area boundary, (b) parcel boundaries and respective property owners, and (c) access constraints identified during the oil cleanup process. The acreage surveyed in Area B38 is 13.2. There were no access issues for this area, however the right bank is a cliff and could not be accessed by foot.

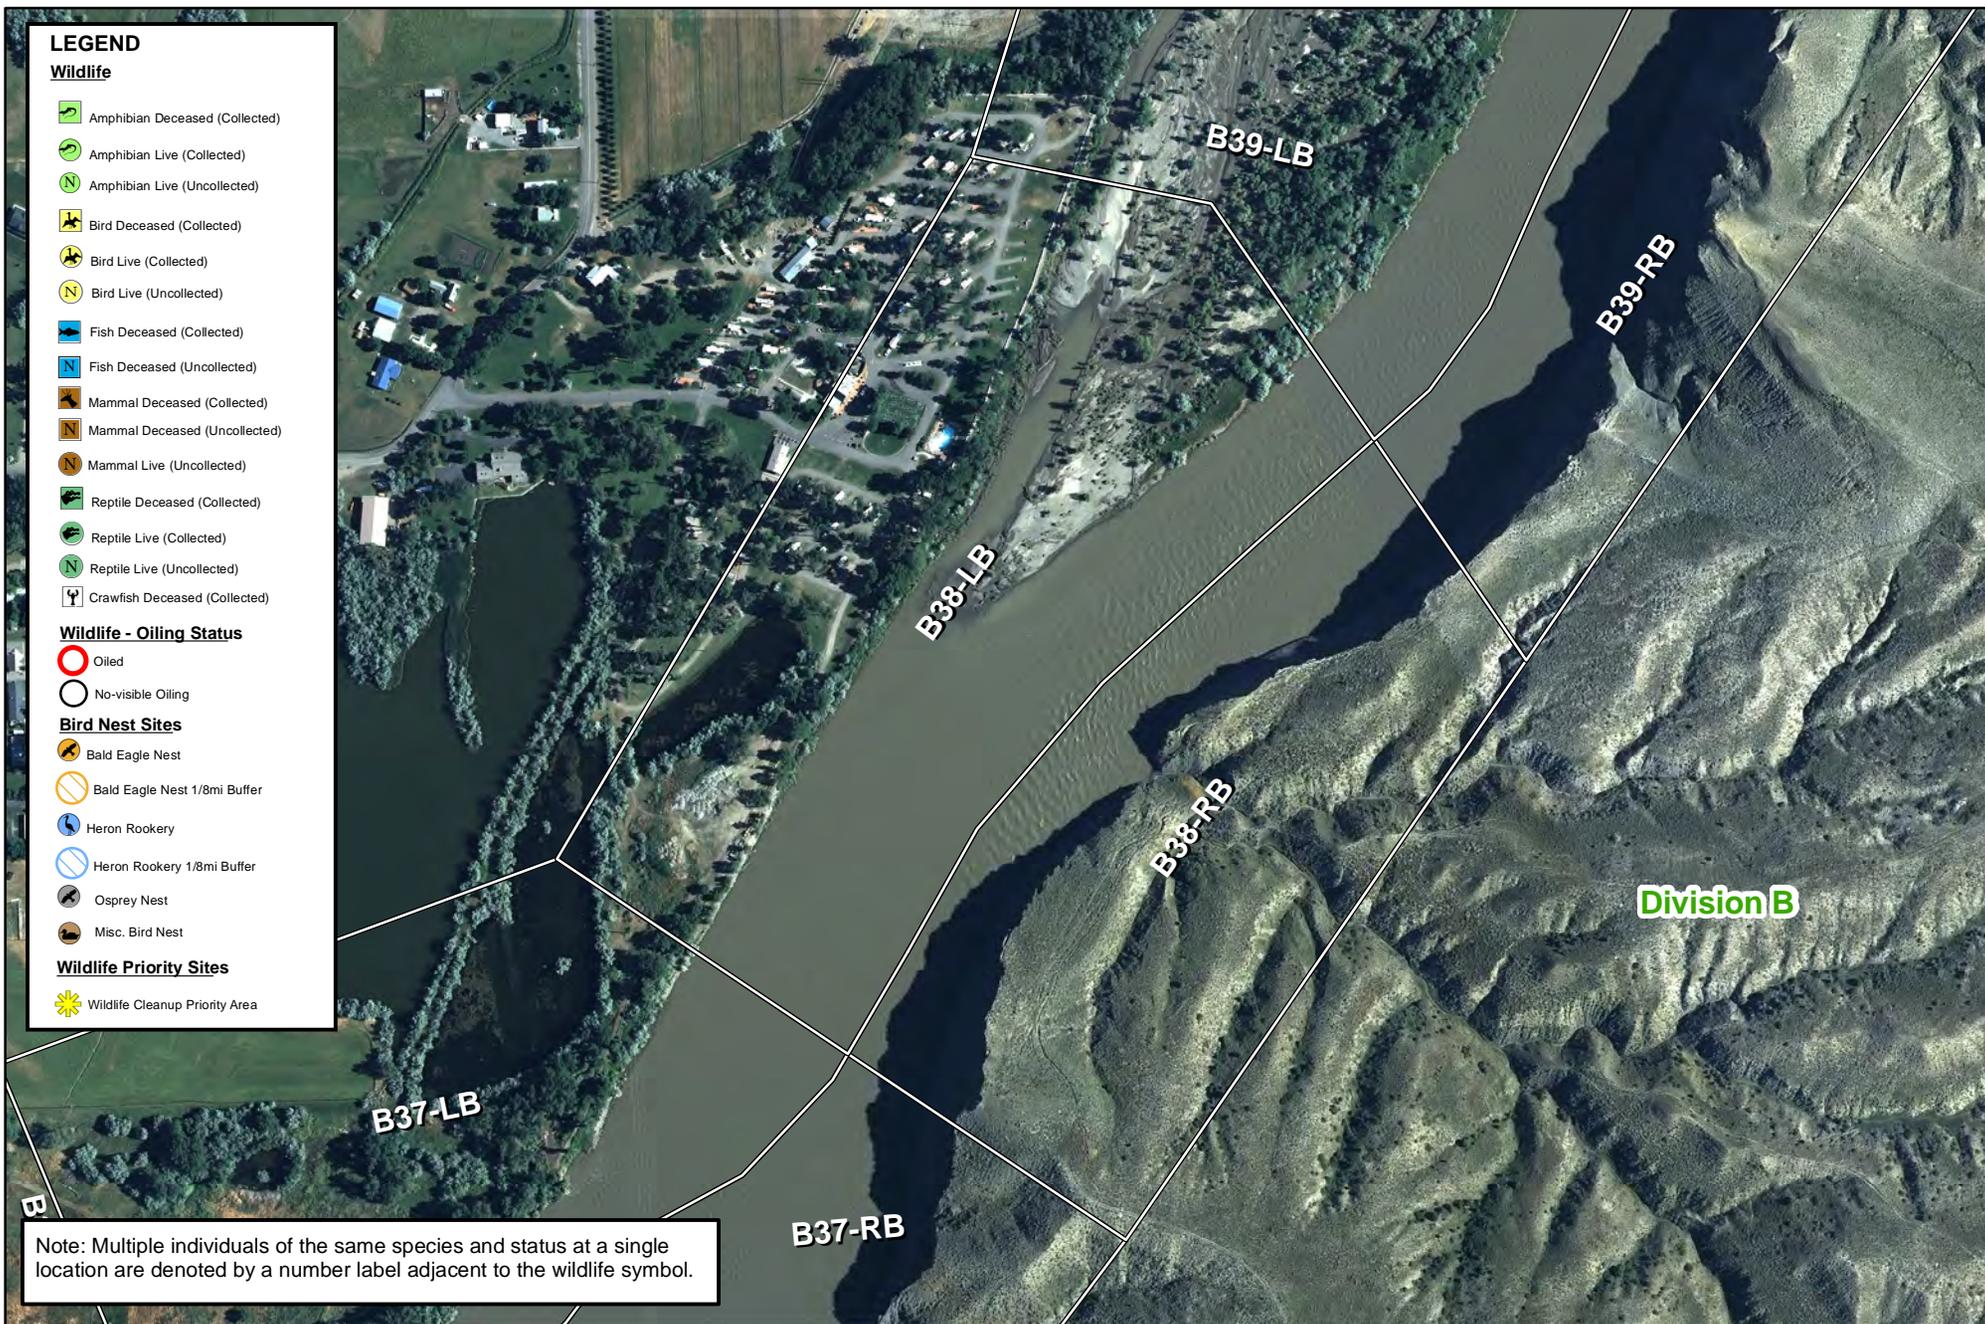
Figure 2
Wildlife Resources

Figure 2 summarizes the natural resources identified in this segment. International Bird Rescue and Resource Advisors from U.S. Fish and Wildlife Service conducted regular inspections of area B38. No oiled wildlife was observed or recovered. No Wildlife Priority Cleanup Areas were identified. No active migratory bird nests were identified in Area B38.

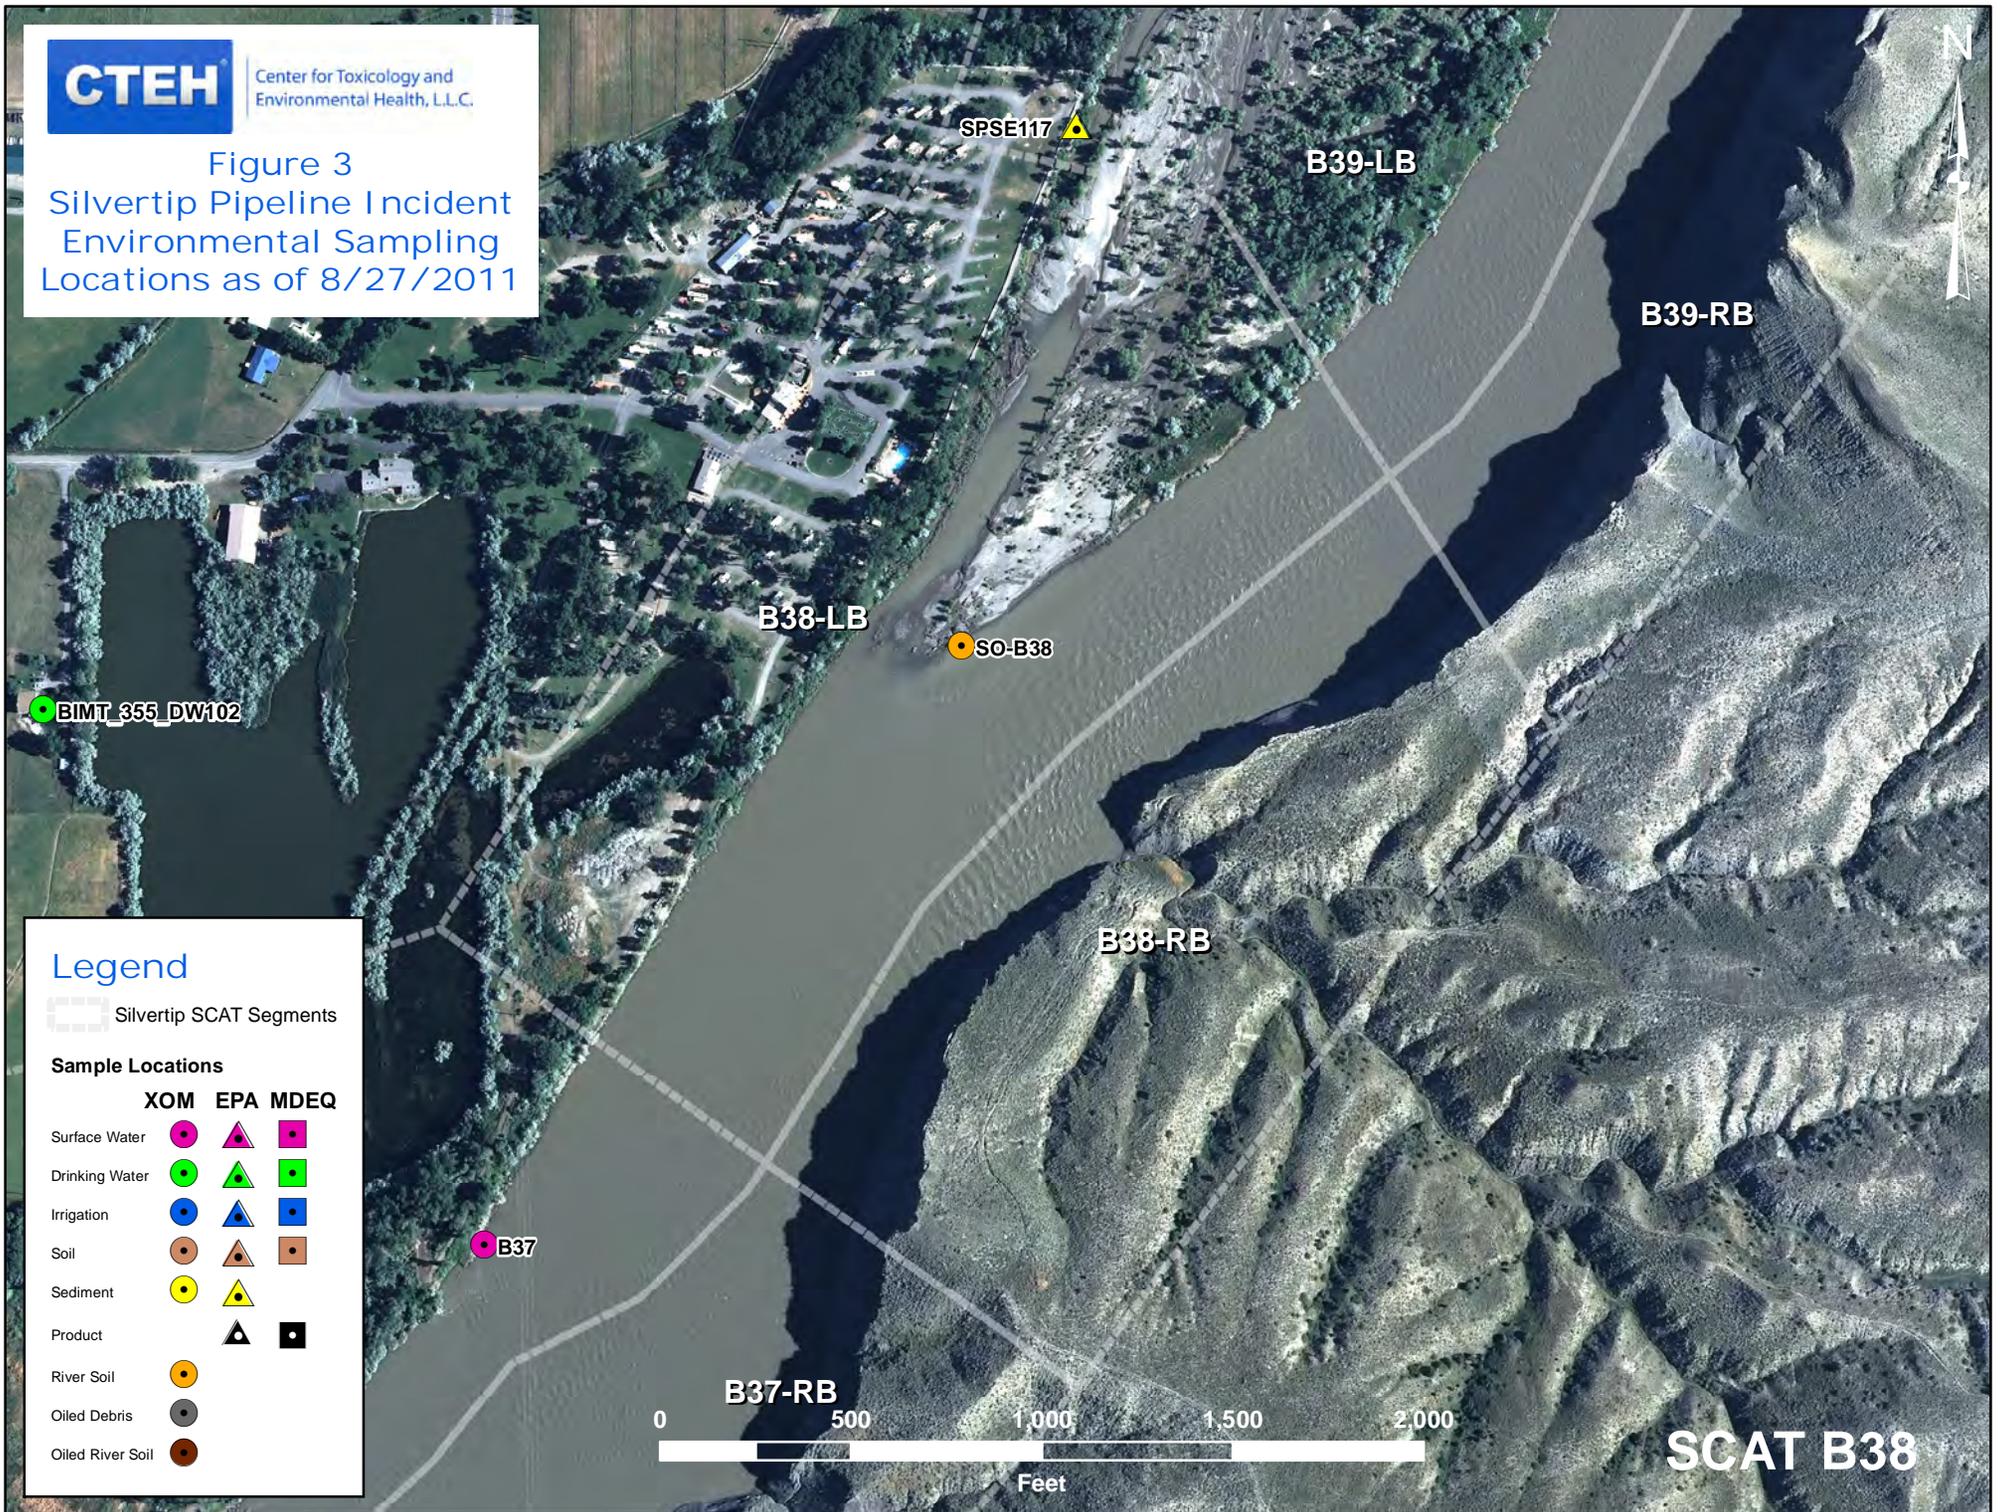
Figure 3
Silvertip Pipeline Incident
Environmental Sampling
Locations as of 8/27/2011

Table 1 (below) summarizes samples collected within Area B38. The analytical results for the samples collected can be accessed through a publicly accessible database on the United States Environmental Protection Agency's (USEPA's) website. The approximate locations of samples collected within Area B38 are provided on Figure 3.

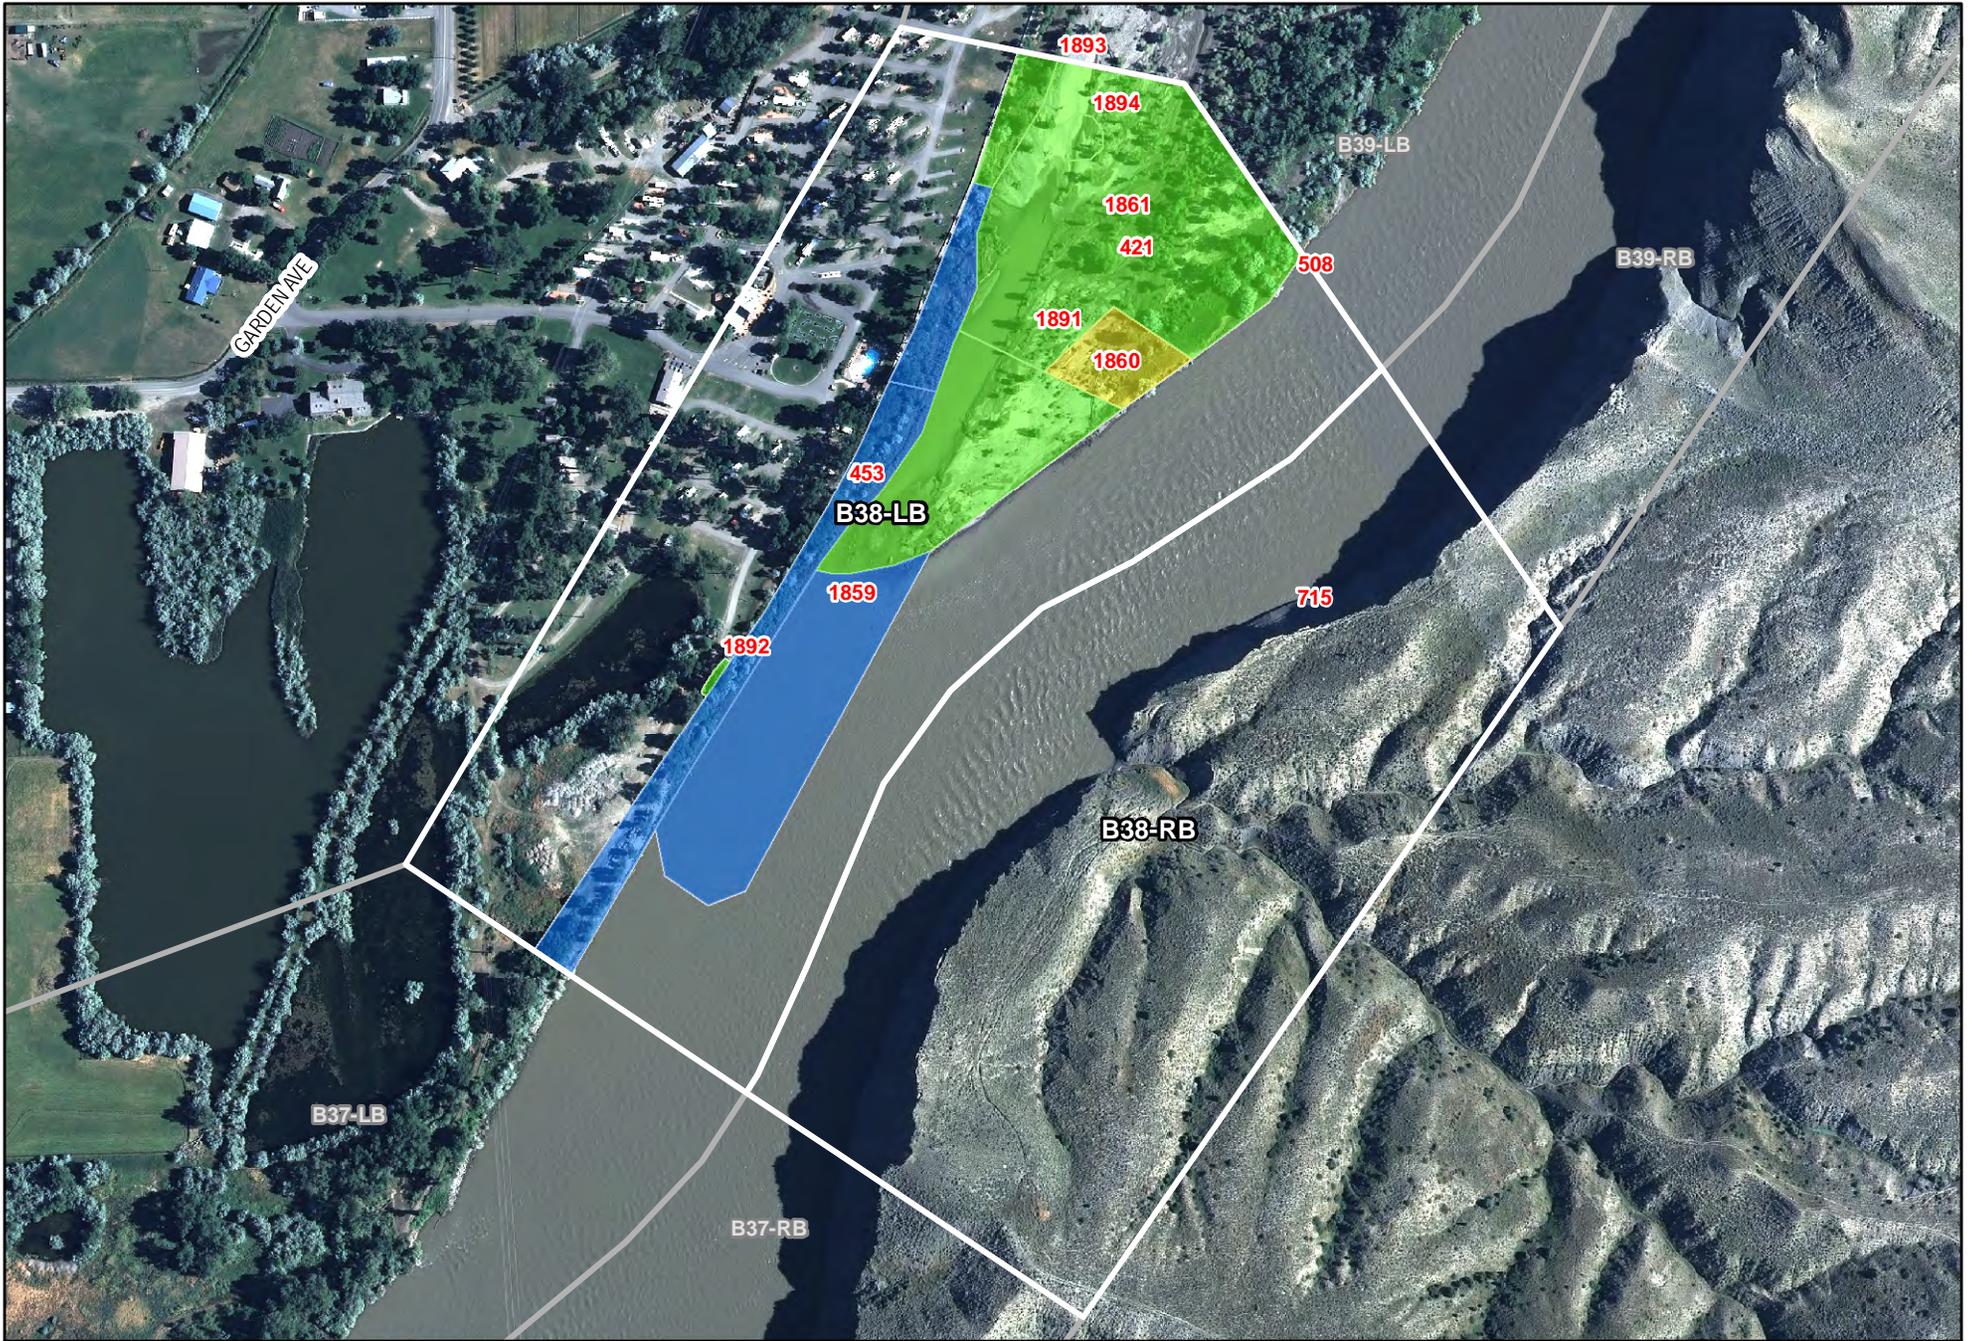
Figure 4 - Maximum SCAT Observations For SCAT Area: B38

The SCAT teams used systematic evaluation criteria and treatment method tables approved by the National Oceanic and Atmospheric Administration to provide a standard approach for data collection and conducting field surveys. The forms and sketches from the initial SCAT surveys performed along the river bank (water edge) and floodplain within Area B38 are included in Appendix B. Figure 4 provides the maximum oiling zones observed by the SCAT team during the initial surveys of Area B38.

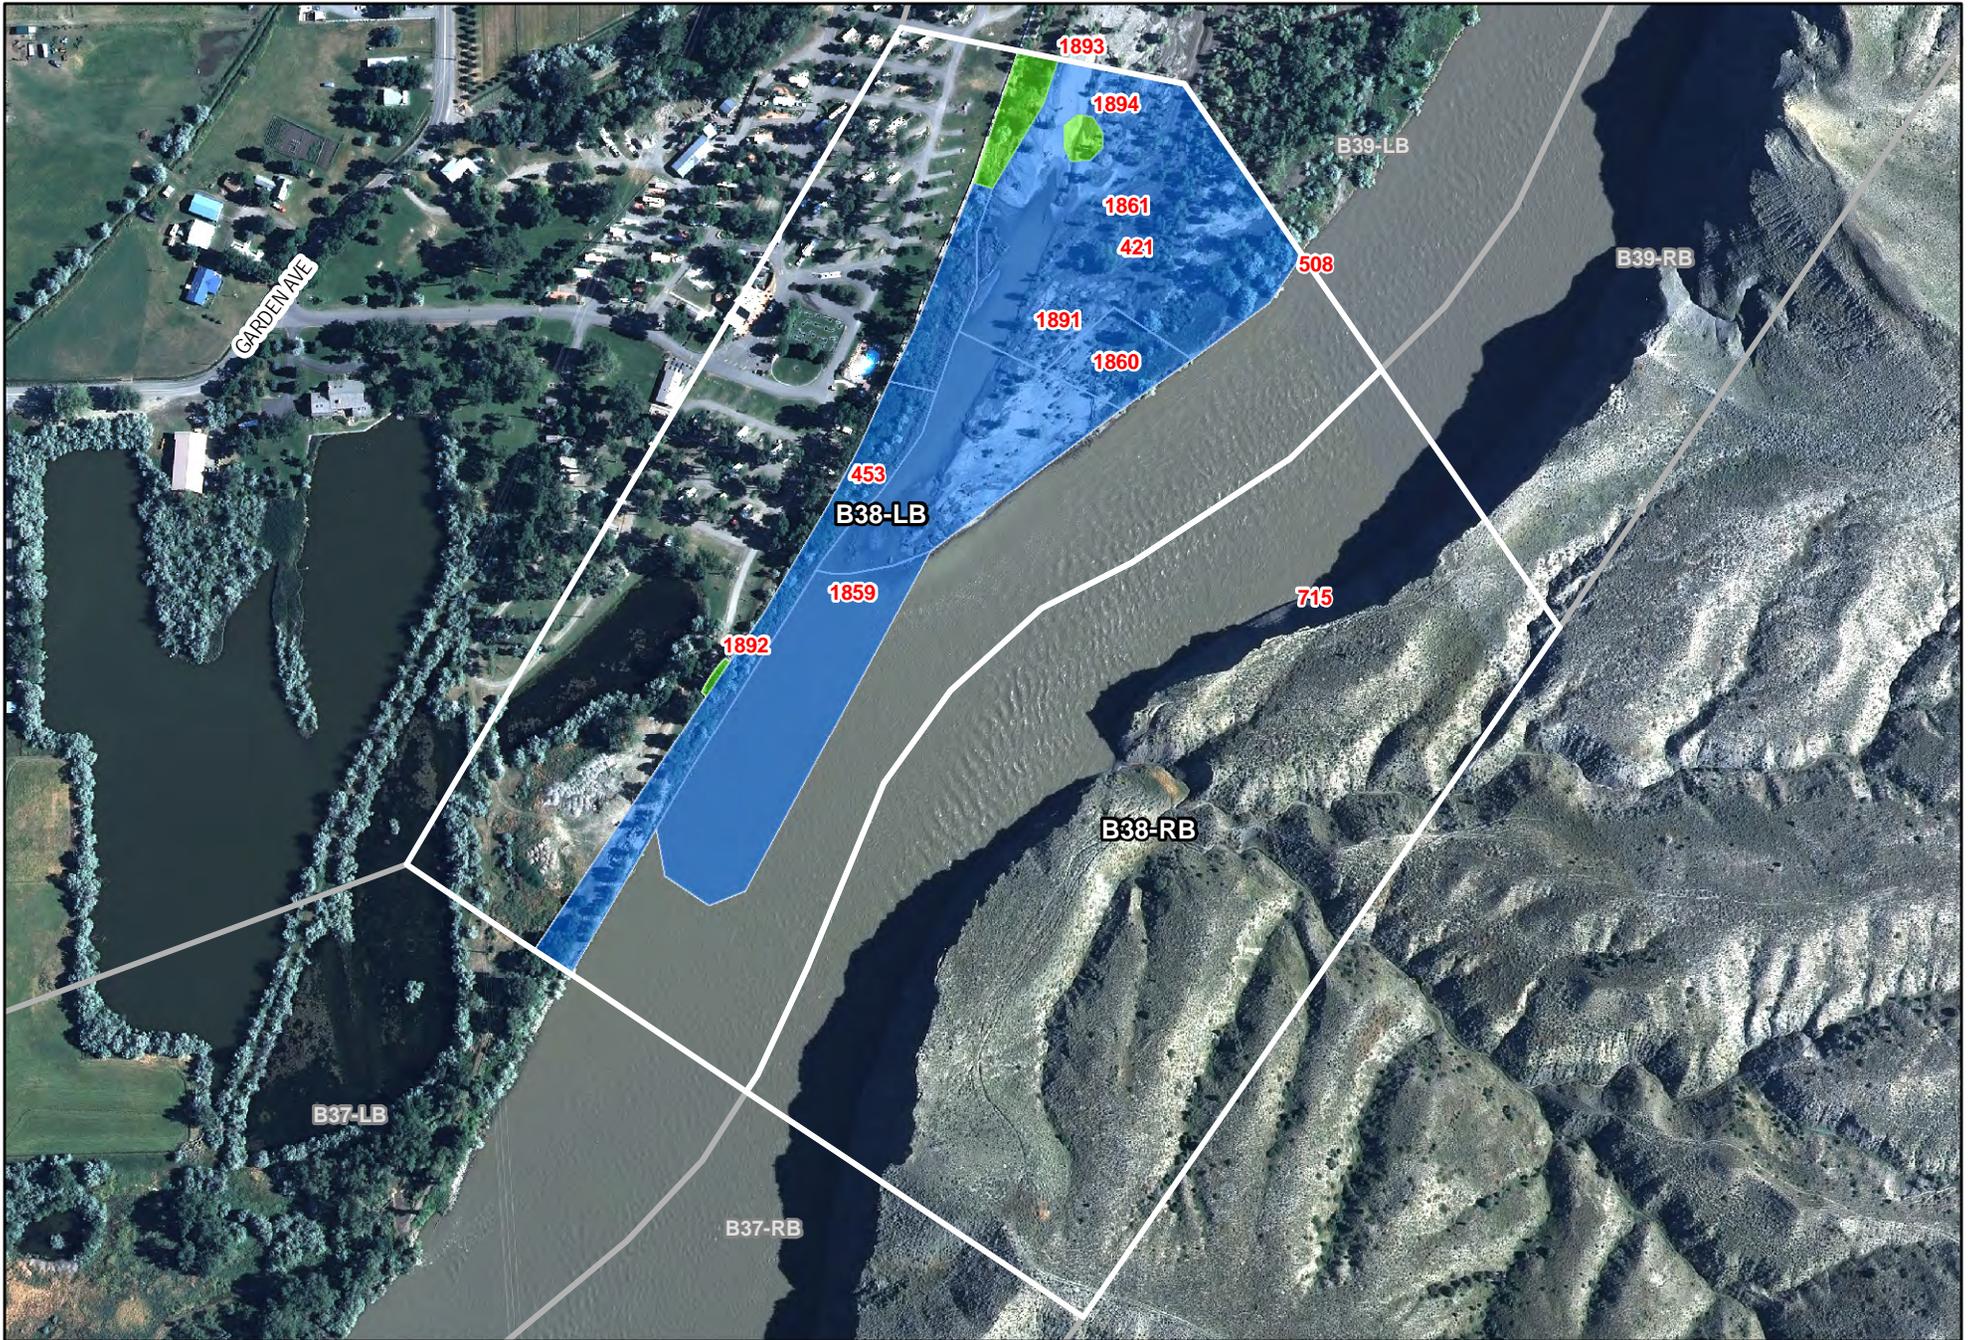
Figure 5 shows the oiling conditions within Area B38 following completion of oil removal activities. The SCAT team performed final surveys of the left bank within SCAT Area B38 to confirm the agreed-upon cleanup endpoints identified in the applicable CTRs had been achieved. The final SCAT survey documentation is presented in Appendix E.

Based on the final SCAT survey performed on the left bank within Area B38, no further treatment is recommended for this area. Based on the initial SCAT surveys, no oiling was observed on the right bank of Area B38. A SCAT Segment Sign-Off Form is included as Appendix F.

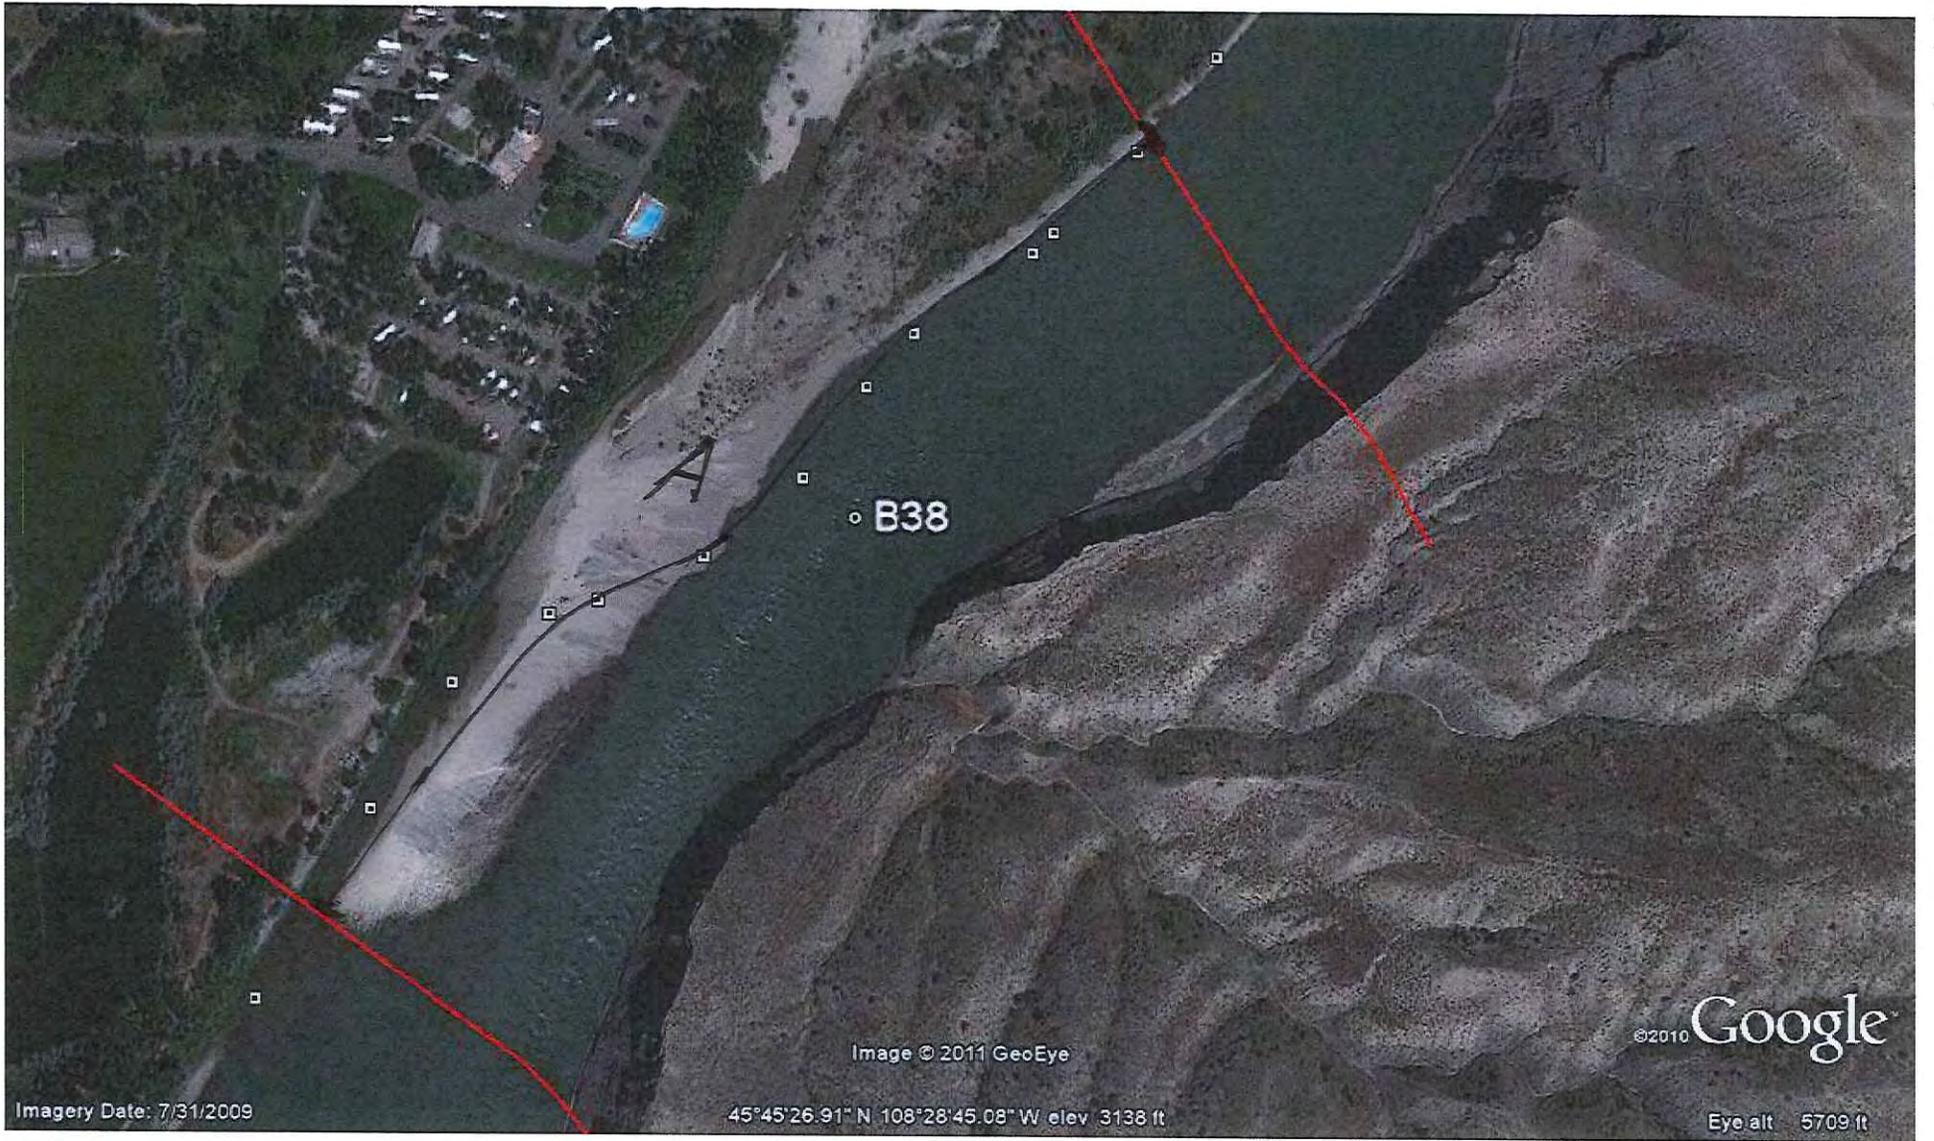
OIL ZONE ID	RIVER BANK ZONE				OIL COVER			OIL THICKNESS					OIL CHARACTER							SUBST. TYPE(S)		
	MS	LB	UB	OB	Length m	Width m	Distrib. %	TO	CV	CT	ST	FL	FR	MS	TB	PT	TC	SR	AP		NO	
A				X	70	1															X	Grass, trees
B				X	30	1	<1			X	X		X									Grass, trees
C				X	390	1															X	Grass, trees

Oil band heights: ~~Zone B=60cm~~ NO

Treatment Recommendations:
 Zone A: No oil observed; no treatment required.
 Zone B: Cut & remove oil coated vegetation smaller than 1" diameter. Wipe larger oil-coated vegetation.
 Zone C: No oil observed; no treatment required.

*Refer to current approved treatment methods #1 (Cutting of Vegetation), #2 (Dead Vegetation and Small Debris), #3 (Large Woody Debris), #6 (Sorbent Use), # (Unconsolidated Sediments)

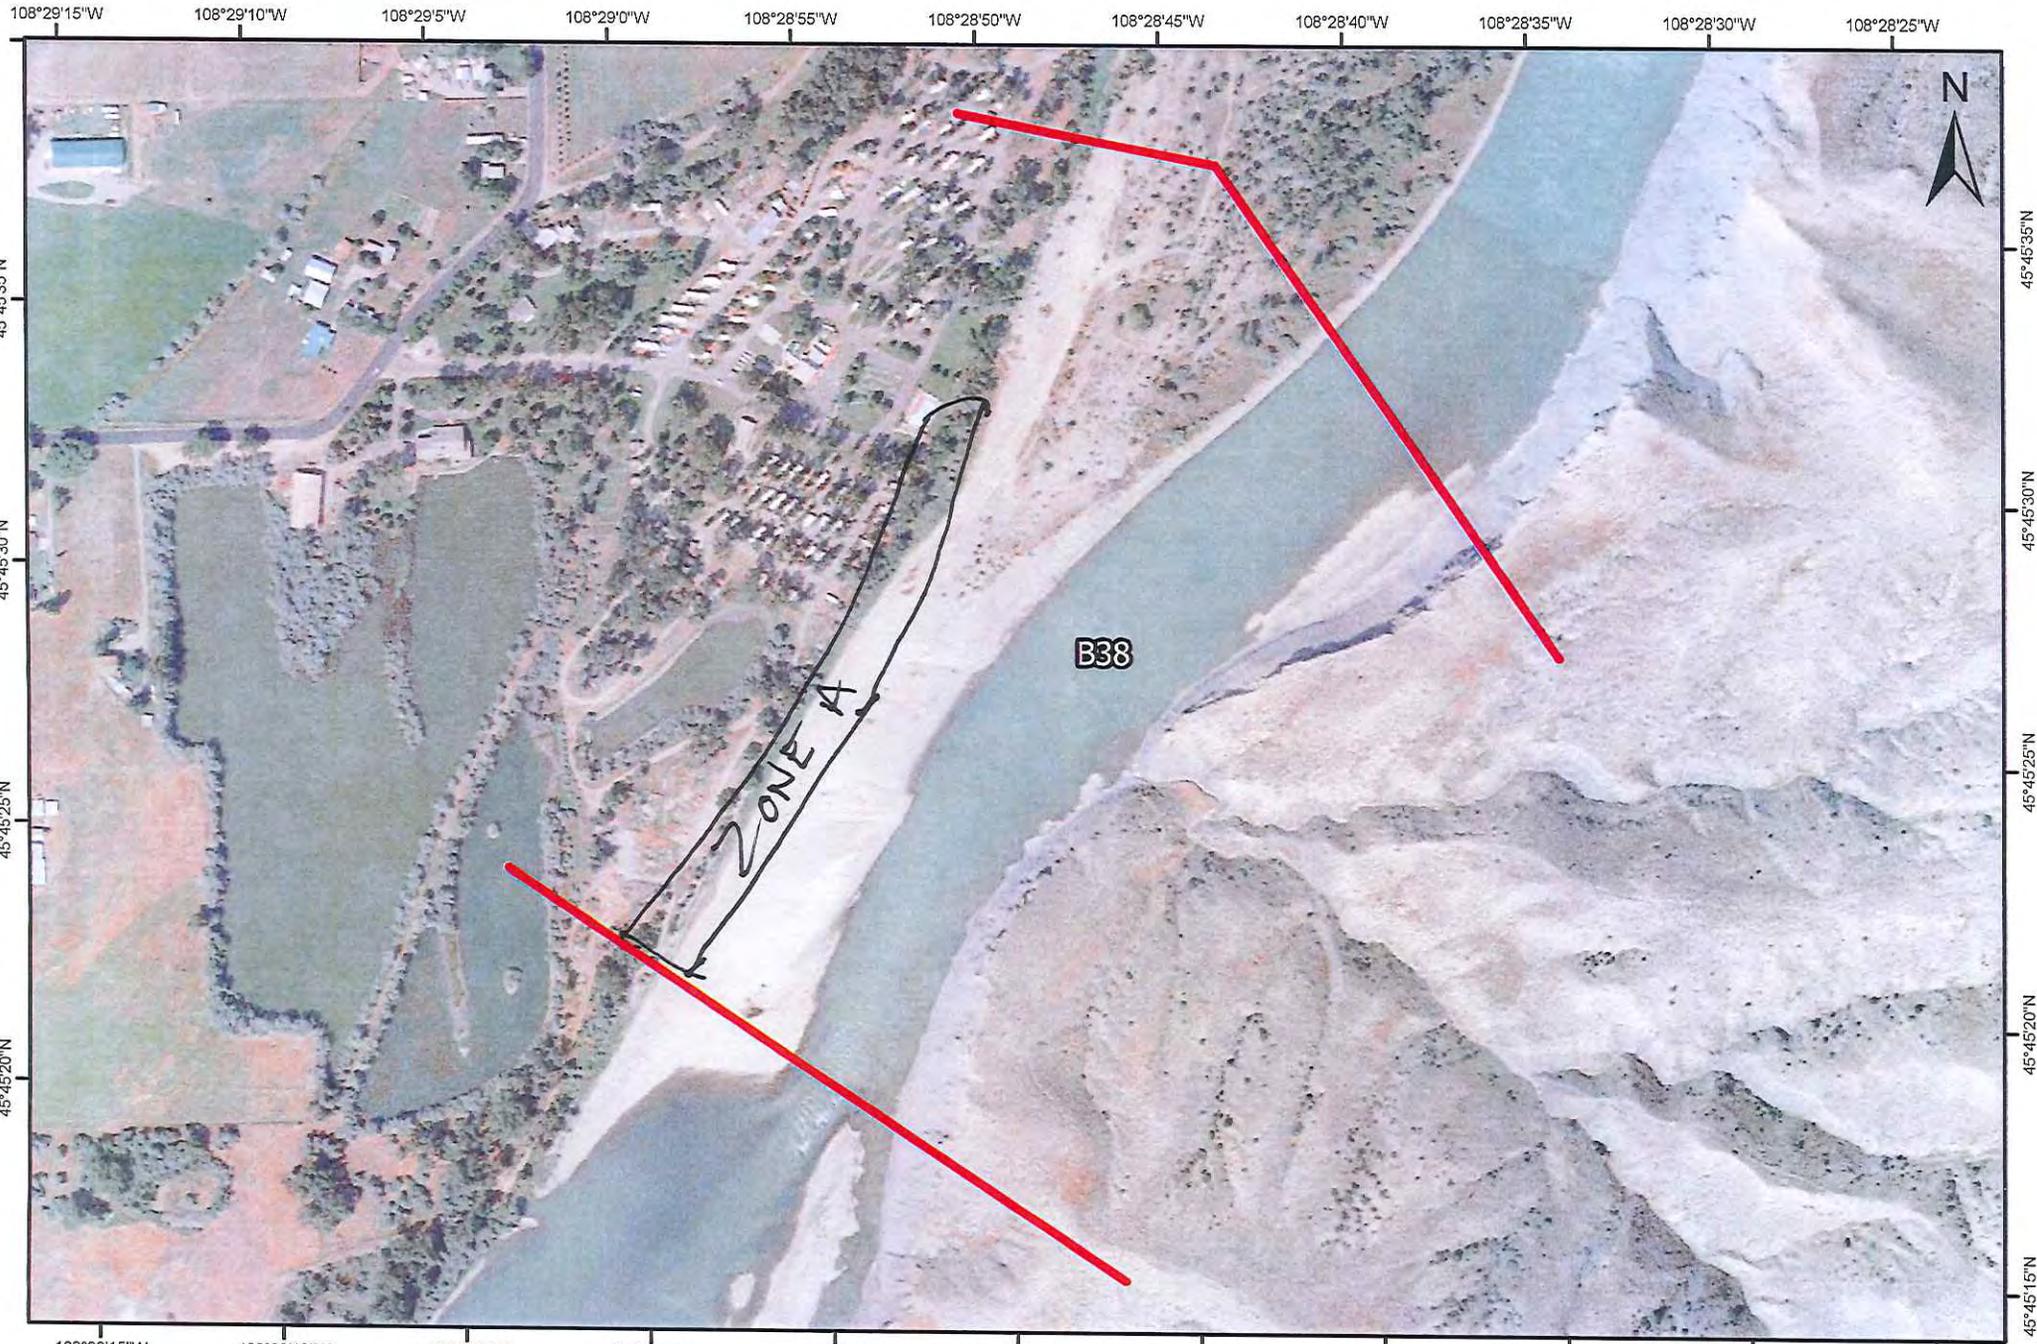
B38 -
(L/R/I)??

B38 only 7 zone - zone A. no oil observed.

COMMENTS: NOO

No further treatment

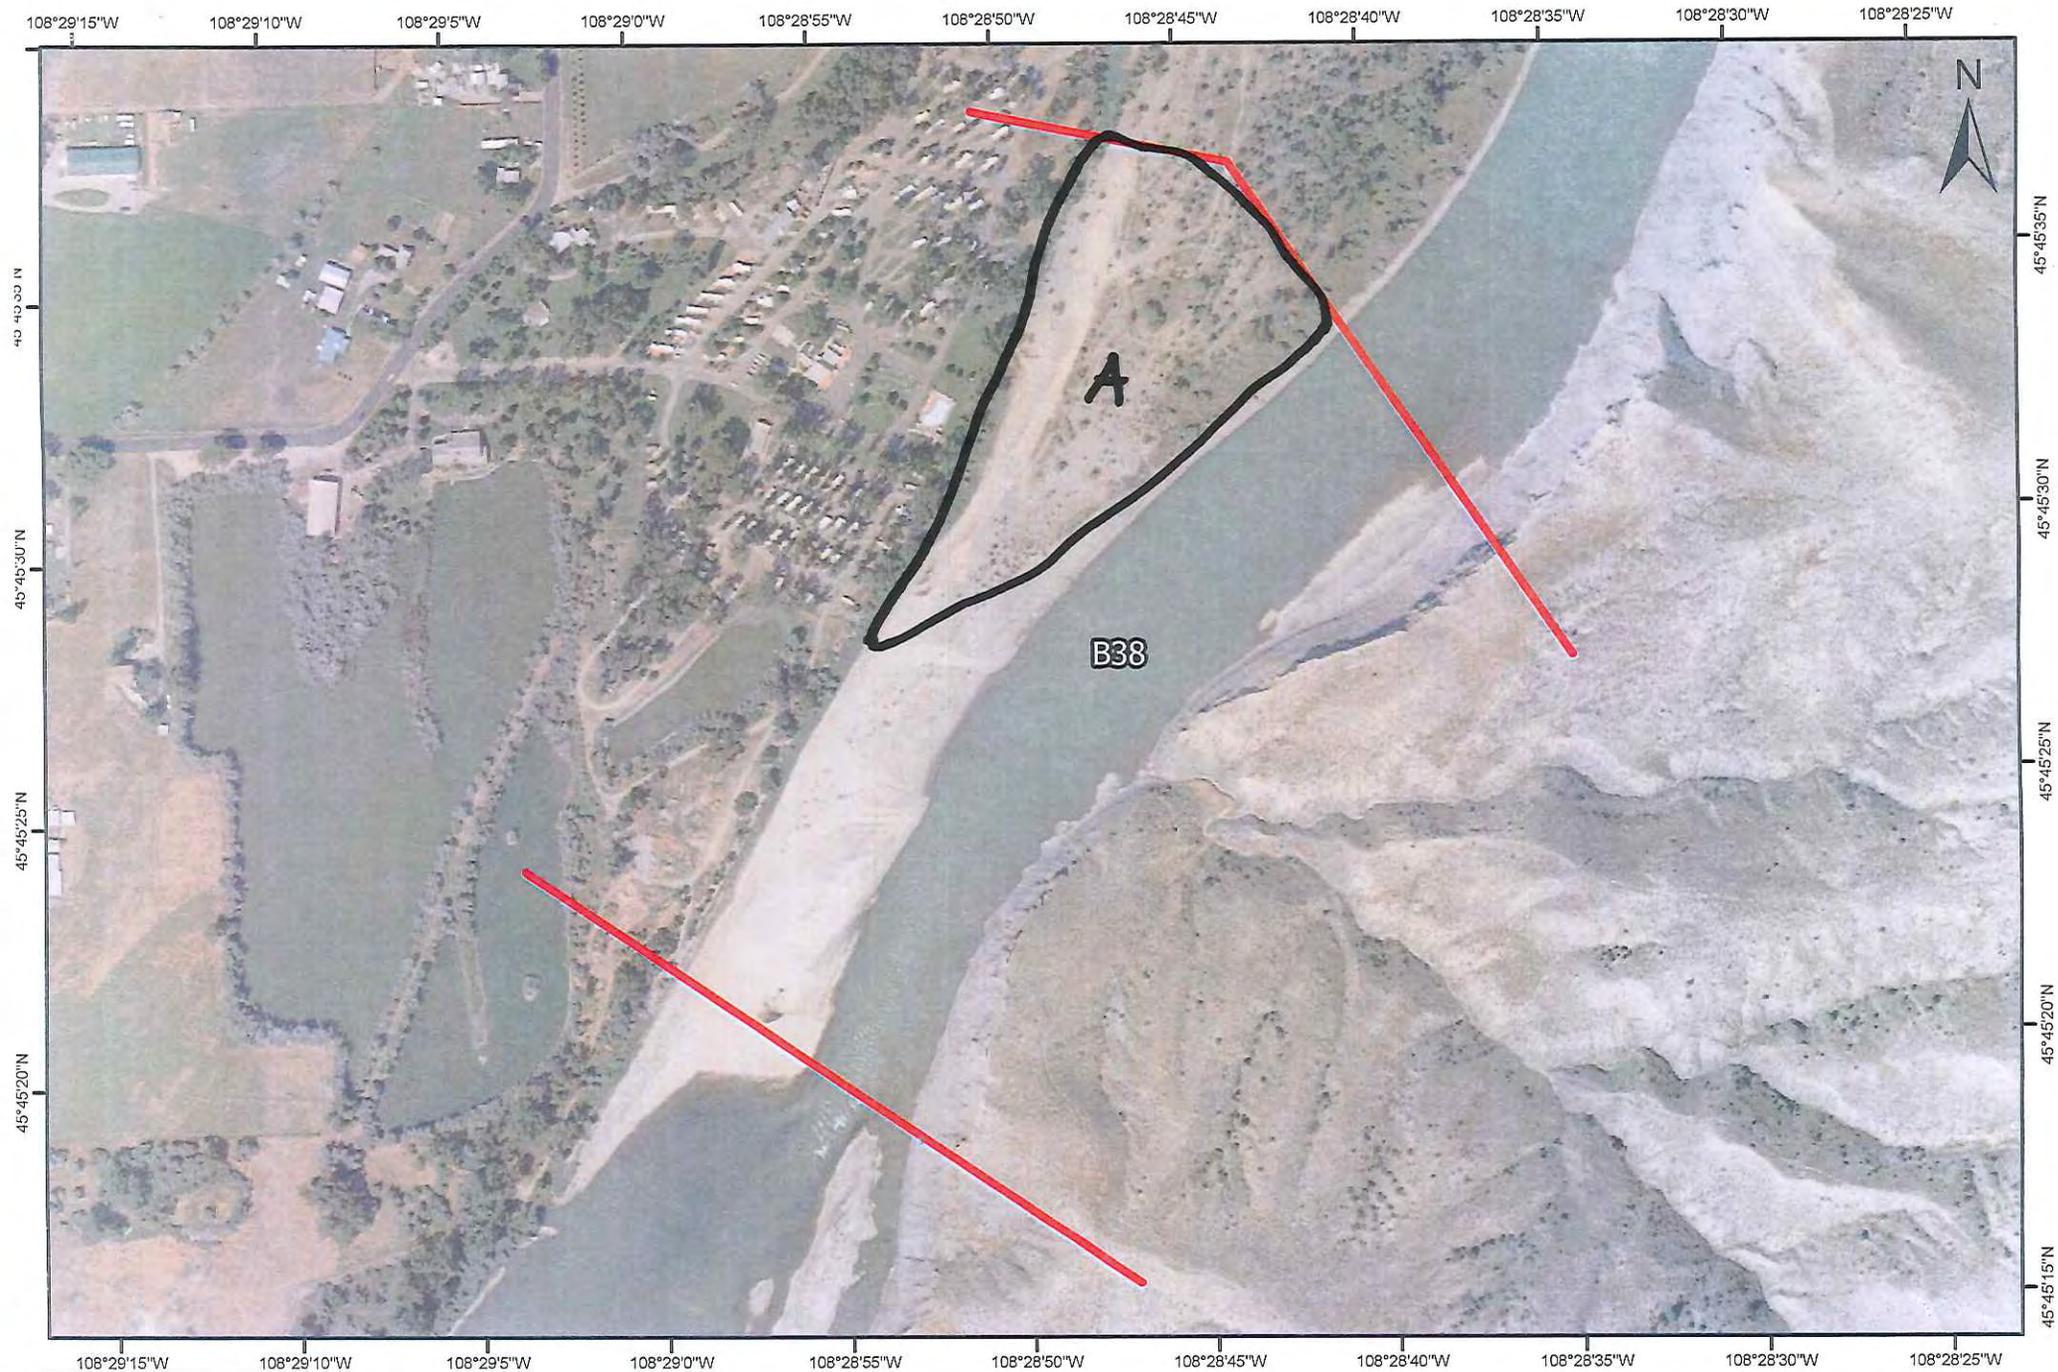
B38 -
(L/R/I)??

Zone has very sparse coating + shrub vegetation and debris. *Debris*

Debris needs to be bagged and removed.

Veget cut and removed
