**SCAT Area Transition Report for
B39**

Silvertip Pipeline Incident
Laurel, Montana

October 20, 2011

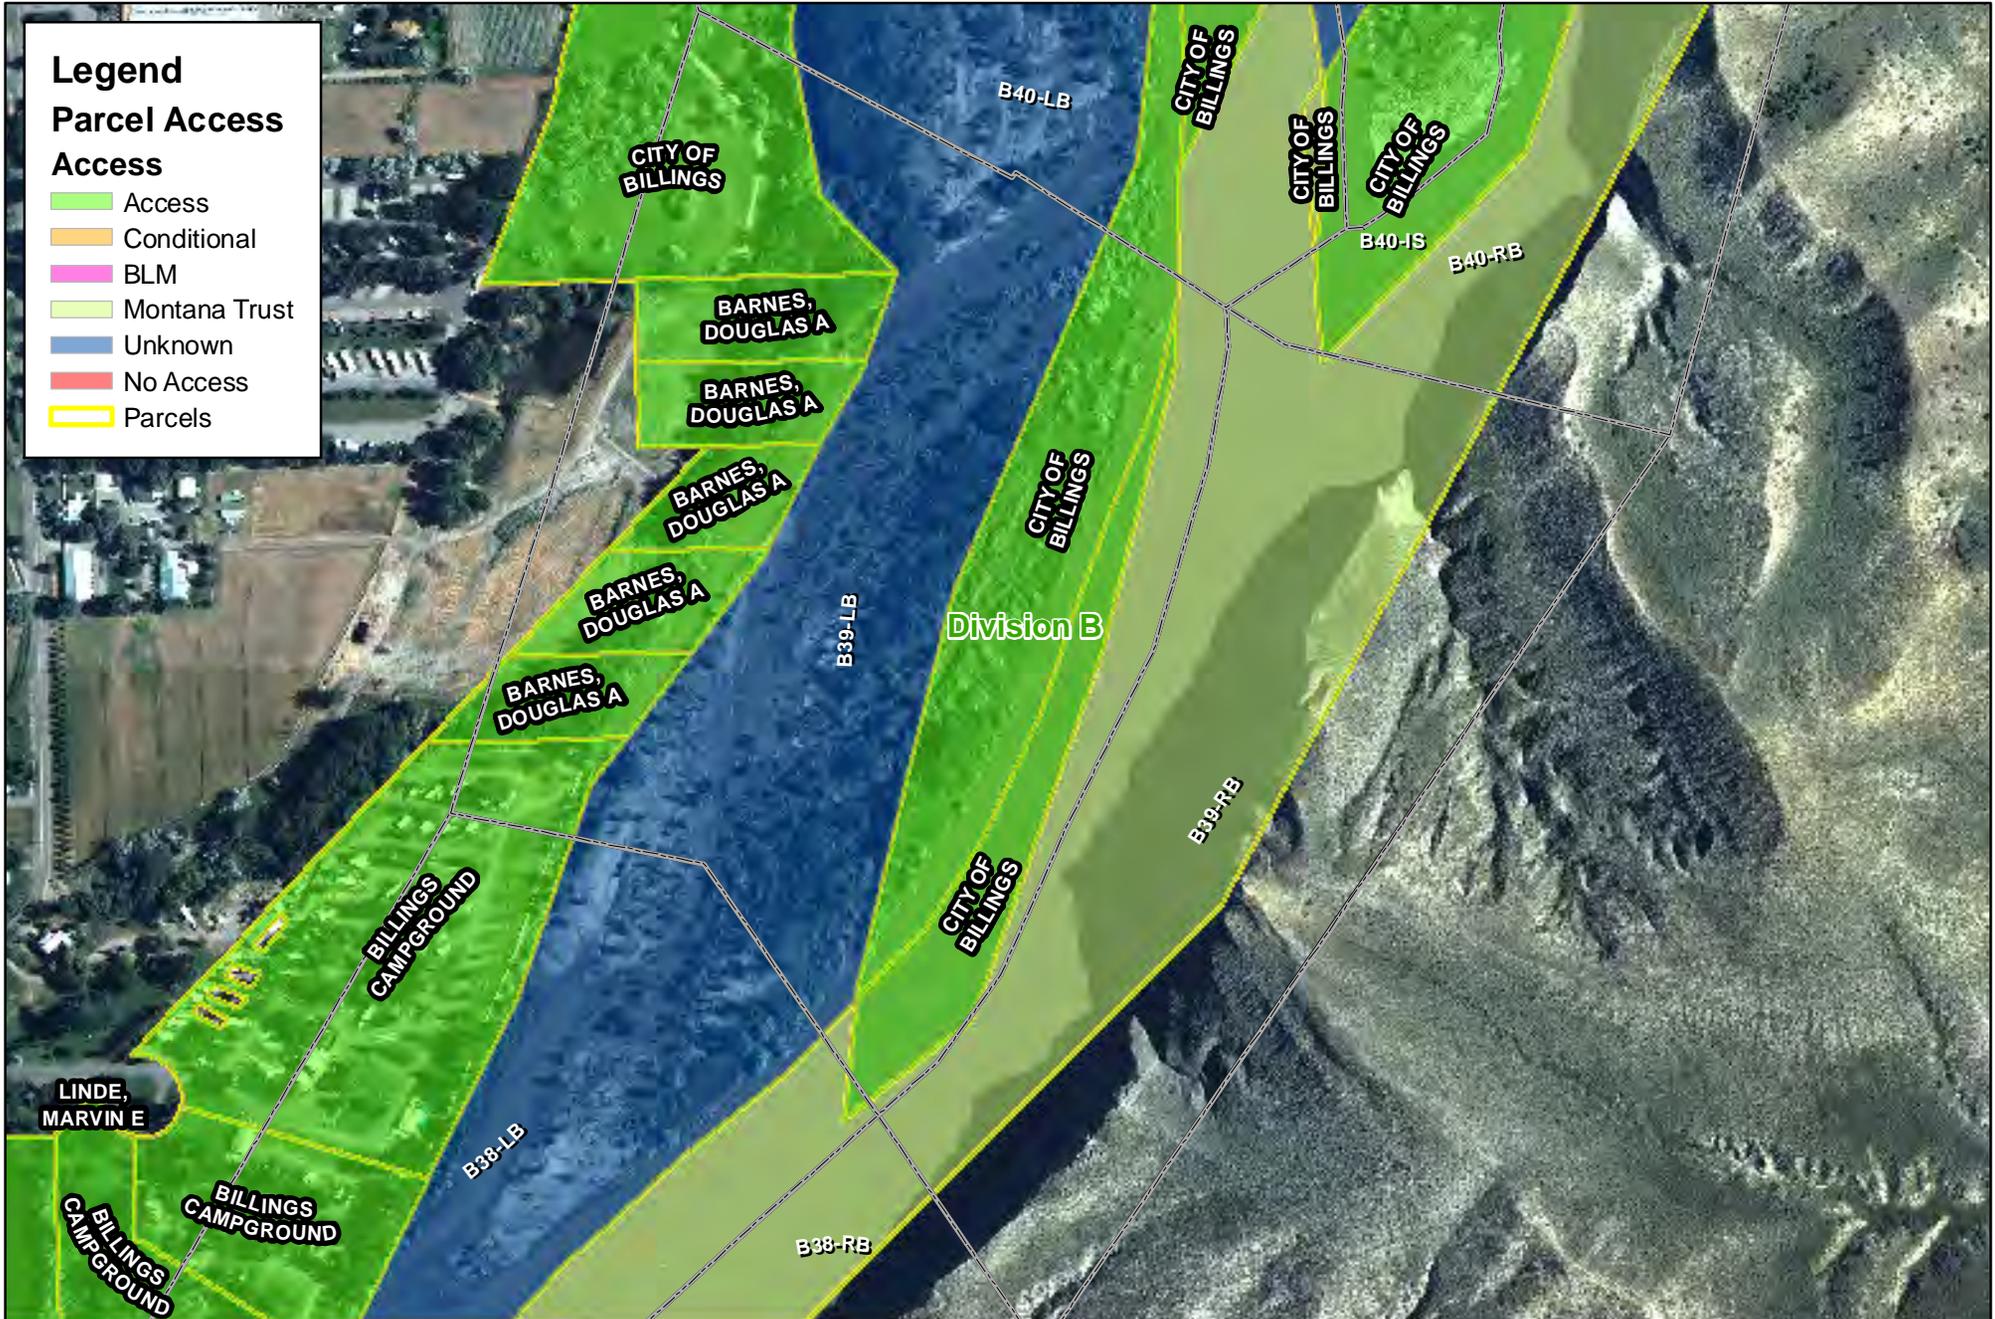
Figure 1 provides an aerial map of SCAT Area B39, along with the (a) SCAT Area boundary, (b) parcel boundaries and respective property owners, and (c) access constraints identified during the oil cleanup process. The acreage surveyed in Area B39 is 27.8. The right bank is a cliff and could not be surveyed by foot; there were no access issues for the left bank.

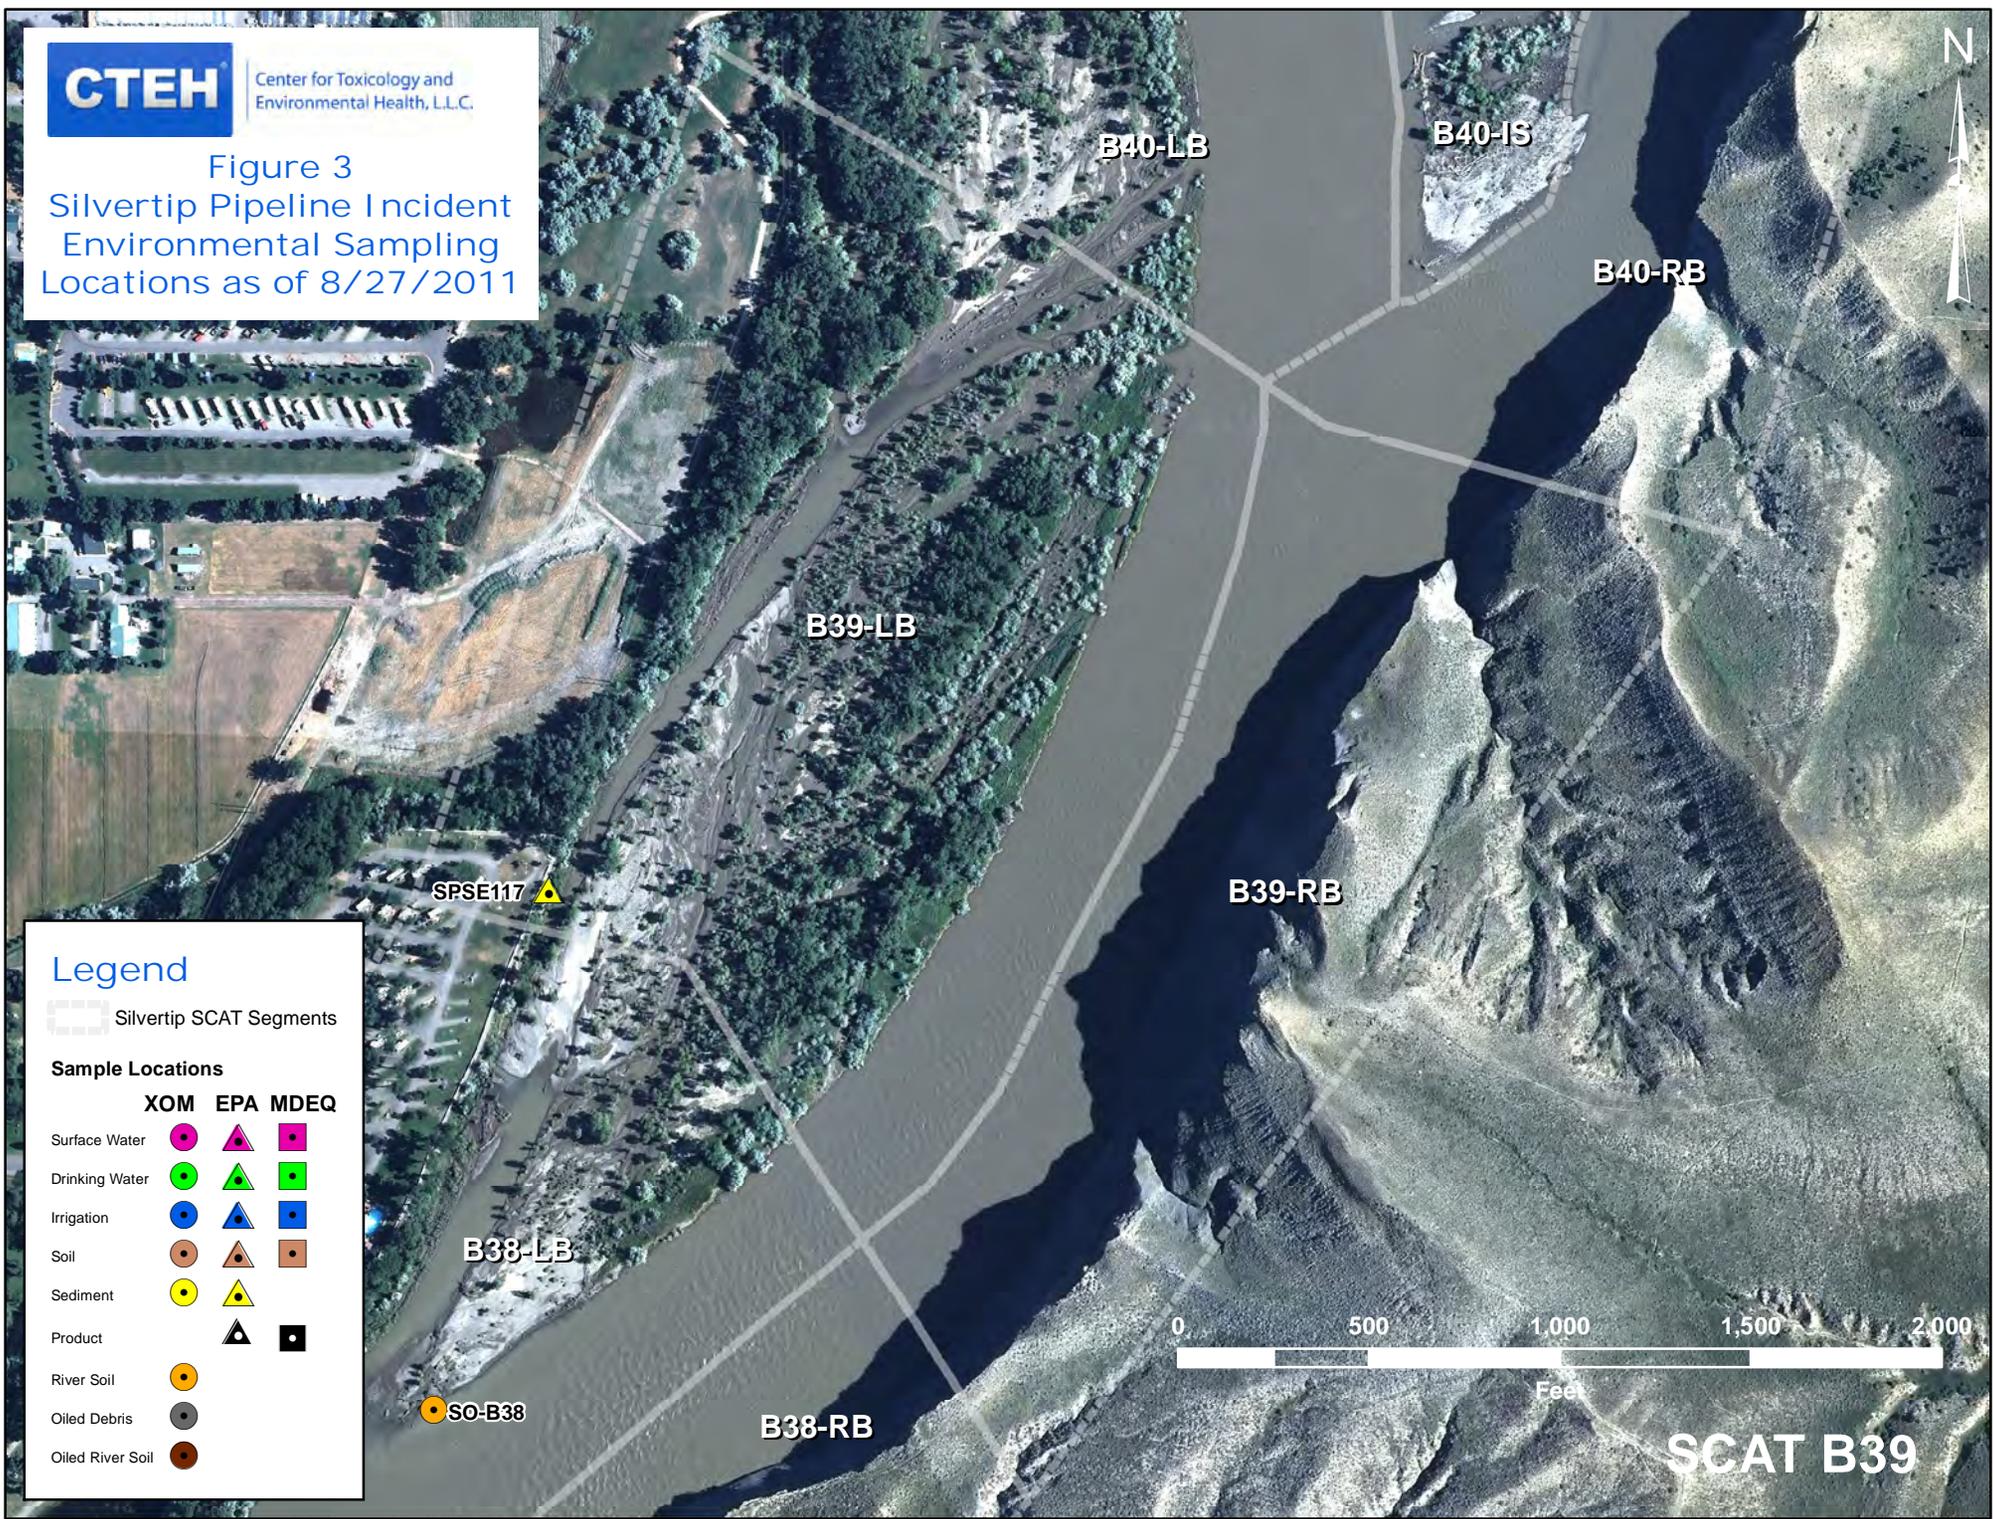
Figure 3
Silvertip Pipeline Incident
Environmental Sampling
Locations as of 8/27/2011

Table 1 (below) summarizes samples collected within Area B39. The analytical results for the samples collected can be accessed through a publicly accessible database on the United States Environmental Protection Agency's (USEPA's) website. The approximate locations of samples collected within Area B39 are provided on Figure 3.

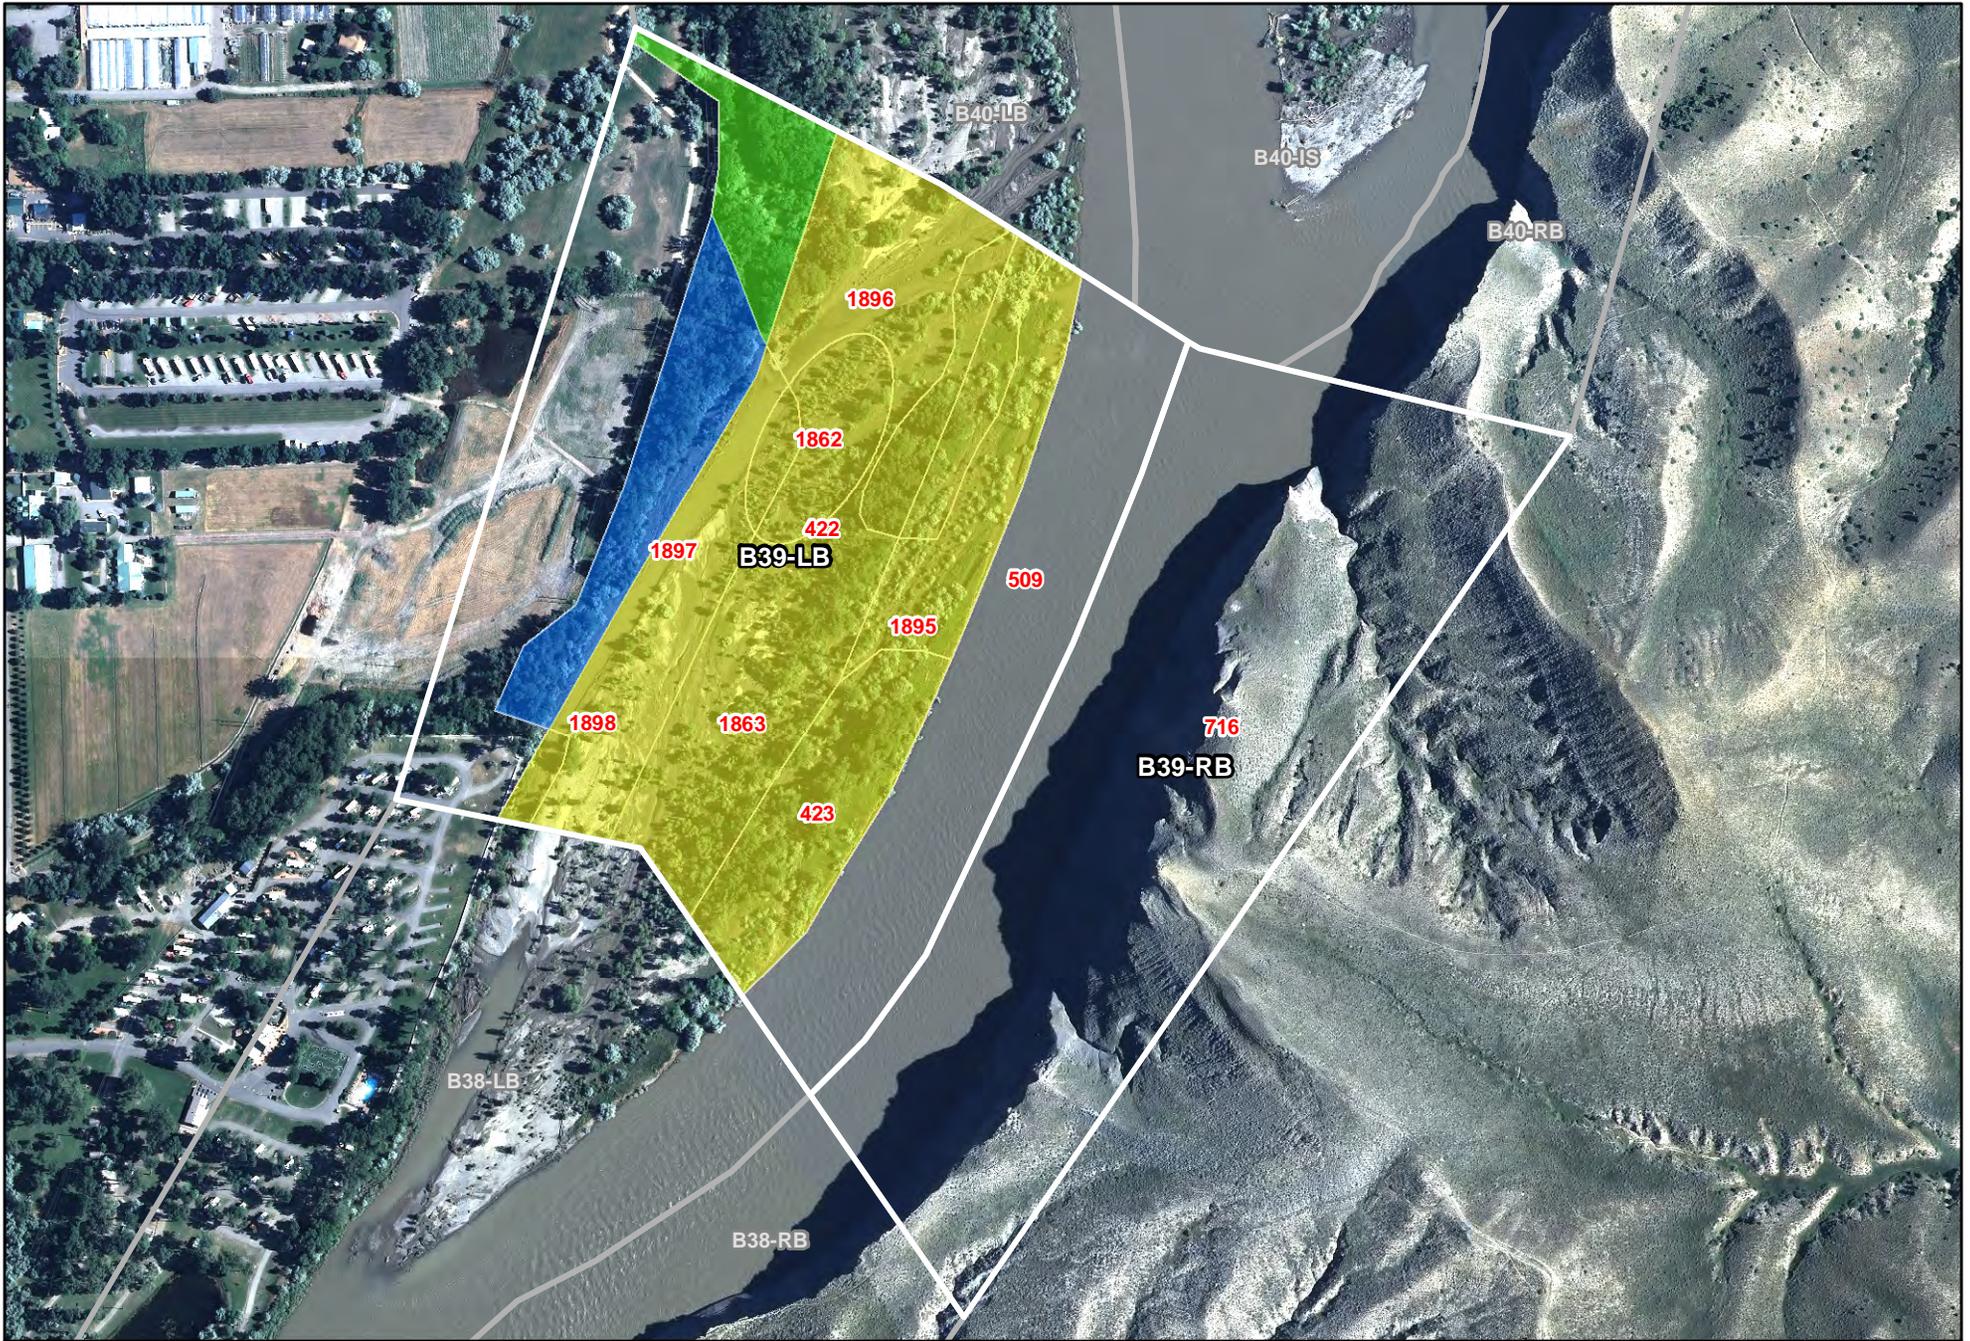
Figure 4 - Maximum SCAT Observations For SCAT Area:

The SCAT teams used systematic evaluation criteria and treatment method tables approved by the National Oceanic and Atmospheric Administration to provide a standard approach for data collection and conducting field surveys. The forms and sketches from the initial SCAT surveys performed along the river bank (water edge) and floodplain within Area B39 are included in Appendix B. Figure 4 provides the maximum oiling zones observed by the SCAT team during the initial surveys of Area B39.

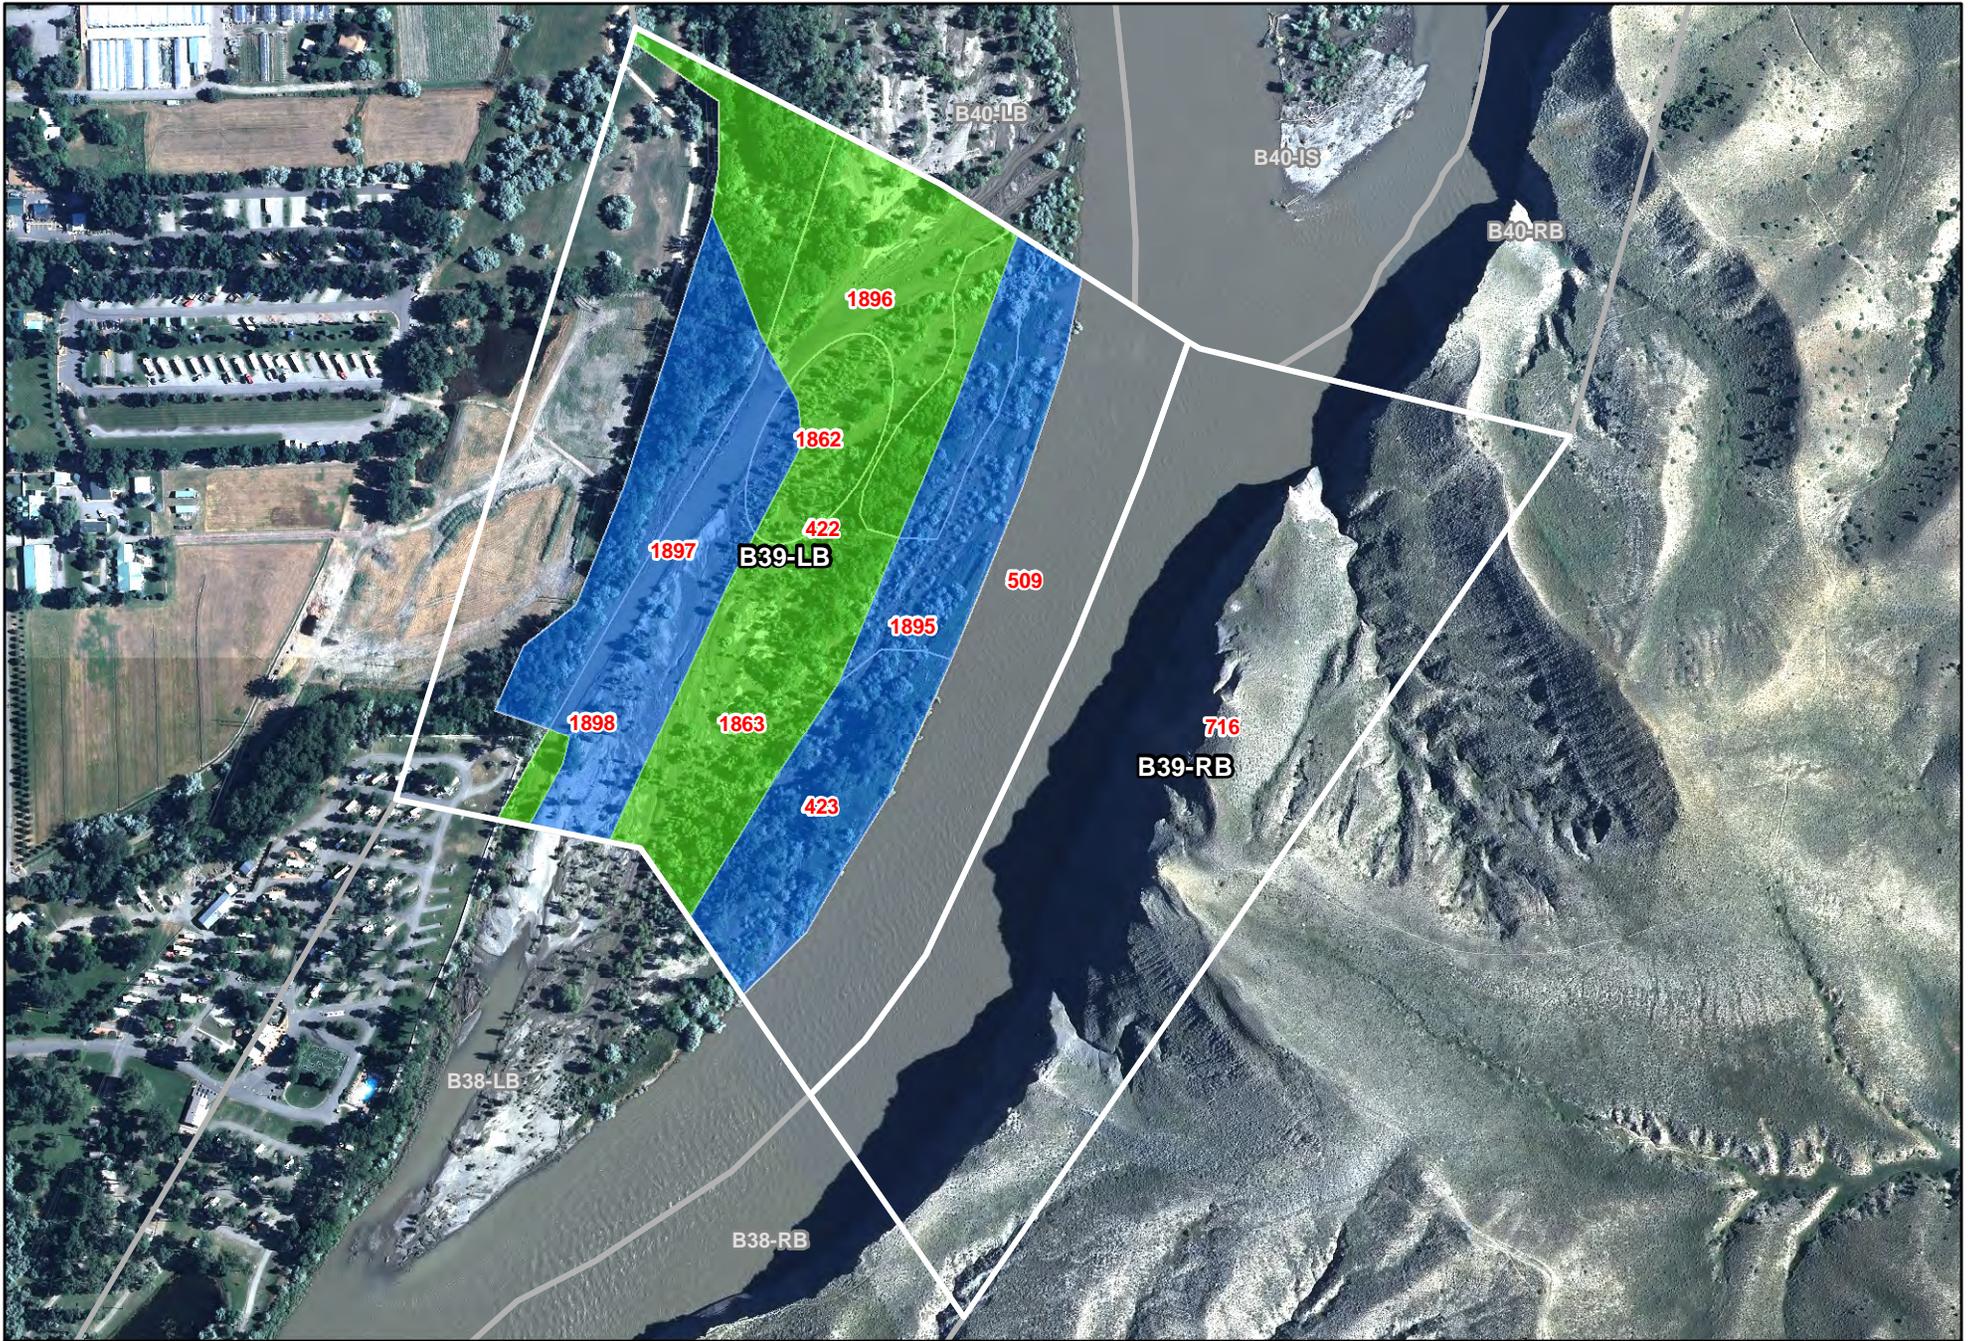
**Figure 5 - Final SCAT Observations
For SCAT Area:**

Figure 5 shows the oiling conditions within Area B39 following completion of oil removal activities. The SCAT team performed final surveys of the left bank within SCAT Area B39 to confirm the agreed-upon cleanup endpoints identified in the applicable CTRs had been achieved. The final SCAT survey documentation is presented in Appendix E.

Based on the final SCAT surveys performed on the left bank within Area B39, no further treatment is recommended for this area. Based on the initial SCAT surveys, no oiling was observed on the right bank of Area B39. A SCAT Segment Sign-Off Form is included as Appendix F.

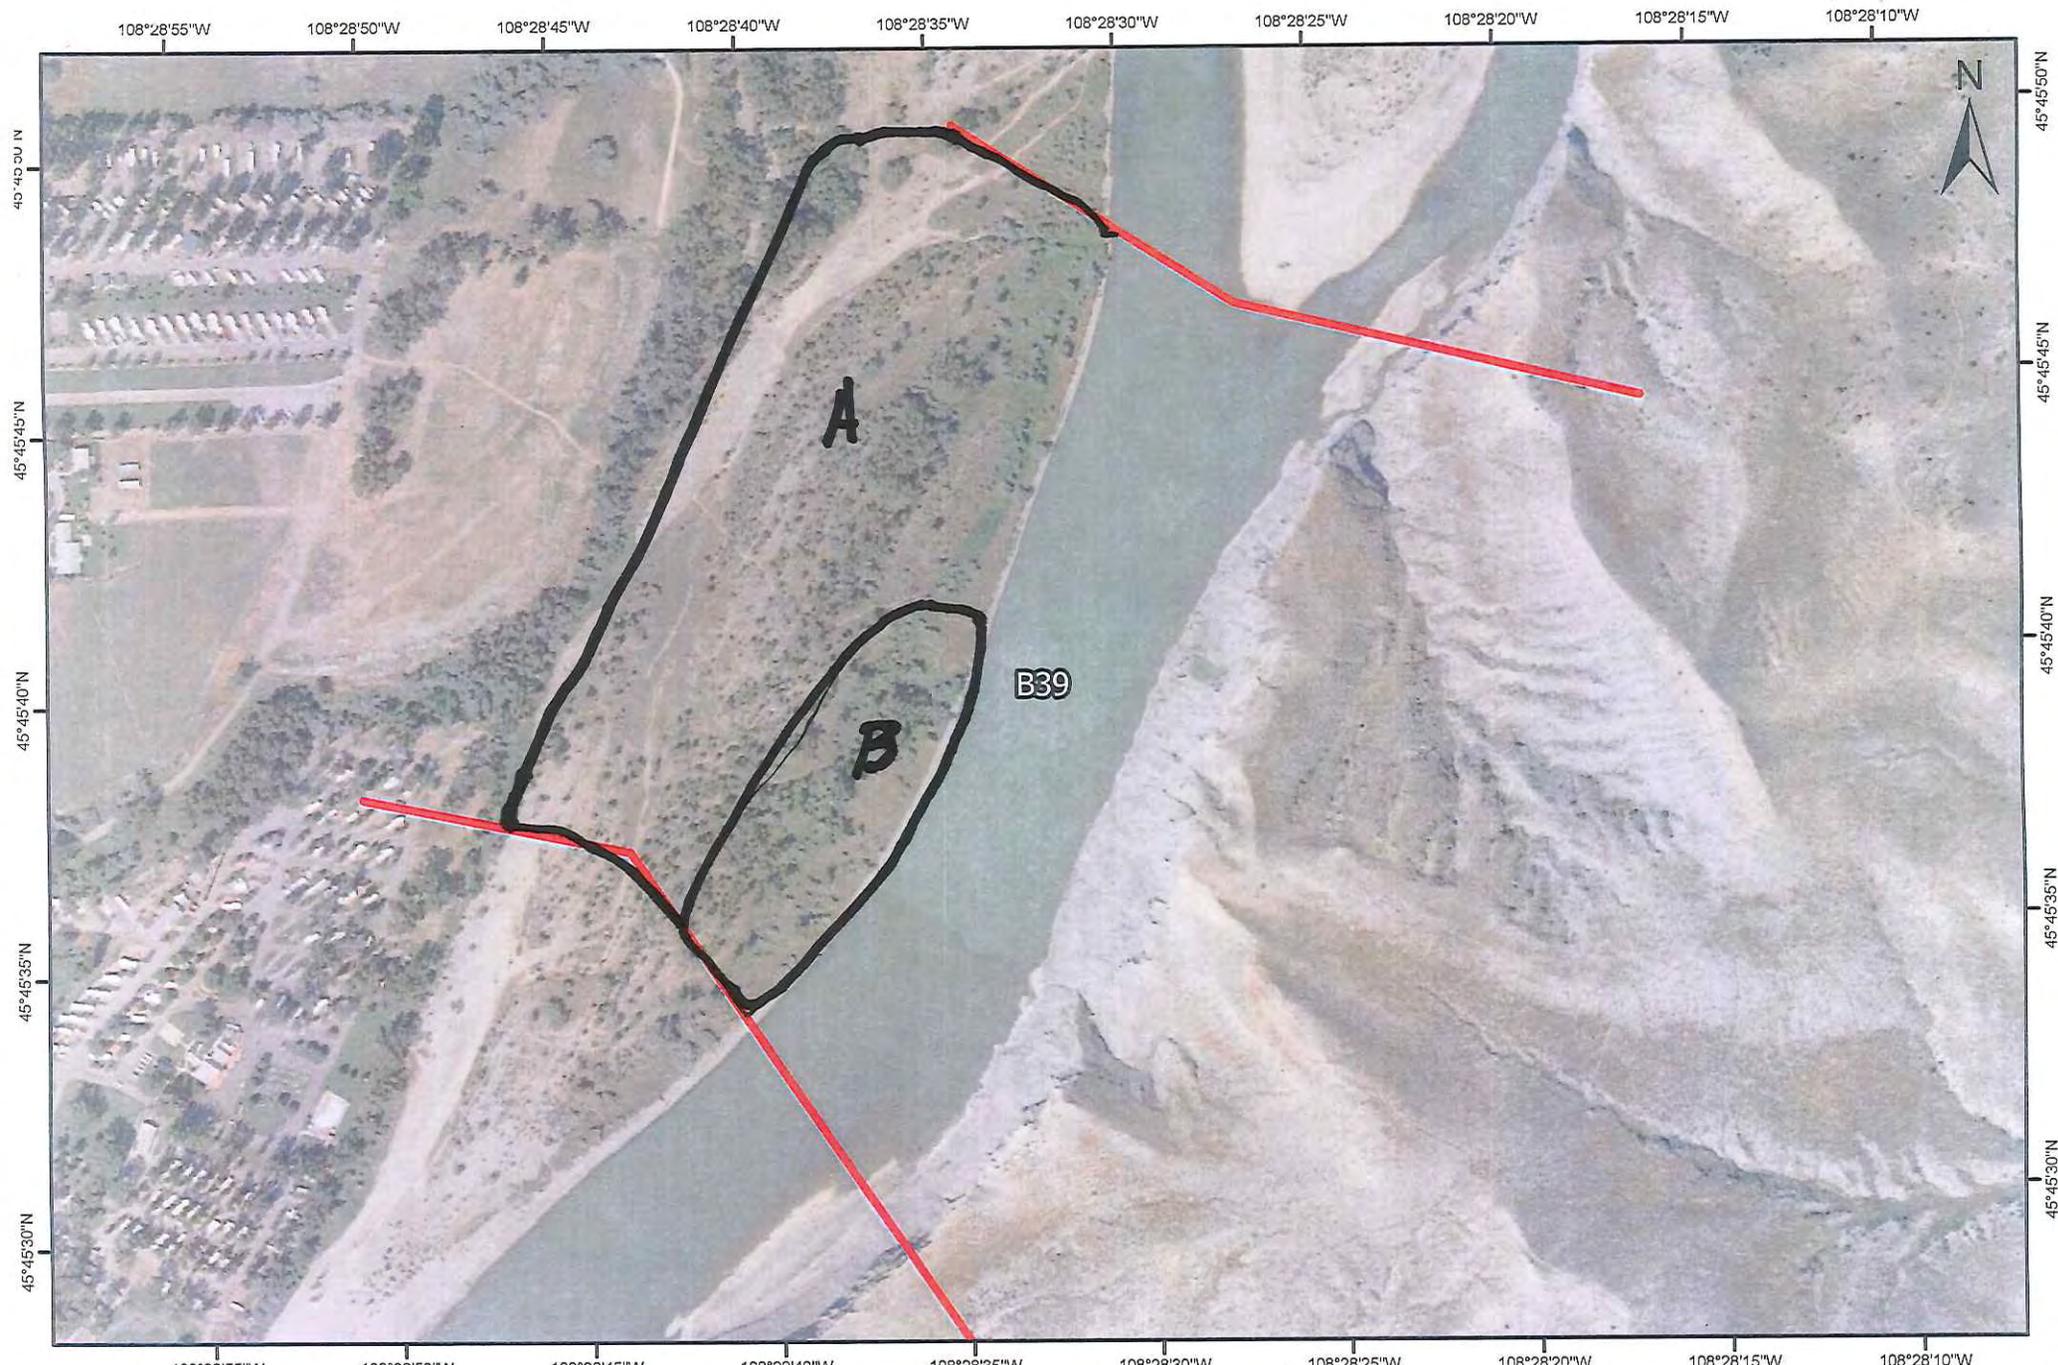
Both zones A+B have coated and stained Veg + Debris.
 Debris needs to be bagged and removed
 Veg needs to be cut or trimmed and removed
 Survey Complete

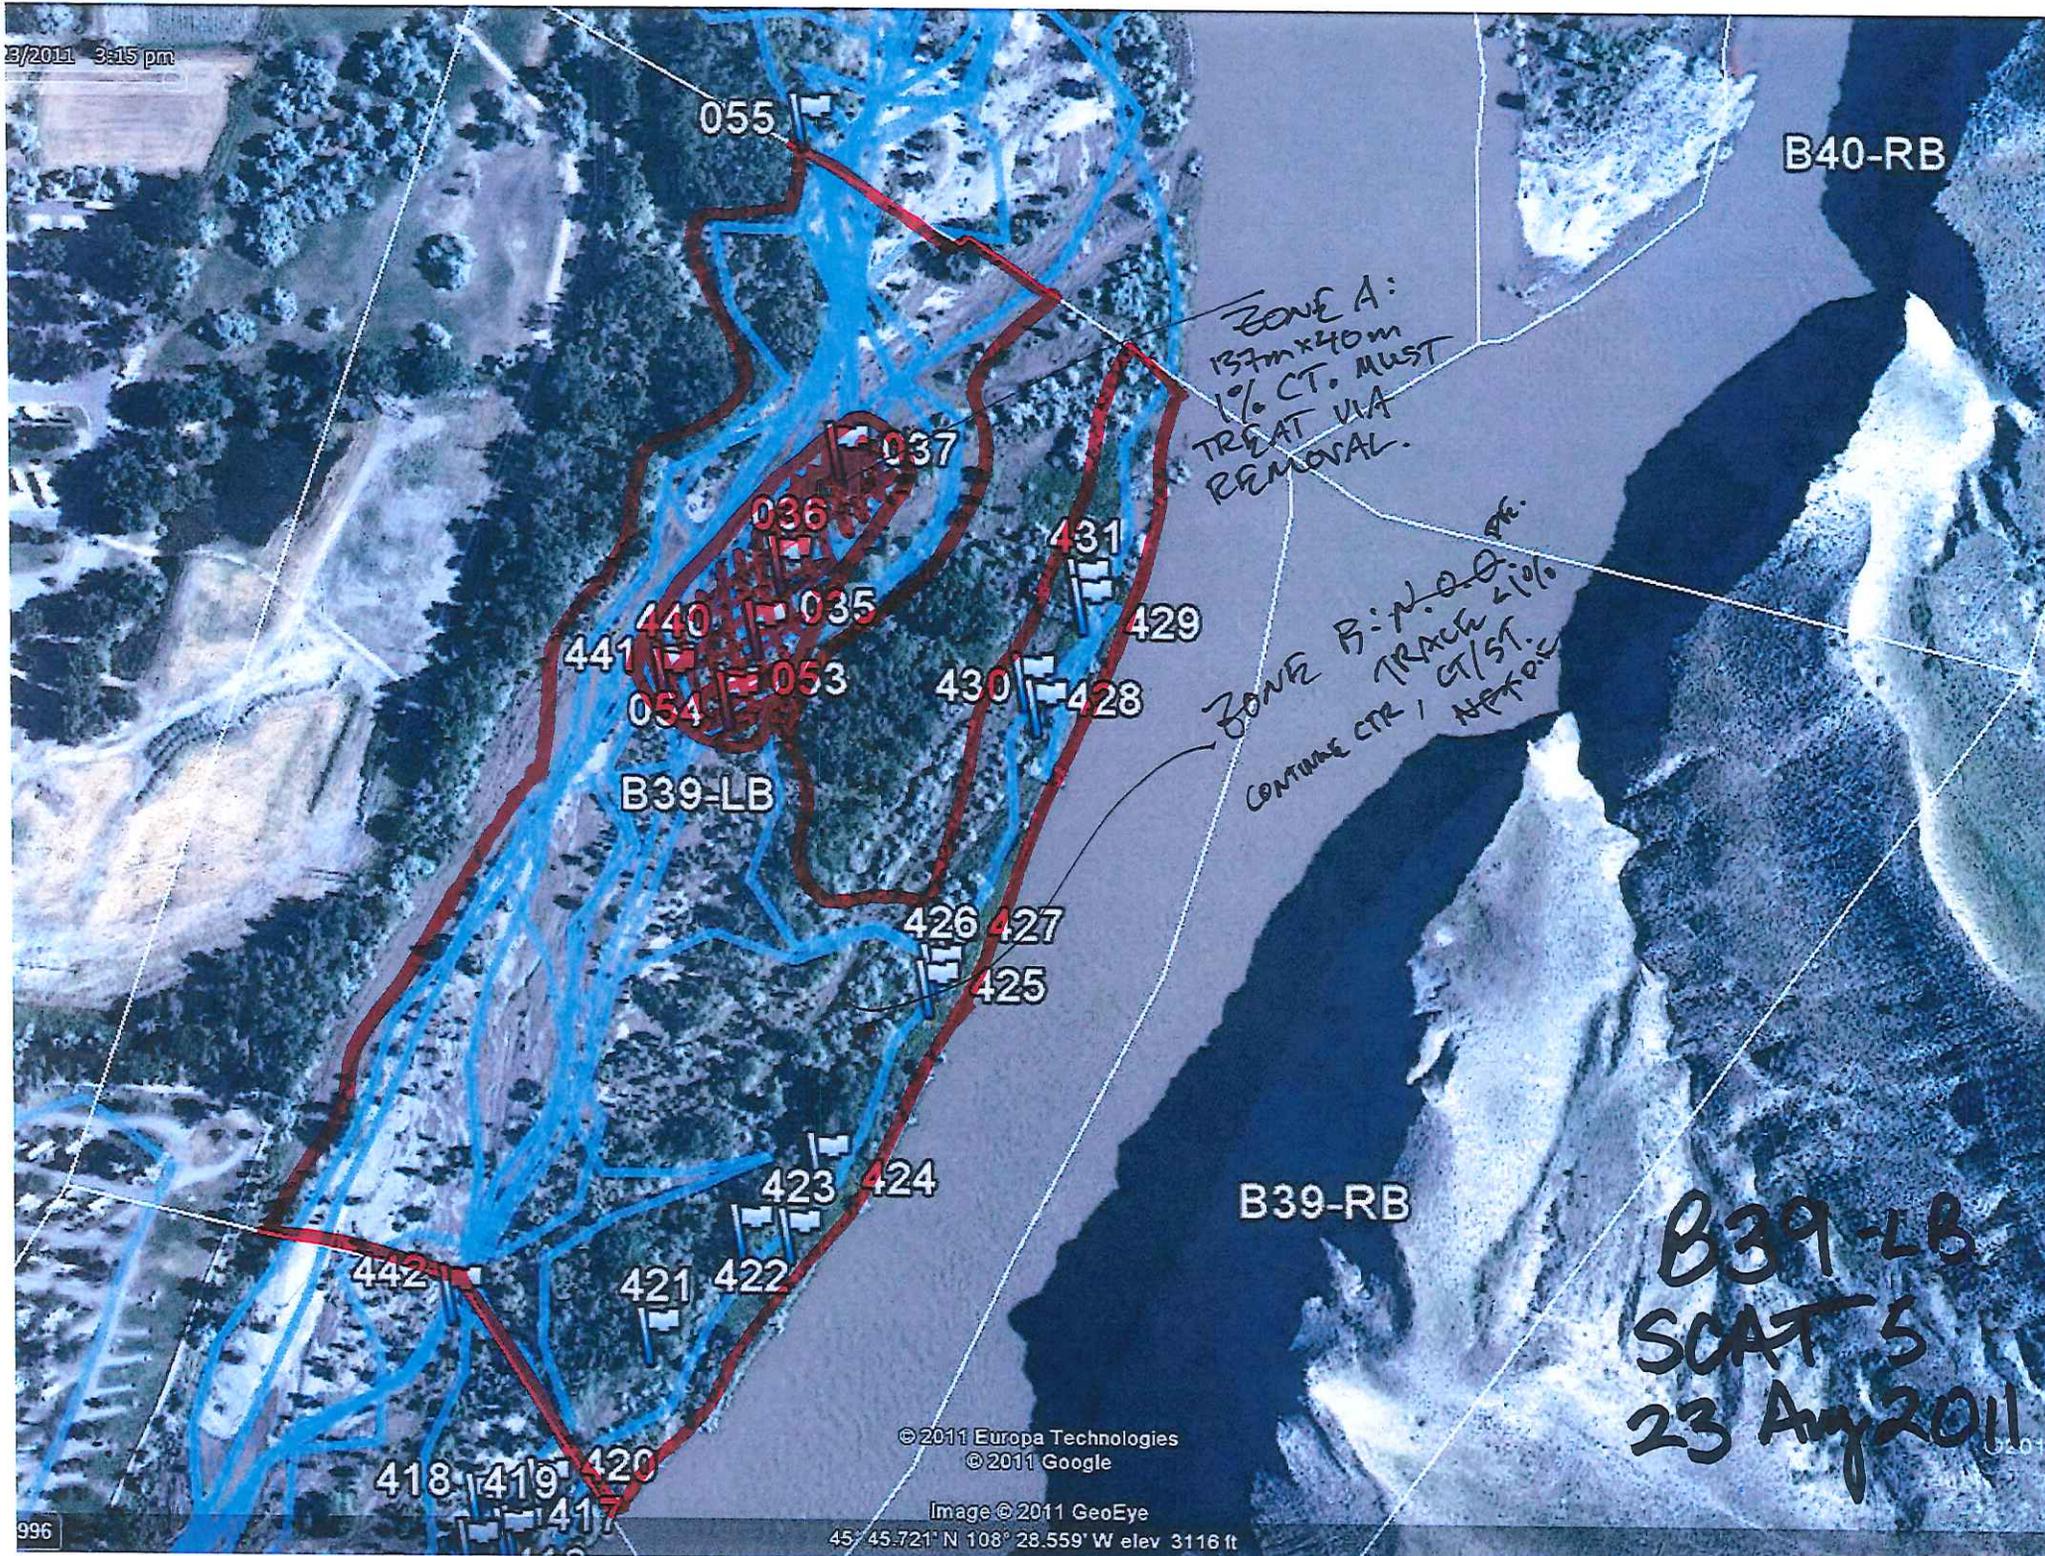
B40-RB

ZONE A:
137m x 40m
1% CT. MUST
TREAT VIA
REMOVAL.

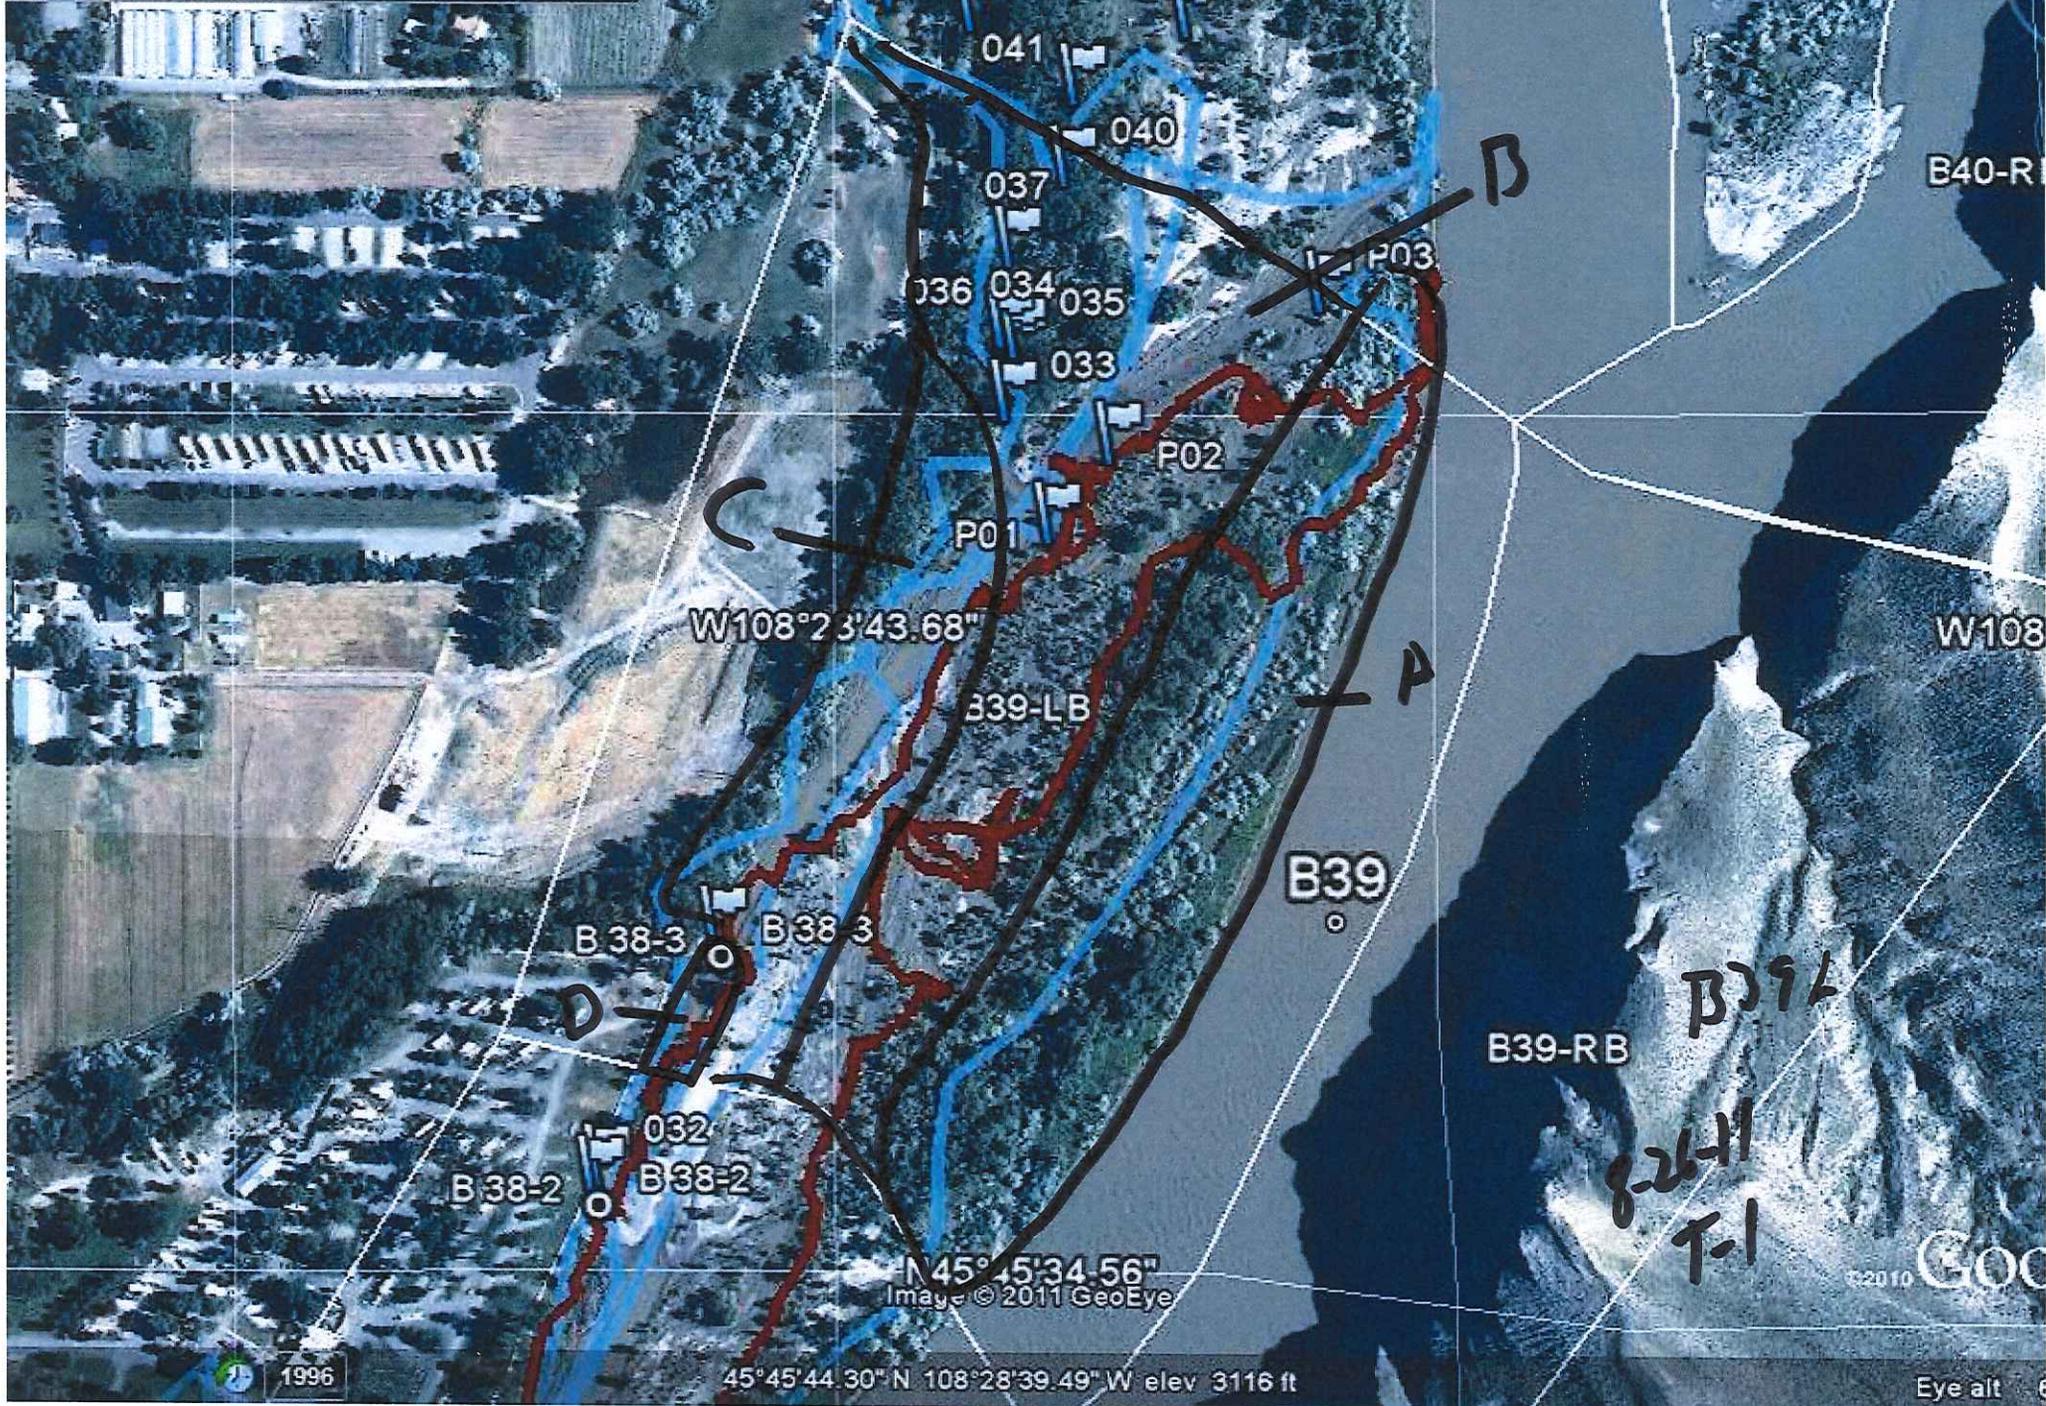
Zone A+C - No oil observed

Zone B - had sparse stained + coated veg + debris. All coated material picked up by Hot Shot crew

Zone D - small shallower channel with standing water covered with or broken up and oil shown
