**SCAT Area Transition Report for  
B44**

Silvertip Pipeline Incident  
Laurel, Montana

October 27, 2011

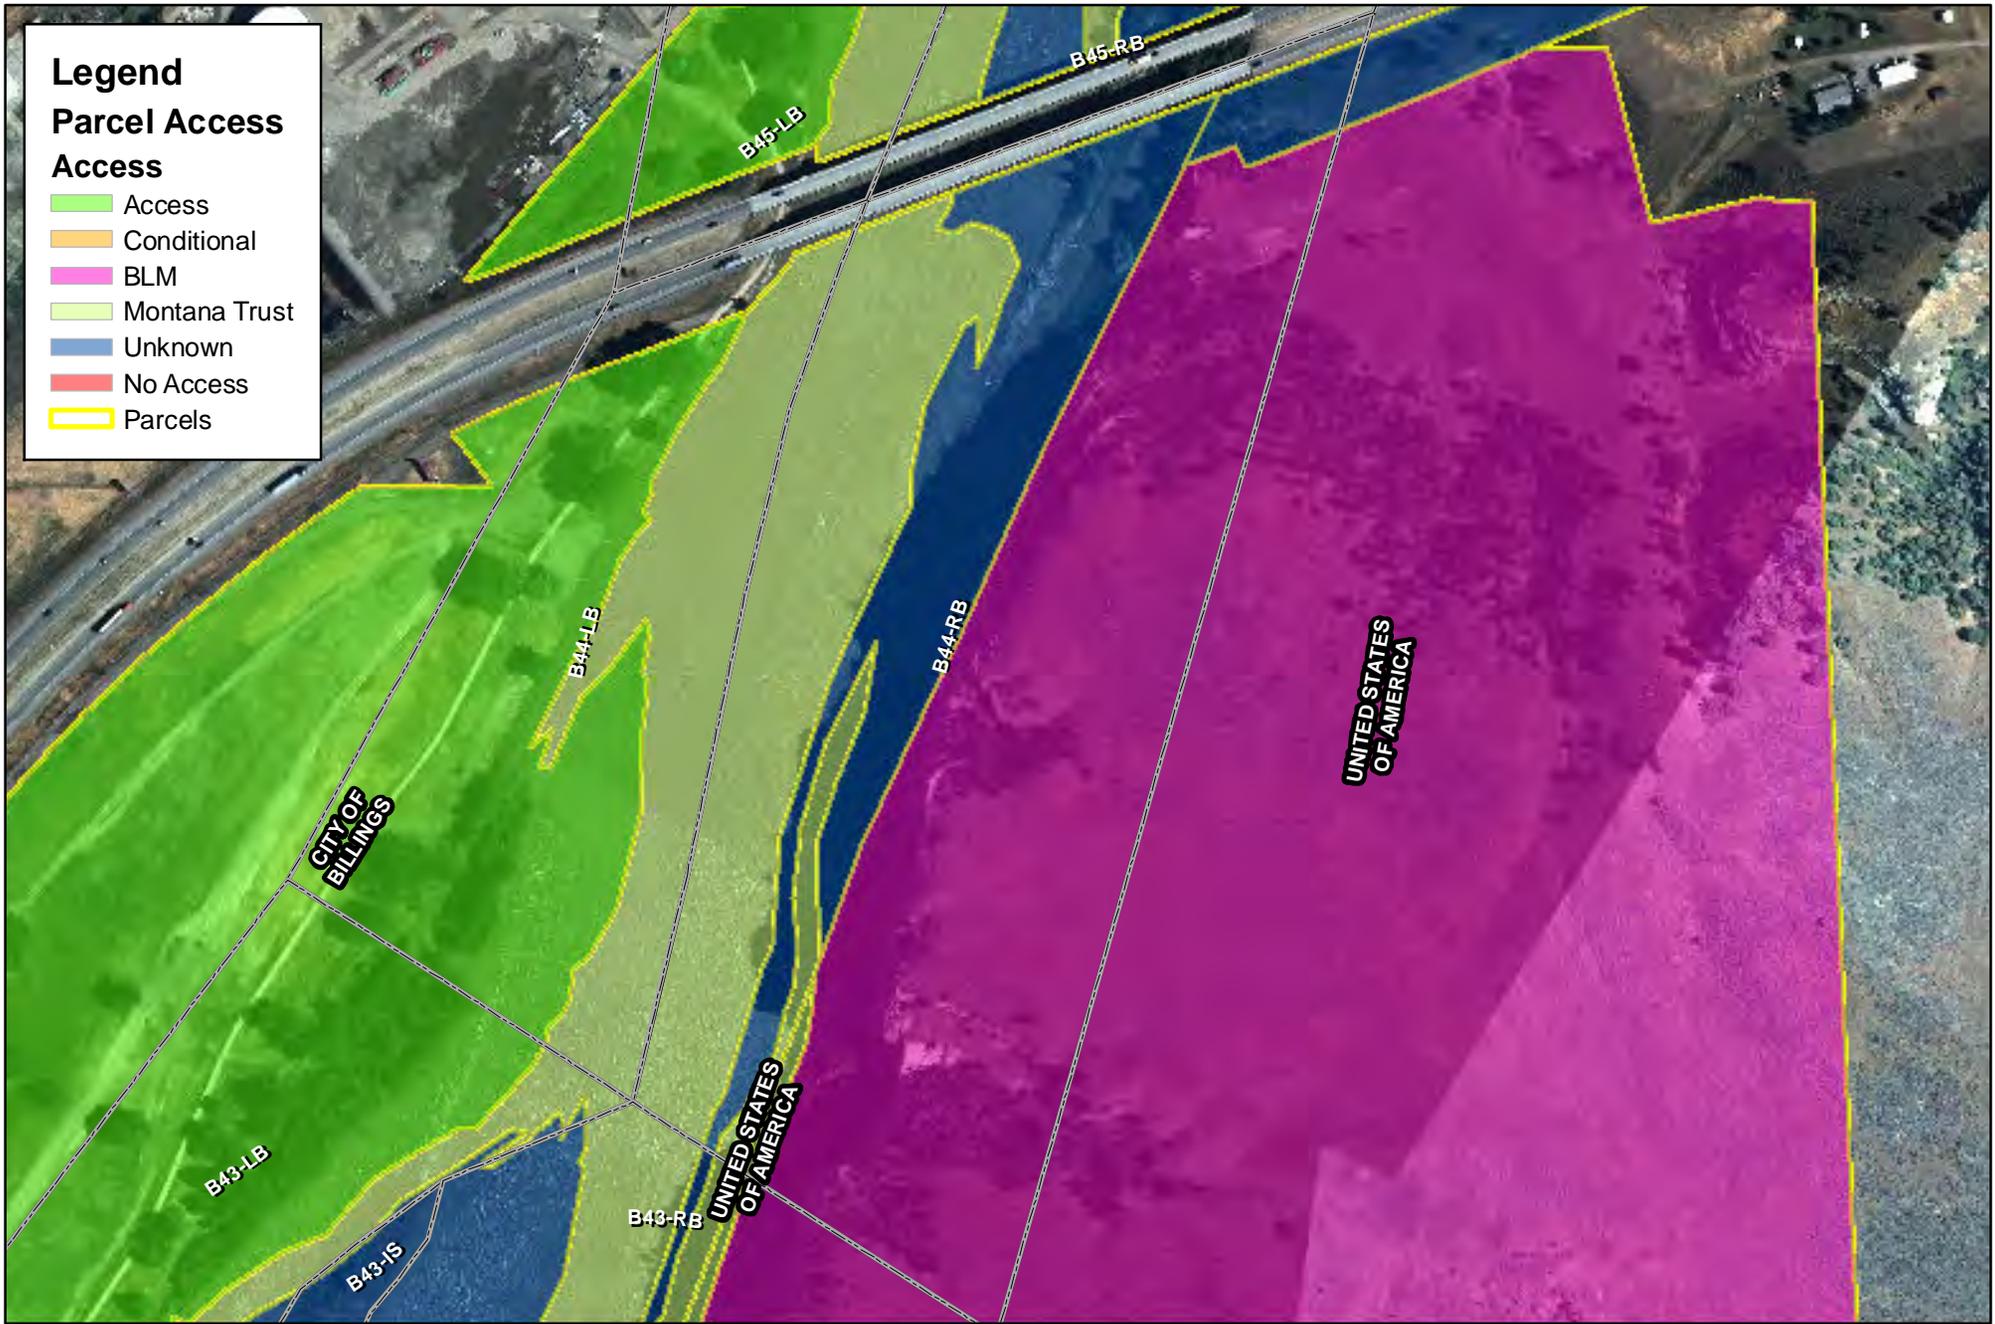
Figure 1 provides an aerial map of SCAT Area B44, along with the (a) SCAT Area boundary, (b) parcel boundaries and respective property owners, and (c) access constraints identified during the oil cleanup process. The acreage surveyed in Area B44 is 7.5. There were no landowner access issues for this area. However, the upstream portion of the right bank was inaccessible, unvegetated and a rocky cliff.

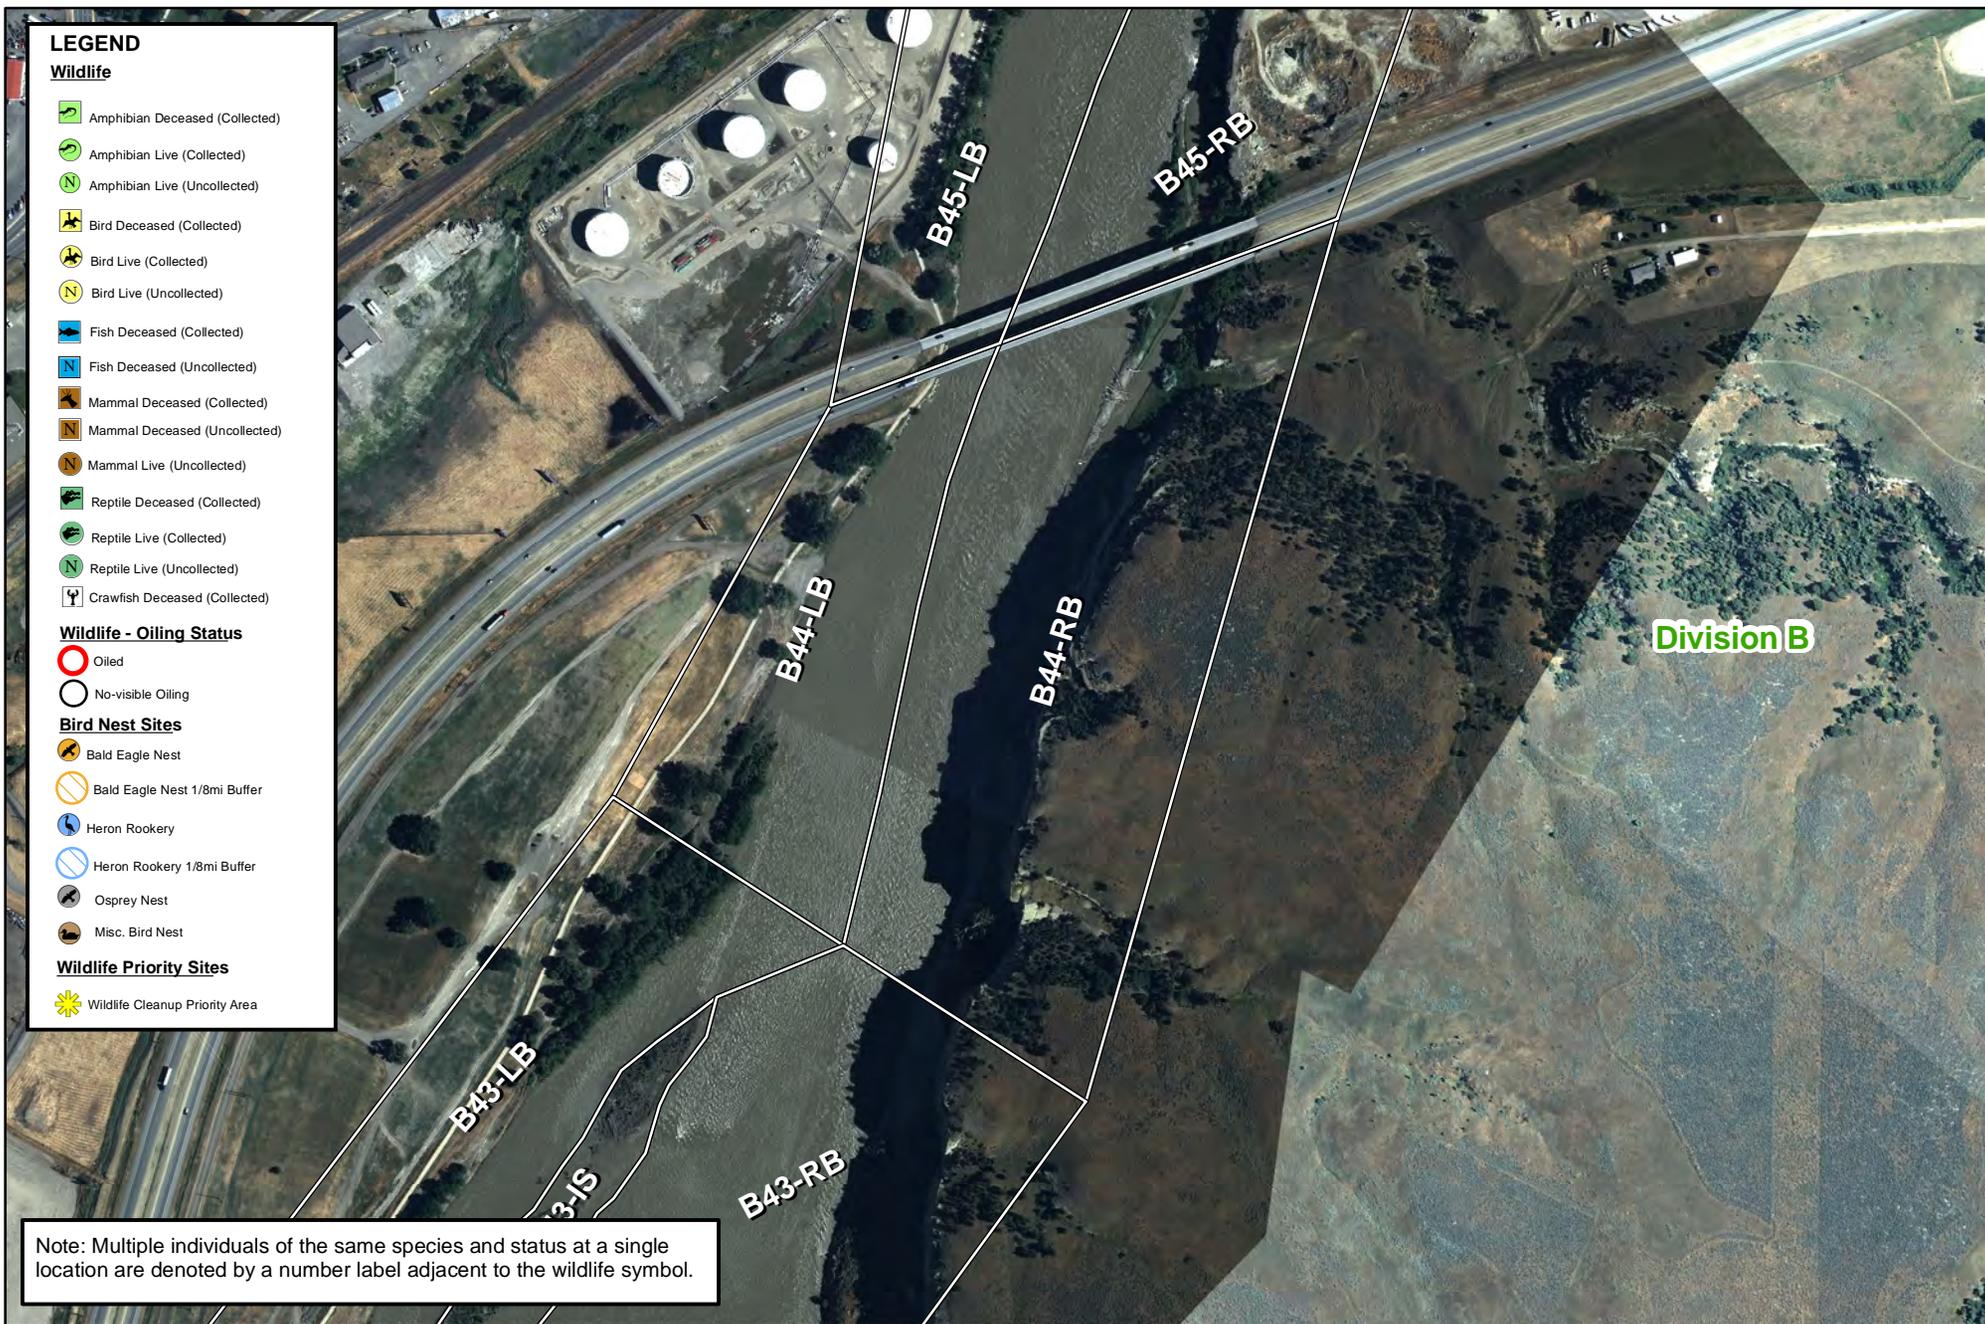
**Figure 2**  
**Wildlife Resources**

Figure 2 summarizes the natural resources identified in this segment. International Bird Rescue and Resource Advisors from U.S. Fish and Wildlife Service conducted regular inspections of Area B44. No oiled wildlife was observed or recovered. No Wildlife Priority Cleanup Areas were identified. No active migratory bird nests were identified in Area B44.

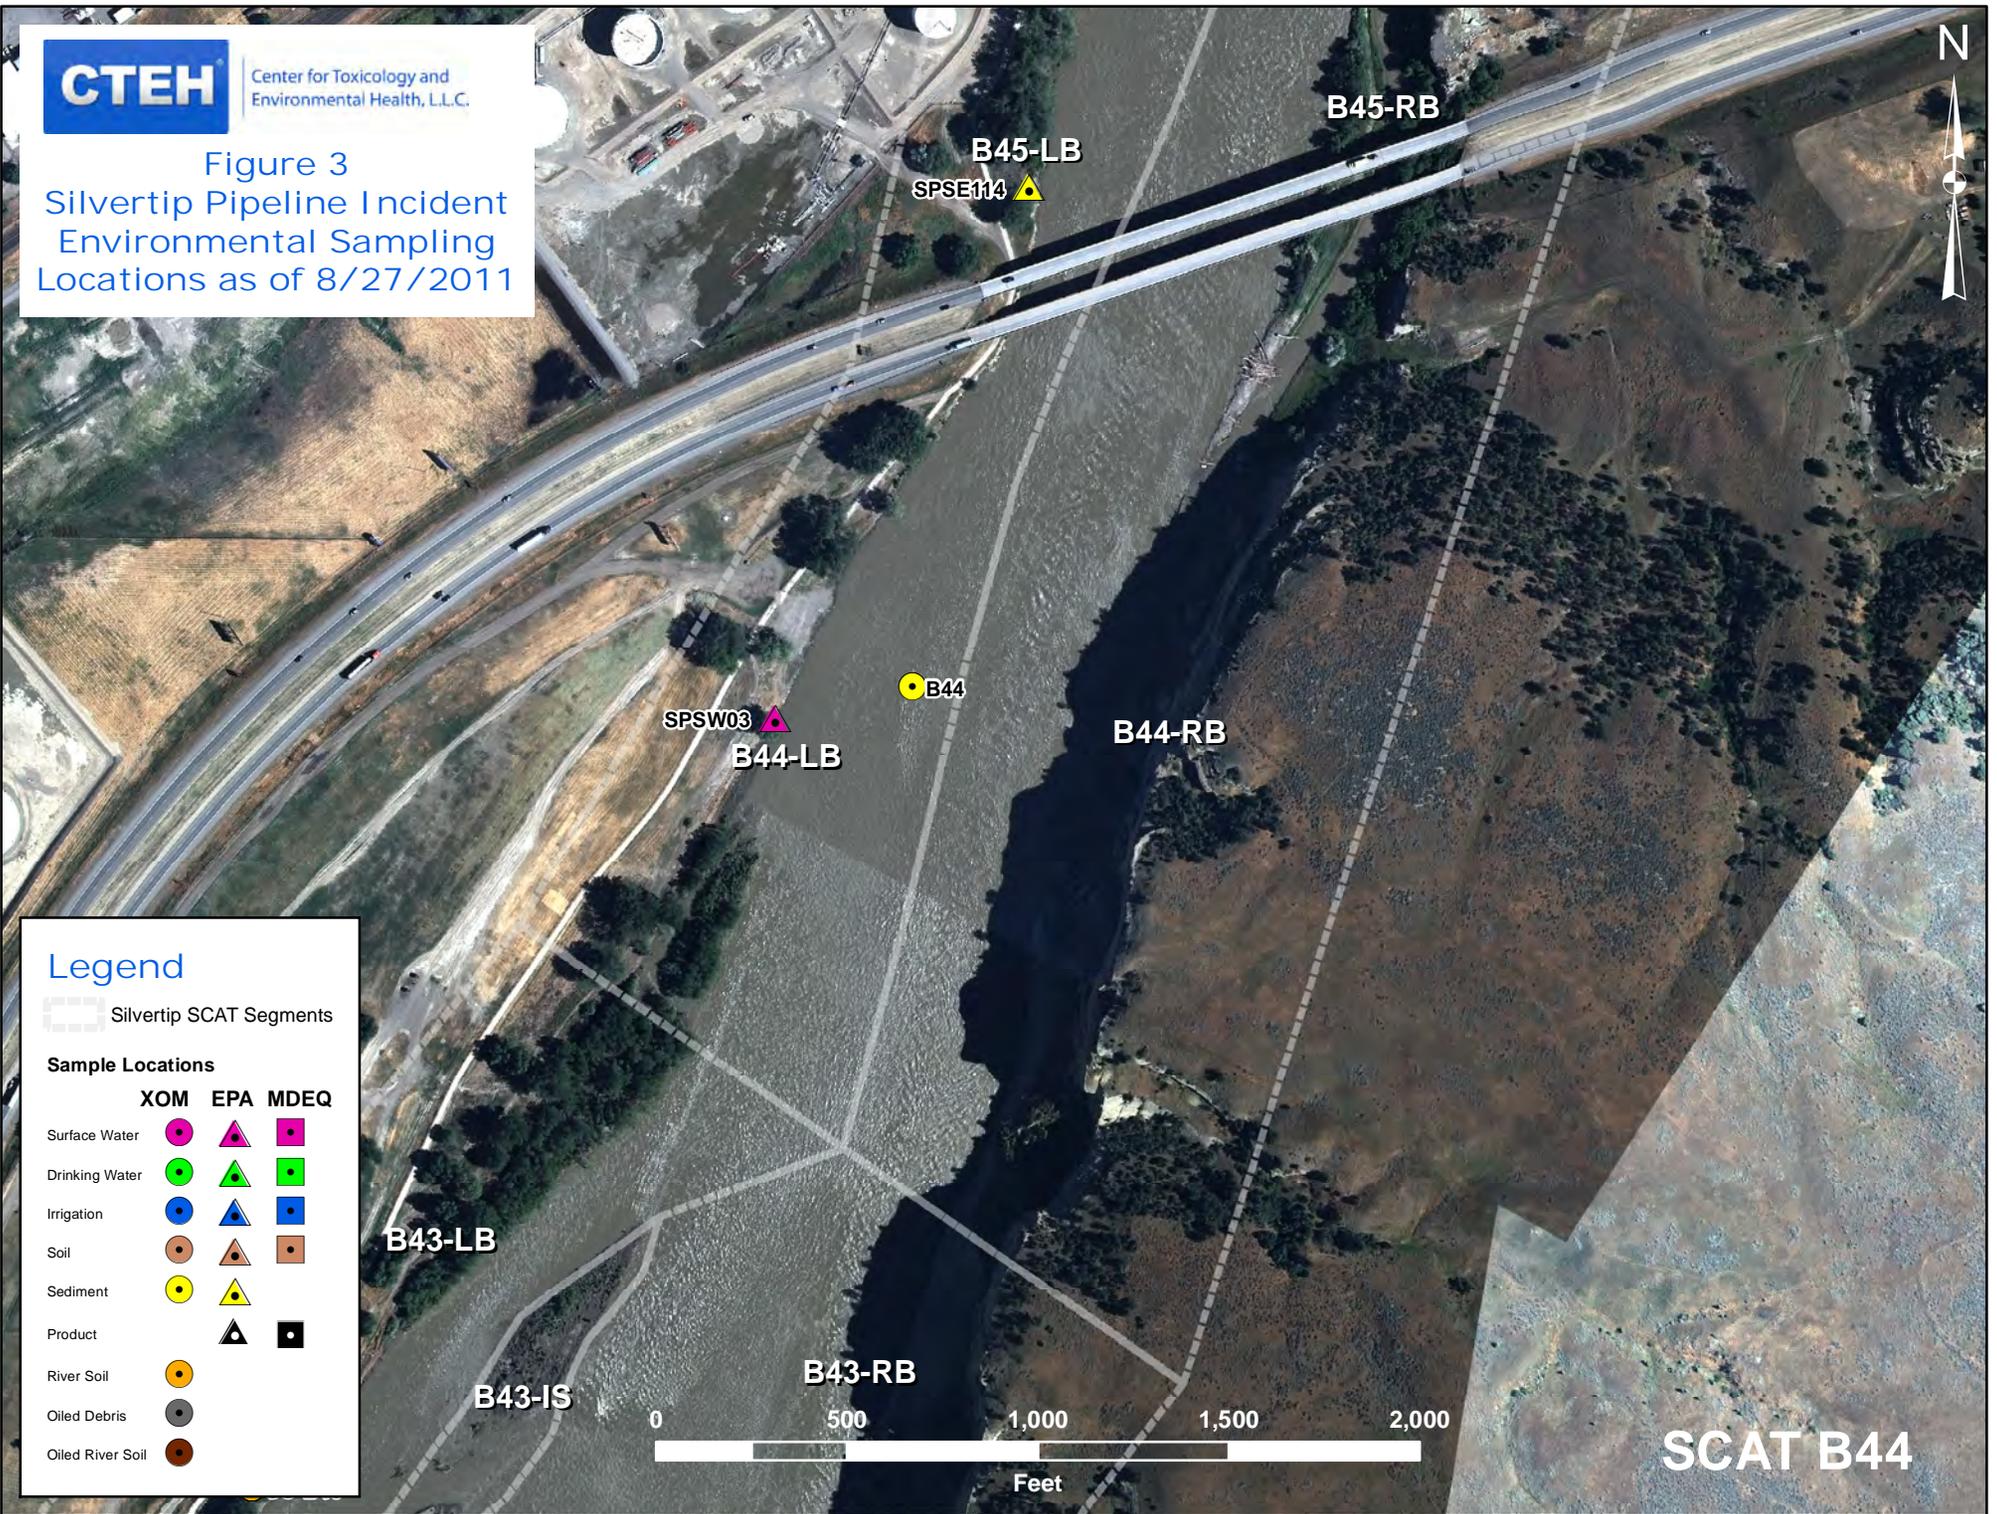
Figure 3  
Silvertip Pipeline Incident  
Environmental Sampling  
Locations as of 8/27/2011

Table 1 (below) summarizes samples collected within Area B44. The analytical results for the samples collected can be accessed through a publicly accessible database on the United States Environmental Protection Agency's (USEPA's) website. The approximate locations of samples collected within Area B44 are provided on Figure 3.

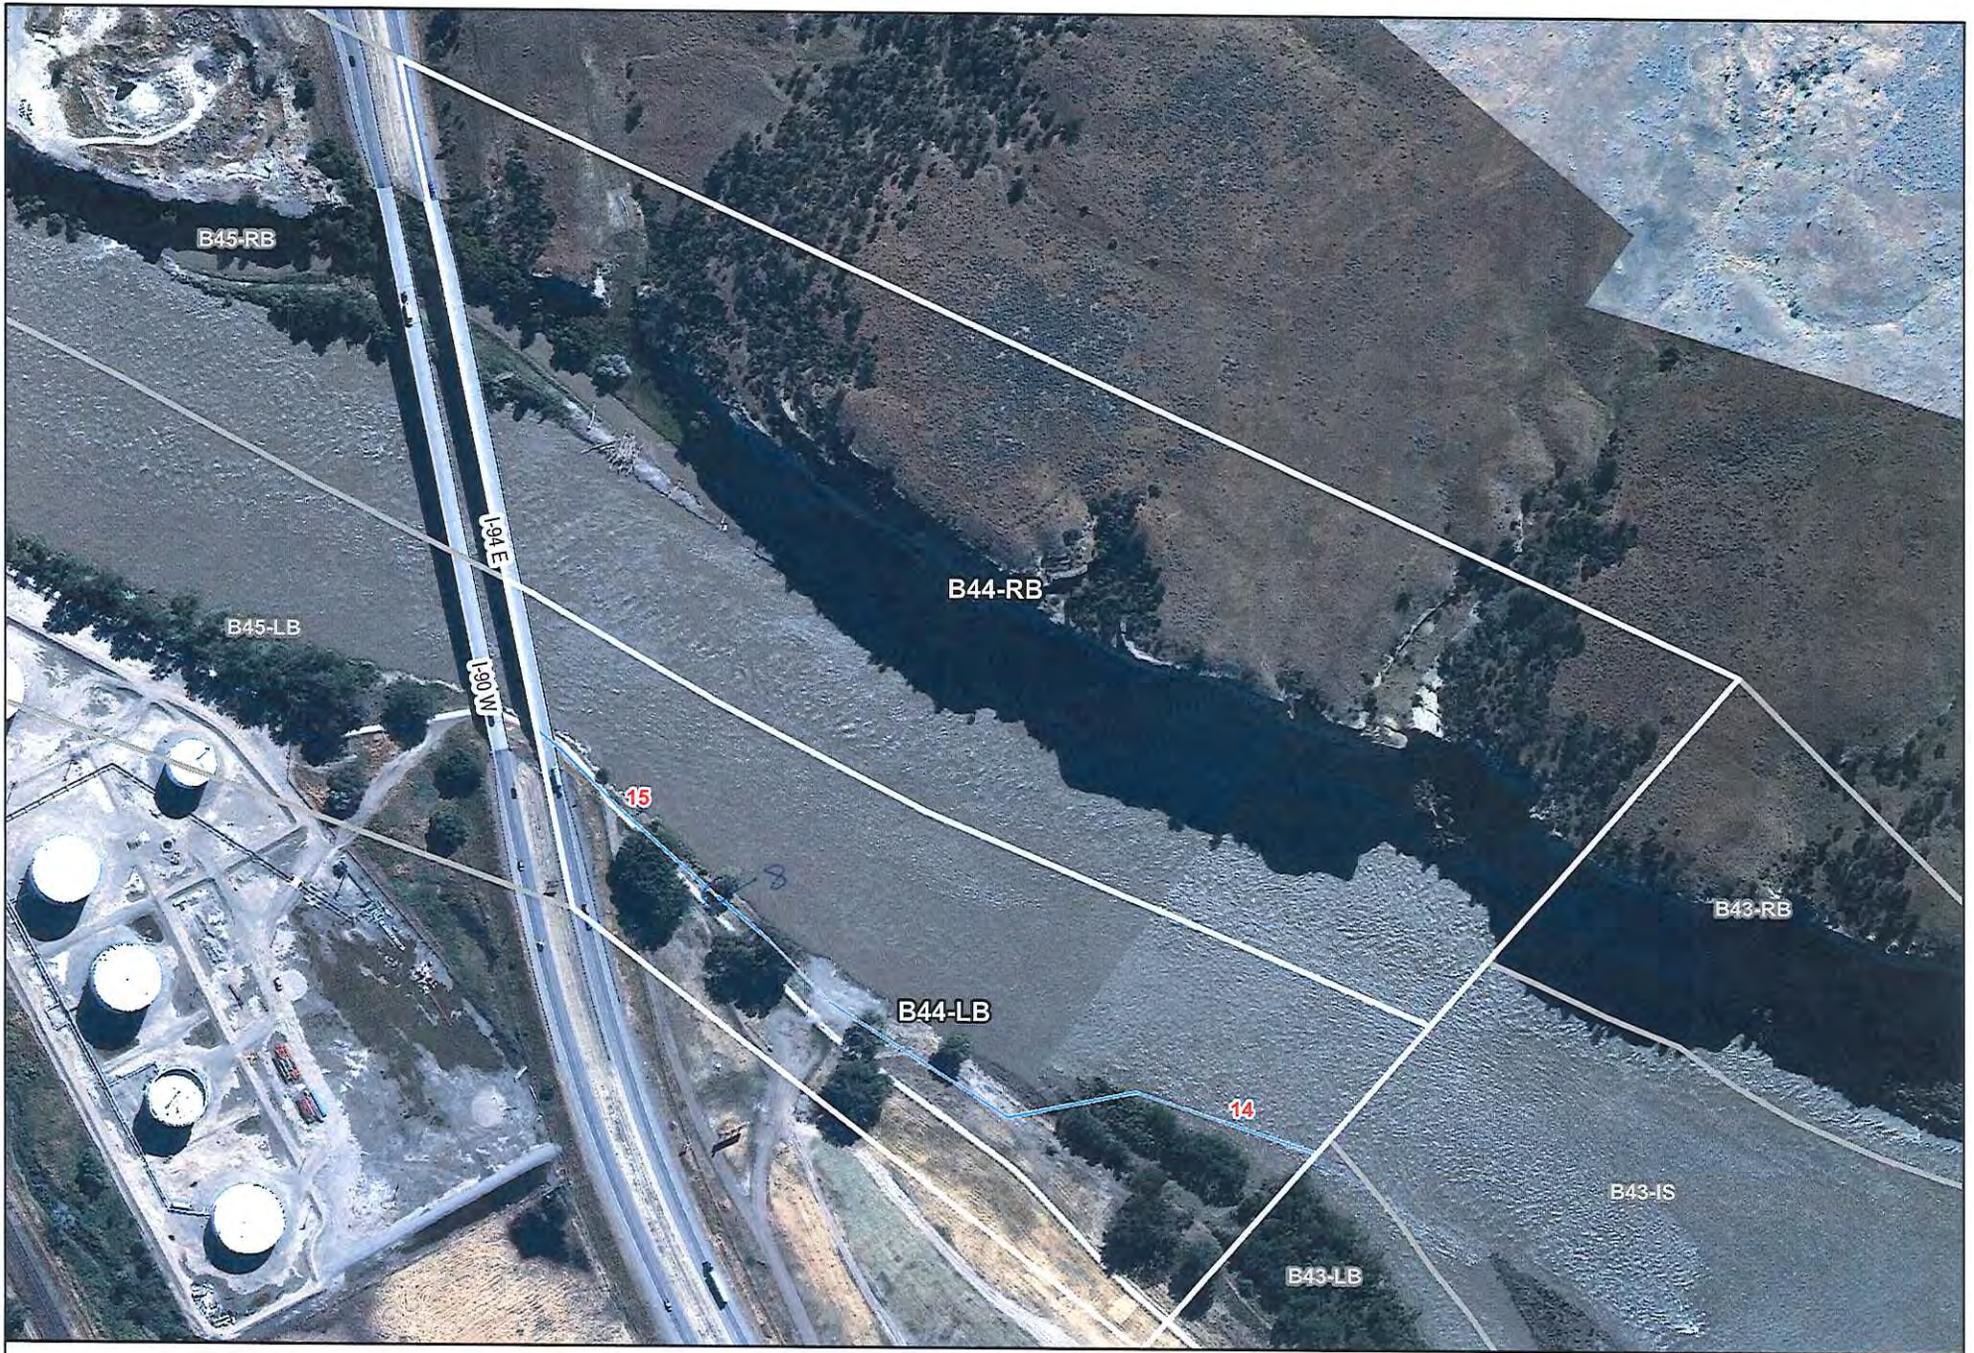
**Figure 4 - Maximum SCAT Observations  
For SCAT Area:**

The SCAT teams used systematic evaluation criteria and treatment method tables approved by the National Oceanic and Atmospheric Administration to provide a standard approach for data collection and conducting field surveys. The forms and sketches from the initial SCAT surveys performed along the river bank (water edge) and floodplain within Area B44 are included in Appendix B. Figure 4 provides the maximum oiling zones observed by the SCAT team during the initial surveys of Area B44.

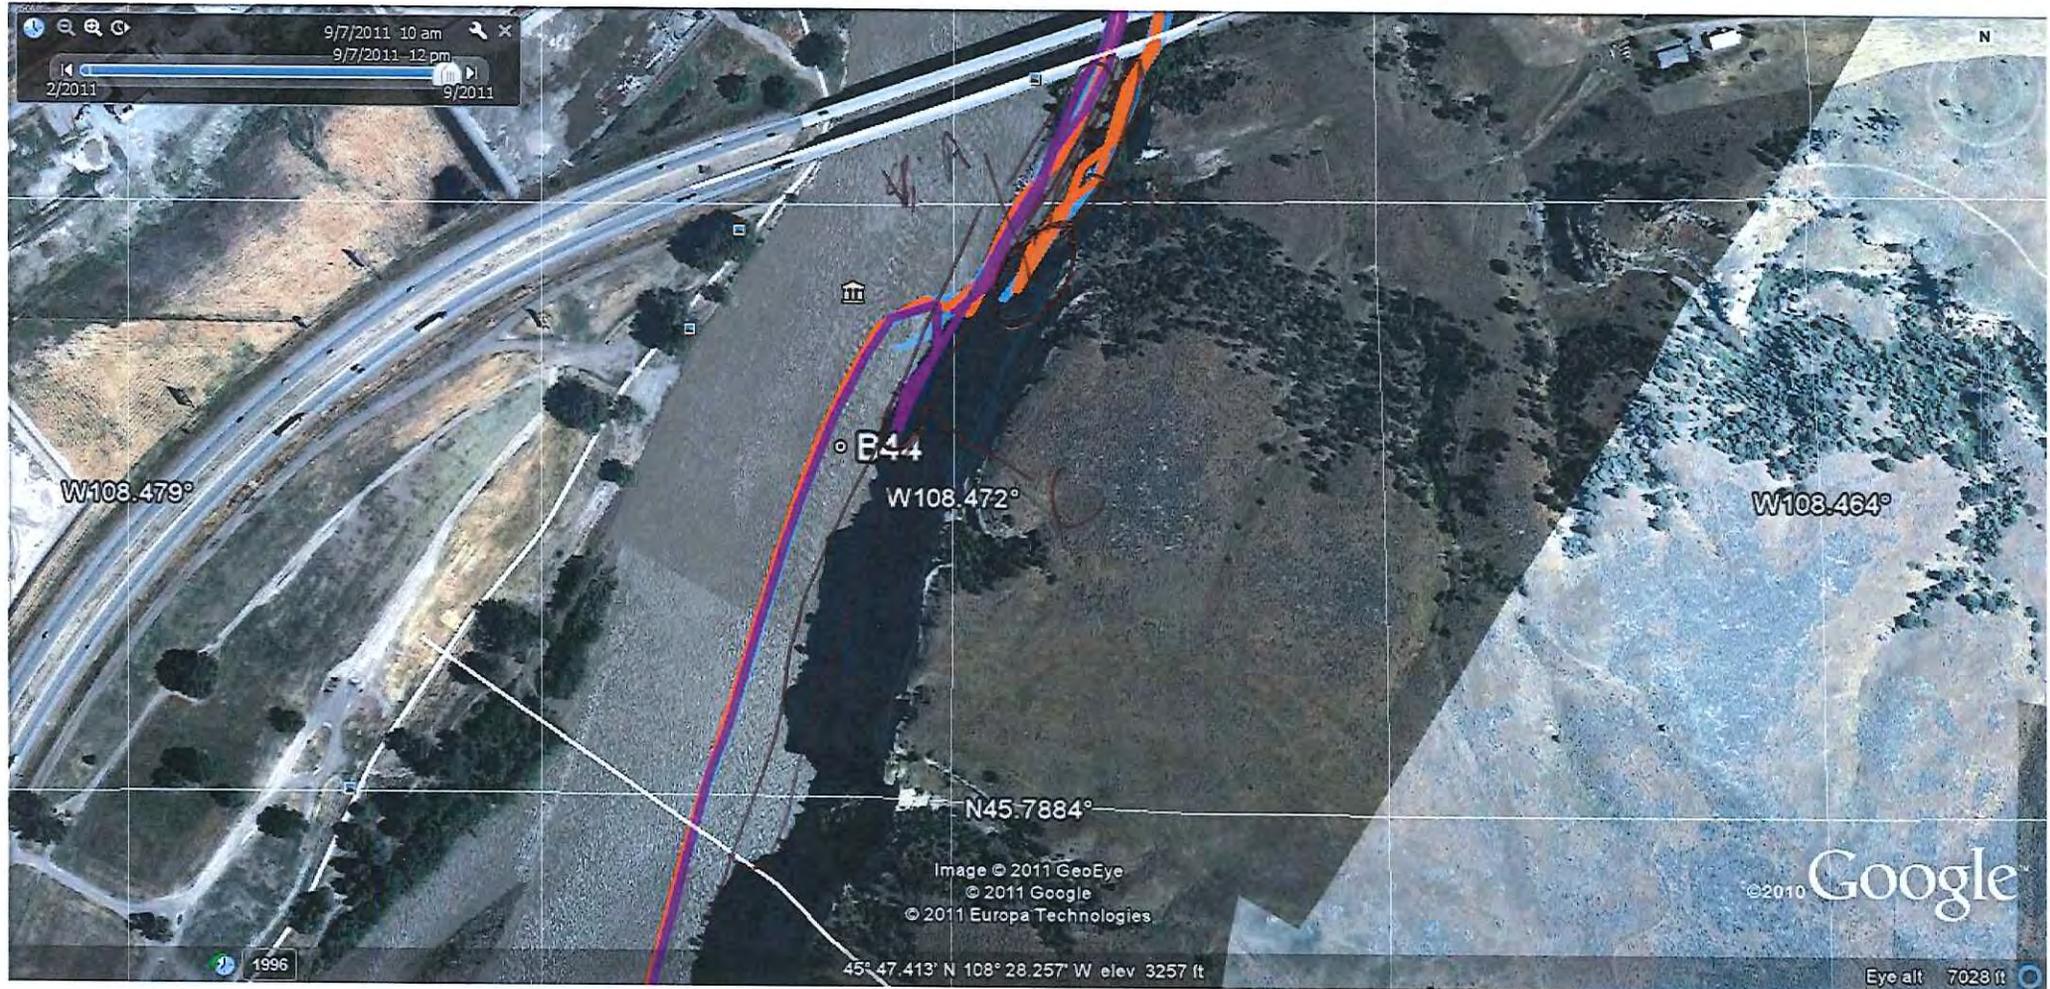
B44  
Team 2  
8/7 Sept 2011

A - Stain on grass and other plants. Oiling is at trace levels. Natural attenuation is recommended for this oiling.

B- No oil observed. No treatment is required.

A = Very light < 1% total stain  
B = NOO  
C = NOO

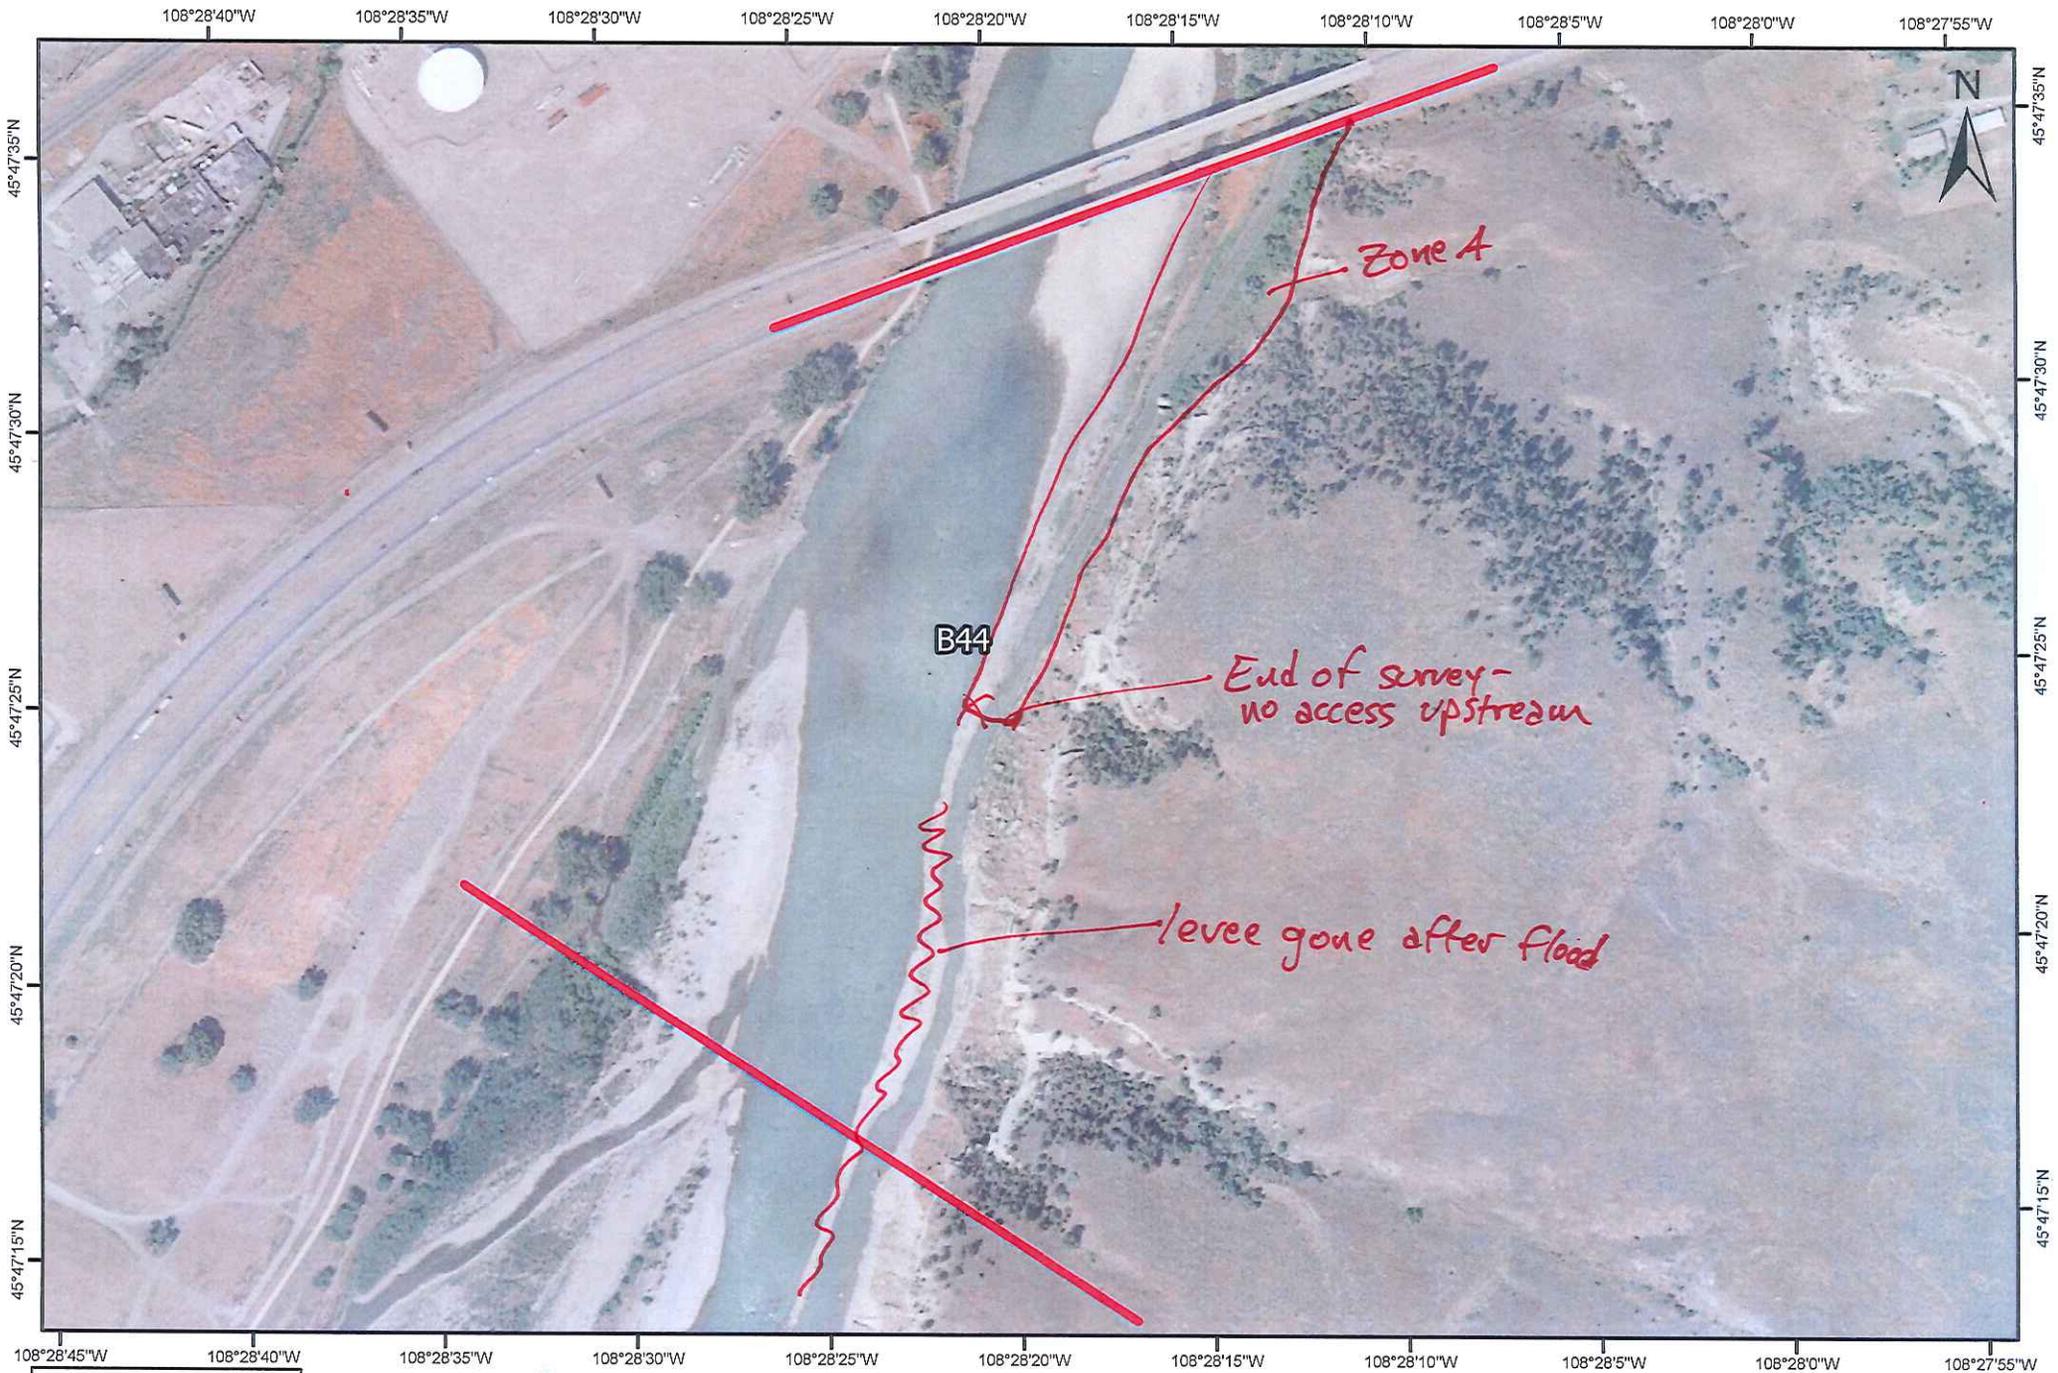
**B44** -  
(L/R/I)??

Zone A- Intermittent patches of CT and ST, tar, along levee and along bank. Treated with hotshot team- removed oiled vegetation >1 inch, removed oil coated debris >4 inches, dusted with silt remaining stains and coats. No further treatment required. Zone A extends to 358m upstream along levee for ditch intake, where the levee ends. Upstream from the end of the levee, the RB shoreline to the end of unit consists of steep rocky cliff with no vegetation at waters edge.

*Lightly oiled area shown on CTR upstream from area surveyed. Would need to survey that area by boat.*

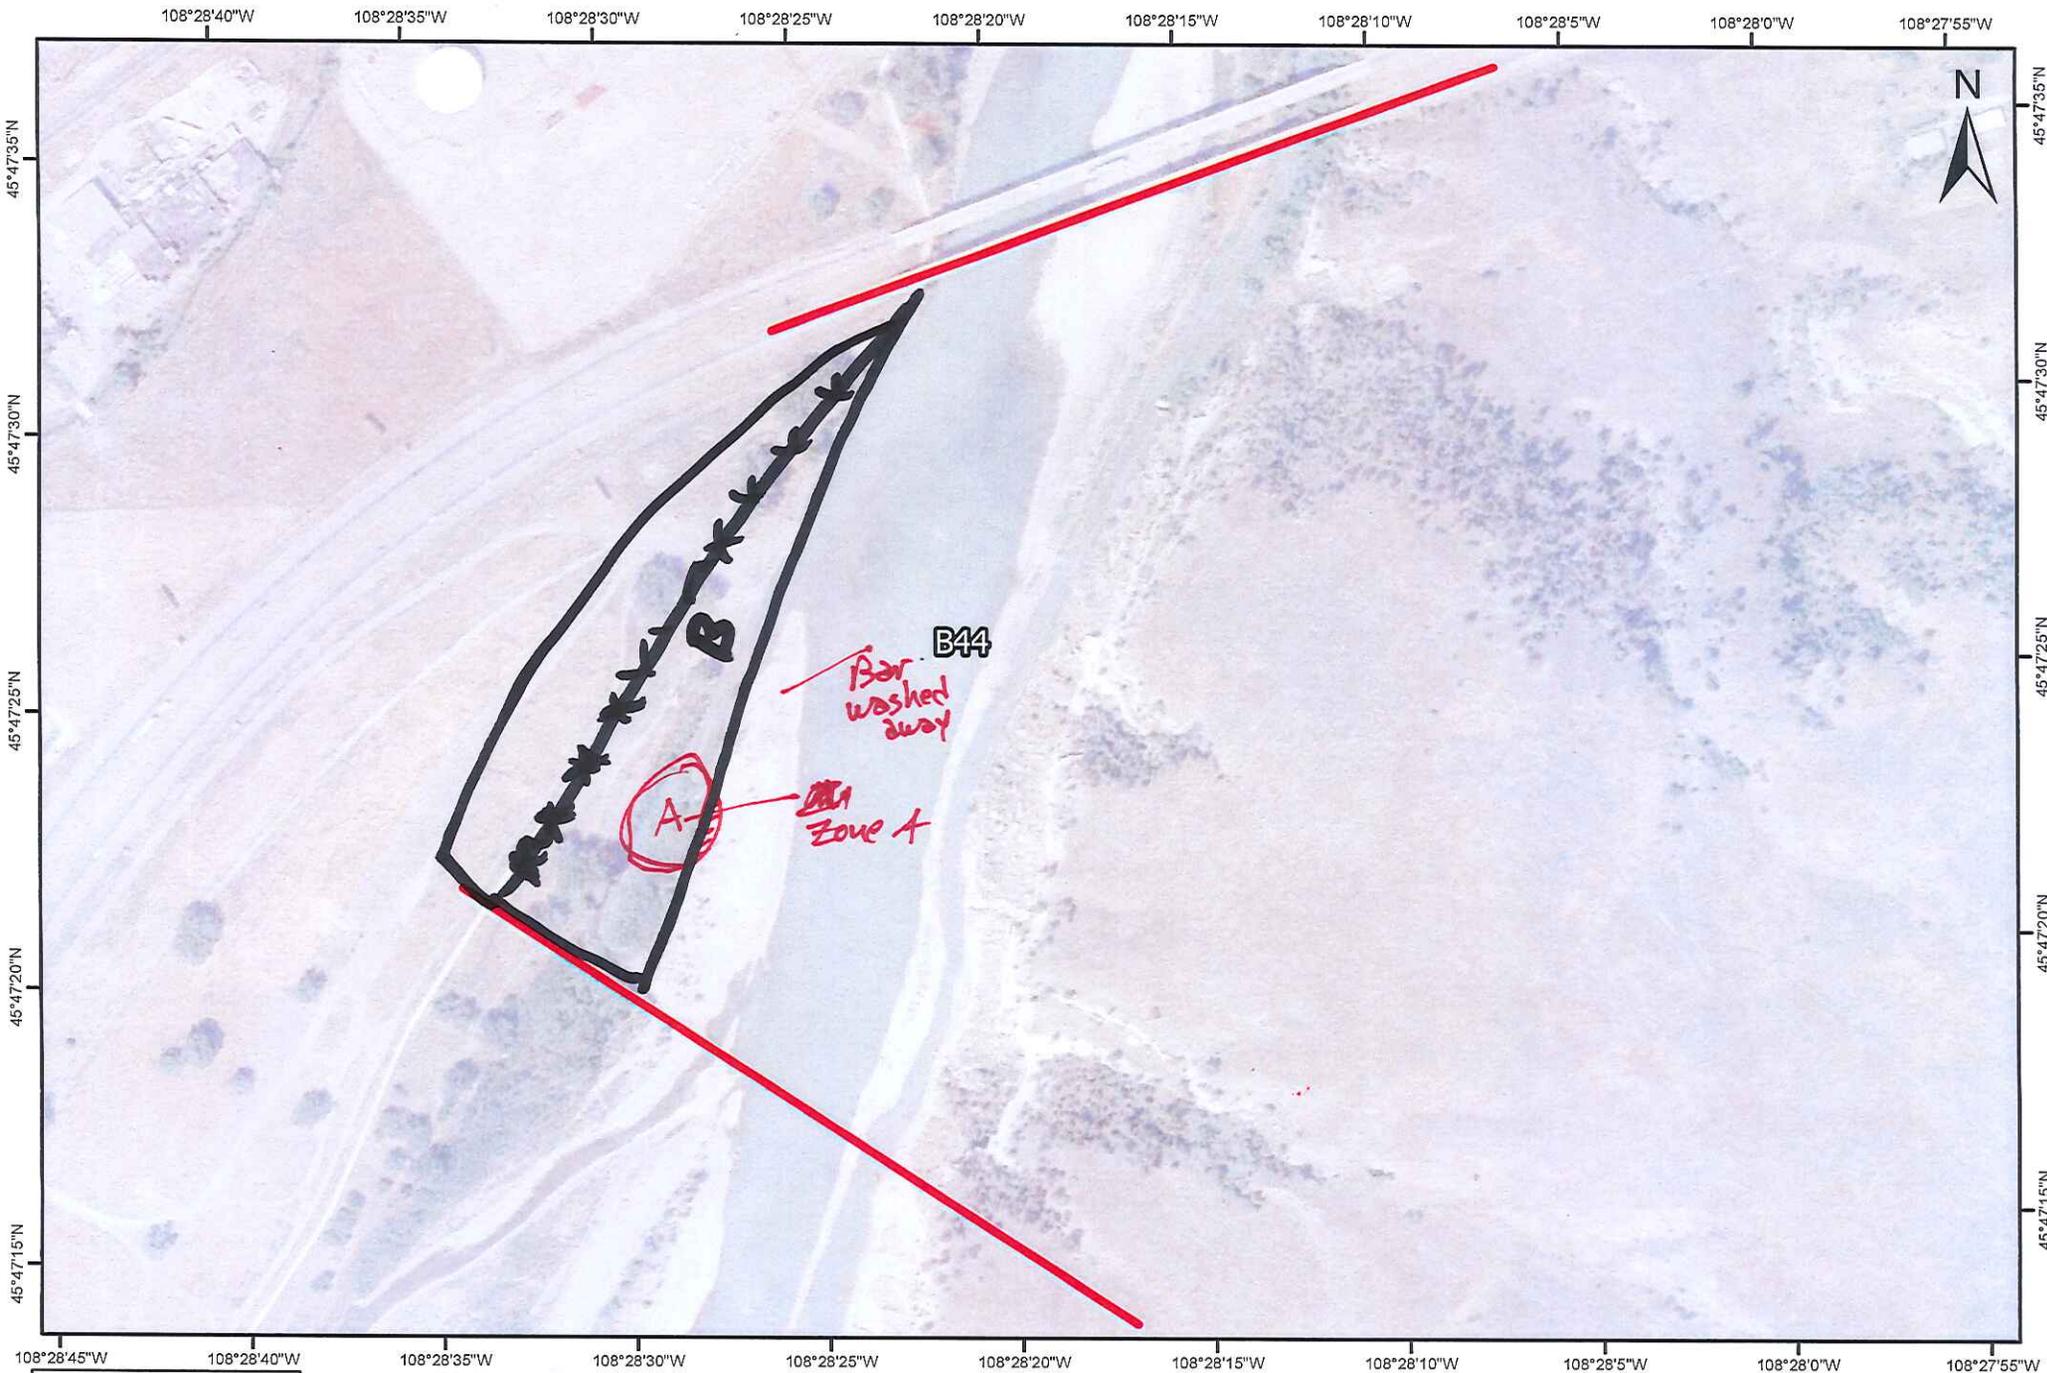
**B44 - LB**  
(L/R/I)??

Zone A- Intermittent oil on vegetation at eye level- coatings & stains, tar consistency. Visited with hotshot team and treated a portion of Zone A, but did not complete it. Treatments included cut and remove oiled vegetation <1 inch, remove oil coated material <4 inches, and dusted oil stained and coated material.

Zone B- Rest of unit- some staining visible along bike trail- non transferable, so NFT. However, some areas with stains are visible from bike trail.

Zone A has less than 1kg of stain veg + debris.
