**SCAT Area Transition Report
for B45**

Silvertip Pipeline Incident
Laurel, Montana

October 28, 2011

Prepared for:
ExxonMobil Pipeline Company

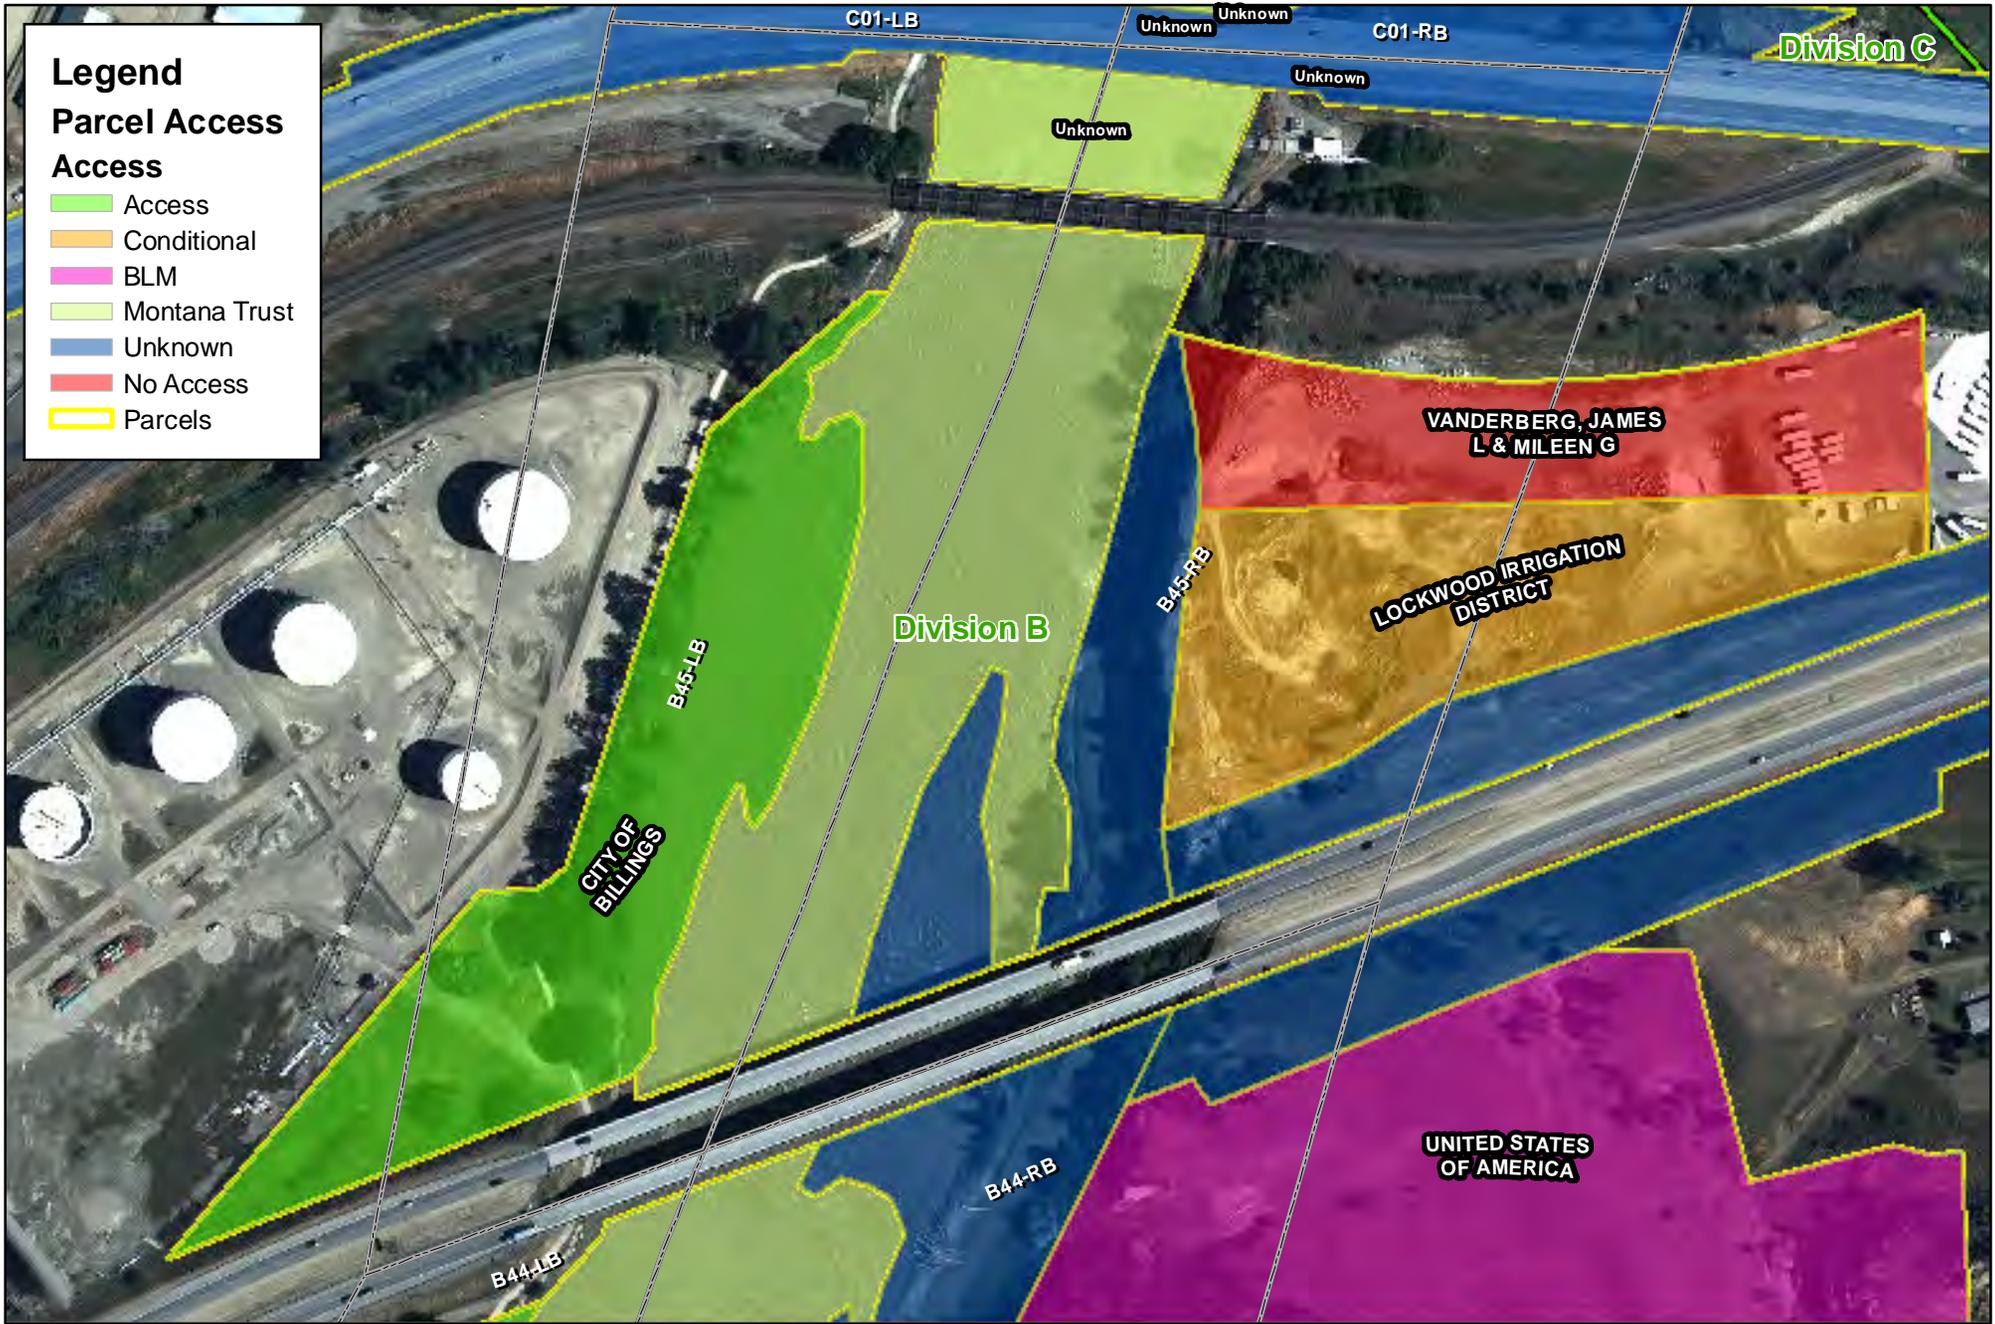
Figure 1 provides an aerial map of SCAT Area B45, along with the (a) SCAT Area boundary, (b) parcel boundaries and respective property owners, and (c) access constraints identified during the oil cleanup process. The acreage surveyed in Area B45 is 7.7. There were access issues for a portion of the right bank.

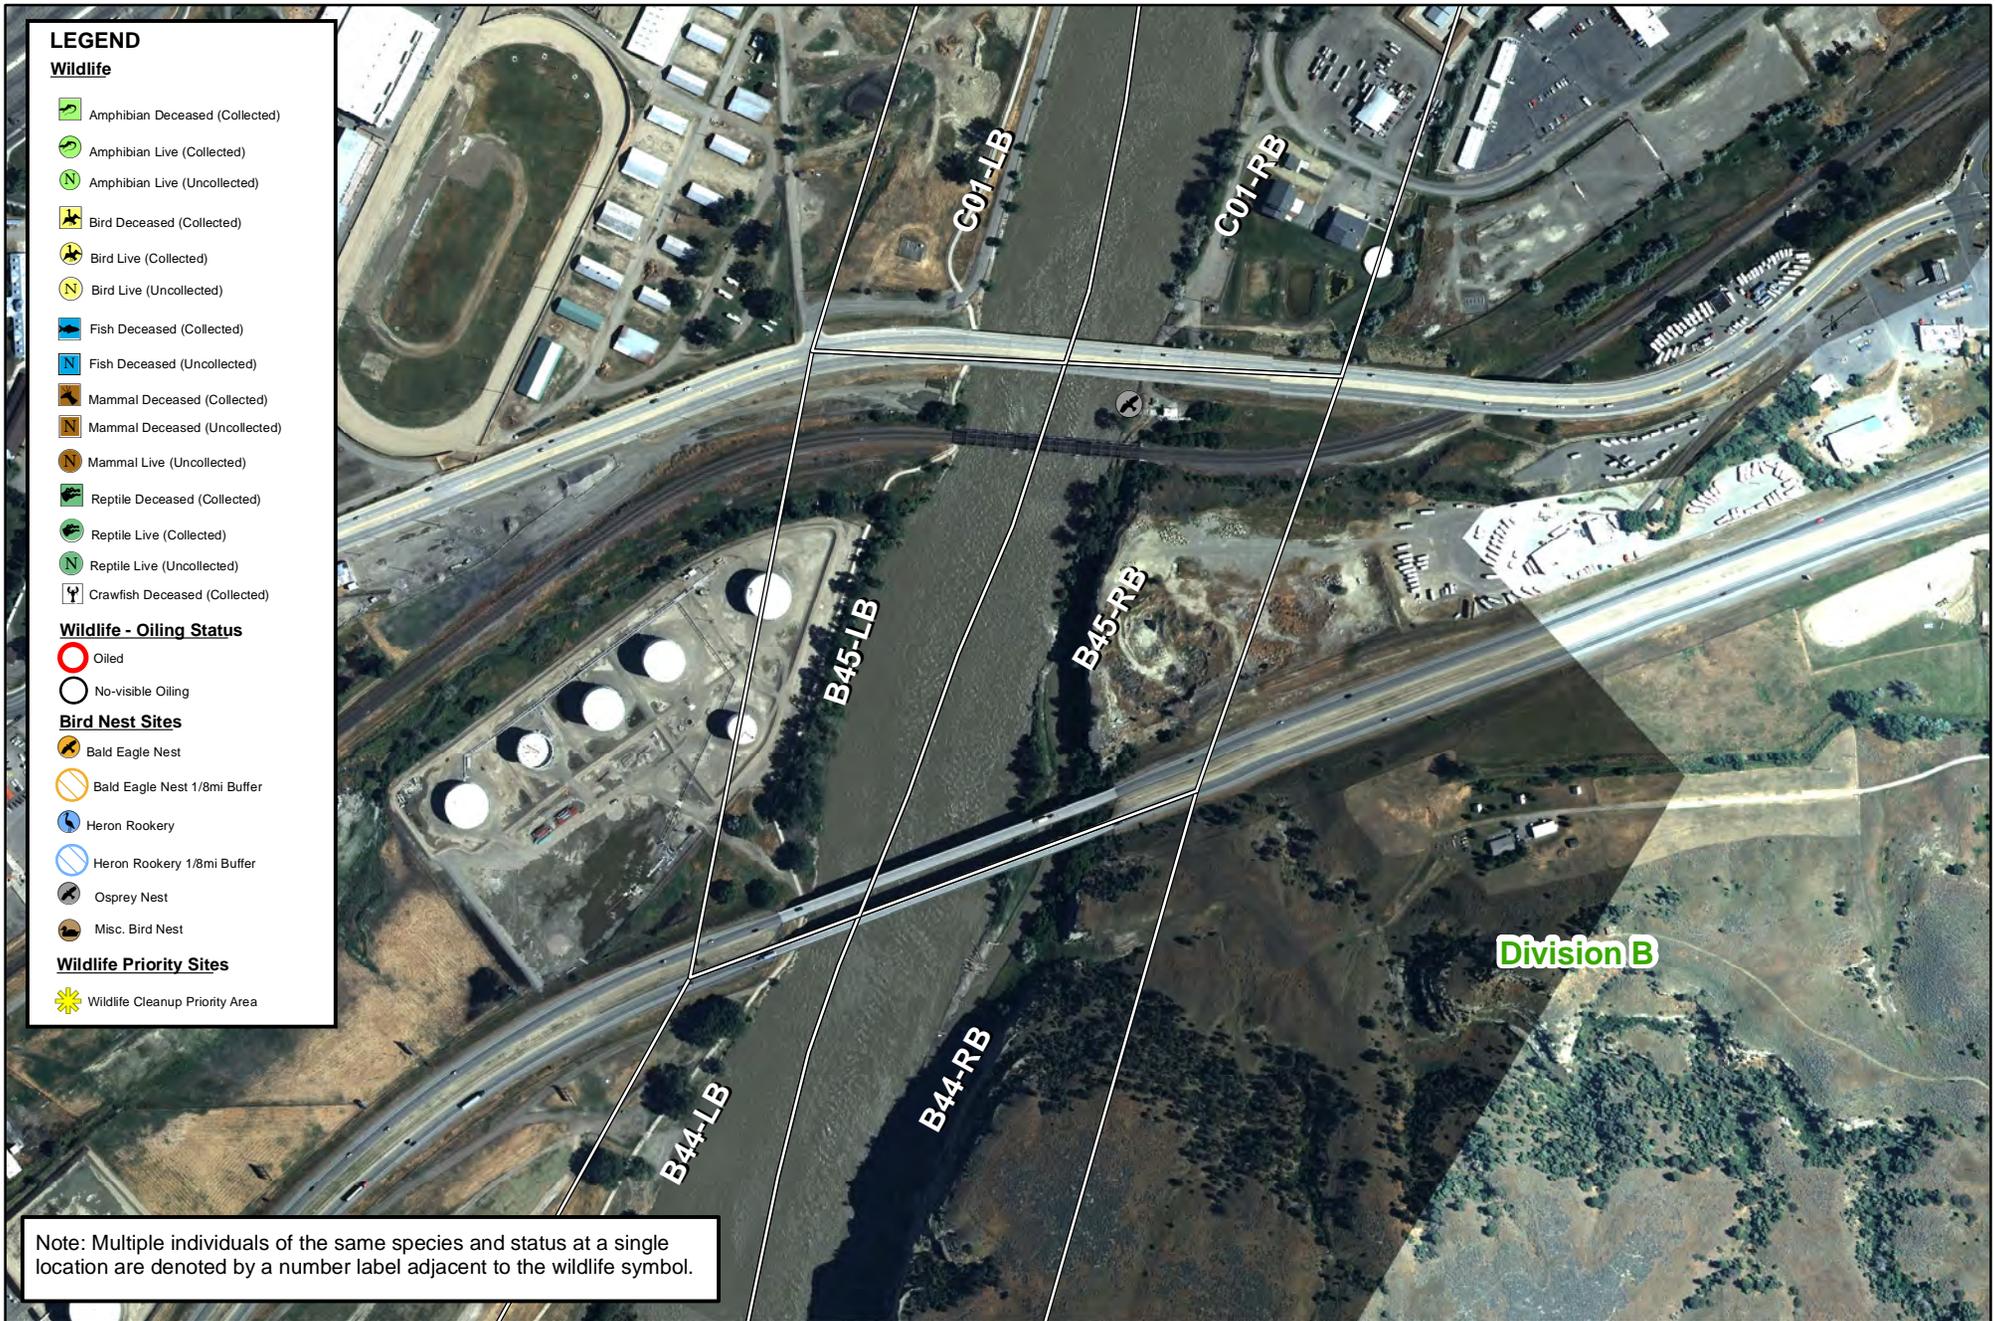
Figure 2
Wildlife Resources

Figure 2 summarizes the natural resources identified in this segment. International Bird Rescue and Resource Advisors from U.S. Fish and Wildlife Service conducted regular inspections of Area B45. No oiled wildlife was observed or recovered. No Wildlife Priority Cleanup Areas were identified. No active migratory bird nests were identified in Area B45.

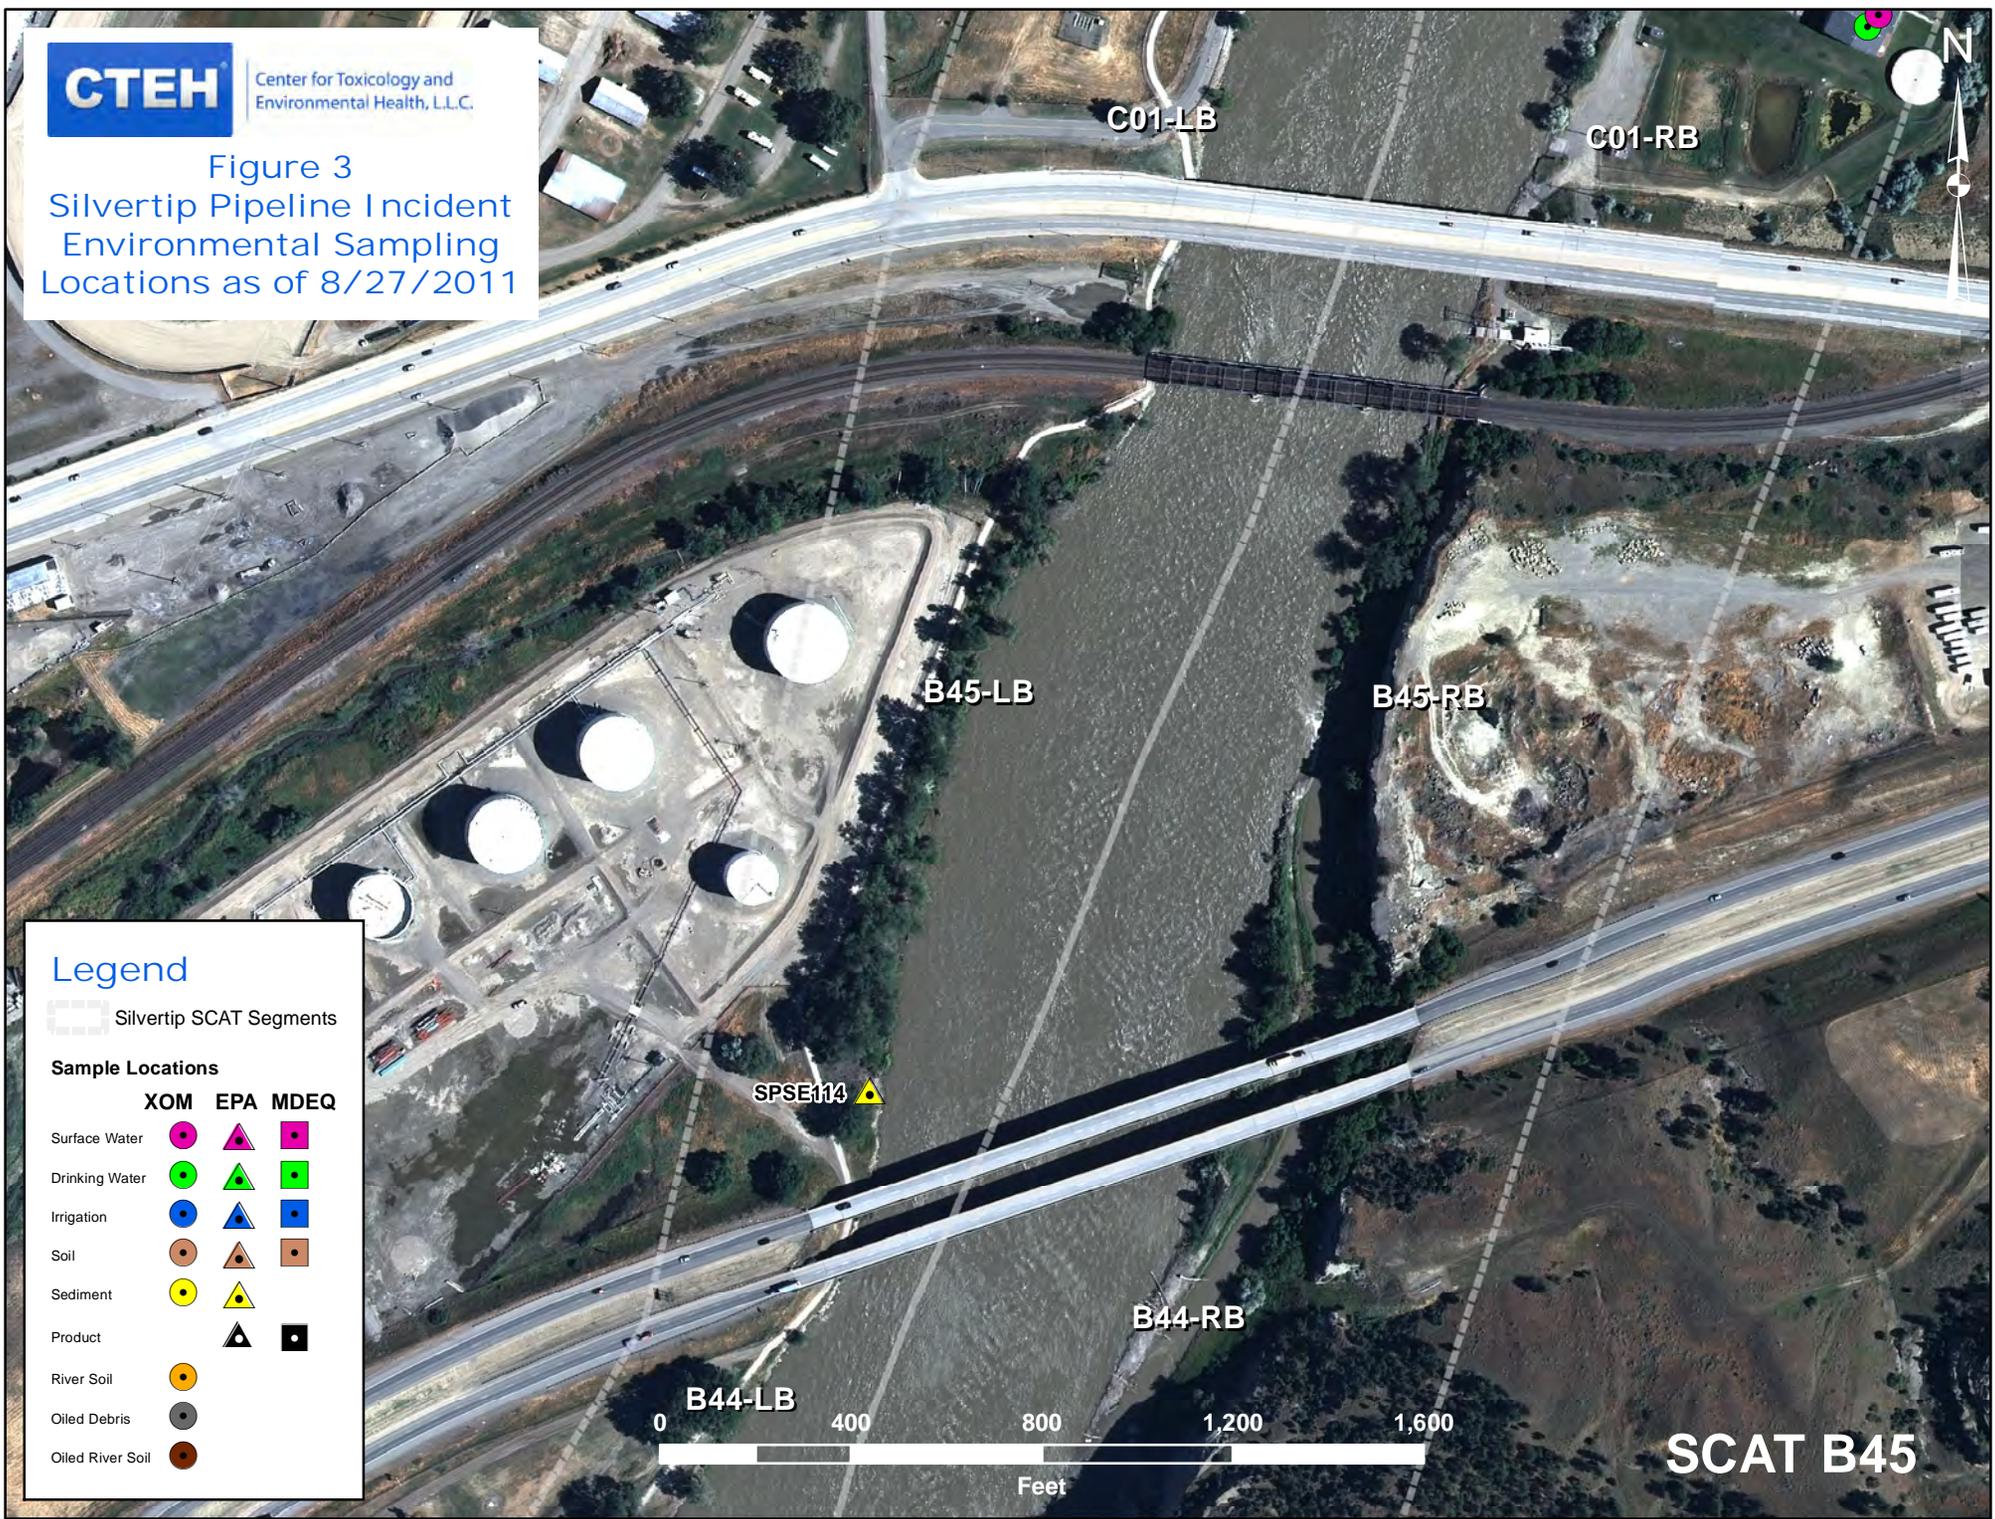
Figure 3
 Silvertip Pipeline Incident
 Environmental Sampling
 Locations as of 8/27/2011

Table 1 (below) summarizes samples collected within Area B45. The analytical results for the samples collected can be accessed through a publicly accessible database on the United States Environmental Protection Agency's (USEPA's) website. The approximate locations of samples collected within Area B45 are provided on Figure 3.

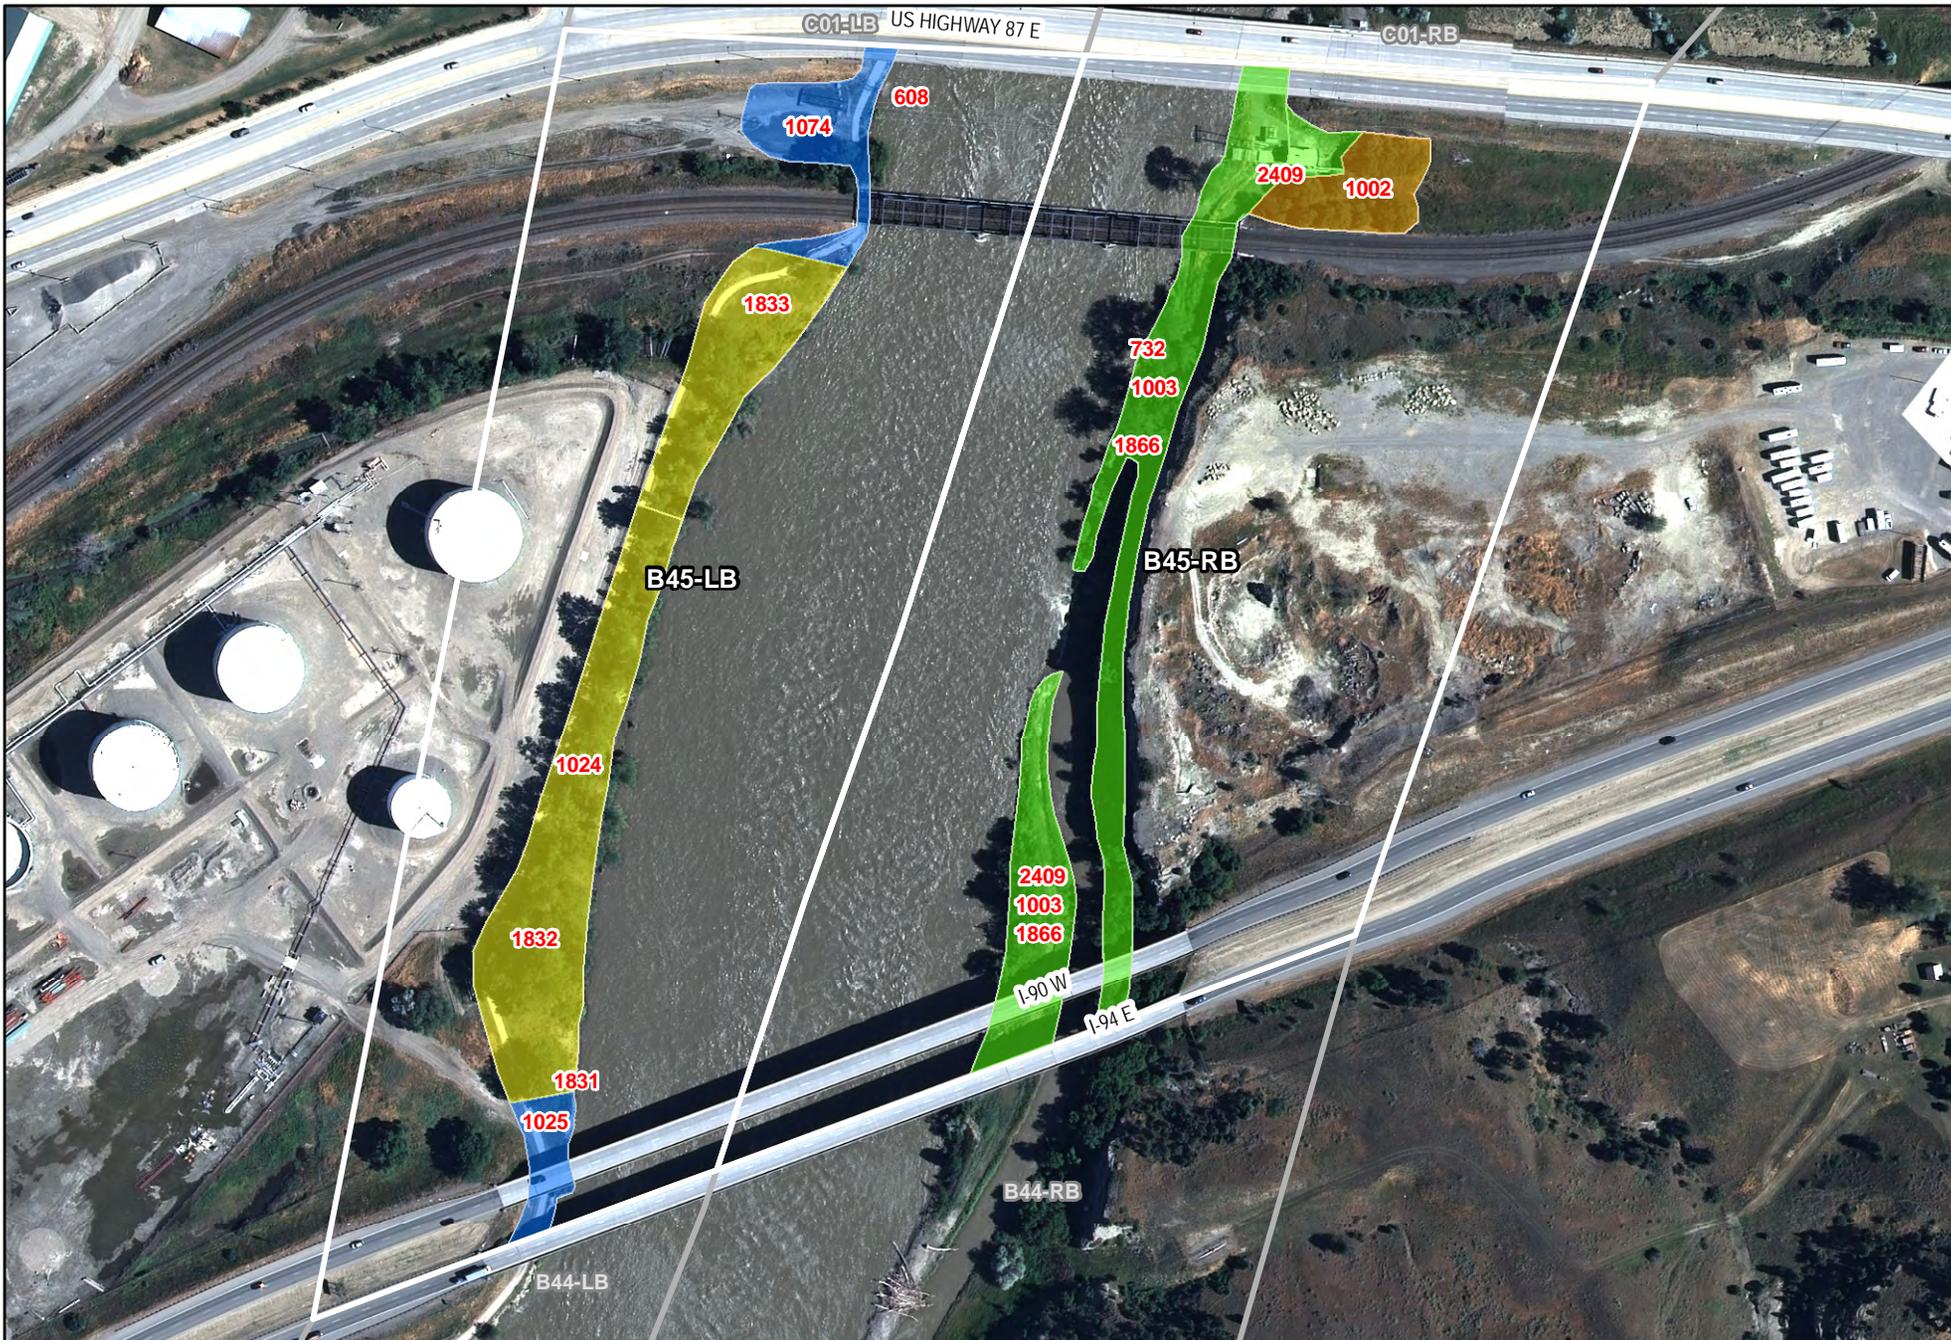
The SCAT teams used systematic evaluation criteria and treatment method tables approved by the National Oceanic and Atmospheric Administration to provide a standard approach for data collection and conducting field surveys. The forms and sketches from the initial SCAT surveys performed along the river bank (water edge) and floodplain within Area B45 are included in Appendix B. Figure 4 provides the maximum oiling zones observed by the SCAT team during the initial surveys of Area B45.

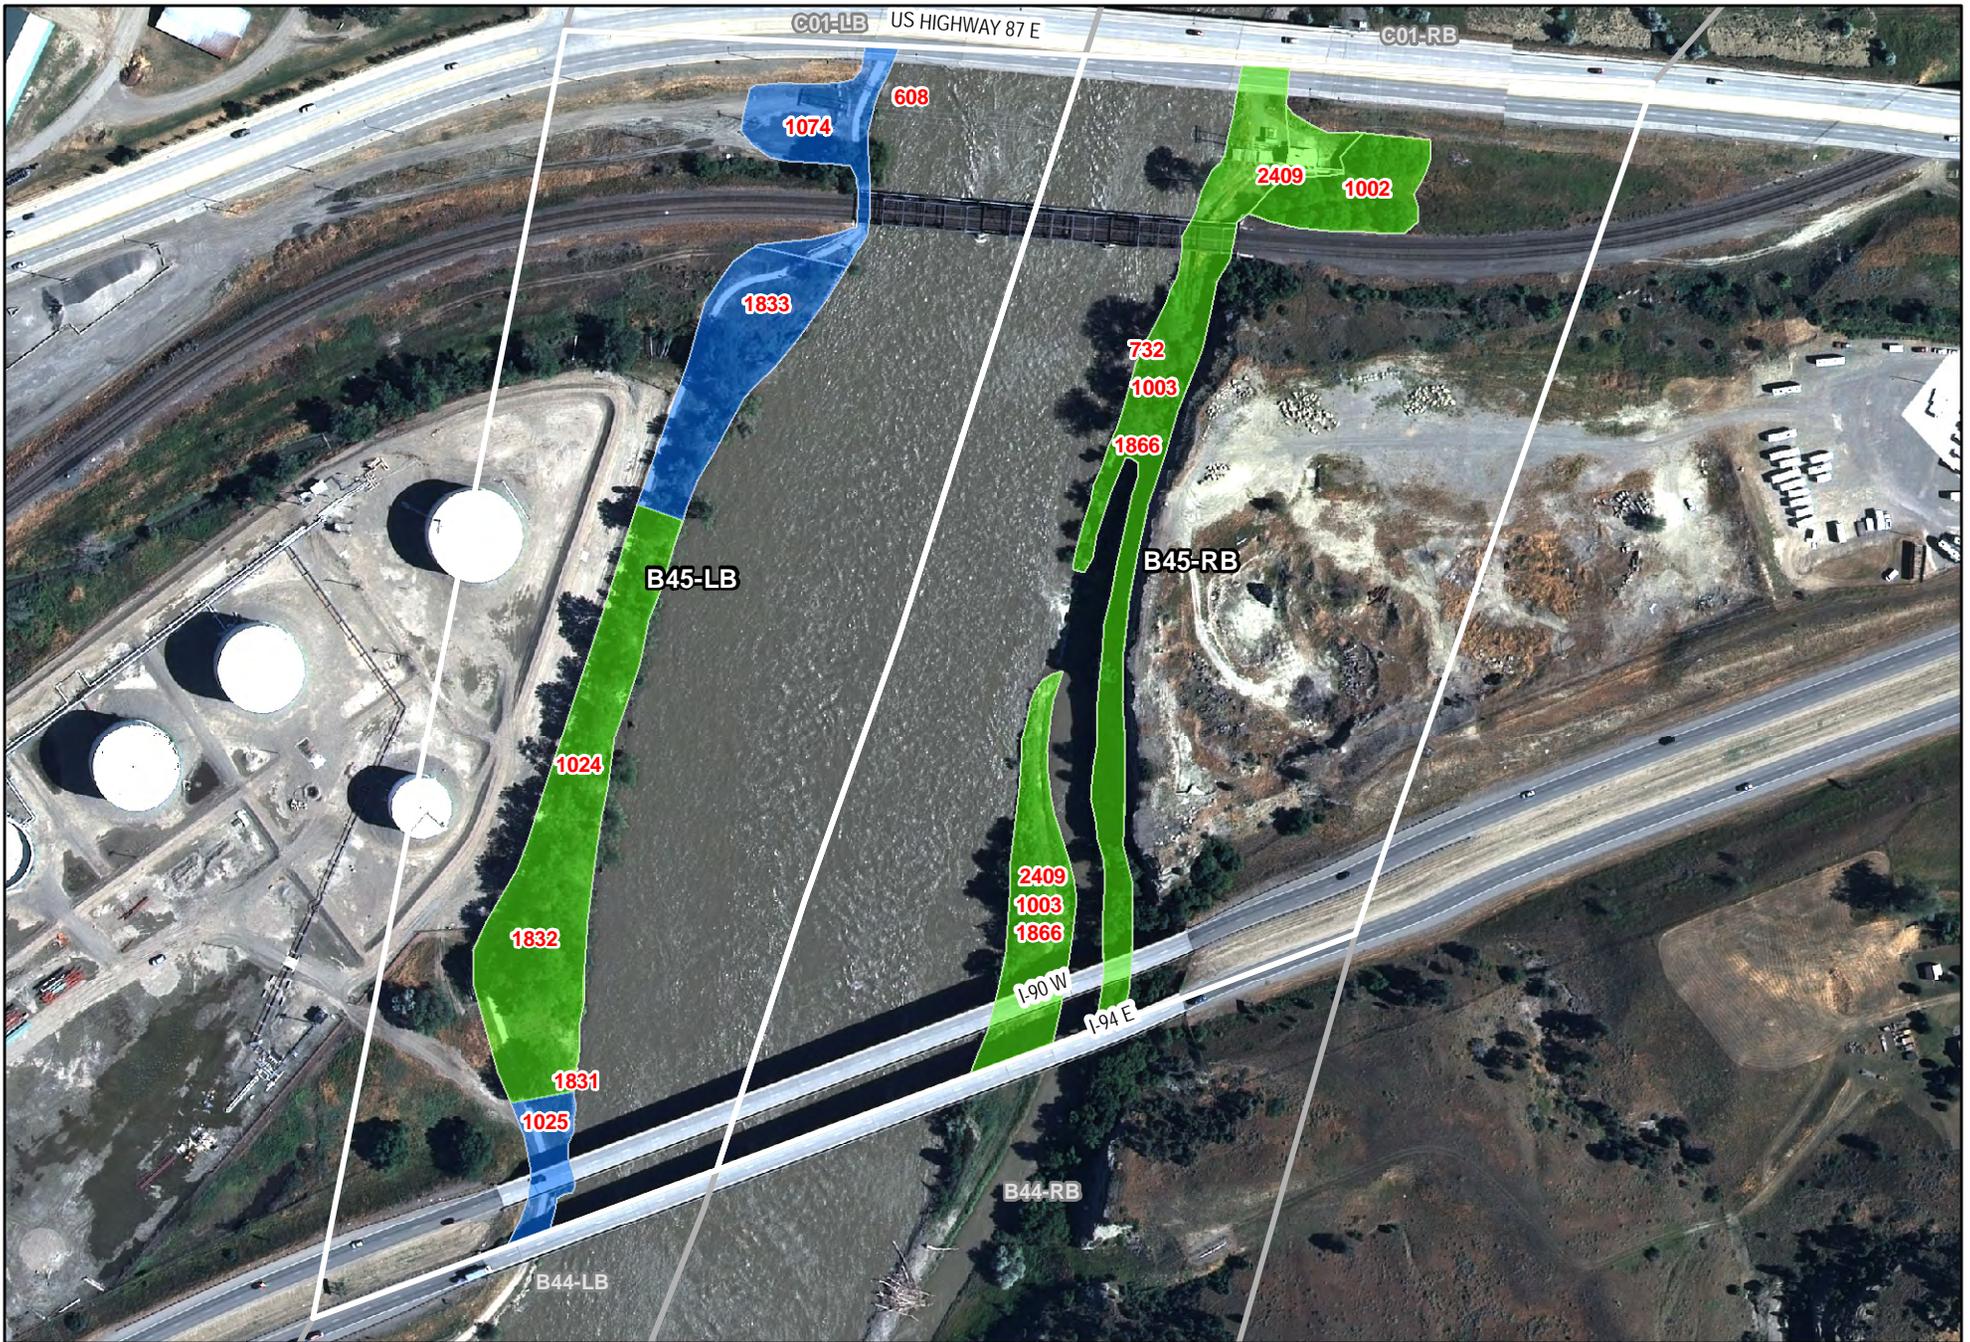
**Figure 5 - Final SCAT Observations
For SCAT Area:**

Figure 5 shows the oiling conditions within Area B45 following completion of oil removal activities. The SCAT team performed final surveys of the right and left banks within SCAT Area B45 to confirm the agreed-upon cleanup endpoints identified in the applicable CTRs had been achieved. The final SCAT survey documentation is presented in Appendix E.

Based on the final SCAT surveys performed on the right and left banks within Area B45, no further treatment is recommended for these segments. SCAT Segment Sign-Off Forms are included as Appendix F.

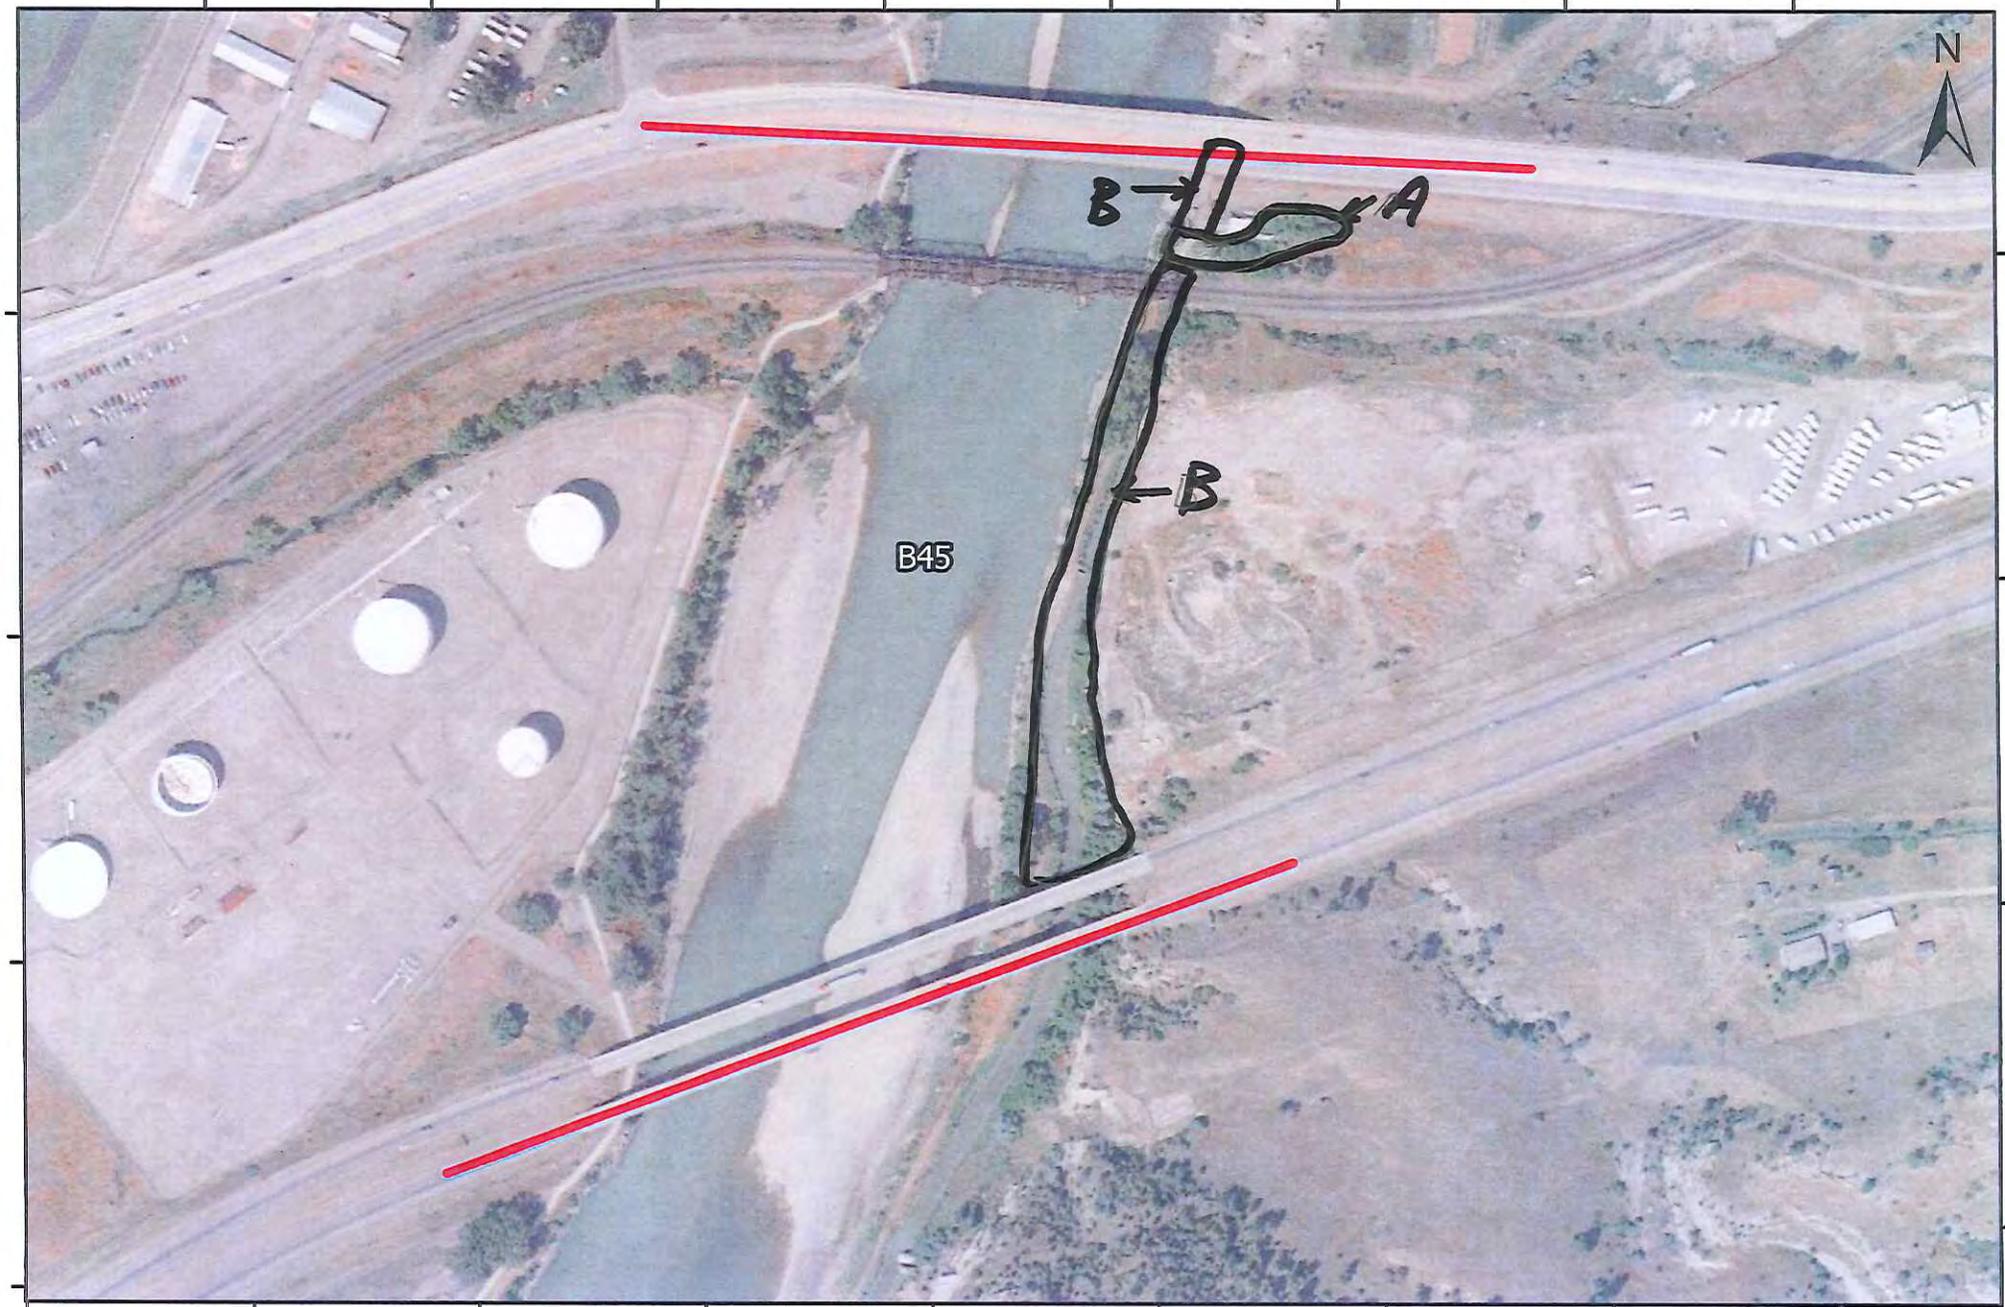
B45 -
(L/R/I)??

Zones A & B - Hand crews cut oiled vegetation.

Zone A - Height above substrate 0.5 m, thickness 2.0 m.
