**SCAT Area Transition Report for
B47**

Silvertip Pipeline Incident
Laurel, Montana

October 26, 2011

Prepared by:
ARCADIS G&M of North Carolina, Inc.
11000 Regency Parkway
West Tower, Suite 205
Cary, North Carolina 27518-8518
Tel 919.469.1952
Fax 919.469.5676

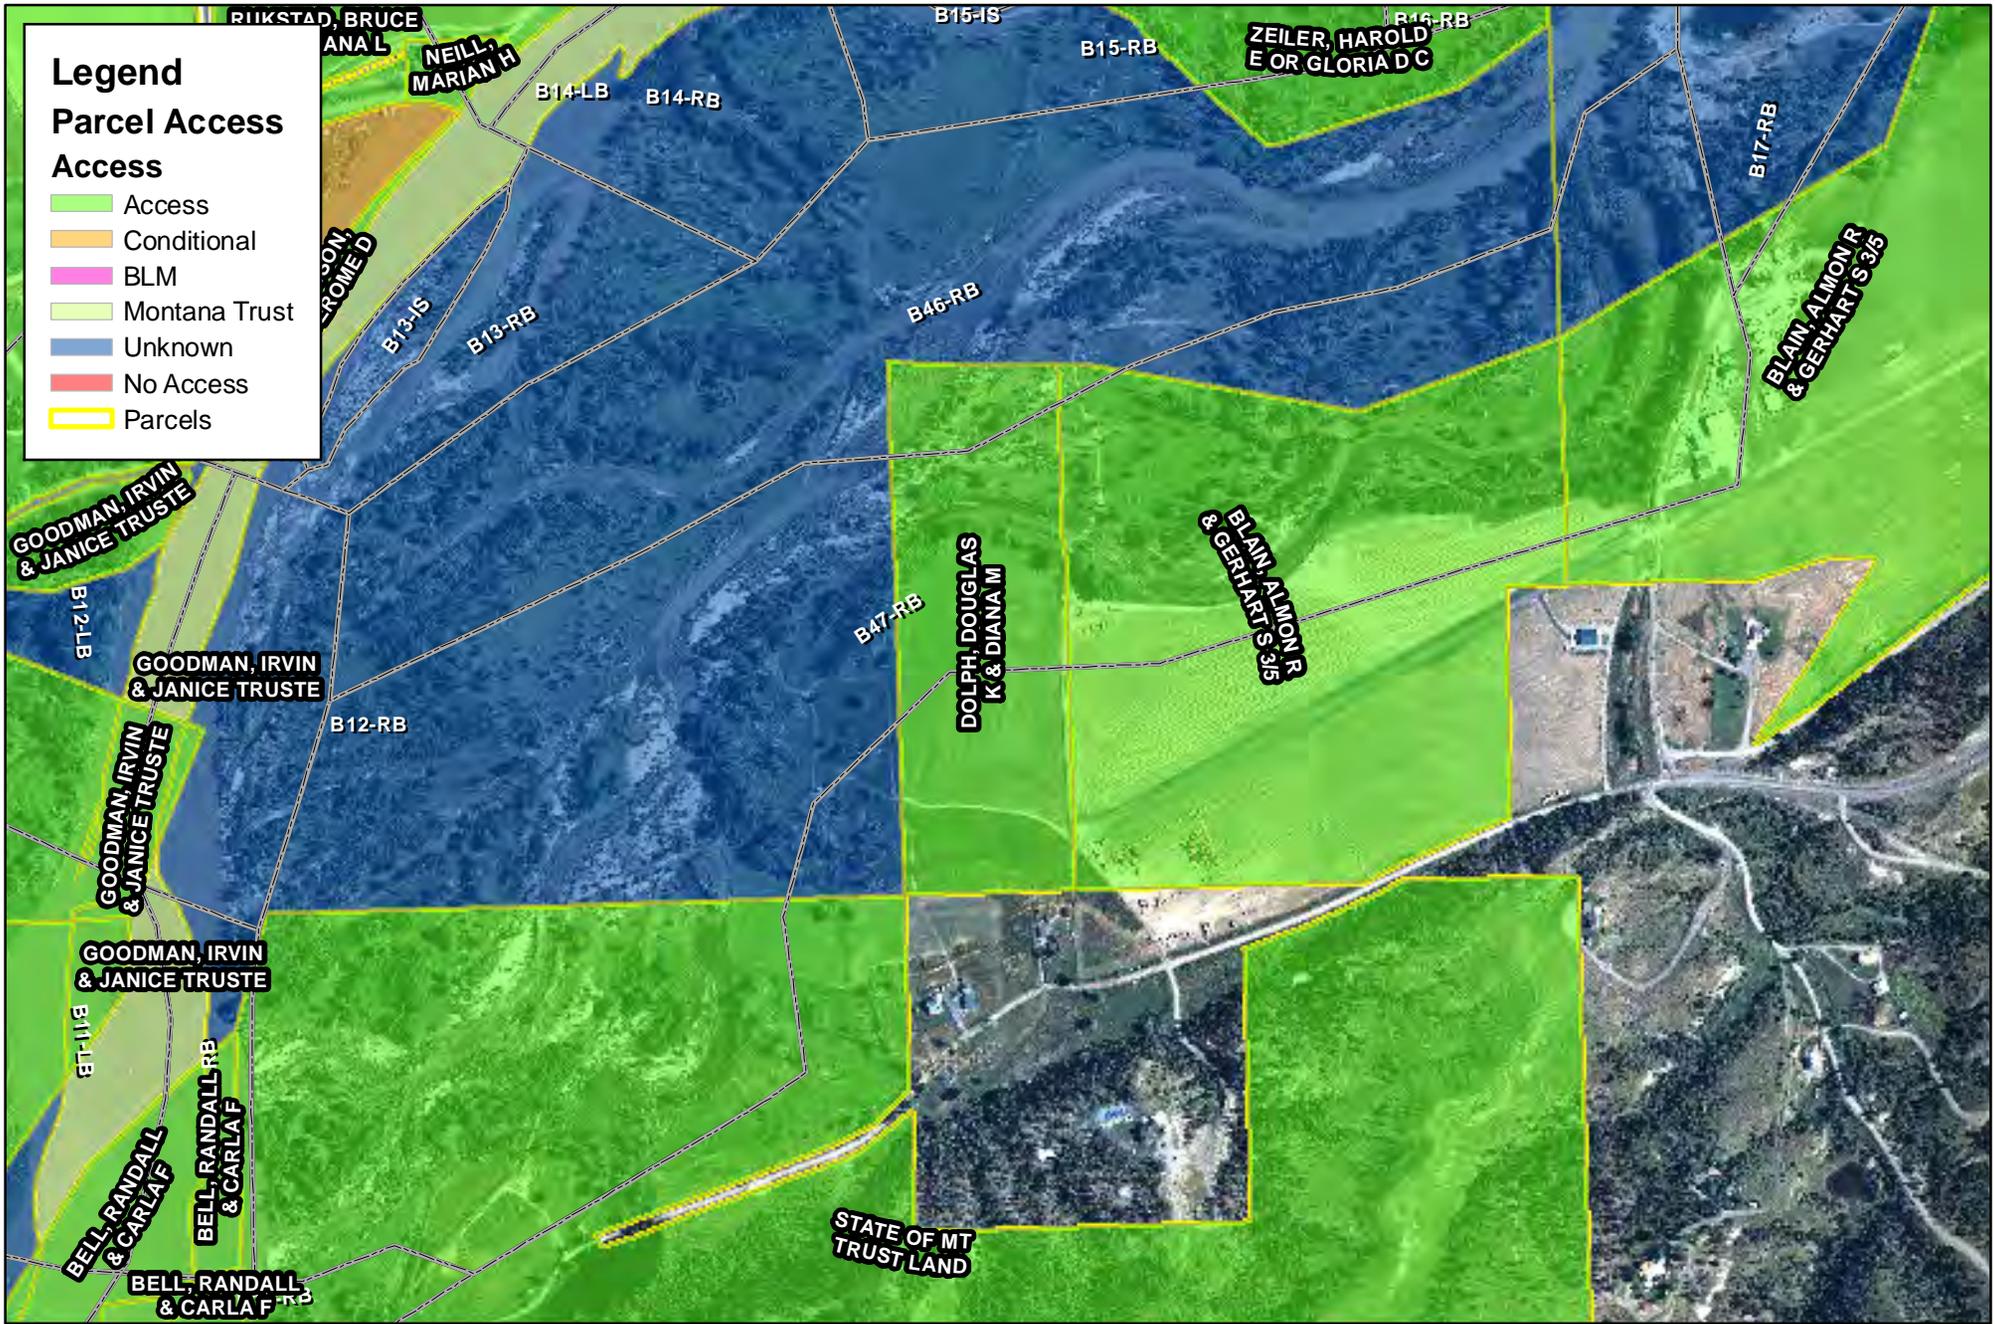
Figure 1 provides an aerial map of SCAT Area B47, along with the (a) SCAT Area boundary, (b) parcel boundaries and respective property owners, and (c) access constraints identified during the oil cleanup process. The acreage surveyed in Area B47 is 166.6. There were no access issues for the right bank, but some land did have unknown ownership.

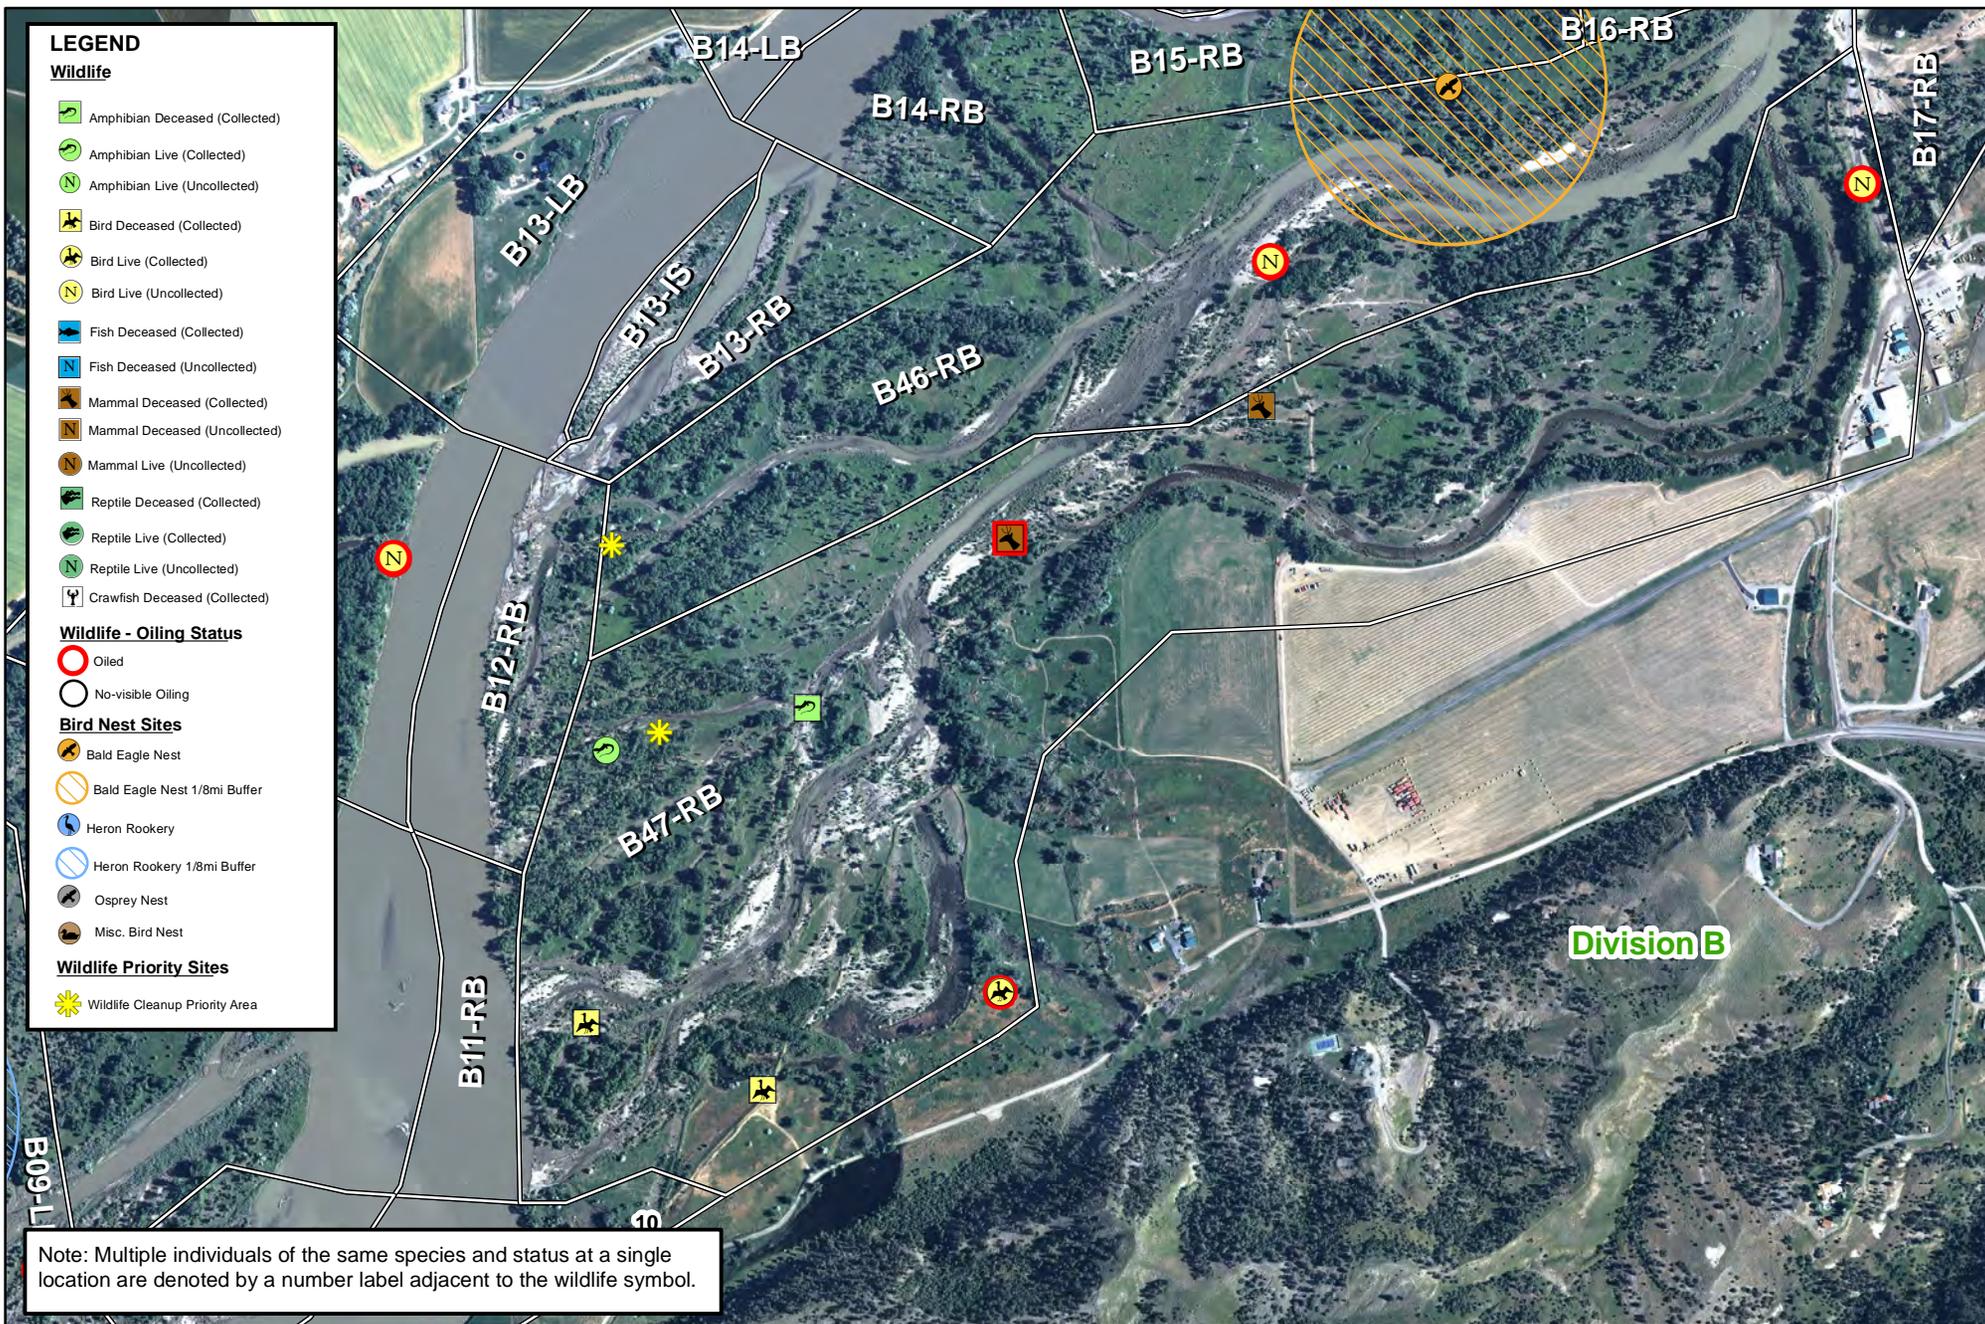
Figure 2
Wildlife Resources

Figure 2 summarizes the natural resources identified in this segment. International Bird Rescue and Resource Advisors from U.S. Fish and Wildlife Service conducted regular inspections of Area B47. One moderately oiled American robin (*Turdus migratorius*) was captured, cleaned, and released. A deceased lightly oiled beaver (*Castor canadensis*) was identified and retained. A lightly oiled mallard (*Anas platyrhynchos*) was observed but not captured for cleaning. A Leopard frog (*Rana pipiens*) was captured and taken to the Wildlife Recovery Center for an oiling evaluation, determined to be un-oiled, and released. Four deceased animals with no visible oiling were identified and retained: a red fox (*Vulpes vulpes*), a Leopard frog (*Rana pipiens*), a wood duck (*Aix sponsa*), and a Cooper's hawk (*Accipiter cooperii*). A Wildlife Priority Cleanup Area (WPCA) was identified. The WPCA consisted of an oiled debris pile with an associated pool with sheen. The WPCA was treated to reduce the potential for wildlife oiling and is no longer considered a wildlife hazard. No active migratory bird nests were identified in Area B47.

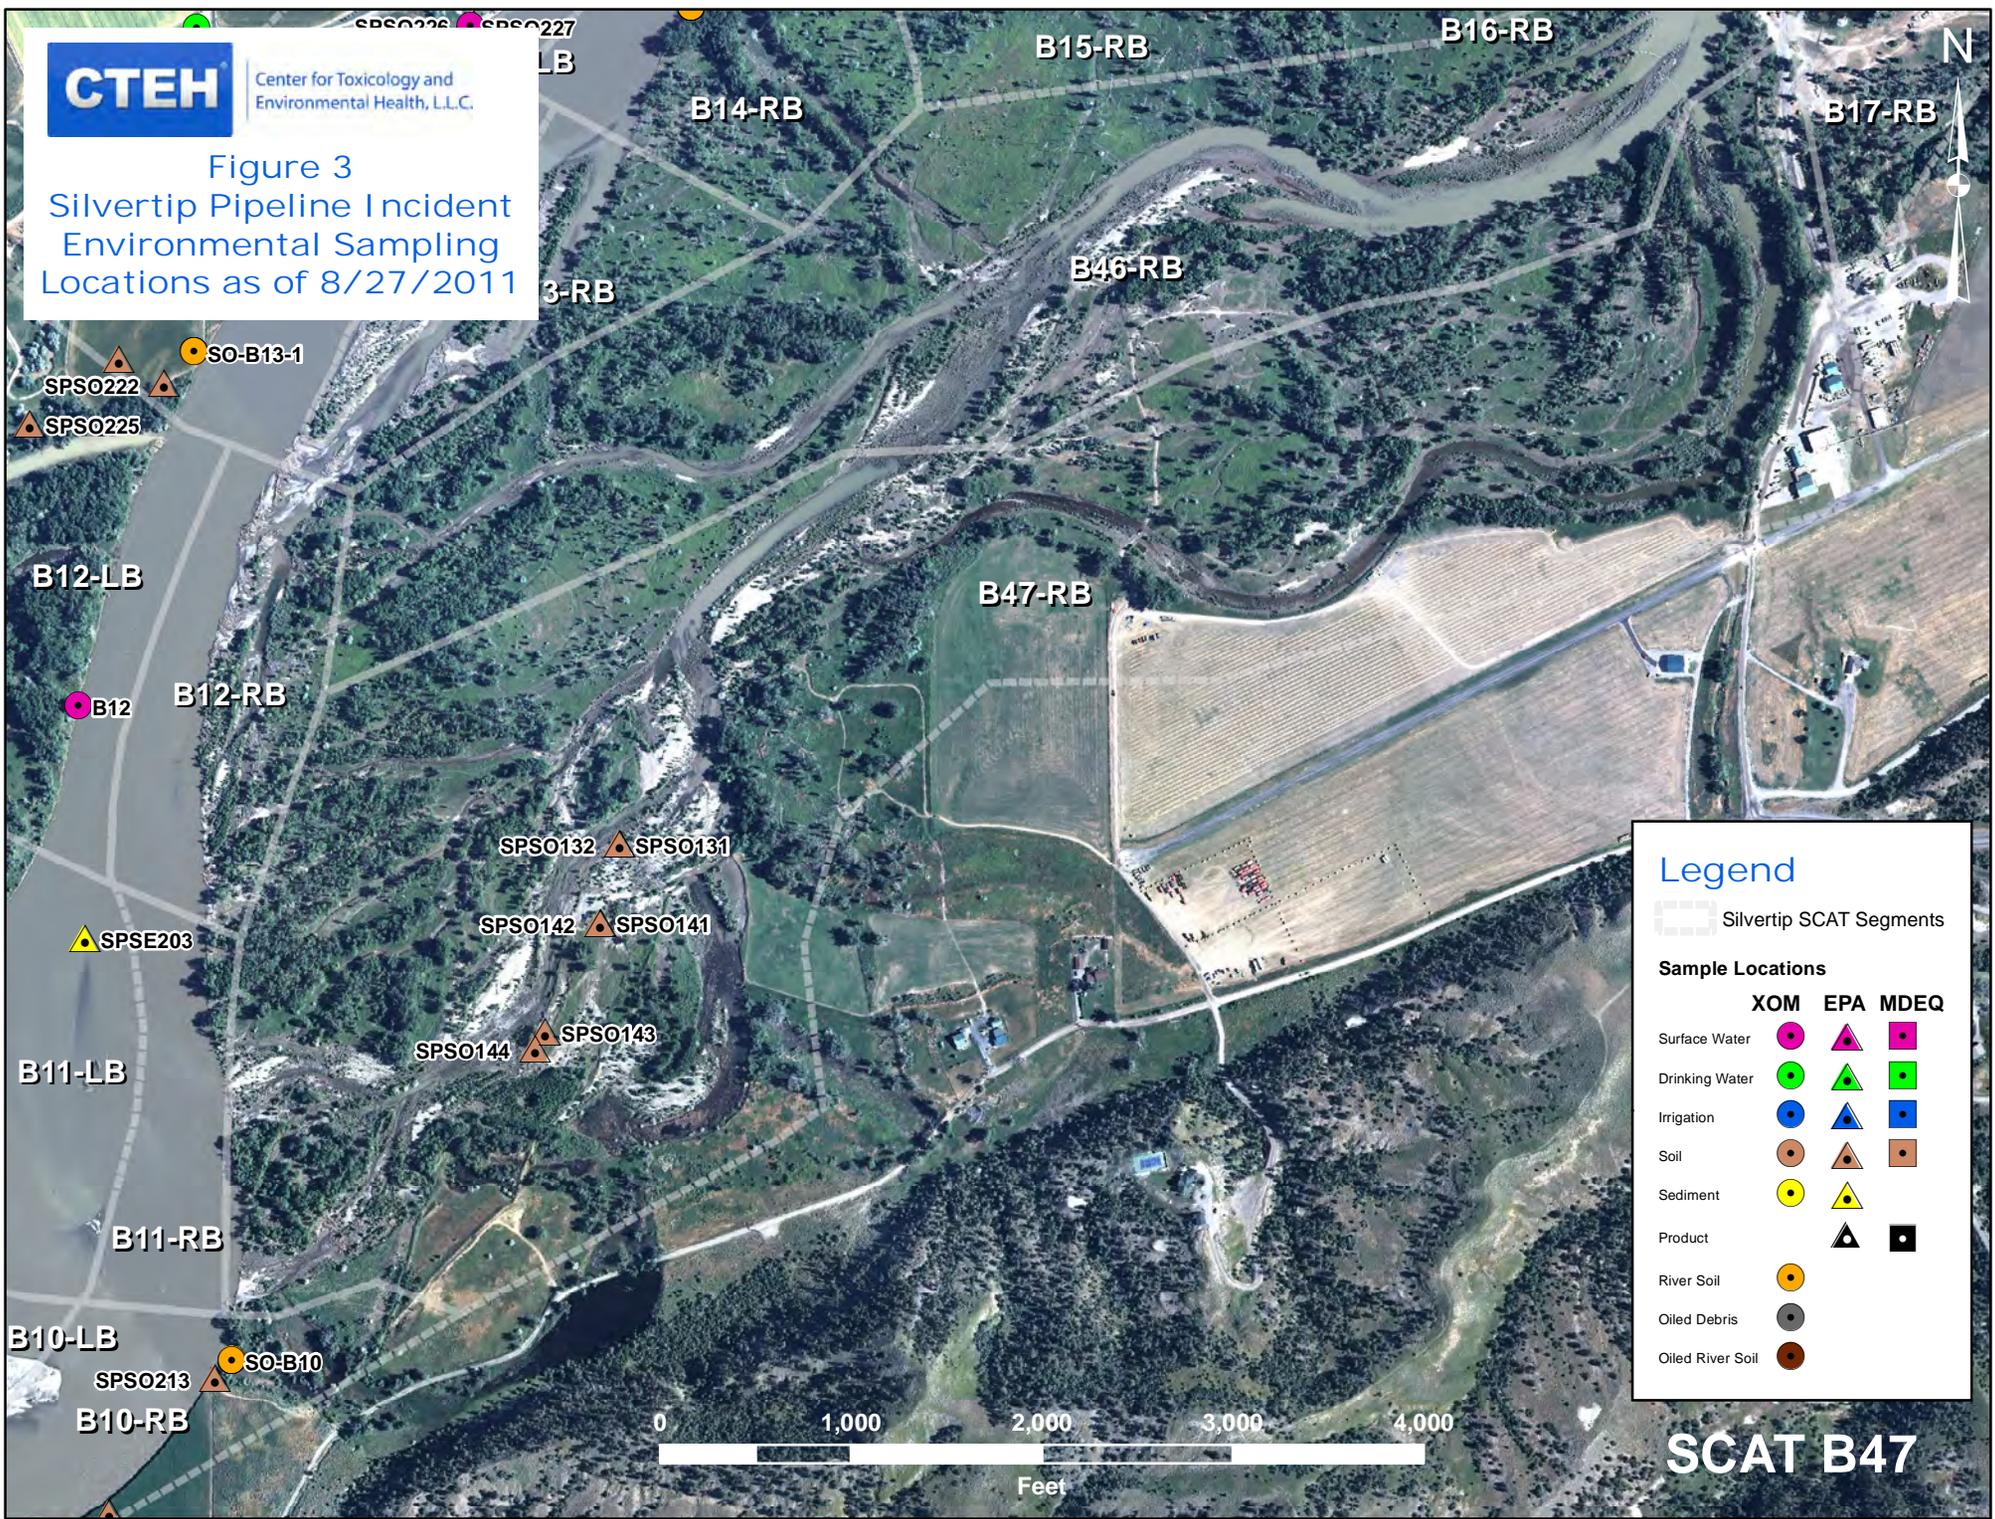
Figure 3
Silvertip Pipeline Incident
Environmental Sampling
Locations as of 8/27/2011

Table 1 (below) summarizes samples collected within Area B47. The analytical results for the samples collected can be accessed through a publicly accessible database on the United States Environmental Protection Agency's (USEPA's) website. The approximate locations of samples collected within Area B47 are provided on Figure 3.

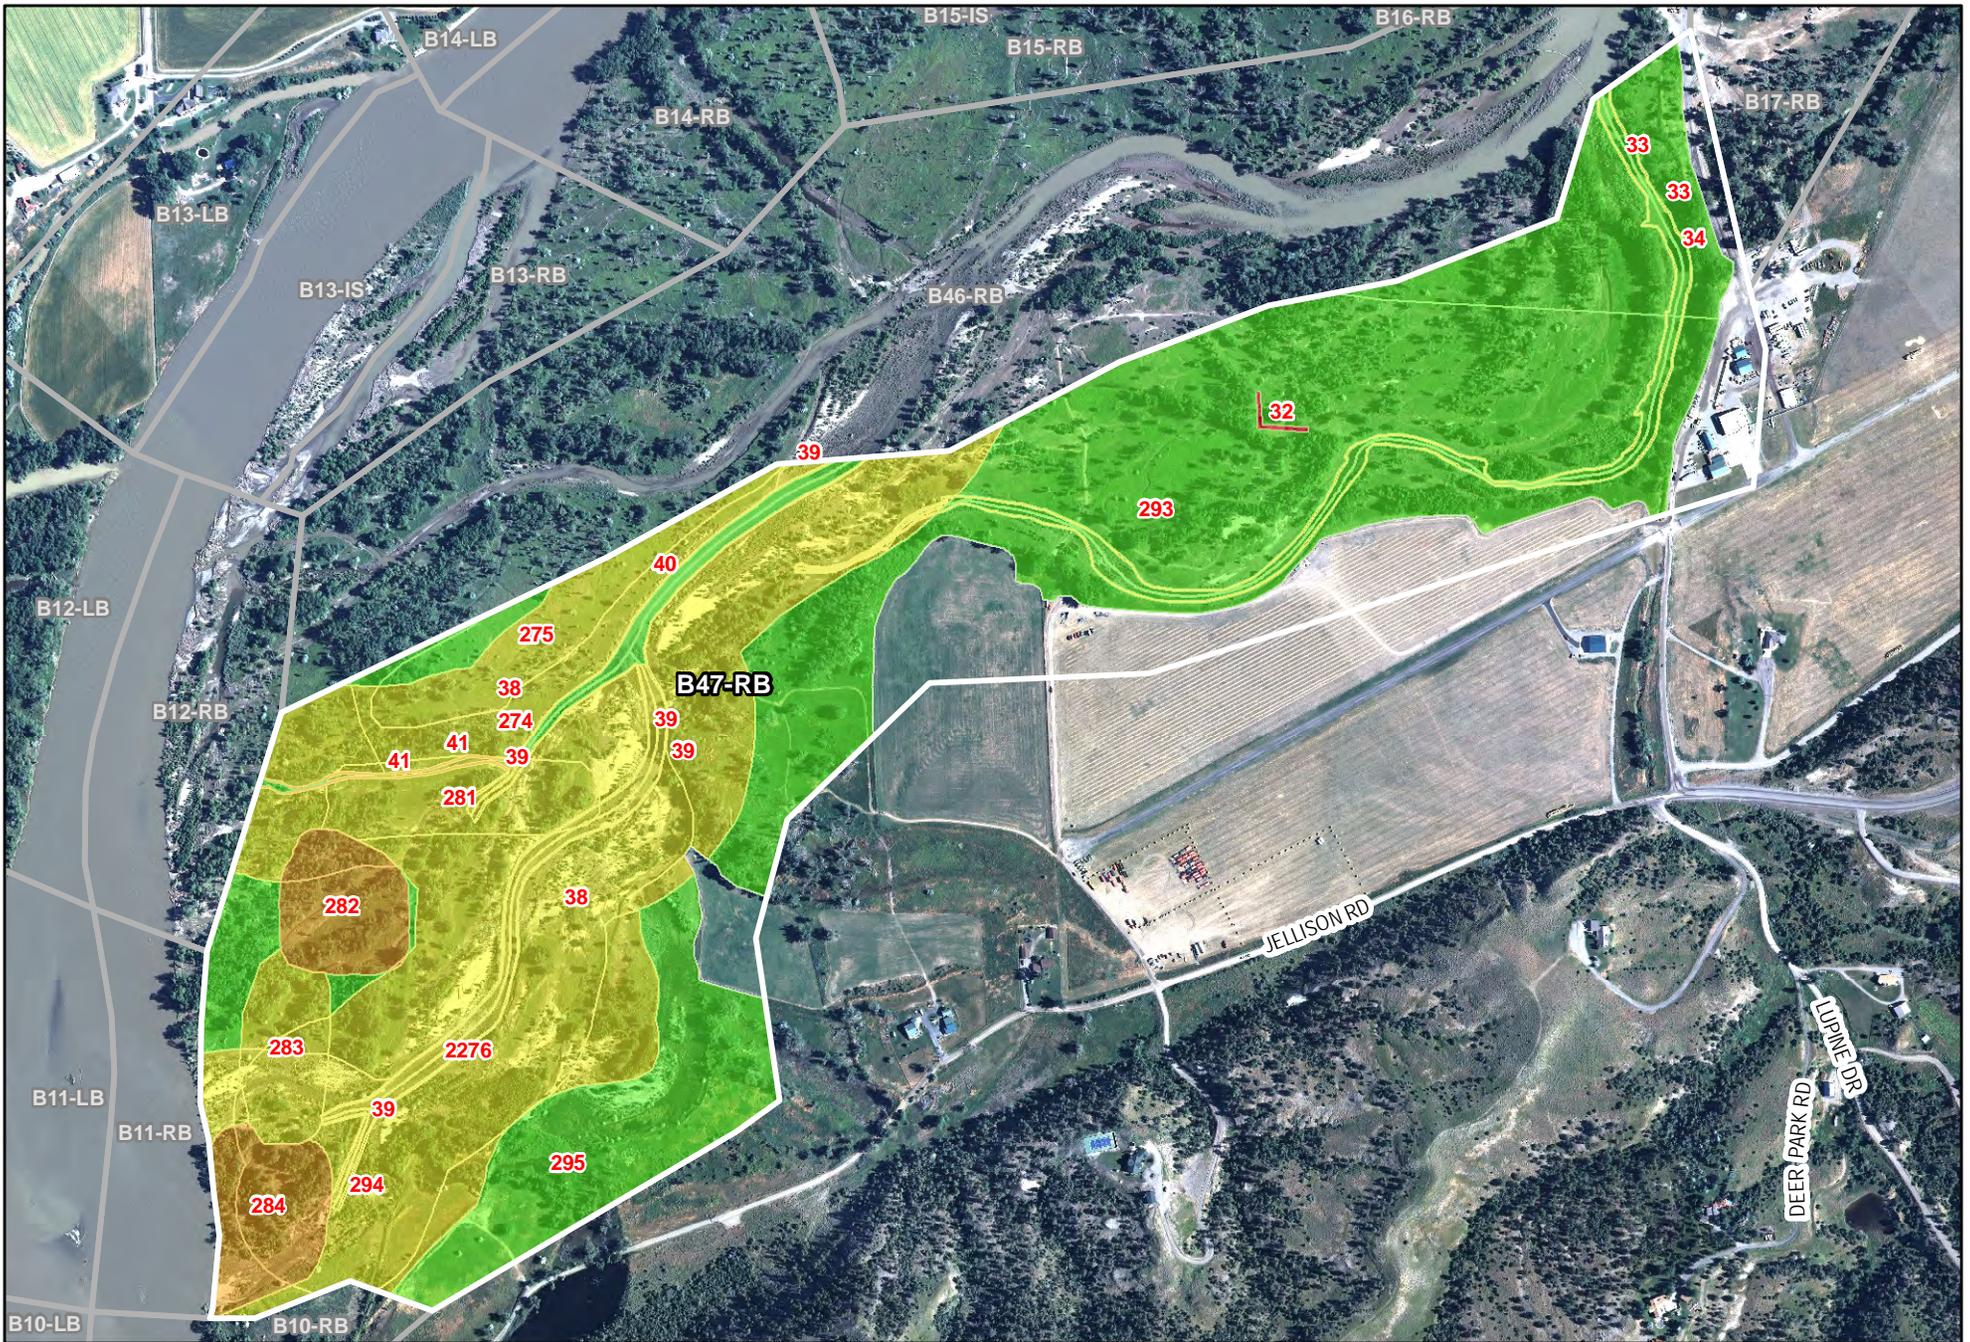
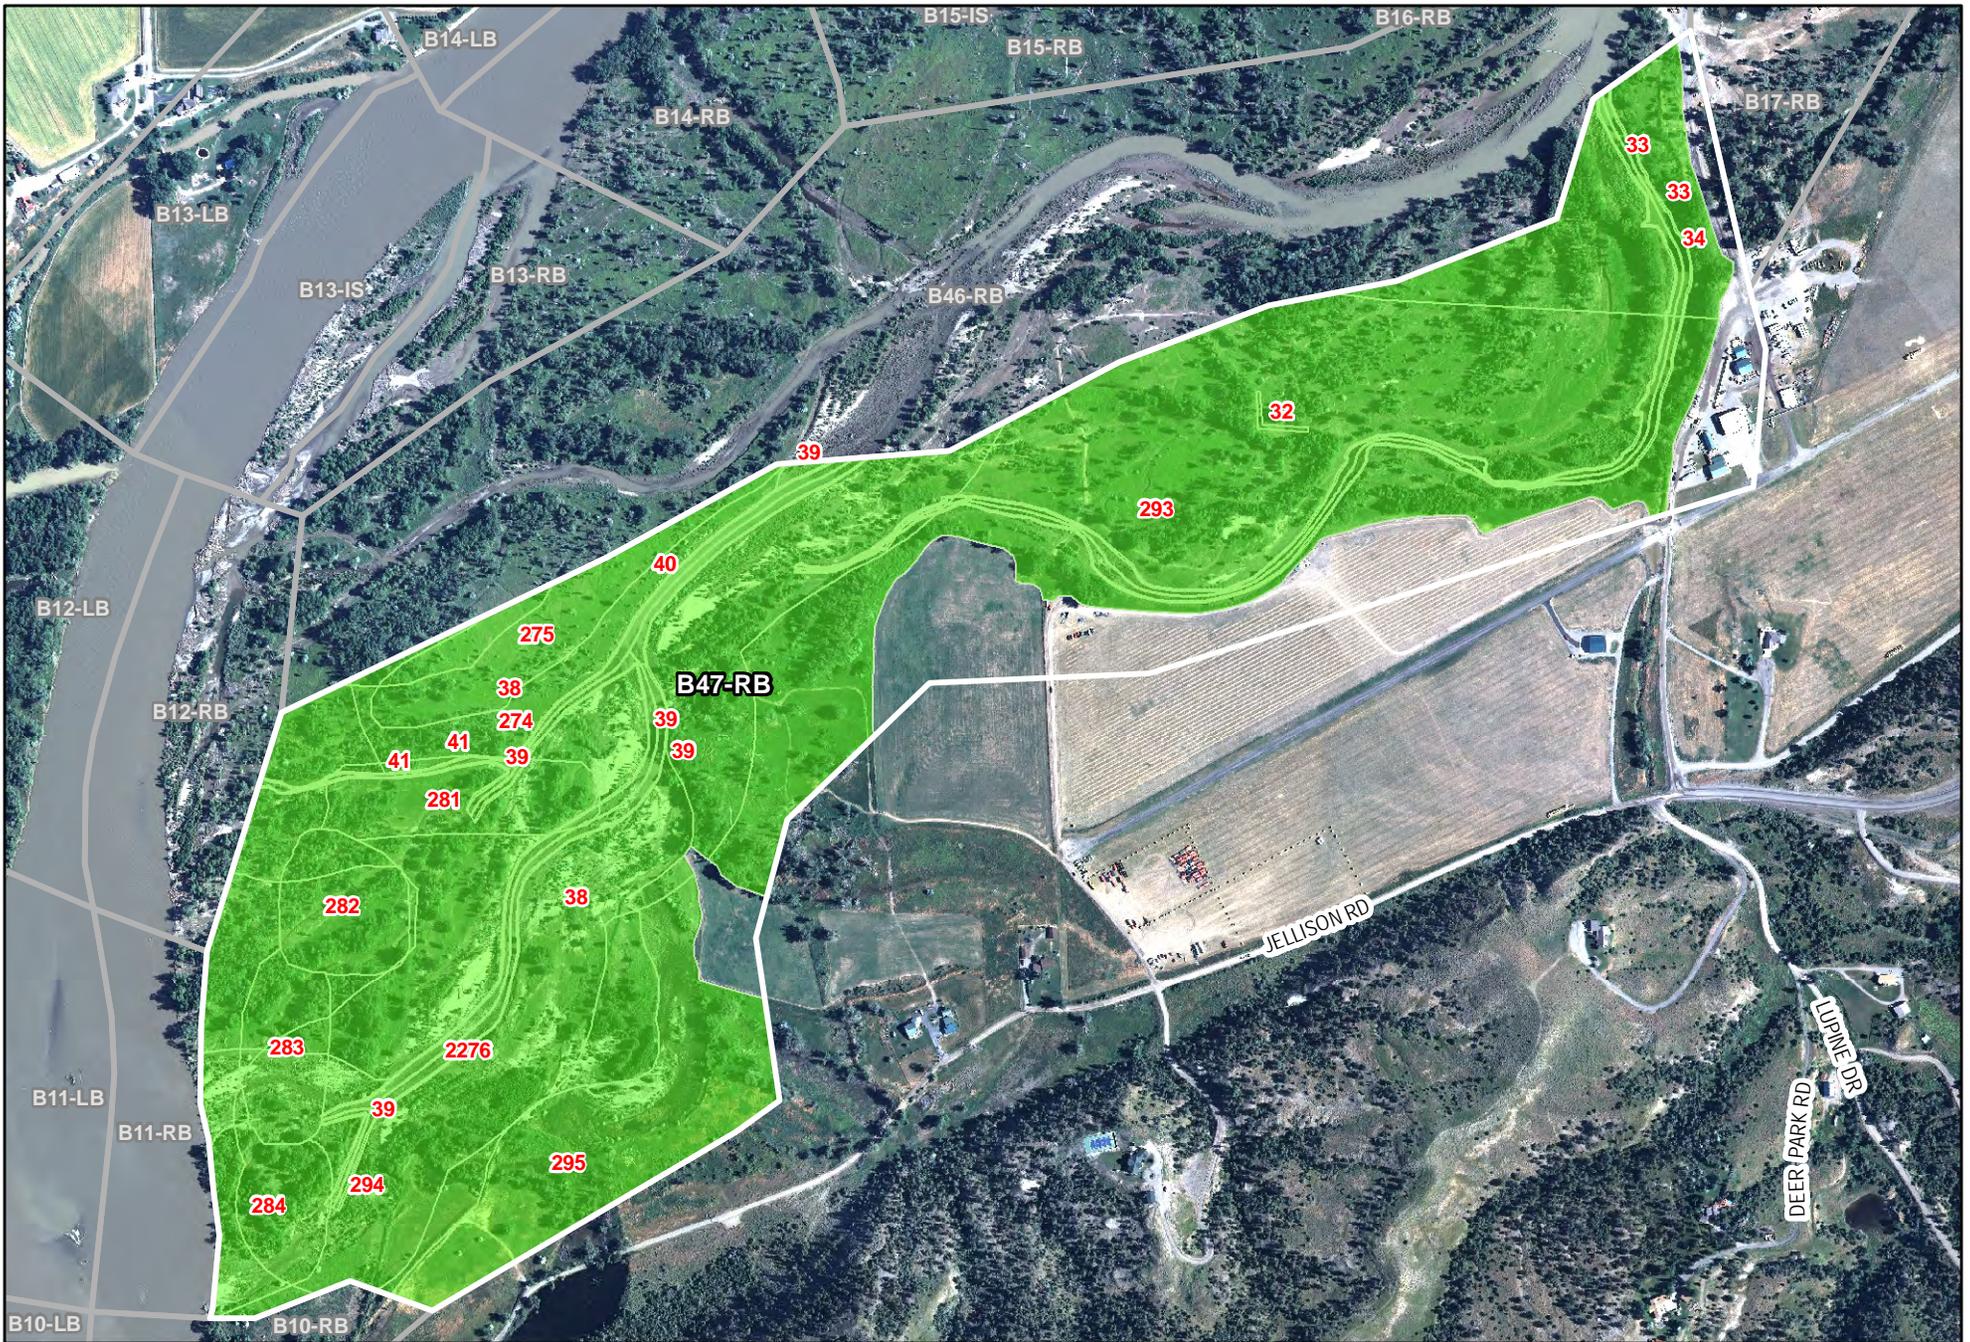
**Figure 5 - Final SCAT Observations
For SCAT Area: B47**

Figure 5 shows the oiling conditions within Area B47 following completion of oil removal activities. The SCAT team performed final surveys of the right bank within SCAT Area B47 to confirm the agreed-upon cleanup endpoints identified in the applicable CTRs had been achieved. The final SCAT survey documentation is presented in Appendix E.

Based on the final SCAT surveys performed on the right bank within Area B47, no further treatment is recommended for these segments. SCAT Segment Sign-Off Forms are included as Appendix F.

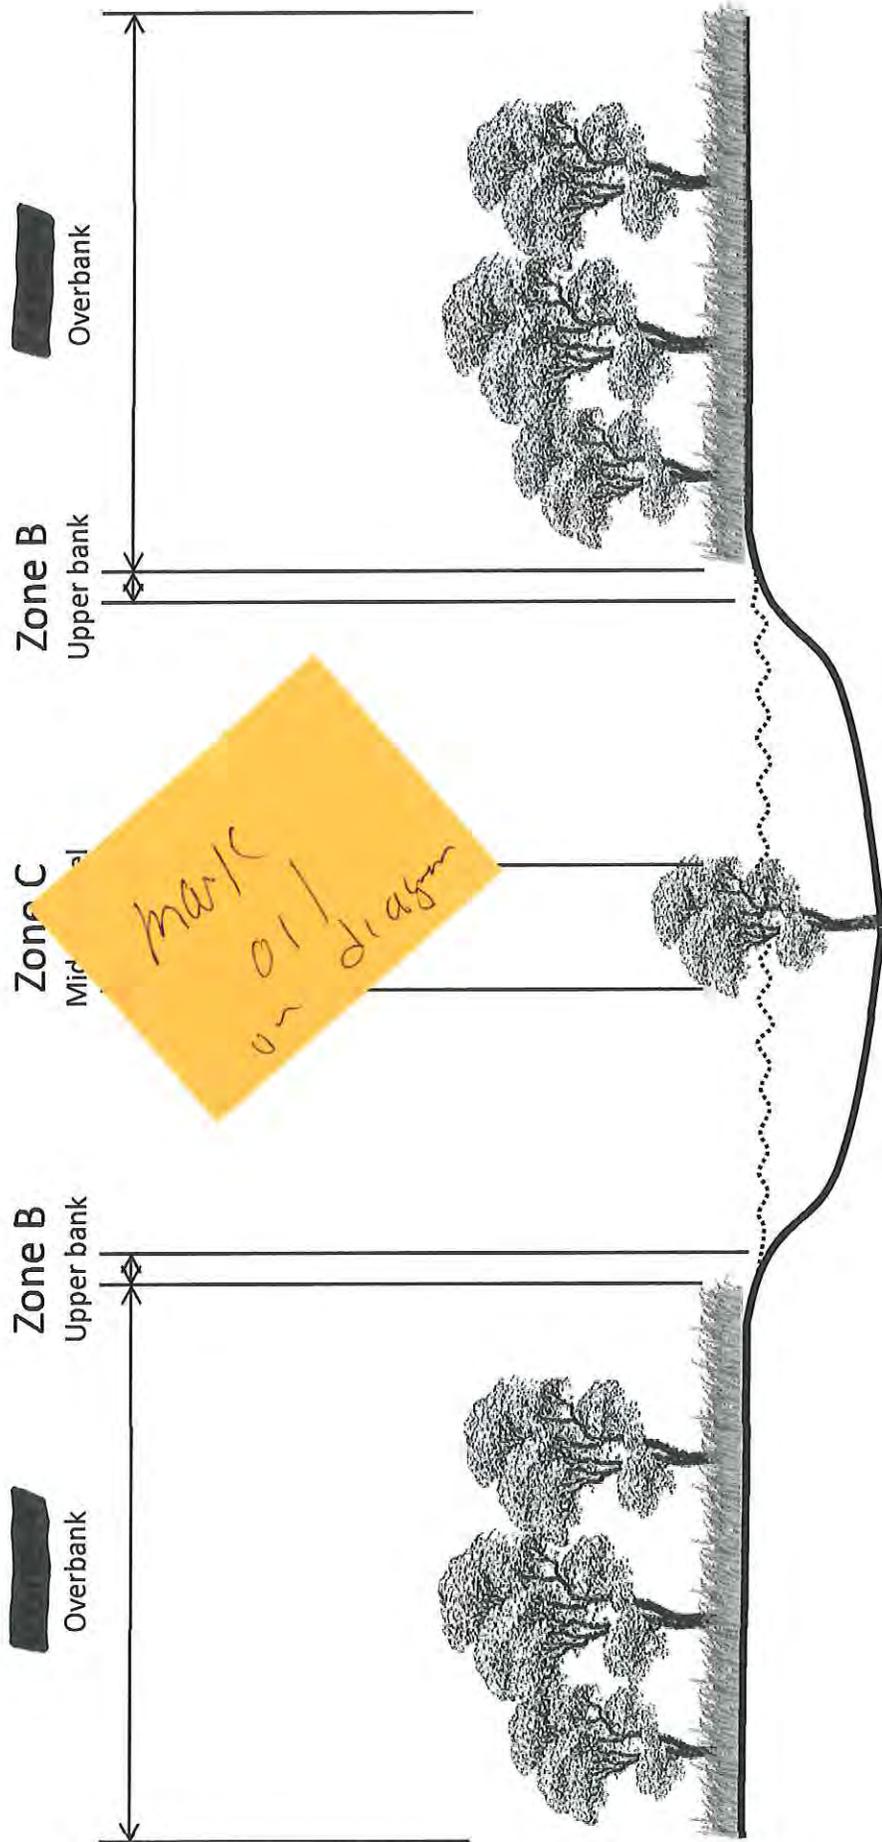
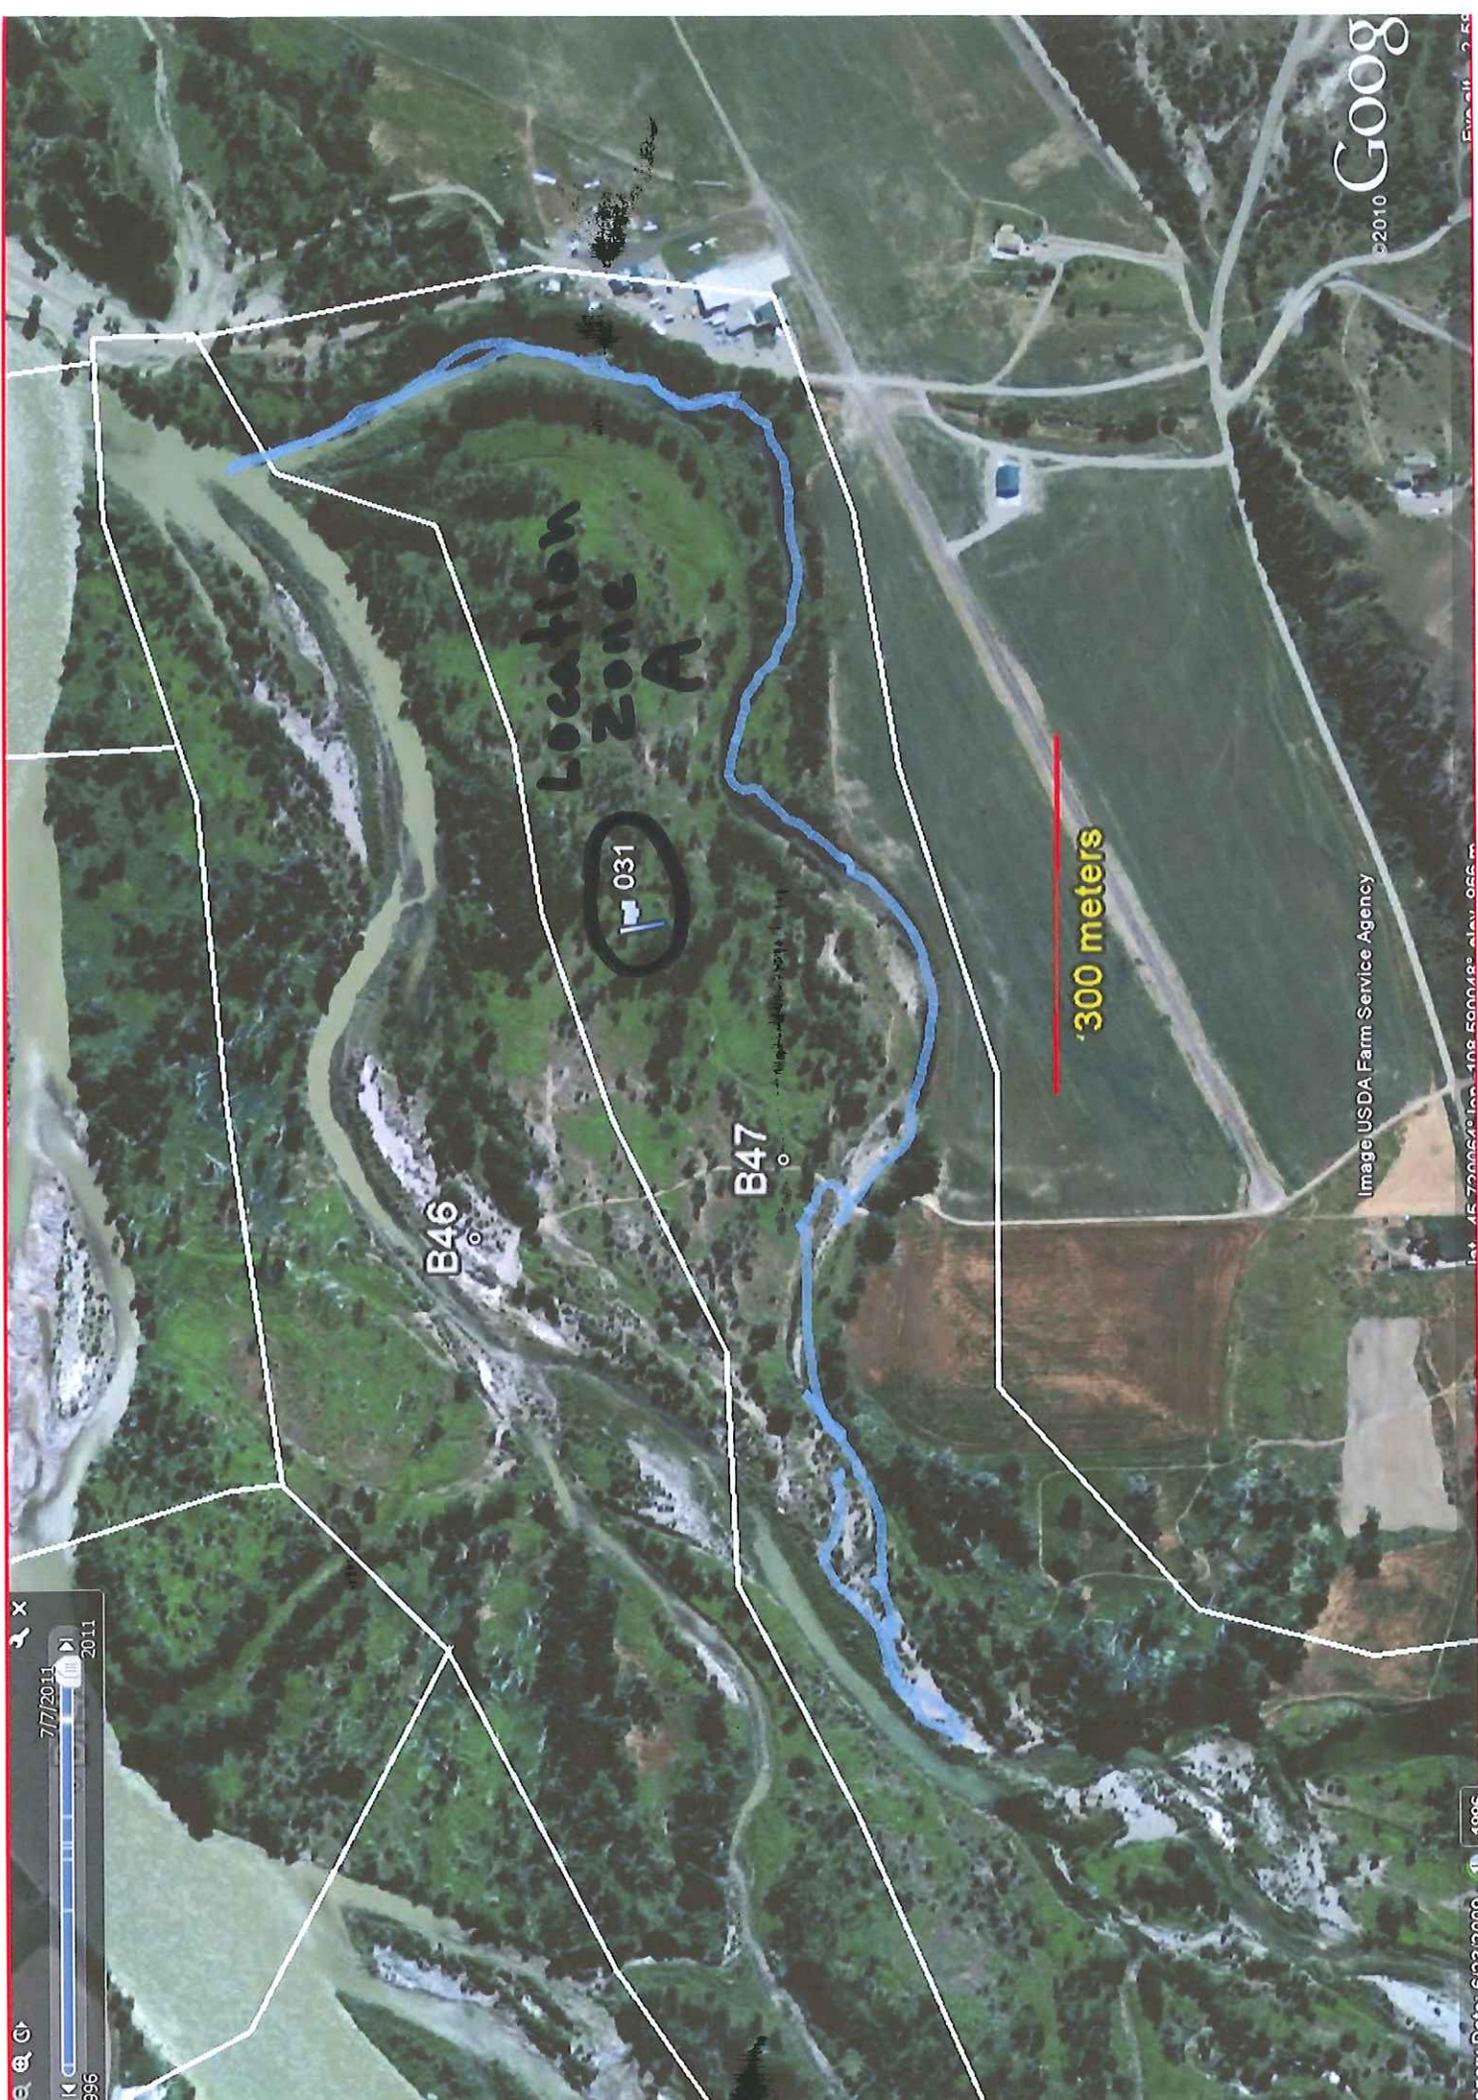
Distributary Stream SCAT Oiling Zones

A) WPT 031 - Stagnant backwater w/ oil on surface, 5 "pockets" pooled along edge of upland (see map)

B) Intermittent grassy banks along edge of channels

C) Stained and oiled River Willow & River Aspen

* see attached diagram depicting relative positions of zones A-C
