**SCAT Area Transition Report for
B47**

Silvertip Pipeline Incident
Laurel, Montana

October 26, 2011

Prepared by:
ARCADIS G&M of North Carolina, Inc.
11000 Regency Parkway
West Tower, Suite 205
Cary, North Carolina 27518-8518
Tel 919.469.1952
Fax 919.469.5676

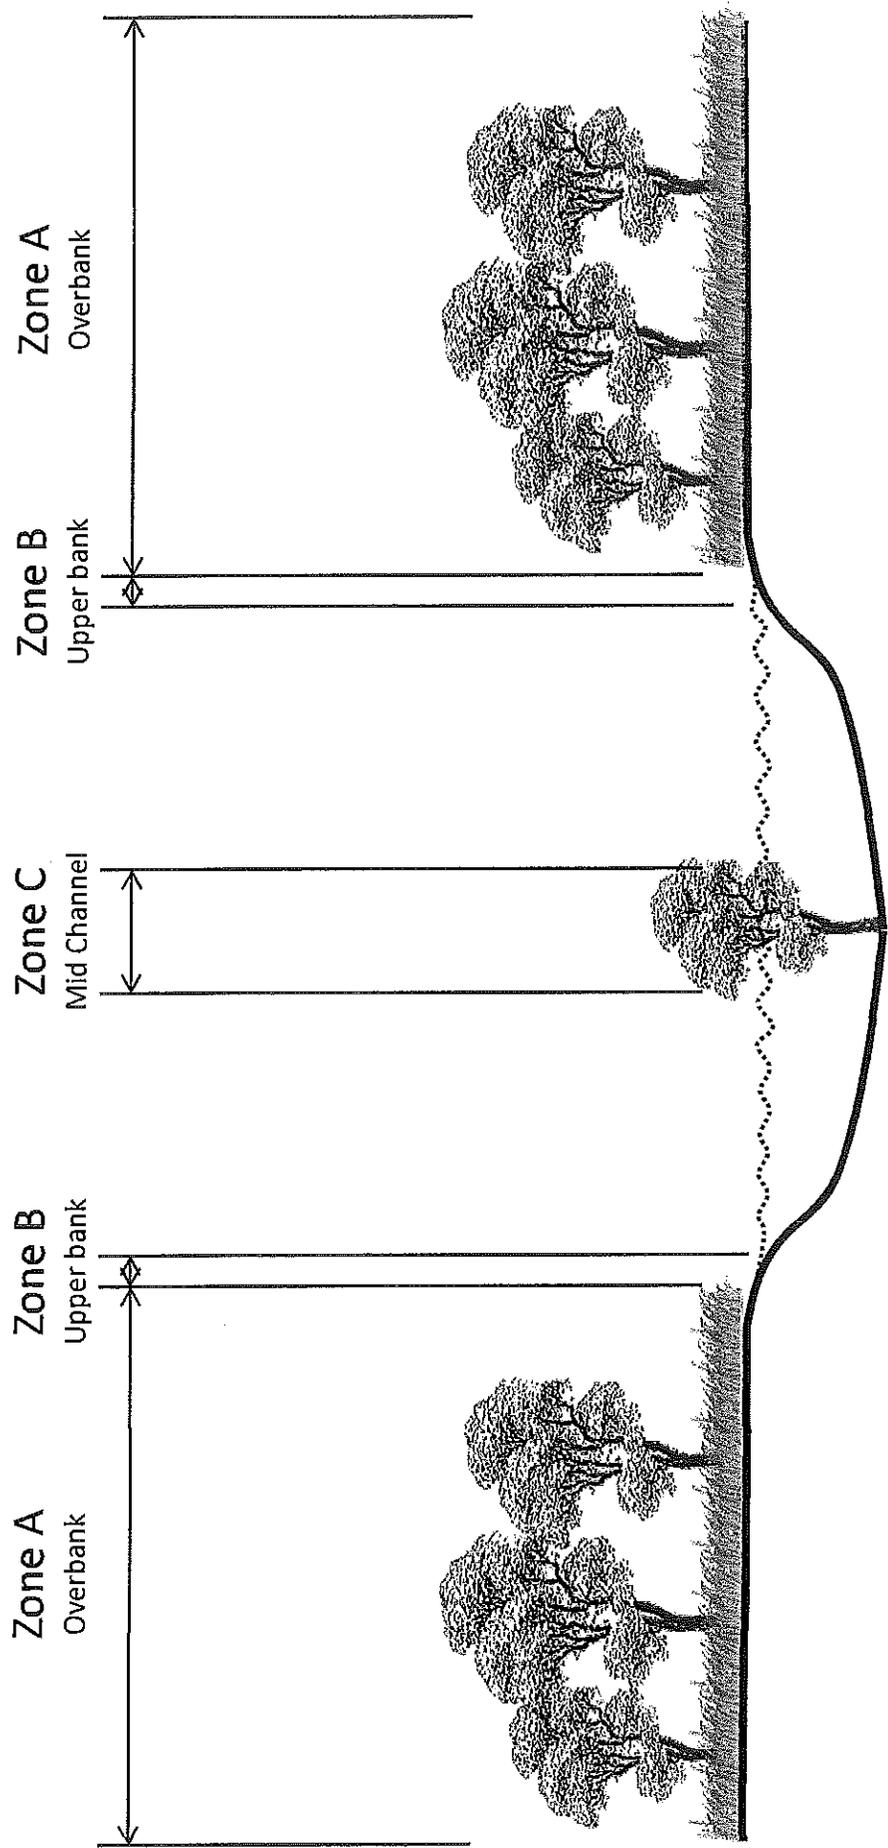
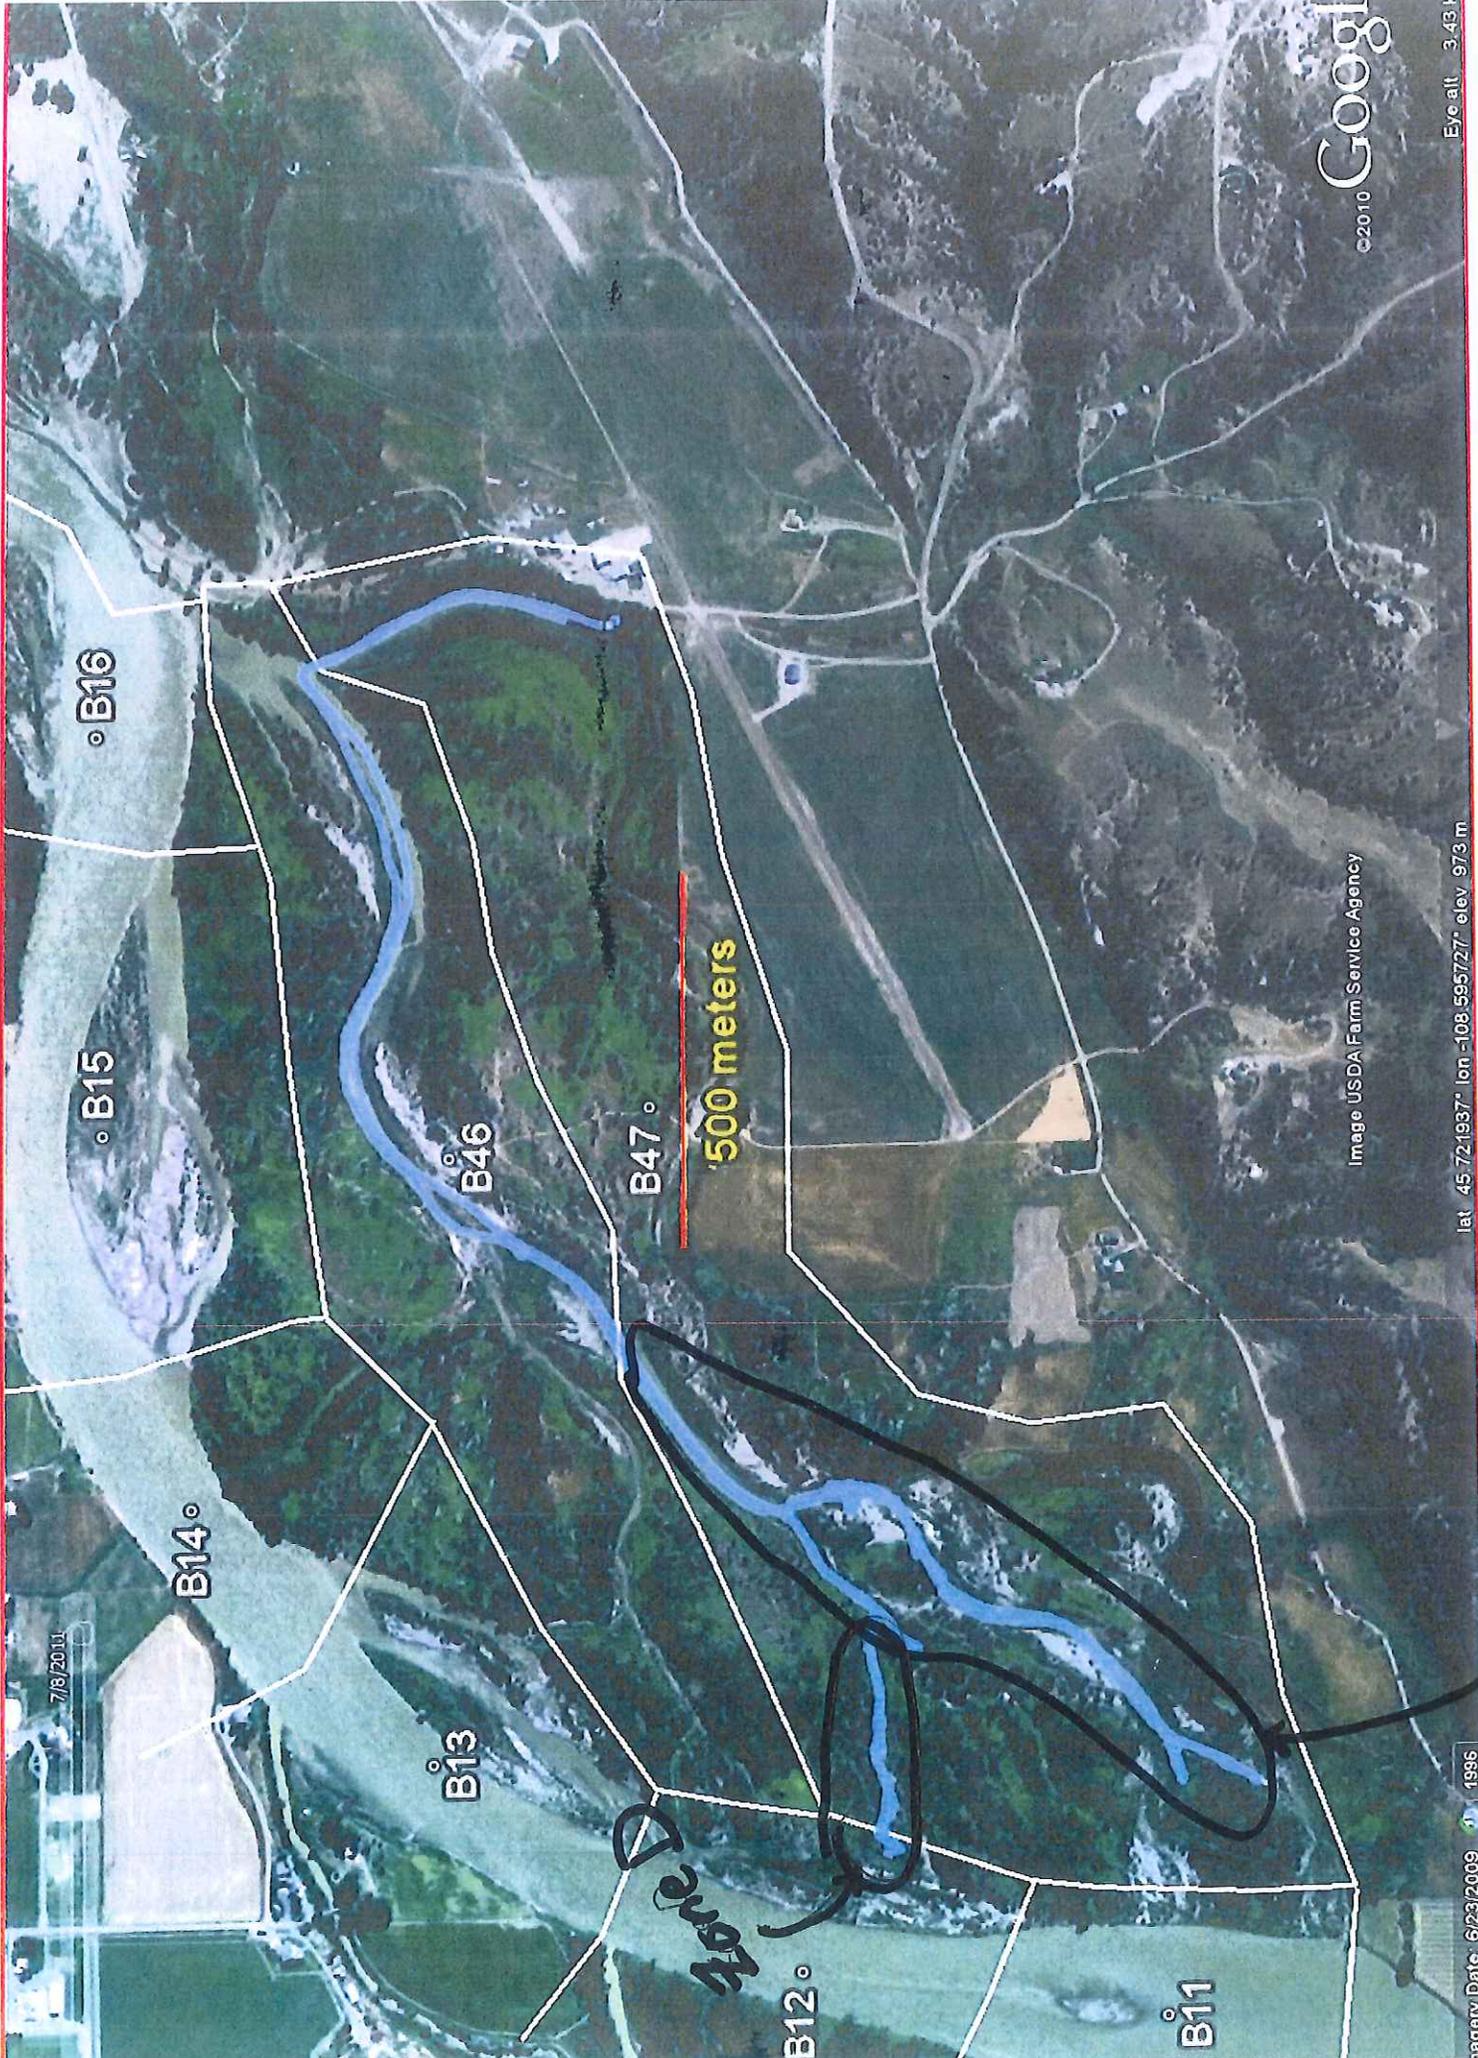
Distributary Stream SCAT Oiling Zones

Zone B Stem Height: 340cm Zone C Stem Height: 80cm
Zone D Stem Height: 1m

See attached sketch for Zone locations. Zones A & B are on both sides of the channel. Widths for Zones A & B are doubled.

Treatment Recommendations: Zone A: Remove oiled debris greater than stain, clean large debris.
Zone B: Remove oiled vegetation greater than stain.
Zone C: Remove oiled vegetation and tree branches greater than stain.
Zone D: Remove oiled vegetation and debris greater than stain. Possible flushing of oiled banks.

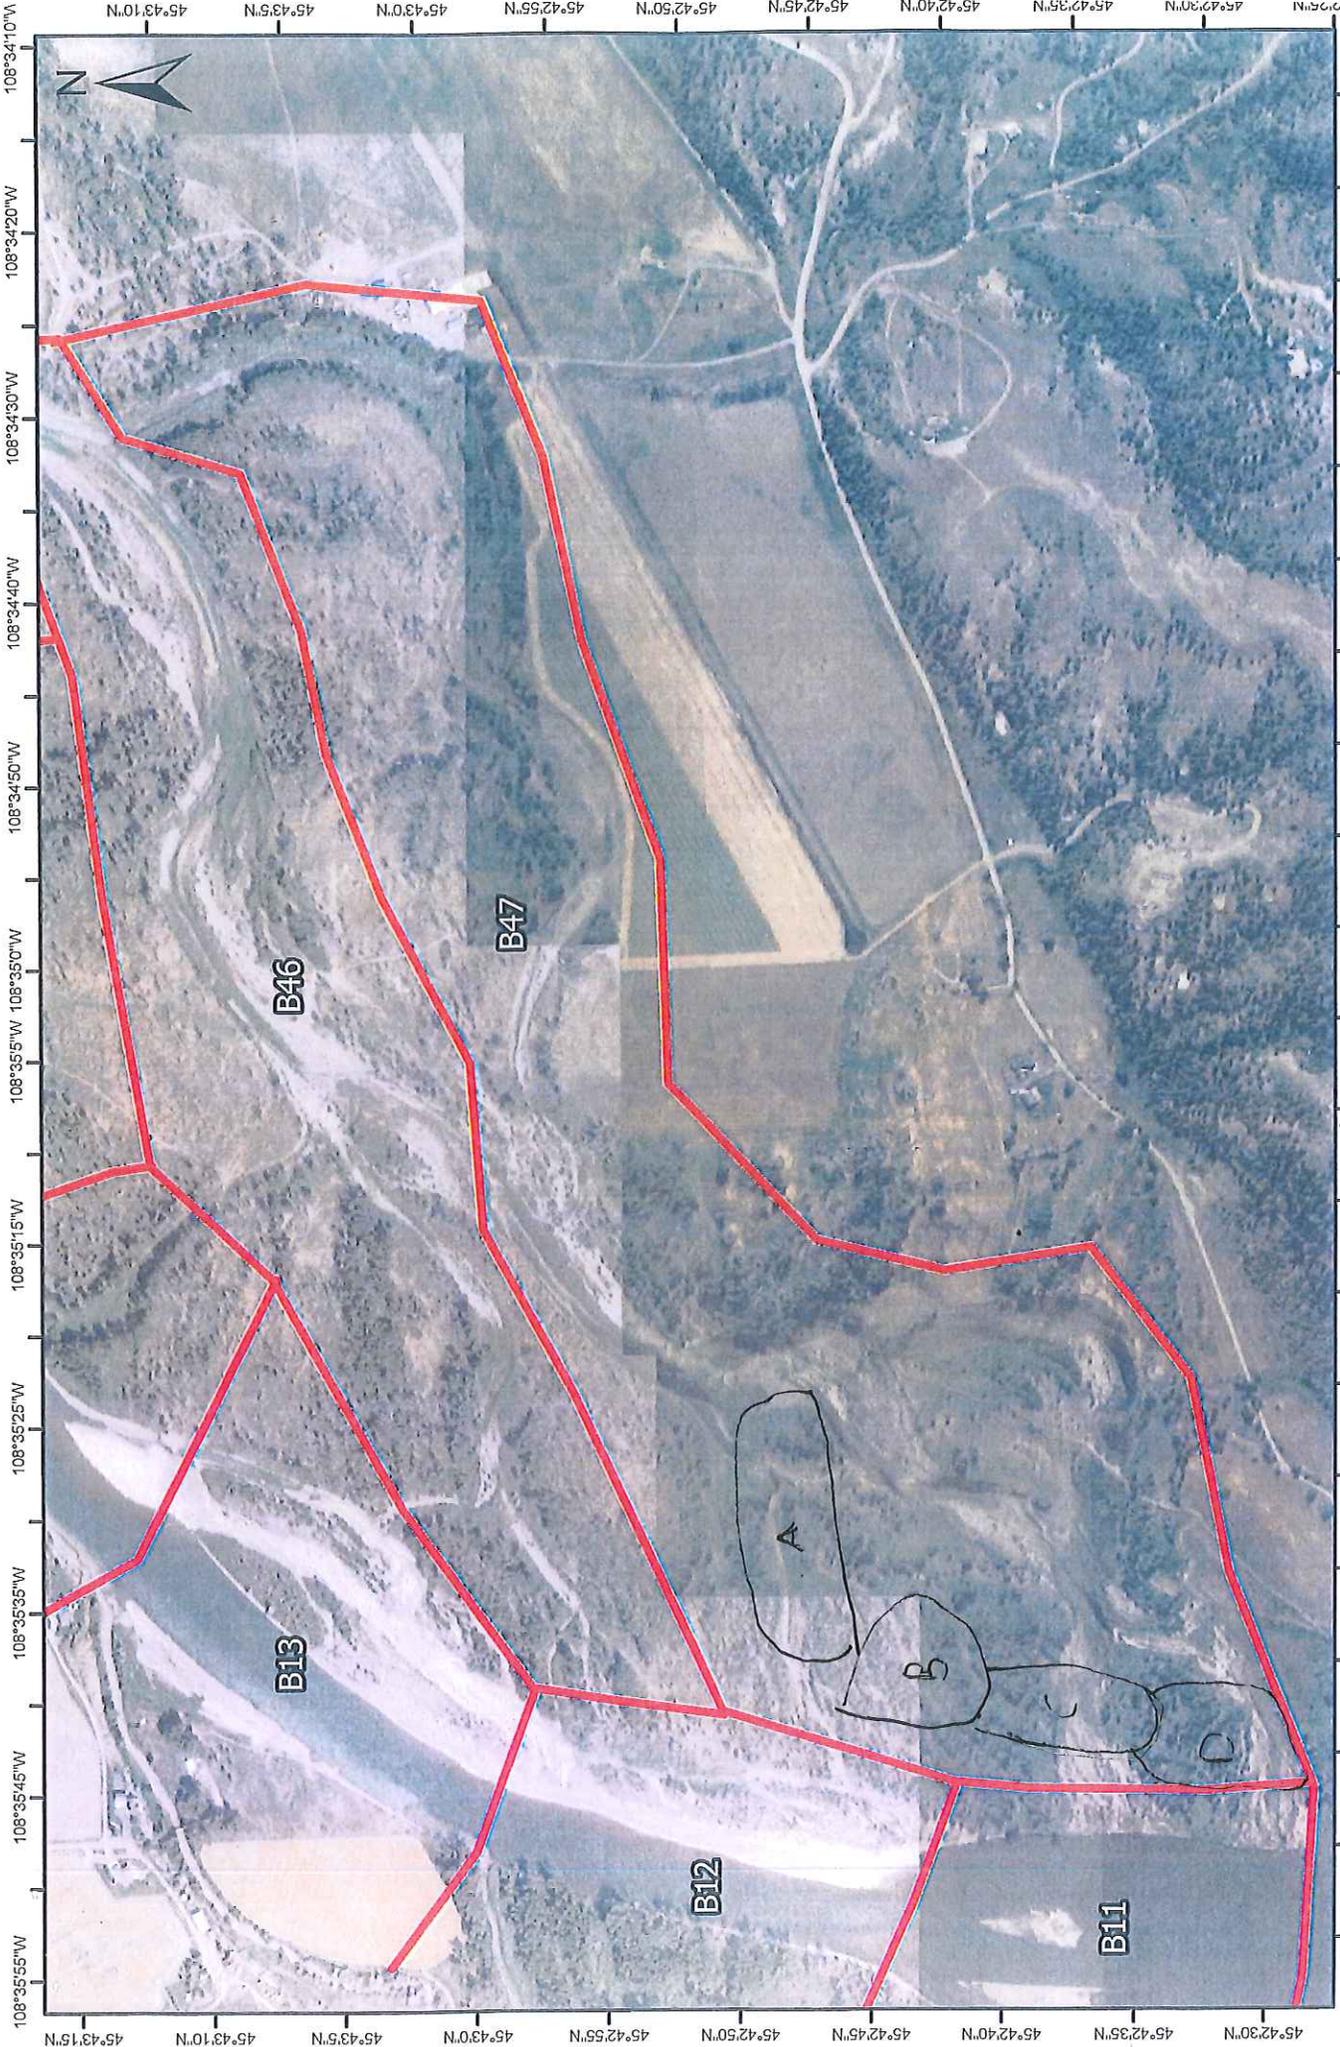
B47 -
(L/R/I)??

B Area of coarse debris throughout. Needs to be manually removed or surgically burned

(for ALL sub-segments record: sub-segment ID, length, length surveyed, and GPS start/end fixes) Debris can be removed or surgically burnt.

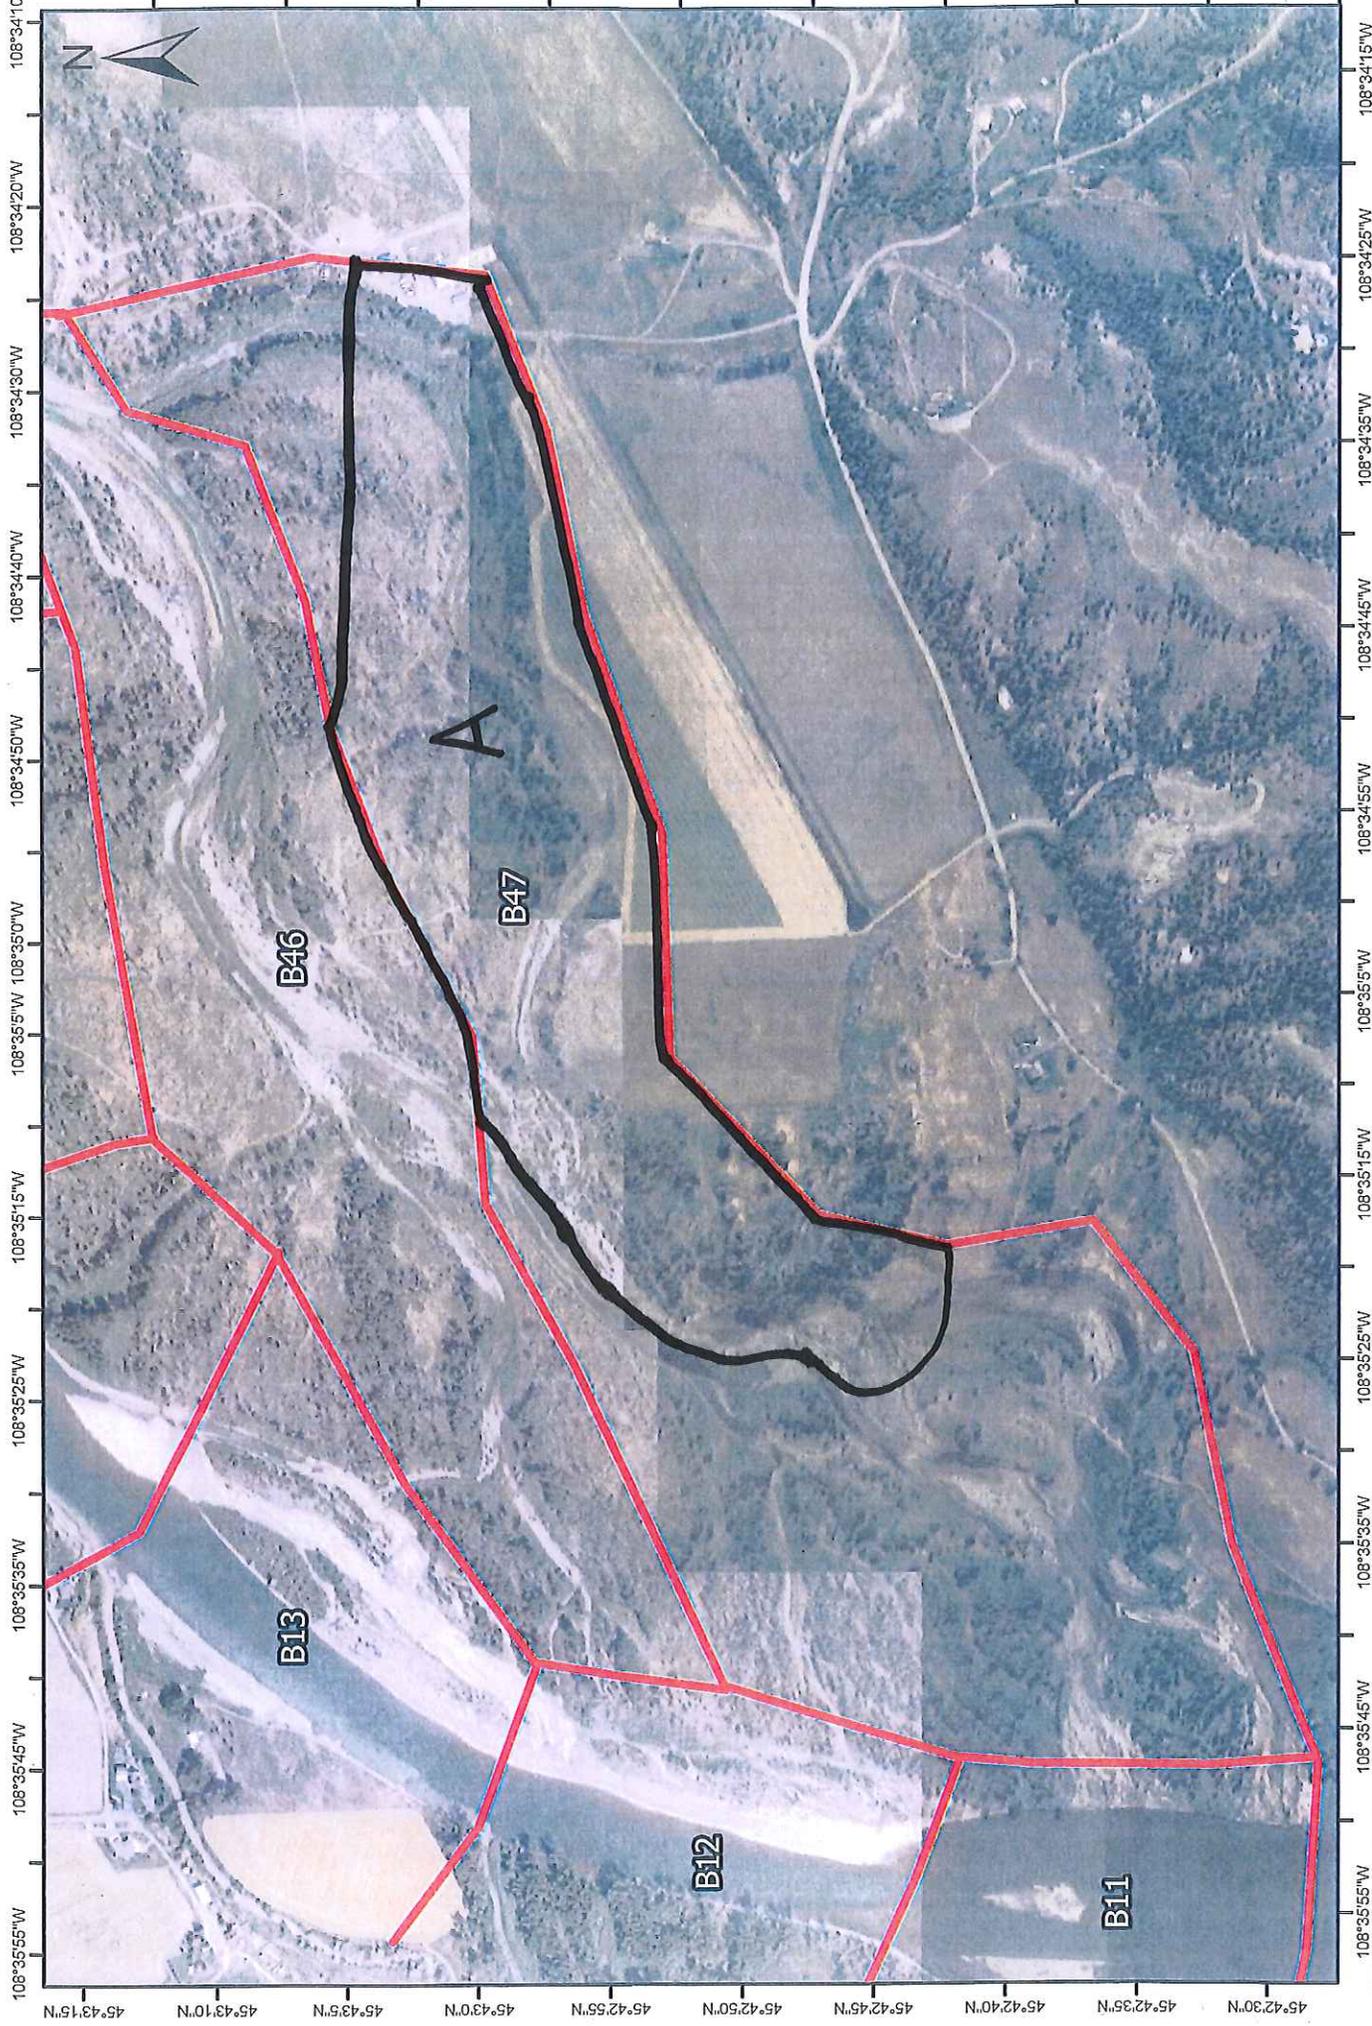
Oil Zone A: Active cleanup observed throughout Oil Zone A. SCAT Team 4 recommends continuing cutting of oiled ^{dw} ~~vegetated~~ vegetation and small woody debris. "Hot spots" of oiled debris were flagged by ^{dw} ~~ES~~ SCAT TEAM 4 with pink/orange tape. Hand tool/shovel removal of oiled ^{CK} ~~sorted~~ soils.

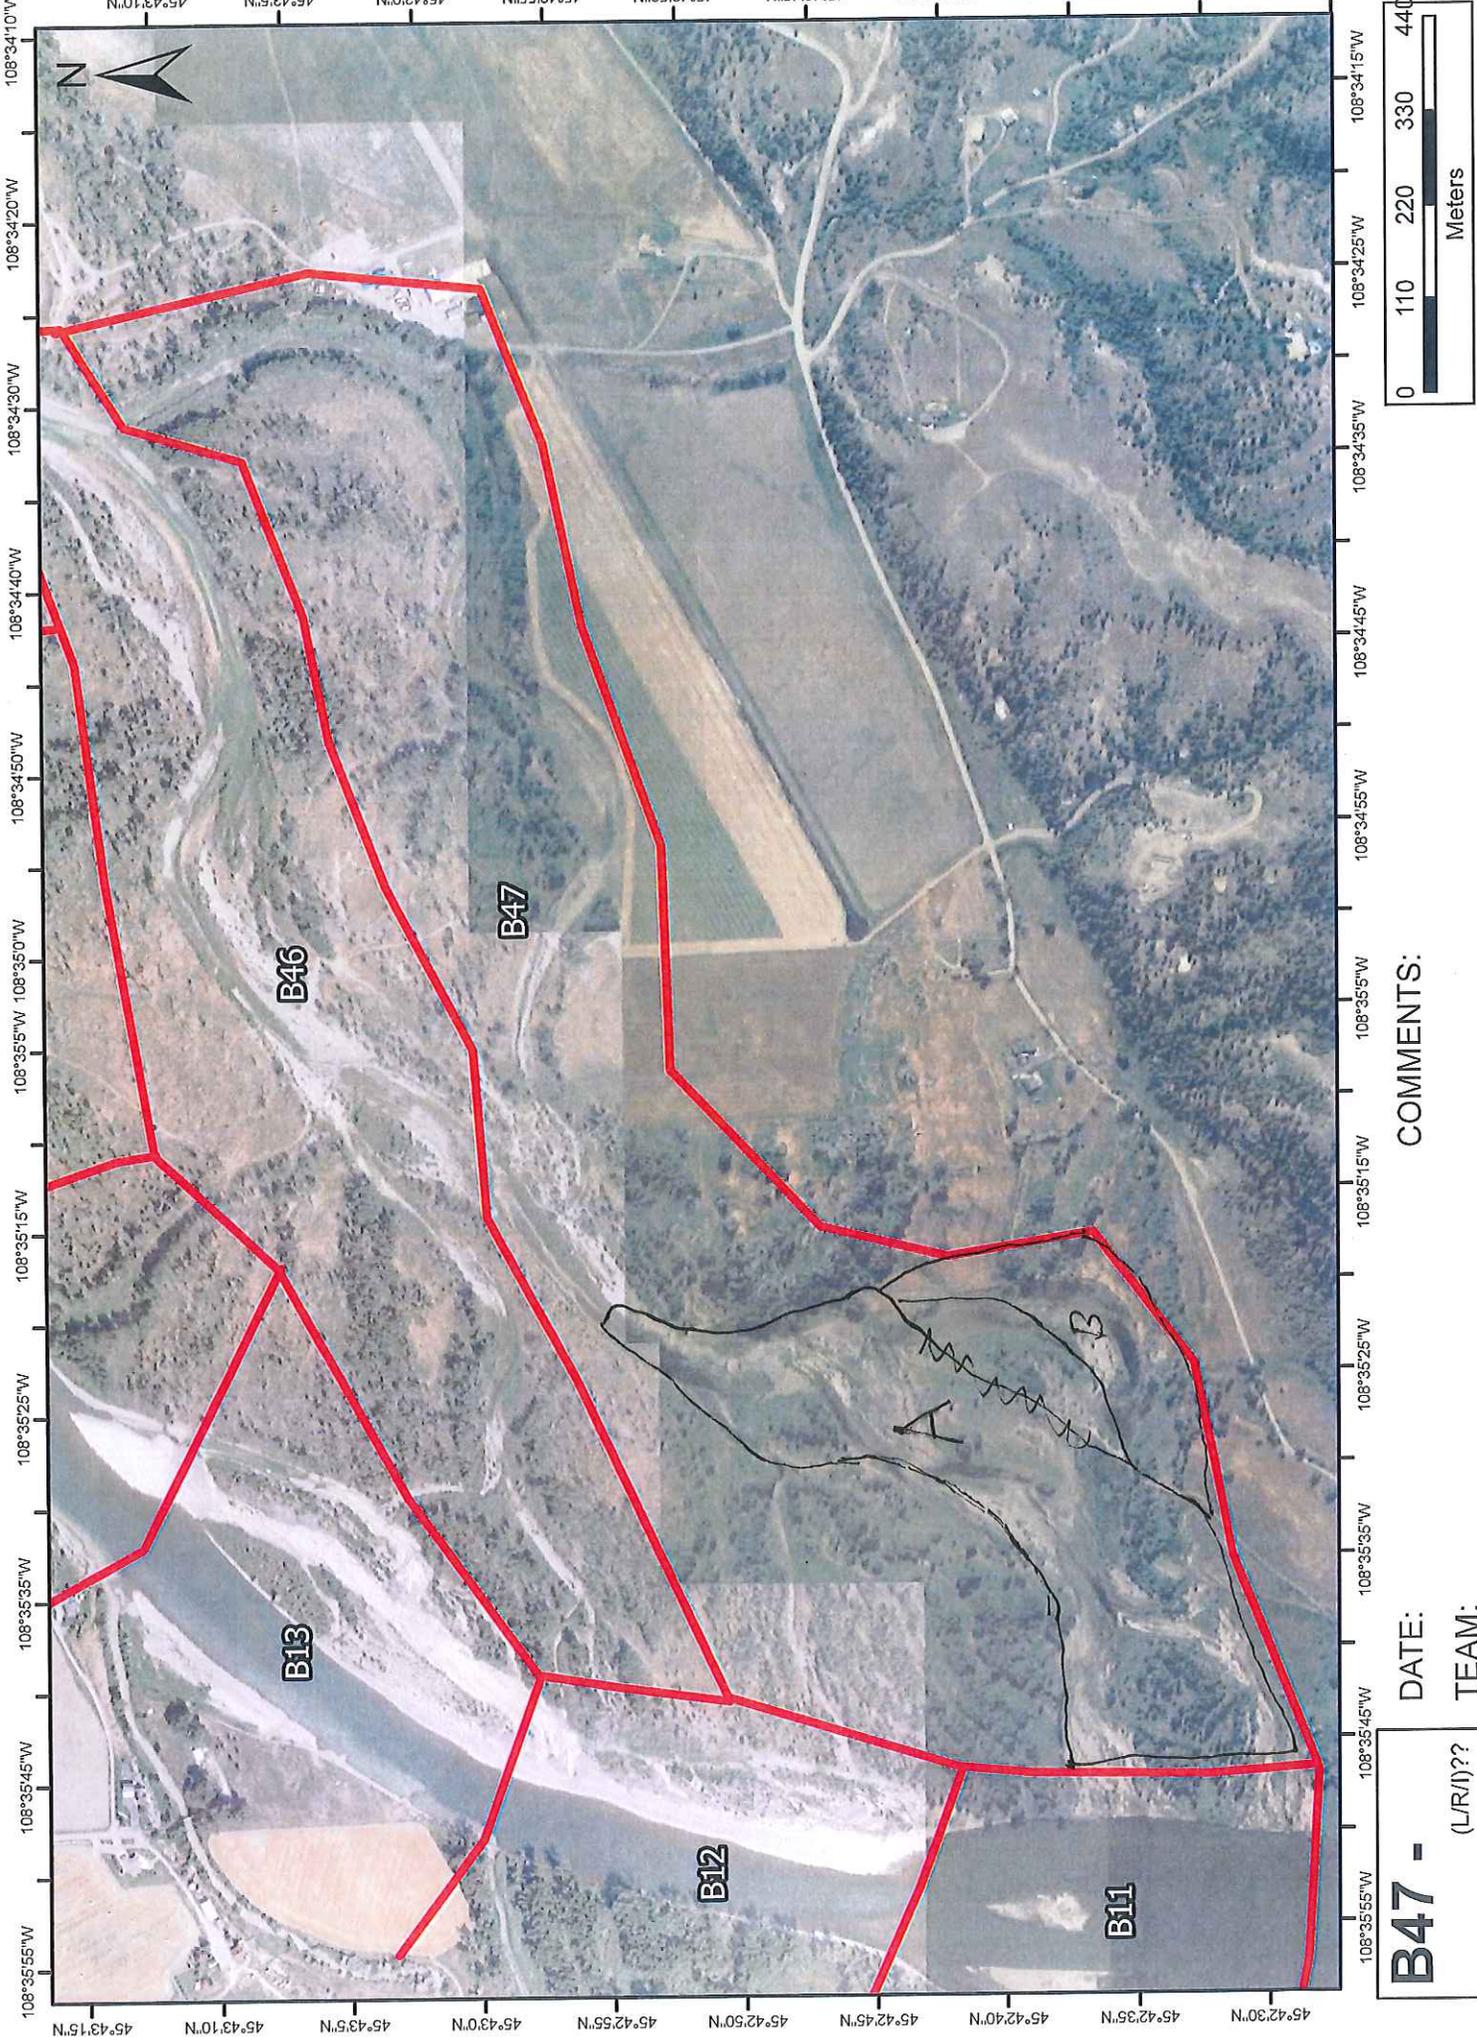
B47 -
(L/R/I)??

Zone A is the main channel of a creek with some branching. Many piles of debris, ~~and~~ shrubs ~~and~~ trees and ~~herbaceous~~ veg coated and stained. Many trees had banded oil at trunks and stems. Small debris can be collected, bagged and removed. Trees and shrubs and herbaceous can be cut and/or treated. Larger piles may need to ~~be~~ be removed using hand tools and/or surgically burned. Cleanup operation have been started. Noted that track vehicles used for access by crew. The vehicles need to be confined to a fixed route and restriction may be necessary afterwards in riparian approaches (stream bank area.)

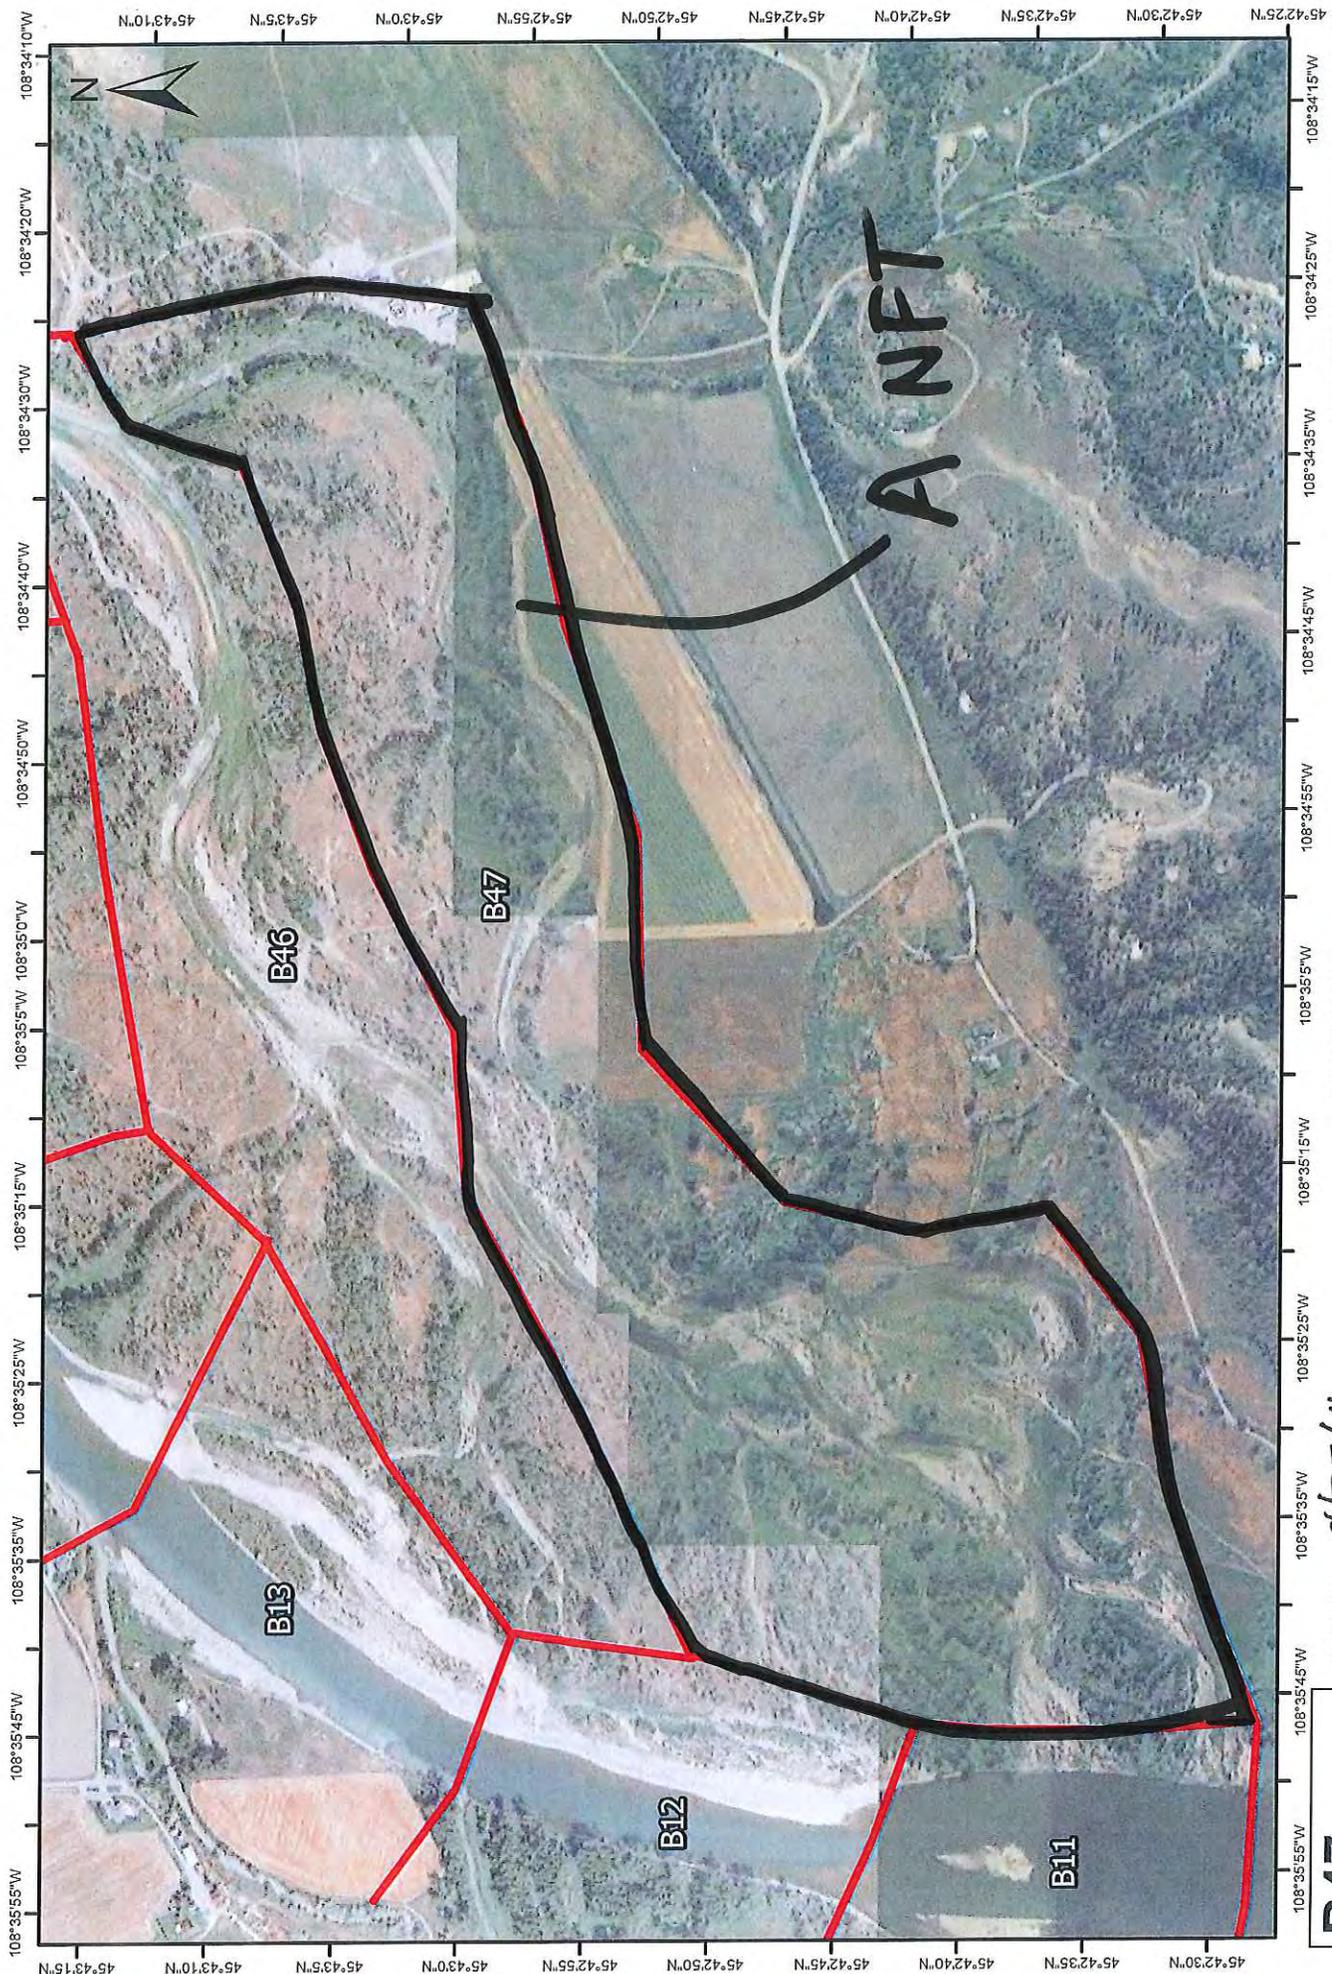
ZONE A <1% ST
