**SCAT Area Transition Report
for C01**

Silvertip Pipeline Incident
Laurel, Montana

October 21, 2011

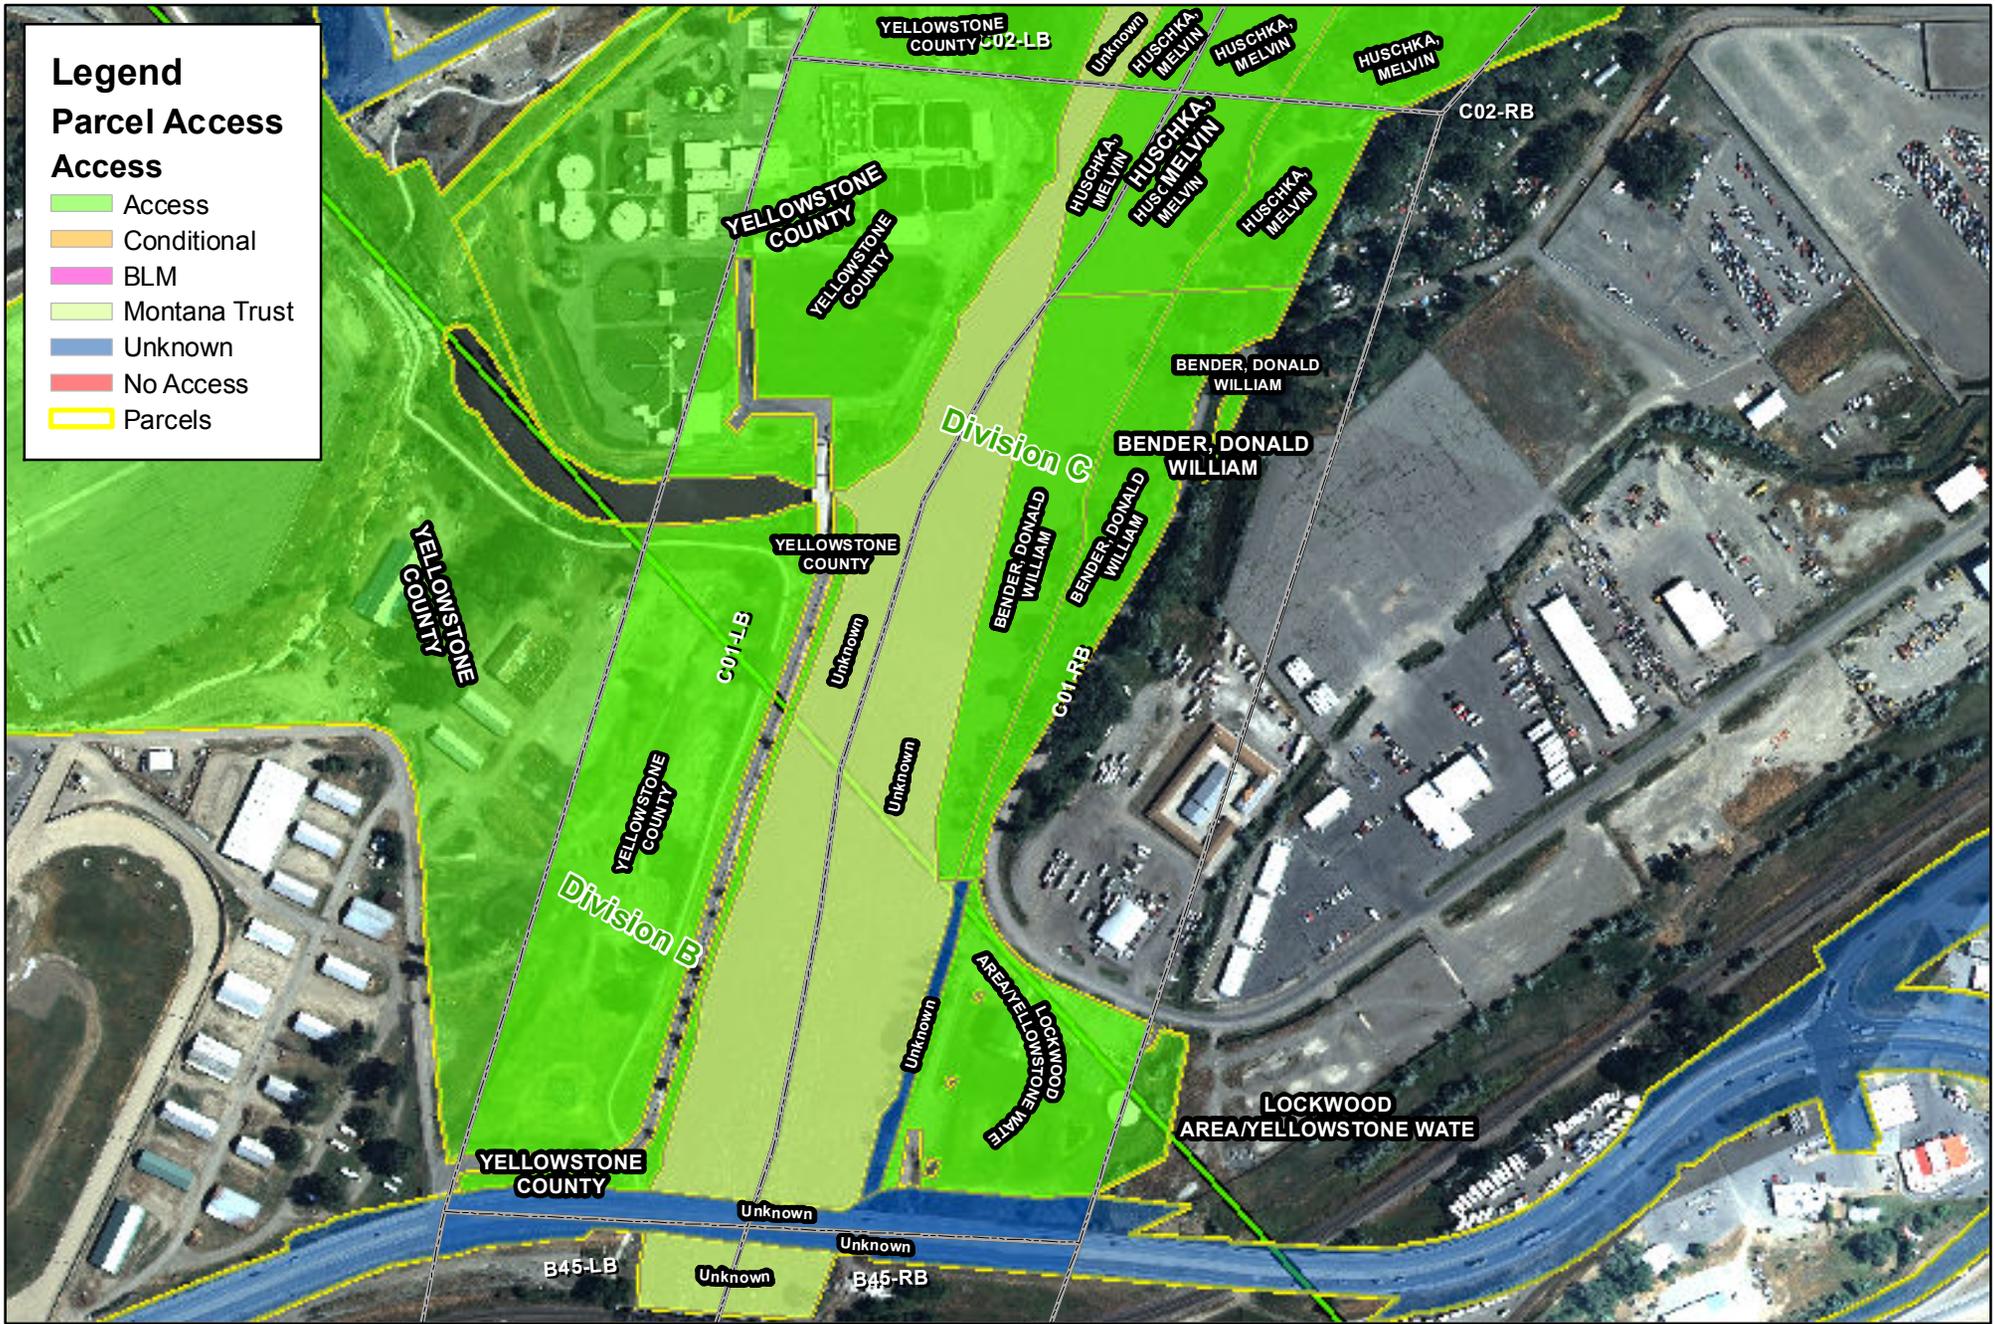
Figure 1 provides an aerial map of SCAT Area C01, along with the (a) SCAT Area boundary, (b) parcel boundaries and respective property owners, and (c) access constraints identified during the oil cleanup process. The acreage surveyed in Area C01 is 29.2. There were no access issues for this area.

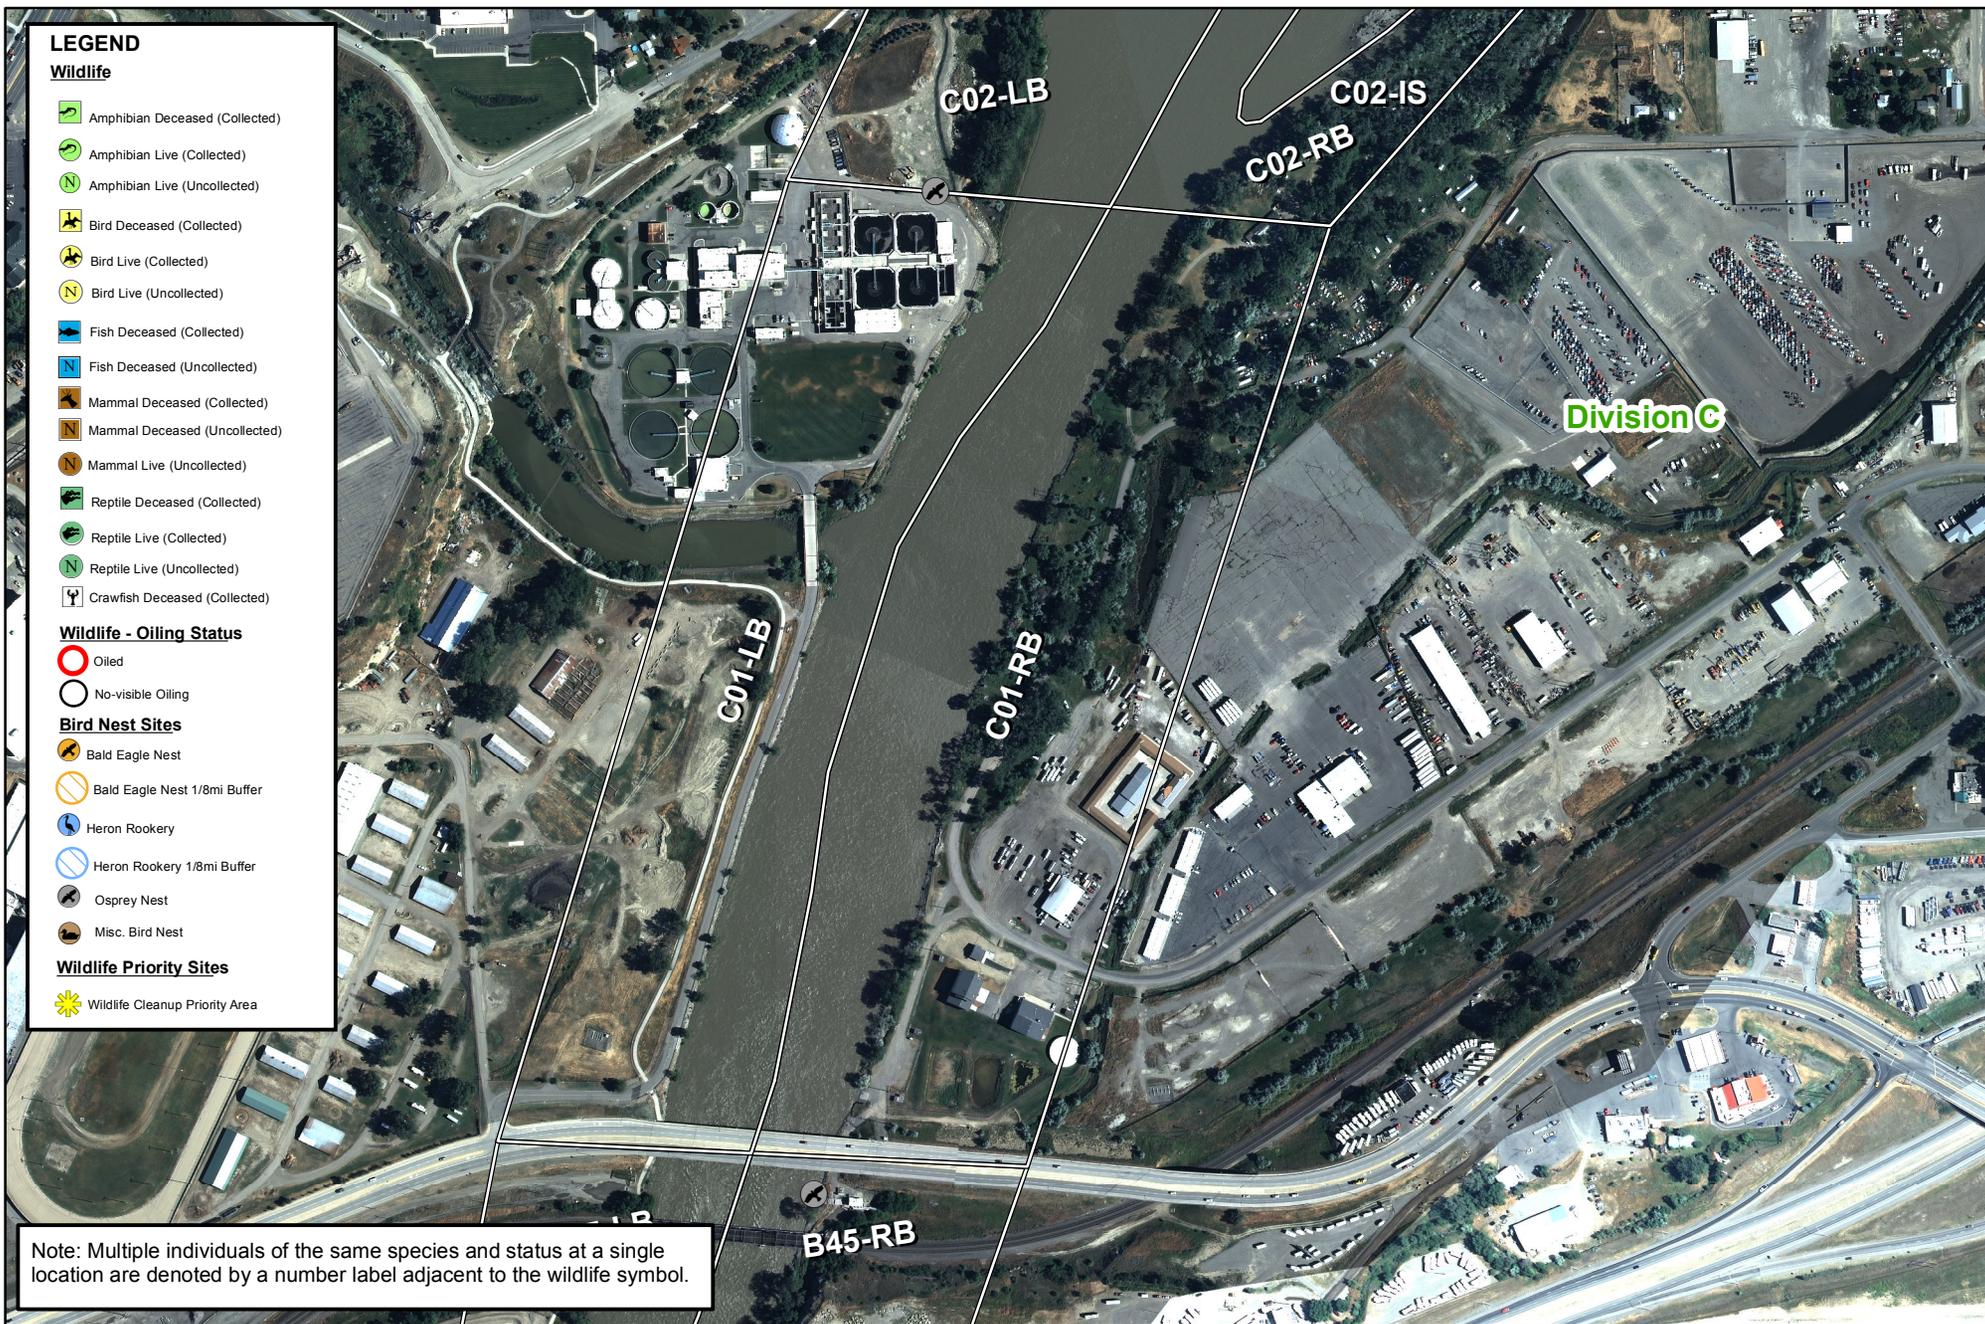
Figure 2
Wildlife Resources

Figure 2 summarizes the natural resources identified in this segment. International Bird Rescue and Resource Advisors from U.S. Fish and Wildlife Service conducted limited inspections of Area C01 due to the low level of oiling in Division C. No oiled wildlife was observed or recovered. No Wildlife Priority Cleanup Areas were identified. An Osprey (*Pandion haliaetus*) nest was identified on the boundary between Area C01 and Area C02.

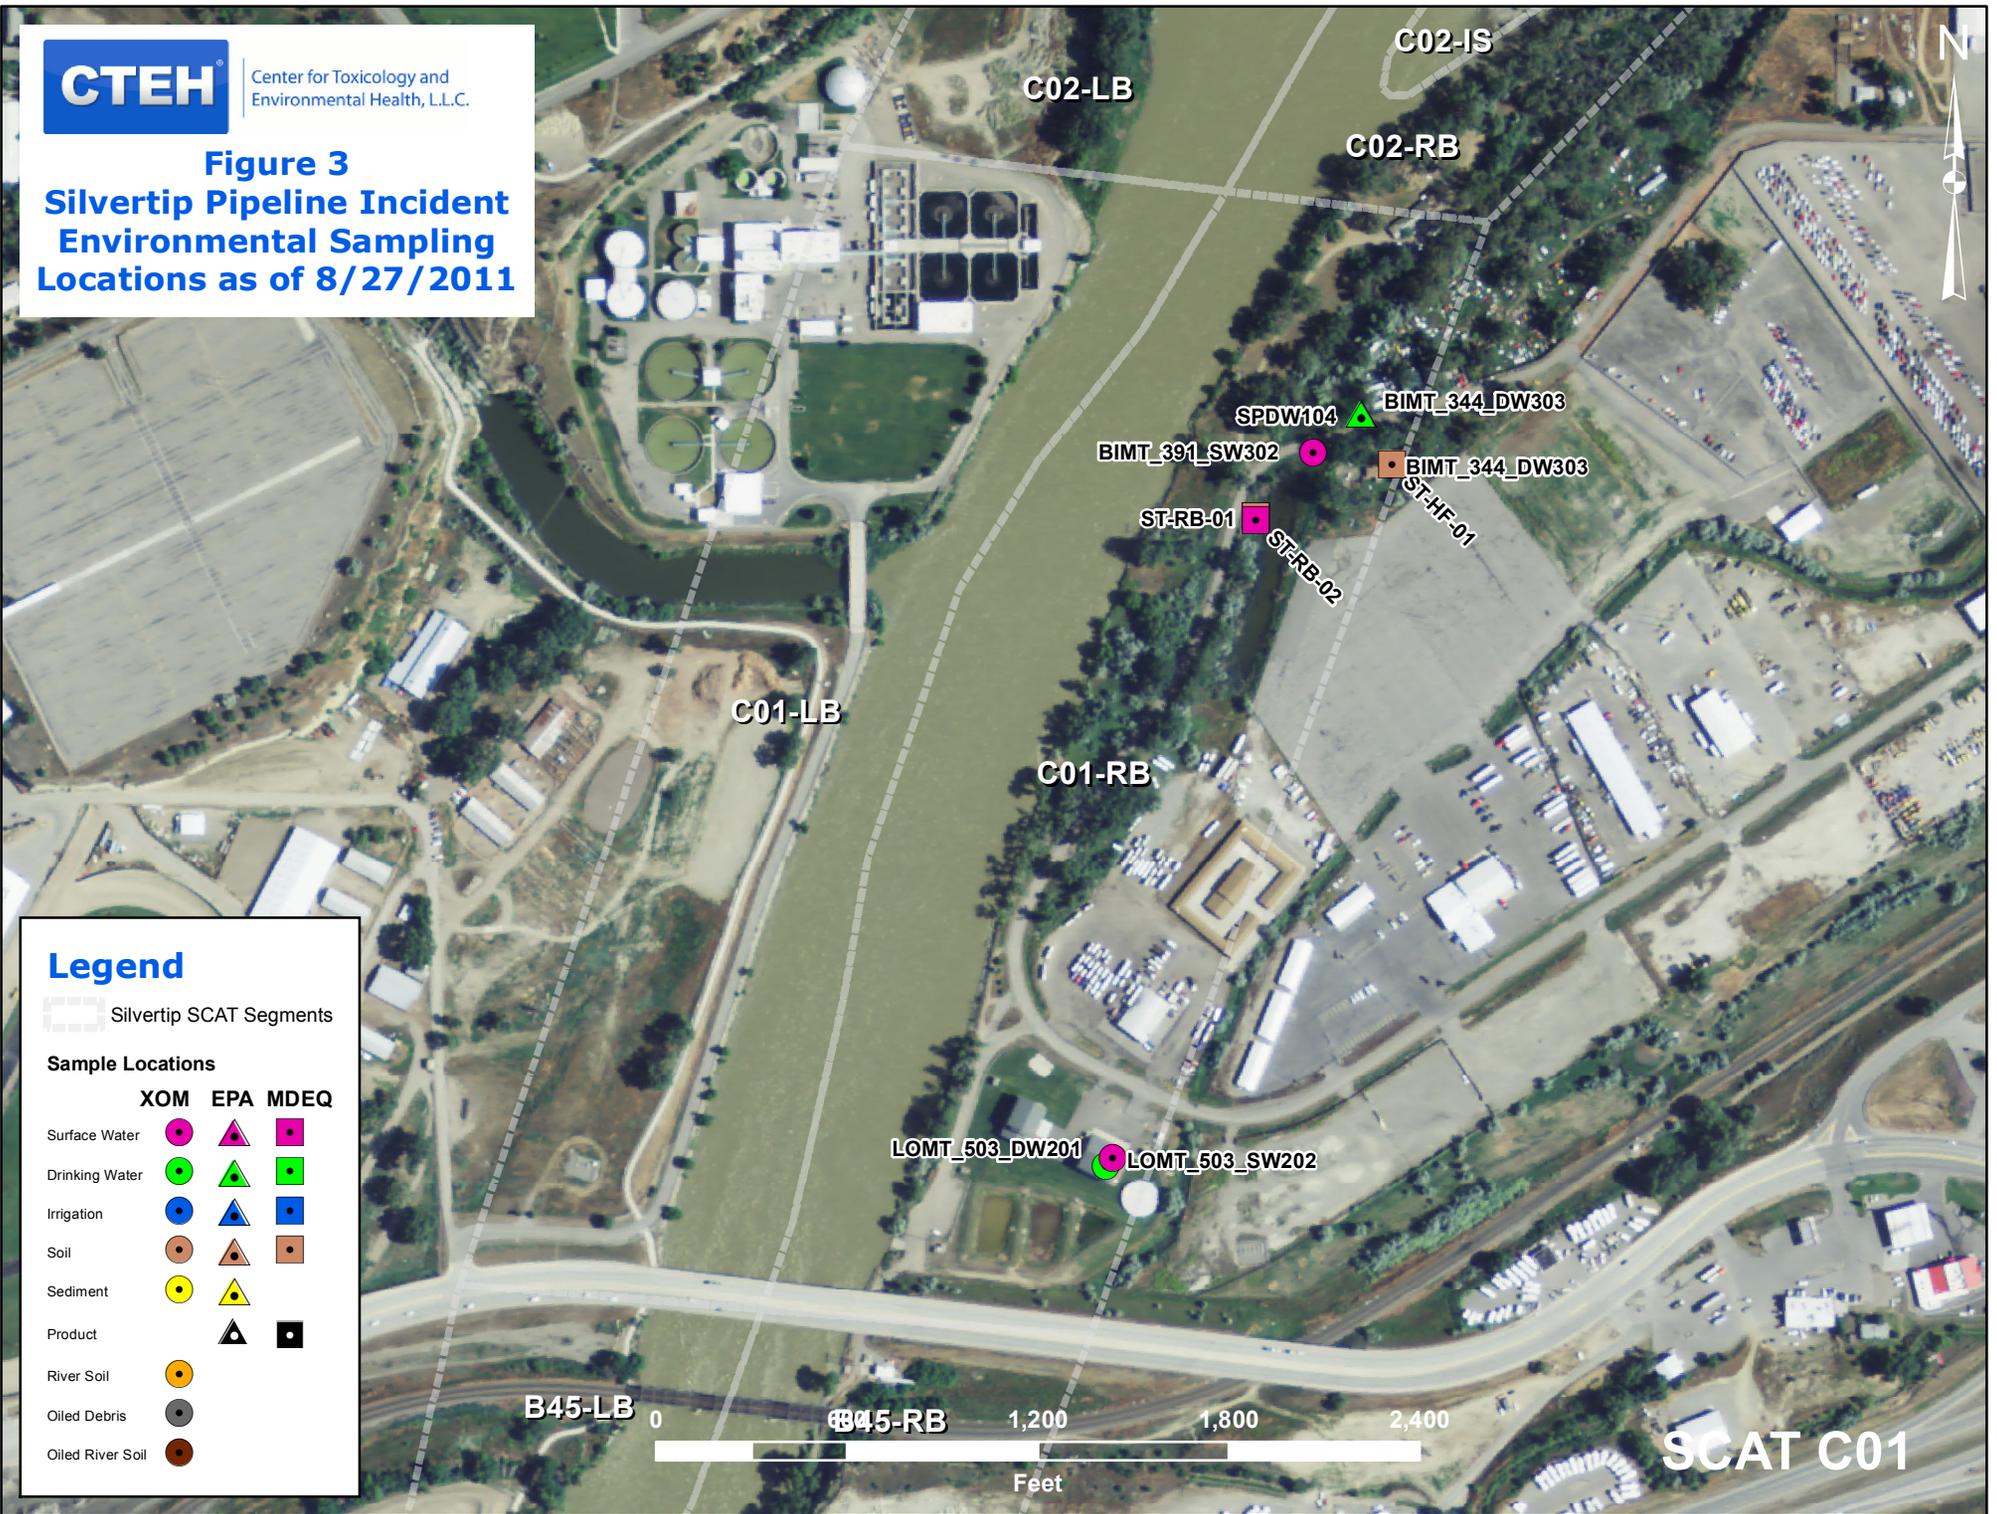
Figure 3
Silvertip Pipeline Incident
Environmental Sampling
Locations as of 8/27/2011

Table 1 (below) summarizes samples collected within Area C01. The analytical results for the samples collected can be accessed through a publicly accessible database on the United States Environmental Protection Agency's (USEPA's) website. The approximate locations of samples collected within Area C01 are provided on Figure 3.

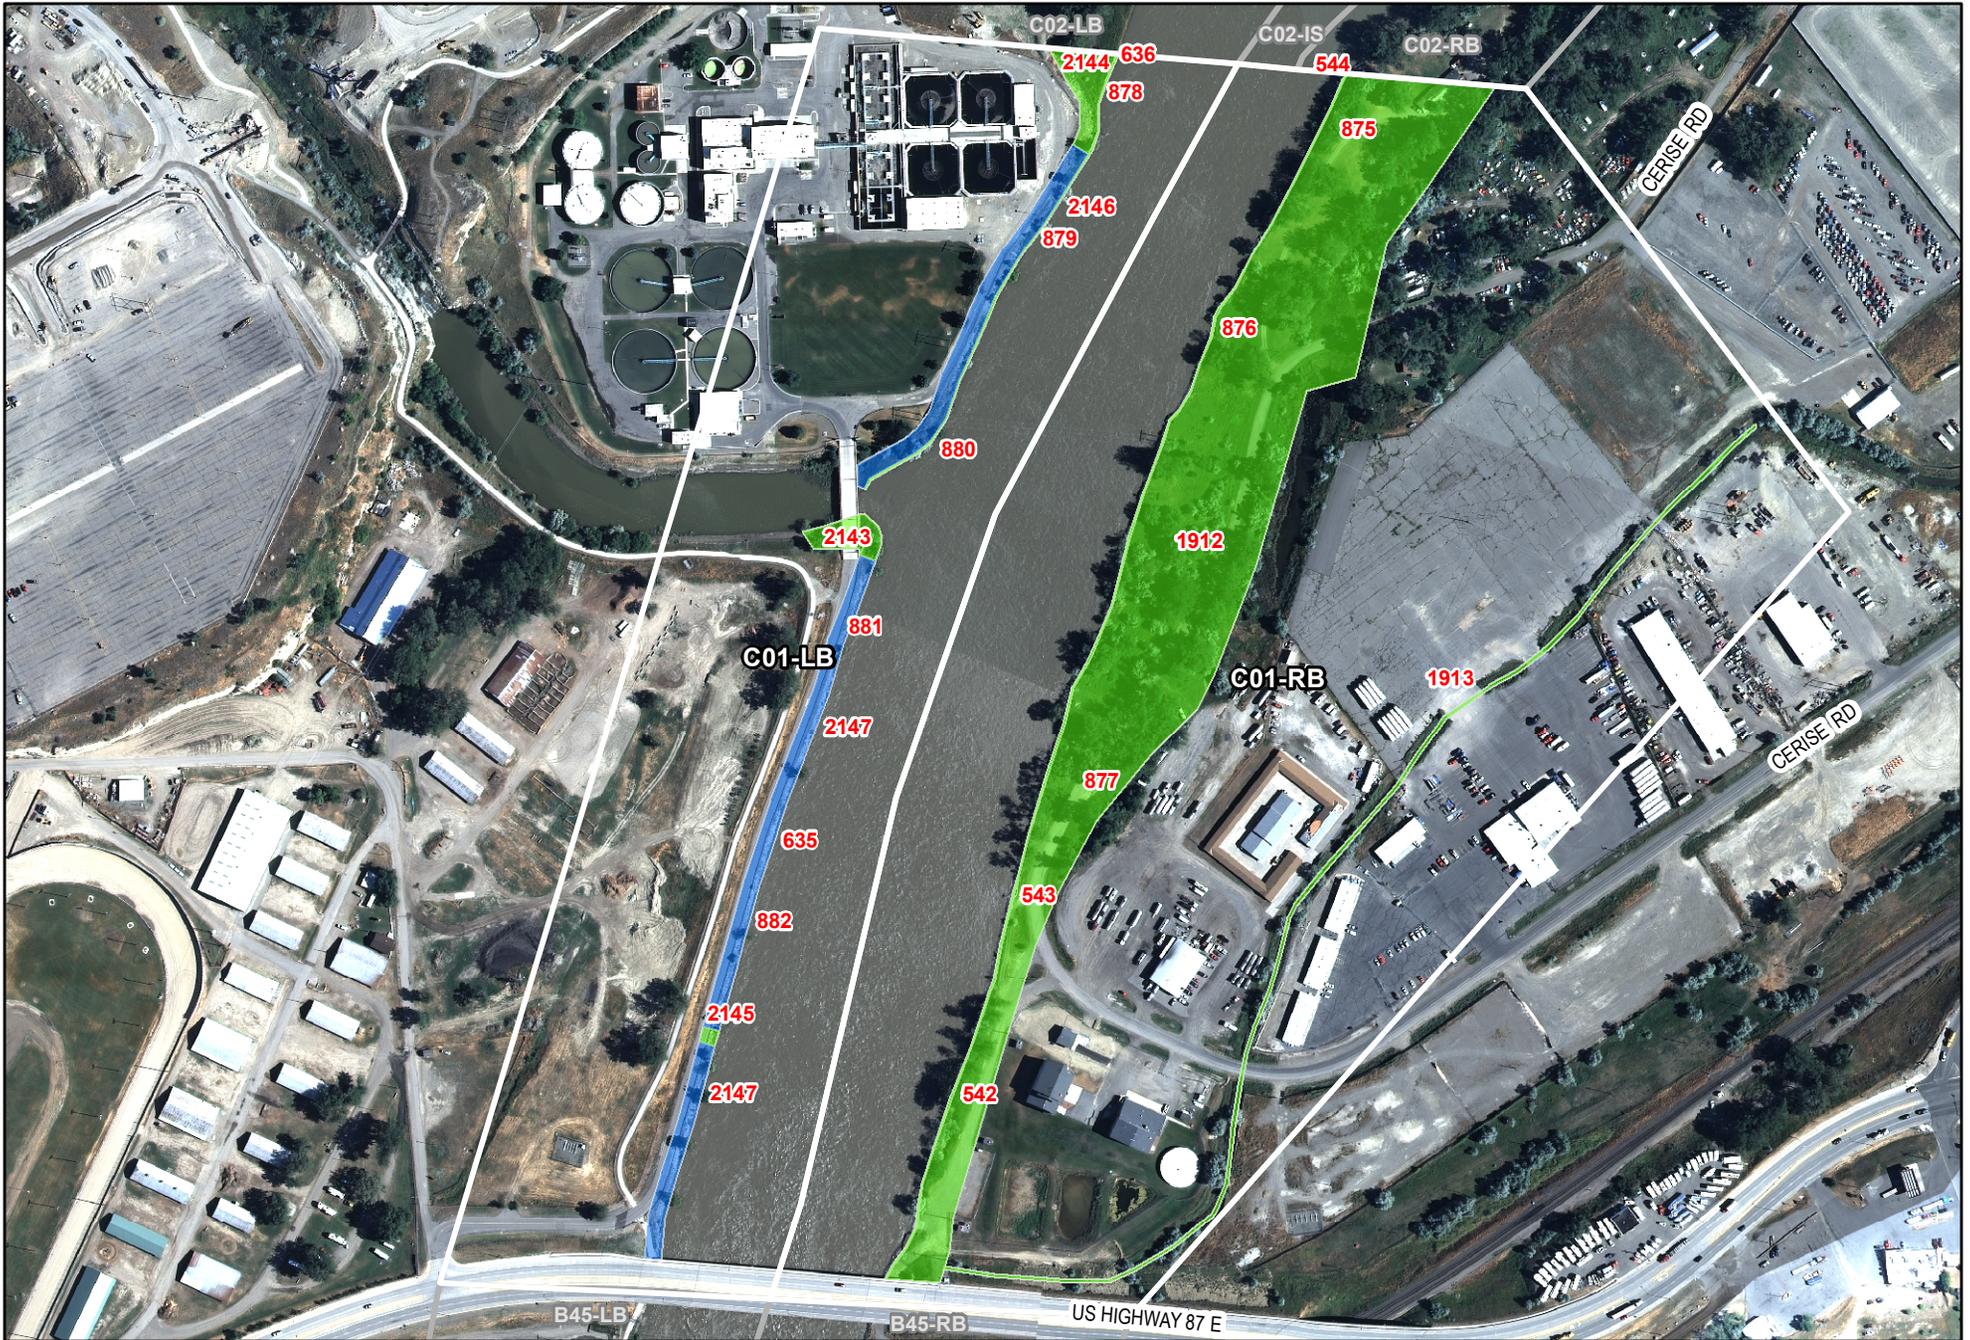
Figure 4 - Maximum SCAT Observations For SCAT Area: C01

The SCAT teams used systematic evaluation criteria and treatment method tables approved by the National Oceanic and Atmospheric Administration to provide a standard approach for data collection and conducting field surveys. The forms and sketches from the initial SCAT surveys performed along the river bank (water edge) and floodplain within Area C01 are included in Appendix B. Figure 4 provides the maximum oiling zones observed by the SCAT team during the initial surveys of Area C01.

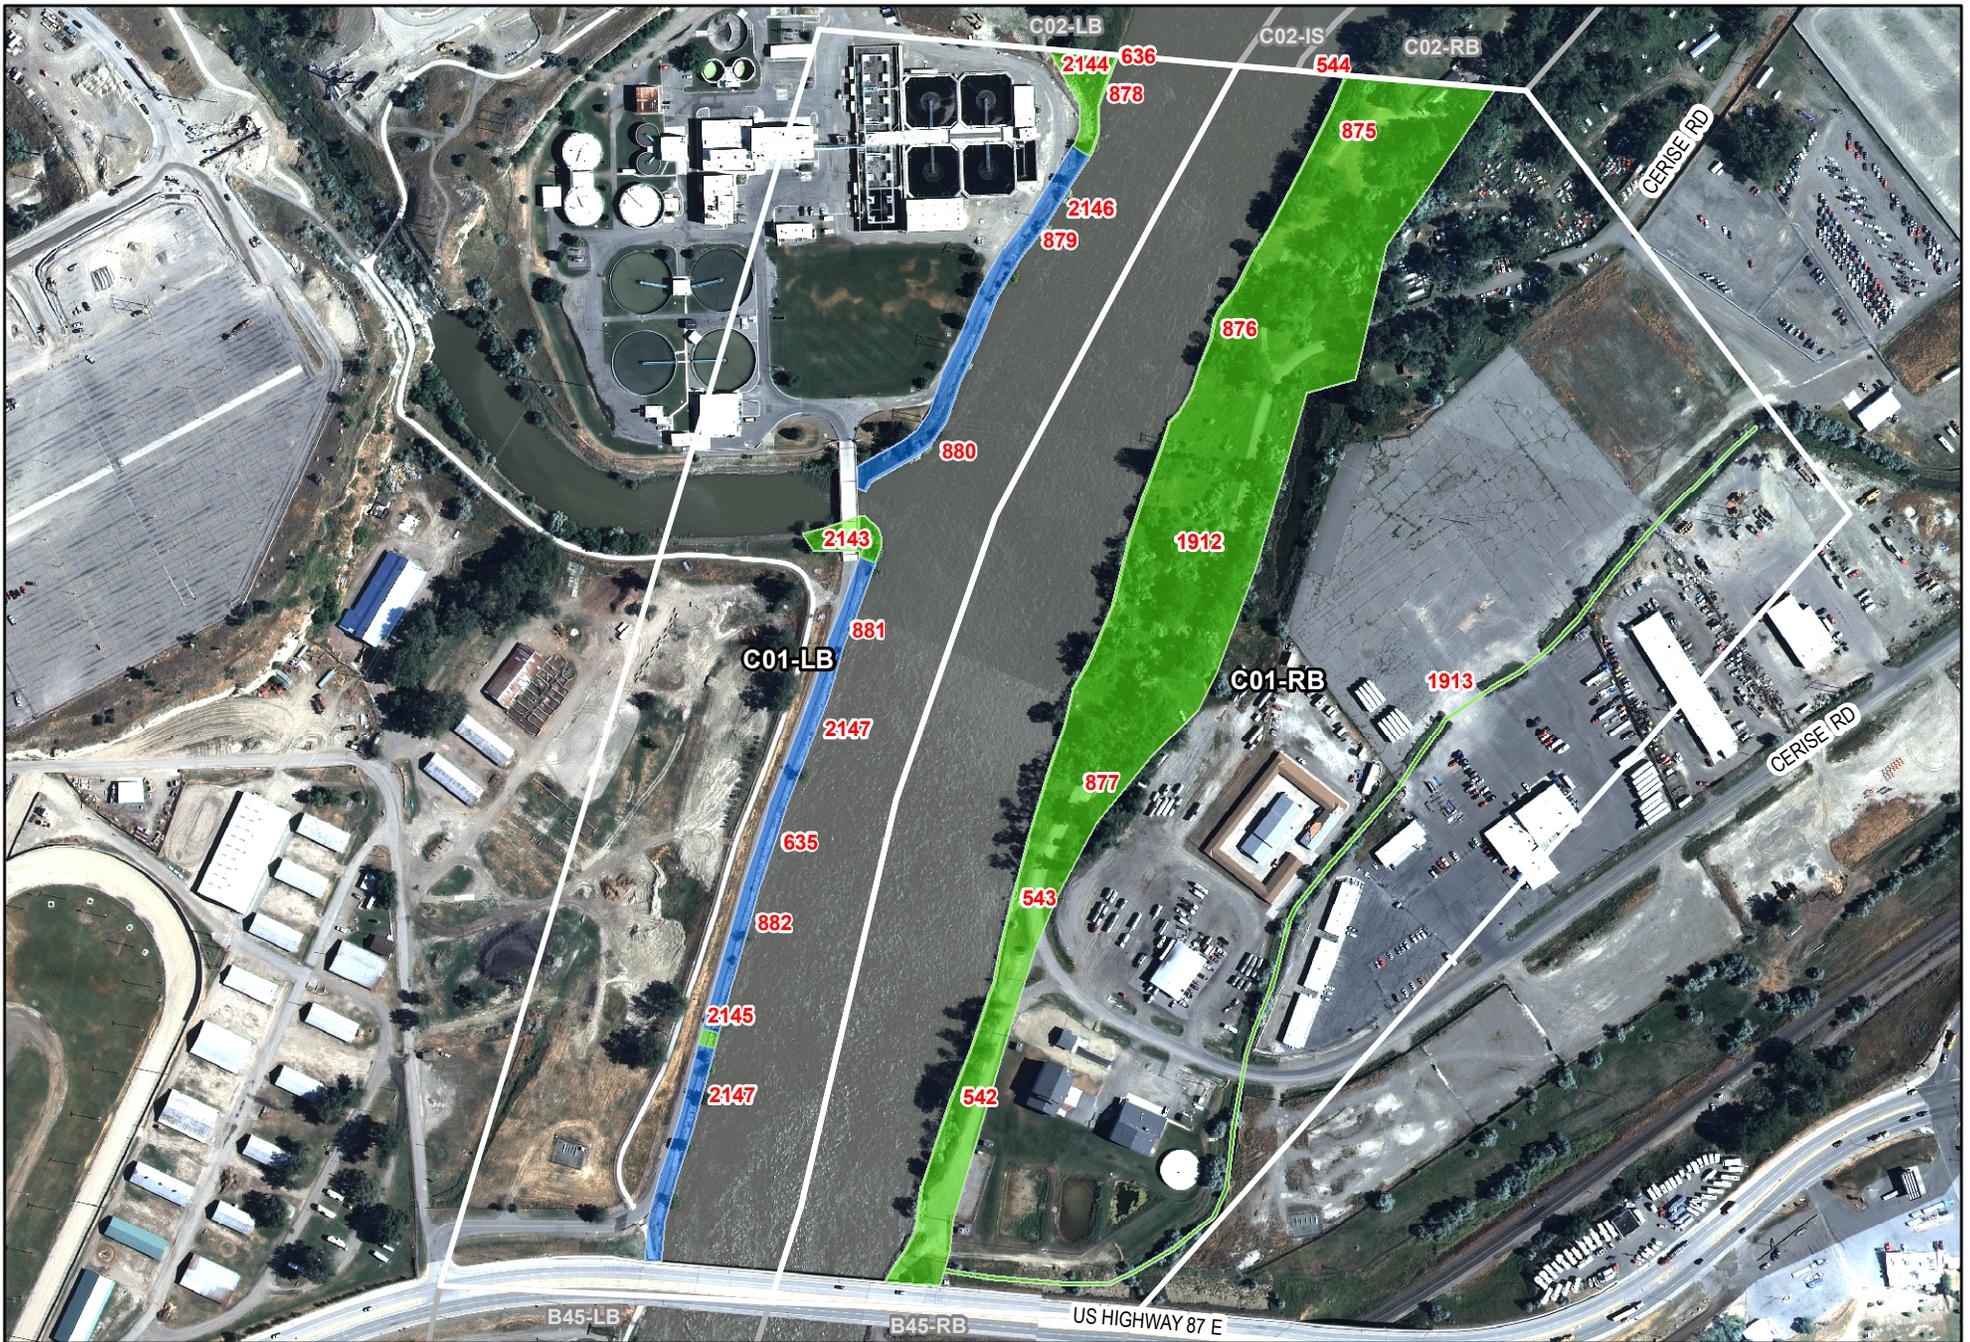
Figure 5 shows the oiling conditions within Area C01 following completion of oil removal activities. The SCAT team performed final surveys of the left and right banks within SCAT Area C01 to confirm the agreed-upon cleanup endpoints identified in the applicable CTRs had been achieved. The final SCAT survey documentation is presented in Appendix E.

No Oil Observed</p>	<p>Figure 5 - Final SCAT Observations</p> <p>For SCAT Area: C01</p>

Based on the final SCAT surveys performed on the left and right banks within Area C01, no further treatment is recommended for these segments. SCAT Segment Sign-Off Forms are included as Appendix F.

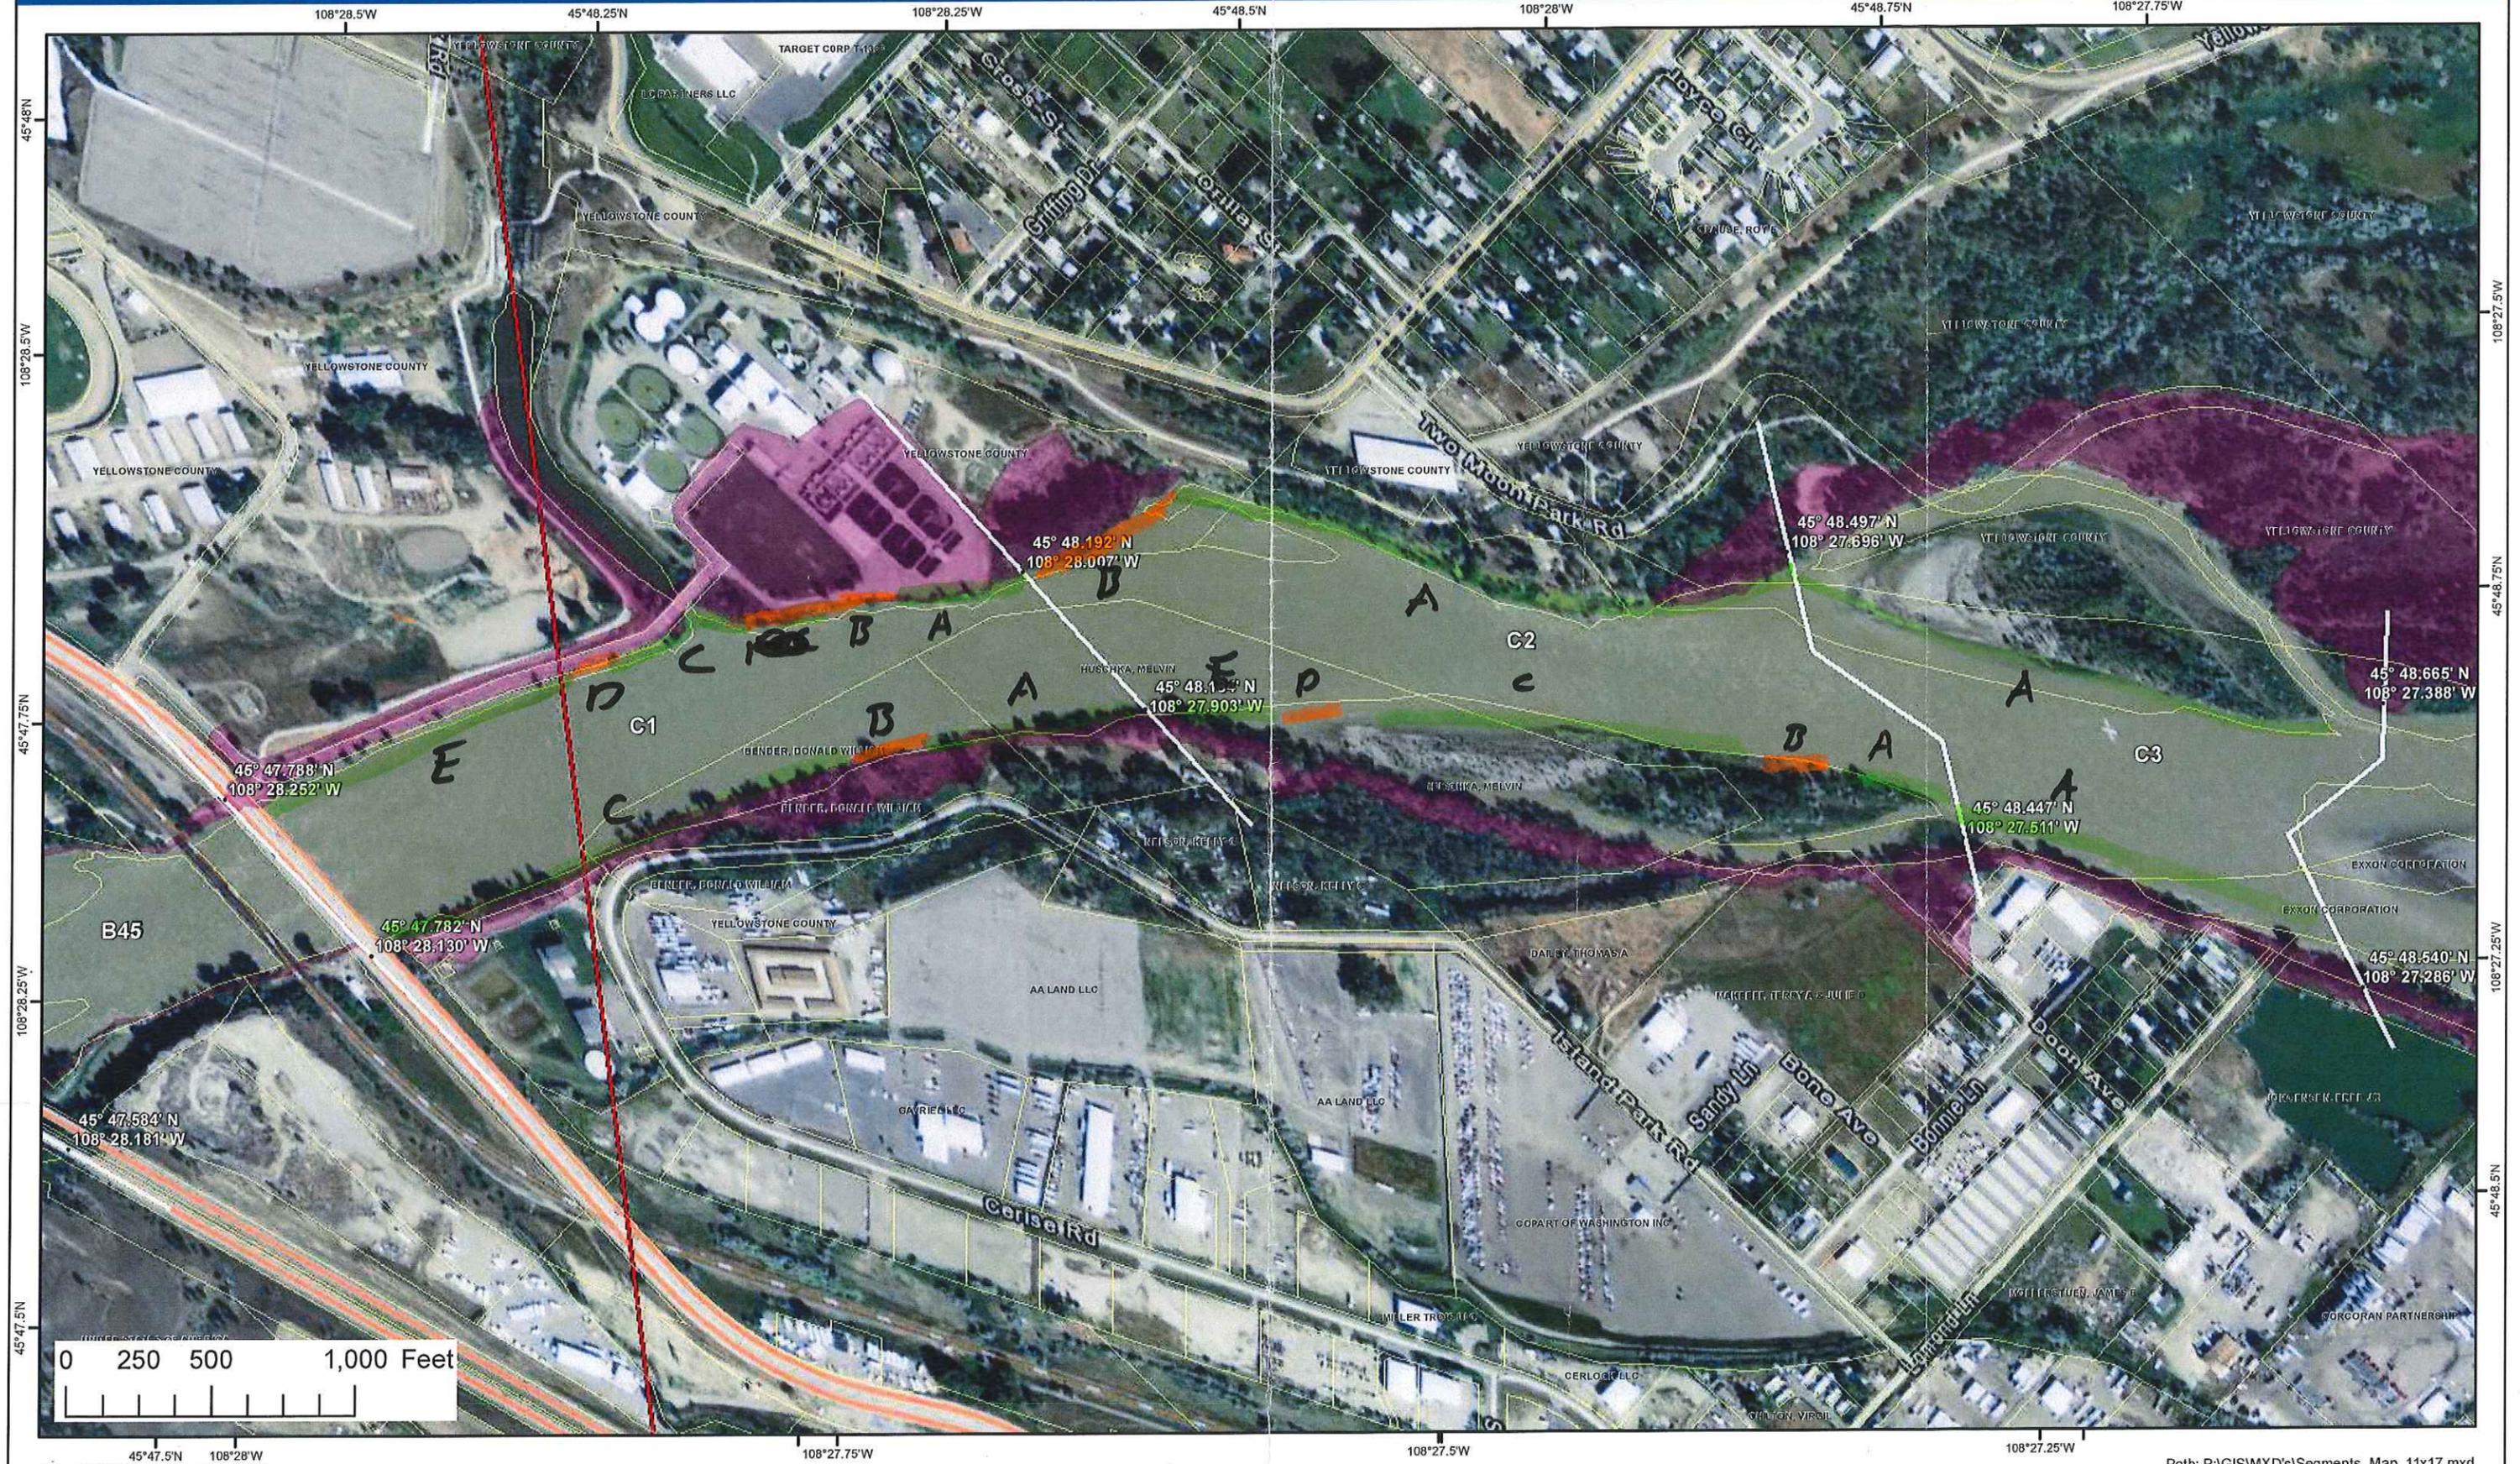
Zone B+D have staid + cont'd veg (primarily grass)
 Veg needs to be cut under trial and removed.

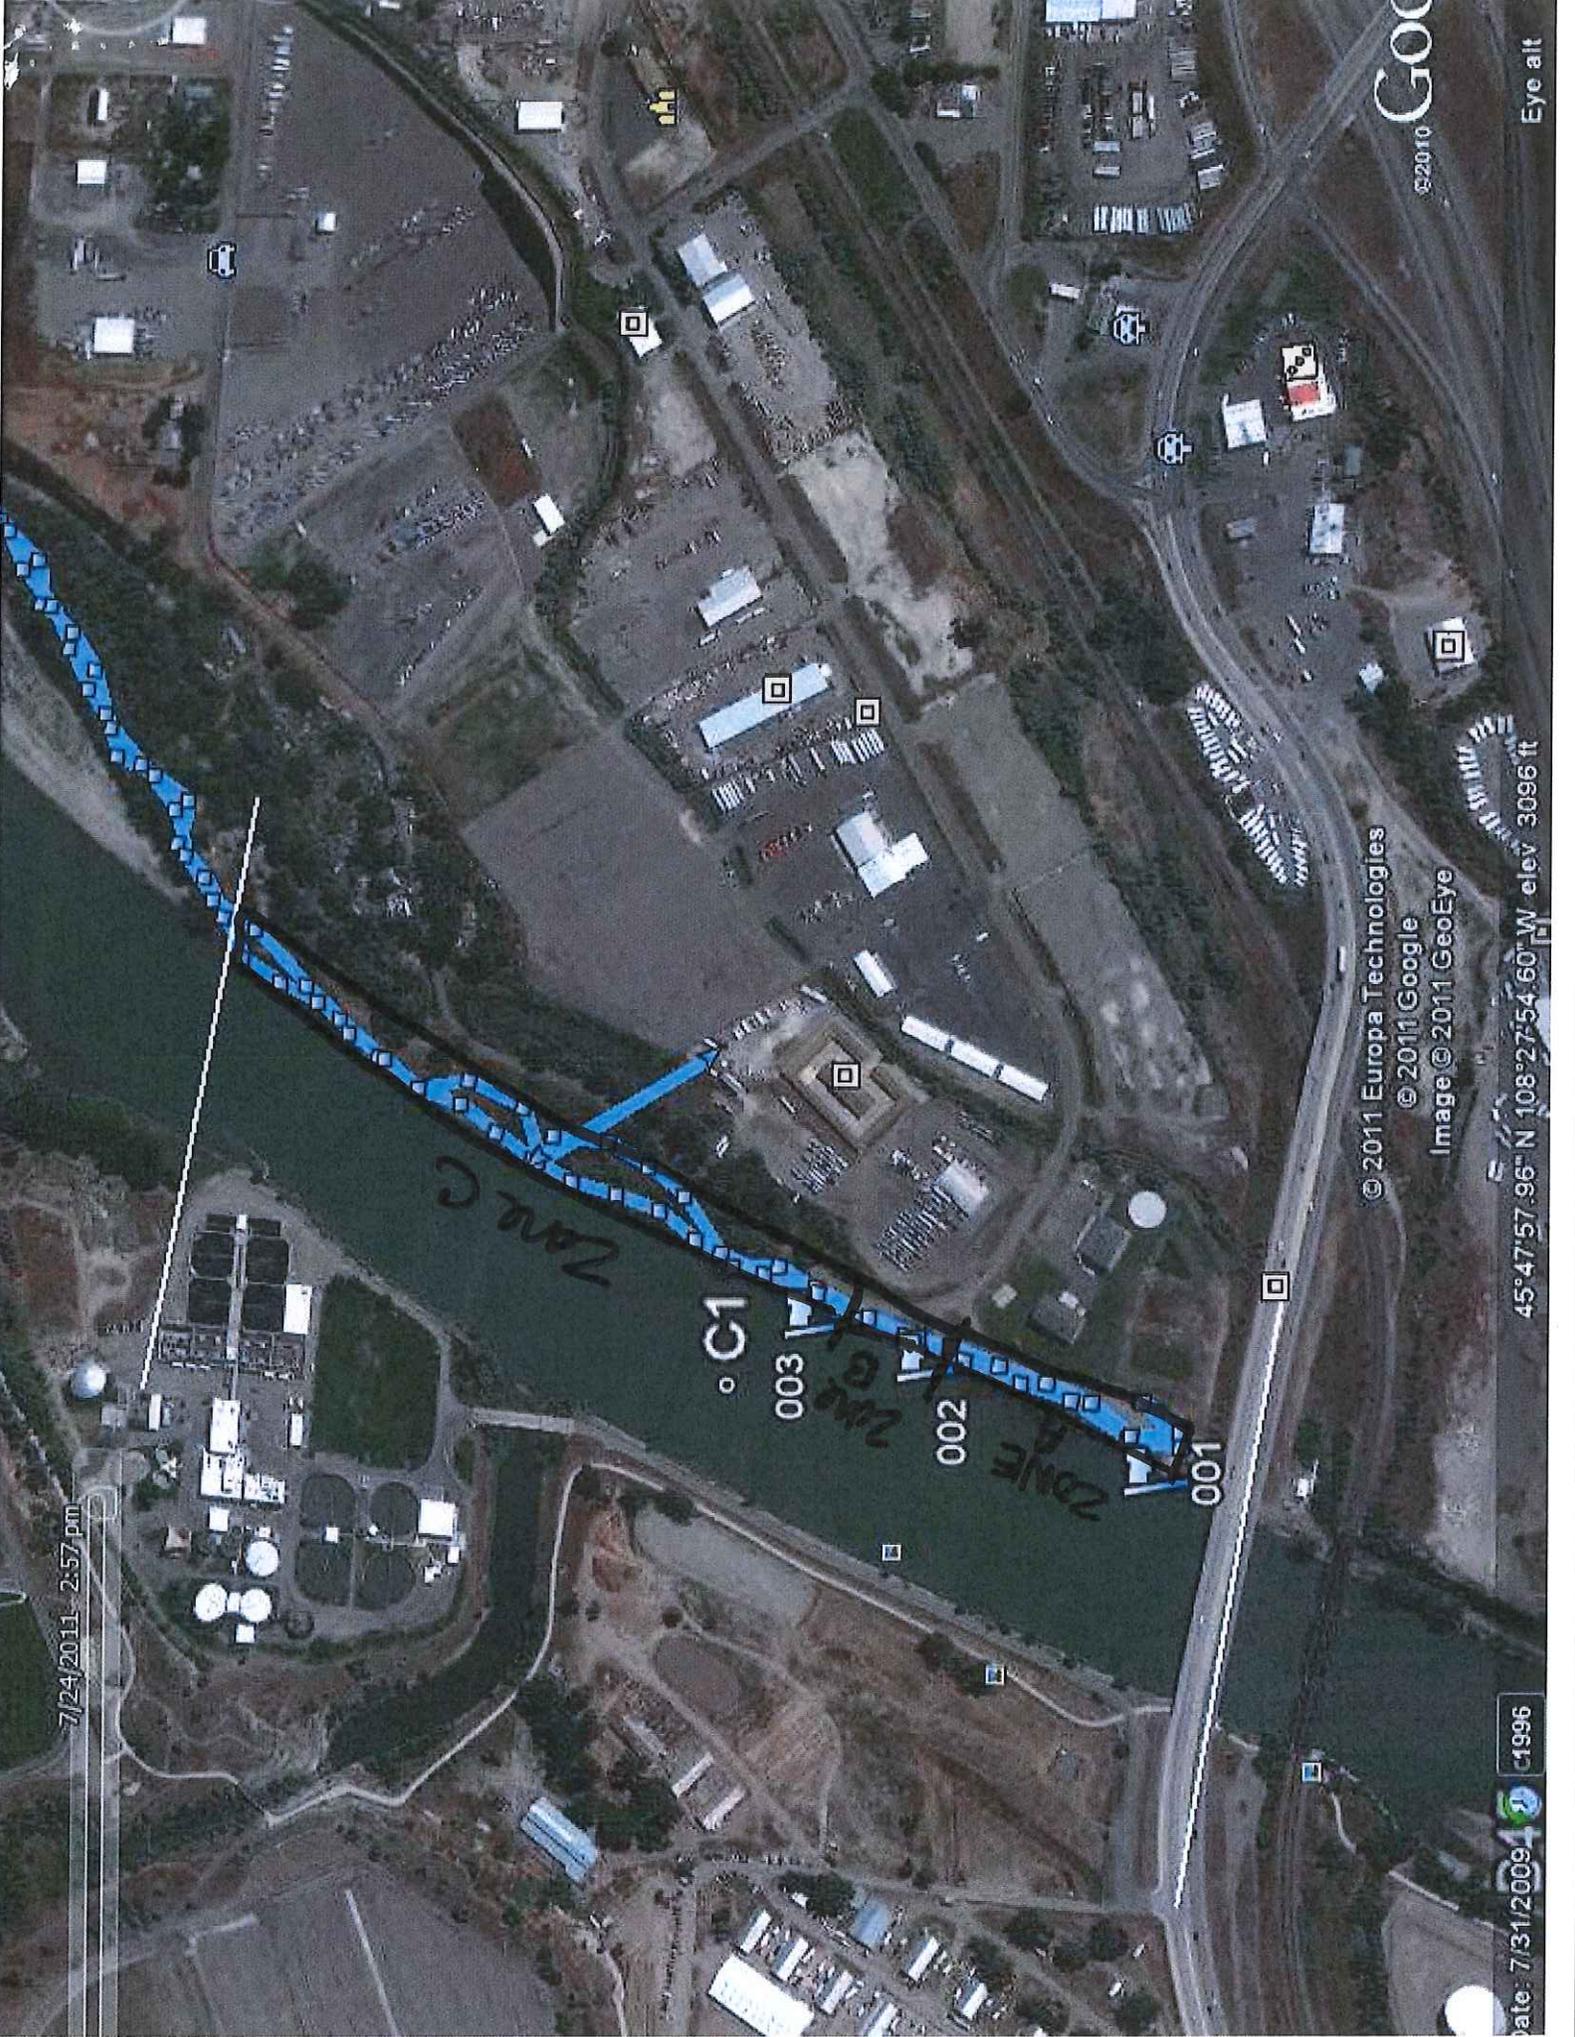
Zone
Map
C1

Notes A: hand removal w/ hand tools; veg piles of stained veg.
