**SCAT Area Transition Report
for C01**

Silvertip Pipeline Incident
Laurel, Montana

October 21, 2011

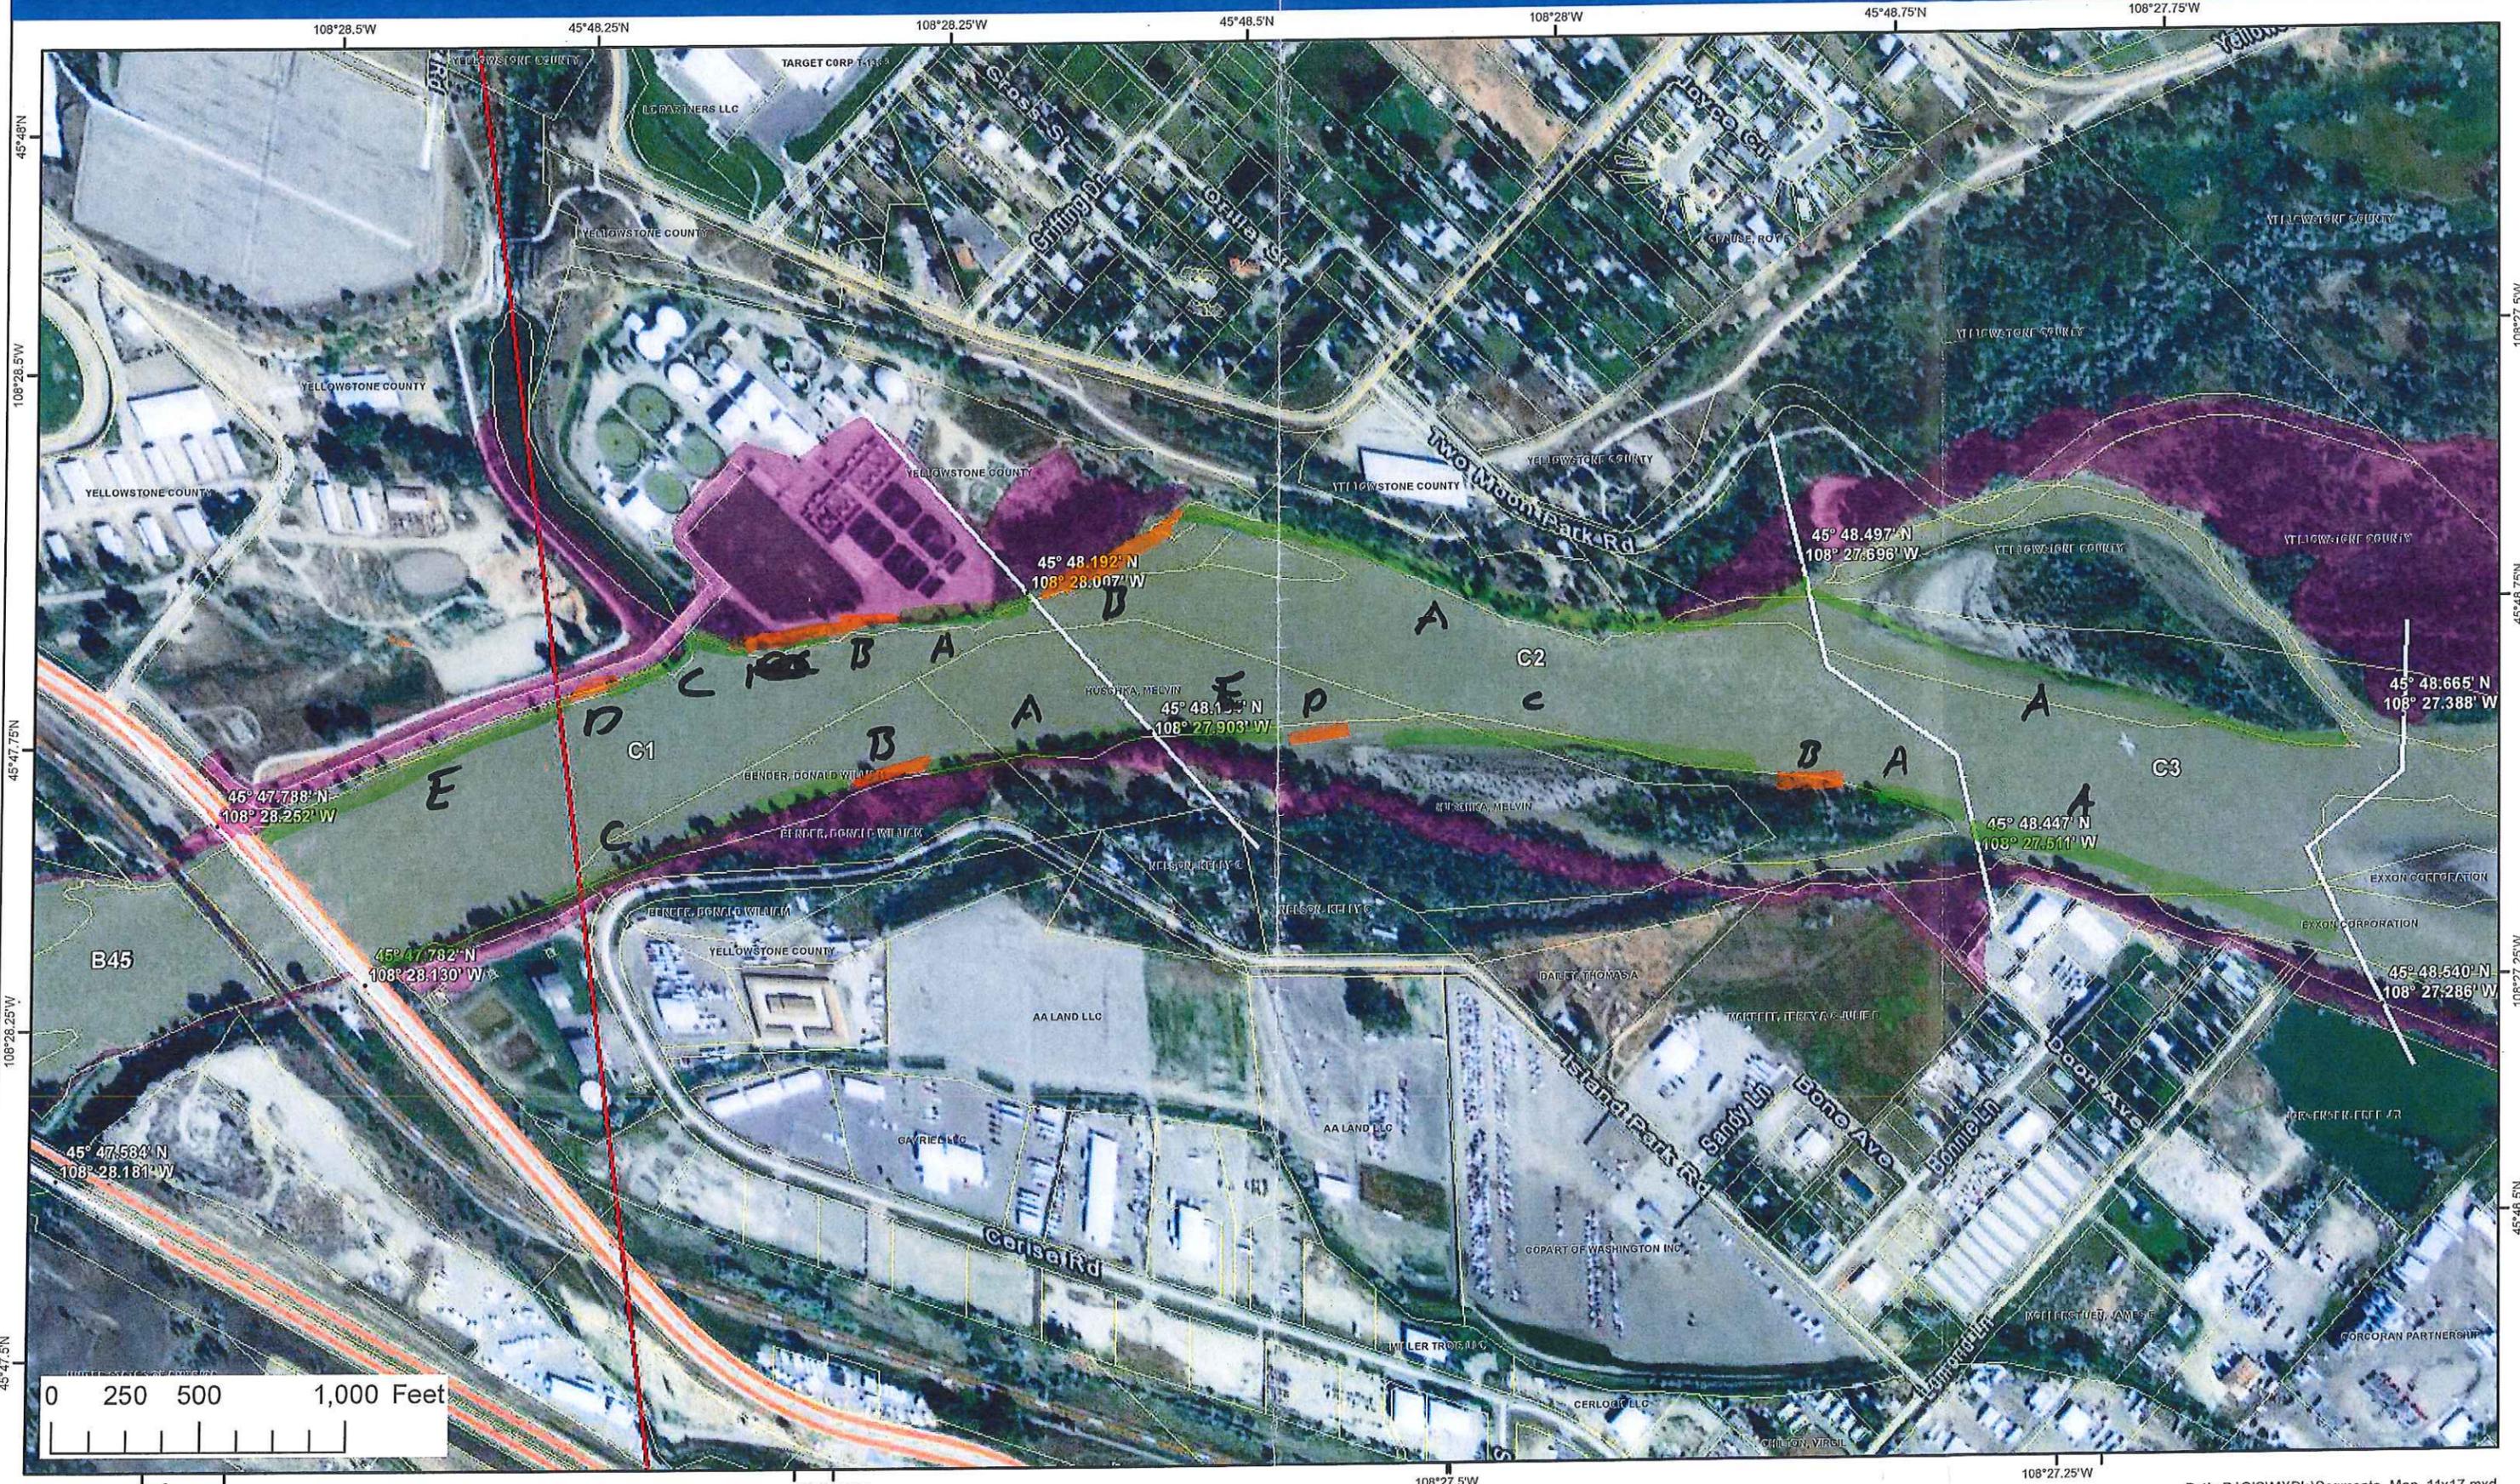
Zone B has stand + creek veg

Vegetation needs to be cut and/or treated and removed

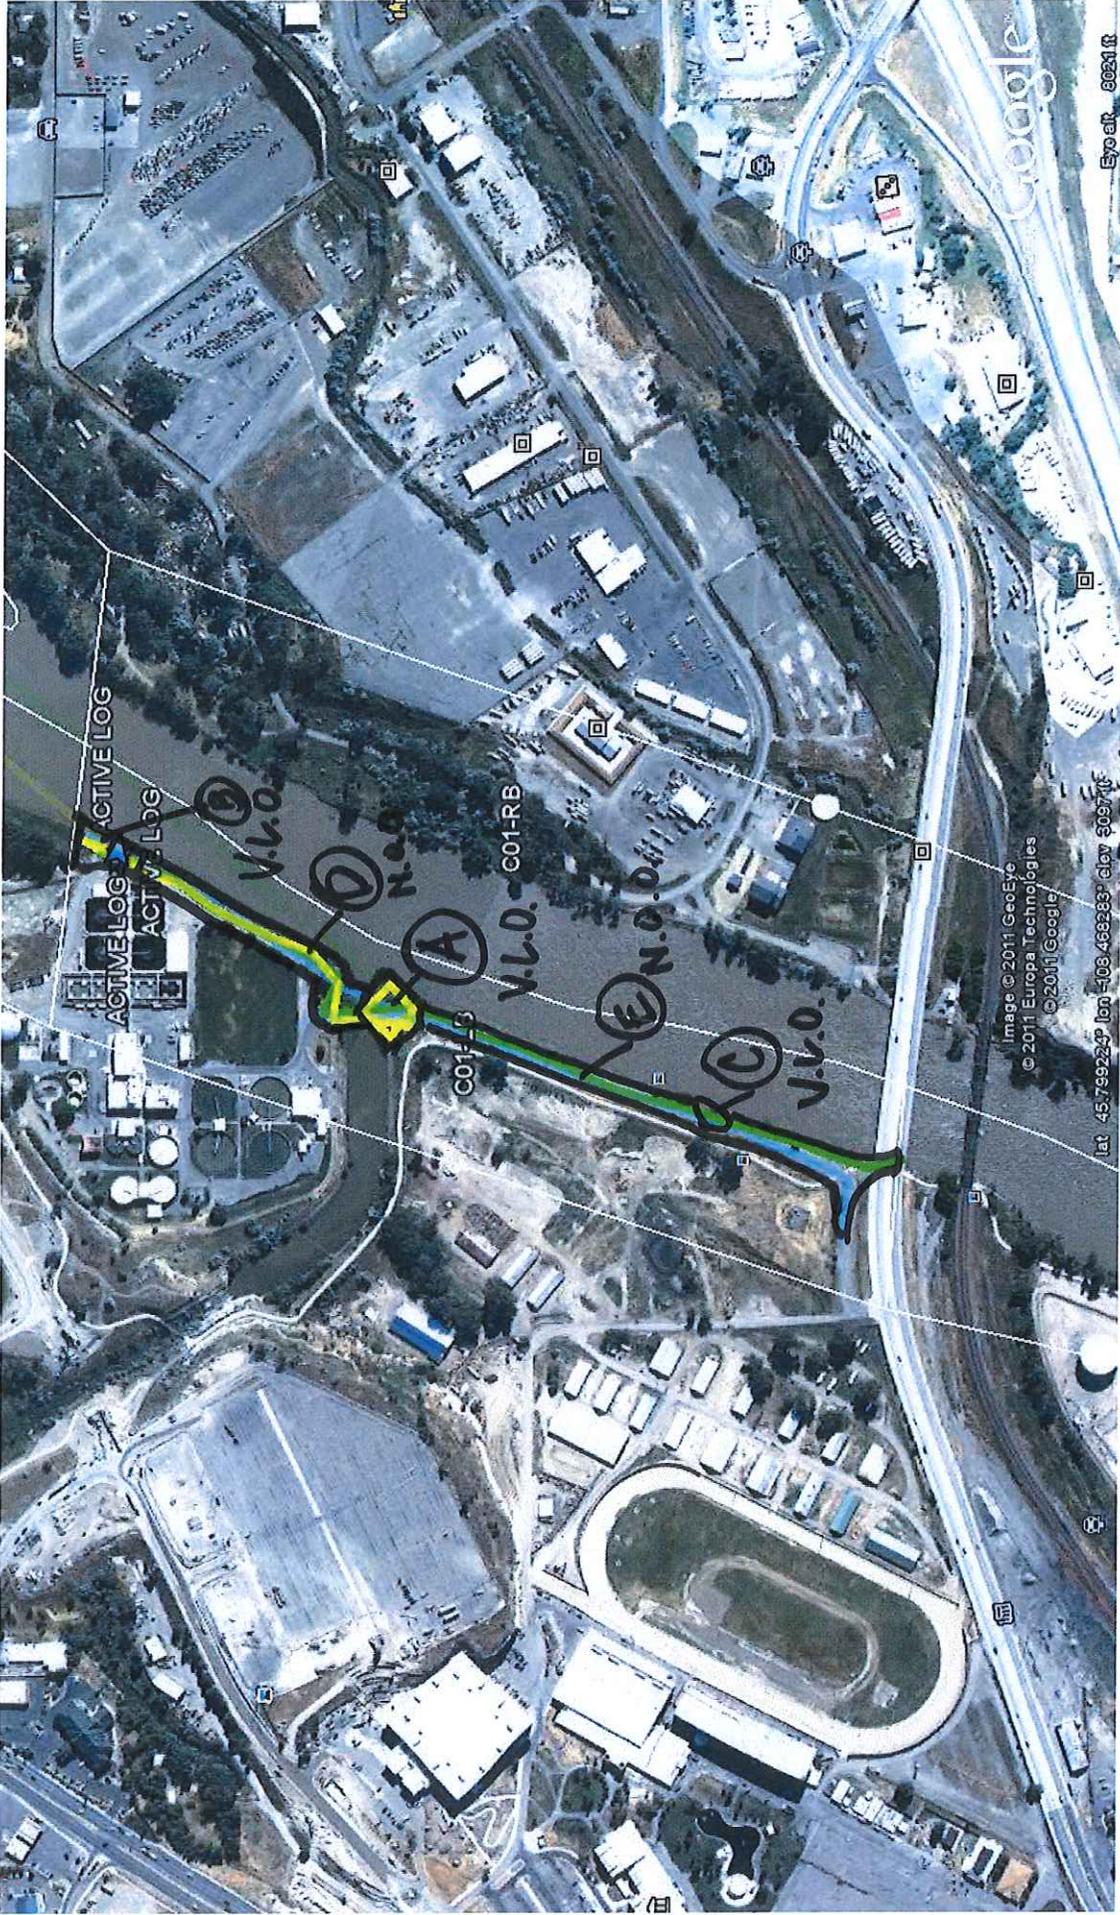
Zones A, B & C: Light treatment by previous teams. Flags observed in zone B from previous SCAT review. Flags were removed. Vegetation with stain and light coat trimmed (ATM#1). No further treatment recommended by consensus.

Zones D & E: No oil observed. No further treatment recommended by consensus.

09/06/11 SCAT TEAM 4 & HOT SHOTS

ZONES A, B, & C: VERY LIGHT OIL, ATM#1. N.F.T.

ZONES D & E: NO OIL OBSERVED. N.F.T.
