**SCAT Area Transition Report
for C05**

Silvertip Pipeline Incident
Laurel, Montana

October 28, 2011

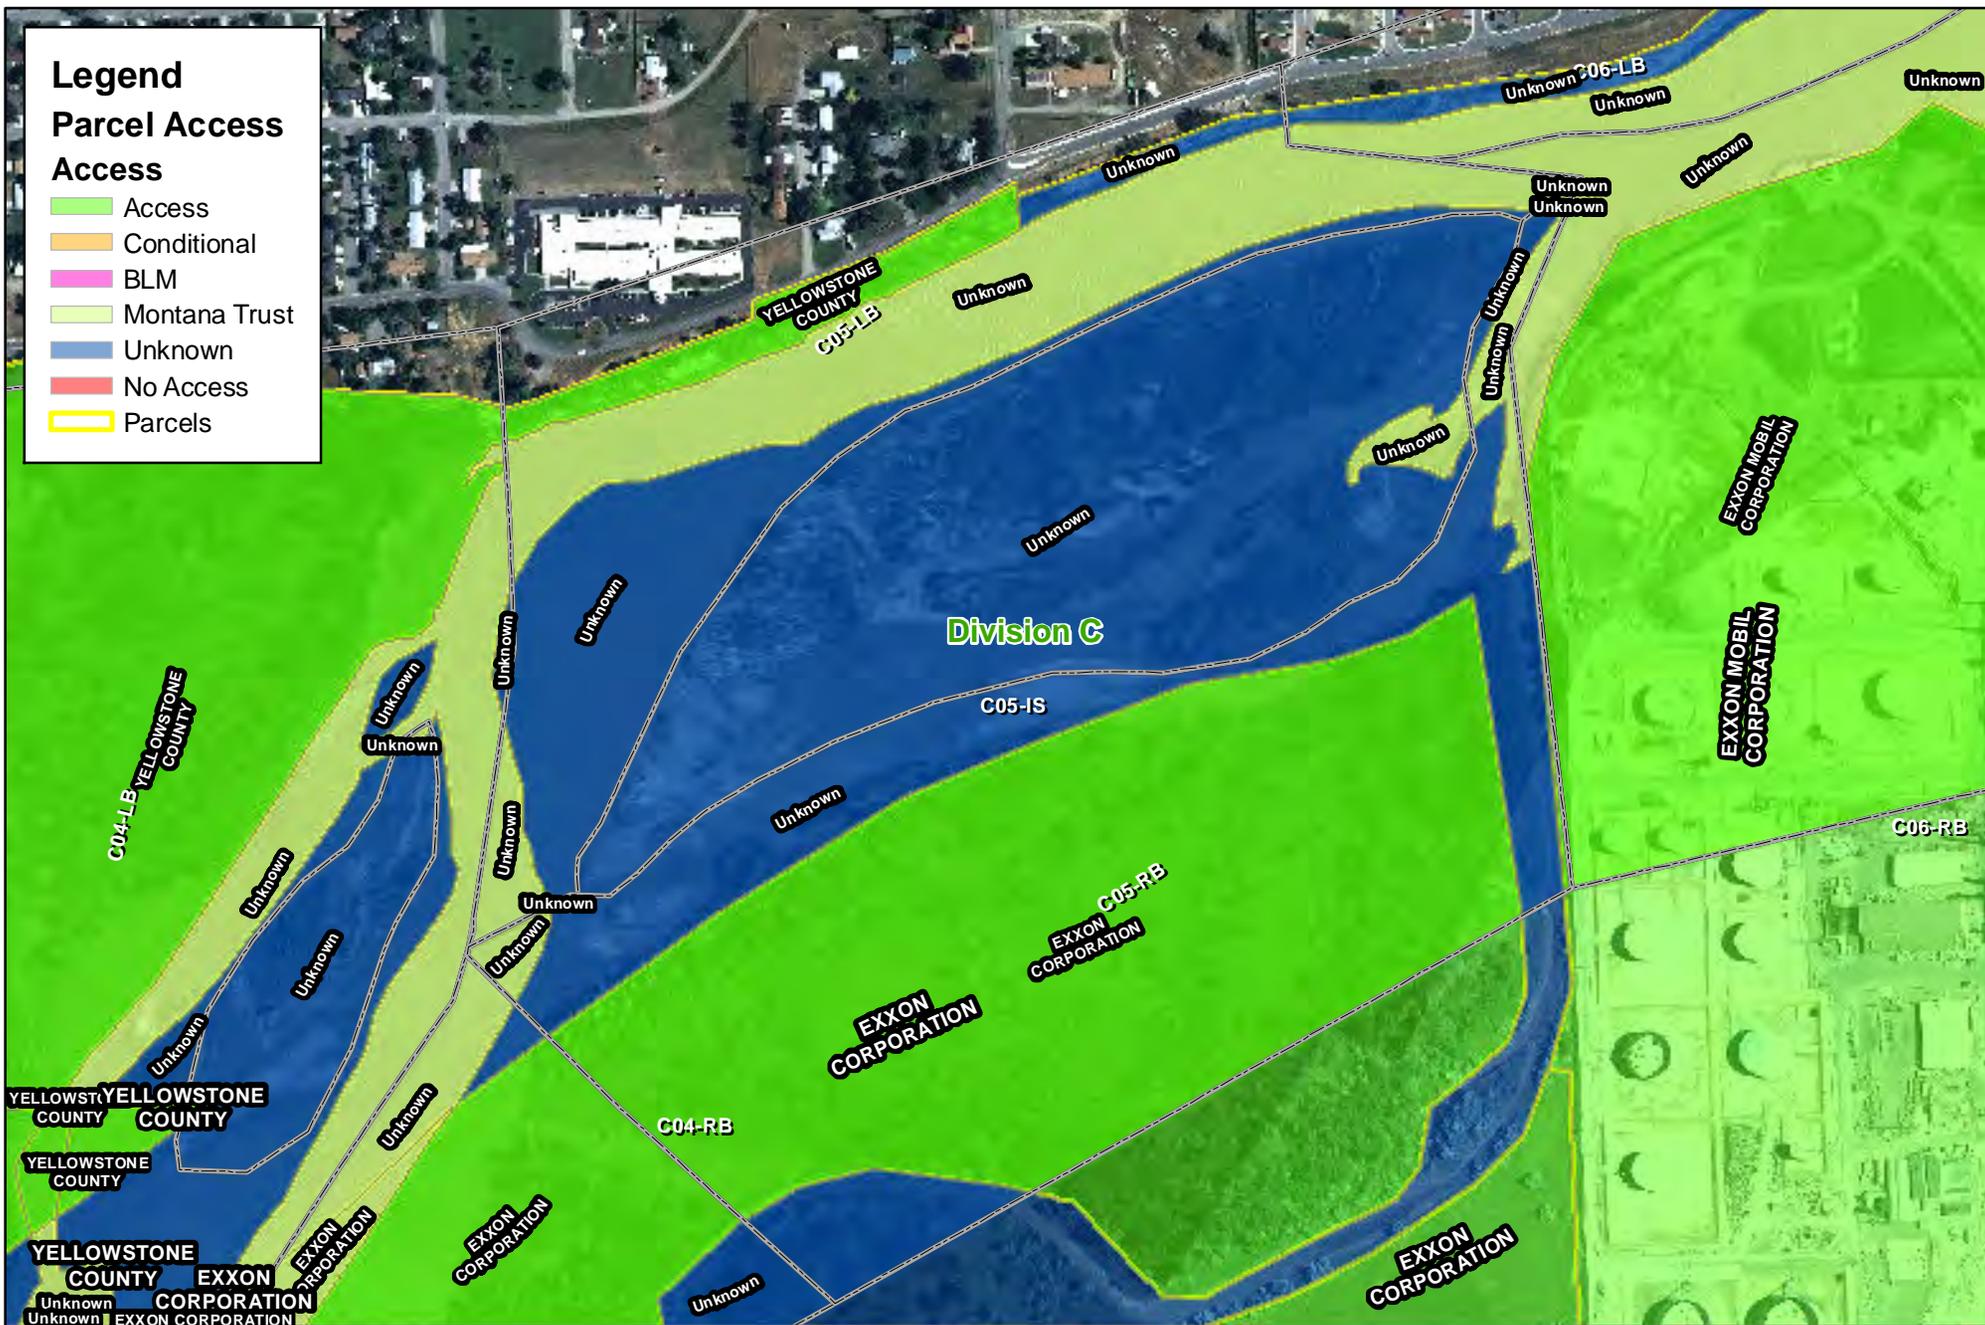
Figure 1 provides an aerial map of SCAT Area C05, along with the (a) SCAT Area boundary, (b) parcel boundaries and respective property owners, and (c) access constraints identified during the oil cleanup process. The acreage surveyed in Area C05 is 55.5. There were no access issues for this area.

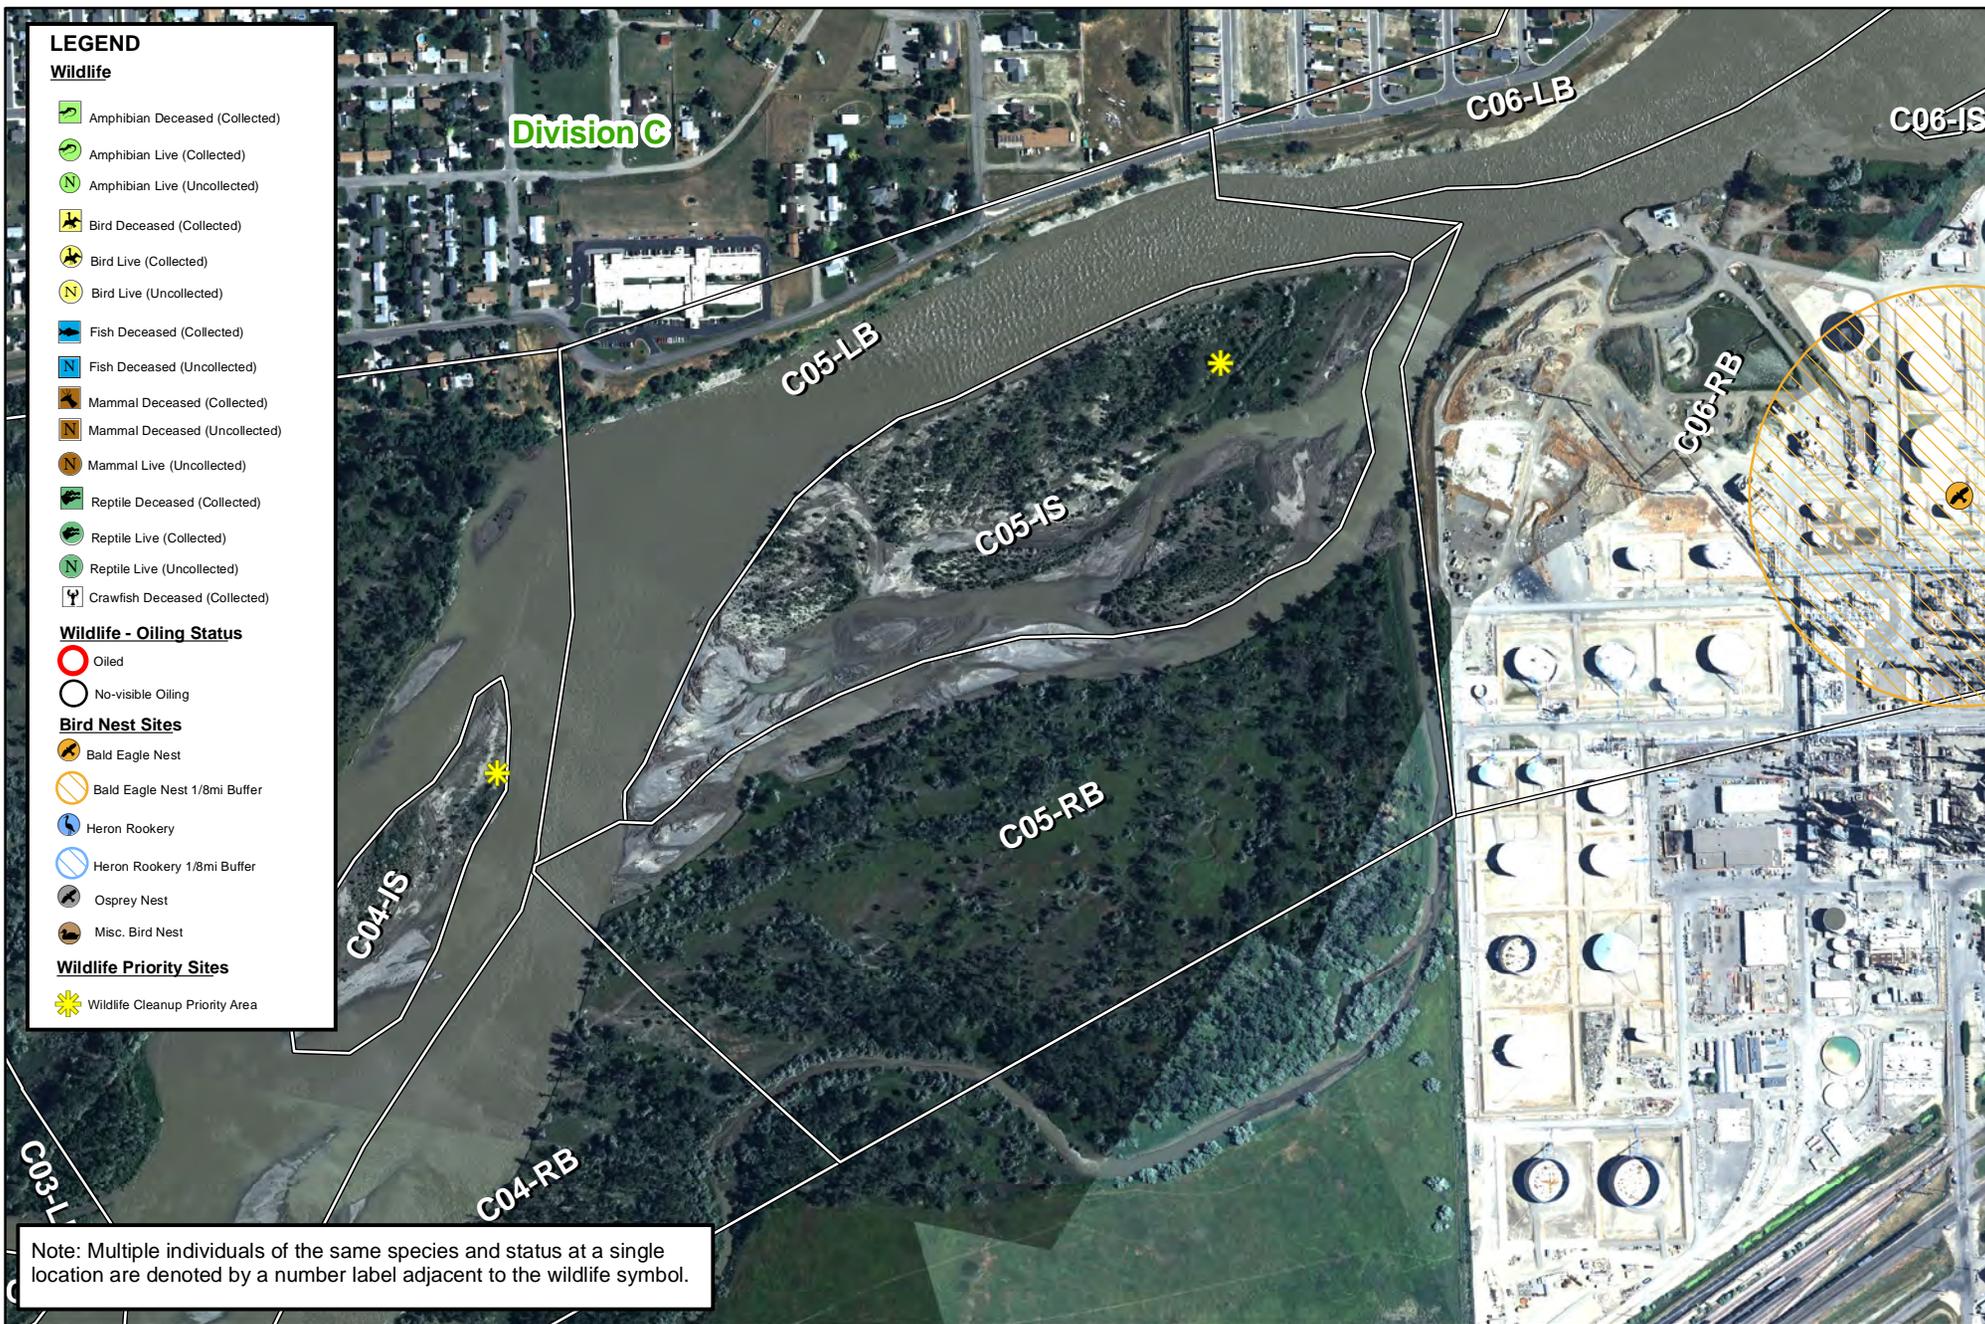
Figure 2
Wildlife Resources

Figure 2 summarizes the natural resources identified in this segment. International Bird Rescue and Resource Advisors from U.S. Fish and Wildlife Service conducted limited inspections of Area C05 due to the low level of oiling in Division C. No oiled wildlife was observed or recovered. One Wildlife Priority Cleanup Areas (WPCA) was identified in Area C05. The WPCA was an area on the island with transferable oil on vegetation and the ground. Operations addressed the WPCA and no further action is required. No active migratory bird nests were identified in Area C05.

A Wildlife Exception Memo was created to identify multiple wildlife hazards in Area C05, as discussed in Section 1.2. The areas identified in the Wildlife Exception Memo were treated and are no longer considered wildlife hazards. No additional work is required in this area. Details of the actions taken are described in Appendix G.

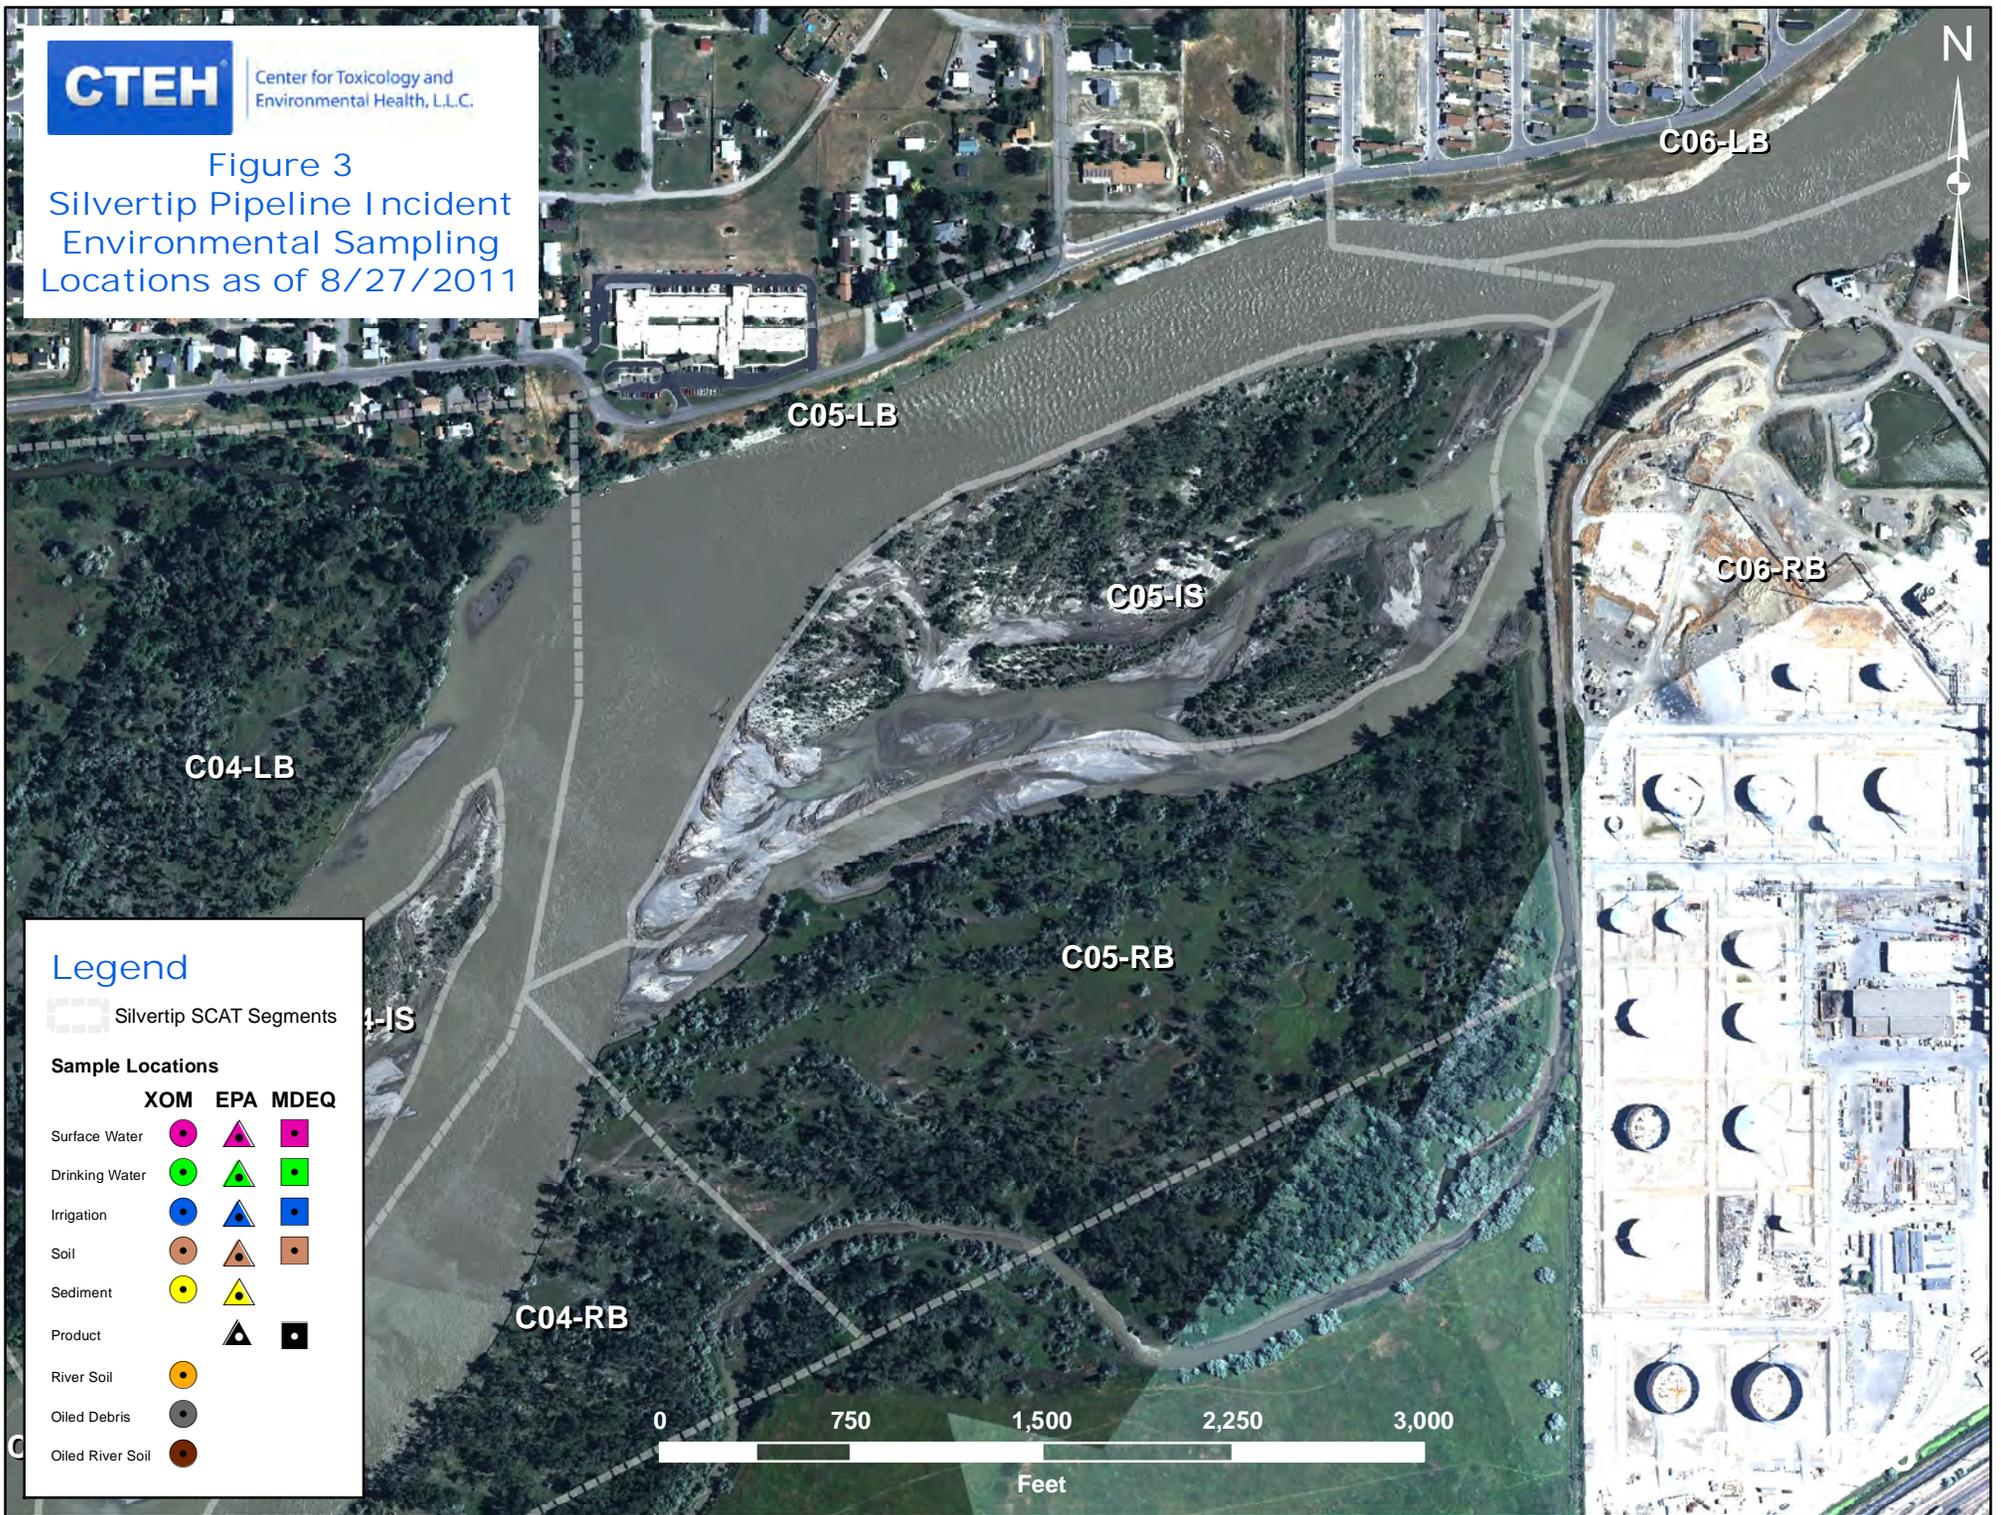
Figure 3
Silvertip Pipeline Incident
Environmental Sampling
Locations as of 8/27/2011

Table 1 (below) summarizes samples collected within Area C05. The analytical results for the samples collected can be accessed through a publicly accessible database on the United States Environmental Protection Agency's (USEPA's) website. The approximate locations of samples collected within Area C05 are provided on Figure 3.

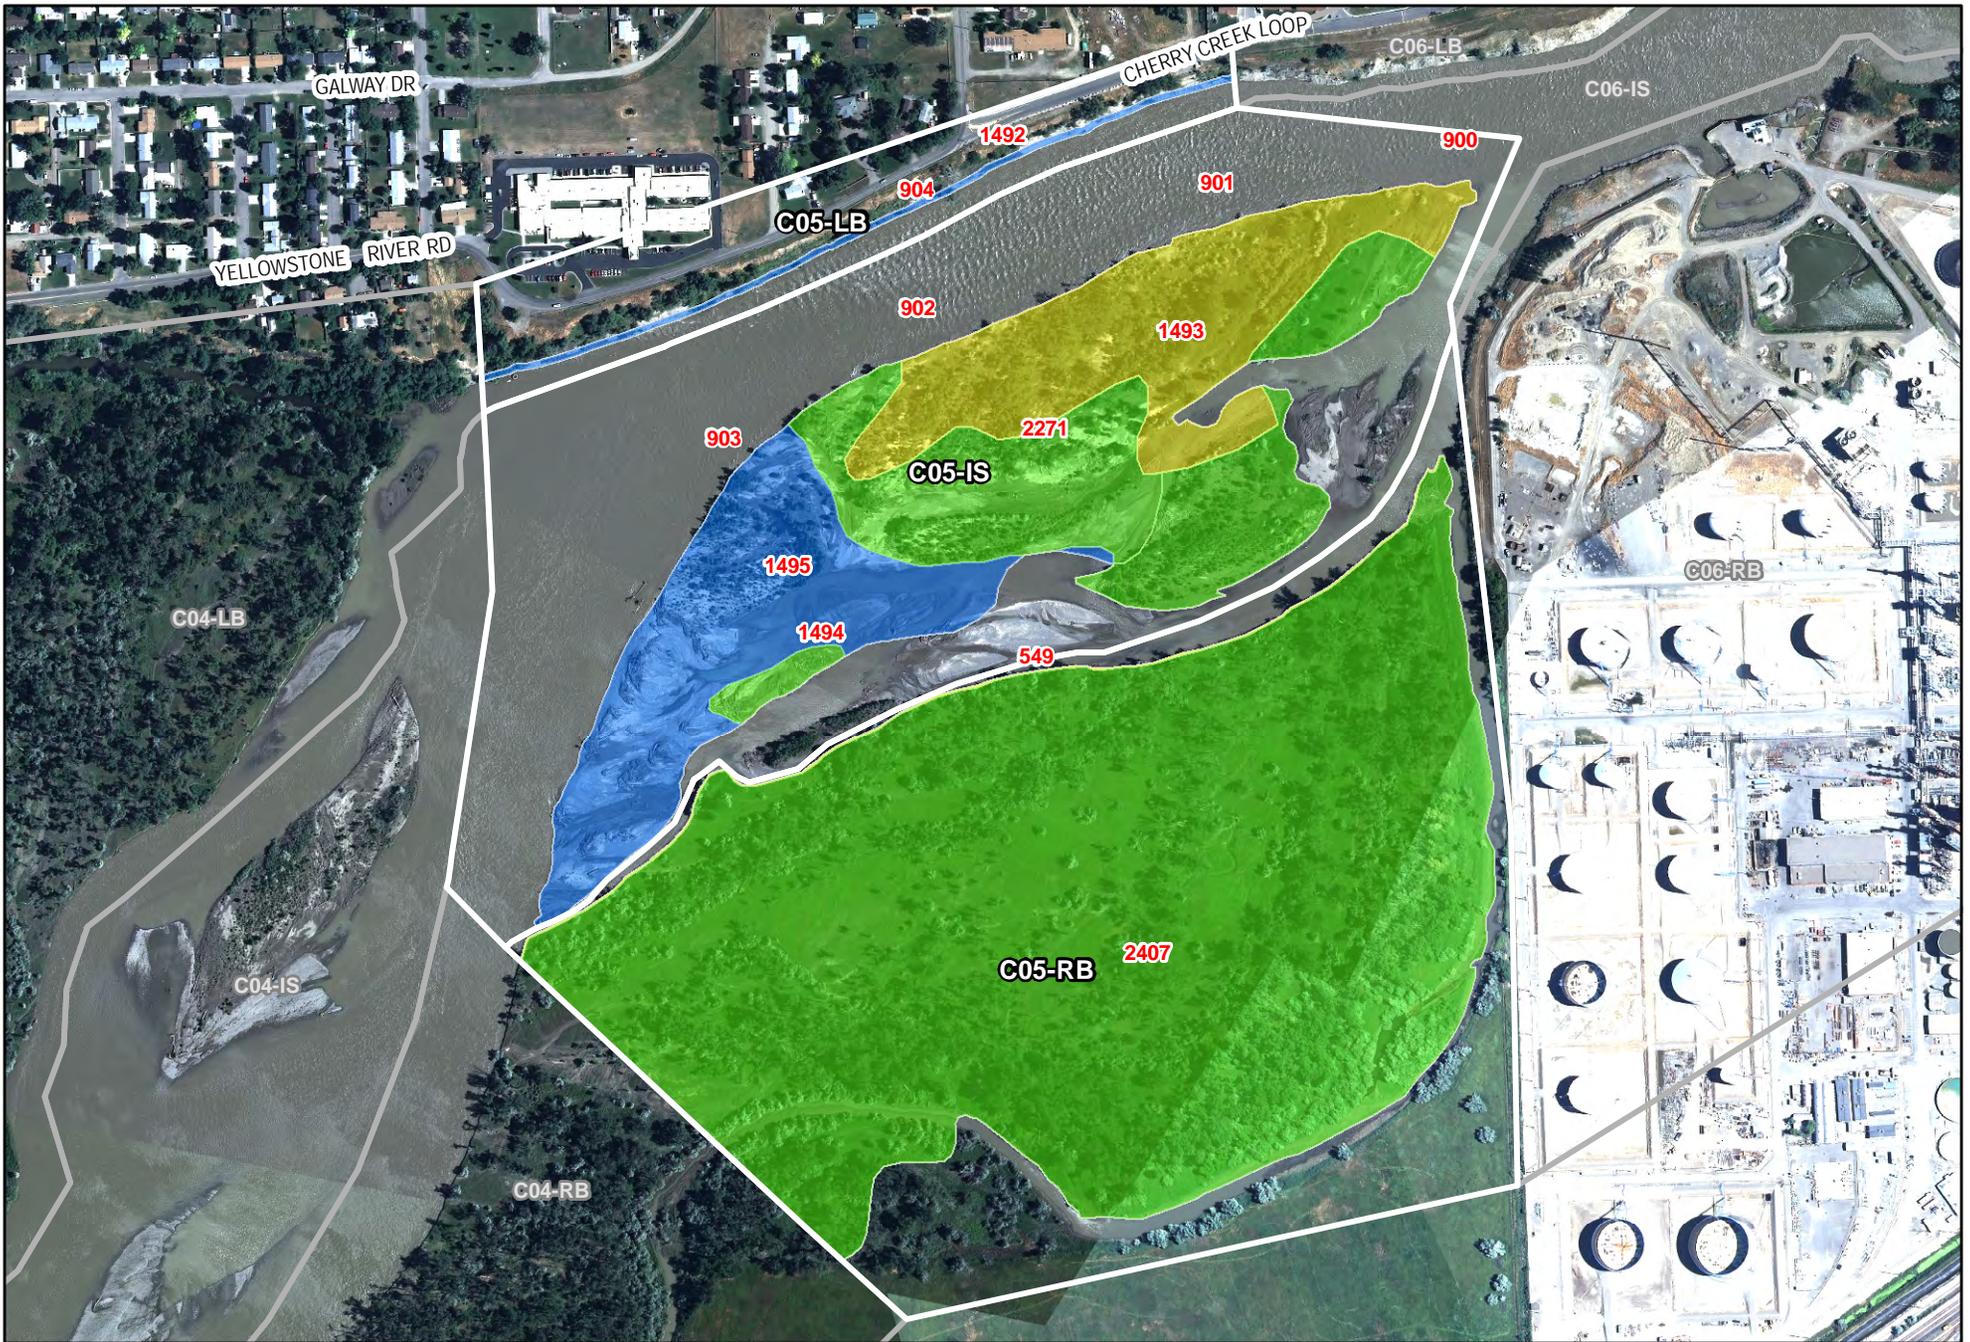
**Figure 4 - Maximum SCAT Observations
For SCAT Area:**

The SCAT teams used systematic evaluation criteria and treatment method tables approved by the National Oceanic and Atmospheric Administration to provide a standard approach for data collection and conducting field surveys. The forms and sketches from the initial SCAT surveys performed along the river bank (water edge) and floodplain within Area C05 are included in Appendix B. Figure 4 provides the maximum oiling zones observed by the SCAT team during the initial surveys of Area C05.

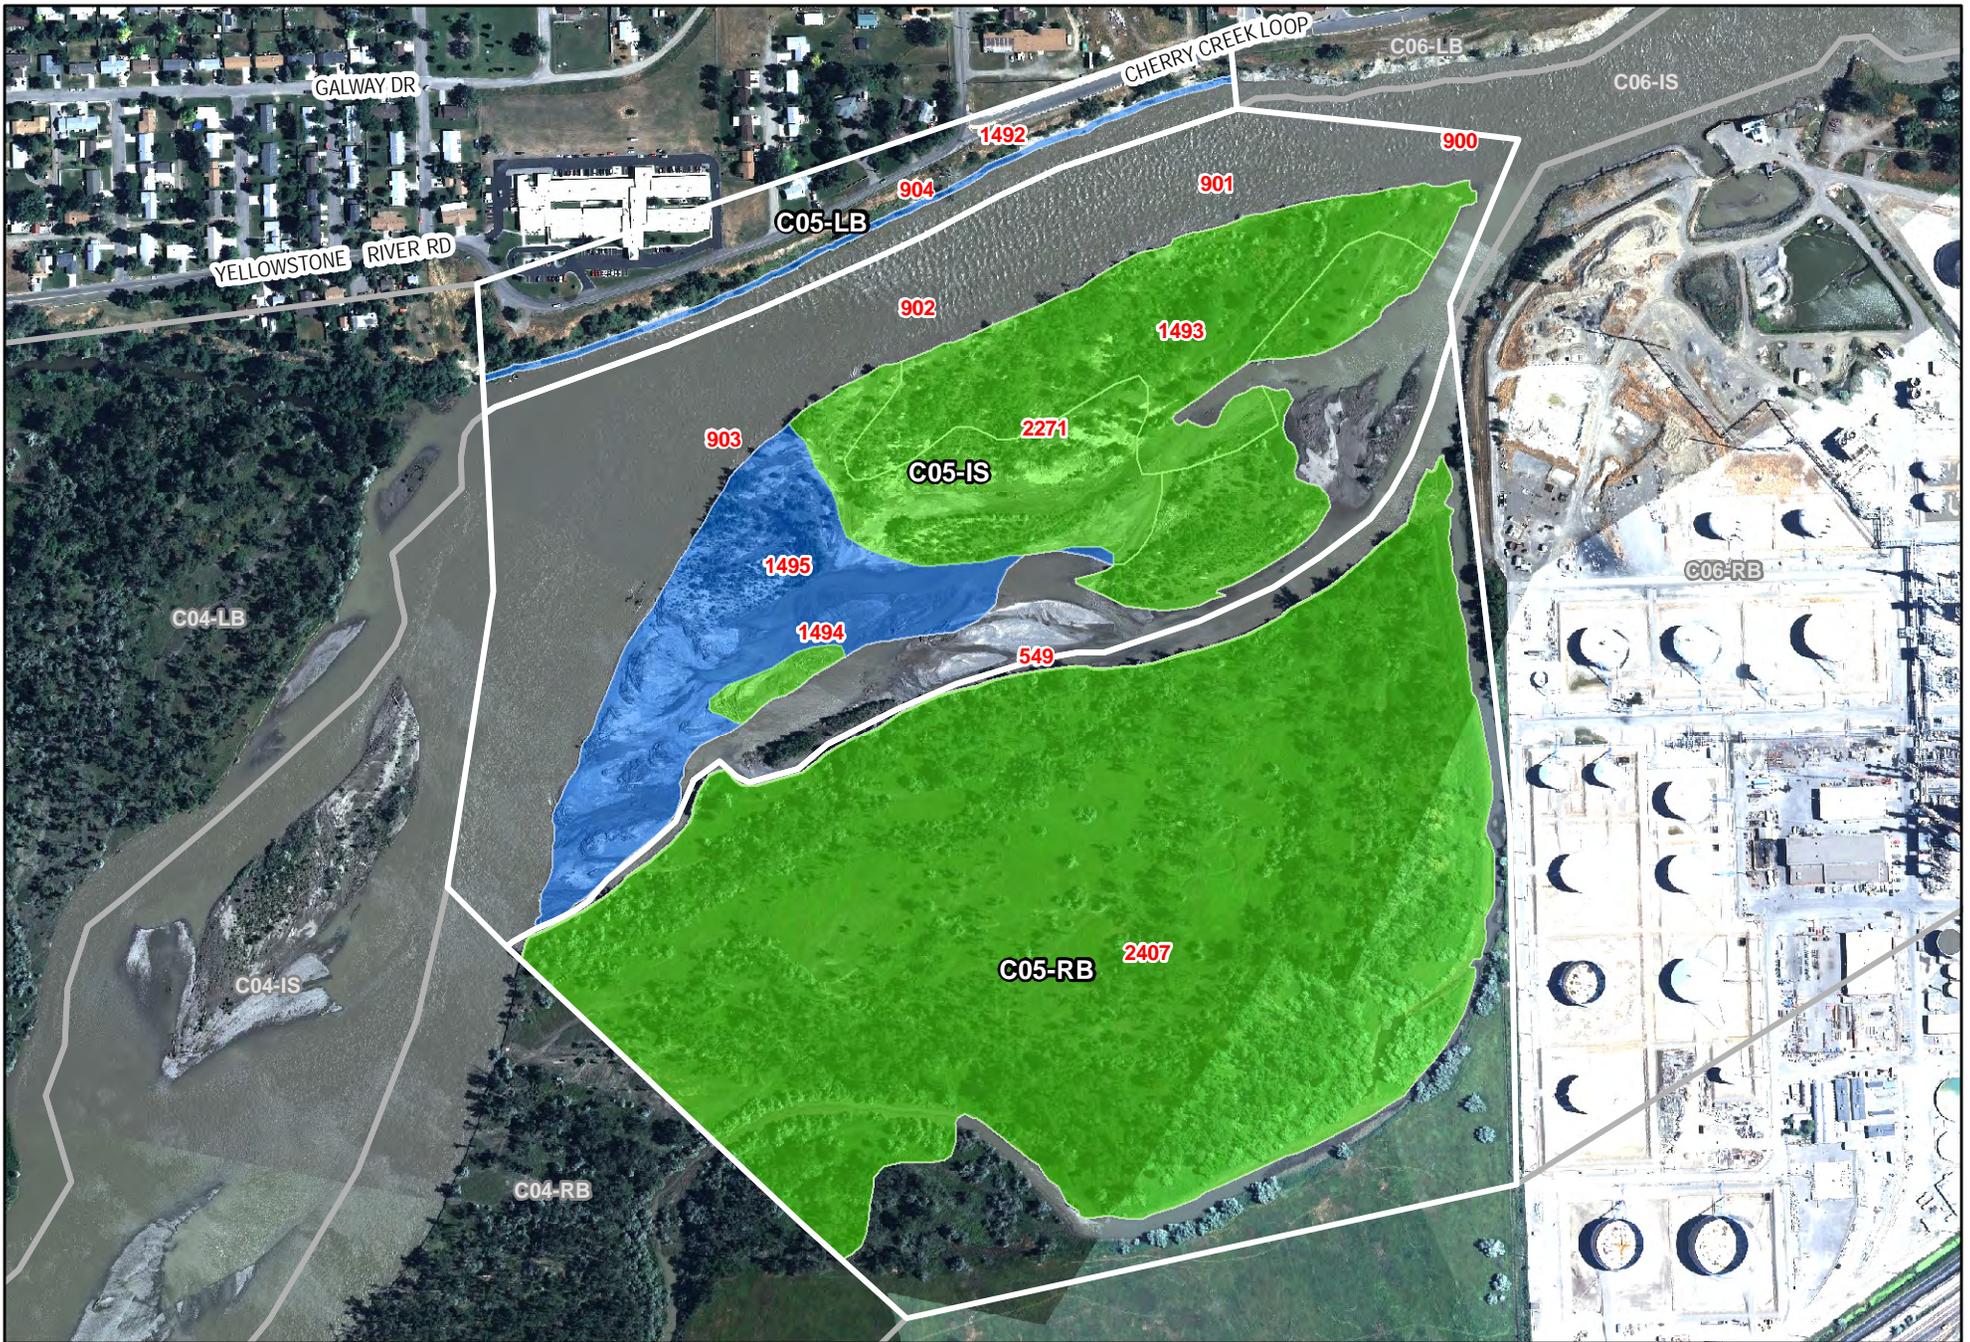
Figure 5 shows the oiling conditions within Area C05 following completion of oil removal activities. The SCAT team performed final surveys of the right bank and island within SCAT Area C05 to confirm the agreed-upon cleanup endpoints identified in the applicable CTRs had been achieved. The final SCAT survey documentation is presented in Appendix E.

Based on the initial SCAT surveys of the left bank within Area C05, no oil was observed and therefore no further treatment was recommended. Based on the final SCAT surveys performed on the right bank and island within Area C05, no further treatment was recommended for these segments. SCAT Segment Sign-Off Forms are included as Appendix F.

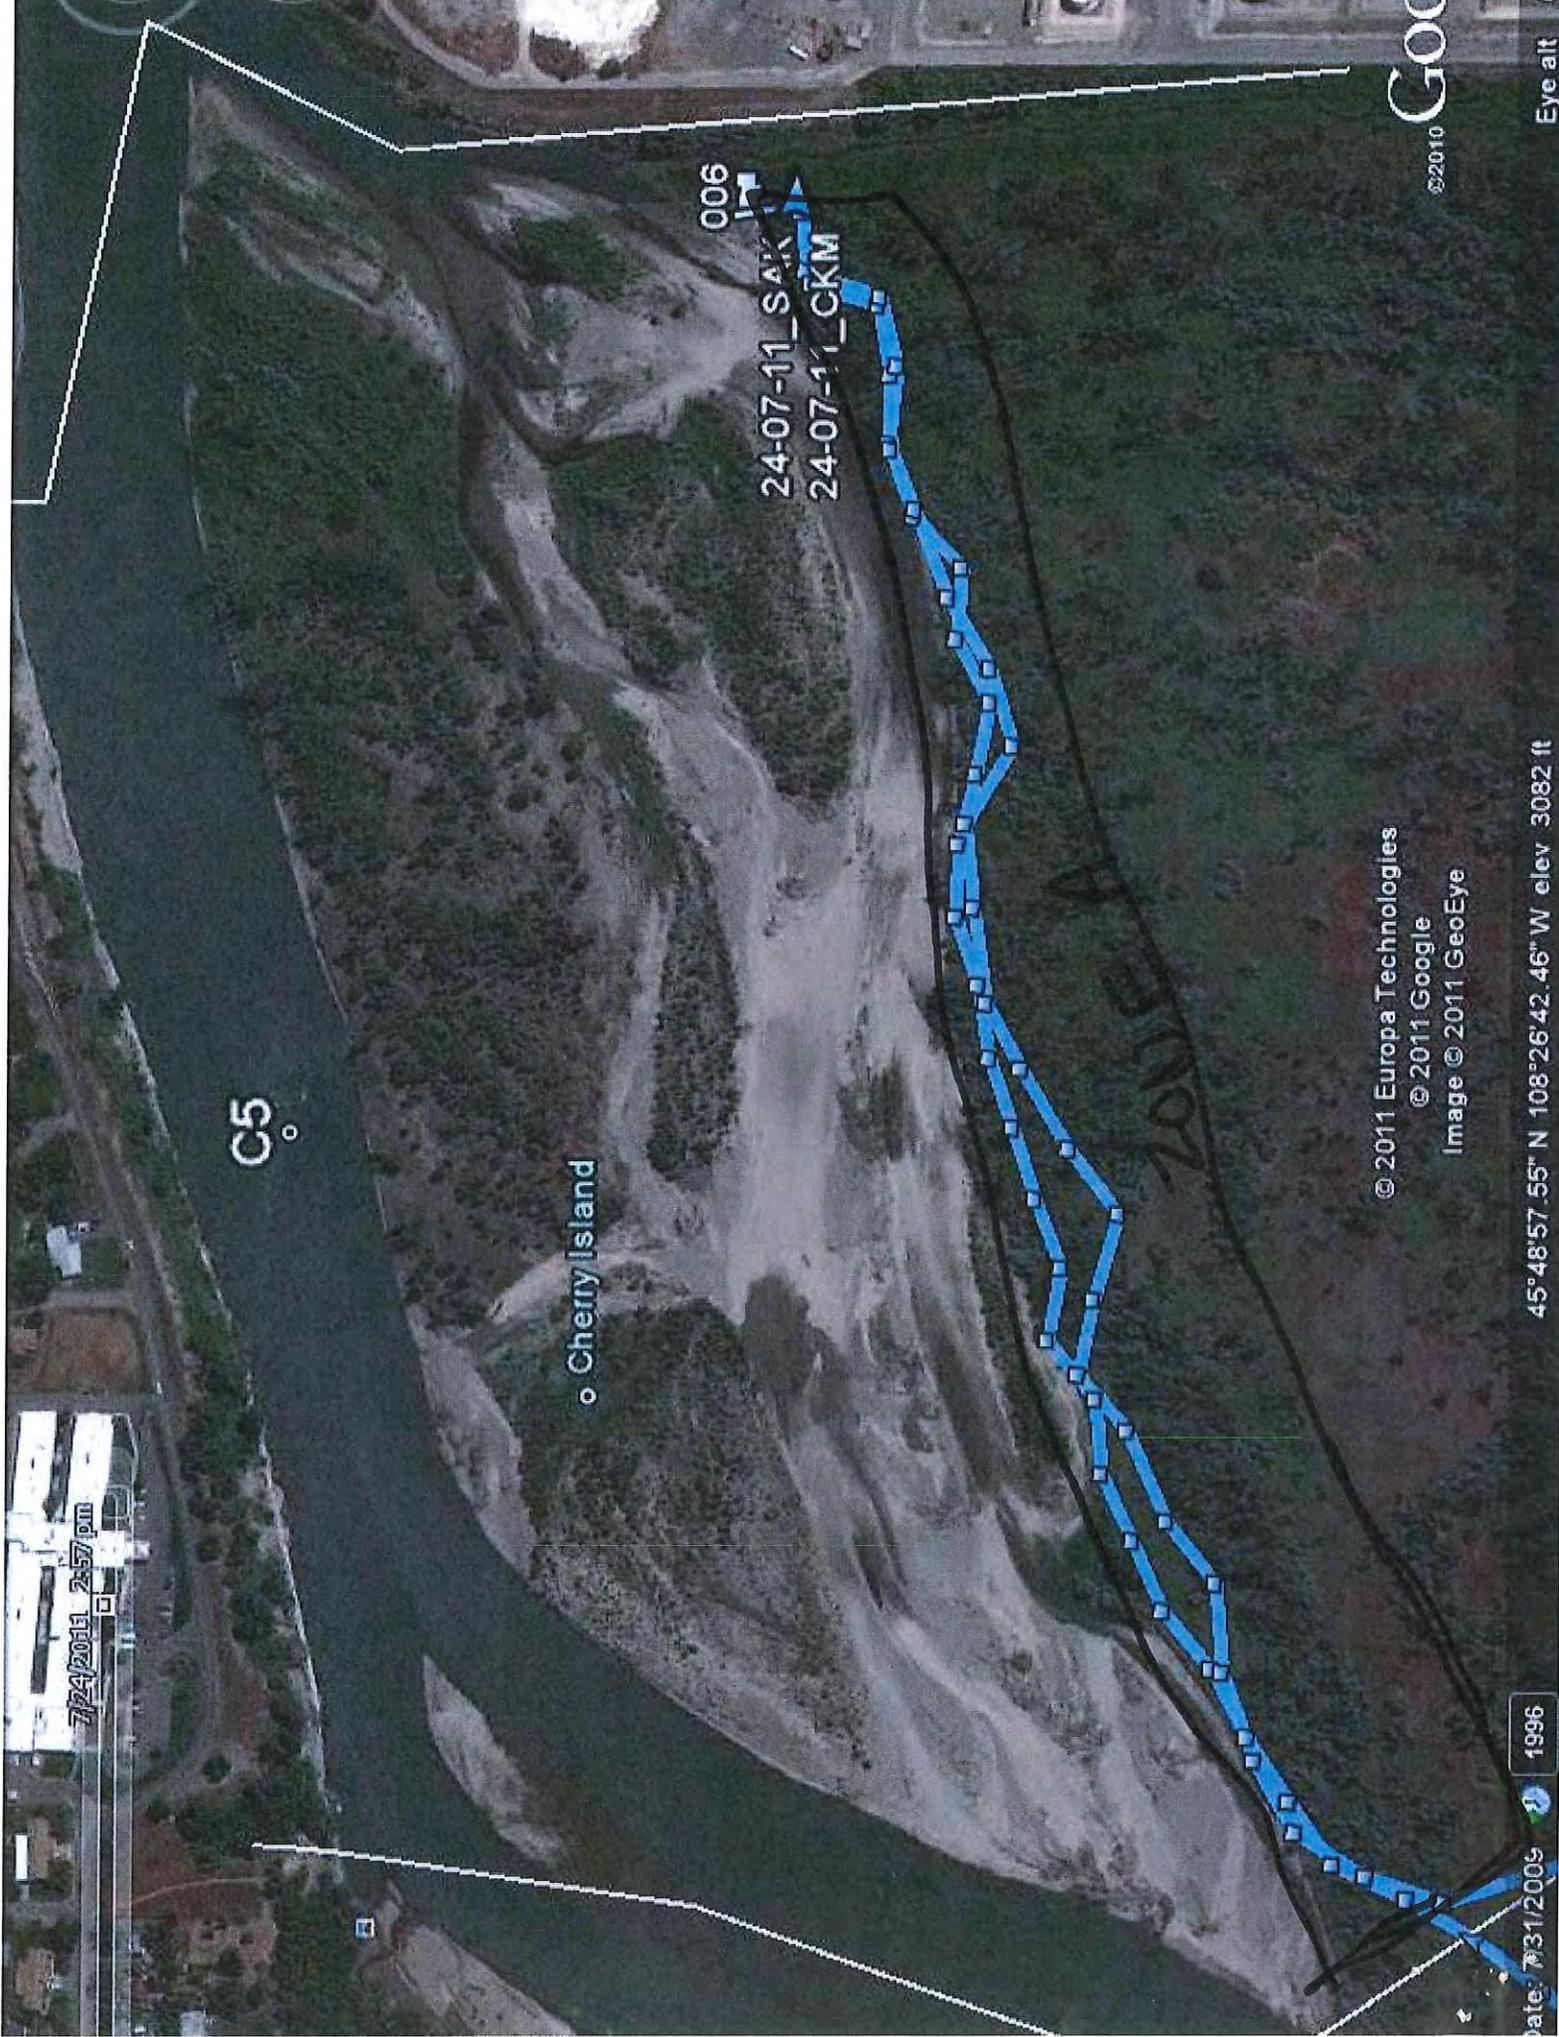
C5

2-CA minor spots only; no further action recommended.

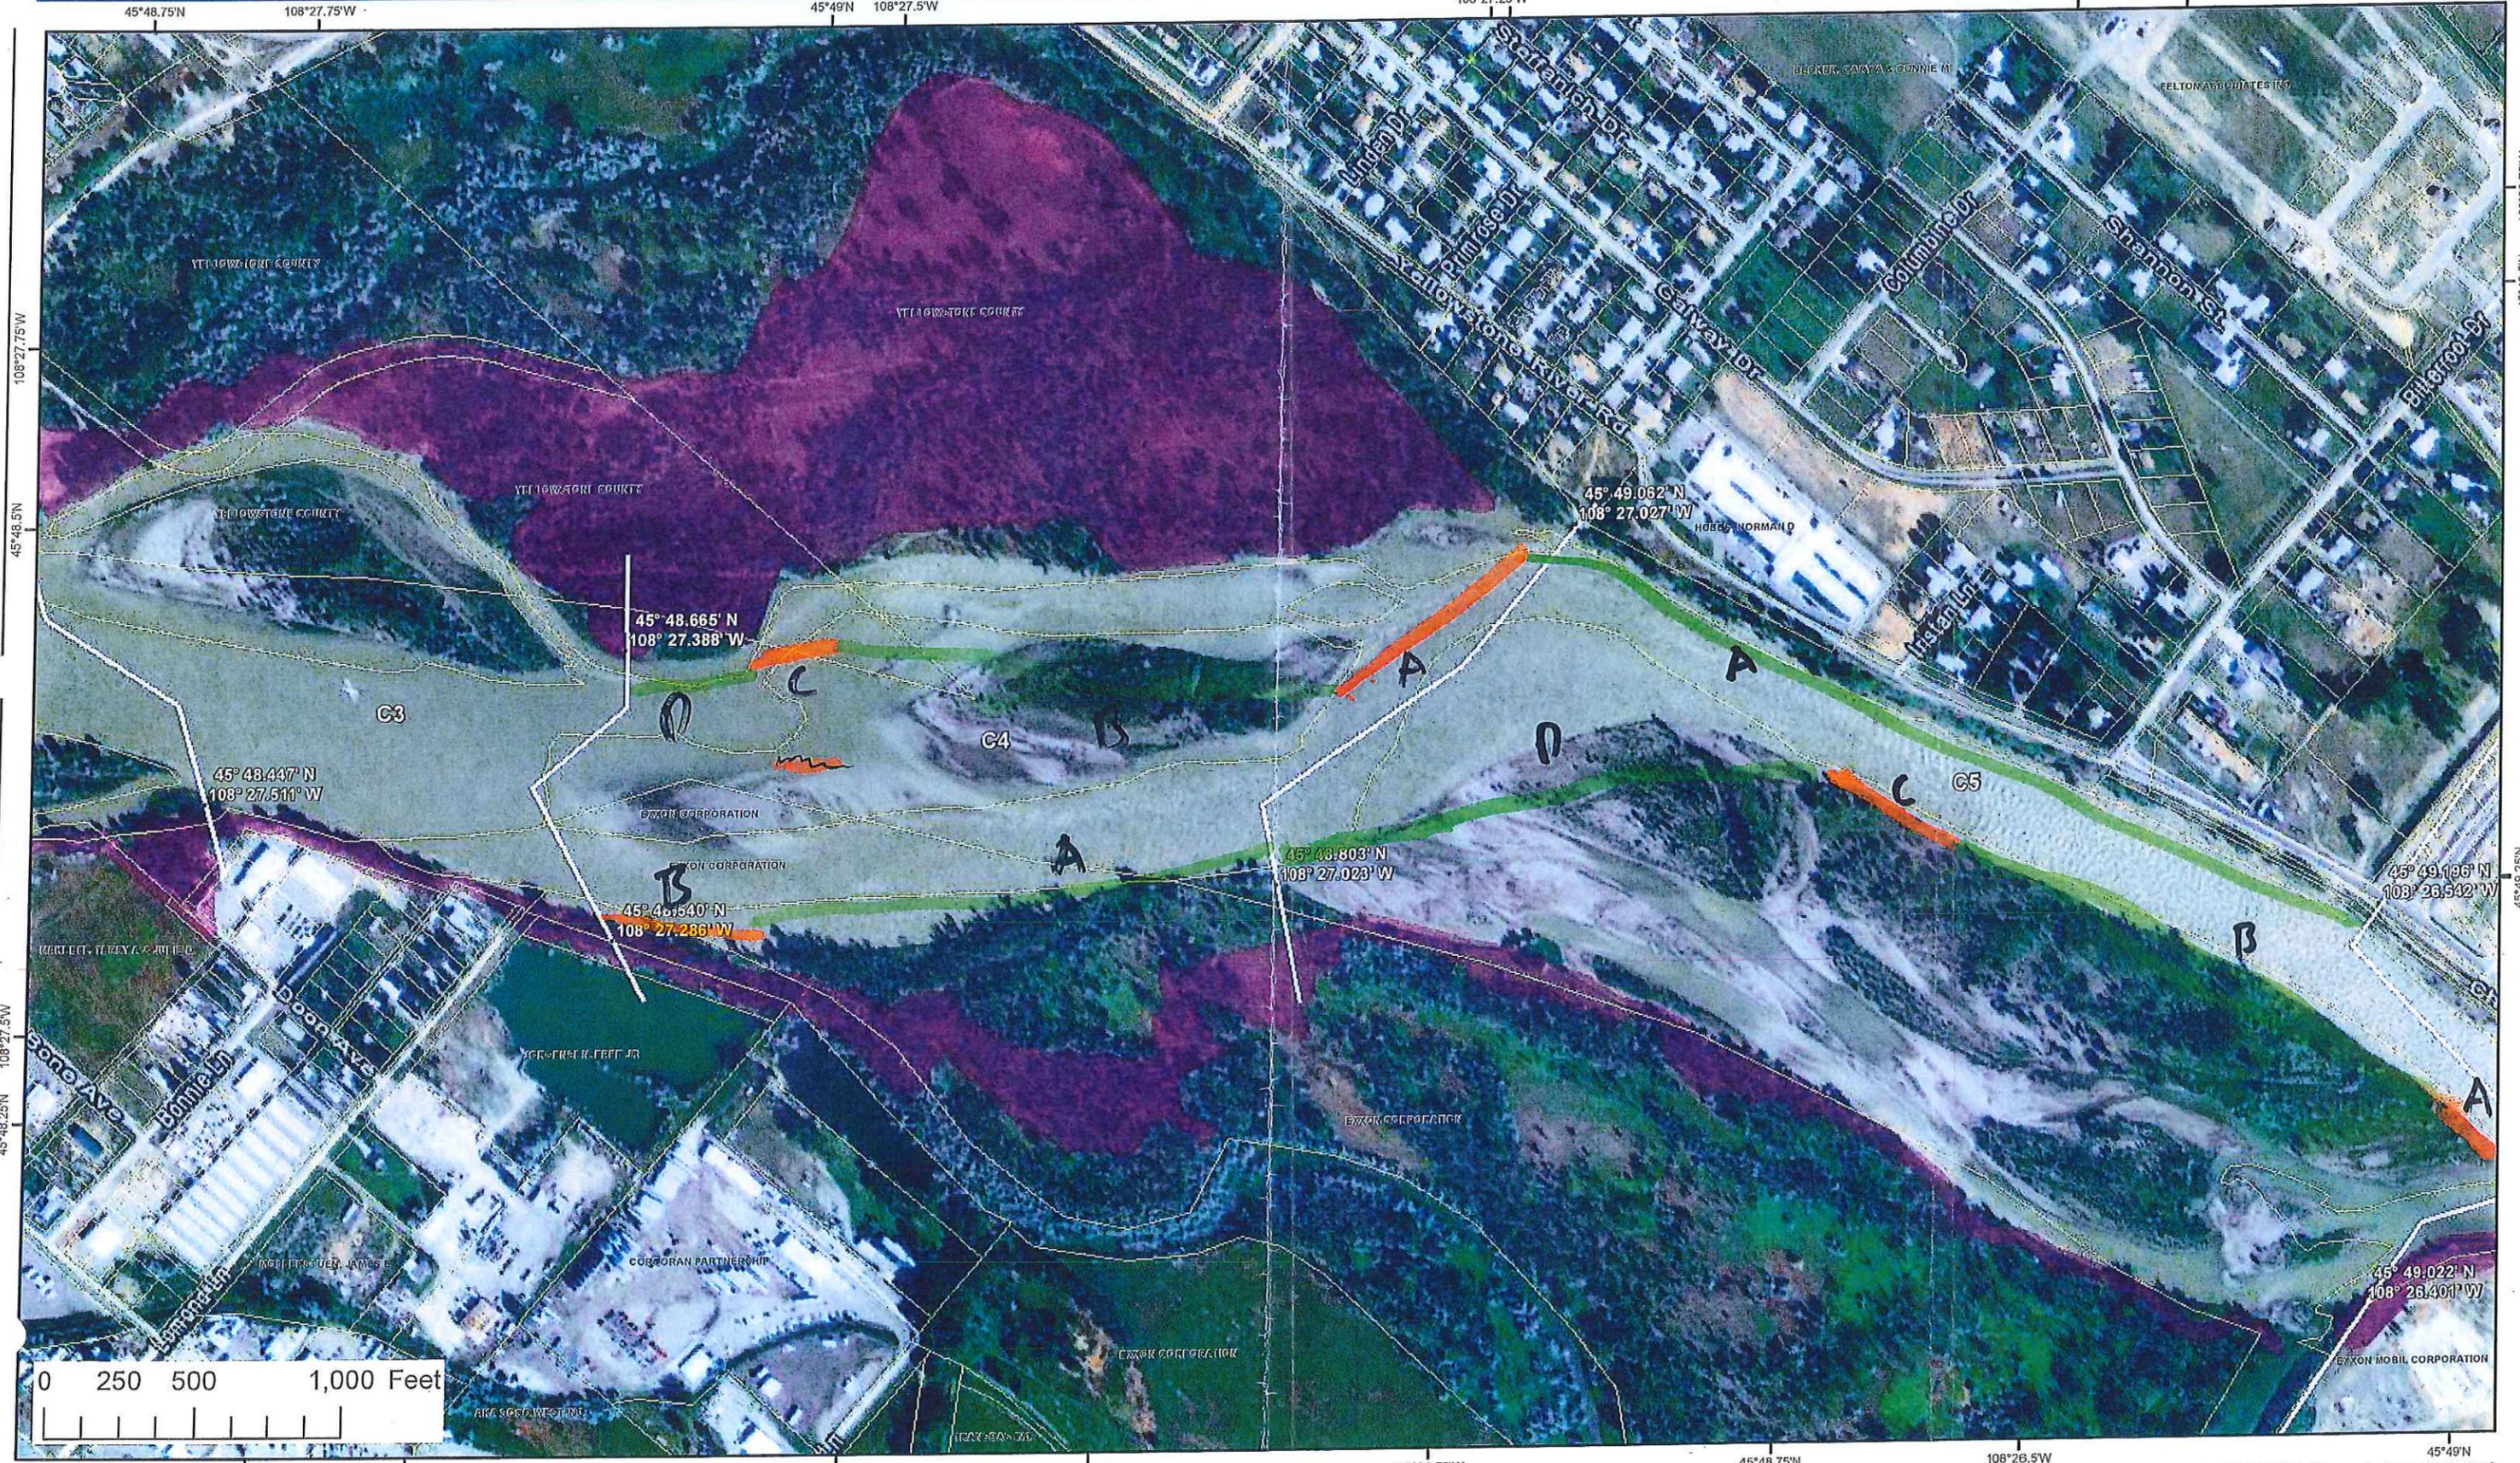
SILVERTIP PIPELINE INCIDENT Yellowstone River Map 26

No oil observed
No Treatment
