**SCAT Area Transition Report
for C05**

Silvertip Pipeline Incident
Laurel, Montana

October 28, 2011

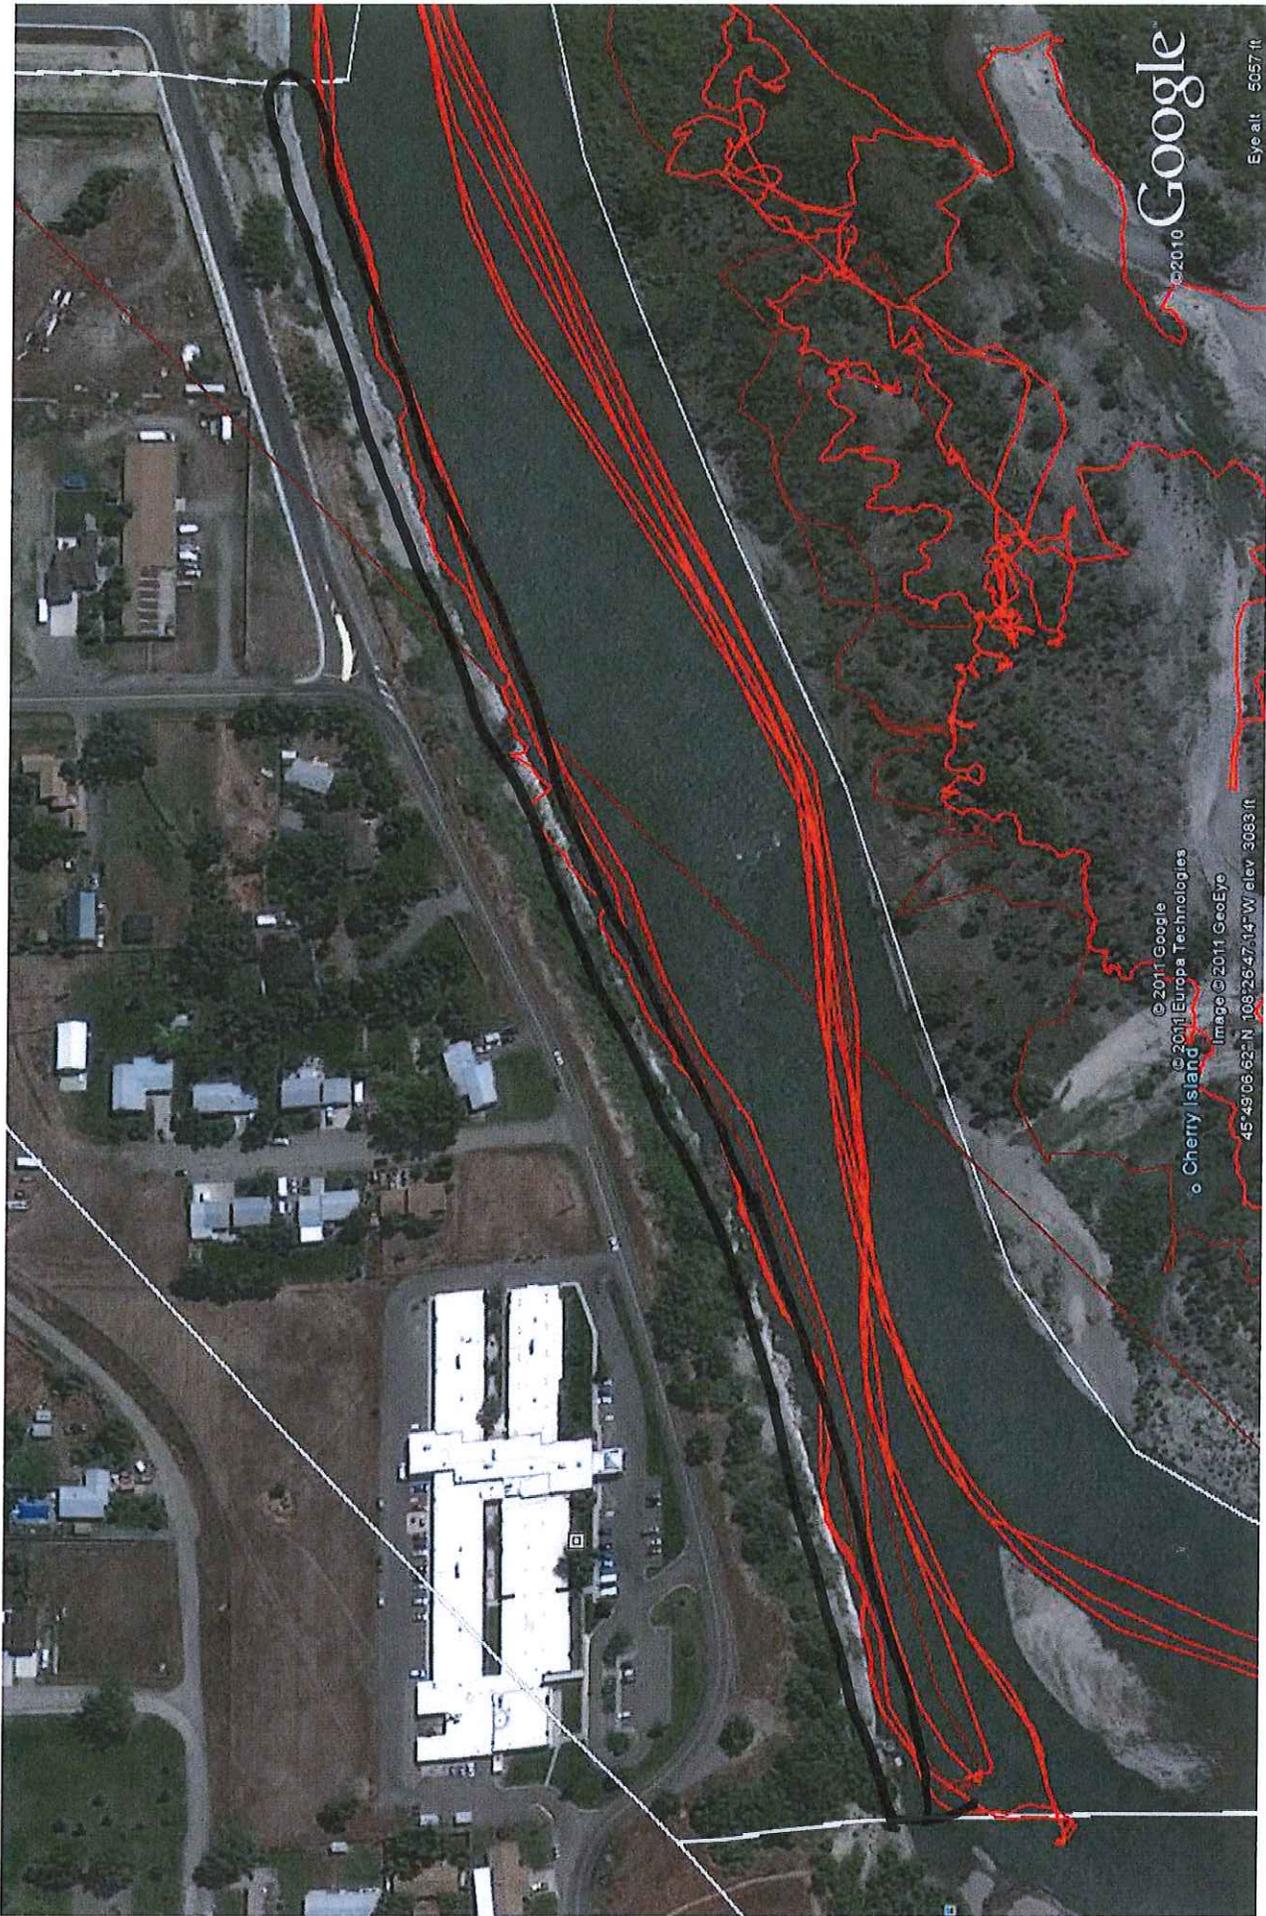
CSLB
Team #1
13/08/11

Zone A - No Oil Observed - Cliffside Un-Vegetated except for one narrow spot

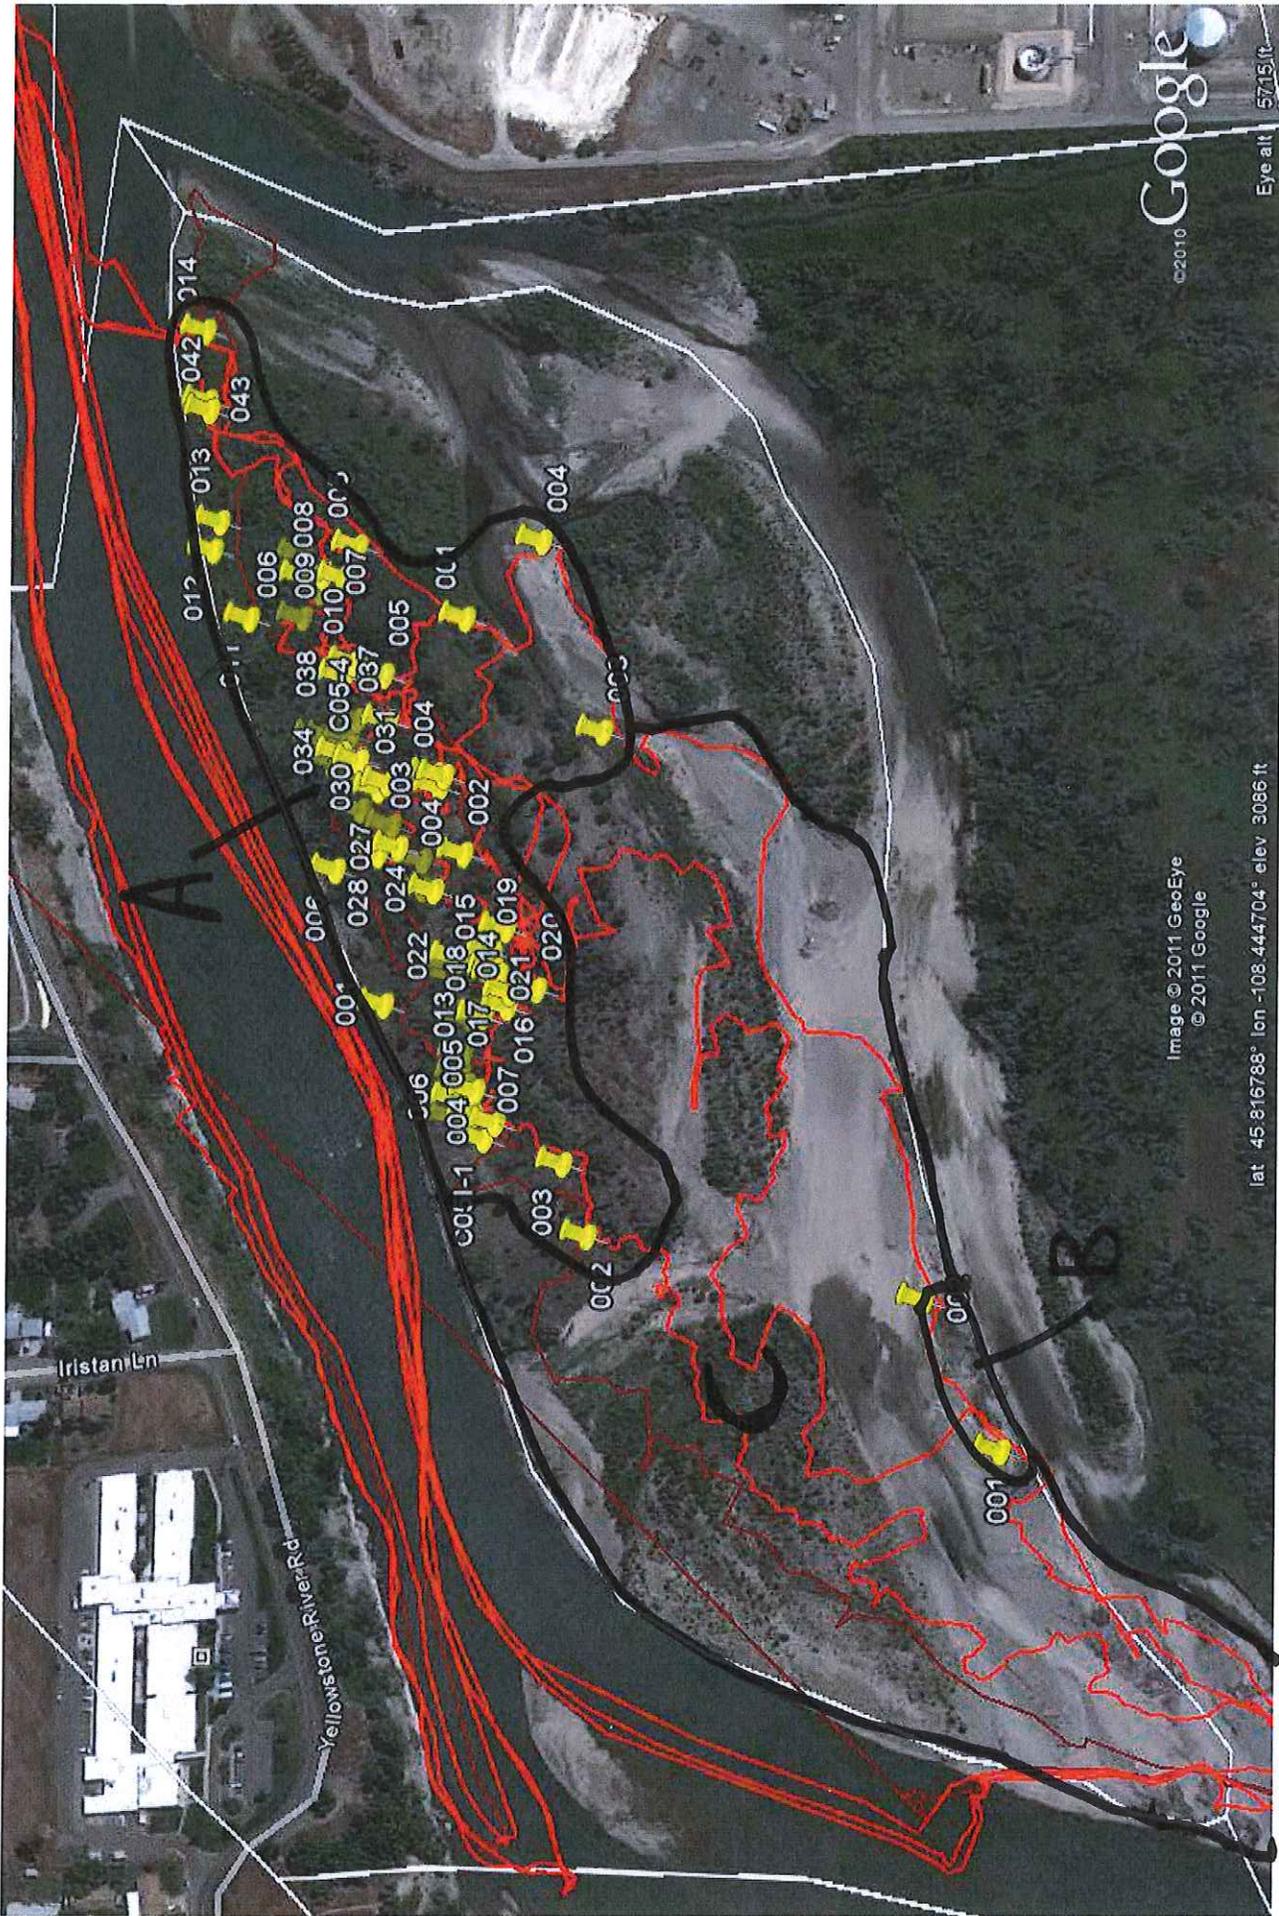
CSI
Team #) + d
13/08/11

Zone A - Several ~ 1m² areas of debris were found w/ moderate cover we recommend removal of oiled debris (~ 20+ bags), in addition several areas of stain/coat on vegetation were identified in this zone recommend natural attenuation

Zone B - sporadic stain on grass/veg - NTR

Zone C - NOO

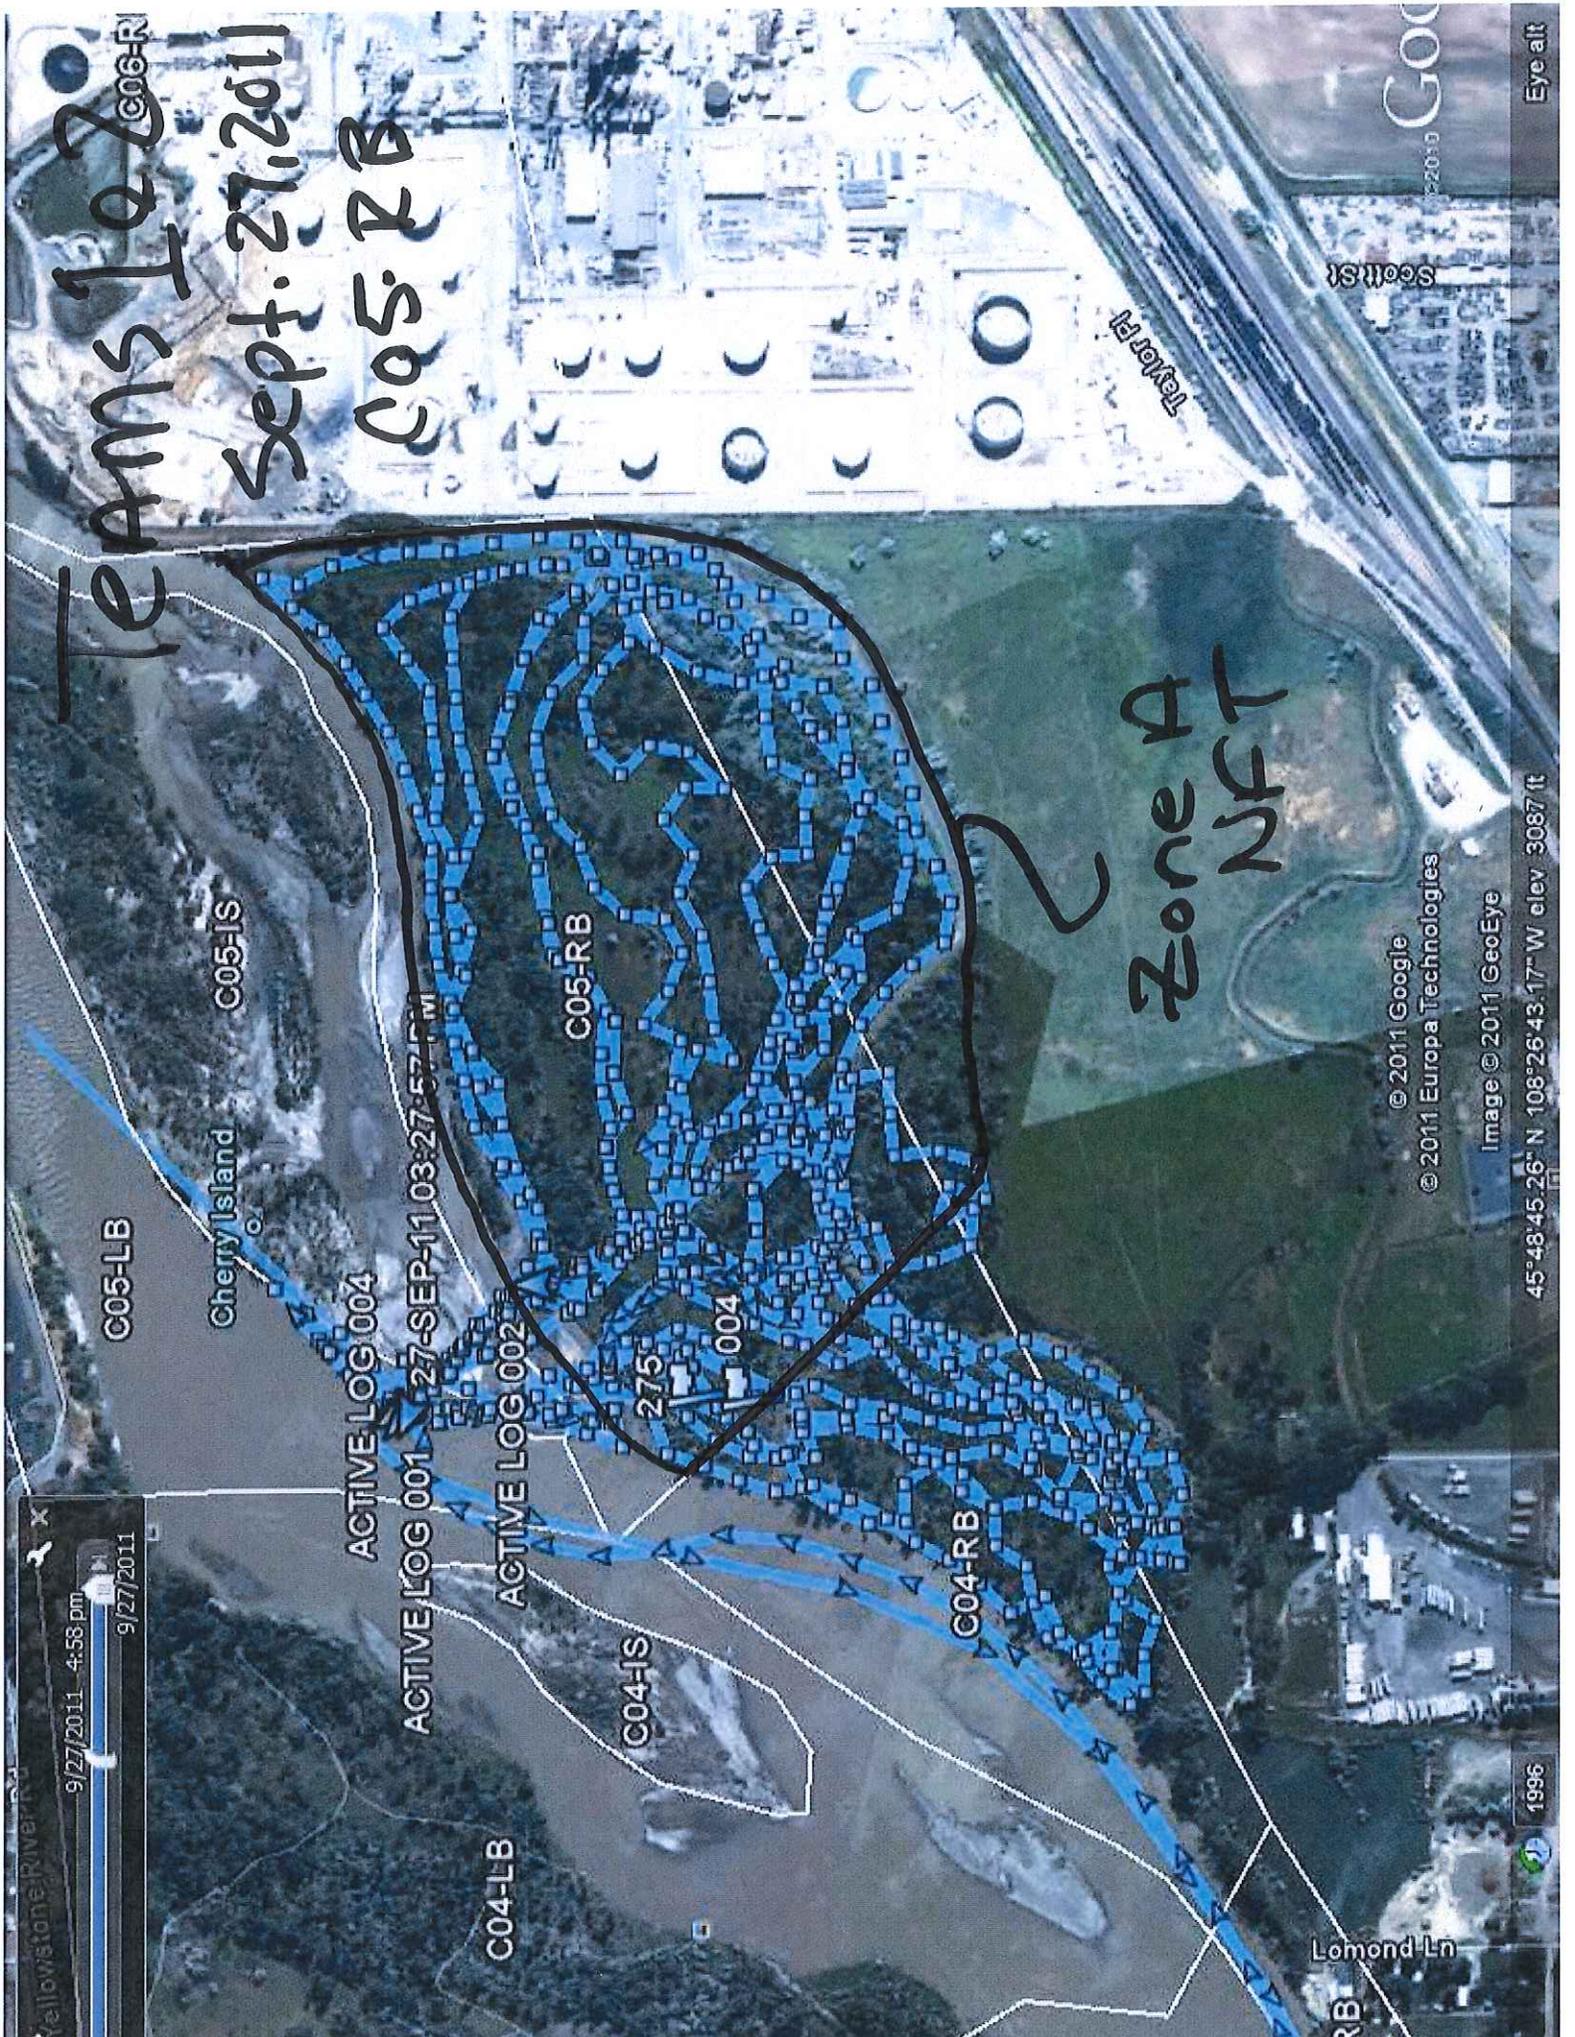
Teams 1 & 2
Sept. 27, 2011
C05 RB

Sporadic Coat & Staining on vegetation & Debris
 Hot shot crew removed or treated oiled material. No further Treatment Required (NFT)

Zone A
NFT

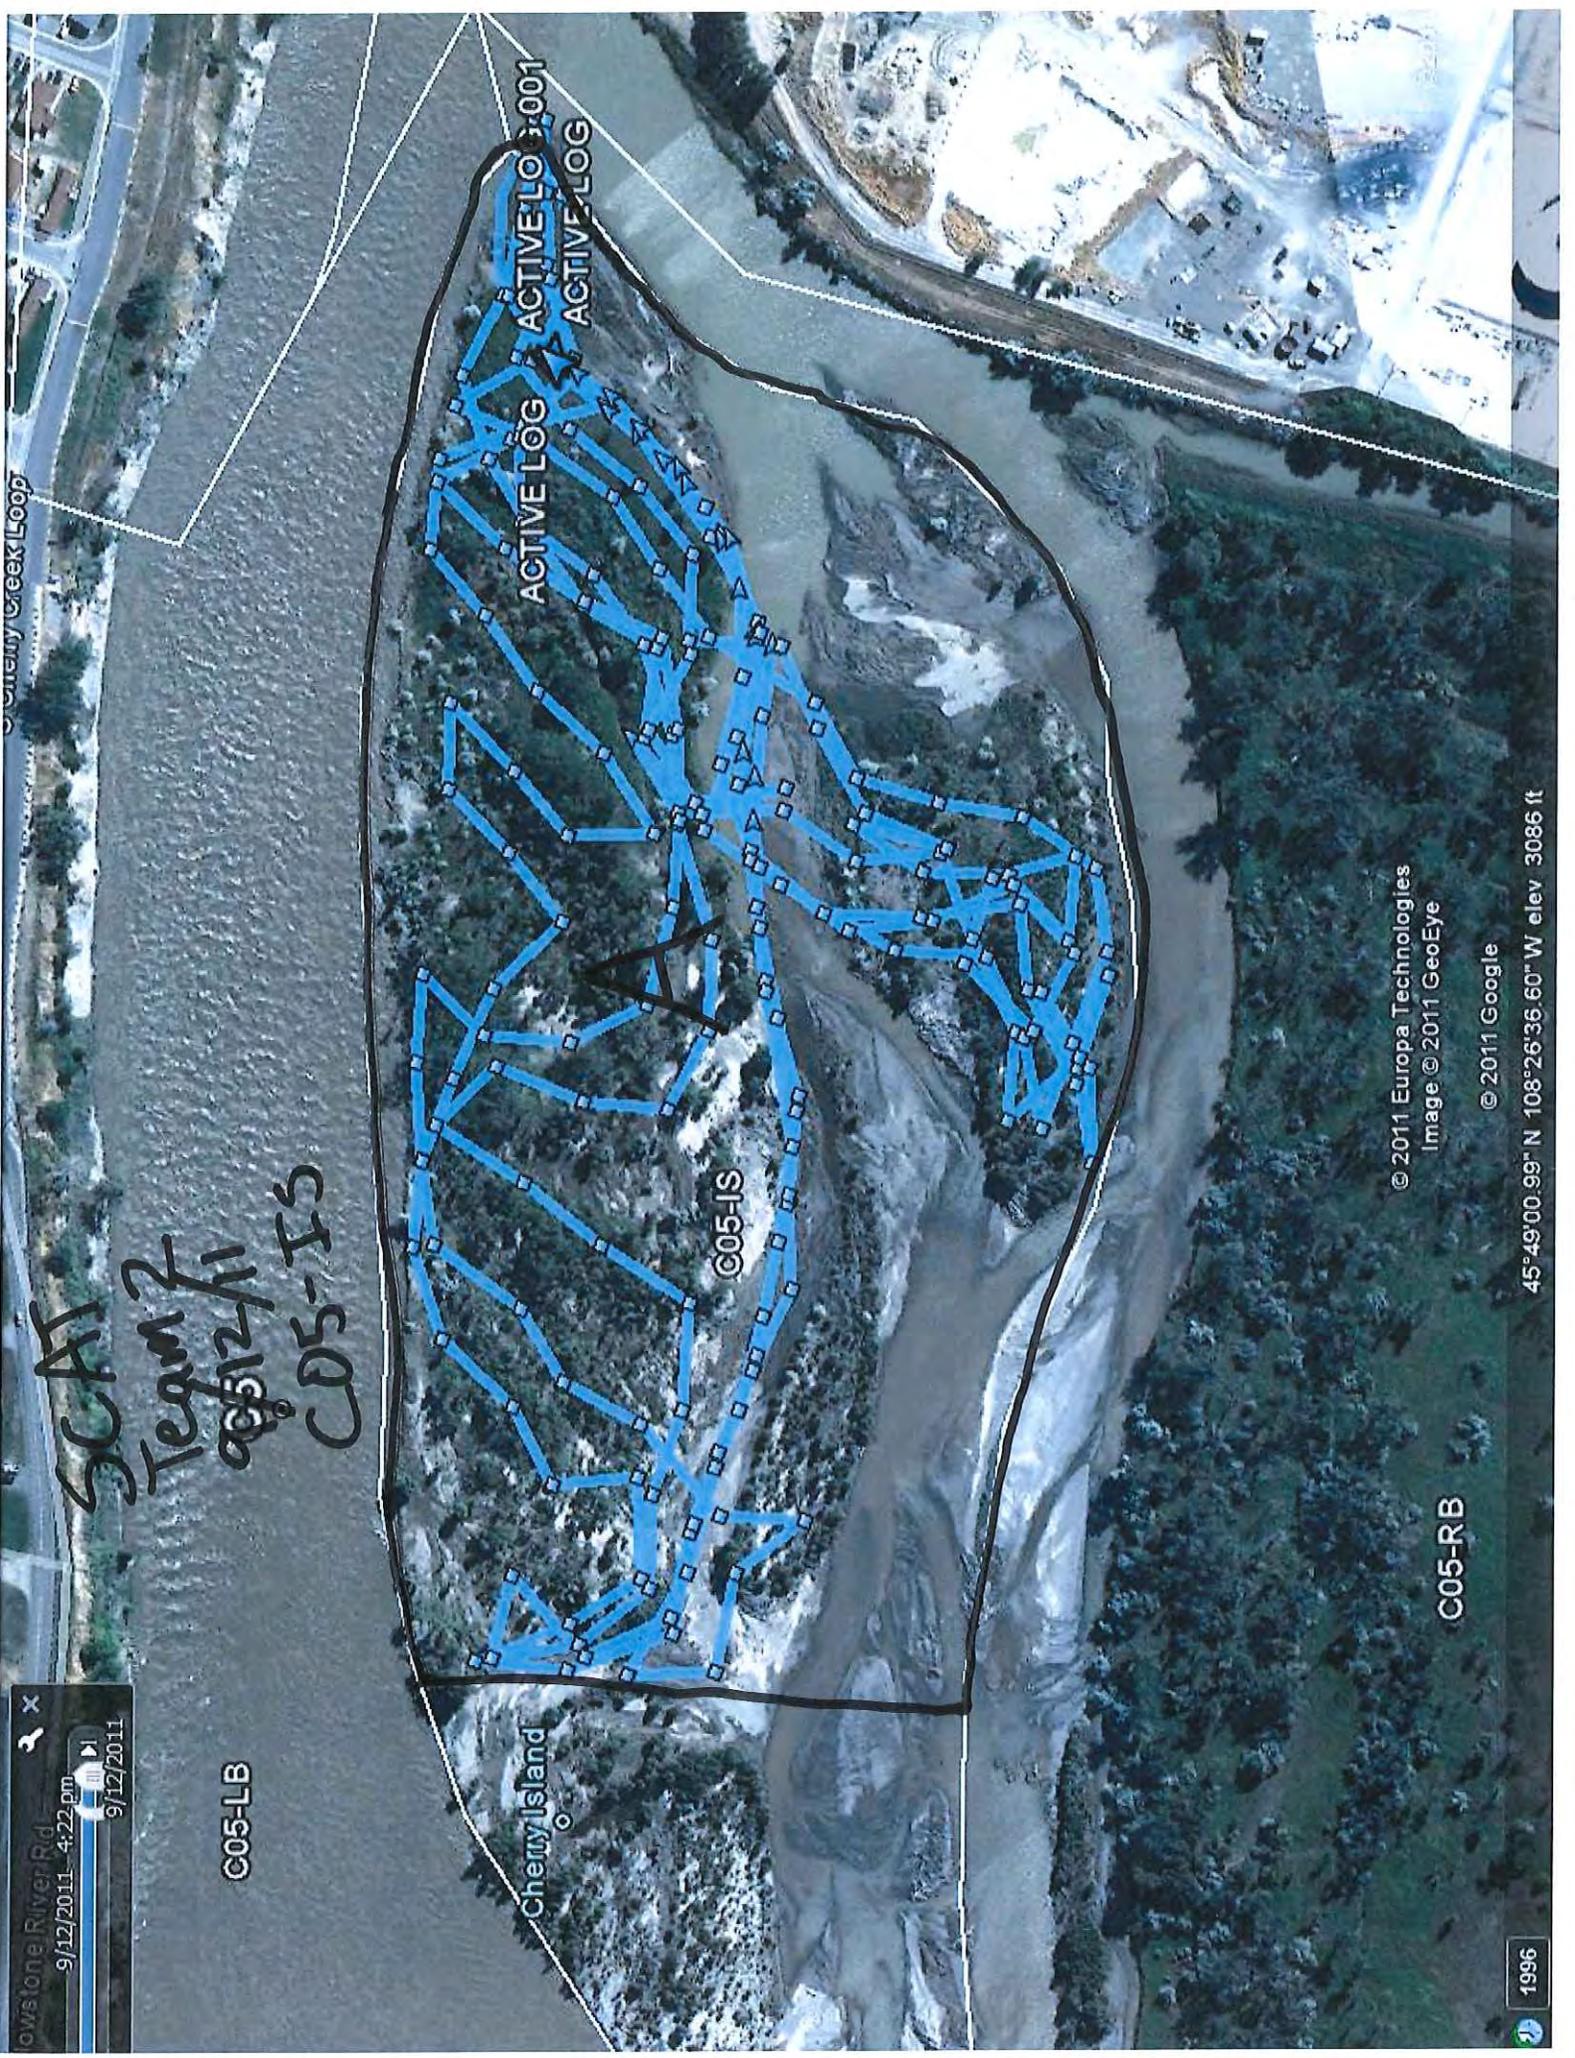
A: Re SCAT, Stain on trees and vegetation and large debris meet the conditions of the CTR, NFT

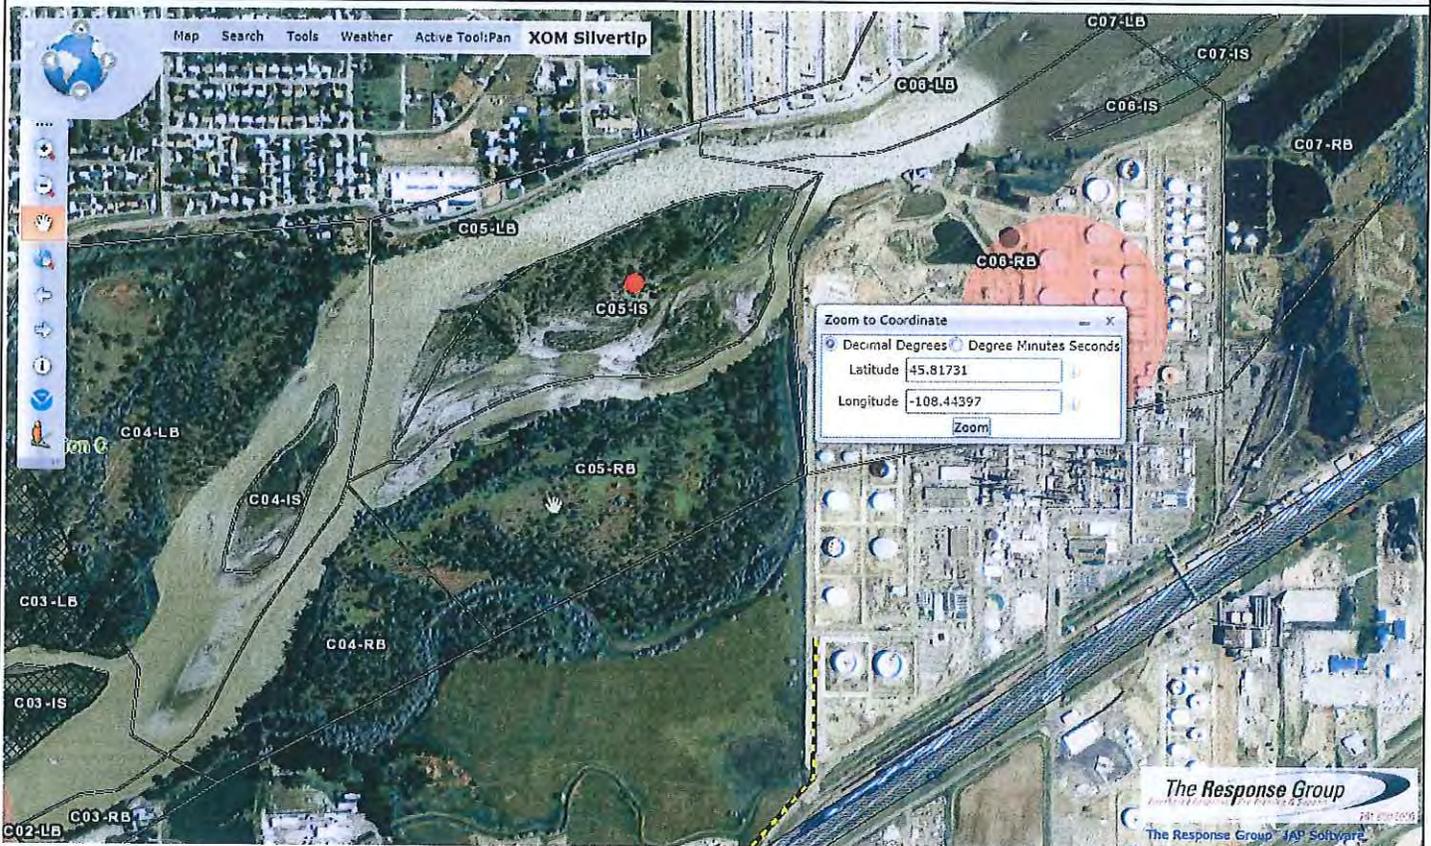
MESSAGE: International Bird Rescue and Resource Advisors with the USFWS identified several areas in SCAT sector C-5 Island. This segment is listed as incomplete but is presenting a threat to wildlife. Several areas are recommended for remediation to reduce potential exposure. Bird activity on the island is high and insect activity in the oiled areas is also high increasing exposure risk. **The area depicted in the map below is high priority area that has oil on tree limbs that is easily transferable even on cool mornings. The other high priority area in this sector is N 45.81754 by W 108.44472, this is a thick oil patty that transfers oil easily.** Several other areas were noted on this island and include the following:

- N 45.81867 by W 108.44213 – light to medium oil on grass
- N 45.81815 by W 108.44243 – light to medium oil on grass
- N 45.81805 by W 108.44235 – small patty of oil on wood debris
- N 45.81737 by W 108.44289—thick oil on tree branches and grass

The oil patties on the north side of the island run the length of the island from west to east.

The Unified Command is aware of this area within SCAT Segments C5IS and that operations within these segments have been completed by operations and Re-SCAT efforts. We agree with the recommended treatment proposed above for this area. ExxonMobil will coordinate any future remediation activities at this site with MTDEQ. In the meantime, this segment will be flagged as a "Wildlife Exception" and excised within GIS maps from the Re-SCAT report that will be produced to close-out the segment. This document will be included as an attachment to the Area Transition Report to document the need for additional work within this segment beyond Re-SCAT and a POST should be used to re-close the segment once these wildlife concerns are addressed by operations teams.
