**SCAT Area Transition Report
for C17**

Silvertip Pipeline Incident
Laurel, Montana

October 29, 2011

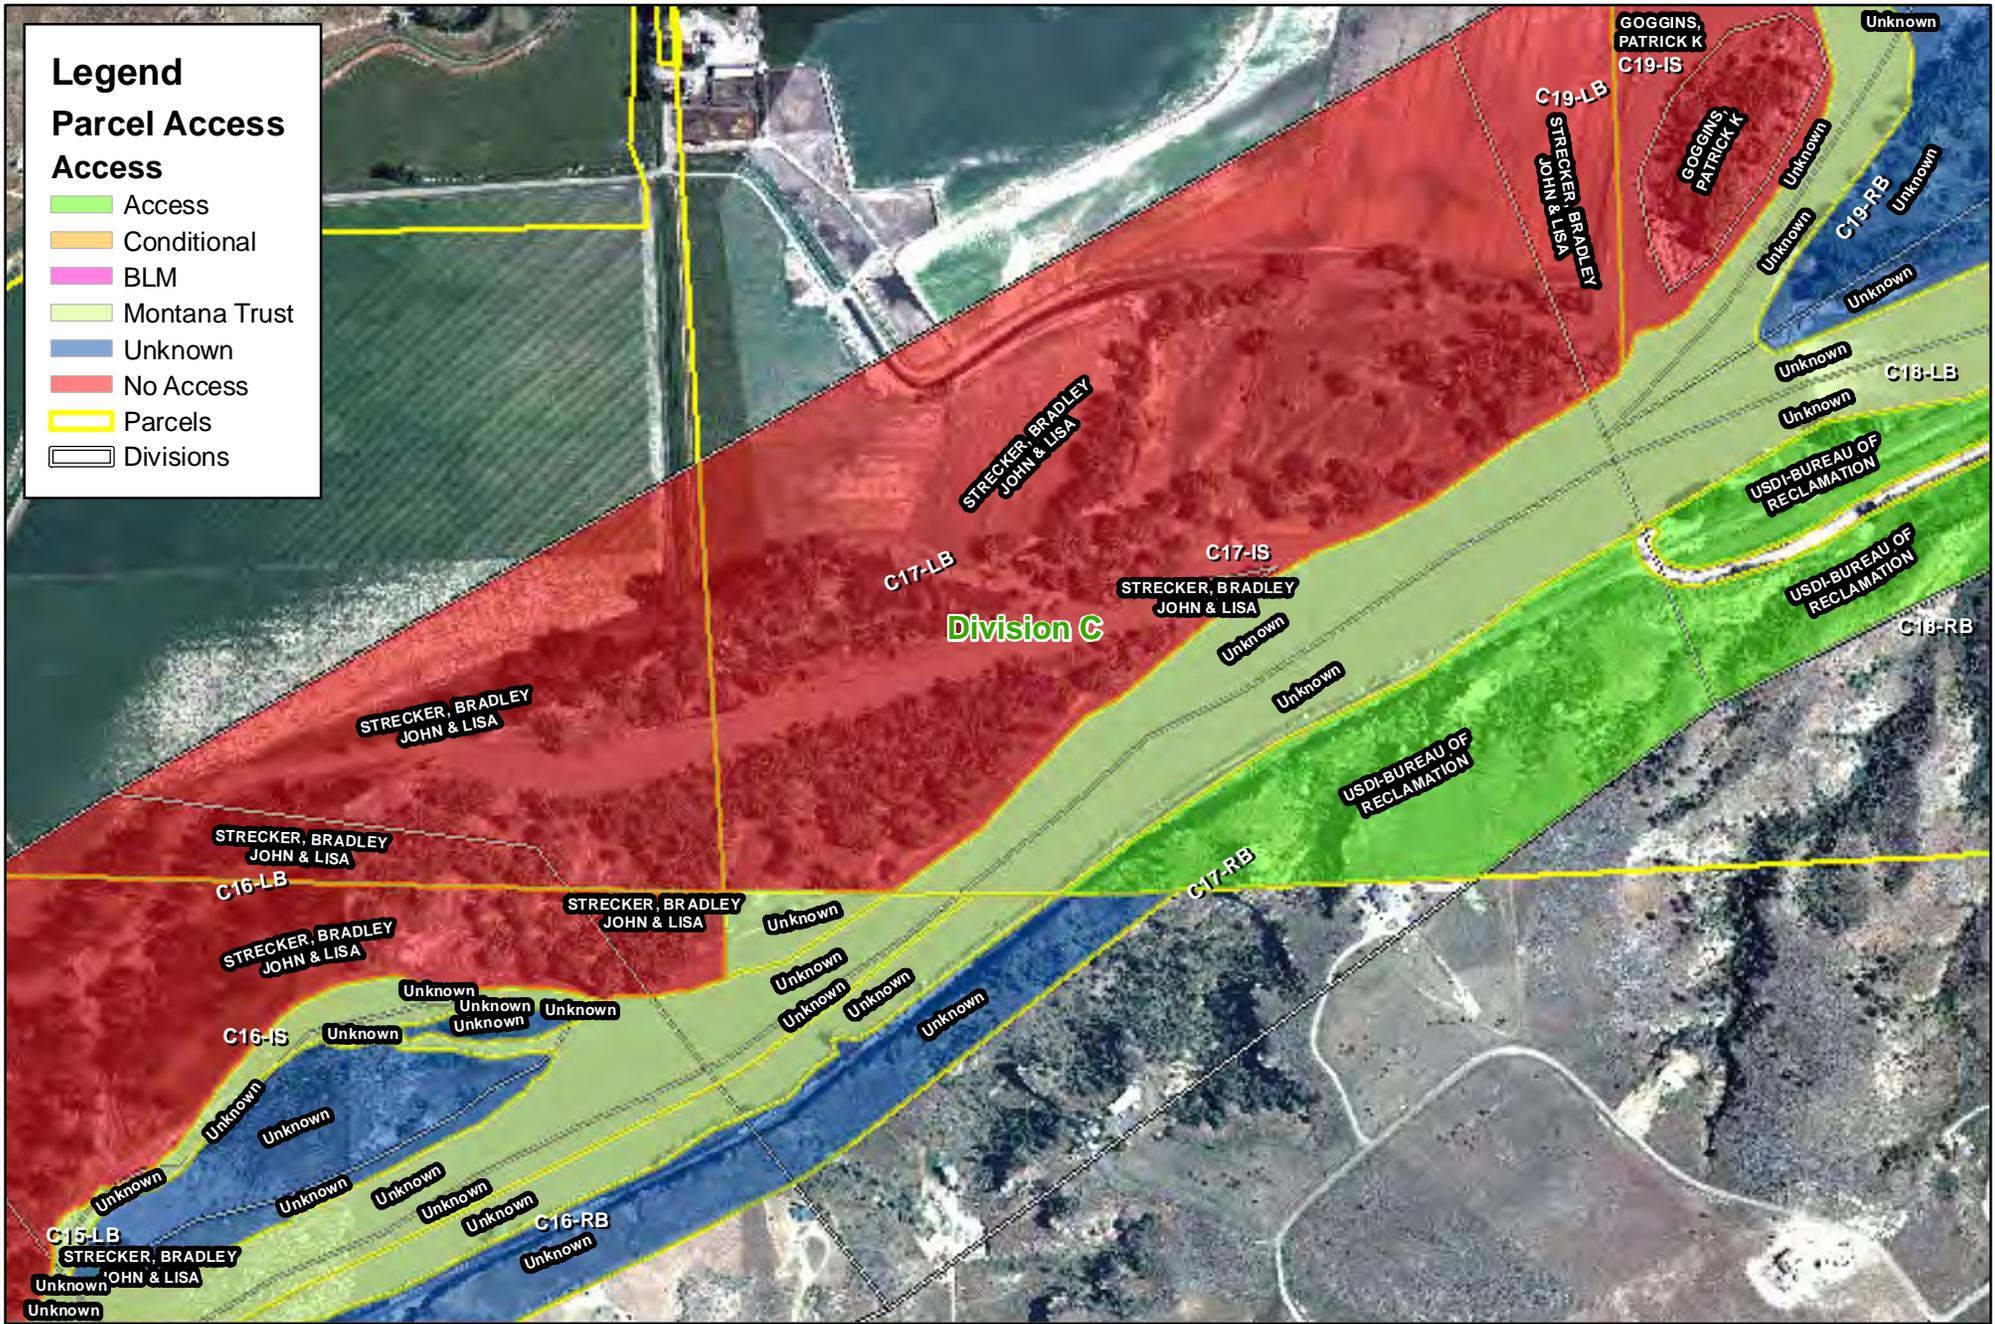
Figure 1 provides an aerial map of SCAT Area C17, along with the (a) SCAT Area boundary, (b) parcel boundaries and respective property owners, and (c) access constraints identified during the oil cleanup process. The acreage surveyed in Area C17 is 89.3. There were no access issues for this area.

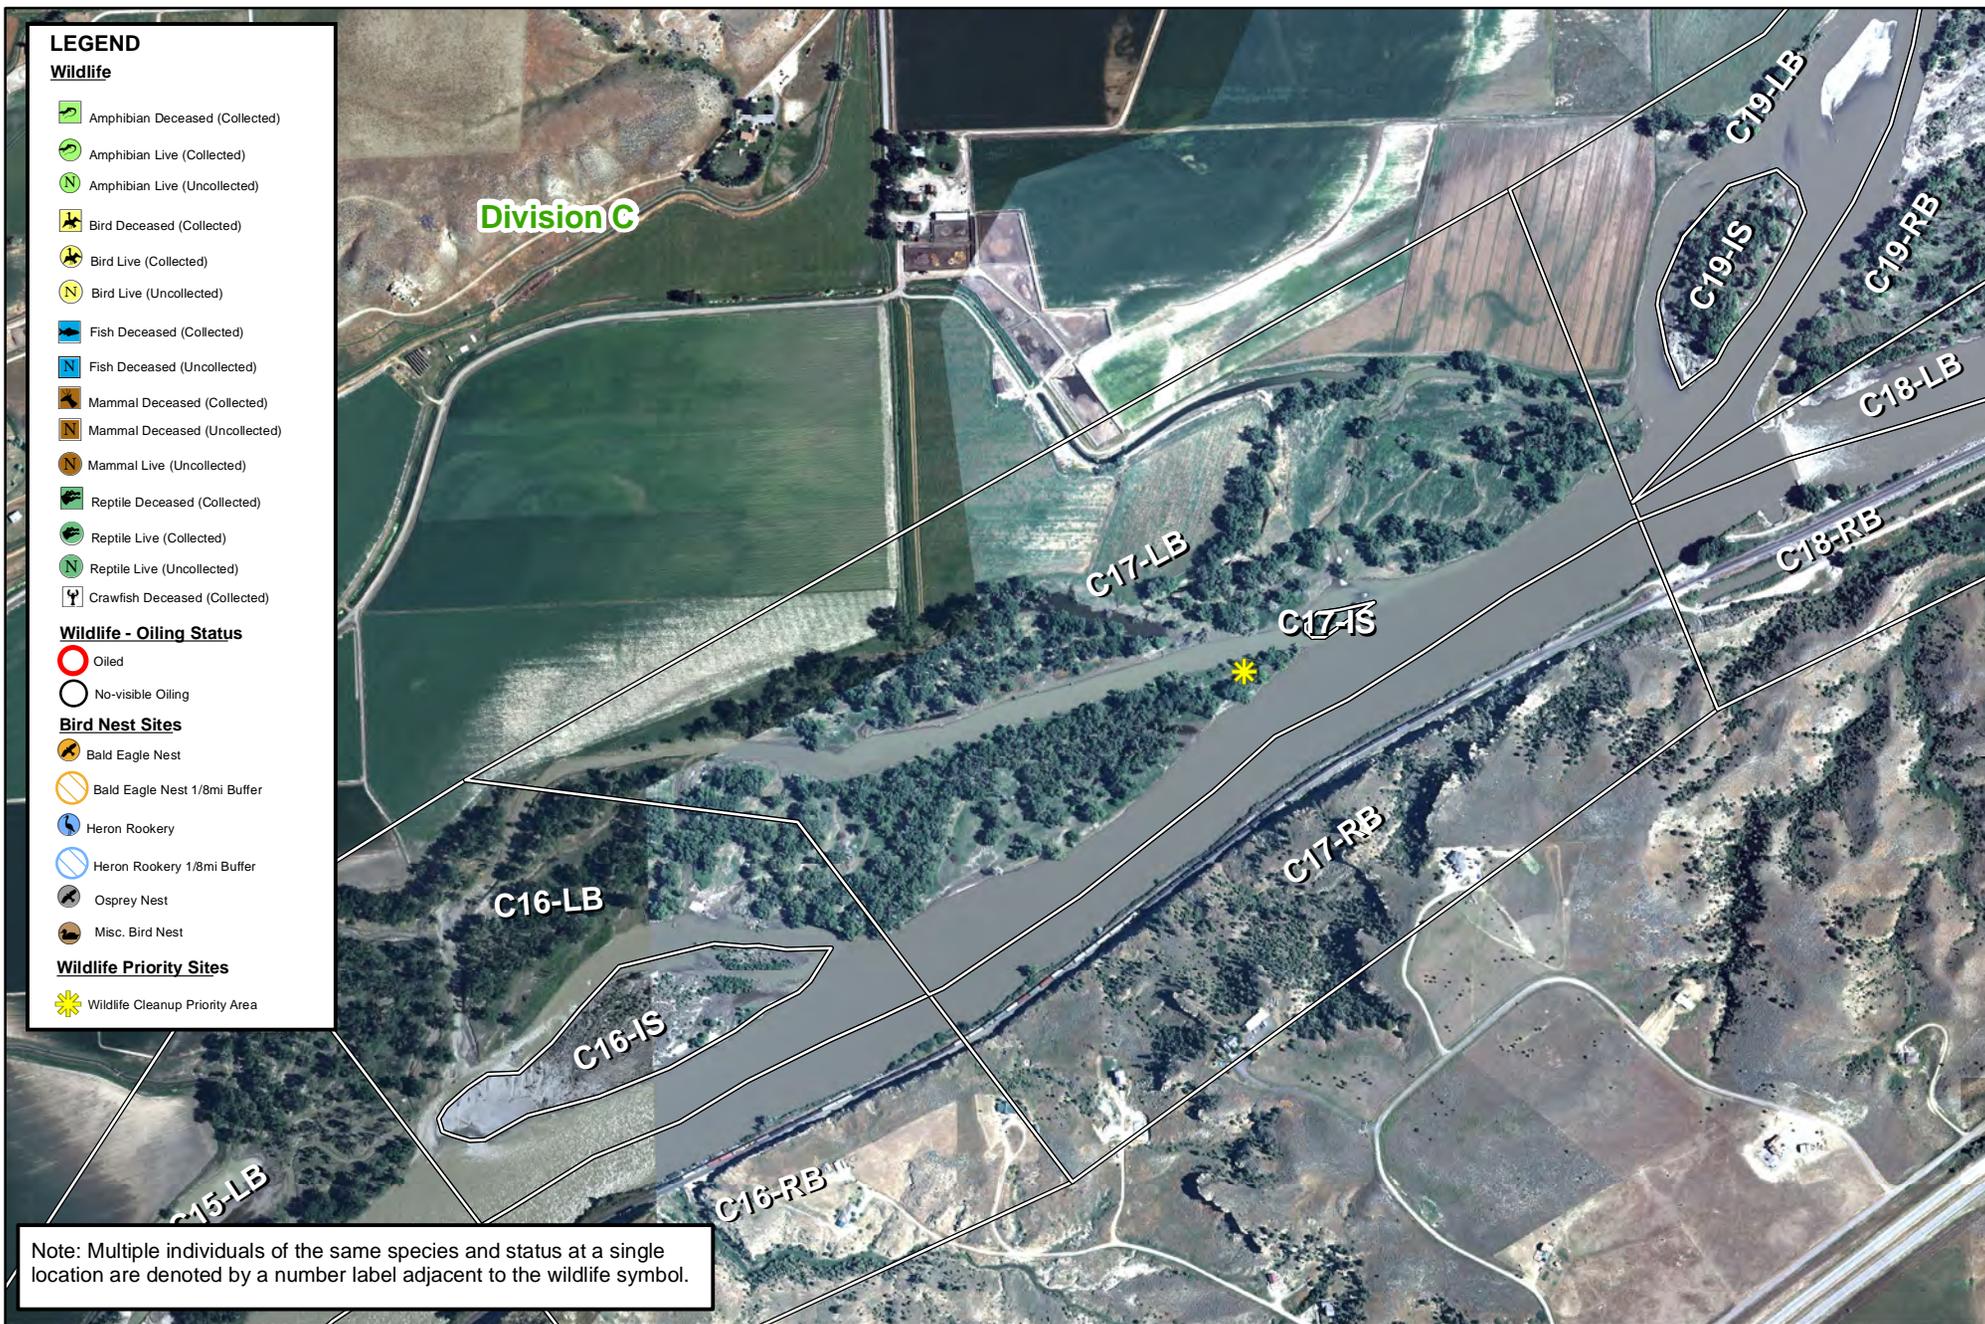
Figure 2
Wildlife Resources

Figure 2 summarizes the natural resources identified in this segment. International Bird Rescue and Resource Advisors from U.S. Fish and Wildlife Service conducted limited inspections of Area C17 due to the low level of oiling in Division C. No oiled wildlife was observed or recovered. One Wildlife Priority Cleanup Area (WPCA) was identified in Area C17. The WPCA consisted of a series of 'paddies' of transferable oil in a dry channel. Operations addressed the WPCA and no further action is required. No active migratory bird nests were identified in Area C17.

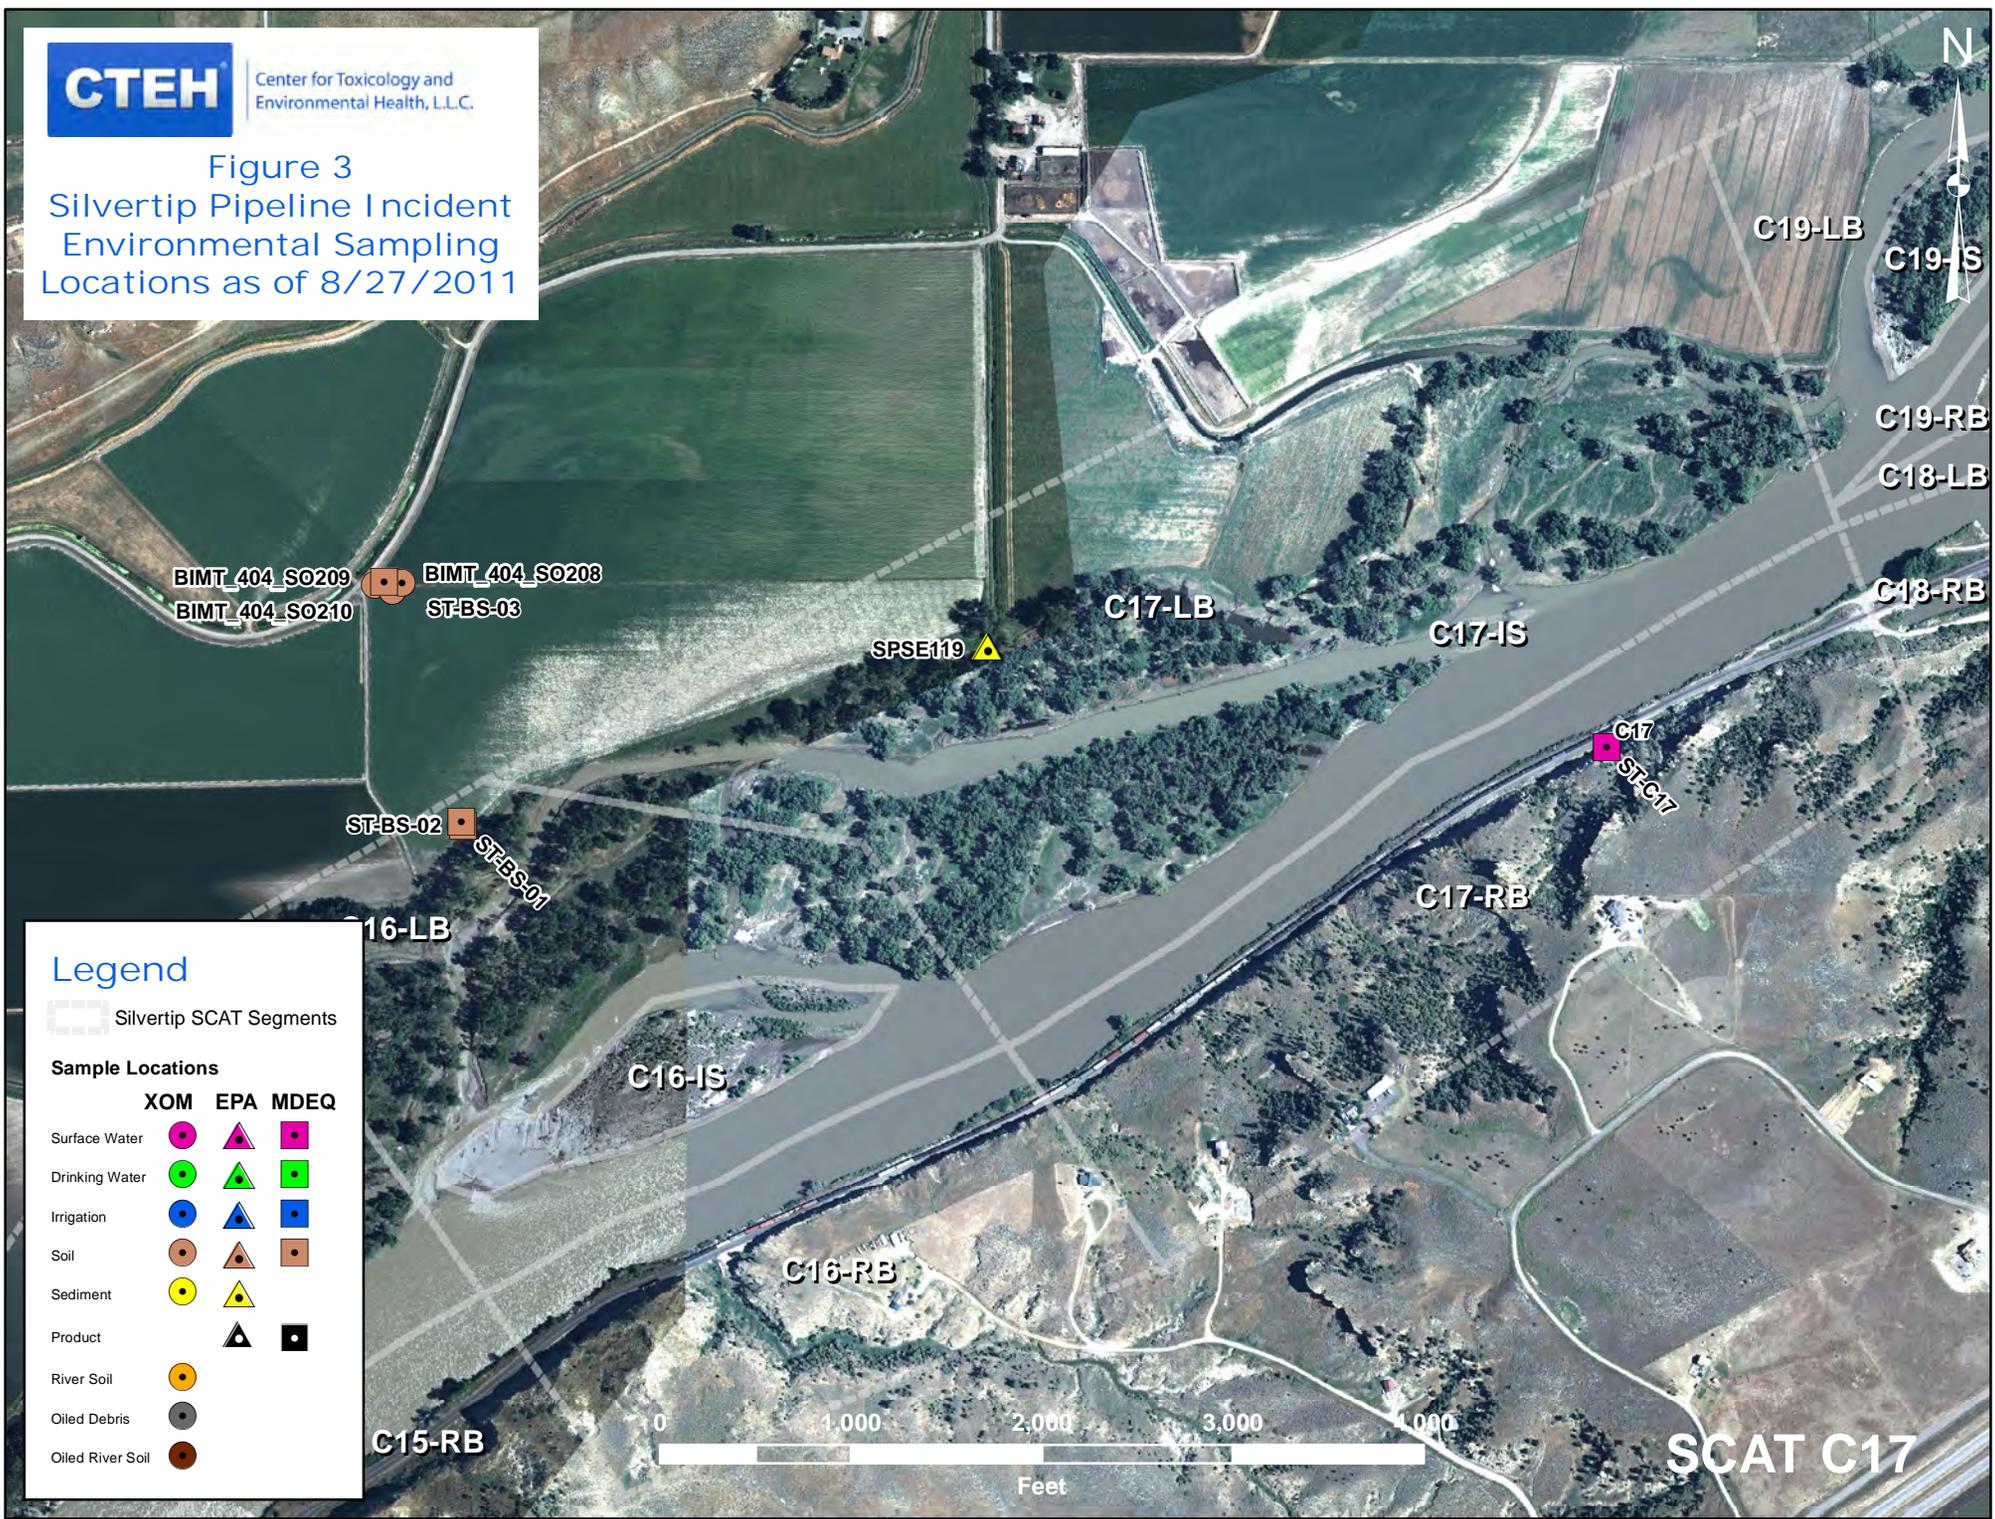
Figure 3
Silvertip Pipeline Incident
Environmental Sampling
Locations as of 8/27/2011

Table 1 (below) summarizes samples collected within Area C17. The analytical results for the samples collected can be accessed through a publicly accessible database on the United States Environmental Protection Agency's (USEPA's) website. The approximate locations of samples collected within Area C17 are provided on Figure 3.

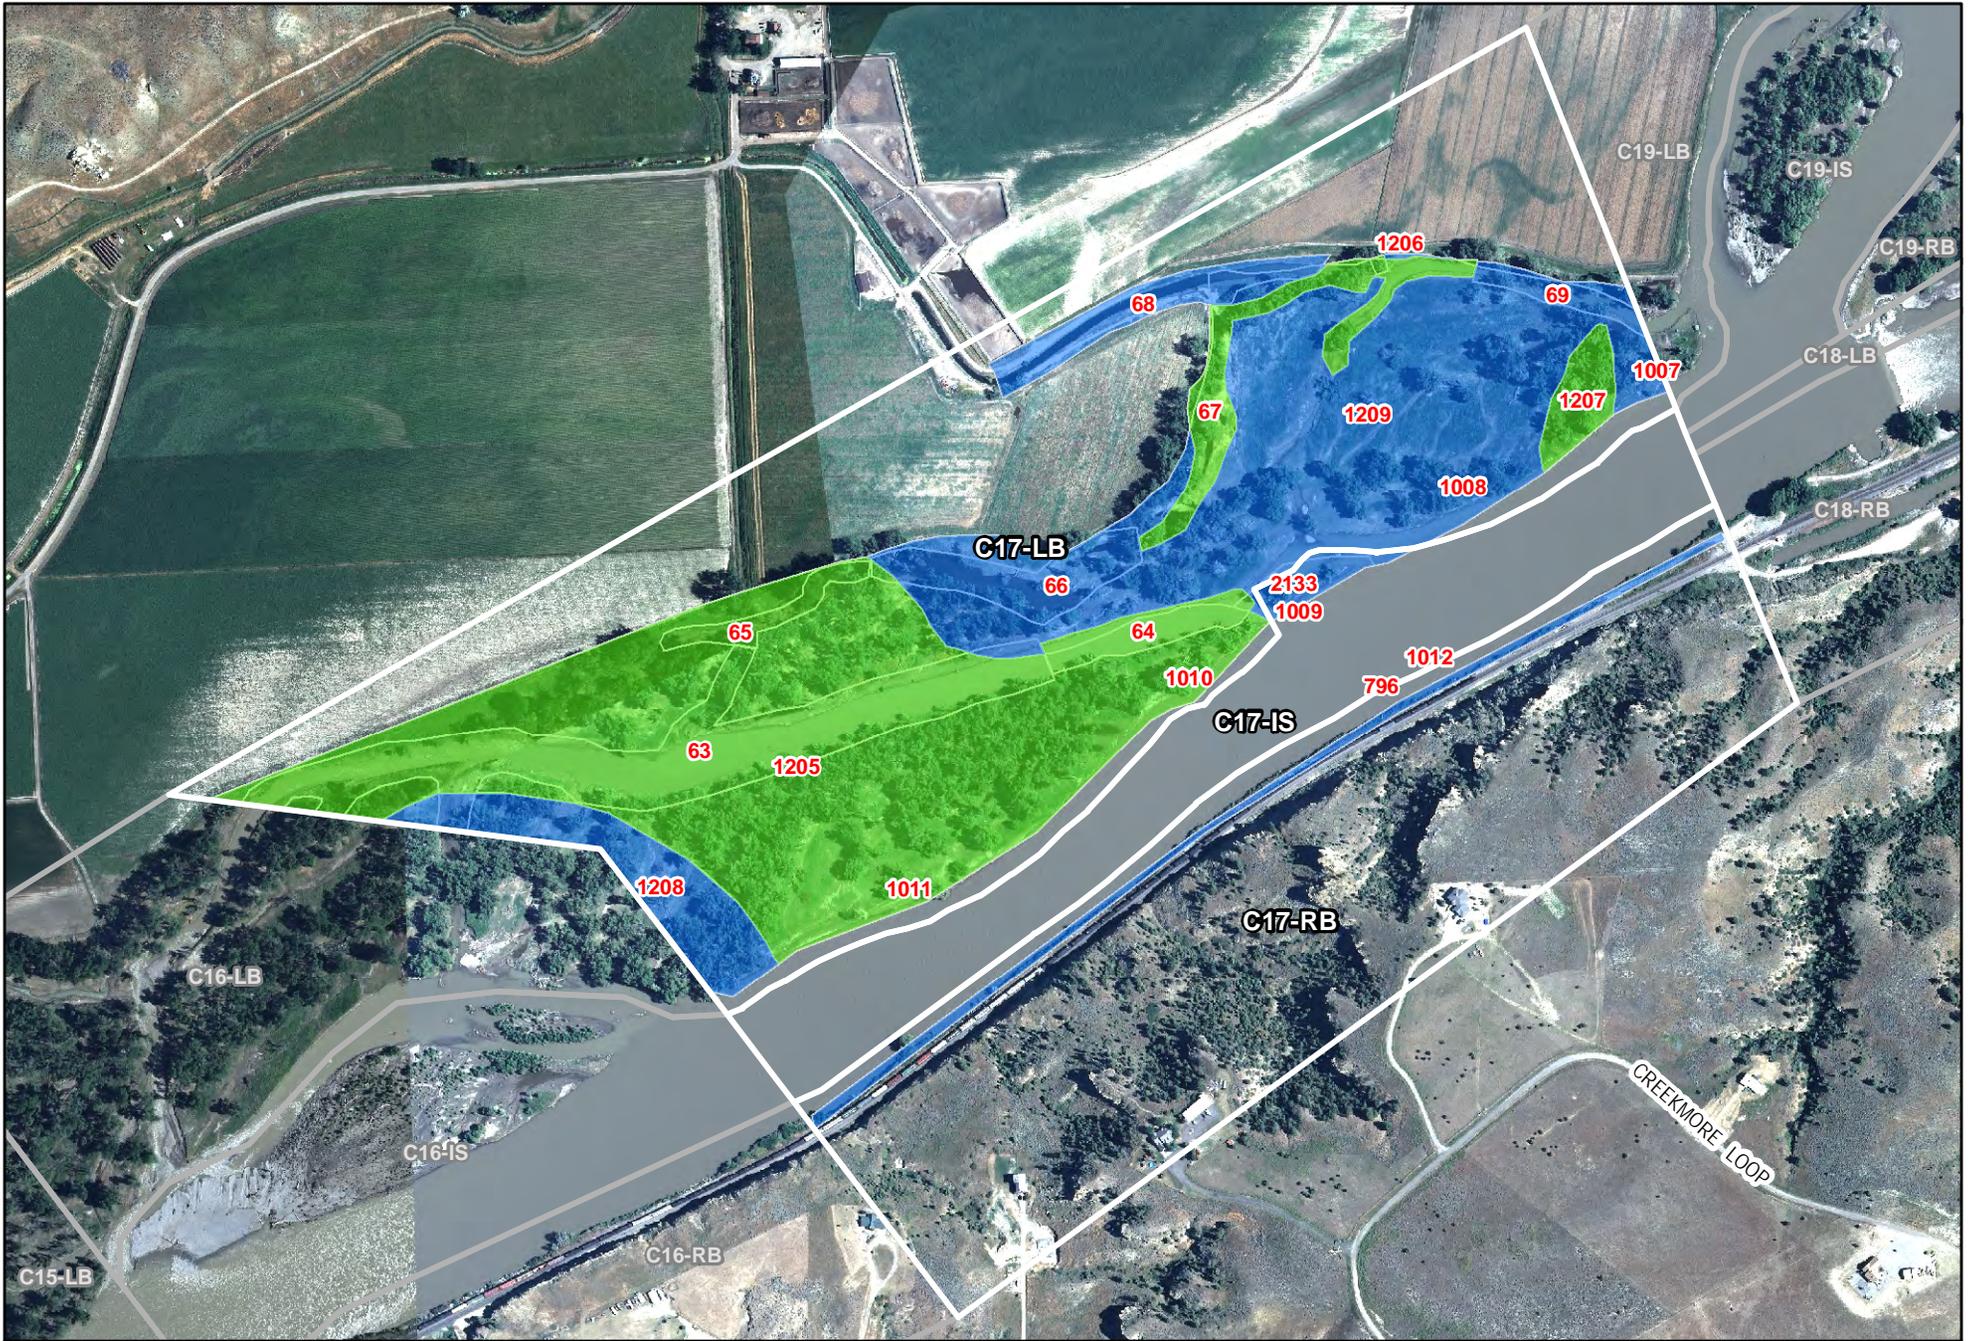
Figure 4 - Maximum SCAT Observations For SCAT Area: C17

The SCAT teams used systematic evaluation criteria and treatment method tables approved by the National Oceanic and Atmospheric Administration to provide a standard approach for data collection and conducting field surveys. The forms and sketches from the initial SCAT surveys performed along the river bank (water edge) and floodplain within Area C17 are included in Appendix B. Figure 4 provides the maximum oiling zones observed by the SCAT team during the initial surveys of Area C17.

Based on the initial SCAT survey performed within Area C17, no oiling was observed on the left bank and no further treatment was recommended. Based on initial SCAT surveys, no oiling was observed on the right bank or island and therefore no further treatment is recommended. Therefore, a PIST, POST, and final SCAT survey were not performed and a SCAT Segment Sign-Off Form is not necessary.

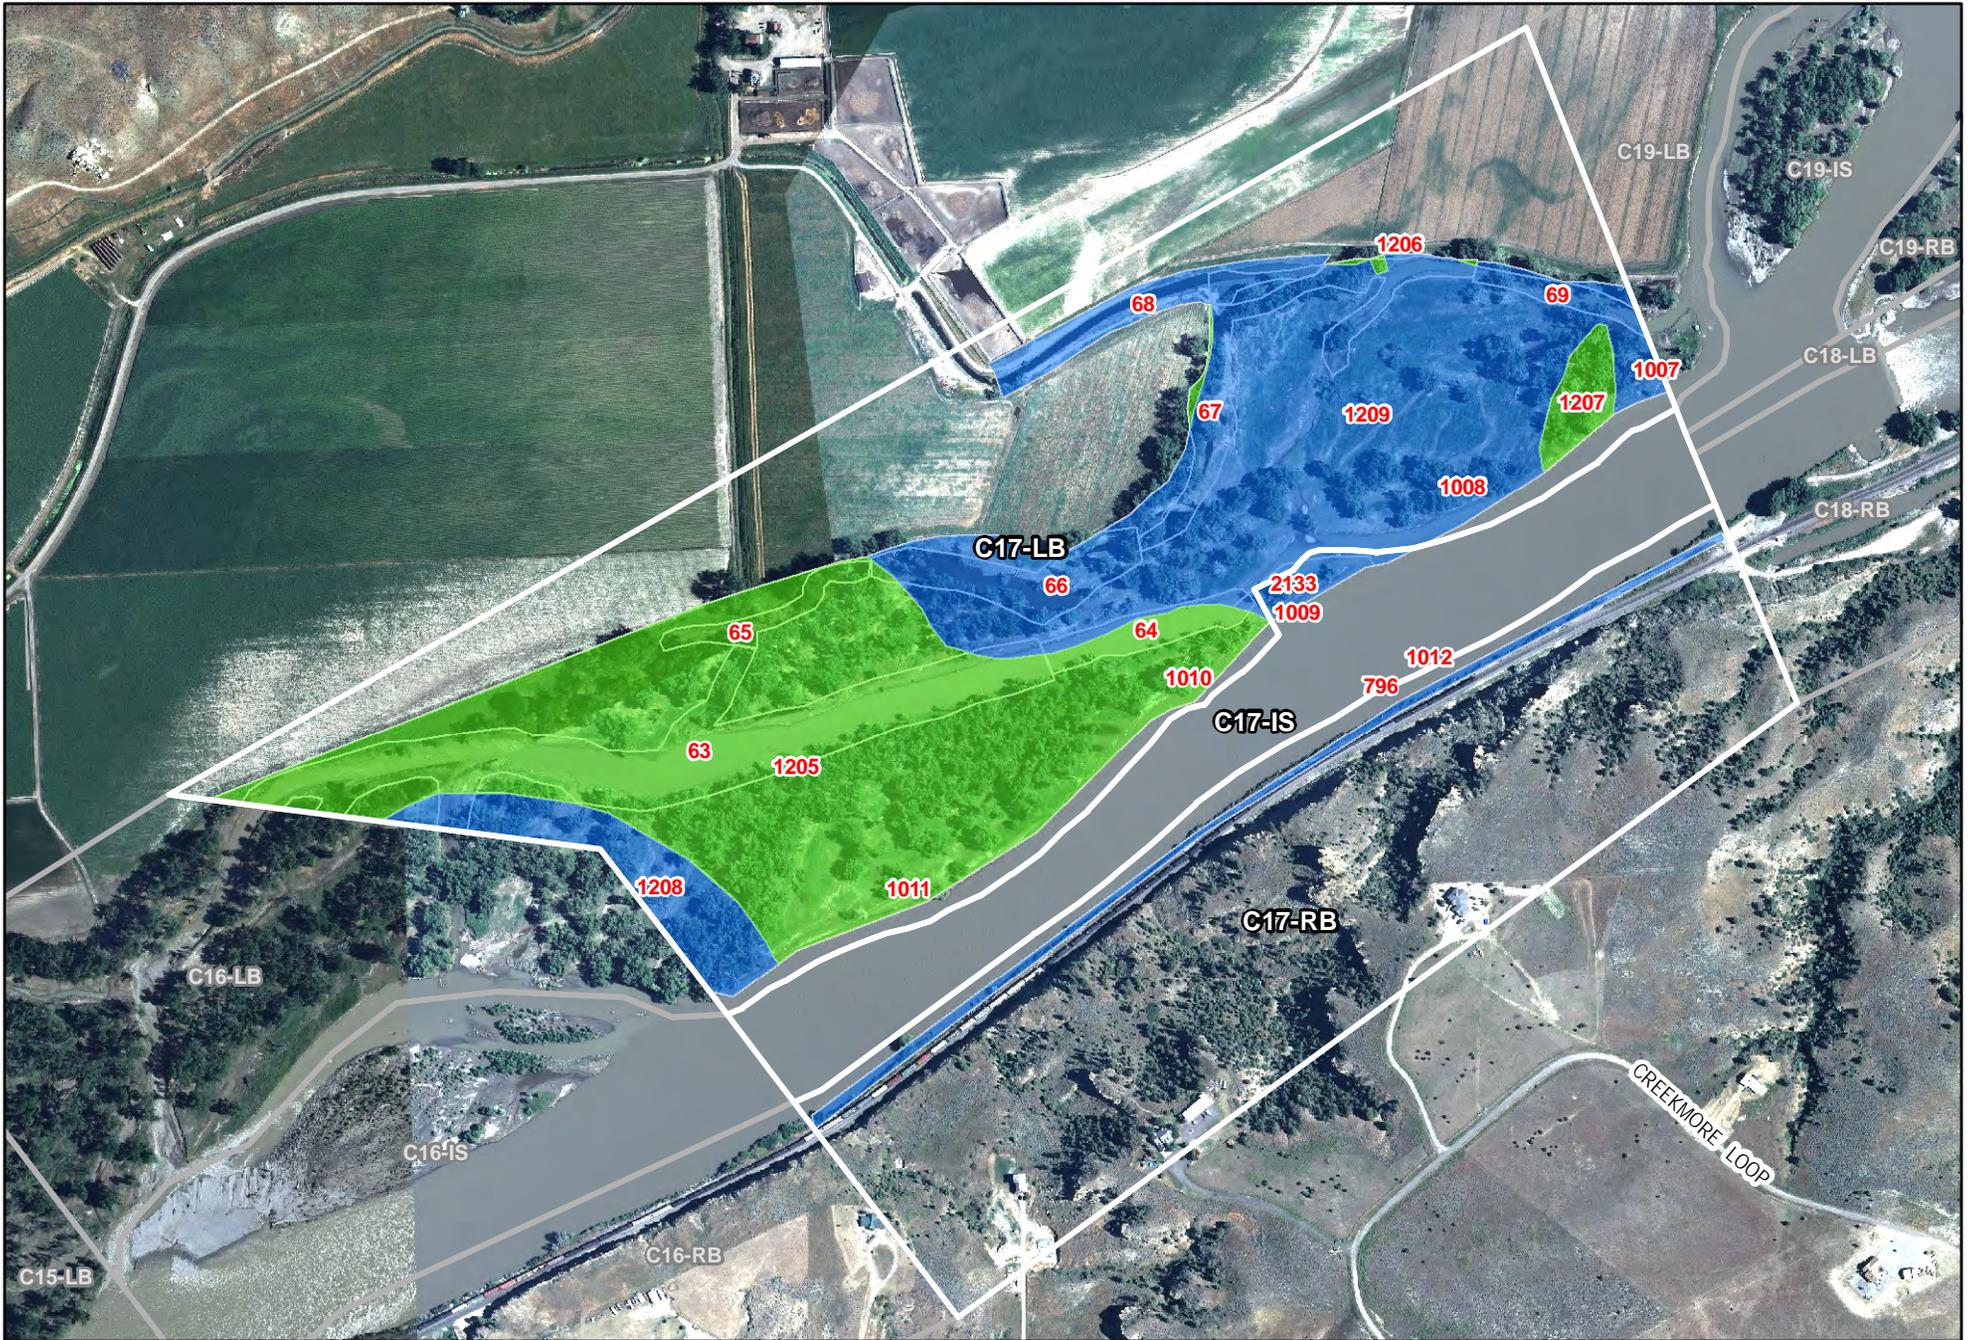
**Figure 5 - Final SCAT Observations
For SCAT Area:**

A final SCAT survey was not conducted for this area.

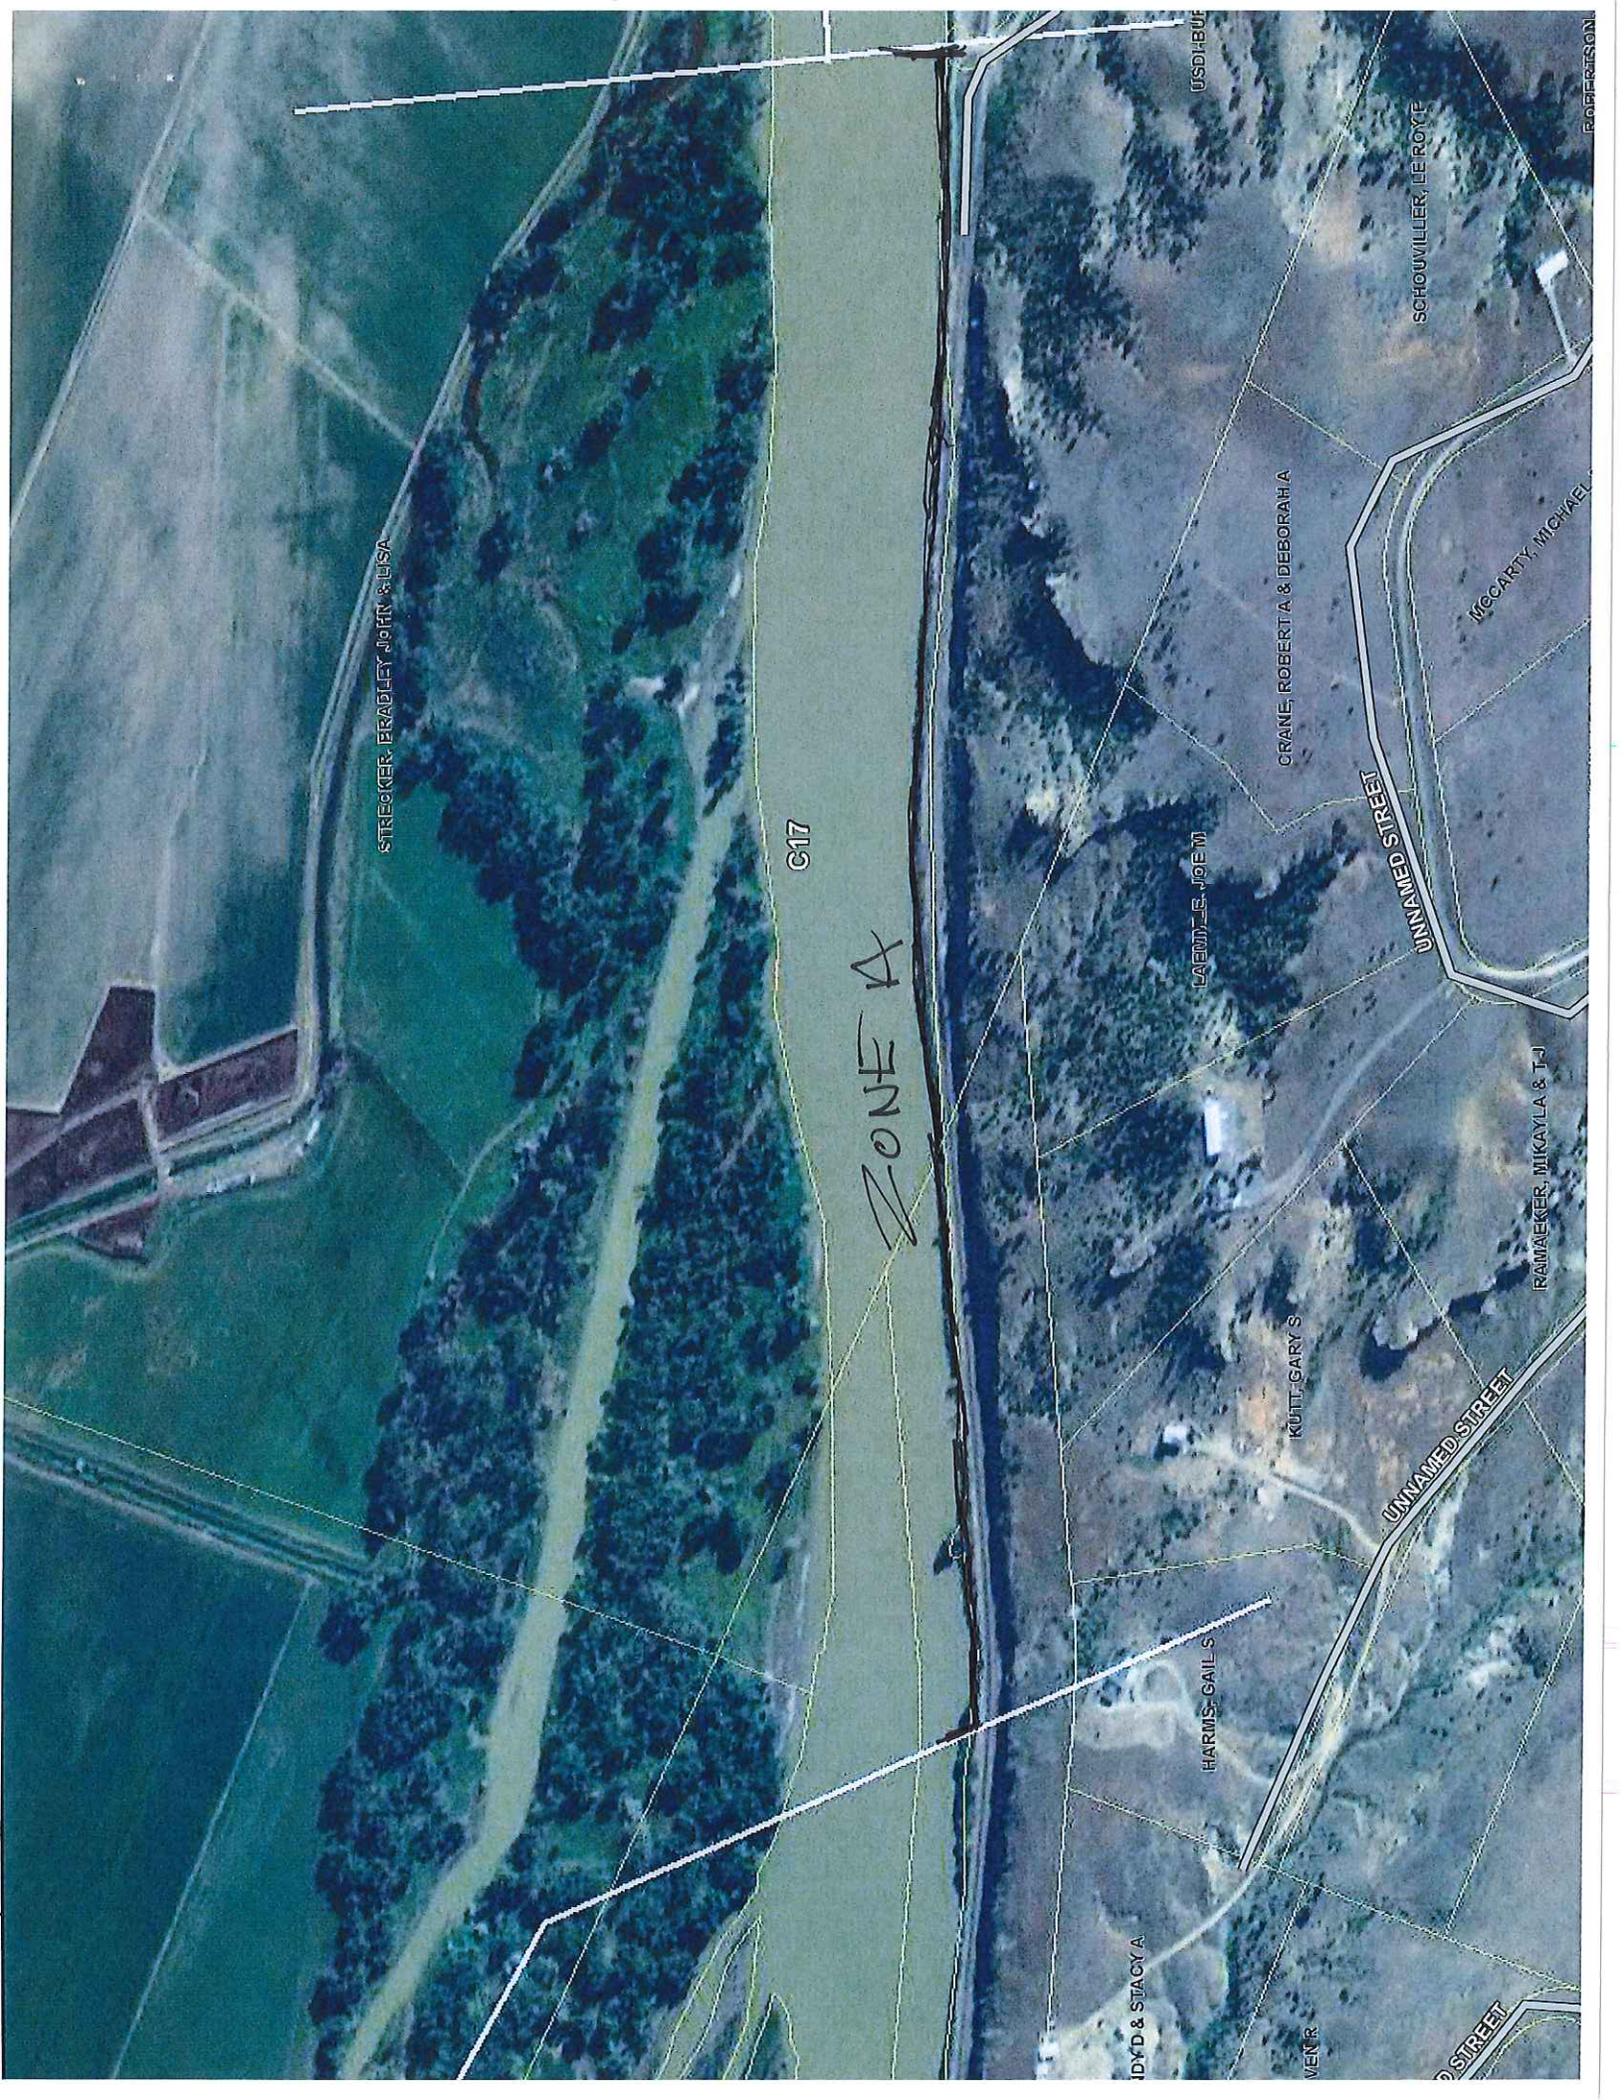
C17

ZONE A: NO oil observed

recommendation: rescaty from boat at low speed lowerbank

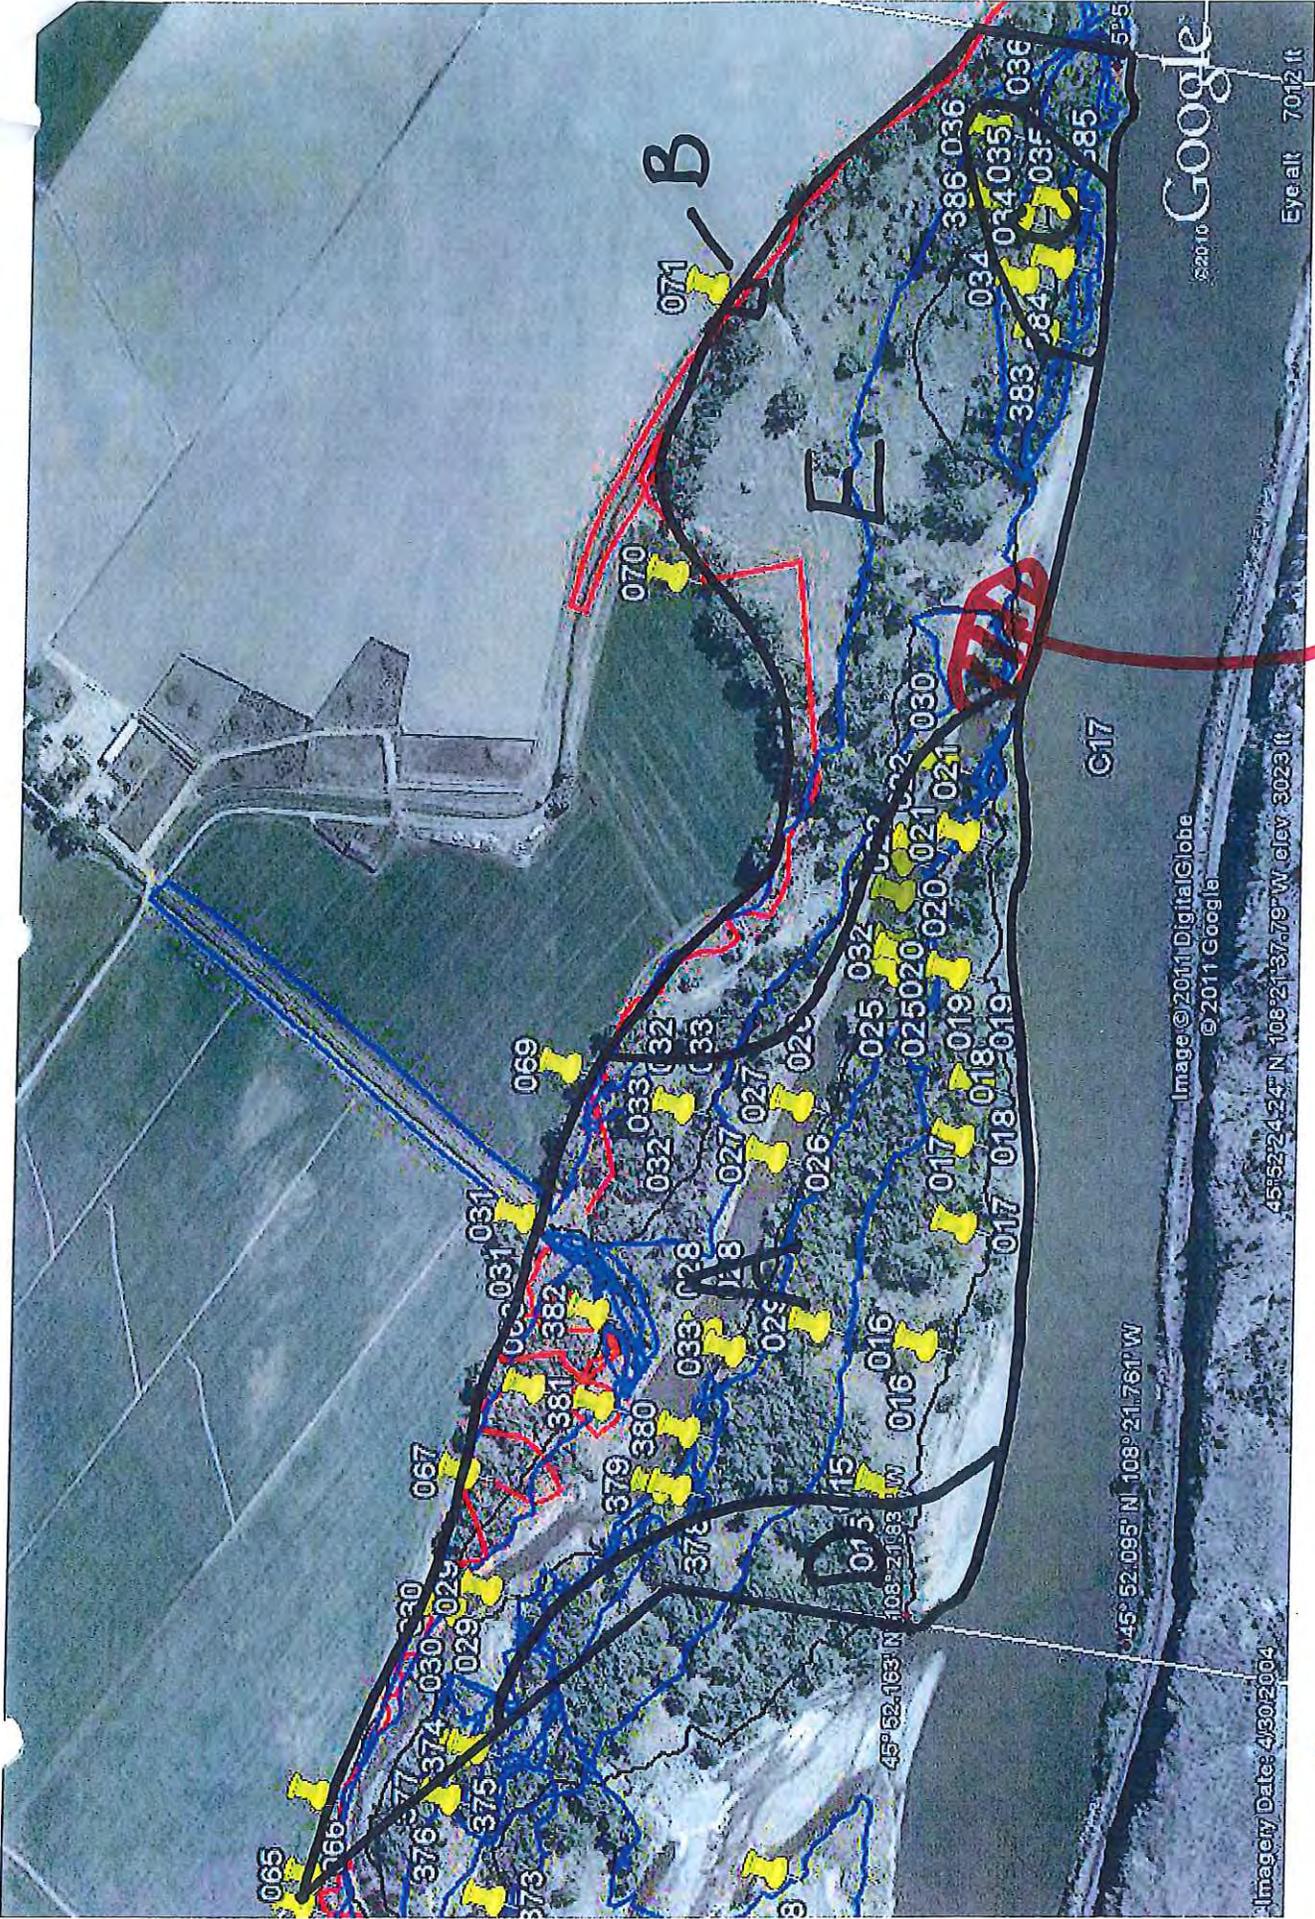
August 4, 2011
 TEAM 5 C17 LB
 zones A,B,C,D+E
 C17-15

Zone A: Isolated and contiguous trace (<1%) oiling coat and stain on vegetation and small vegetative debris. Silver oil sheen within isolated slack waters/ox bows within floodplain. No further treatment (NFT) recommended.																					
Zone B: Isolated trace (<1%) oiling coat and stain on vegetation and small vegetative debris. No further treatment (NFT) recommended.																					
Zone C: Isolated and contiguous trace (<1%) oiling coat and stain on vegetation and small vegetative debris. No further treatment (NFT) recommended.																					
Zone D: No oiling observed. No further treatment (NFT) recommended.																					
Zone E: No oiling observed. No further treatment (NFT) recommended.																					
Sketch Yes / No		Photos Yes / No		Frames/Photographer: _____

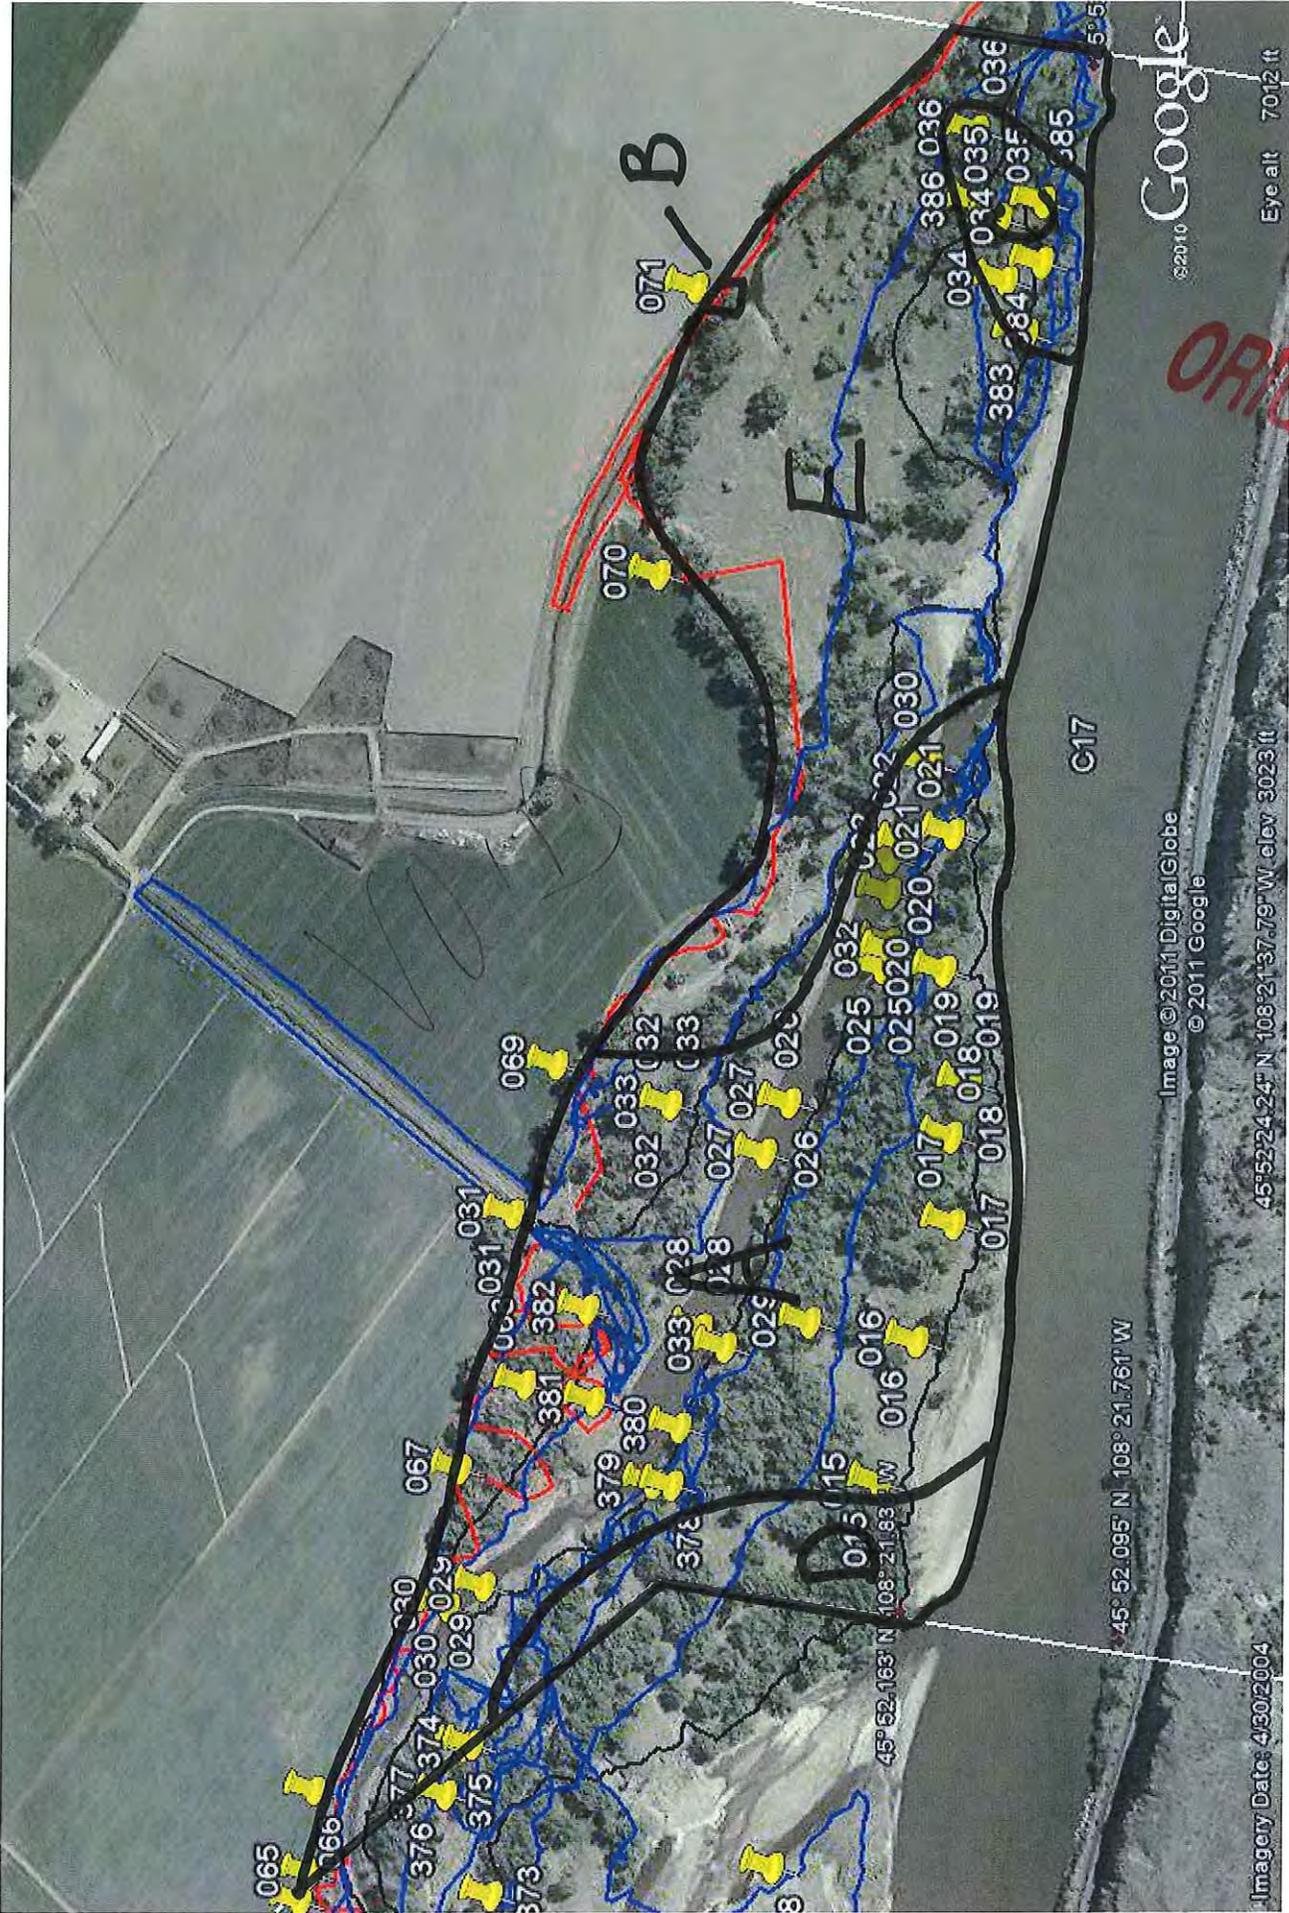
August 4, 2011
 TEAM 5 C17 LB
 zones A,B,C,D,E

Zone A: Isolated and contiguous trace (<1%) oiling coat and stain on vegetation and small vegetative debris. Silver oil sheen within isolated slack waters/ox bows within floodplain. No further treatment (NFT) recommended.

Zone B: Isolated trace (<1%) oiling coat and stain on vegetation and small vegetative debris. No further treatment (NFT) recommended.

Zone C: Isolated and contiguous trace (<1%) oiling coat and stain on vegetation and small vegetative debris. No further treatment (NFT) recommended.

Zone D: No oiling observed. No further treatment (NFT) recommended.

Zone E: No oiling observed. No further treatment (NFT) recommended.
