**SCAT Area Transition Report
for C17**

Silvertip Pipeline Incident
Laurel, Montana

October 29, 2011

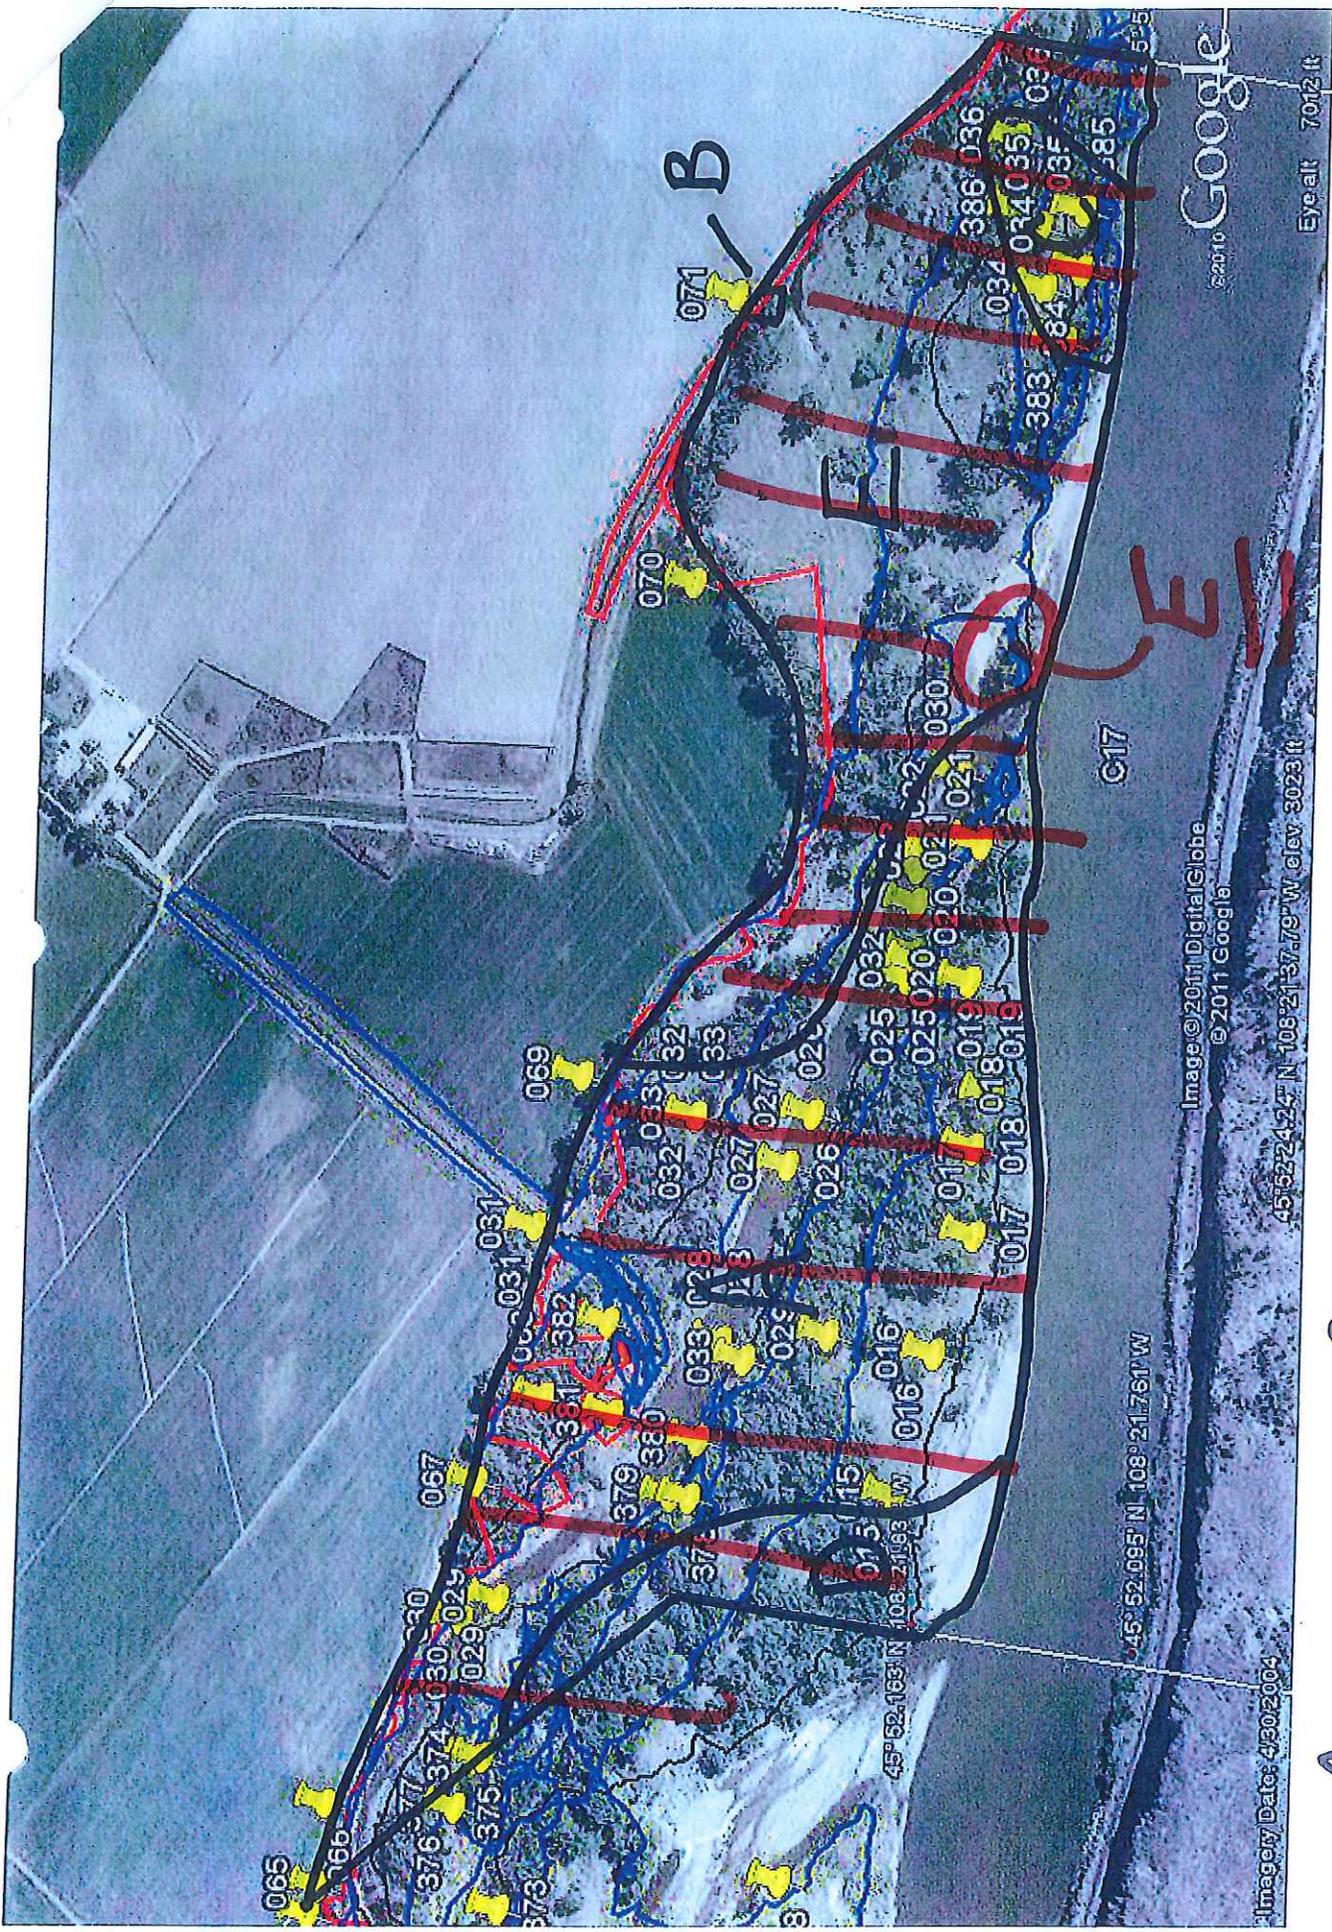
August 4, 2011
 TEAM 5 C17 LB
 zones A,B,C,D+E

Zone A: Isolated and contiguous trace (<1%) oiling coat and stain on vegetation and small vegetative debris. Silver oil sheen within isolated slack waters/ox bows within floodplain. No further treatment (NFT) recommended.

Zone B: Isolated trace (<1%) oiling coat and stain on vegetation and small vegetative debris. No further treatment (NFT) recommended.

Zone C: Isolated and contiguous trace (<1%) oiling coat and stain on vegetation and small vegetative debris. No further treatment (NFT) recommended.

Zone D: No oiling observed. No further treatment (NFT) recommended.

Zone E: No oiling observed. No further treatment (NFT) recommended.

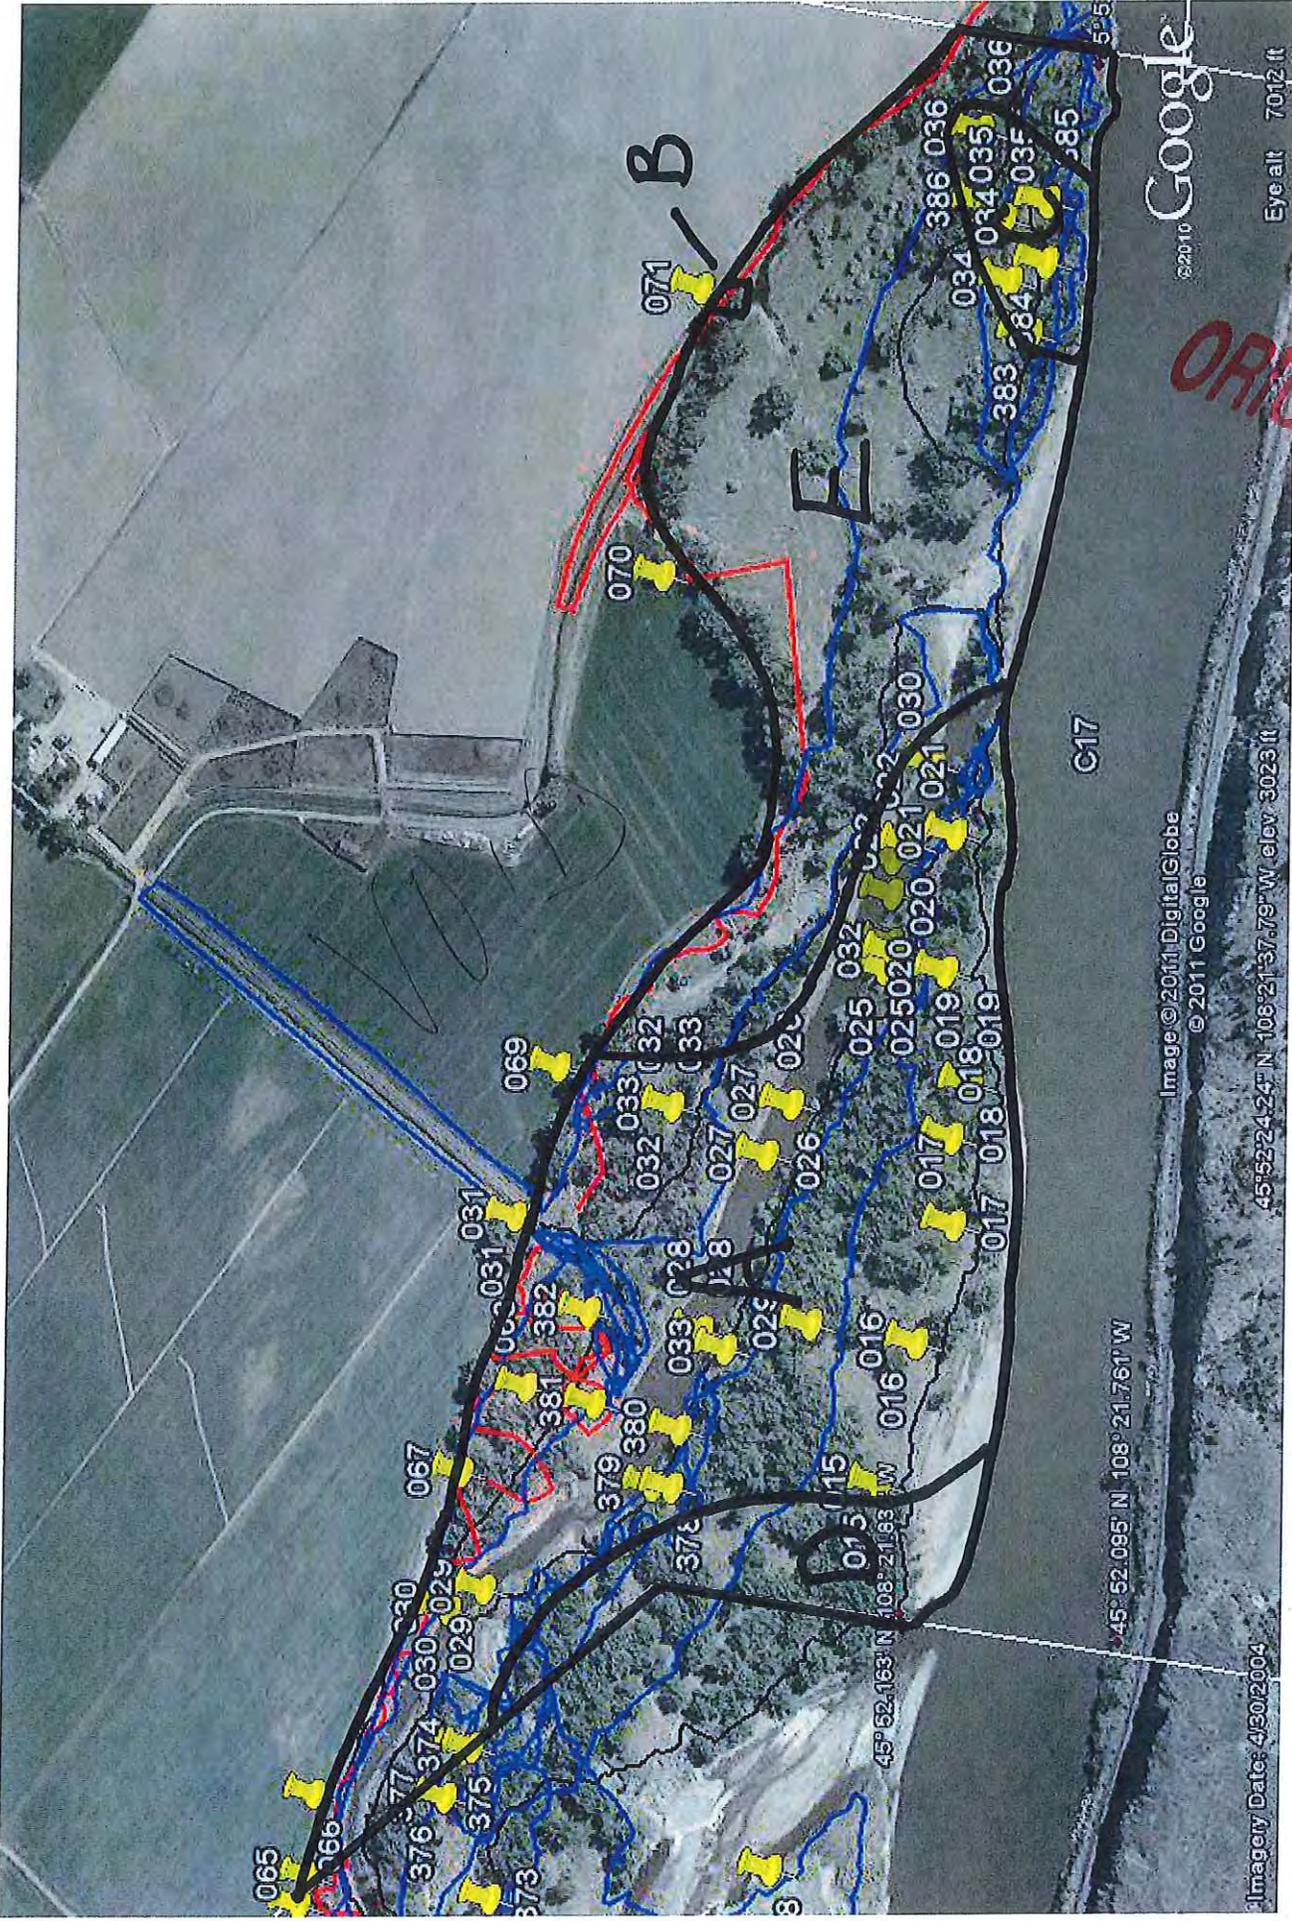
August 4, 2011
 TEAM 5 C17 LB
 ZONES A, B, C, D, E

Zone A: Isolated and contiguous trace (<1%) oiling coat and stain on vegetation and small vegetative debris. Silver oil sheen within isolated slack waters/ox bows within floodplain. No further treatment (NFT) recommended.

Zone B: Isolated trace (<1%) oiling coat and stain on vegetation and small vegetative debris. No further treatment (NFT) recommended.

Zone C: Isolated and contiguous trace (<1%) oiling coat and stain on vegetation and small vegetative debris. No further treatment (NFT) recommended.

Zone D: No oiling observed. No further treatment (NFT) recommended.

Zone E: No oiling observed. No further treatment (NFT) recommended.
