**SCAT Area Transition Report  
for C28**

Silvertip Pipeline Incident  
Laurel, Montana

October 29, 2011

Our Ref.:  
B0085883.1103

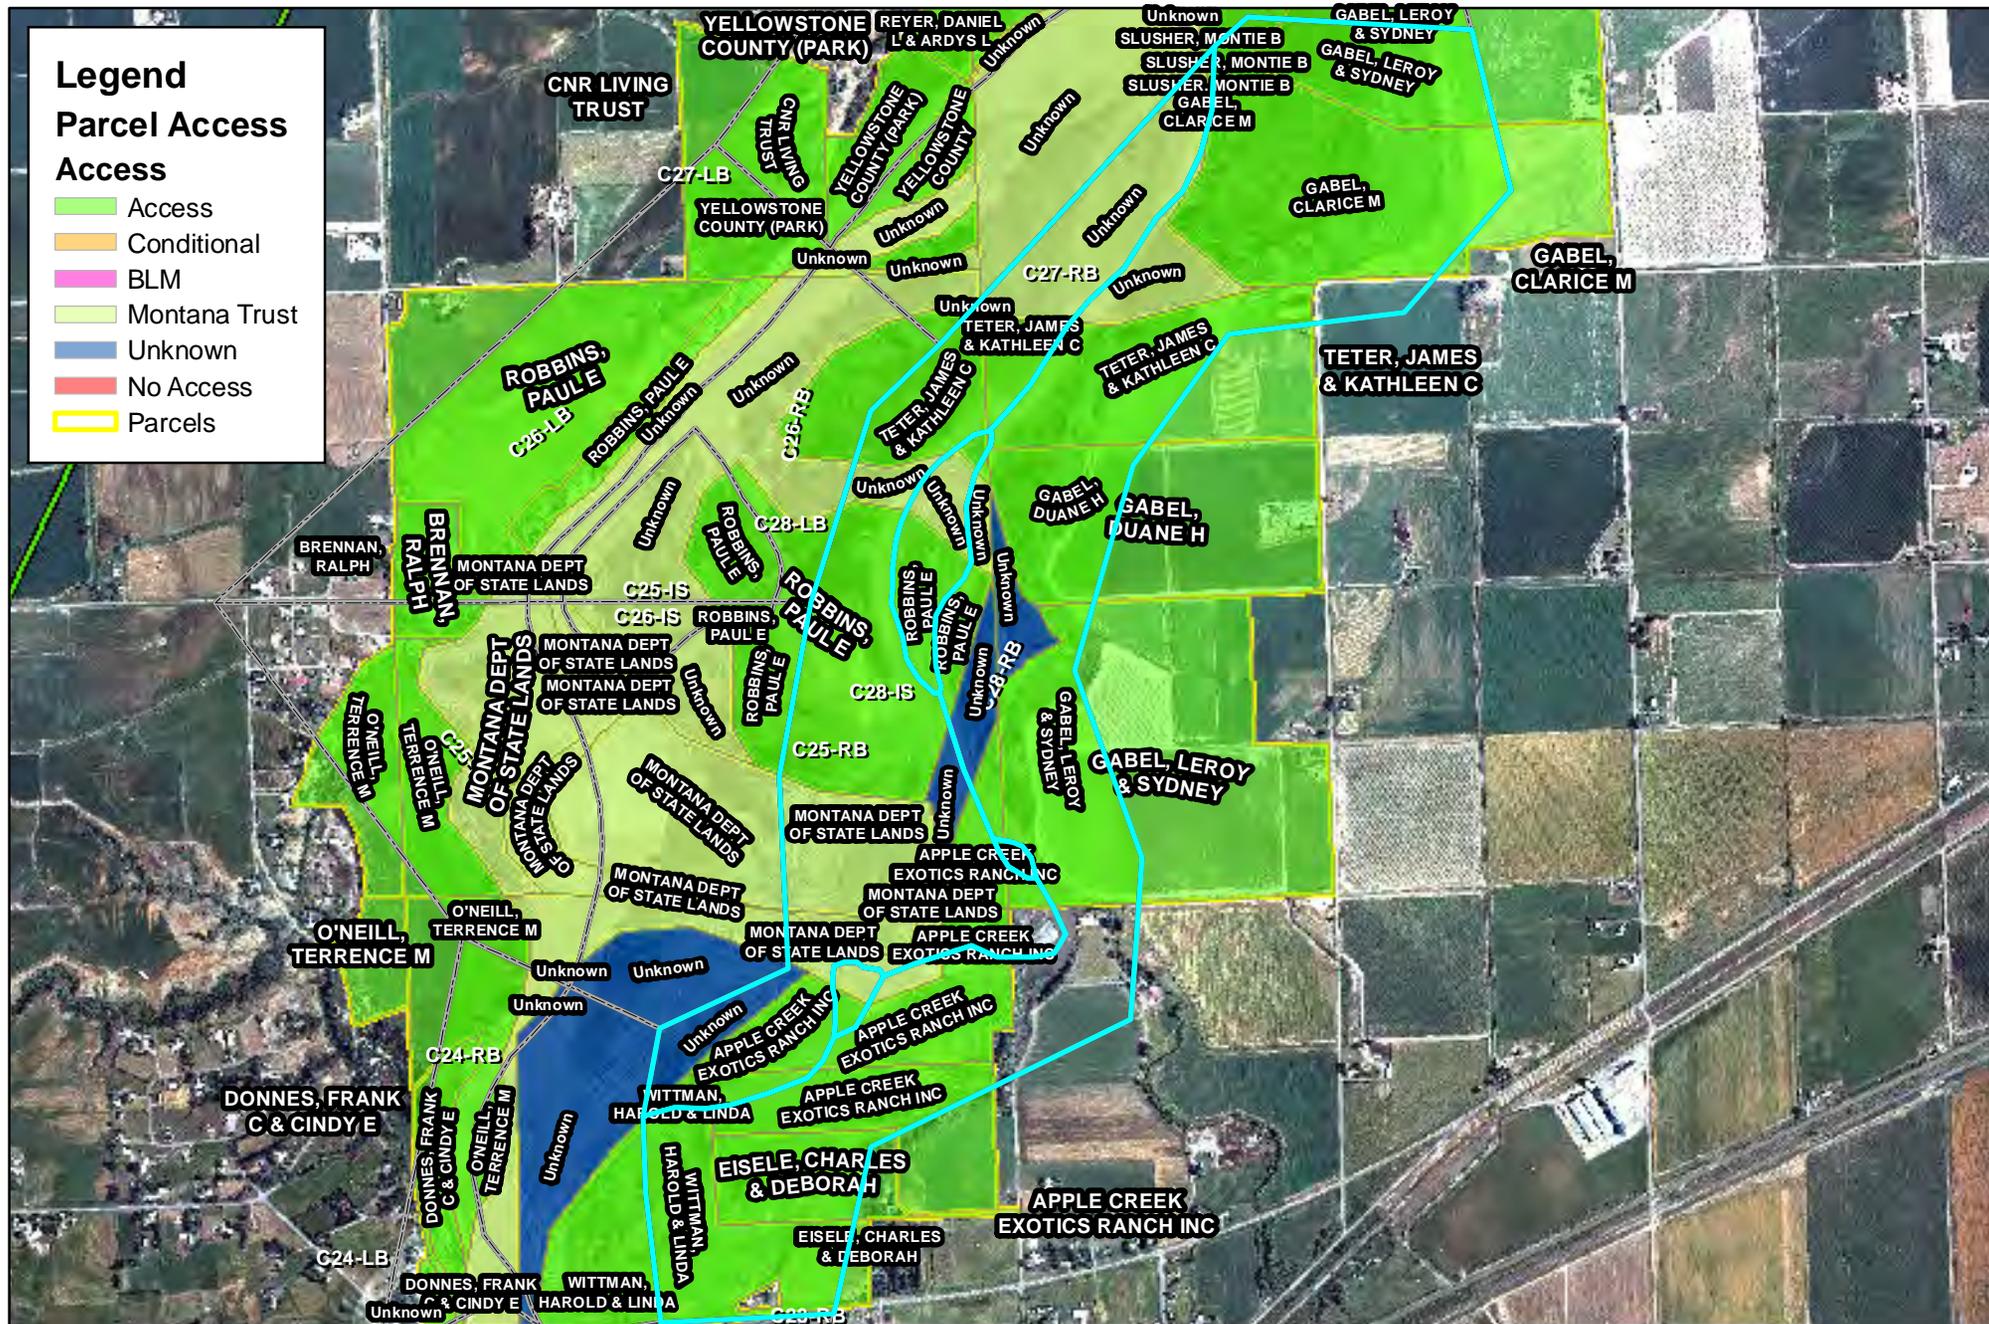
Figure 1 provides an aerial map of SCAT Area C28, along with the (a) SCAT Area boundary, (b) parcel boundaries and respective property owners, and (c) access constraints identified during the oil cleanup process. The acreage surveyed in Area C28 is 446.5. There were no access issues for this area.

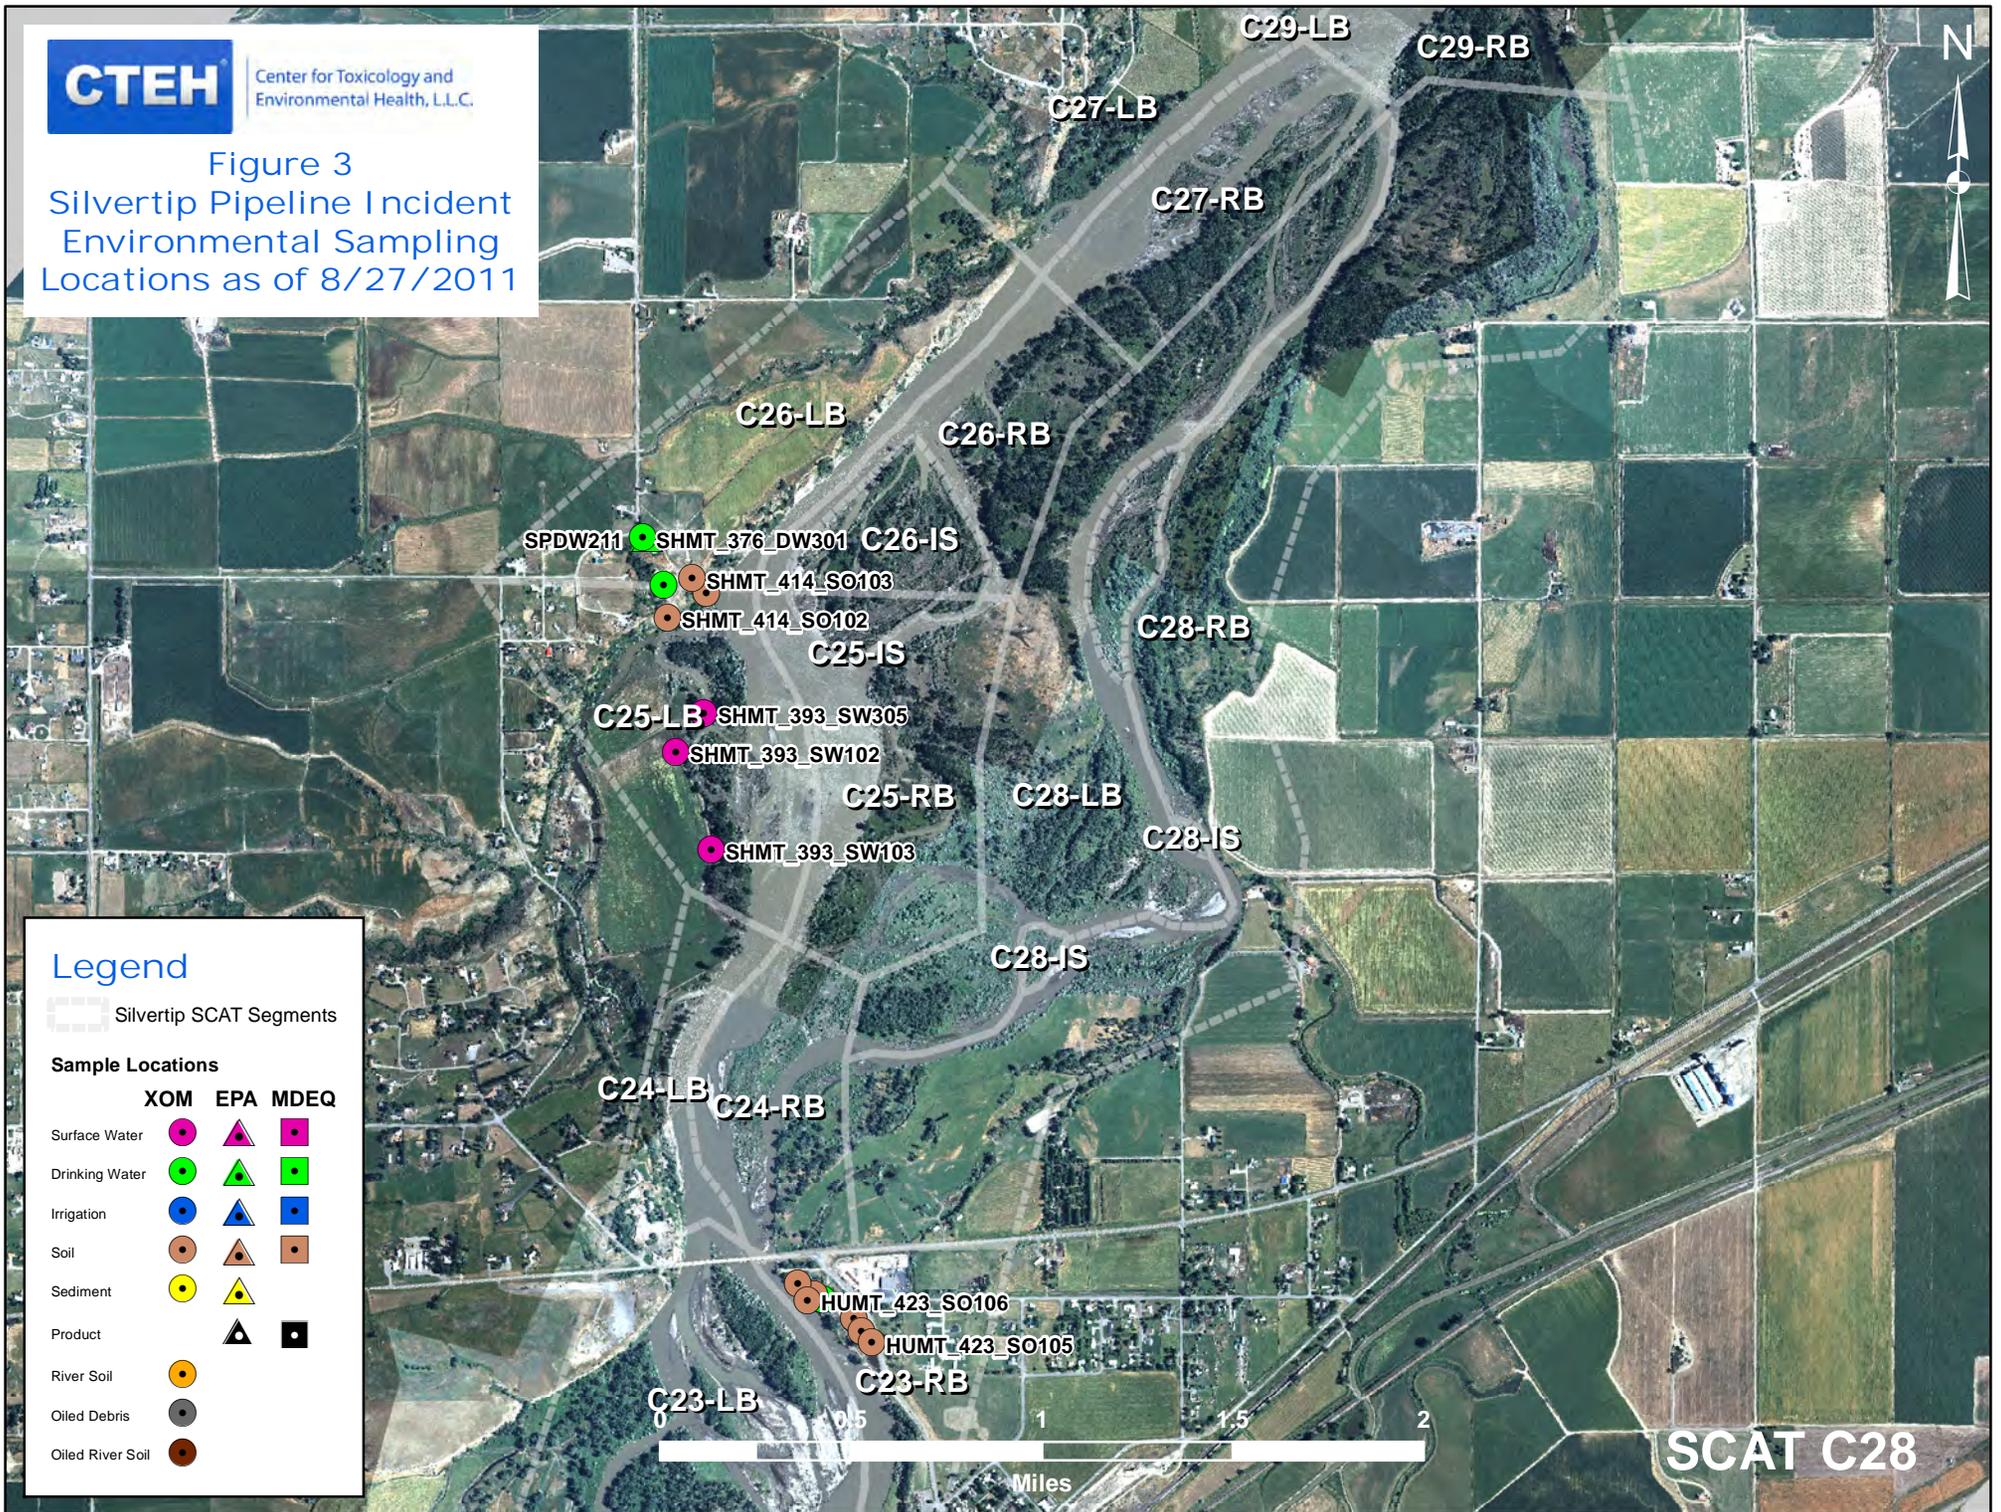
Figure 3  
Silvertip Pipeline Incident  
Environmental Sampling  
Locations as of 8/27/2011

Table 1 (below) summarizes samples collected within Area C28. The analytical results for the samples collected can be accessed through a publicly accessible database on the United States Environmental Protection Agency's (USEPA's) website. The approximate locations of samples collected within Area C28 are provided on Figure 3.

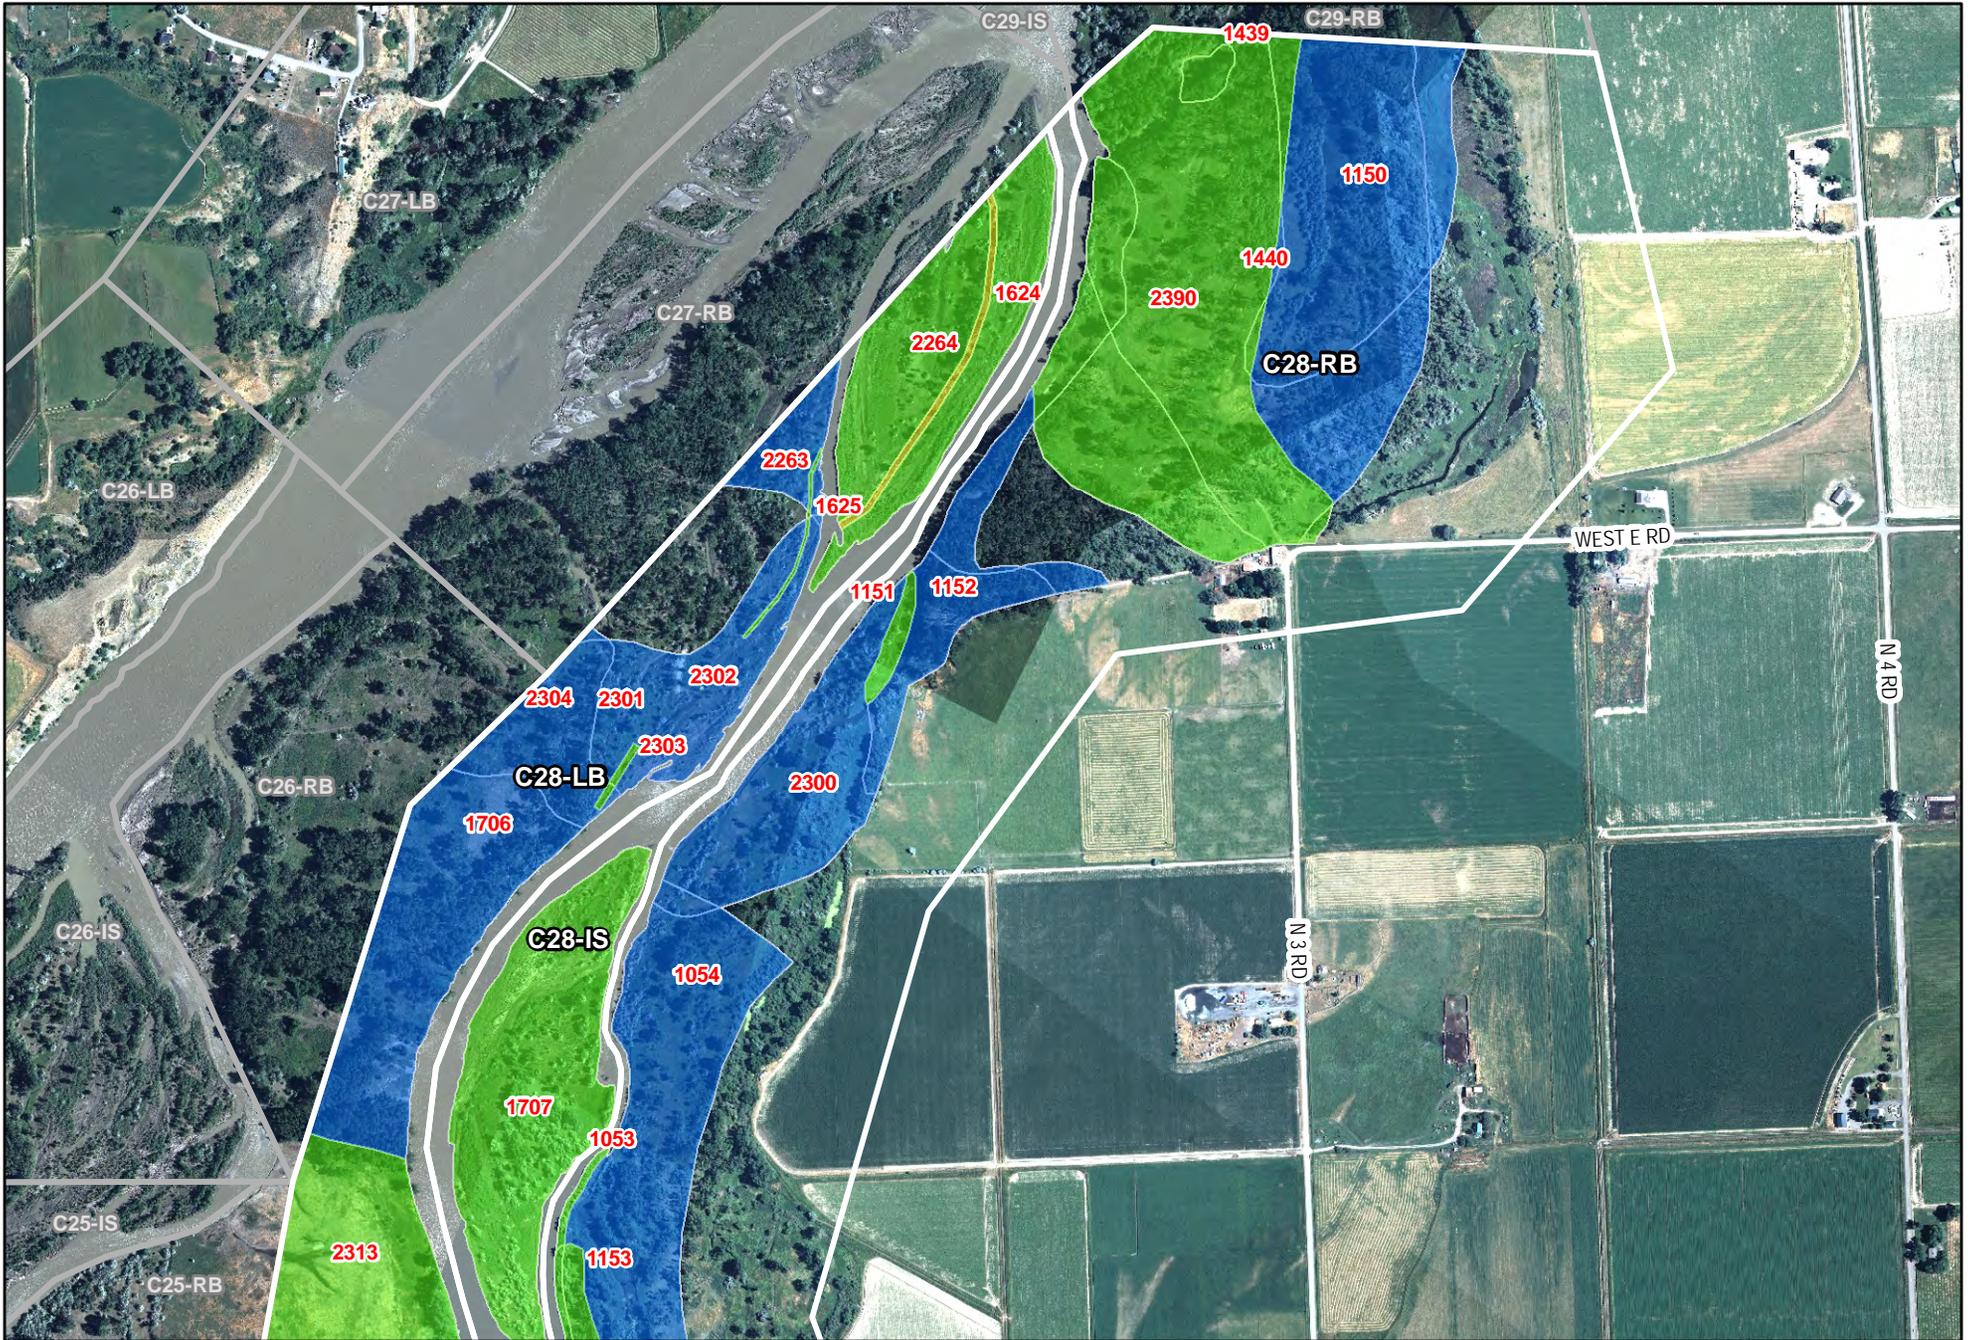
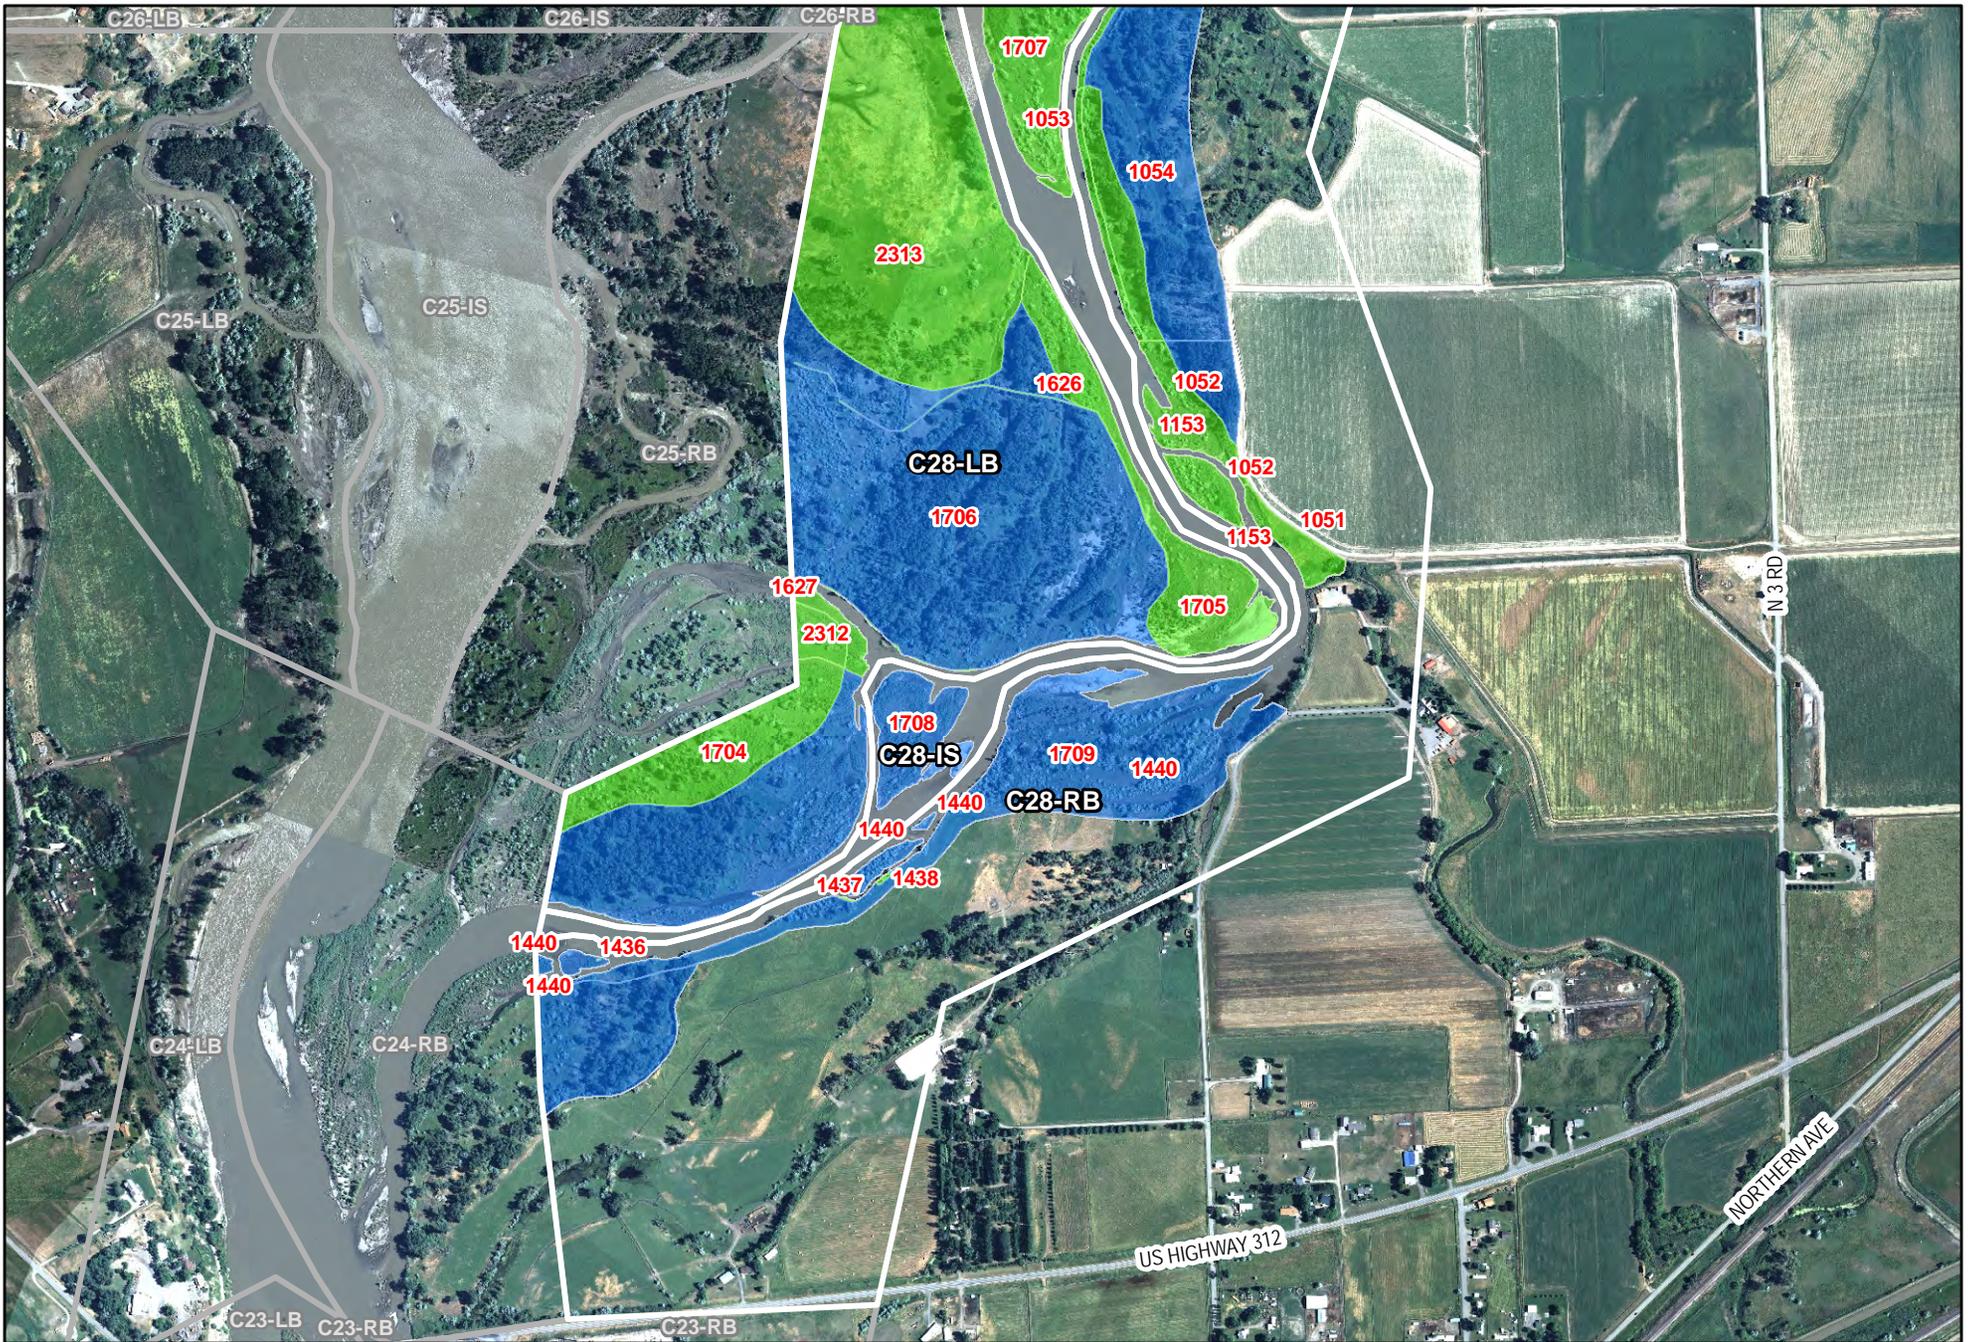
**Figure 4a - Maximum SCAT Observations For SCAT Area:**

The SCAT teams used systematic evaluation criteria and treatment method tables approved by the National Oceanic and Atmospheric Administration to provide a standard approach for data collection and conducting field surveys. The forms and sketches from the initial SCAT surveys performed along the river bank (water edge) and floodplain within Area C28 are included in Appendix B. Figure 4 provides the maximum oiling zones observed by the SCAT team during the initial surveys of Area C28.

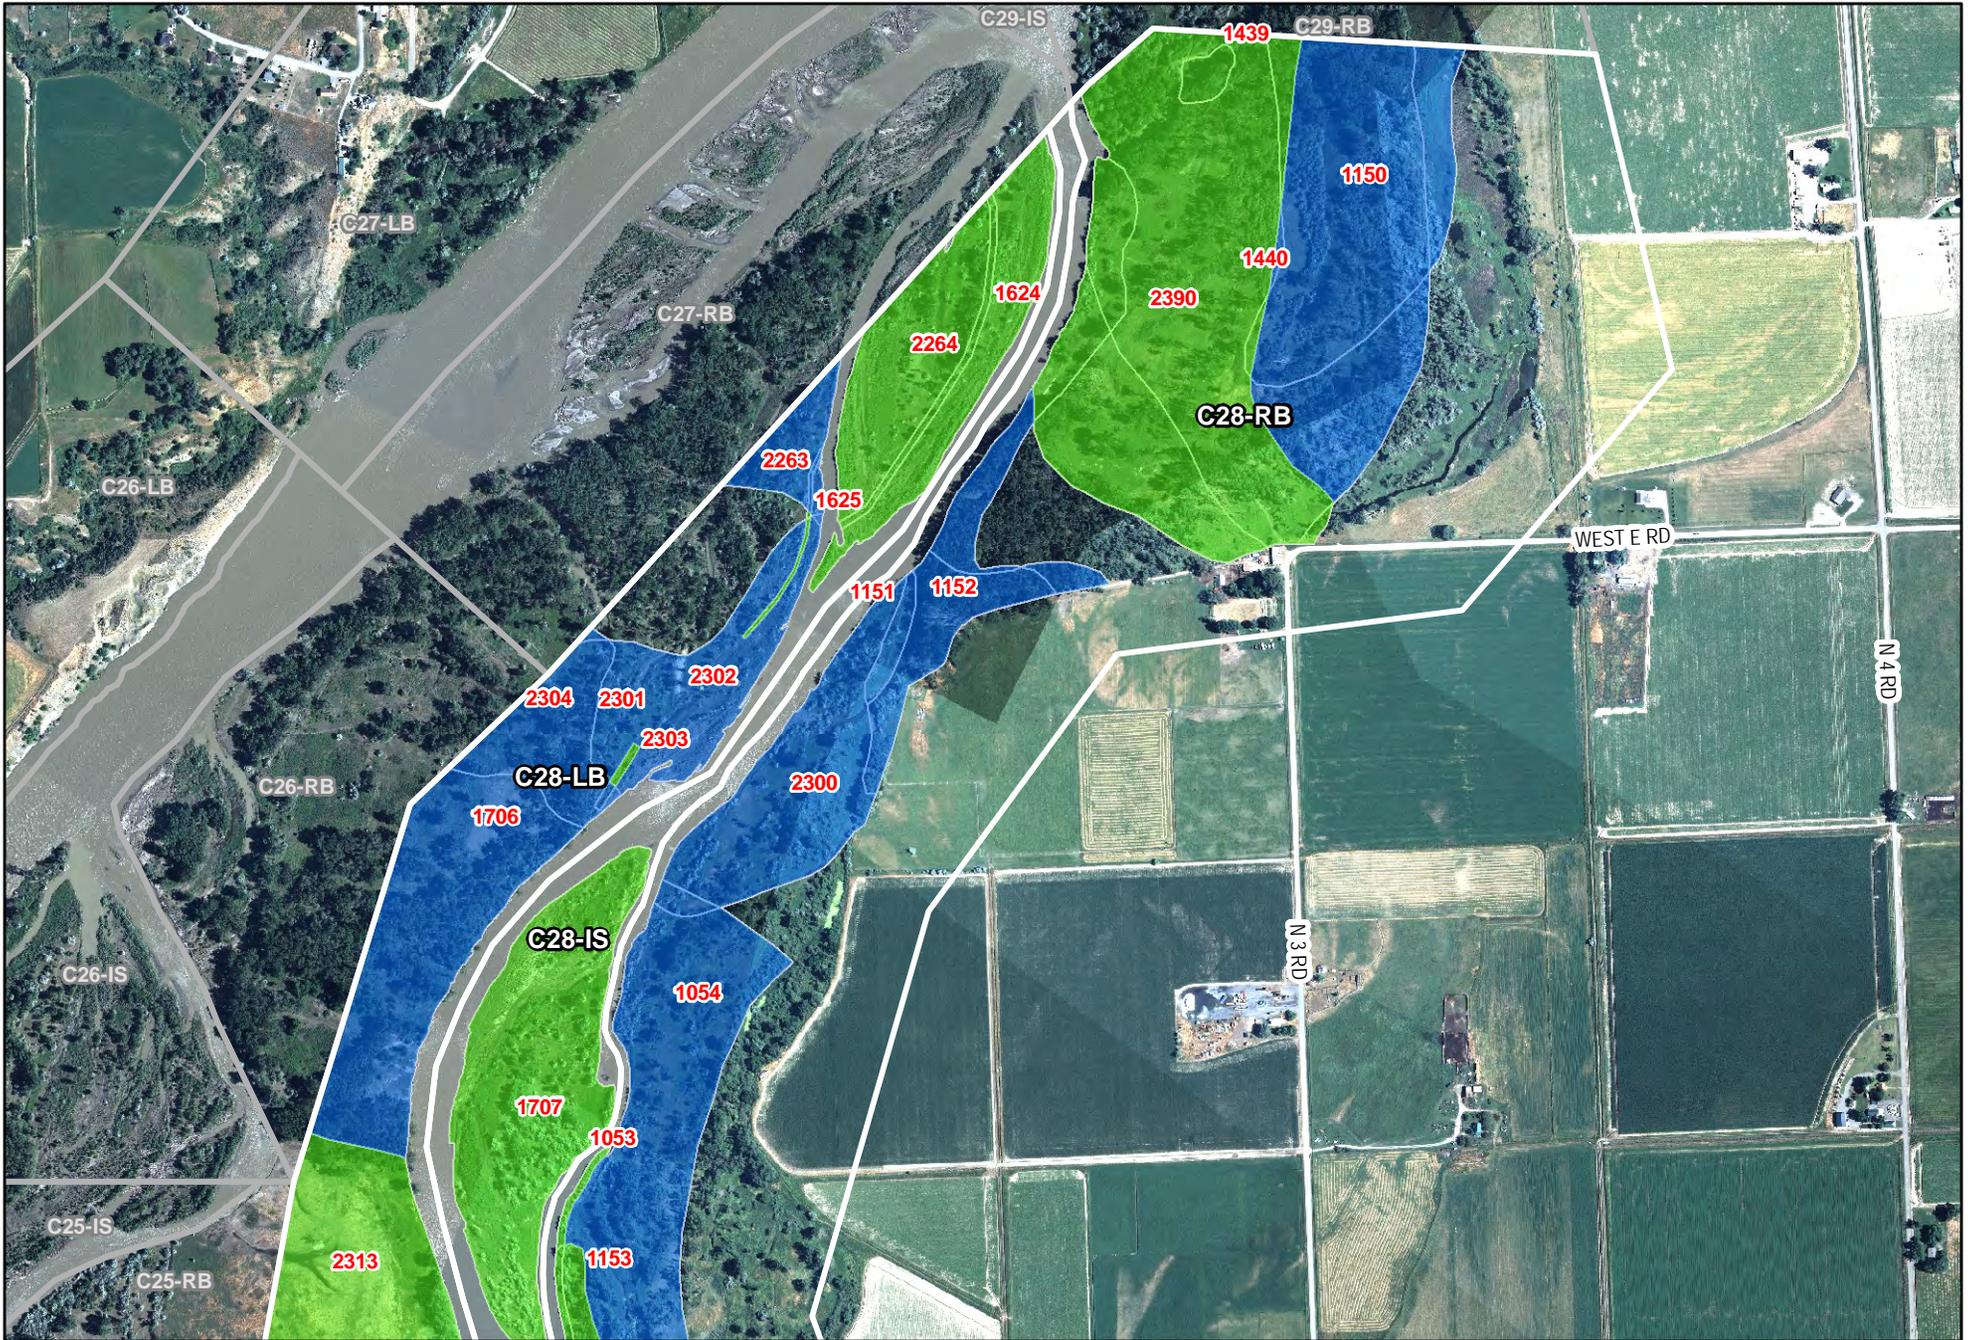
**Figure 5a - Final SCAT Observations**  
**For SCAT Area:**

Figure 5 shows the oiling conditions within Area C28 following completion of oil removal activities. The SCAT team performed final surveys of the right and left banks within SCAT Area C28 to confirm the agreed-upon cleanup endpoints identified in the applicable CTRs had been achieved. The final SCAT survey documentation is presented in Appendix E.

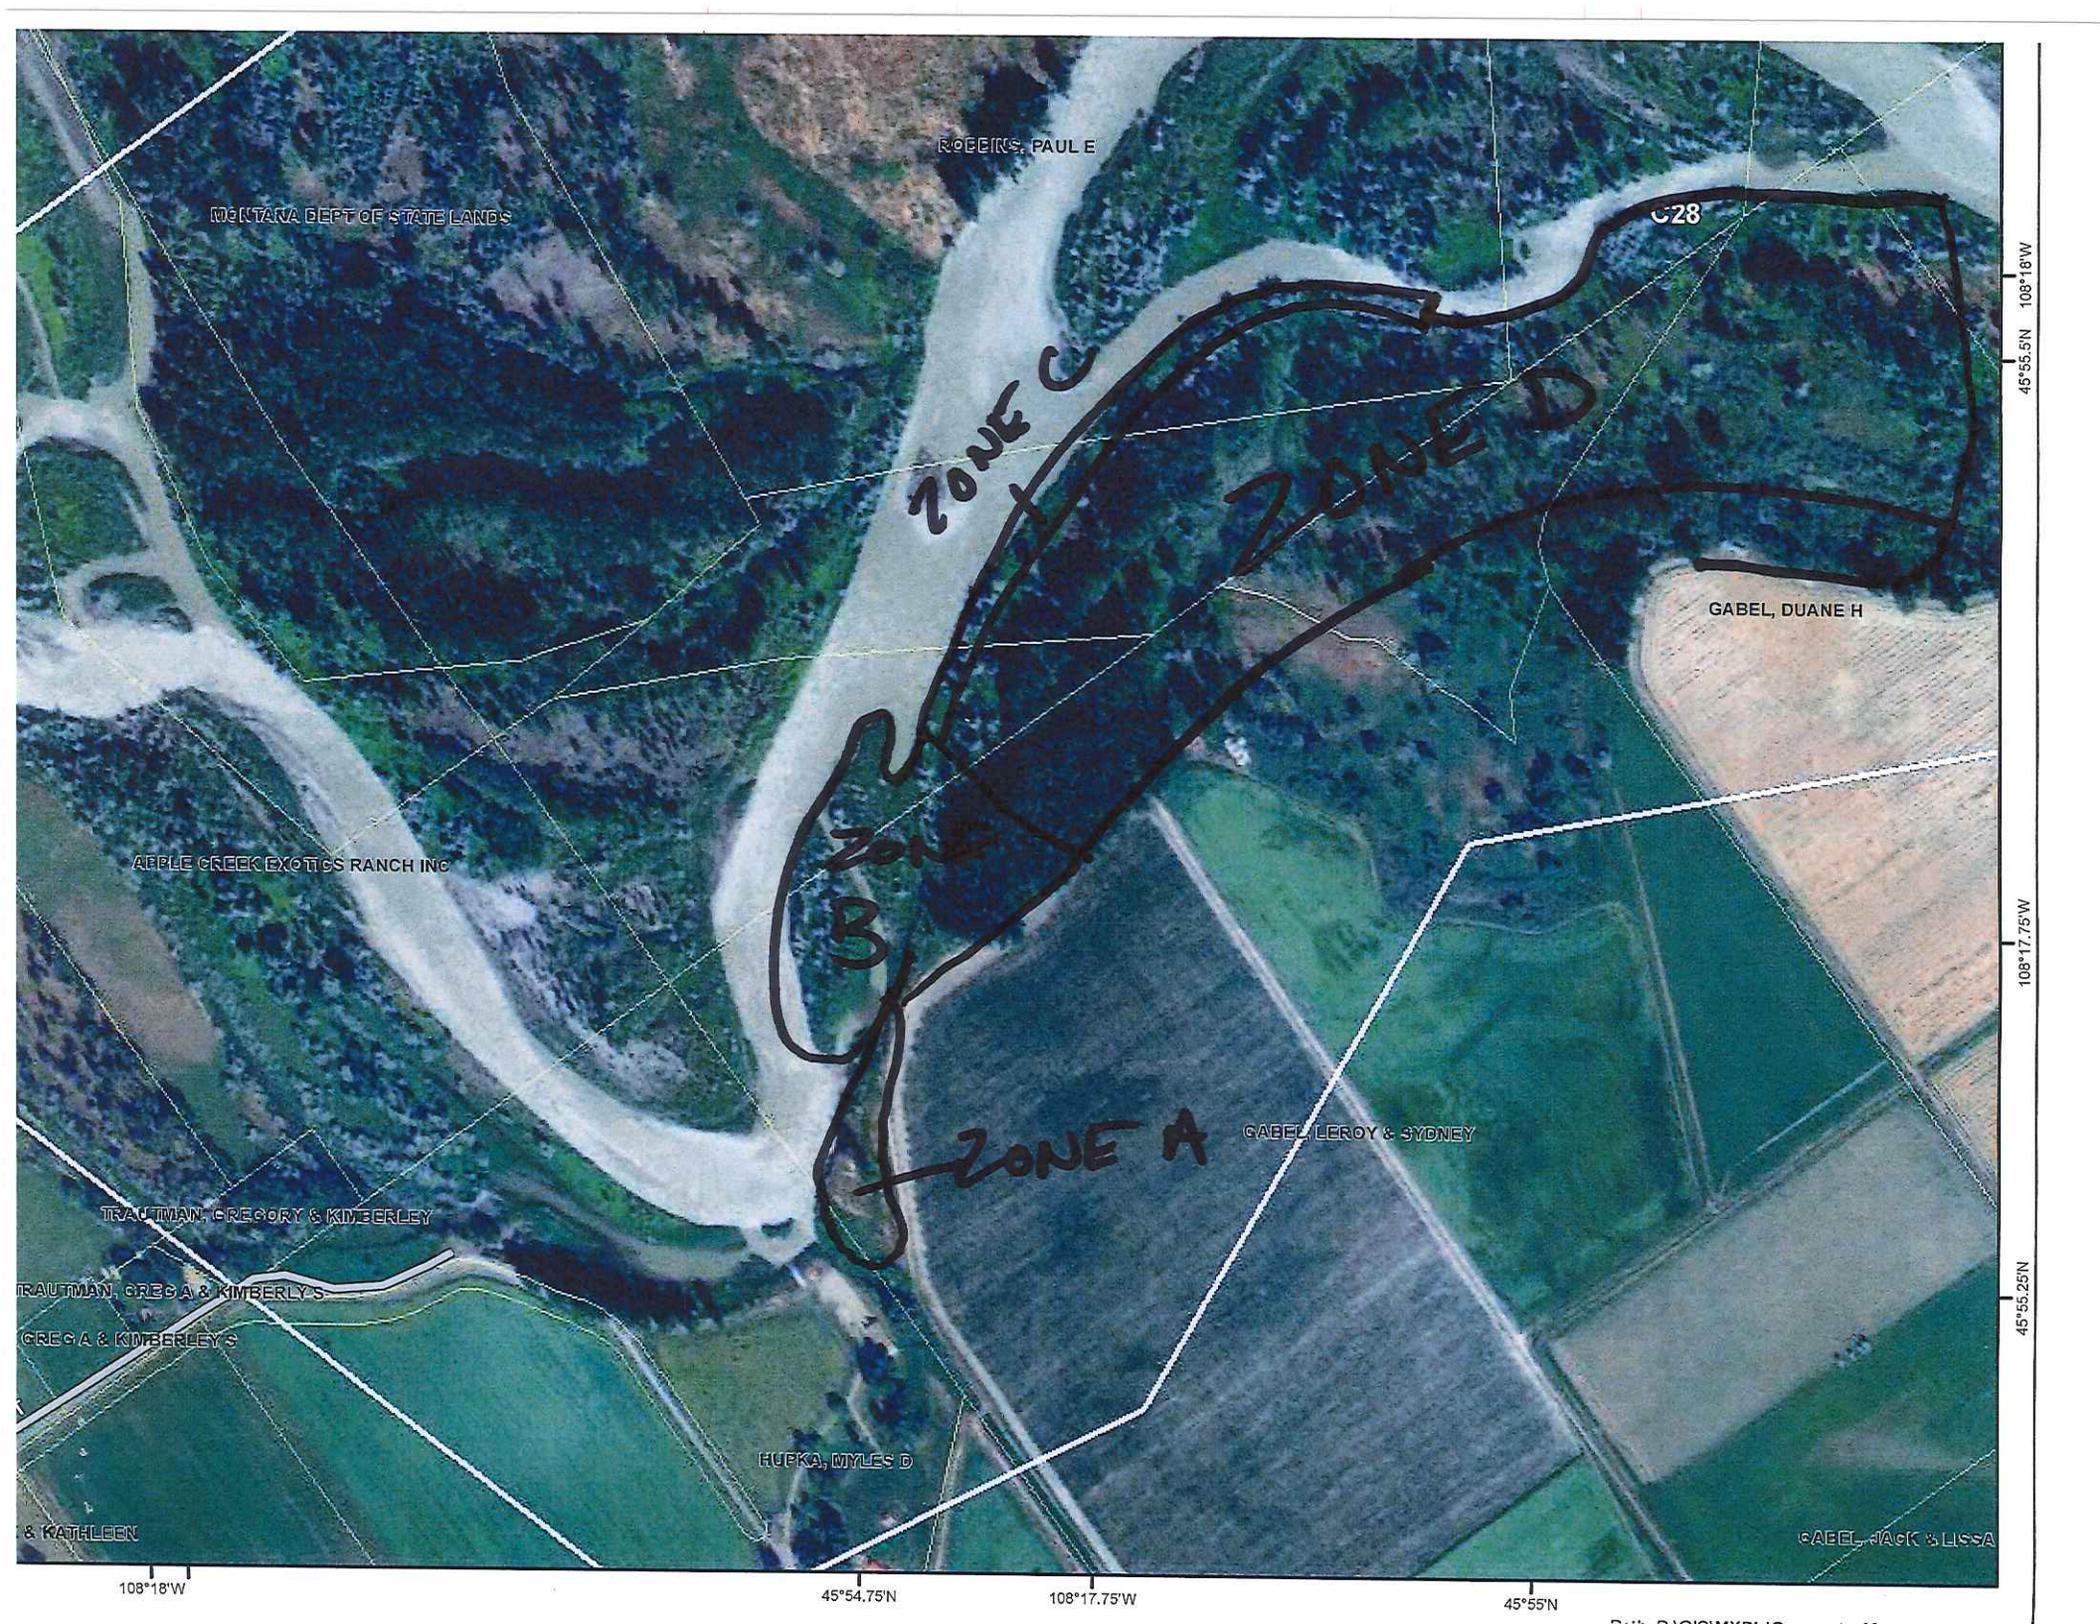
A - light stain on vegetation, recommended natural attenuation

B - no oil observed

C - Weathered (Paint), Sporadic stain on vegetation, recommend natural attenuation

D - no oil observed (shoreline)

Beginning of zone A (should be re-scattered by boat and the end of C28 needs to be completed. Islands in this area need to be scattered downstream.

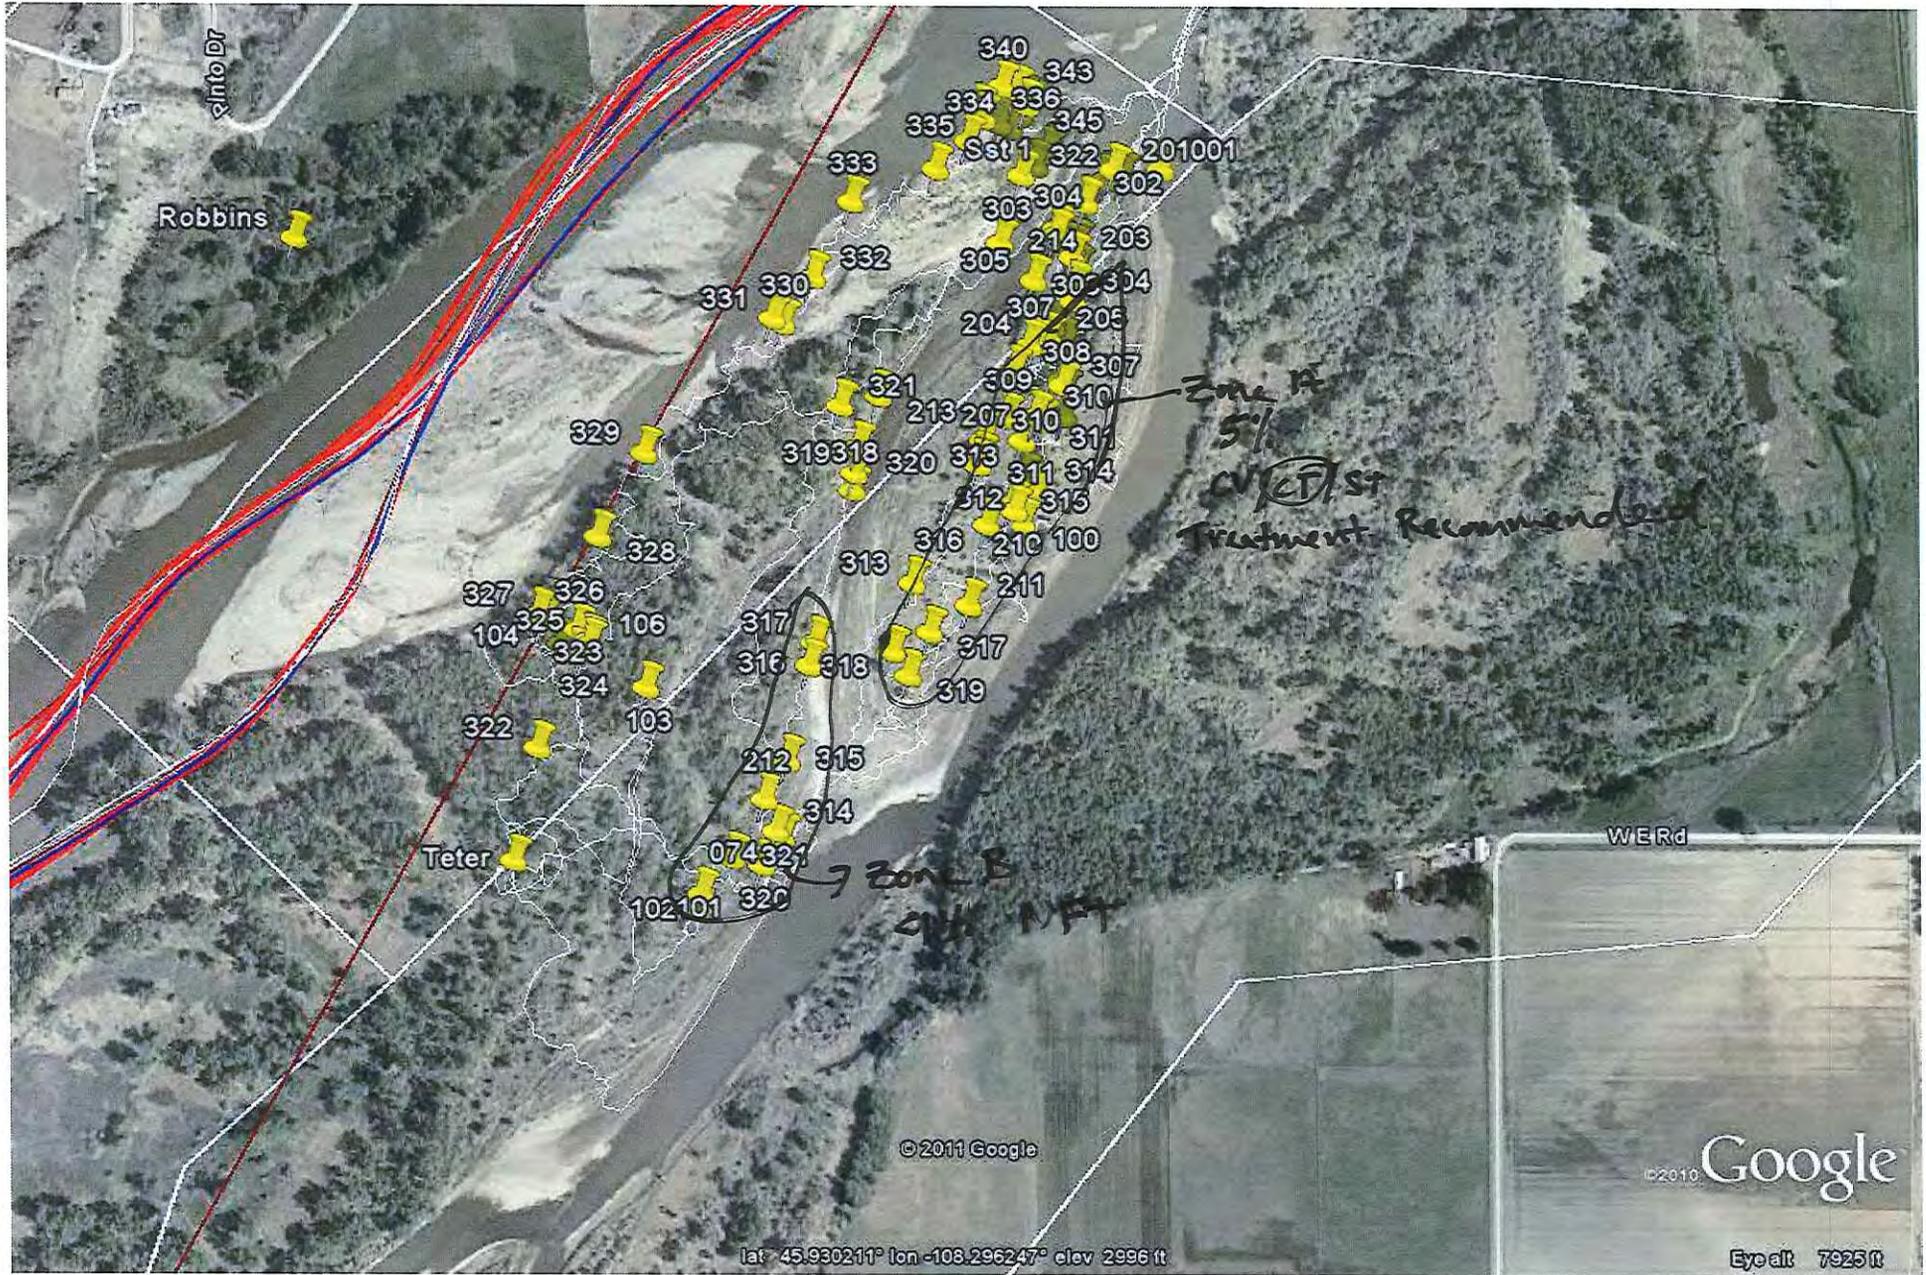
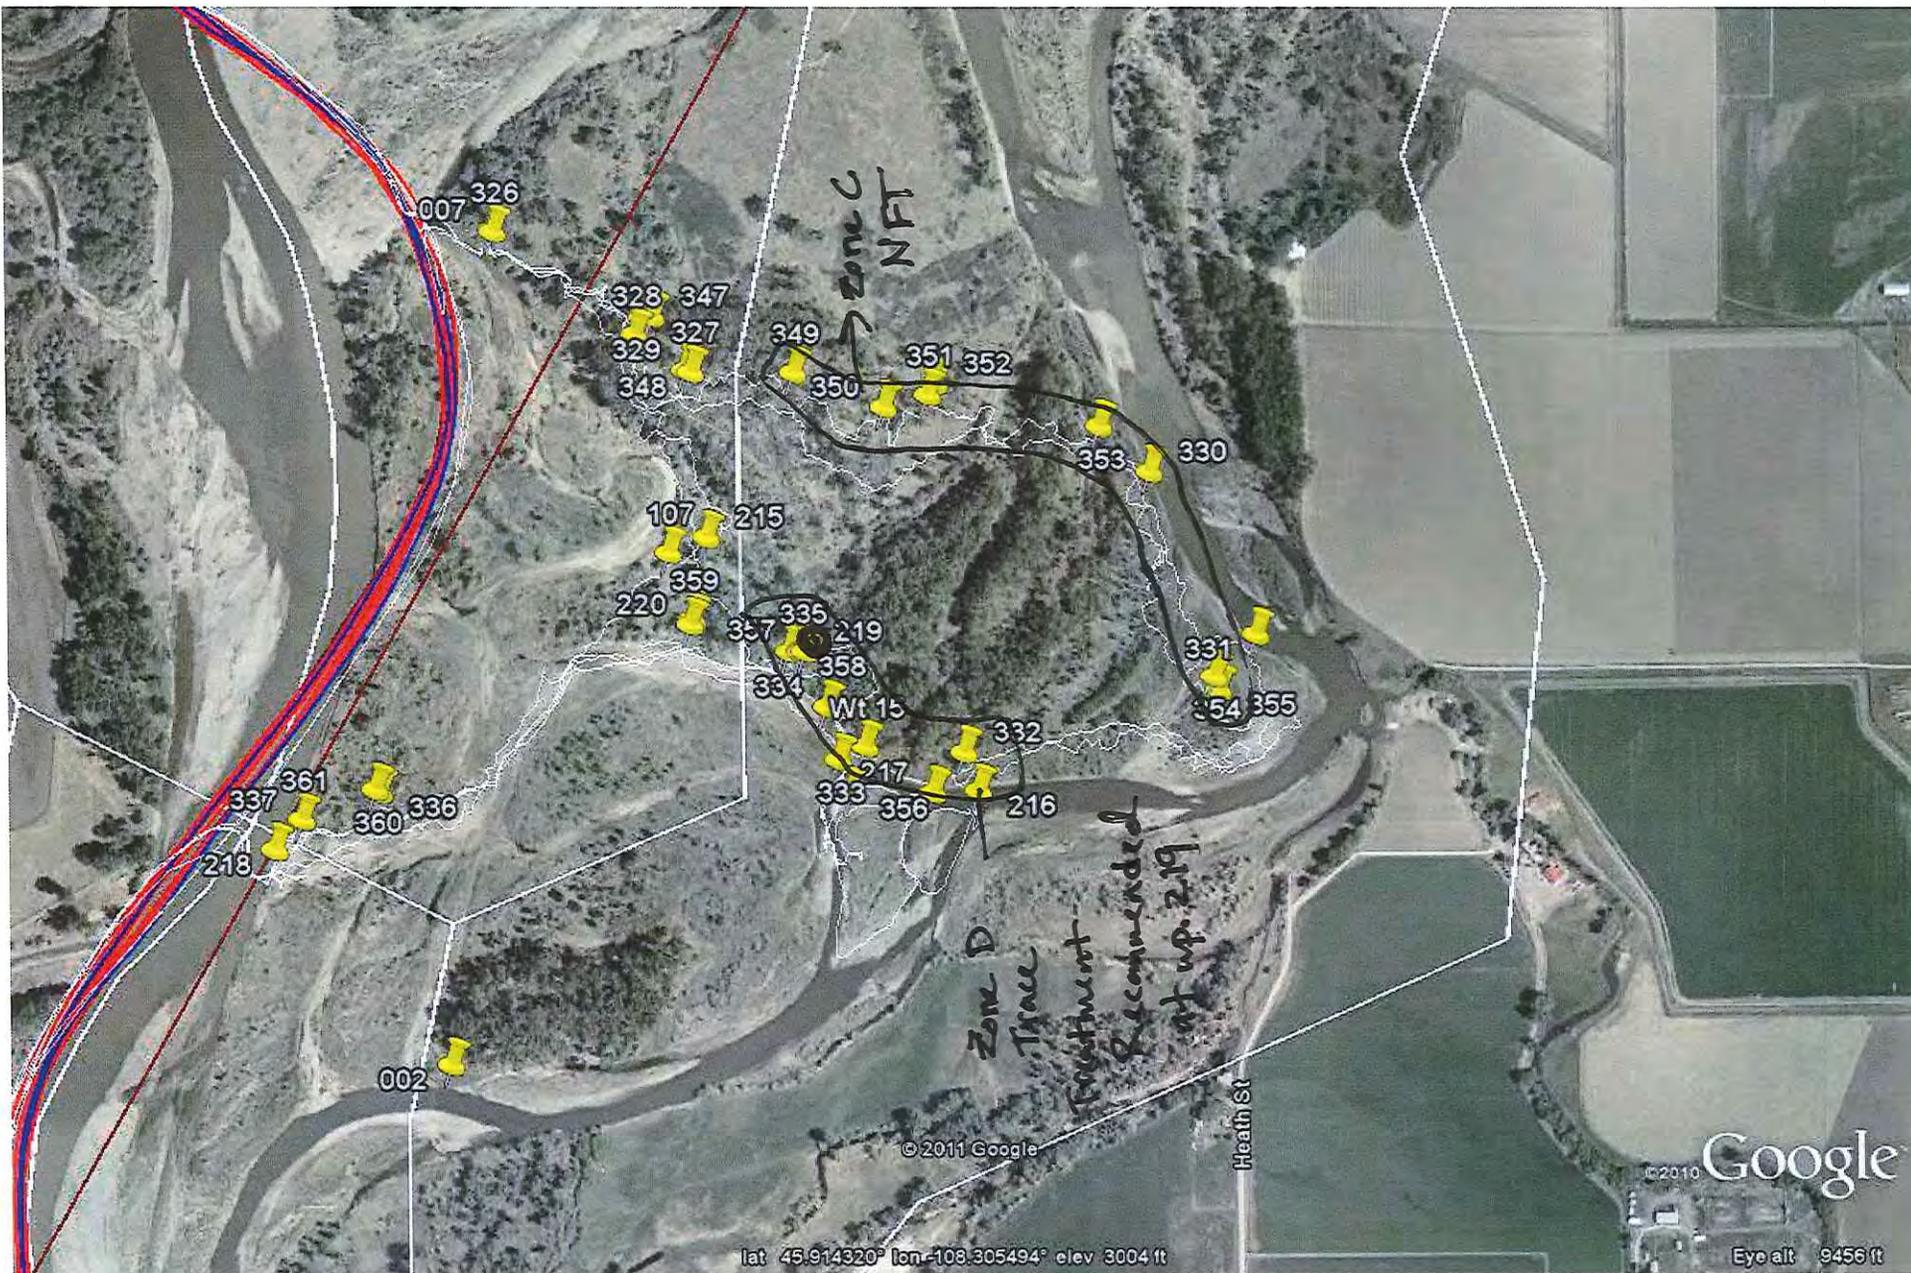
C28  
 SCAT 1+2  
 18 Aug 2011

Zones A & D, treatment recommended

Zones B & C, NFT
