**SCAT Area Transition Report  
for C28**

Silvertip Pipeline Incident  
Laurel, Montana

October 29, 2011

Our Ref.:  
B0085883.1103

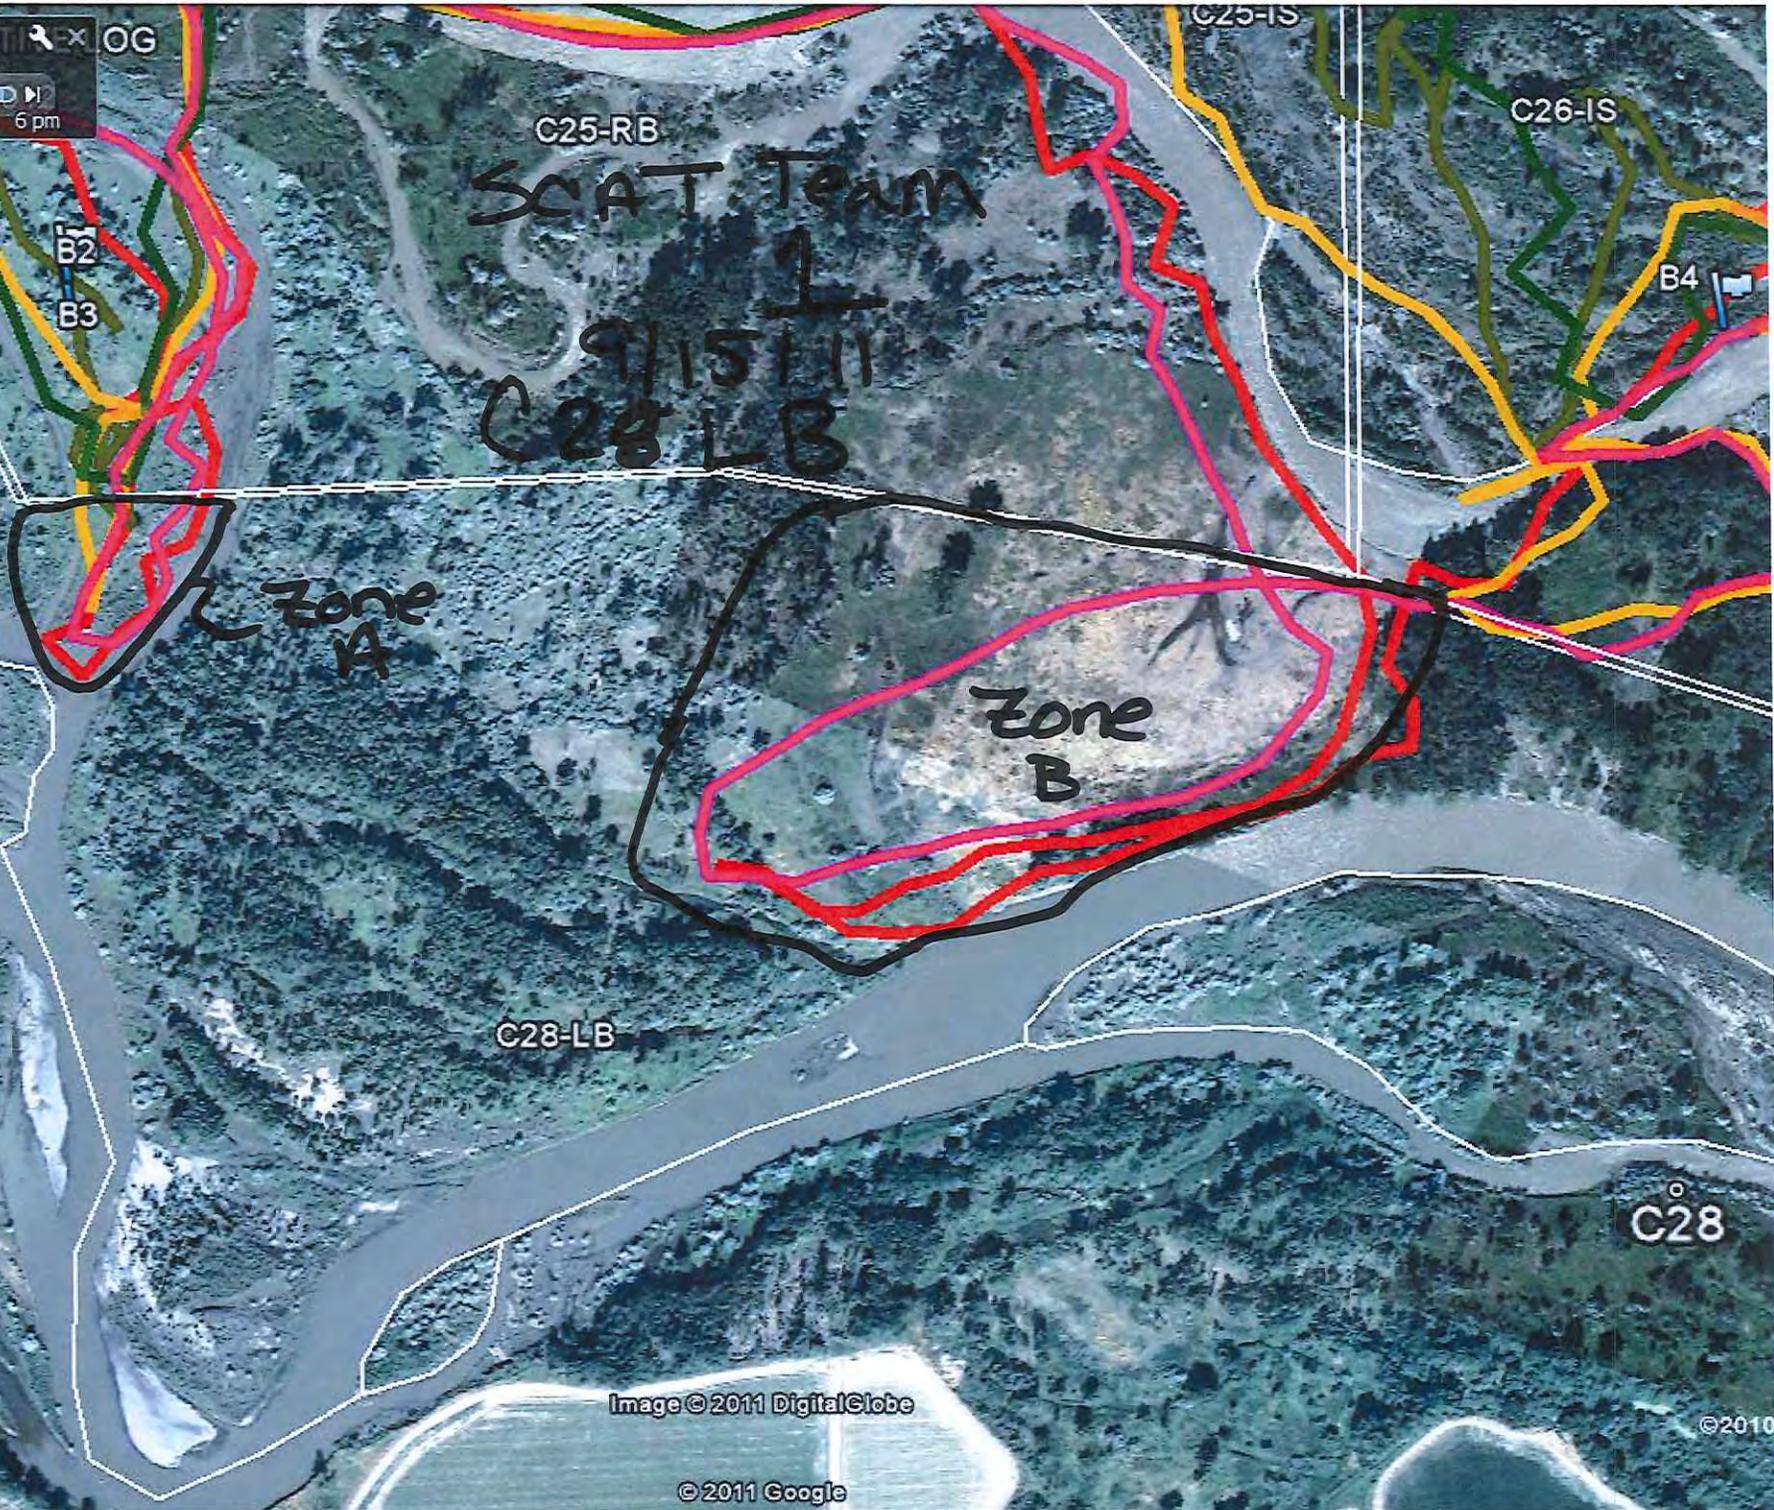
C25-RB  
SCAT Team  
1  
9/15/11  
C28 LB

This survey completes a portion of the segment which was not previously surveyed due to access restrictions. Zones A & B had coat a stain sporadically distributed throughout the area. We had a hot shot crew that removed or treated the oiled vegetation - No further Treatment (NFT)
