**SCAT Area Transition Report for  
C31**

Silvertip Pipeline Incident  
Laurel, Montana

October 20, 2011

ARCADIS G&M of North Carolina, Inc.

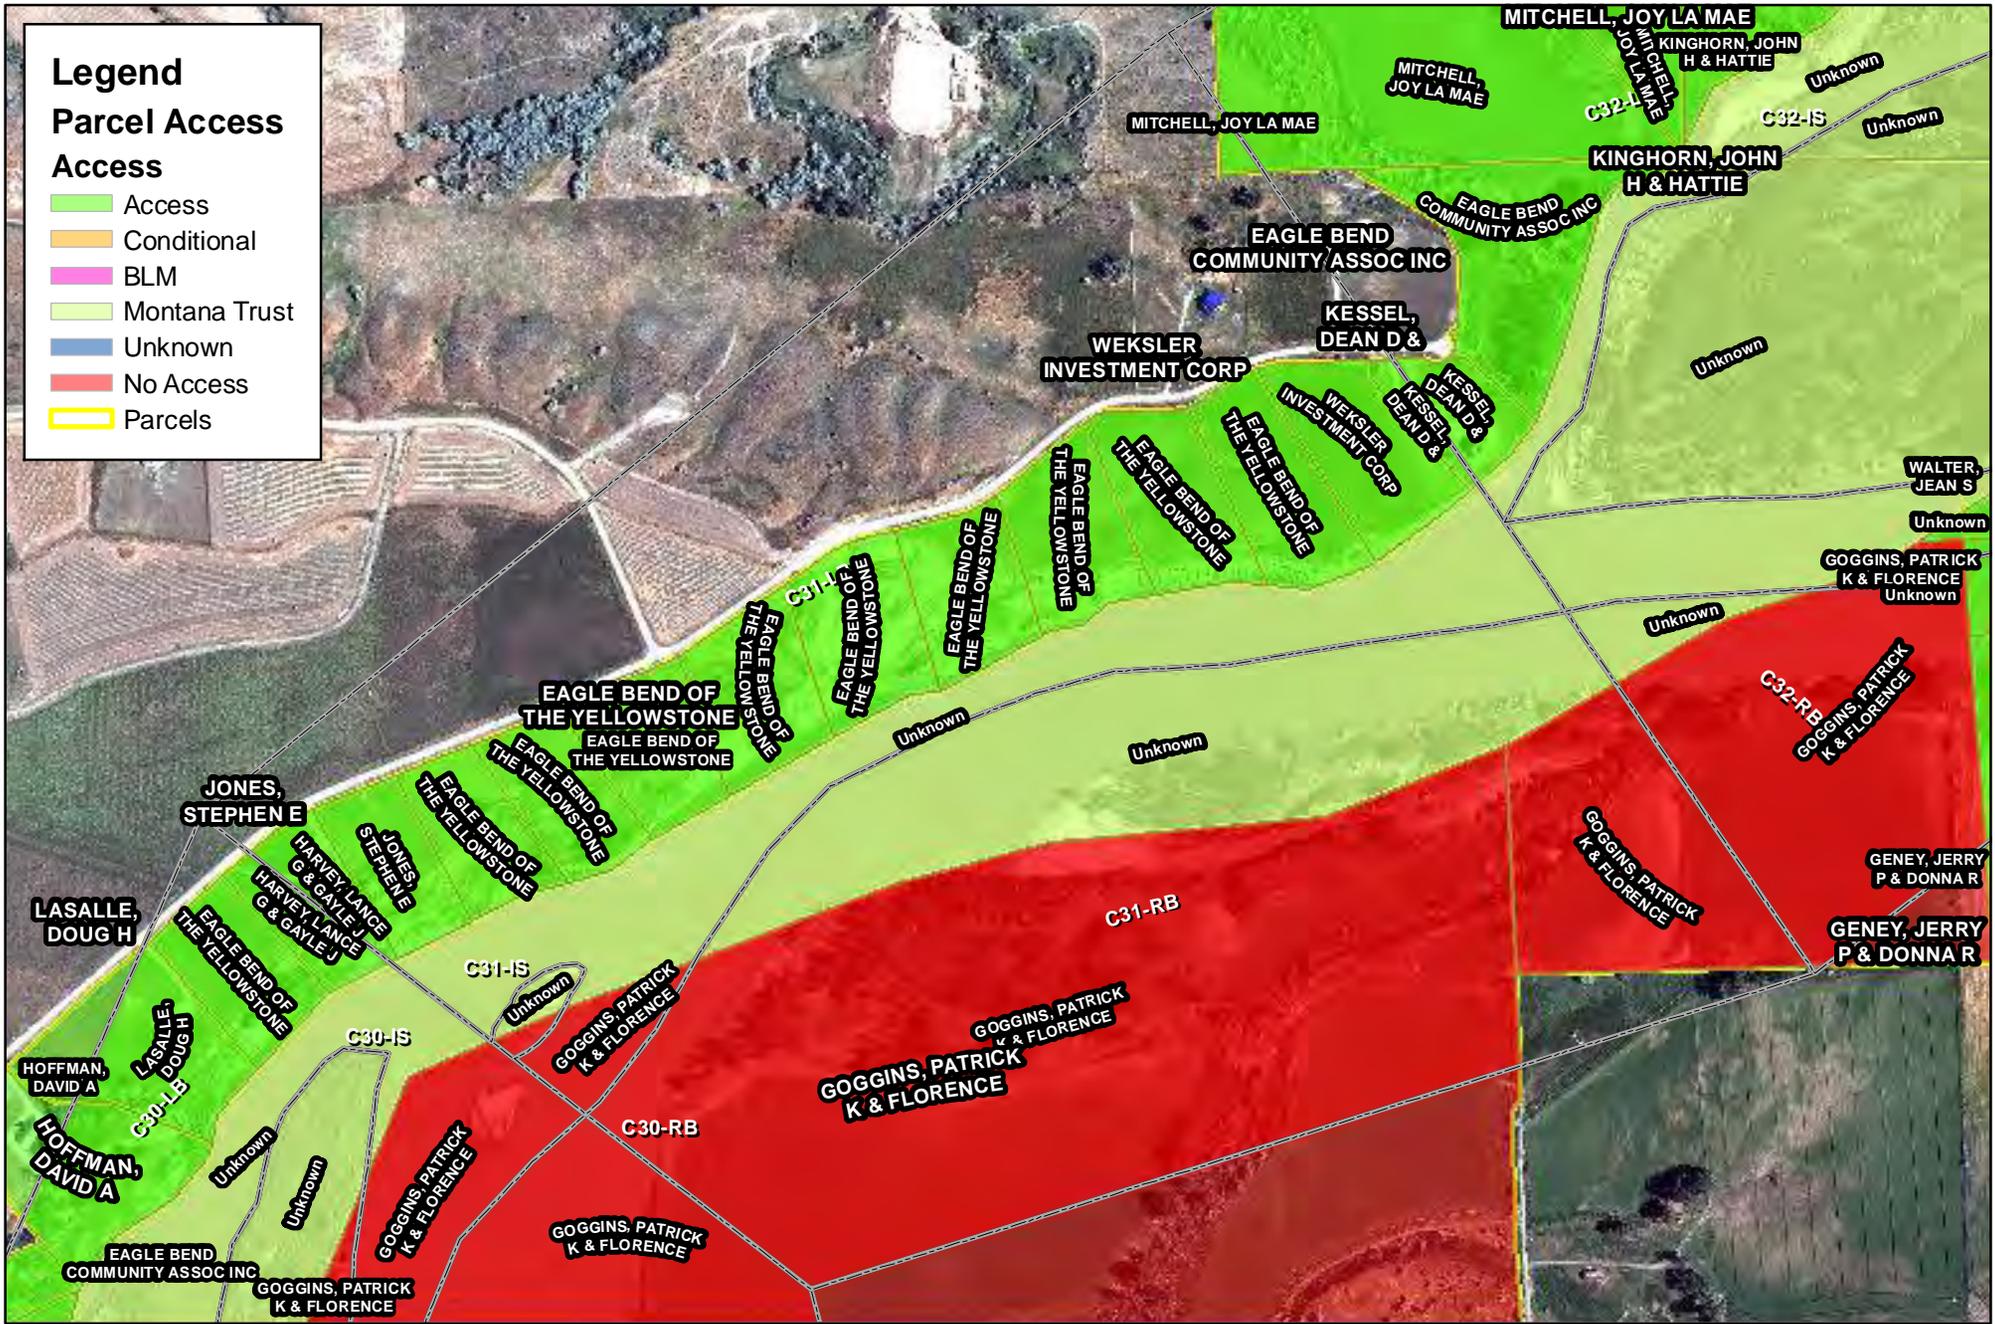
Figure 1 provides an aerial map of SCAT Area C31, along with the (a) SCAT Area boundary, (b) parcel boundaries and respective property owners, and (c) access constraints identified during the oil cleanup process. The acreage surveyed in Area C31 is 21.0. There were access issues for the right bank.

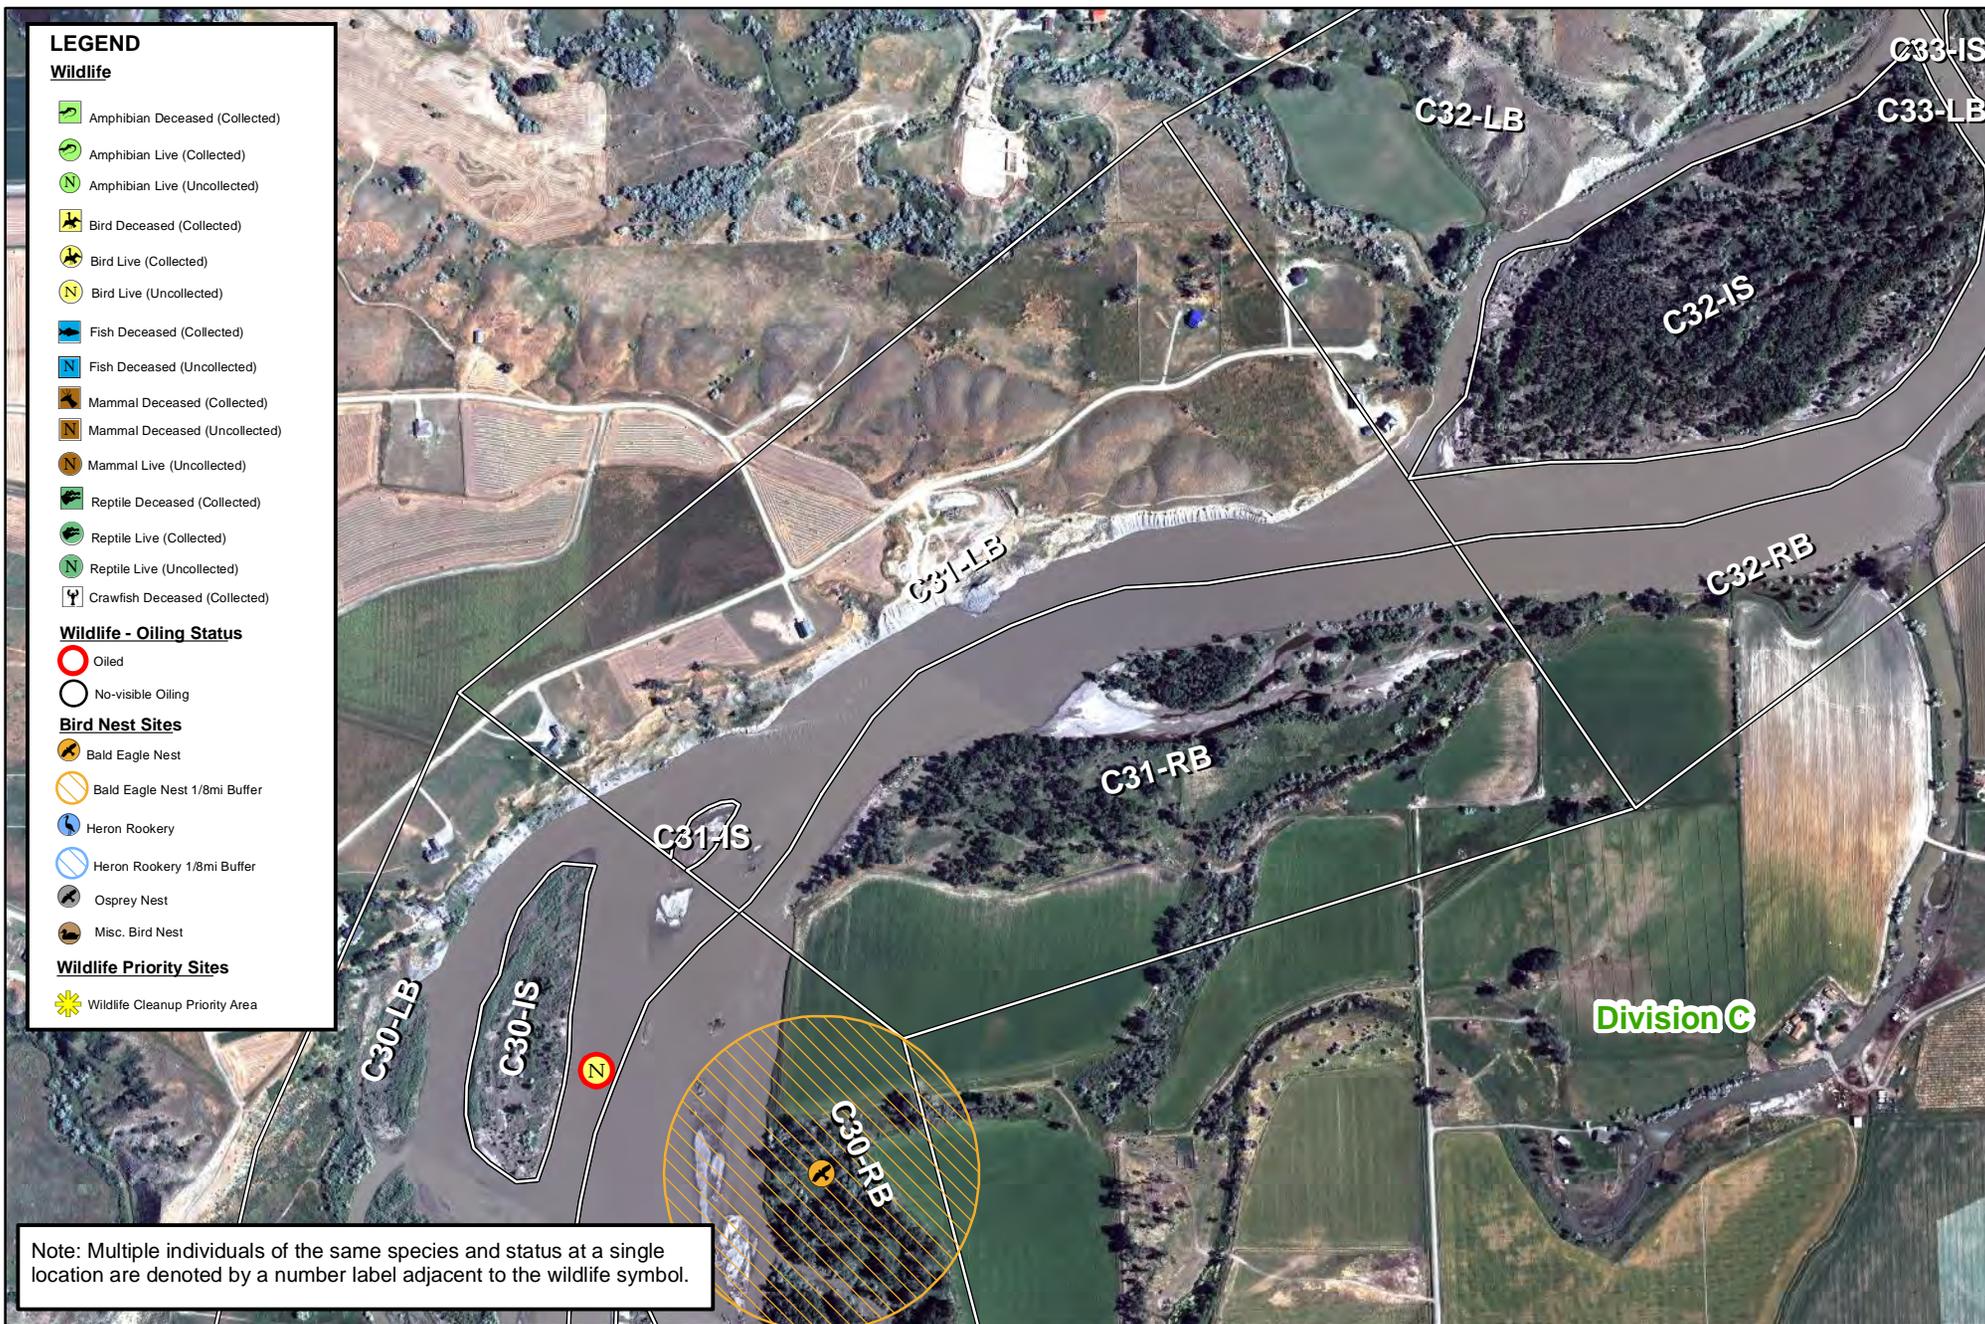
**Figure 2**  
**Wildlife Resources**

Figure 2 summarizes the natural resources identified in this segment. International Bird Rescue and Resource Advisors from U.S. Fish and Wildlife Service conducted limited inspections of Area C31 due to the low level of oiling in Division C. No oiled wildlife was observed or recovered. No Wildlife Priority Cleanup Areas were identified. No active migratory bird nests were identified in Area C31.

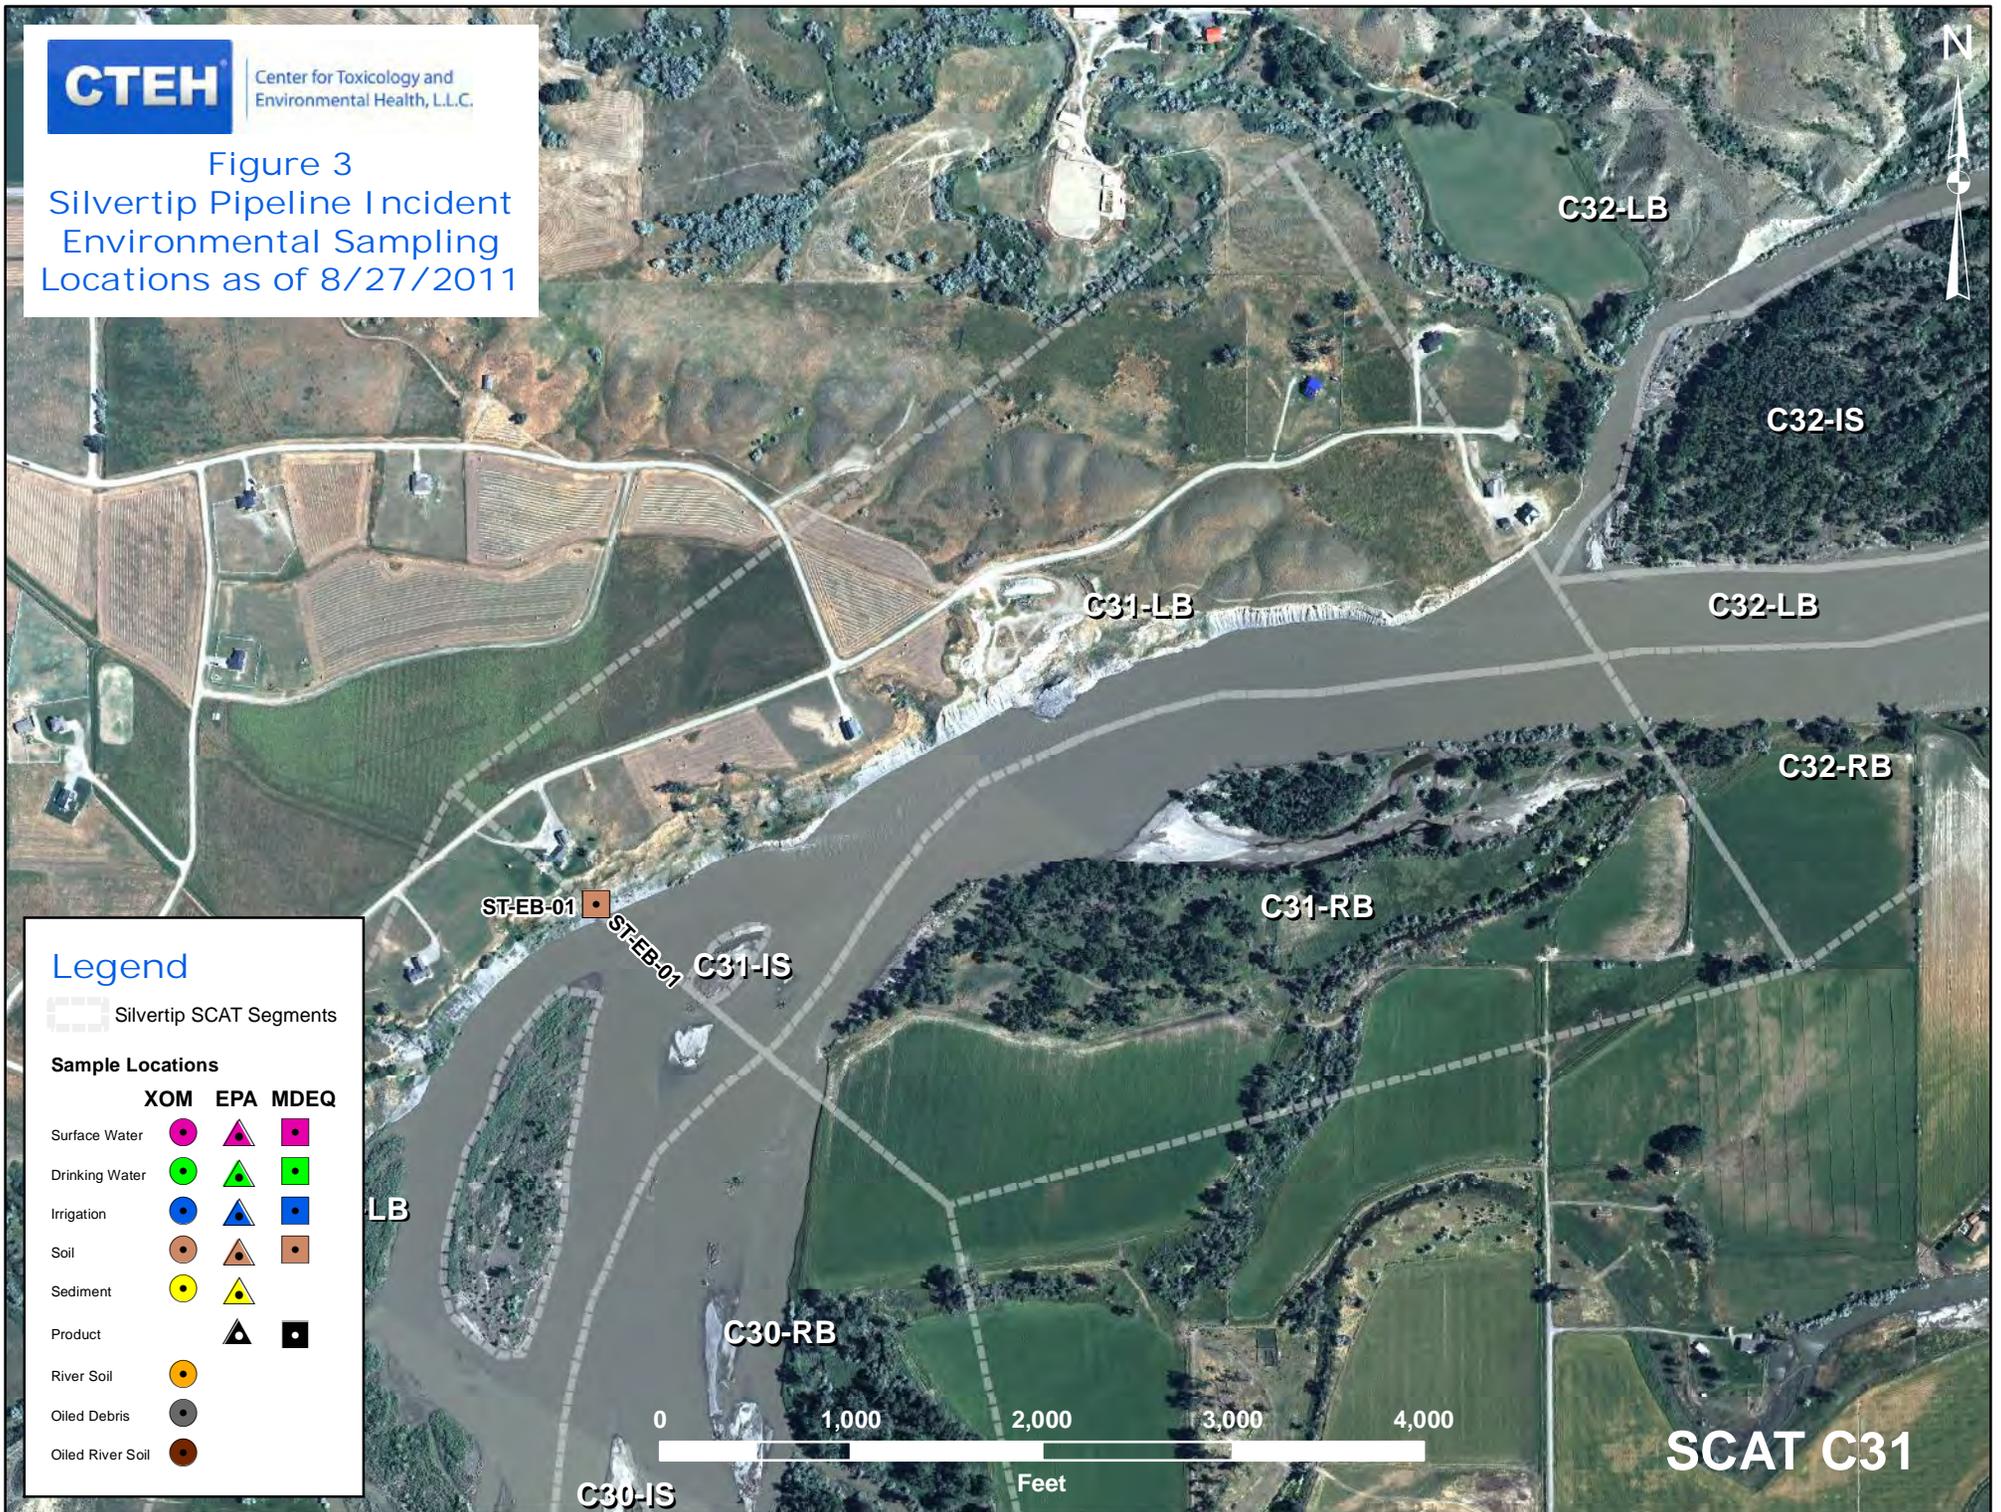
Figure 3  
Silvertip Pipeline Incident  
Environmental Sampling  
Locations as of 8/27/2011

Table 1 (below) summarizes samples collected within Area C31. The analytical results for the samples collected can be accessed through a publicly accessible database on the United States Environmental Protection Agency's (USEPA's) website. The approximate locations of samples collected within Area C31 are provided on Figure 3.

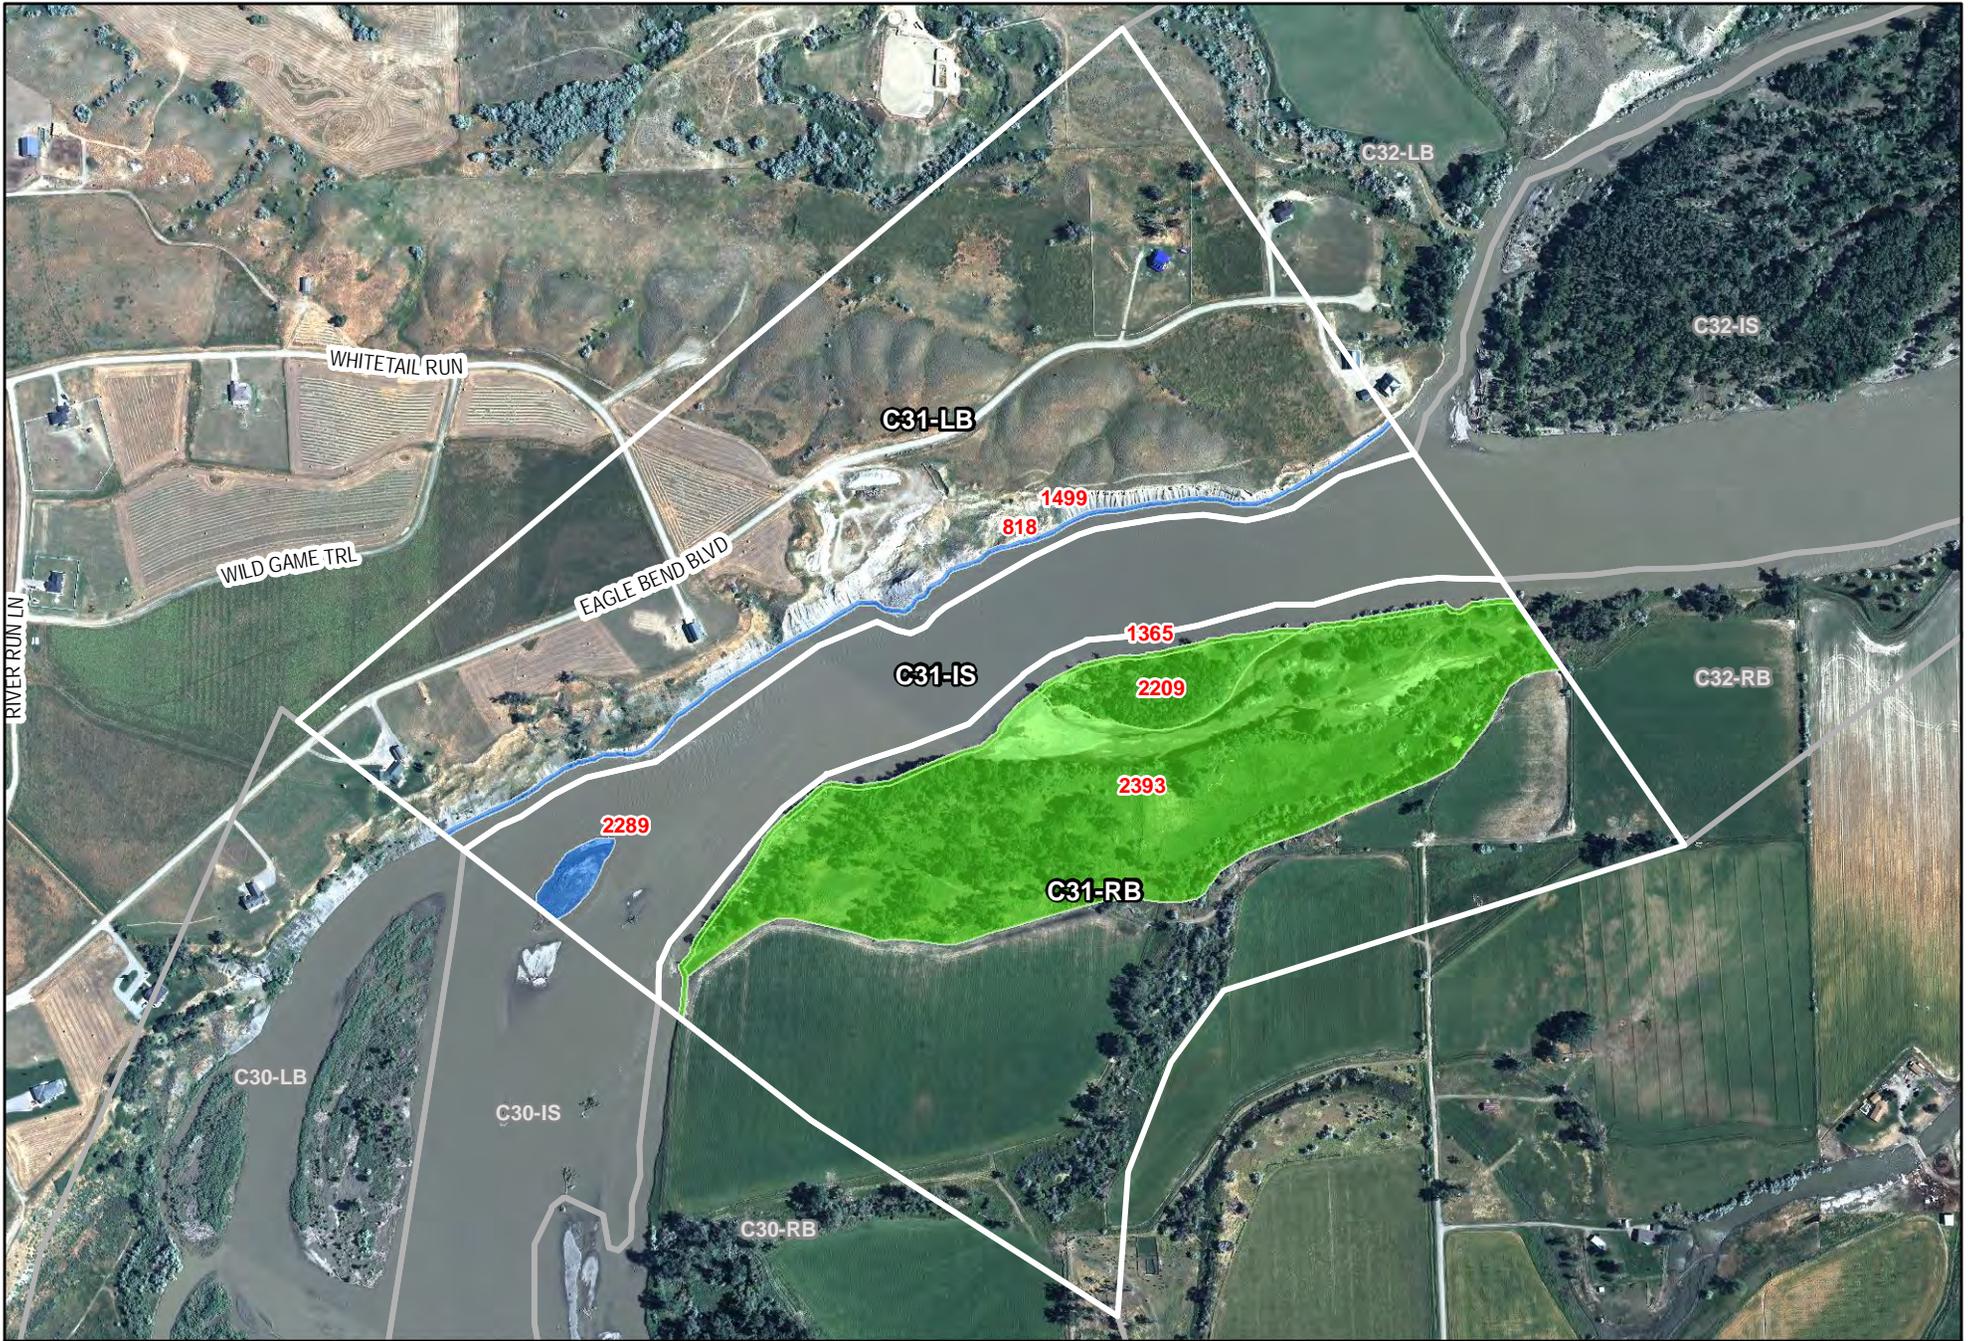
**Figure 4 - Maximum SCAT Observations For SCAT Area:**

The SCAT teams used systematic evaluation criteria and treatment method tables approved by the National Oceanic and Atmospheric Administration to provide a standard approach for data collection and conducting field surveys. The forms and sketches from the initial SCAT surveys performed along the river bank (water edge) and floodplain within Area C31 are included in Appendix B. Figure 4 provides the maximum oiling zones observed by the SCAT team during the initial surveys of Area C31.

<b>9999</b> Oiling Zone ID	Light Oiling
	Heavy Oiling	Very Light Oiling
	Moderate Oiling	No Oil Observed

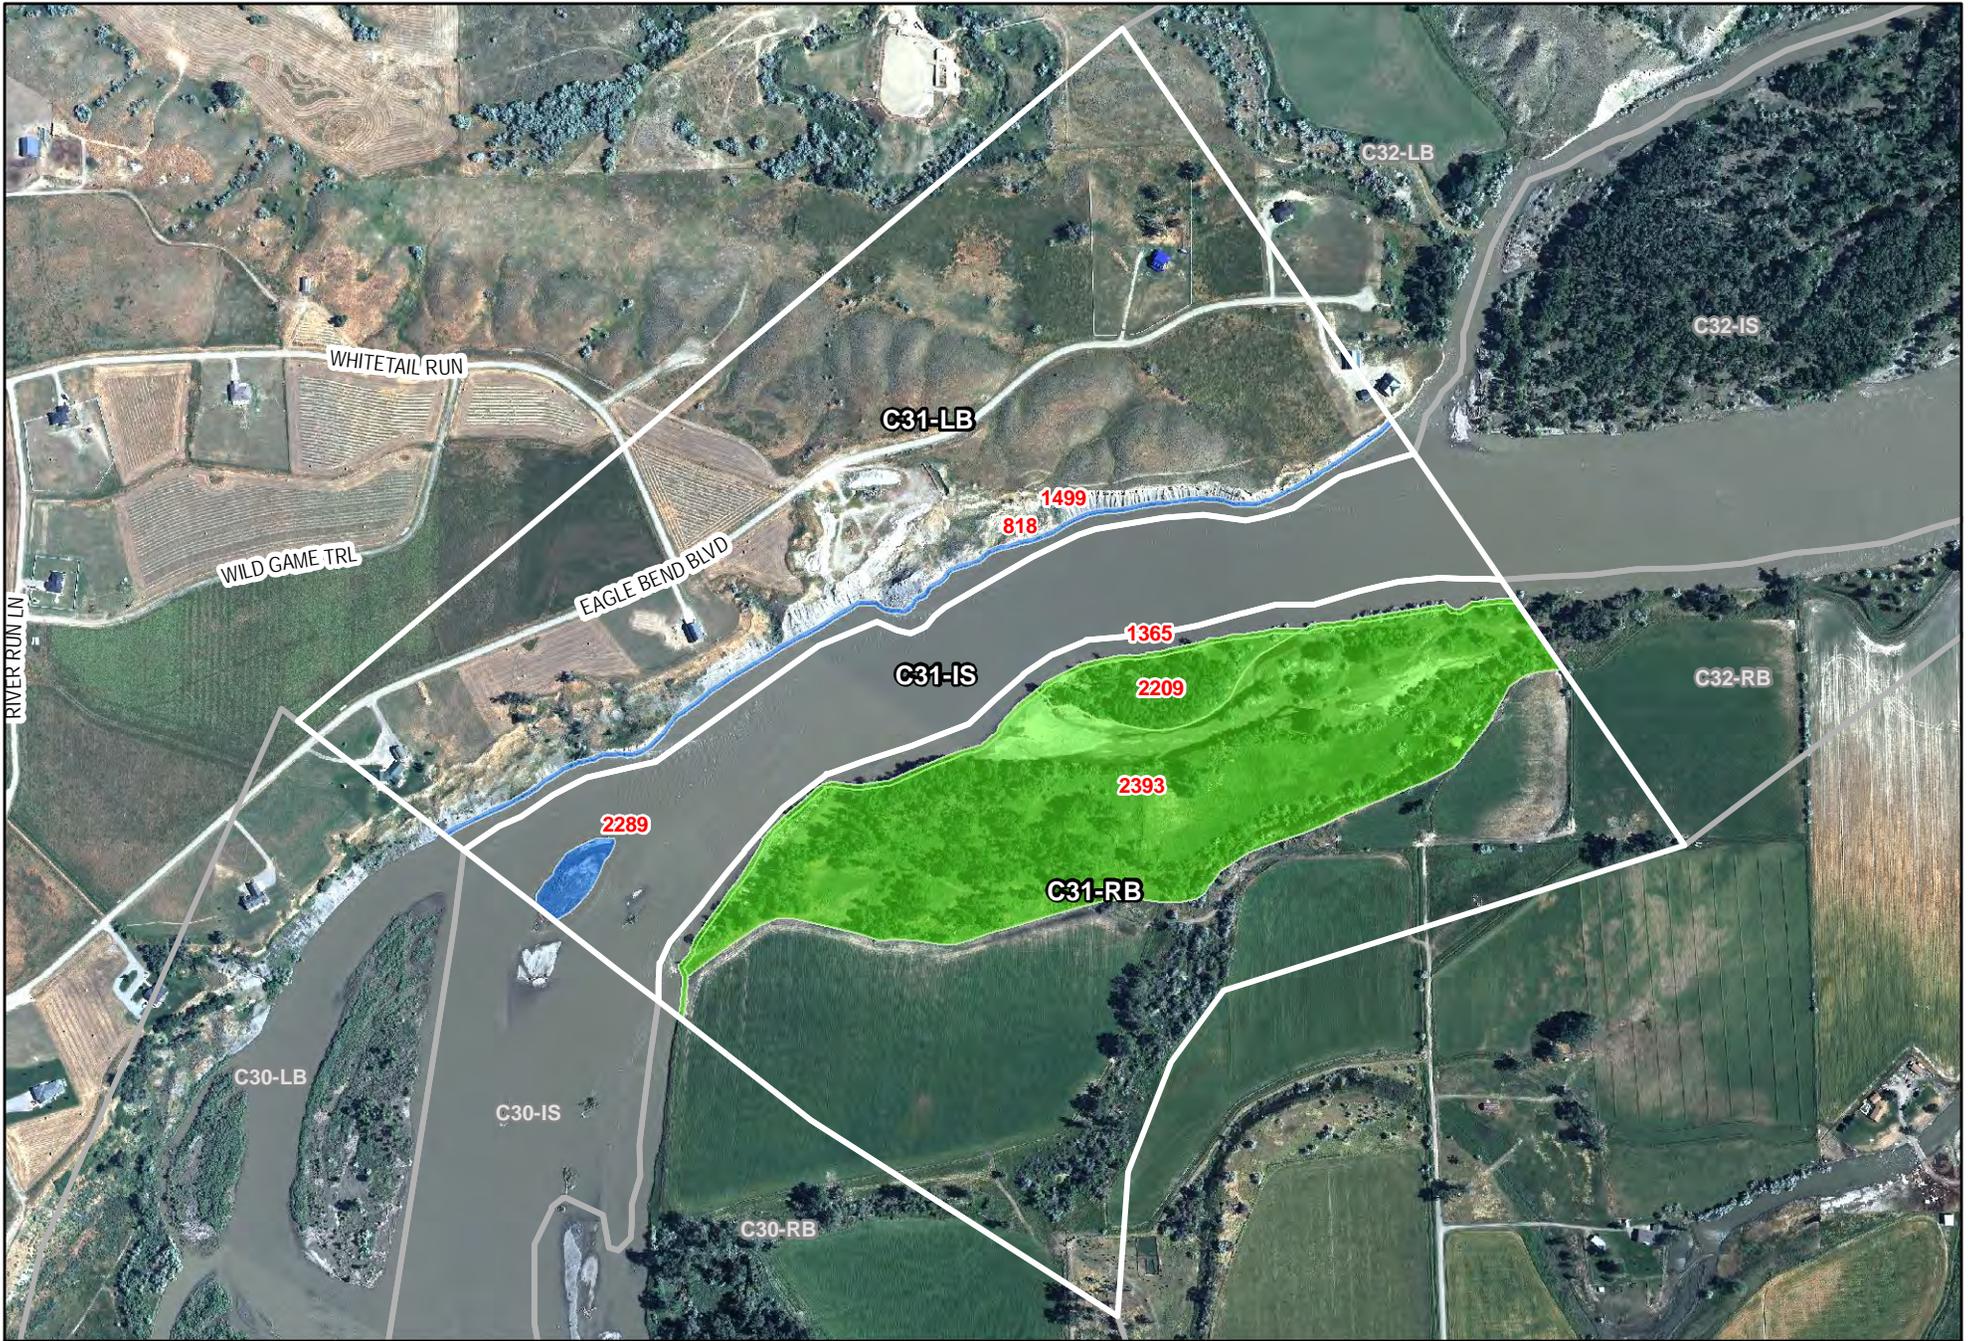
Figure 5 shows the oiling conditions within Area C31 following completion of oil removal activities. The SCAT team performed final surveys of the right bank within SCAT Area C31 to confirm the agreed-upon cleanup endpoints identified in the applicable CTRs had been achieved. The final SCAT survey documentation is presented in Appendix E.

Based on the initial SCAT surveys performed within Area C31, no oiling was observed on the island and left bank. Based on the final SCAT surveys performed on the right bank within Area C31, no further treatment is recommended for this segment. SCAT Segment Sign-Off Forms are included as Appendix F.

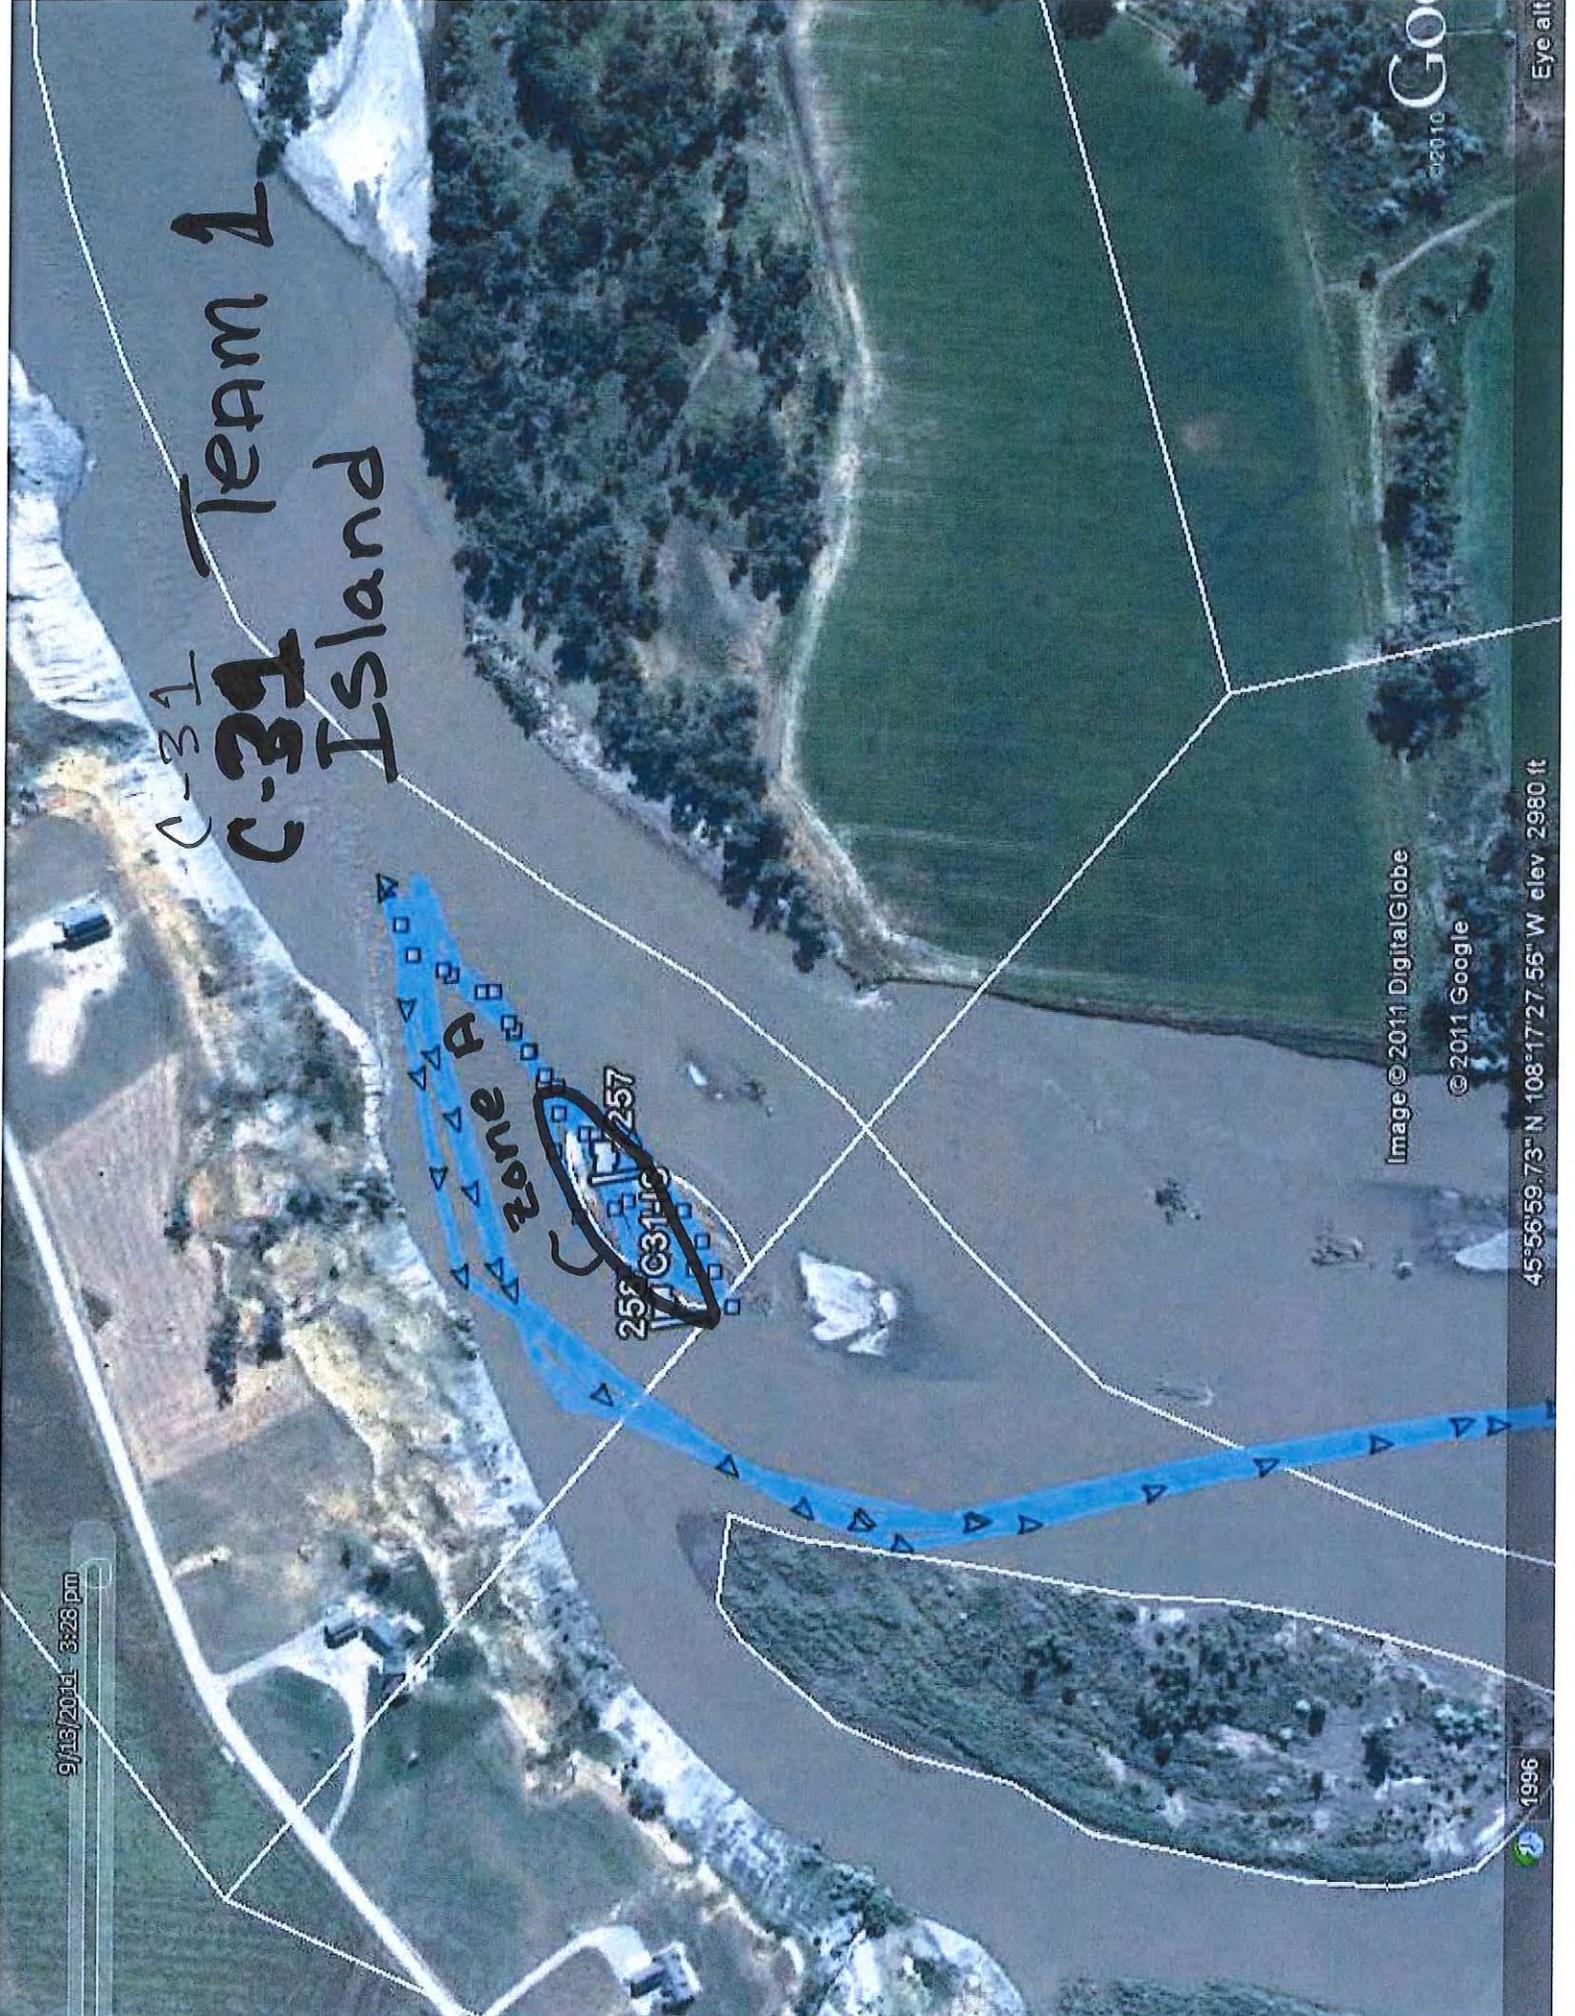
C-31  
Team 1  
C-31  
Island

Zone A consists of the portion of the Island not having restricted Access. The rest of Island on Boggins property. There was No Oil Observed. (NOO)

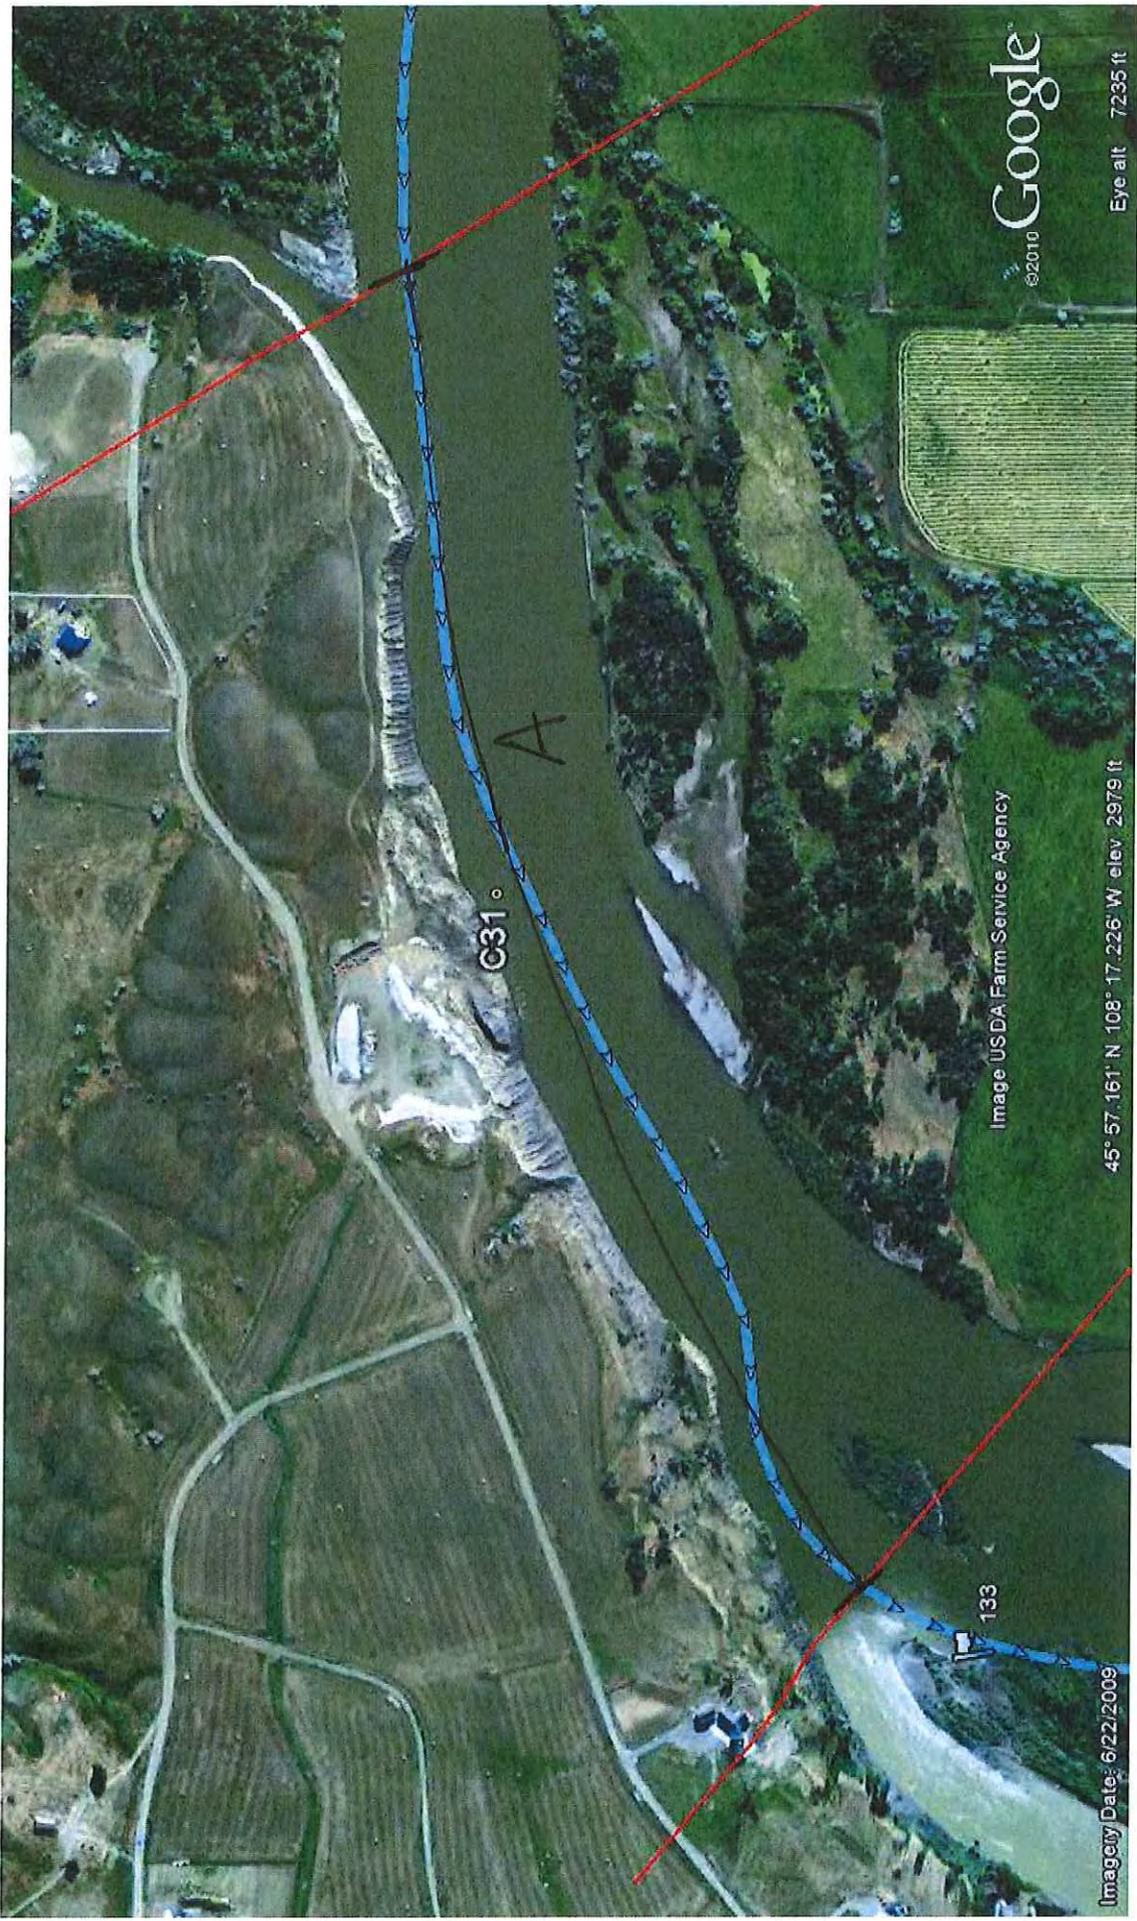
C31°

Oil height: NO

Zone A : No oil observed; no treatment required.

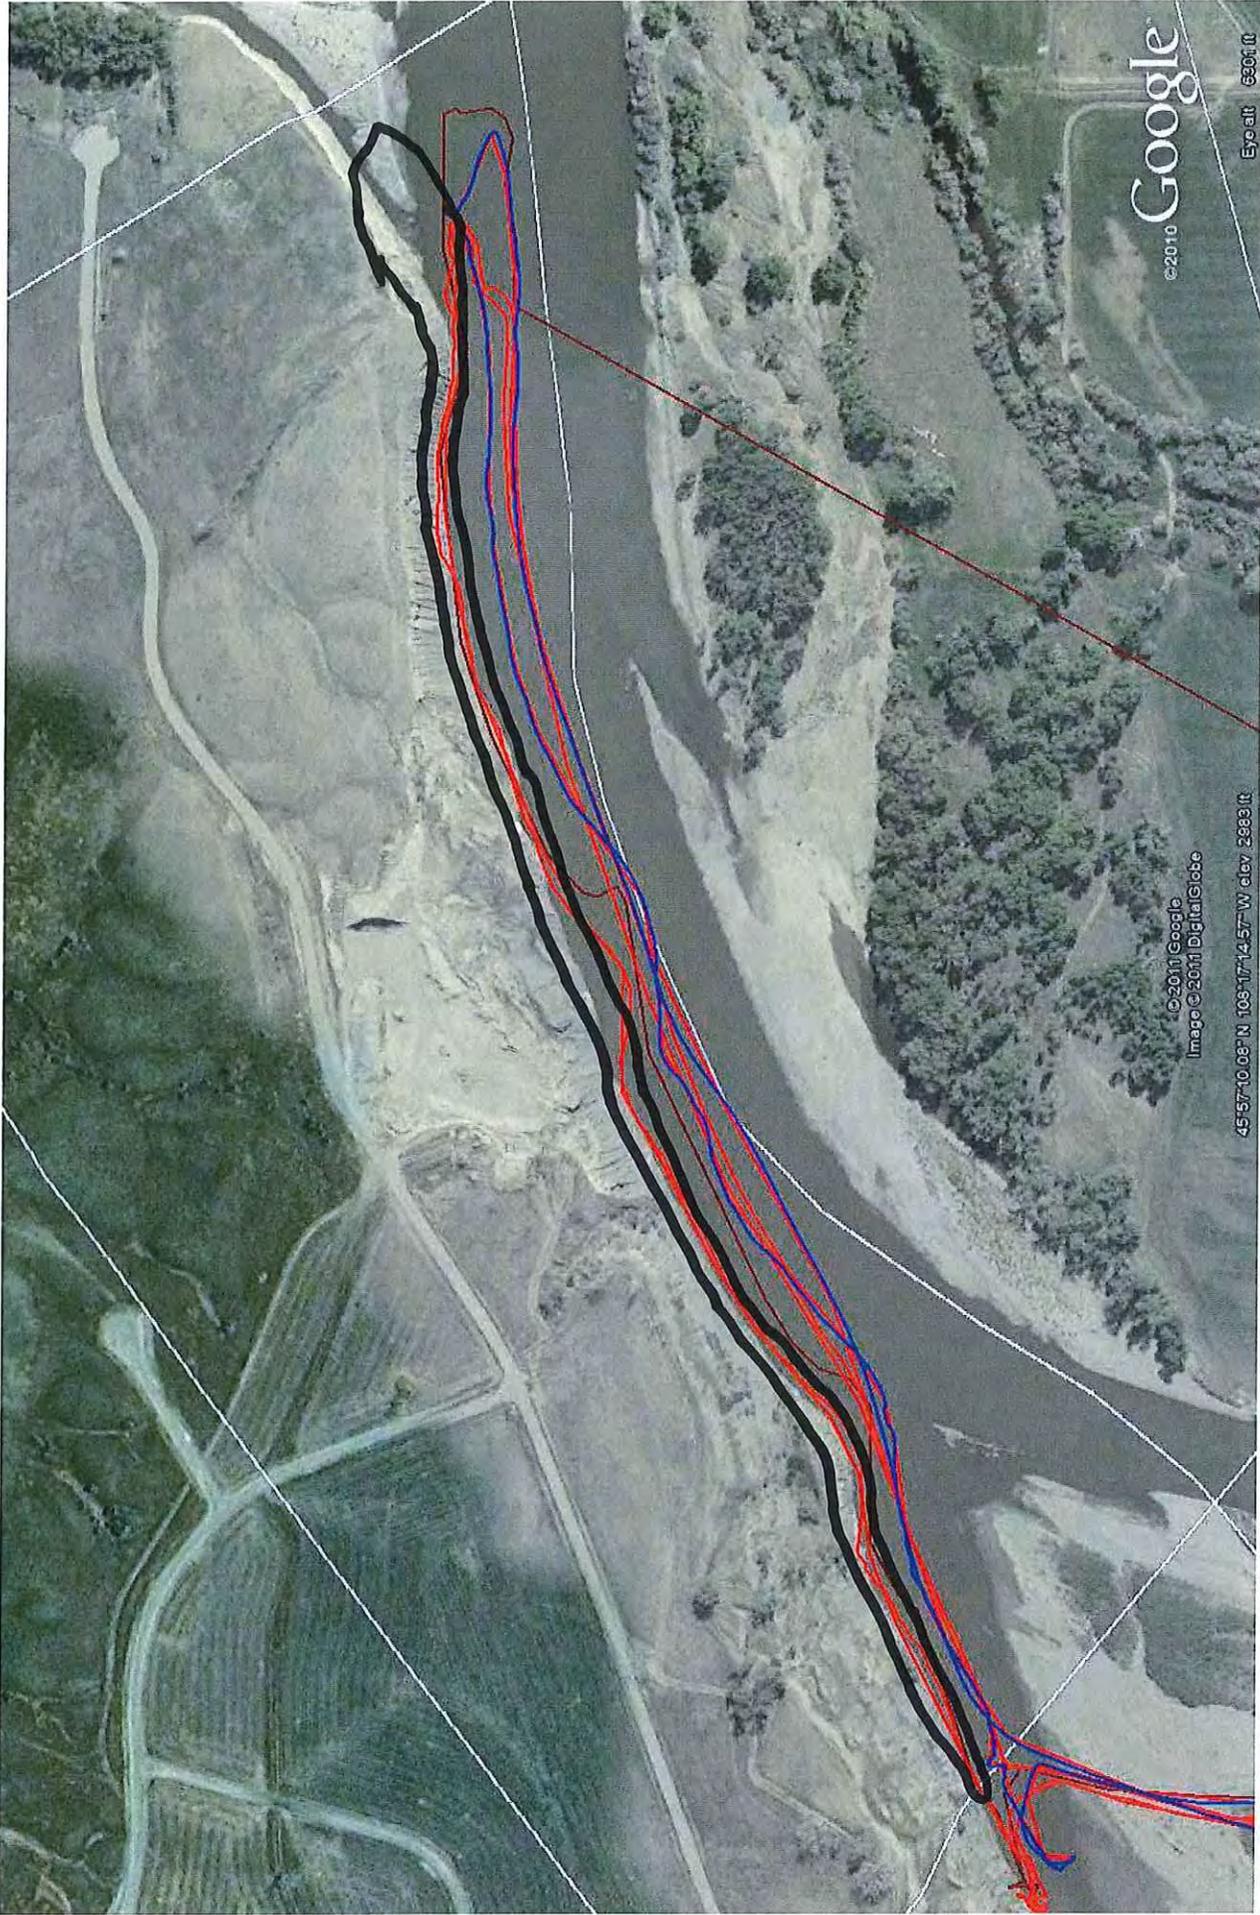
CS1LB  
Team #1  
13/08/11

Zone A - No Oil Observed - Cliffside Un-Vegetated. One narrow section of Vegetation
