**SCAT Area Transition Report for  
C31**

Silvertip Pipeline Incident  
Laurel, Montana

October 20, 2011

ARCADIS G&M of North Carolina, Inc.

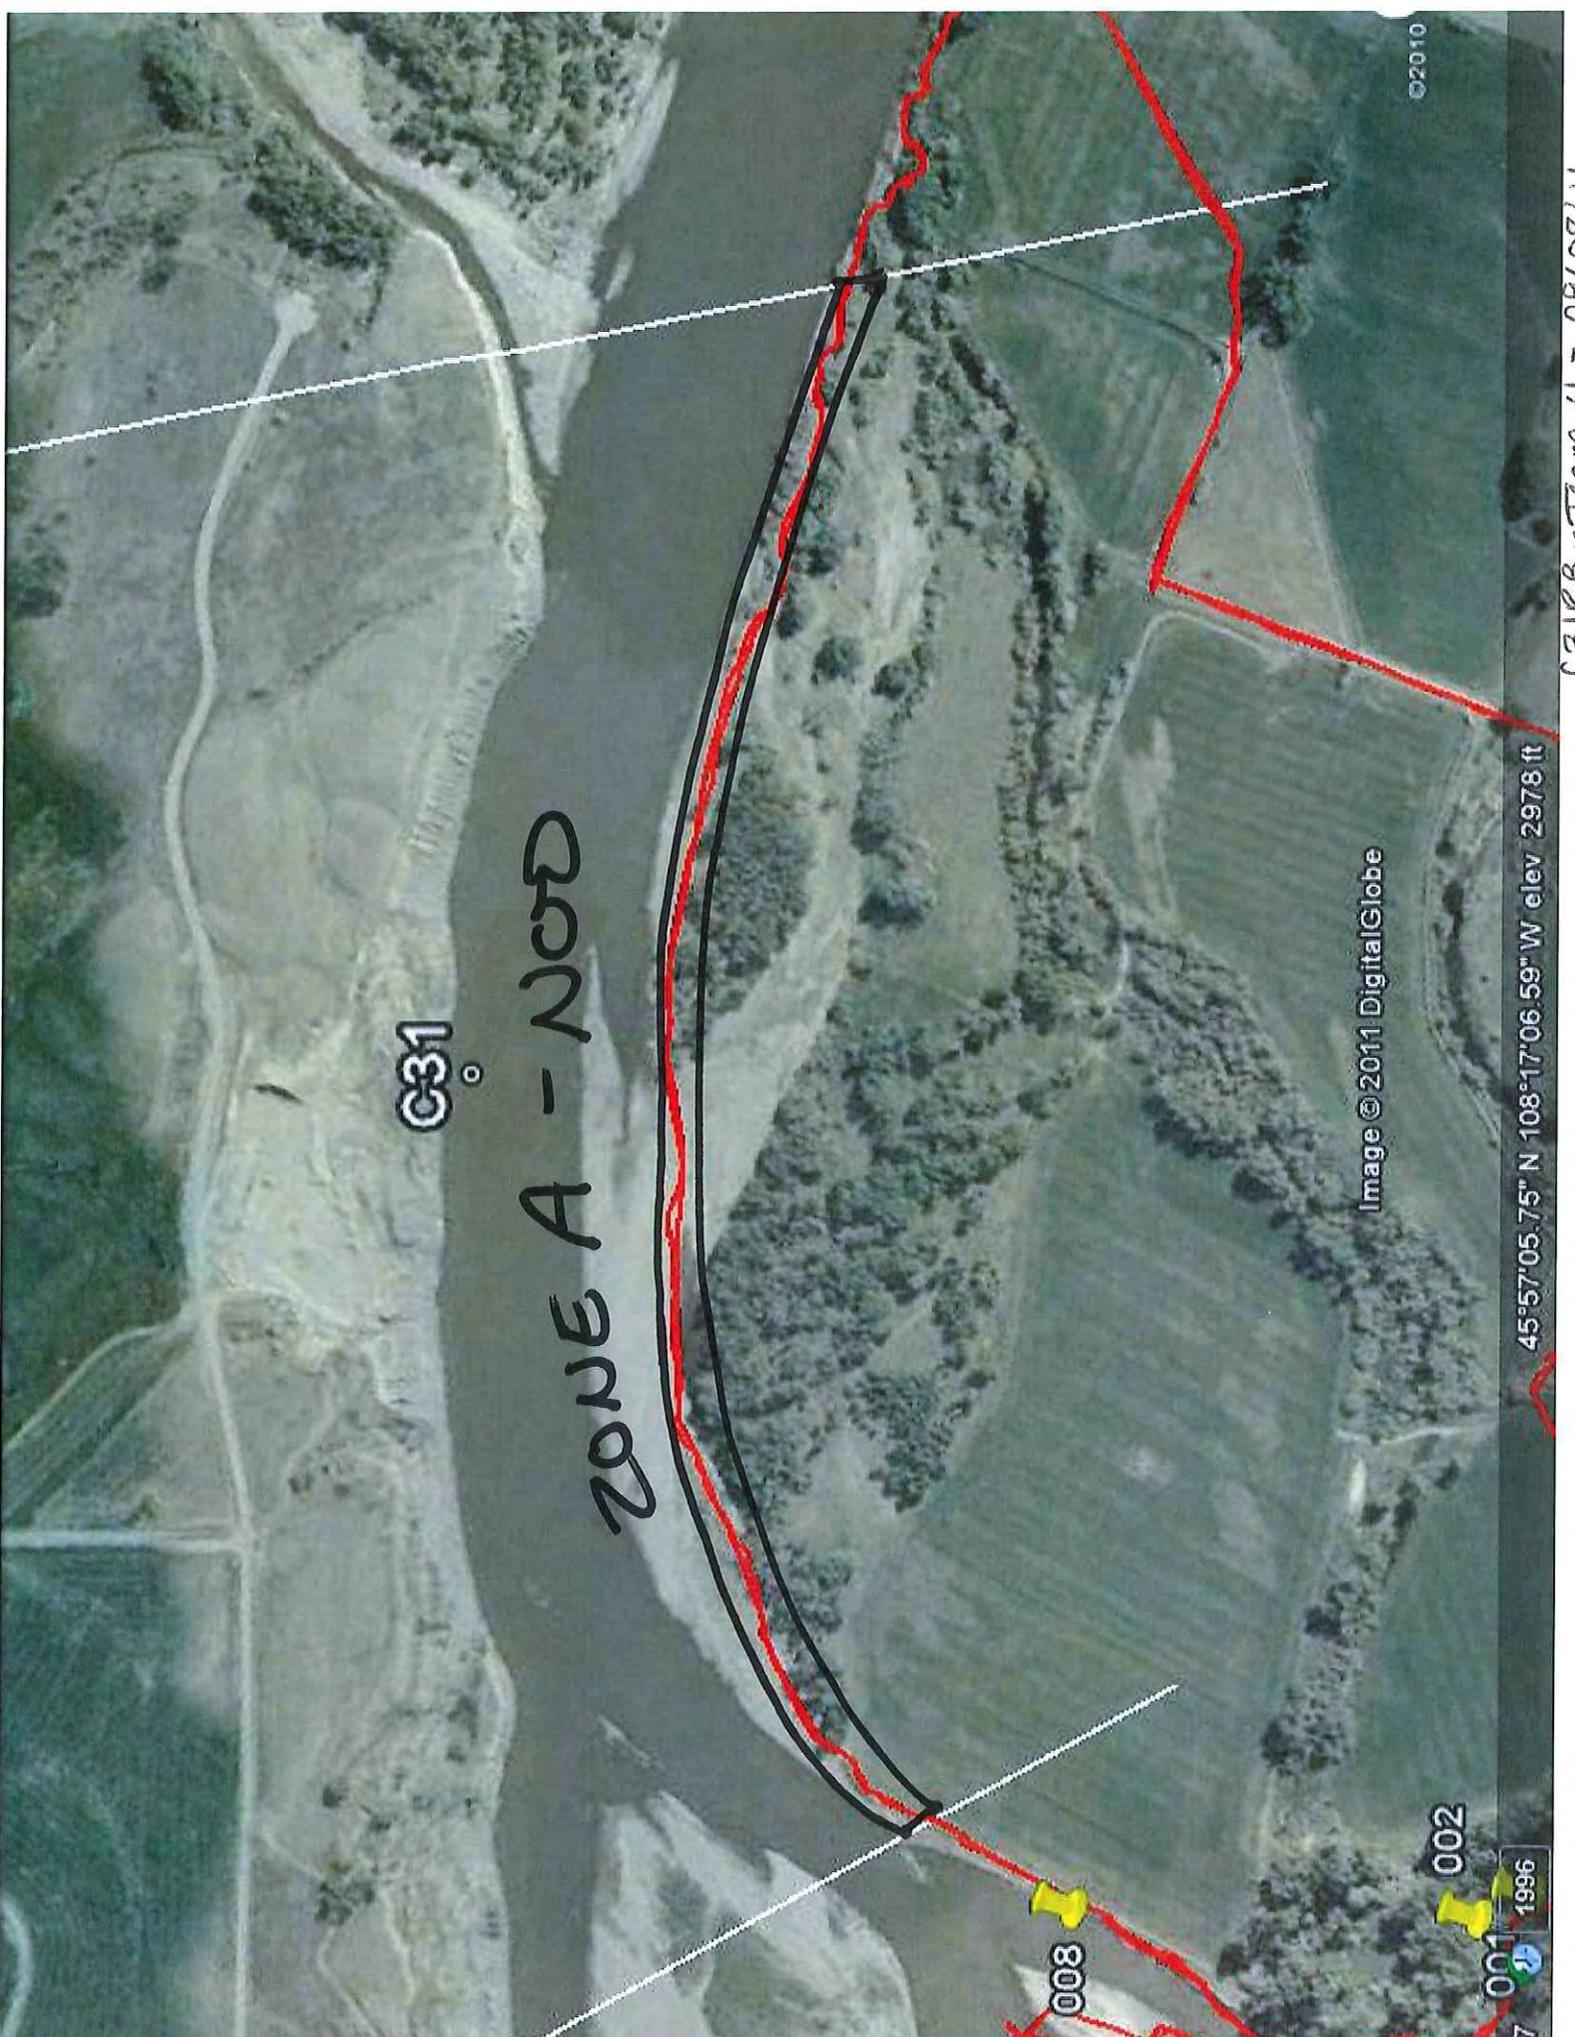
C31

Zone A - NOO

ZONE A - NOD

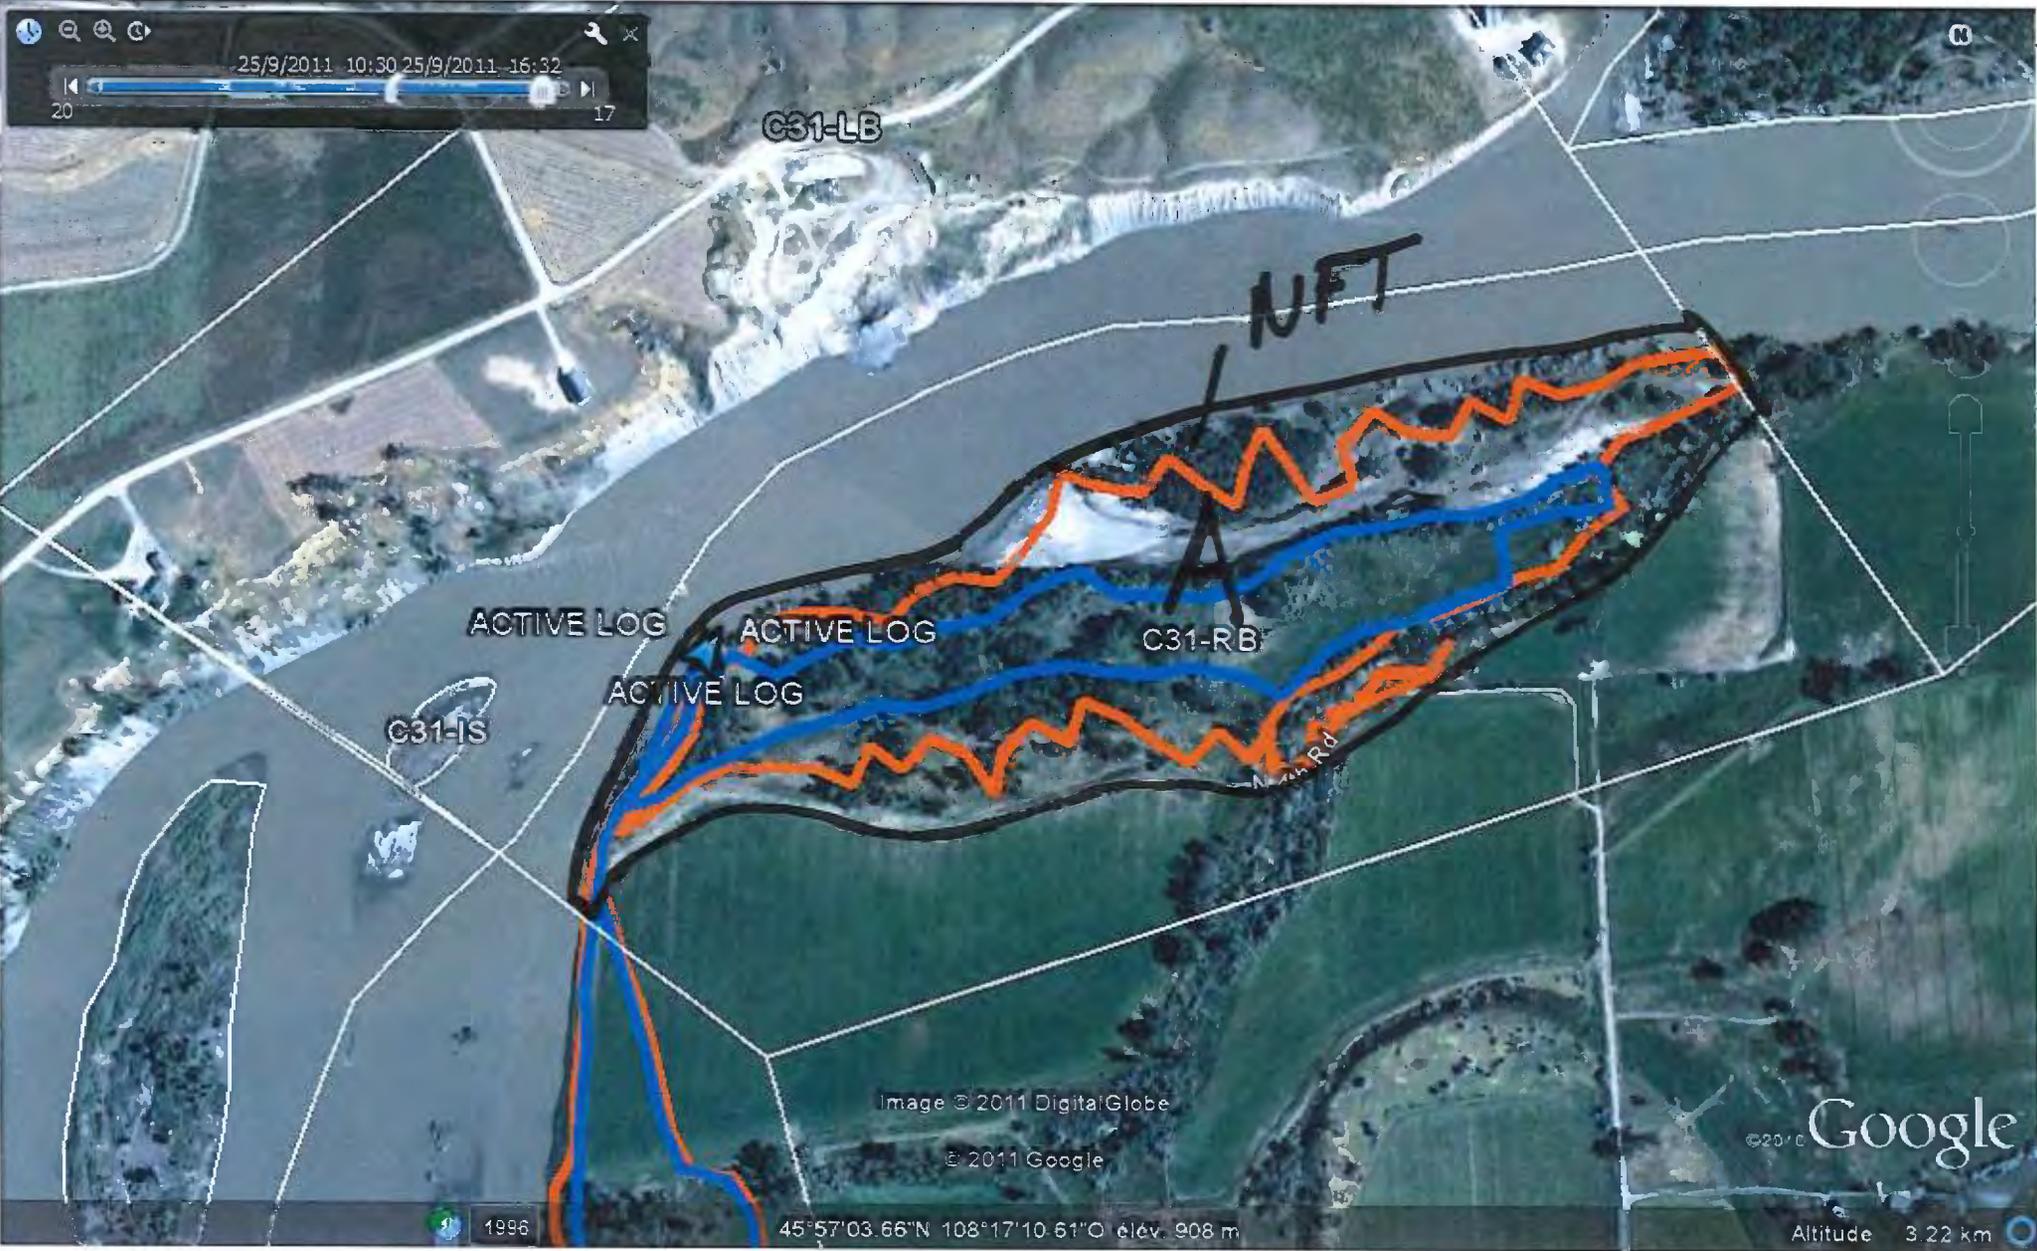
Re SCAT C31-RB

Zone A: Minor rare small "patches" of stain on stranded debris piles. Generally patches less than 30cm diameter. Meets NFT Standards
