**SCAT Area Transition Report
for C33**

Silvertip Pipeline Incident
Laurel, Montana

October 23, 2011

Prepared by:
ARCADIS G&M of North Carolina, Inc.
11000 Regency Parkway
West Tower, Suite 205
Cary, North Carolina 27518-8518
Tel 919.469.1952
Fax 919.469.5676

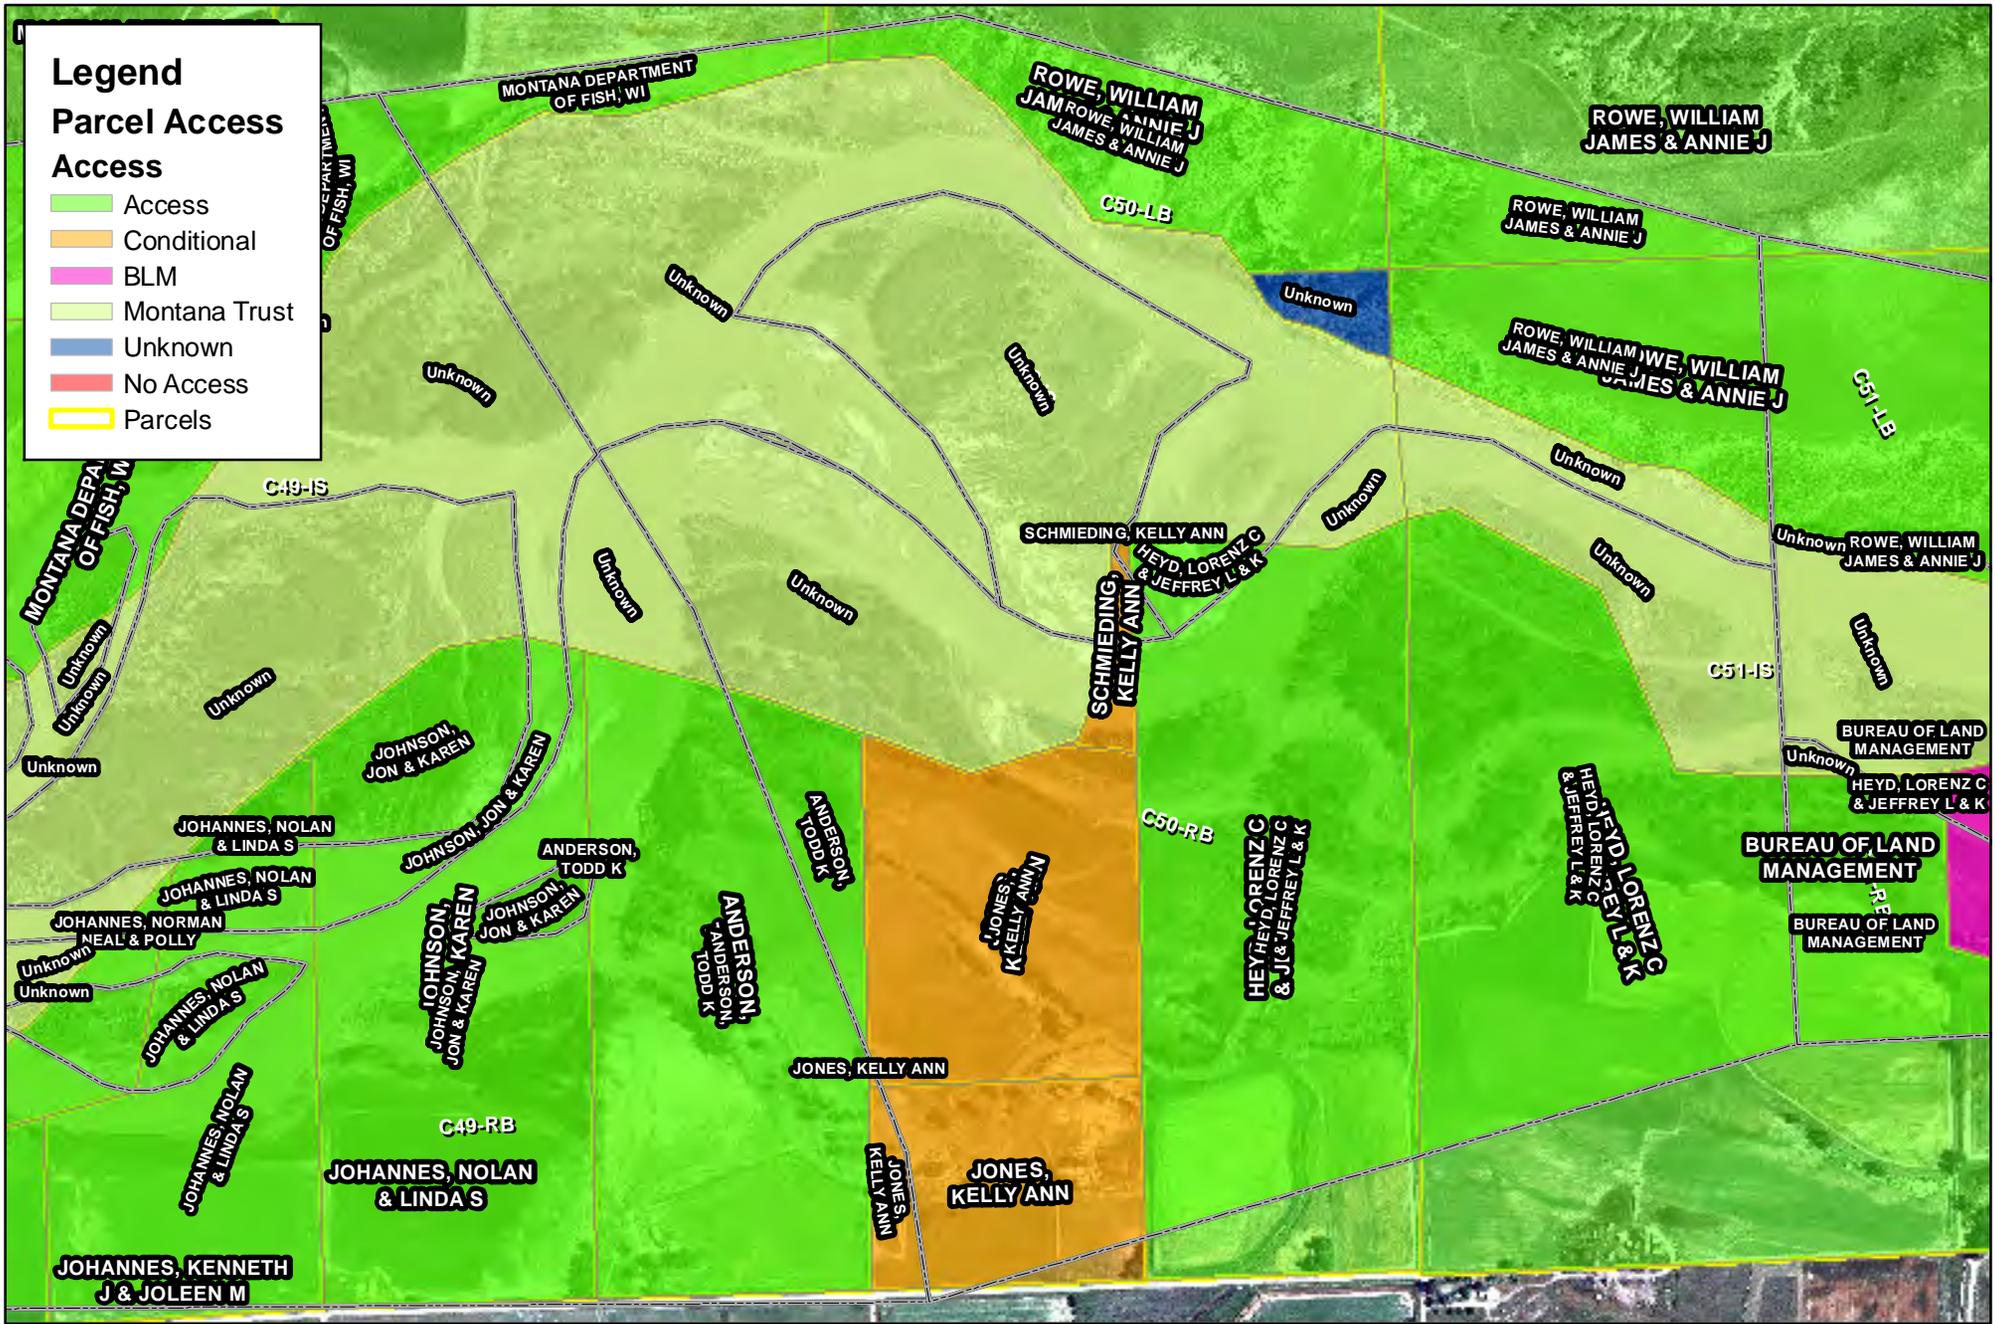
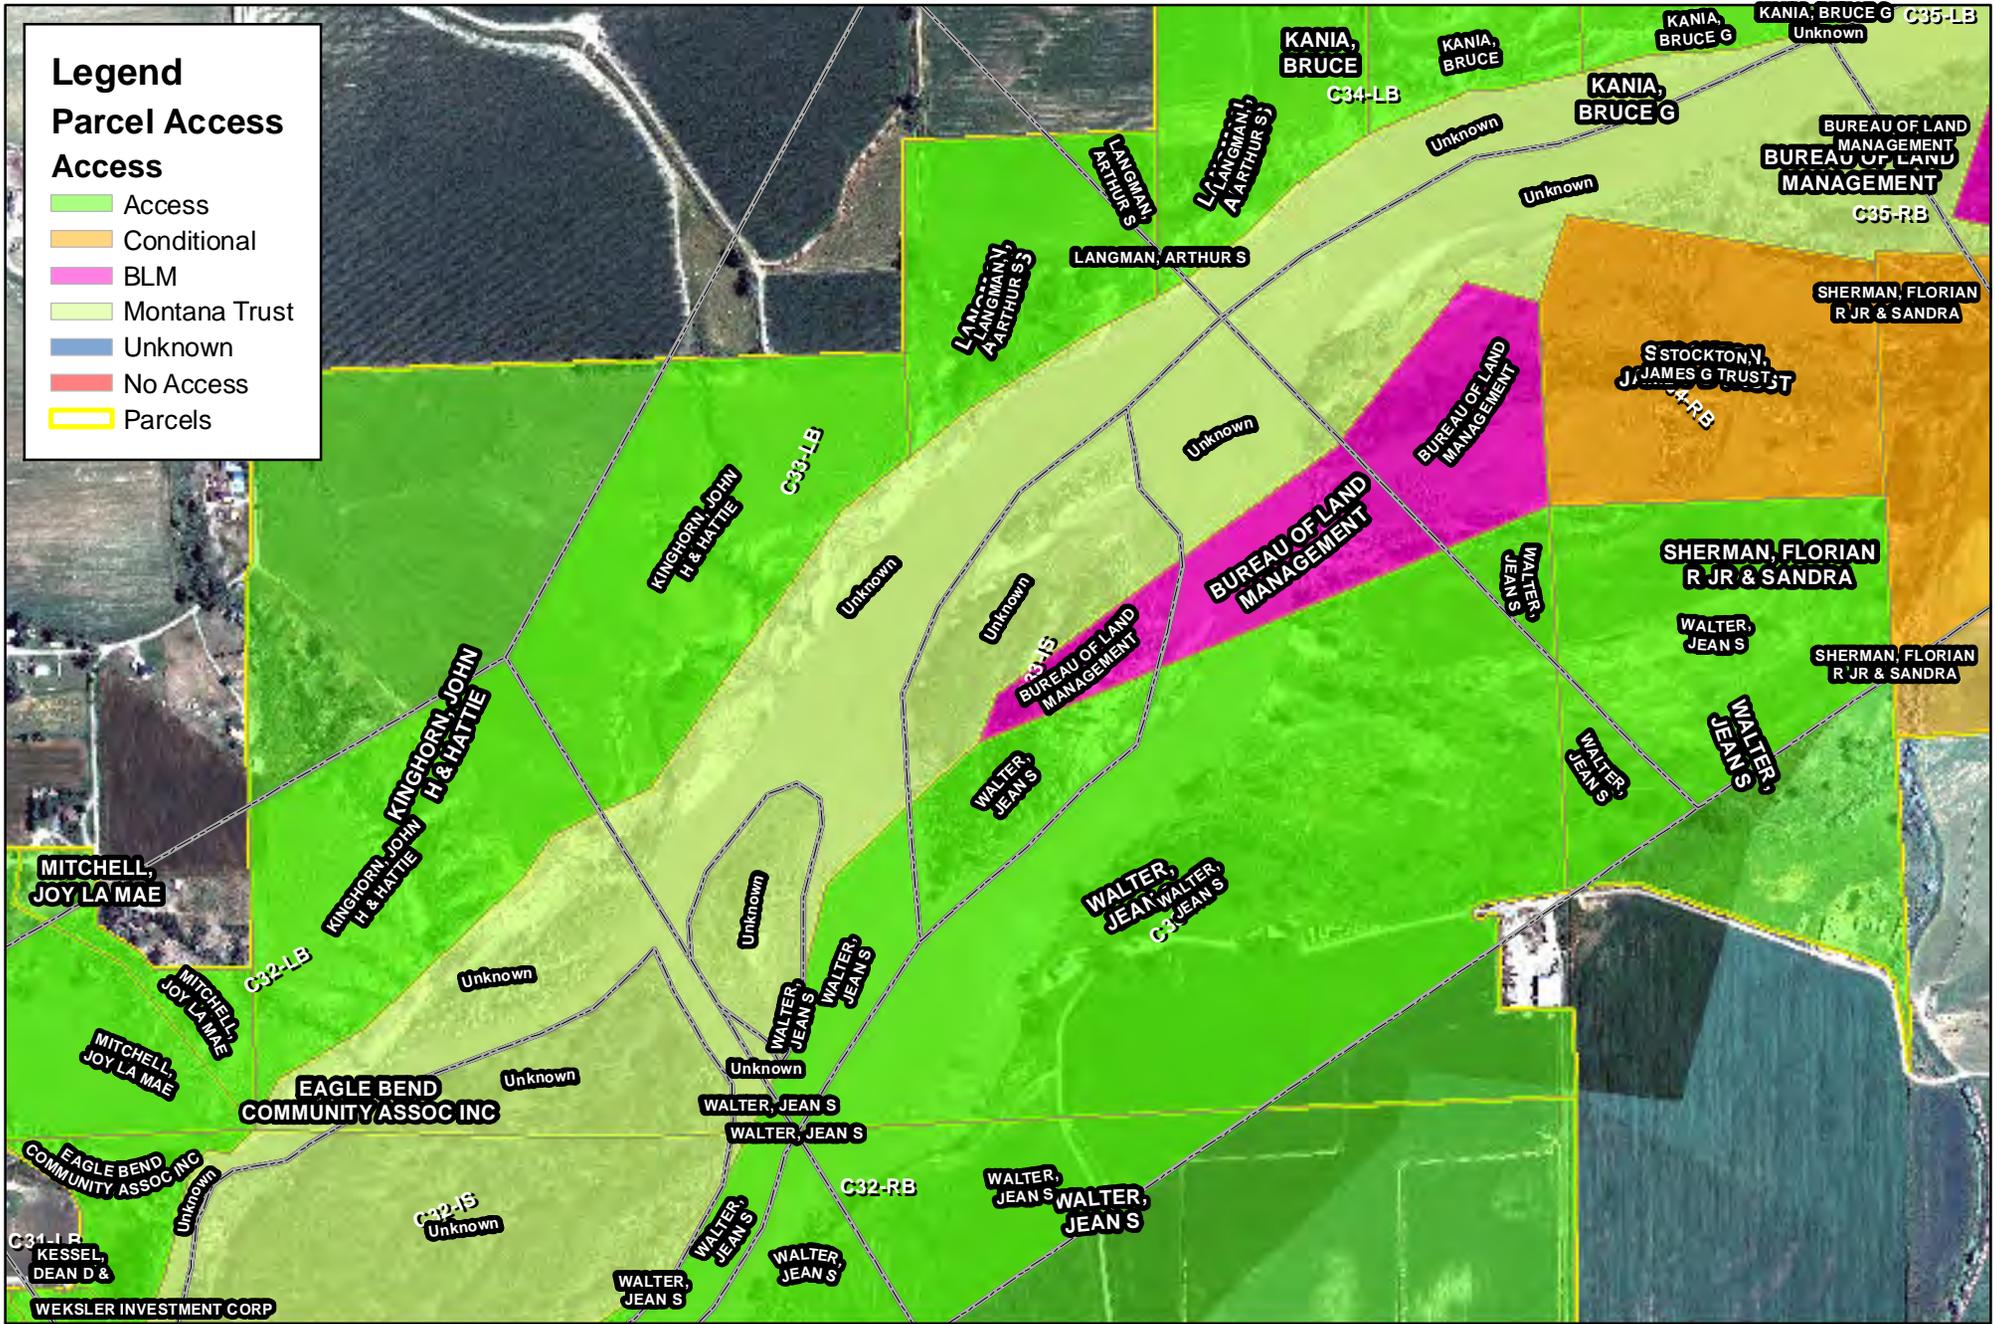
Figure 1 provides an aerial map of SCAT Area C33, along with the (a) SCAT Area boundary, (b) parcel boundaries and respective property owners, and (c) access constraints identified during the oil cleanup process. The acreage surveyed in Area C33 is 82.7. There were no access issues for this area.

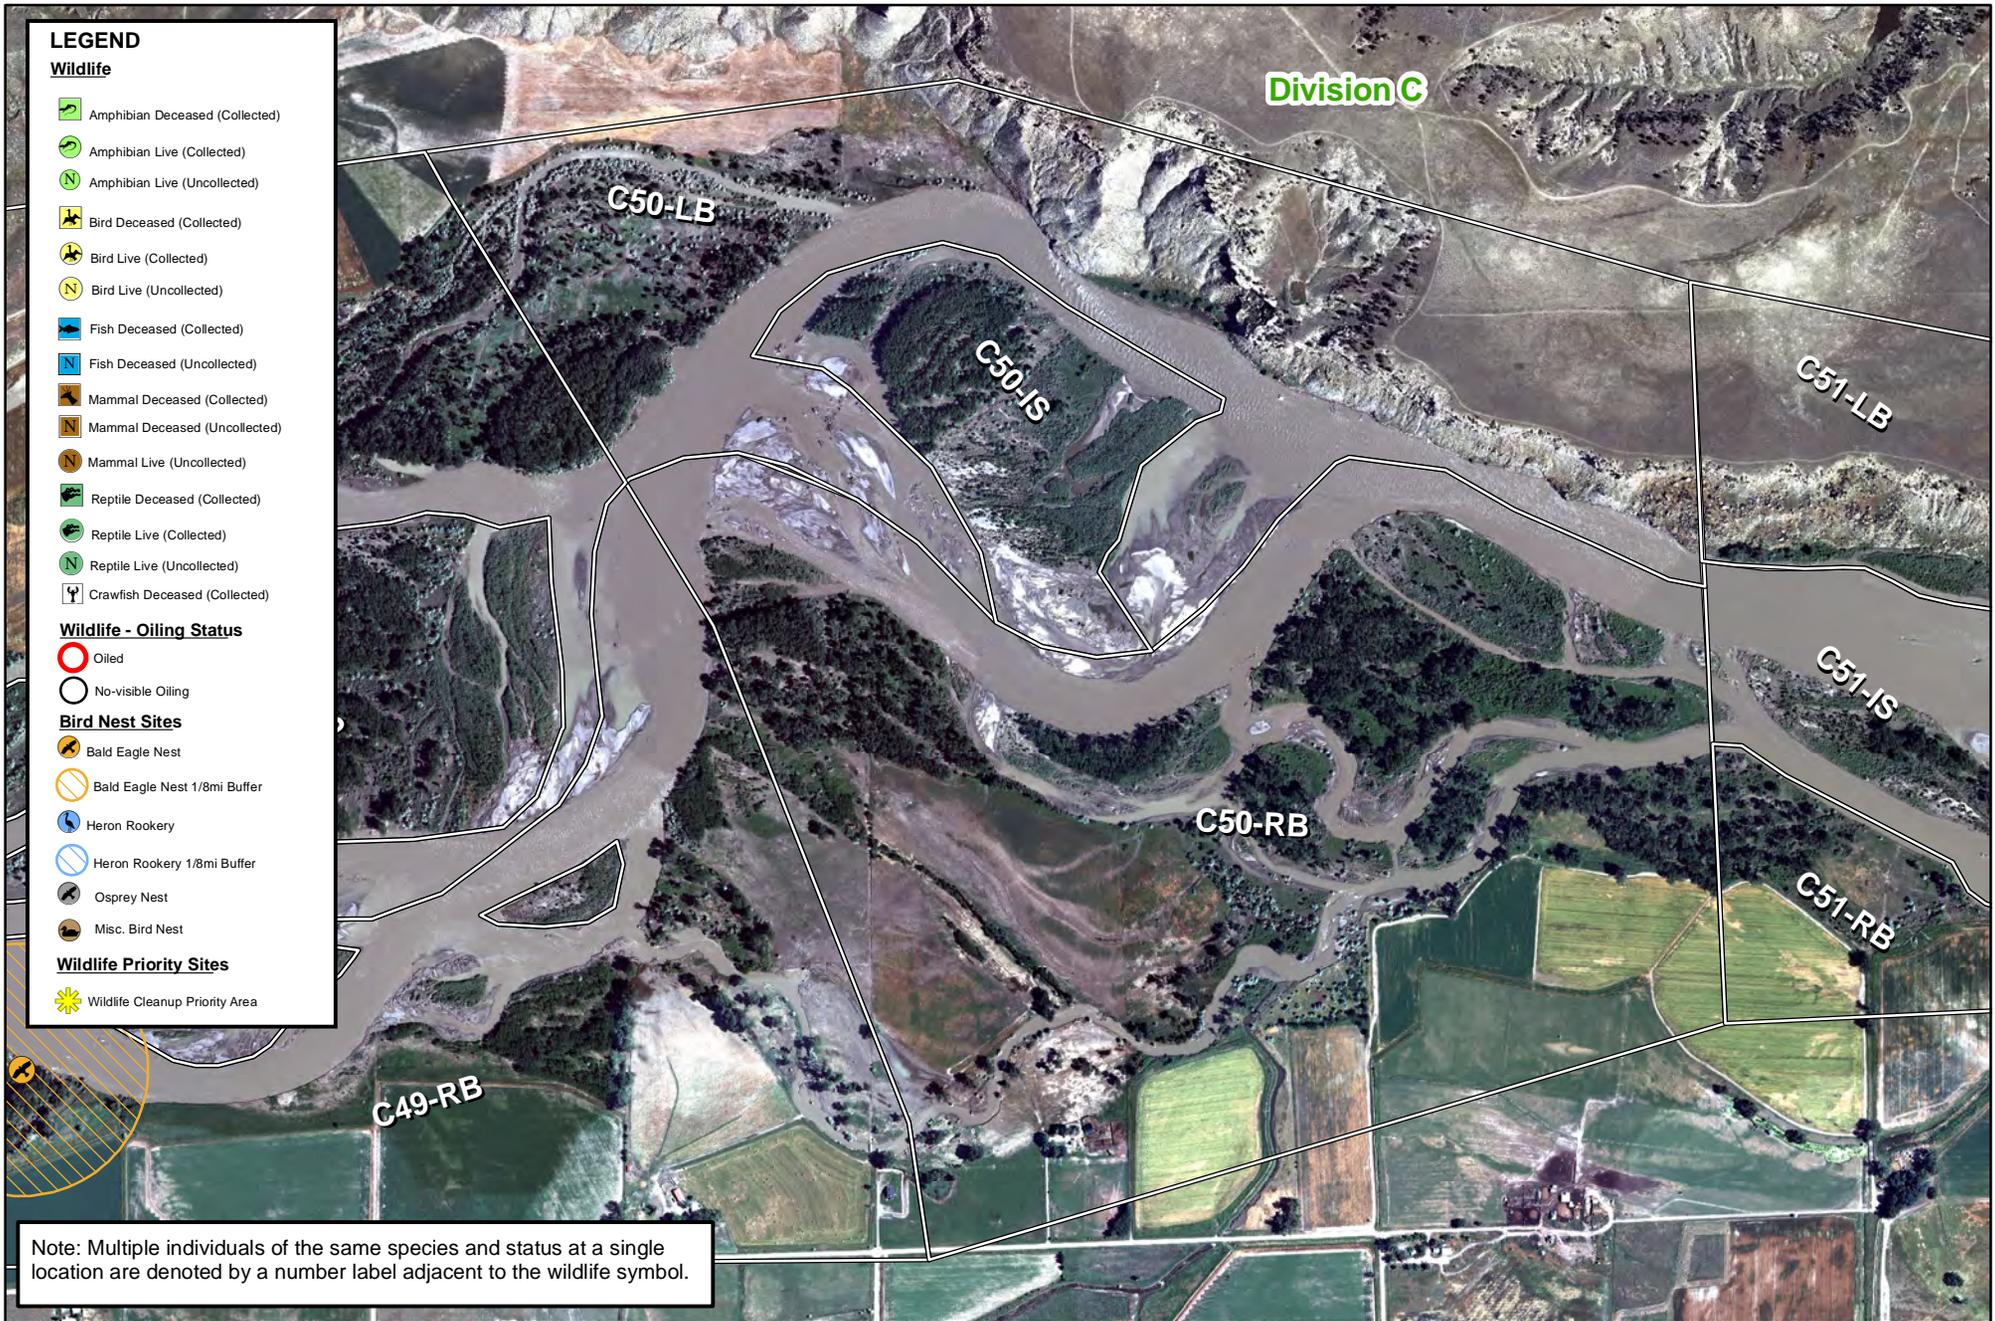
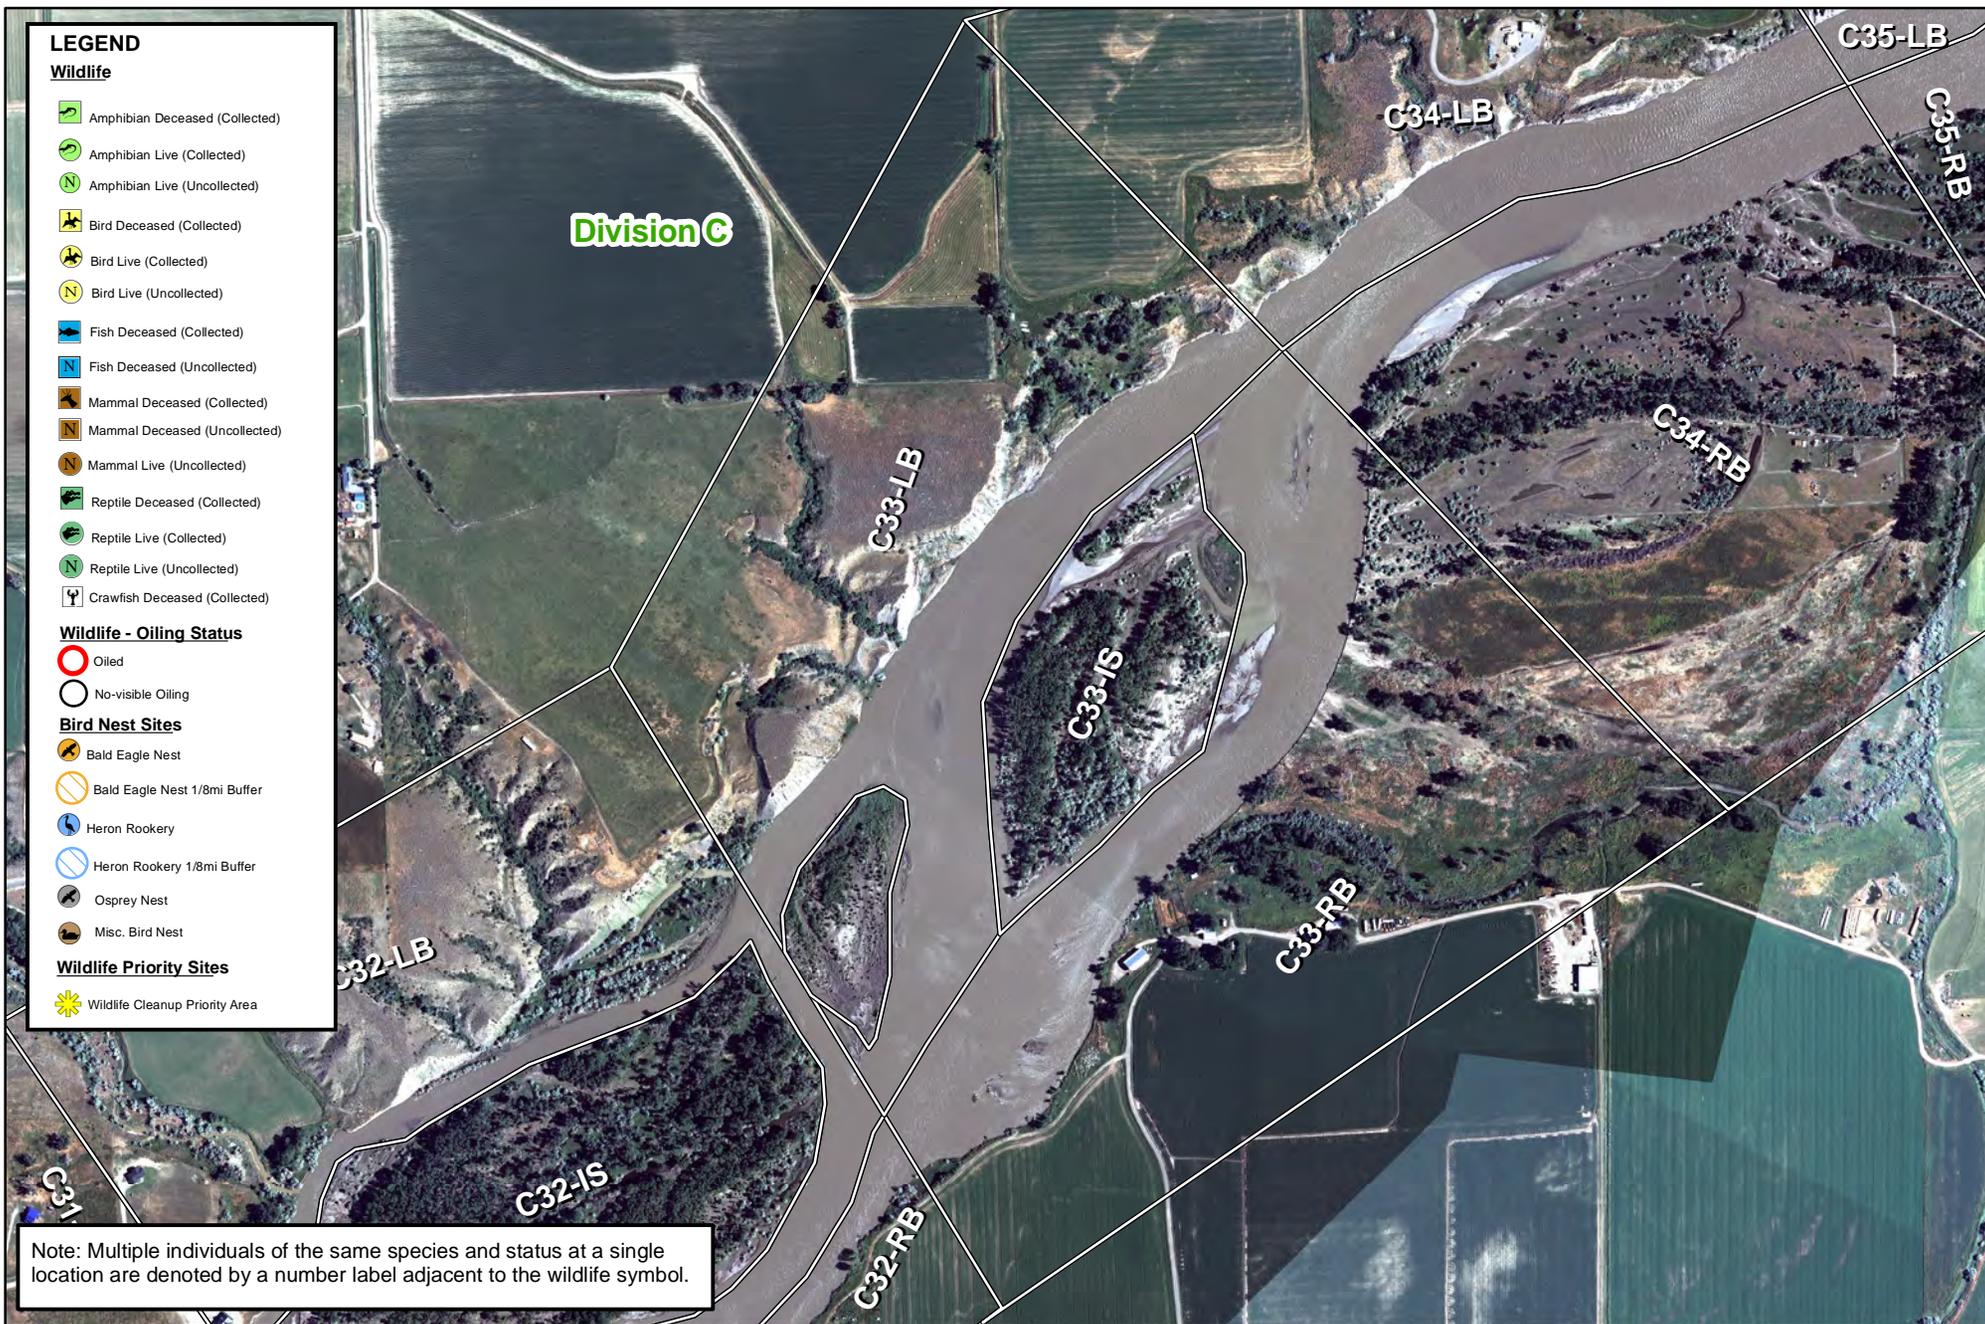
Figure 2
Wildlife Resources

Figure 2 summarizes the natural resources identified in this segment. International Bird Rescue and Resource Advisors from U.S. Fish and Wildlife Service conducted limited inspections of Area C33 due to the low level of oiling in Division C. No oiled wildlife was observed or recovered. No Wildlife Priority Cleanup Areas were identified. No active migratory bird nests were identified in Area C33.

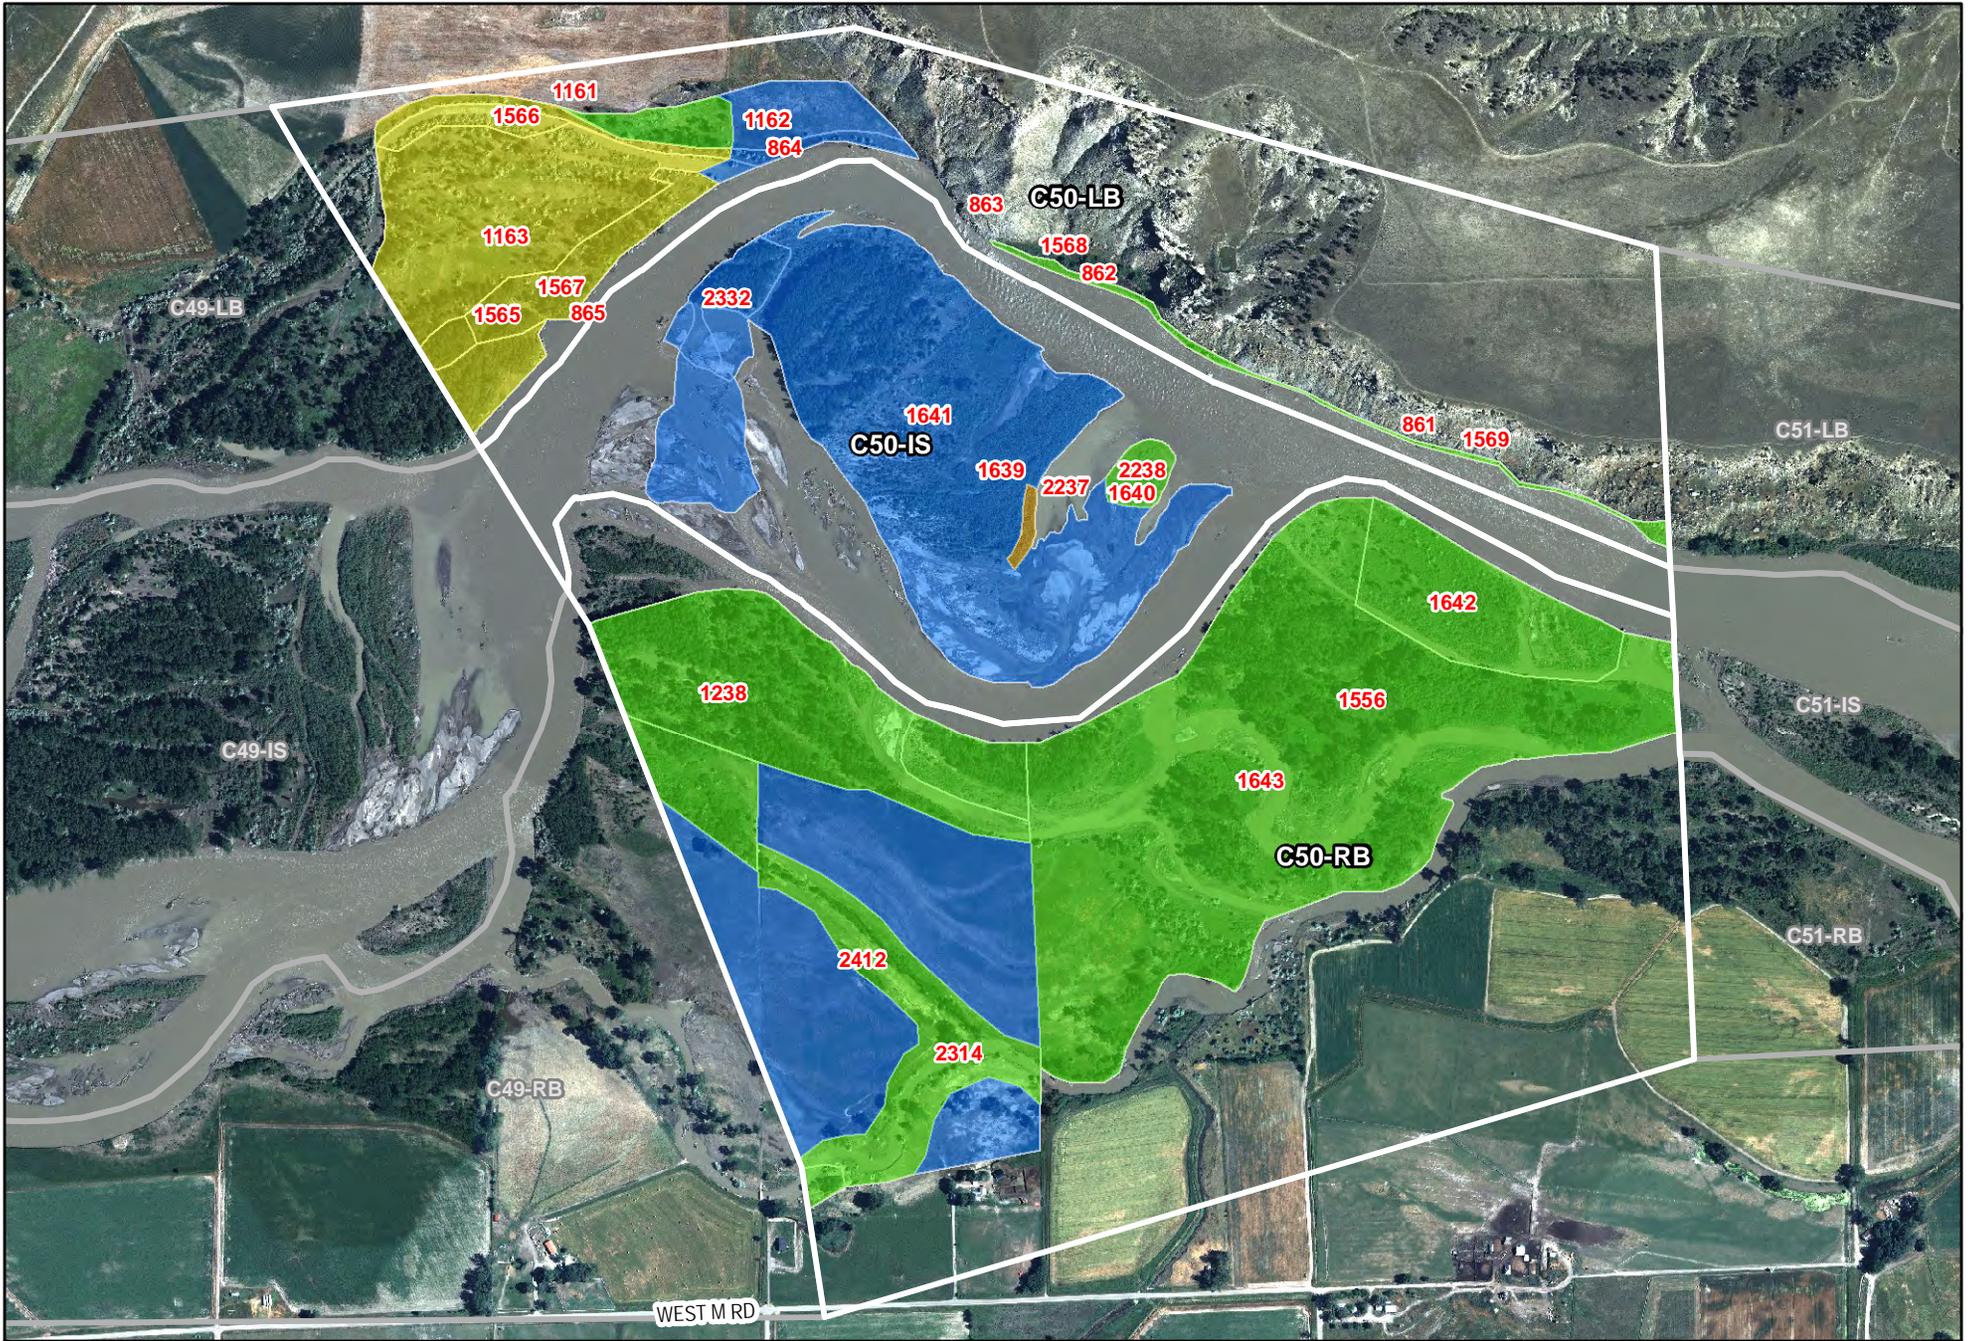
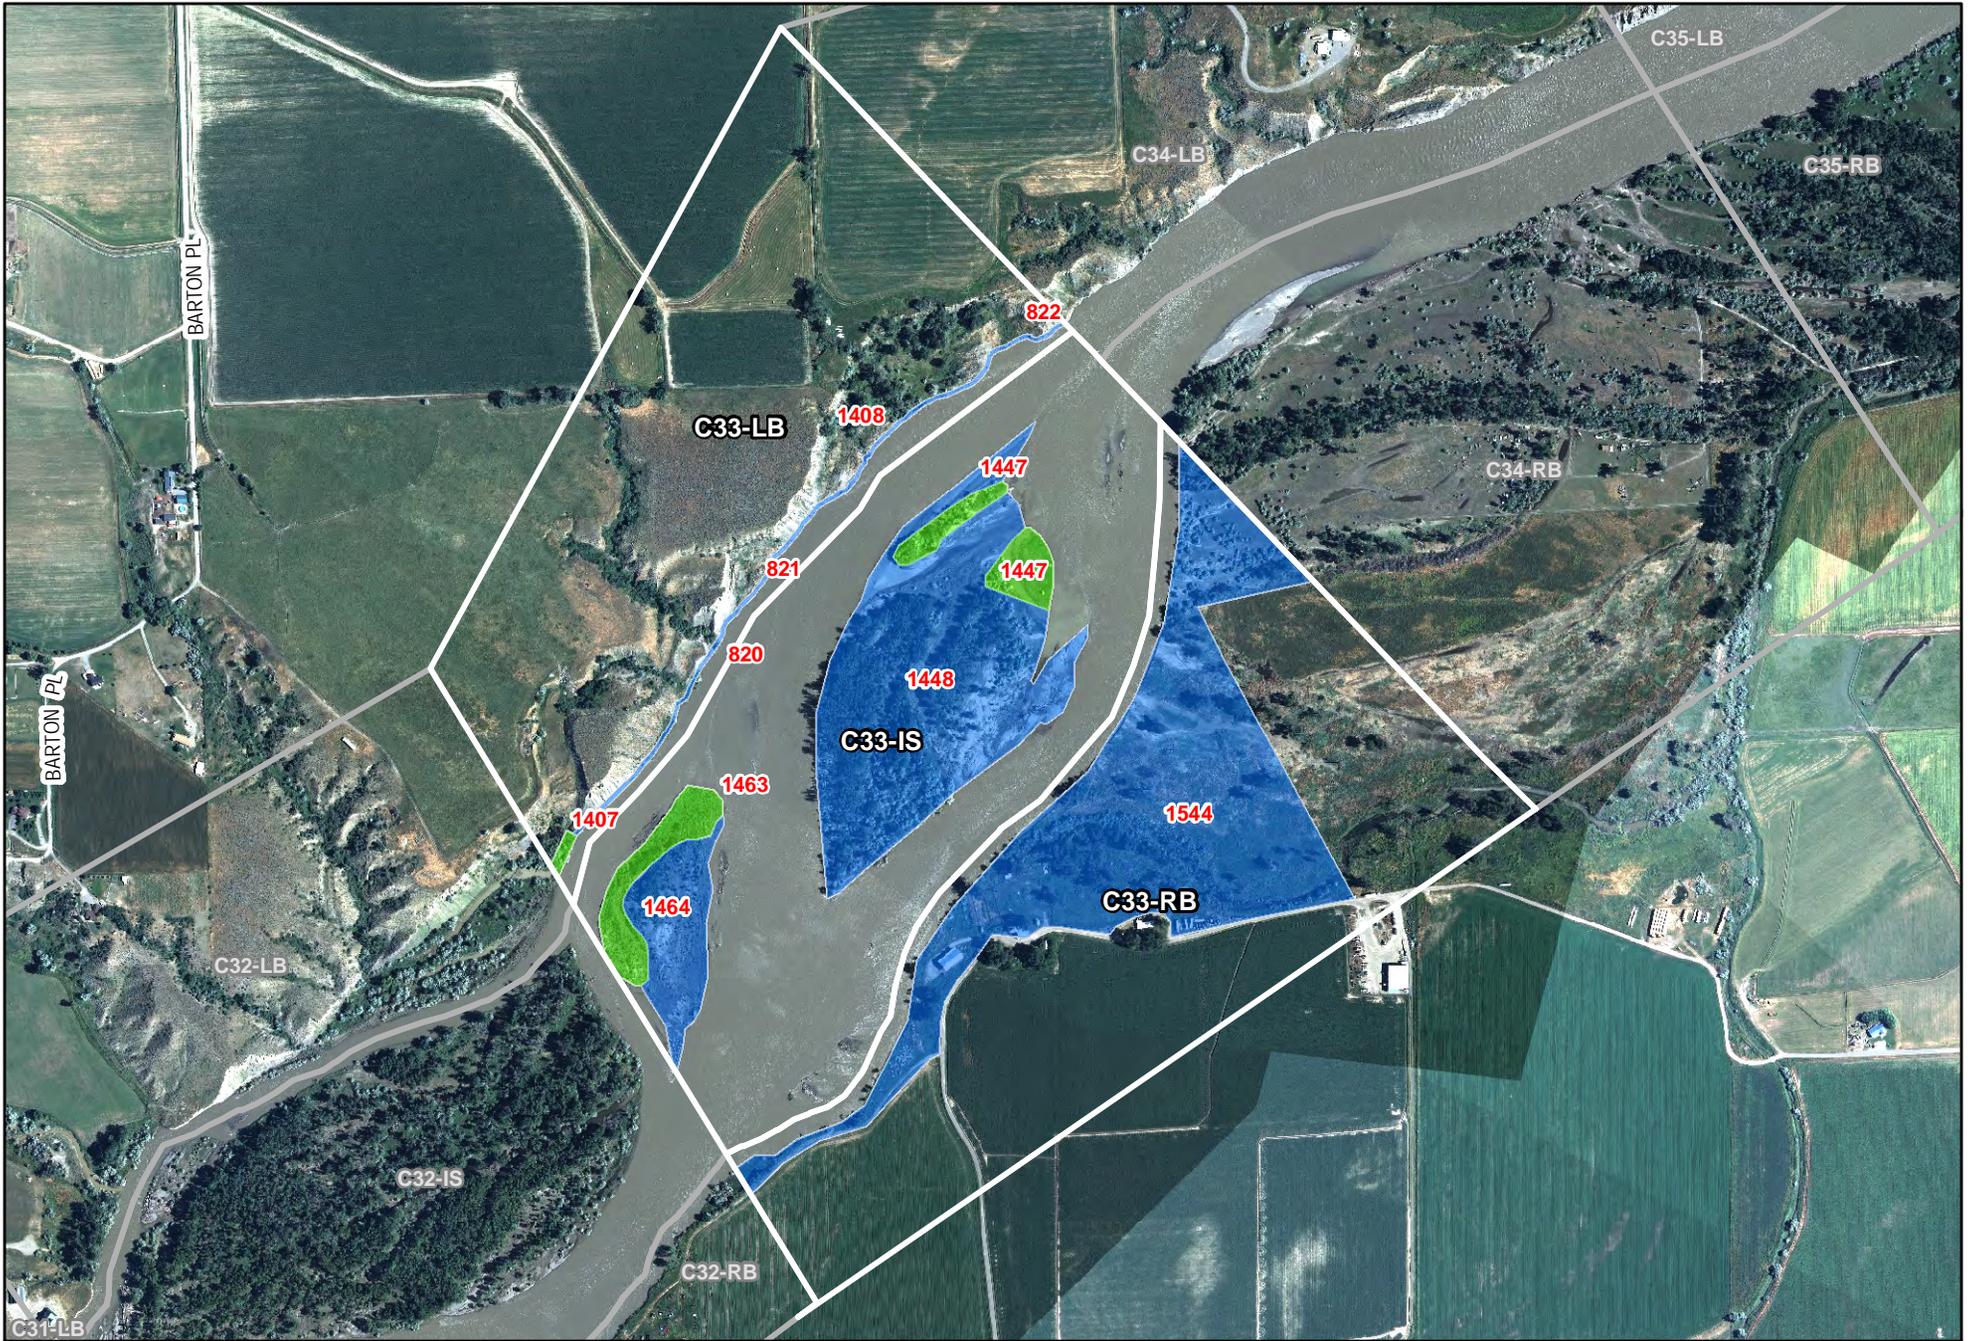
Figure 4 - Maximum SCAT Observations For SCAT Area: C50

Based on the initial SCAT survey performed within Area C33, only very light oiling was observed on a portion of the left bank and island, and no oiling was observed in the remainder of Area C33. The very light oiling zones will be addressed through natural attenuation. Therefore, a PIST, POST, and final SCAT survey were not performed and a SCAT Segment Sign-Off Form is not necessary.

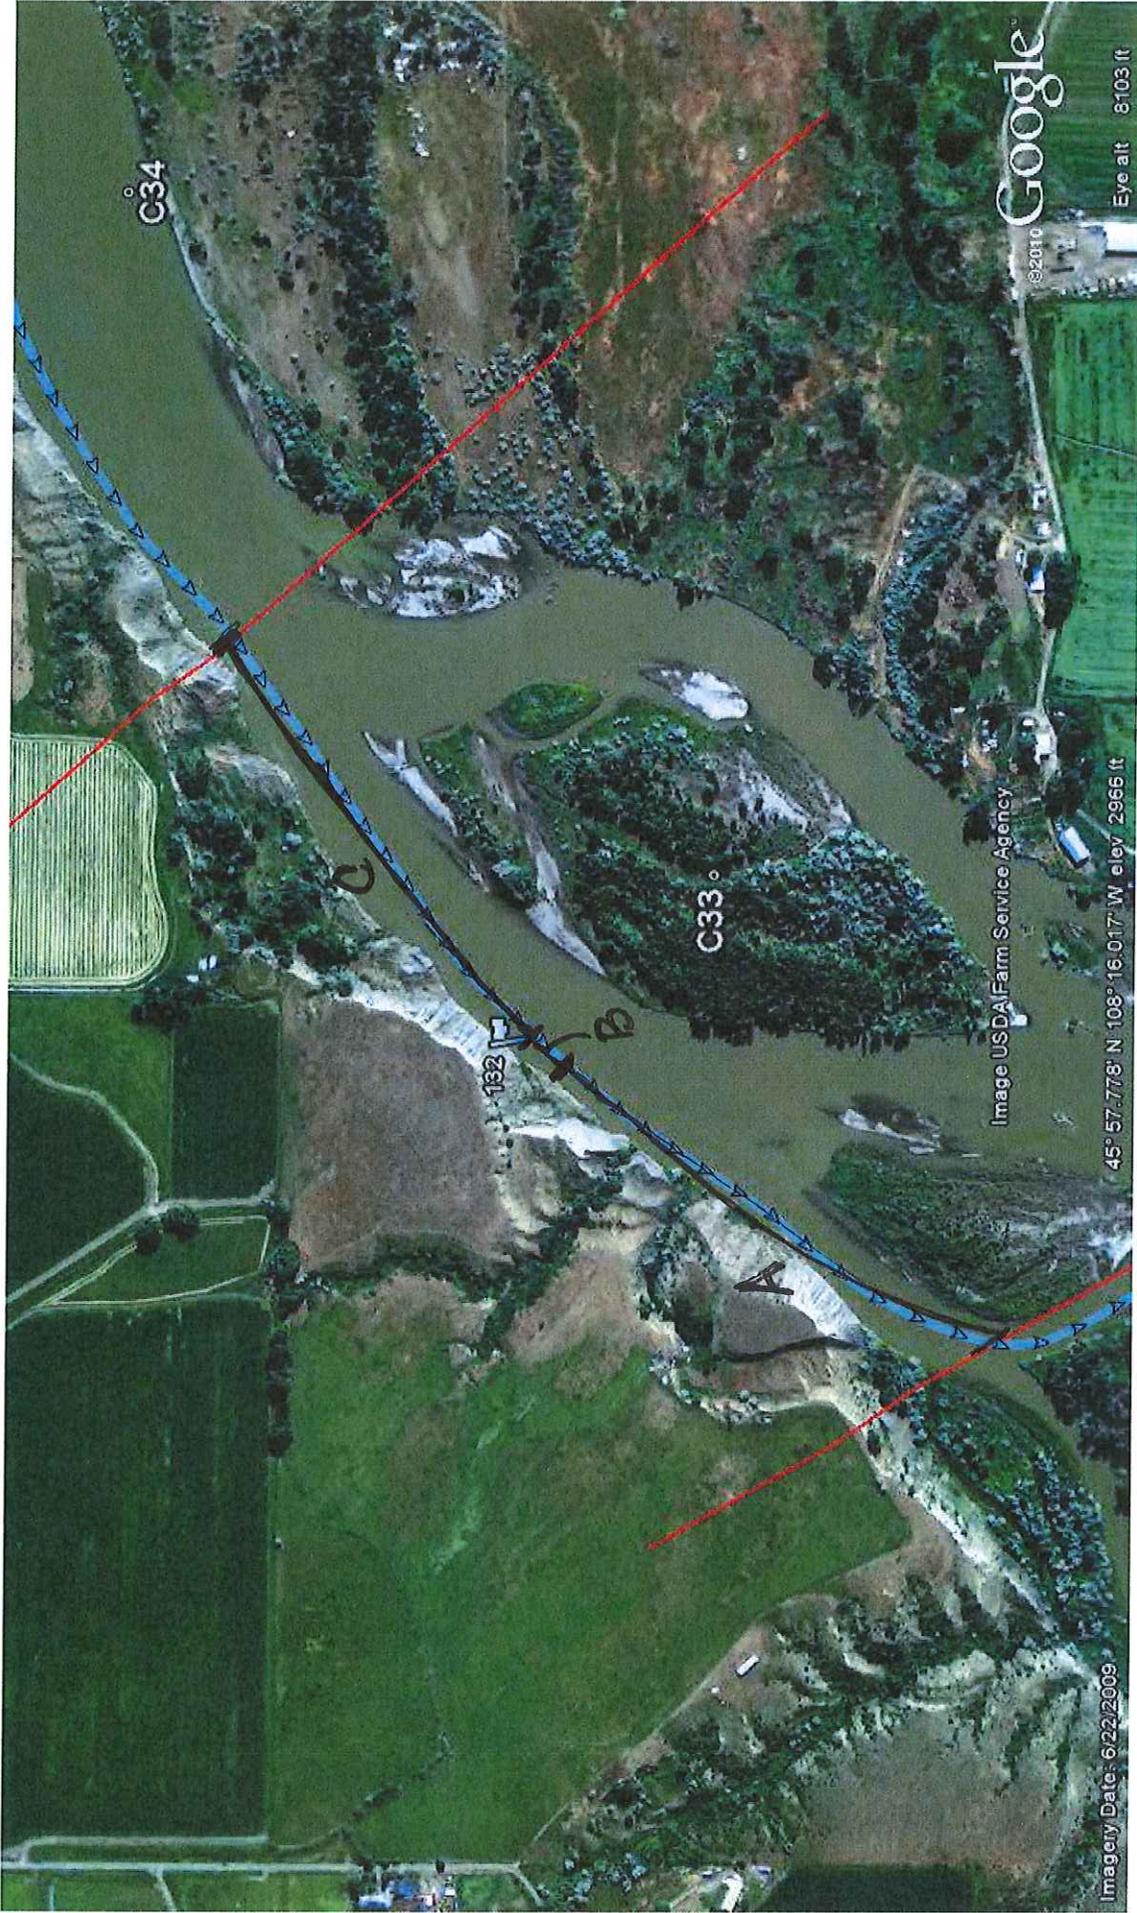
OIL ZONE	RIVER BANK ZONE				OIL COVER			OIL THICKNESS					OIL CHARACTER						SUBST. TYPE(S)				
					Length	Width	Distrib.	TO	CV	CT	ST	FL	FR	MS	TB	PT	TC	SR		AP	NO		
ID	MS	LB	UB	OB	m	m	%																
A		X			514	1																X	Cliff
B		X			20	1	100	100			X	X		X									Trees, Cliff
C		X			473	1																X	Cliff

Oil height: 60 cm

A = 93 + 421
C = 136 + 337

Zone B is 20m before WP 132

Zone A, C : No oil observed; no treatment required.

Zone B : Cut & remove oil coated vegetation smaller than 1" diameter. Remove debris smaller than 4" diameter. Wipe larger oil coated vegetation.

*Refer to current approved treatment methods #1 (Cutting of Vegetation), #2 (Dead Vegetation and Small Debris), #3 (Large Woody Debris), #6 (Sorbent Use), # (Unconsolidated Sediments)

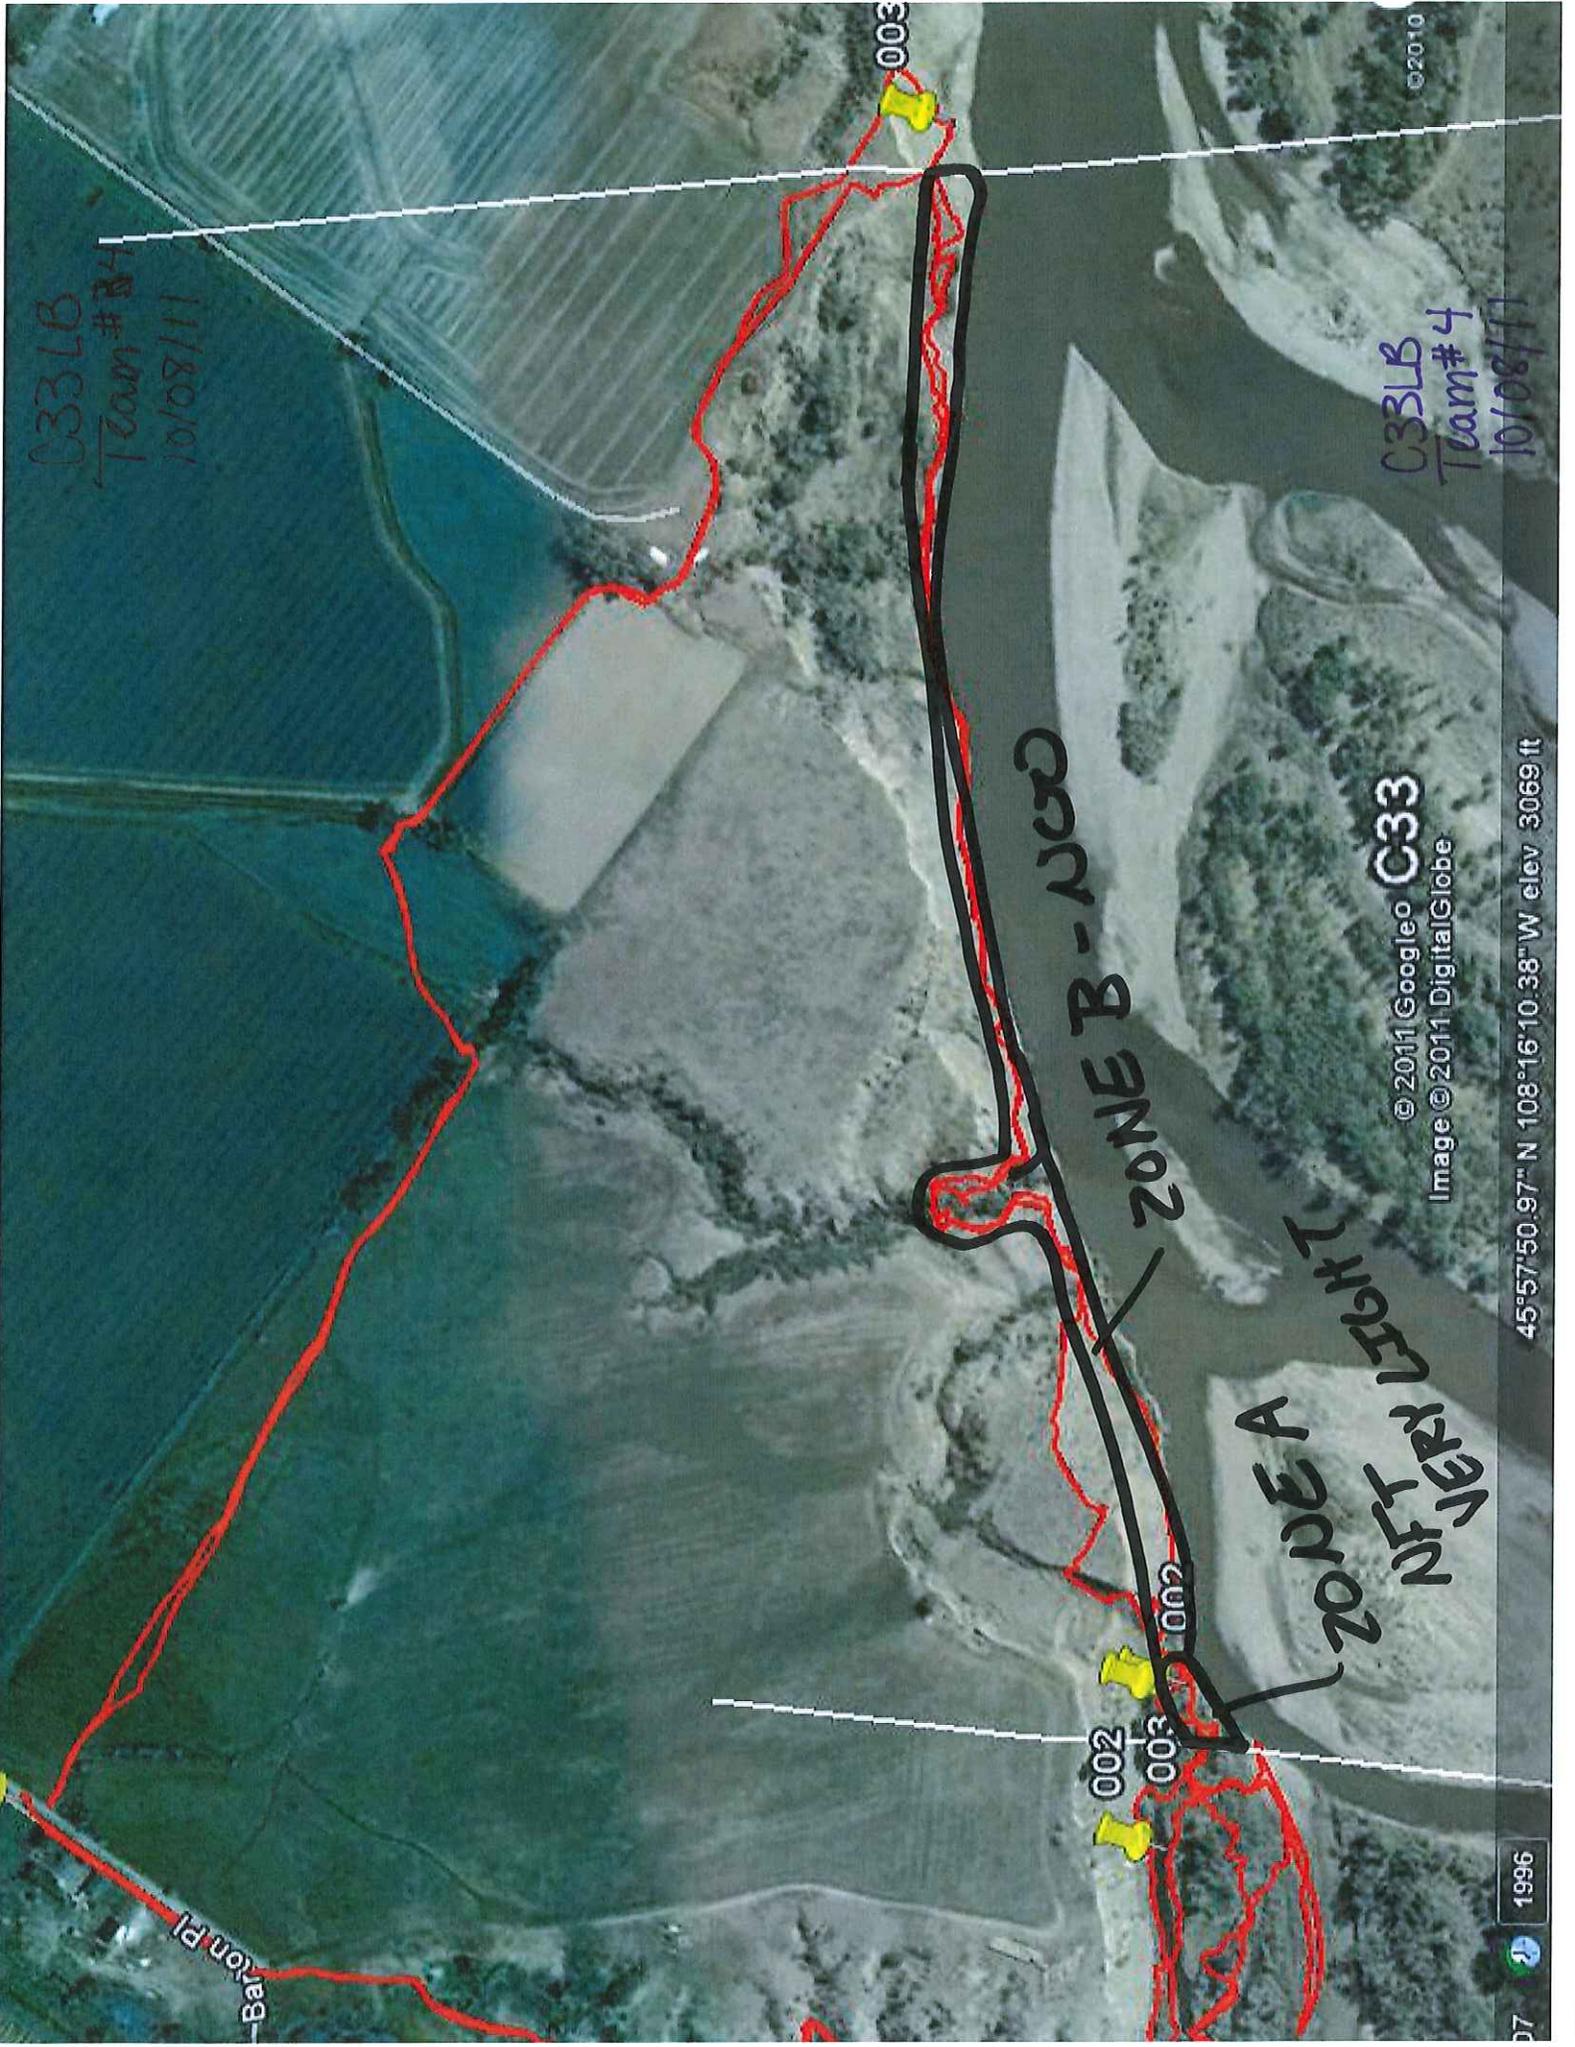
C33LB
Team # 4
10/08/11

OIL ZONE ID	RIVER BANK ZONE				OIL COVER			OIL THICKNESS										OIL CHARACTER										SUBST. TYPE(S)
	MS	LB	UB	OB	Length m	Width m	Distrib. %	TO	CV	CT	ST	FL	FR	MS	TB	PT	TC	SR	AP	NO								
A			X		60	15	<1			S	P												grass					
B			P		905	5	0																✓

Zone A - Ops team on location during SCAT operations - observed oiling was cleaned in adherence to ATML; cutting of vegetation (Grass) - NFT recommended.

ZONE B - NCO

ZONE A
NFT JERRY LIGHT
