**SCAT Area Transition Report
for C33**

Silvertip Pipeline Incident
Laurel, Montana

October 23, 2011

Prepared by:
ARCADIS G&M of North Carolina, Inc.
11000 Regency Parkway
West Tower, Suite 205
Cary, North Carolina 27518-8518
Tel 919.469.1952
Fax 919.469.5676

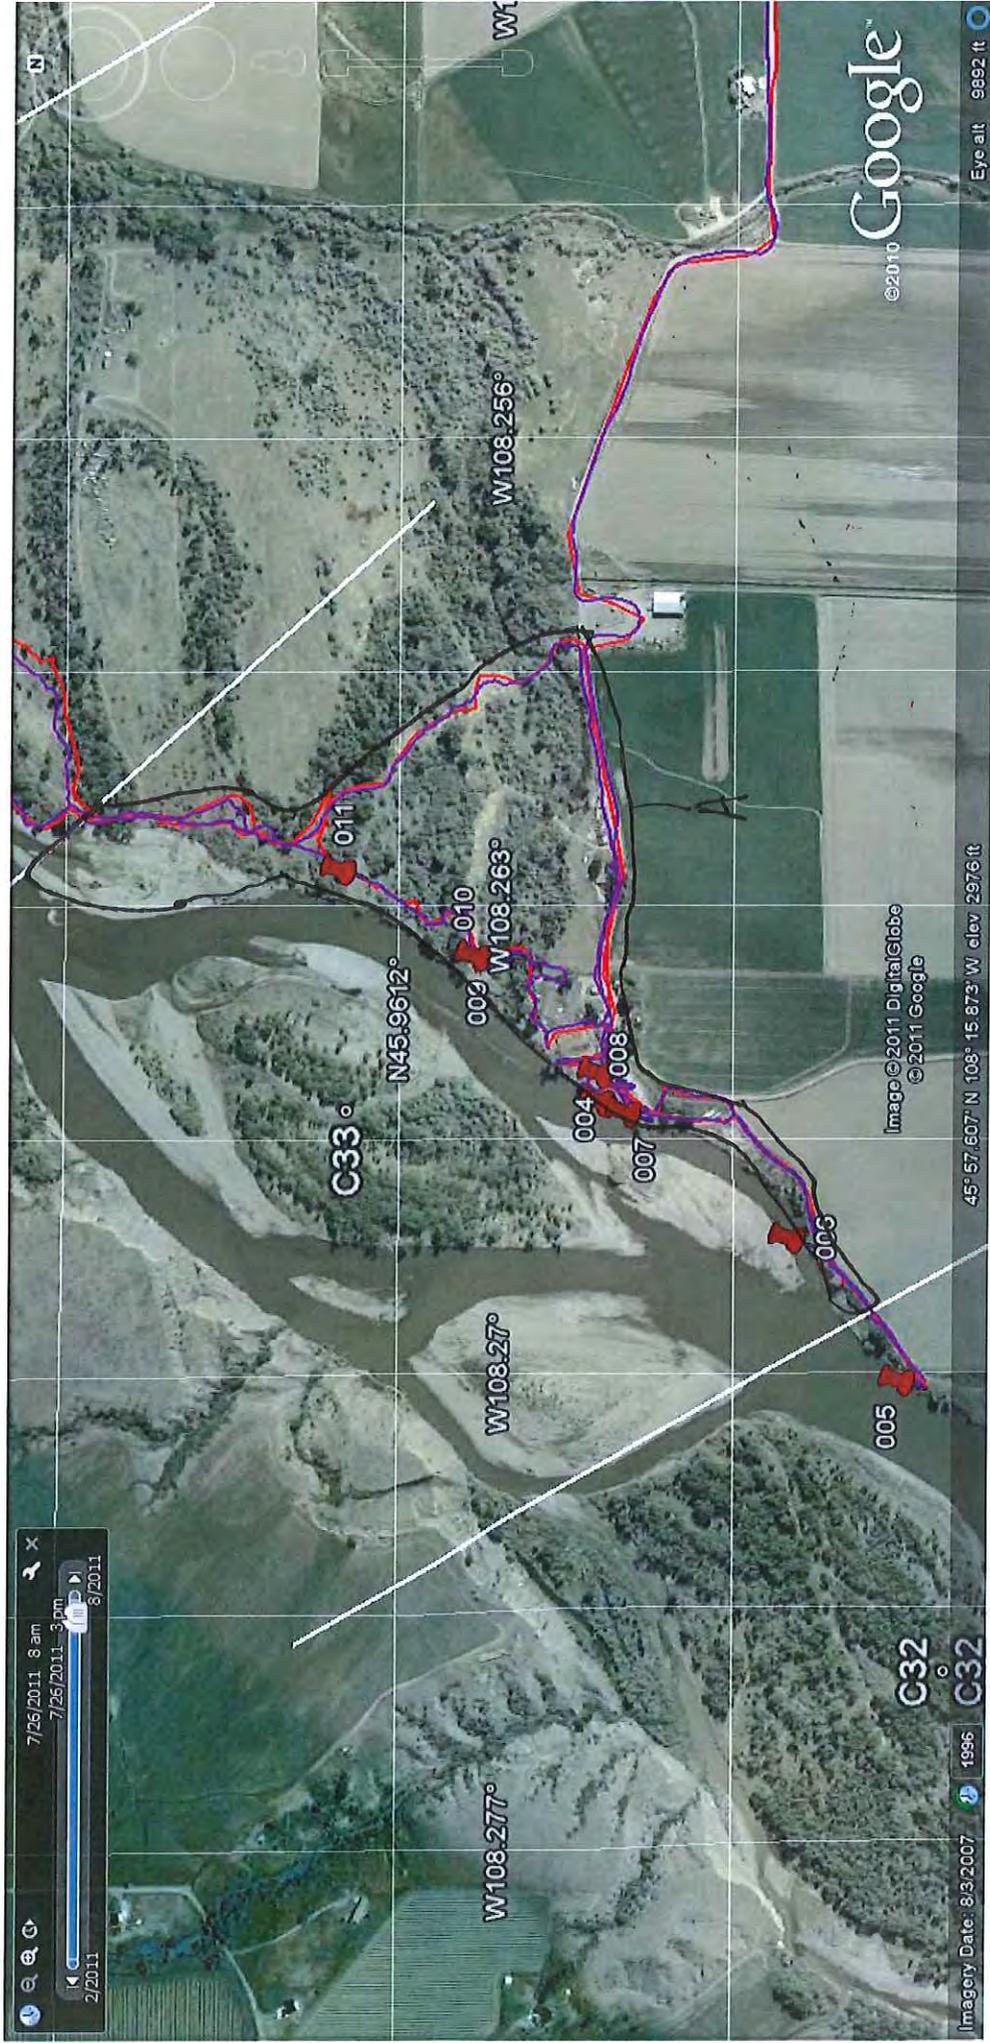
Segment C33RB
SCAT Team 3
14 August 2011
Complete Survey

A = NoO 1100m 50m.
