**SCAT Area Transition Report  
for C34**

Silvertip Pipeline Incident  
Laurel, Montana

October 23, 2011

Prepared by:  
ARCADIS G&M of North Carolina, Inc.  
11000 Regency Parkway  
West Tower, Suite 205  
Cary, North Carolina 27518-8518  
Tel 919.469.1952  
Fax 919.469.5676

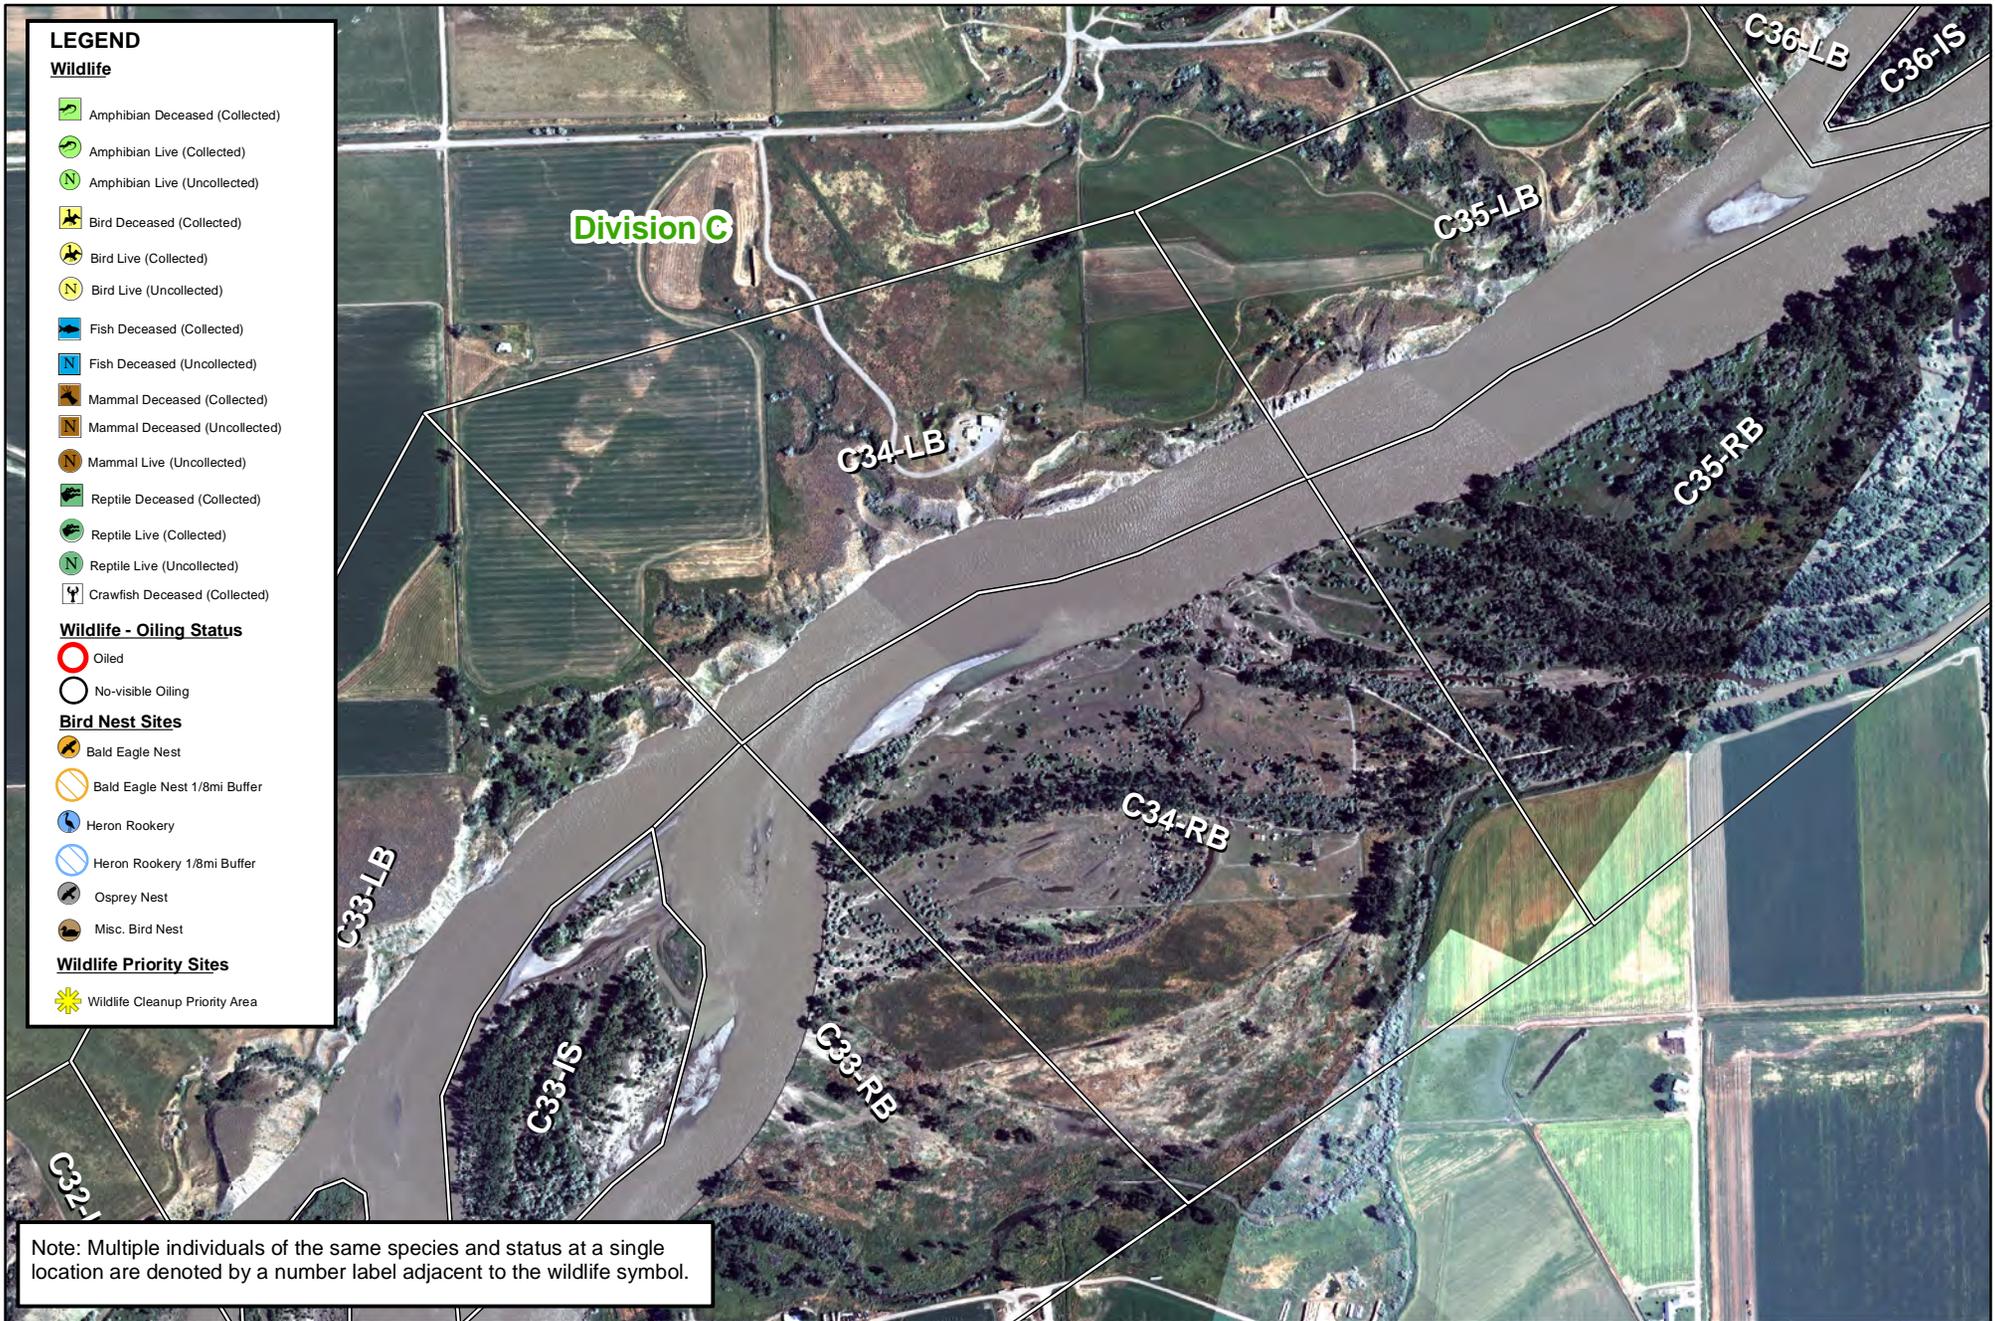
**Figure 2**  
**Wildlife Resources**

Figure 2 summarizes the natural resources identified in this segment. International Bird Rescue and Resource Advisors from U.S. Fish and Wildlife Service conducted limited inspections of Area C34 due to the low level of oiling in Division C. No oiled wildlife was observed or recovered. No Wildlife Priority Cleanup Areas were identified. No active migratory bird nests were identified in Area C34.

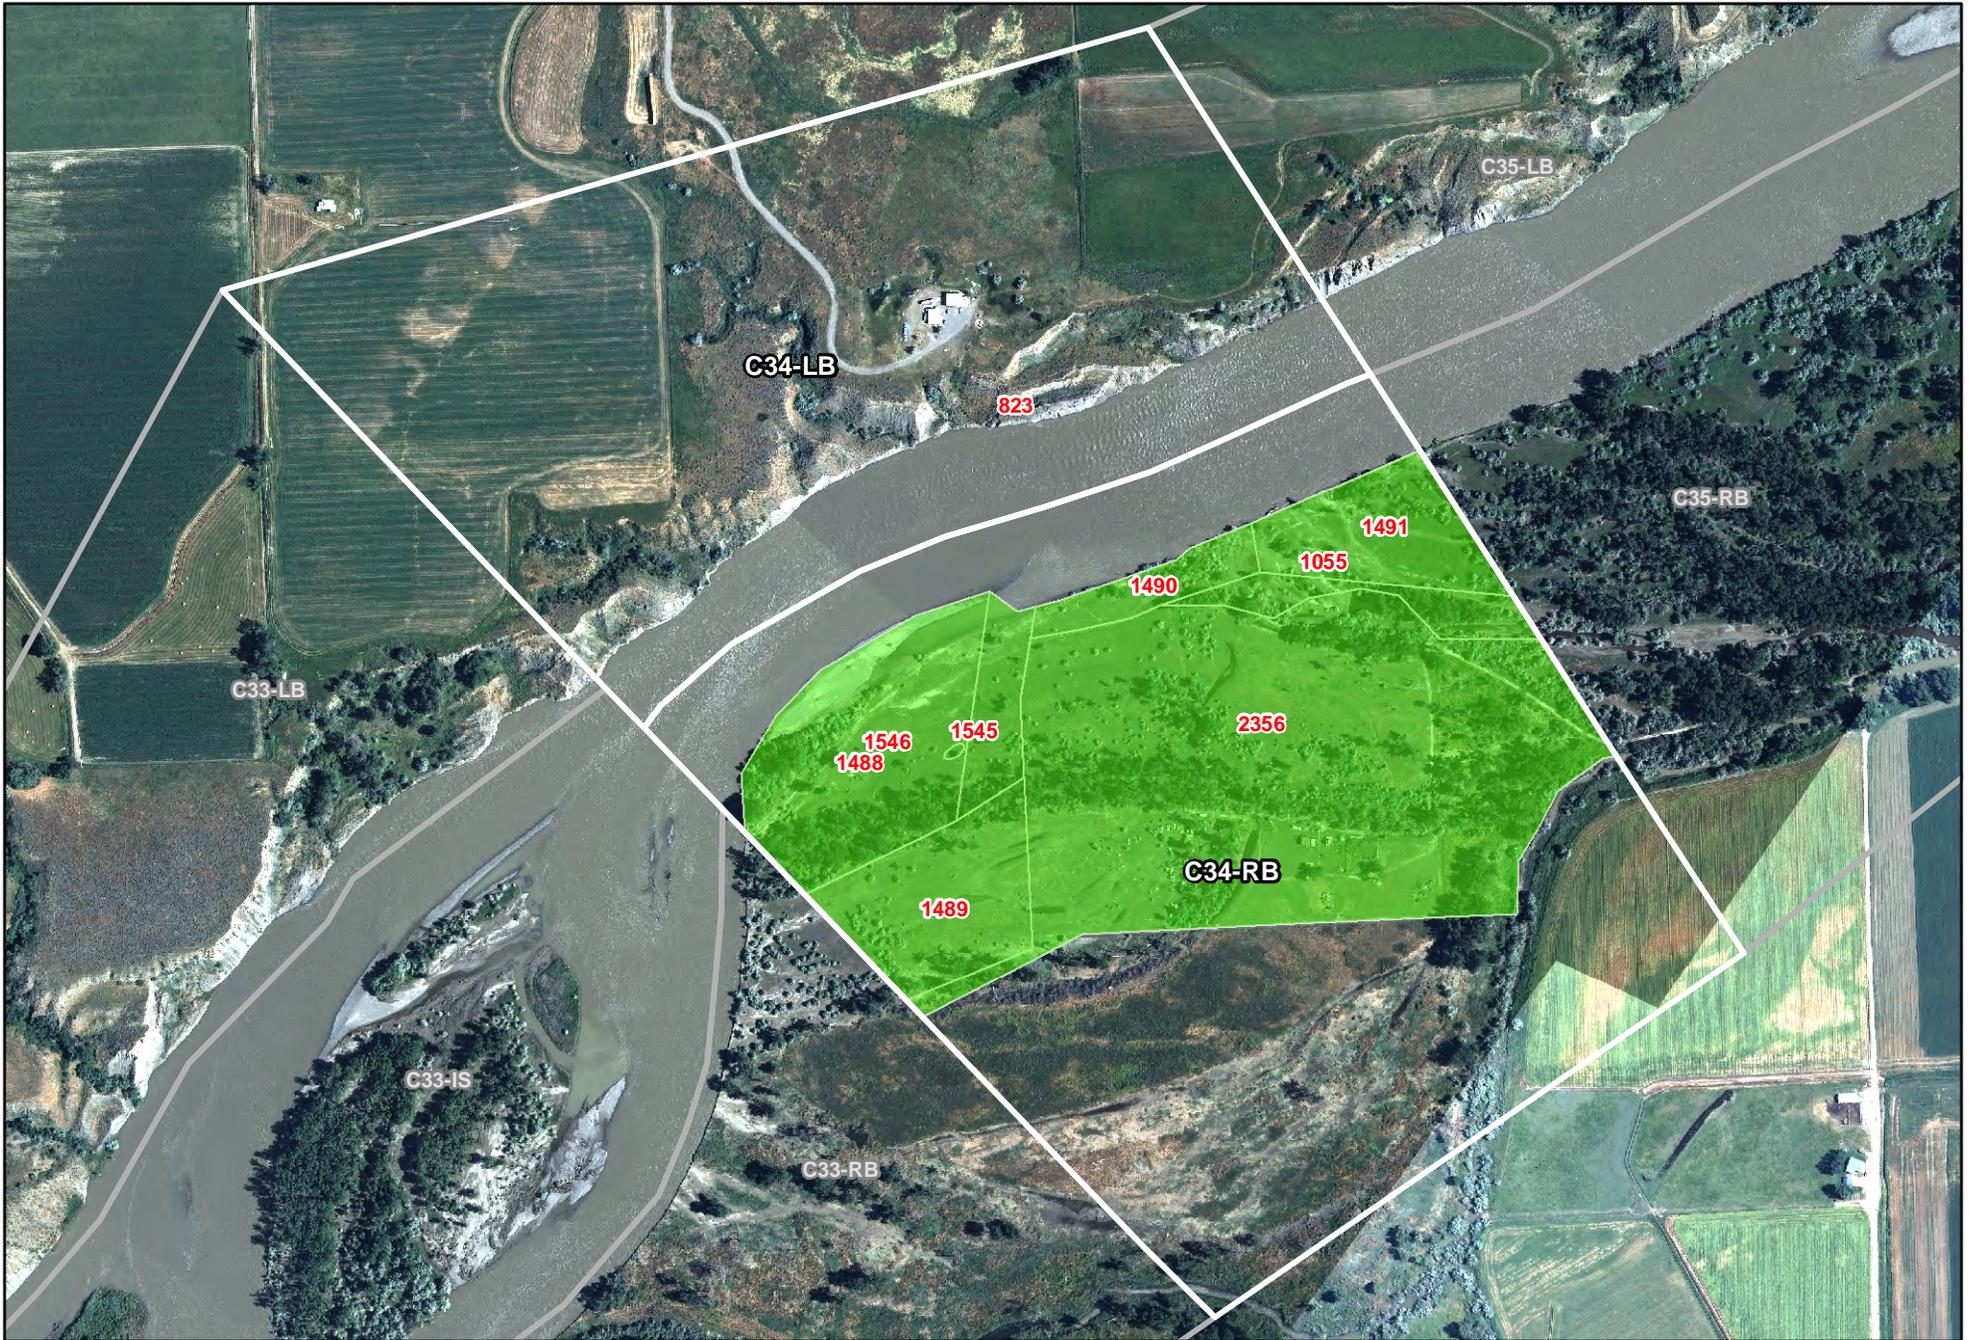
**Figure 4 - Maximum SCAT Observations  
For SCAT Area:**

The SCAT teams used systematic evaluation criteria and treatment method tables approved by the National Oceanic and Atmospheric Administration to provide a standard approach for data collection and conducting field surveys. The forms and sketches from the initial SCAT surveys performed along the river bank (water edge) and floodplain within Area C34 are included in Appendix B. Figure 4 provides the maximum oiling zones observed by the SCAT team during the initial surveys of Area C34.

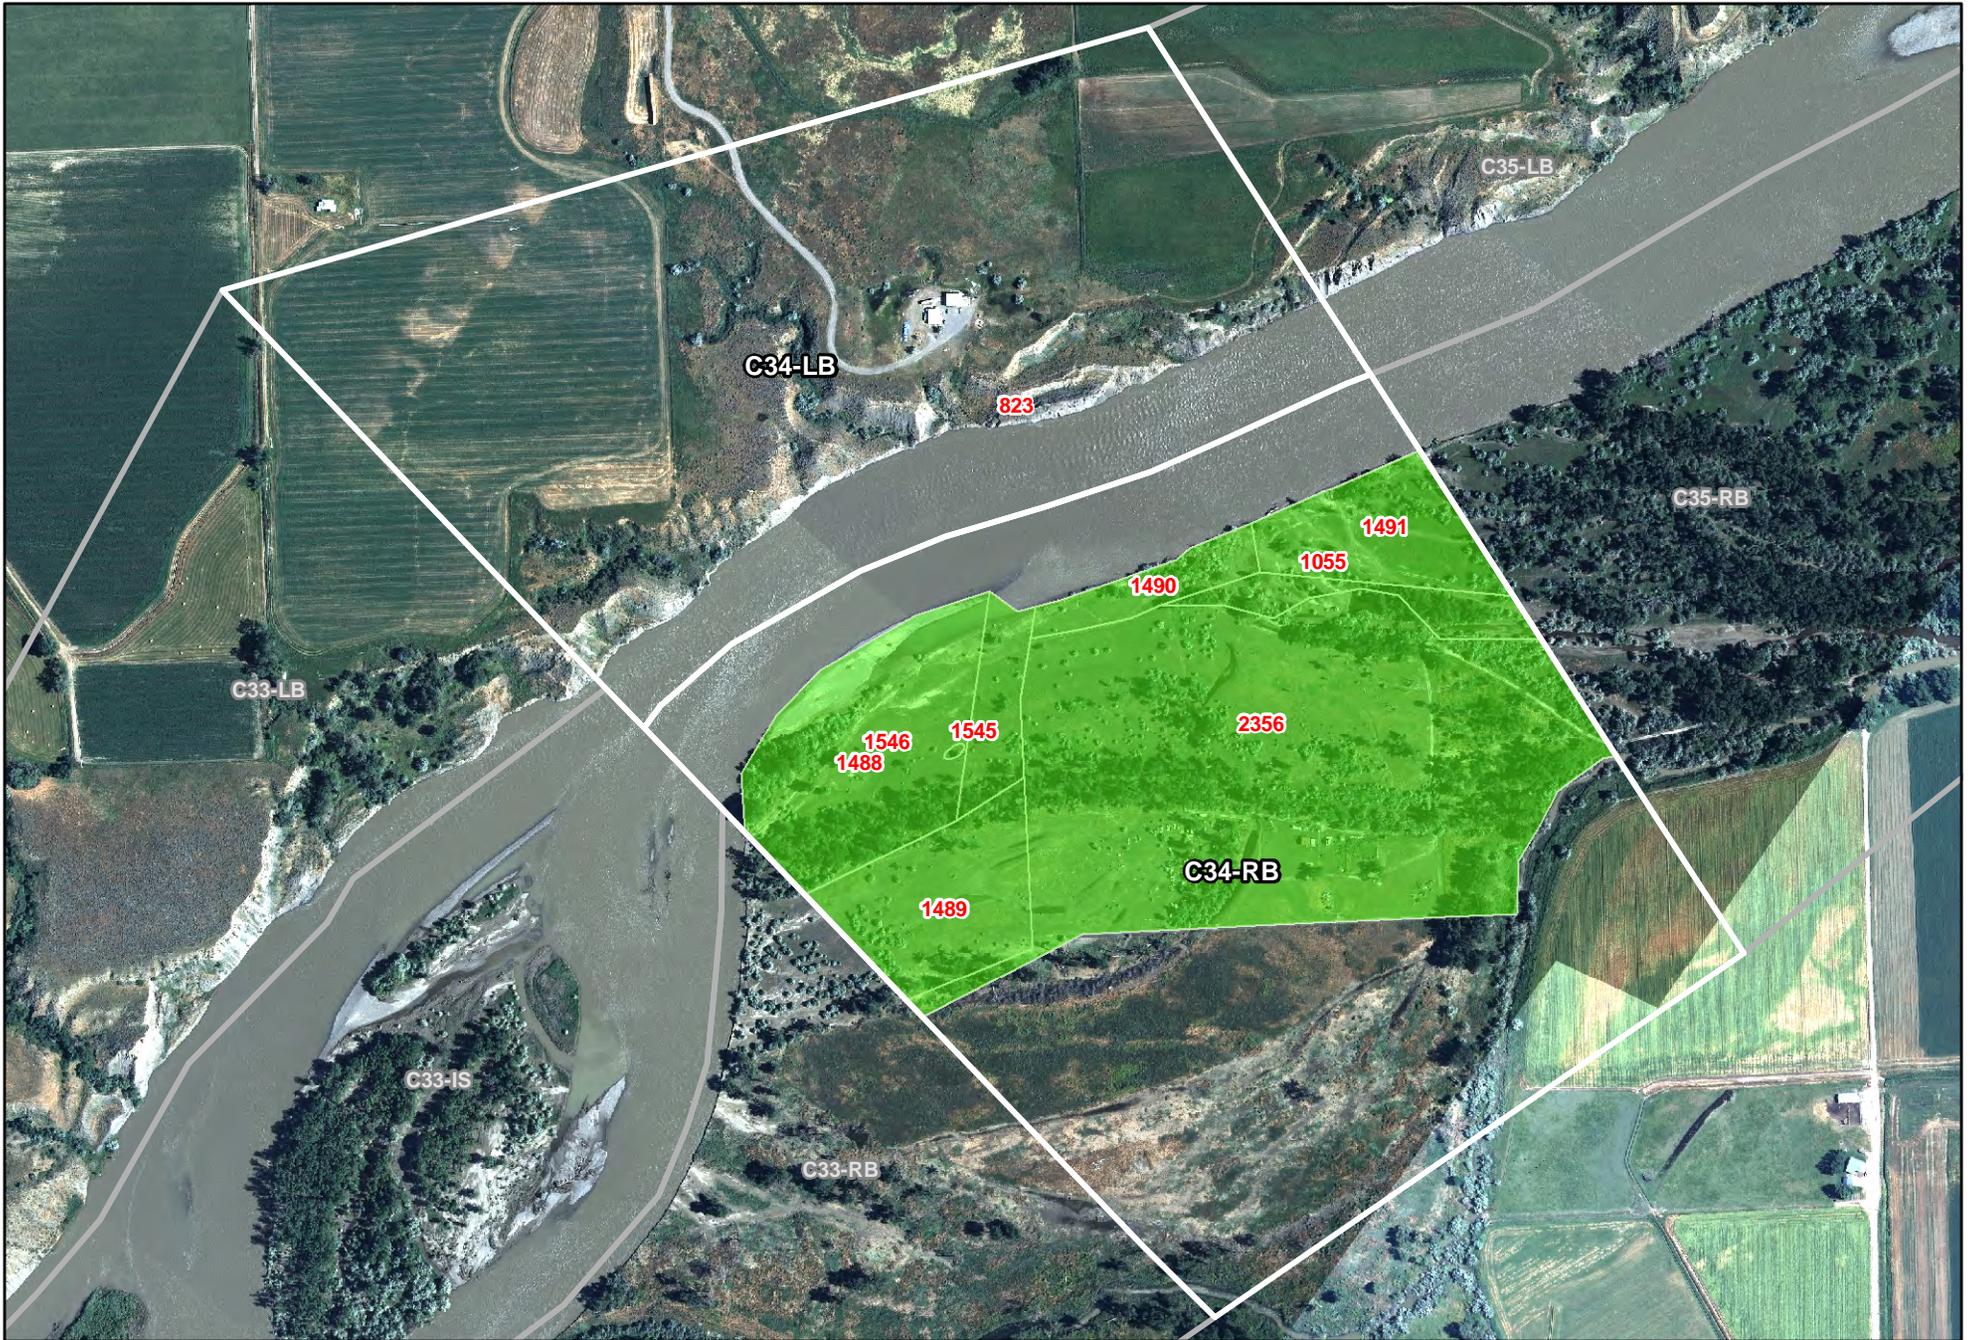
**Figure 5 - Final SCAT Observations**  
**For SCAT Area: C34**

Figure 5 shows the oiling conditions within Area C34 following completion of oil removal activities. The SCAT team performed a final survey of the right bank within SCAT Area C34 to confirm the agreed-upon cleanup endpoints identified in the applicable CTRs had been achieved. The final SCAT survey documentation is presented in Appendix E.

Based on the initial SCAT surveys performed on the left bank, no oil was observed. Based on the final SCAT survey performed on the right bank, no further treatment is recommended for this segment. SCAT Segment Sign-Off Forms are included as Appendix F.

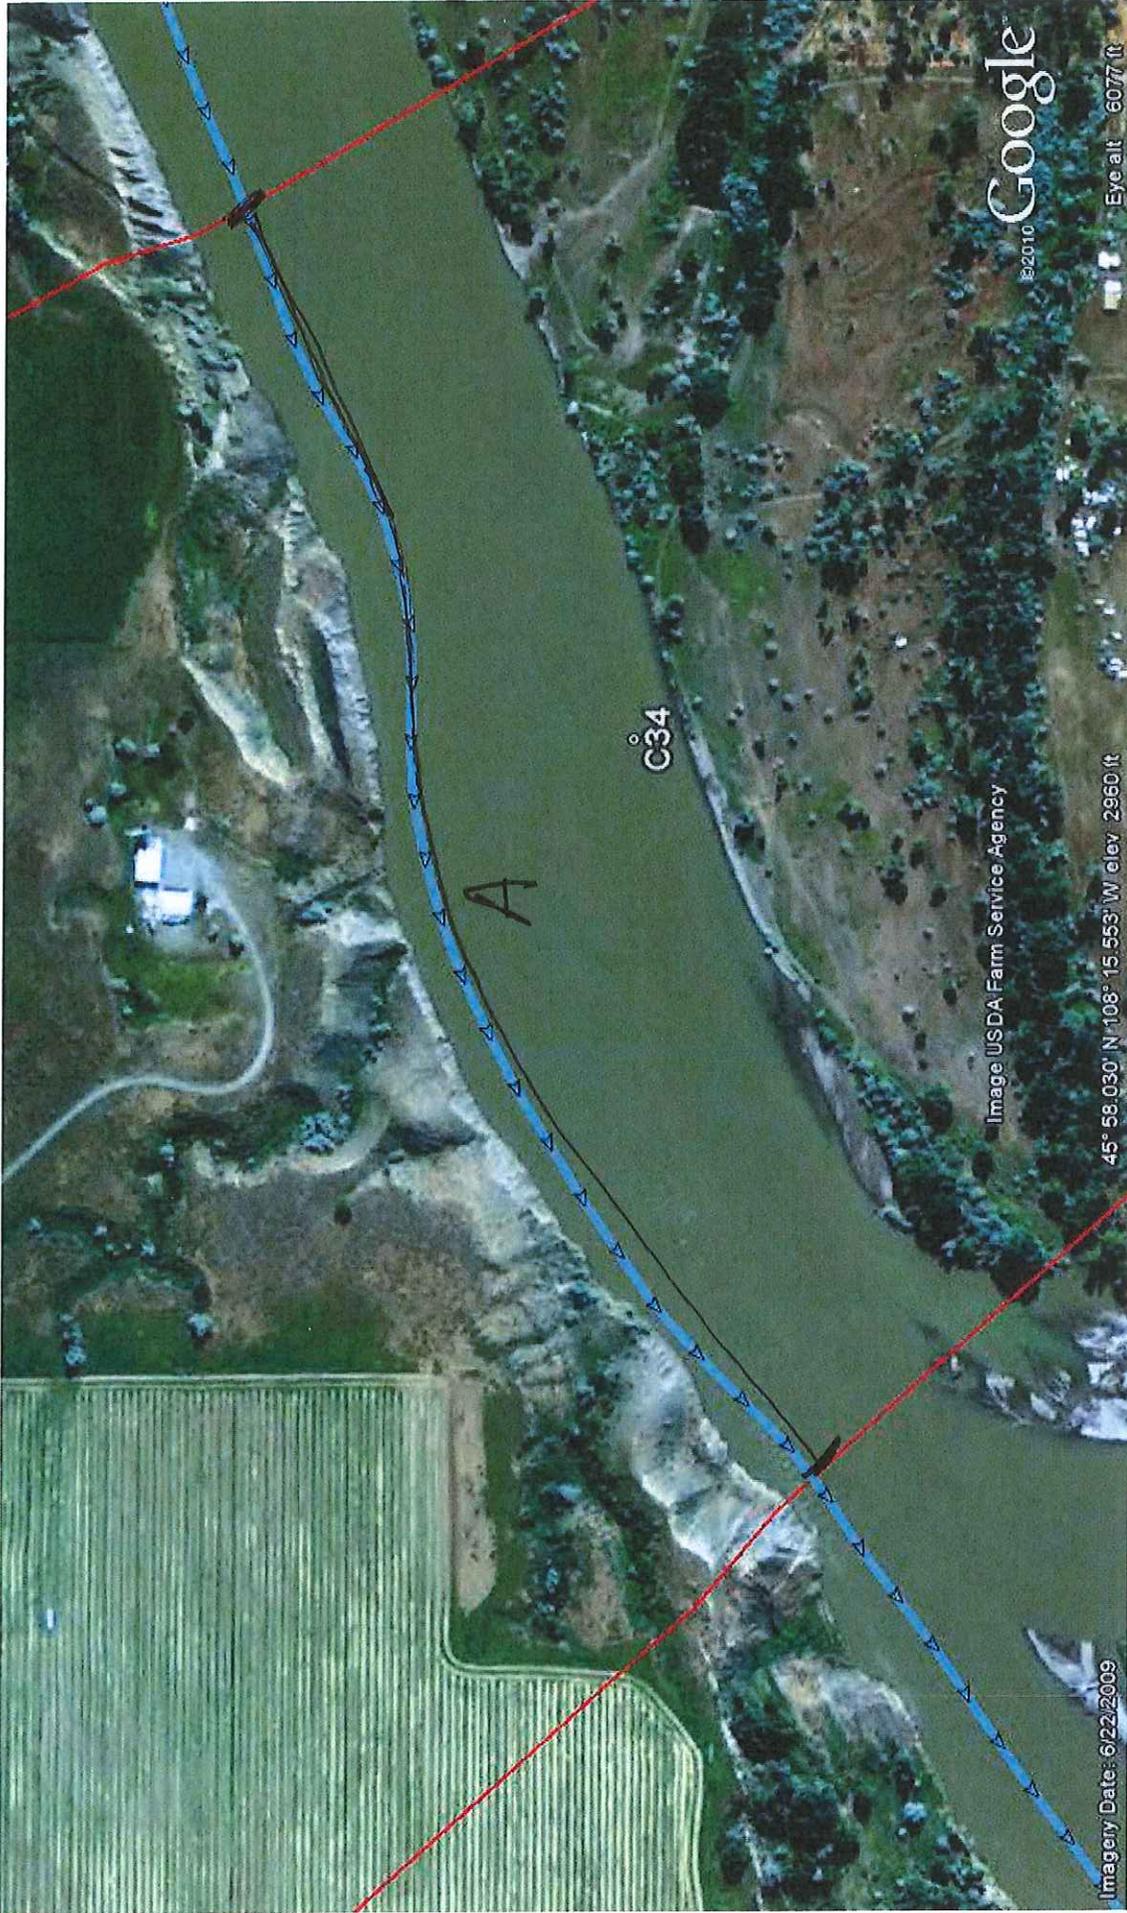
OIL ZONE ID	RIVER BANK ZONE				OIL COVER			OIL THICKNESS					OIL CHARACTER							SUBST. TYPE(S)		
	MS	LB	UB	OB	Length m	Width m	Distrib. %	TO	CV	CT	ST	FL	FR	MS	TB	PT	TC	SR	AP		NO	
A		<u>X</u>			<u>819</u>	<u>1</u>															<u>X</u>	<u>Cliff</u>

Oil height: NO

Zone A : No oil observed; no treatment required.

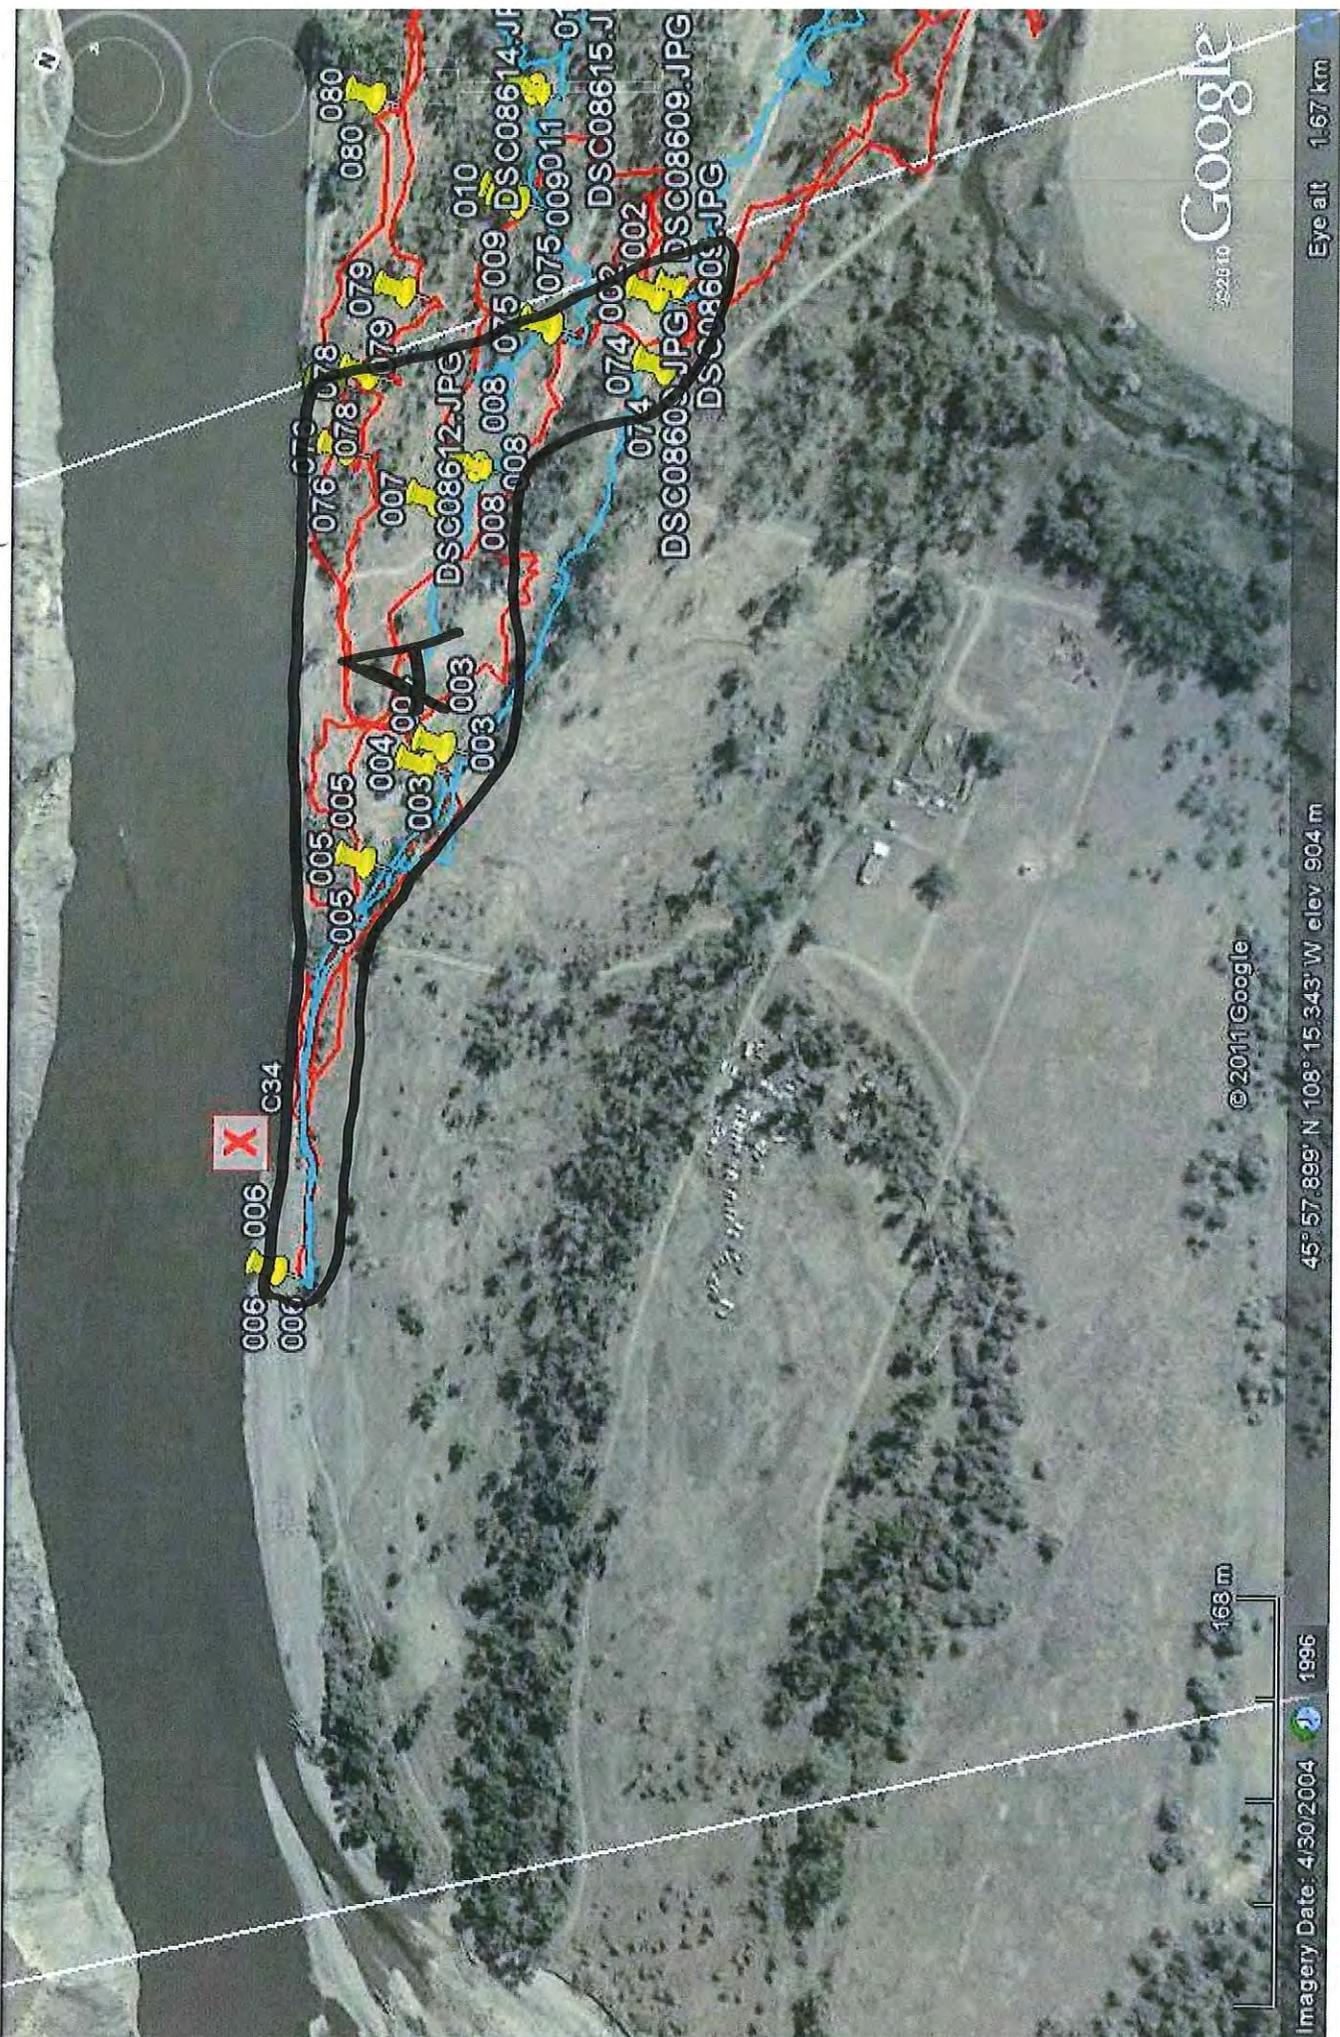
C 34 R July 28, 2011 JEAN I

OIL ZONE	RIVER BANK ZONE				OIL COVER			OIL THICKNESS					OIL CHARACTER							SUBST. TYPE(S)		
	MS	LB	UB	OB	Length m	Width m	Distrib. %	TO	CV	CT	ST	FL	FR	MS	TB	PT	TC	SR	AP		NO	
																						ID
1055 A					450	80	21		X	X	X		X				X					Veg Debris

Oil band heights: 0 - 30 cm

**Treatment Recommendations:**  
Zone: A; Cut and remove oiled grass. Remove oiled debris concentrated in dry stream channels with debris piles.

Refer to current approved treatment methods#1 (Cutting of vegetation, #2 (Dead Vegetation and Small Debris), #3 (Large Woody Debris),

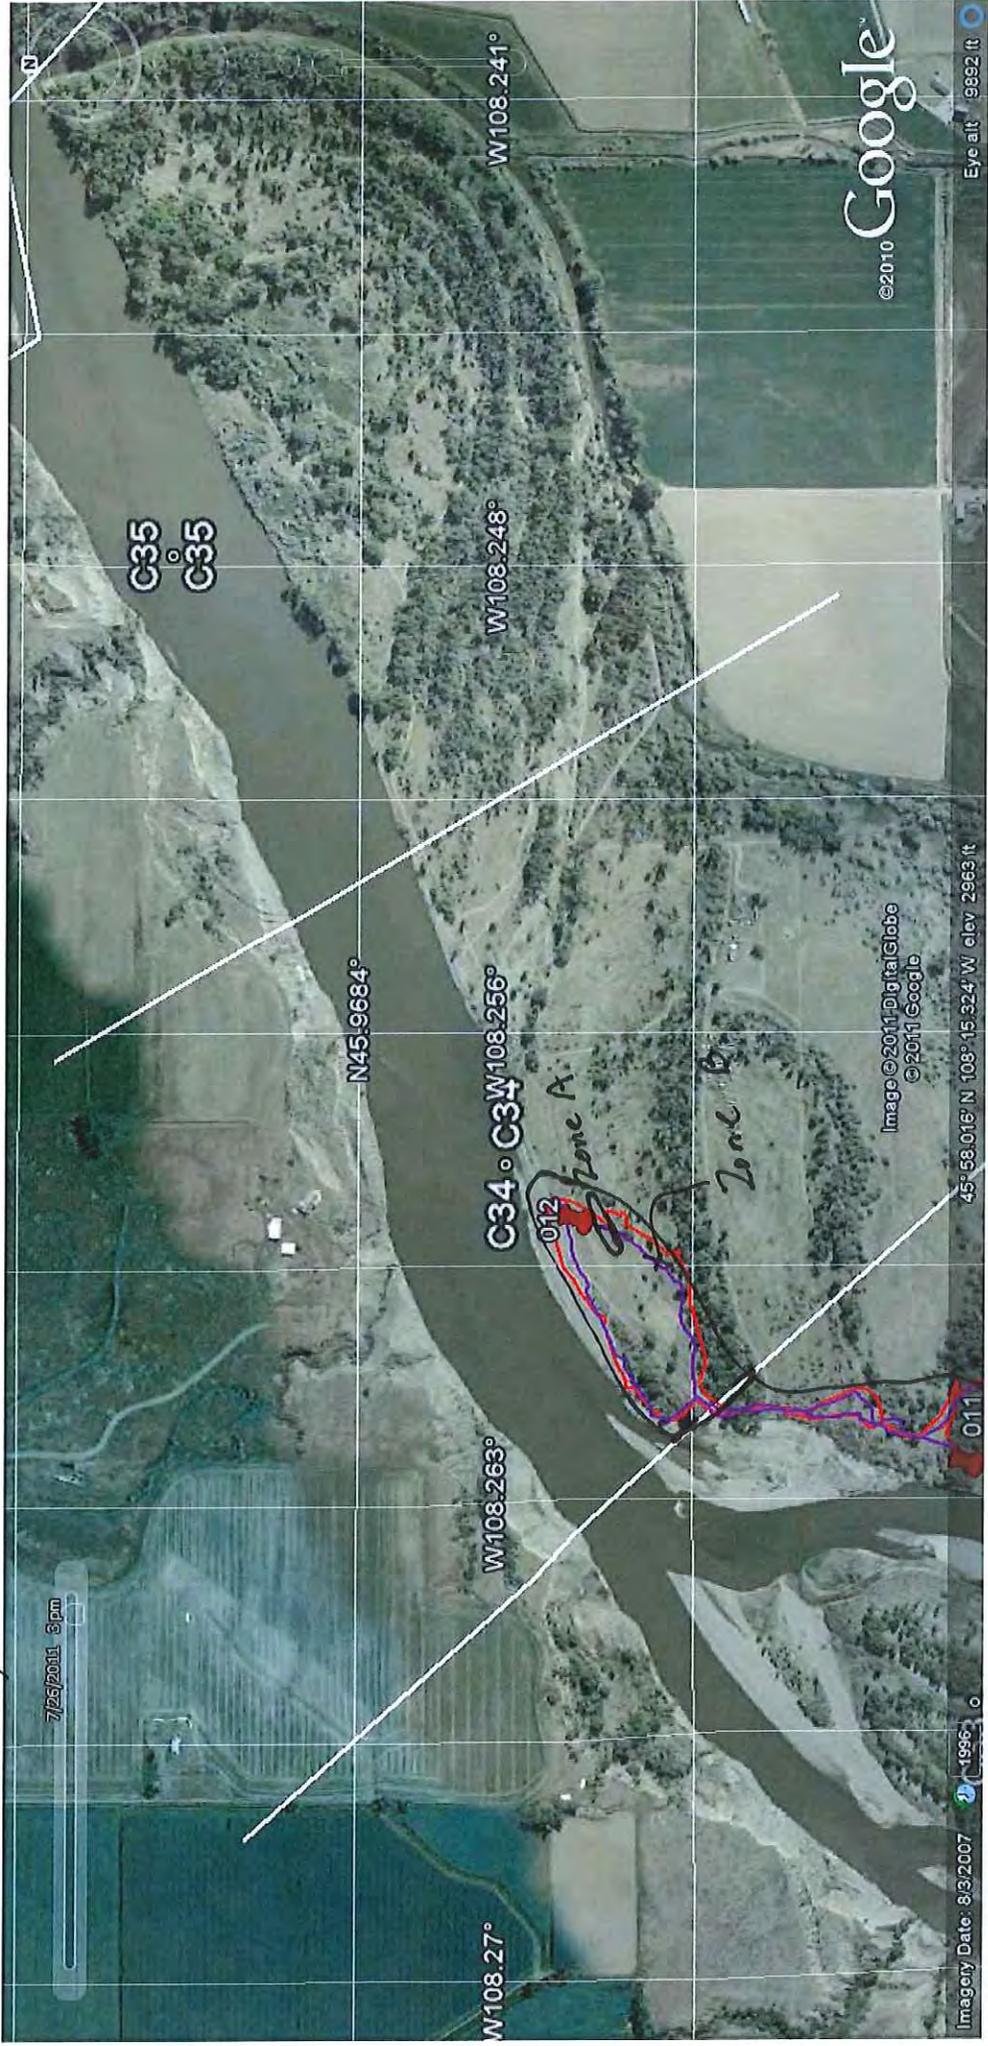
Segment C34 RB  
SCAT Team 3  
14 August 2011  
Partial Survey

This is a partial survey to complement an earlier survey of the segment.  
 Oiling in Zone A is trace oiling on vegetation. The oiling is a tarry stain which is mostly non-transferable. Natural Attenuation or No Further Treatment is appropriate for the oiling in this zone.

Zone A 25m x 10m St & CE on veg / stems Trace 12-14cm up.  
Zone B NOD. 300m x 170m wide
