**SCAT Area Transition Report
for C38**

Silvertip Pipeline Incident
Laurel, Montana

October 23, 2011

Prepared by:
ARCADIS G&M of North Carolina, Inc.
11000 Regency Parkway
West Tower, Suite 205
Cary, North Carolina 27518-8518
Tel 919.469.1952
Fax 919.469.5676

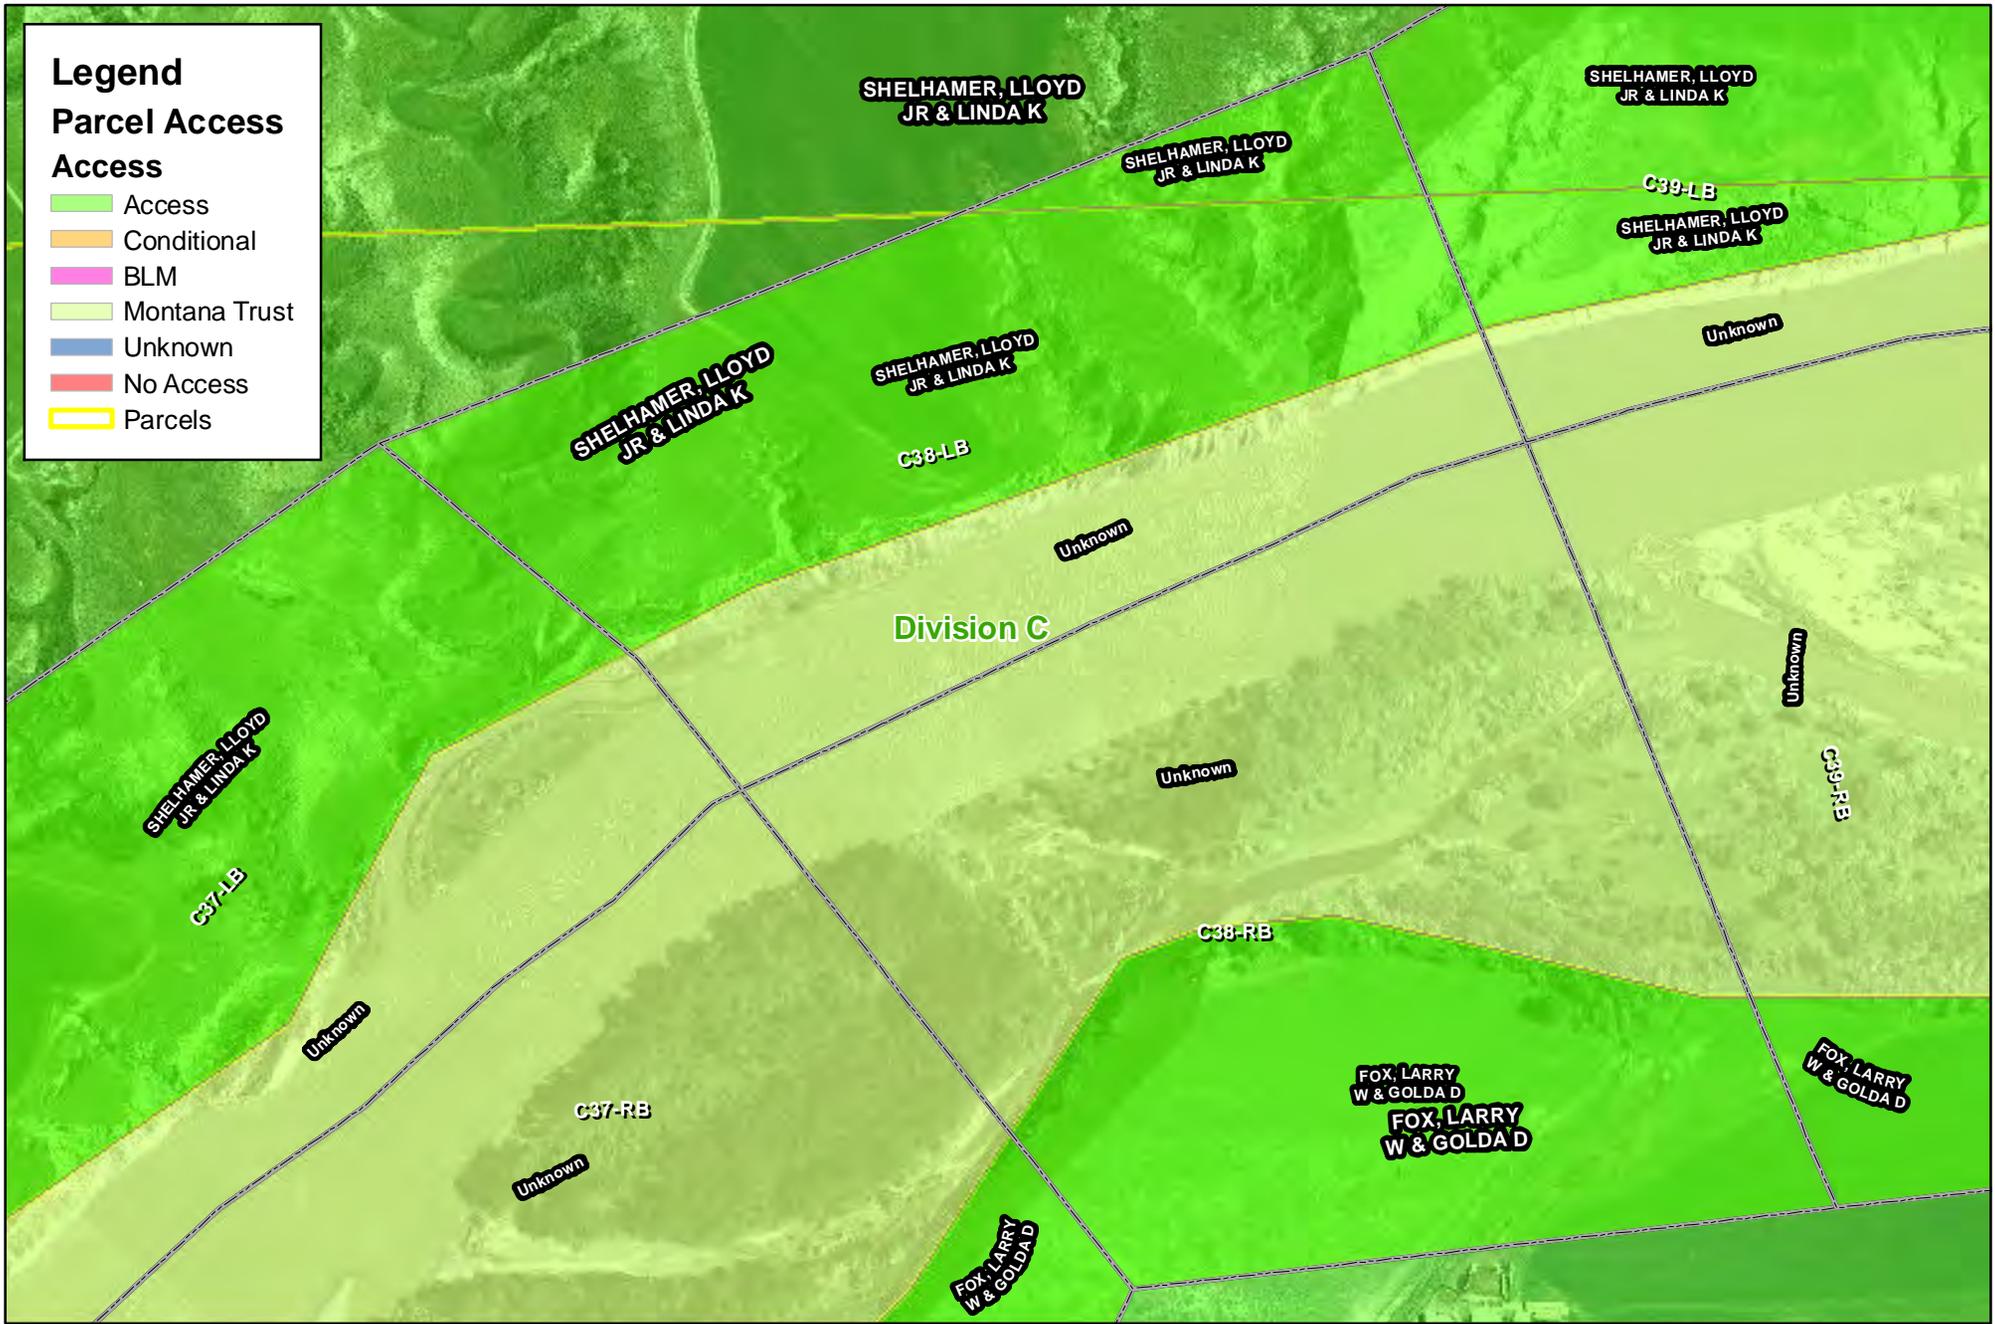
Figure 1 provides an aerial map of SCAT Area C38, along with the (a) SCAT Area boundary, (b) parcel boundaries and respective property owners, and (c) access constraints identified during the oil cleanup process. The acreage surveyed in Area C38 is 13.5. There were no access issues for this area.

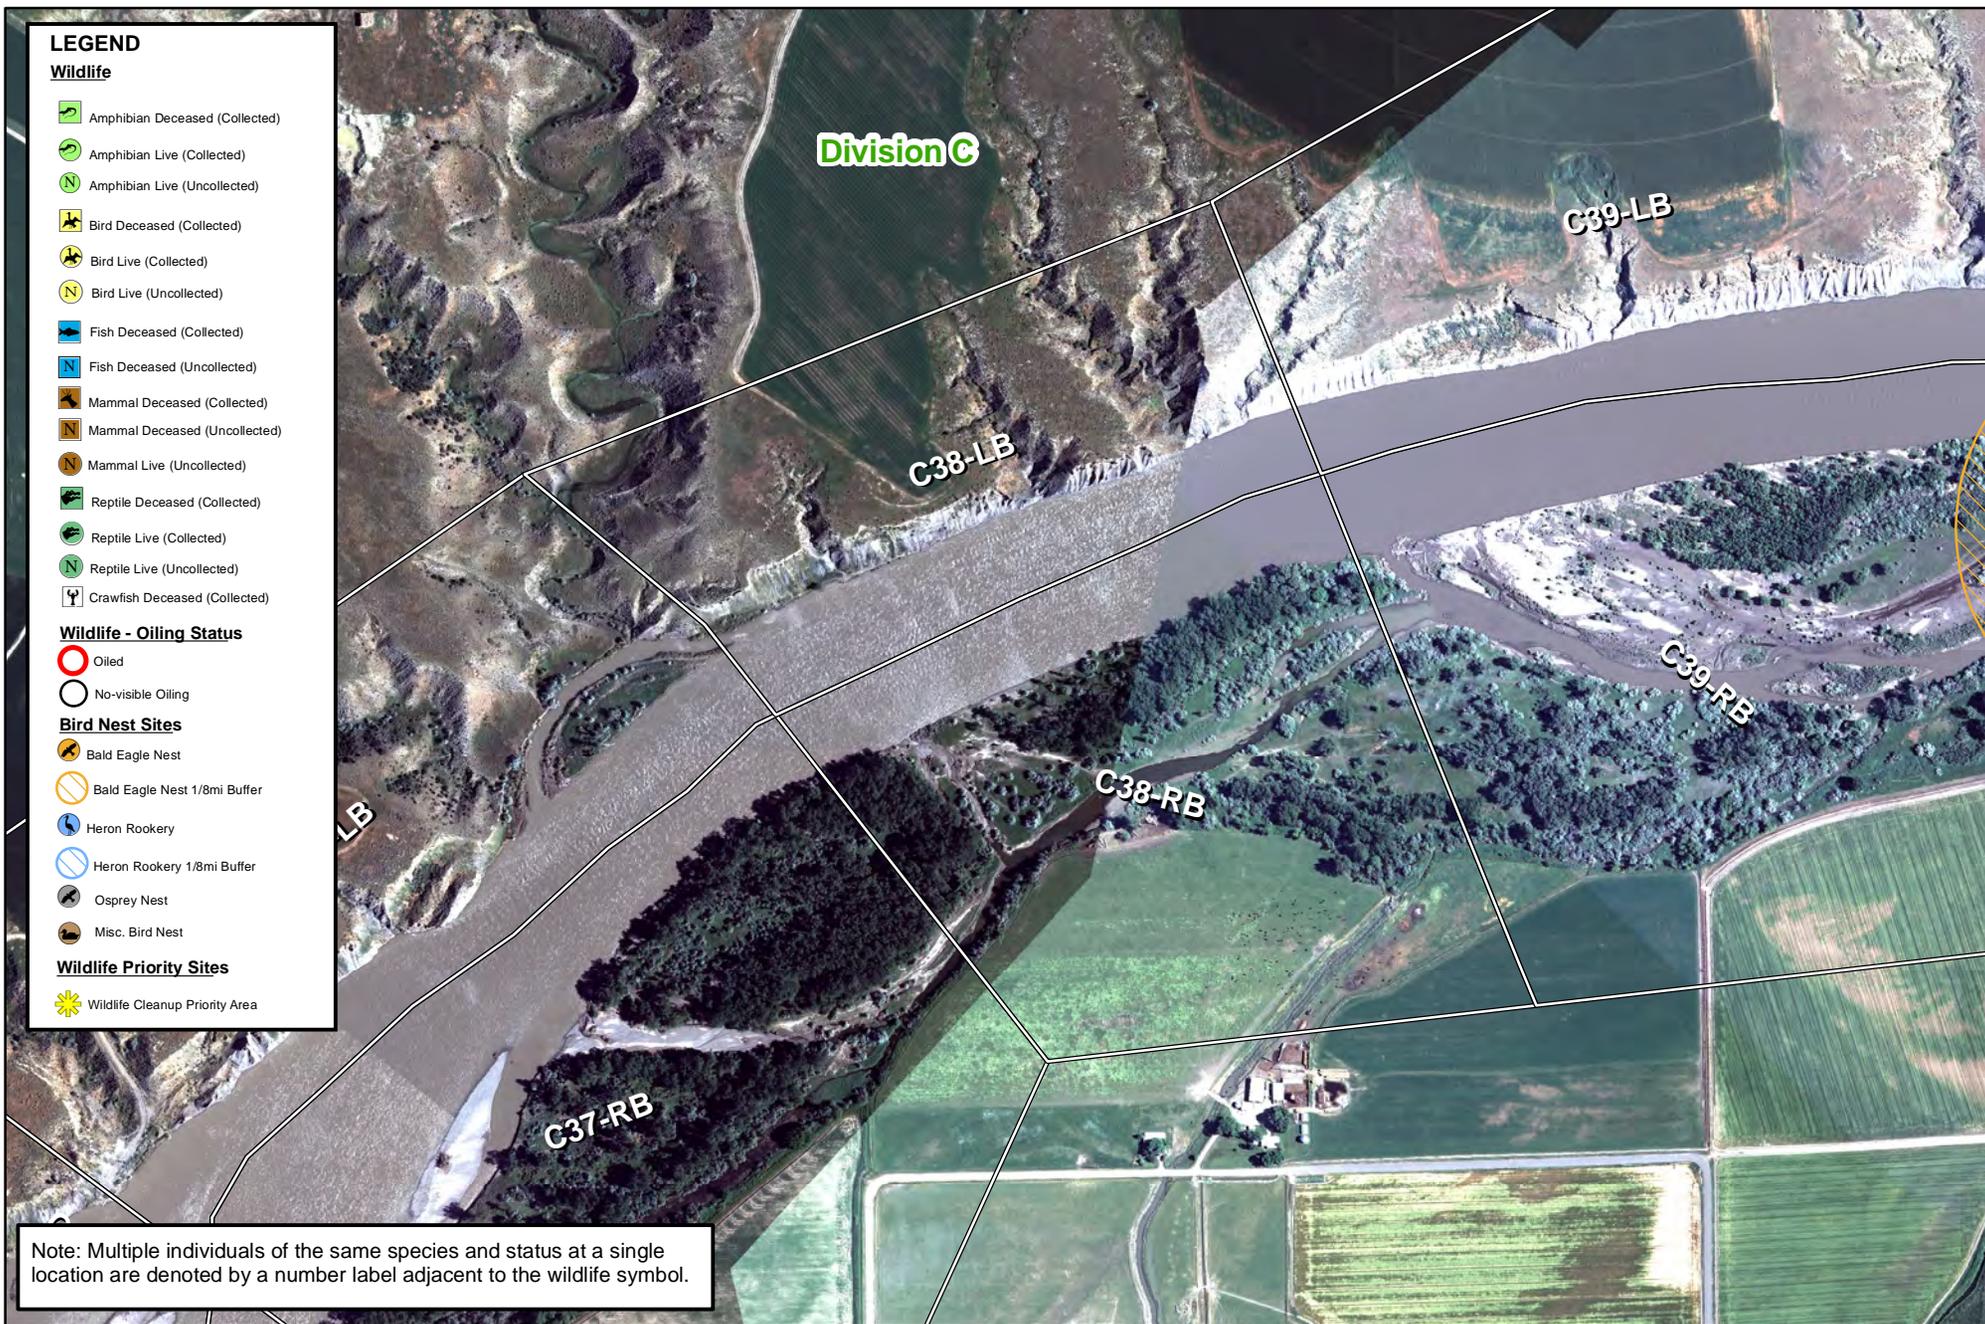
Figure 2
Wildlife Resources

Figure 2 summarizes the natural resources identified in this segment. International Bird Rescue and Resource Advisors from U.S. Fish and Wildlife Service conducted limited inspections of Area C38 due to the low level of oiling in Division C. No oiled wildlife was observed or recovered. No Wildlife Priority Cleanup Areas were identified. No active migratory bird nests were identified in Area C38.

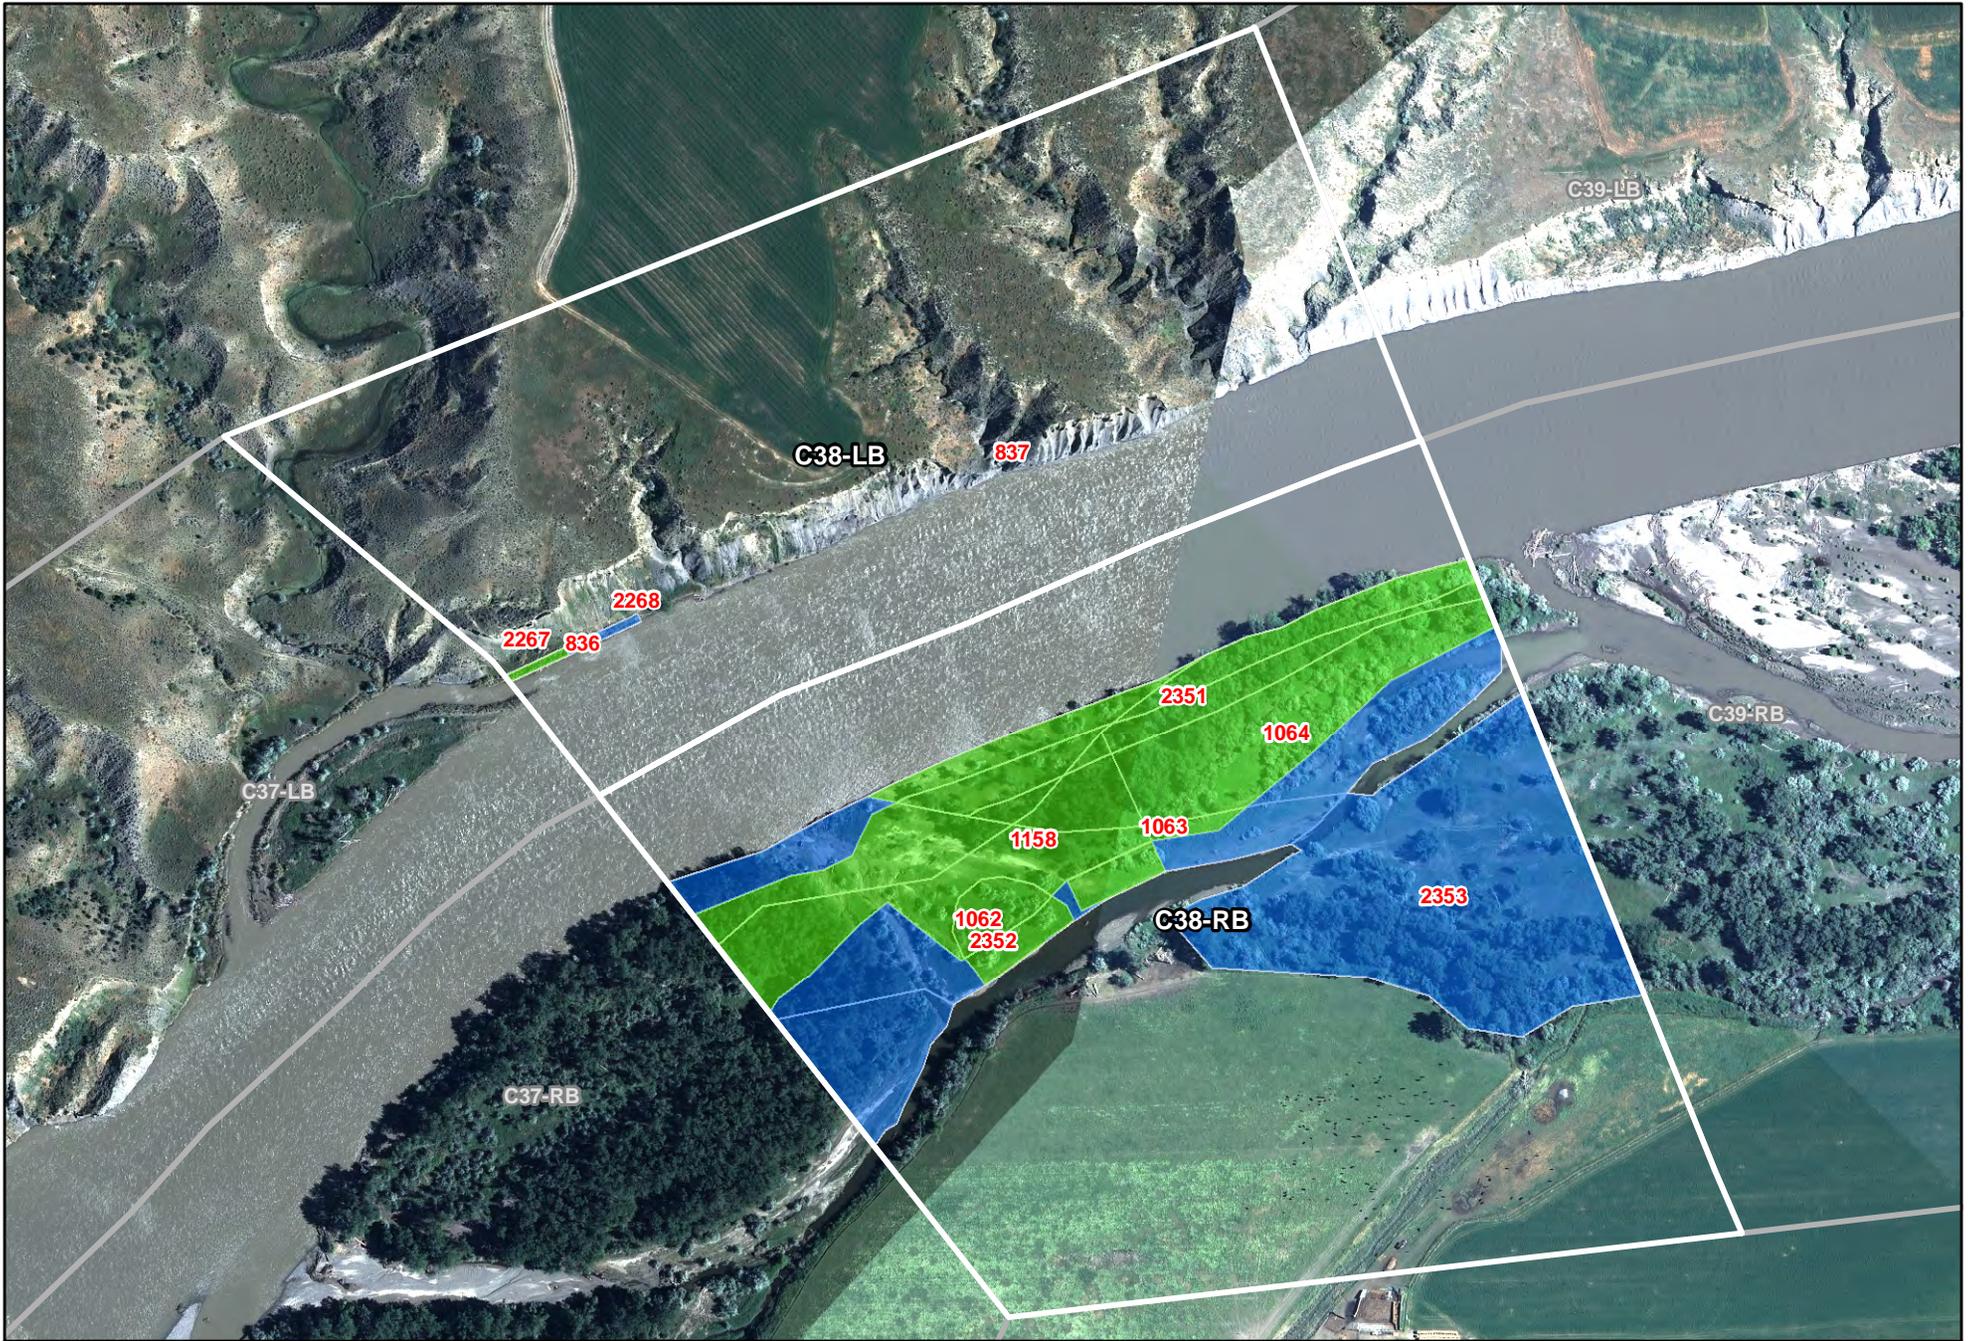
Figure 4 - Maximum SCAT Observations For SCAT Area:

The SCAT teams used systematic evaluation criteria and treatment method tables approved by the National Oceanic and Atmospheric Administration to provide a standard approach for data collection and conducting field surveys. The forms and sketches from the initial SCAT surveys performed along the river bank (water edge) and floodplain within Area C38 are included in Appendix B. Figure 4 provides the maximum oiling zones observed by the SCAT team during the initial surveys of Area C38.

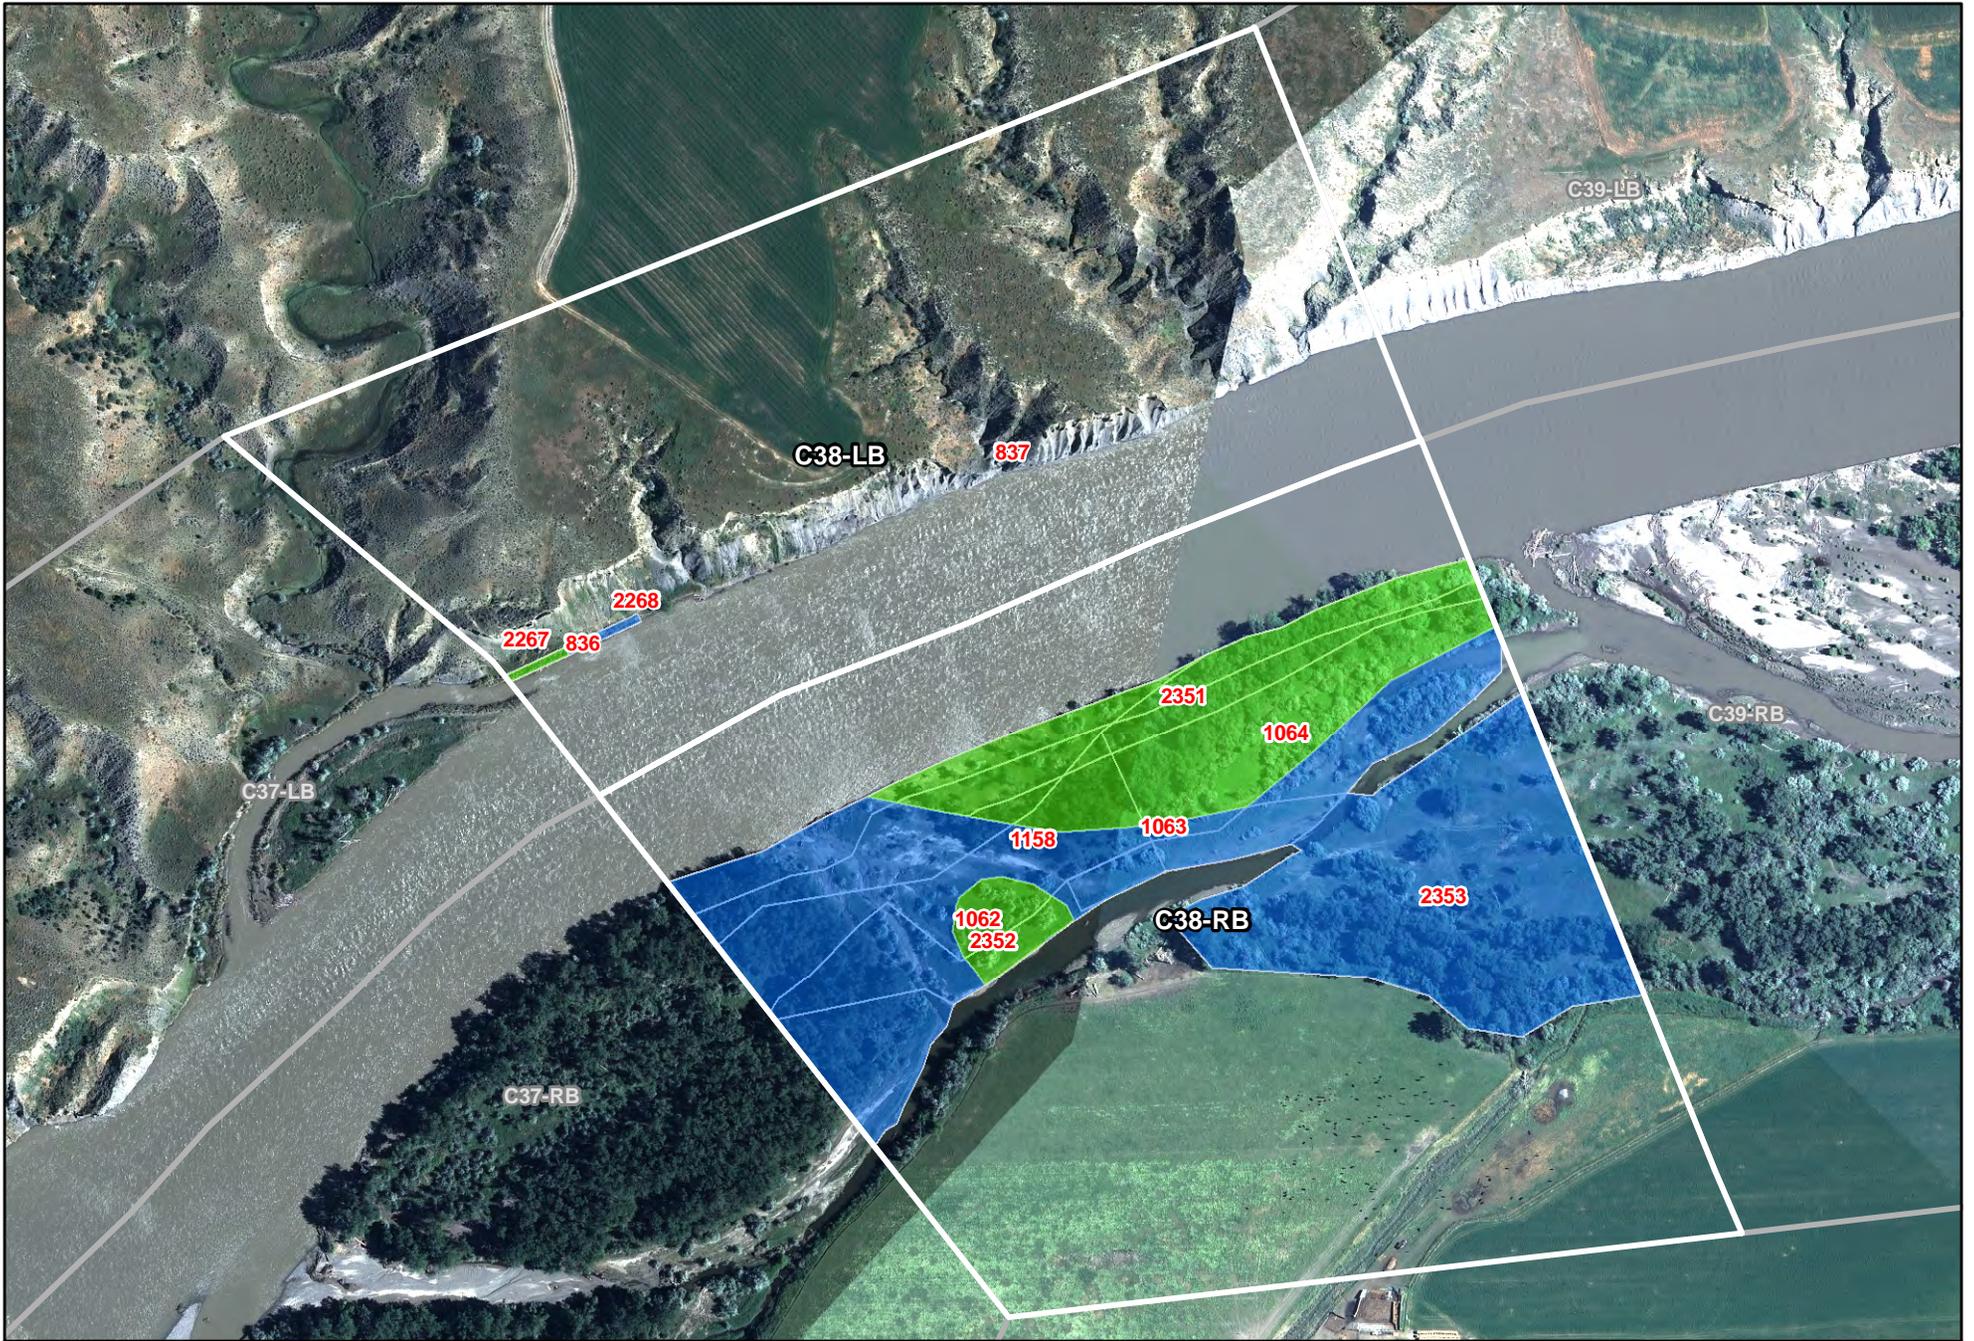
Figure 5 - Final SCAT Observations
For SCAT Area: C38

Figure 5 shows the oiling conditions within Area C38 following completion of oil removal activities. The SCAT team performed final surveys of the left and right banks within SCAT Area C38 to confirm the agreed-upon cleanup endpoints identified in the applicable CTRs had been achieved. The final SCAT survey documentation is presented in Appendix E.

Based on the final SCAT surveys performed on the left and right banks within Area C38, no further treatment is recommended for these segments. SCAT Segment Sign-Off Forms are included as Appendix F.

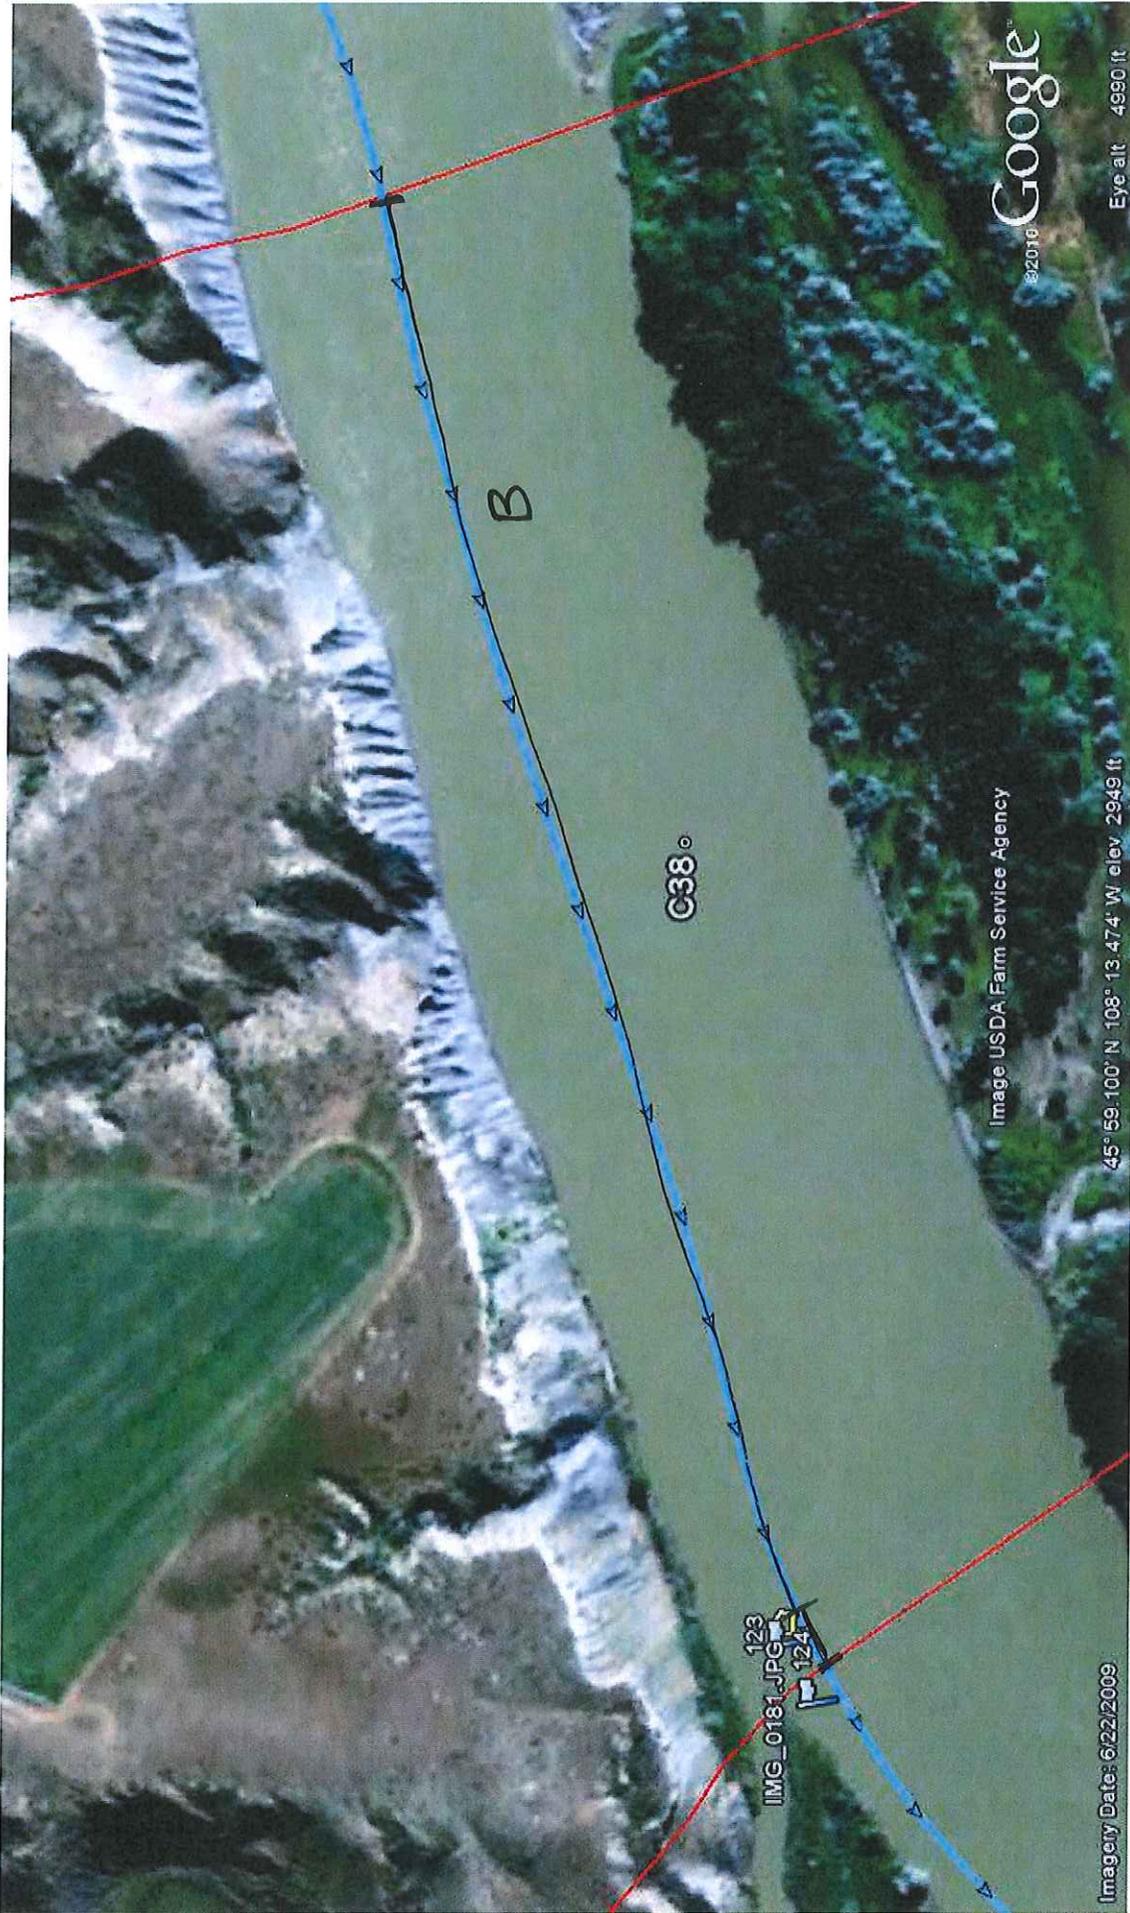
OIL ZONE ID	RIVER BANK ZONE				OIL COVER			OIL THICKNESS					OIL CHARACTER							SUBST. TYPE(S)		
	MS	LB	UB	OB	Length m	Width m	Distrib. %	TO	CV	CT	ST	FL	FR	MS	TB	PT	TC	SR	AP		NO	
A				X	20	1	100			X	X		X									Grass, trees
B		X			577	1														X		Cliff, trees

Oil height: 90cm

Zone B : No oil observed; no treatment required.

B slats @ seg. bound.

Zone A : Cut & remove oil coated vegetation smaller than 1" diameter. Remove debris smaller than 4" diameter. Wipe larger oil coated vegetation.

*Refer to current approved treatment methods #1 (Cutting of Vegetation), #2 (Dead Vegetation and Small Debris), #3 (Large Woody Debris), #6 (Sorbent Use), # (Unconsolidated Sediments)

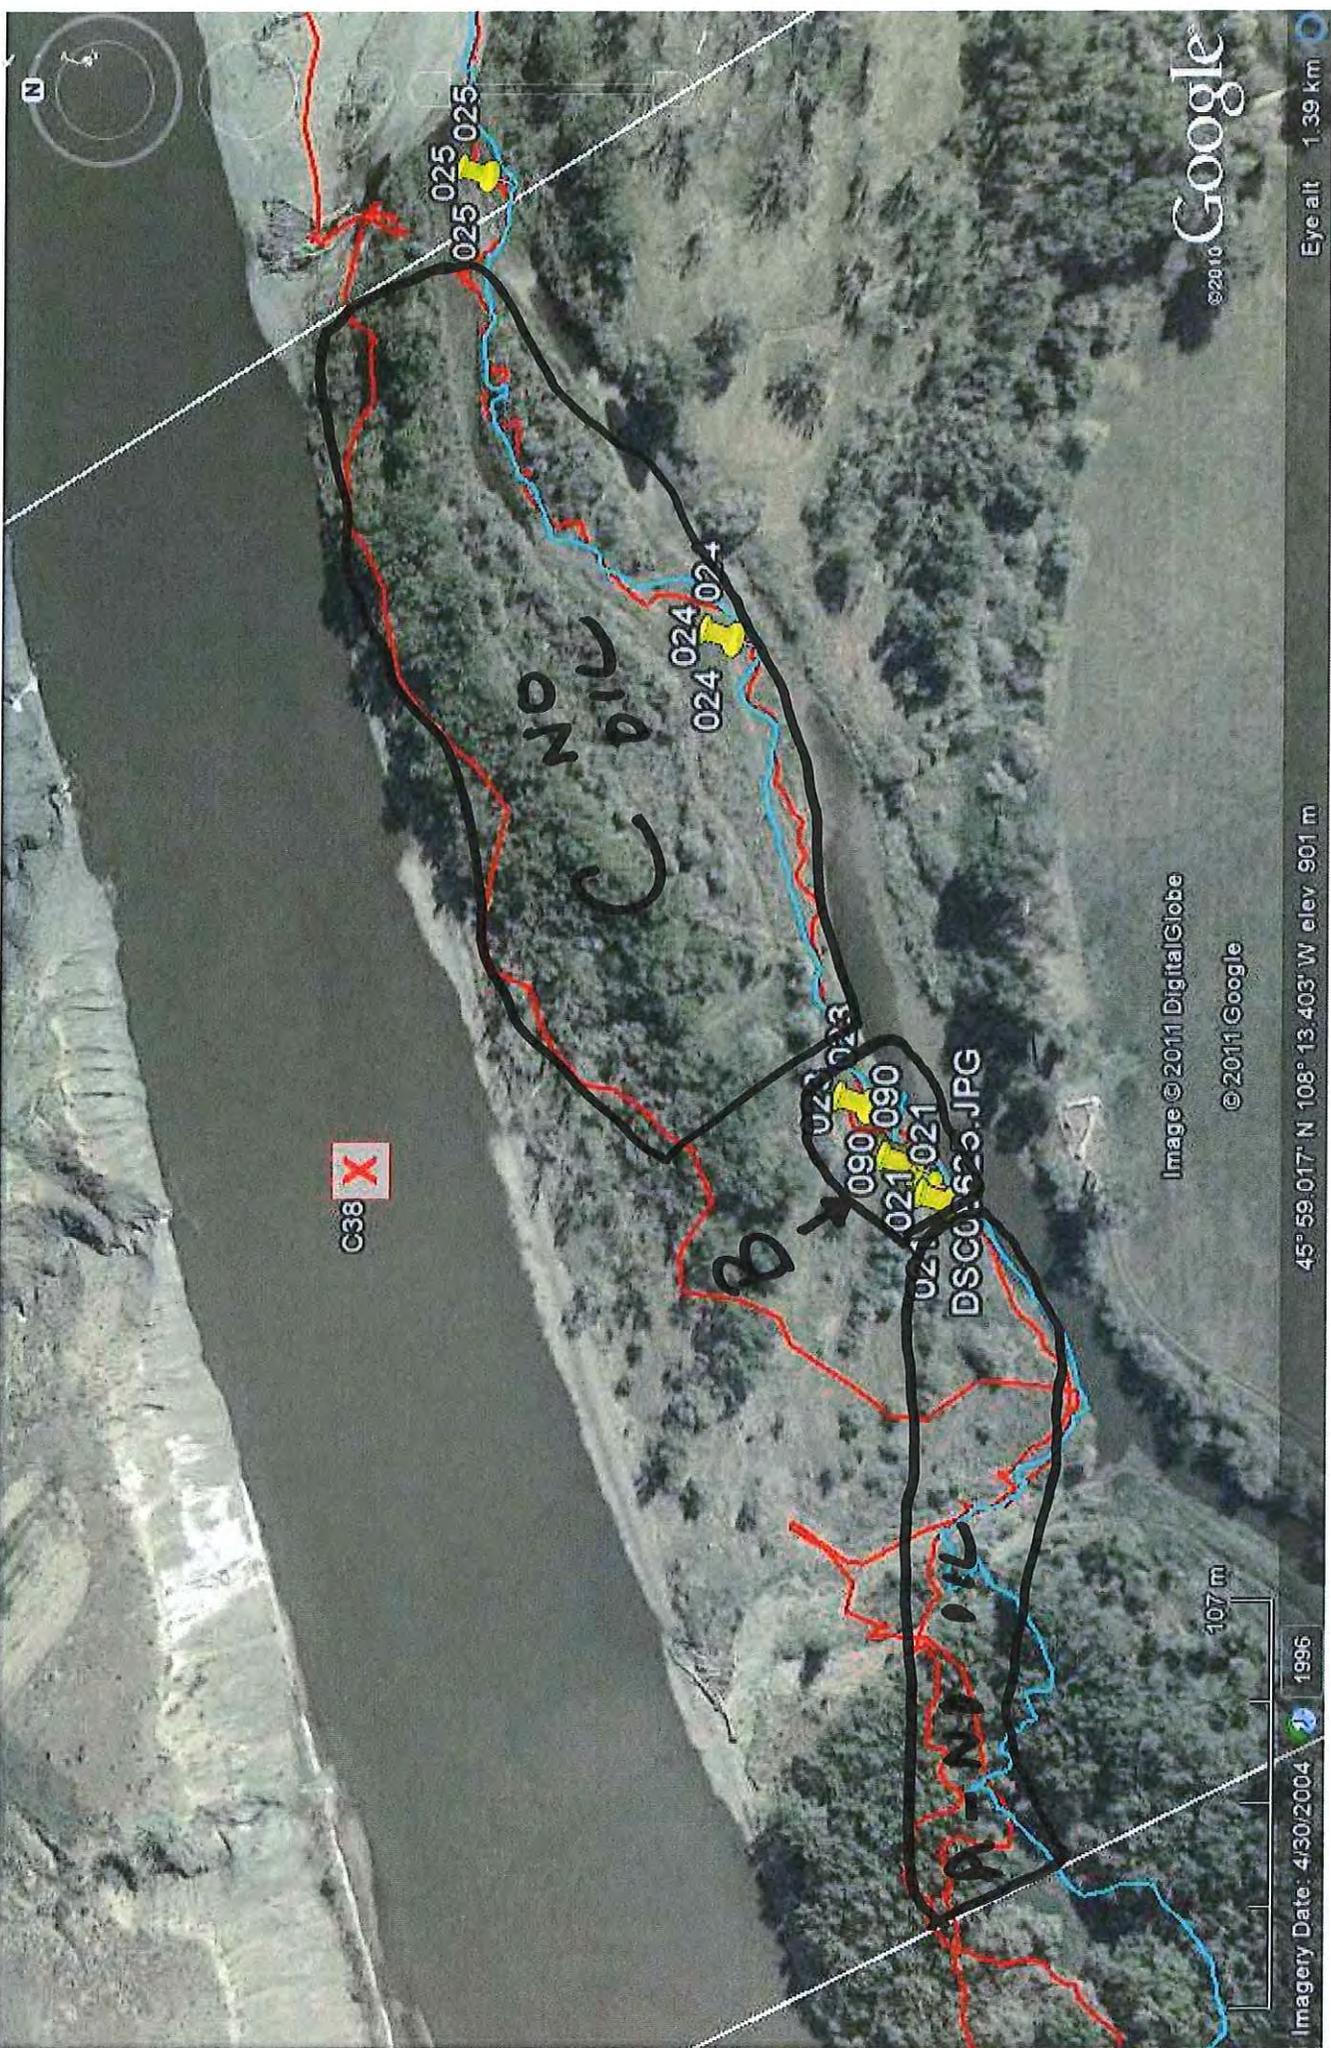
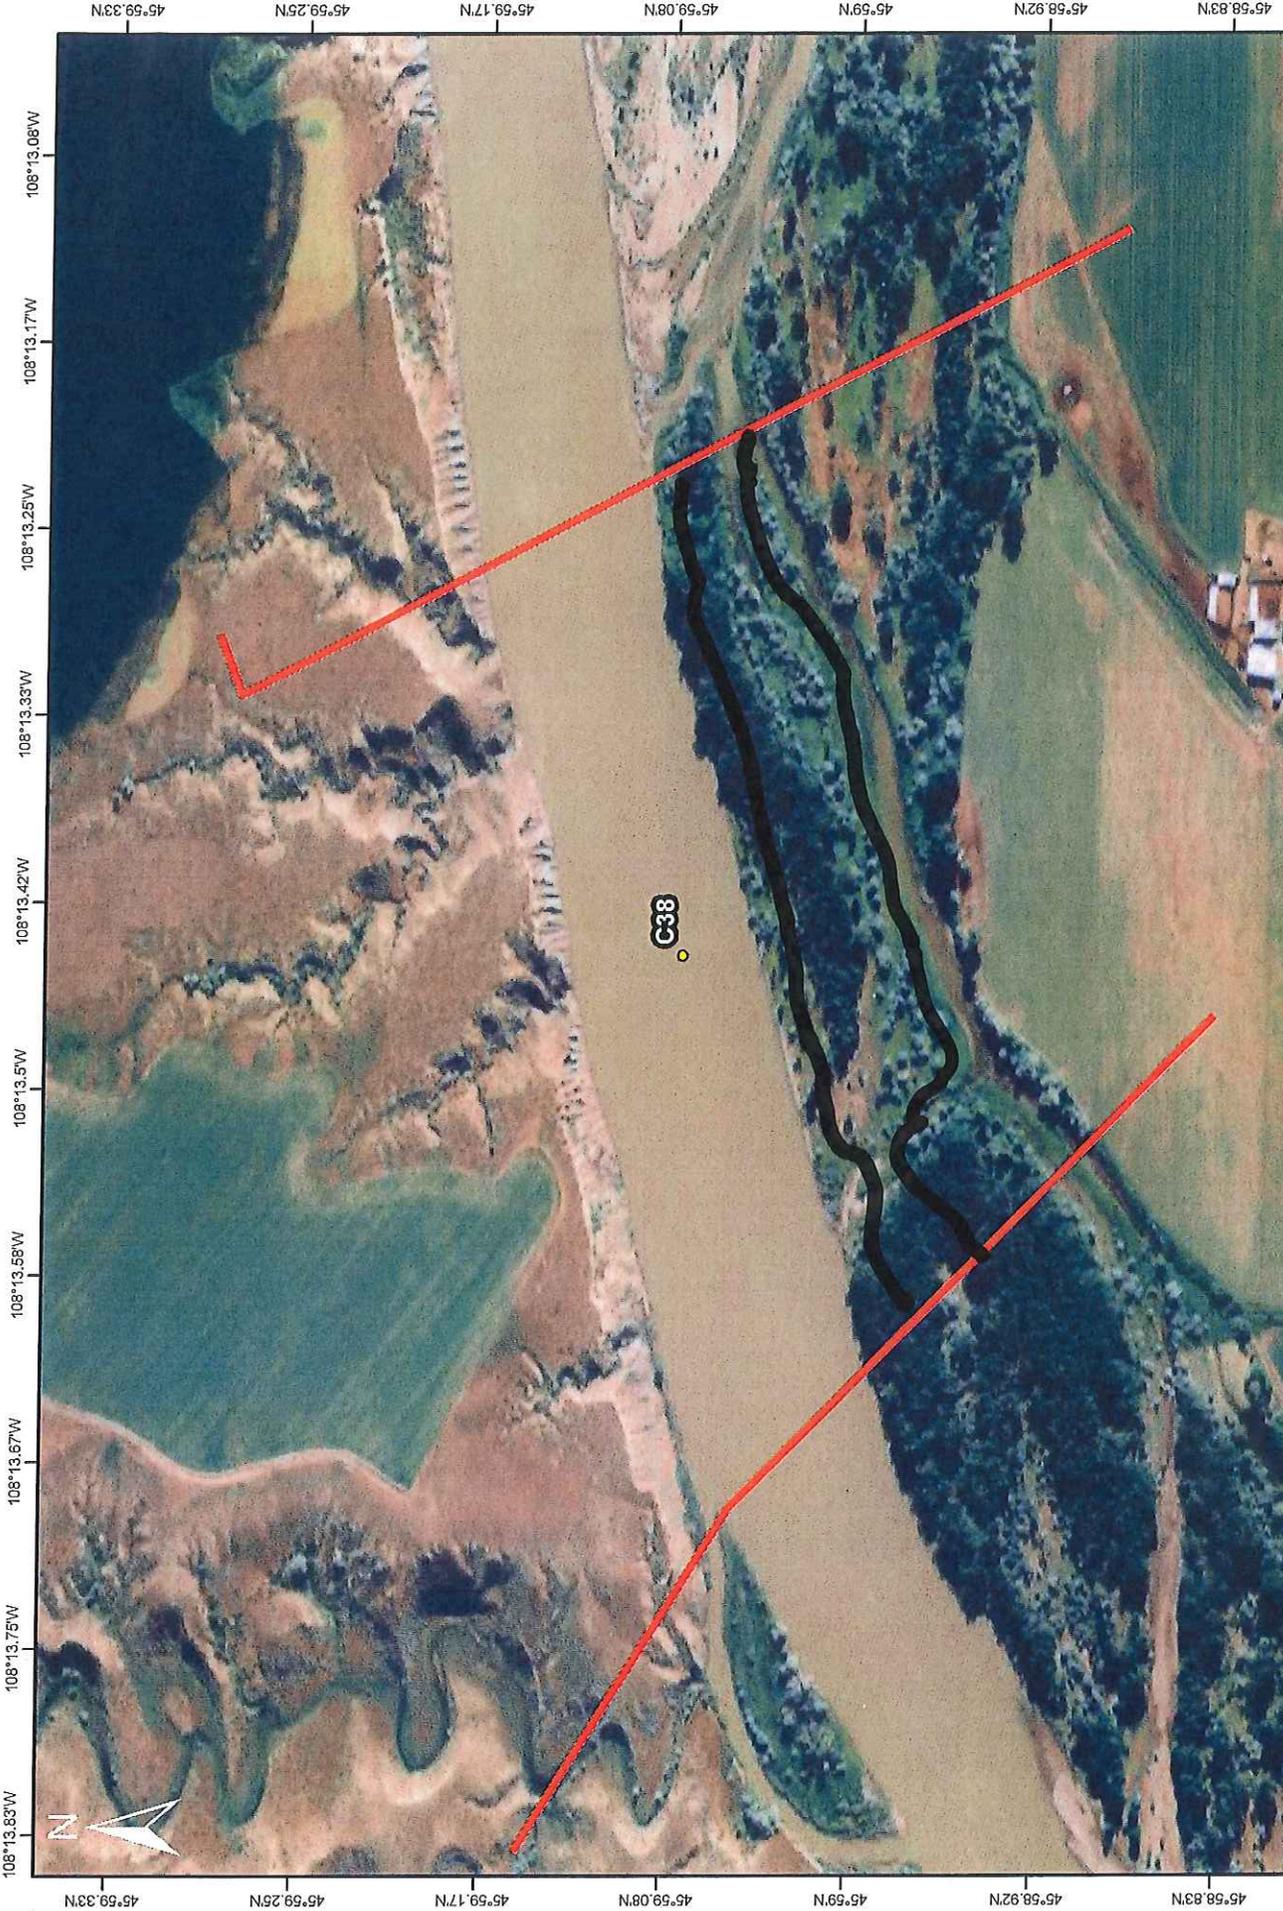
C 38 R July 28, 2011 Team 3

Oil band heights: 0-30cm

Treatment Recommendations:
Zone : A, C; no oil observed
Zone B : Cut and remove oiled grass. Remove oiled debris concentrated in dry stream channels with debris piles.

Zone A

Refer to current approved treatment methods#1 (Cutting of vegetation, #2 (Dead Vegetation and Small Debris), #3 (Large Woody Debris), #

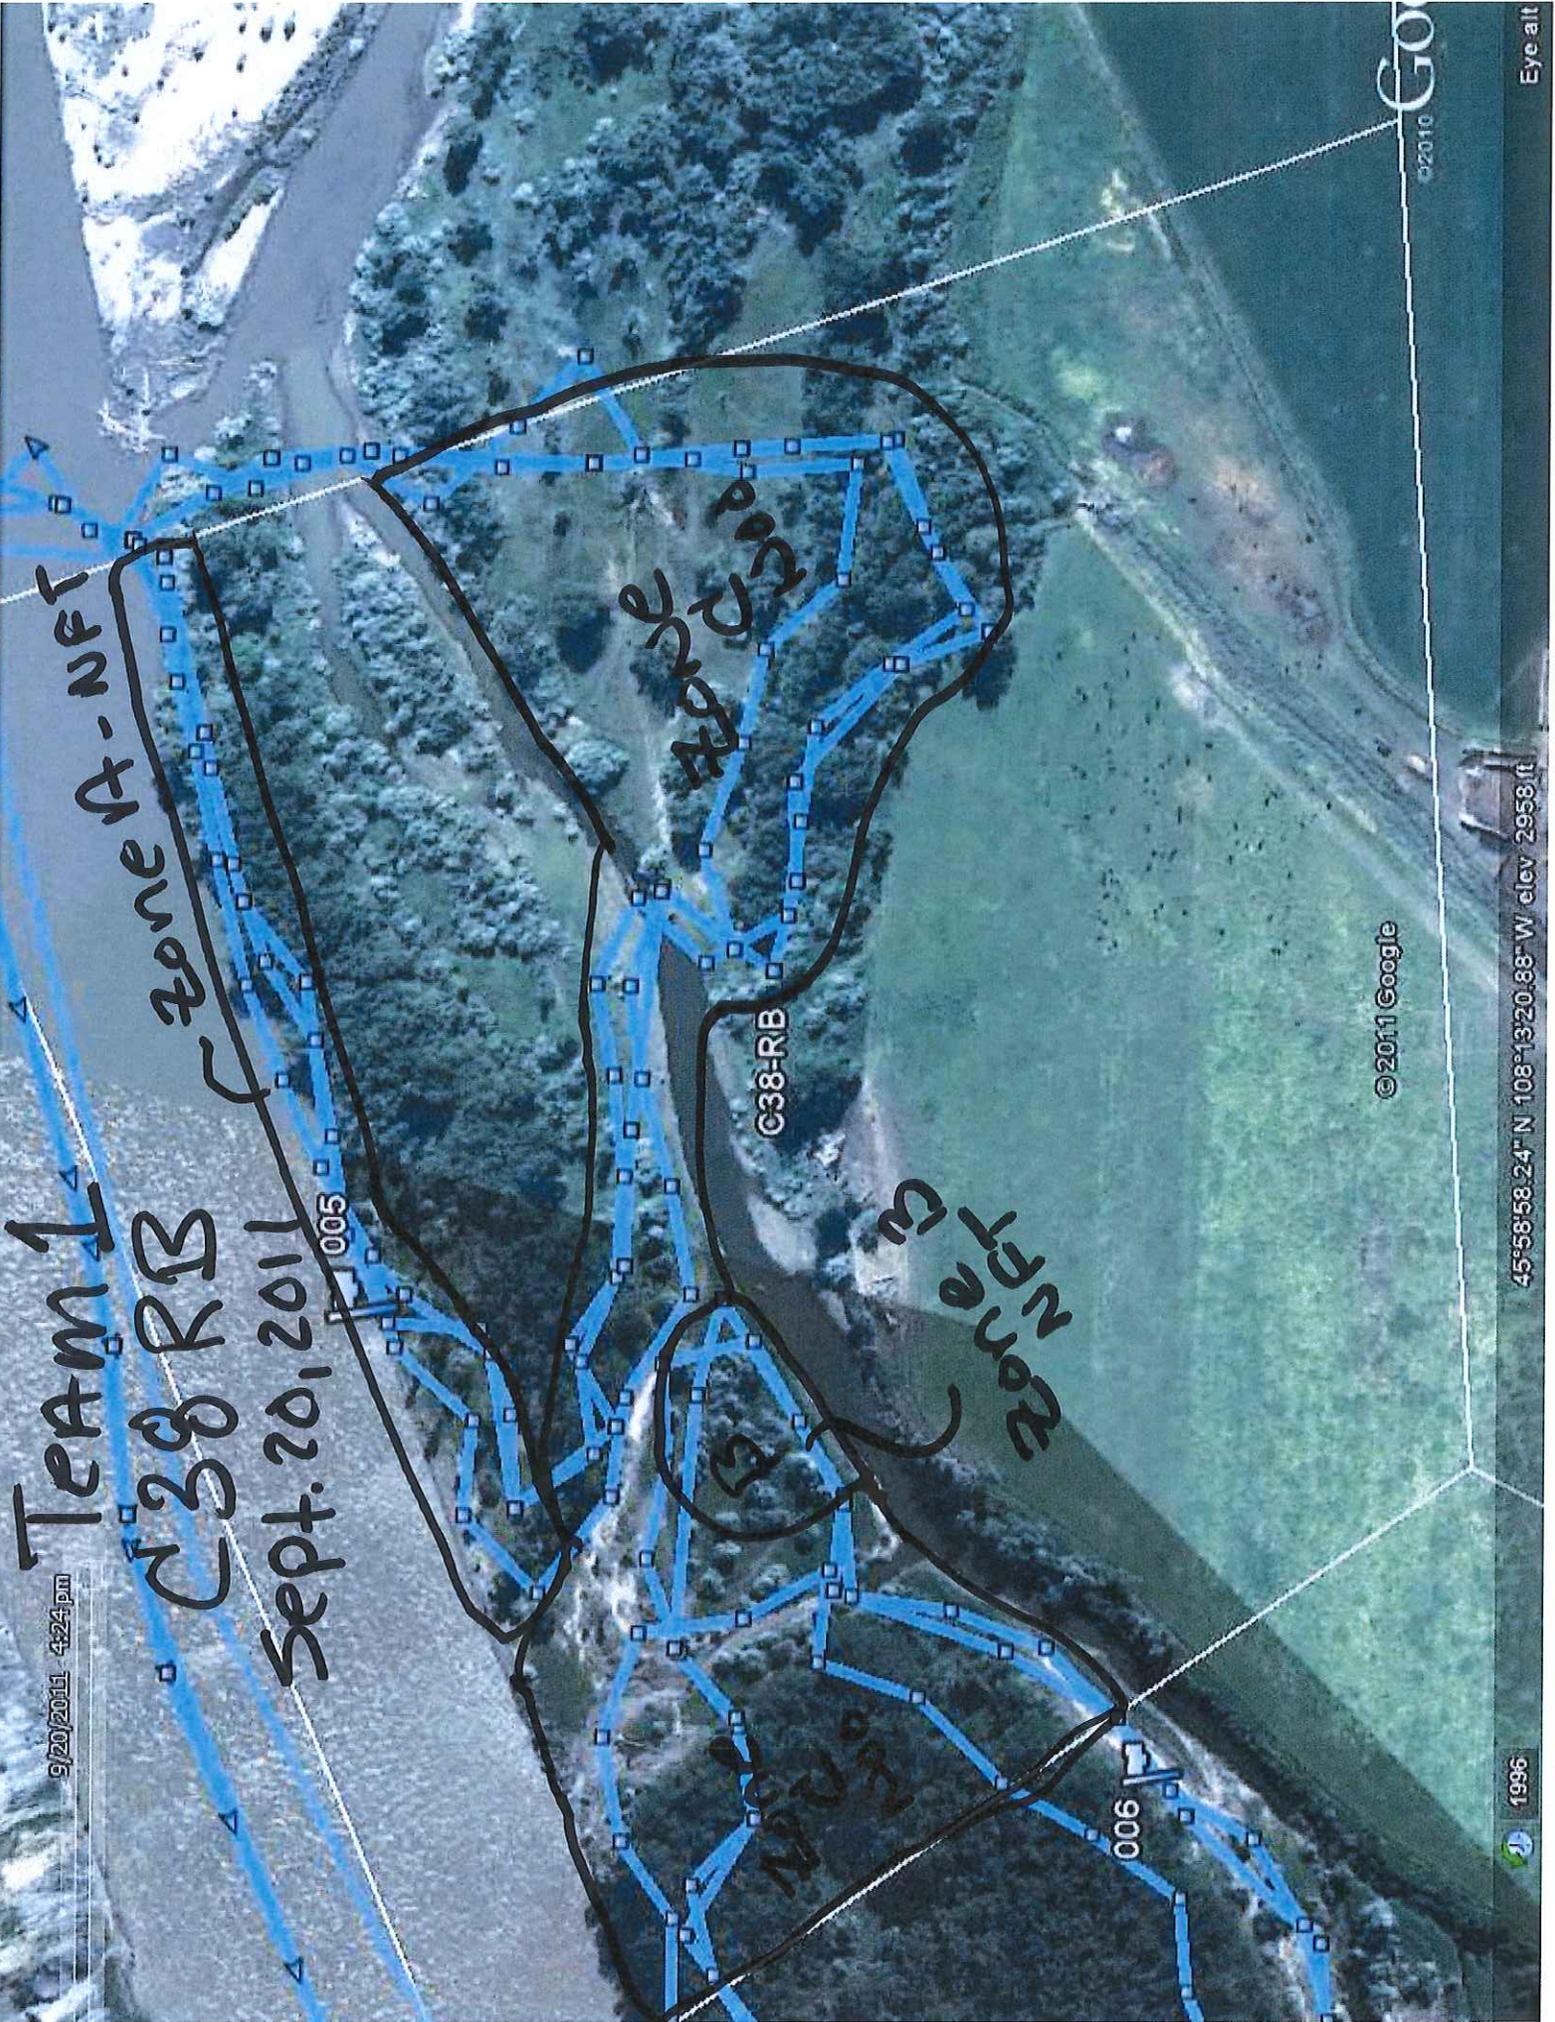
C38-RB

C38 RB

Zone A - NFI

Zone B

Zone C

Zone D
