**SCAT Area Transition Report for
C39**

Silvertip Pipeline Incident
Laurel, Montana

October 24, 2011

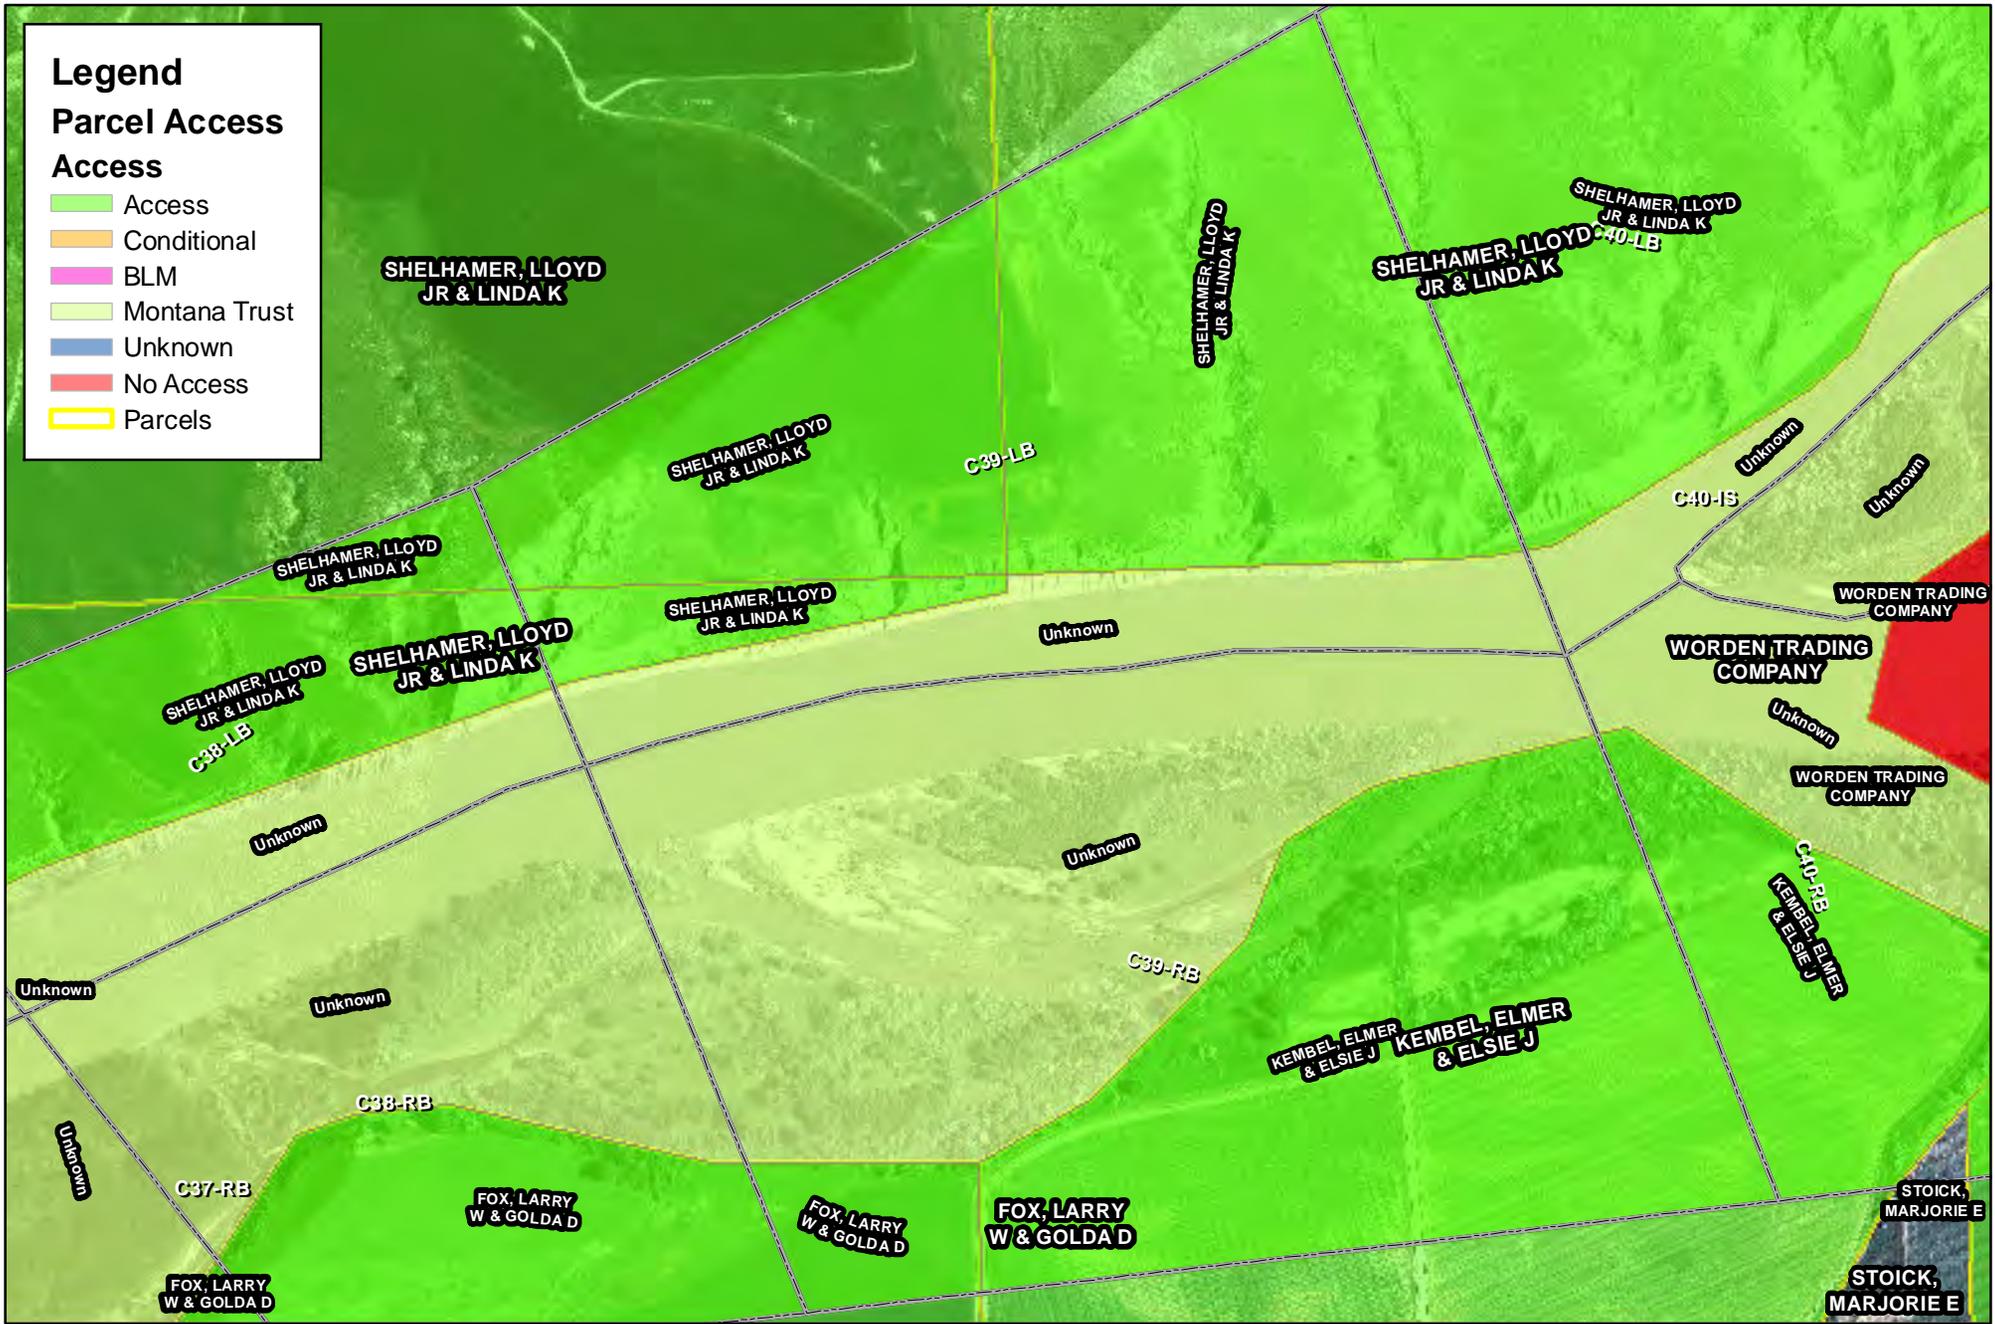
Figure 1 provides an aerial map of SCAT Area C39, along with the (a) SCAT Area boundary, (b) parcel boundaries and respective property owners, and (c) access constraints identified during the oil cleanup process. The acreage surveyed in Area C39 is 28.4. There were no access issues for this area.

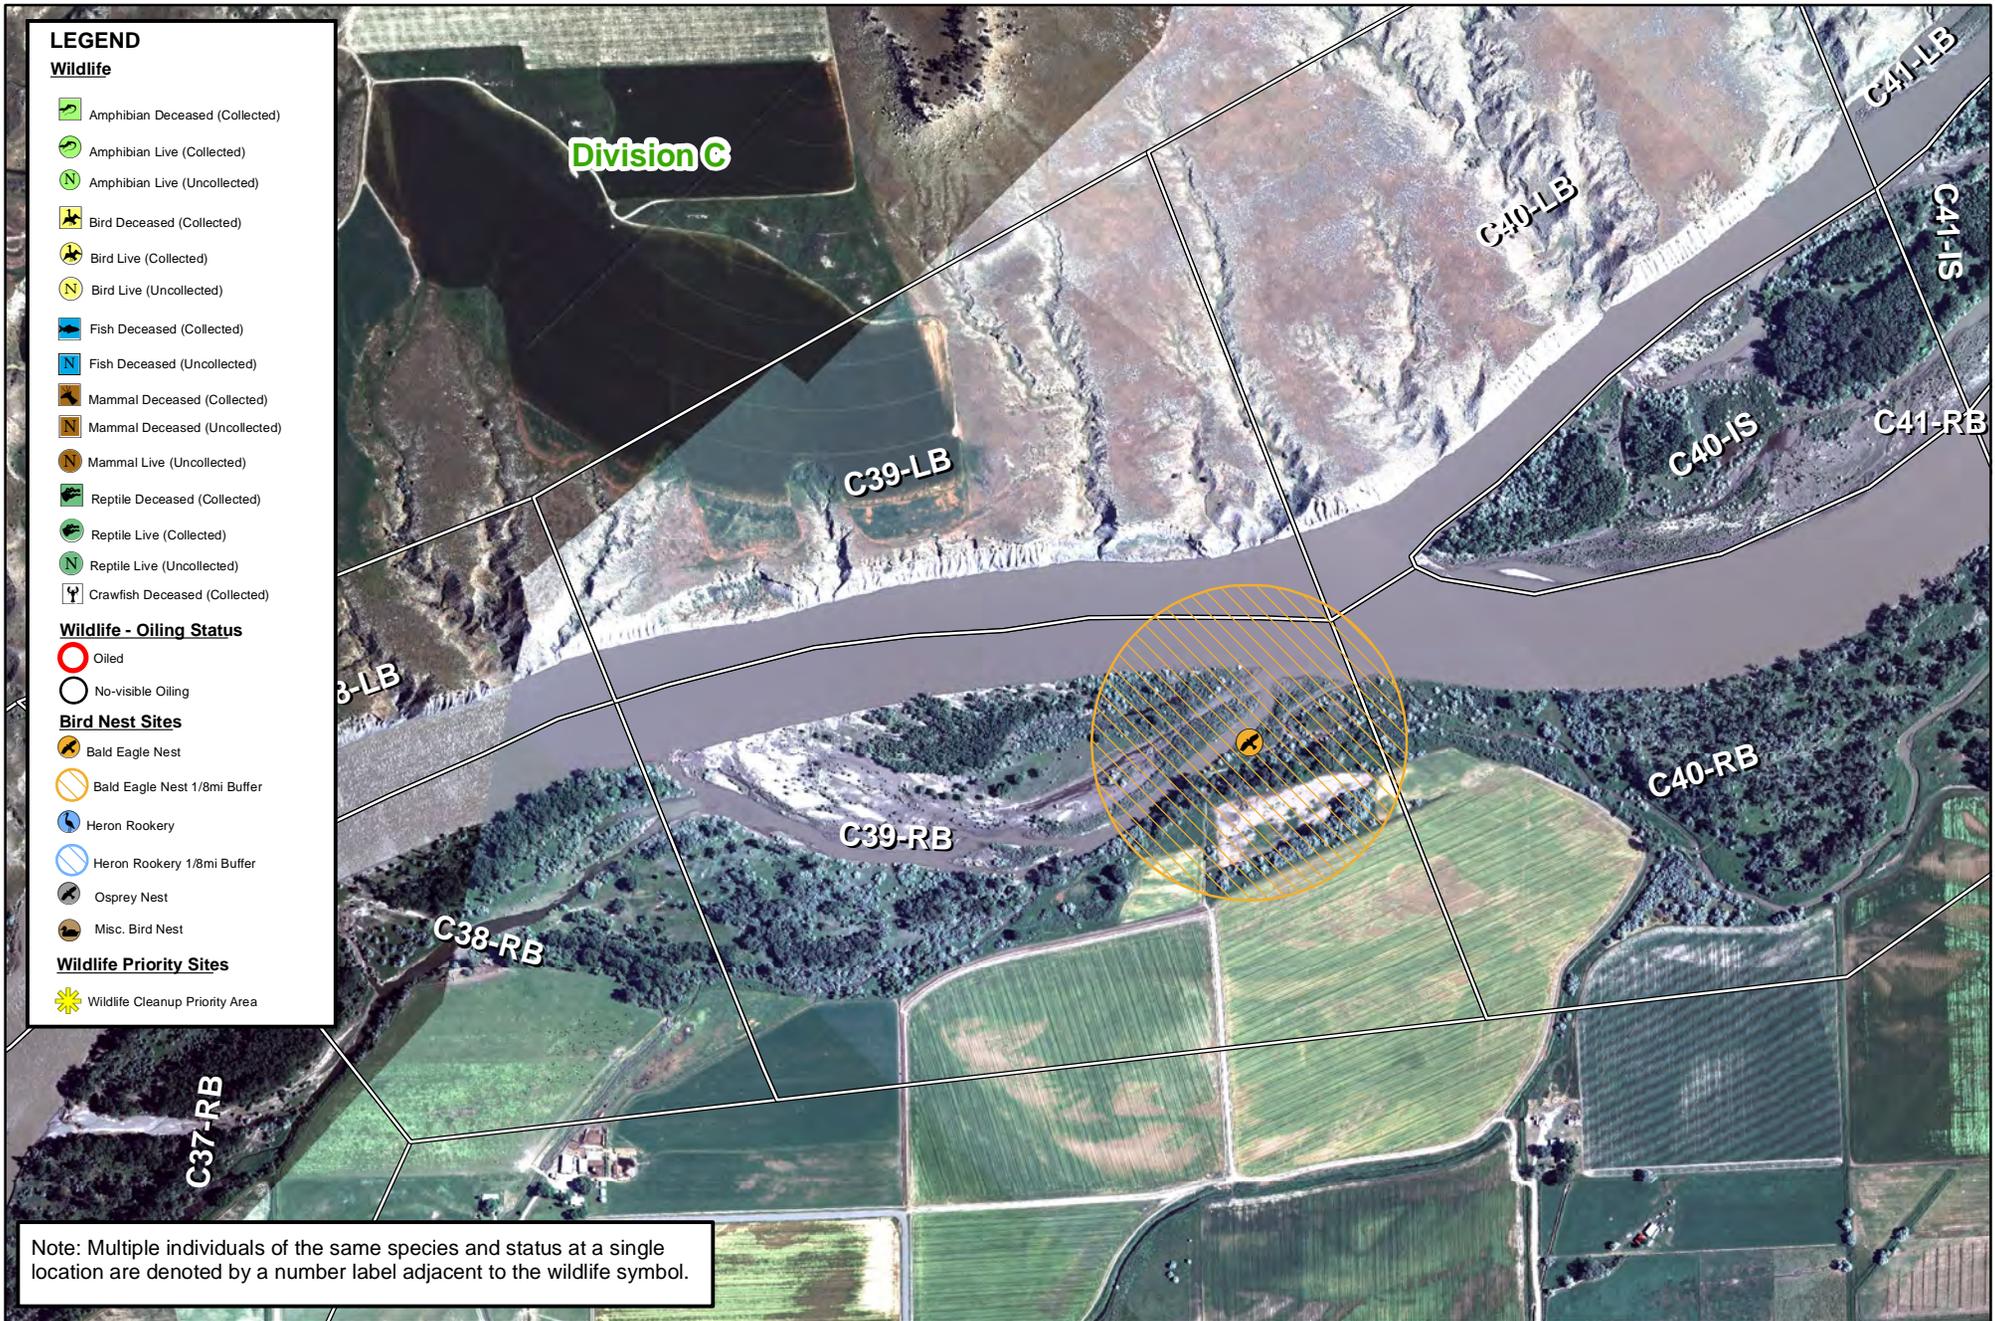
Figure 2
Wildlife Resources

Figure 2 summarizes the natural resources identified in this segment. International Bird Rescue and Resource Advisors from U.S. Fish and Wildlife Service conducted limited inspections of Area C39 due to the low level of oiling in Division C. No oiled wildlife was observed or recovered. No Wildlife Priority Cleanup Areas were identified. A bald eagle (*Haliaeetus leucocephalus*) nest was identified in Area C39 and a buffer zone was provided to Operations to protect the nest.

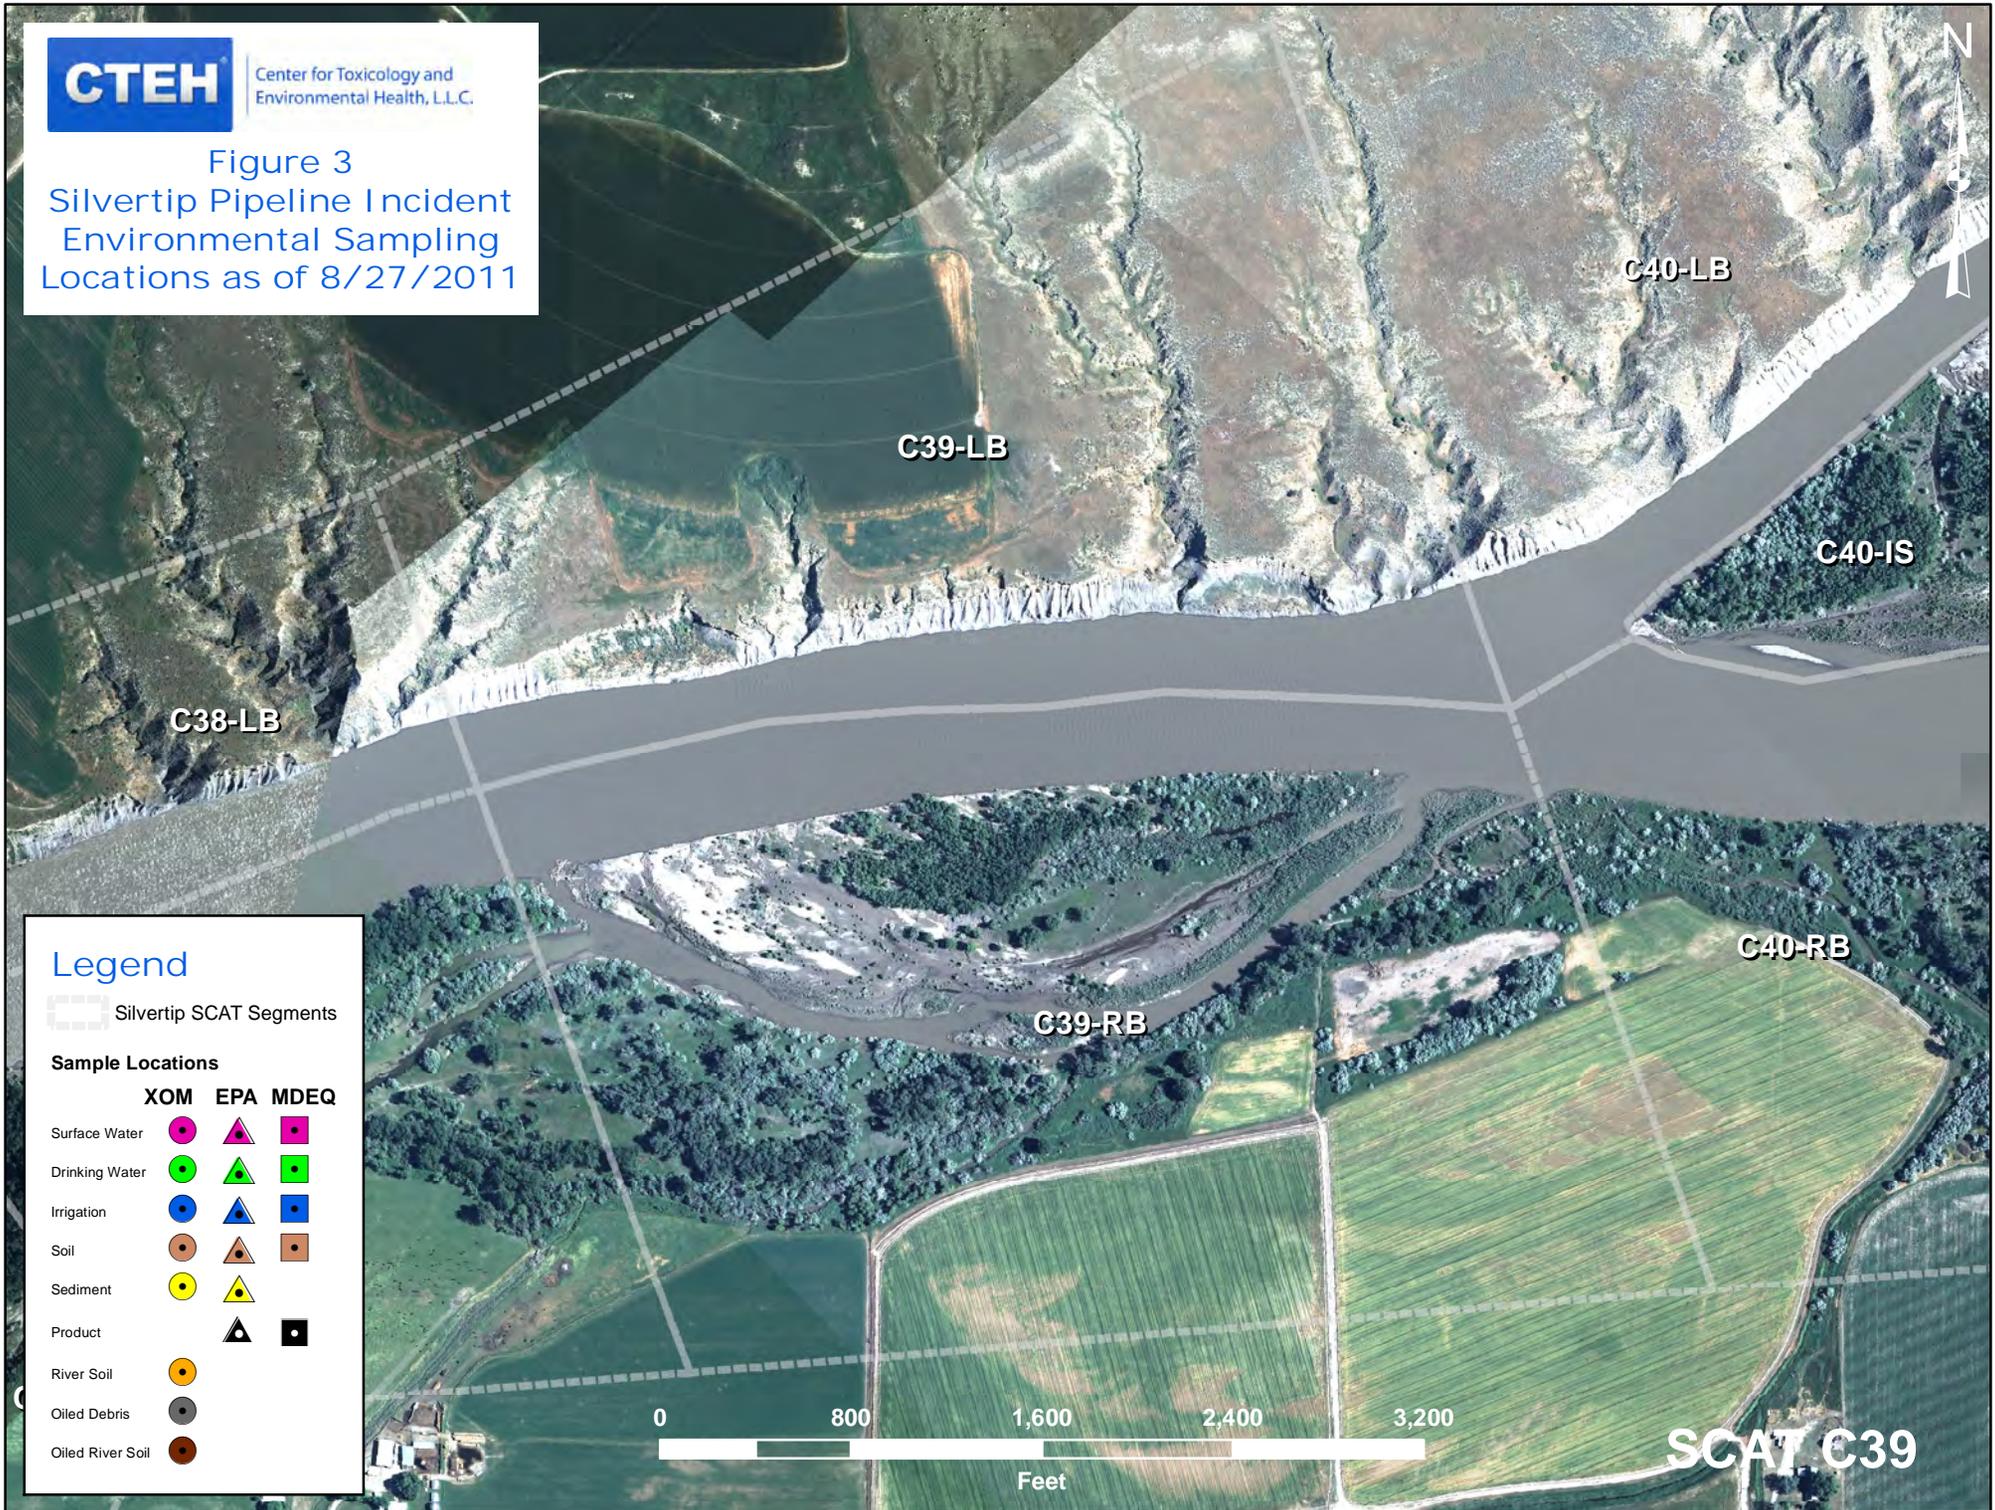
Figure 3
Silvertip Pipeline Incident
Environmental Sampling
Locations as of 8/27/2011

Table 1 (below) summarizes samples collected within Area C39. The analytical results for the samples collected can be accessed through a publicly accessible database on the United States Environmental Protection Agency's (USEPA's) website. The approximate locations of samples collected within Area C39 are provided on Figure 3. However, to date, no samples have been collected in this area.

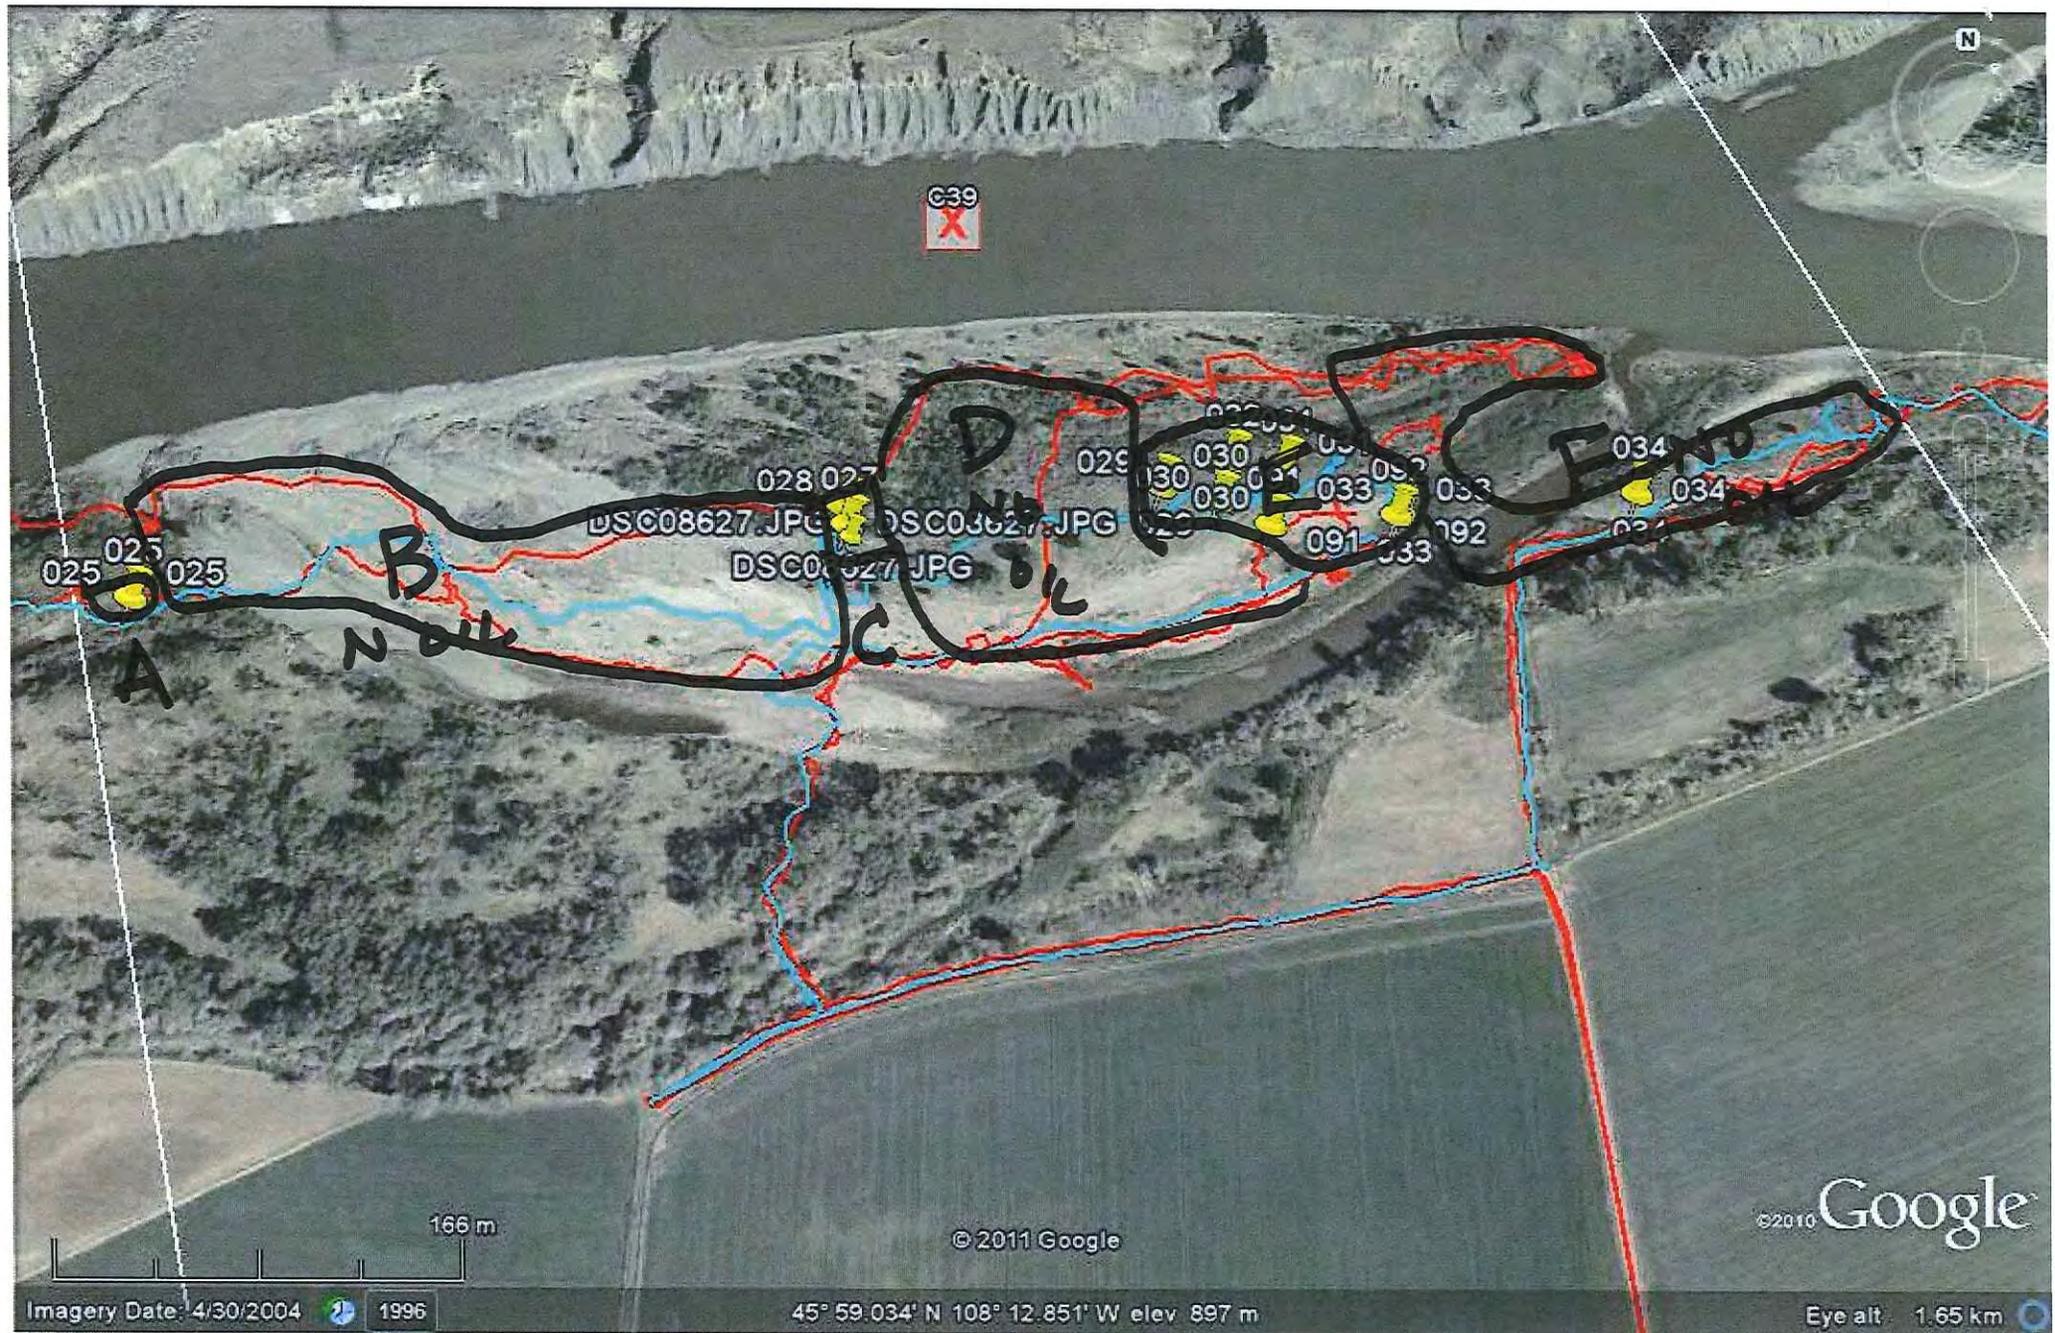
C 39 R July 28, 2011 Team 3

OIL ZONE	RIVER BANK ZONE				OIL COVER			OIL THICKNESS					OIL CHARACTER						SUBST. TYPE(S)				
	ID	MS	LB	UB	OB	Length m	Width m	Distrib. %	TO	CV	CT	ST	FL	FR	MS	TB	PT	TC		SR	AP	NO	
A					X	10	2	10			X	(X)		(X)									Veg. Debris
B					X	290	90															X	
C					X	3	1	30			(X)	X		(X)									Veg. Debris
D					X	140	170															X	
E					X	130	50	5			(X)	X		(X)									Veg. Debris
F					X	250	130															X

Oil band heights: 0-30 cm

Treatment Recommendations:
 Zone : A, C, E; Cut and remove oiled grass. Remove oiled debris concentrated in dry stream channels with debris piles
 Zone: B, D, F; No oil.

Refer to current approved treatment methods#1 (Cutting of vegetation, #2 (Dead Vegetation and Small Debris), #3 (Large Woody Debris), #6

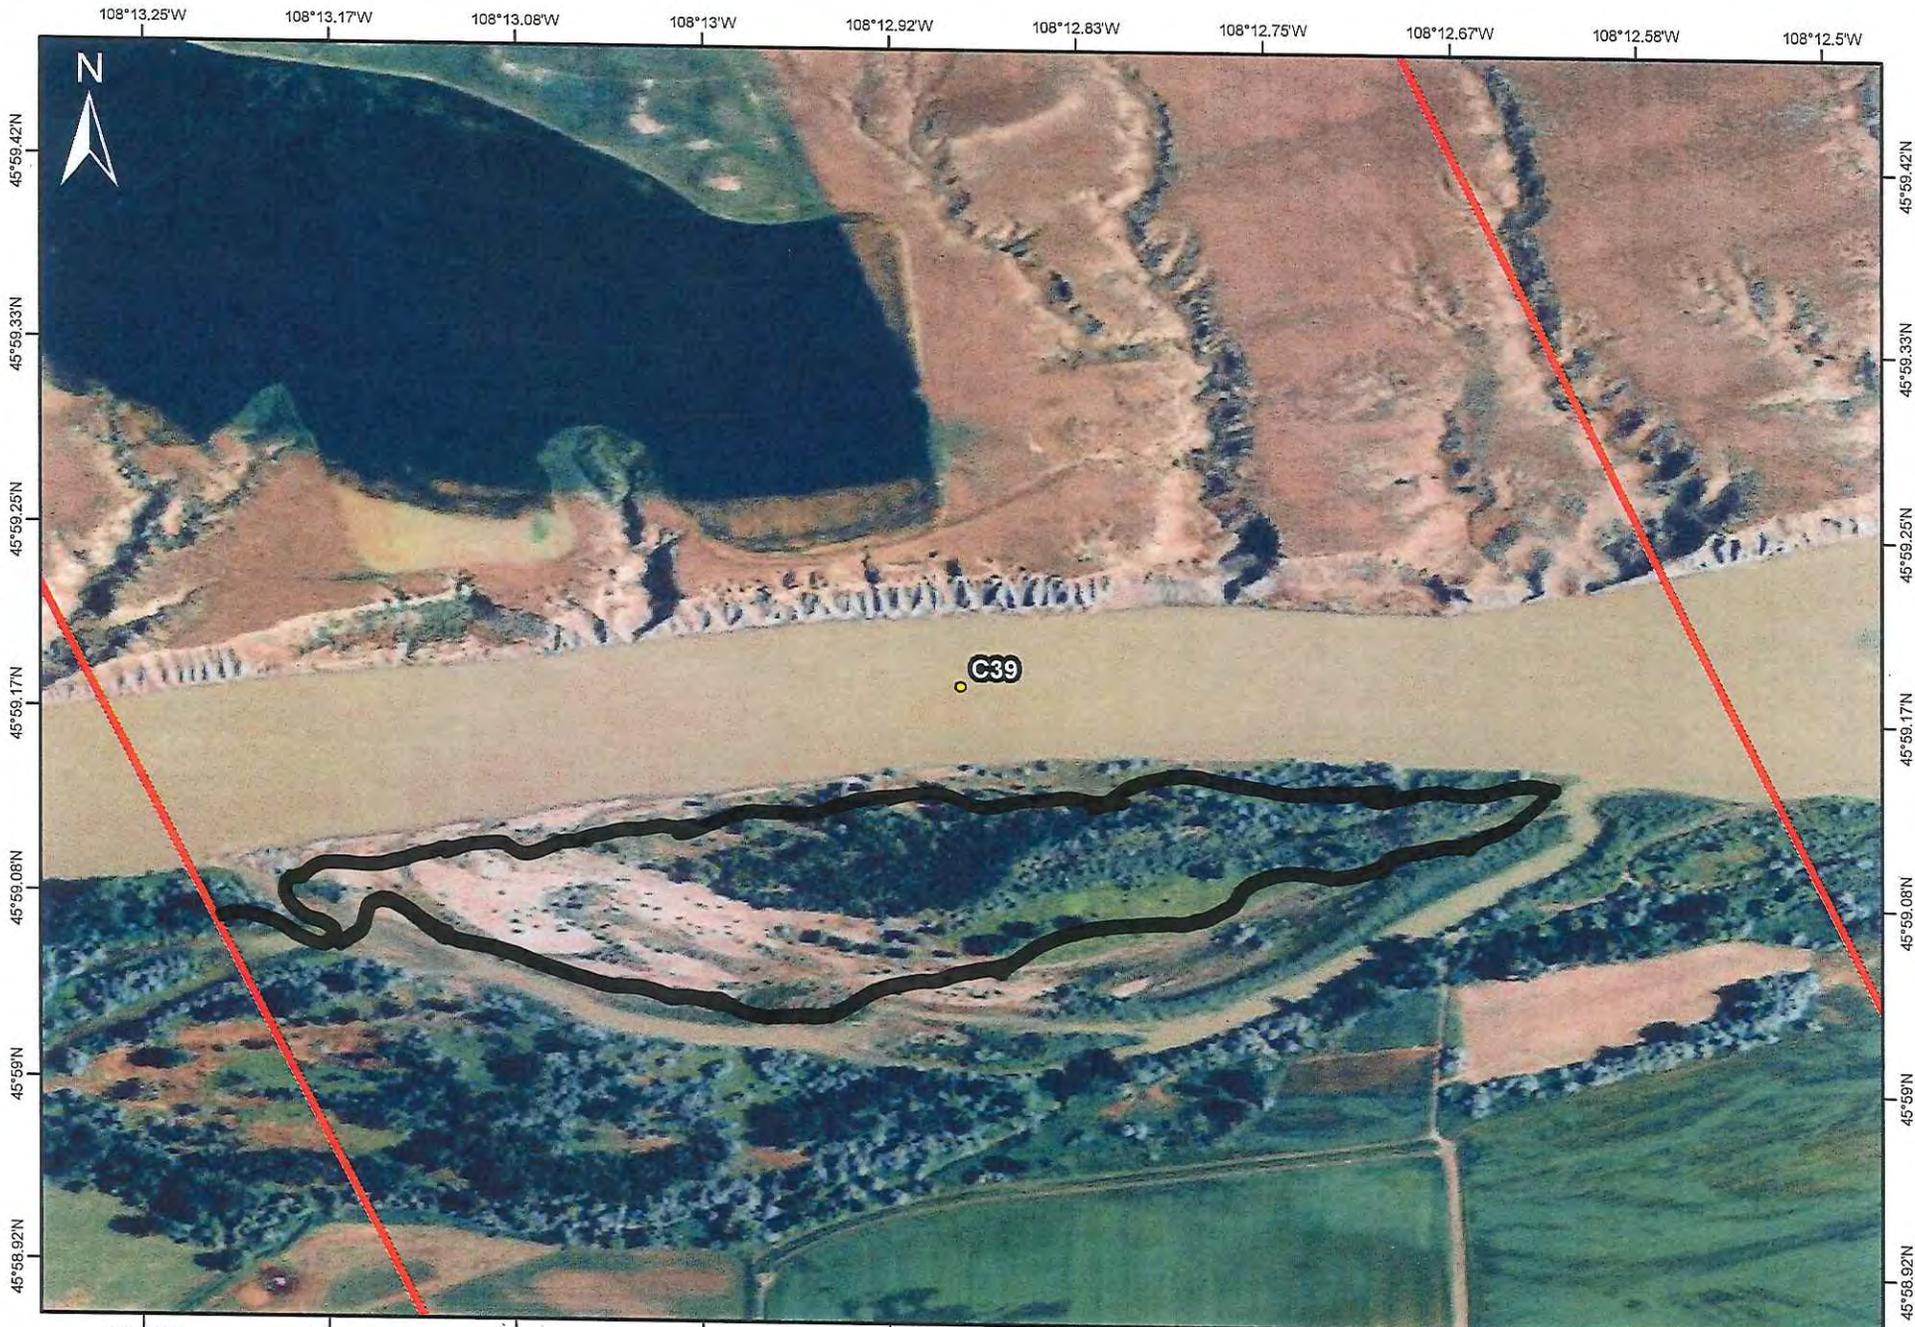
C39-R

OIL ZONE ID	RIVER BANK ZONE				OIL COVER			OIL THICKNESS					OIL CHARACTER						SUBST. TYPE(S)			
	MS	LB	UB	OB	Length m	Width m	Distrib. %	TO	CV	CT	ST	FL	FR	MS	TB	PT	TC	SR		AP	NO	
A				x	788	176	<1				x						x					Woody debris

Zone A: No treatment recommended.

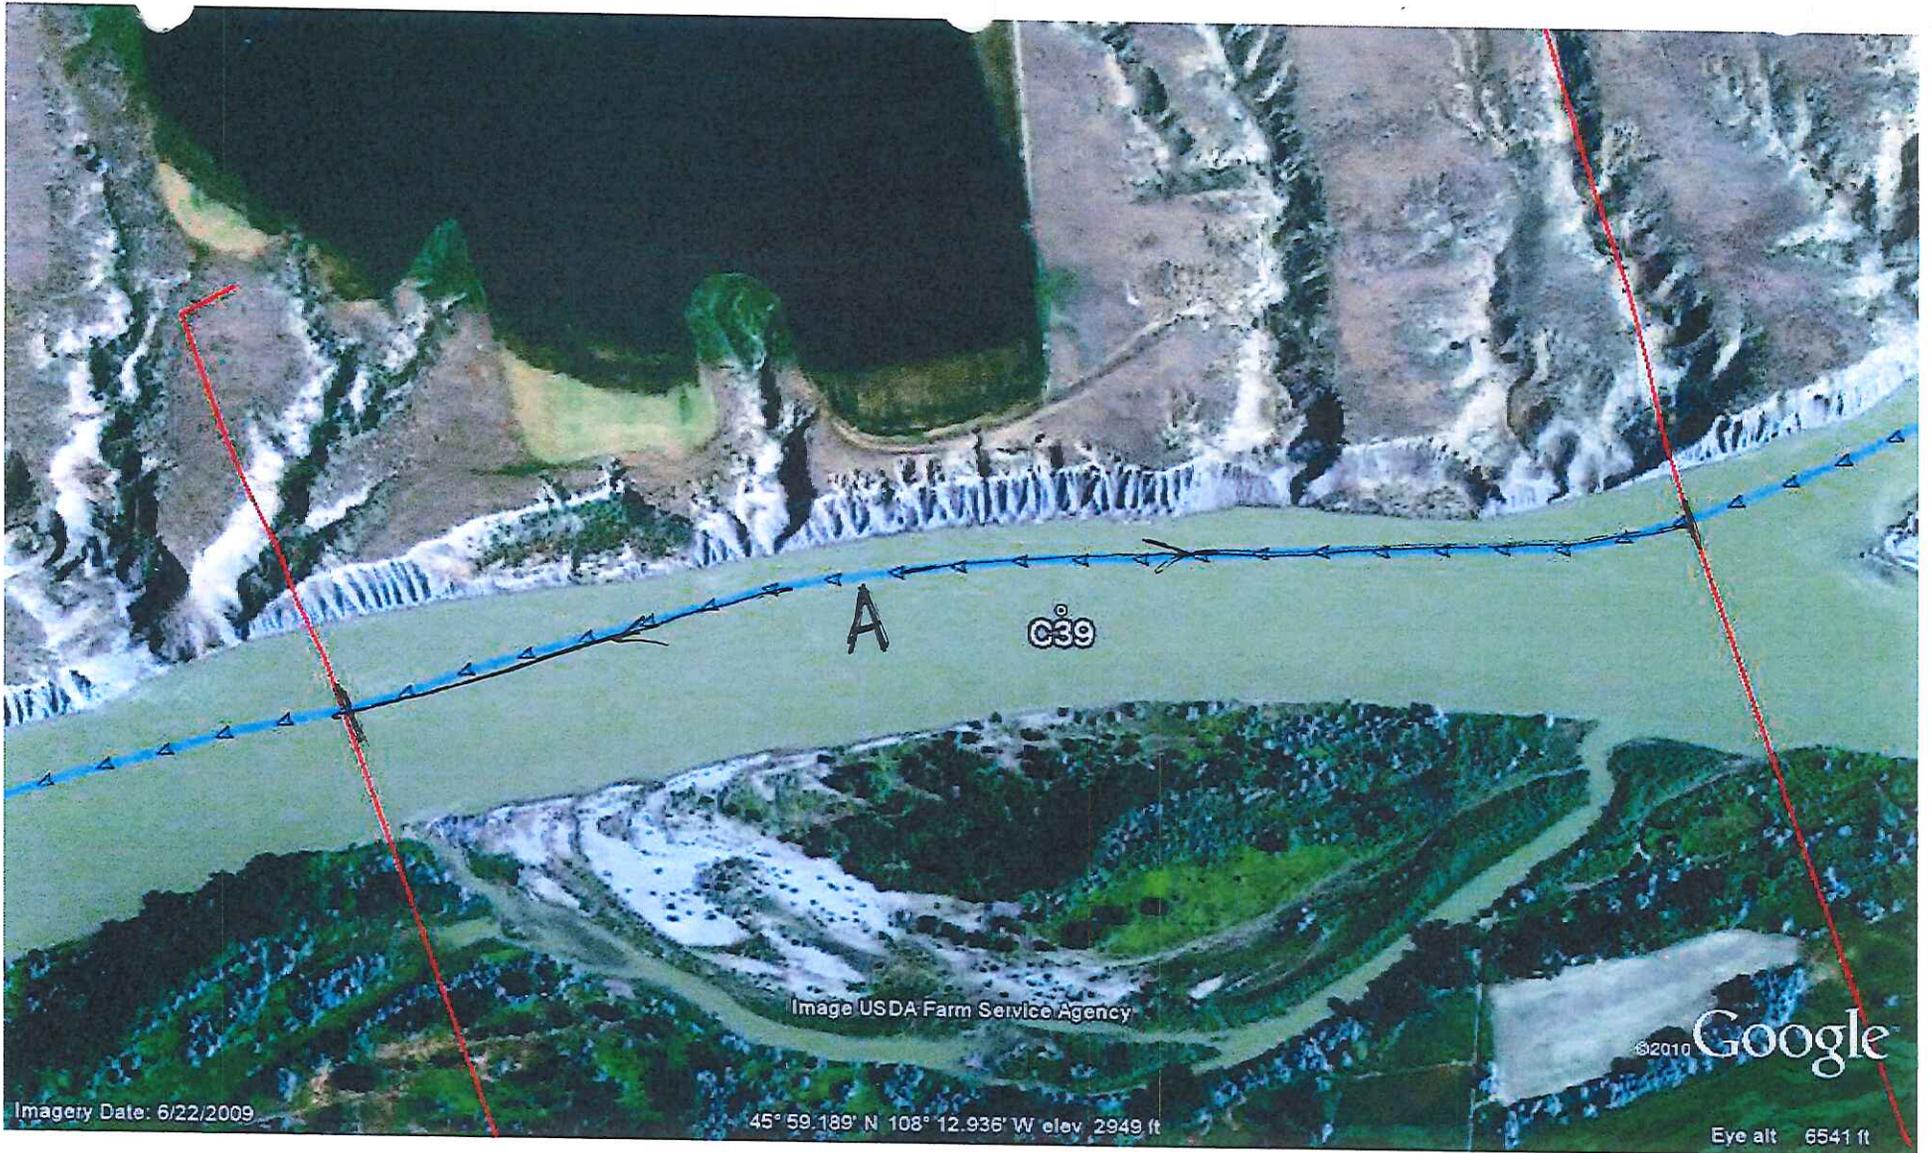
C39

OIL ZONE ID	RIVER BANK ZONE				OIL COVER			OIL THICKNESS					OIL CHARACTER							SUBST. TYPE(S)			
	MS	LB	UB	OB	Length m	Width m	Distrib. %	TO	CV	CT	ST	FL	FR	MS	TB	PT	TC	SR	AP		NO		
A		X			905	1																X	Cliff

Zone A : No oil observed; no treatment required.

e : Cut & remove oil coated vegetation smaller than 1" diameter. Remove debris smaller than 4" diameter. Wipe larger oil coated vegetation.

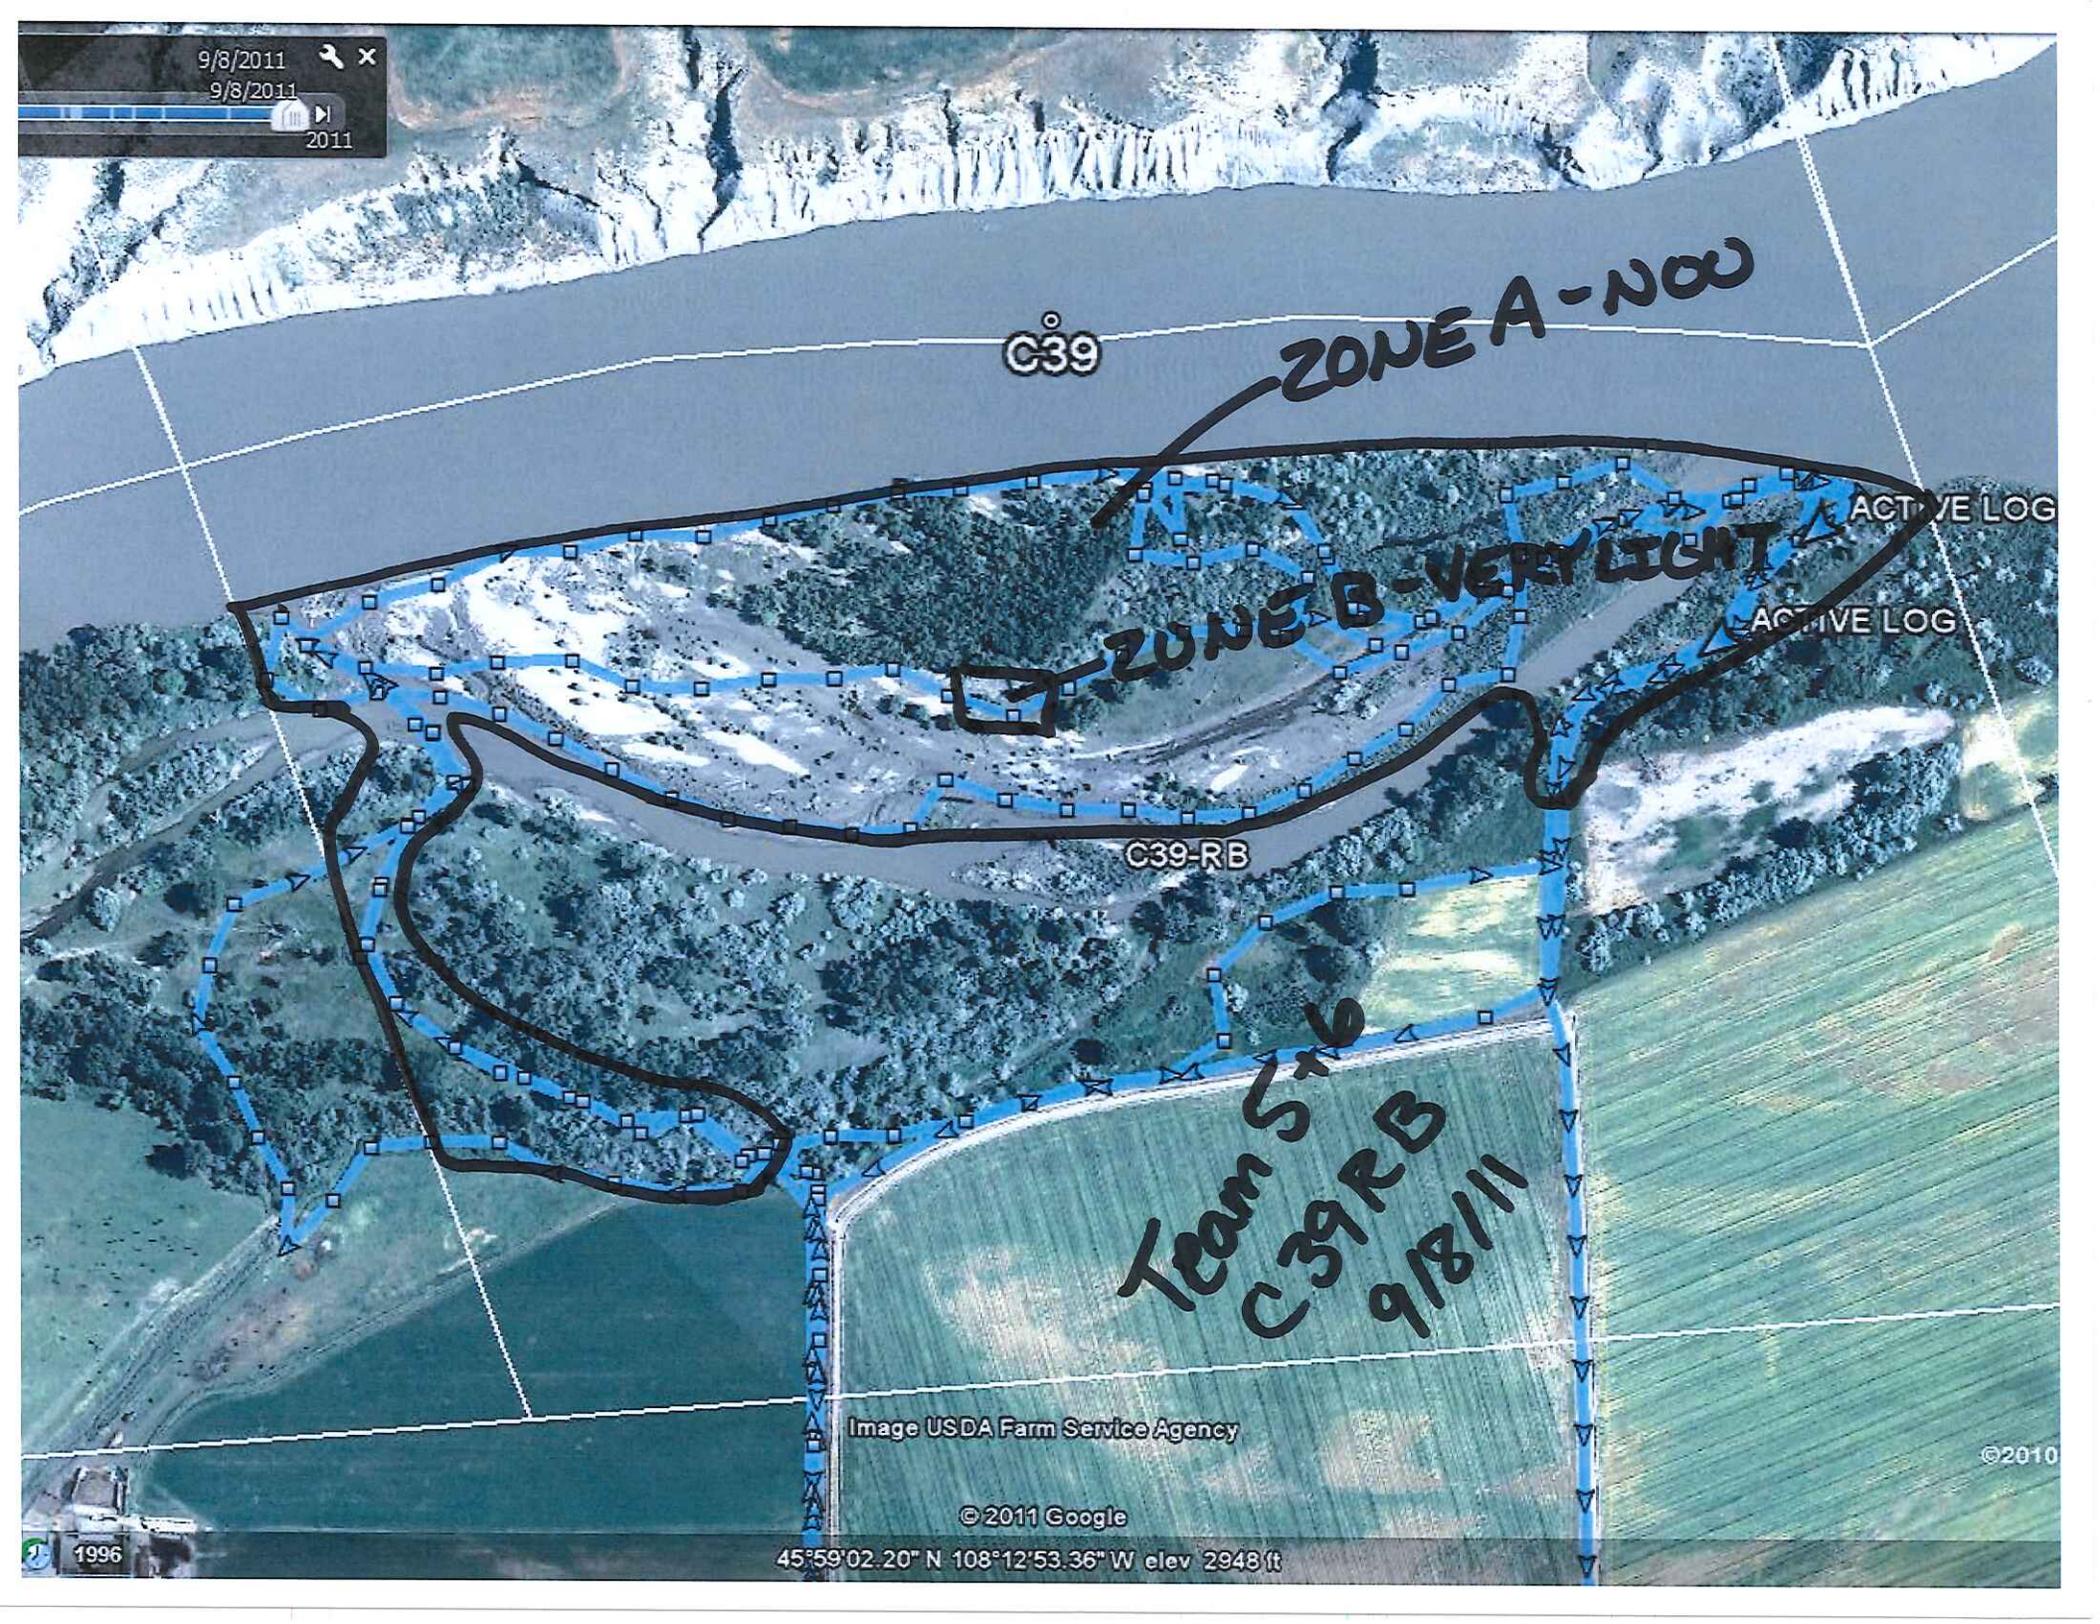
Team 5+6
C39 RB
9/8/11

Figure 5 shows the oiling conditions within Area C39 following completion of oil removal activities. The SCAT team performed final surveys of the right bank within SCAT Area C39 to confirm the agreed-upon cleanup endpoints identified in the applicable CTRs had been achieved. The final SCAT survey documentation is presented in Appendix E.

Zone A - NOO

ZONE A - NOW

ZONE B - VERY LIGHT

Based on the initial SCAT surveys performed on the left bank within Area C39, no oiling was observed. Based on the final SCAT surveys performed on the right bank within Area C39, no further treatment is recommended for this segment. SCAT Segment Sign-Off Forms are included as Appendix F.

Zone B - Hot shot crew utilized ATM2 to collect 1/4 of a bag of oiled debris, NFT
