**SCAT Area Transition Report
for C43**

Silvertip Pipeline Incident
Laurel, Montana

October 21, 2011

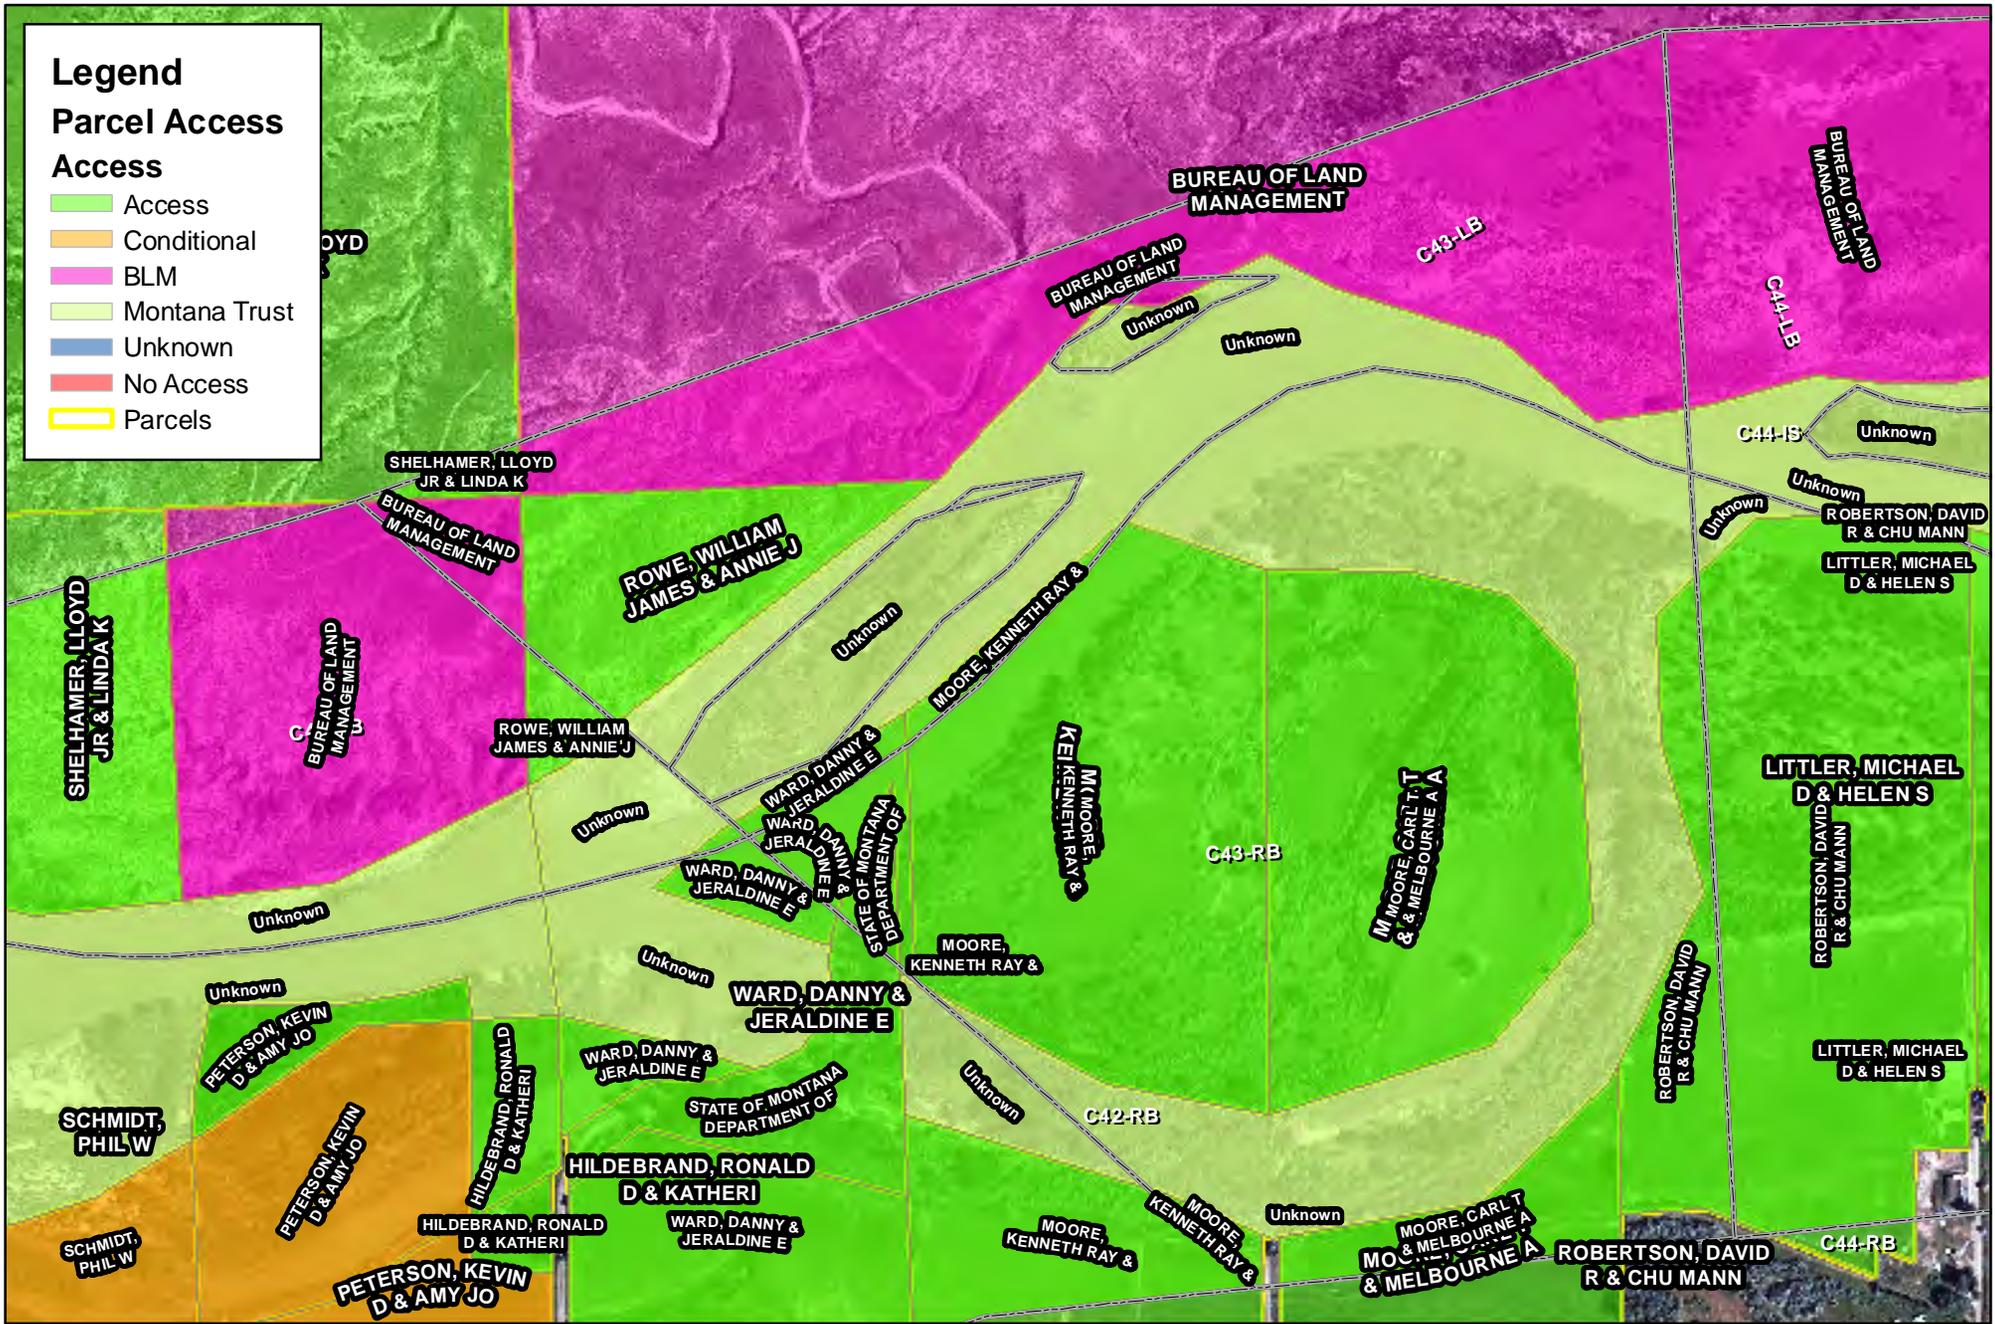
Figure 1 provides an aerial map of SCAT Area C43, along with the (a) SCAT Area boundary, (b) parcel boundaries and respective property owners, and (c) access constraints identified during the oil cleanup process. The acreage surveyed in Area C43 is 171.8. There were no access issues for this area.

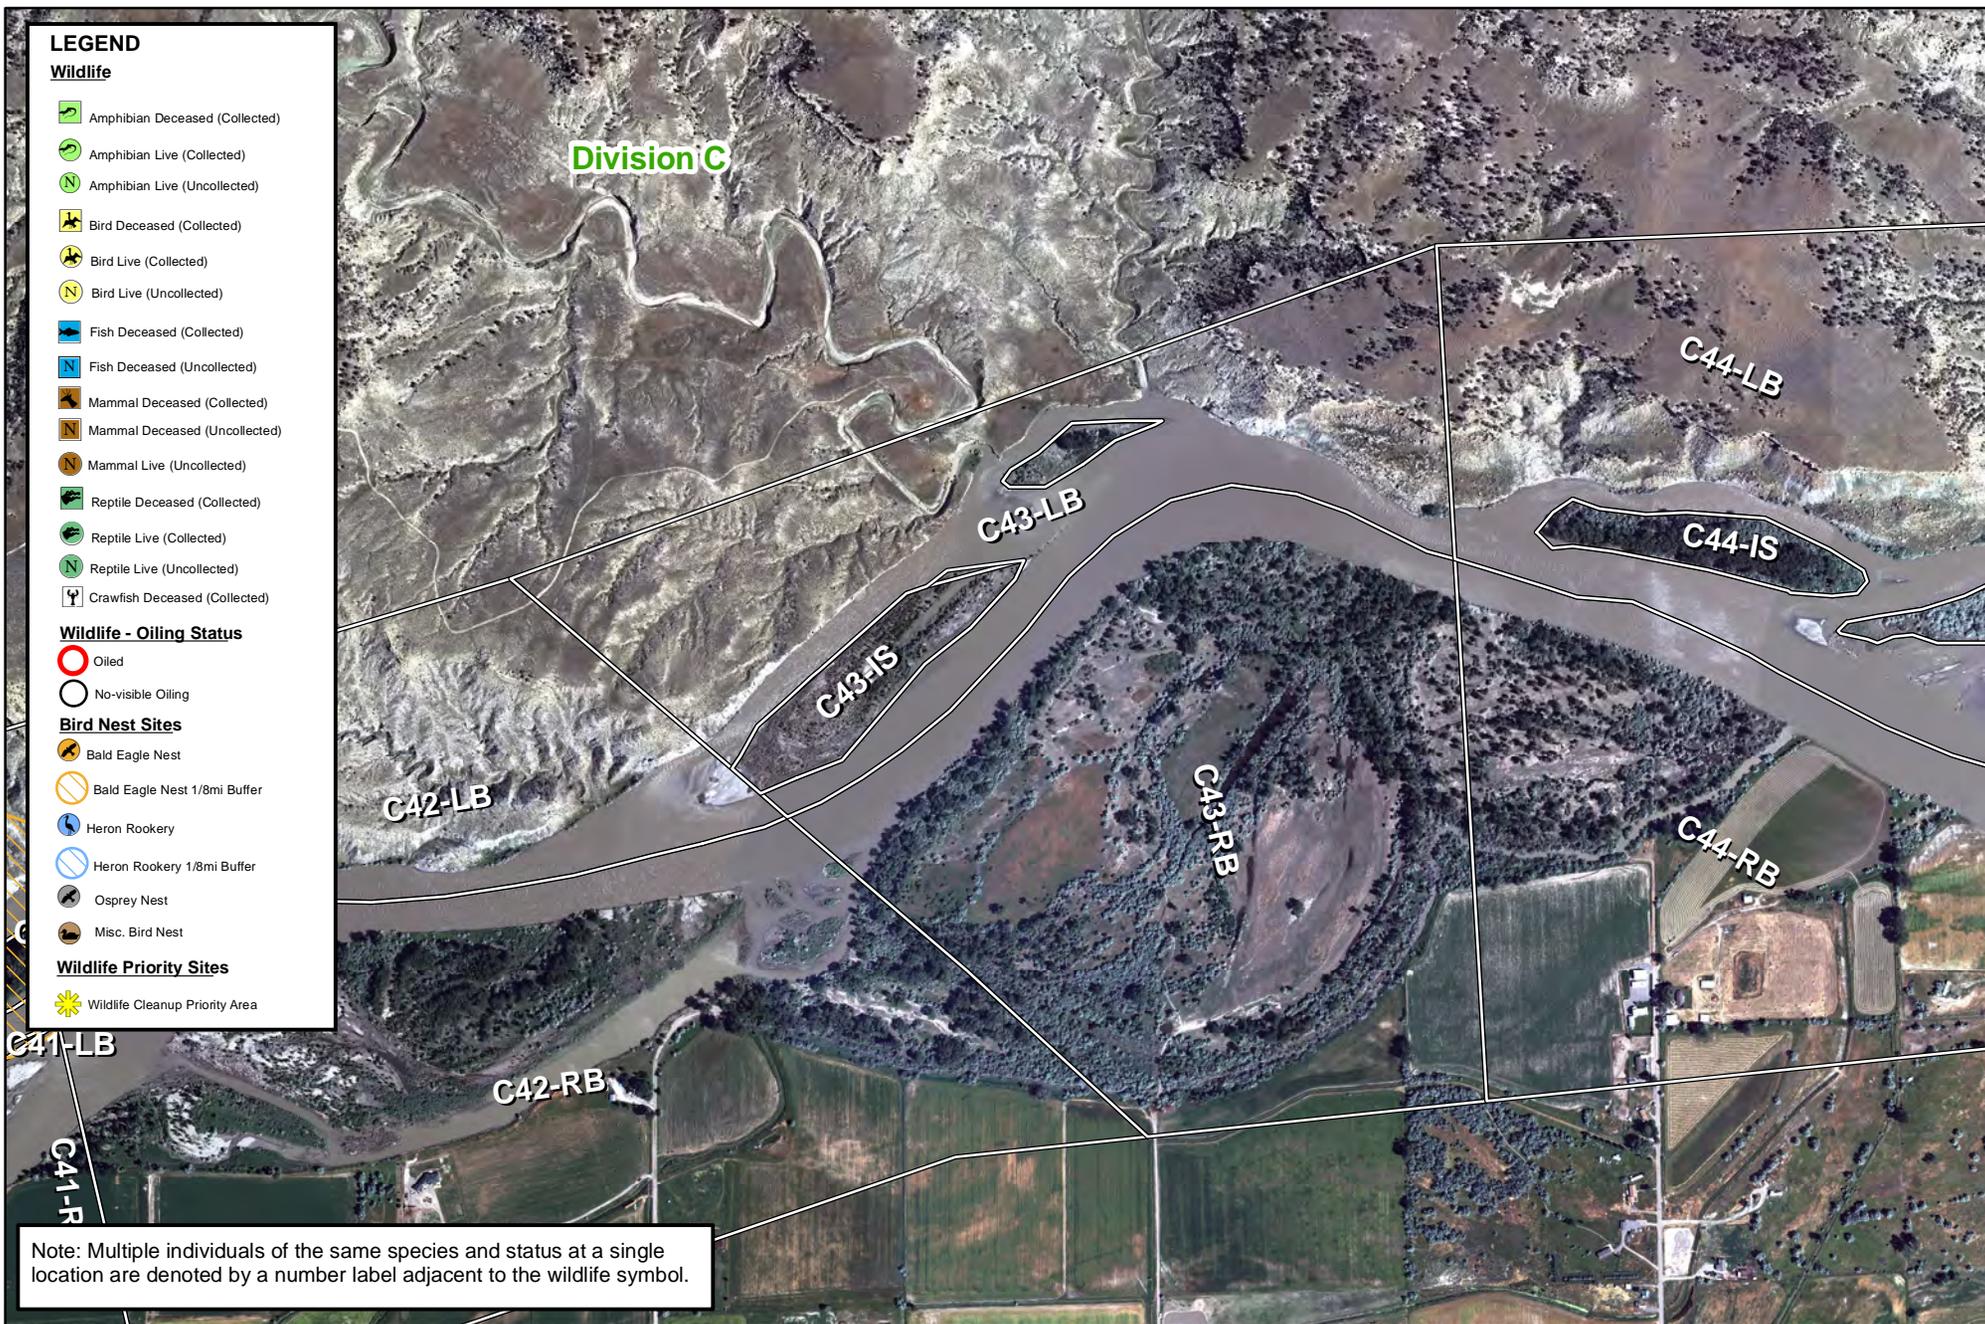
Figure 2
Wildlife Resources

Figure 2 summarizes the natural resources identified in this segment. International Bird Rescue and Resource Advisors from U.S. Fish and Wildlife Service conducted limited inspections of Area C43 due to the low level of oiling in Division C. No oiled wildlife was observed or recovered. No Wildlife Priority Cleanup Areas were identified. No active migratory bird nests were identified in Area C43.

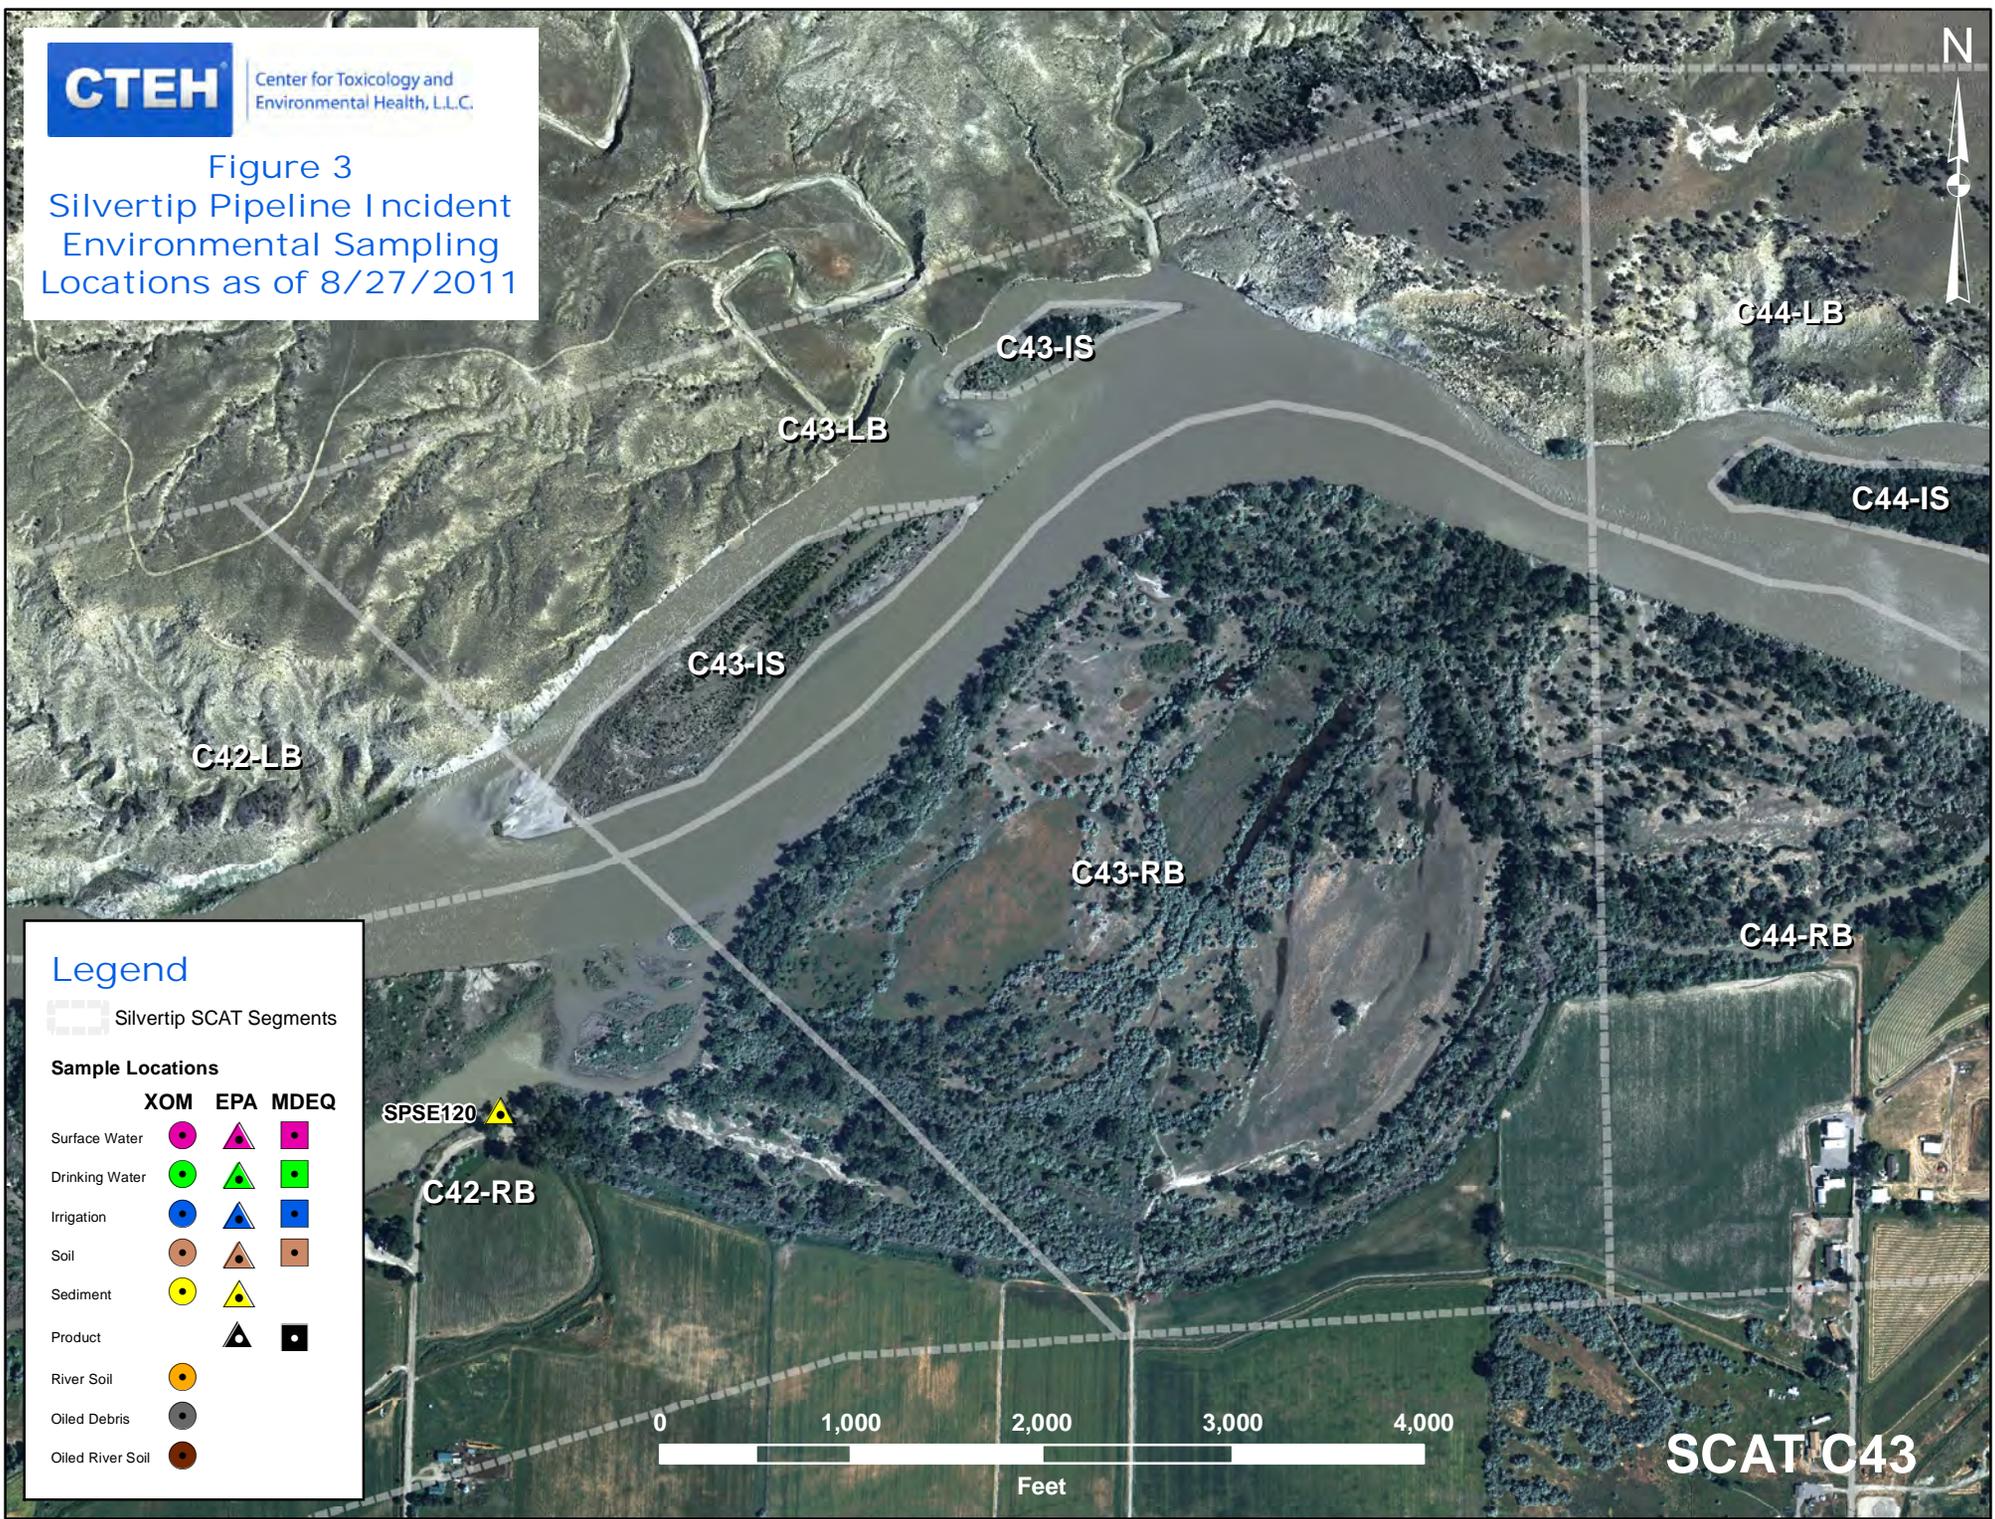
Figure 3
 Silvertip Pipeline Incident
 Environmental Sampling
 Locations as of 8/27/2011

Table 1 (below) summarizes samples collected within Area C43. The analytical results for the samples collected can be accessed through a publicly accessible database on the United States Environmental Protection Agency's (USEPA's) website. The approximate locations of samples collected within Area C43 are provided on Figure 3. However, to date, no samples have been collected in this area.

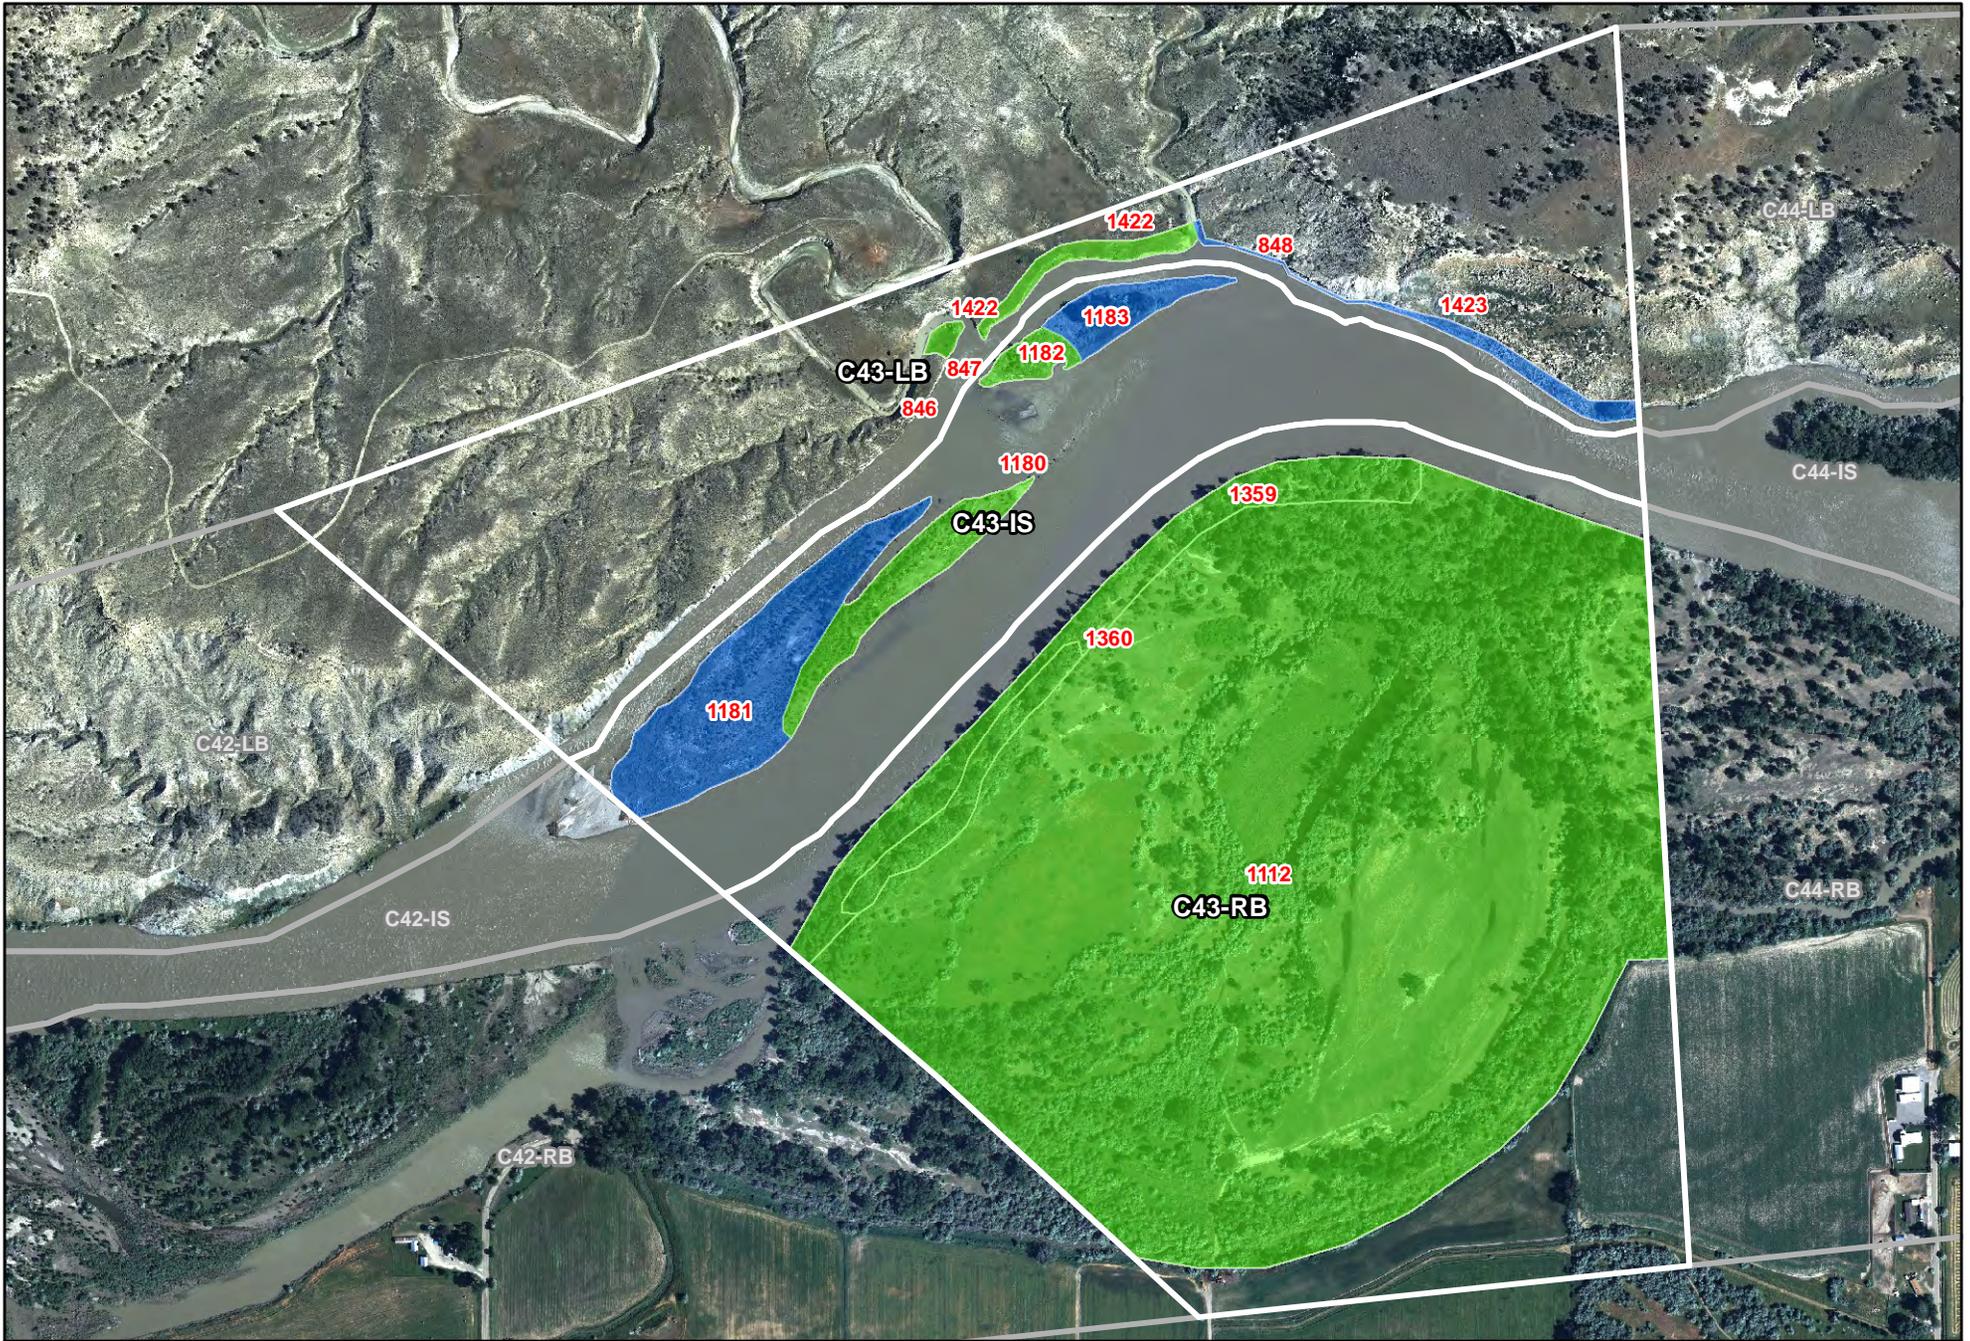
**Figure 4 - Maximum SCAT Observations
For SCAT Area:**

The SCAT teams used systematic evaluation criteria and treatment method tables approved by the National Oceanic and Atmospheric Administration to provide a standard approach for data collection and conducting field surveys. The forms and sketches from the initial SCAT surveys performed along the river bank (water edge) and floodplain within Area C43 are included in Appendix B. Figure 4 provides the maximum oiling zones observed by the SCAT team during the initial surveys of Area C43. Figure 5 shows the oiling zones as of the most recent SCAT surveys.

Based on the initial SCAT surveys performed within Area C43, only very light oiling was observed on a portion of the left and right banks and no oiling was observed in the remainder of Area C43. The very light oiling zones will be addressed through natural attenuation. Therefore, a PIST, POST, and final SCAT survey were not performed and a SCAT Segment Sign-Off Form is not necessary.

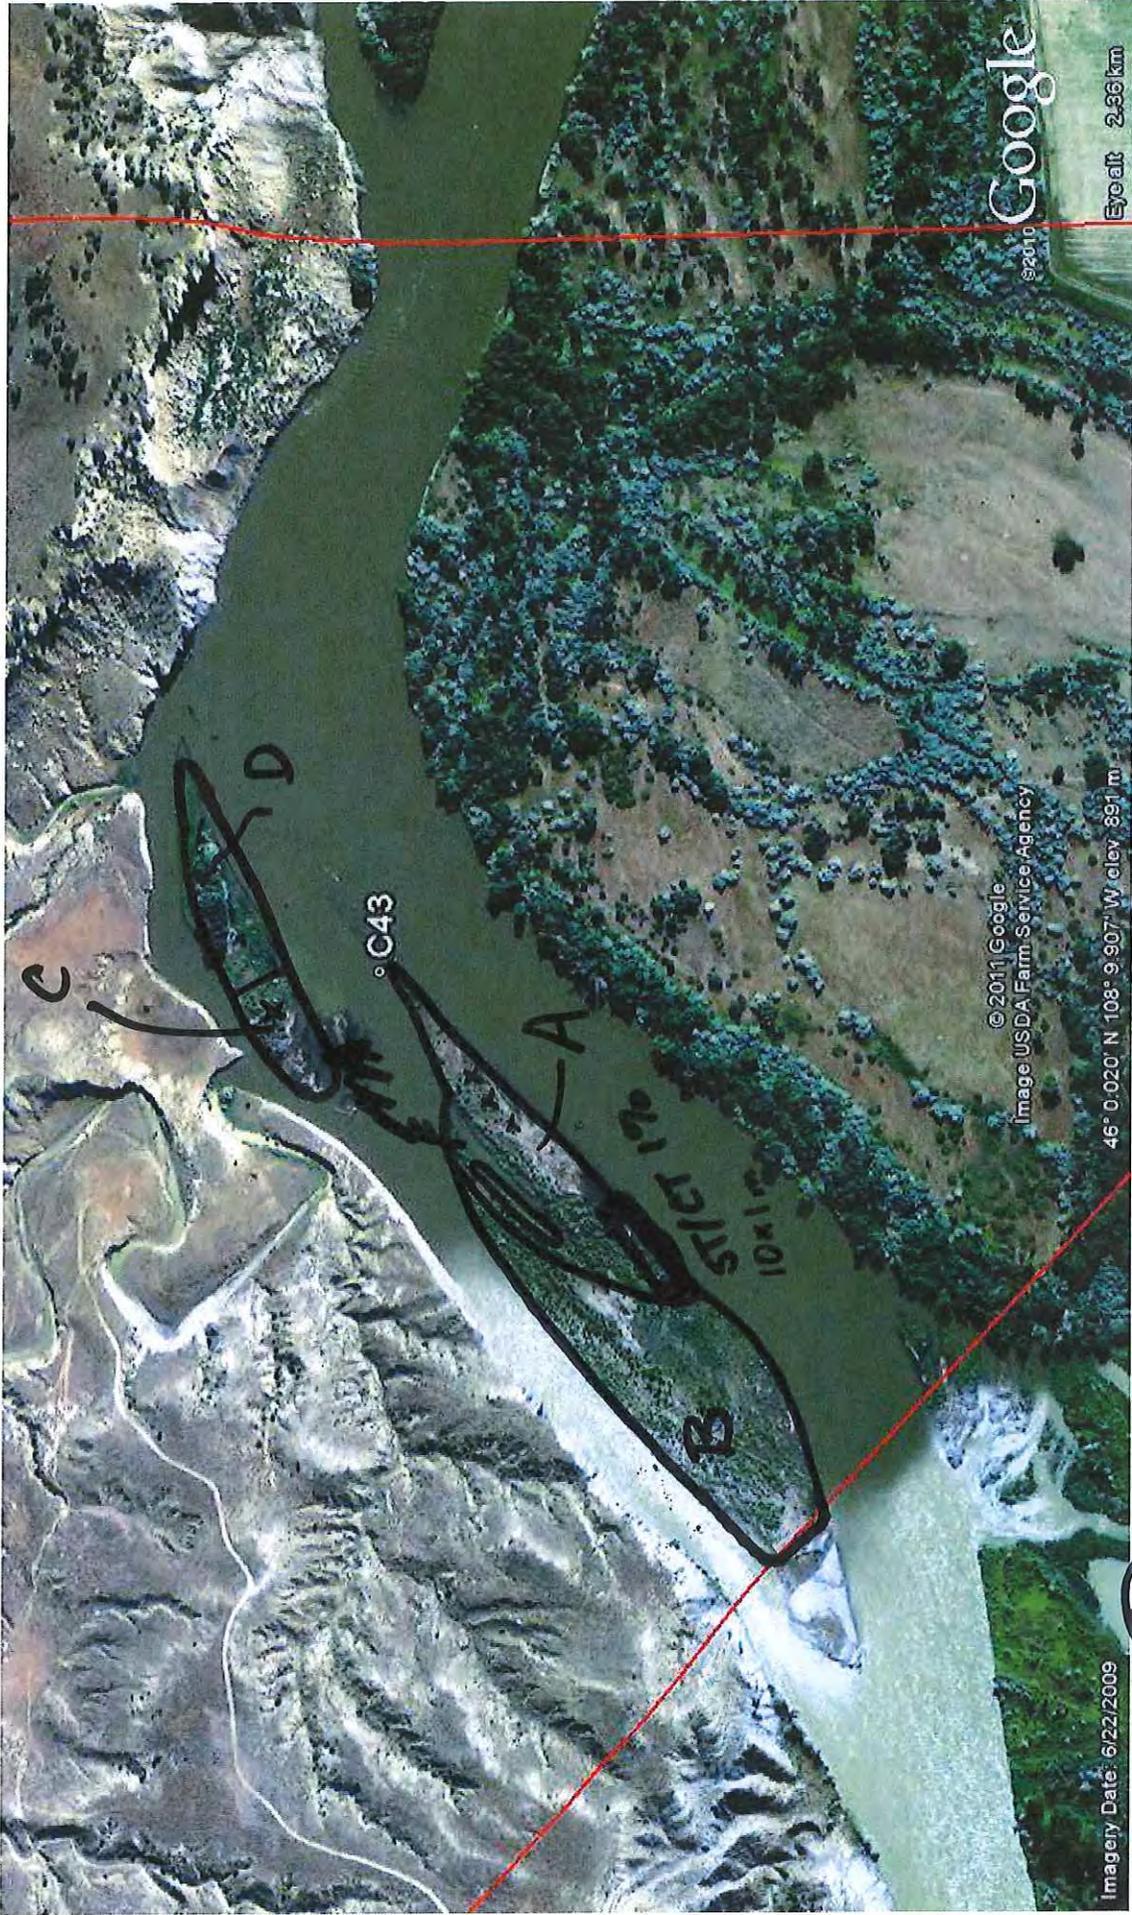
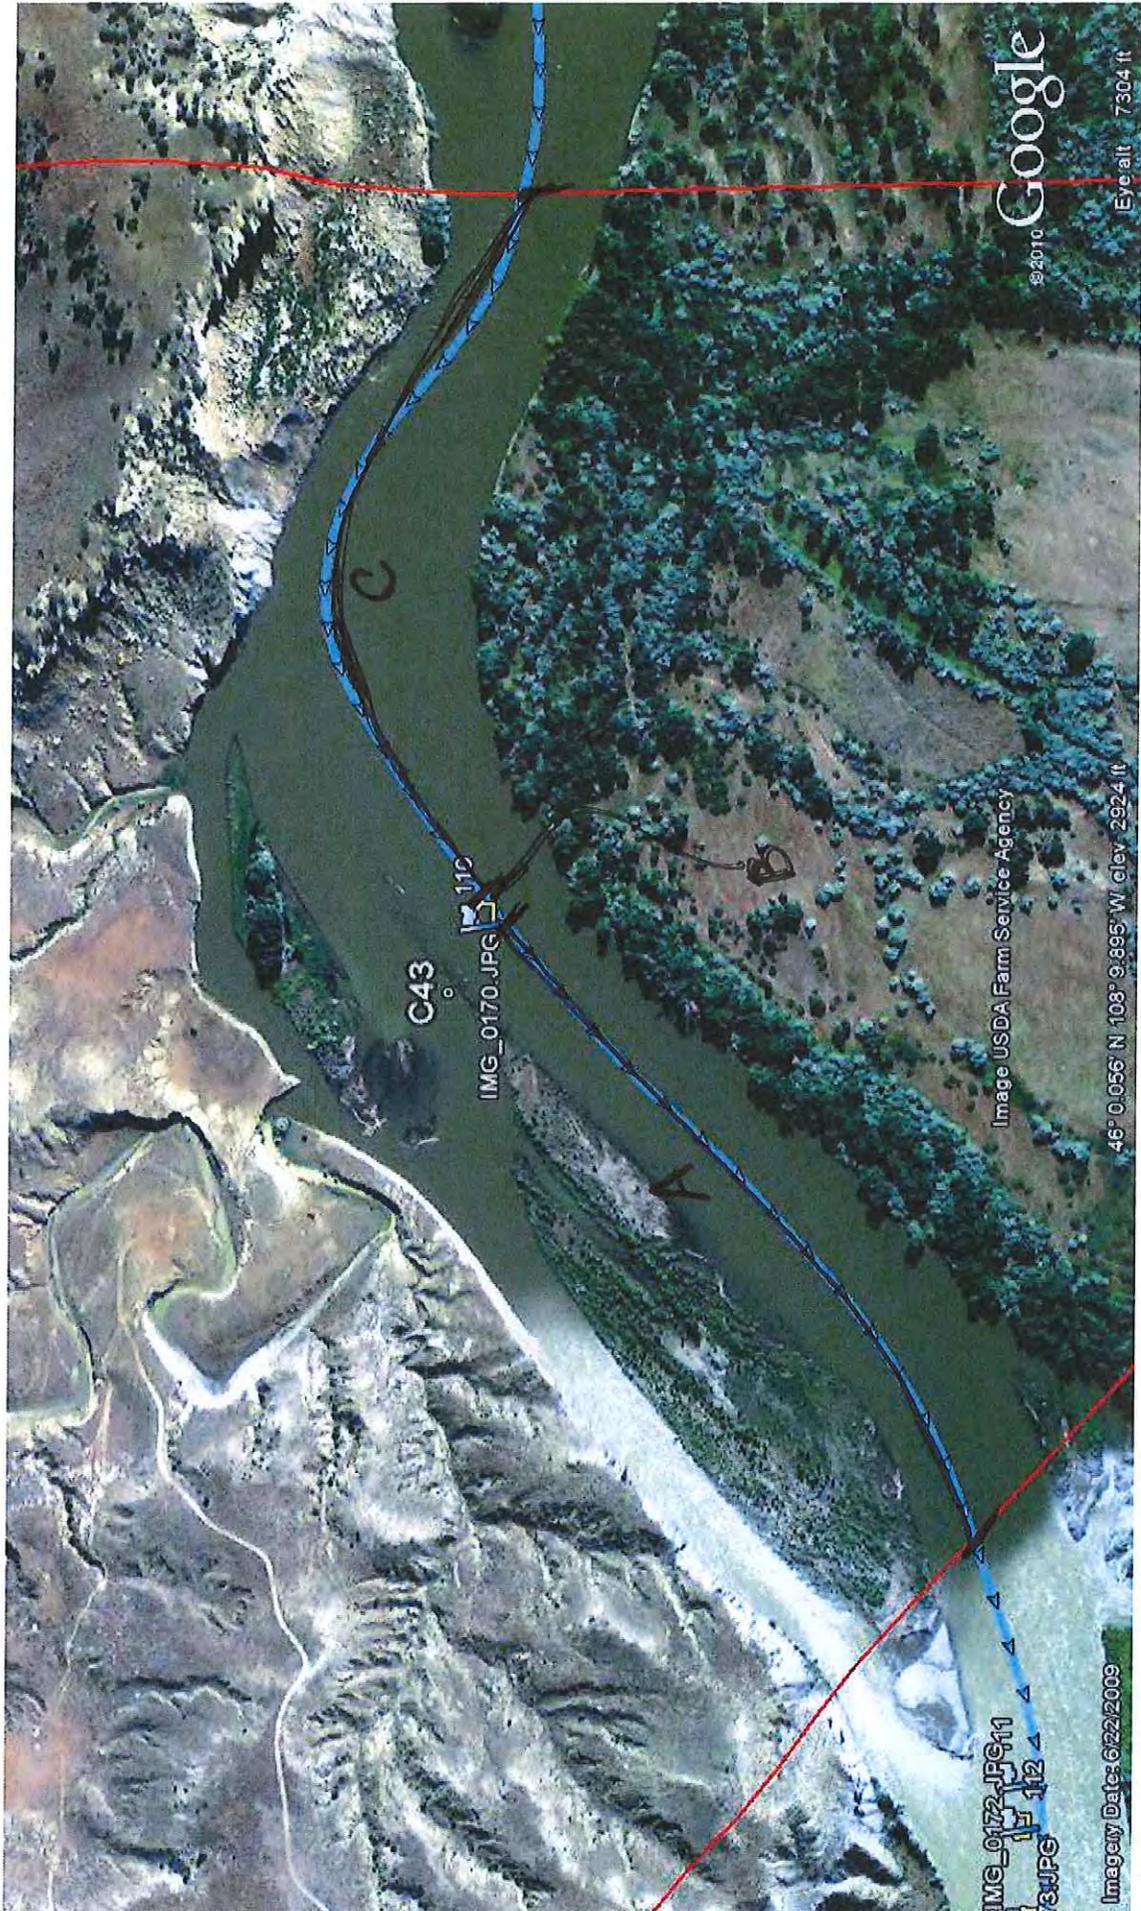
C43 Island
 TEAM '12.
 Aug 4, 2011

OIL ZONE ID	RIVER BANK ZONE				OIL COVER			OIL THICKNESS					OIL CHARACTER						SUBST. TYPE(S)			
	MS	LB	UB	OB	Length m	Width m	Distrib. %	TO	CV	CT	ST	FL	FR	MS	TB	PT	TC	SR		AP	NO	
A				X	330	80	<1			X	(X)		(X)				X					VEG
B				X	330	115															X	VEG
C				X	100	50	<1			X	(X)		(X)				X					VEG
D				X	210	43															X	VEG

Zone :
 A: Oiled tree branches and leaves 1-2m above ground surface. No treatment recommended
 C: Oiled debris piles. No treatment recommended
 B,D No oil observed. No treatment required

A - < 1% STRICT NTR, C

B - NOD, D

B starts @ pre 110 and extends 10m

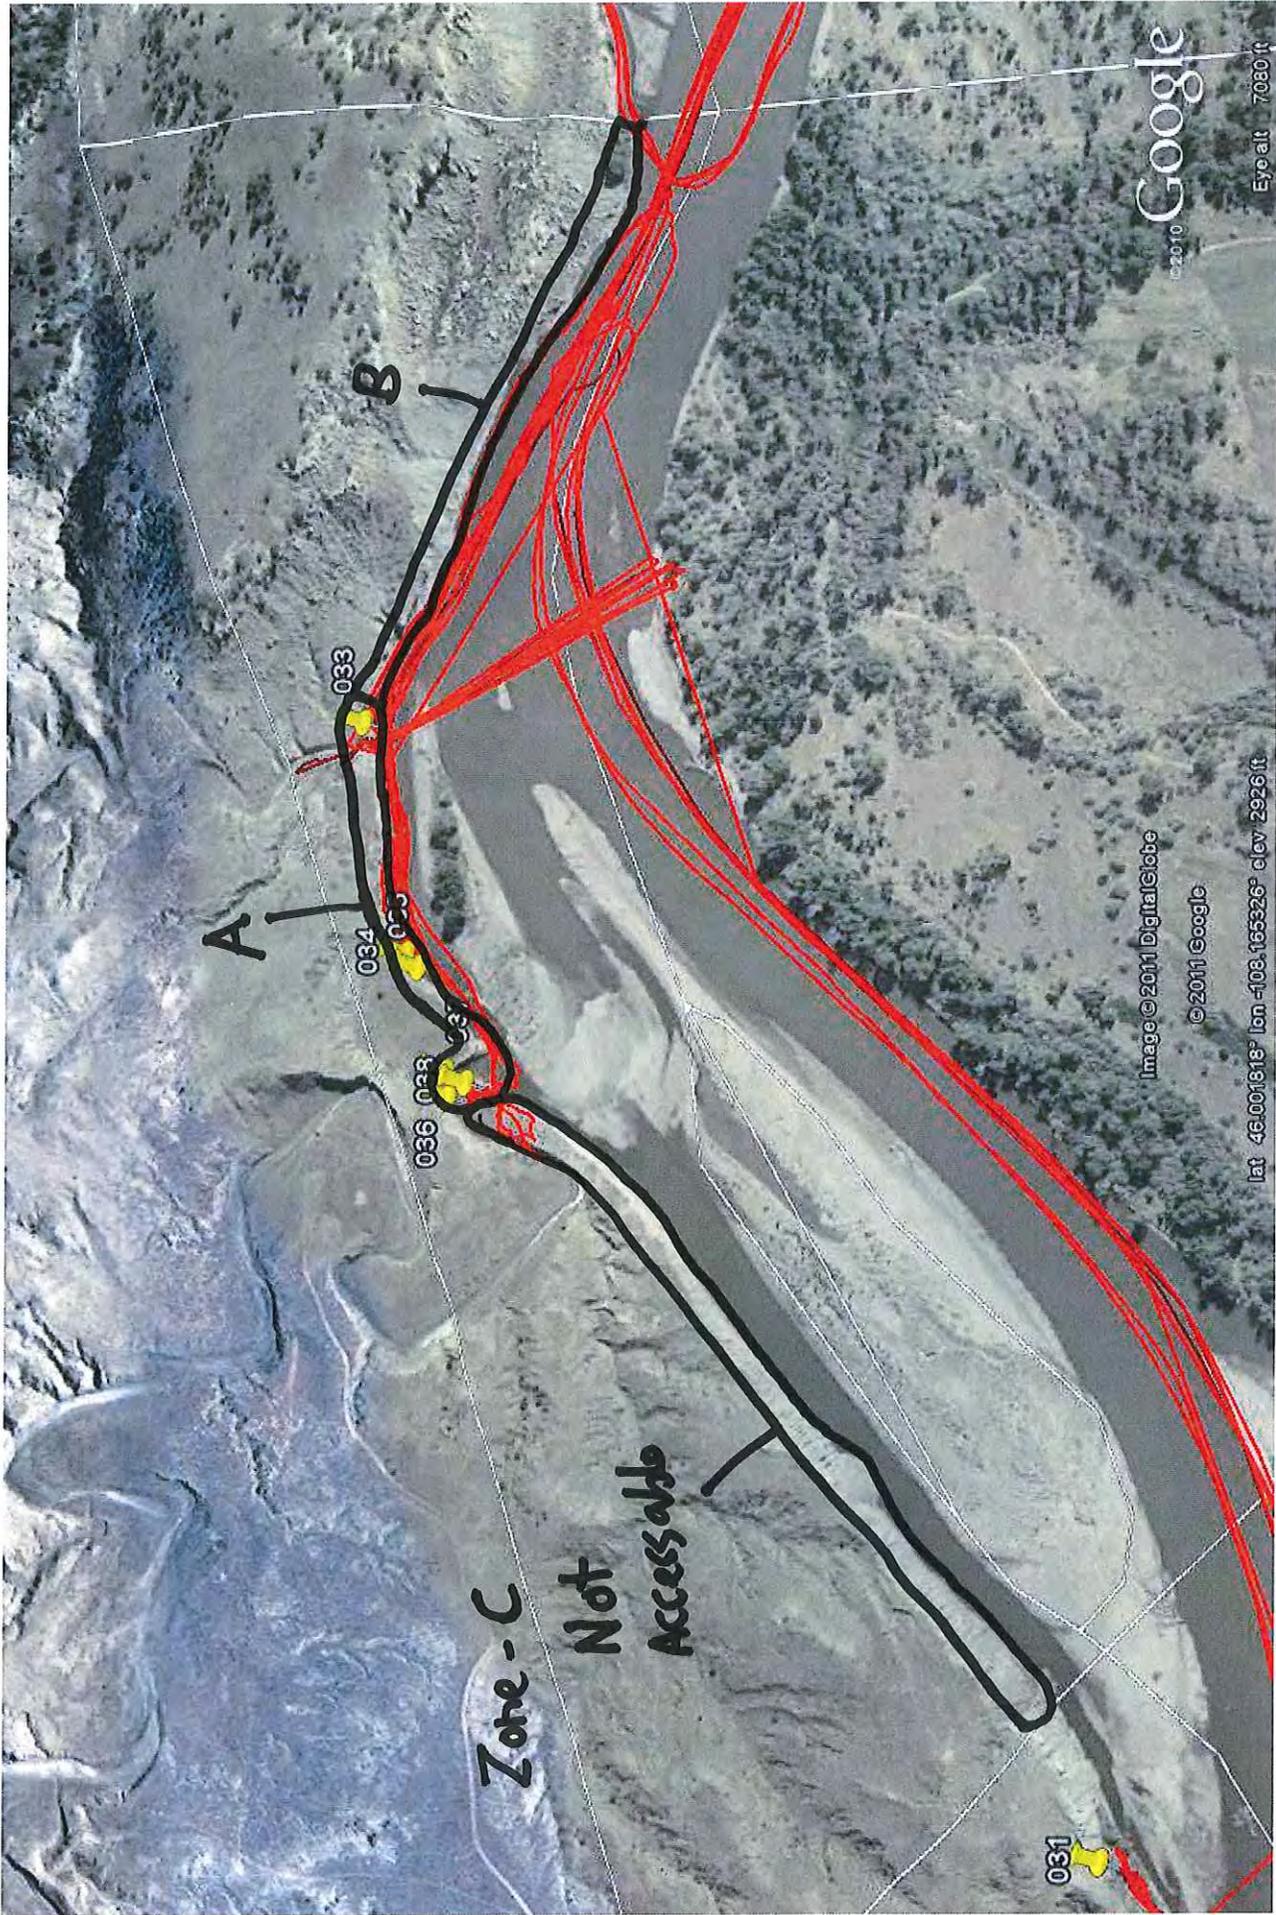
CH3LB
Teams 1+2
10/08/11

Zone A - ~~several~~ ^{few} areas of sporadic stumps on grass, some root, access very difficult. NTR. ~~etc~~

Zone B - NOO

Zone C - No access, not surveyed.

Zone - C
Not
Accessable

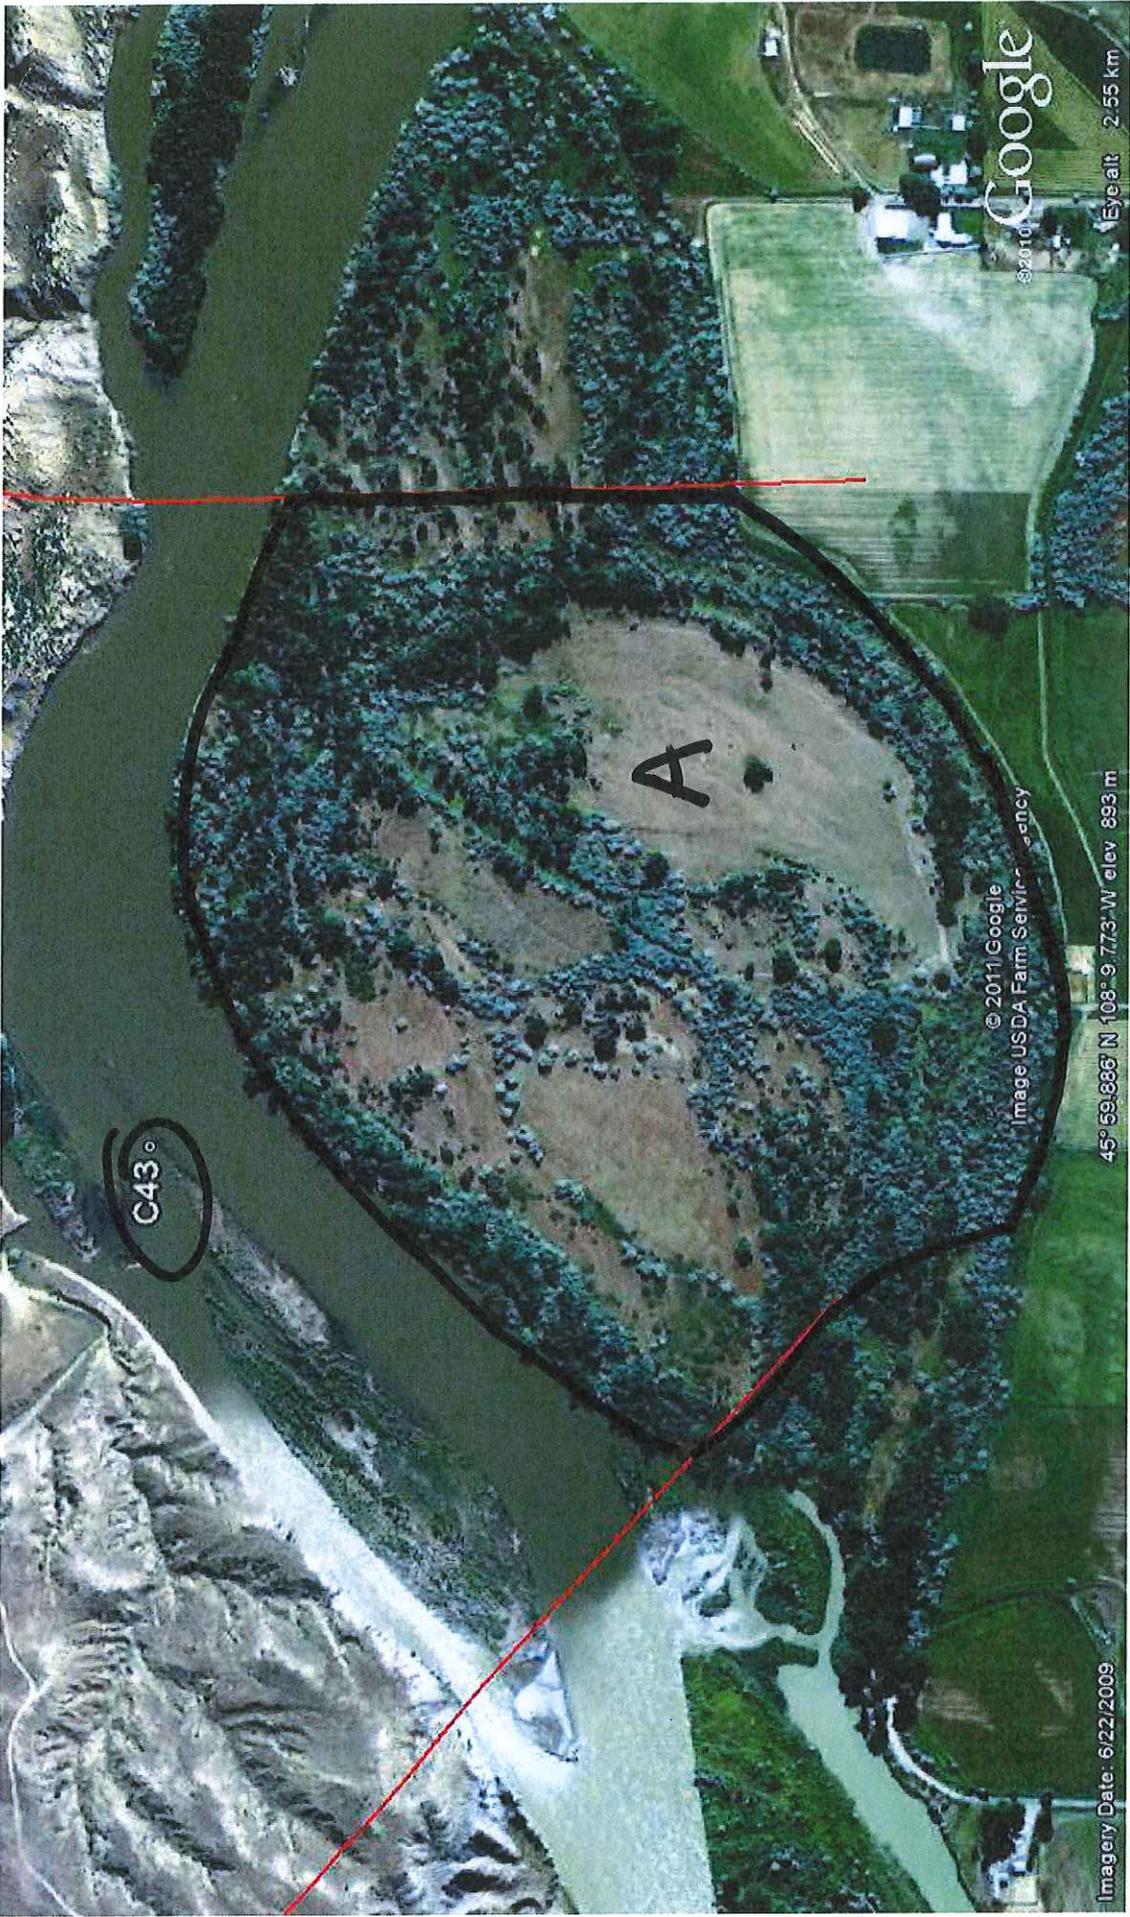
C43

OIL ZONE	RIVER BANK ZONE				OIL COVER			OIL THICKNESS					OIL CHARACTER						SUBST. TYPE(S)					
					Length	Width	Distrib.	TO	CV	CT	ST	FL	FR	MS	TB	PT	TC	SR		AP	NO			
ID	MS	LB	UB	OB	m	m	%																	
A				X	1159	900	<1			X	X			X										Grass, trees, debris

Oil height: 30-180cm

Zone A : No oil observed; no treatment required; very light oil categorization

Zone : Cut & remove oil-coated vegetation smaller than 1" diameter. Remove debris smaller than 4" diameter. Wipe larger oil-coated vegetation.

*Refer to current approved treatment methods #1 (Cutting of Vegetation), #2 (Dead Vegetation and Small Debris), #3 (Large Woody Debris), #6 (Sorbent Use), # (Unconsolidated Sediments)

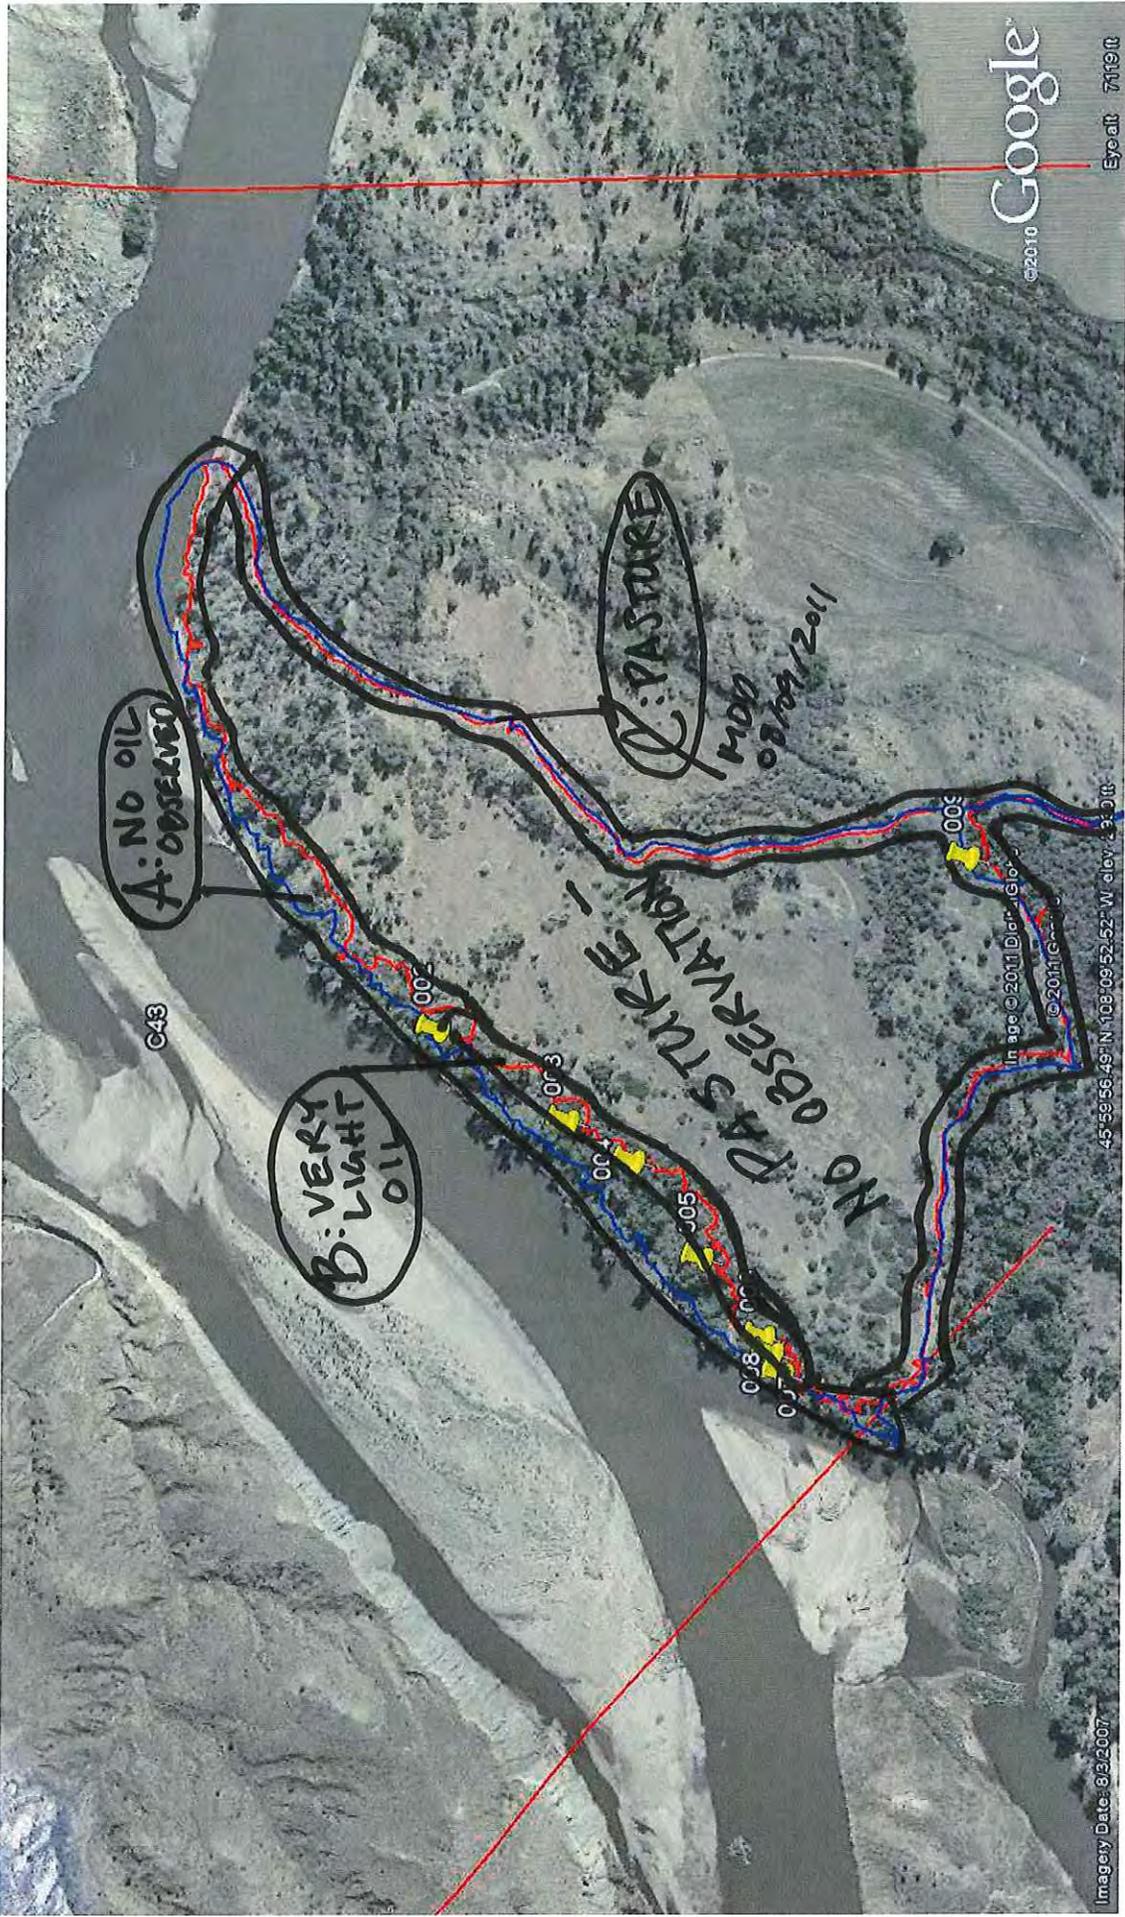
SCAT TEAM 5 08.09.2011
 C43 RB

Zone A: No oiling observed, no further treatment recommended in the riparian corridor on the right bank.

Zone B: Very light oiling, <1% distribution of coating on debris piles in the upper bank, Russian Olive woodland. No further treatment.

Pasture: Tracked 1,360 m long, 15 m wide not included in the SCAT survey. Property owner has made a claim.
