**SCAT Area Transition Report  
for C52**

Silvertip Pipeline Incident  
Laurel, Montana

October 22, 2011

Prepared for:  
ExxonMobil Pipeline Company

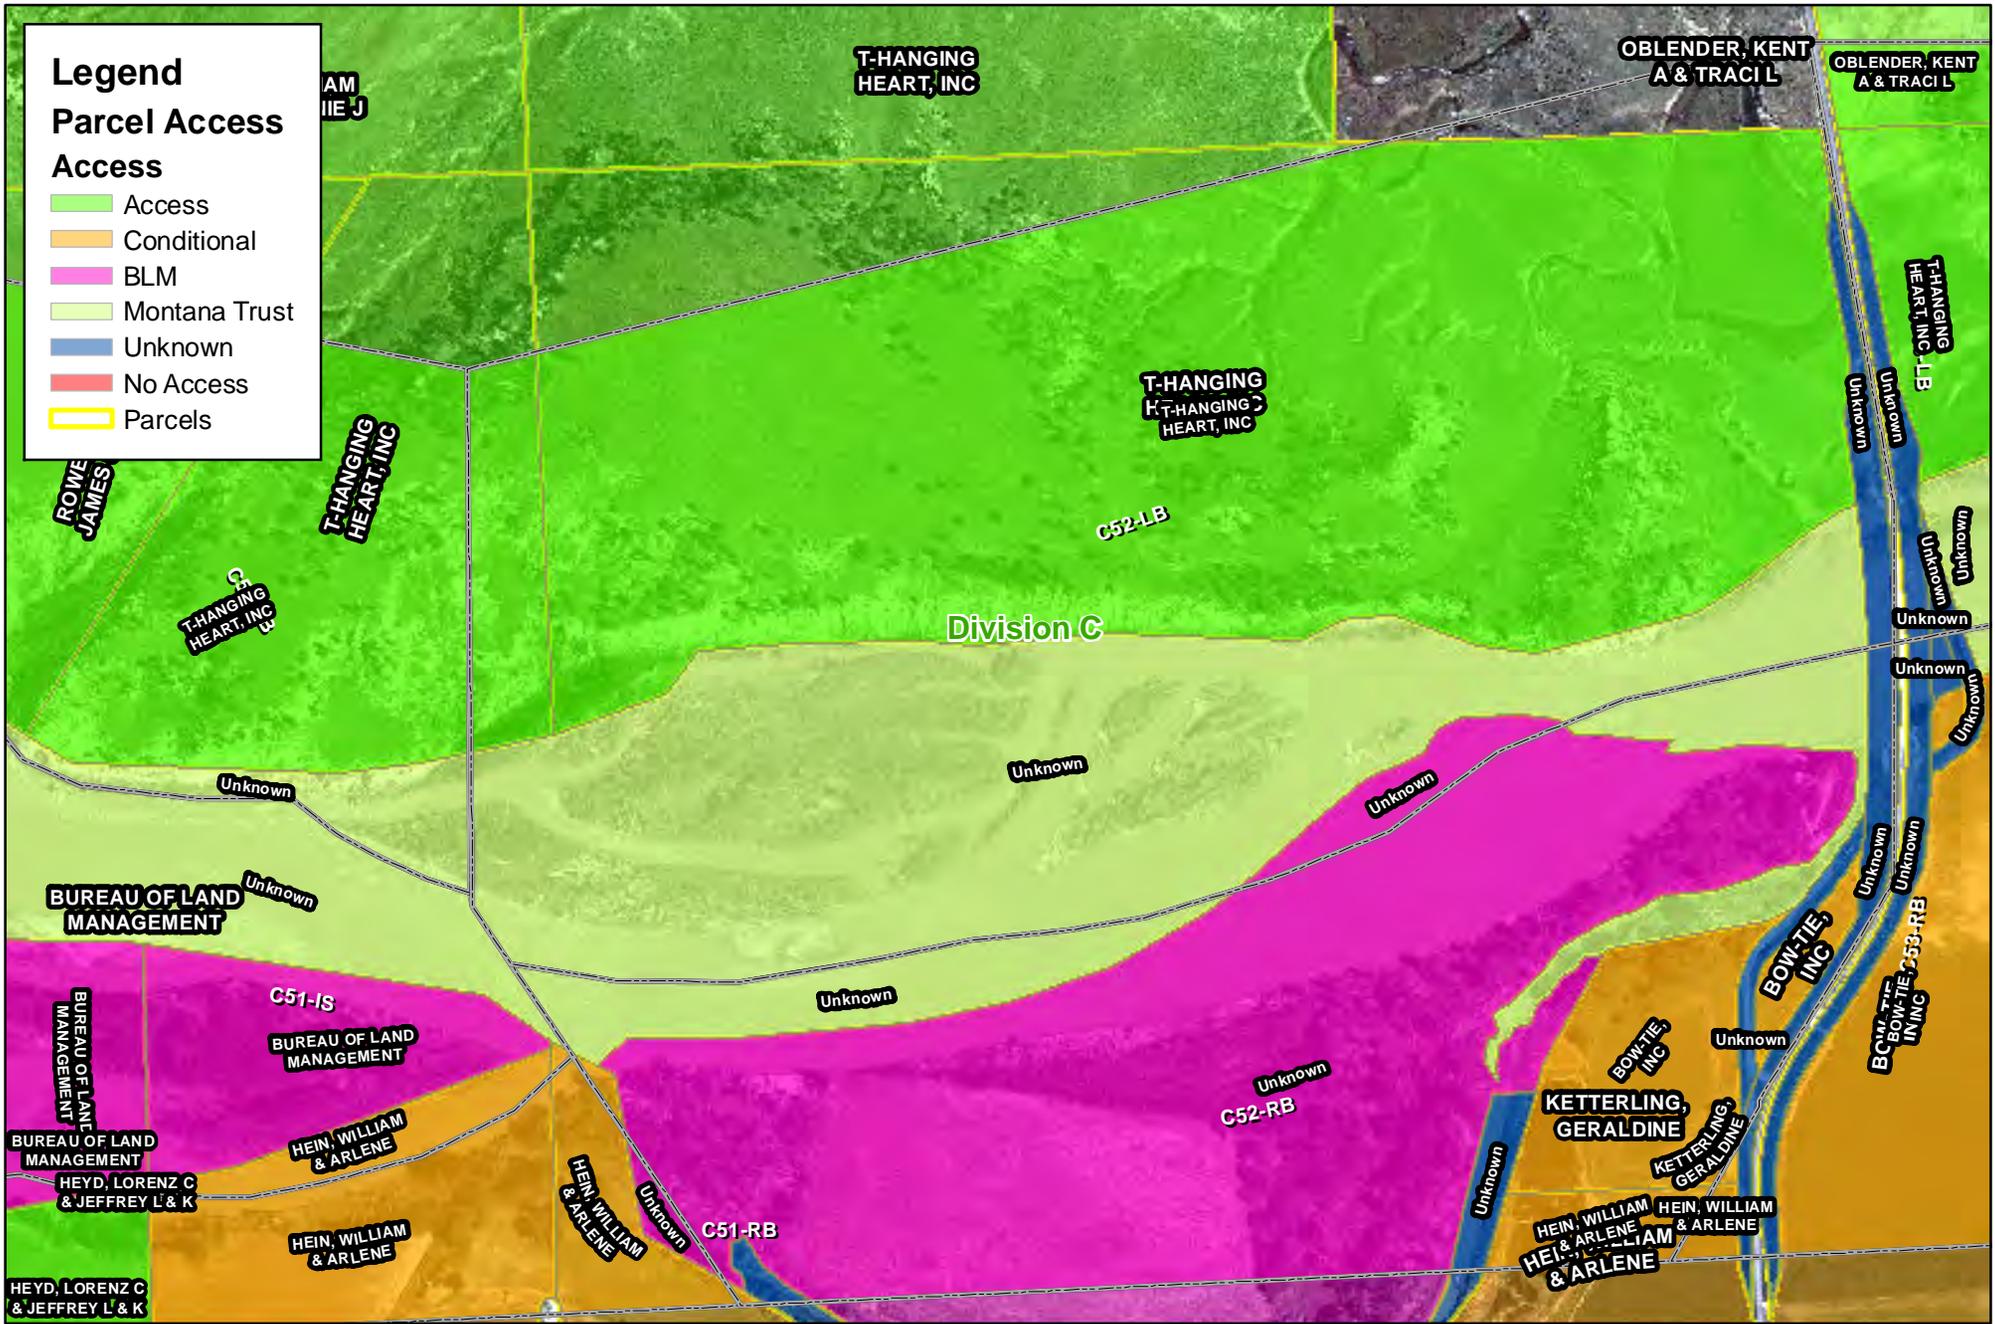
Figure 1 provides an aerial map of SCAT Area C52, along with the (a) SCAT Area boundary, (b) parcel boundaries and respective property owners, and (c) access constraints identified during the oil cleanup process. The acreage surveyed in Area C52 is 112.3. There were no access issues for this segment.

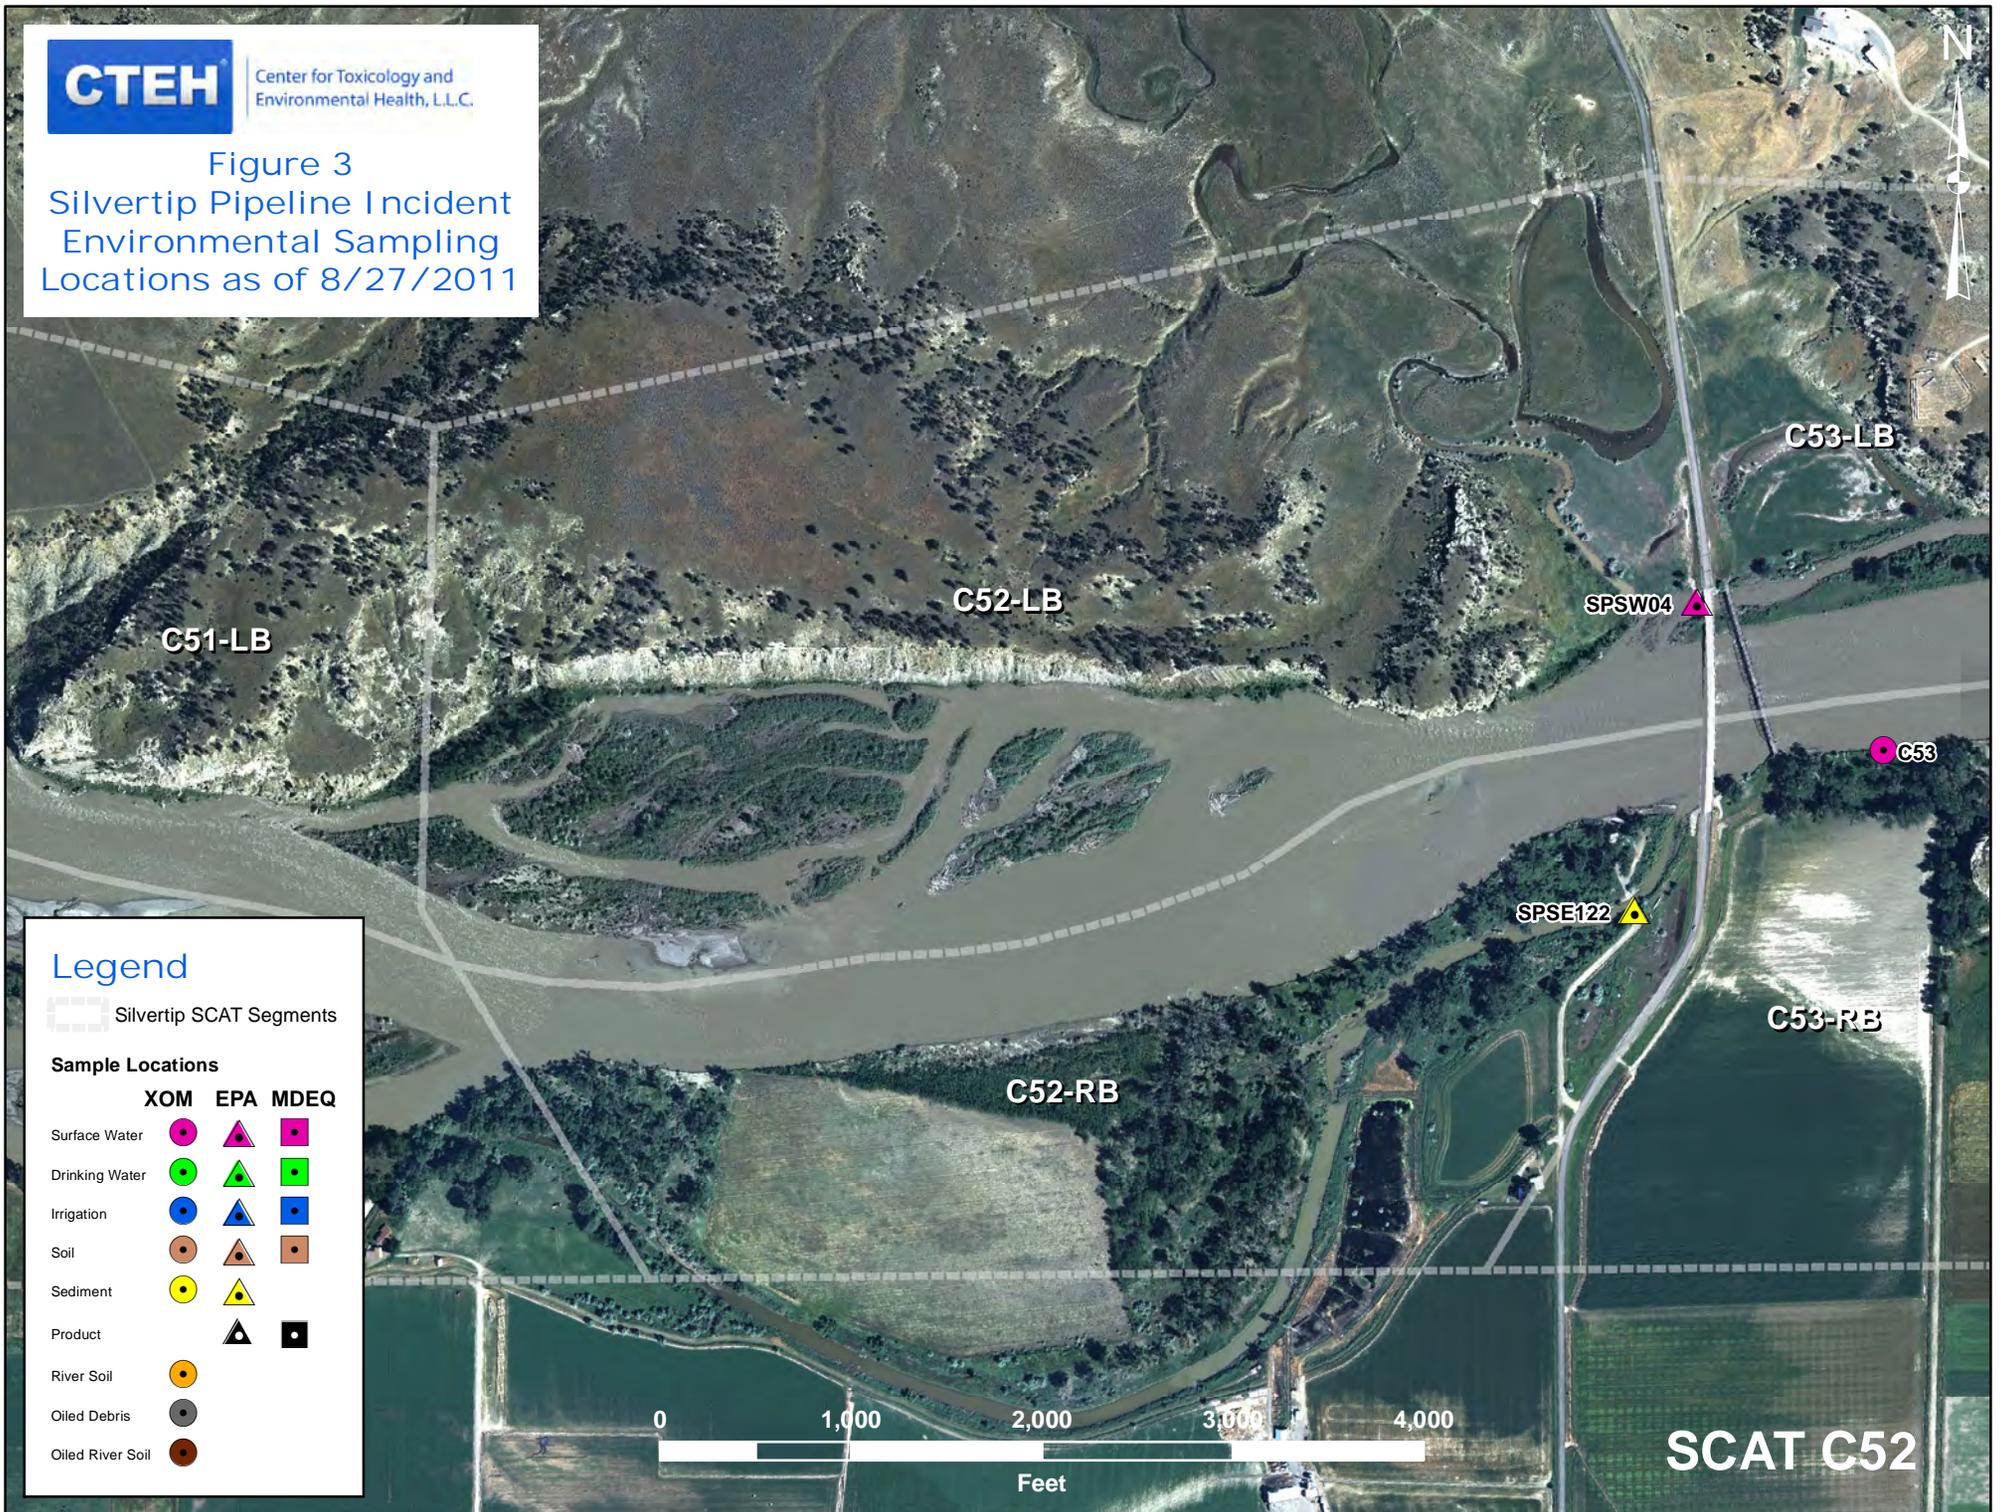
Figure 3  
 Silvertip Pipeline Incident  
 Environmental Sampling  
 Locations as of 8/27/2011

Table 1 (below) summarizes samples collected within Area C52. The analytical results for the samples collected can be accessed through a publicly accessible database on the United States Environmental Protection Agency's (USEPA's) website. The approximate locations of samples collected within Area C52 are provided on Figure 3.

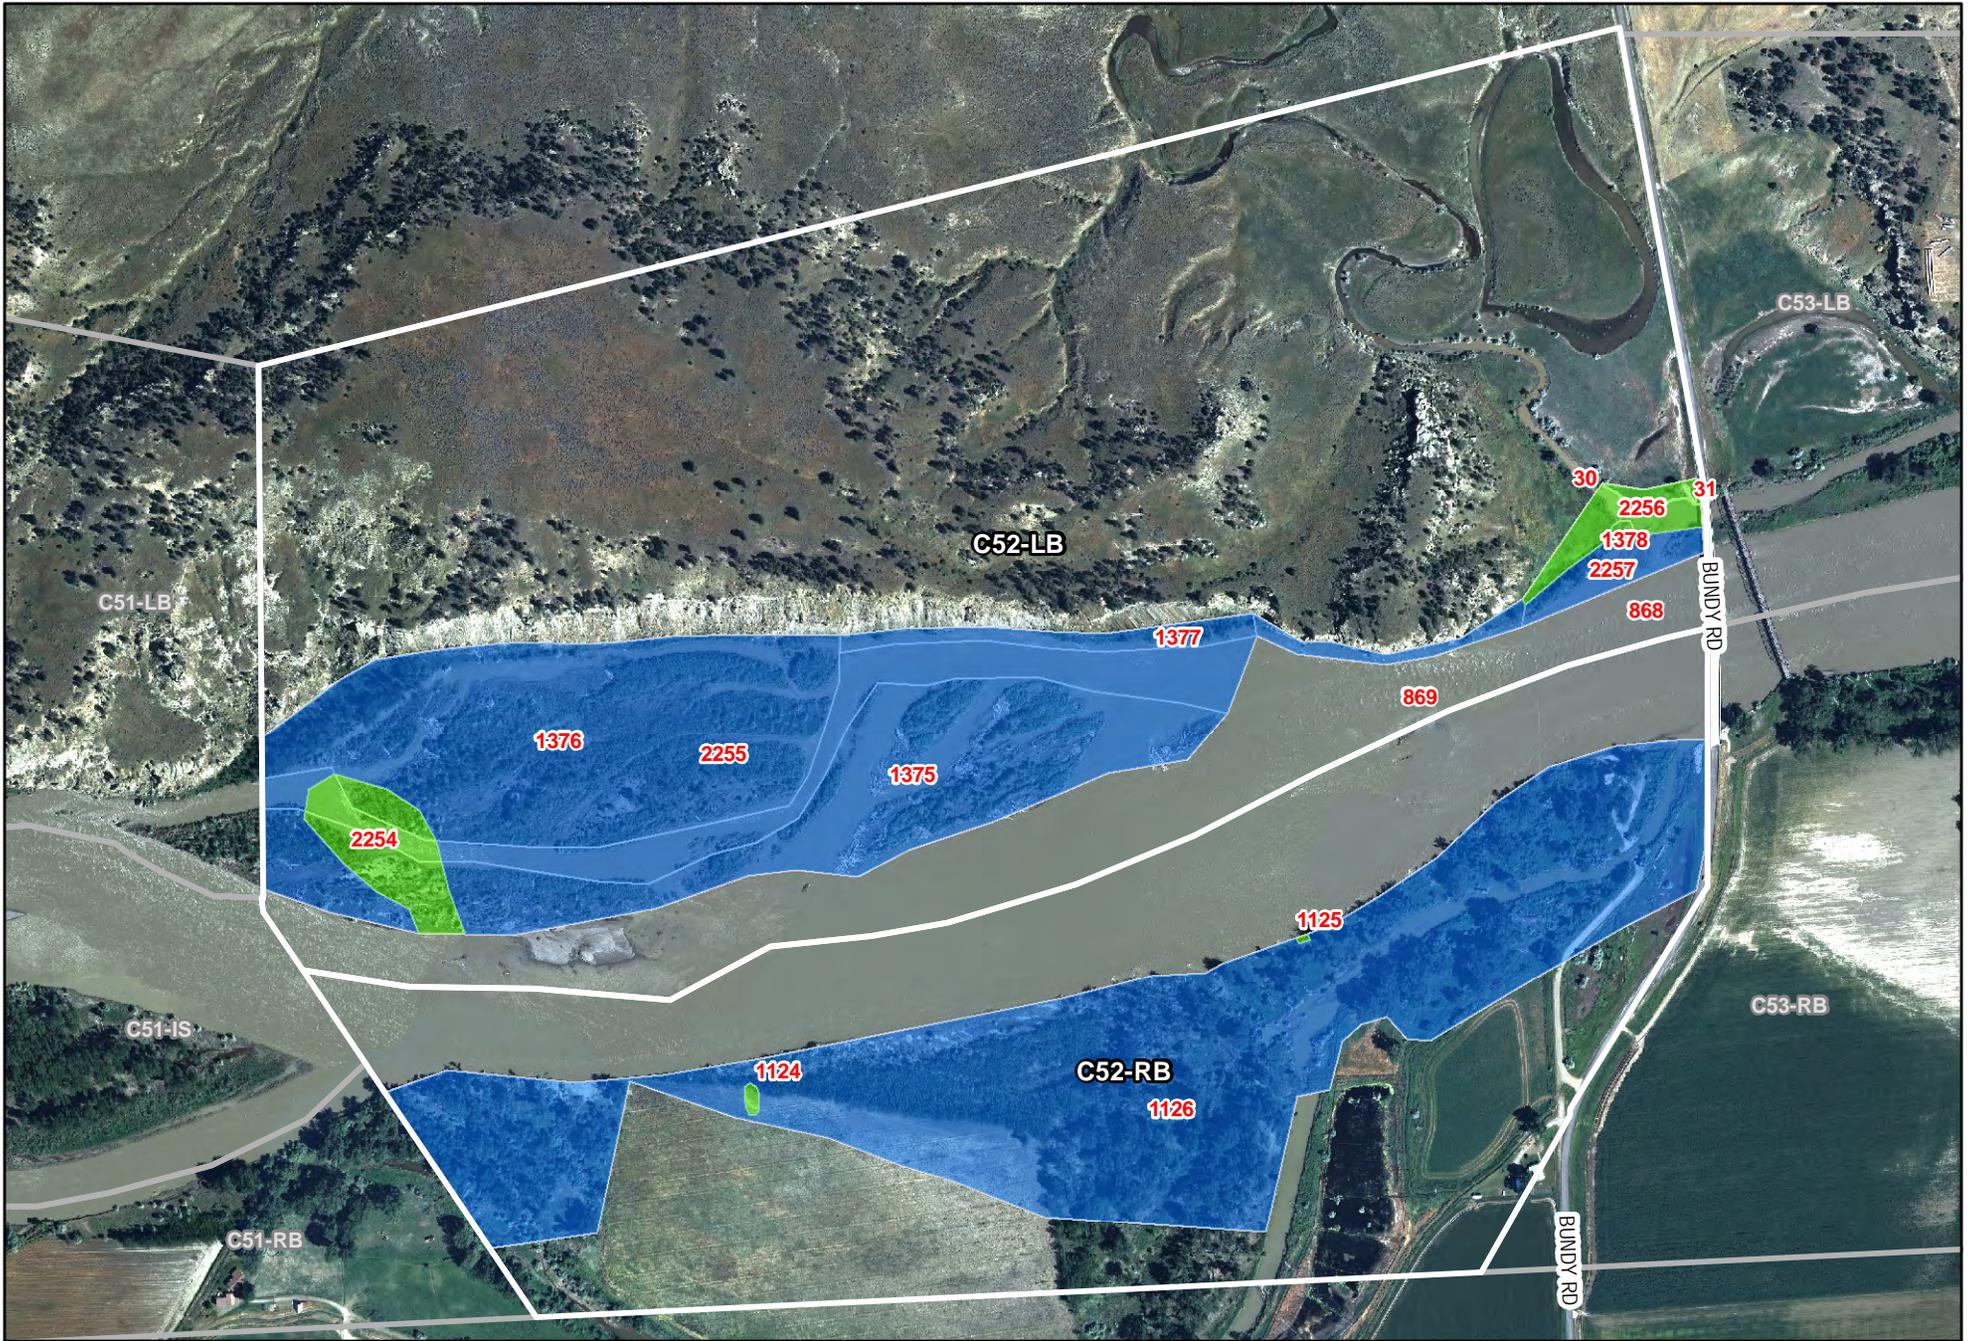
**Figure 5 - Final SCAT Observations  
For SCAT Area:**

Figure 5 shows the oiling conditions within Area C52 following completion of oil removal activities. The SCAT team performed final surveys of the left bank within SCAT Area C52 to confirm the agreed-upon cleanup endpoints identified in the applicable CTRs had been achieved. The final SCAT survey documentation is presented in Appendix E.

Based on the final SCAT surveys performed on the left bank within Area C52, no further treatment is recommended for this segment. Based on the initial SCAT survey of the right bank, no treatment was recommended for the small portions where oiling was observed. SCAT Segment Sign-Off Forms are included as Appendix F.

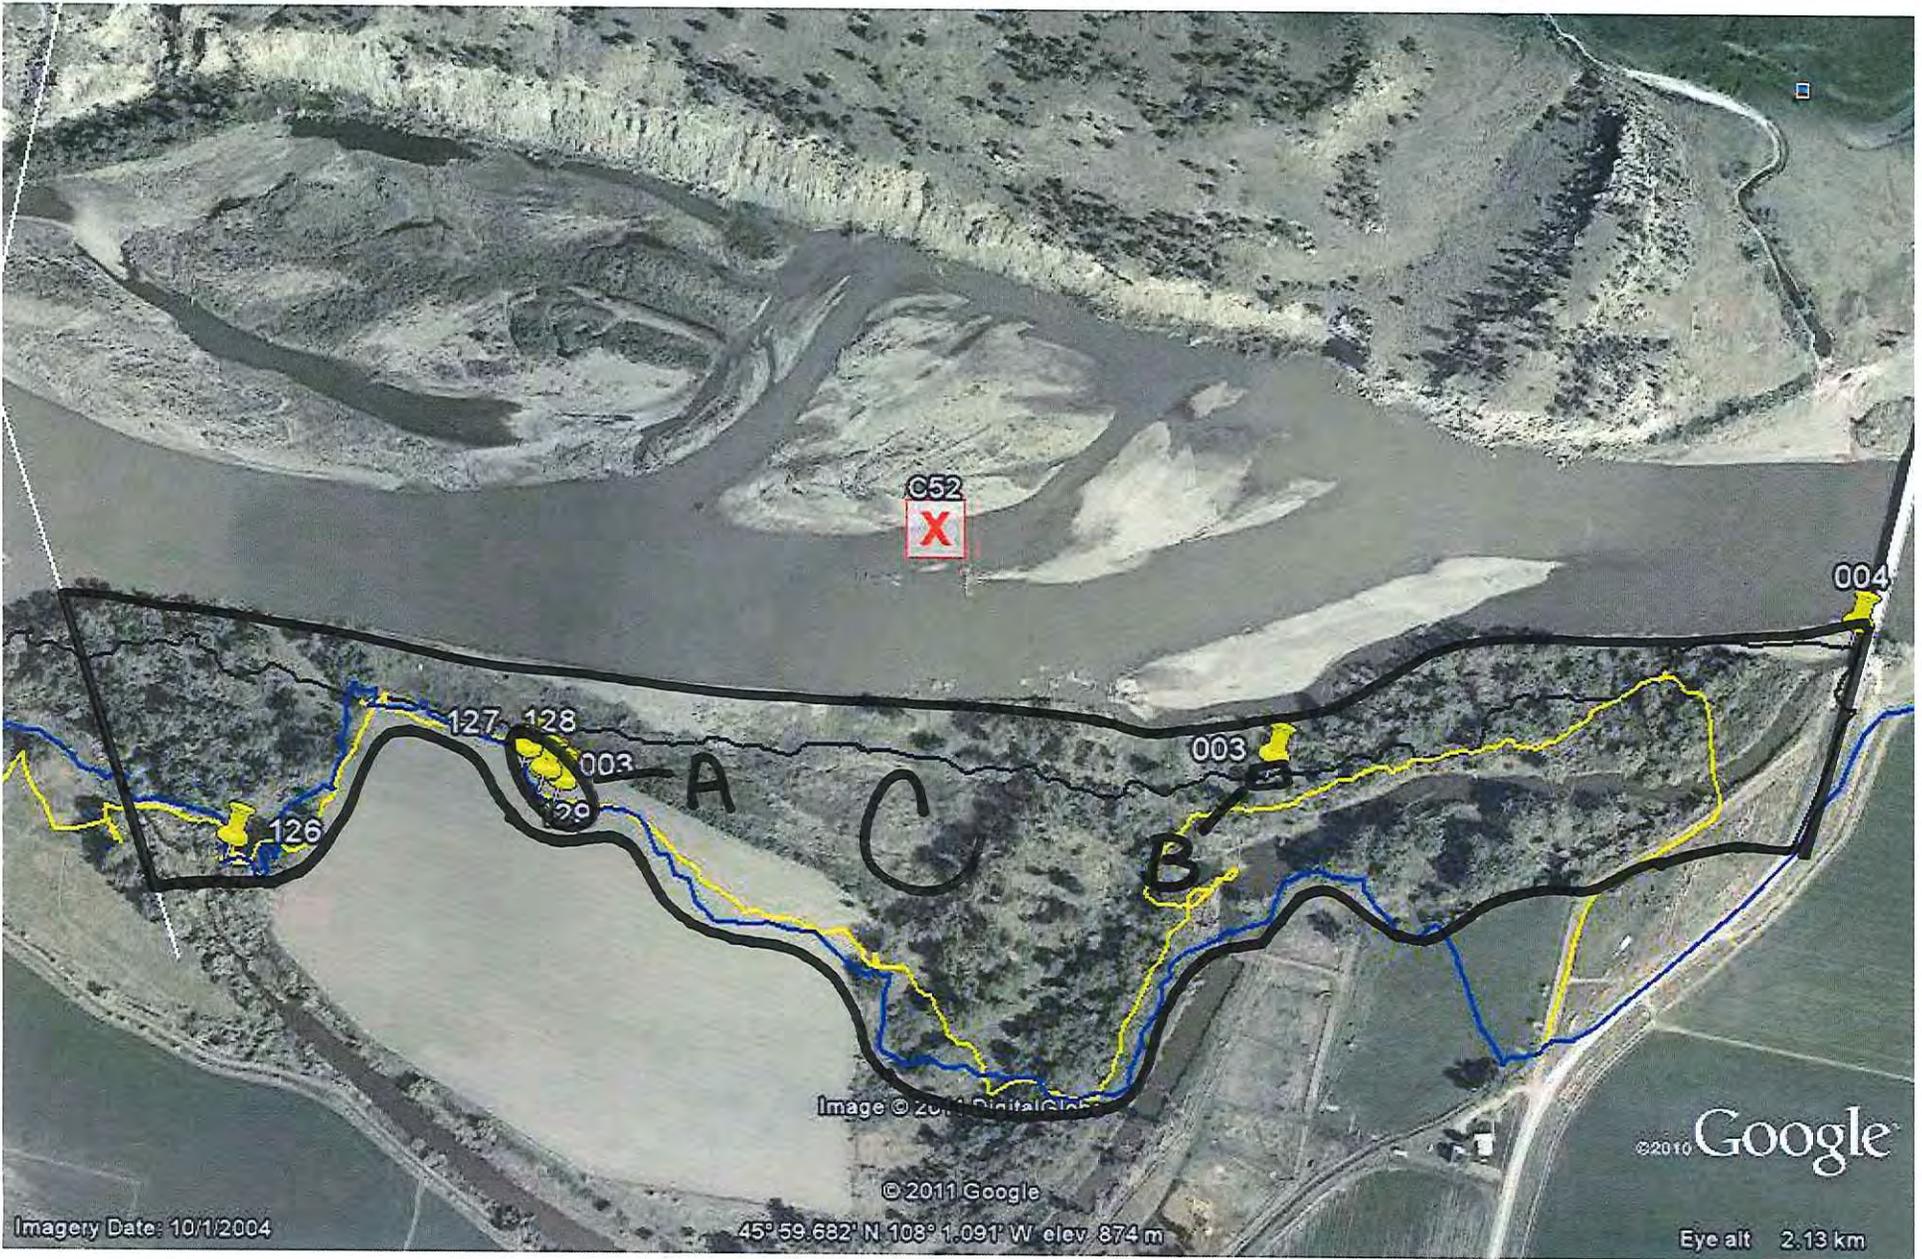
August 2, 2011  
TEAM 3 C52<sup>R</sup>  
ZONES A, B, + C

Treatment Recommendations: No Treatment for A. GP / LF (BLM) oiled

Zone : A: Cut and remove oiled grass. Remove dead vegetation and oiled small debris

B: no treatment recommended

C: no. no treatment recommended

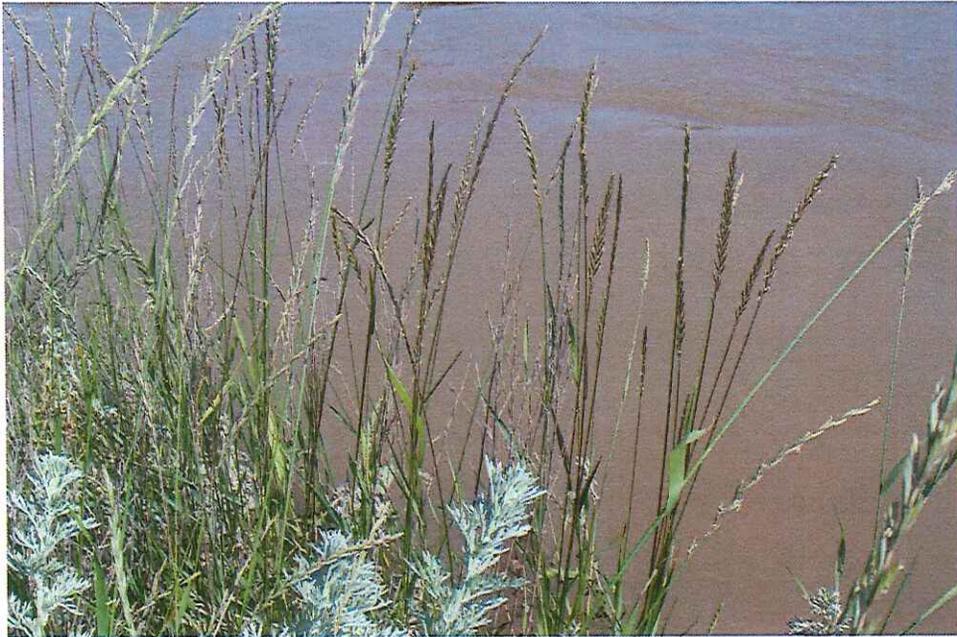
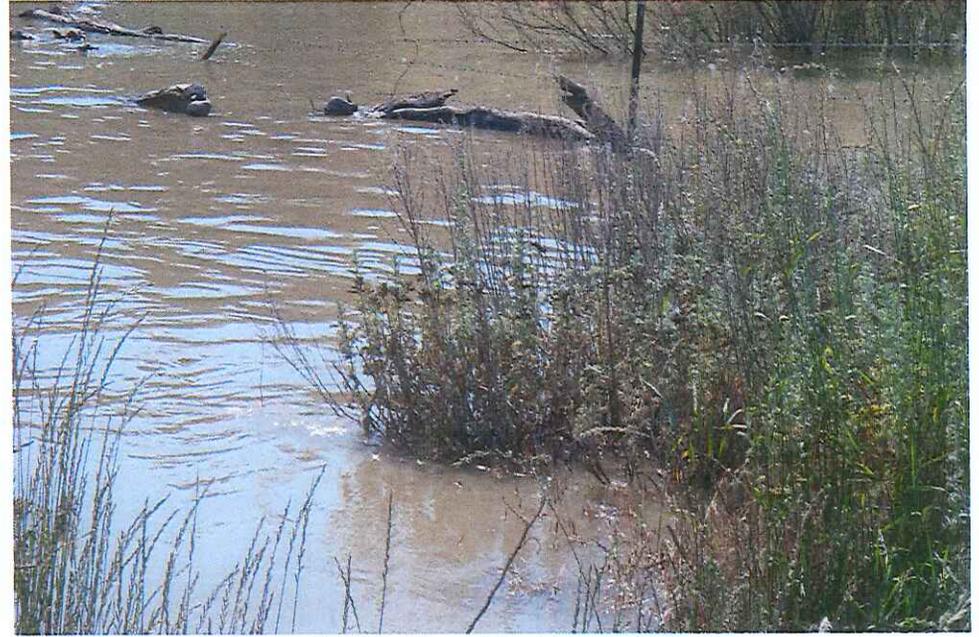
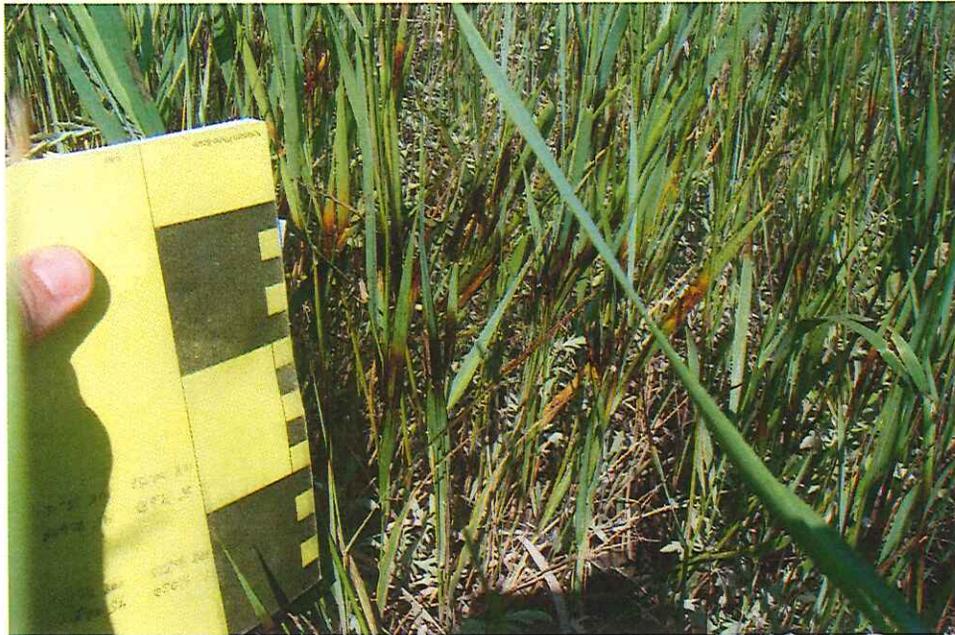
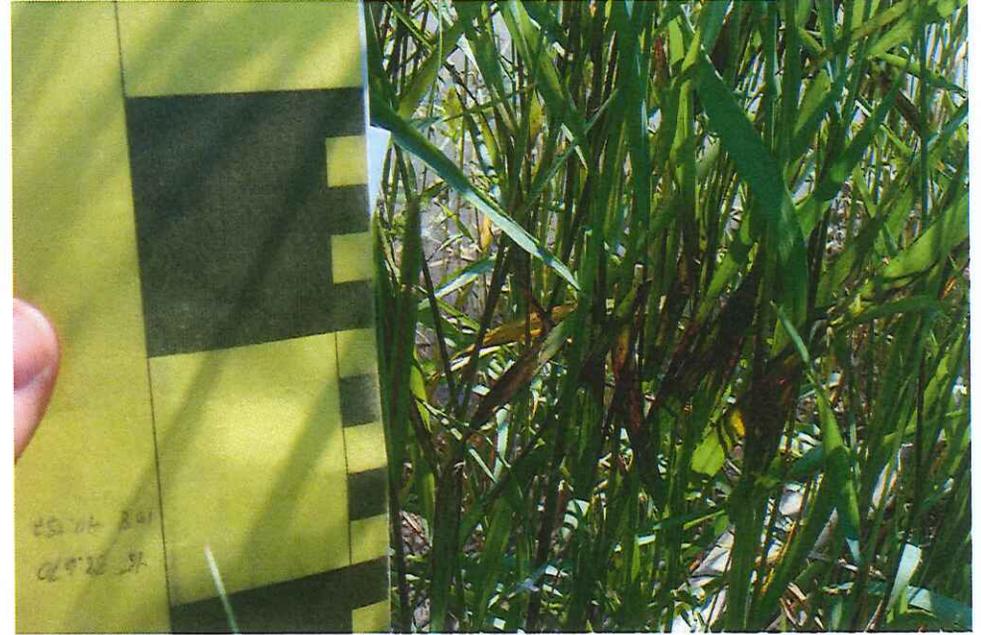
Zone A = oiled band 2-10cm, ST/CT 25-30% up to 5 meters wide likely continued up small channel but no access

~~C51~~-LB, Zone A  
C52

~~C51~~-LB, Zone A looking up river  
C52

no treatment recommended

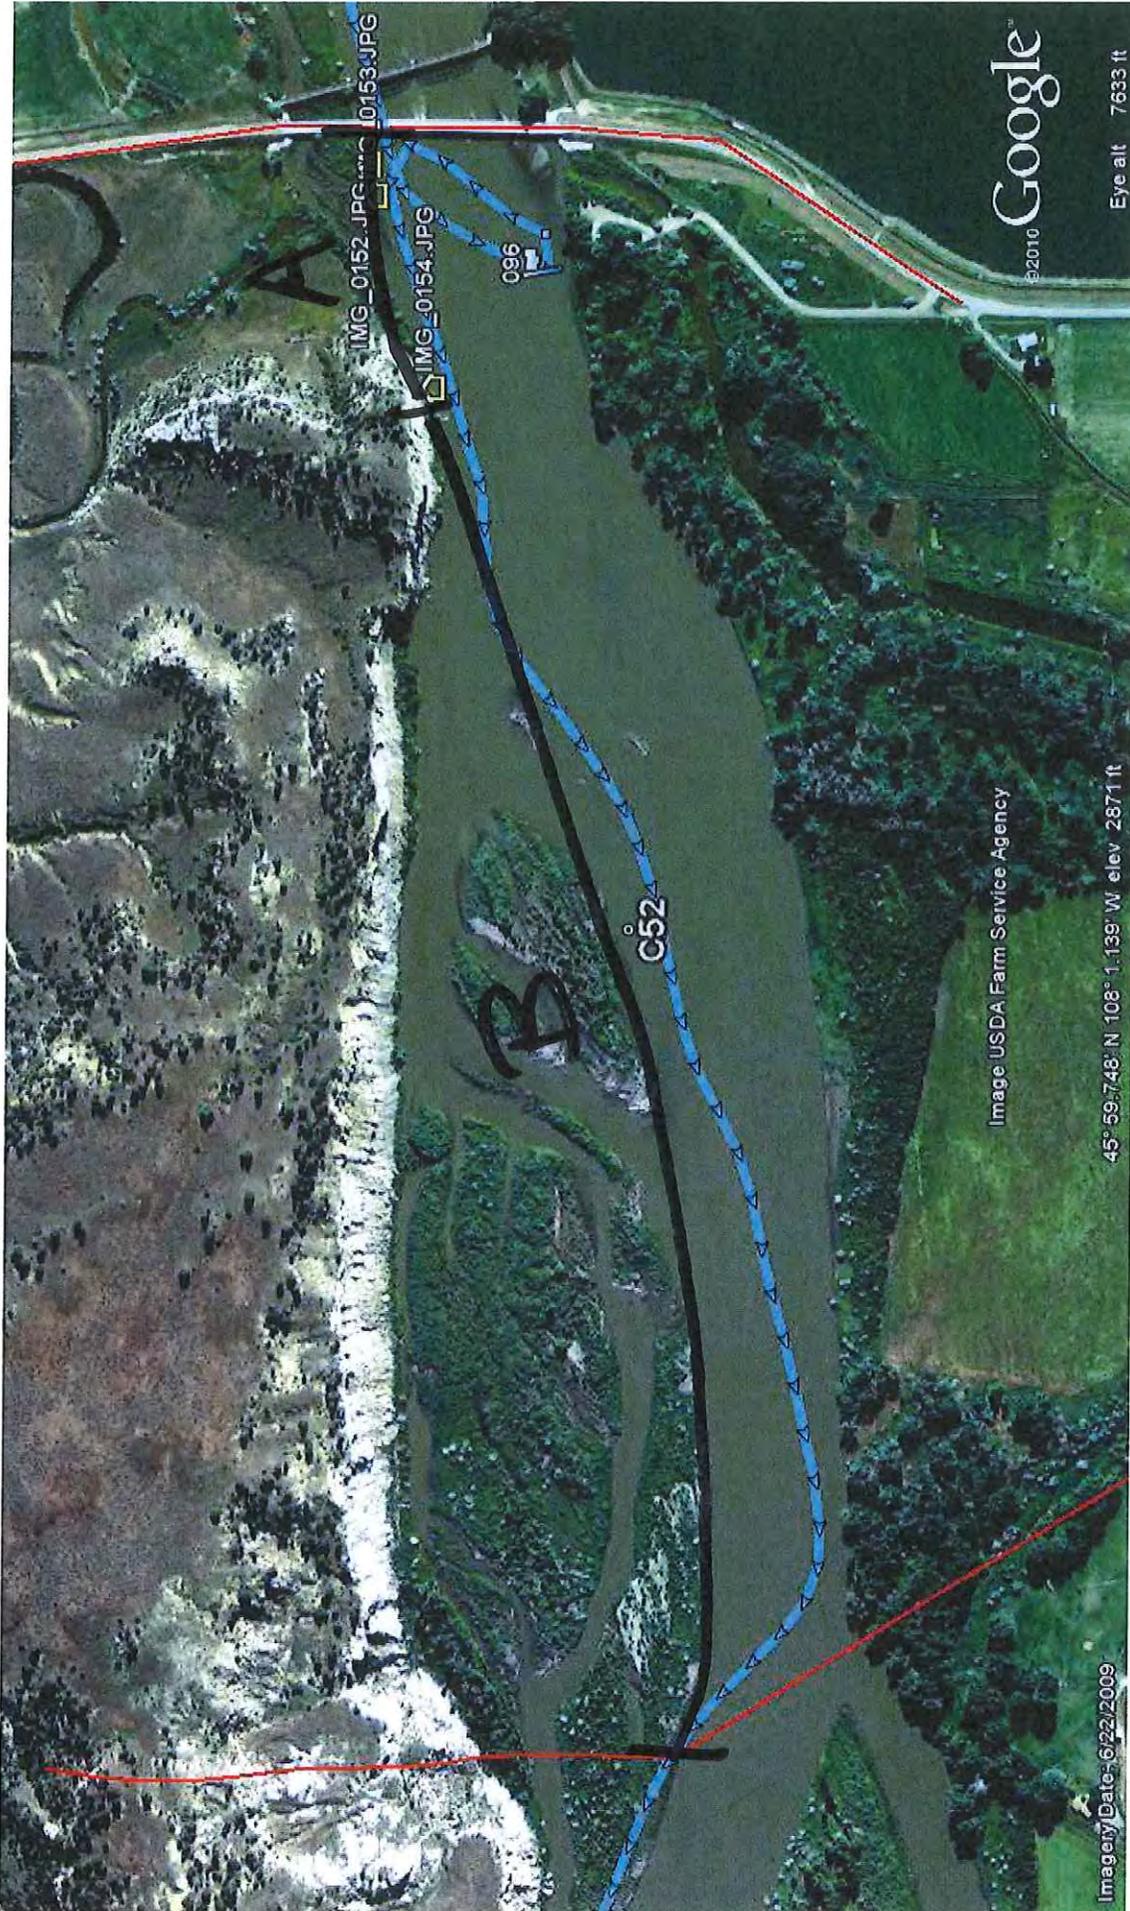
C52

Zone A : No oil observed; no treatment required.

Zone \_\_\_\_\_ : Cut & remove oil coated vegetation smaller than 1" diameter. Remove debris smaller than 4" diameter. Wipe larger oil coated vegetation.

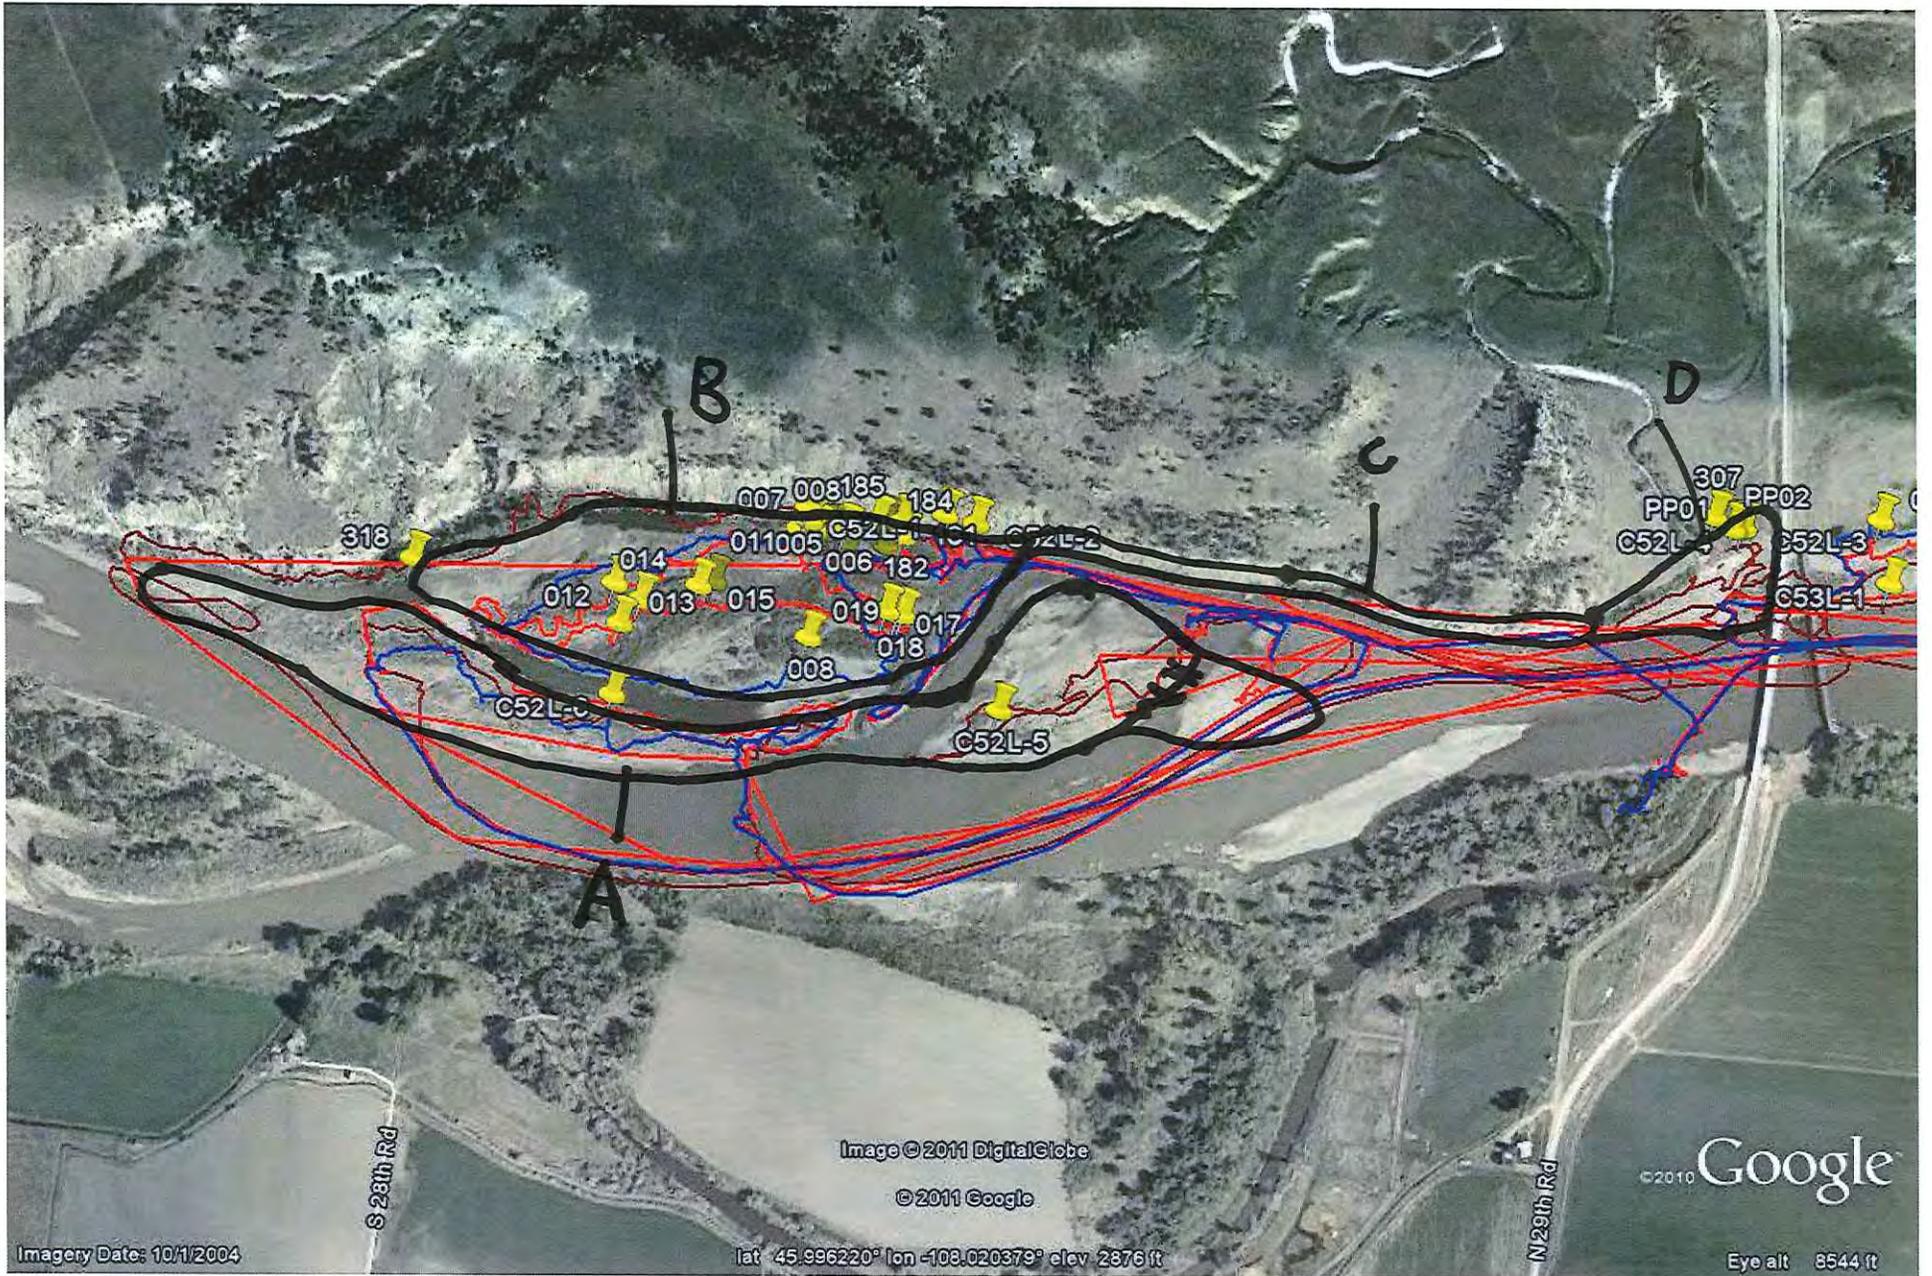
C52LB  
Teams 1 + 2  
09/08/11

Zone C - NOO

Zone D - cut grass in over bank area LB adjacent west of Bumpin Bridge  
 'bathtub ring' on grass (FWP Opinion High-Use Public Access Area - Aesthetic Concerns)  
 However staining on grass Not Transferable Does Not Fall Under Current Guidelines

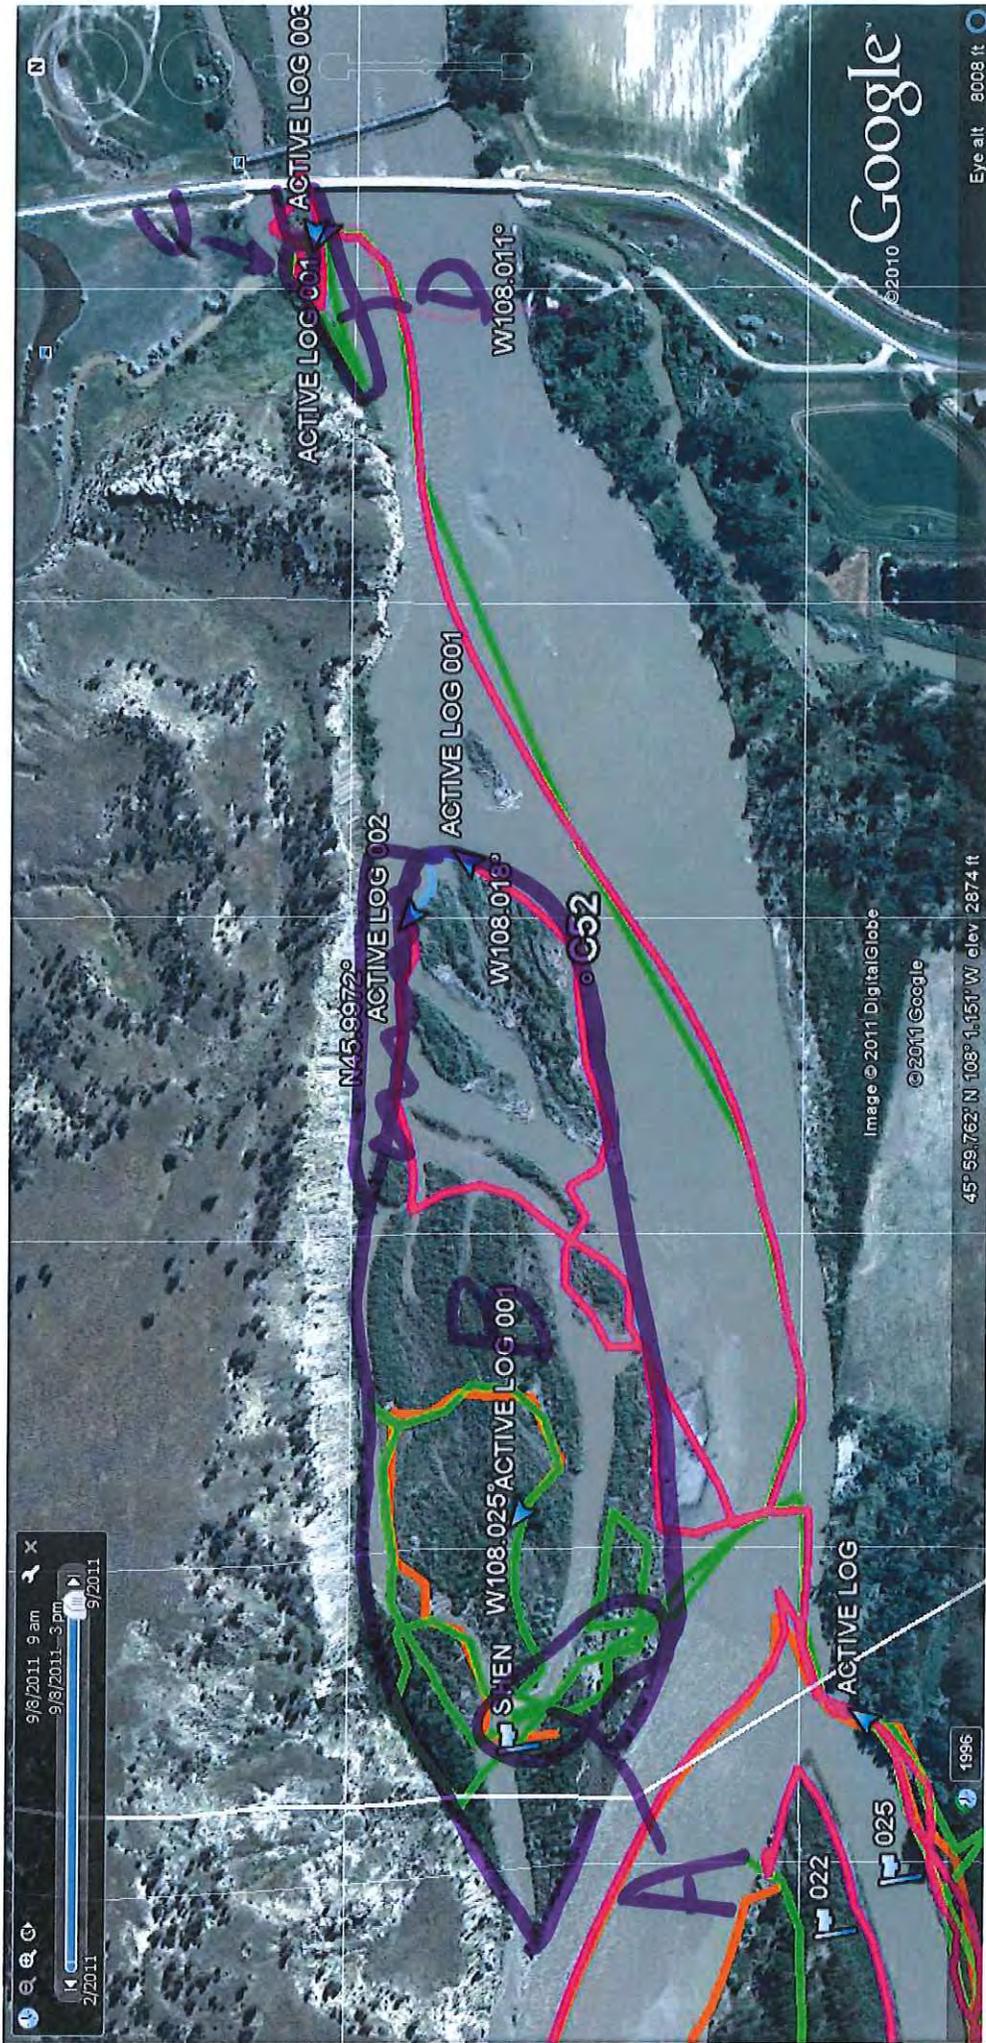
C52LB  
8 Sept. 2011  
Team 2

Area has been cleaned by operations. The two oil zones that were present have been reduced to traces of stain.

**A** - oiled area, cleaned by hot shot crew. Remaining oil reduced to traces of stain. Natural Attenuation

**C** - oiled area of bath tub ring. Cleaned by hot shot crew. Remaining oil reduced to traces of stain. Natural Attenuation

A - Very Light  
B - NOB  
C - Very Light  
D = NOO

**B**  
A - No oil observed. No additional treatment is required.
