**SCAT Area Transition Report
for C53**

Silvertip Pipeline Incident
Laurel, Montana

October 25, 2011

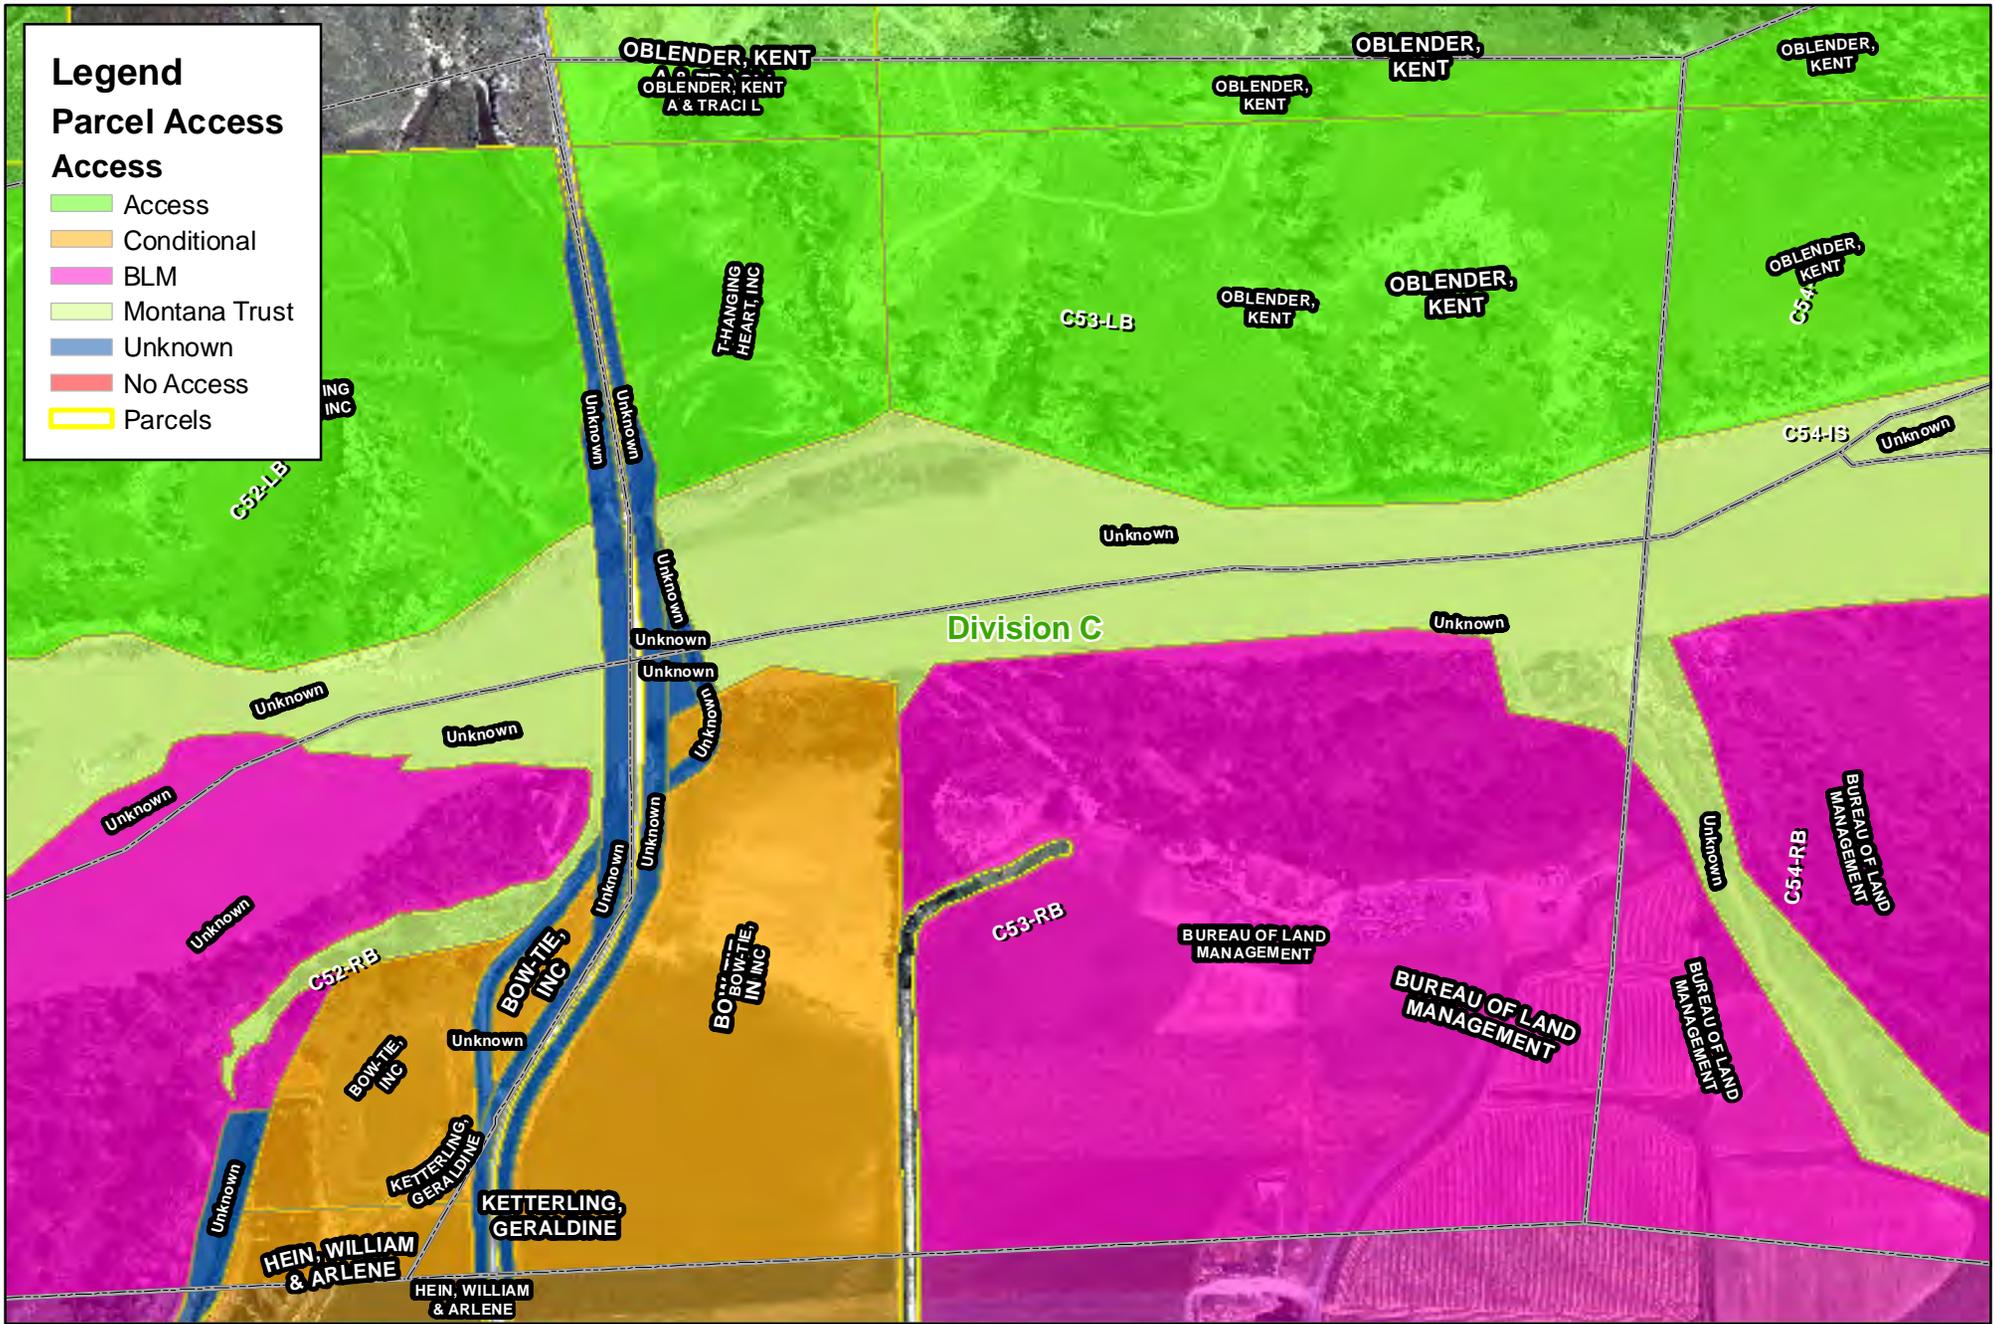
Figure 1 provides an aerial map of SCAT Area C53, along with the (a) SCAT Area boundary, (b) parcel boundaries and respective property owners, and (c) access constraints identified during the oil cleanup process. The acreage surveyed in Area C53 is 57.0. There were no access issues for this area.

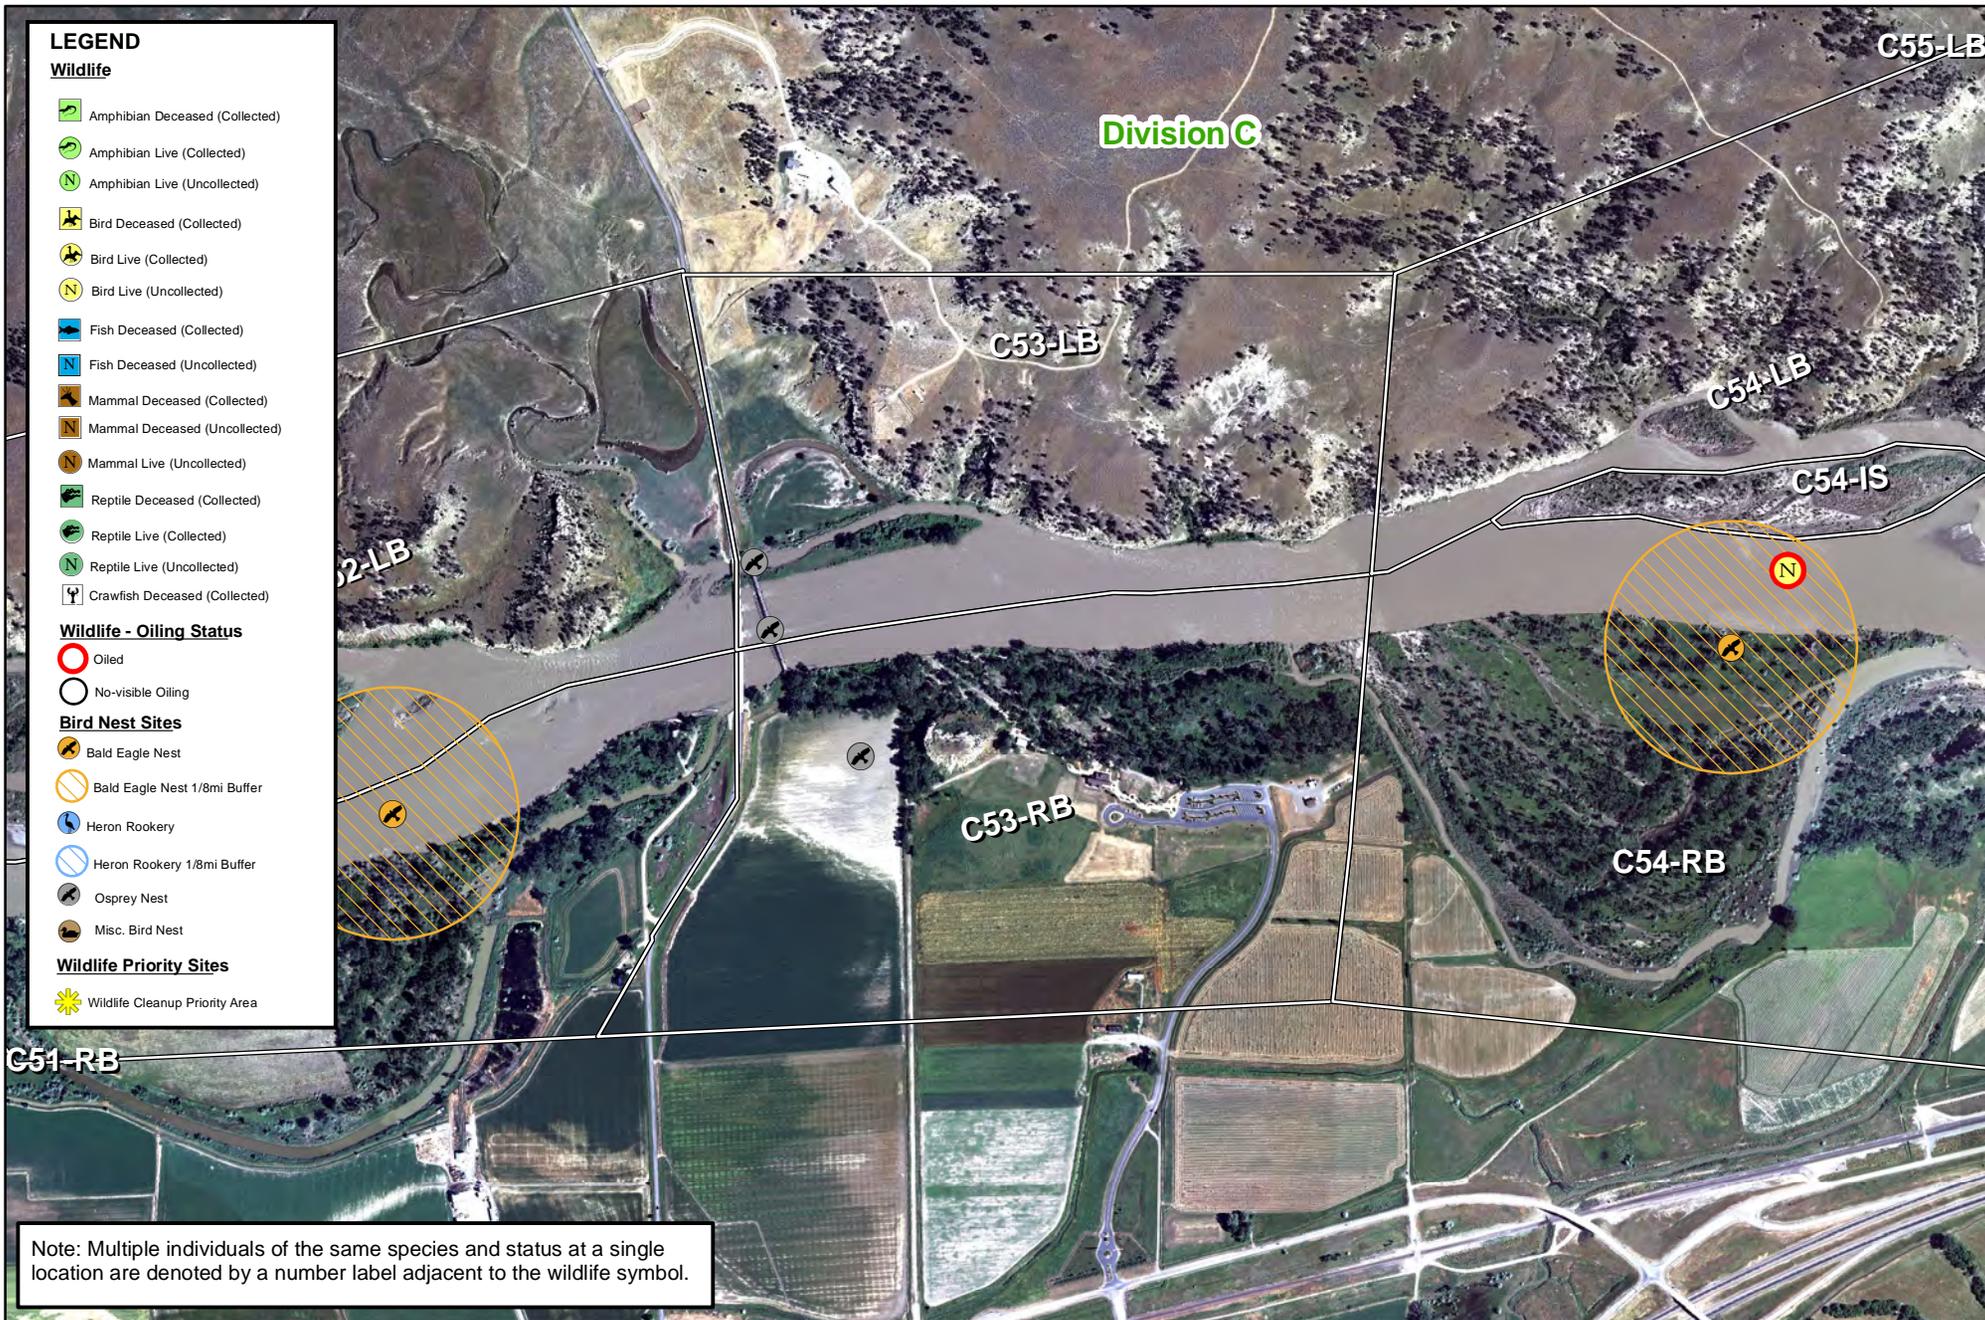
Figure 3
Silvertip Pipeline Incident
Environmental Sampling
Locations as of 8/27/2011

Table 1 (below) summarizes samples collected within Area C53. The analytical results for the samples collected can be accessed through a publicly accessible database on the United States Environmental Protection Agency's (USEPA's) website. The approximate locations of samples collected within Area C53 are provided on Figure 3.

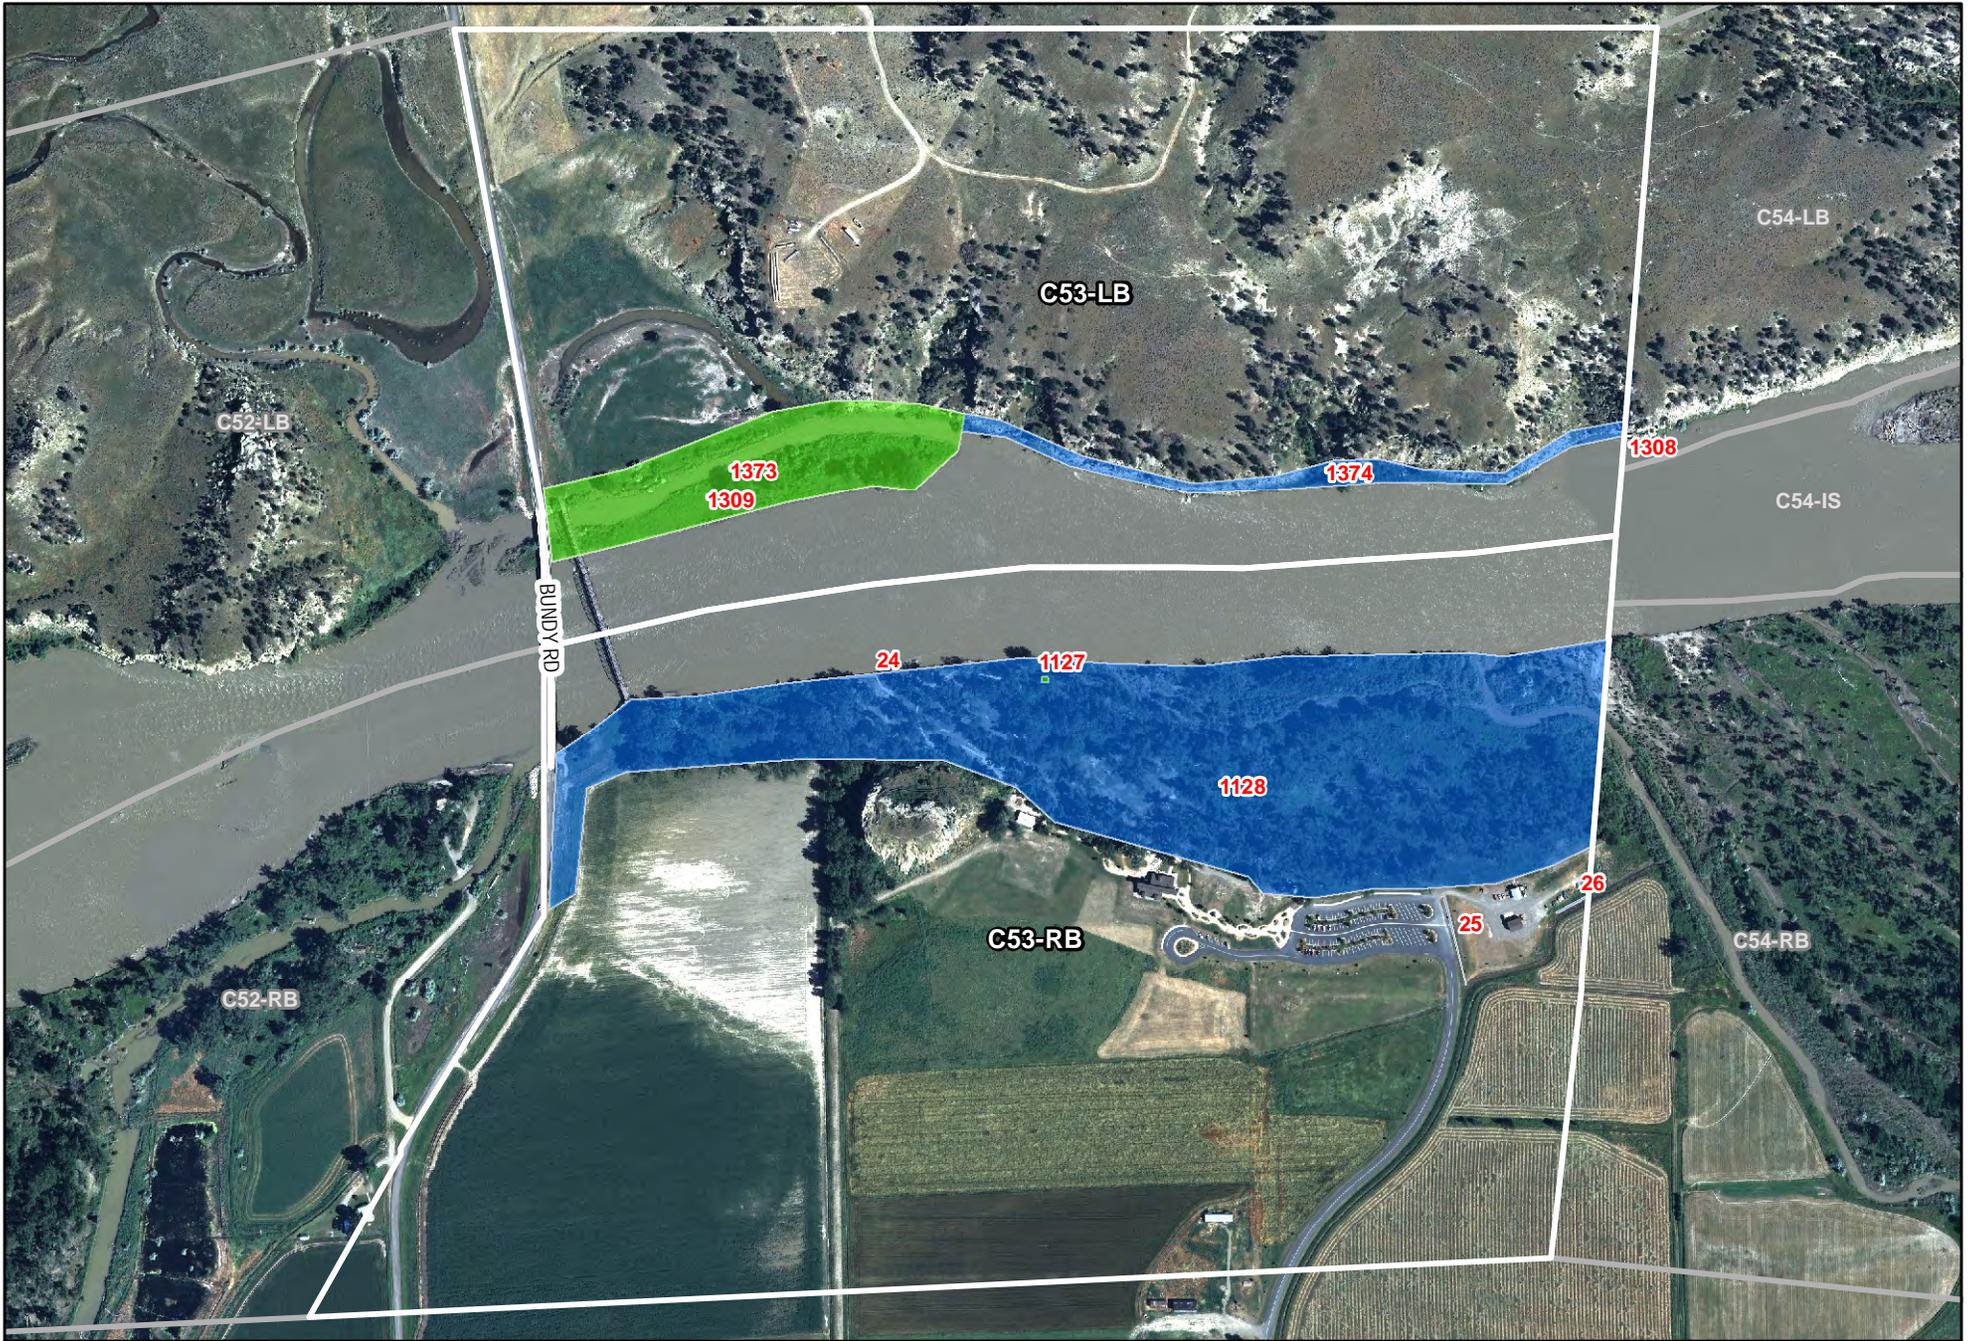
<p>9999 Oiling Zone ID Red Heavy Oiling Orange Moderate Oiling</p>	<p>Yellow Light Oiling Green Very Light Oiling Blue No Oil Observed</p>	<p>Figure 4 - Maximum SCAT Observations For SCAT Area:</p> <p>470 0 470 940

The SCAT teams used systematic evaluation criteria and treatment method tables approved by the National Oceanic and Atmospheric Administration to provide a standard approach for data collection and conducting field surveys. The forms and sketches from the initial SCAT surveys performed along the river bank (water edge) and floodplain within Area C53 are included in Appendix B. Figure 4 provides the maximum oiling zones observed by the SCAT team during the initial surveys of Area C53.

Based on the initial SCAT survey performed within Area C53, only very light oiling was observed on a portion of the left bank and no oiling was observed in the remainder of Area C53. The very light oiling zones will be addressed through natural attenuation. Therefore, a PIST, POST, and final SCAT survey were not performed and a SCAT Segment Sign-Off Form is not necessary.

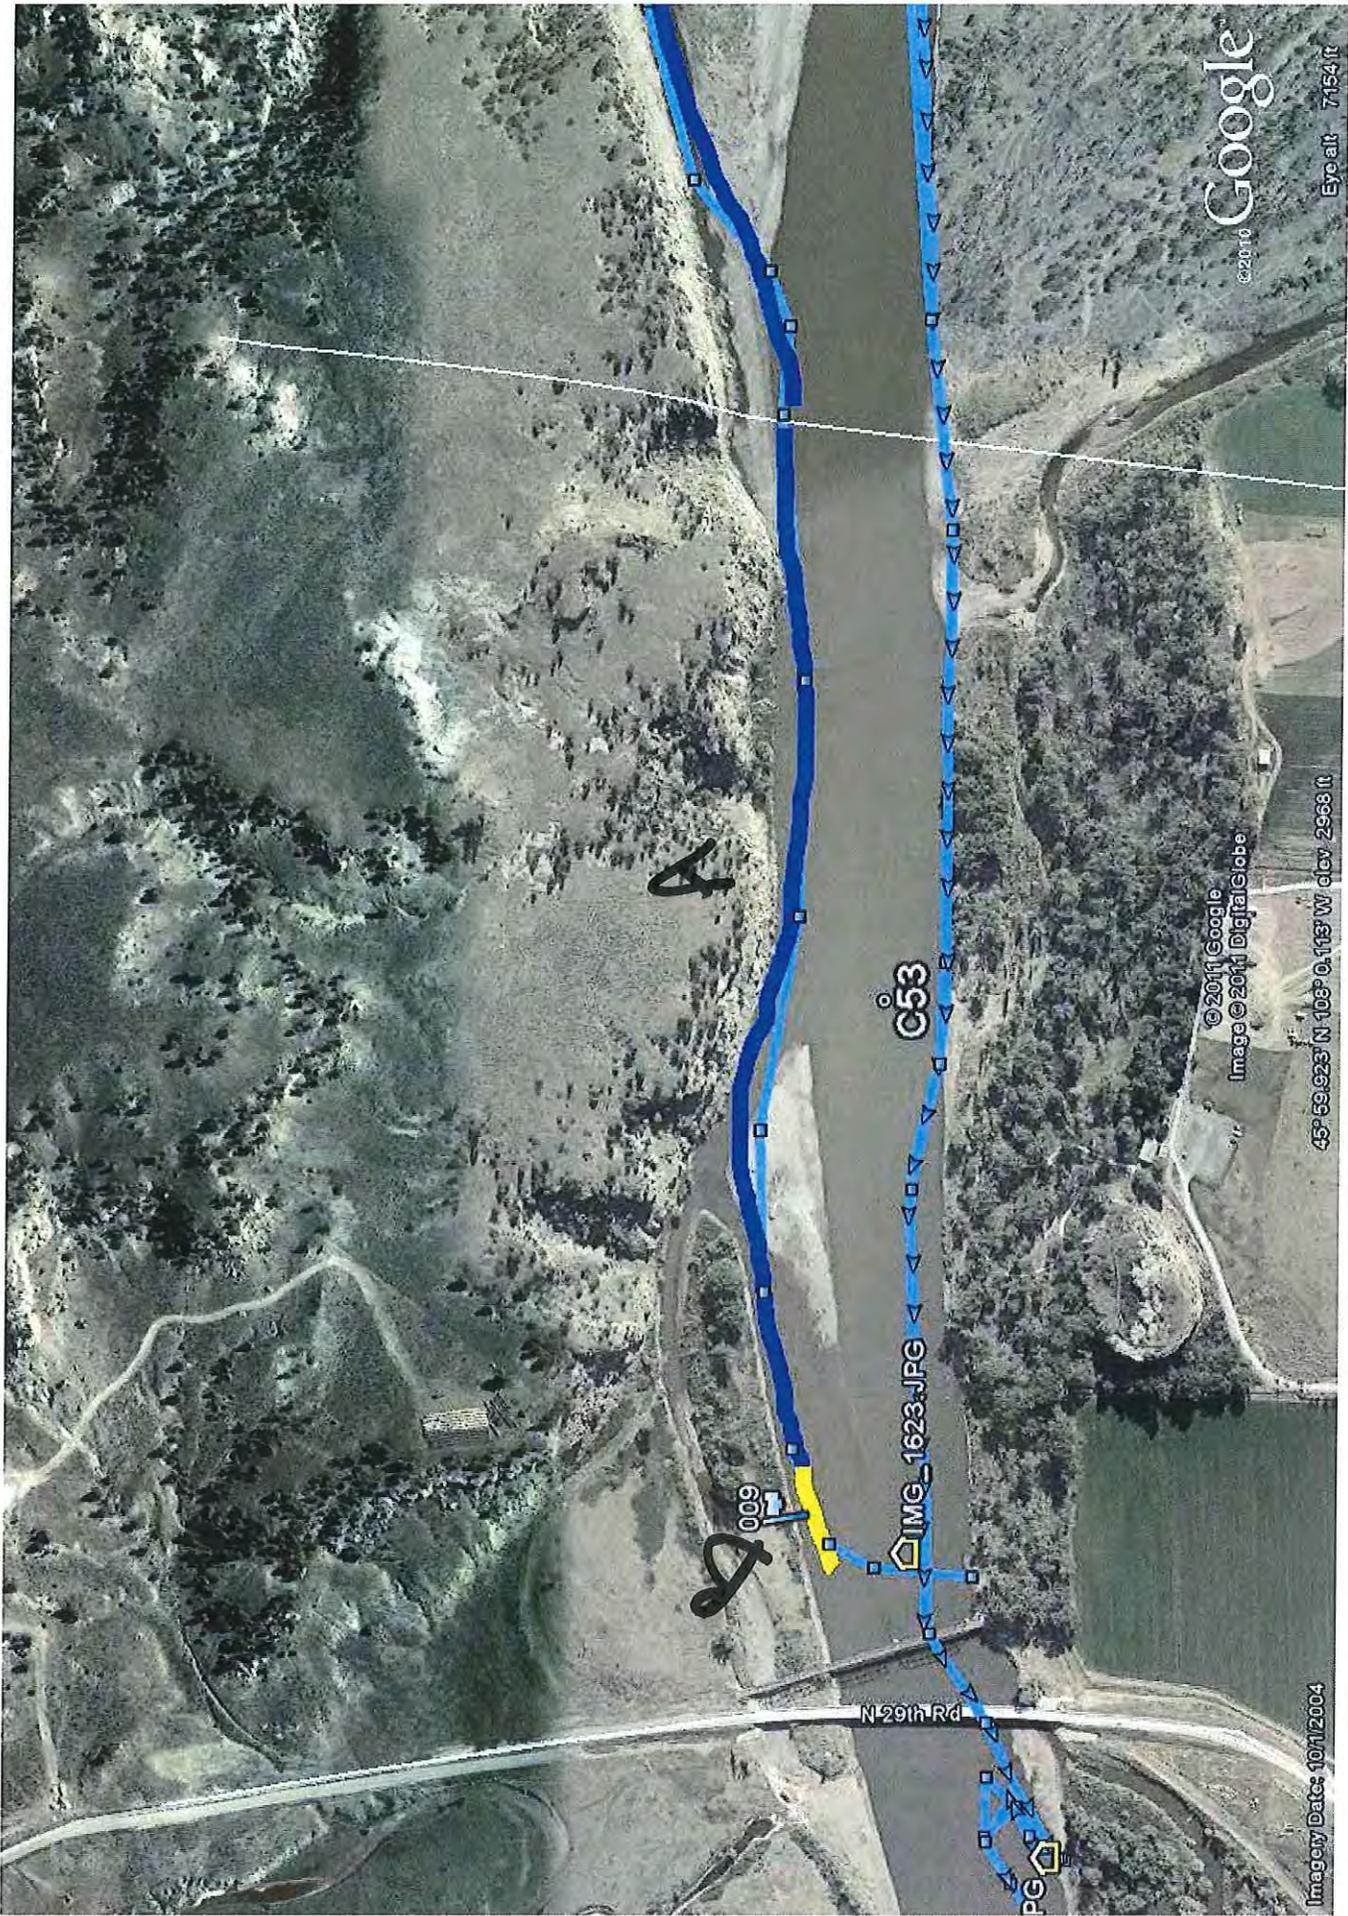
C53LB
Team #6
25/07/11

Zone A - NOO - NFT

Zone B - 3" oil band on veg ~1/2' above shoreline - Further SCAT recommended - appears to be a stain.

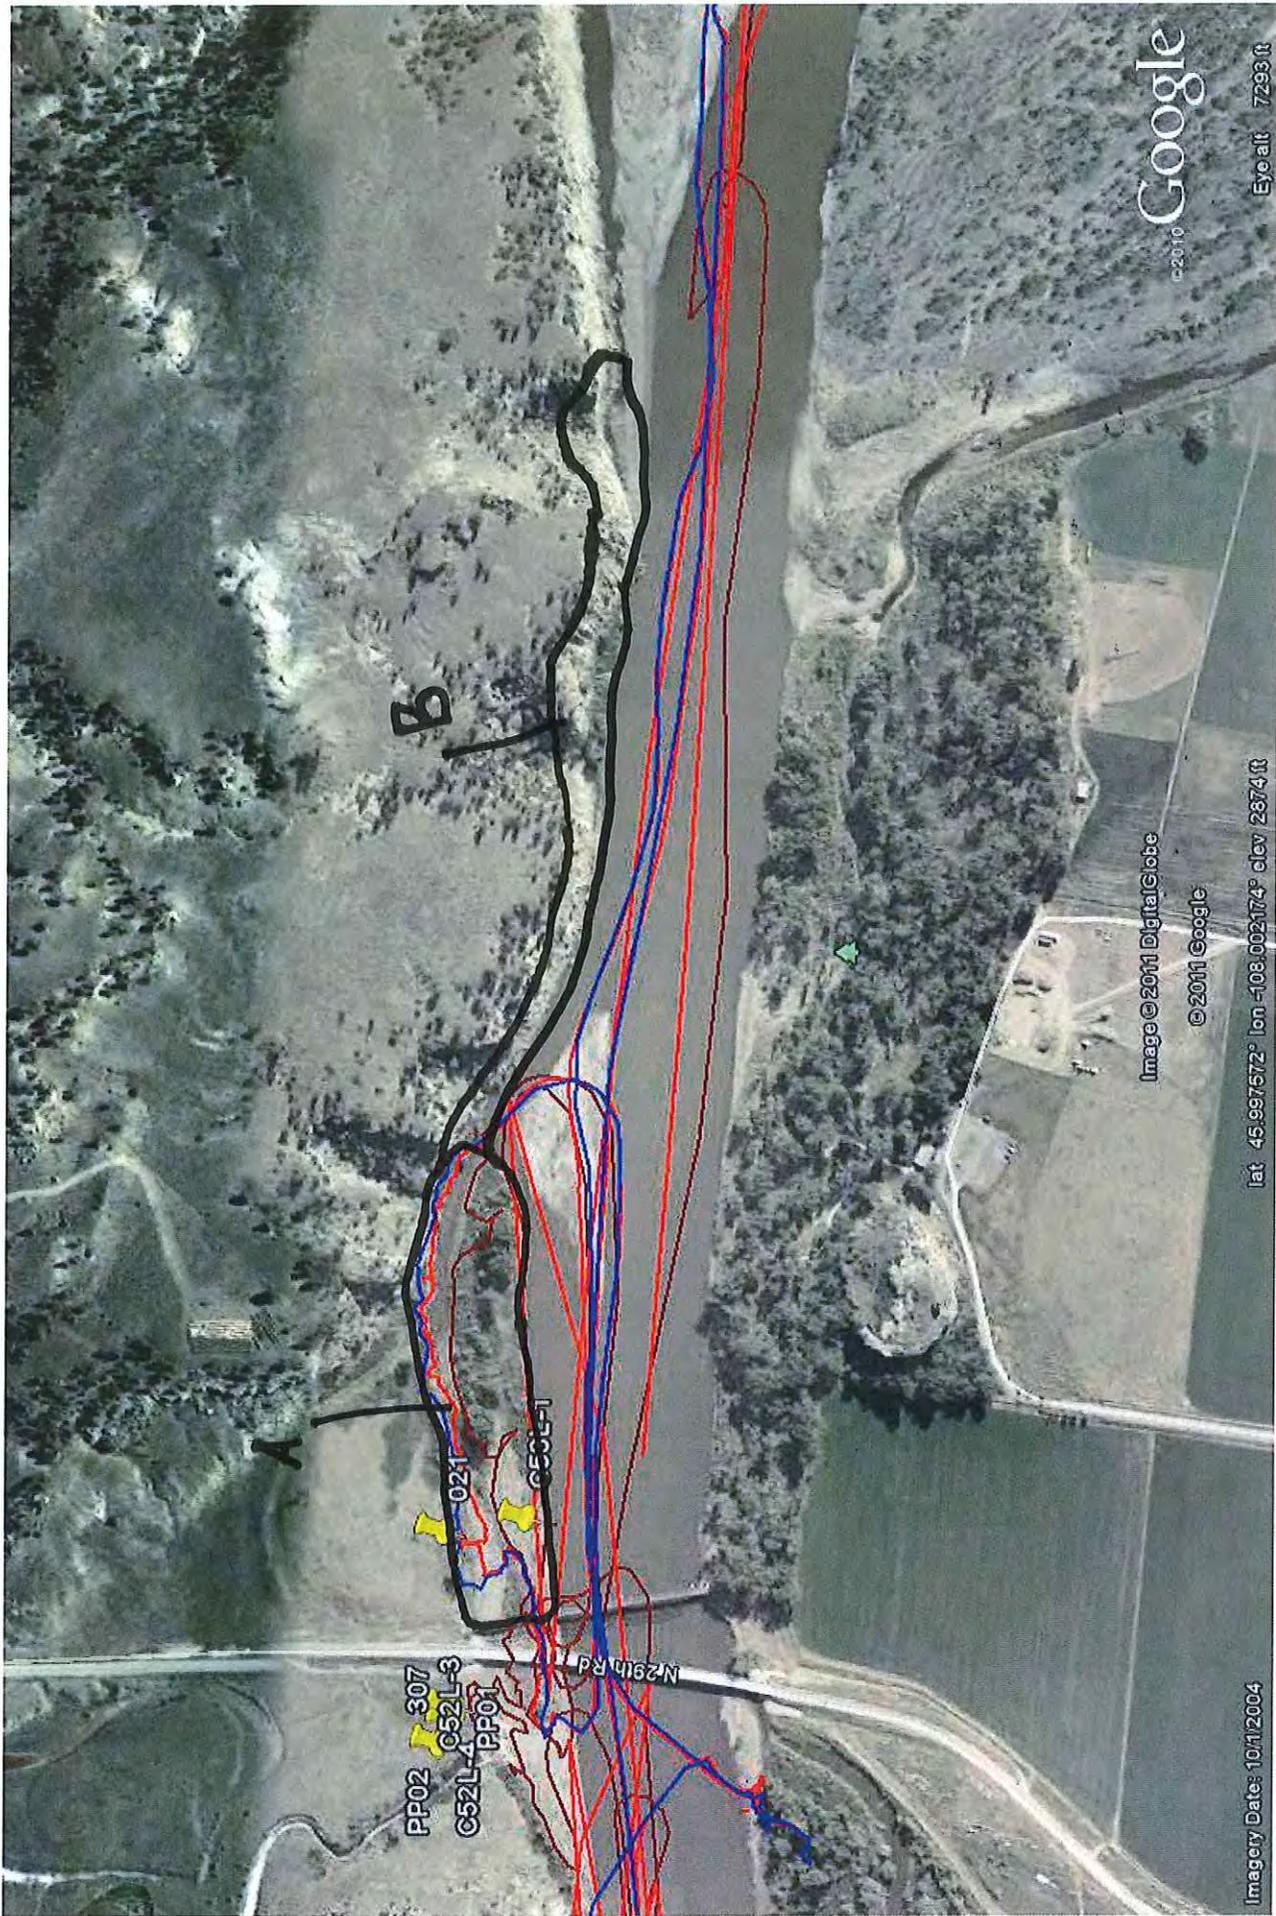
V53LB
Teams # 1 + 8
09/08/11

Zone A - ~~cut and remove grass along LB from Bunkie Bridge to 100m east.~~ NFT

Zone B - N00

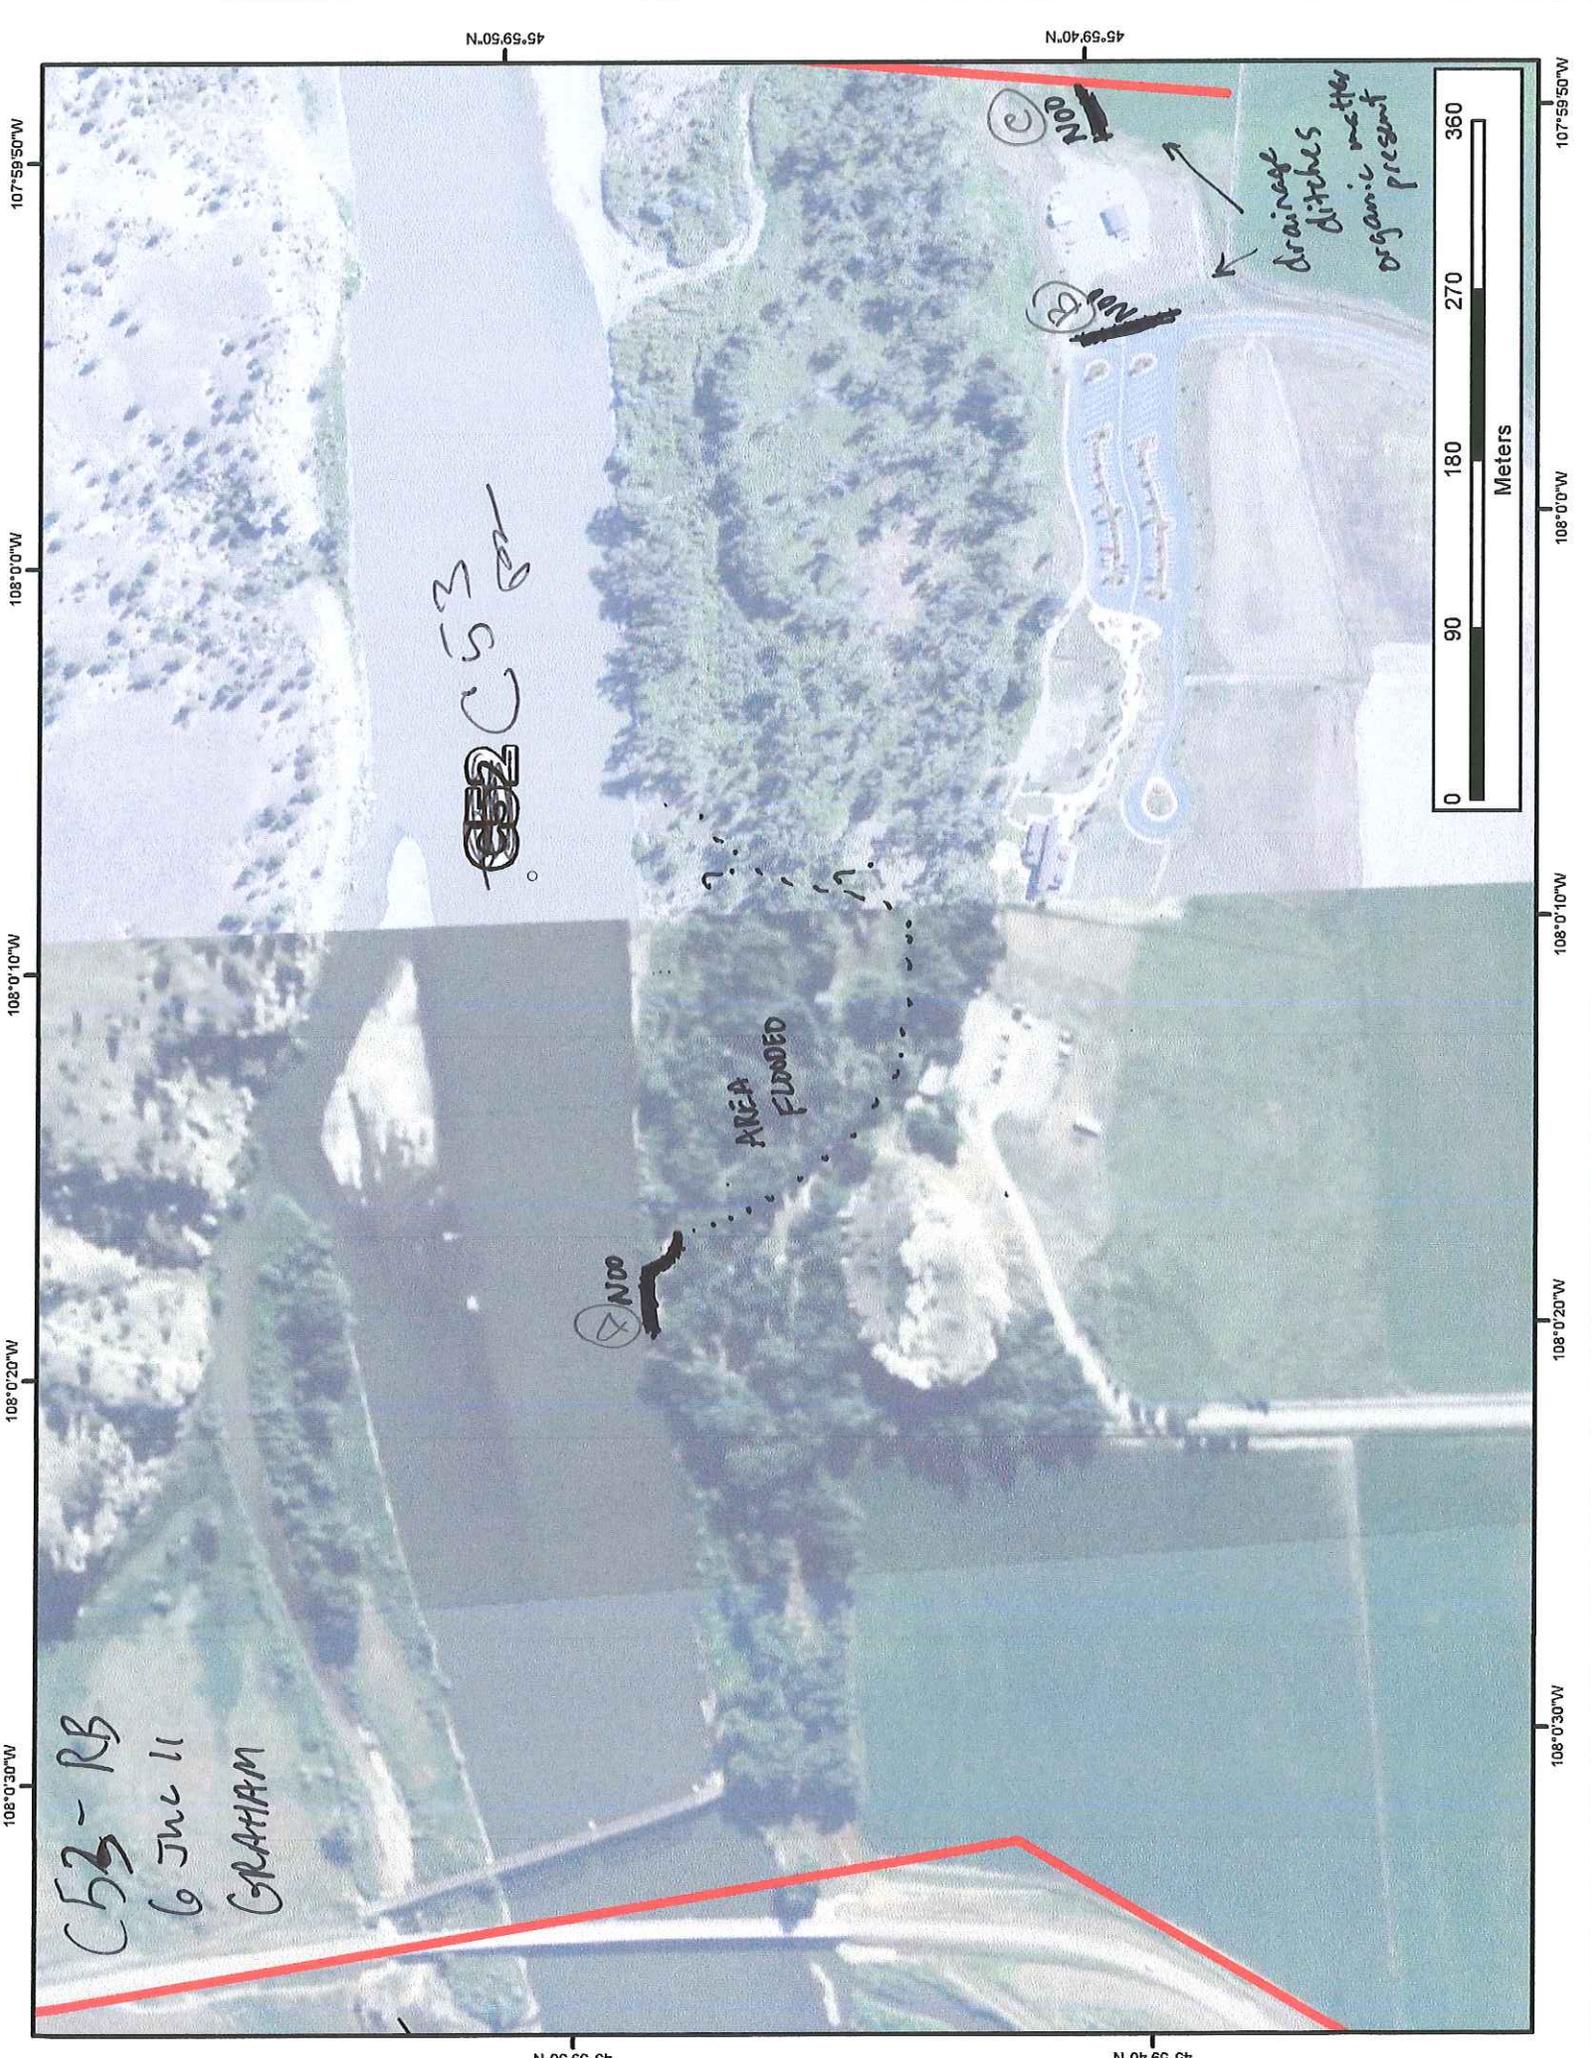
C53

NOD
Pompeii's Pillar - NPS site
 mission was to investigate reports of oiling
 looked at 2 drainage ditches - only organic material + natural sheen
 checked out small area on river - NOD
 *Lengths and Widths added based on map drawings by AM, TS, CK on 9/20/11. No LxW originally entered.

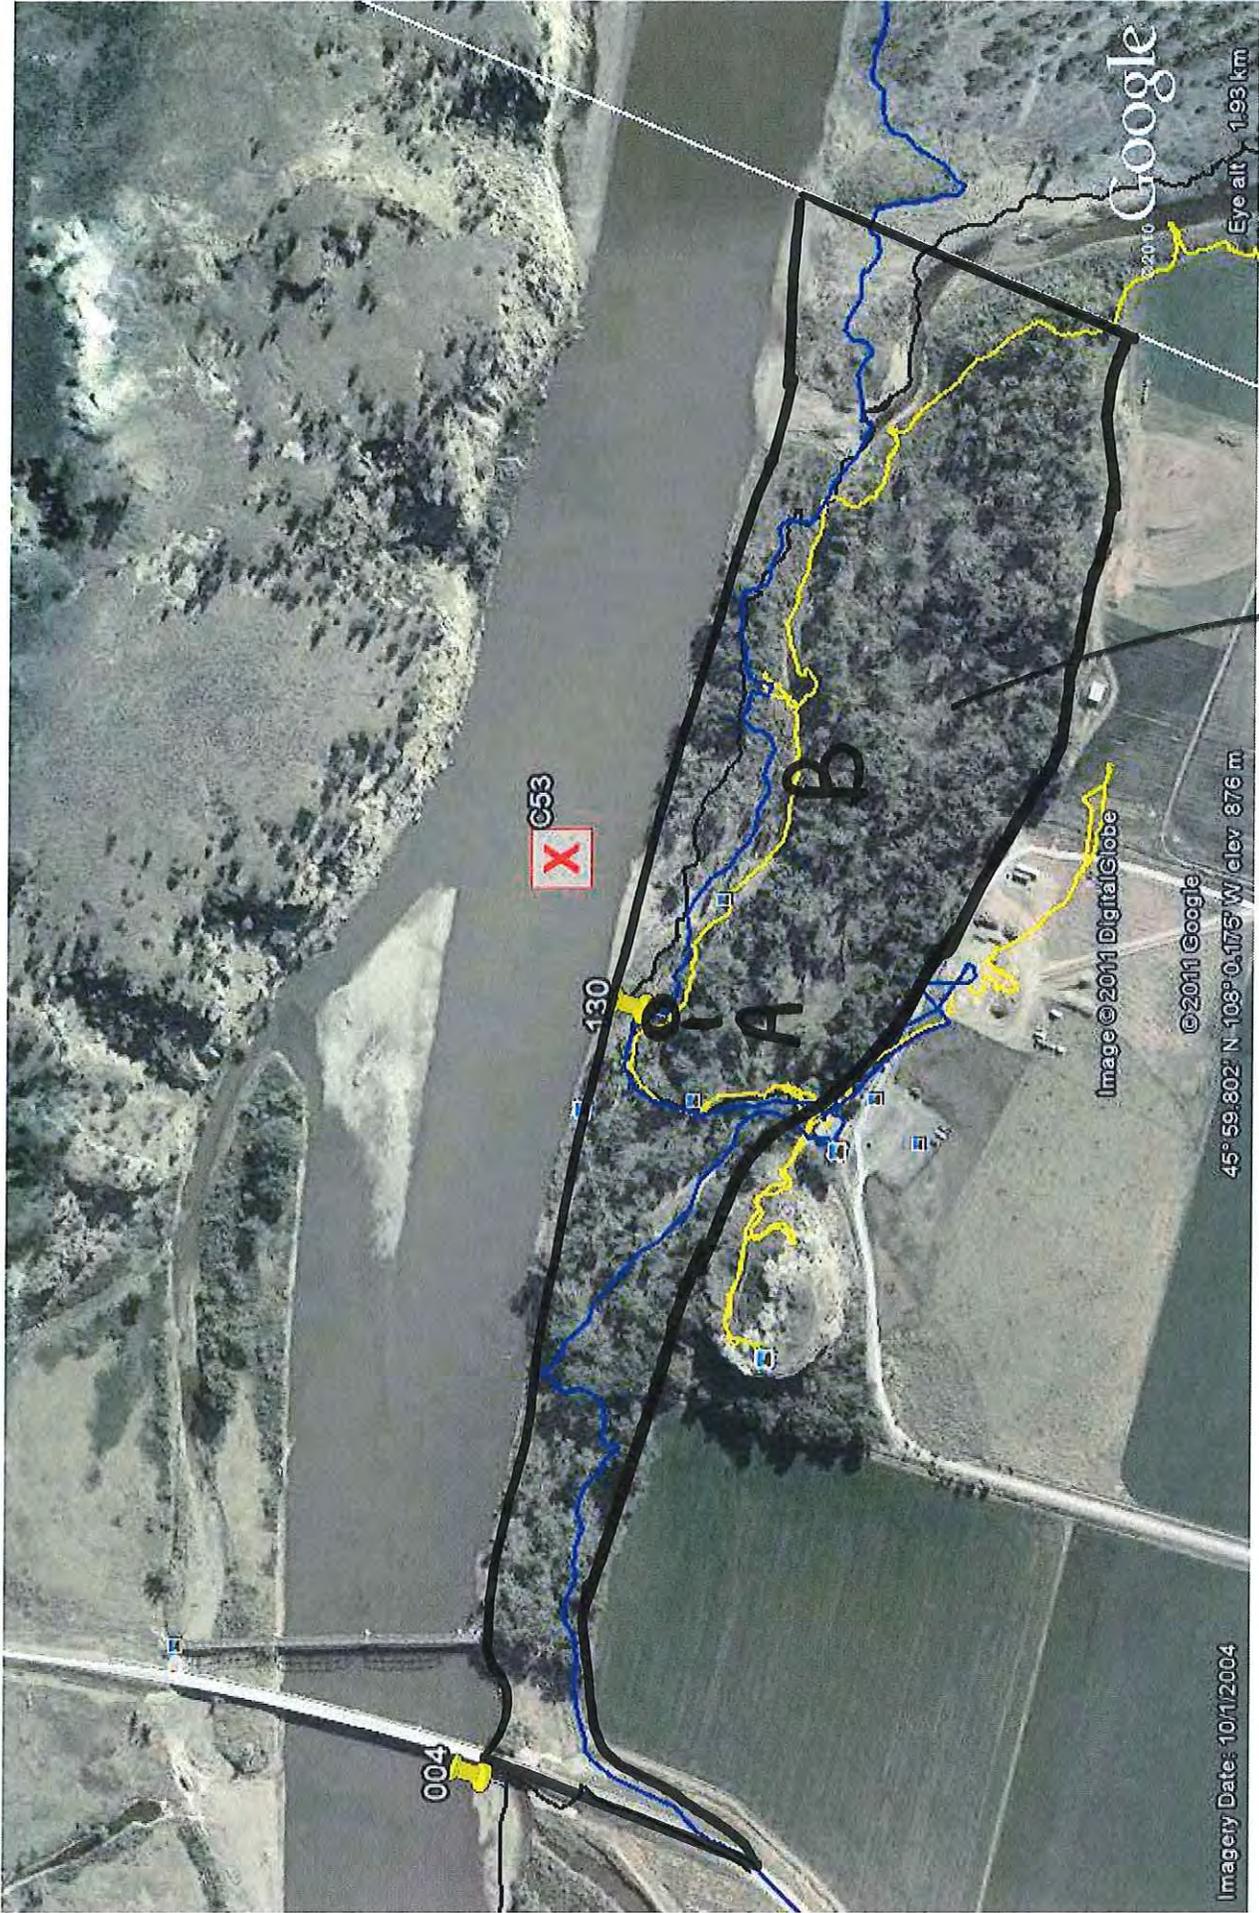
August 2, 2011
TEAM 3 C53

BML (2x) this area surveyed this area Zones A+B

Treatment Recommendations:
Zone : A: no treatment recommended
B NOO. no treatment recommended
