**SCAT Area Transition Report for
C54**

Silvertip Pipeline Incident
Laurel, Montana

October 25, 2011

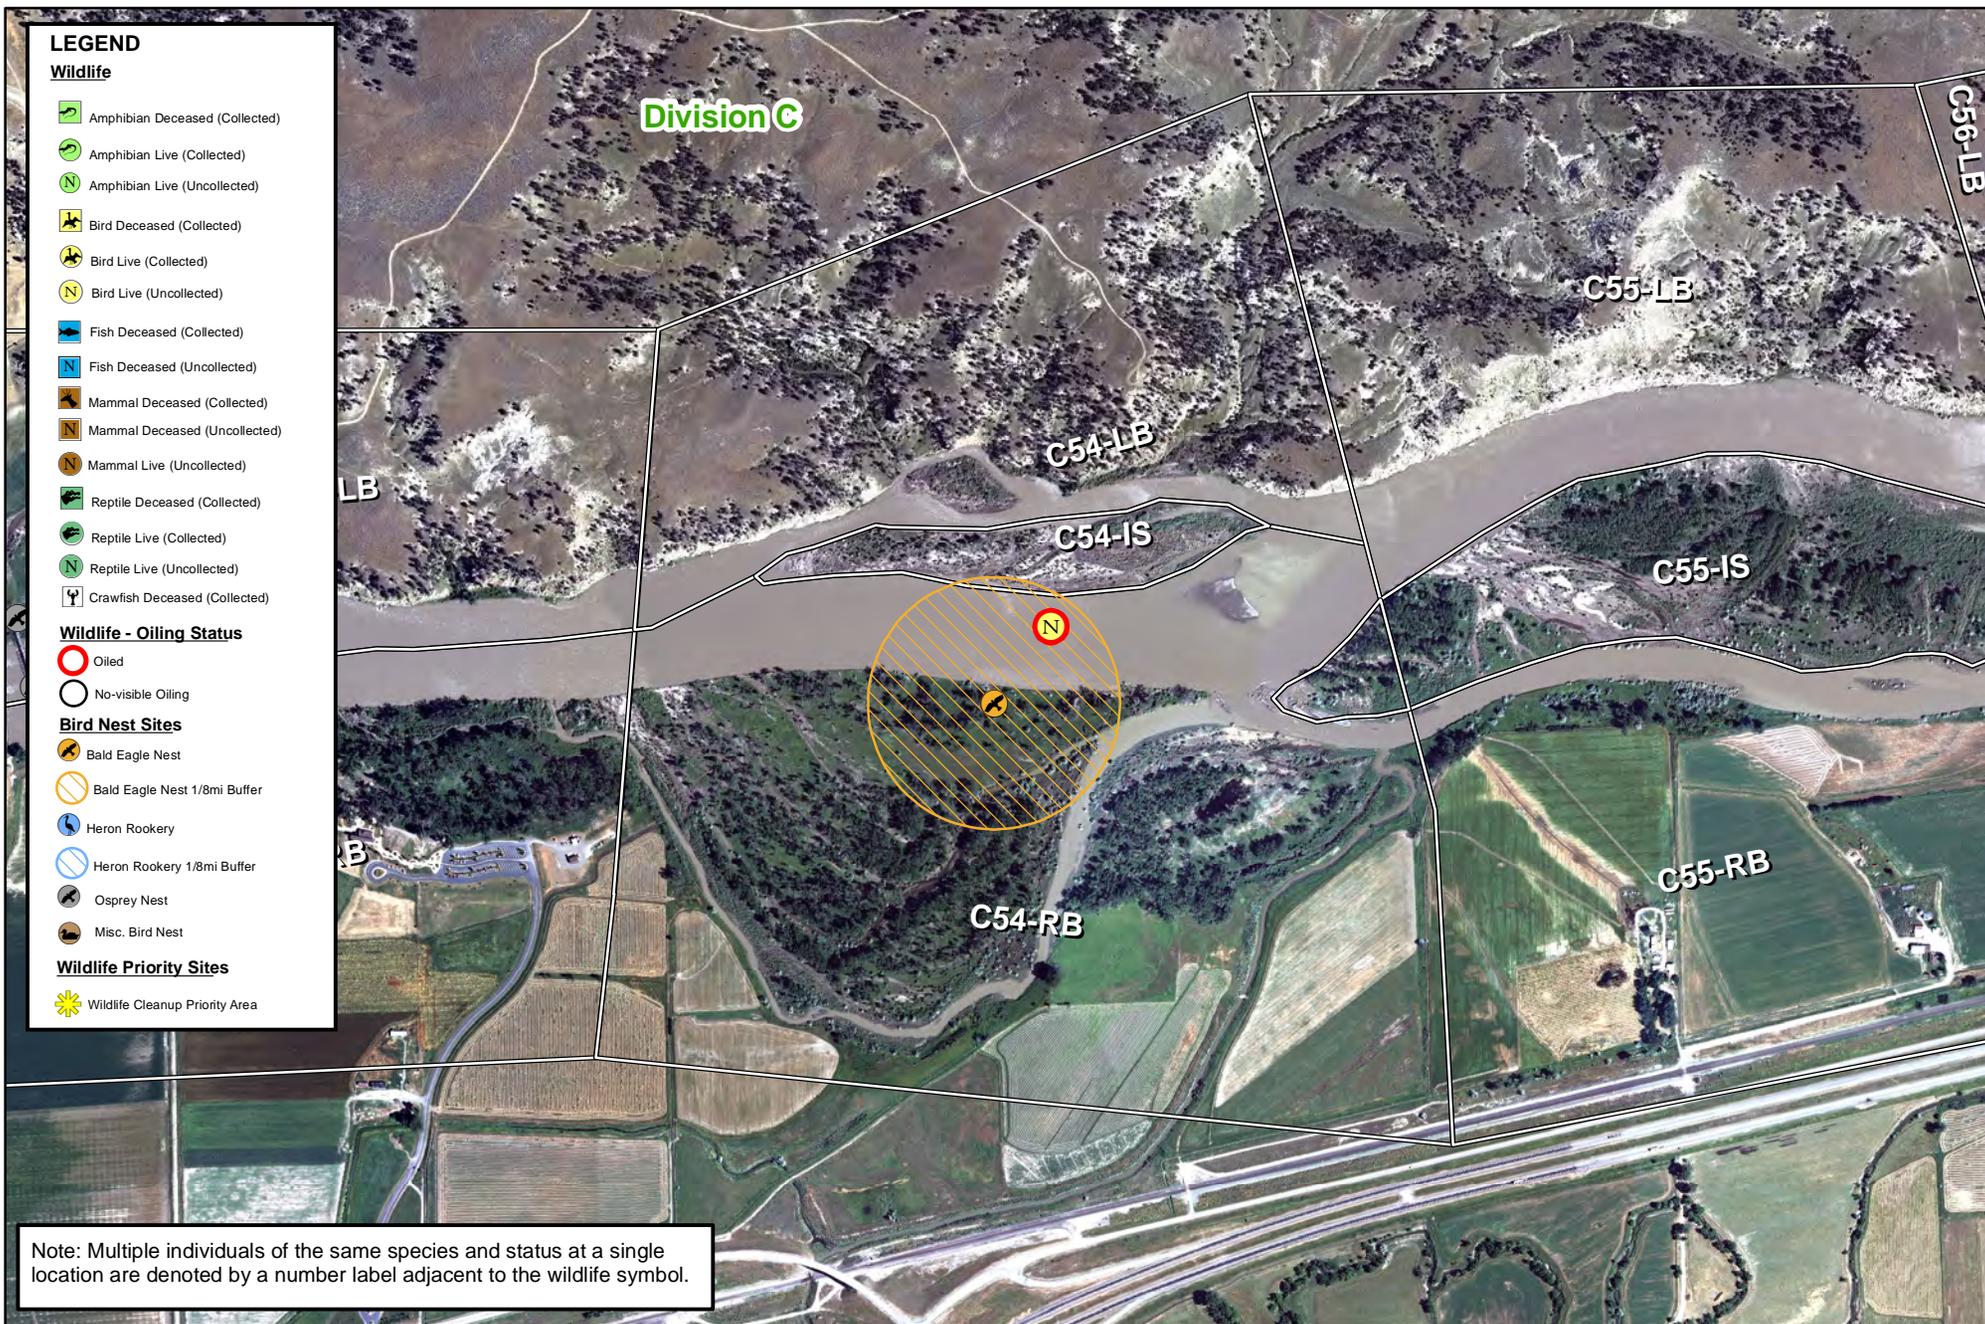
Figure 2
Wildlife Resources

Figure 2 summarizes the natural resources identified in this segment. International Bird Rescue and Resource Advisors from U.S. Fish and Wildlife Service conducted limited inspections of Area C54 due to the low level of oiling in Division C. One oiled America white pelican (*Pelecanus erythrorhynchos*) was observed, but was not able to be captured for cleaning. No Wildlife Priority Cleanup Areas were identified. A bald eagle (*Haliaeetus leucocephalus*) nest was identified in Area C54 and the appropriate buffer zone was maintained around it.

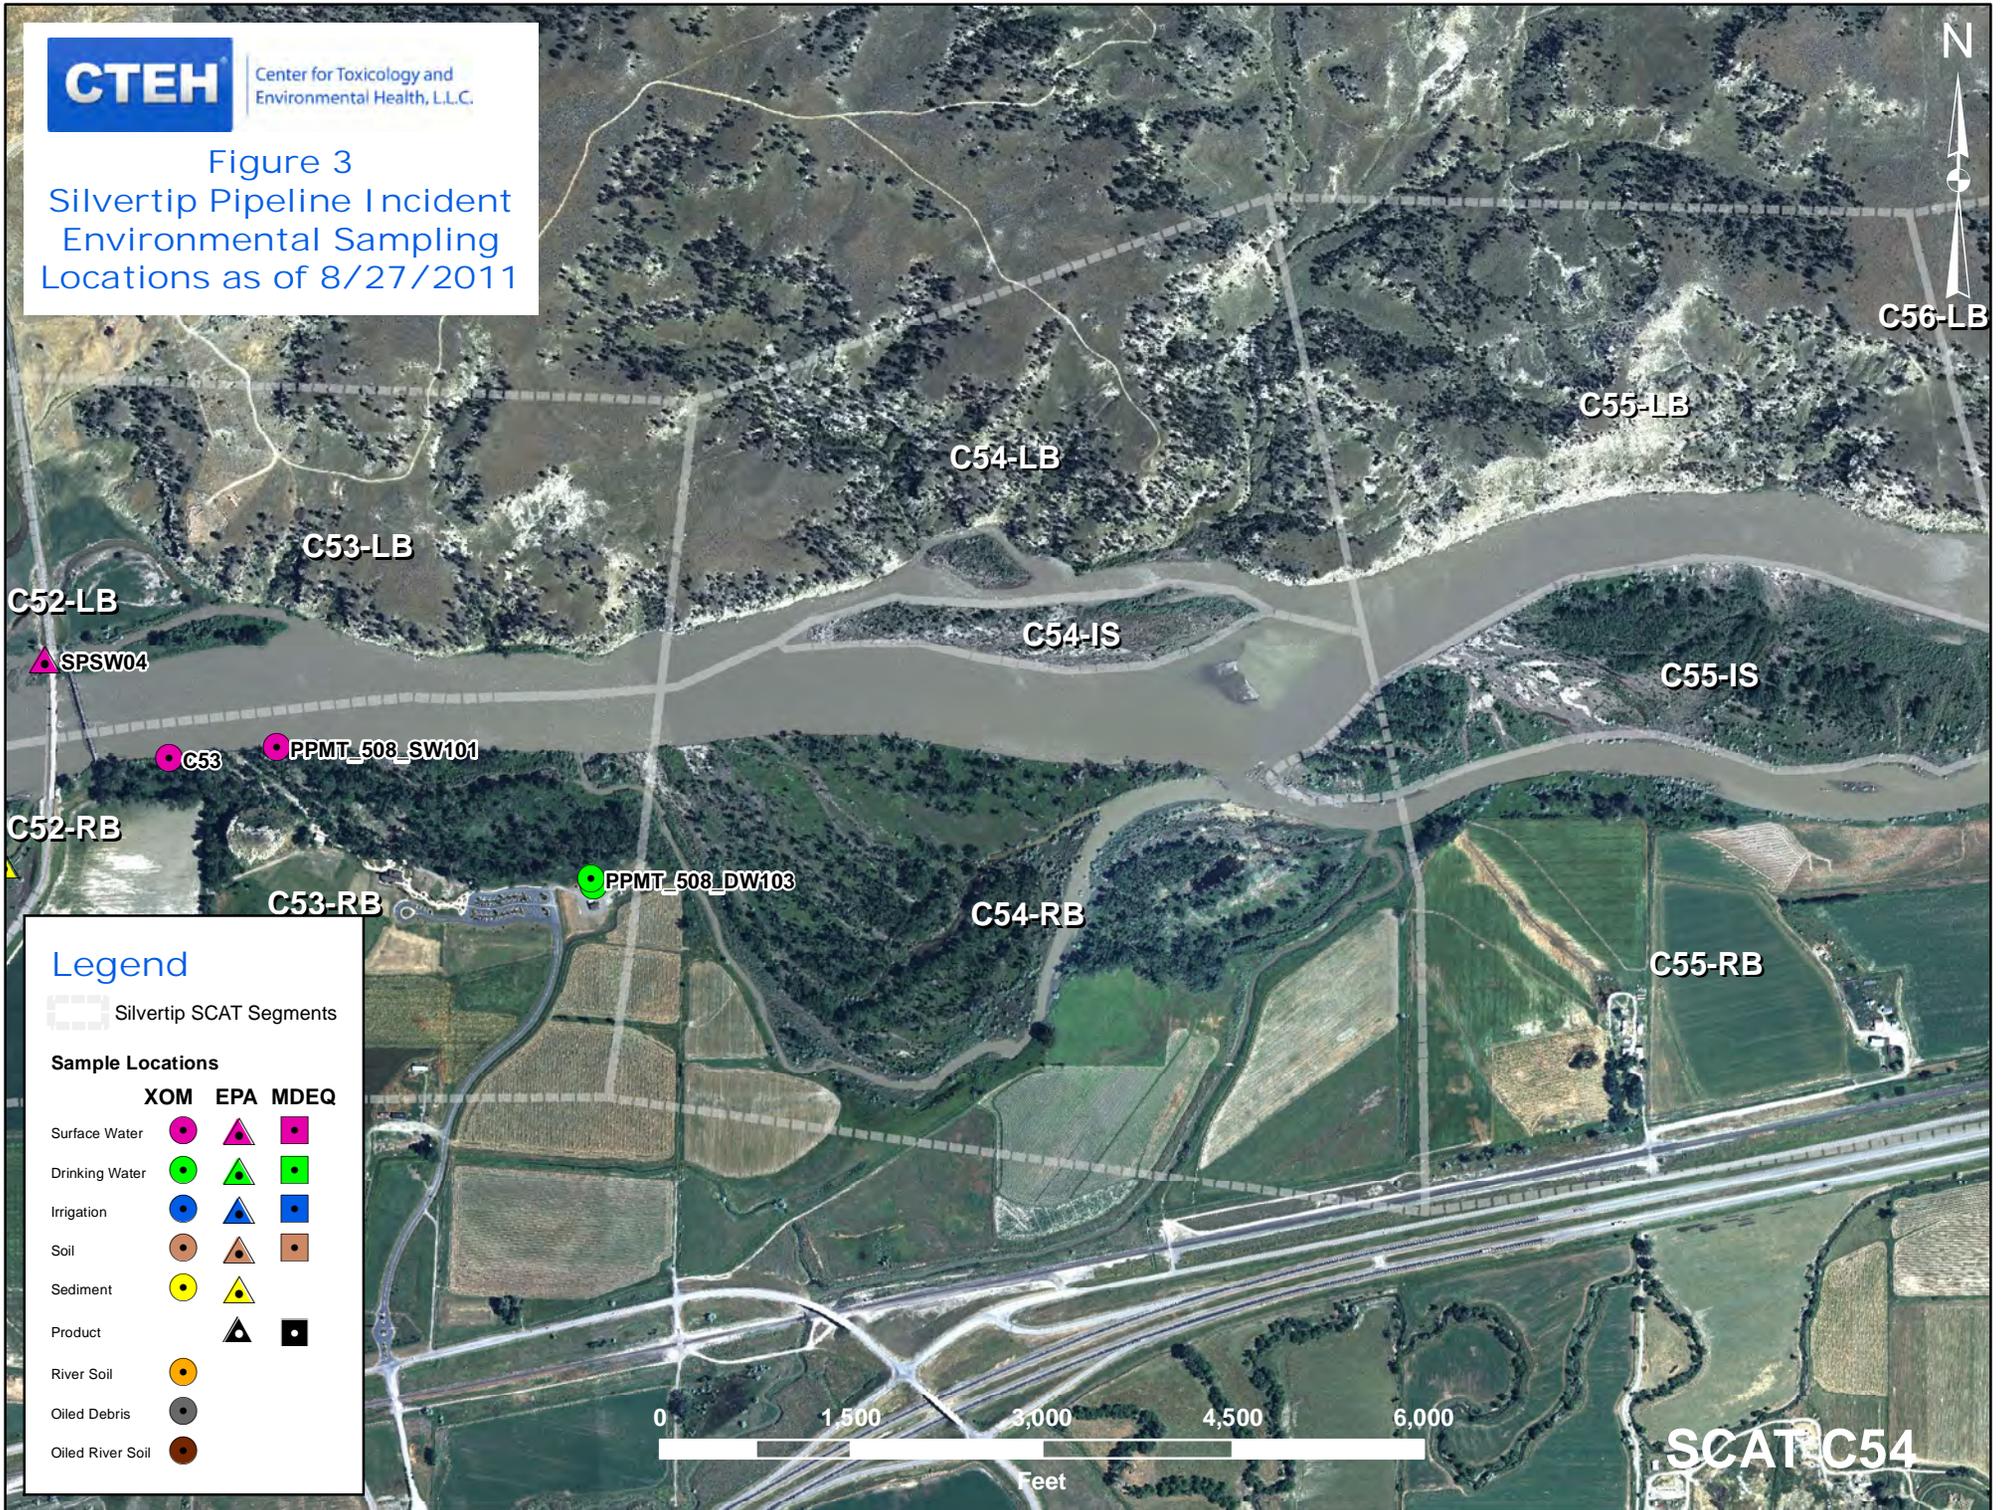
Figure 3
 Silvertip Pipeline Incident
 Environmental Sampling
 Locations as of 8/27/2011

Table 1 (below) summarizes samples collected within Area C54. The analytical results for the samples collected can be accessed through a publicly accessible database on the United States Environmental Protection Agency's (USEPA's) website. The approximate locations of samples collected within Area C54 are provided on Figure 3. However, to date, no samples have been collected in this area.

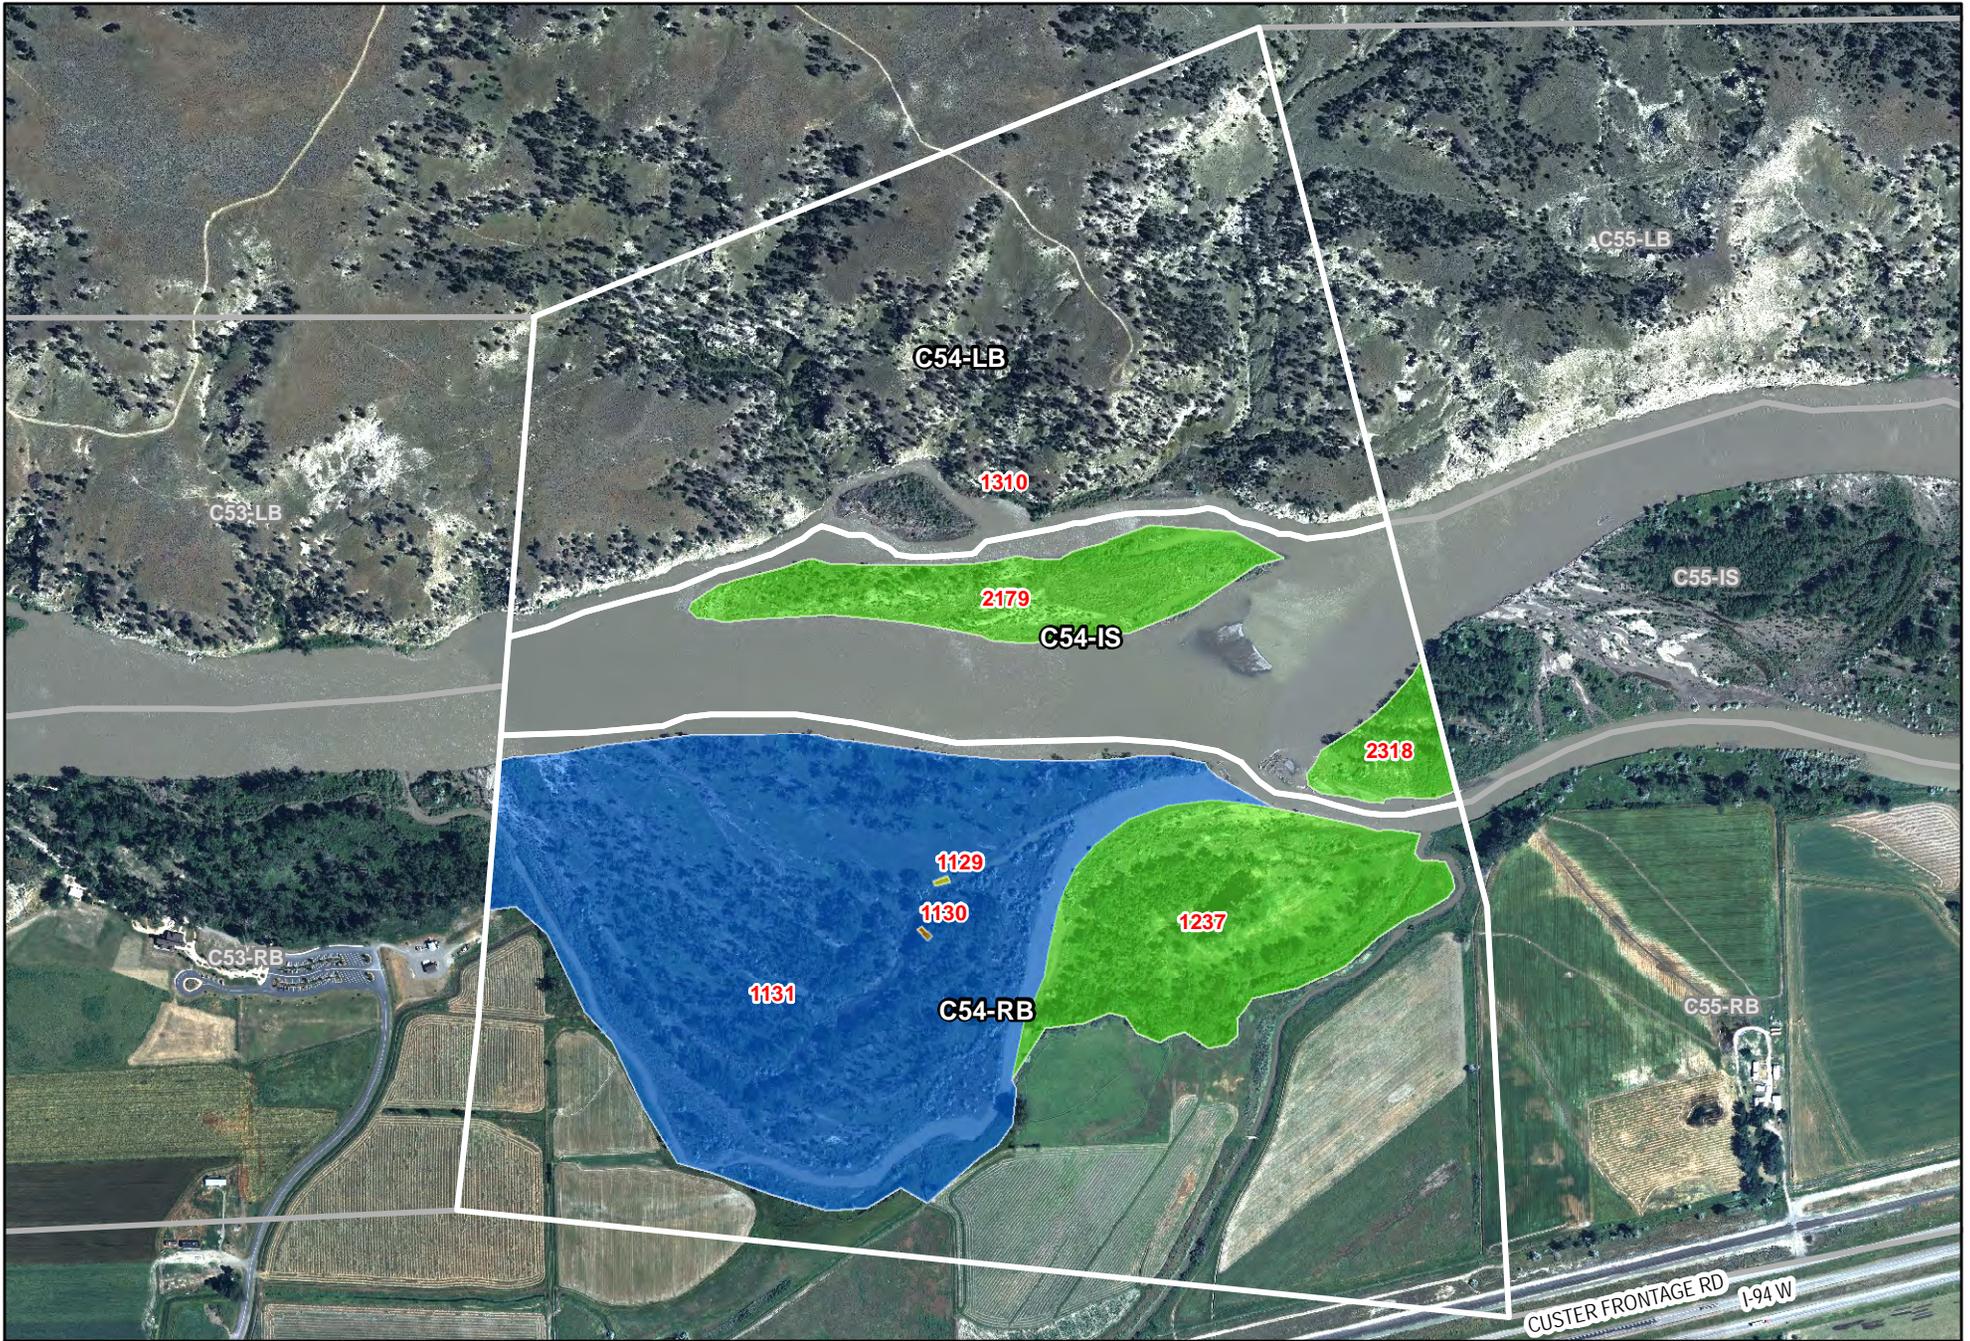
Figure 4 - Maximum SCAT Observations For SCAT Area: C54

The SCAT teams used systematic evaluation criteria and treatment method tables approved by the National Oceanic and Atmospheric Administration to provide a standard approach for data collection and conducting field surveys. The forms and sketches from the initial SCAT surveys performed along the river bank (water edge) and floodplain within Area C54 are included in Appendix B. Figure 4 provides the maximum oiling zones observed by the SCAT team during the initial surveys of Area C54.

Based on the initial SCAT survey performed within Area C54, only very light oiling was observed on a portion of the right bank and no oiling was observed on the left bank. The very light oiling zones will be addressed through natural attenuation. Based on the final SCAT surveys performed on the island within Area C54, no further treatment is recommended for this segment. SCAT Segment Sign-Off Forms are included as Appendix F.

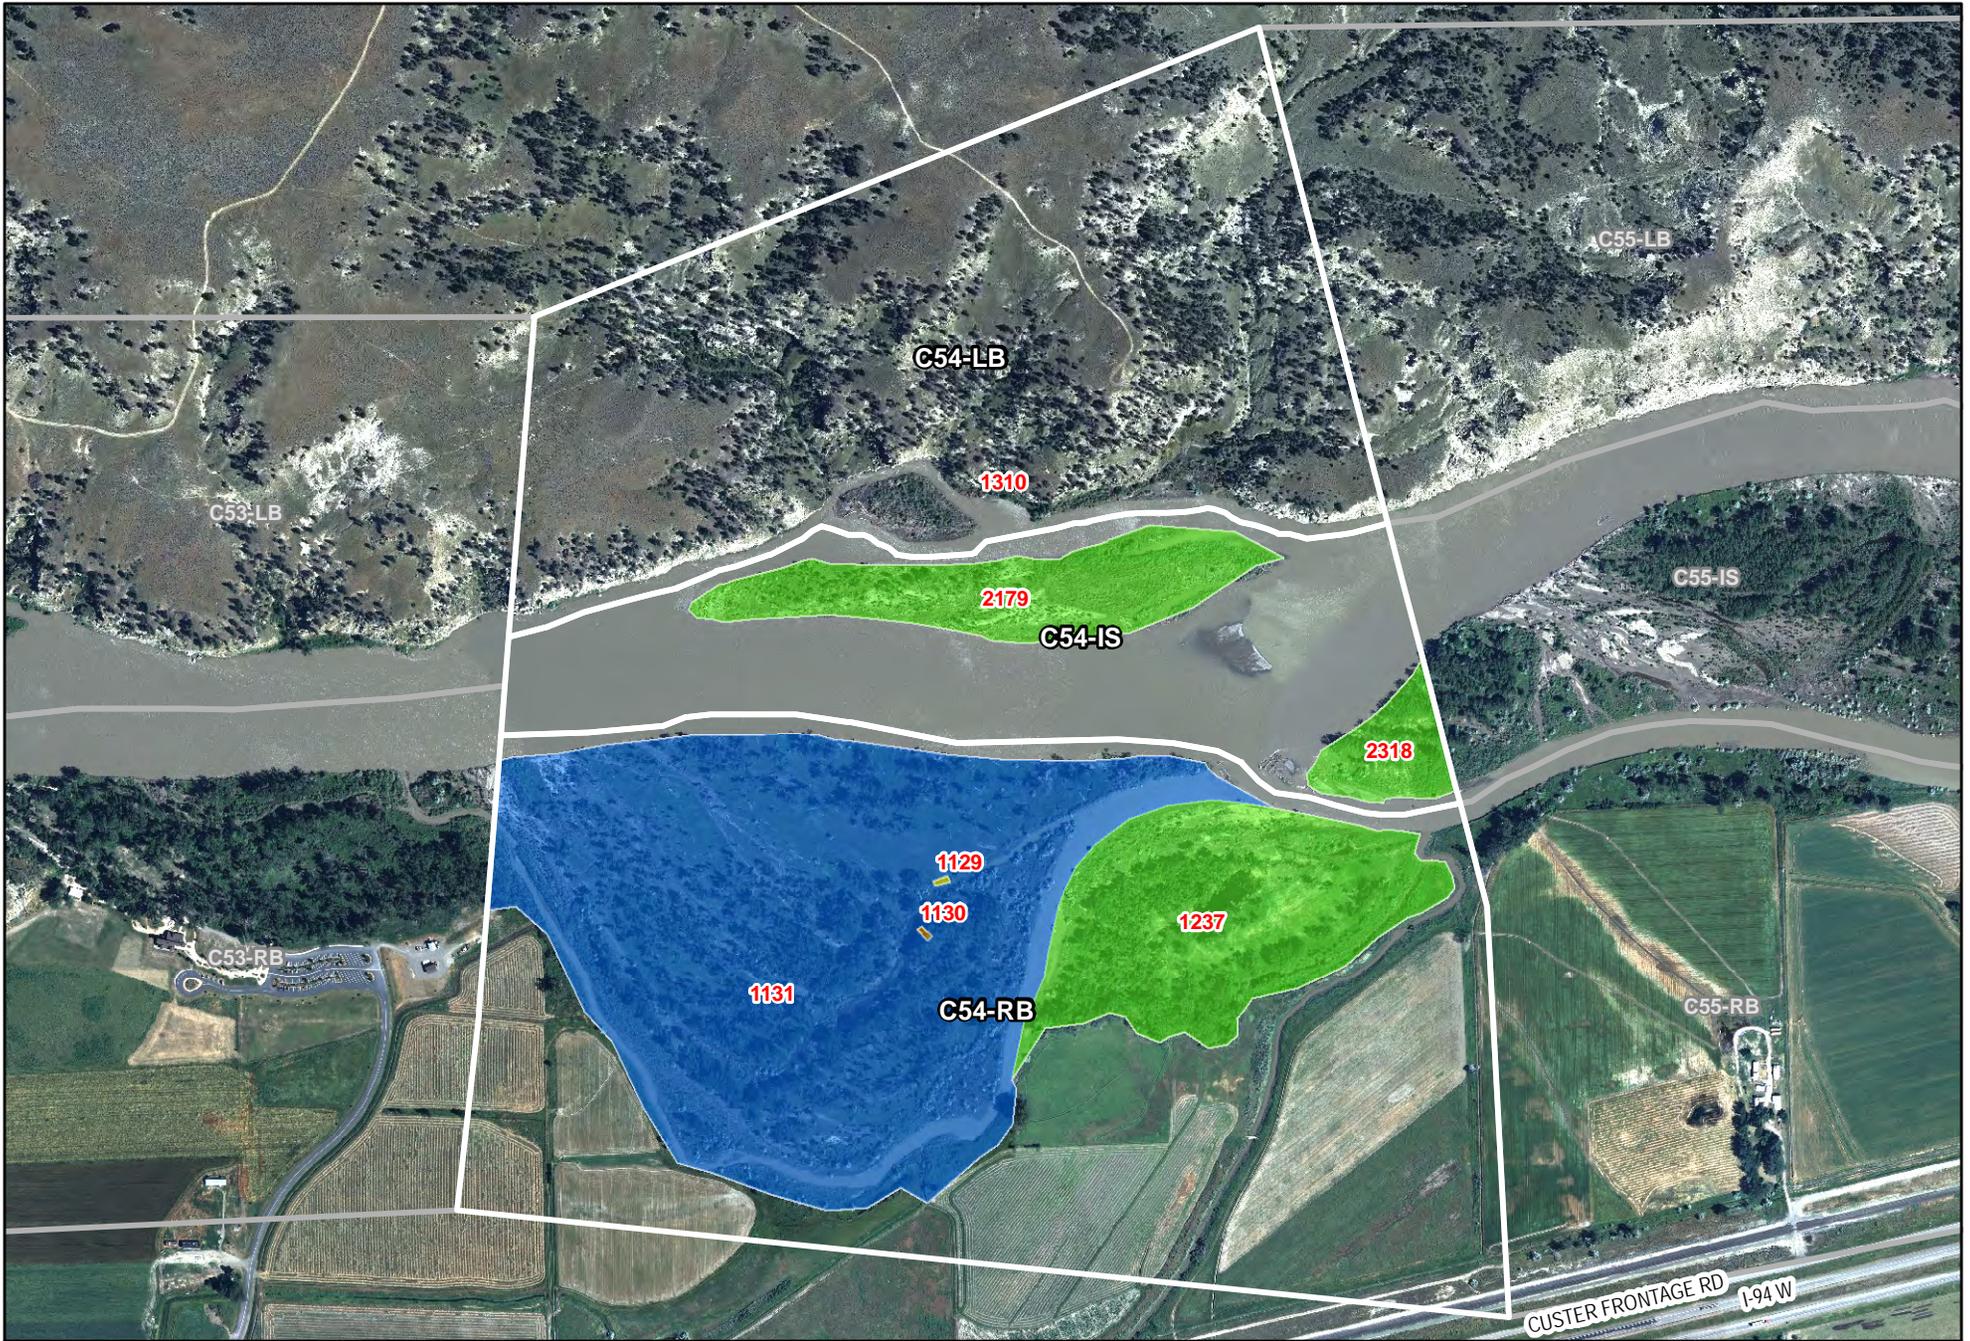
**Figure 5 - Final SCAT Observations
For SCAT Area:**

Figure 5 shows the oiling conditions within Area C54 following completion of oil removal activities. The SCAT team performed final surveys of the island within SCAT Area C54 to confirm the agreed-upon cleanup endpoints identified in the applicable CTRs had been achieved. The final SCAT survey documentation is presented in Appendix E.

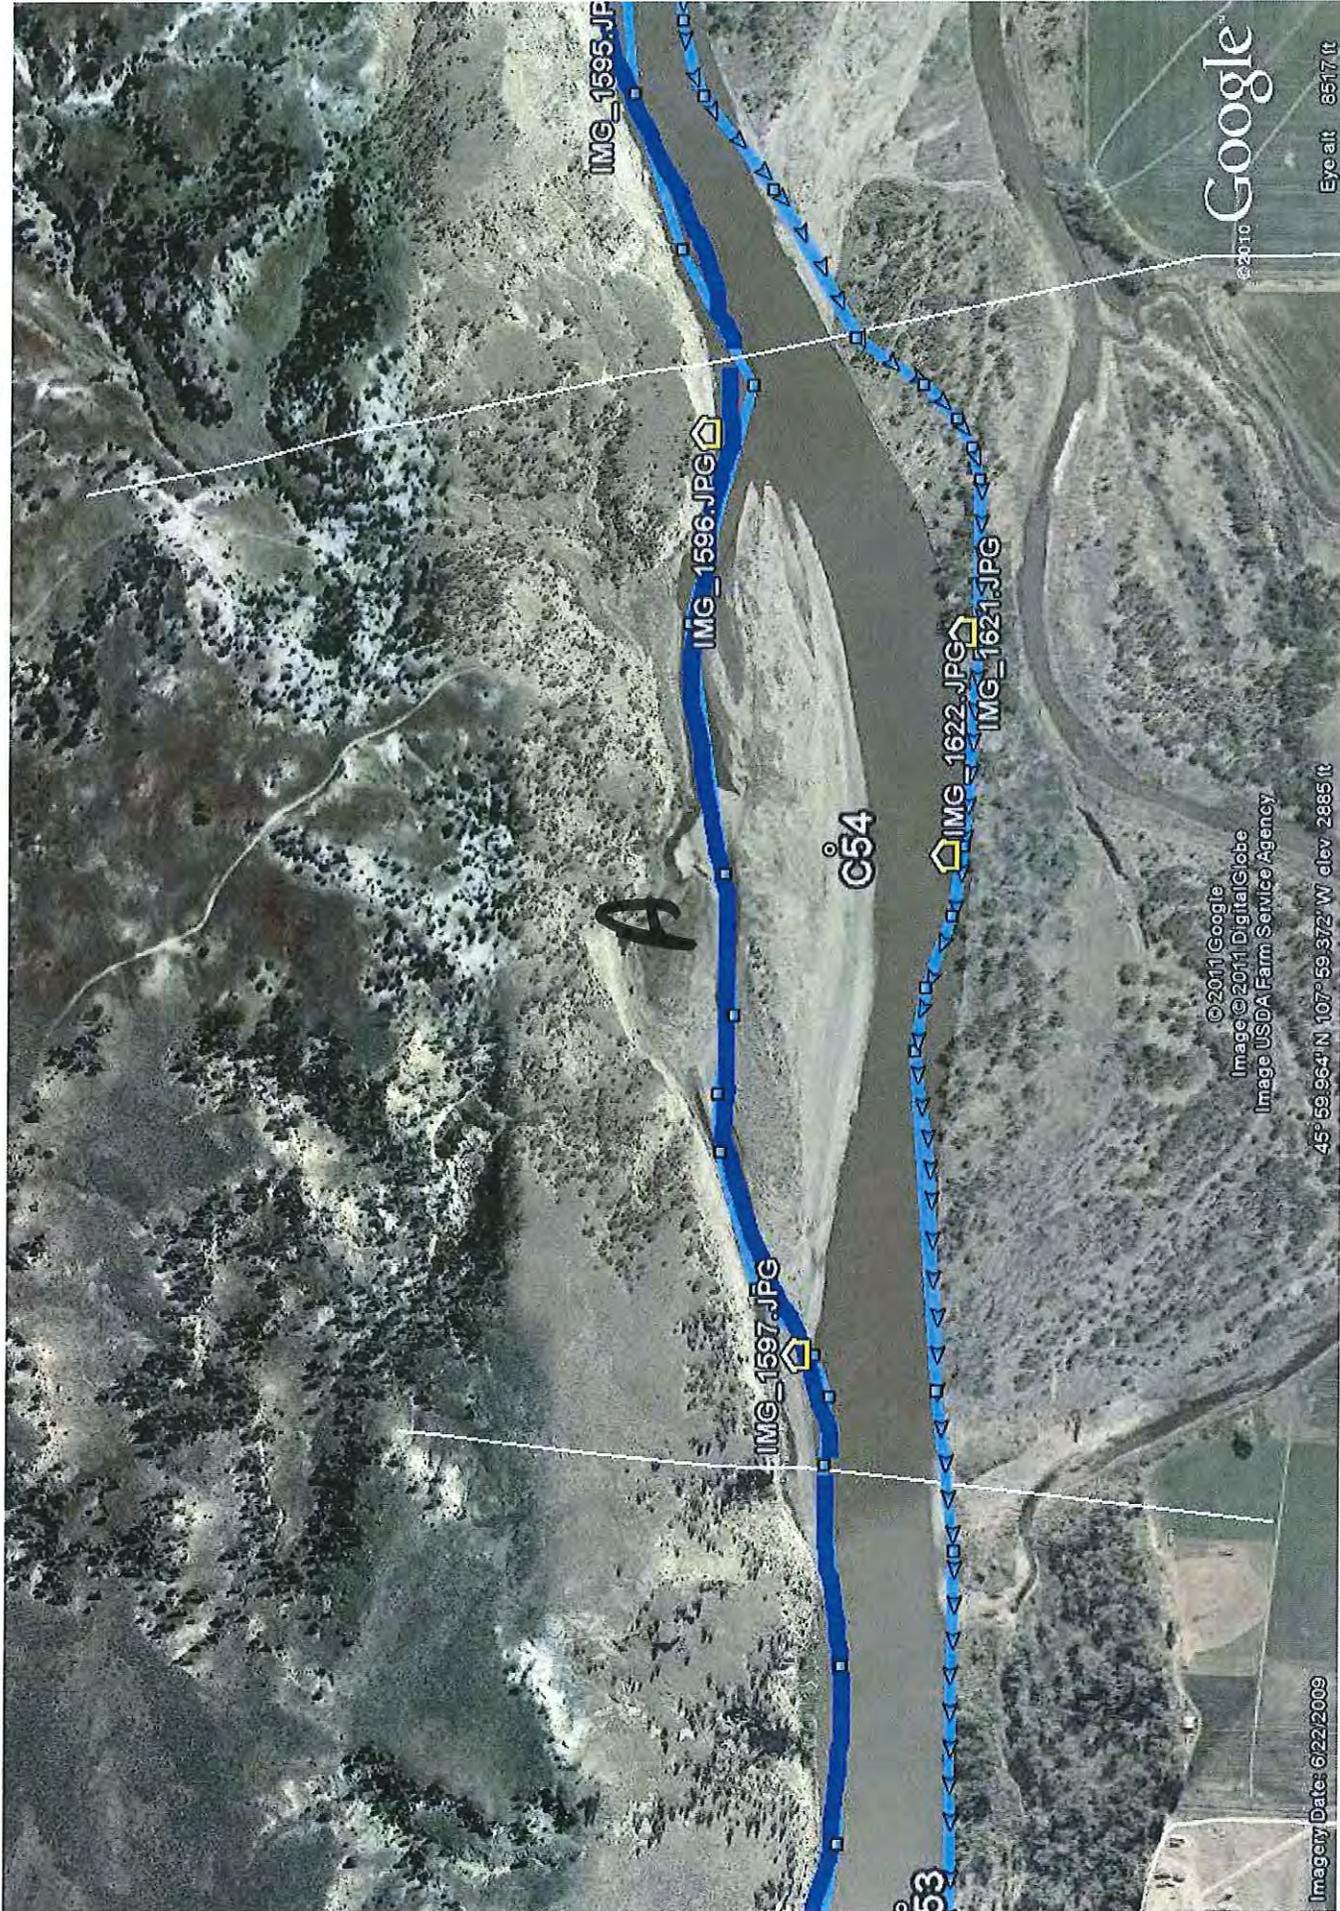
C54LB
Team#6
25/07/11

Zone A - NOO - NFT

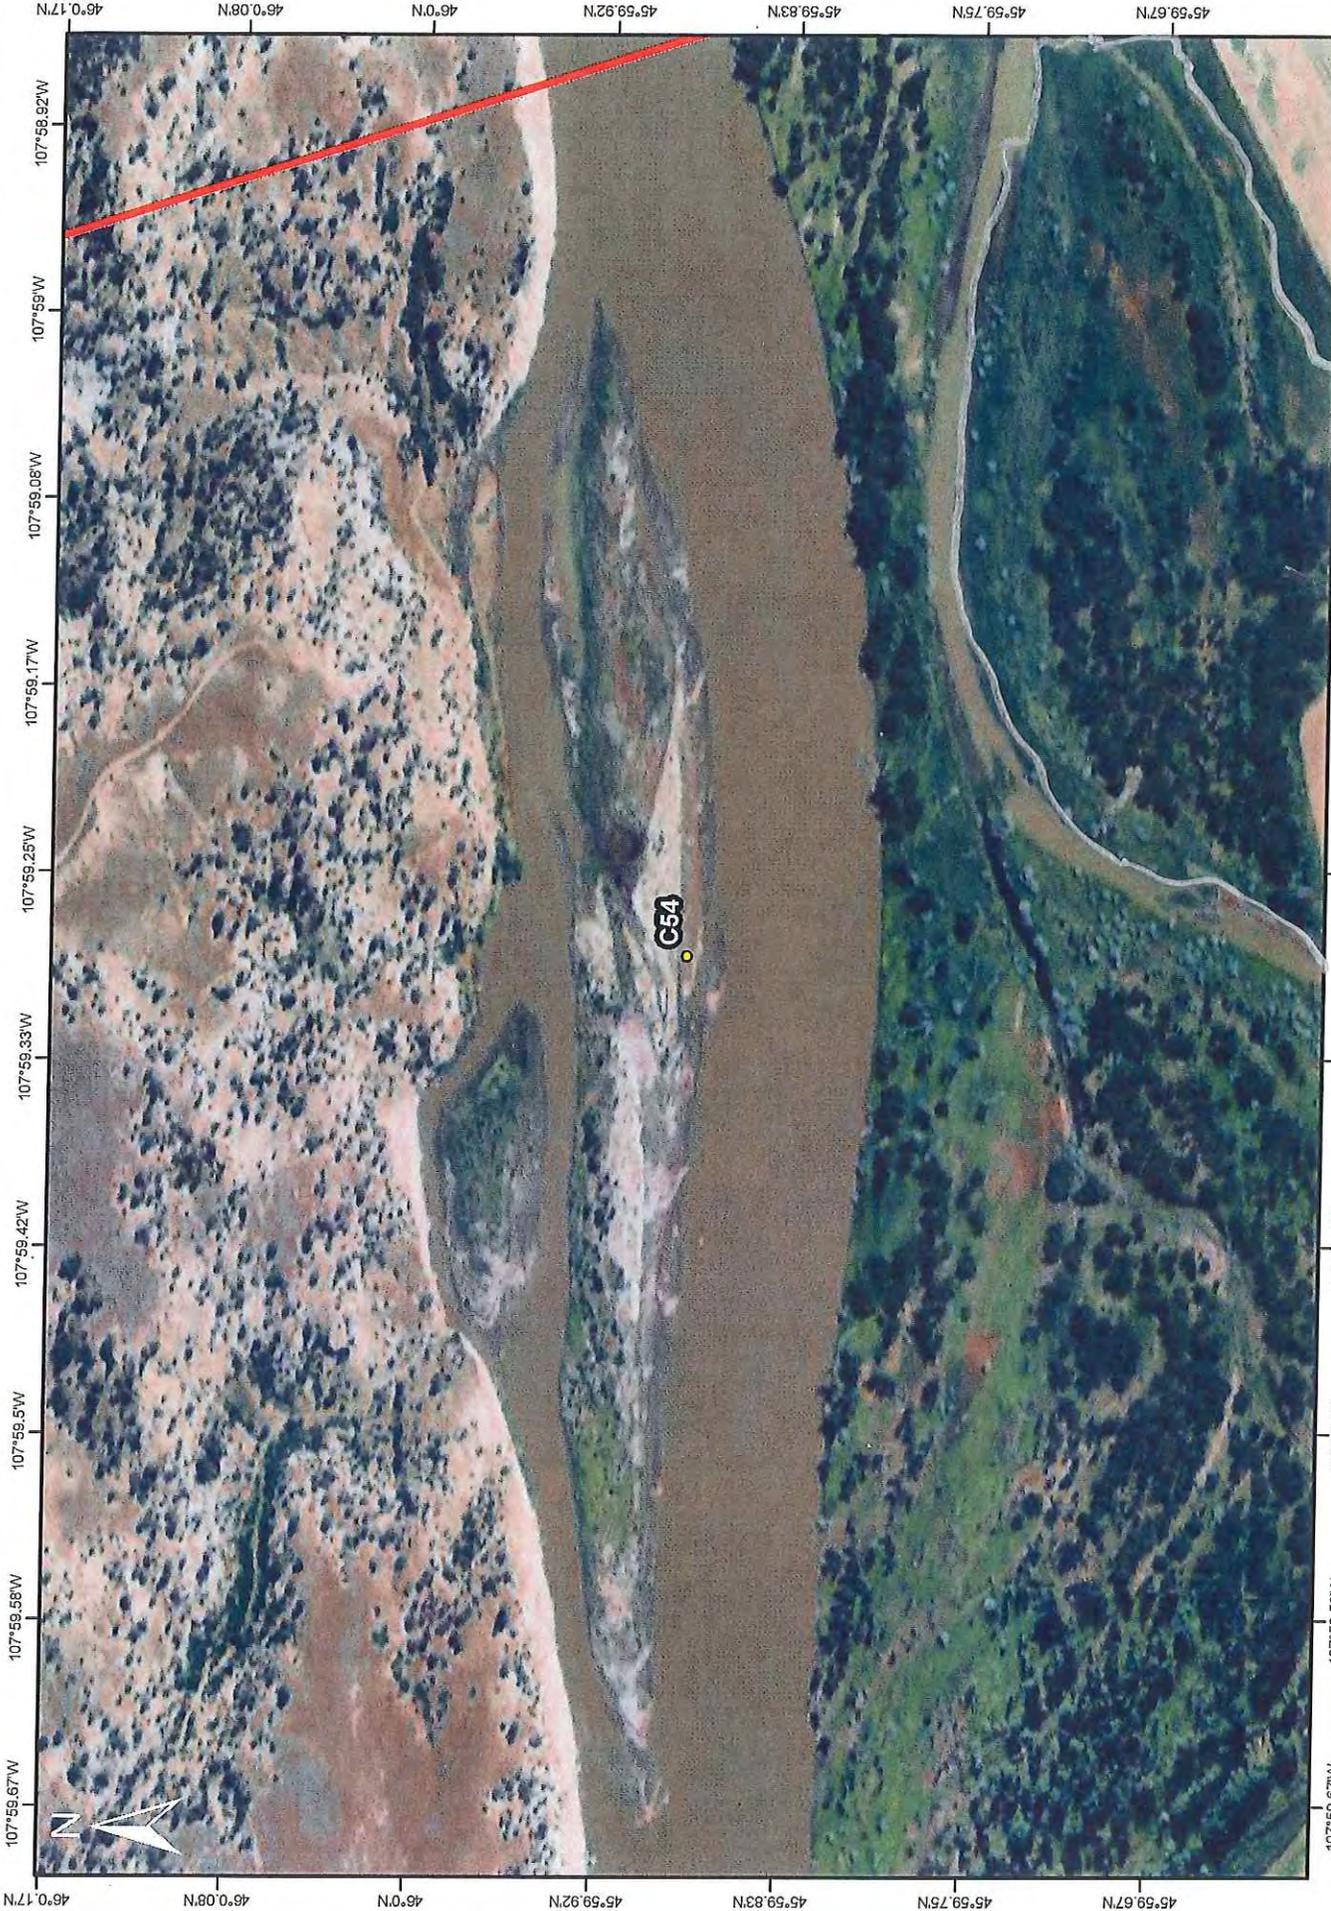
Team #6
05/08/11

Zone A: -1% cover, primarily staining (trace) on shrub 491955
 BLM Representative on site for survey: Jay Parks (406) 698-2007
 Recommend: Natural Attenuation, NTR

0 335 670 1,340
Feet
Very Light, -1% cover
NTS

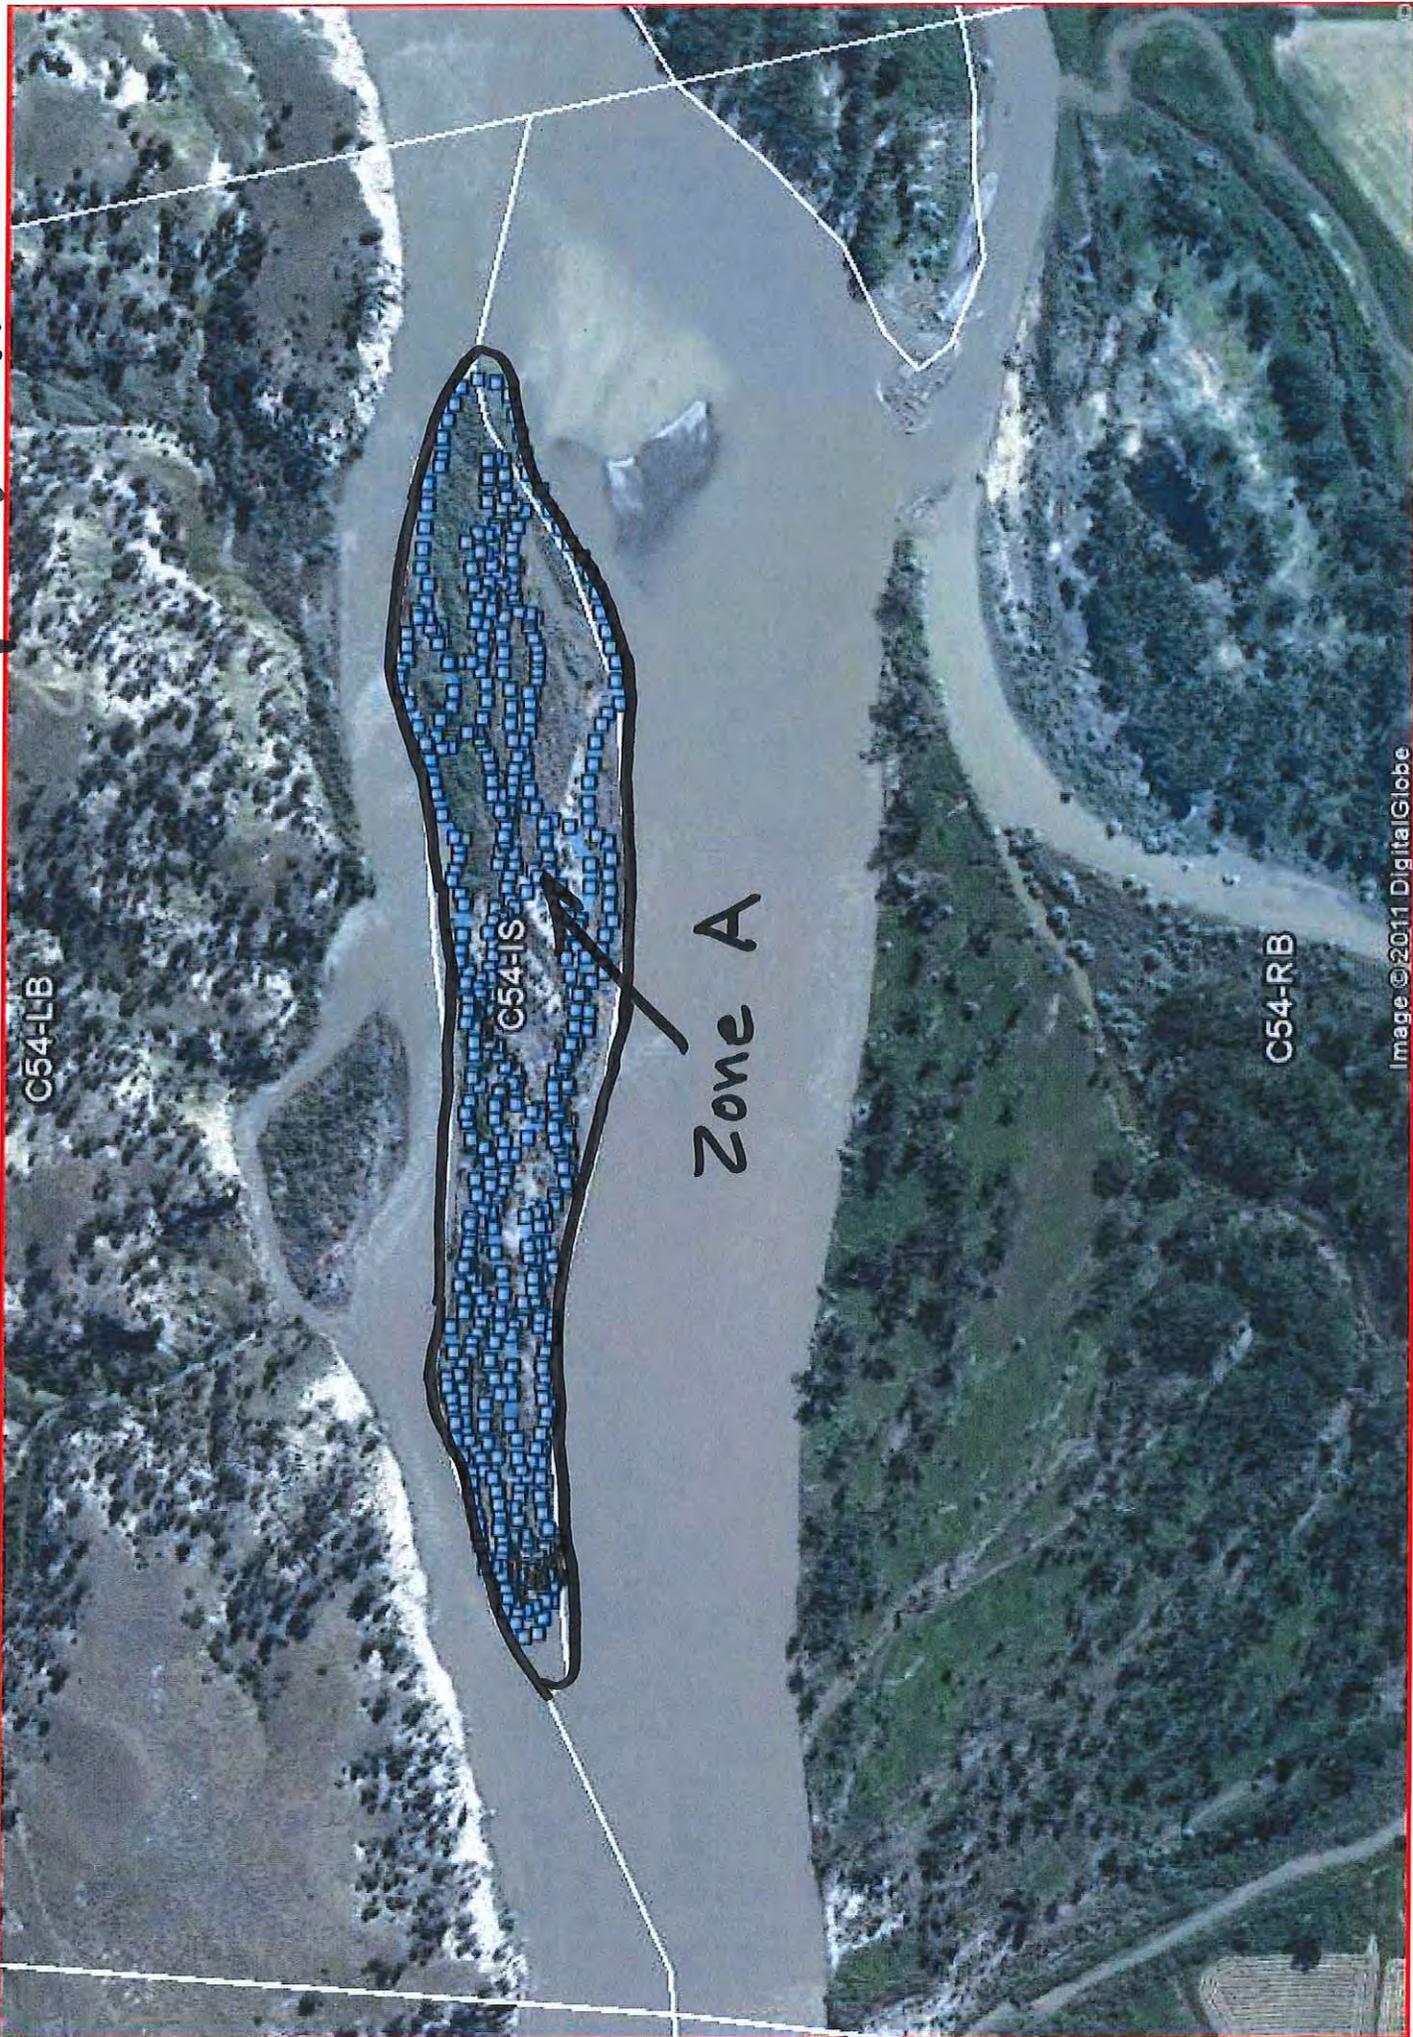
C 54 Island S&AT Team 1 Sept 7, 2011

6 SURFACE OILING CONDITIONS																						begin with "A" in the lowest tidal zone - circle the zone/s that correspond to primary shoreline type	
OIL ZONE	RIVER BANK ZONE				OIL COVER			OIL THICKNESS					OIL CHARACTER							SUBST. TYPE(S)			
					Length	Width	Distrib.																
	ID	MS	LB	UB	OB	m	m	%	TO	CV	CT	ST	FL	FR	MS	TB	PT	TC	SR		AP	NO	
A				X	785	115	<1				X						X				Veg/Debris
