**SCAT Area Transition Report
for C55**

Silvertip Pipeline Incident
Laurel, Montana

October 25, 2011

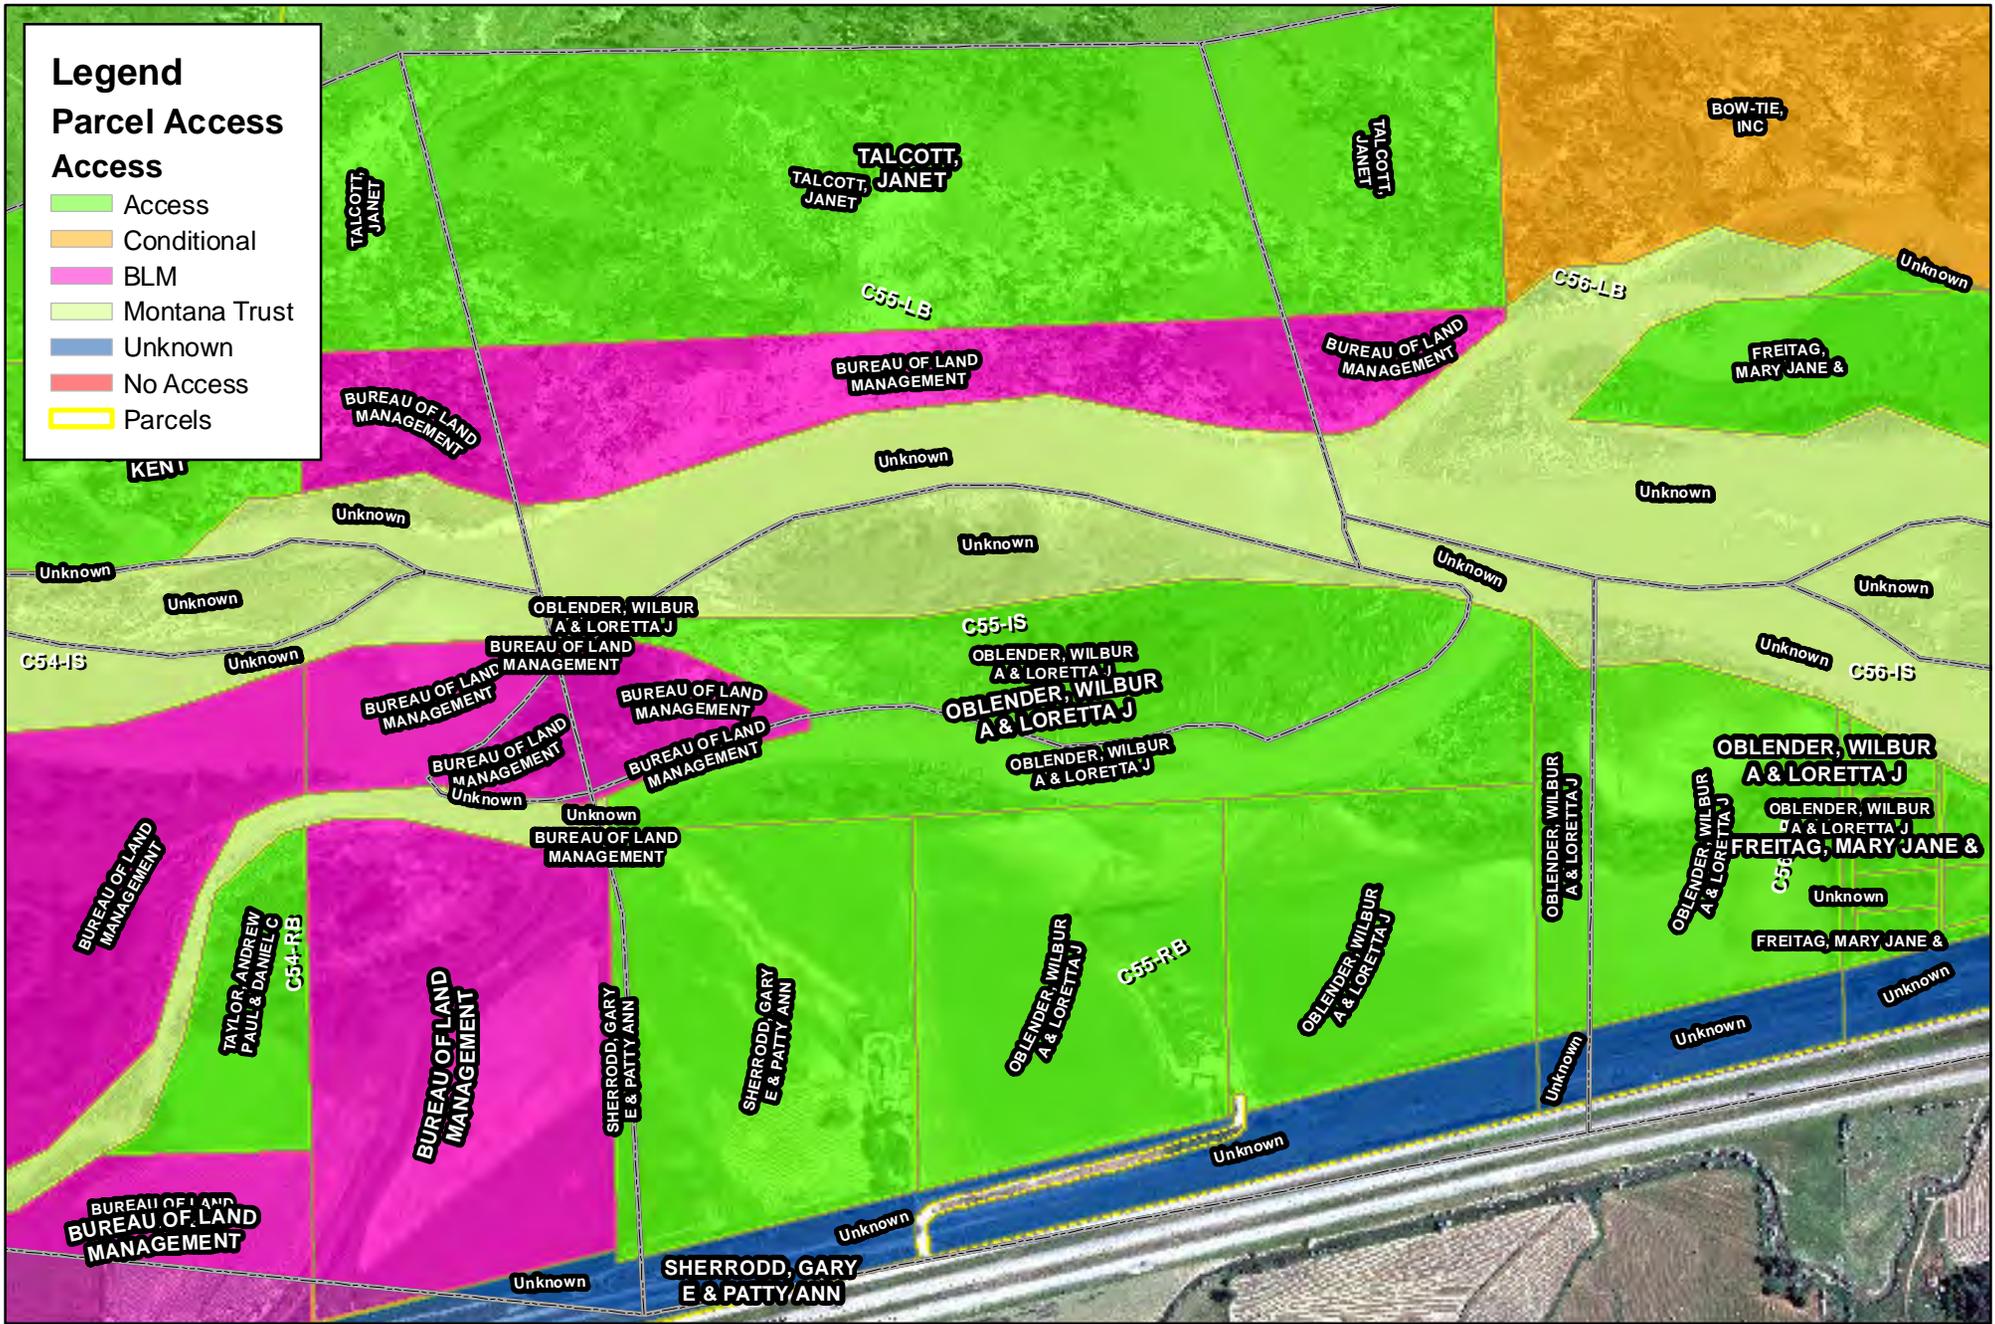
Figure 1 provides an aerial map of SCAT Area C55, along with the (a) SCAT Area boundary, (b) parcel boundaries and respective property owners, and (c) access constraints identified during the oil cleanup process. The acreage surveyed in Area C55 is 118.1. There were no access issues for this segment.

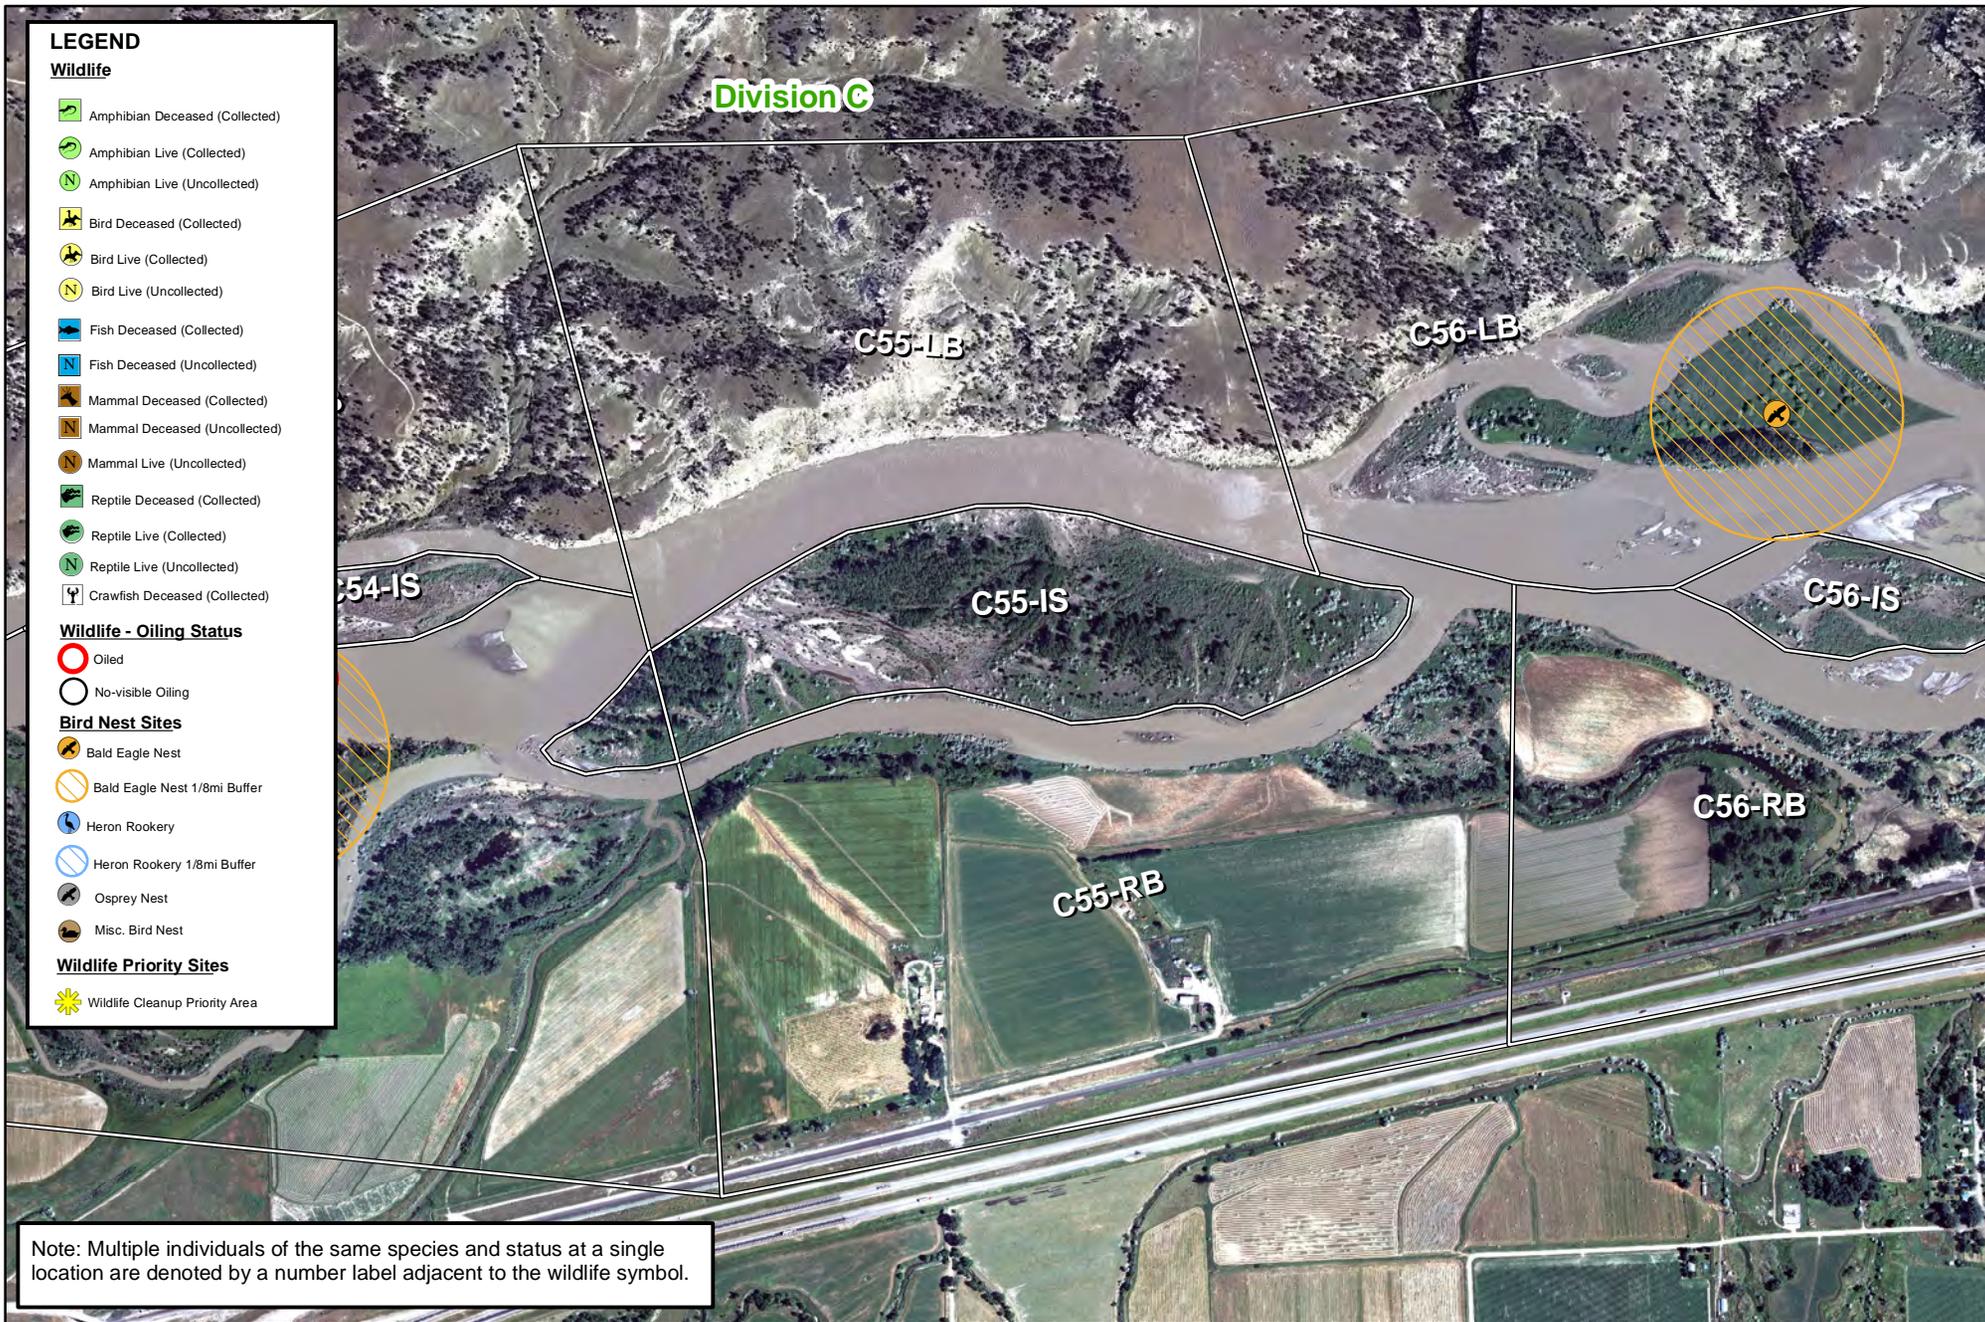
Figure 2
Wildlife Resources

Figure 2 summarizes the natural resources identified in this segment. International Bird Rescue and Resource Advisors from U.S. Fish and Wildlife Service conducted limited inspections of Area C55 due to the low level of oiling in Division C. No oiled wildlife was observed or recovered. No Wildlife Priority Cleanup Areas were identified. No active migratory bird nests were identified in Area C55.

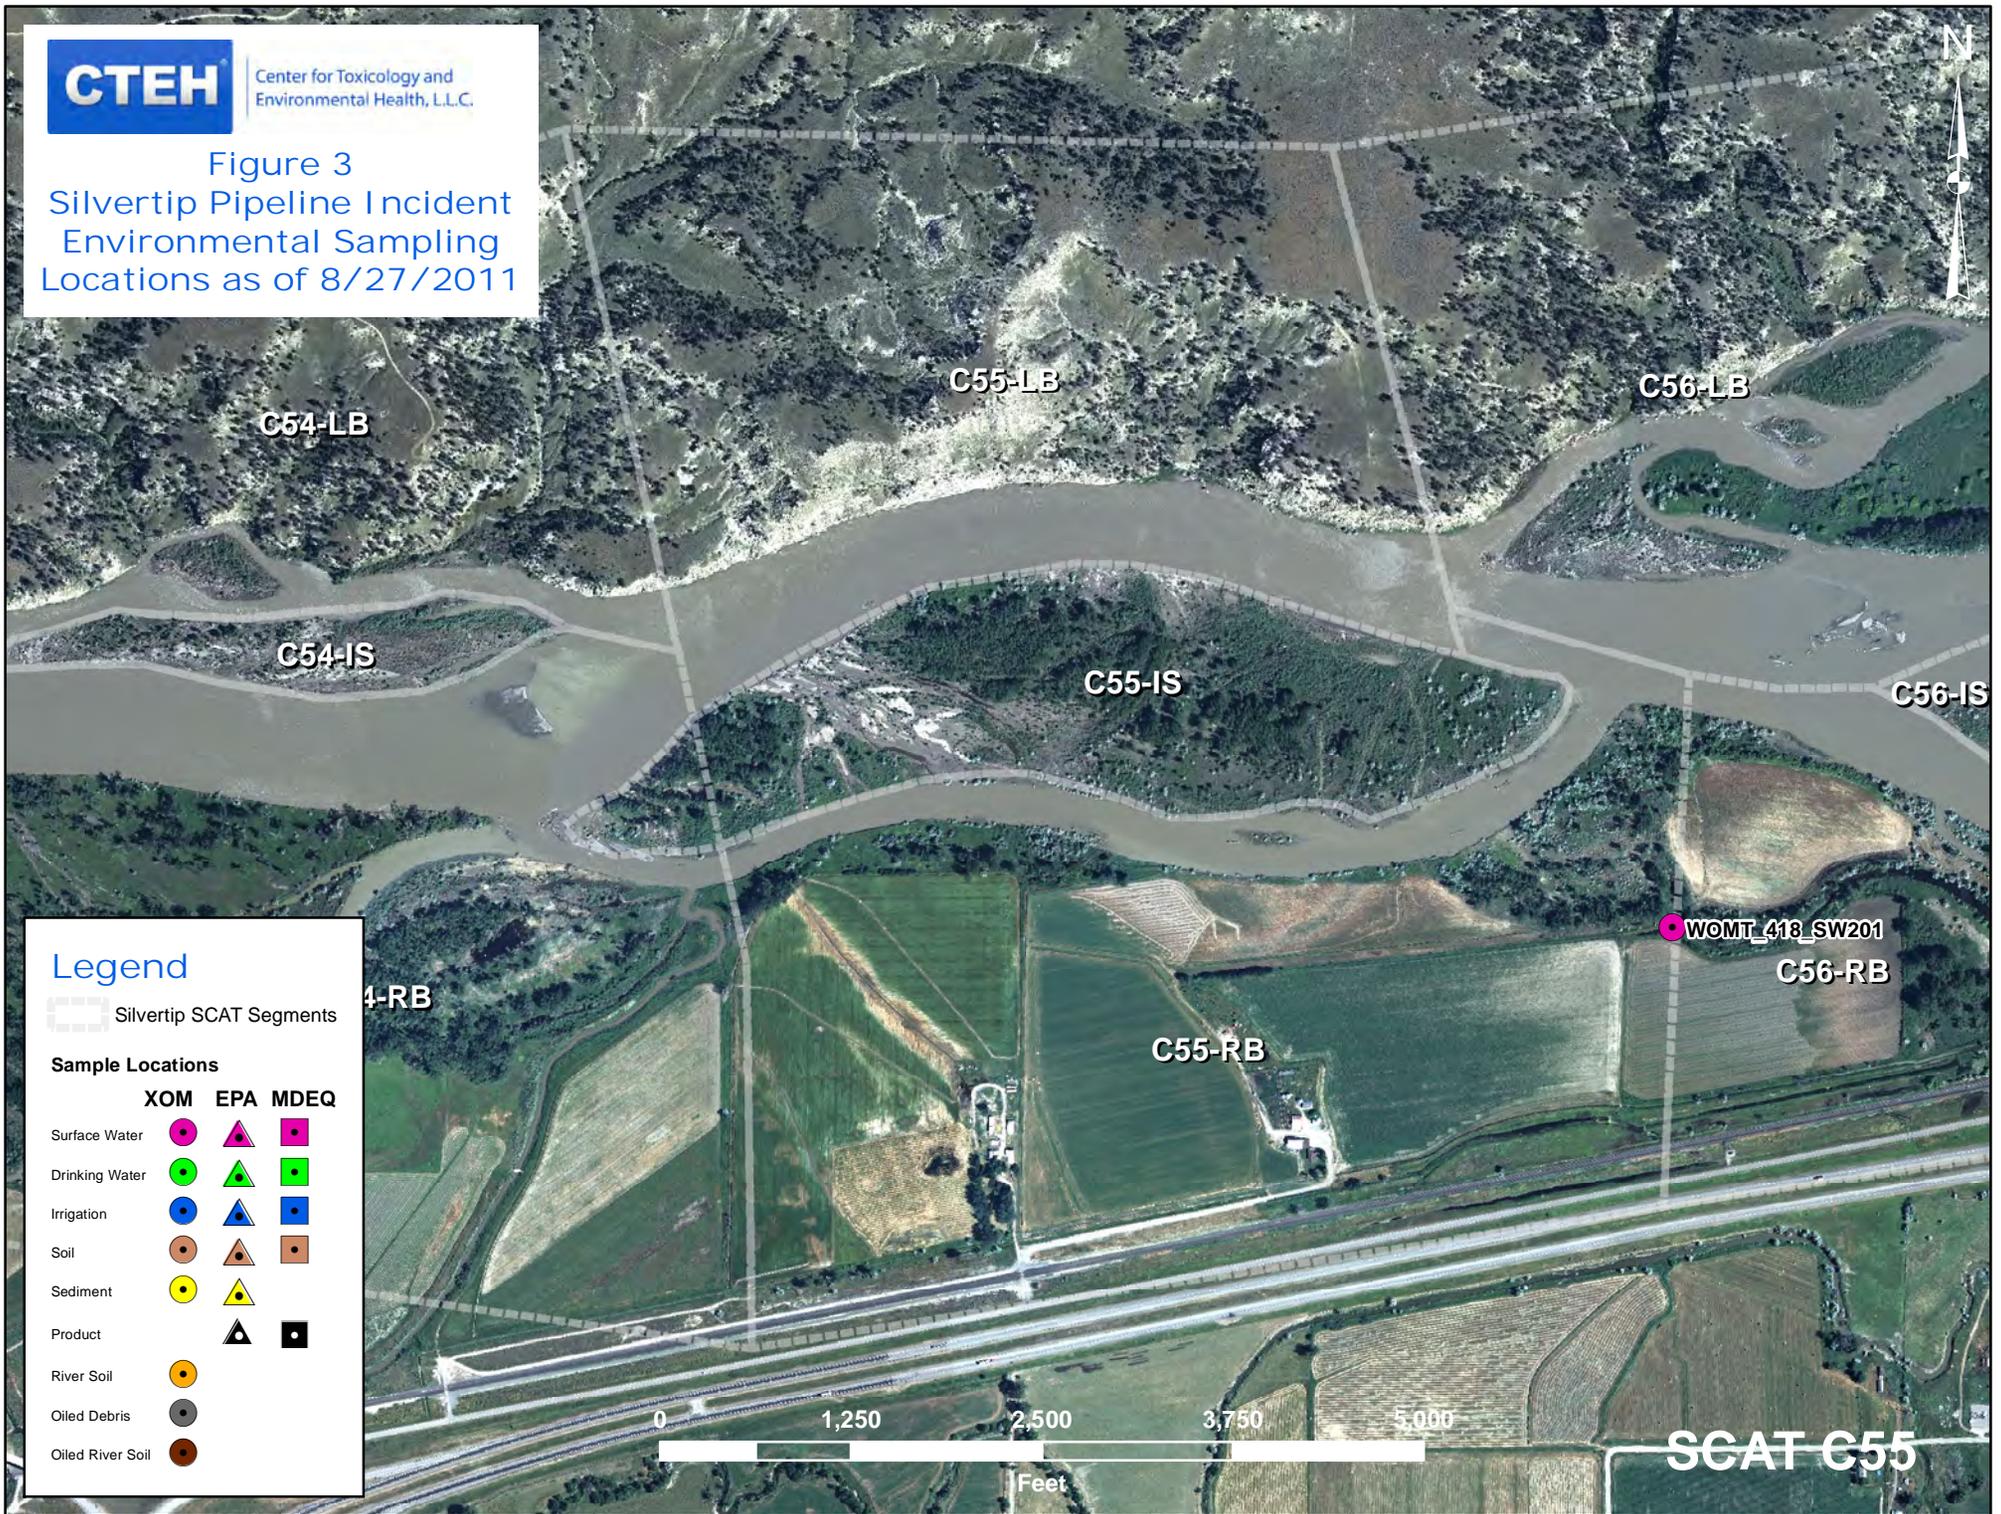
Figure 3
 Silvertip Pipeline Incident
 Environmental Sampling
 Locations as of 8/27/2011

Table 1 (below) summarizes samples collected within Area C55. The analytical results for the samples collected can be accessed through a publicly accessible database on the United States Environmental Protection Agency's (USEPA's) website. The approximate locations of samples collected within Area C55 are provided on Figure 3.

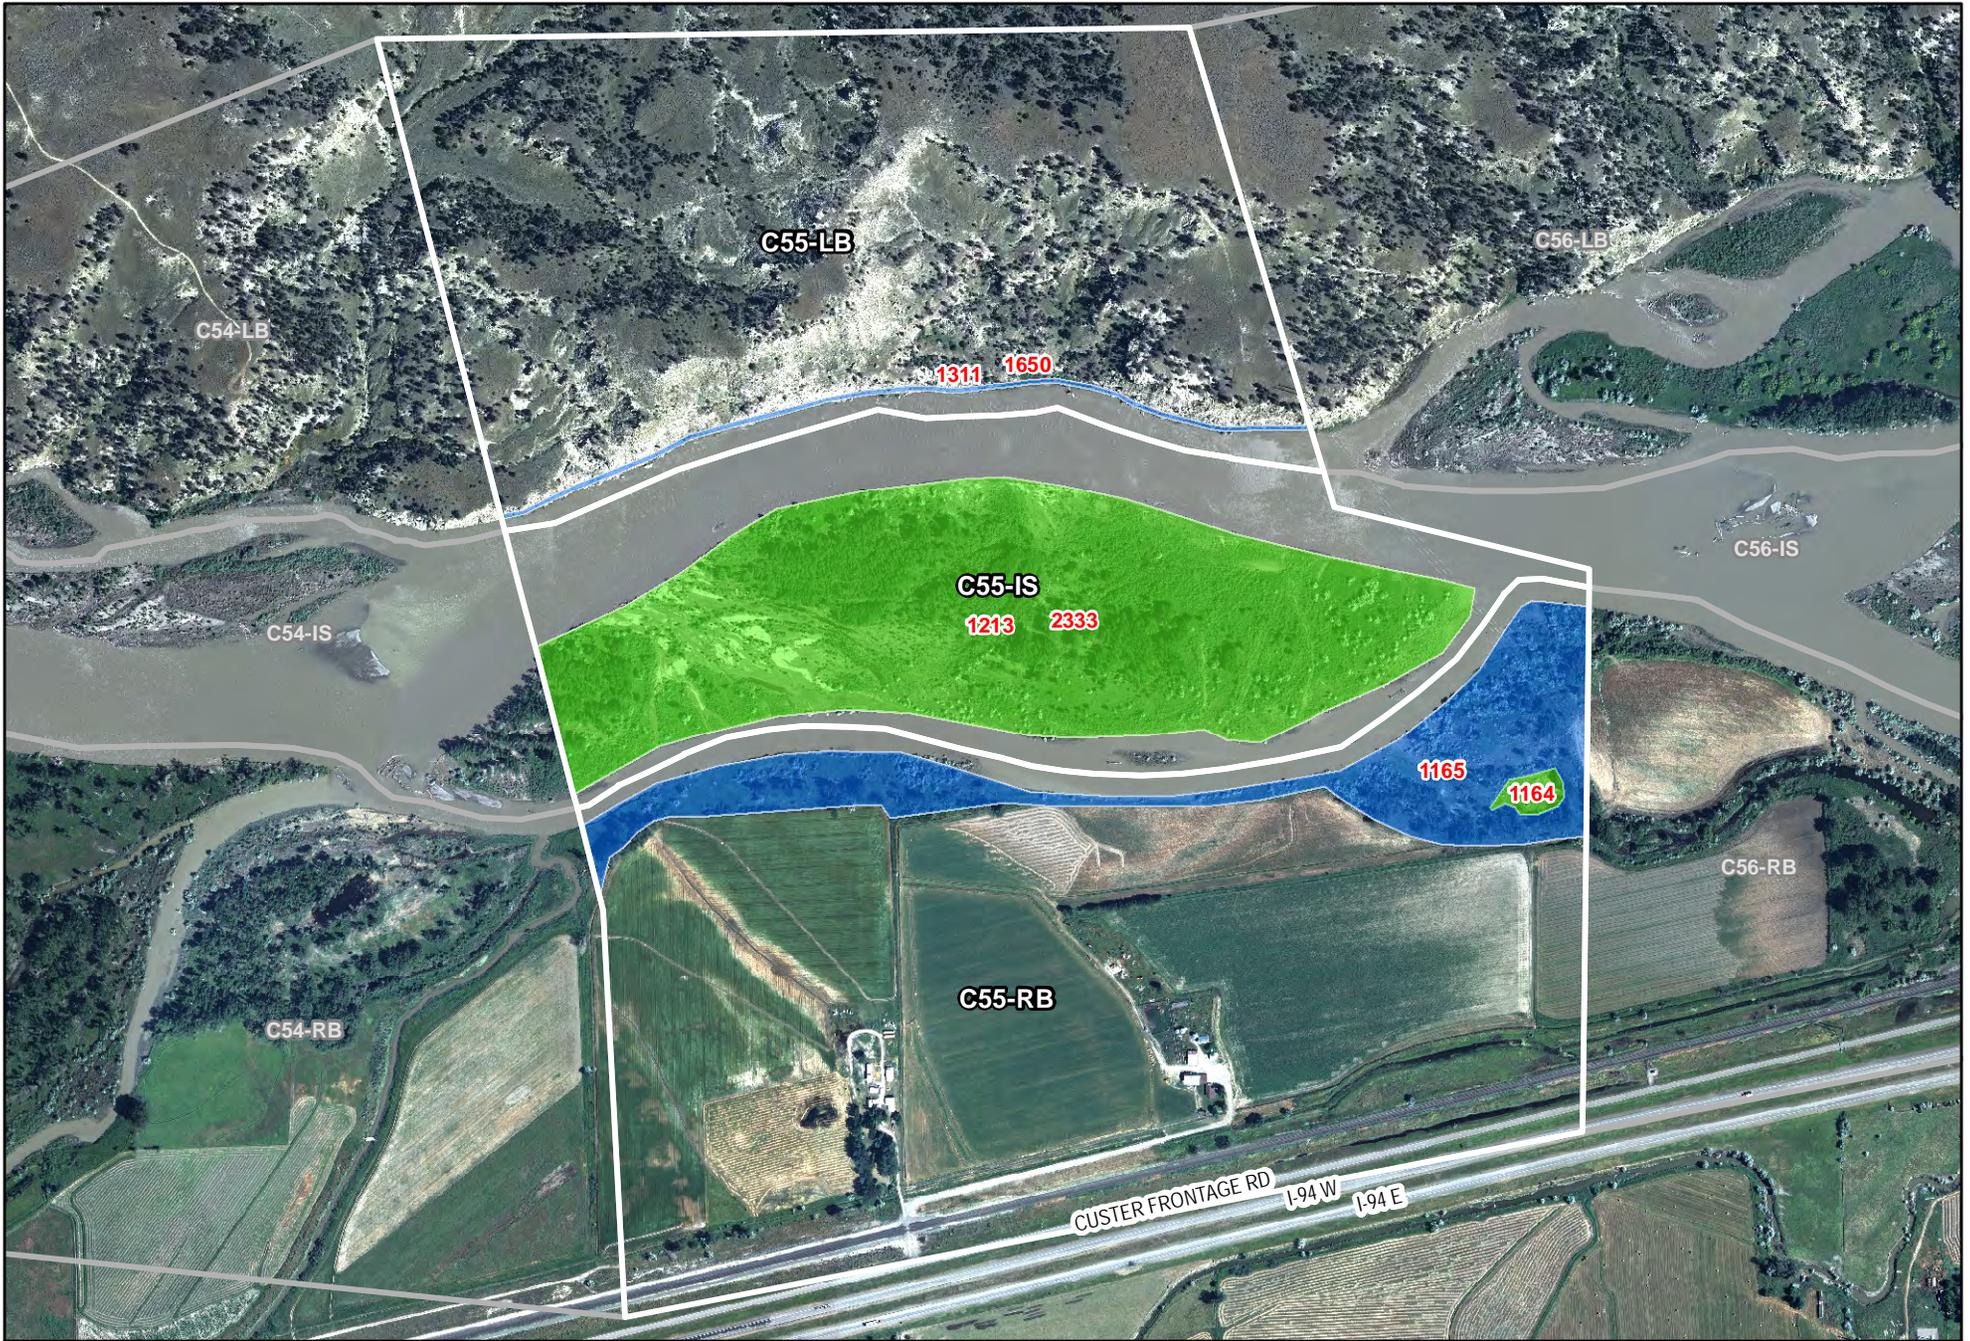
**Figure 4 - Maximum SCAT Observations
For SCAT Area:**

The SCAT teams used systematic evaluation criteria and treatment method tables approved by the National Oceanic and Atmospheric Administration to provide a standard approach for data collection and conducting field surveys. The forms and sketches from the initial SCAT surveys performed along the river bank (water edge) and floodplain within Area C55 are included in Appendix B. Figure 4 provides the maximum oiling zones observed by the SCAT team during the initial surveys of Area C55.

Based on the initial SCAT survey performed within Area C55, very light oiling was observed on a portion of the right bank, and no oiling was observed in the remainder of this segment and the left bank. The very light oiling zones will be addressed through natural attenuation. Based on the final SCAT surveys performed on the island within Area C55, no further treatment is recommended for this area. The SCAT Area Sign-Off Forms are included as Appendix F.

The SCAT team developed compiled treatment recommendations (CTRs) providing approved treatment methods (ATMs) for each oiling zone identified during the initial SCAT surveys ([CTR No. 48](#), [CTR No. 61](#), and [CTR No. 62](#)).

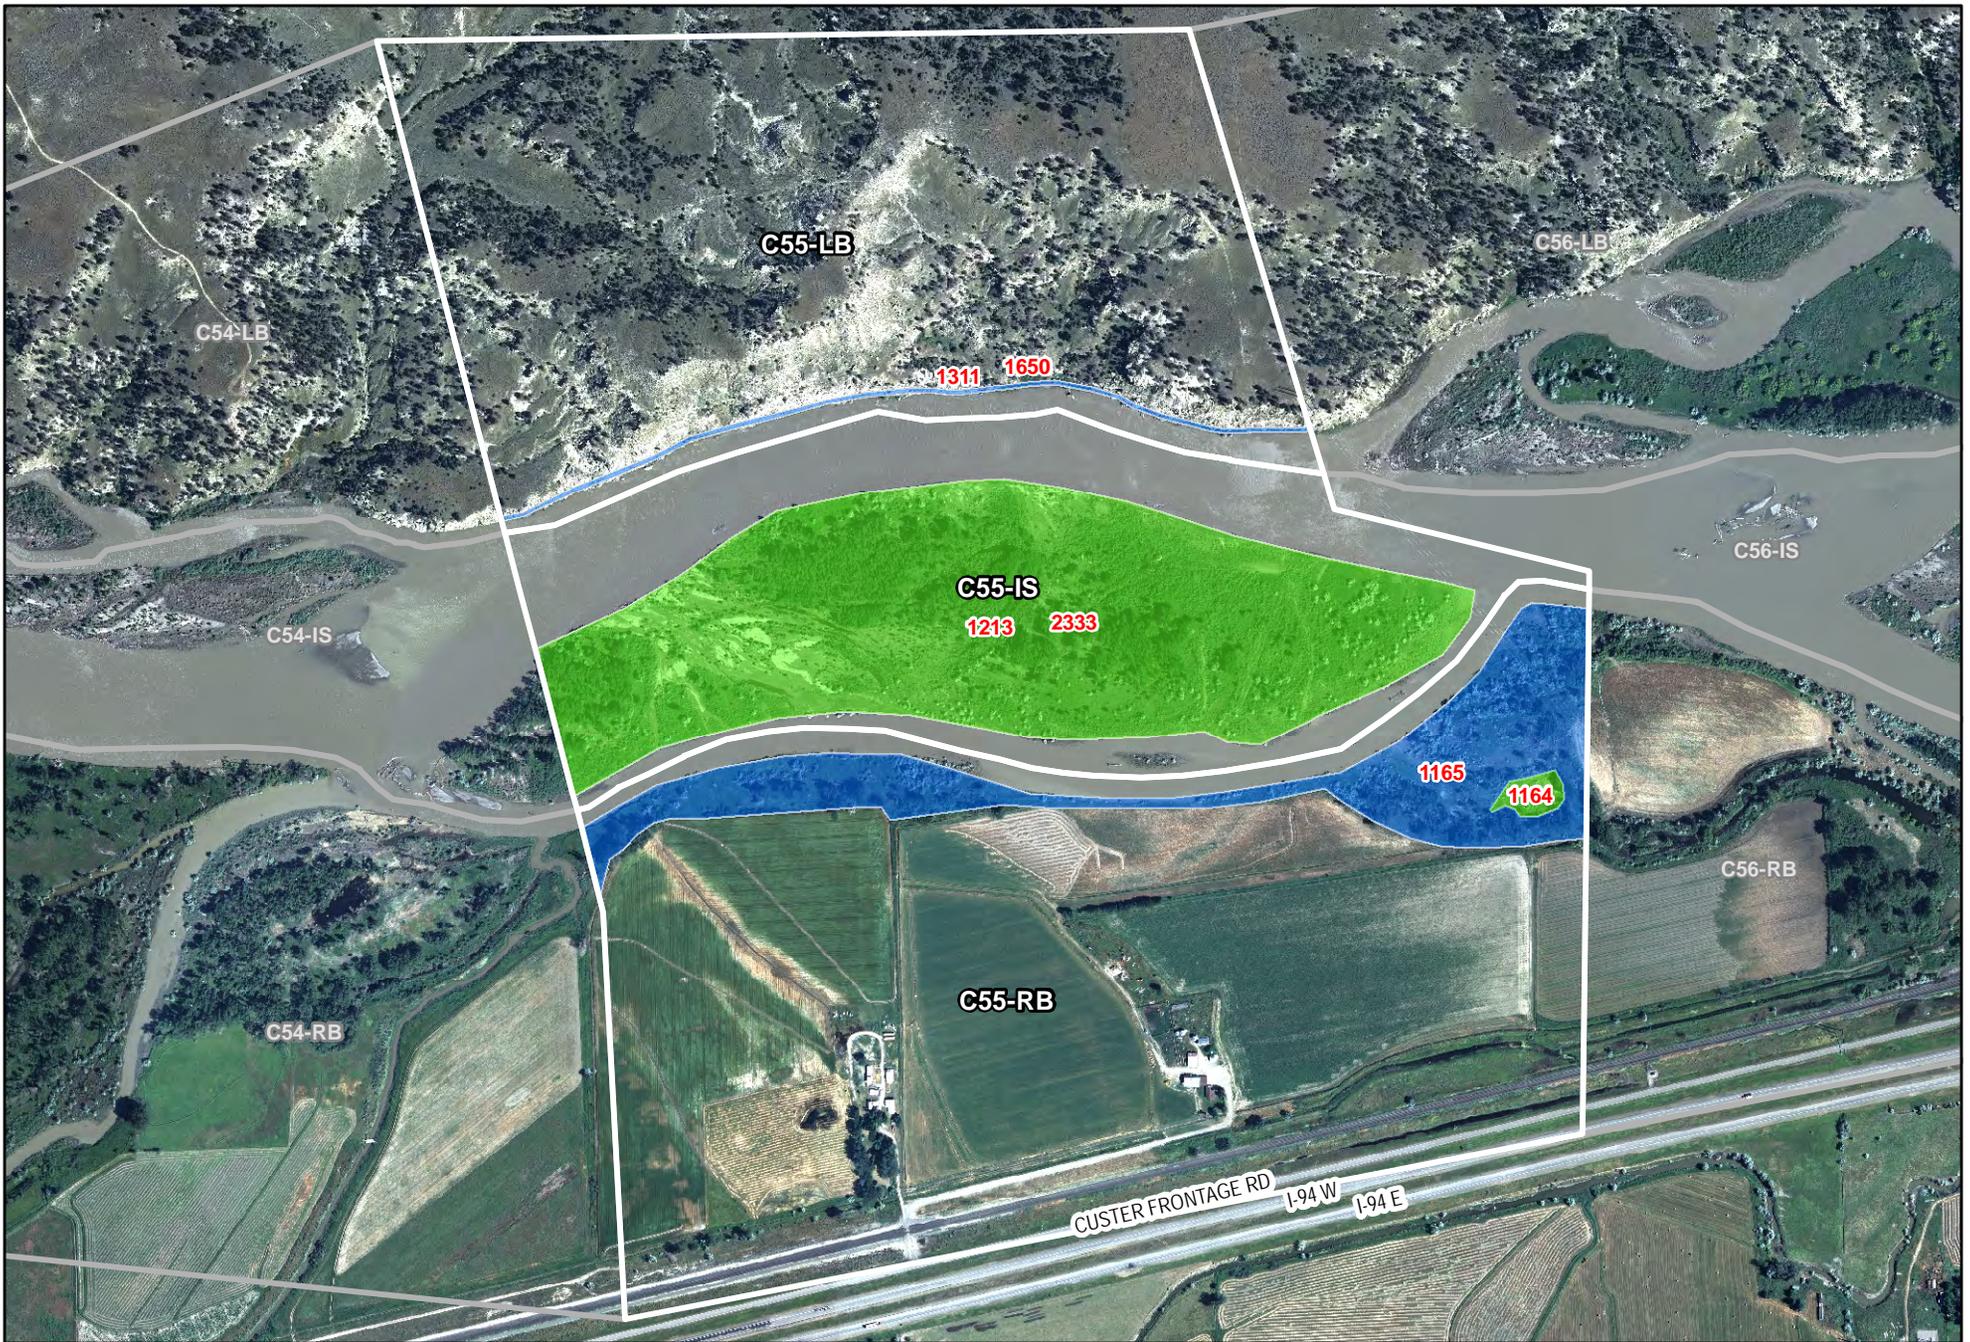
**Figure 5 - Final SCAT Observations
For SCAT Area:**

Figure 5 shows the oiling conditions within Area C55 following completion of oil removal activities. The SCAT team performed final surveys of the island within SCAT Area C55 to confirm the agreed-upon cleanup endpoints identified in the applicable CTRs had been achieved. The final SCAT survey documentation is presented in Appendix E.

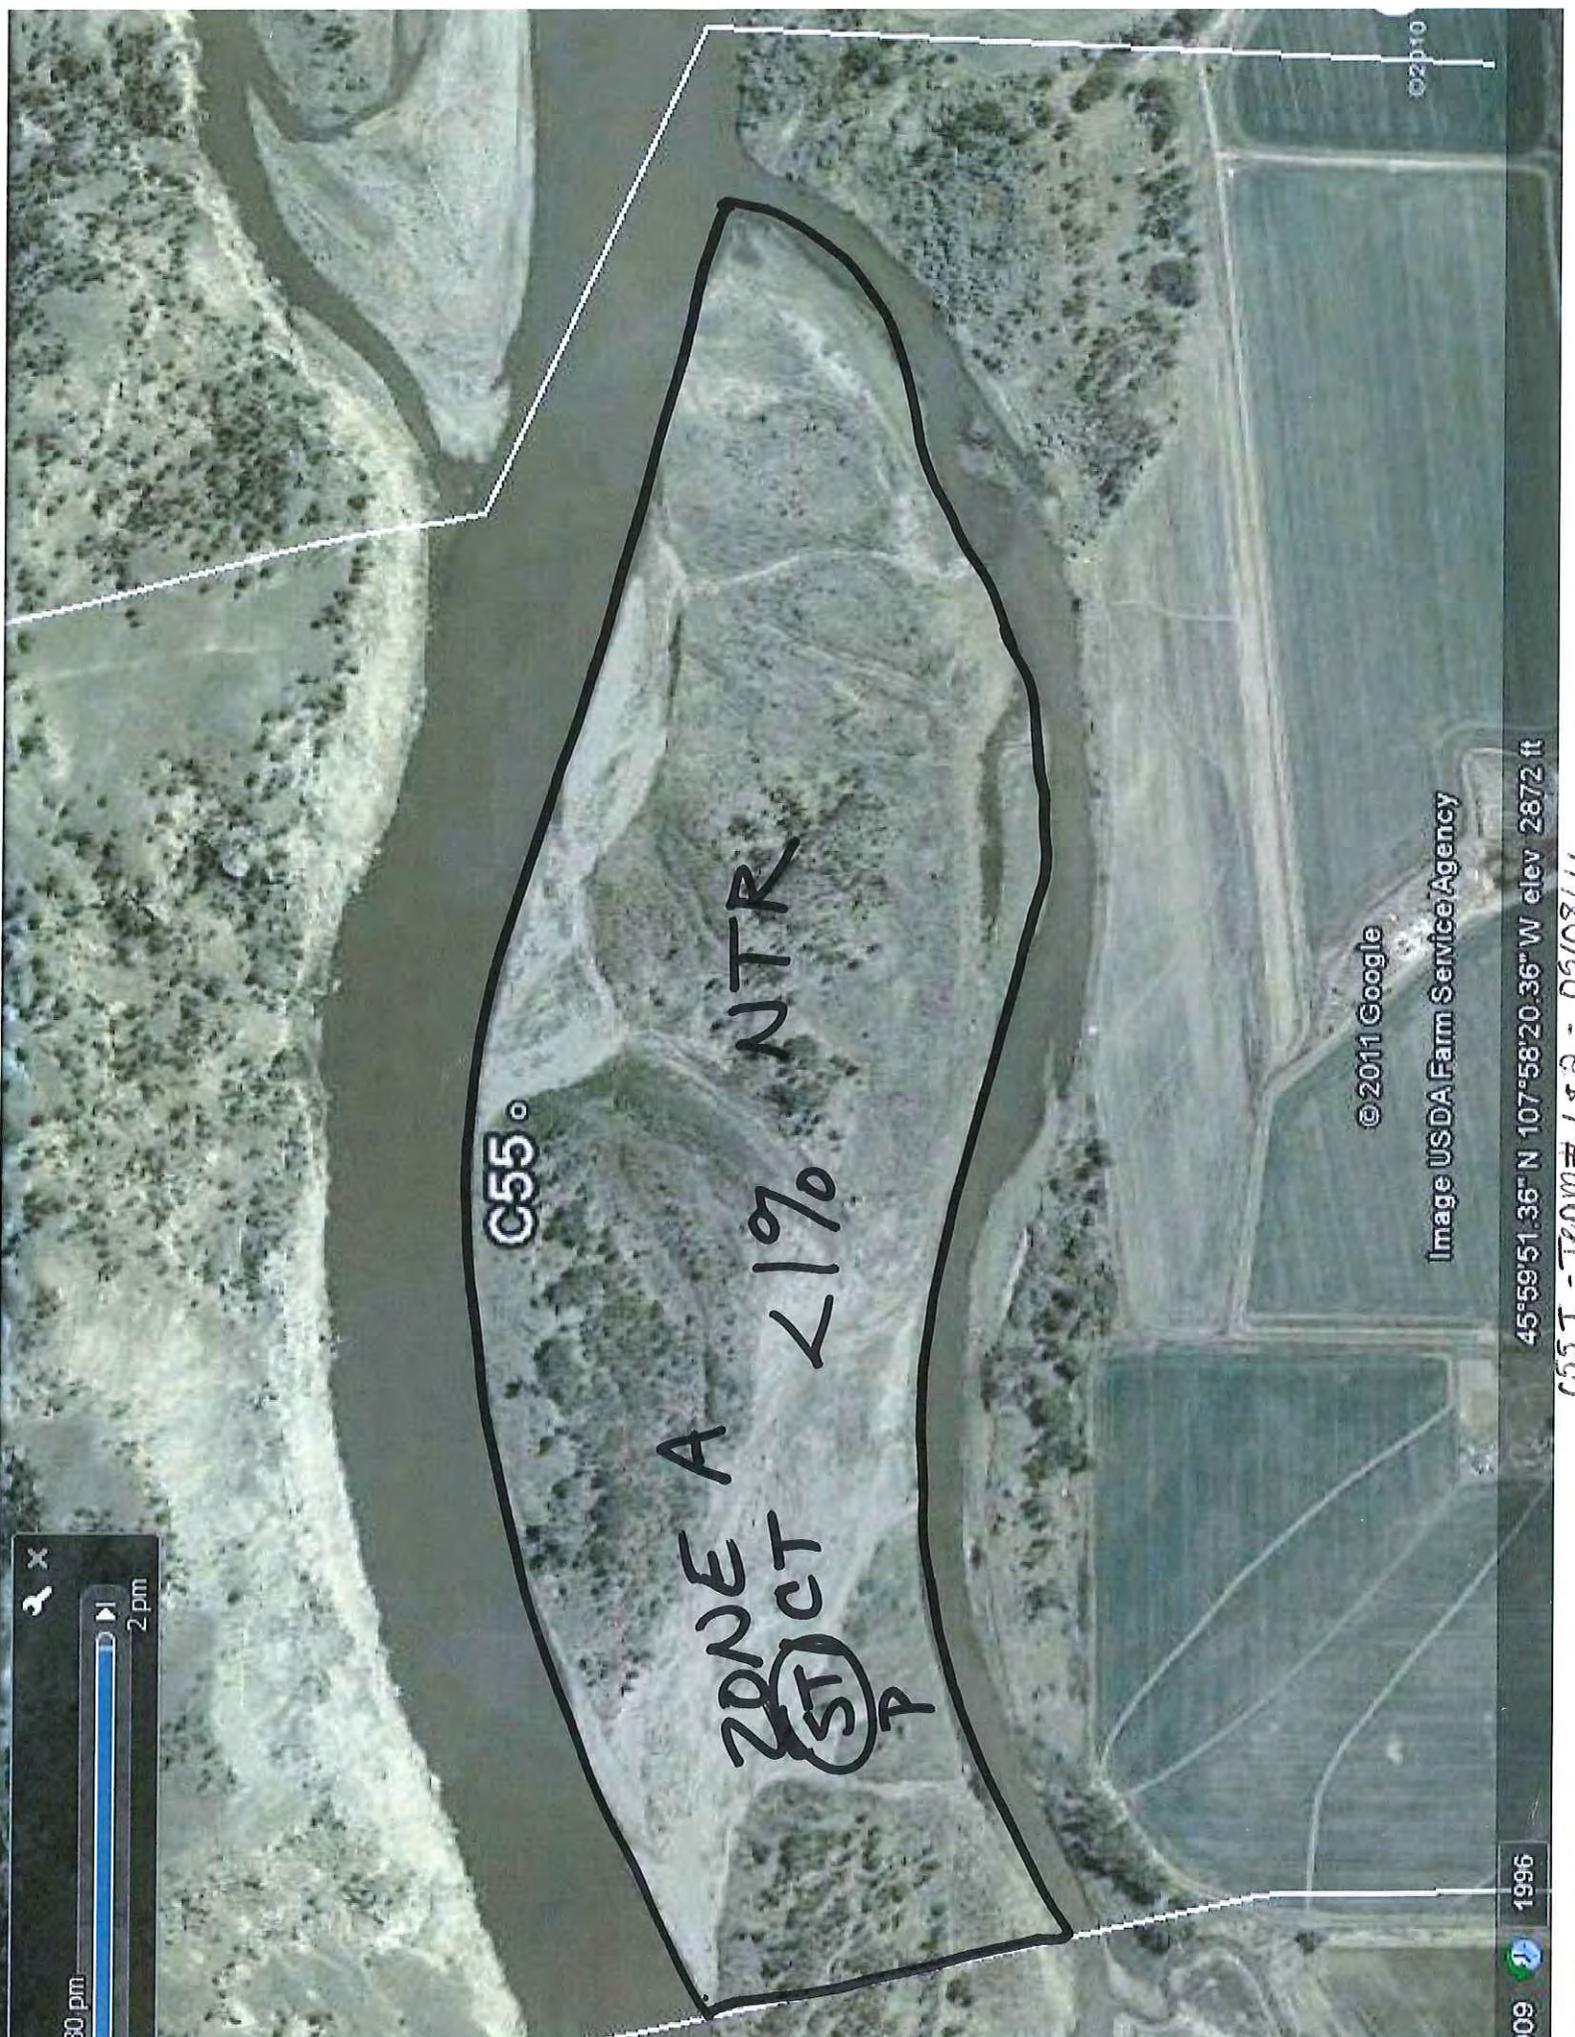
C55 I - TEAM# 1 & 2 - 05/03/11

Zone A - NTR

ZONE A
 STRICT P
 <19% NTR

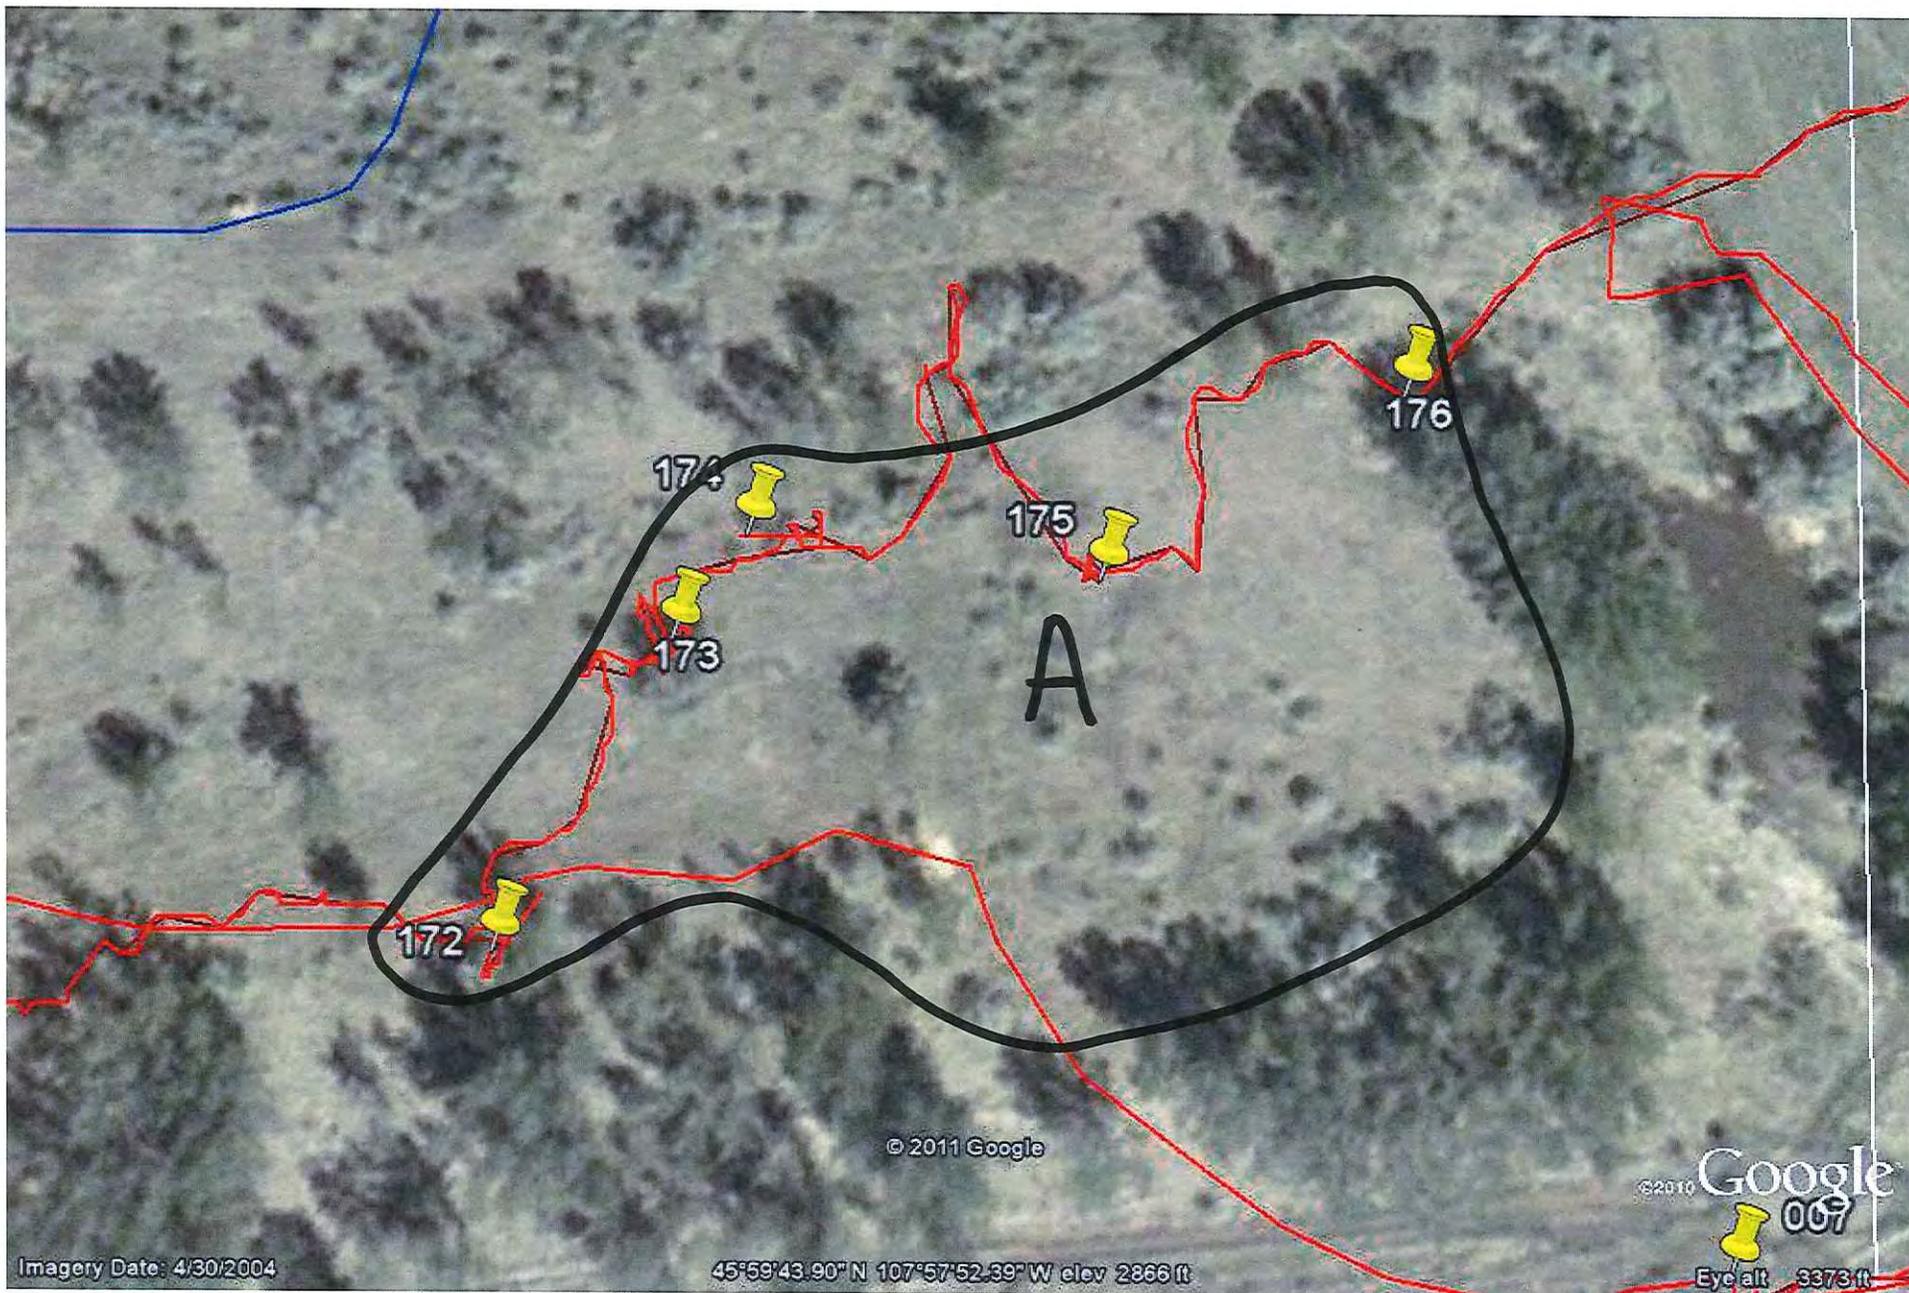
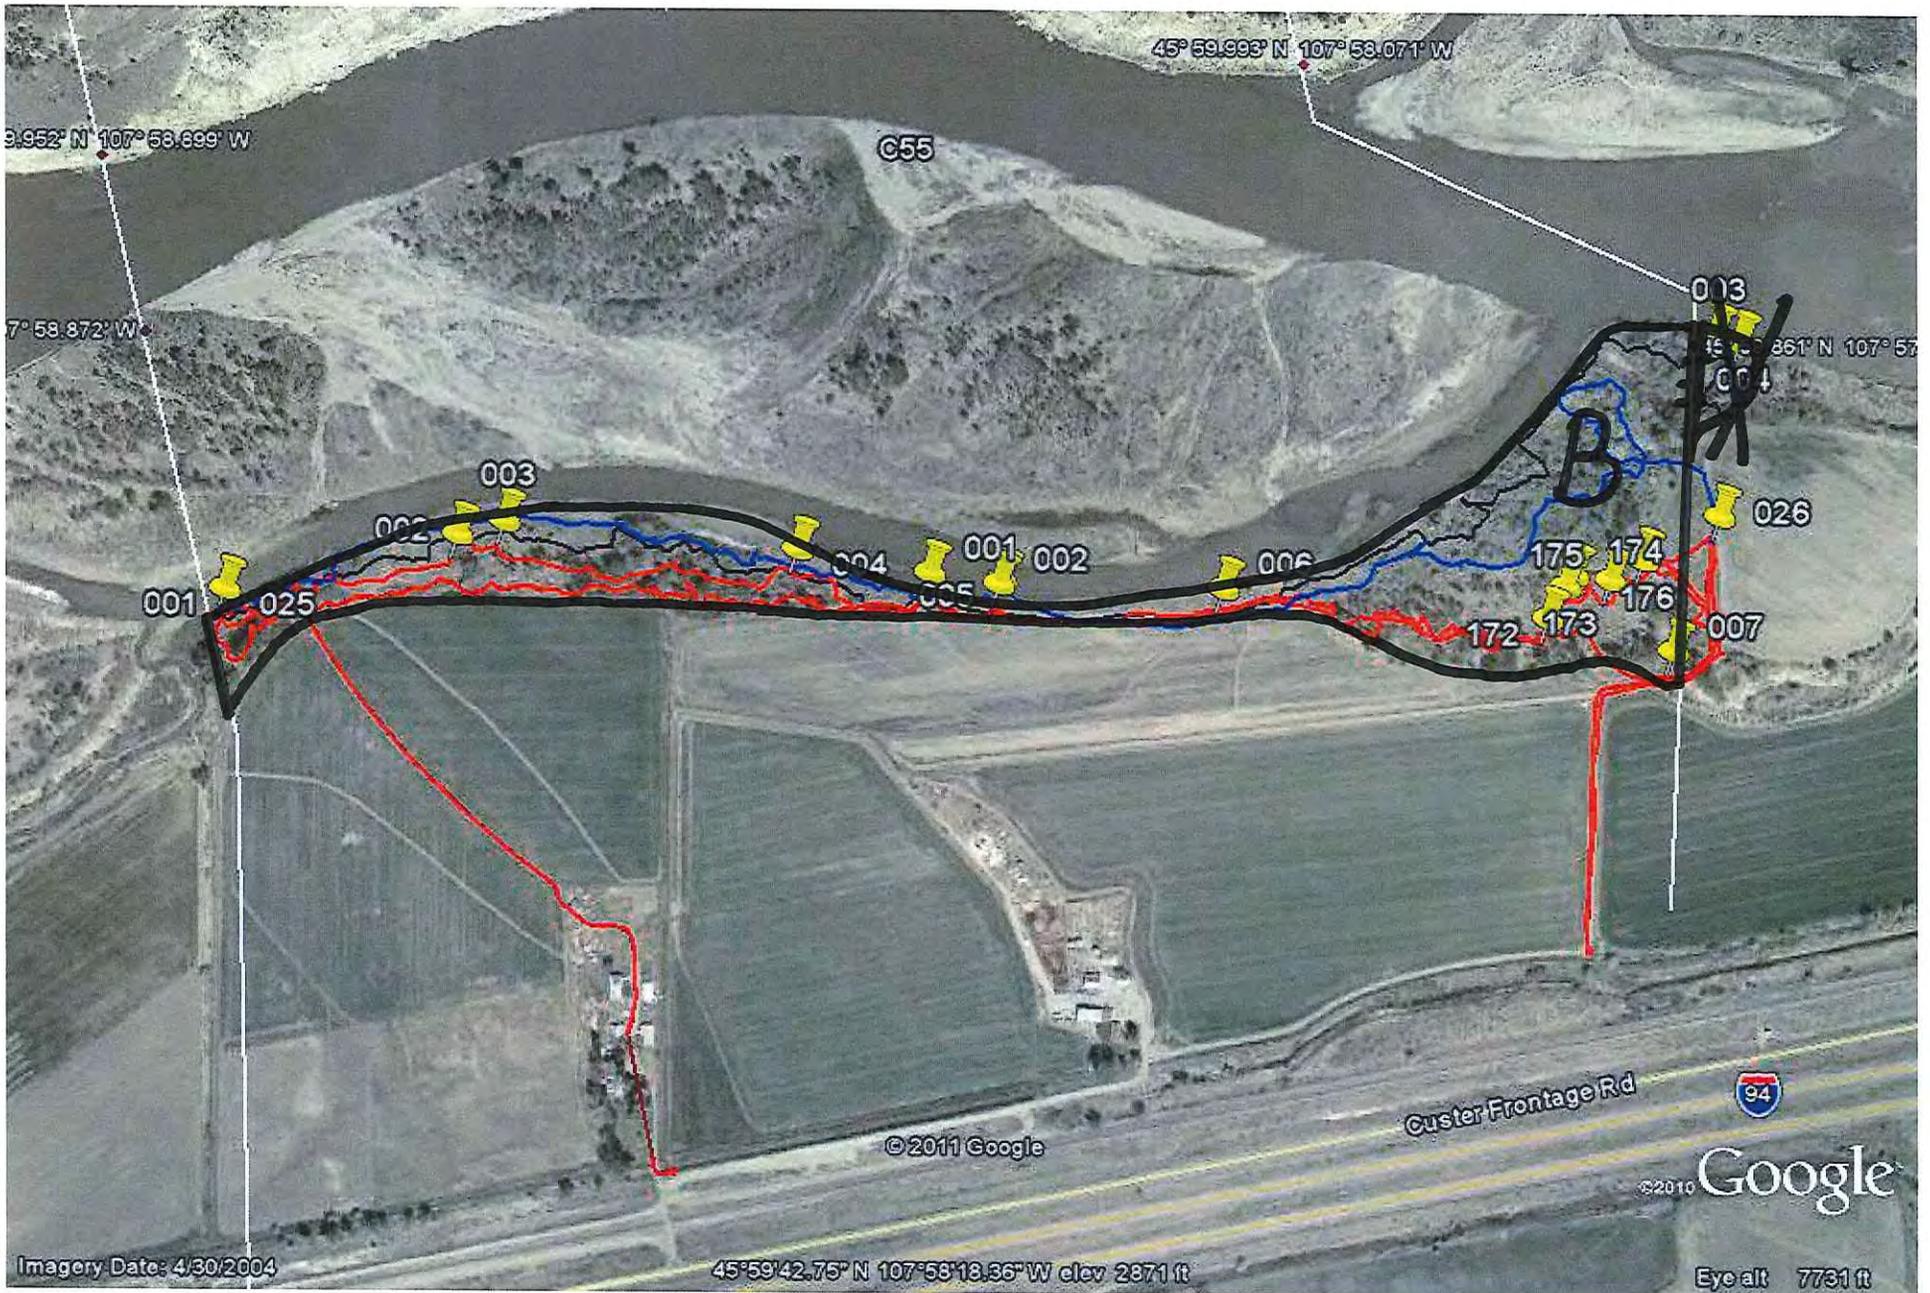
August 3, 2011
TEAM 5 CSSR

Zone A: Trace (<1%) oil stain and coat on grass, Russian olive and small vegetative debris. No further treatment (NFT).

Zone B: No oil observed. No further treatment (NFT).

Zone C: Trace oil stain and coat on grass. NFT

Zone D: Rainbow sheen on slack water/oxbow. NFT
