**SCAT Area Transition Report
for C55**

Silvertip Pipeline Incident
Laurel, Montana

October 25, 2011

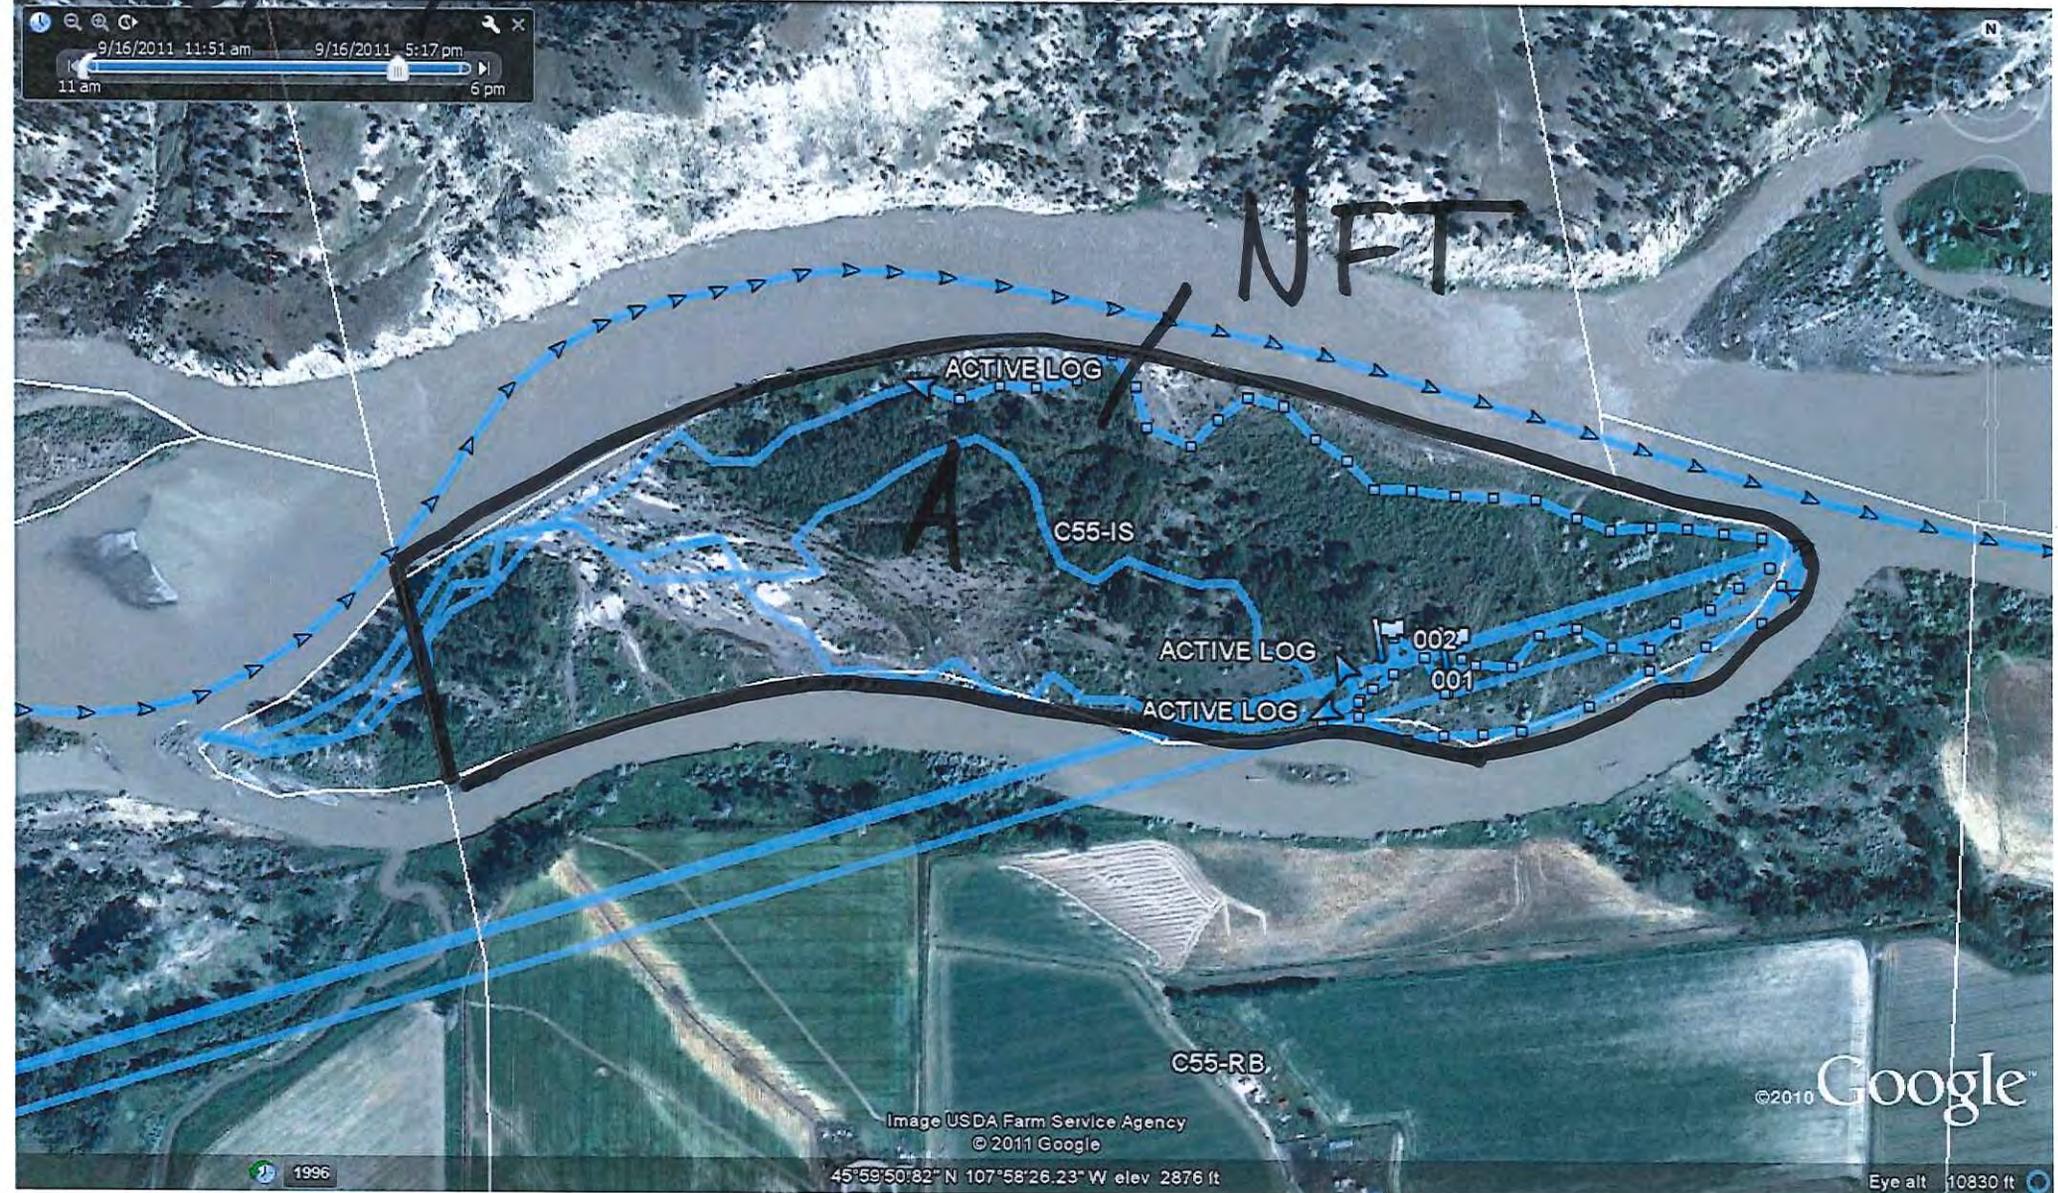
ReSCAT
C-55 IS

A: ReSCAT with Ops Hot Shot
 Stain on trees and debris, clean by Hot shot.
 Meet the condition of the CTR, NFT.
