Re: Submittal of Final Natural Attenuation Monitoring Report  
Docket No. WQA-12-08  
Silvertip Pipeline Incident Response  
Laurel, Montana

**Final Natural Attenuation  
Monitoring Report**

Silvertip Pipeline Incident Response  
Laurel, Montana

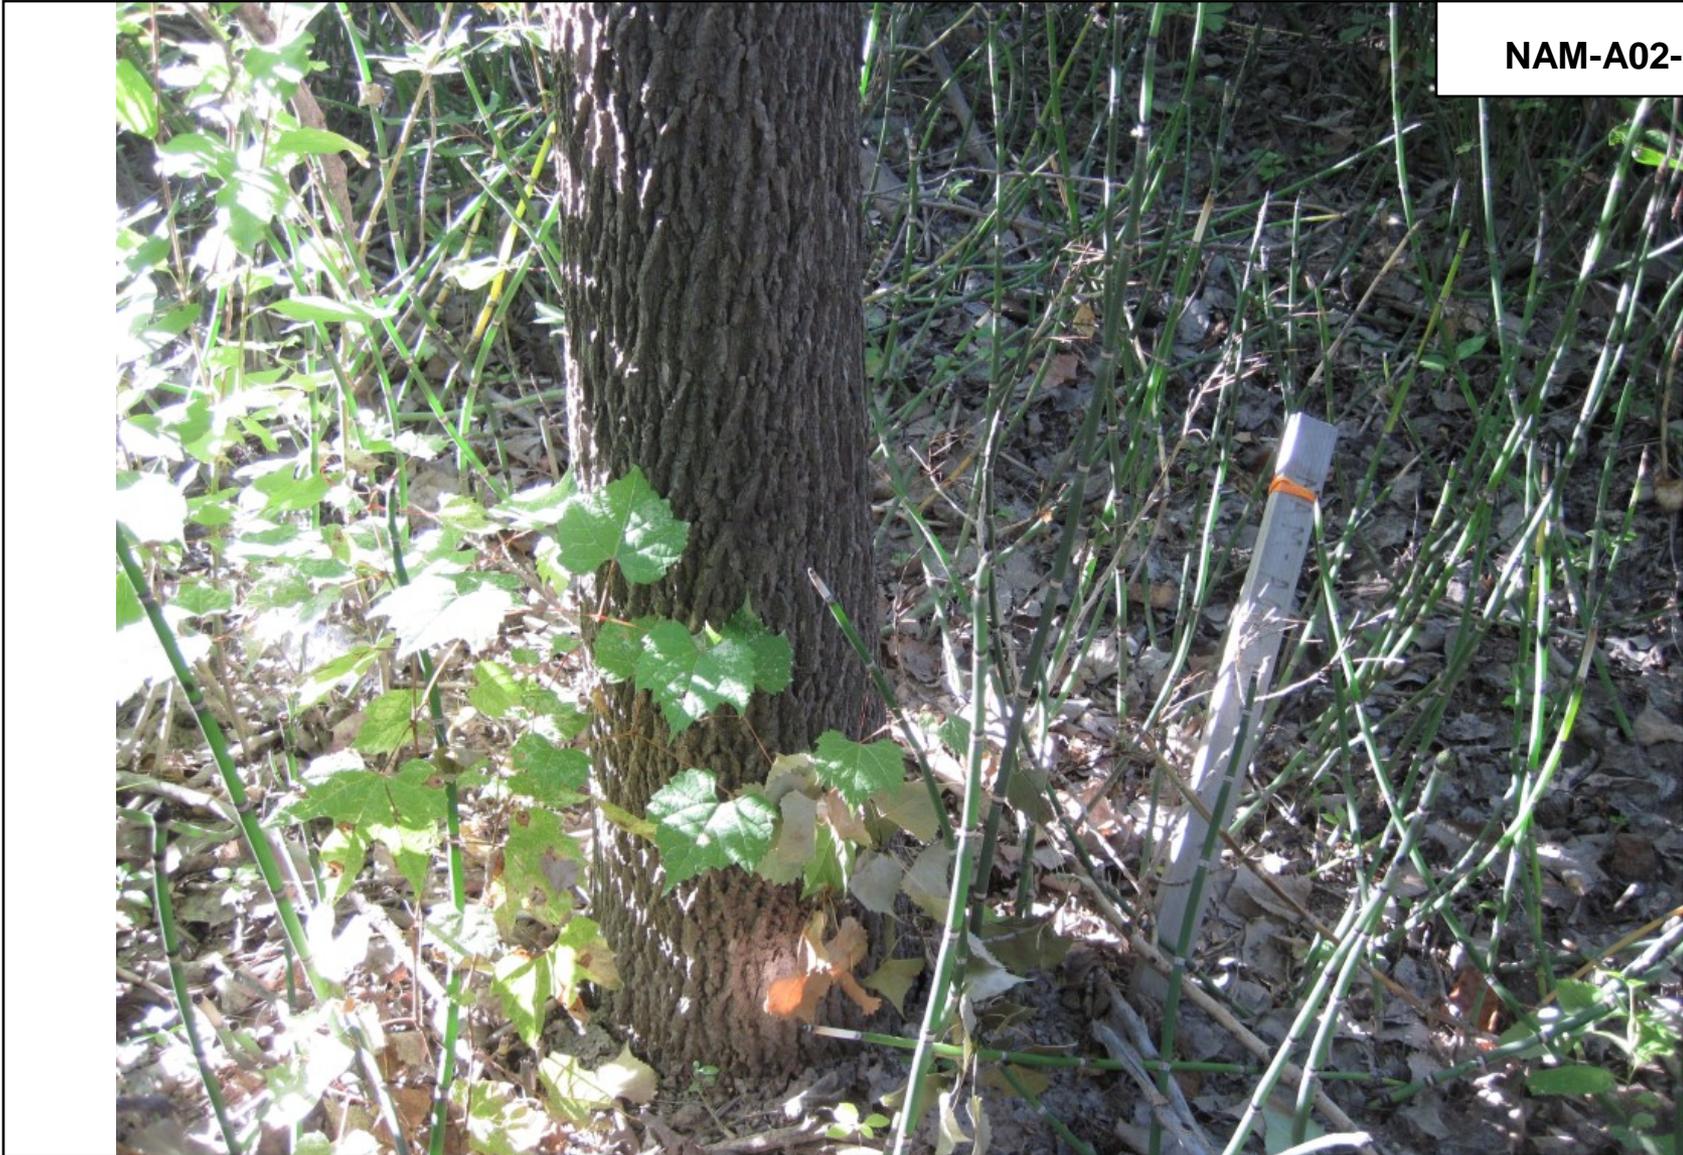
**NAM-A02-RB-1**

<b>4B OILED VEGETATION TYPE</b> <i>write "COAT" or "STAIN" as appropriate</i>				
leaves ___ bark <input checked="" type="checkbox"/> stems ___ willows ___				
logs ___ grasses ___ Other: _____				
<b>5 PHOTOGRAPH</b>				
Photo Number: <u>1625</u>	Direction Photo Taken: <u>162°</u>			
Height above ground (inches): <u>41</u>				
<b>6 COMMENTS</b>				
<p><u>Natural attenuation is apparent</u>                      <u>Stake retrieved</u></p>				
<b>7 SKETCH</b> <i>tripod setup in relation to nearby features, trees, rocks, water bodies, parcel boundaries</i>

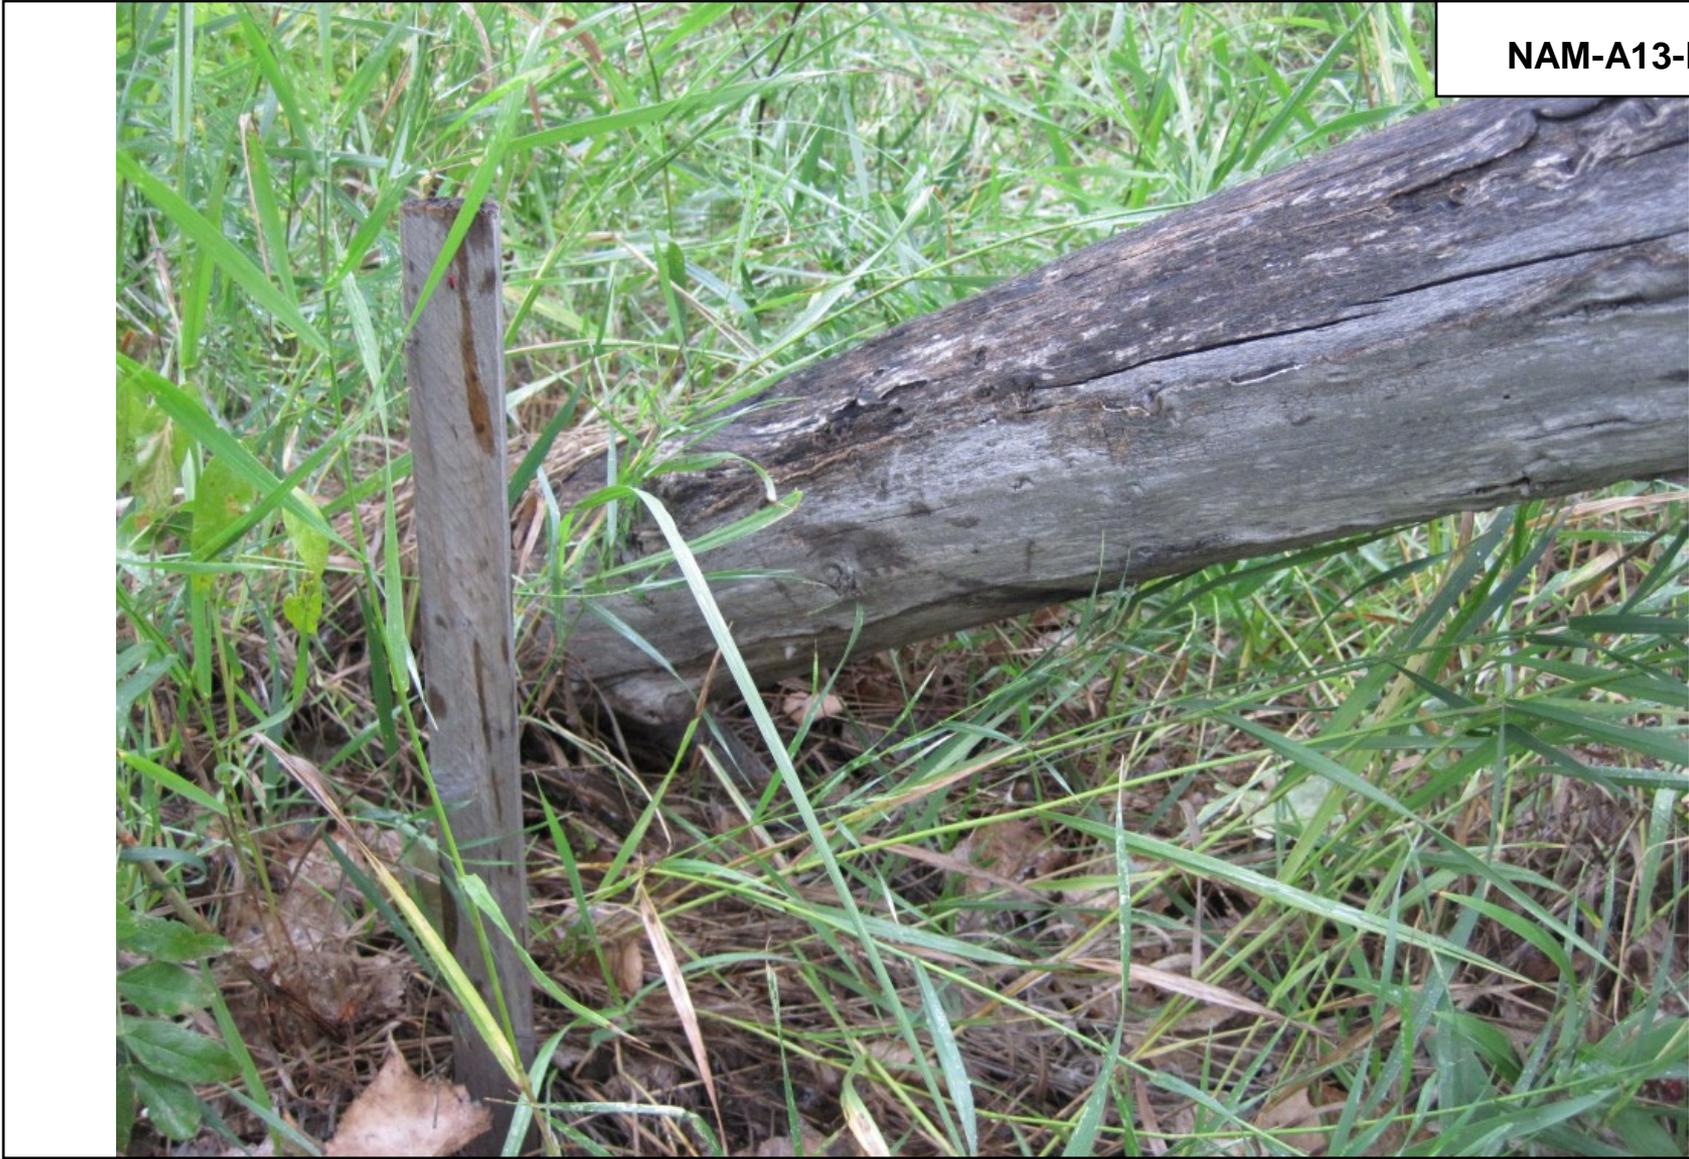
**NAM-A13-LB-1**

logs <input checked="" type="checkbox"/> grasses _____ Other: _____				
<b>5 PHOTOGRAPH</b>				
Photo Number:	<u>1039</u>	Direction Photo Taken:		
Height above ground (inches):	<u>41</u>	<u>351</u>		
<b>6 COMMENTS</b>				
<p>Natural Attenuation is apparent</p> <p style="text-align: right;">Stake recovered</p>				
<b>7 SKETCH</b> <i>tripod setup in relation to nearby features, trees, rocks, water bodies, parcel boundaries</i>				
Sketch area

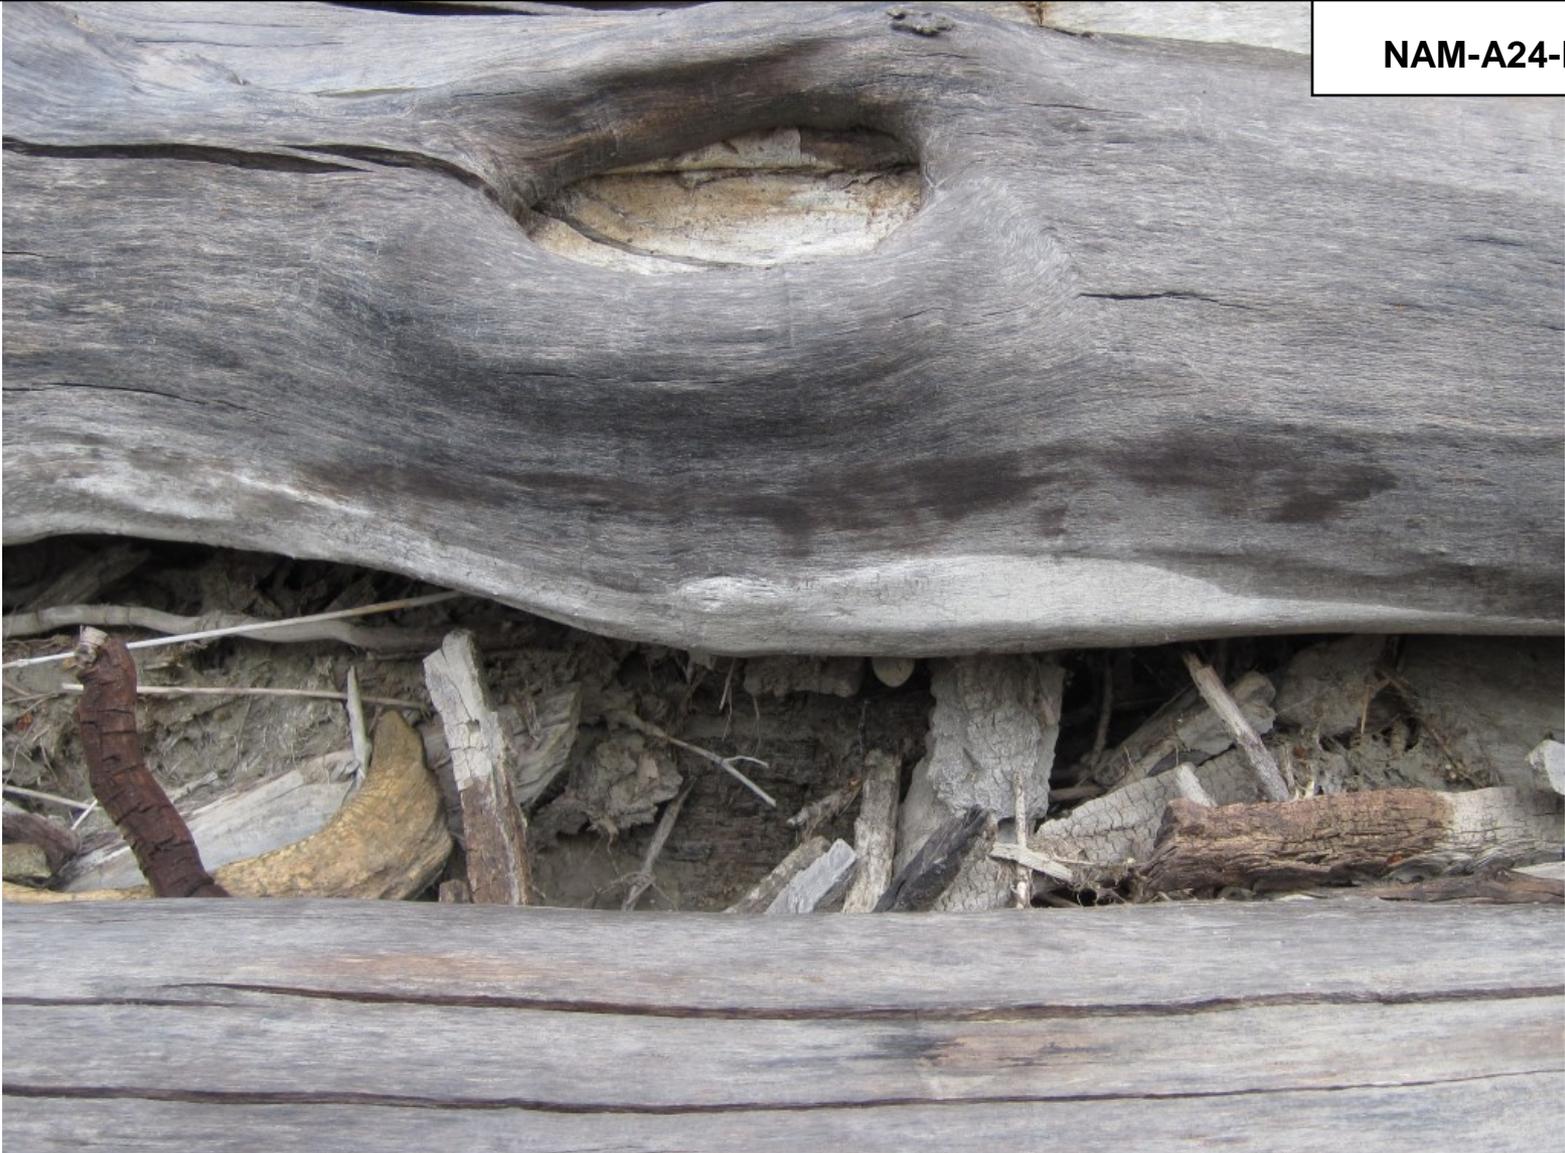
**NAM-A24-LB-1**

logs dark & wet

Natural Attenuation is apparent

Stake recovered

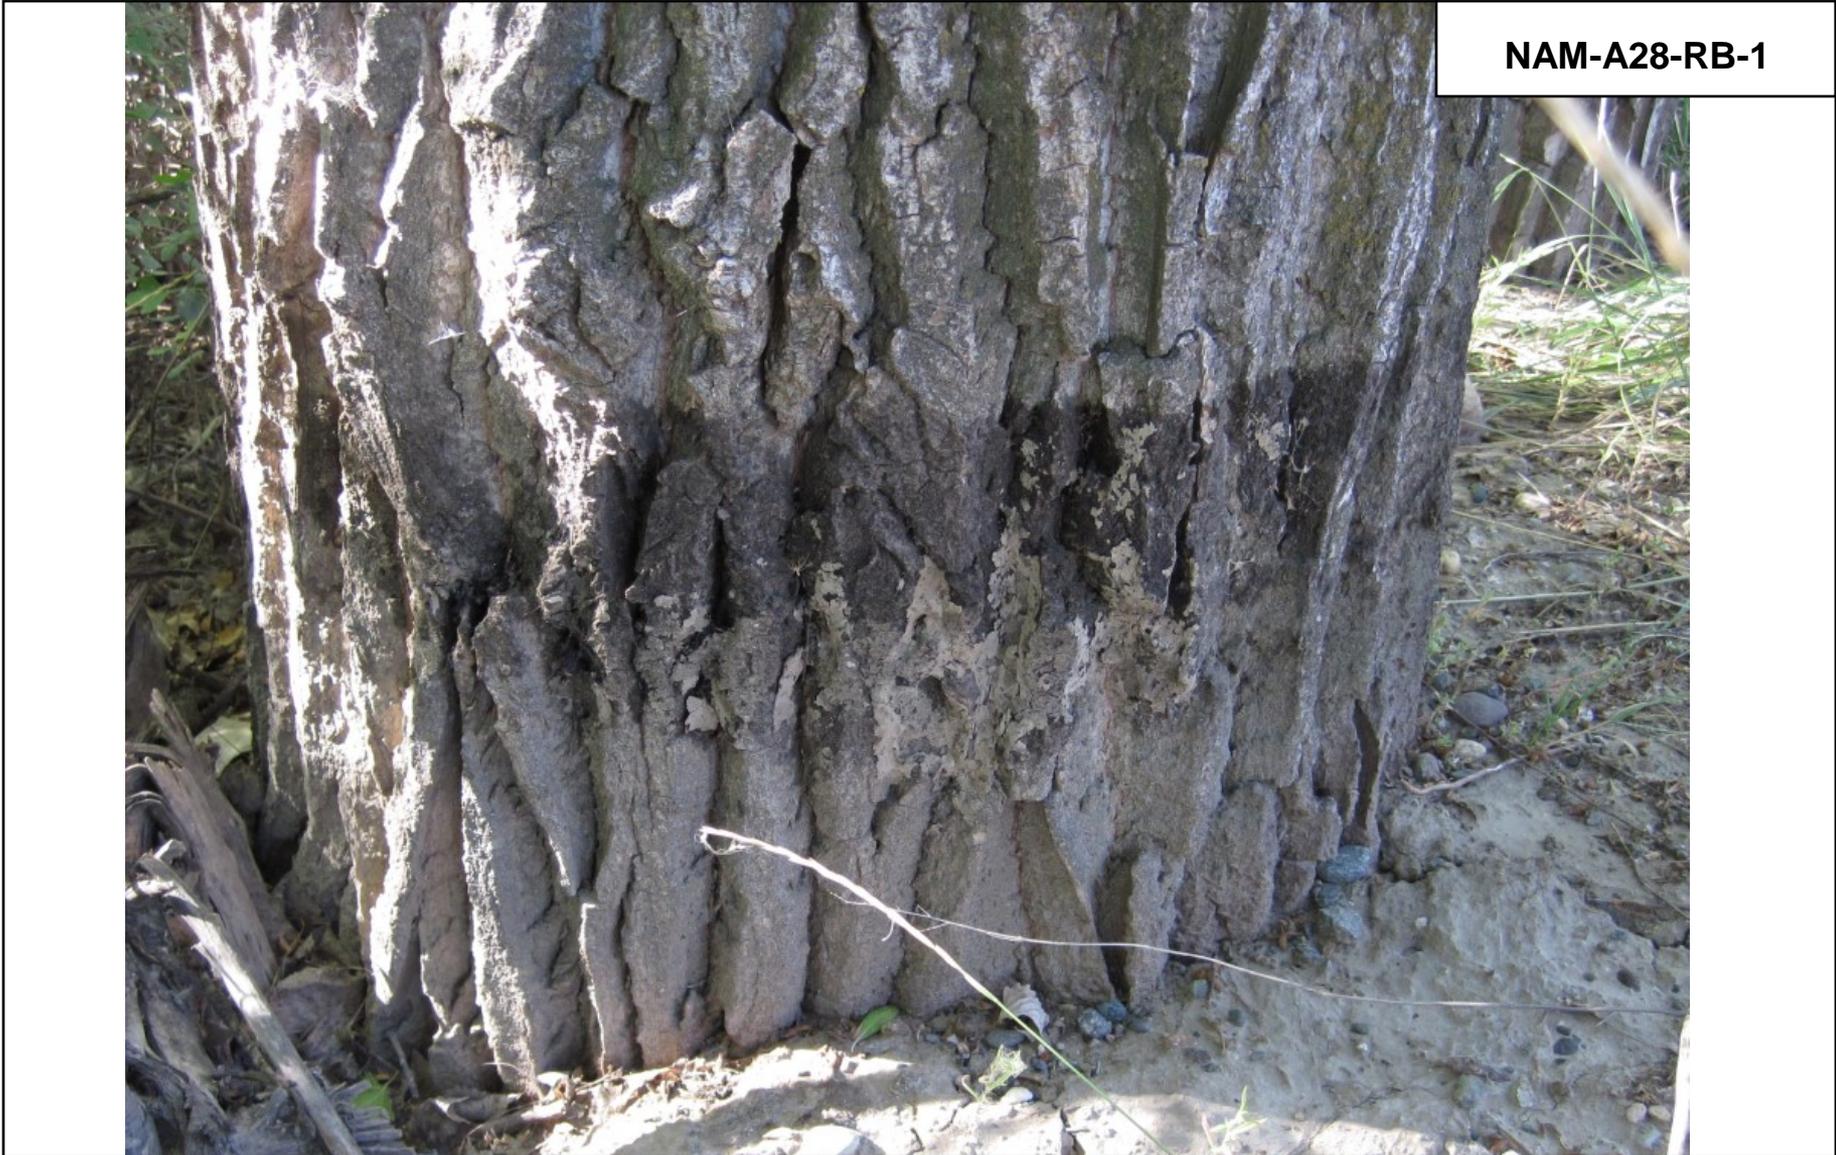
**NAM-A28-RB-1**

<b>4B OILED VEGETATION TYPE</b> <i>write "COAT" or "STAIN" as appropriate</i>				
leaves _____ bark <input checked="" type="checkbox"/> stems _____ willows _____				
logs _____ grasses _____ Other: _____				
<b>5 PHOTOGRAPH</b>				
Photo Number:	<u>1629</u>	Direction Photo Taken:	<u>213</u>	
Height above ground (inches):	<u>4</u>			
<b>6 COMMENTS</b>				
<u>No stake present</u>				
<b>7 SKETCH</b> <i>tripod setup in relation to nearby features, trees, rocks, water bodies, parcel boundaries</i>

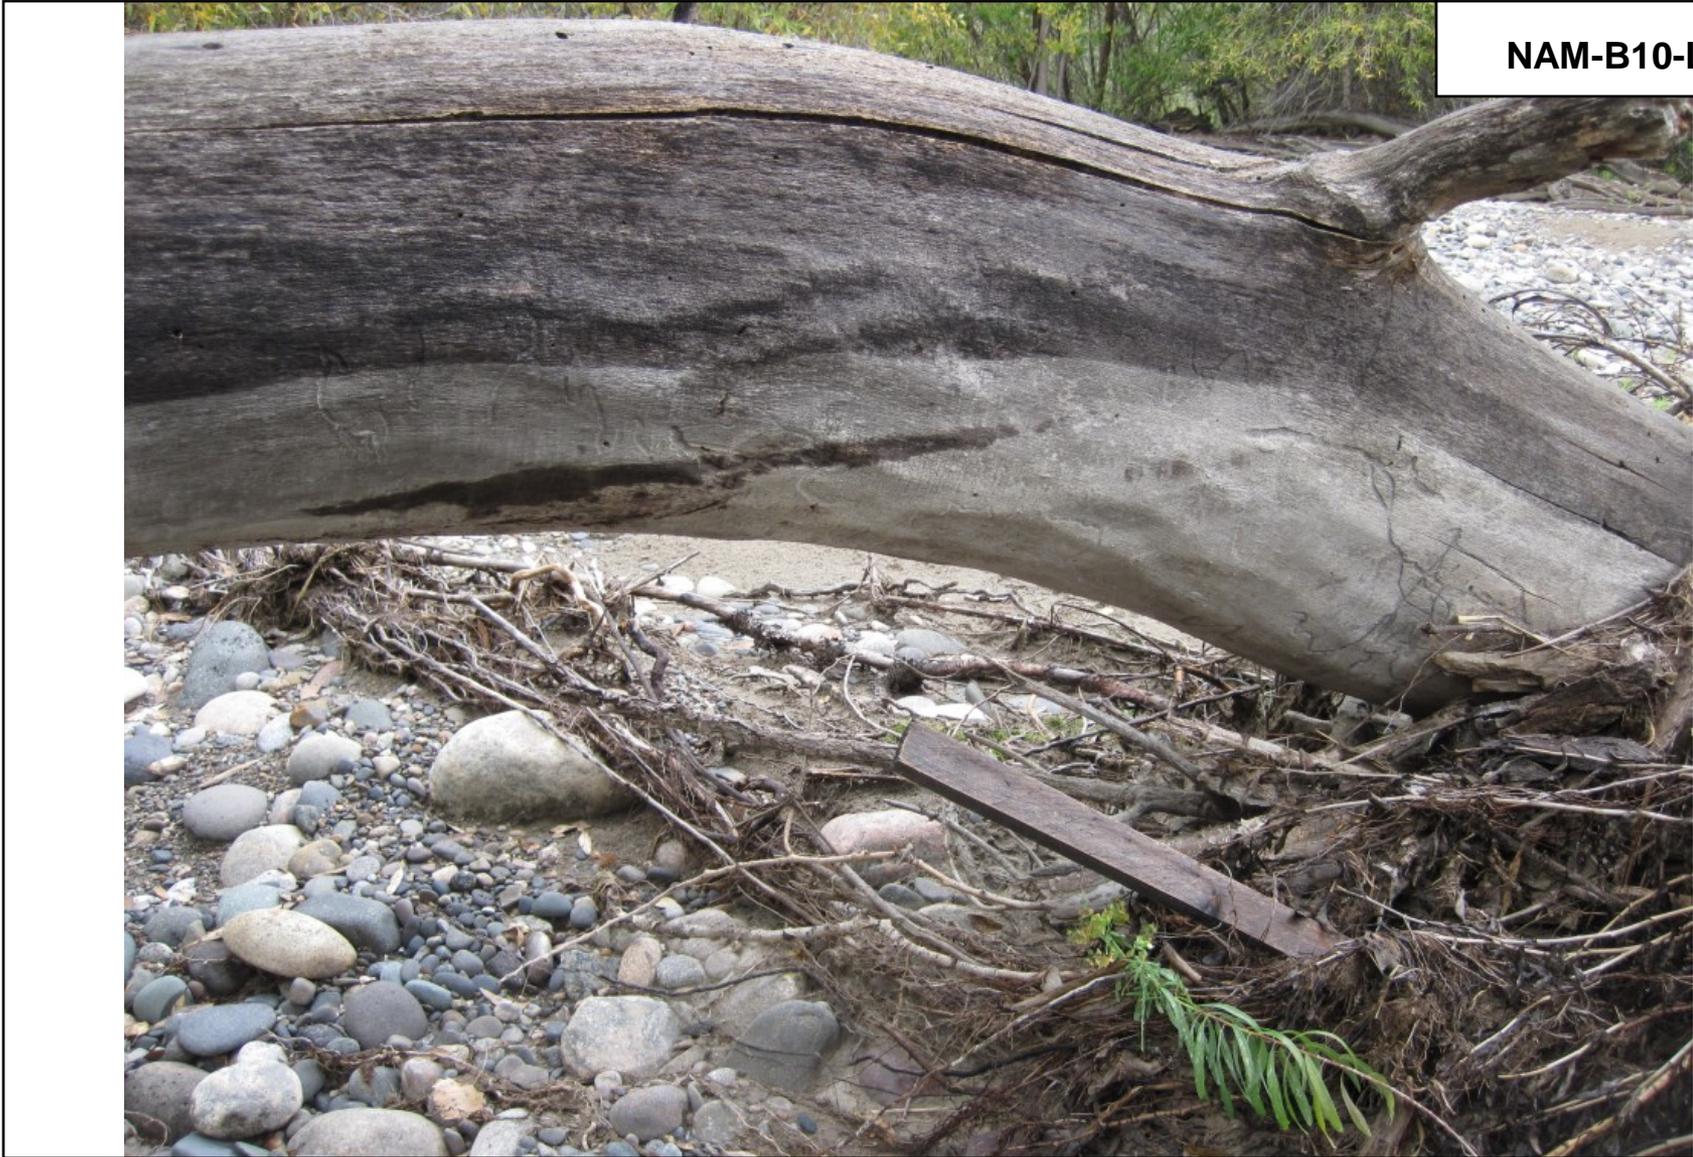
**NAM-B10-LB-1**

<b>4B OILED VEGETATION TYPE</b> <i>write "COAT" or "STAIN" as appropriate</i>				
leaves _____ bark _____ stems _____ willows _____				
logs <input checked="" type="checkbox"/> grasses _____ Other: _____				
<b>5 PHOTOGRAPH</b>				
Photo Number:		Direction Photo Taken: <u>335</u>		
Height above ground (inches): <u>2'</u>				
<b>6 COMMENTS</b>				
<p>Natural Attenuation Apparent</p> <p style="text-align: right;">Stake recovered</p>				
<b>7 SKETCH</b> <i>tripod setup in relation to nearby features, trees, rocks, water bodies, parcel boundaries</i>

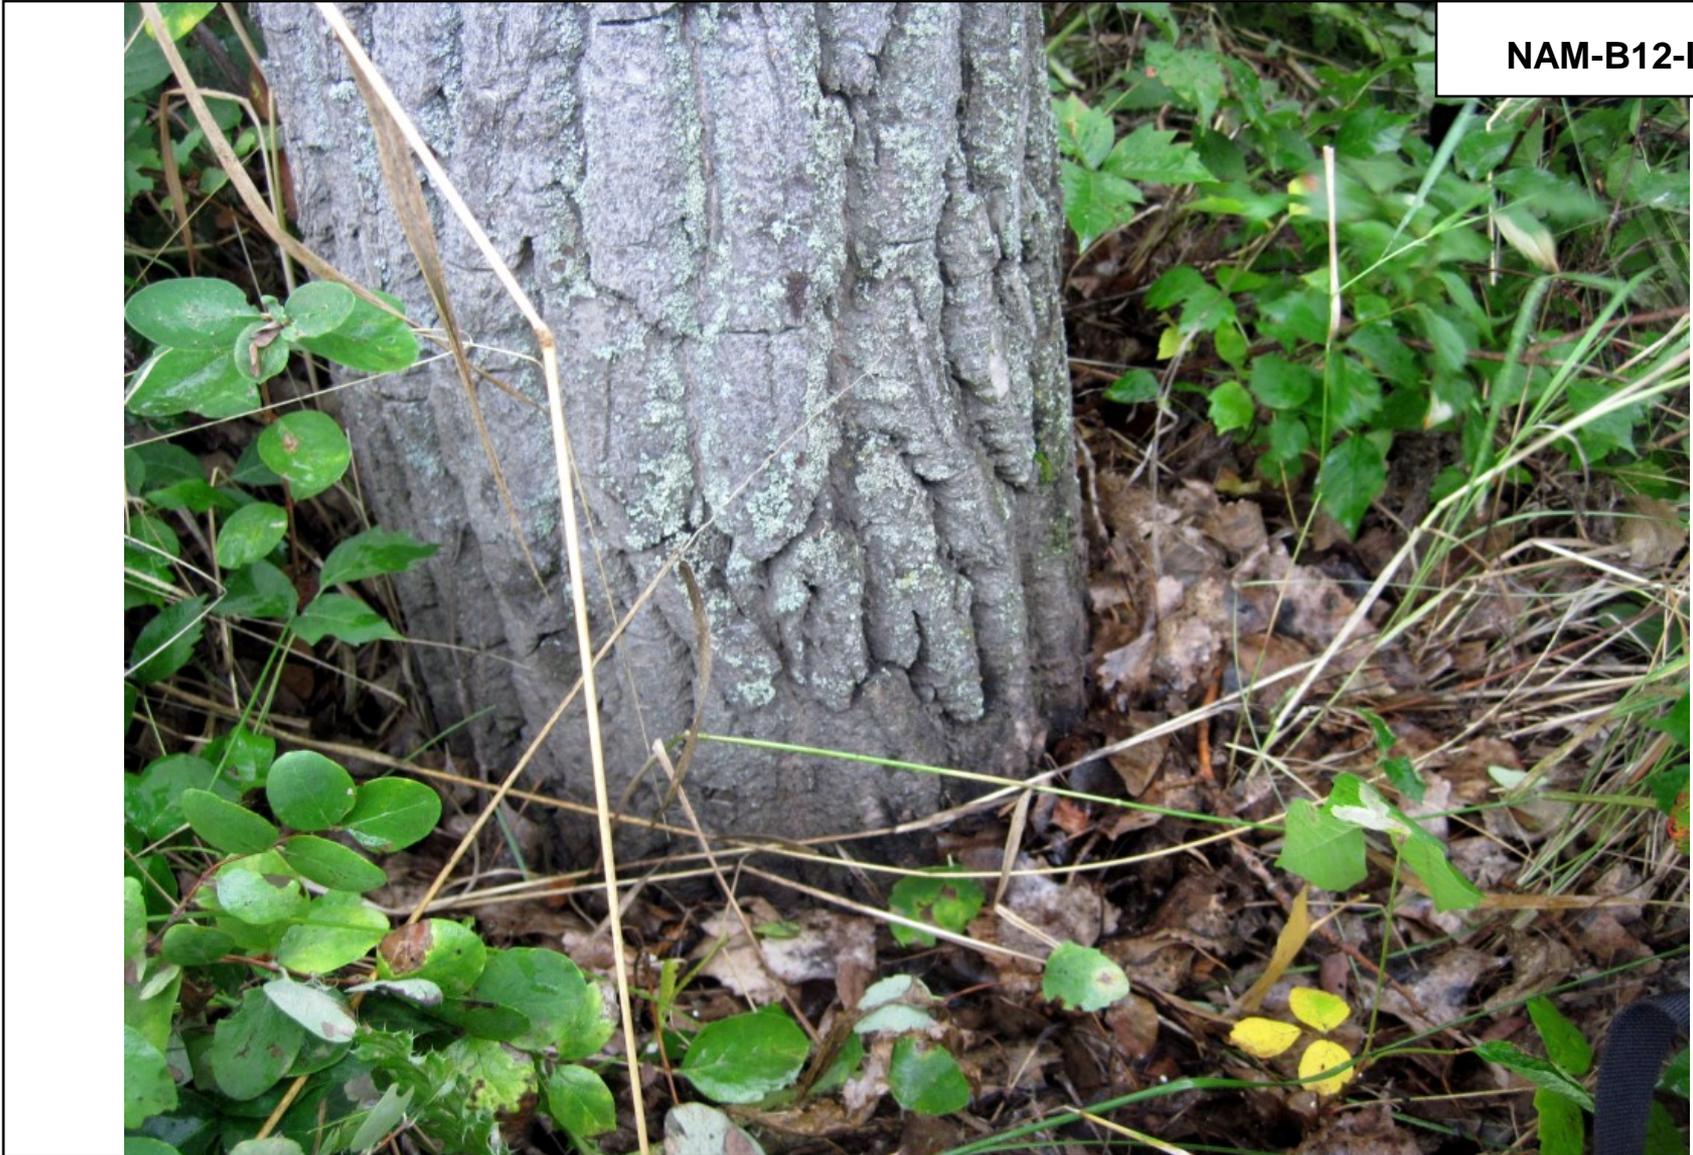
**NAM-B12-LB-1**

leaves ___ bark <input checked="" type="checkbox"/> stems ___ willows ___				
logs ___ grasses ___ Other: ___				
<b>5 PHOTOGRAPH</b>				
Photo Number:		Direction Photo Taken: <u>252</u>		
Height above ground (inches): <u>41</u>				
<b>6 COMMENTS</b>				
<p>No staining observed</p> <p style="text-align: right;">No stake</p>				
<b>7 SKETCH</b> <i>tripod setup in relation to nearby features, trees, rocks, water bodies, parcel boundaries</i>				
Empty sketch area

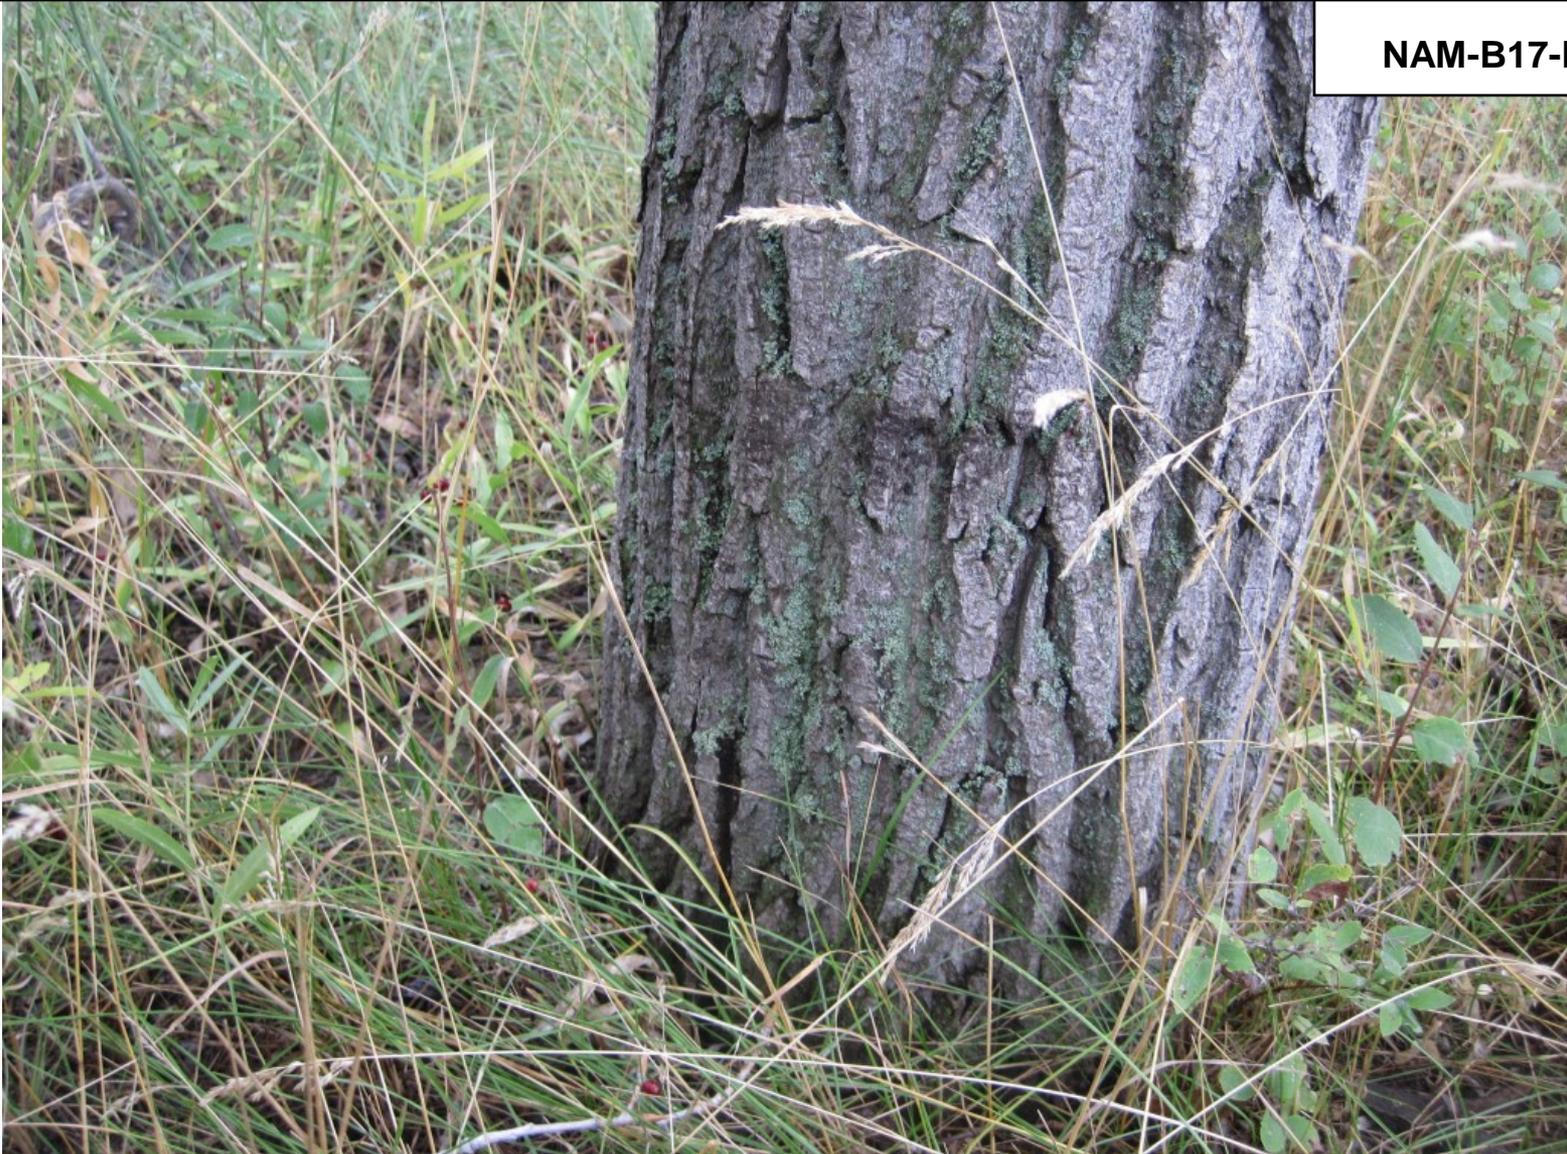
**NAM-B17-RB-1**

leaves _____ bark <input checked="" type="checkbox"/> stems _____ willows _____				
logs _____ grasses _____ Other: _____				
<b>5 PHOTOGRAPH</b>				
Photo Number:		Direction Photo Taken: 170		
Height above ground (inches): 4'				
<b>6 COMMENTS</b>				
<p>Natural attenuation is apparent</p> <p style="text-align: right;">Stake recovered</p>				
<b>7 SKETCH</b> <i>tripod setup in relation to nearby features, trees, rocks, water bodies, parcel boundaries</i>

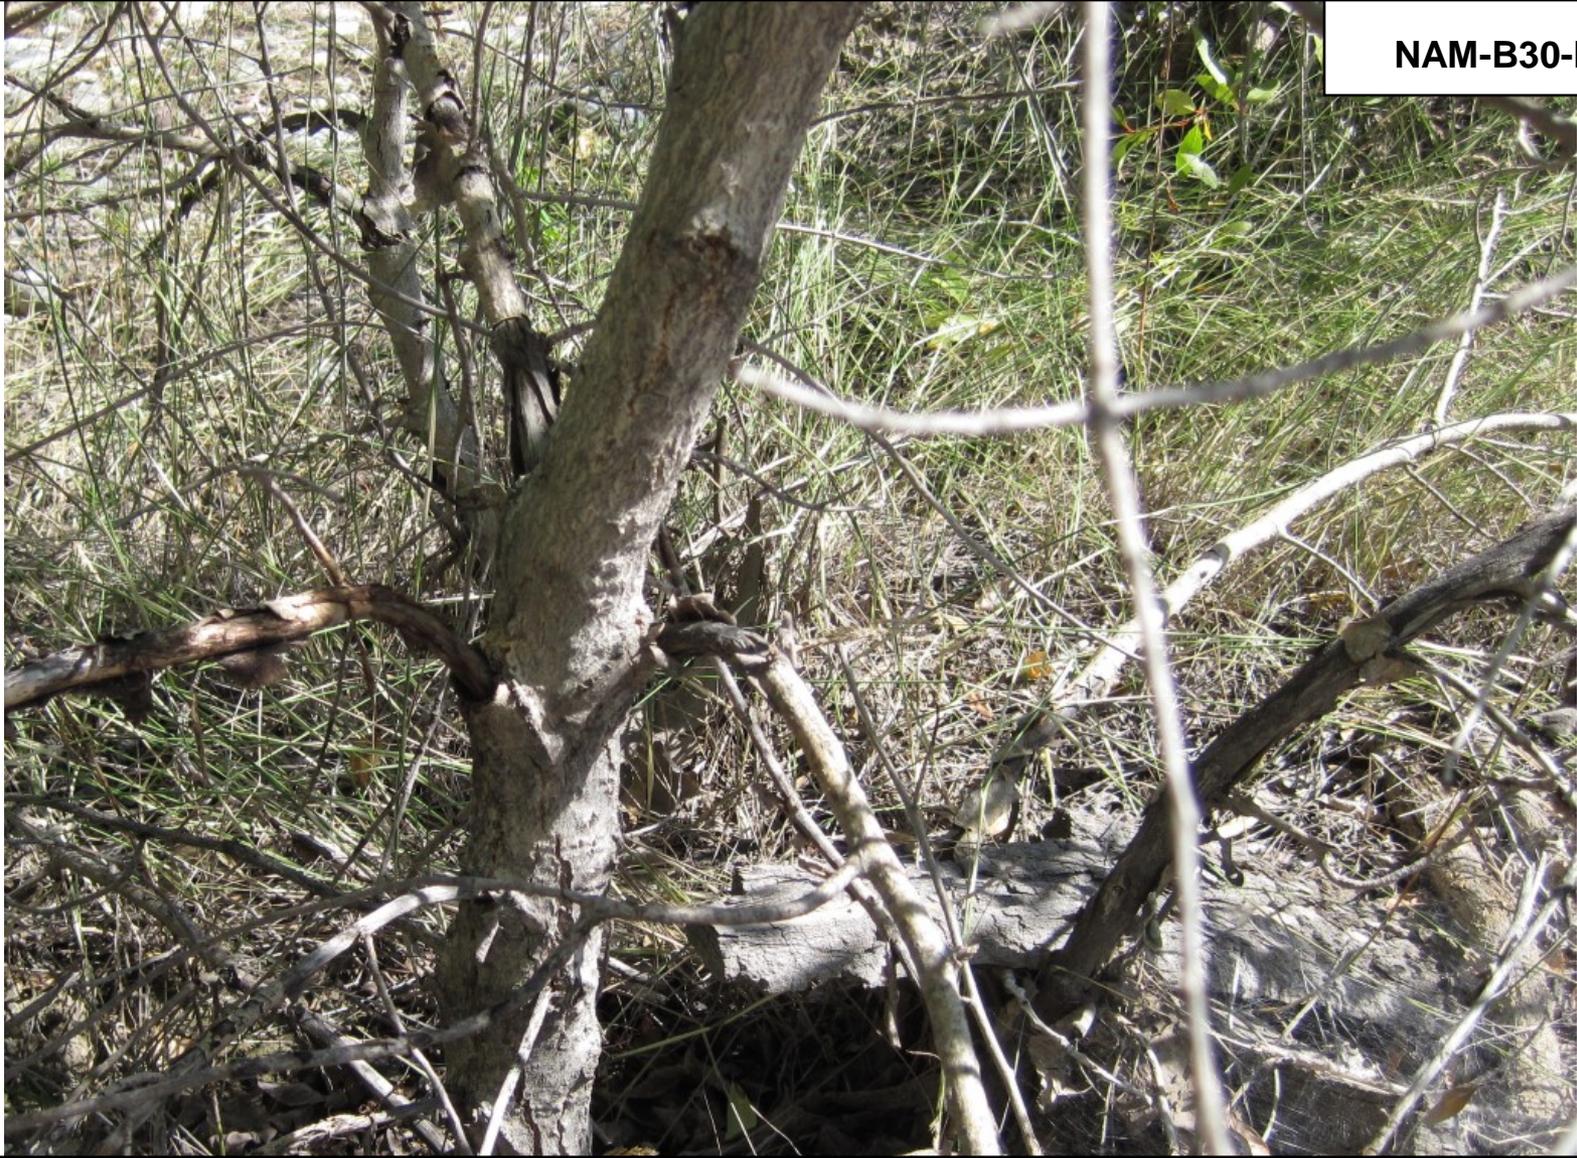
**NAM-B30-LB-1**

45.73985 -108.523726				
No staining observed				
No stake				
<b>7 SKETCH</b> <i>tripod setup in relation to nearby features, trees, rocks, water bodies, parcel boundaries</i>

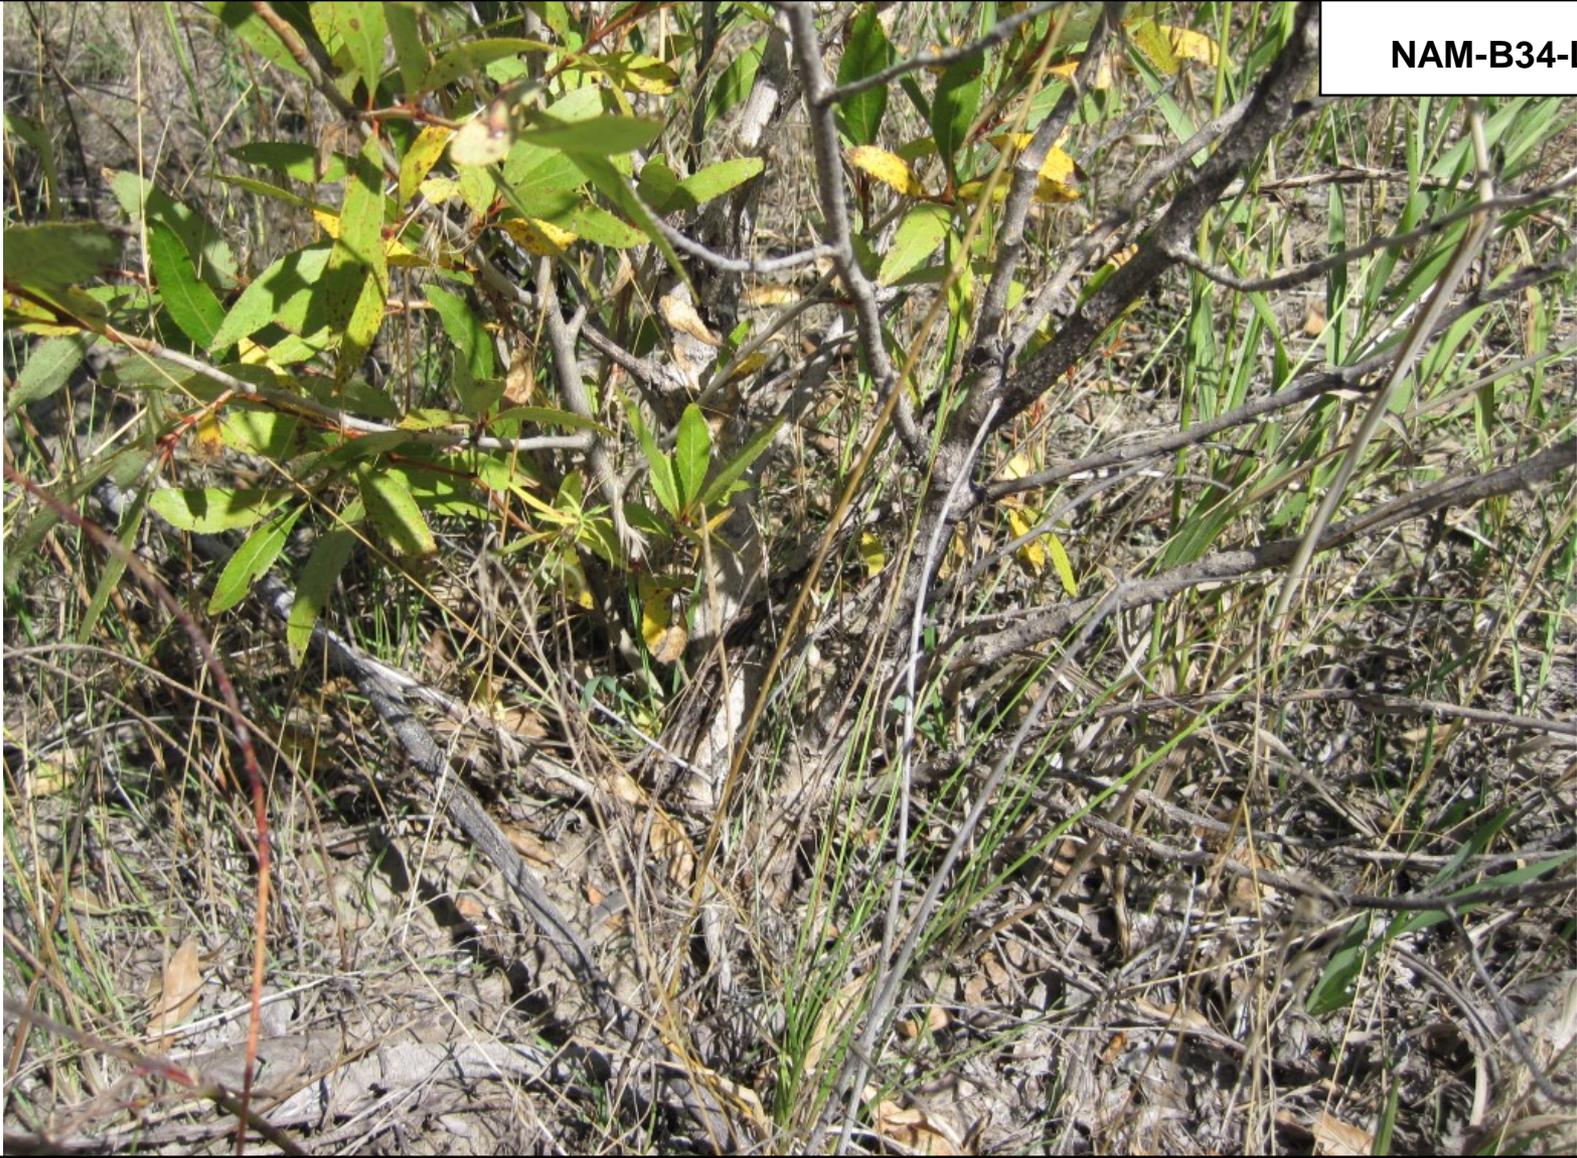
**NAM-B34-LB-1**

leaves _____ bark <input checked="" type="checkbox"/> stems <input checked="" type="checkbox"/> willows _____				
logs _____ grasses _____ Other: _____				
<b>5 PHOTOGRAPH</b>		Photo Number: _____ Direction Photo Taken: <u>068</u>		
Height above ground (inches): <u>41</u>				
<b>6 COMMENTS</b>		<p style="text-align: center;">45.747527 -108.504568</p> <p>No stains observed</p> <p style="text-align: right;">Stake recovered</p>		
<b>7 SKETCH</b>		tripod setup in relation to nearby features, trees, rocks, water bodies, parcel boundaries

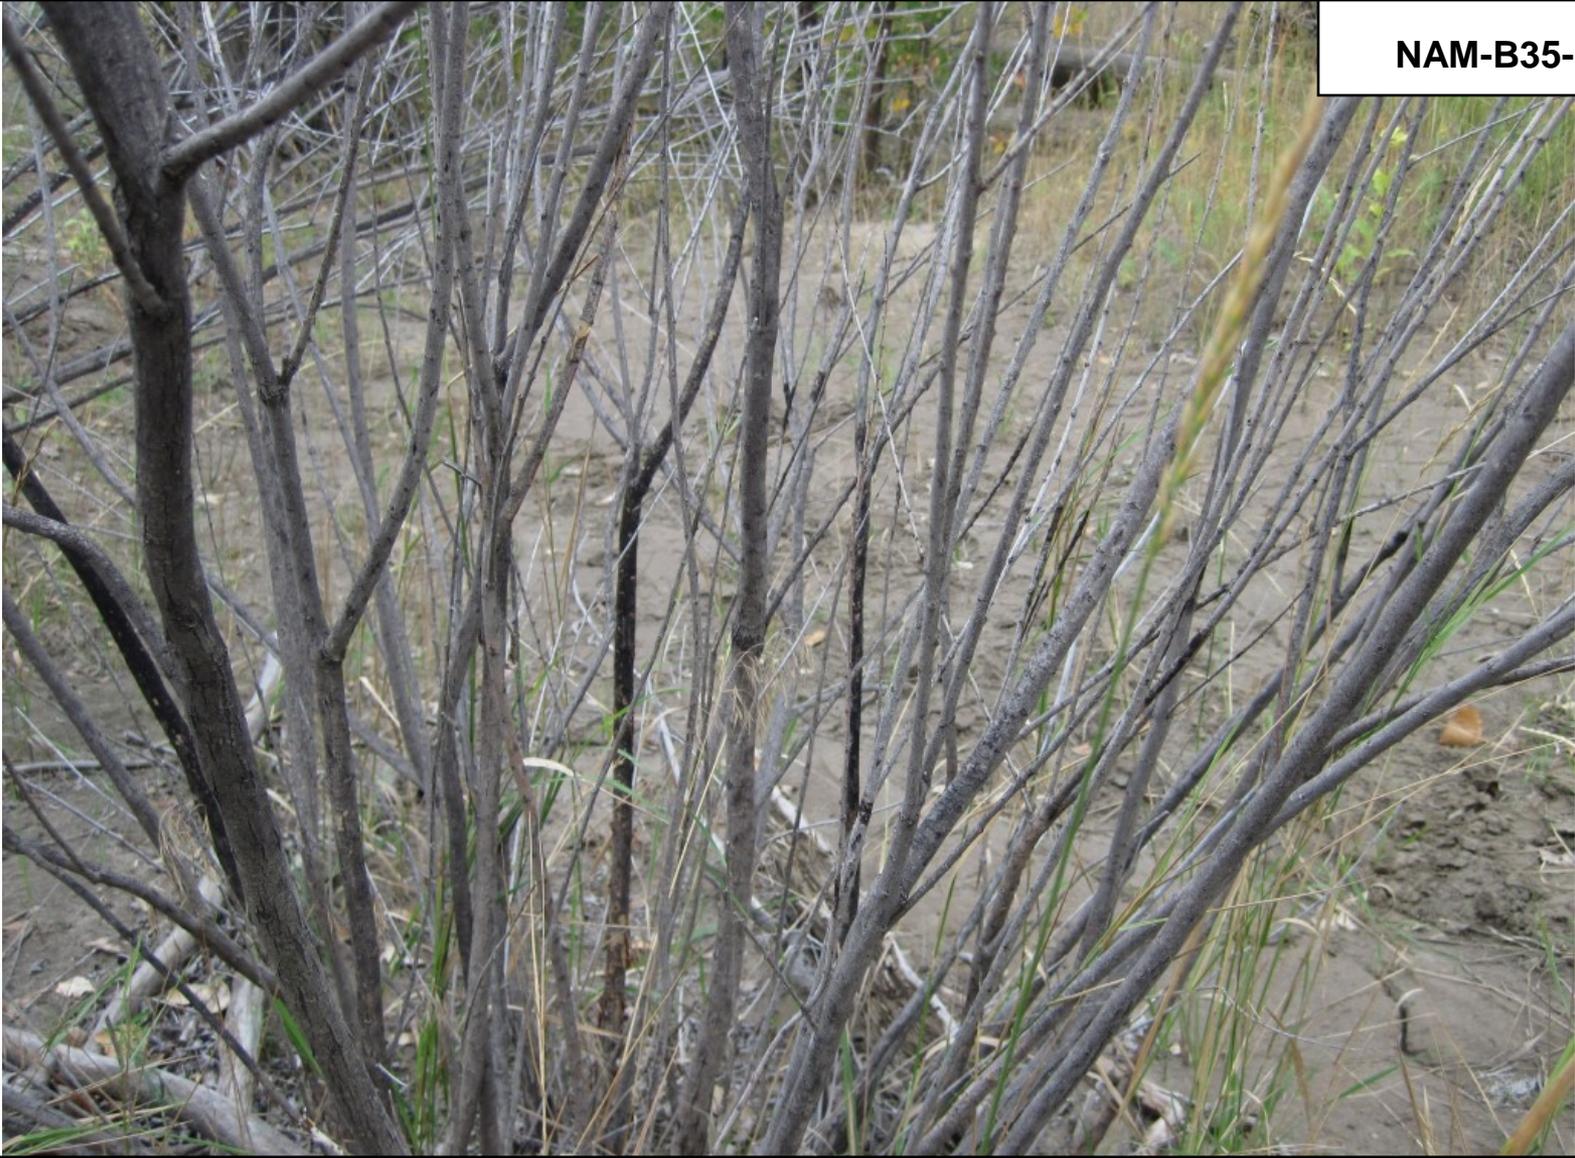
**NAM-B35-IS-1**

<b>5 PHOTOGRAPH</b>				
Photo Number:		Direction Photo Taken: 045		
Height above ground (inches): 41				
<b>6 COMMENTS</b>				
<p>natural attenuation is apparent</p> <p style="text-align: right;">no stake, flagging recommended</p>				
<b>7 SKETCH</b> tripod setup in relation to nearby features, trees, rocks, water bodies, parcel boundaries

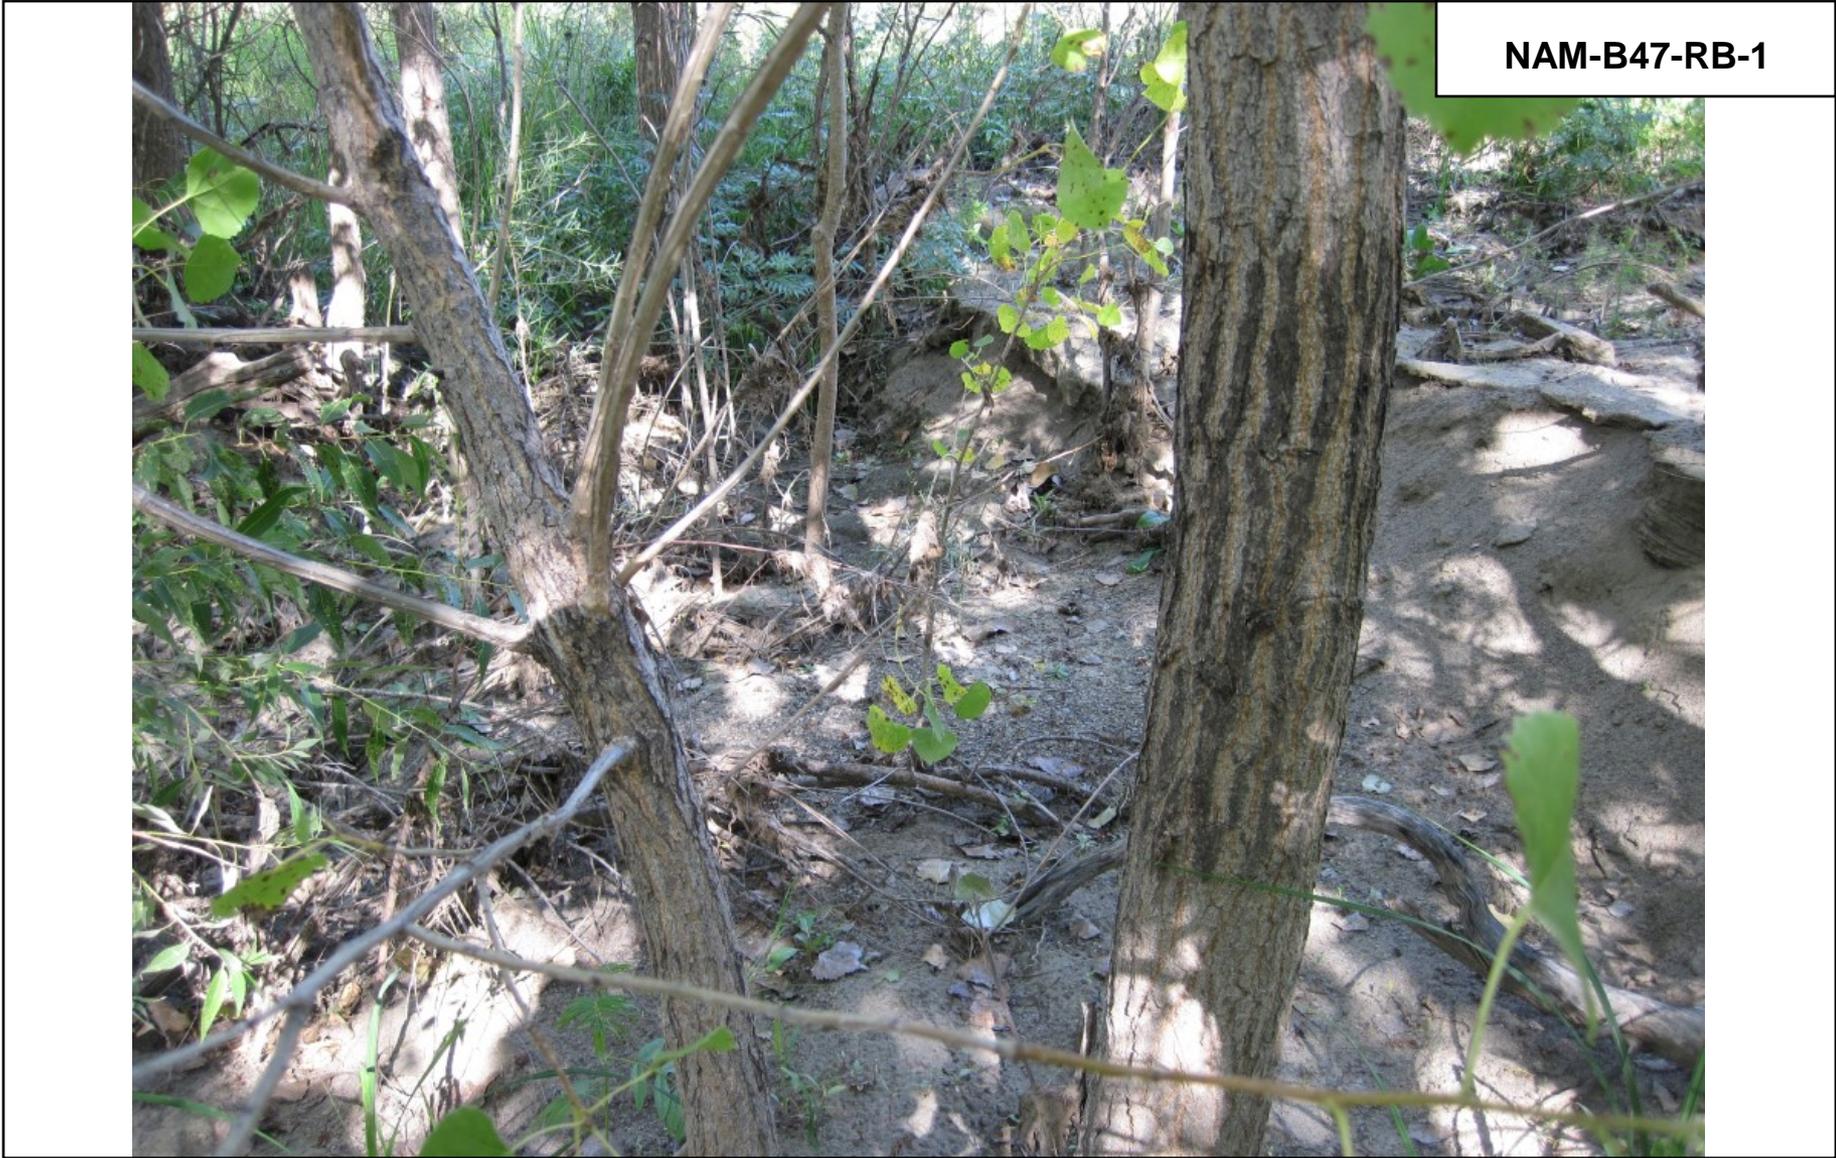
**NAM-B47-RB-1**

leaves _____ bark <input checked="" type="checkbox"/> stems _____ willows _____				
logs _____ grasses _____ Other: _____				
<b>5 PHOTOGRAPH</b>				
Photo Number:		Direction Photo Taken: <u>312</u>		
Height above ground (inches): <u>4'</u>				
<b>6 COMMENTS</b>				
<p>Twig with small coat observed, no other oil stains observed</p> <p>No stake</p>				
<b>7 SKETCH</b> <i>tripod setup in relation to nearby features, trees, rocks, water bodies, parcel boundaries</i>				
Empty sketch area
