Re: Submittal of Final Natural Attenuation Monitoring Report  
Docket No. WQA-12-08  
Silvertip Pipeline Incident Response  
Laurel, Montana

**Final Natural Attenuation  
Monitoring Report**

Silvertip Pipeline Incident Response  
Laurel, Montana

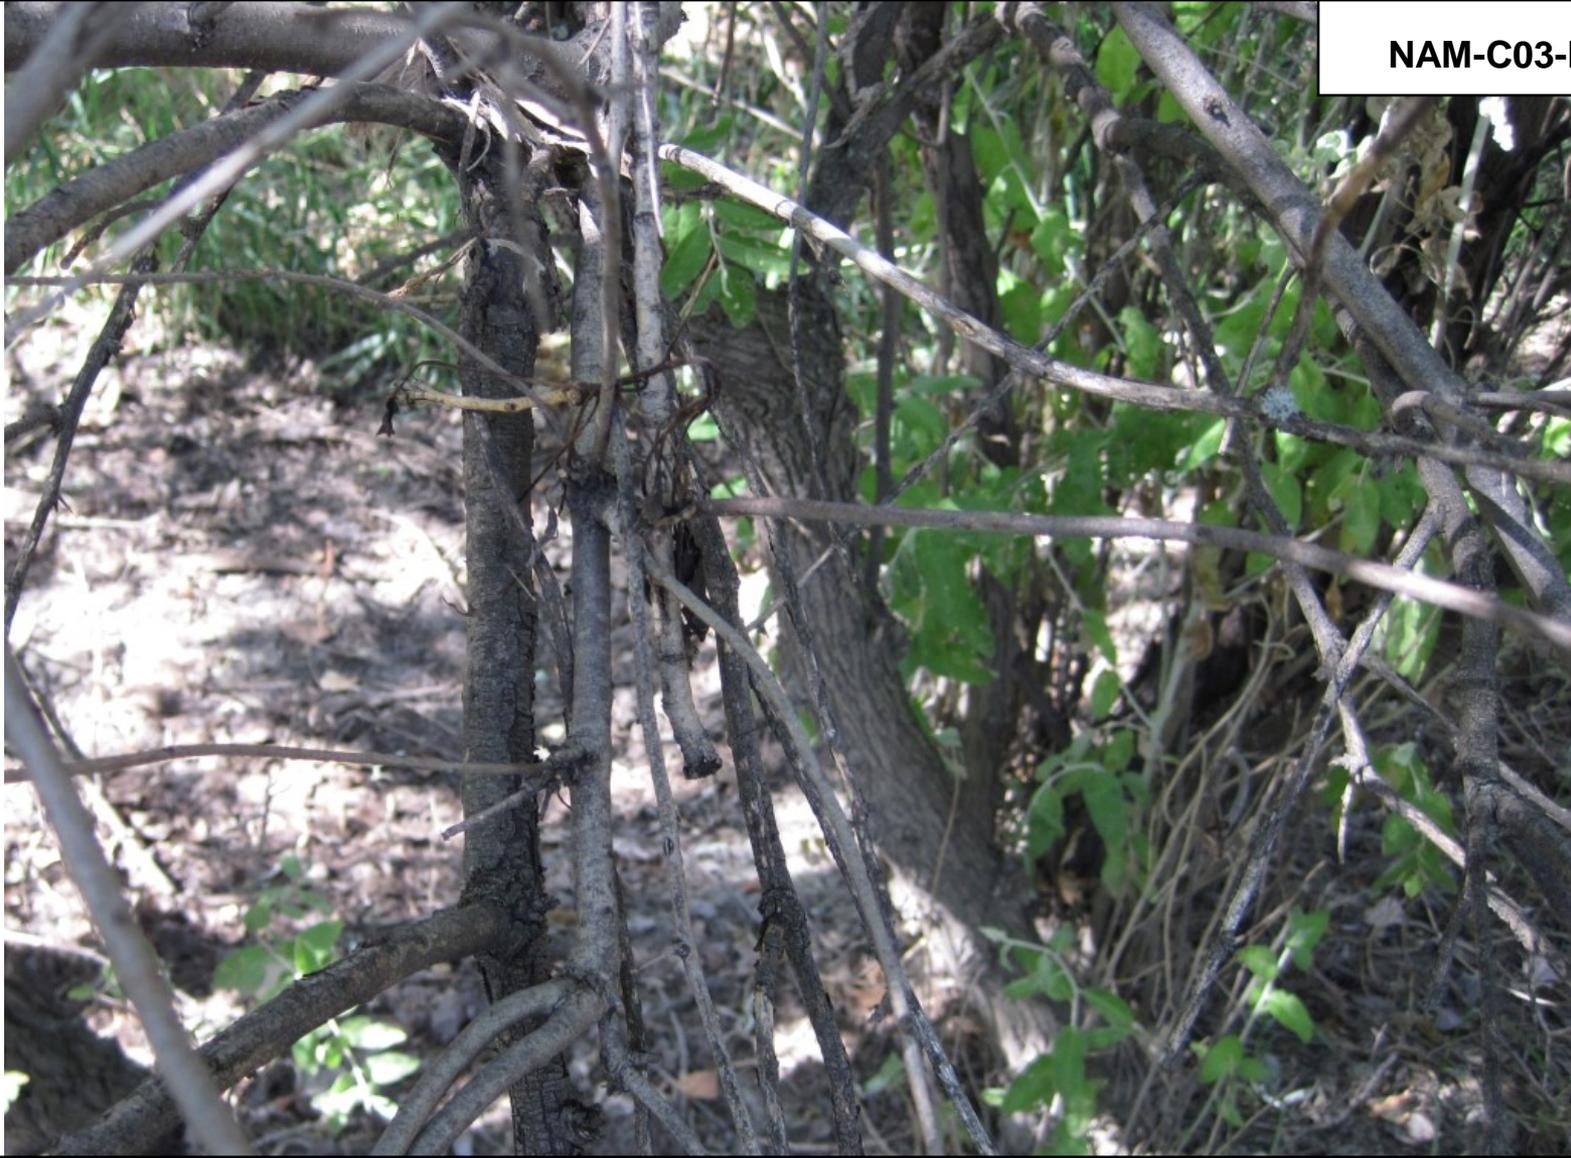
**NAM-C03-LB-1**

logs _____ grasses _____ Other: _____				
<b>5 PHOTOGRAPH</b>				
Photo Number:		Direction Photo Taken: 300		
Height above ground (inches): 2'				
<b>6 COMMENTS</b>				
<p>Mild staining observed</p> <p style="text-align: right;">Stake retrieved</p>				
<b>7 SKETCH</b> <i>tripod setup in relation to nearby features, trees, rocks, water bodies, parcel boundaries</i>
