Subject:
Reclamation Summary Report
Silvertip Pipeline Incident, Laurel, Montana

Reclamation Summary Report

Silvertip Pipeline Incident
Laurel, Montana

November 21, 2011

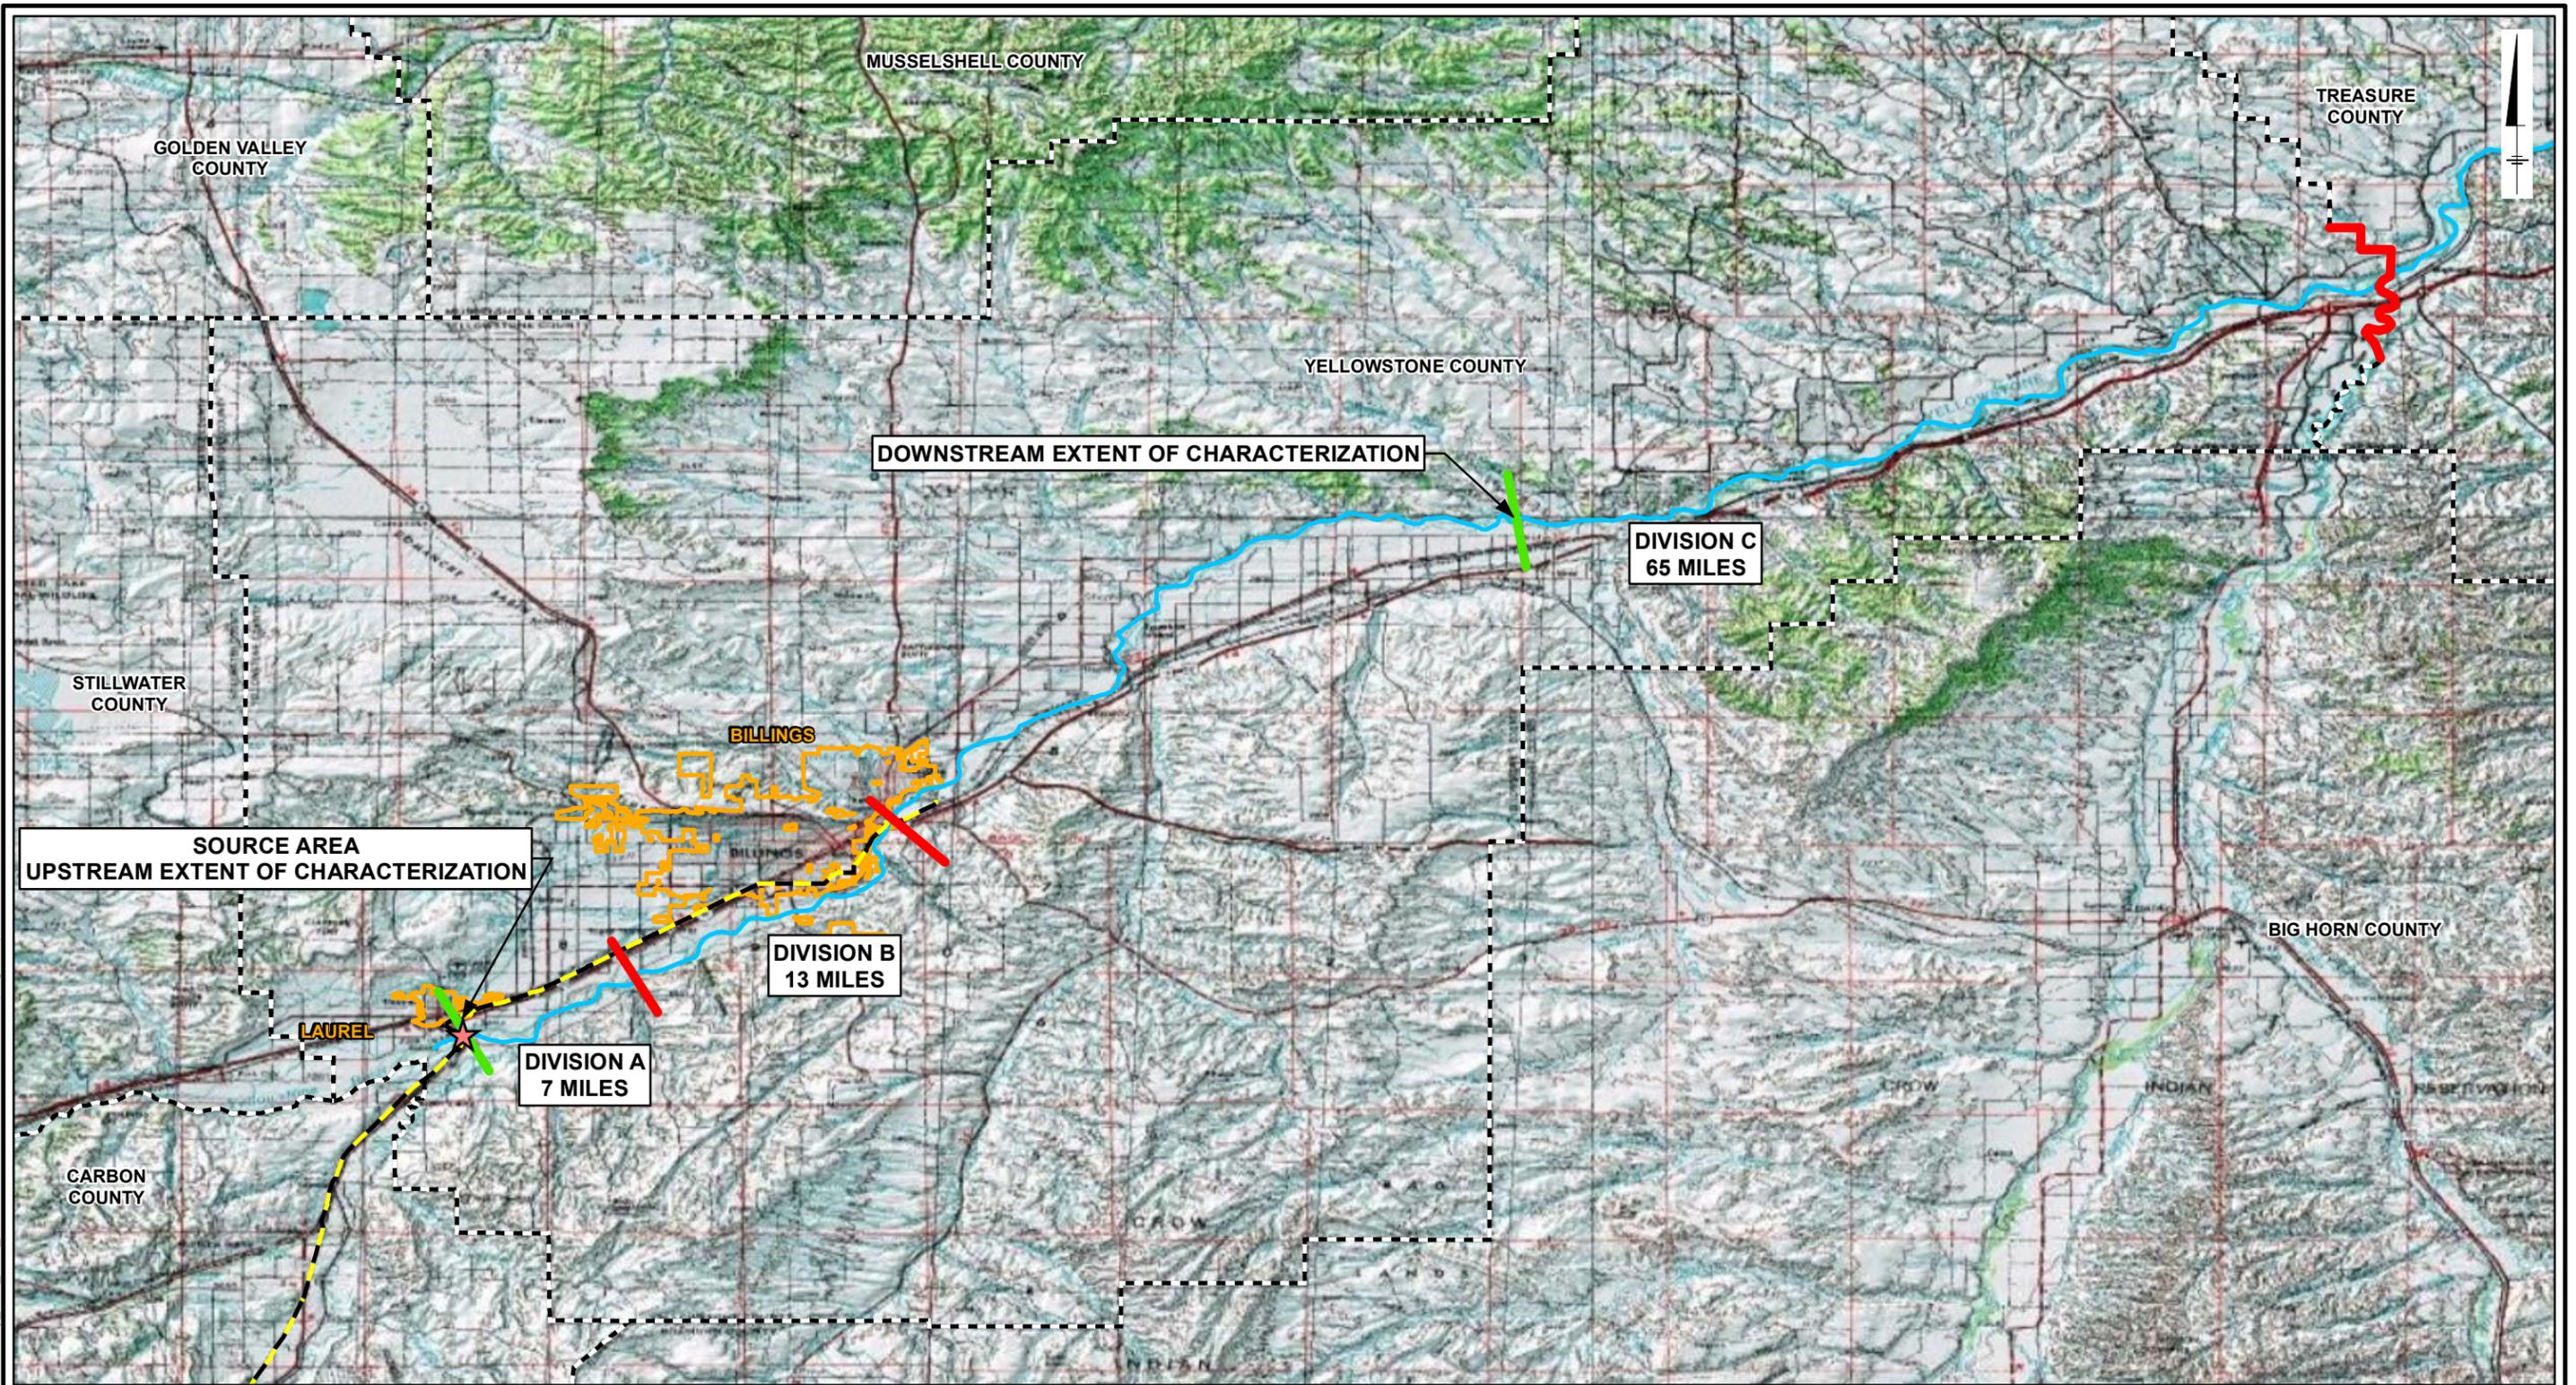
2

SILVERTIP PIPELINE INCIDENT
 RECLAMATION SUMMARY REPORT
**YELLOWSTONE RIVER RECLAMATION
 CHARACTERIZATION AREA**

A map of the divisions included in the Yellowstone River Study Area is shown in Figure 2. This section summarizes the methods used for characterizing potentially impacted vegetation habitats, evaluating the extent of vegetation disturbance, and identifying the applicable reclamation strategies to address disturbed vegetated habitats.

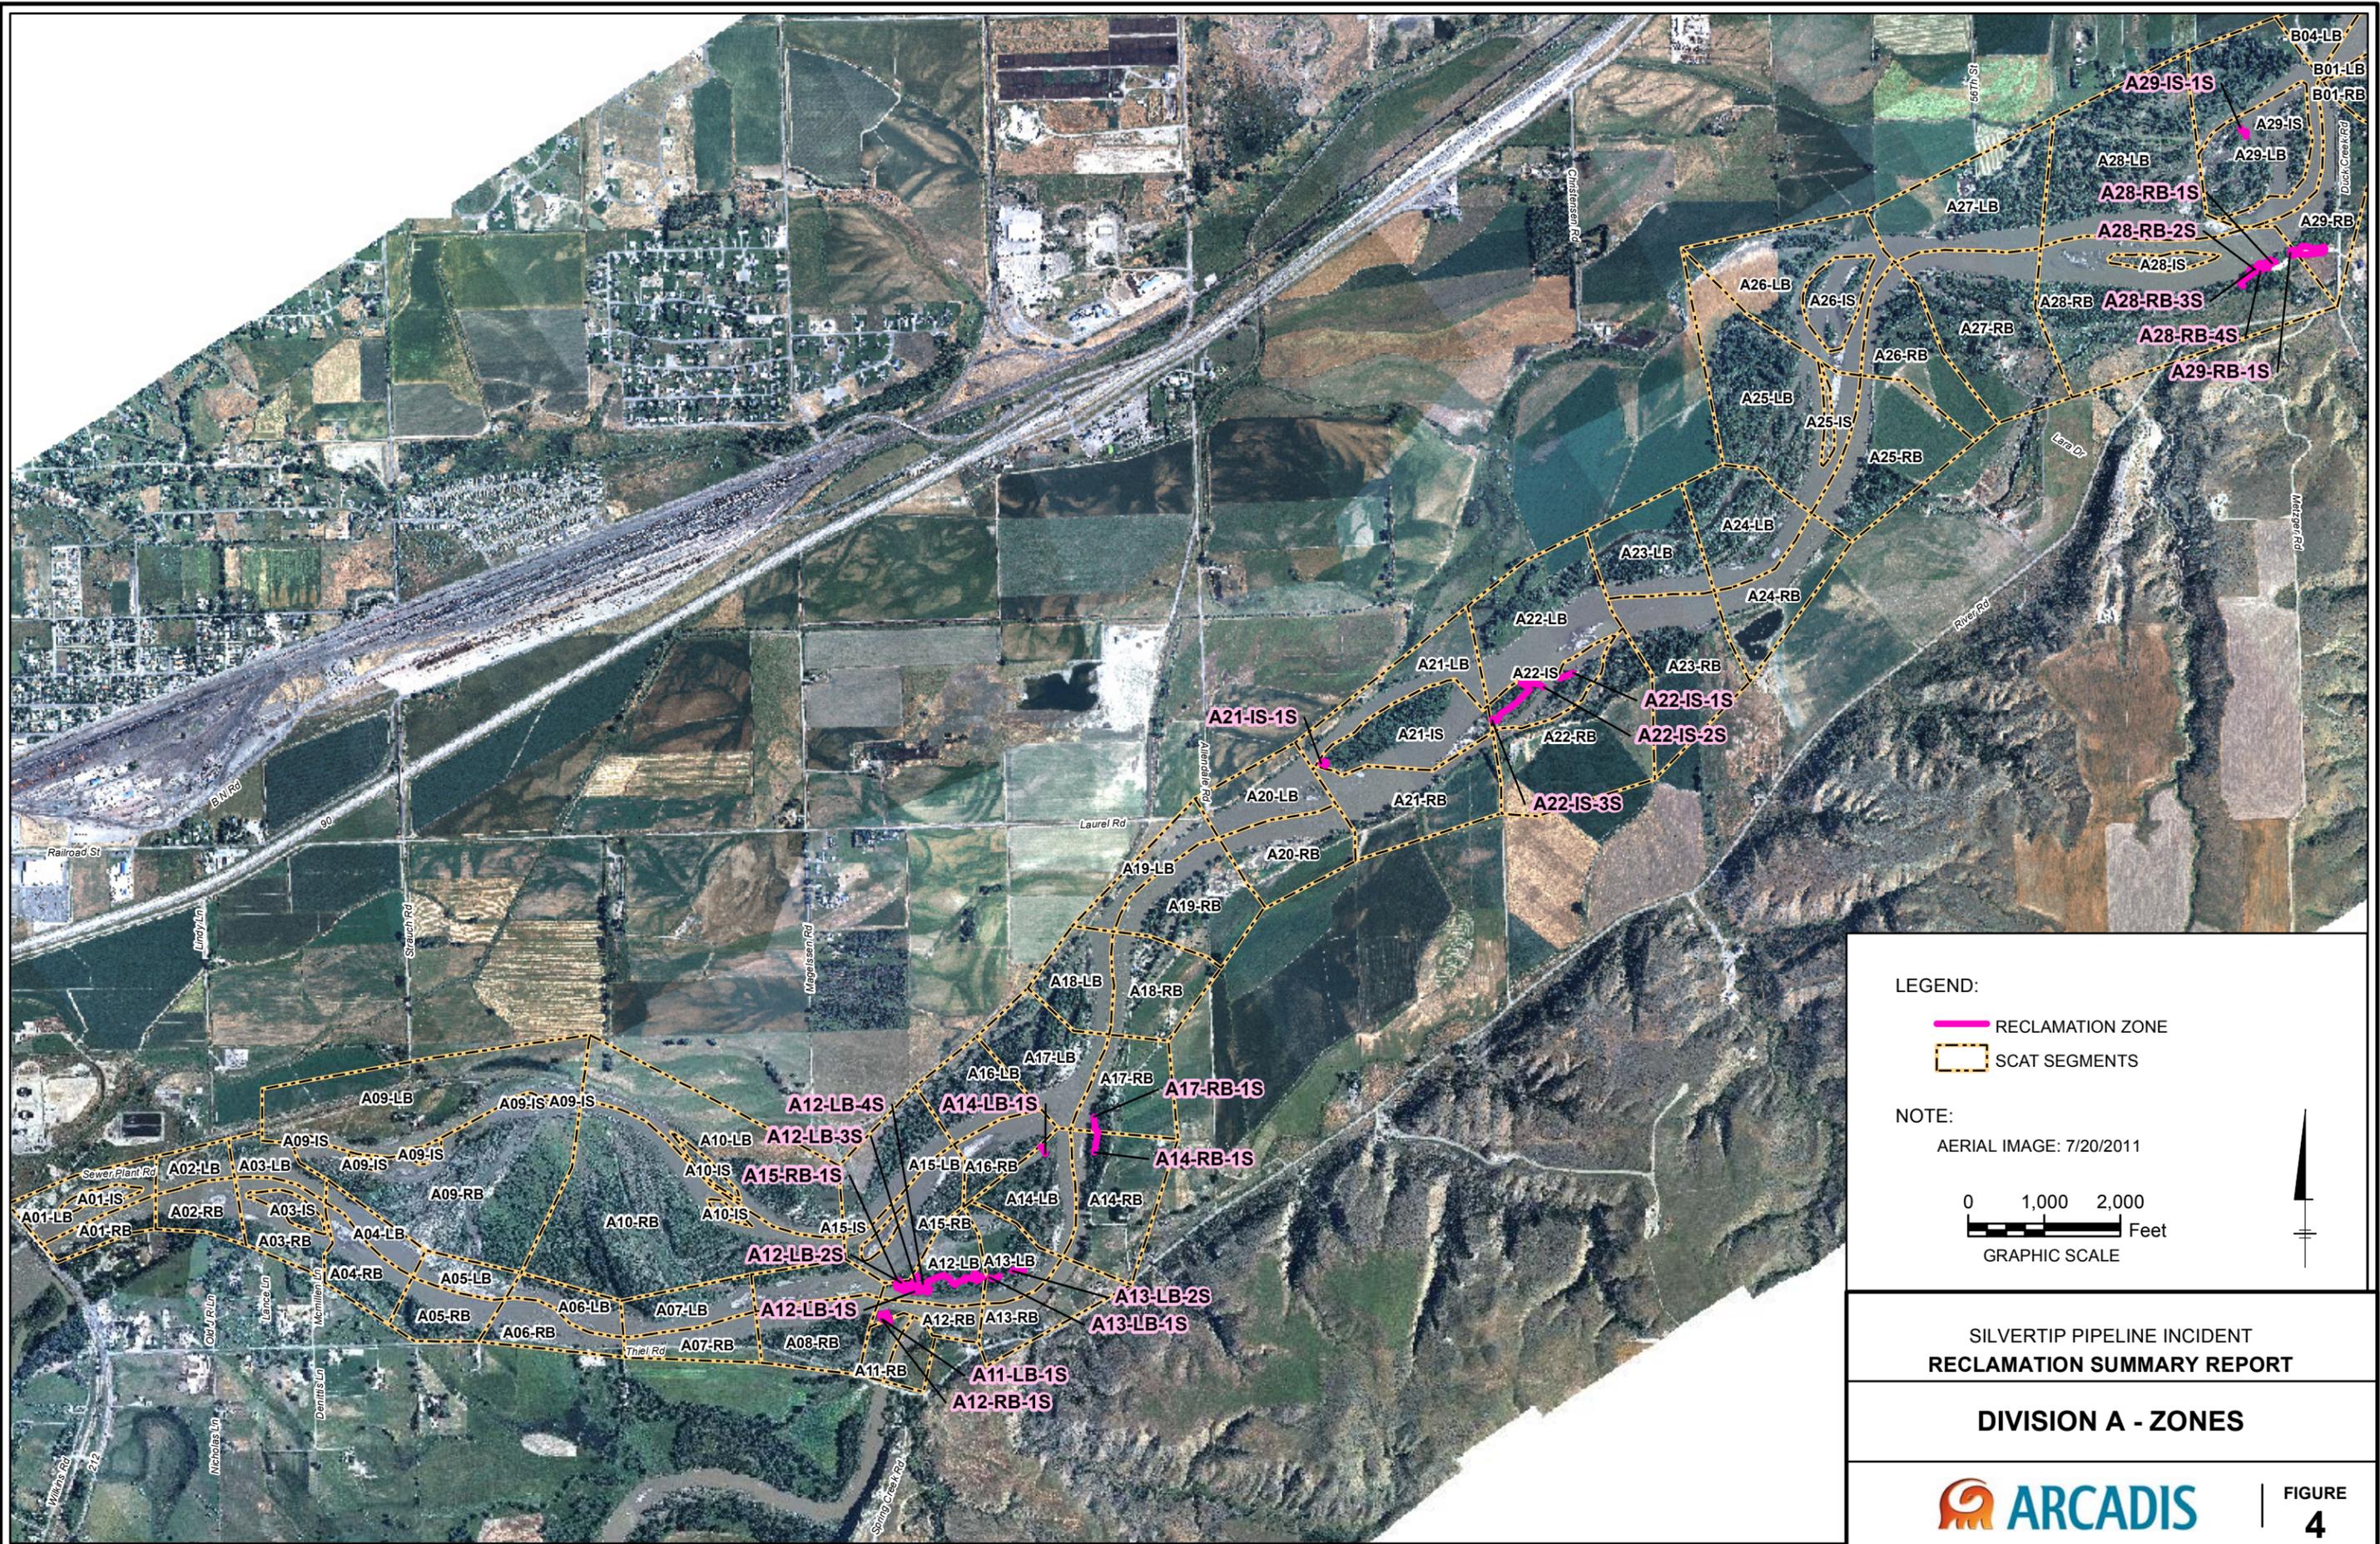
DIVISION A - ZONES

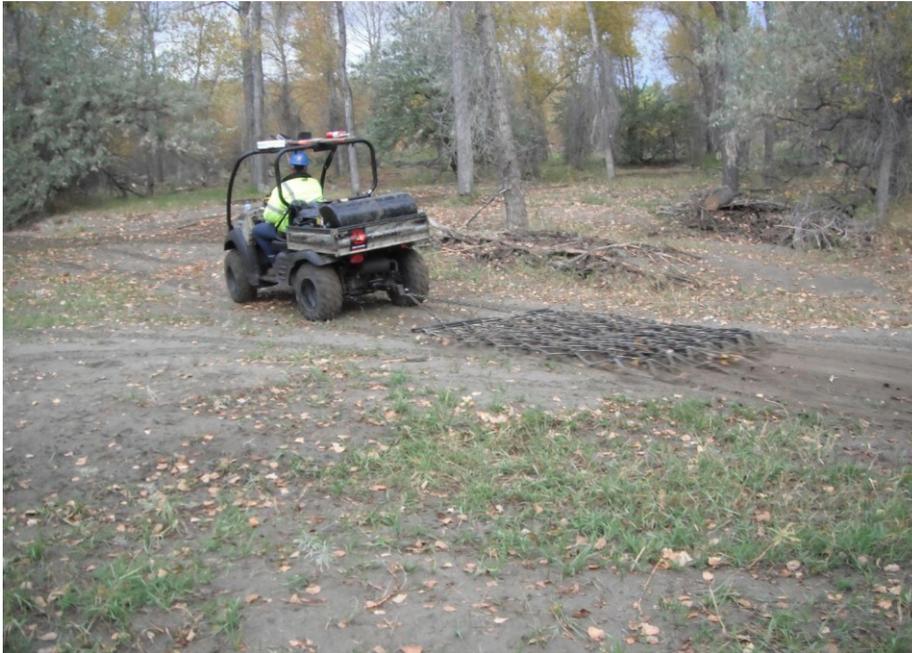
Photo No.: 1

Description:
Harrowing.

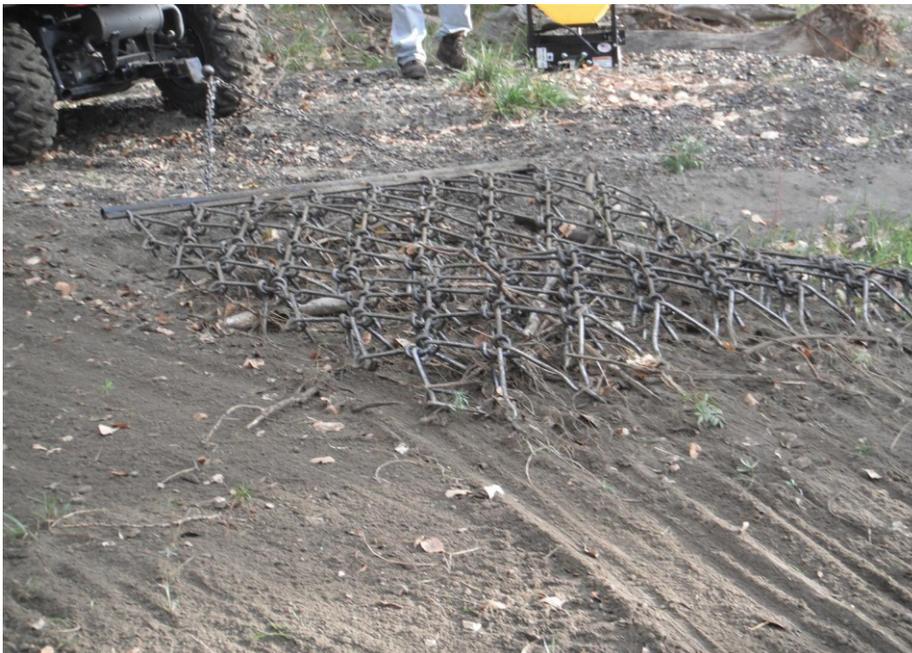
Photo No.: 2

Description:
Rake harrowing.

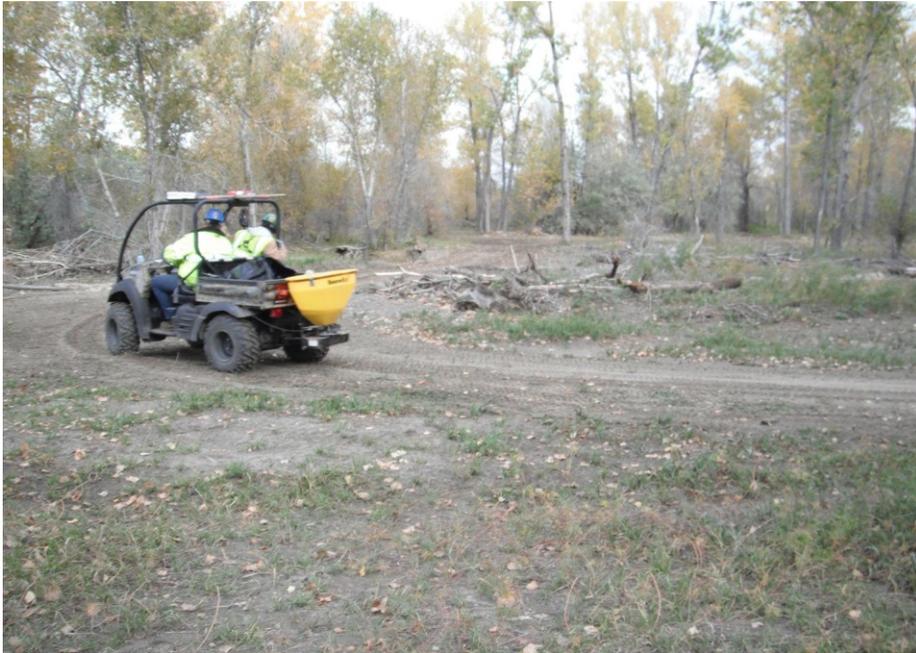
Photo No.: 3

Description:
Seeding.

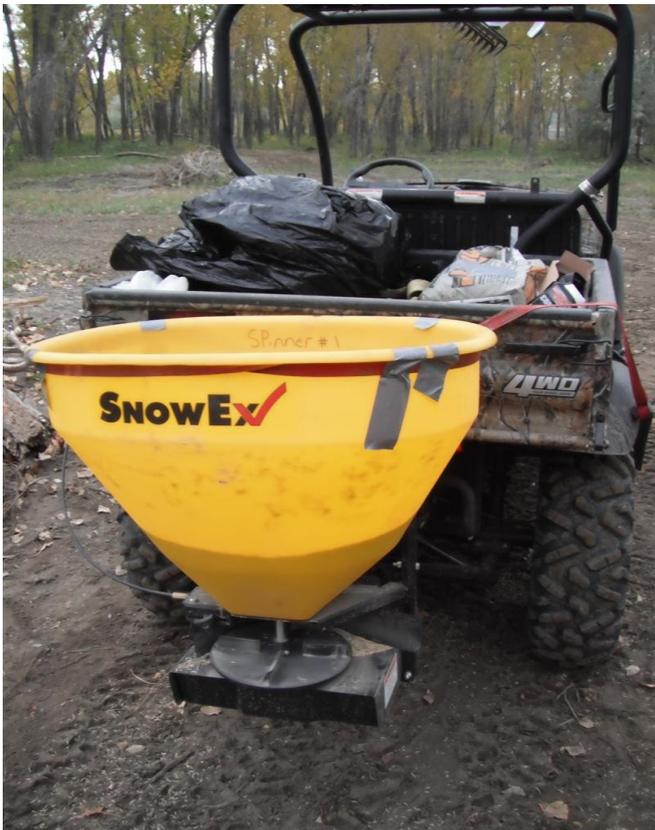
Photo No.: 4

Description:
Broadcast seeder.

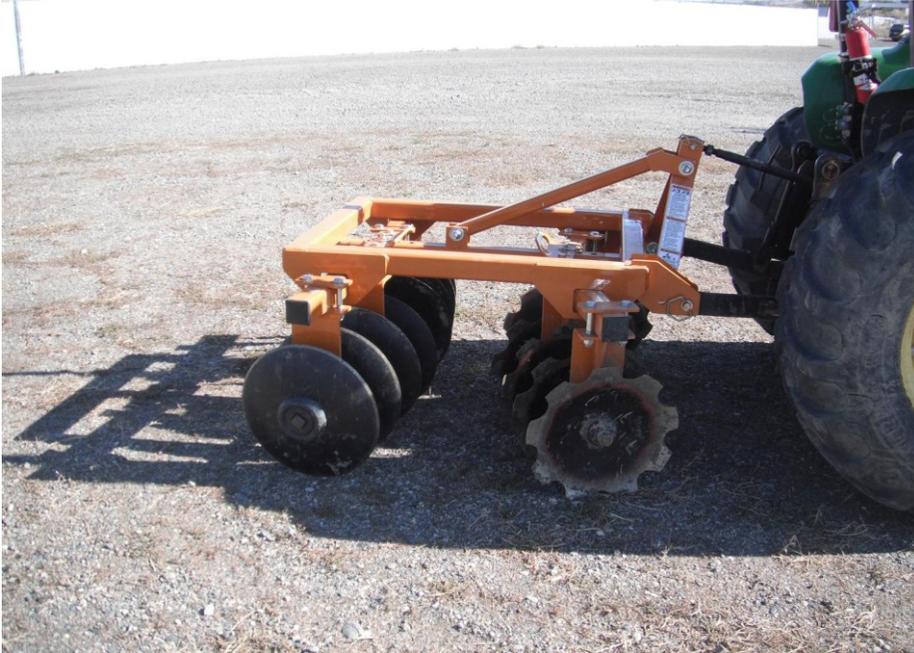
Photo No.: 5

Description:
Disk.

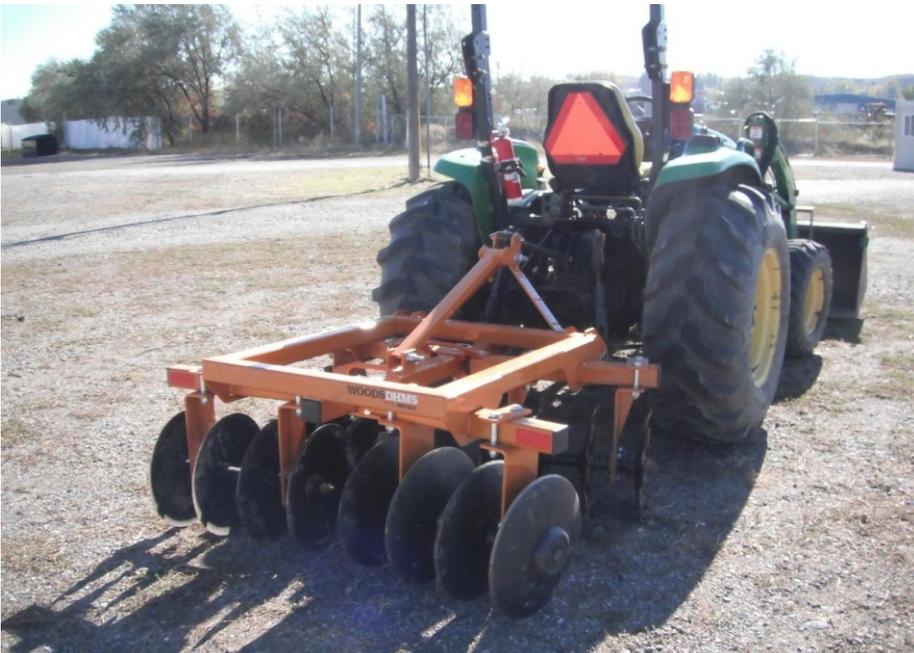
Photo No.: 6

Description:
Disk behind tractor.
