ATTACHMENT A - BITTERROOT RIVER FLIR TEMPERATURE ANALYSIS INTERPRETIVE REPORT

Bitterroot River FLIR Temperature Analysis Interpretive Report

Watershed Consulting, LLC

Montana Dept. of Environmental Quality

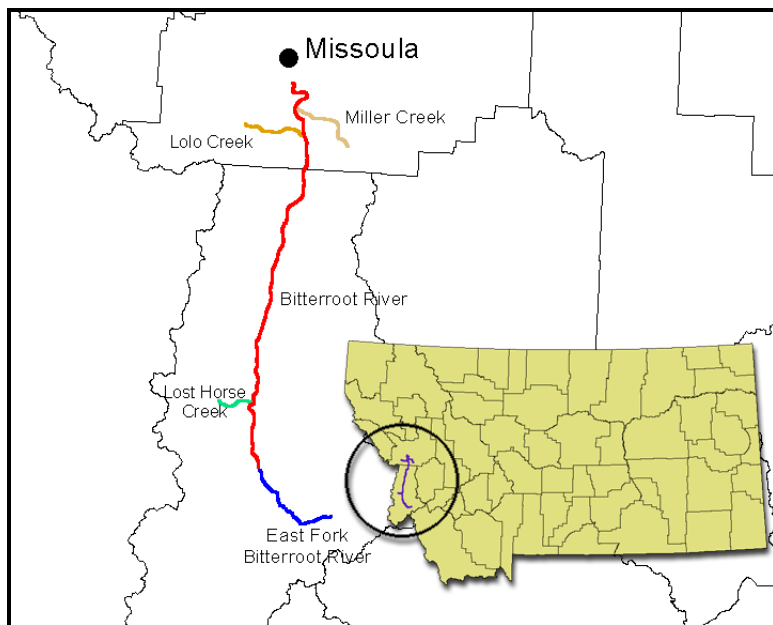
Figure 1. Project area overview.

During the summer of 2004, Infrared Image Solutions, Inc. of Hermiston, OR was contracted to collect multi-spectral imagery on the Bitterroot River and selected tributaries near Missoula, Montana (Figure 1).

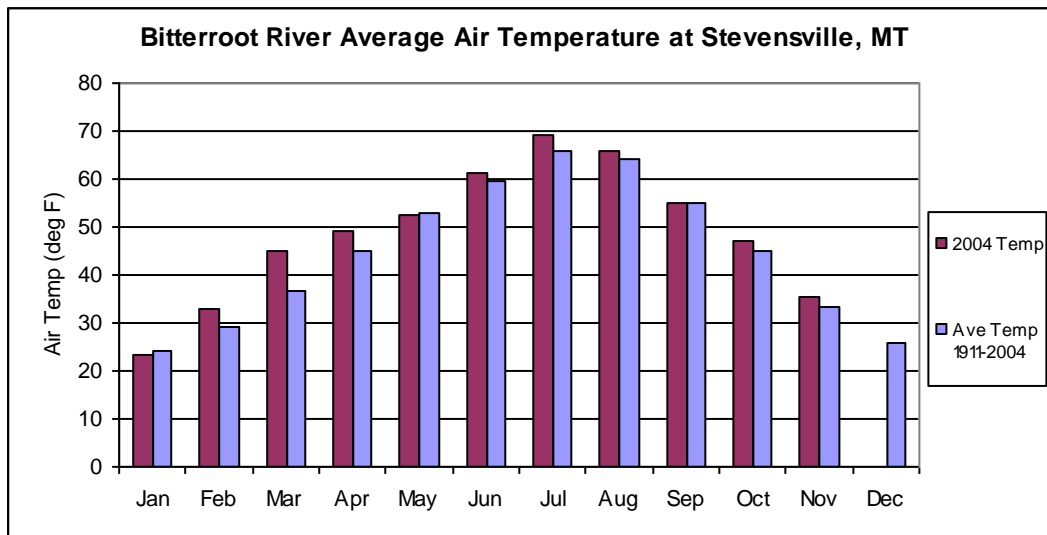
Figure 2. Average annual air temperature at Stevensville, Montana. Source: Western Regional Climate Center.

This date was chosen because it is during what is historically the hottest 2-week period of the year in the Bitterroot valley. Figure 2 shows the historic temperatures in the Bitterroot watershed and the temperature trends for 2004.

As illustrated in Figure 2, temperatures in 2004 were consistent with historic averages.

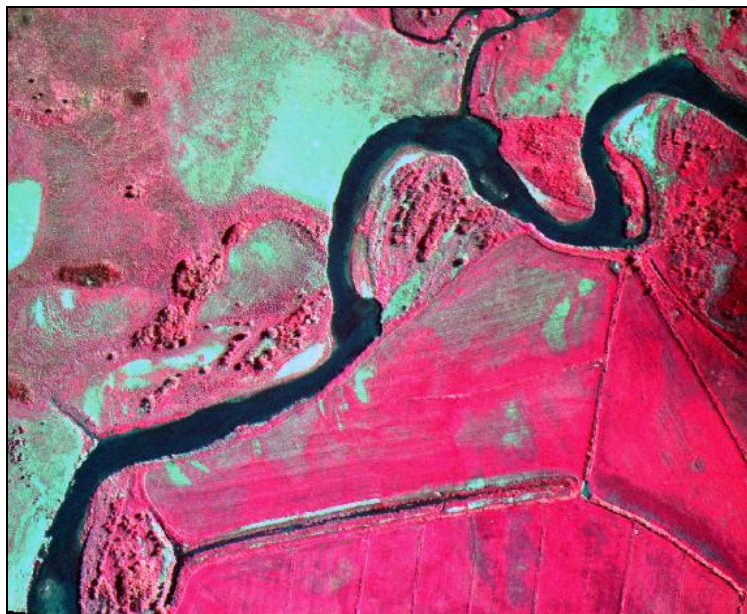
Figure 4. CIR Image on the Bitterroot.

Color-infrared images were collected from a fixed-wing airplane on August 2nd and 4th, 2004. The CIR camera has a much higher resolution than the FLIR camera and therefore can be flown from a higher altitude. The higher altitude affords a wider field of view while still maintaining pixel resolutions of less than a meter. The CIR images put the watershed into context by showing the adjacent terrain and associated land use practices (Figure 3 and 4).

CIR images were captured at a rate of 1 image every 5 seconds. This rate yielded an endlap of approximately 60%. A shapefile of the CIR image locations was created to facilitate comparison of FLIR and CIR images. Additionally, the CIRs were geo-referenced and put in mosaic at a 2 meter resolution to facilitate comparison of temperature trends and land use practices over a greater area.

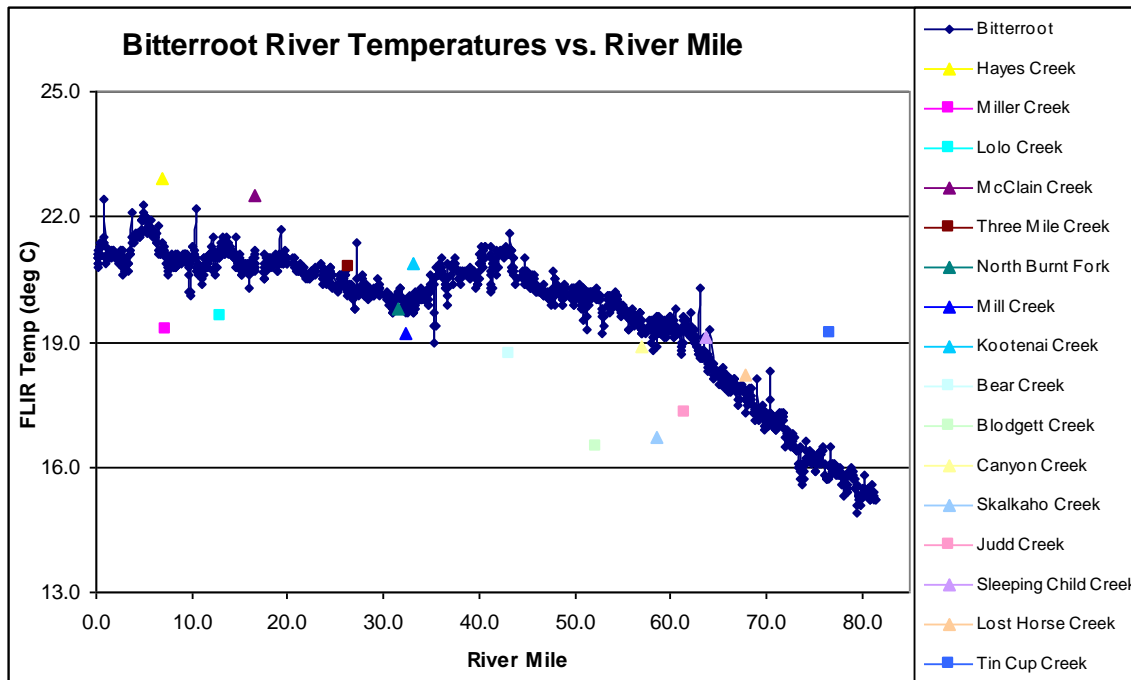
Figure 6. Channel temperatures plotted by river mile for Bitterroot River

The FLIR temperatures for the Bitterroot River were plotted versus the corresponding river mile (Figure 6). This figure shows the temperatures during the evening flight. The plot also contains temperatures of 16 tributaries. The tributary temperatures are from FLIR temperatures at the downstream end of each named tributary (just above confluence with the Ruby). There were a few tributaries for which FLIR temperatures could not be clearly determined, which are not included in Figure 4. The downstream end of the study segment (river mile 0) is on the left side of the graph, therefore trends downstream of a tributary are to the left of the data point for that tributary.

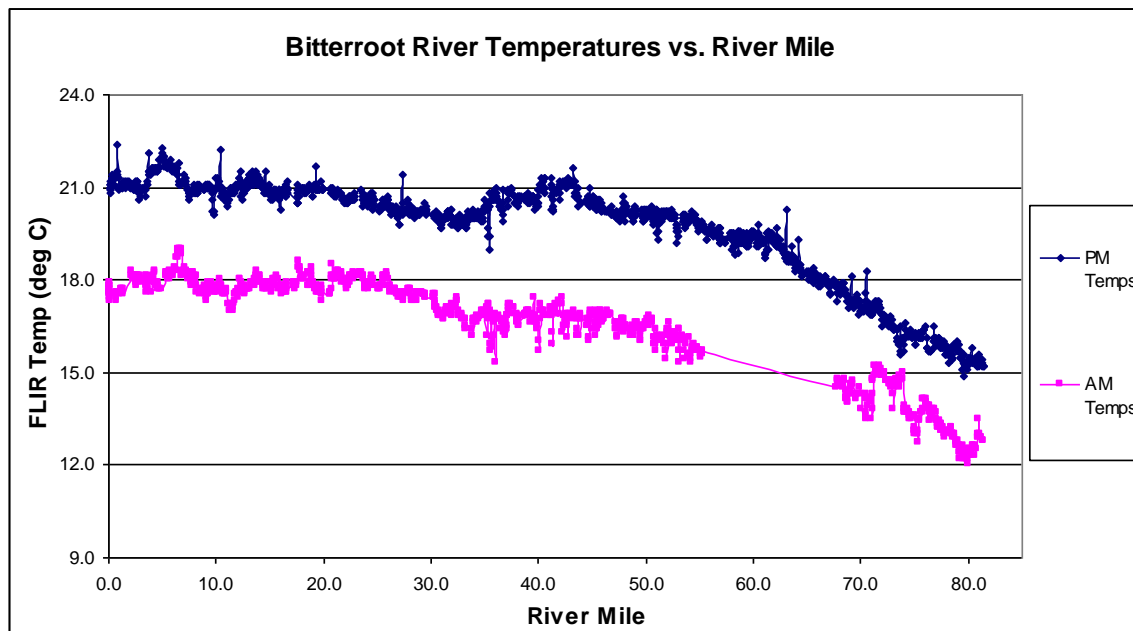
Figure 7. Afternoon and morning channel temperatures plotted by river mile for Bitterroot River

Temperatures on the main Bitterroot ranged from a maximum of 22.4°C and a minimum of 14.9°C on the afternoon of August 2, 2004. Average afternoon temperature was 19.7°C. During the morning flight, the maximum temperature was 19.0°C and the minimum temperature was 12.0°C. The average morning temperature was 16.6°C. In general the temperature trends

were similar at both flight times, with the morning temperatures around 3°C cooler overall (Figure 7, also Map1-3 Appendix A).

Because of the similarities in temperature trends in the Bitterroot, only the afternoon flight will be discussed in detail for the remainder of this section. The exception to this is where temperatures dramatically differed from the trend of being approximately 3°C cooler in the morning.

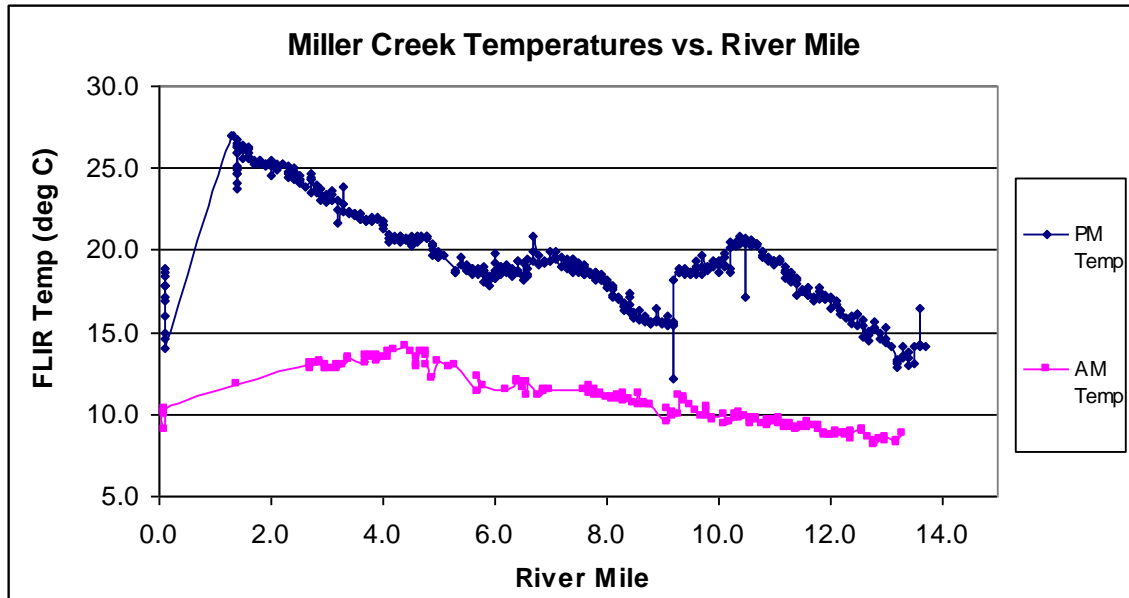
Figure 15. Afternoon and morning channel temperatures plotted vs river mile for Miller Creek.

The median water temperatures for each sampled image of Miller Creek were plotted versus river mile (Figure 15). The morning and afternoon temperatures showed the same basic trend, and the morning temperatures were approximately 6°C cooler than the afternoon temperatures. However, there was less variability on the steady warming trend in the morning flight. Furthermore, the drop in temperature seen at the mouth of Miller Creek occurred farther upstream in the morning. The afternoon temperatures on Miller Creek will be the primary focus of the following discussion.

Afternoon temperatures on Miller Creek ranged from 27.0 to 12.2°C (Appendix A, Map 3). This was a large temperature fluctuation (14.8°C) relative to the fluctuations seen on other streams included in this survey. The mean temperature was 19.5°C. Miller Creek showed a basic warming trend from the upstream to the downstream end, however, there was a greater temperature range seen on Miller Creek than on any other stream included in this survey. Miller Creek was broken into two reaches.

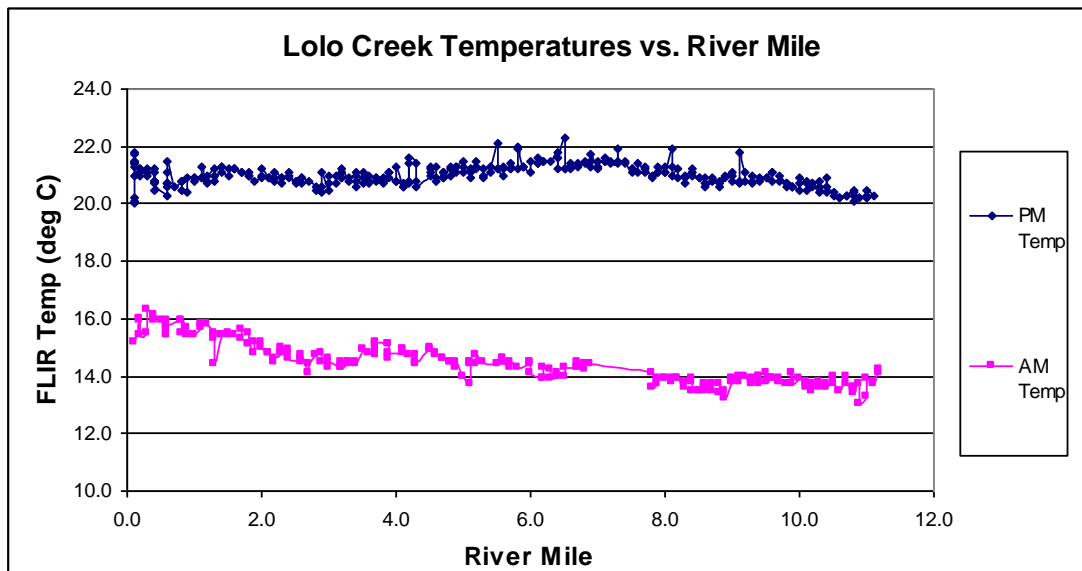
Figure 17. Afternoon and morning channel temperatures plotted vs. river mile for Lolo Creek.

The median water temperatures for each sampled image of Lolo Creek were plotted versus river mile (Figure 17). The morning and afternoon surveys show similar temperature trends with the morning stream temperatures 6-7°C cooler than the afternoon temperatures. The following discussion will focus primarily on the afternoon FLIR temperatures.

As seen in Figure 17, the temperatures on Lolo Creek were relatively stable. The high afternoon stream temperature was 22.3°C while the low temperature was 20.0°C (Appendix A, Map 3). Lolo Creek was broken out into two reaches.

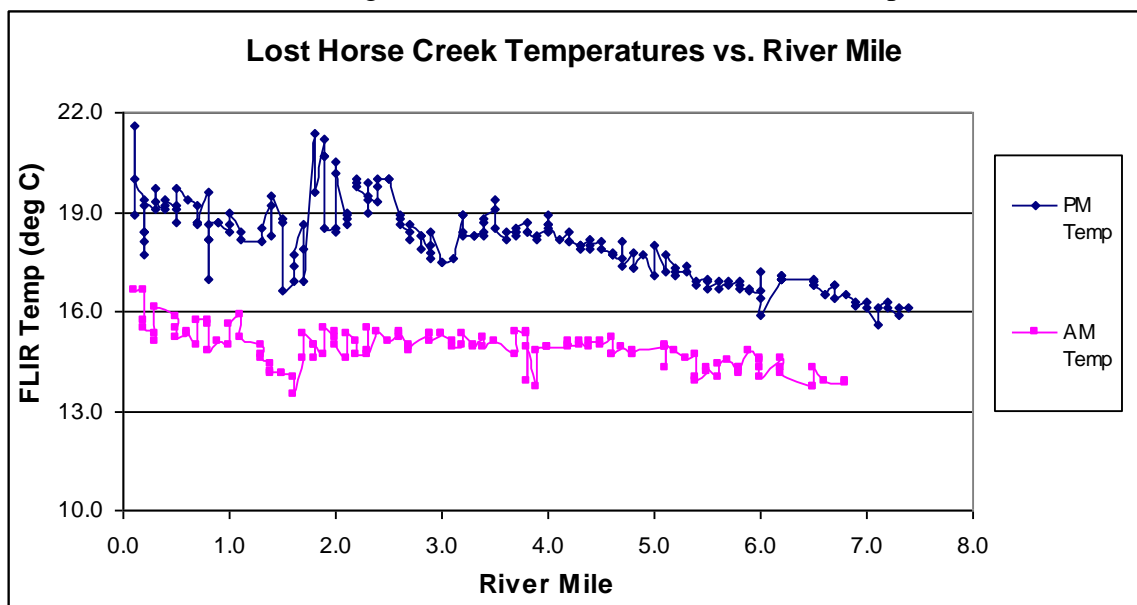
Figure 19. Afternoon and morning channel temperatures plotted vs. river mile for Lost Horse Creek.

Lost Horse Creek shows a general warming trend as you move downstream. The upstream temperature (river mile 7.4) was 16.1°C. The downstream temperature (river mile 0.1) was 21.6°C for a total temperature gain of 5.5°C. The longitudinal profile (Figure 19 and Appendix A, Map 1) showed that Lost Horse Creek had many significant temperature fluctuations in short distances, particularly at the downstream end. The morning and afternoon temperatures were similar, however the temperature spikes were not consistent in the two times. Despite these inconsistencies, the following section will focus on the afternoon temperatures.

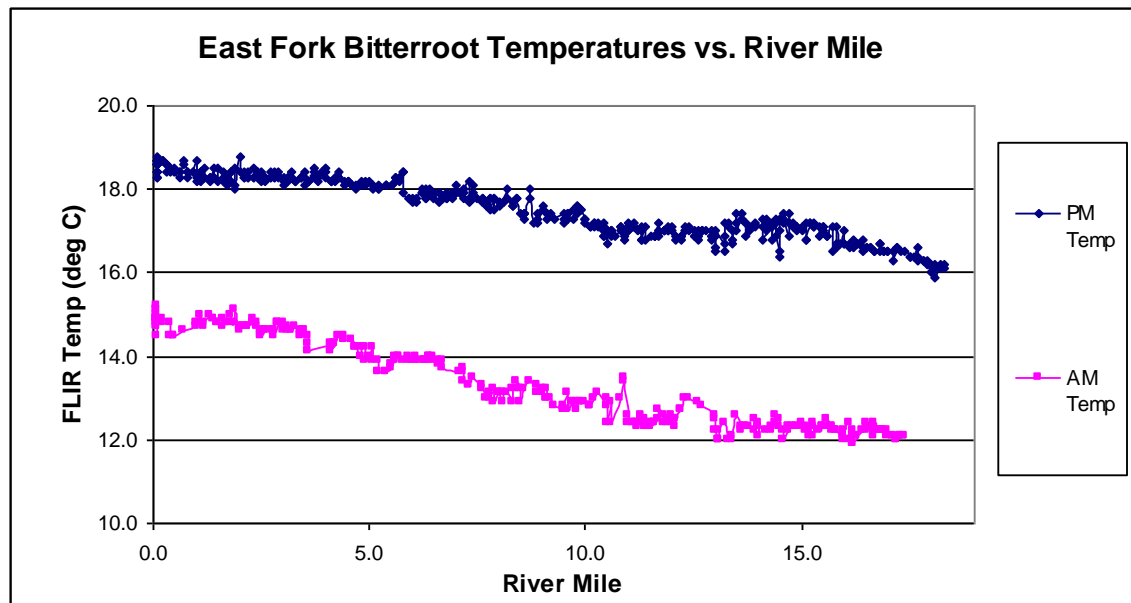
Figure 21. Afternoon and morning channel temperatures plotted by river mile for East Fork Bitterroot River.

The median water temperatures for each sampled image of East Fork of Bitterroot were plotted versus river mile (Figure 21). Temperature trends were similar during the morning and afternoon flights. The afternoon temperatures were 4-5 °C warmer than the morning temperatures. Afternoon temperatures will be the focus of the following section.

The temperature at the upstream end of East Fork of Bitterroot was 16.2°C and the temperature at the mouth was 18.6°C (Appendix A, Map 1). This is an overall increase in stream temperature of 2.9°C over 18 miles. The maximum temperature on East Fork of Bitterroot was 18.8°C and the minimum stream temperature was 15.9°C. The East Fork was divided into three reaches.
