UPPER AND NORTH FORK BIG HOLE RIVER PLANNING AREA TMDLS AND FRAMEWORK WATER QUALITY RESTORATION APPROACH

June 30, 2009

Montana Department of Environmental Quality
P.O. Box 200901
Helena, MT 59620-0901

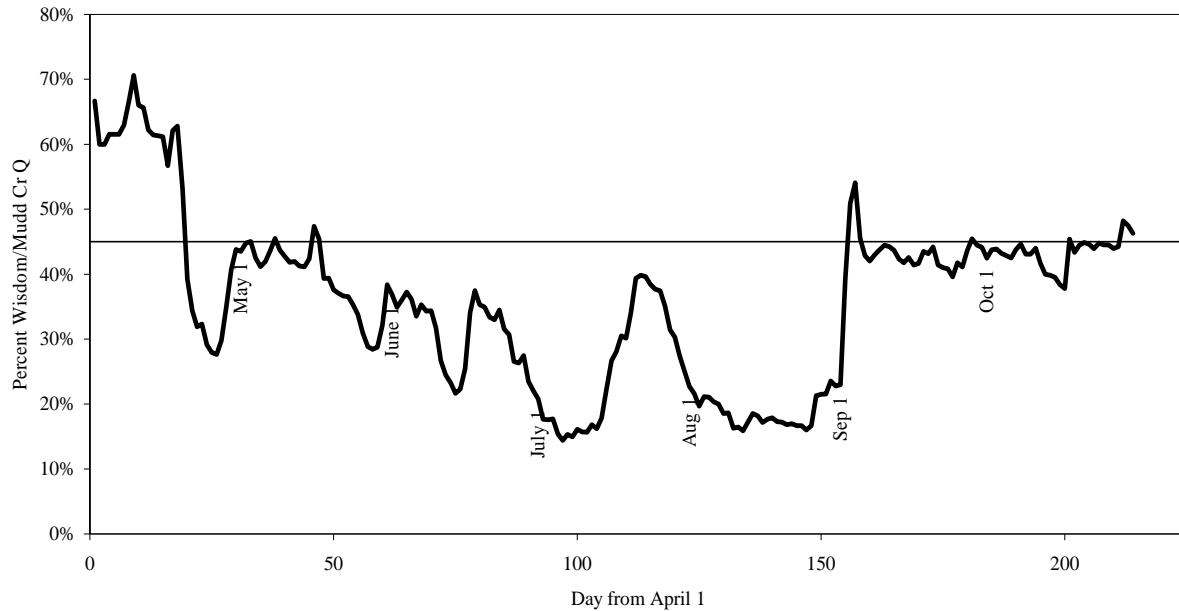
A comparison of the stream flow contributed from individual major sub-watersheds identifies spatial trends in surface water withdrawals. Fundamentally, in a single basin, the relative contribution of flow from contributing sub-watersheds relates in part to the sub-watershed's drainage area. The contributing drainage area above the Wisdom gage (575 sq mi) is approximately 45% of that contributing to the gage below Mudd Creek. (1267 sq mi). The largest contributing sub-watershed between Wisdom and Mudd Creek is the North Fork Big Hole River. As the upper basin characteristics on the North Fork are physiographically similar to those of the Upper Big Hole River above Wisdom, it would follow that flows at Wisdom should be about 45% of those at Mudd Creek. Nevertheless, on average, mean daily summer flows at Wisdom are significantly less than 45% of those at Mudd Creek. In 1999, mid-summer flows at Wisdom were commonly less than 20% of those at Mudd Creek (**Figure 2-5**). By fall, relative flow contributions from the mainstem of the Upper Big Hole increased to 40% of the total flow below Mudd Creek. The relatively low surface water yield from the Upper Big Hole sub-watershed above Wisdom during summer months indicates that dewatering is a more significant impact in the sub-watershed area above Wisdom than the North Fork Big Hole River sub-watershed.

Figure 2-5: Ratio of mean daily flows on the Upper Big Hole River at Wisdom and near Mudd Creek.

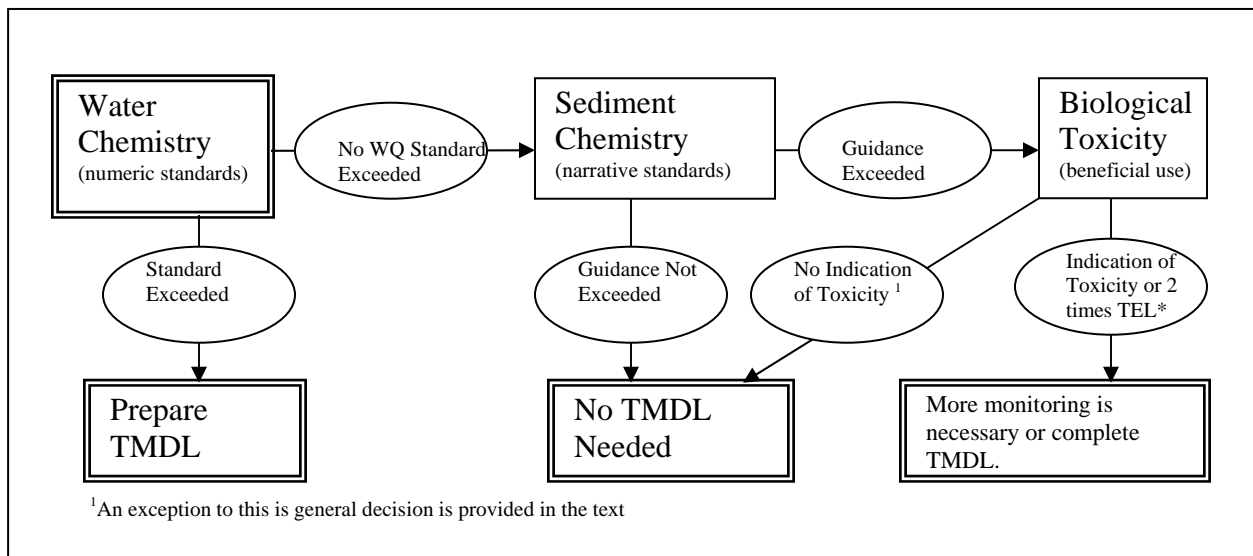
Figure 4-1: Decision Process to Determine if a Specific Metal is Impacting a Use for Upper/NF Big Hole TPAs.

*NOAA SQIRTS freshwater threshold effect level.

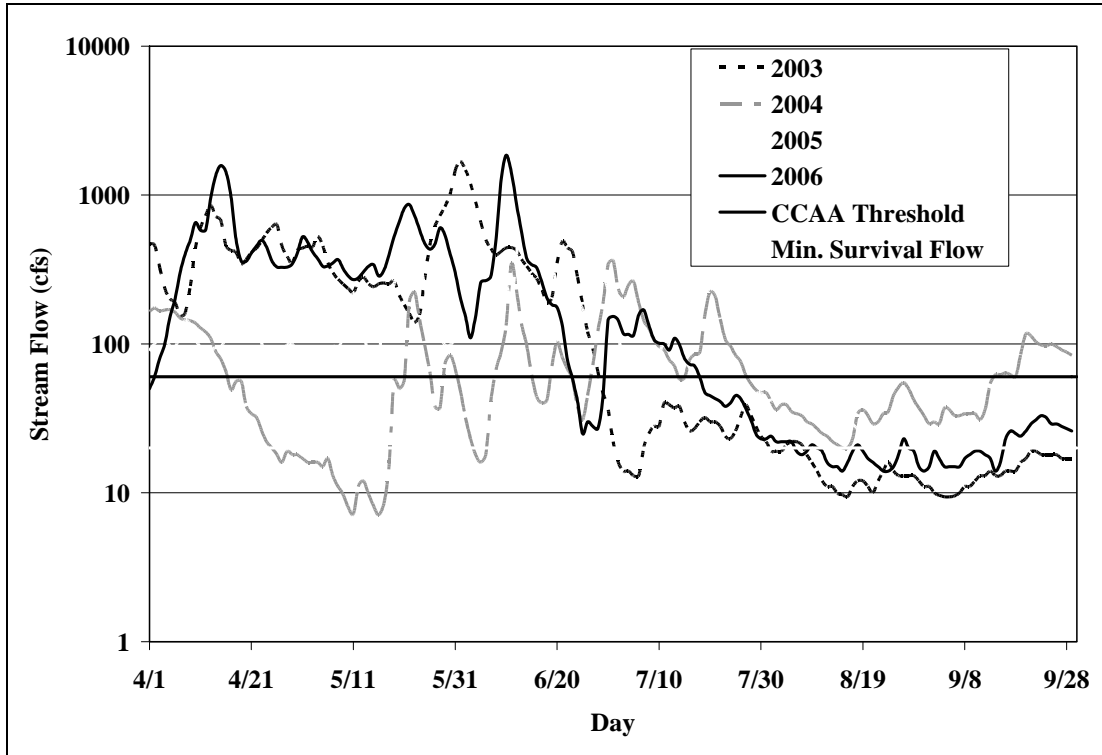
Figure 5-1: Stream flow measured on the Big Hole River at the Wisdom Bridge (USGS Gage 06024450)

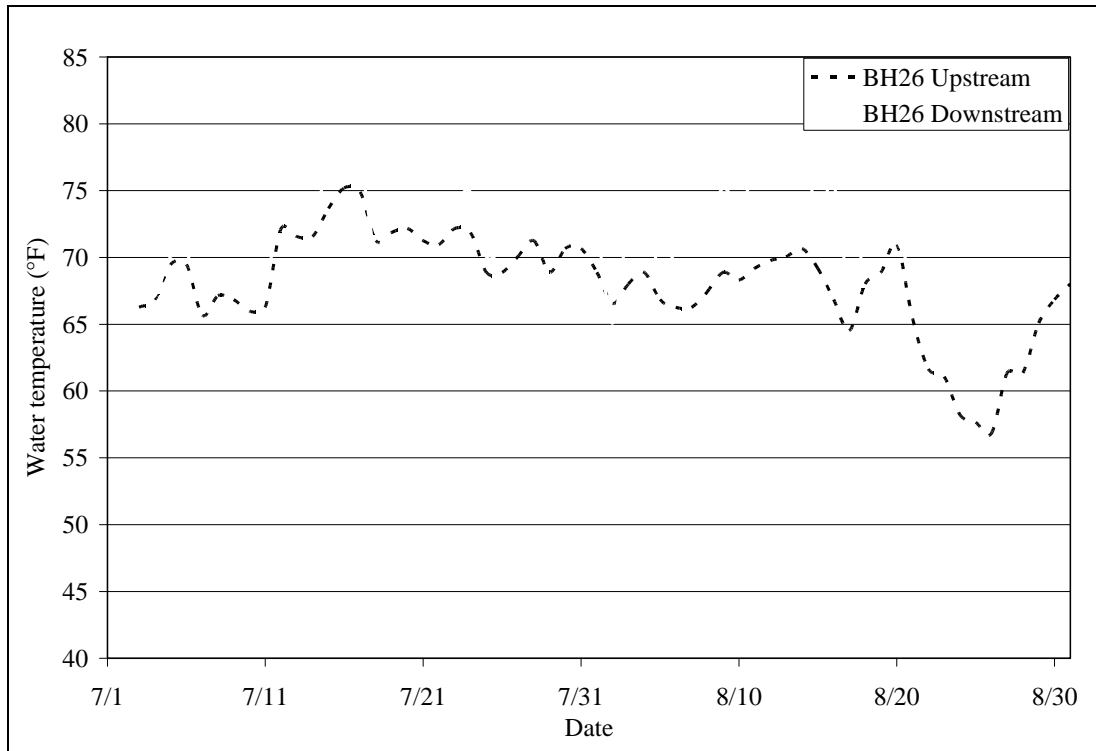
Data from thermographs installed at the upper and lower ends reach BH26 indicate substantial thermal loading between the thermographs (**Figure 5-3**). The tendency for the downstream site to have markedly greater maximum daily temperatures accentuates the potential for these overly wide reaches with greatly reduced shrub cover to accrue heat during daylight hours. Additionally, the downstream site exhibits more rapid changes in temperature on both heating and cooling cycles, attributable to lower upstream canopy density, lower stream flows and higher width-to-depth ratios.

Figure 5-3: Temperatures measured using thermographs at the upstream and downstream boundaries of reach BH26 on the Big Hole River in 2004.

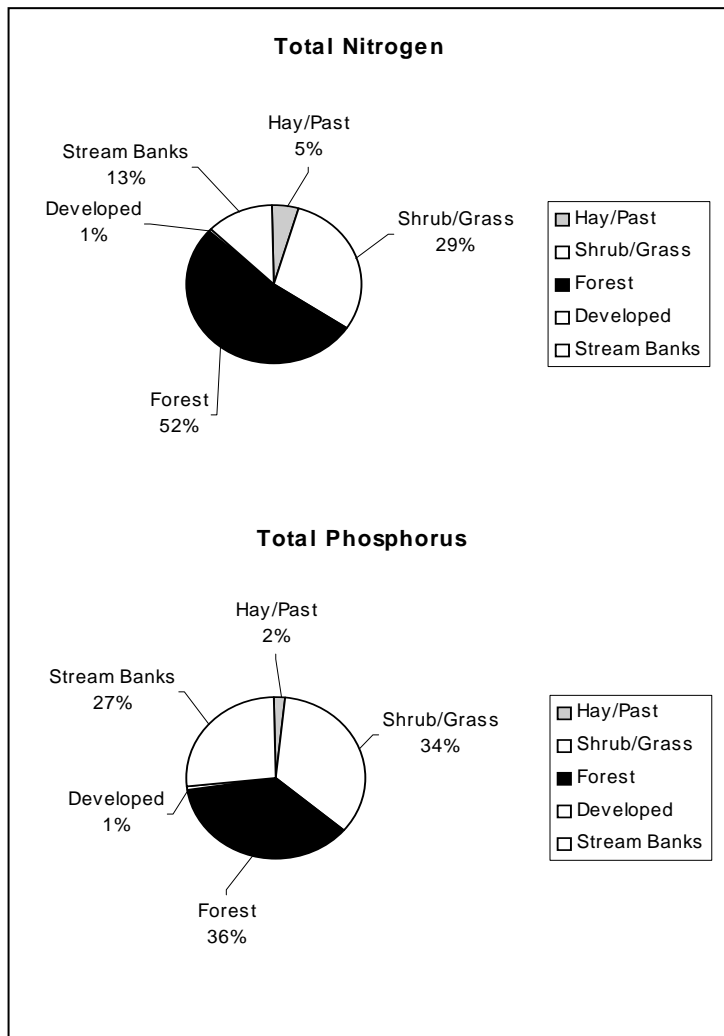
Francis Creek’s phosphorus source assessment results reveal forest land as the most major contributor, yet this source is mostly natural except for limited grazing. Grassland and shrubland combined make the next largest phosphorus source and include both natural background and the human influence of reduced upland vegetation from grazing systems which slightly elevates erosion. Bank erosion is the next largest source of phosphorus to the stream, although it is likely one of the more controllable human influenced sources. Bank erosion is highly influenced by domesticated livestock riparian grazing. Hay/pasture areas are likely a larger contributor of phosphorus than identified and will also be considered in TMDL allocations and restoration approaches. Suburban areas are a very small source of phosphorus in this watershed. Farm animal waste via grazing systems contributes a very minor contribution of phosphorus.

Figure 9-1: Francis Creek Nutrient Source Assessment Results

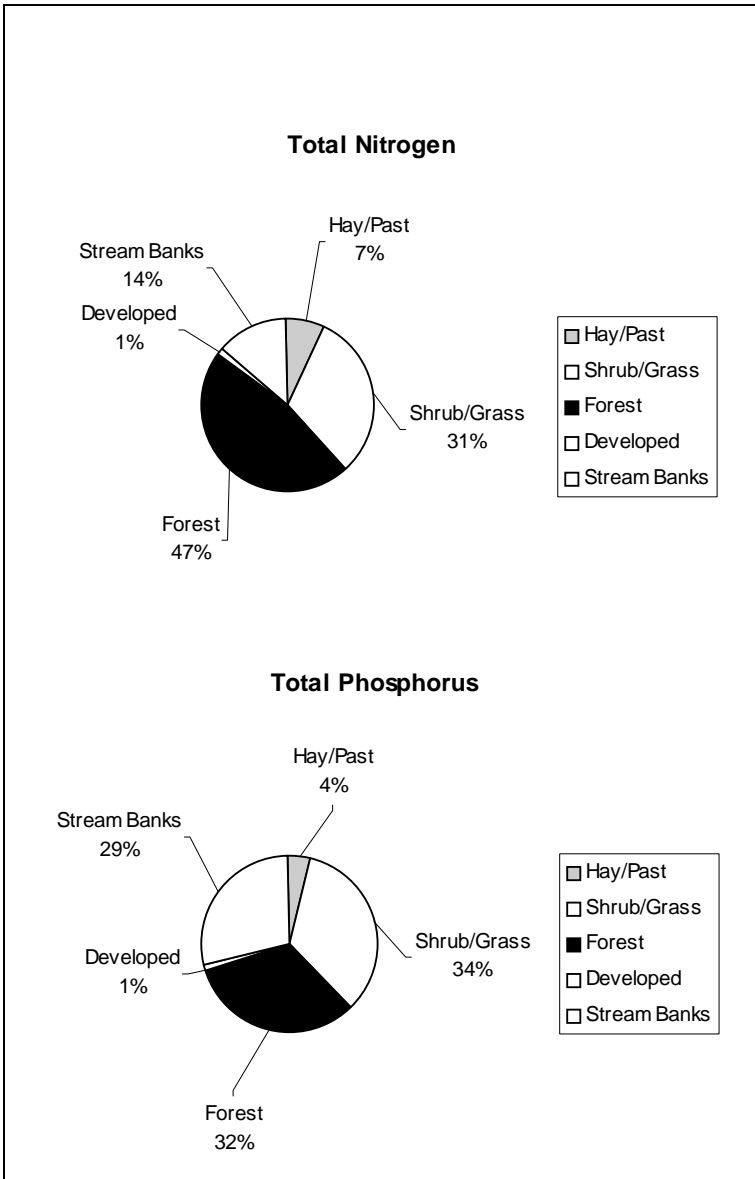
Steel Creek's phosphorus source assessment results reveal forest land as the most major contributor, yet this source is mostly natural except for limited grazing. Grassland and shrubland combined make the next largest phosphorus source and include both natural background and the human influence of reduced upland vegetation from grazing systems which slightly elevates erosion. Bank erosion is the next largest source of phosphorus to the stream although it is likely one of the more controllable human influenced sources. Bank erosion is highly influenced by domesticated livestock riparian grazing. Hay/pasture areas are likely a larger contributor of phosphorus than identified and will also be considered in TMDL allocations and restoration approaches. Suburban area is a very small source of phosphorus in this watershed. Farm animal waste via grazing systems contributes a very minor contribution of phosphorus.

Figure 9-4: Steel Creek Nutrient Source Assessment Results
