# FINAL Preliminary Assessment Report Army Aviation Support Facility, Helena, Montana

Perfluorooctane-Sulfonic Acid (PFOS) and Perfluorooctanoic  
Acid (PFOA) Impacted Sites  
ARNG Installations, Nationwide

October 2018

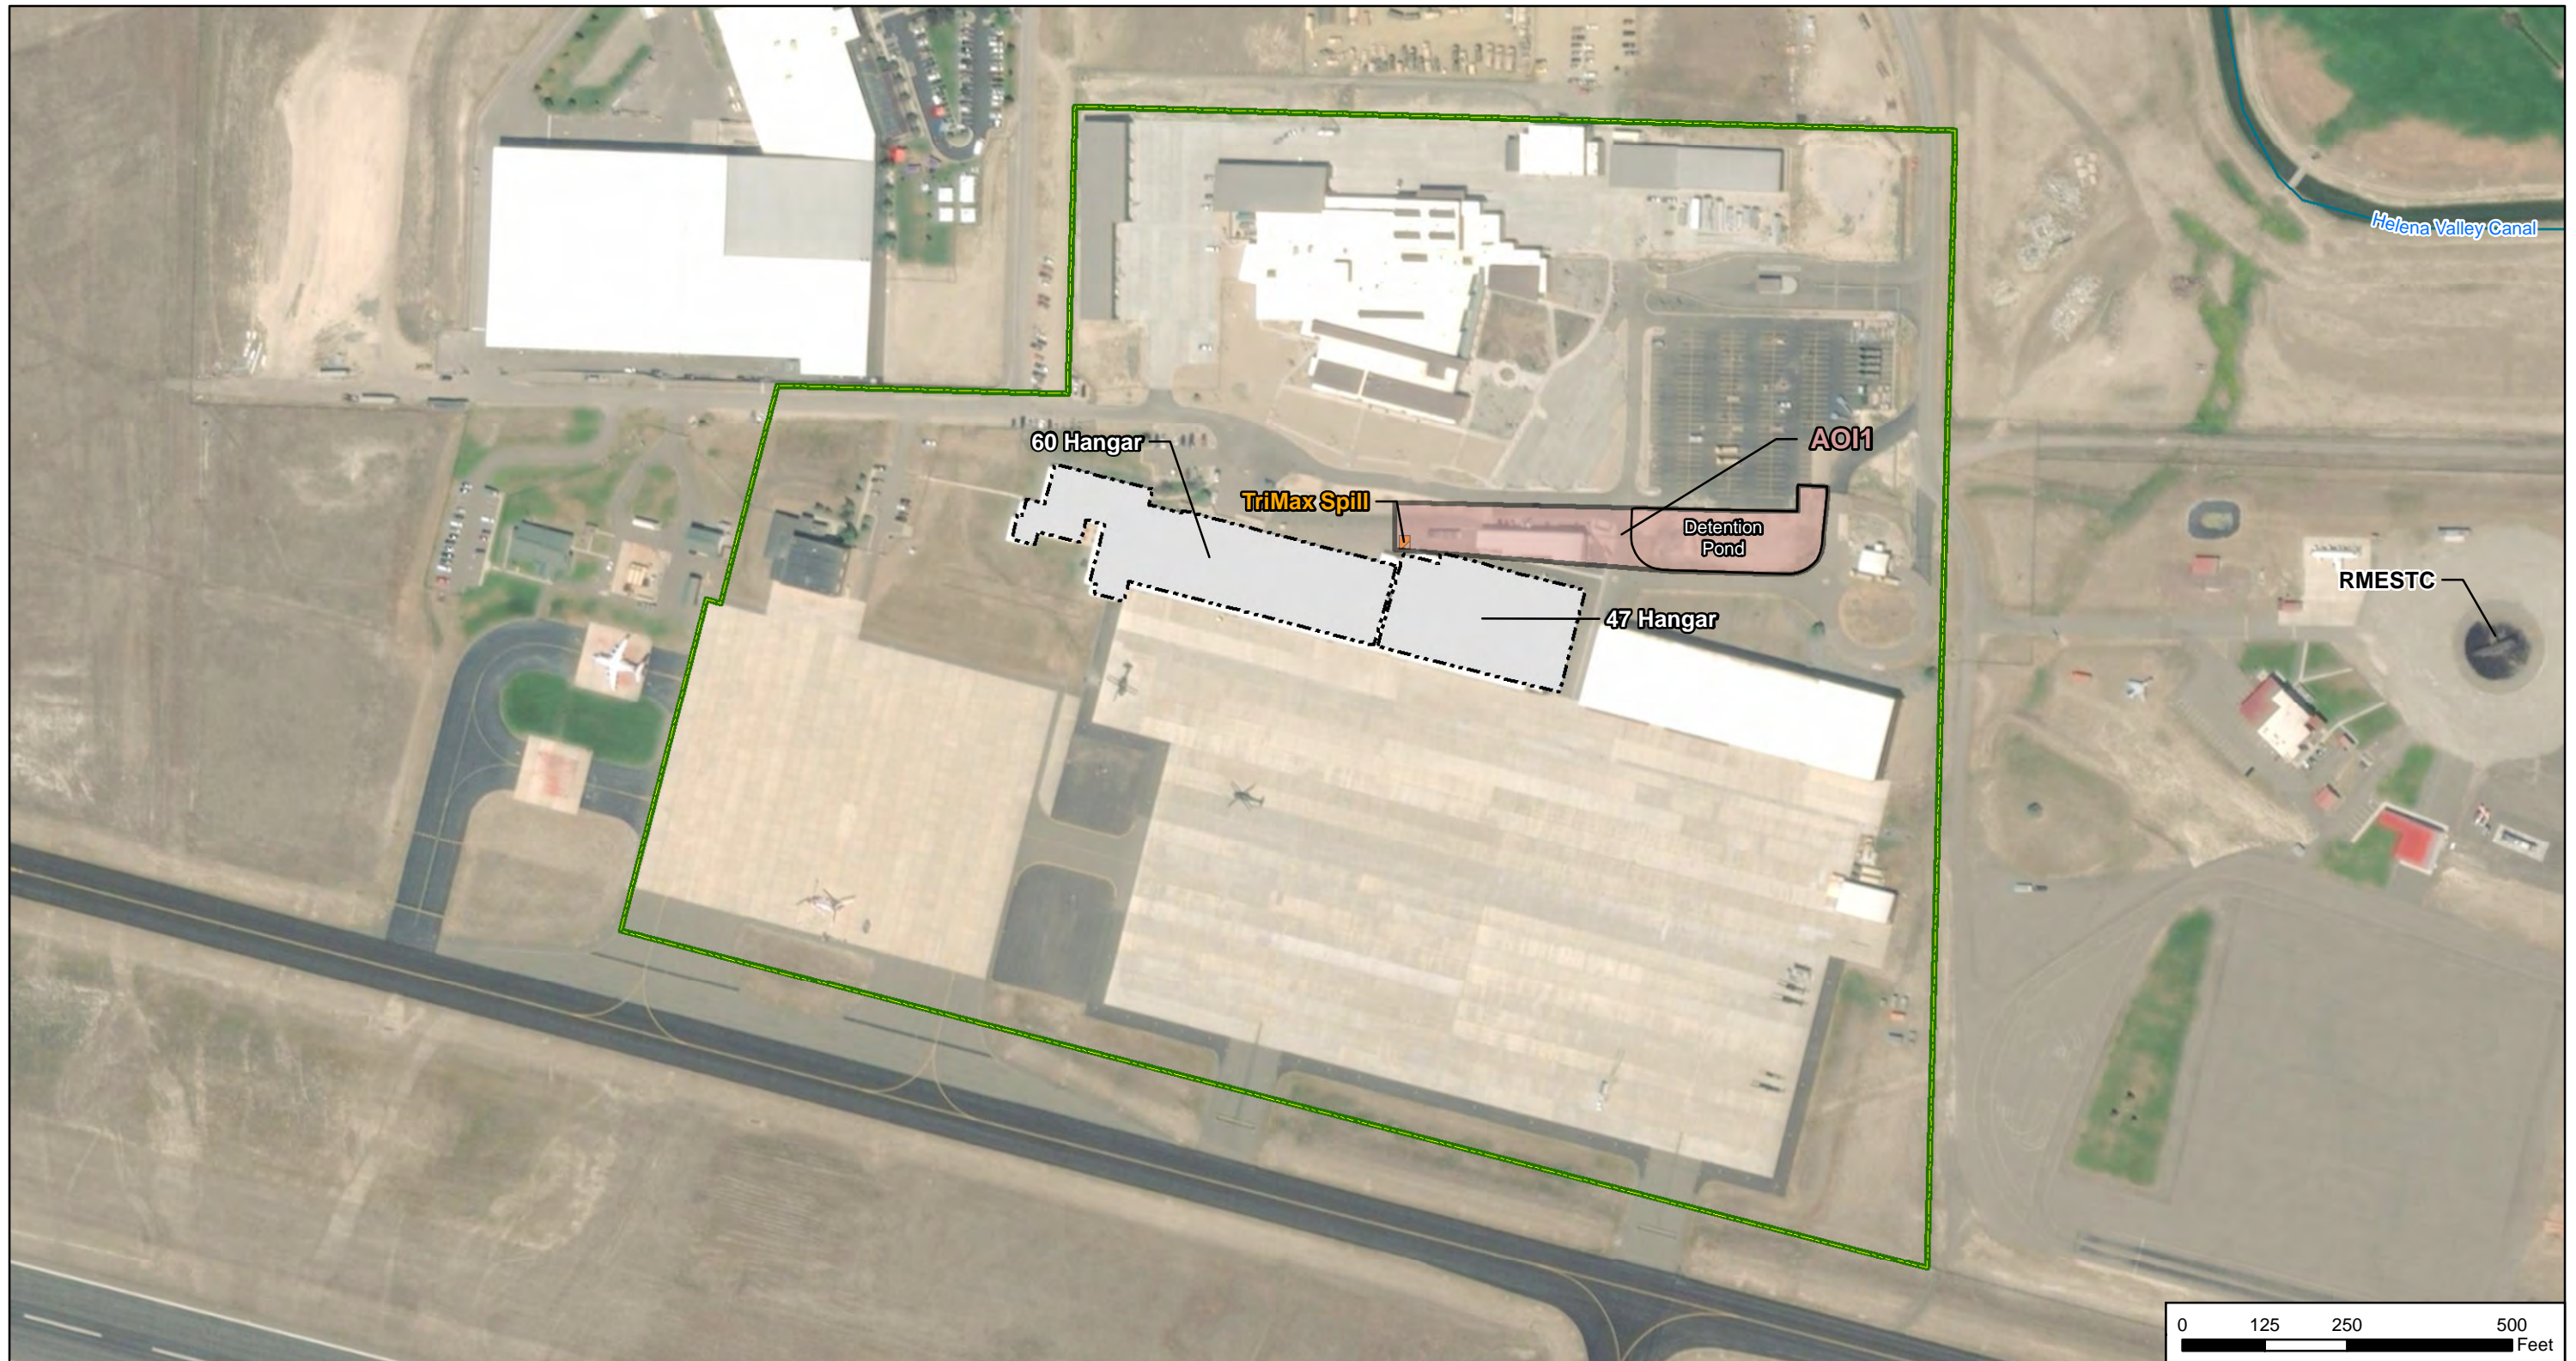
One AOI related to a potential PFAS release was identified at the current Helena AASF during the PA. The AOI is shown on **Figure ES-1** and described below:

Area of Interest	Name	Used by	Potential Release Date
AOI 1	TriMax Spill Area	MTARNG	Early 2000s

Based on a potential PFAS release at this AOI, there is potential for exposure to PFAS contamination in surface soil and intermittent surface water and sediments to site and construction workers via ingestion and inhalation of dust, subsurface soil to site and construction workers via ingestion, and groundwater to off-facility residents via ingestion. Potential off-facility PFAS release areas exist adjacent to the current Helena AASF. Because these areas include property upgradient of the facility, it is unknown whether or not the off-facility sources effect the current Helena AASF. The CSM for the current Helena AASF is shown on **Figure ES-2**.

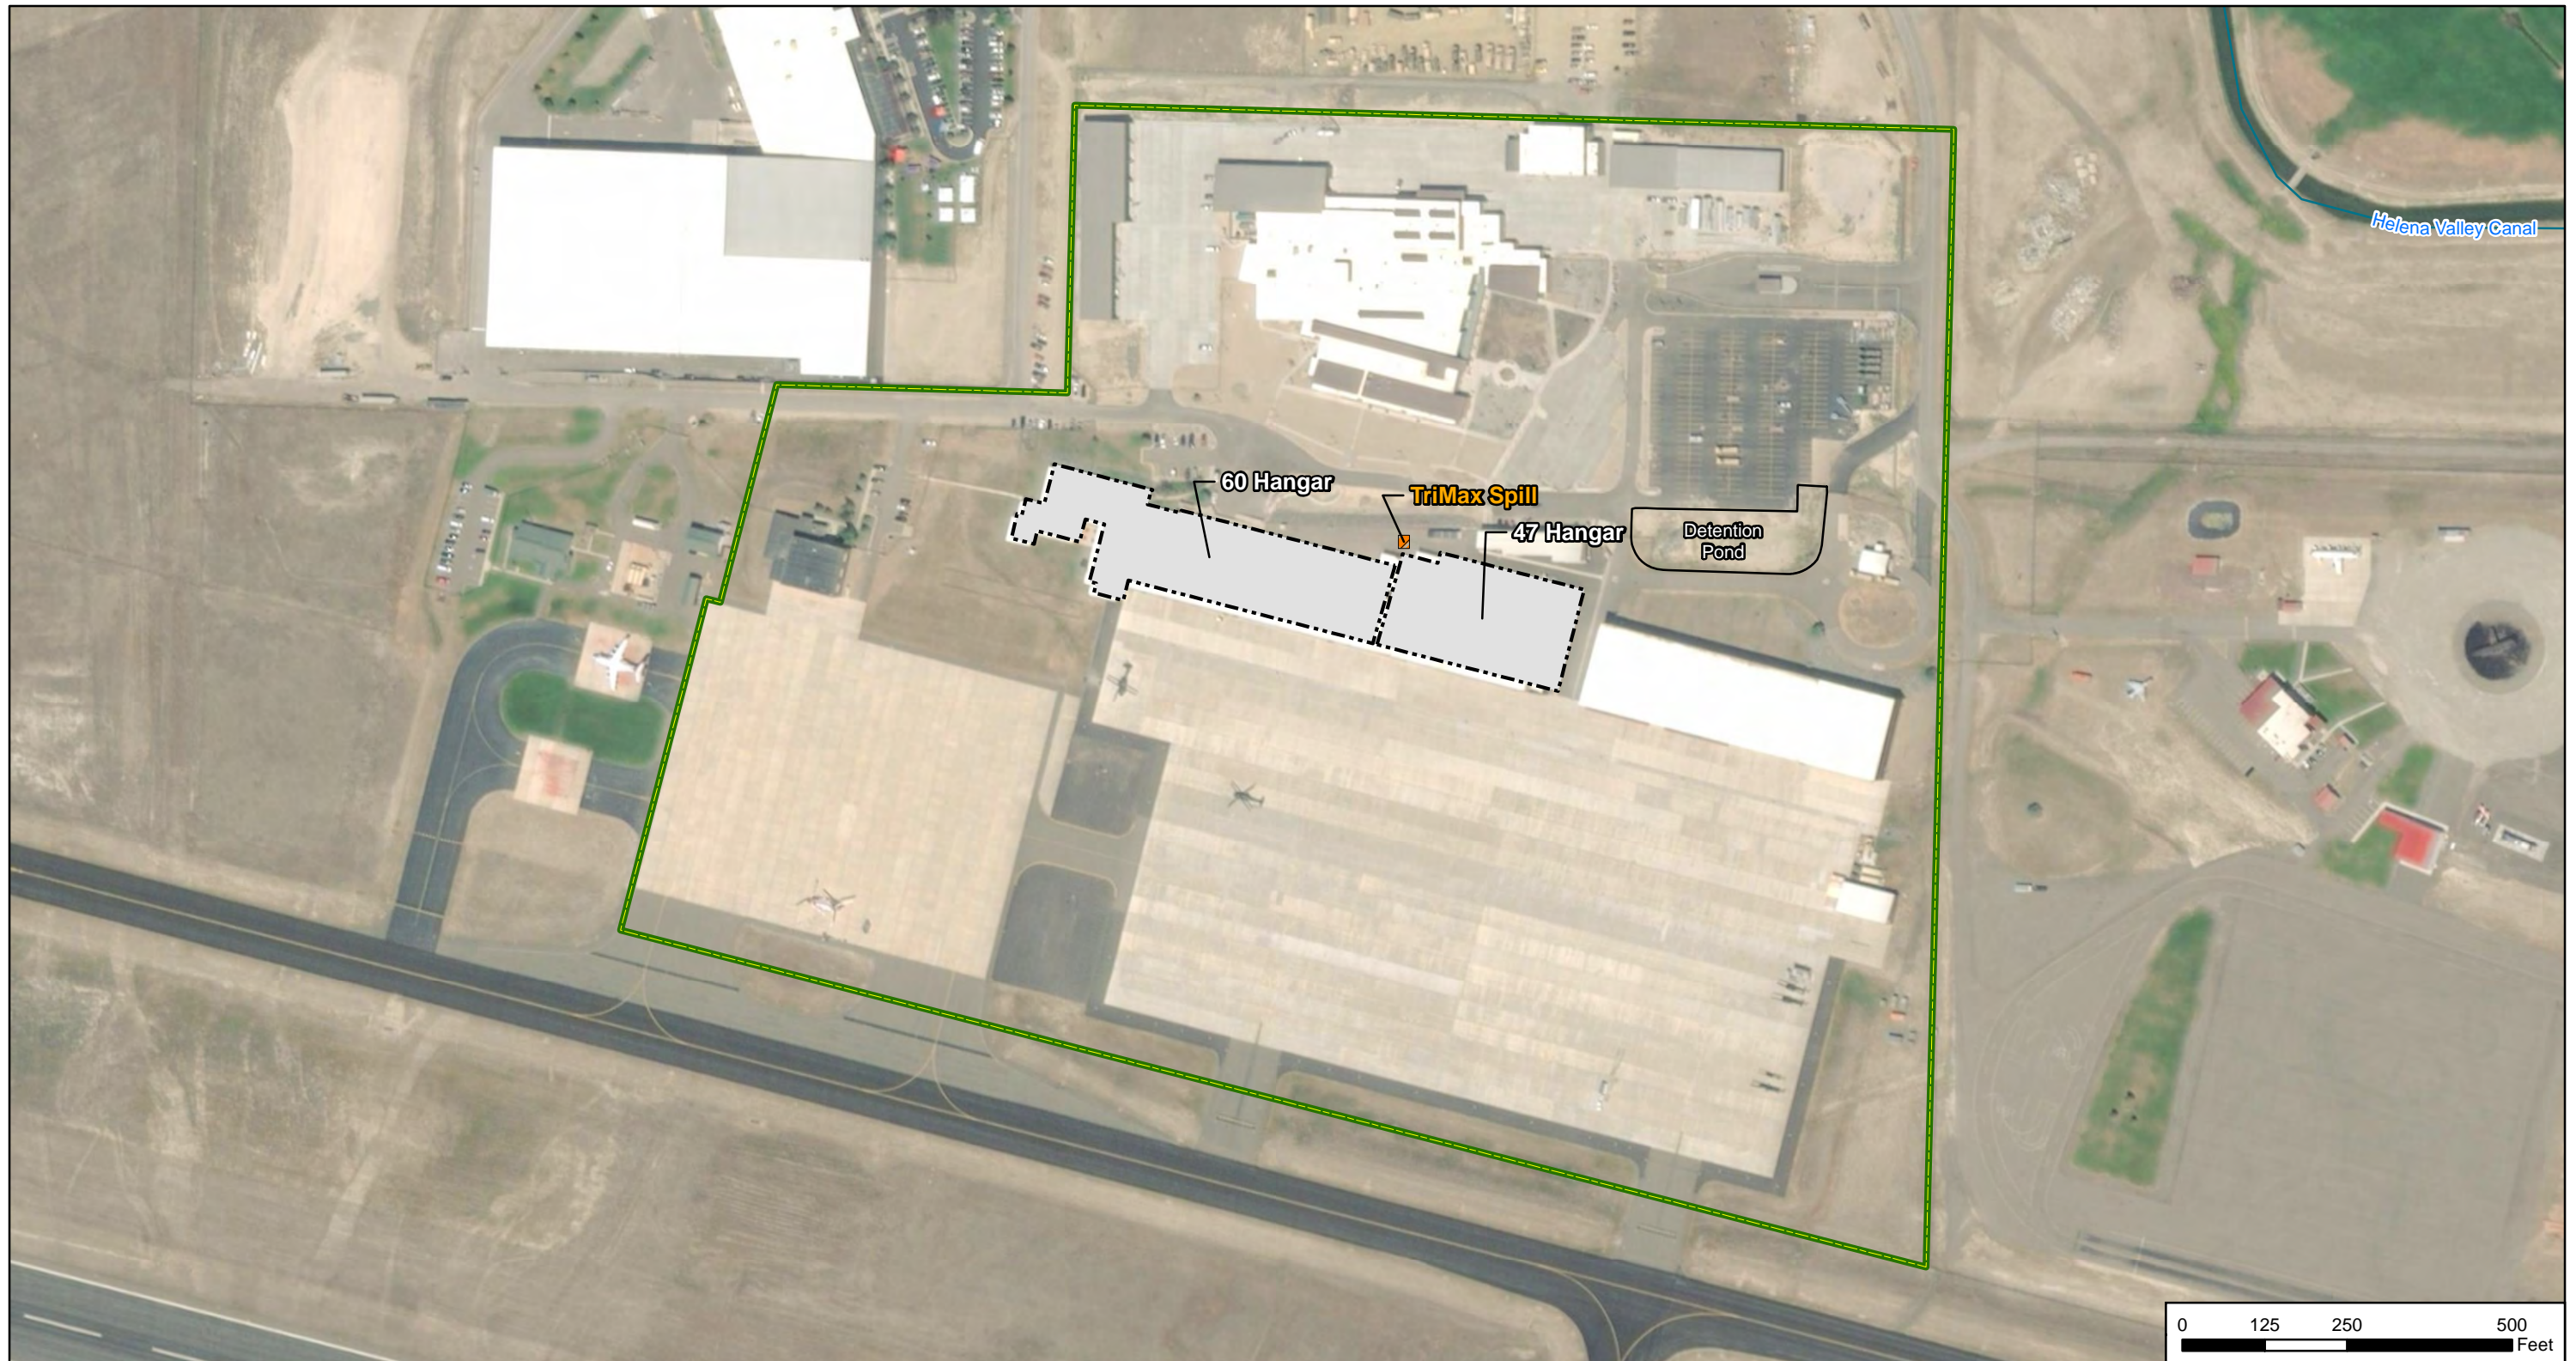
**Figure 3-1**

Three non-FTAs where AFFF was stored and/or potentially released were identified during the PA. A description of each non-FTA is presented below, and the non-FTAs are shown on **Figure 3-1**.

The 60 Hangar is located on the western side of the current AASF (**Figure 3-1**). The geographic coordinates are 46°36'31.50"N and 111°58'18.55"W. The 60 Hangar was built in 1999 and houses rotary-winged aircraft. Originally, AFFF was stored at the 60 Hangar in a 400-gallon aboveground storage tank and supplied the fire suppression system. According to interviewees, the AFFF was never released, and in 2011, the fire suppression system was retrofitted. During the renovation, the AFFF was removed by Tyco SimplexGrinnell and replaced with Jet-X High Expansion Foam. The Jet-X High Expansion Foam system was tested in 2012 during which all material from the new suppression system flowed into a floor drain that runs the length of the 60 Hangar and discharged to the Helena Publicly Owned Treatment Works. Interview documents appear in **Appendix B**. Because the AFFF was discharged to the Helena Publicly Owned Treatment Works, a potential PFAS release to the environment at the 60 Hangar is not suspected.

The 47 Hangar is located adjacent to the 60 Hangar on the eastern side of the current AASF (**Figure 3-1**). The geographic coordinates are 46°36'30.97"N and 111°58'13.86"W. The 47 Hangar was constructed in 2006 and houses rotary-winged aircraft. According to interviewees, the 47 Hangar contains a fire suppression system supplied with Jet-X High Expansion Foam and was tested once in 2006. For the test, 60 gallons of Jet-X concentrate was mixed with 1940 gallons of water. All Jet-X High Expansion Foam flowed into a floor drain that runs the length of the 47 Hangar and discharged to the Helena Publicly Owned Treatment Works. Interview documents appear in **Appendix B**. Because the AFFF was discharged to the Helena Publicly Owned Treatment Works, a potential PFAS release to the environment at the 47 Hangar is not suspected.

The current AASF is equipped with 16 TriMax 30 foam fire extinguishers. Prior to construction of the 47 Hangar in 2006, these fire extinguishers were filled behind the most eastern end of the 60 Hangar. Interviewees indicated that one time in the early 2000s, during filling of the fire extinguishers, a 5-gallon jug of TriMax 30 concentrate (3 percent AFFF) spilled onto the concrete (**Figure 3-1**). The spilled TriMax 30 possibly ran into a drain that empties into a detention pond to the northeast of the 47 Hangar (**Figure 3-1**). The geographic coordinates of the TriMax Spill Area are 46°36'32.14"N and 111°58'15.60"W. The geographic coordinates of the detention pond are 46°36'32.92"N and 111°58'8.53"W. Photographs appear in **Appendix C**.

Interviewees also indicated that the fire extinguishers were initially stored outside, and during the winter of 1998 or 1999, one of the fire extinguishers froze and split the casing. A spill was not noted, and fire extinguishers are now stored in the Hangars. Fire extinguisher training is conducted annually with dish soap on the ramp to the south of the 60 Hangar. According to interviewees, the fire extinguishers have never been used for putting out fires at the current AASF. The Helena Regional Airport is now responsible for servicing the fire extinguishers. Interview documents appear in **Appendix B**.

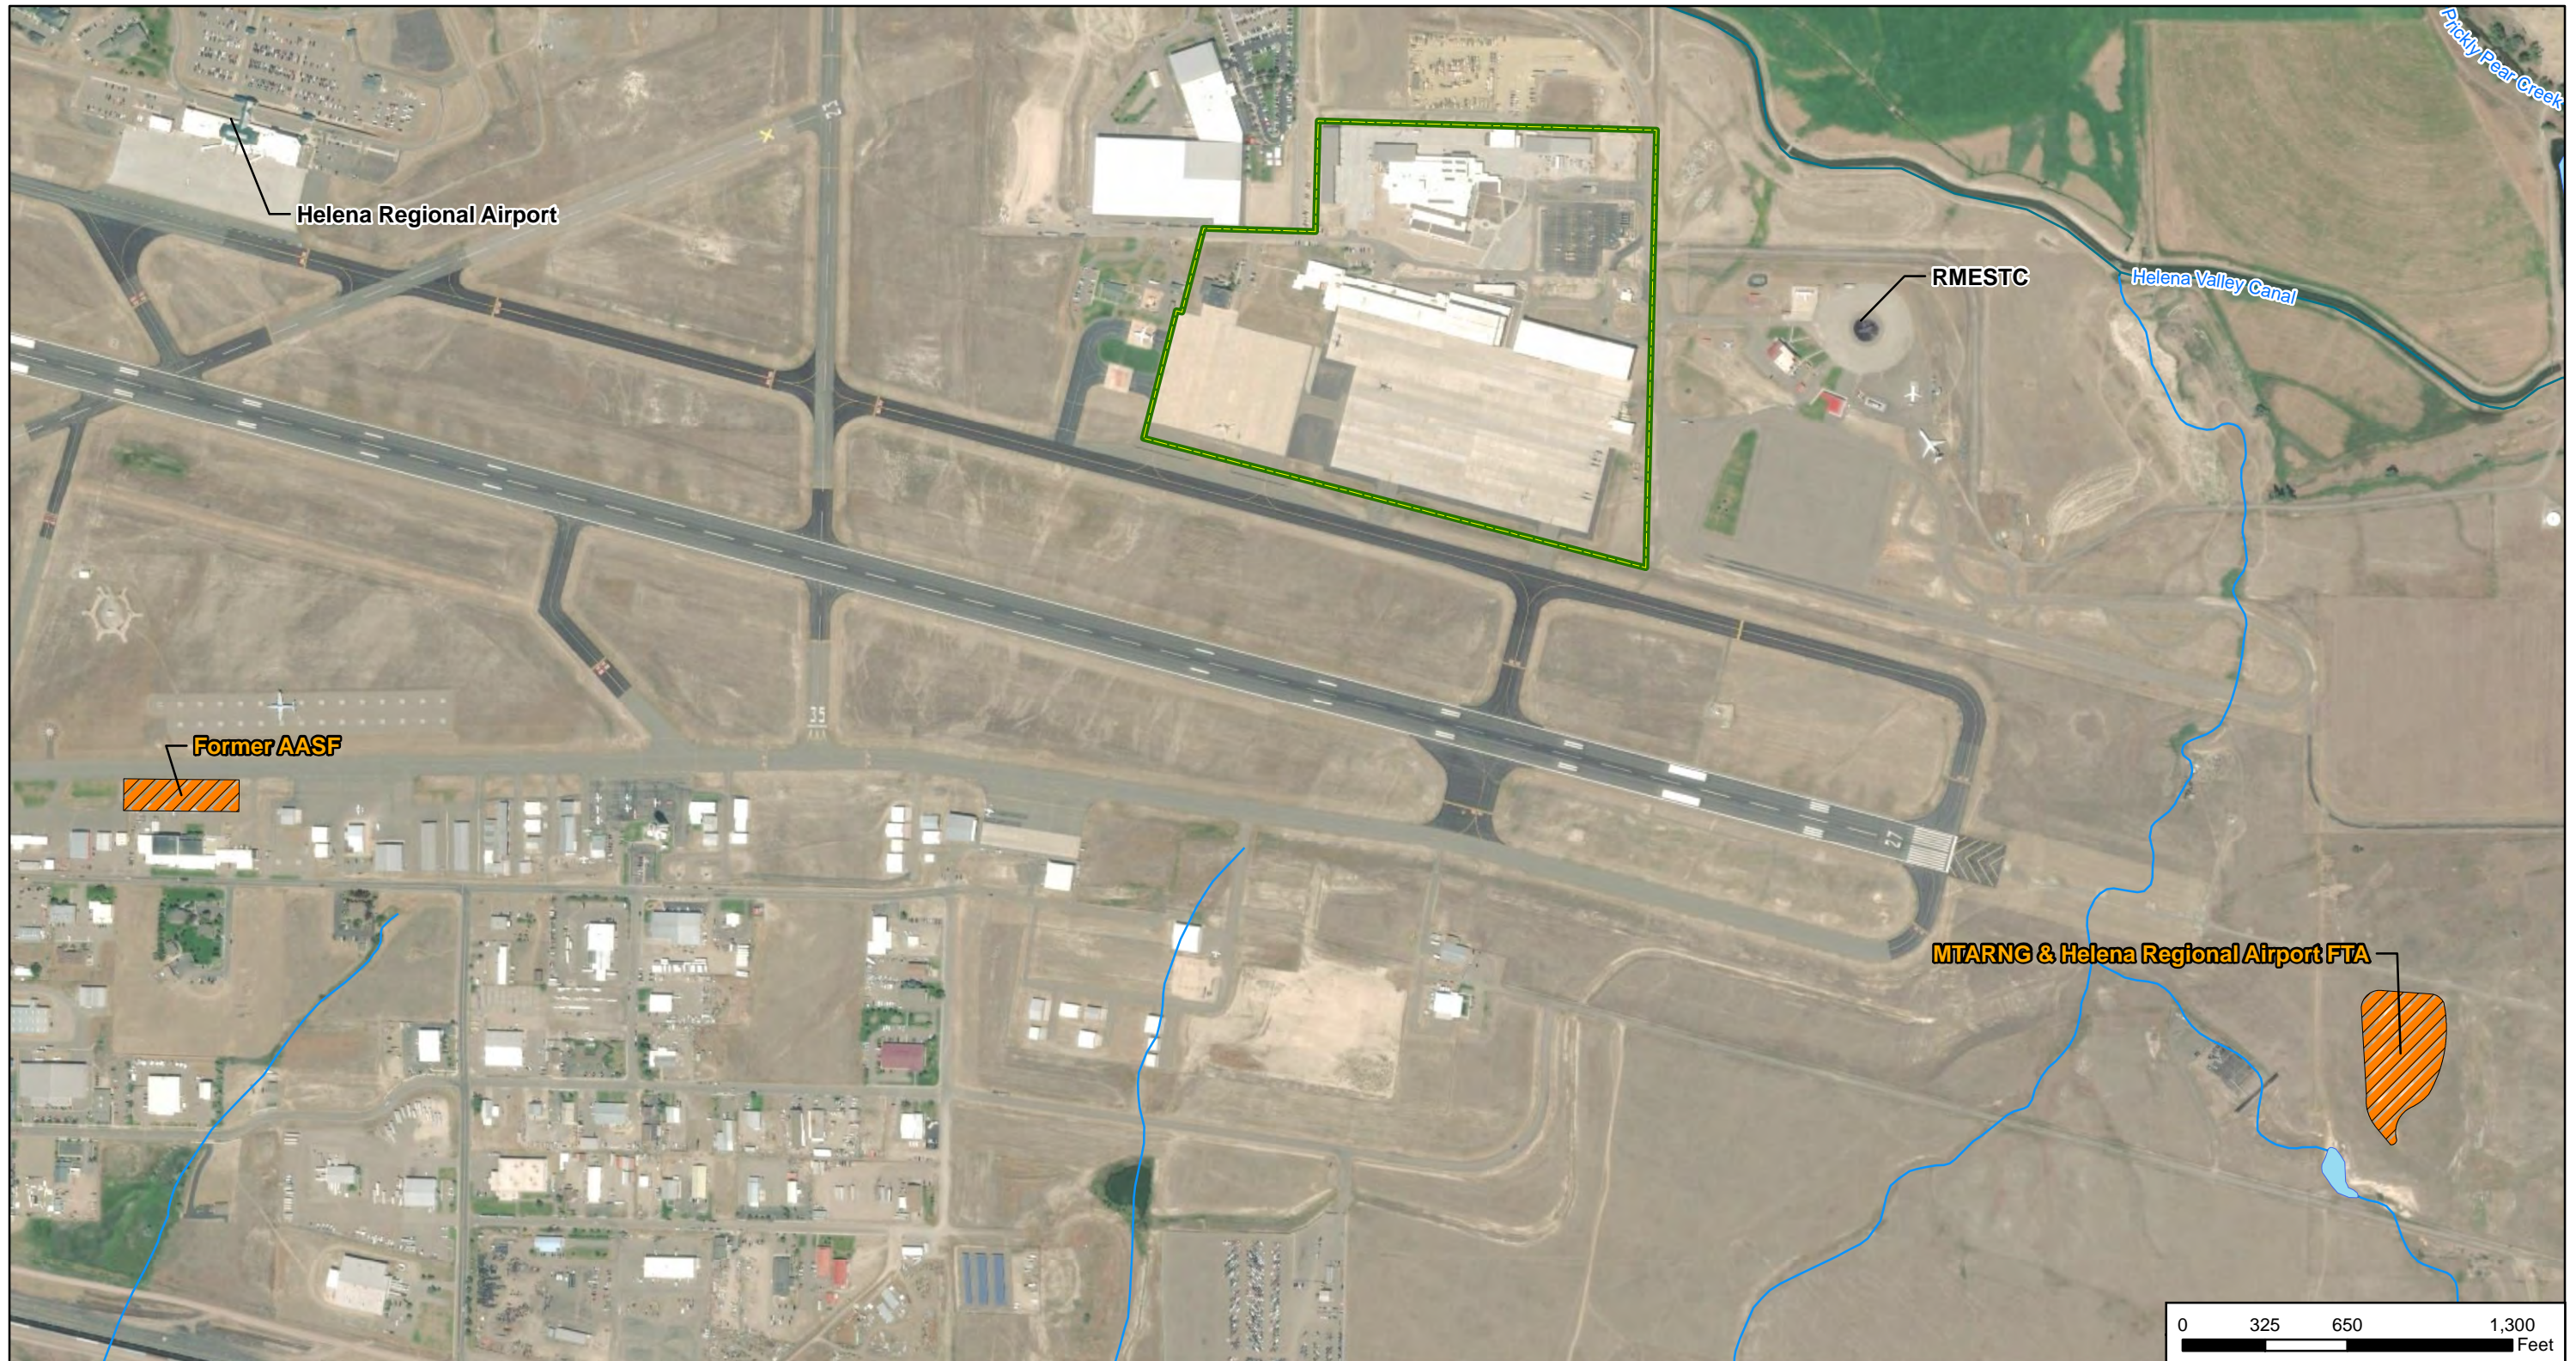
<b>Potential Off-Facility Sources</b>	
<b>AECOM</b>	12420 Milestone Center Drive Germantown, MD 20876
<b>Figure 5-1</b>

Four potential off-facility sources of PFAS adjacent to the current AASF, not under the control of the MTARNG, were identified during the PA. A description of each adjacent source is presented below, and the adjacent sources are shown on **Figure 5-1**.

The Former AASF is located due south of the Helena Regional Airport, just north of Airport Road (**Figure 5-1**). The geographic coordinates are 46°36'07.6"N and 111°59'24.3"W. The Former AASF was constructed in 1958, with additions completed in 1972 and 1978. One interviewee indicated the MTARNG periodically sprayed AFFF behind the red brick building at this location. No information was available on the amount or concentration of AFFF used at the Former AASF. Interview documents appear in **Appendix B**. The AASF moved to the current location in 1998.

The MTARNG 1049th Engineer Detachment conducted coordinated fire training with the Helena Regional Airport at the east end of Runway 9/27 (**Figure 5-1**) at least once per year from 1982 until the early 2000s. The geographic coordinates are 46°36'04.1"N and 111°57'21.3"W. According to the MTARNG 1049th Team Chief, fuels and solvents contained on an old school bus were ignited during the training and extinguished with AFFF. No information was available on the amount or concentration of AFFF used during the training. Interview documents appear in **Appendix B**. The FTA is on land owned and operated by the HRAA.

The Helena Regional Airport terminal is located approximately 3/4 mile west of the current AASF (**Figure 5-1**). The geographic coordinates are 46°36'36.8"N and 111°59'24.7"W. The runways for the Helena Regional Airport are located within 100 feet south of the AASF ramp. The Helena Regional Airport was dedicated in 1928 and is owned and operated by the HRAA. No information was available on the use of AFFF by the Helena Regional Airport; however, the Helena Regional Airport is a primary commercial service airport and provides all emergency services for the current AASF. Therefore, the potential for PFAS use by the Helena Regional Airport exists.

The RMESTC is located approximately 1/4 mile east of the current AASF (**Figure 5-1**). The geographic coordinates are 46°36'31.4"N and 111°57'52.2"W. The RMESTC was dedicated in 1996 and is owned and operated by the HRAA. The RMESTC contains a variety of fire training scenarios within an 8,800 square foot fire pit and is used for training by various entities, including the current MTARNG AASF and the Helena Regional Airport. No information was available on the use of PFAS at the RMESTC.

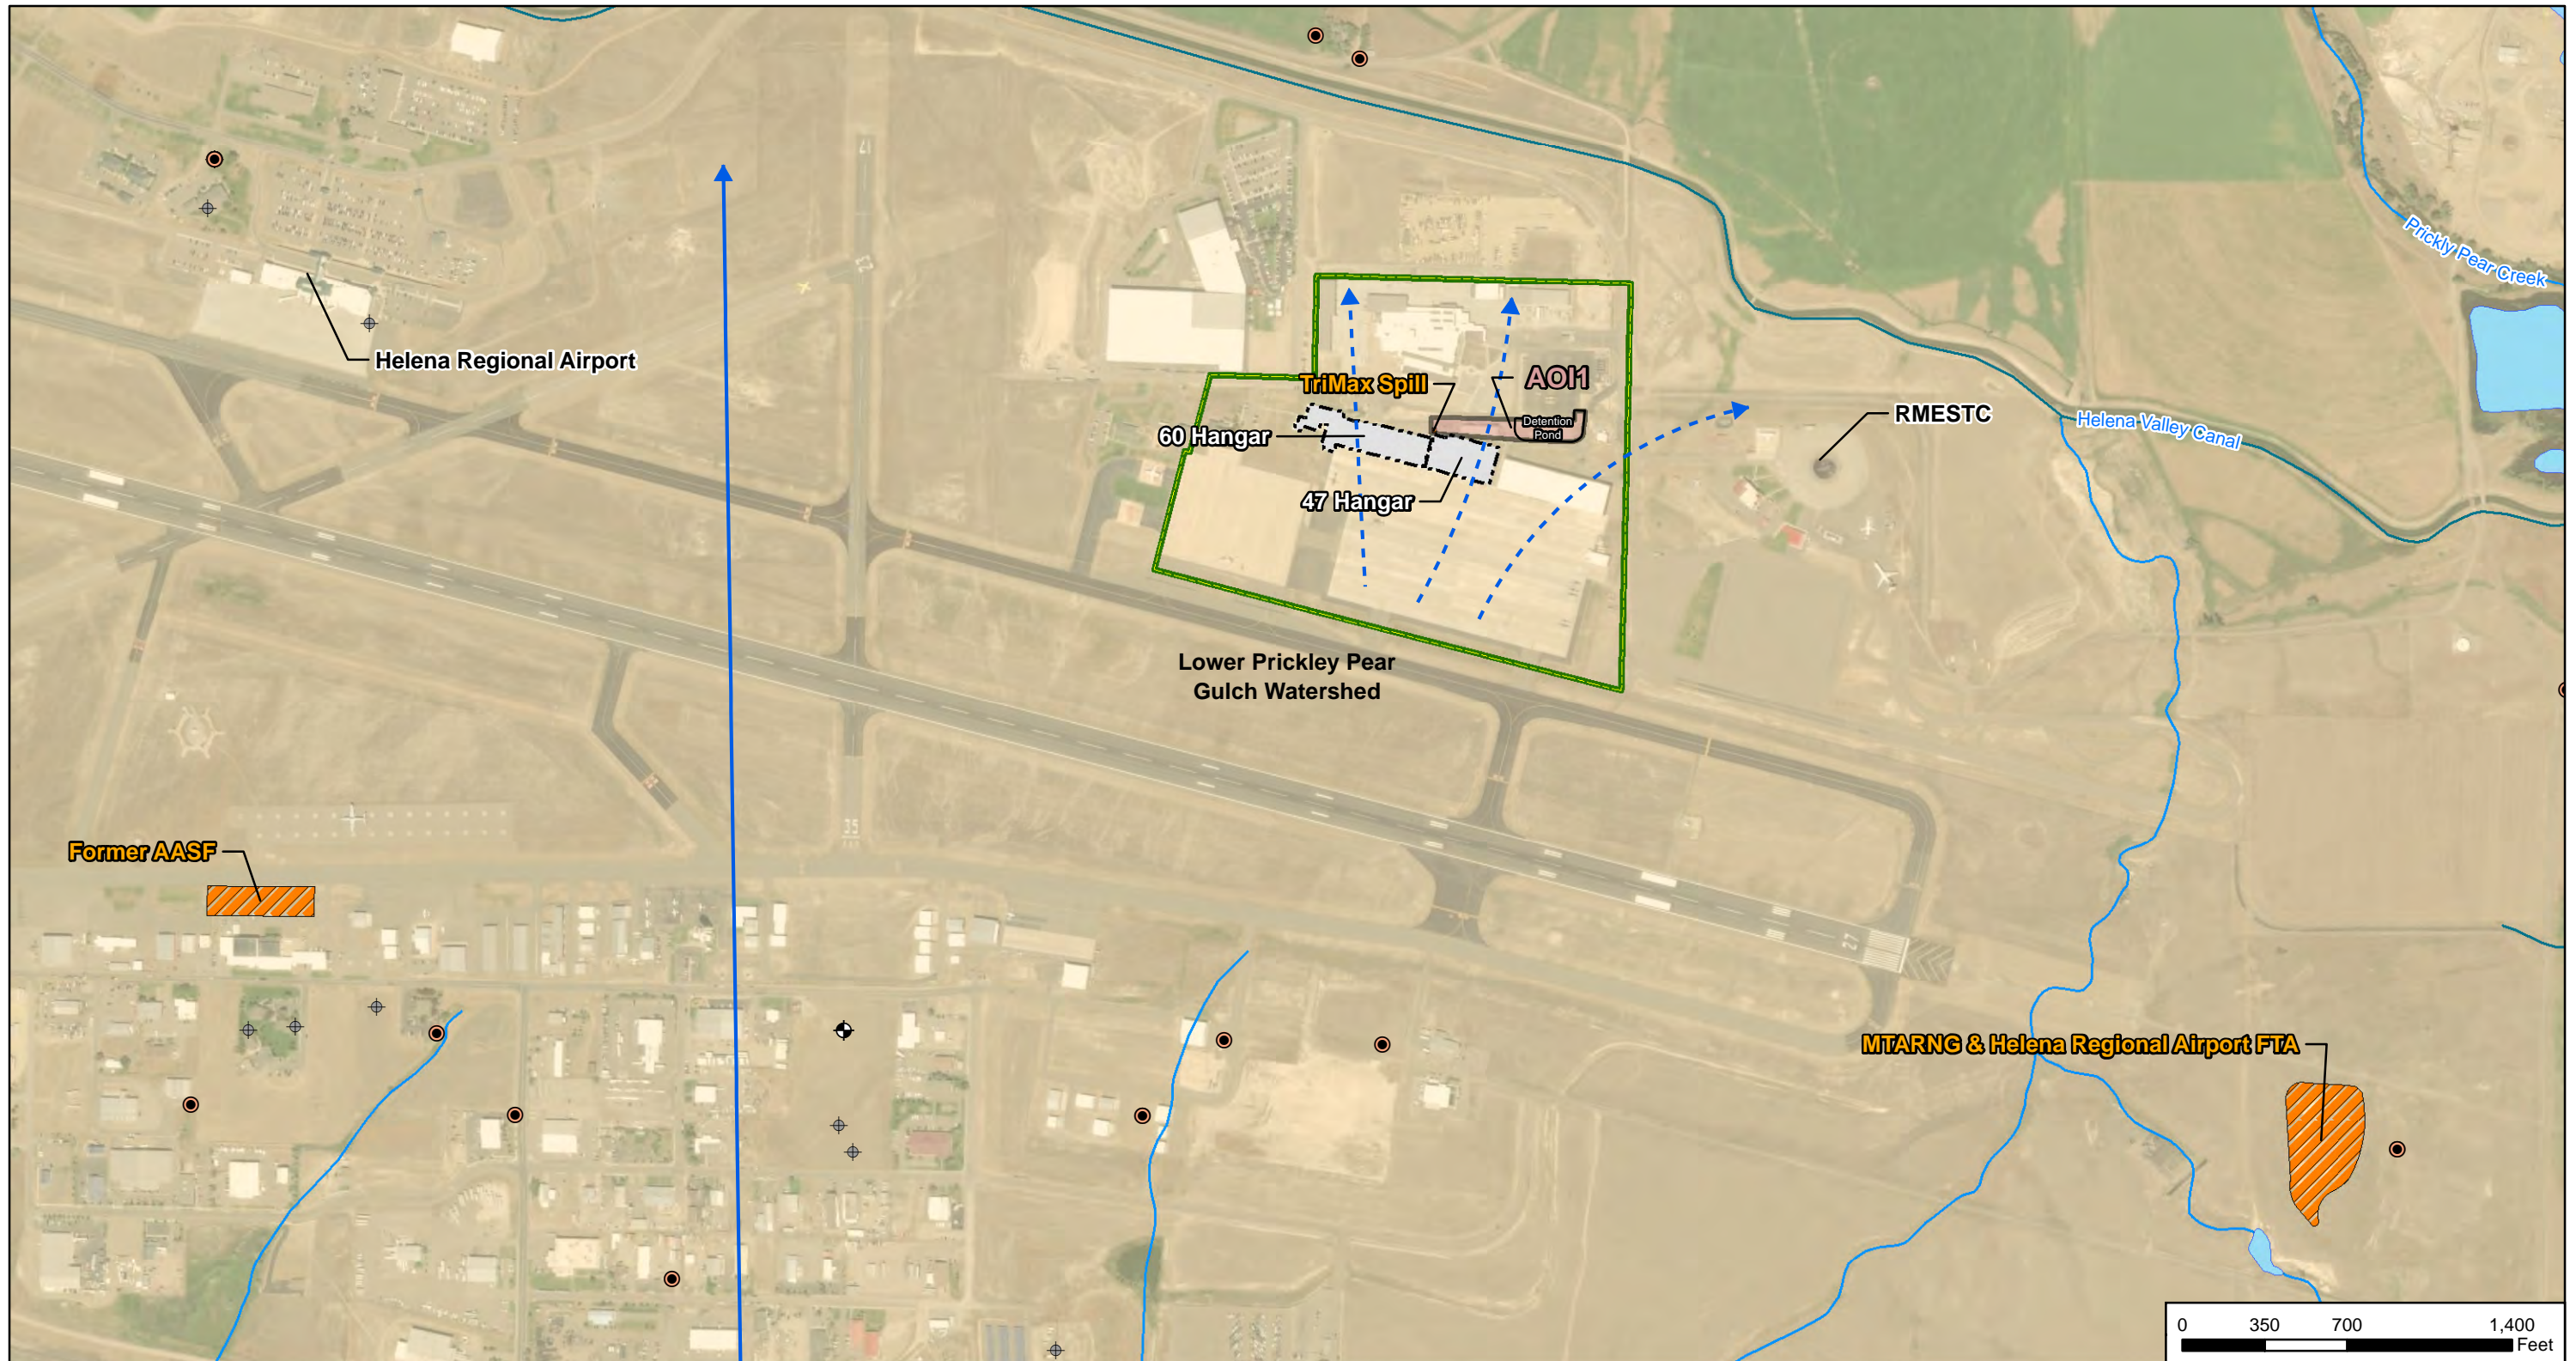
<b>Areas of Interest</b>	
	12420 Milestone Center Drive Germantown, MD 20876
<b>Figure 6-1</b>

Based on the PA findings, one area of interest (AOI) was identified at the current AASF: AOI 1 TriMax Spill Area. The AOI location is shown on **Figure 6-1**. The following sections describe the CSM components and the specific CSMs developed for AOI 1. The CSM identifies the three components necessary for a potentially complete exposure pathway: (1) source, (2) pathway, (3) receptor. If any of these elements are missing, the pathway is considered incomplete.

AOI 1 is the TriMax Spill Area. PFAS was potentially released once to the concrete surface at AOI 1 by the MTARNG in the early 2000s. During filling of fire extinguishers, a 5-gallon jug of TriMax 30 spilled onto the concrete behind the most eastern end of the 60 Hangar. The spilled TriMax 30 possibly ran into a drain that empties into a detention pond to the northeast of the 47 Hangar.

The detention pond is approximately 3 feet deep and collects runoff from most of the facility, including industrial stormwater runoff. Drainages have been diverted around the current AASF and unprocessed surface water is not used in the area, except for irrigation. Drinking water is supplied by the City of Helena; however, domestic wells are located downgradient of AOI 1 within four miles of the current AASF.

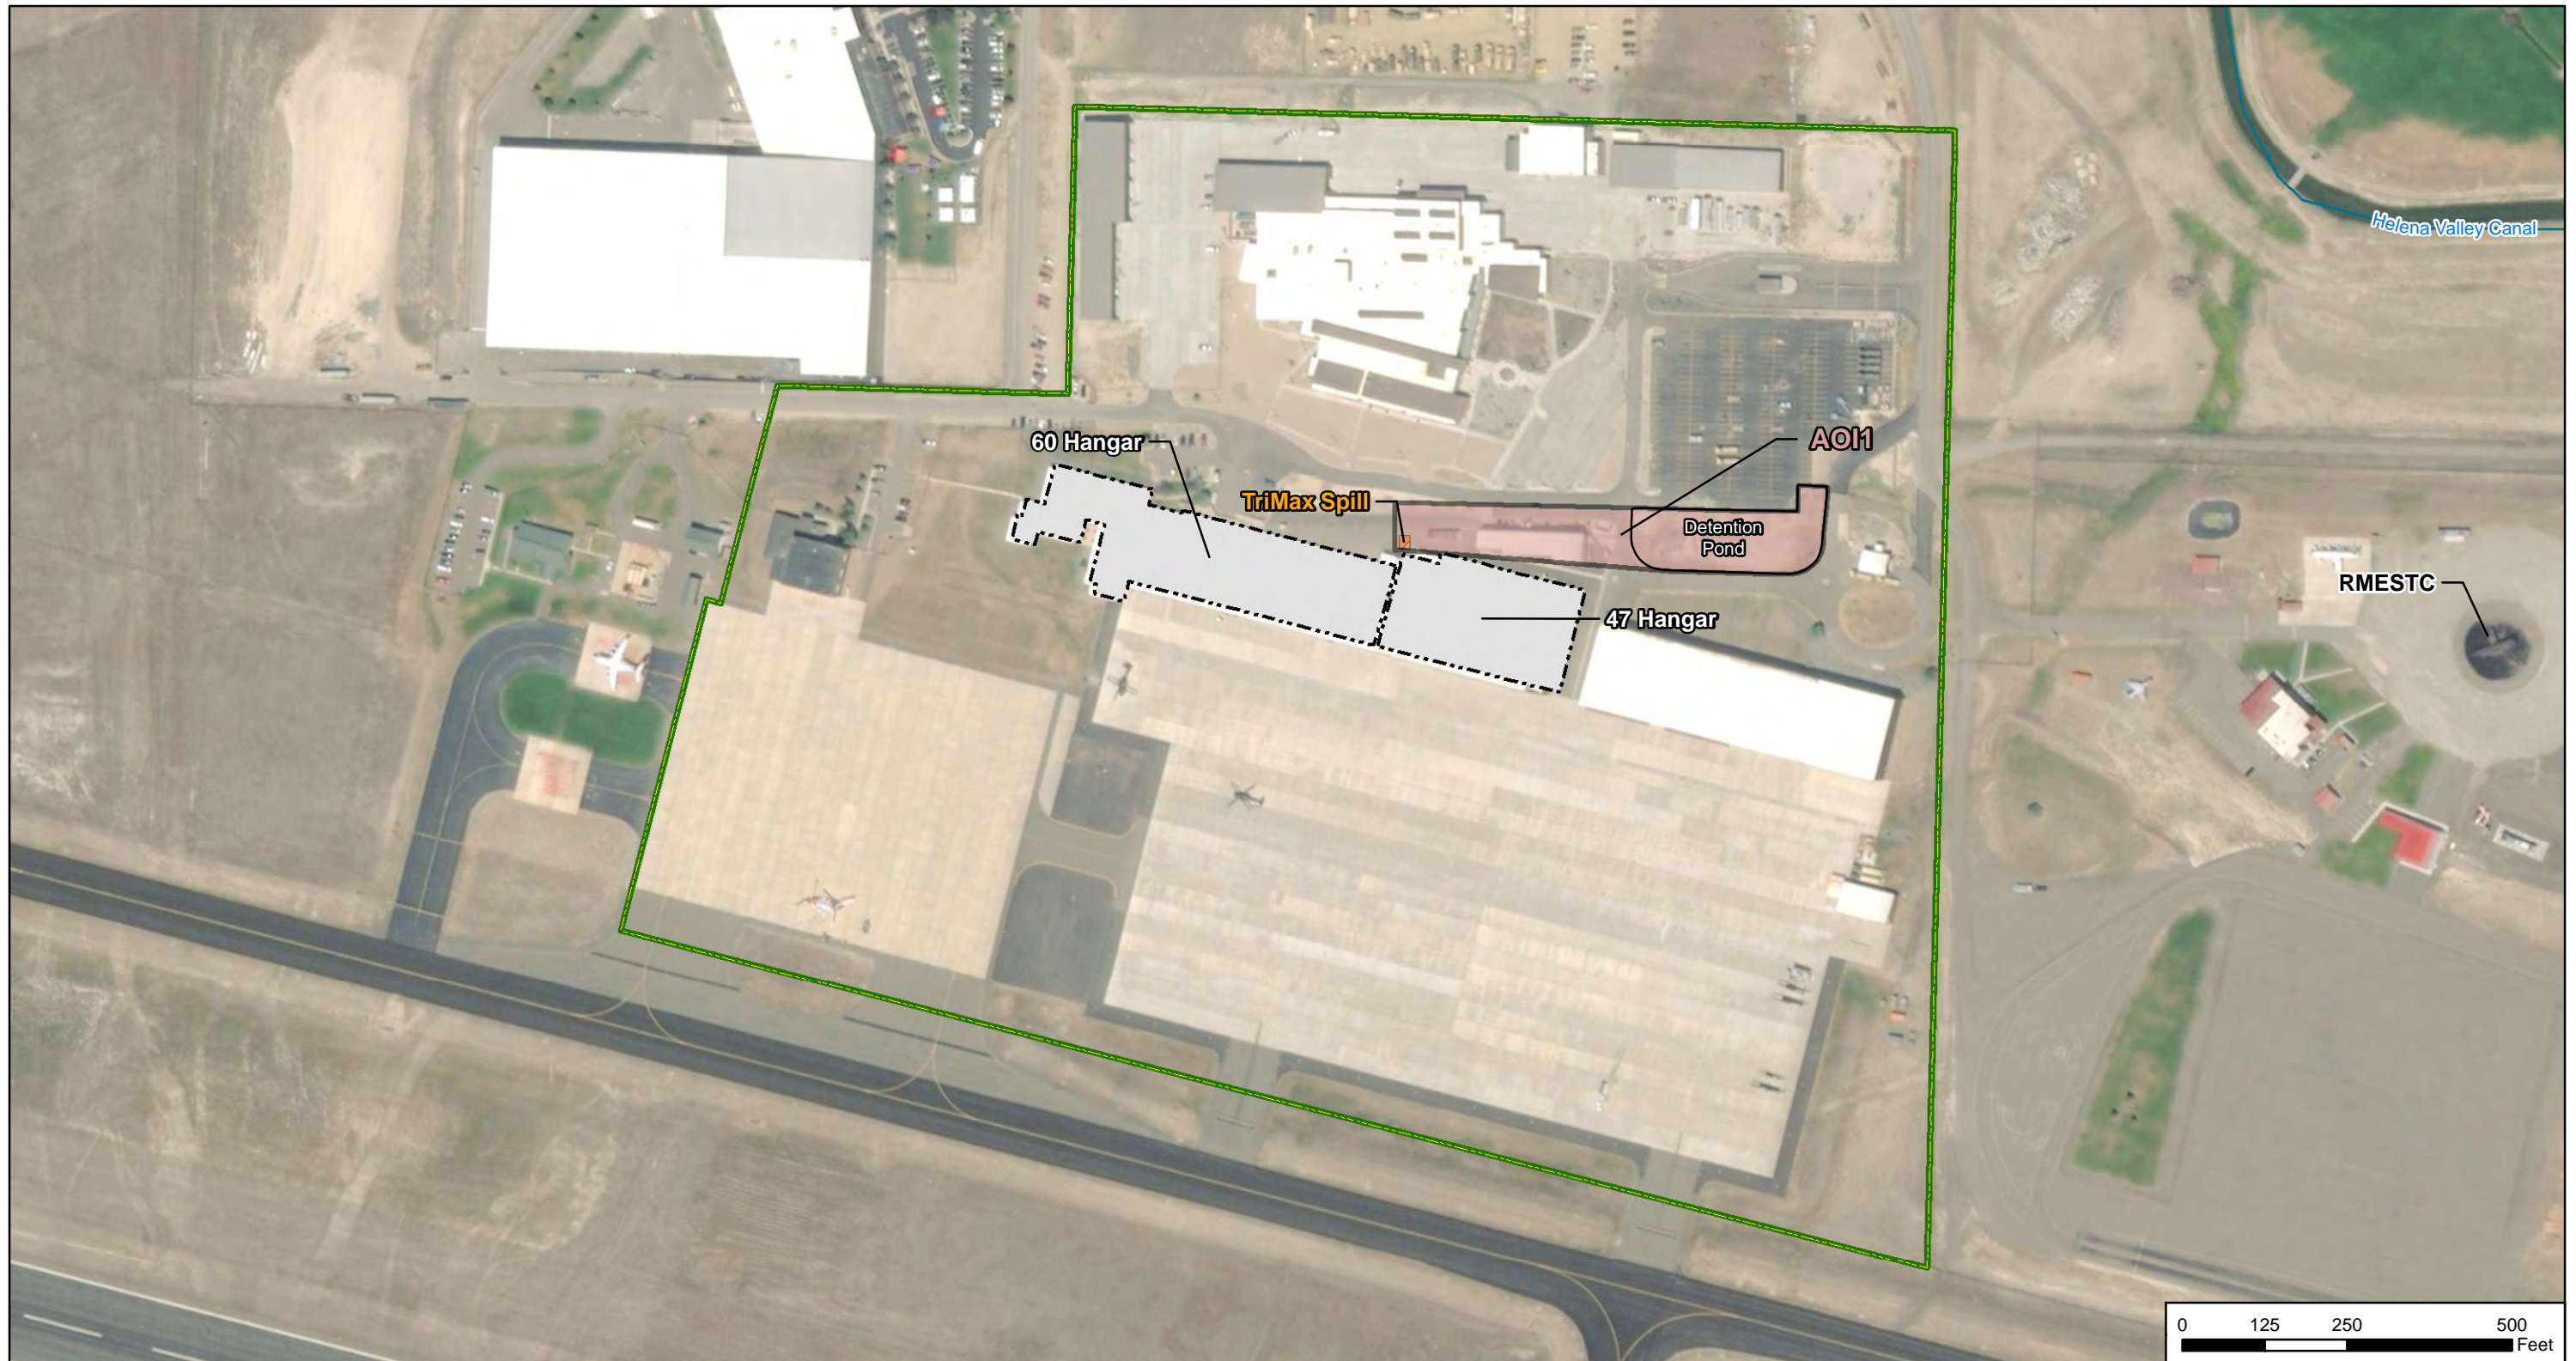
**Figure 7-1**

One AOI related to potential PFAS release was identified at the current Helena AASF during the PA (**Figure 7-1**):

Area of Interest	Name	Used by	Potential Release Dates
AOI 1	TriMax Spill Area	MTARNG	Early 2000s

Based on potential PFAS releases at this AOI, there is potential for exposure to PFAS contamination in surface soil and intermittent surface water and sediments to all receptors via ingestion and inhalation of dust, subsurface soil to site and construction workers via inhalation, and groundwater to residents via ingestion.
