FINAL Preliminary Assessment Report Fort William Henry Harrison, Montana

Perfluorooctane-Sulfonic Acid (PFOS) and Perfluorooctanoic
Acid (PFOA) Impacted Sites
ARNG Installations, Nationwide

August 2018

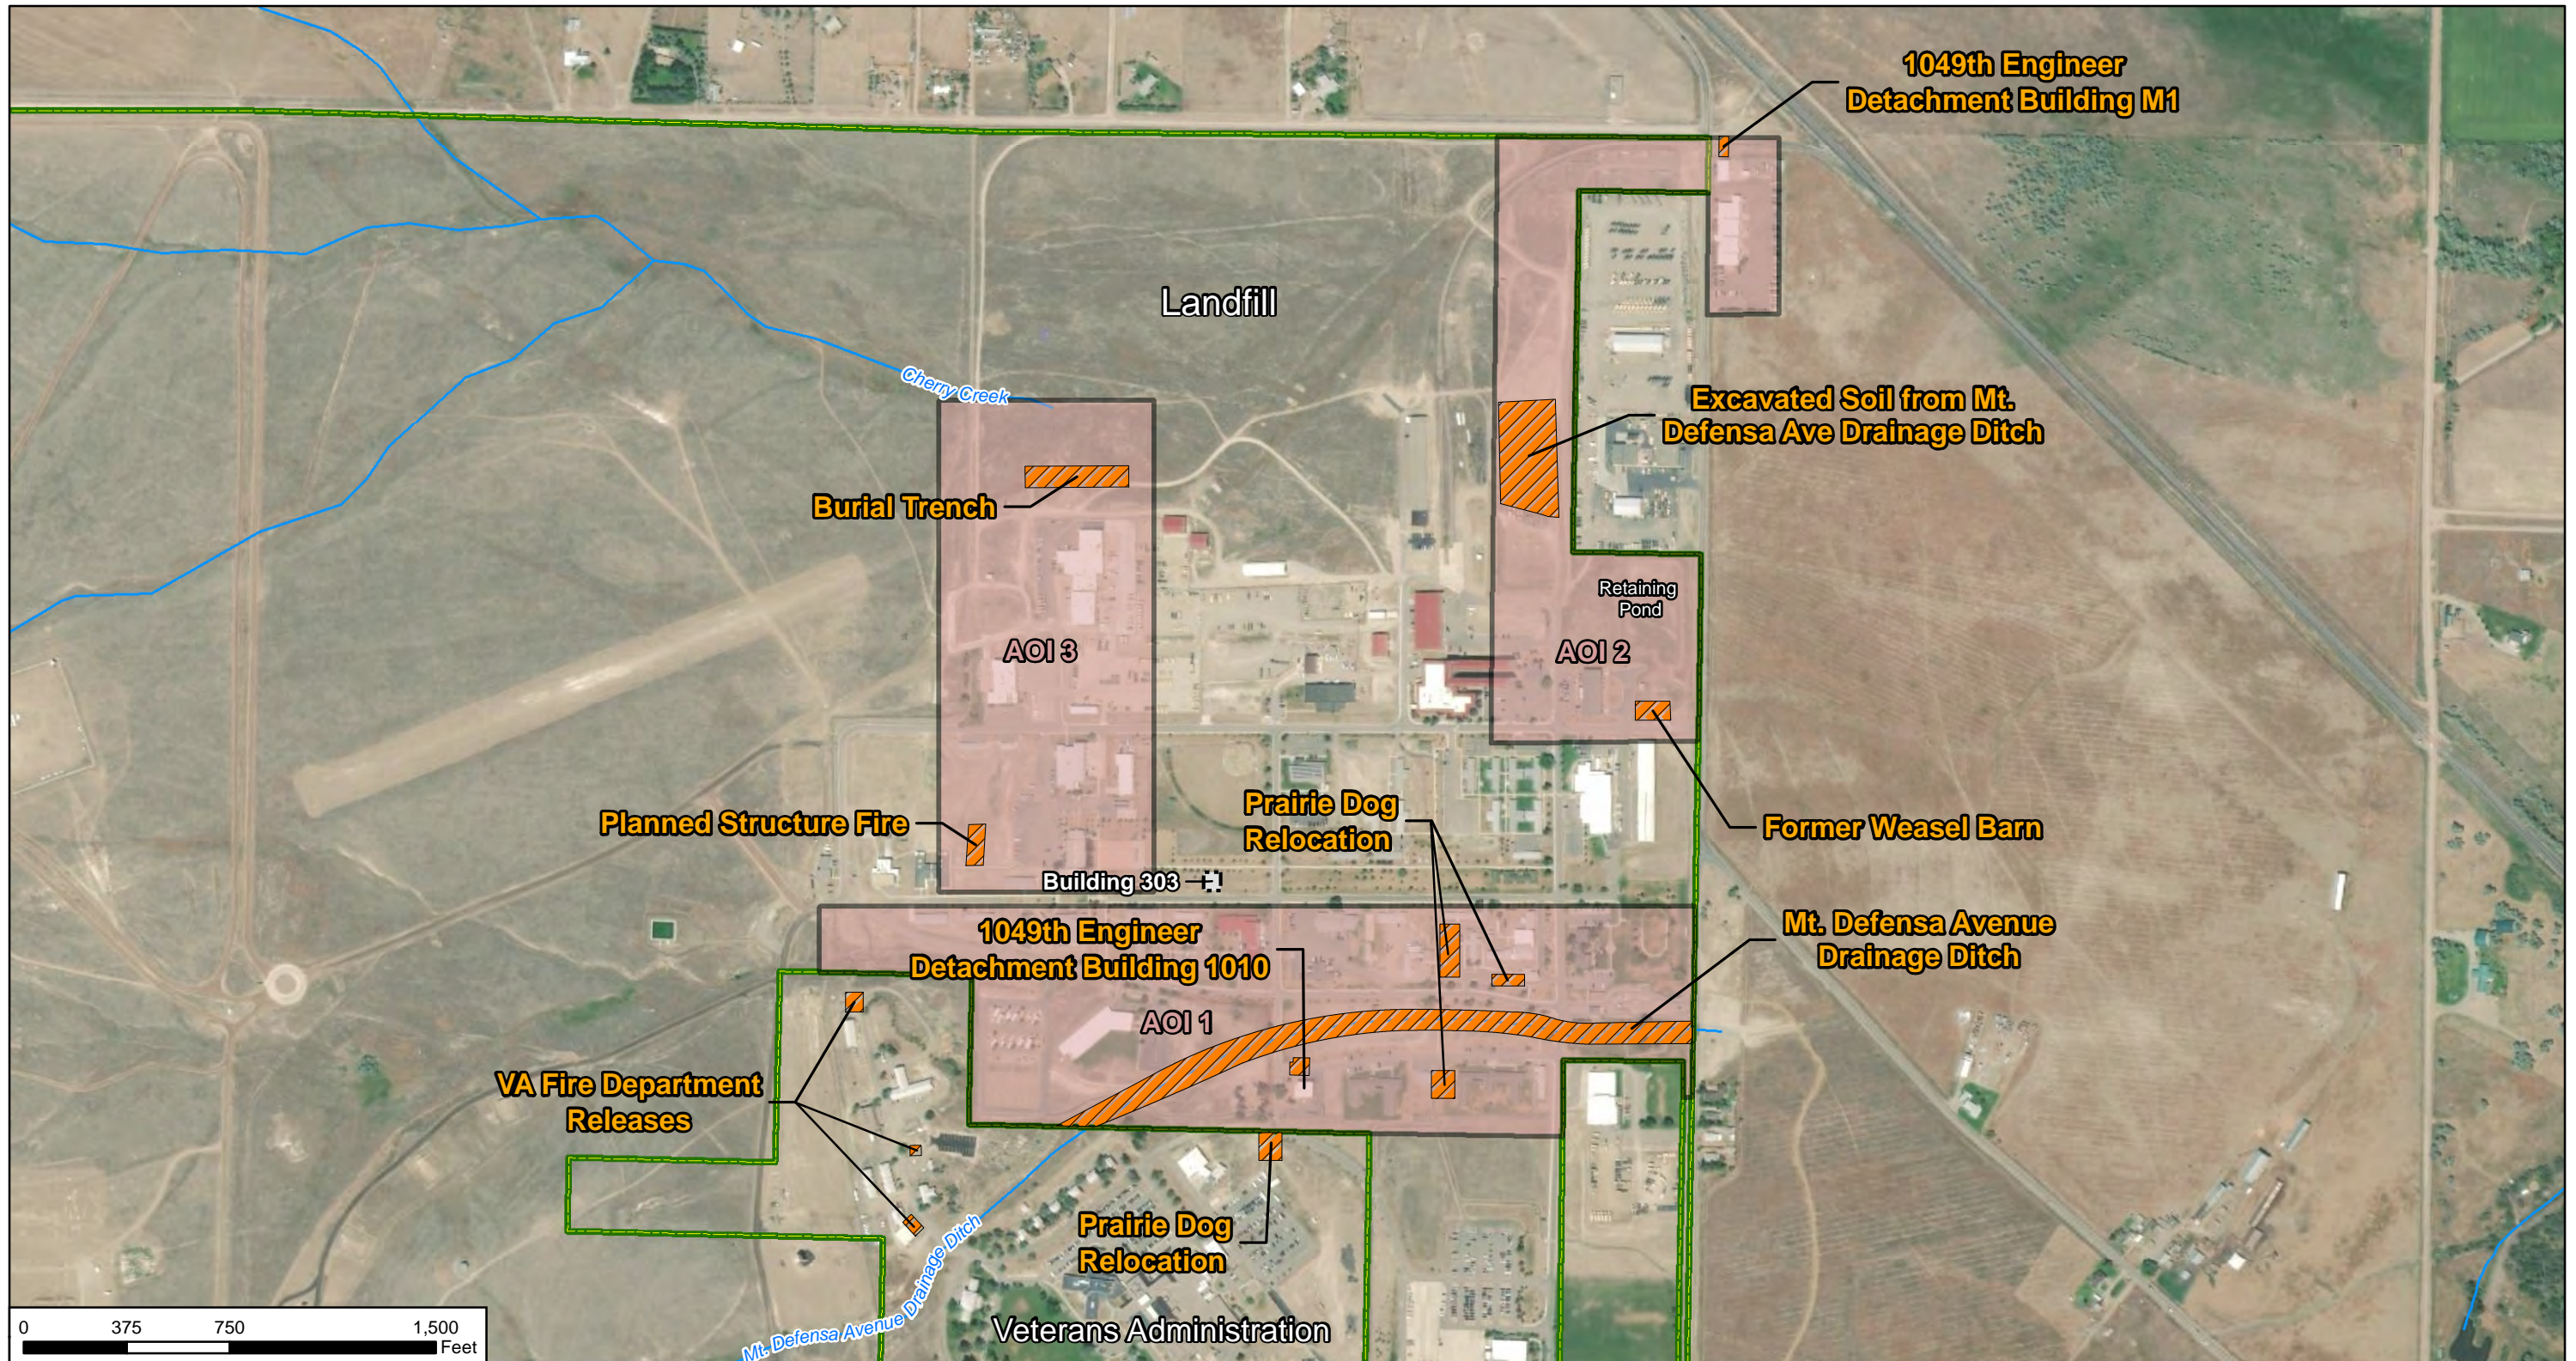
Figure ES-1

Three Areas of Interest (AOIs) related to potential PFAS releases were identified at FTWHH during the PA. The AOIs are shown on **Figure ES-1** and described below:

Summary of Findings

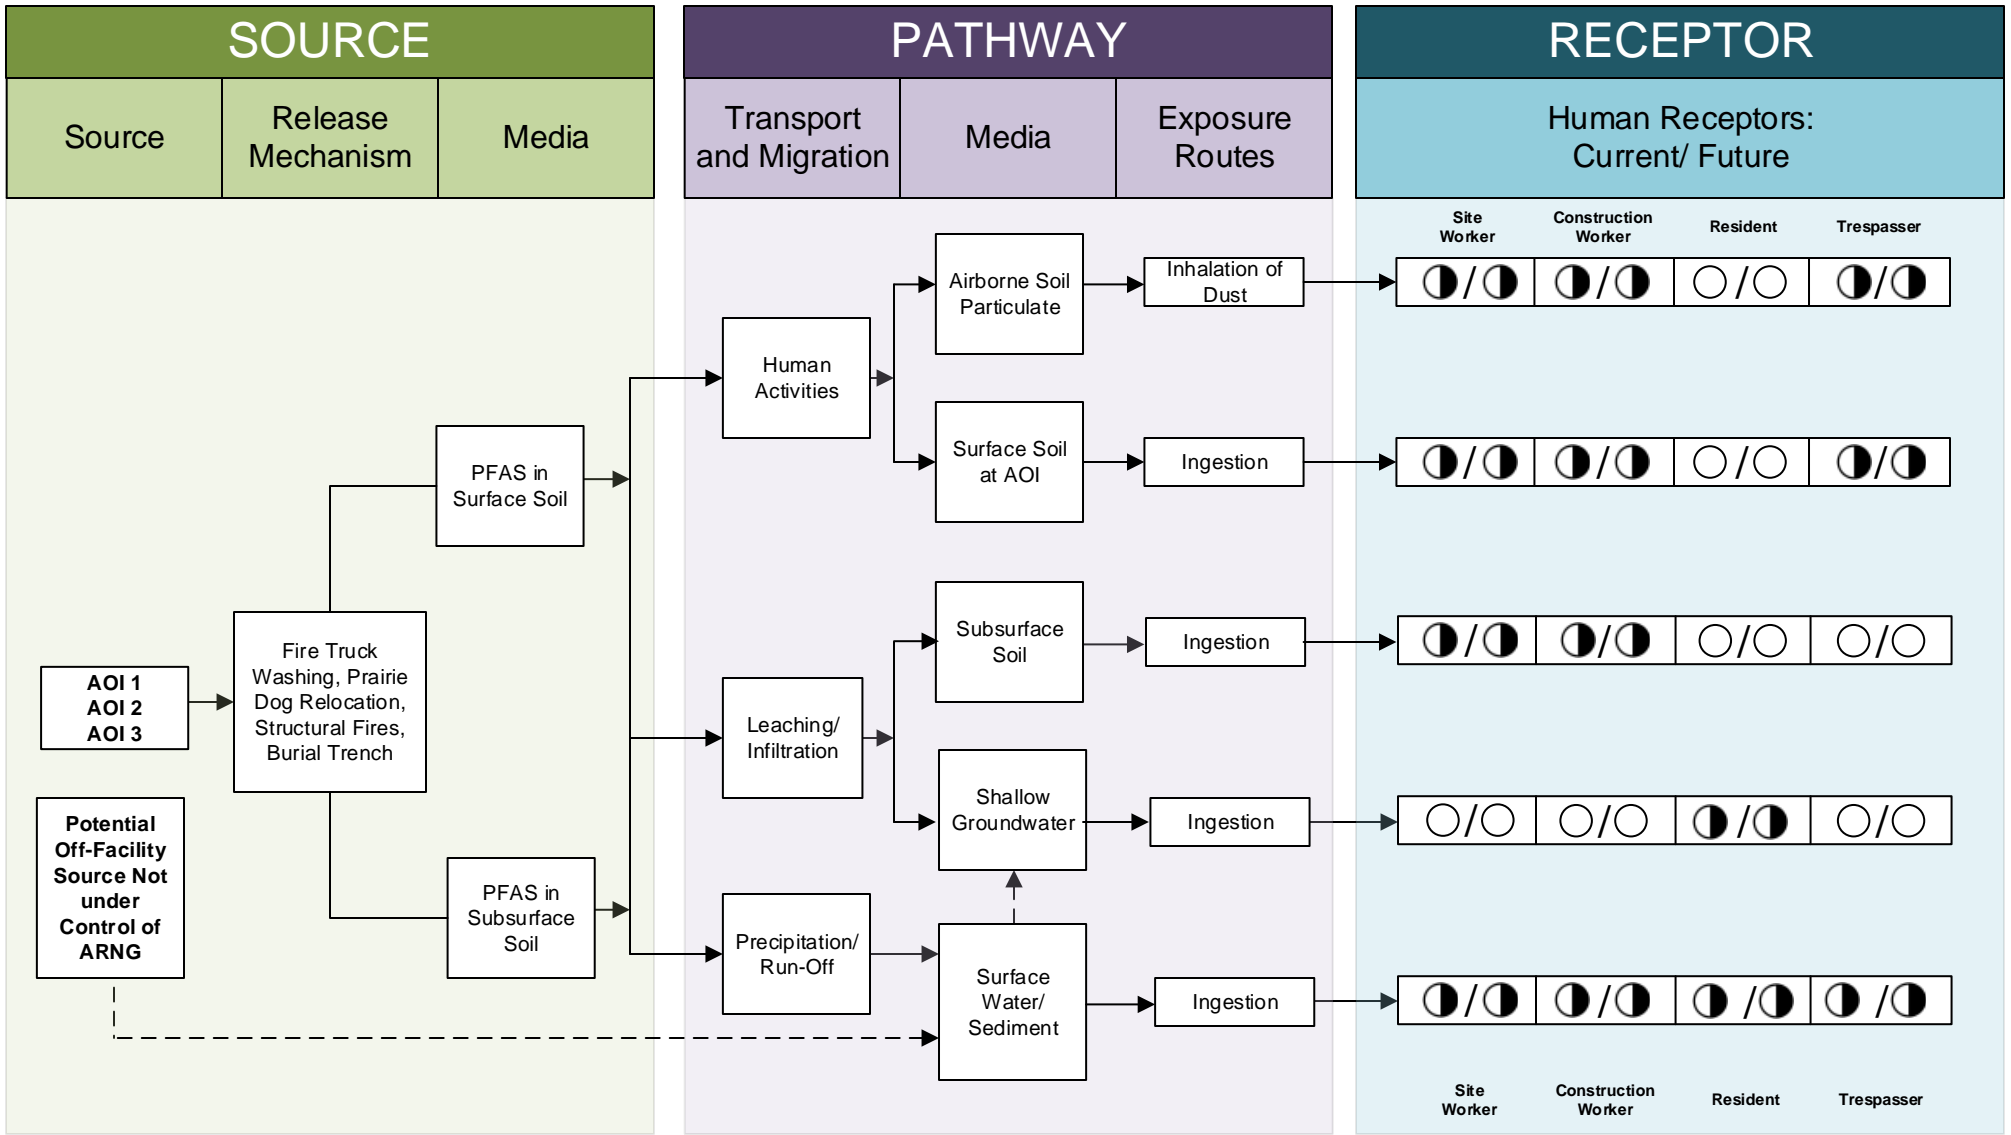
Figure ES-2
Conceptual Site Model
Fort William Henry Harrison

Based on documented potential PFAS releases at these AOIs, there is potential for exposure to PFAS contamination in surface soil and intermittent surface water and sediments to site and construction workers and trespassers via ingestion and inhalation, subsurface soil to site and construction workers via inhalation, and groundwater to residents via ingestion. The CSM for FTWHH is shown on **Figure ES-2**.

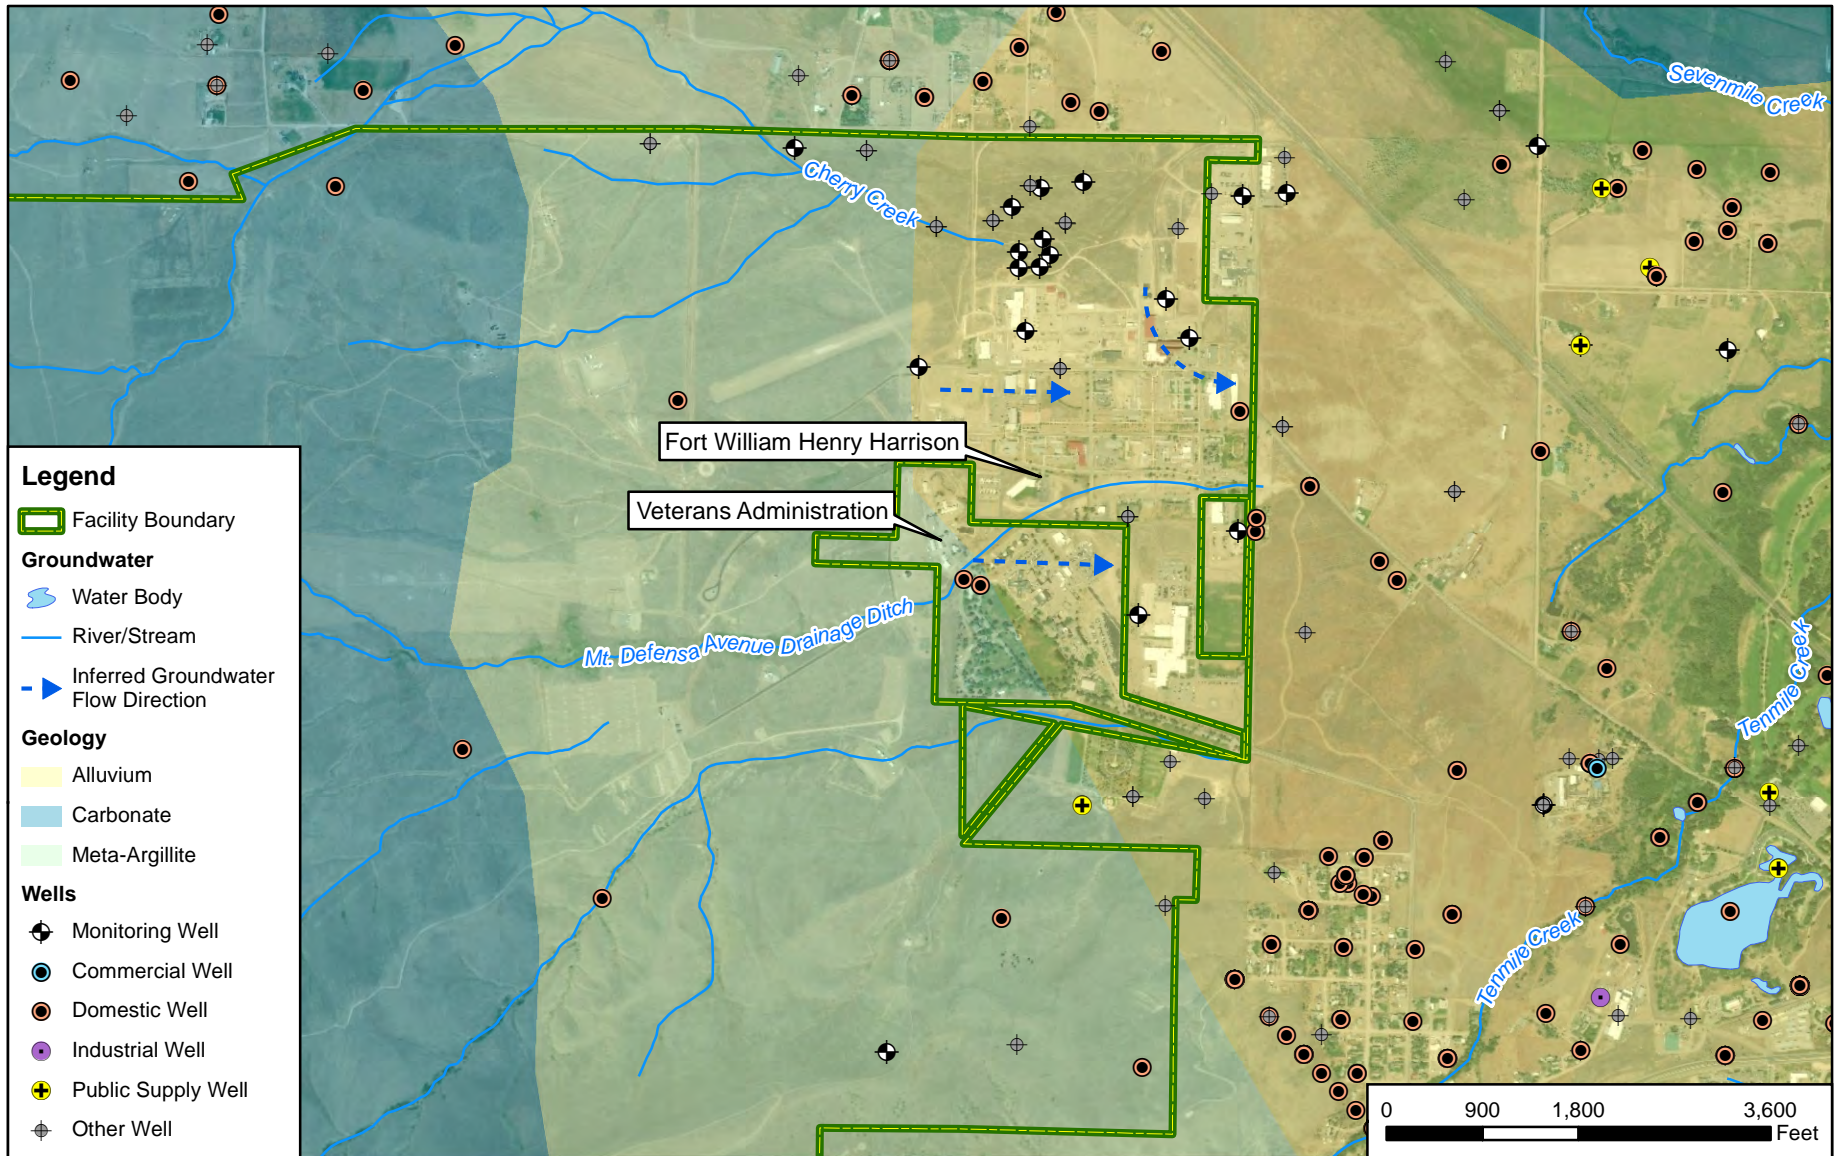
TITLE	Groundwater Features	
AECOM	12420 Milestone Center Drive Germantown, MD 20876	Figure 1-2

(MTDEQ 2006) (**Figure 1-2**). However, groundwater flow direction may be seasonally impacted by watering of the golf course at Green Meadow Country Club, which is approximately one mile southeast of the facility.

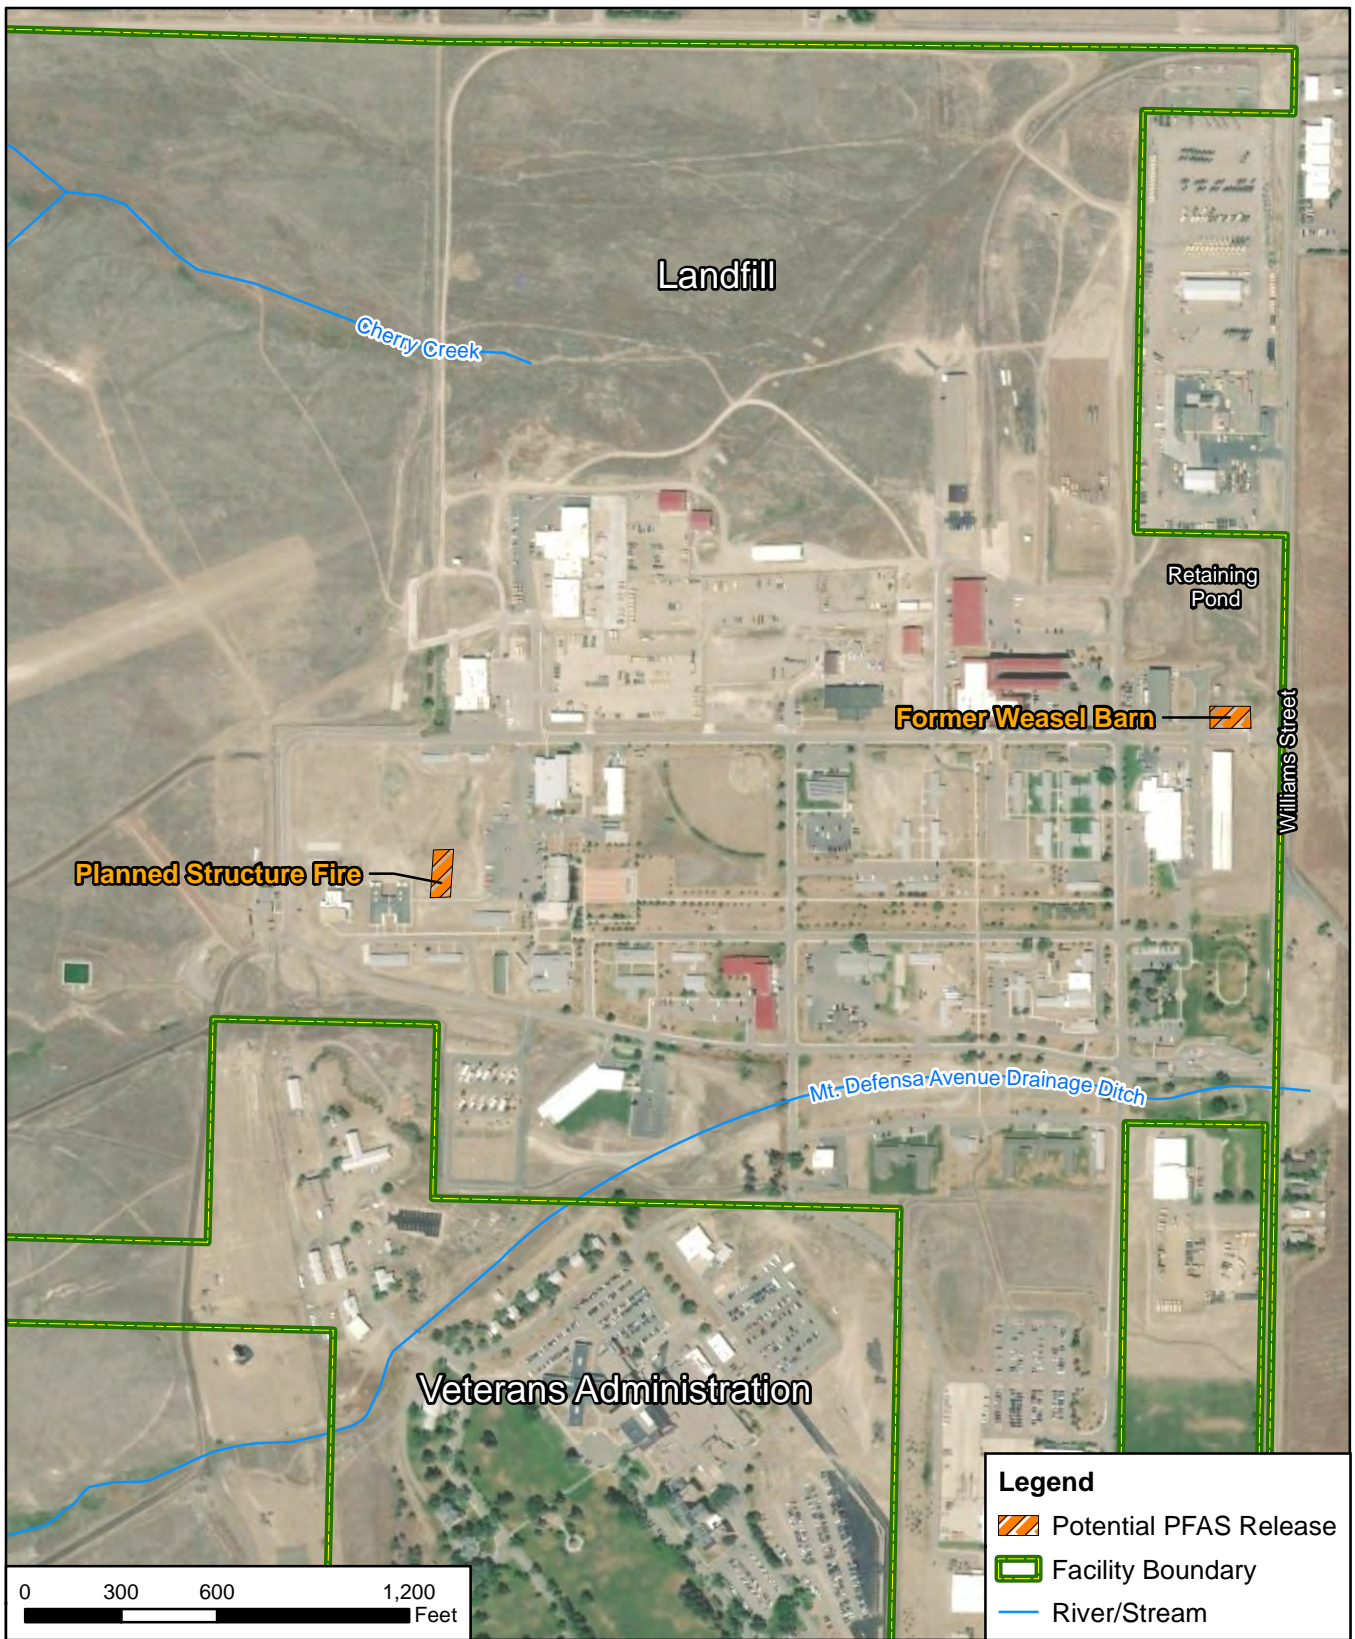
Two planned structure fires used for fire training at FTWHH were identified during the PA (**Figure 2-1**). The former Weasel Barn located in the northeast section of the Cantonment Area, north of Sanananda Drive, was demolished in the winter of 2002 as part of a fire training exercise. The geographic coordinates are 46°37'29.5"N and 112°05'43.4"W. The MTARNG 1049th burned the structure, and the MTARNG 1049th Team Chief recalled using AFFF to extinguish the fire. No information was available on the concentration or amount of AFFF used during the event, and no remediation activities have occurred at this location. The Montana Tools Program building was constructed at the location of the former weasel barn.

A second structure was burned in the northwest portion of the Cantonment Area near the current Dining Facility (Building 410). The geographic coordinates are 46°37'24.4"N and 112°06'17.9"W. The MTARNG 1049th Team Chief also recalled using AFFF to extinguish this structure fire. Based on aerial photography, the structure was burned sometime between 1995 and 2002. No information was available on the concentration or amount of AFFF used during the event, and no remediation activities have occurred at this location.

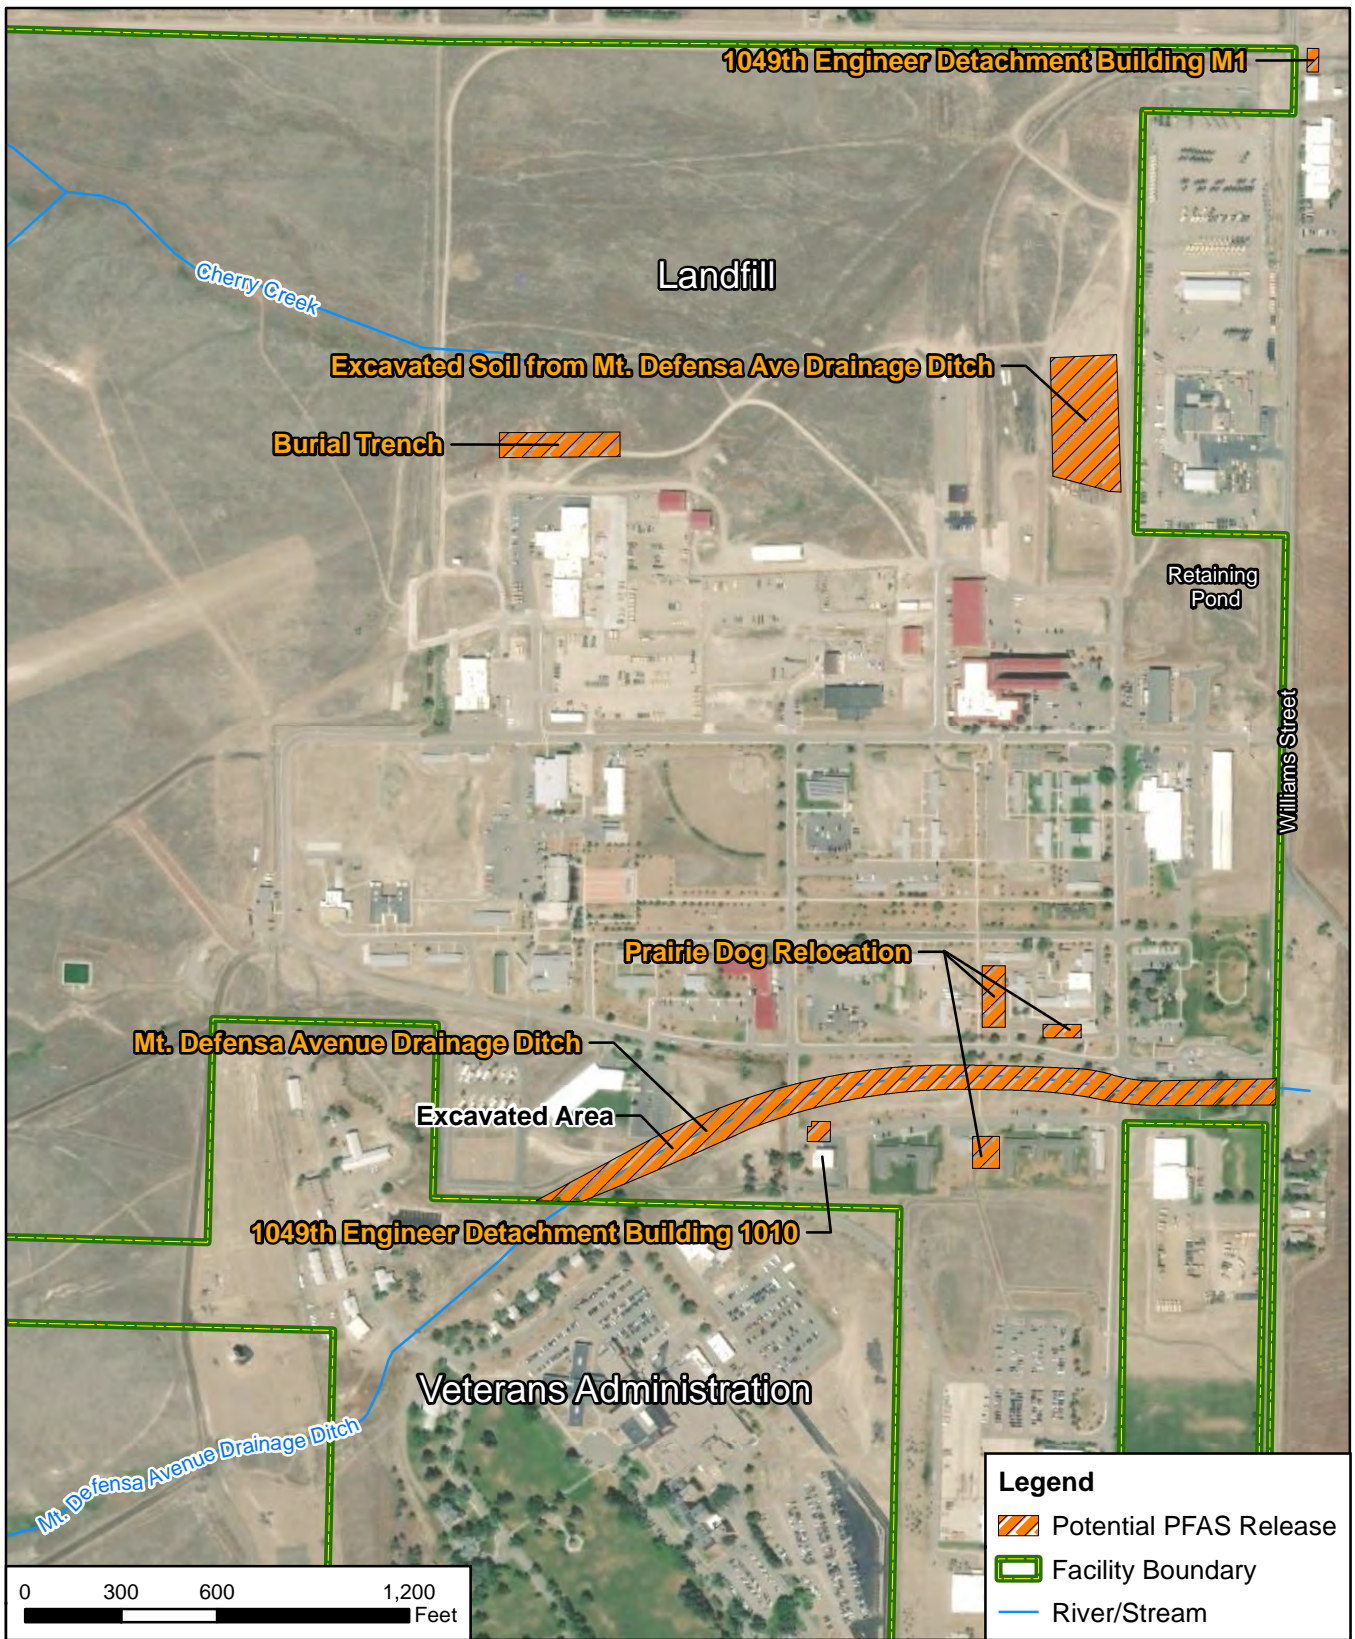
Non-Fire Training Areas	
	Figure 3-1
12420 Milestone Center Drive Germantown, MD 20876

Prior to 1987, an area about 200 feet north of Colle Ferro Avenue in the northwest section of the Cantonment Area was used to dig a burial trench and dispose of debris and ordnance (**Figure 3-1**). The geographic coordinates are 46°37'37.1"N and 112°06'14.2"W. One MTARNG retiree recollected to MTARNG Environmental personnel that vehicles were placed in the burial trench, burned, and extinguished with AFFF by MTARNG fire fighters. This use of AFFF could not be confirmed by any other interviewees during the PA, and no information was available on the concentration or amount of AFFF used. The Combined Support Maintenance Shop was constructed due south of the burial trench in 1987.

A large, unnamed drainage ditch runs from west to east through the VA property adjacent to FTWHH, through FTWHH along Mt. Defensa Avenue, and off-Post by the Main Gate to a retention pond inside the ACUB area on the east side of Williams Street. For the purposes of this report, this drainage ditch will be referred to as the Mt. Defensa Avenue Drainage Ditch (**Figure 3-1**).

The MTARNG 1049th Engineer Detachment currently operates out of Building 1010 located at the southeast corner of Rome Avenue and Middle Road (**Figure 3-1**). The geographic coordinates are 46°37'15.4"N and 112°06'00.7"W. This building was constructed in 1995. Prior to construction, the MTARNG 1049th Engineer Detachment operated out of the former Post Engineers Maintenance Shop (Building M1), near the Field Maintenance Shop #3, at the southeast corner of Williams Street and Barrett Road in the 1980s. The geographic coordinates are 46°37'49.0"N and 112°05'40.1"W. Between the Building M1 location and the current location at Building 1010, the MTARNG 1049th Engineer Detachment briefly operated out of the buildings currently known as the Troop Medical Clinic (Building 1009) and out of a building located where the Range Operations (Building 1017) currently exists.

There is one known landfill area at FTWHH north of the Combined Support Maintenance Shop. The geographic coordinates are 46°37'47.6"N and 112°06'08.3"W (**Figure 3-1**). Information collected during a previous PA (Argonne 1993), indicates 40 to 50 burial trenches were in operation in this area from at least 1964 until the mid-1970s and interred waste from all of FTWHH. The burial cells were reportedly filled one by one and contain solid waste, including 55-gallon and smaller drums of unknown contents.

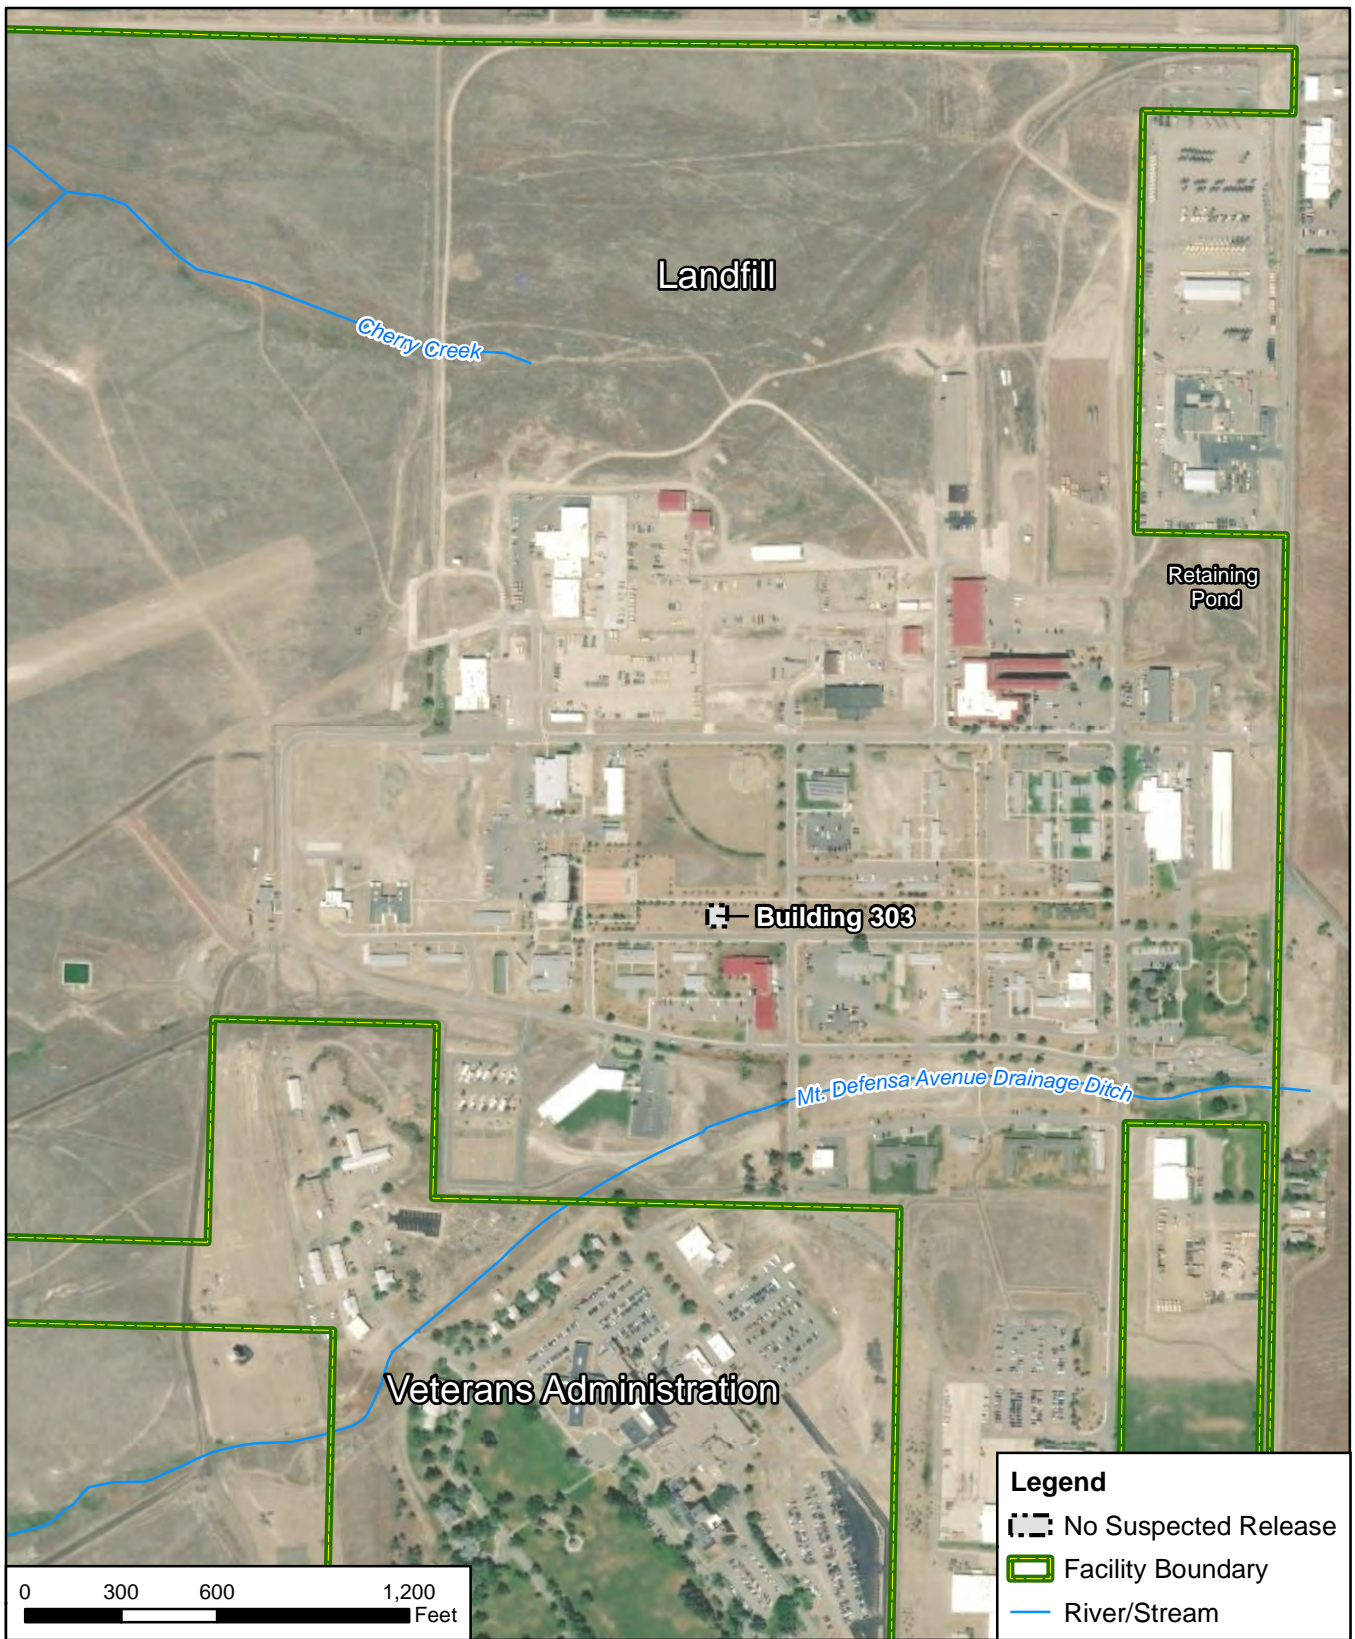
Emergency Response Area	
AECOM 12420 Milestone Center Drive Germantown, MD 20876	Figure 4-1

The former Dining Facility (Building 303) was located in the Cantonment Area west of Middle Road and north of Central Avenue (**Figure 4-1**). The geographic coordinates are 46°37'22.8"N and 112°06'05.9"W. This structure was considered a potential PFAS release area because in January 2012 the structure caught fire due a faulty heating system and was extinguished by the VA Fire Department. Interviewees did not recall the use of AFFF to extinguish the fire, and photographs viewed during the site visit indicate only water was used. The photographs were not available for use in this report. Therefore, Building 303 is not considered a potential PFAS release area. Based on aerial photography, the remains of Building 303 were demolished in 2012 or 2013.

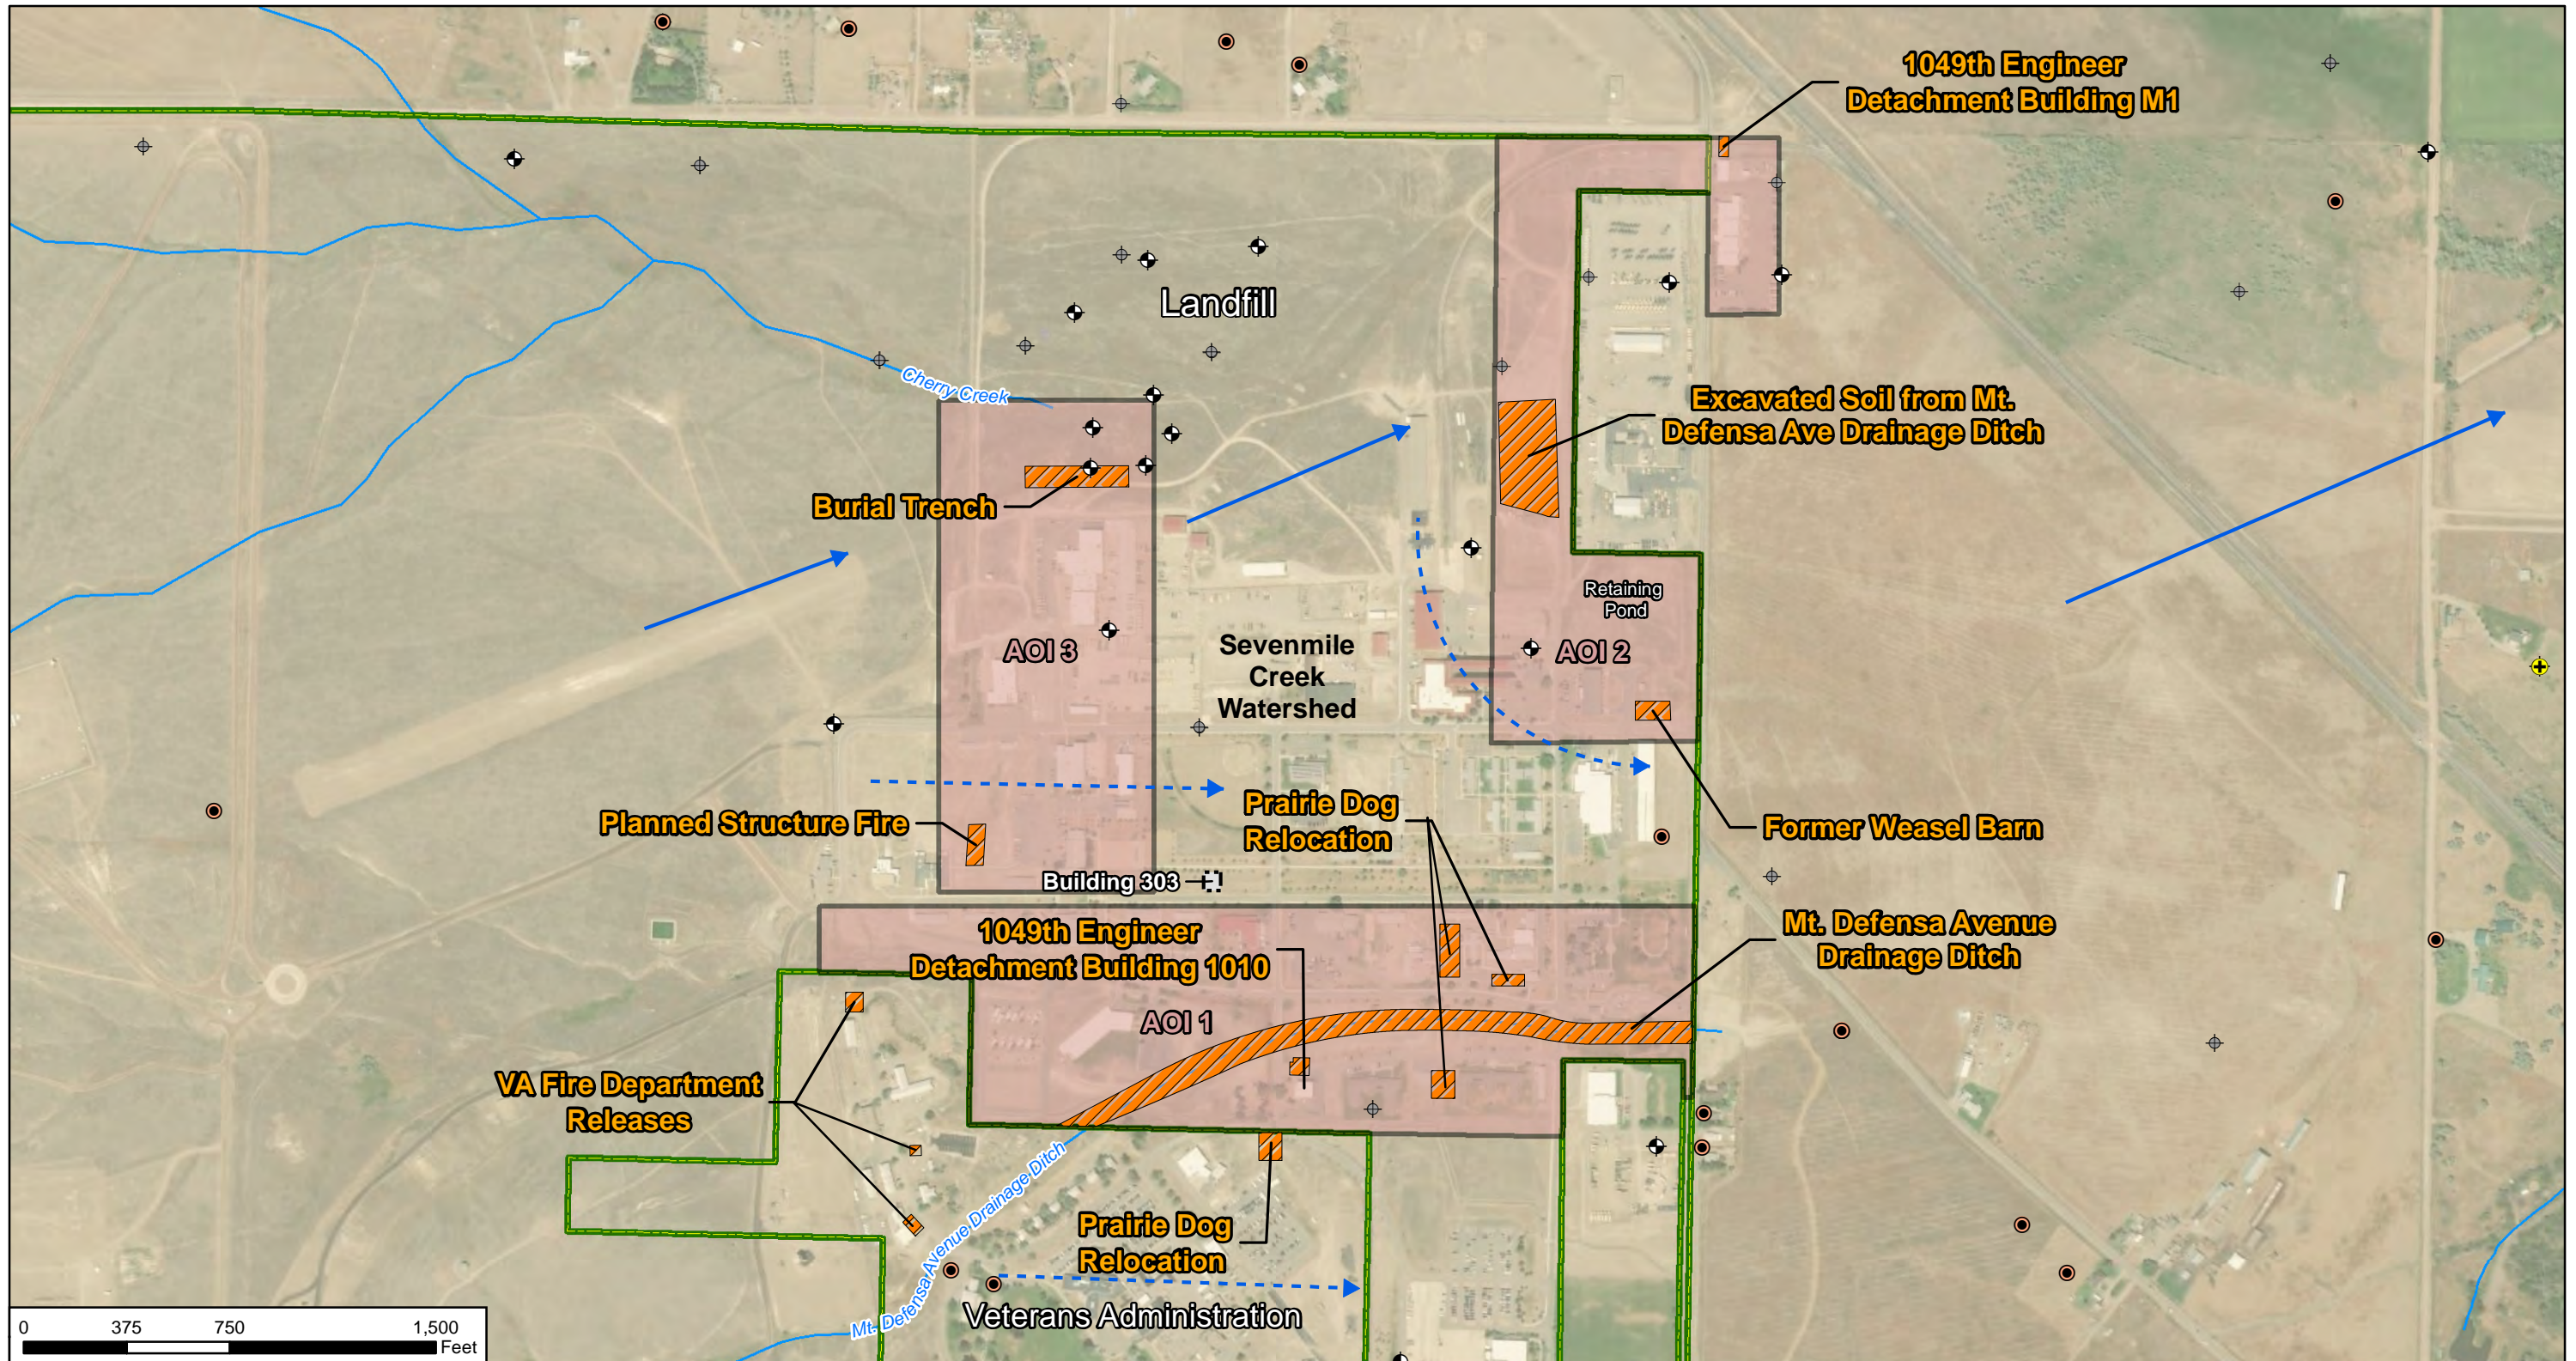
Figure 6-1

Based on the PA findings, the potential release areas were grouped into three areas of interest (AOIs): AOI 1 Mt. Defensa Avenue Drainage Ditch; AOI 2 Cantonment Area Northeast; and AOI 3 Cantonment Area Northwest. The AOI locations are shown on **Figure 6-1**. The following sections describe the CSM components and the specific CSMs developed for each AOI. The CSM identifies the three components necessary for a potentially complete exposure pathway: (1) source, (2) pathway, (3) receptor. If any of these elements are missing, the pathway is considered incomplete.

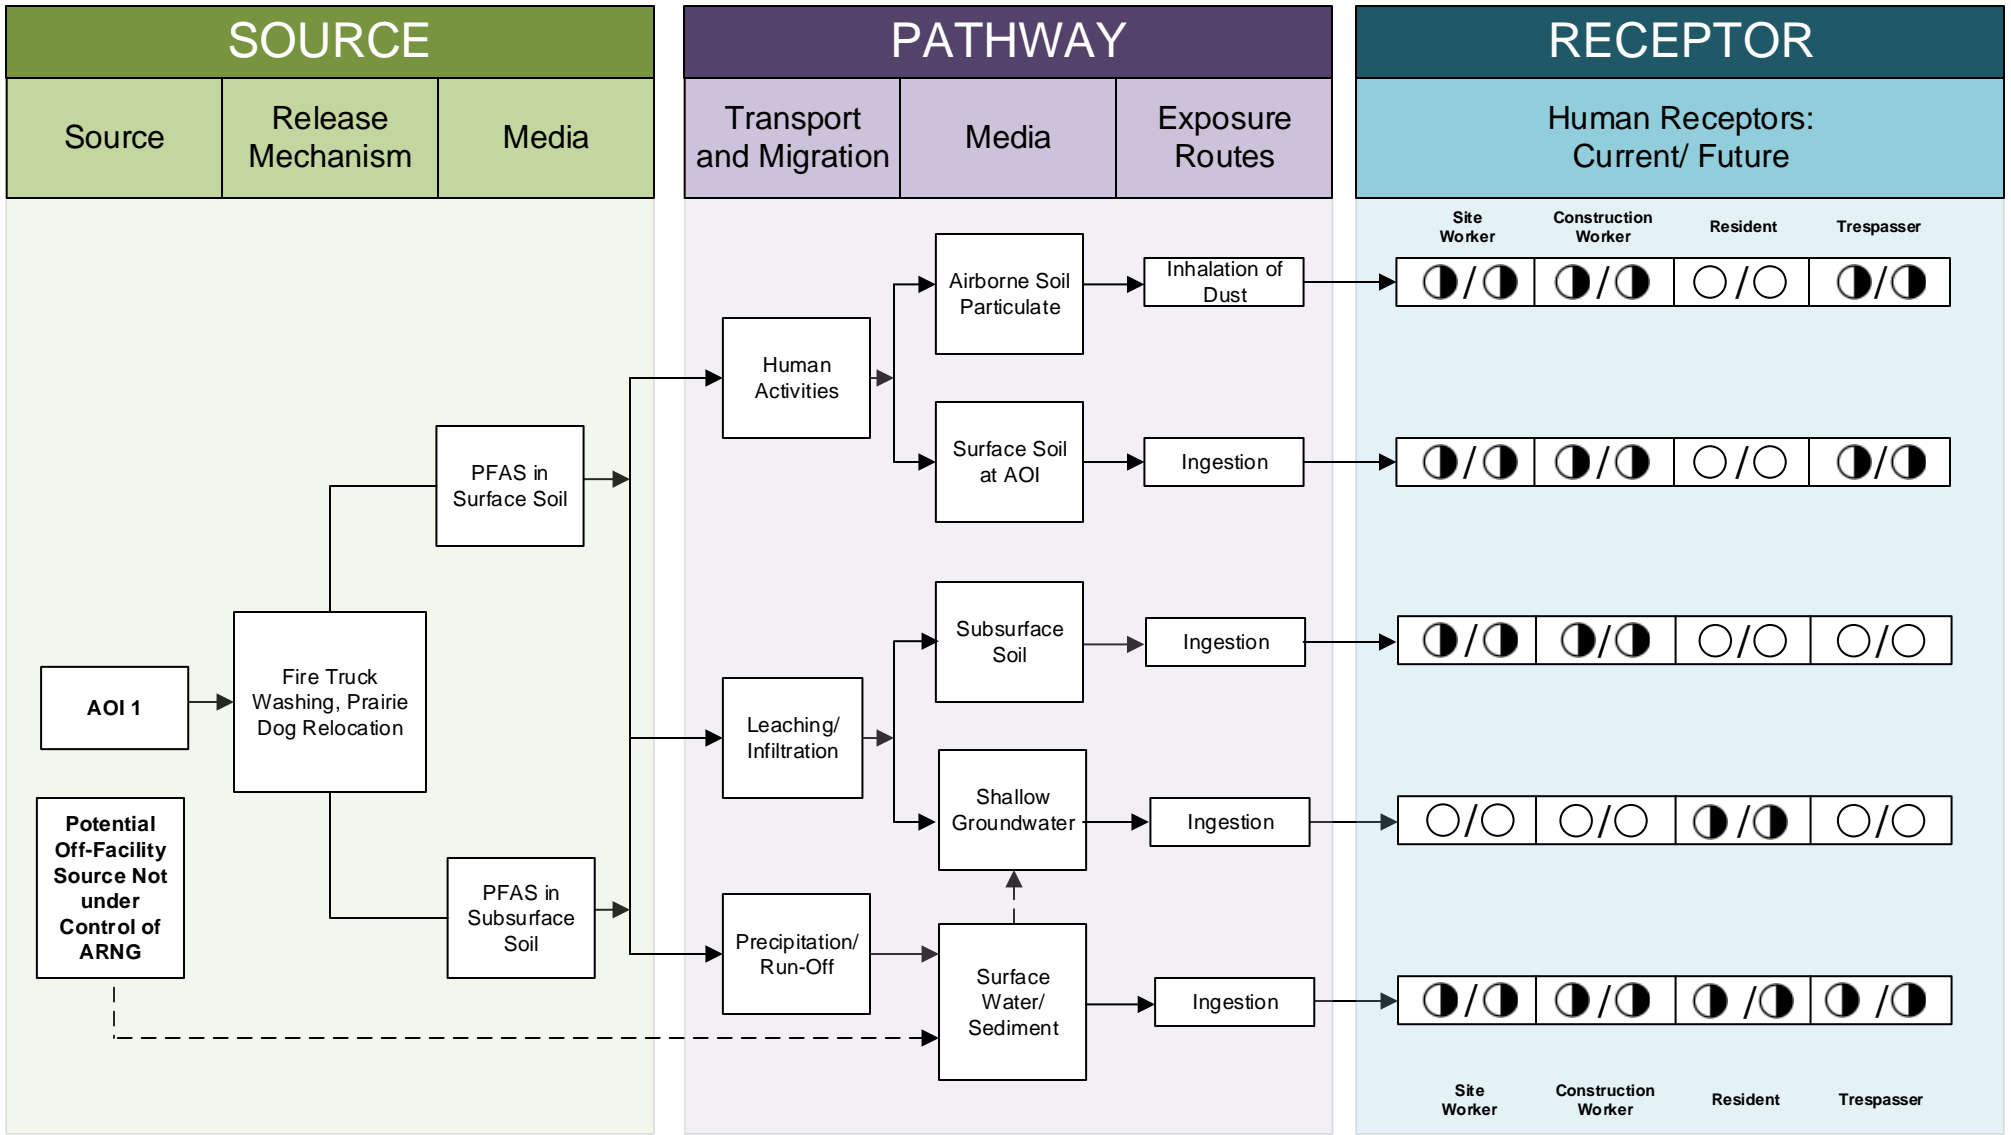
Figure 6-2
 Conceptual Site Model
 AOI 1 Mt. Defensa Avenue Drainage Ditch

In February 2012, a rapid snowmelt event caused an intermittent stream at AOI 1. The vigorous movement of the stream created foaming in the water flowing through FTWHH then off-Post to a retention pond in the ACUB area east of Williams Street. The cause of the foaming is unknown; however, PFAS are surfactants and potential PFAS releases in and around AOI 1 were noted during the PA. Therefore, it is possible that the cause of the foaming was residual AFFF. PFAS are water soluble and can migrate readily from soil to groundwater or surface water via leaching and run-off. Because potential PFAS releases to surface and subsurface soil have occurred, it is possible that PFAS migrated from the surface soil at AOI 1 to intermittent surface water and to the ACUB area soil via over land surface water flow during rapid snowmelt and large rainfall events. In addition, precipitation infiltrating AOI 1 and the ACUB area may cause the migration of PFAS from surface and subsurface soil to groundwater which is estimated to be 22 to 55 ft bgs (CDM 2006).
