FINAL Preliminary Assessment Report Fort William Henry Harrison, Montana

Perfluorooctane-Sulfonic Acid (PFOS) and Perfluorooctanoic
Acid (PFOA) Impacted Sites
ARNG Installations, Nationwide

August 2018

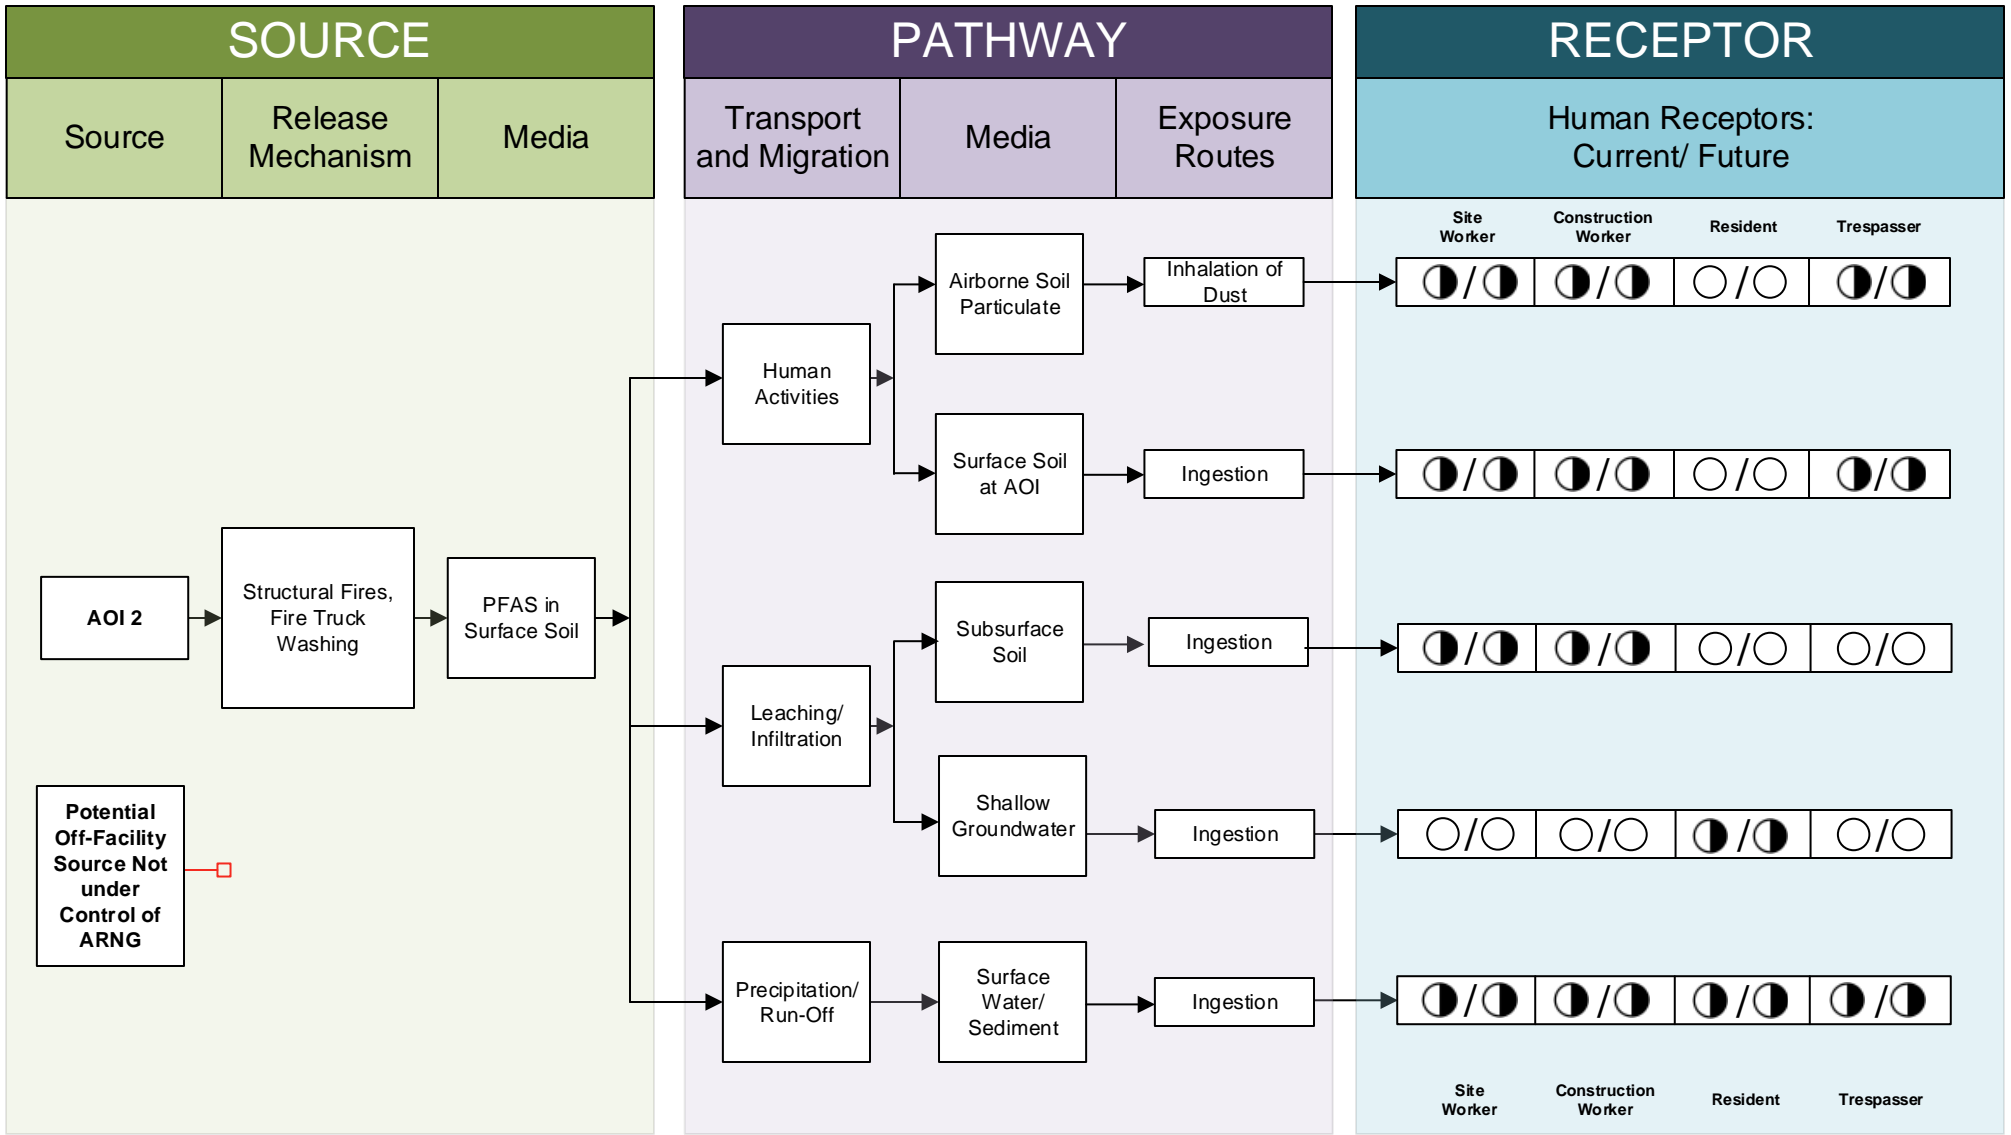
Figure 6-3
 Conceptual Site Model
 AOI 2 Cantonment Area Northeast

AOI 2 Cantonment Area Northeast	At the Building M1 location for the 1049 th Engineer Detachment, fire trucks were washed after AFFF use; therefore, PFAS releases to soil may have occurred. According to the 1049 th Team Chief, the trucks were washed outside of Building M1, but the exact location of the fire truck washing and potential PFAS release could not be determined. A drainage area where the discharge may have been allowed to dissipate was observed to the east of Building M1.

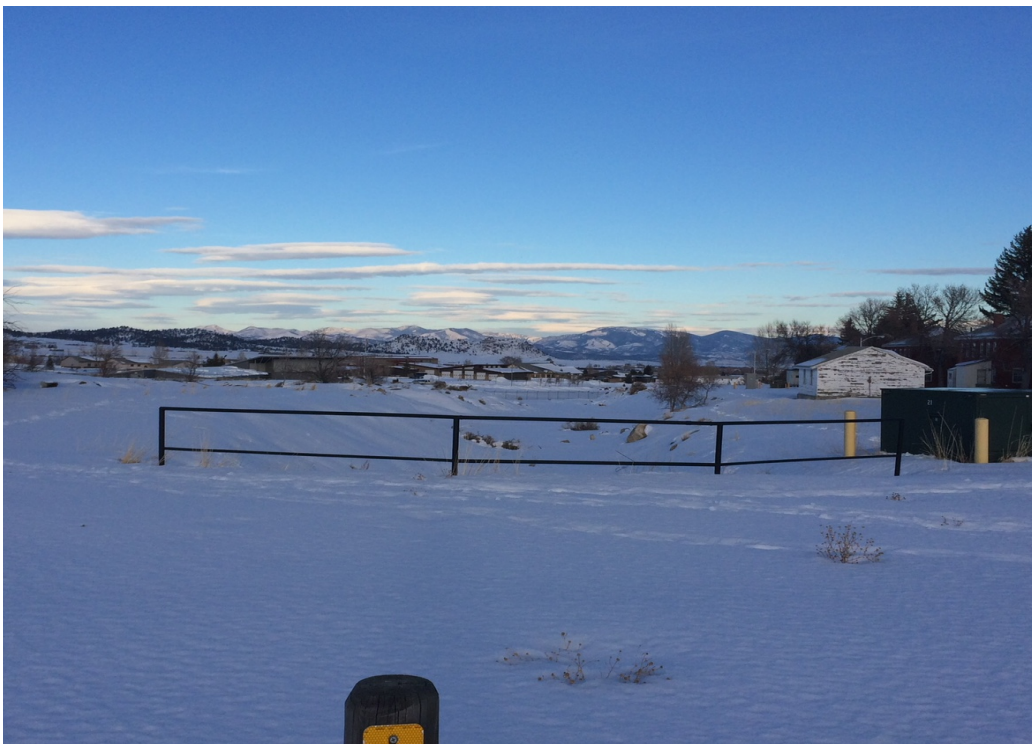
Photograph No. 2

Looking east. Intermittent
stream in the Mt. Defensa
Avenue Drainage Ditch after
rapid snowmelt. Location is
on-Post, upgradient of the
MTARNG 1049th Fire
Department (Building 1010).
Photograph provided by
MTARNG.

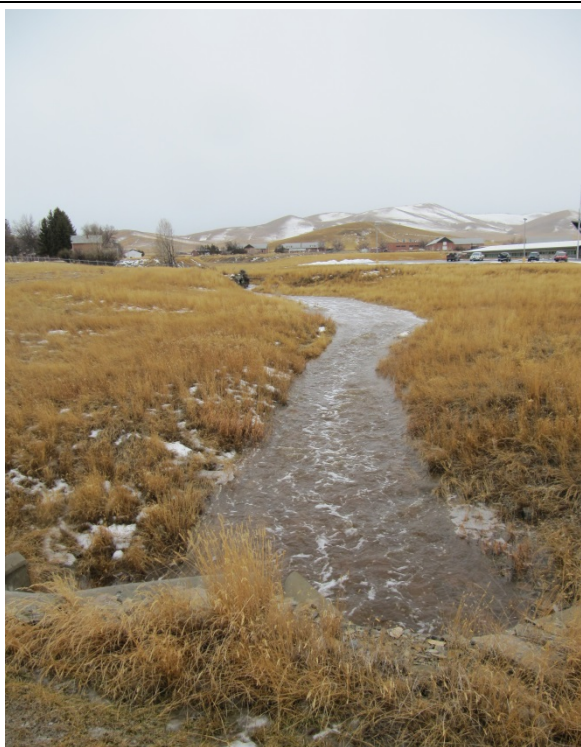
Looking east. Intermittent stream in the Mt. Defensa Avenue Drainage Ditch after rapid snowmelt. Location is on-Post, downgradient of the MTARNG 1049th Fire Department (Building 1010). The white material in the photograph is suspected AFFF. Photograph provided by MTARNG.

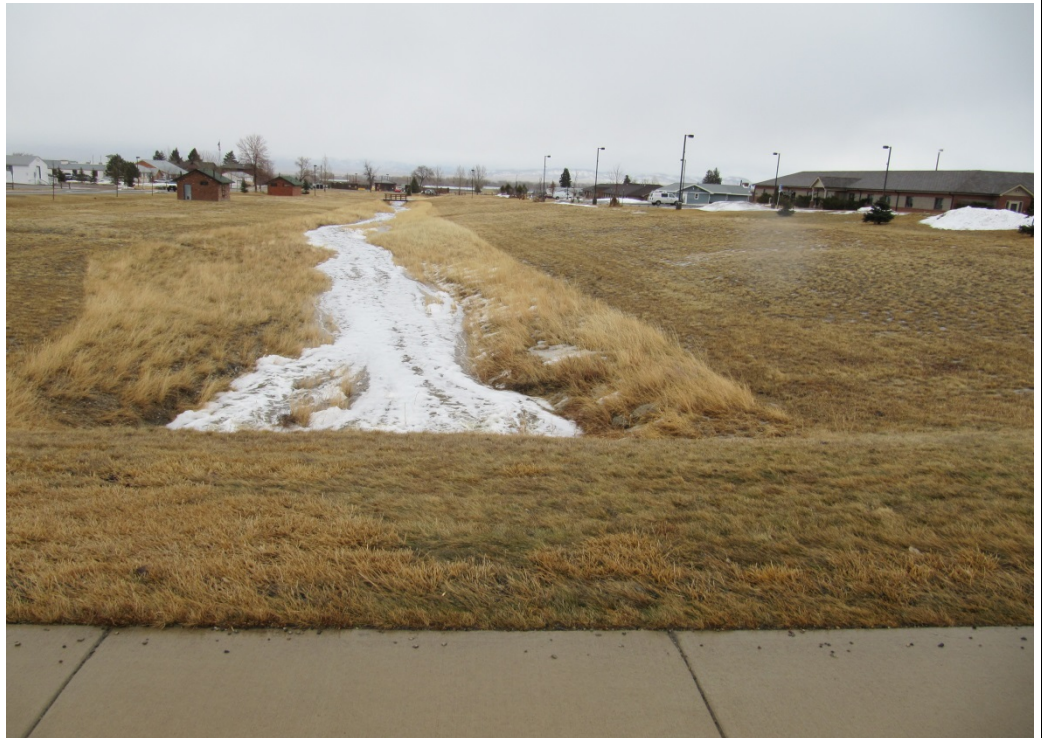
Photograph No. 4

Looking southeast. Intermittent stream in the Mt. Defensa Avenue Drainage Ditch after rapid snowmelt. Location is on the west side of the Main Gate (on-Post). The white material in the photograph is suspected AFFF. Photograph provided by MTARNG.

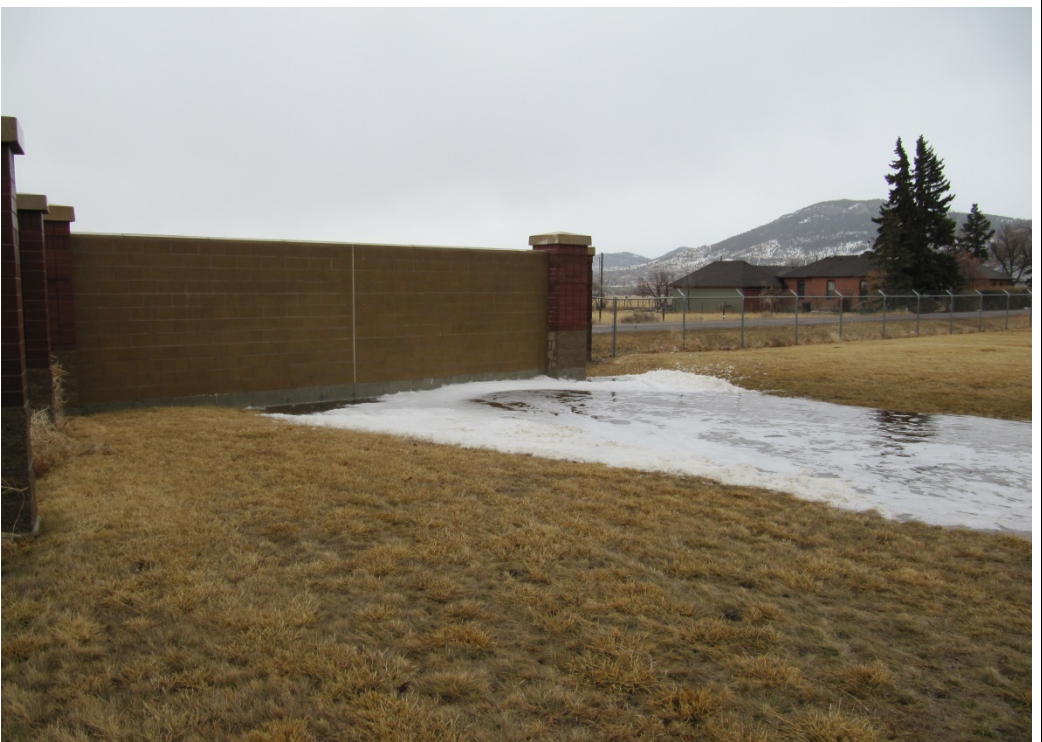
Looking south. Foam in the intermittent stream in the Mt. Defense Avenue Drainage Ditch after rapid snowmelt. Location is on the west side of the Main Gate (on-Post). The white material in the photograph is suspected AFFF. Photograph provided by MTARNG.

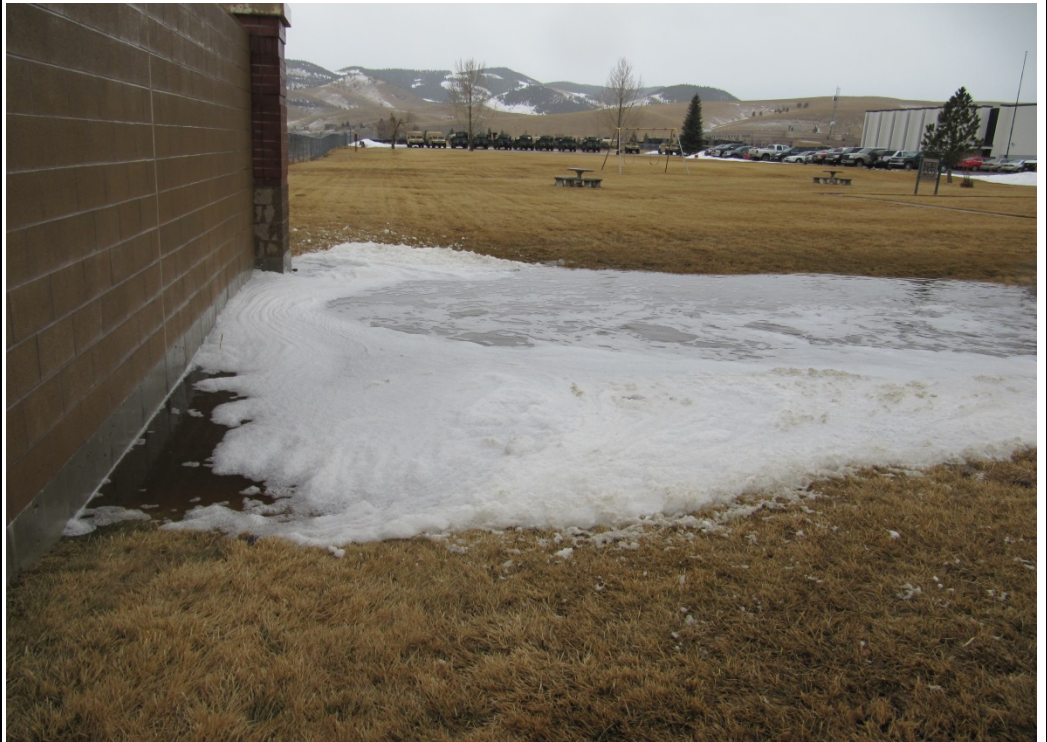
Photograph No. 6

Looking southeast. Intermittent stream running off-Post into a culvert on the east side of the Main Gate. The white material in the photograph is suspected AFFF. Photograph provided by MTARNG.

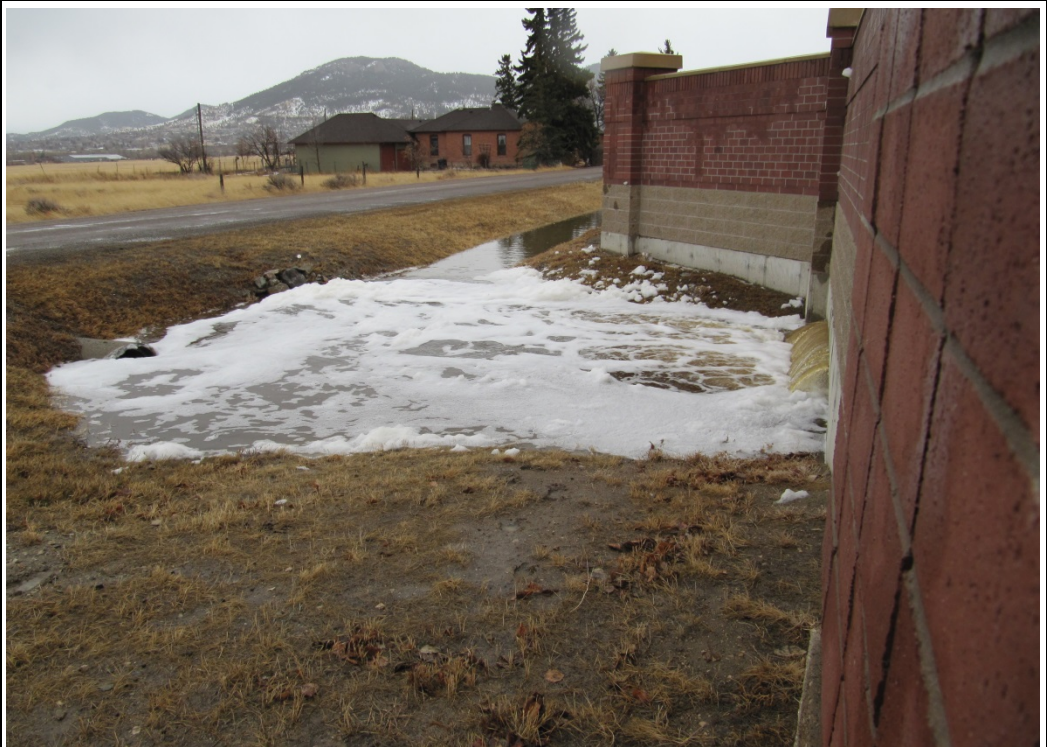
Looking east. Intermittent stream off-Post in the ACUB area after rapid snowmelt. Location is on the east side of Williams Street. The white material in the photograph is suspected AFFF. Photograph provided by MTARNG.

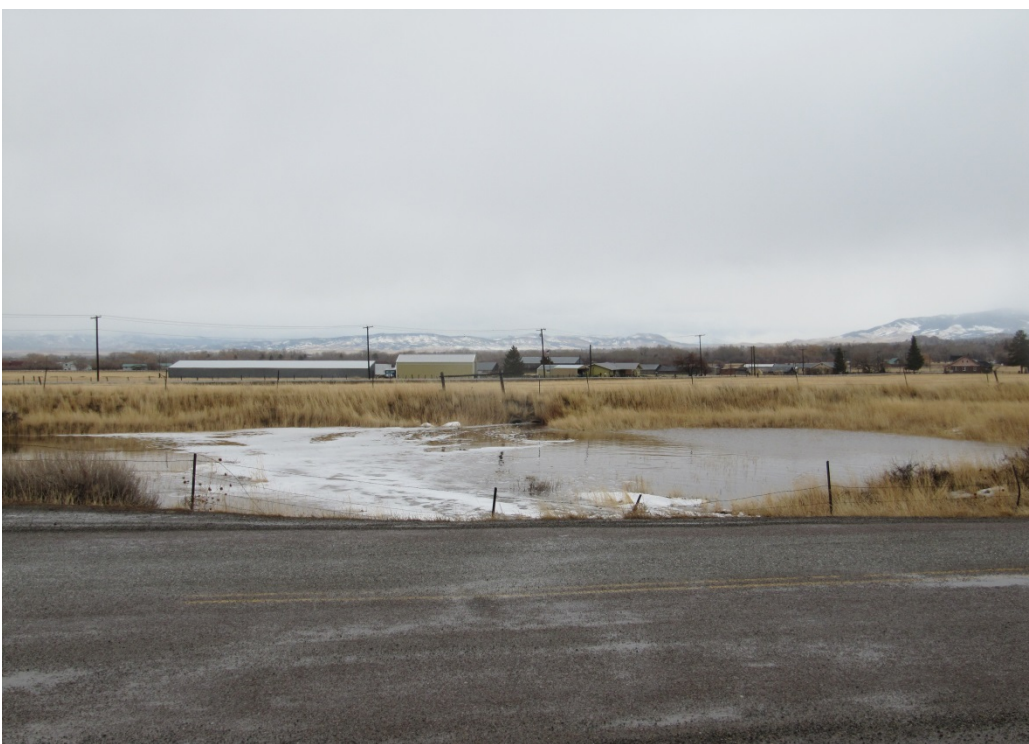
Photograph No. 8

Looking northeast. Retention pond in the northeast section of the Cantonment Area after rapid snowmelt. The white material in the photograph is snow. Photograph provided by MTARNG.

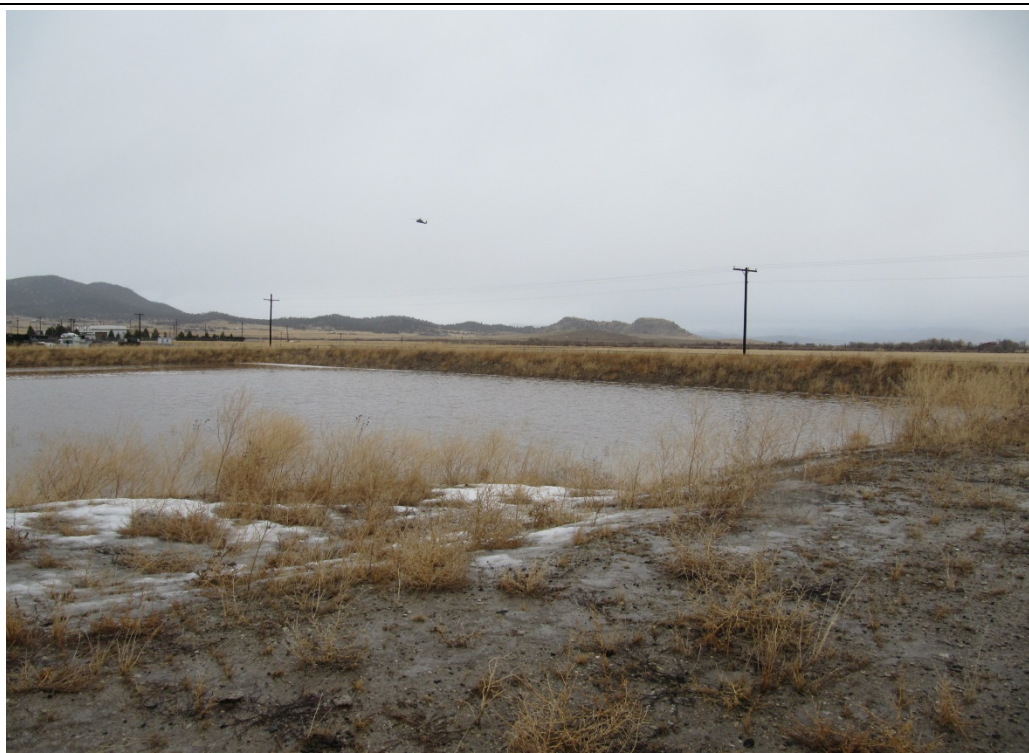
APPENDIX C – Photographic Log		
Army National Guard, Preliminary Assessment for PFAS	Fort William Henry Harrison	Helena, Montana
<p>Photograph No. 9</p> <p>Description:</p> <p>Looking northwest. Previous MTARNG 1049th Fire Station. The white material in the photograph is snow.</p>	 	
<p>Photograph No. 10</p> <p>Description:</p> <p>Looking northeast. Drainage area due north of the previous MTARNG 1049th Fire Station. The white material in the photograph is snow.</p>

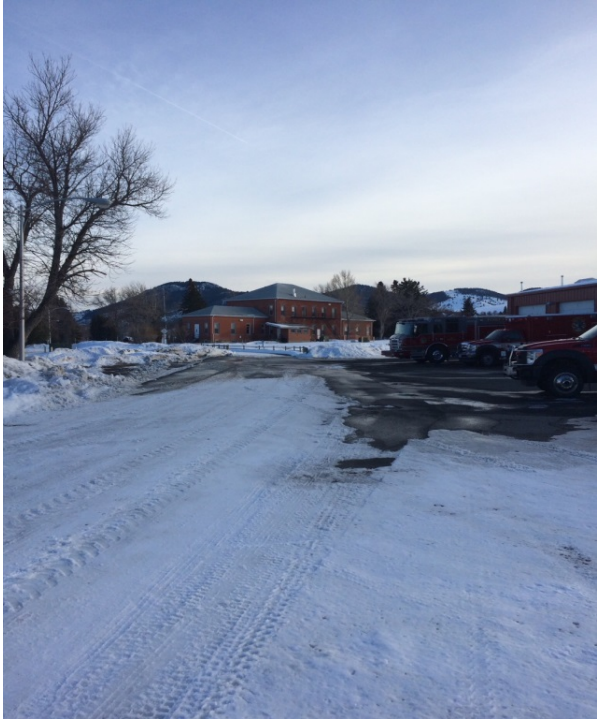
APPENDIX C – Photographic Log		
Army National Guard, Preliminary Assessment for PFAS	Fort William Henry Harrison	Helena, Montana
Photograph No. 11

Description:		
Looking southeast. Parking lot in front of the VA Fire Station. The white material in the photograph is snow.
