Karstolite Insulation and Other Asbestos

Know the facts.
Know what to do.

Karstolite and other asbestos—what to do if you find it

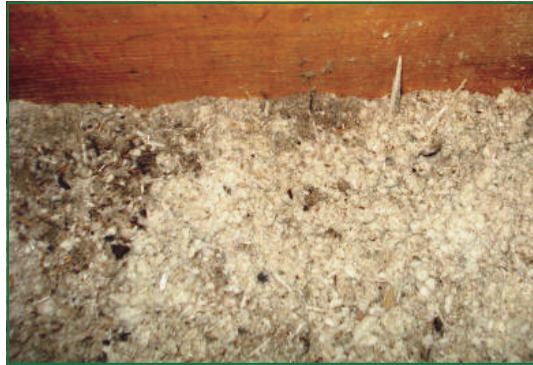
Karstolite insulation in an attic

Karstolite insulation can appear like dirty cottage cheese, white, khaki, brown or gray fibrous material, and/or fine powder.

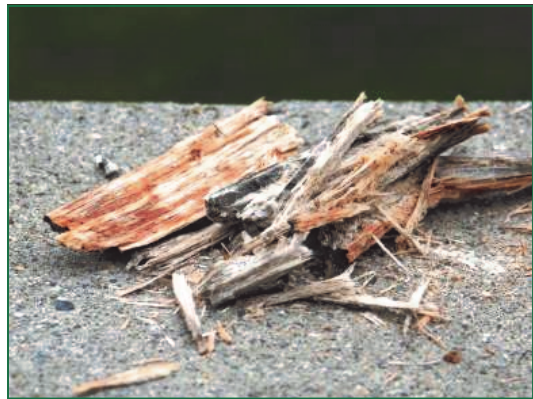
Asbestos ore (anthophyllite)

Asbestos ore may look like fibrous rocks, petrified wood, shiny chunks and/or fiber bundles. This ore is primarily white, but may also be brown, gray or green.

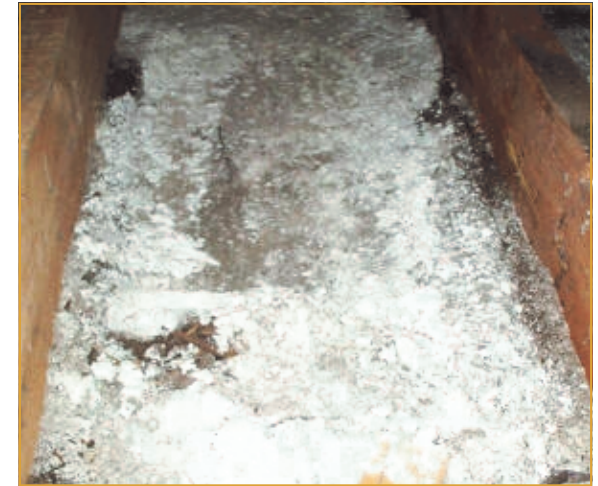
Karstolite insulation in an attic

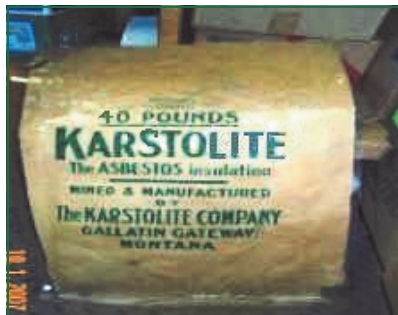
Karstolite insulation bag

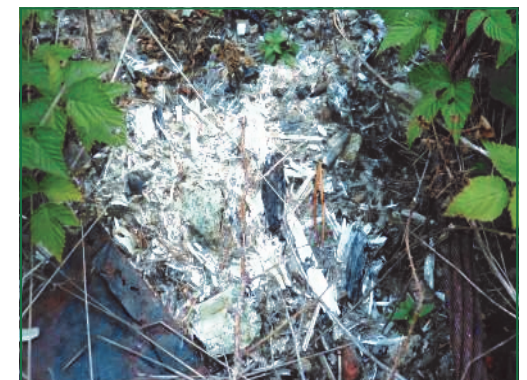
Asbestos ore from the Karst Mine
