Rock Creek Watershed Total Maximum Daily Loads and Water Quality Improvement Plans

September 2013

Water Quality Planning Bureau
Watershed Management Section

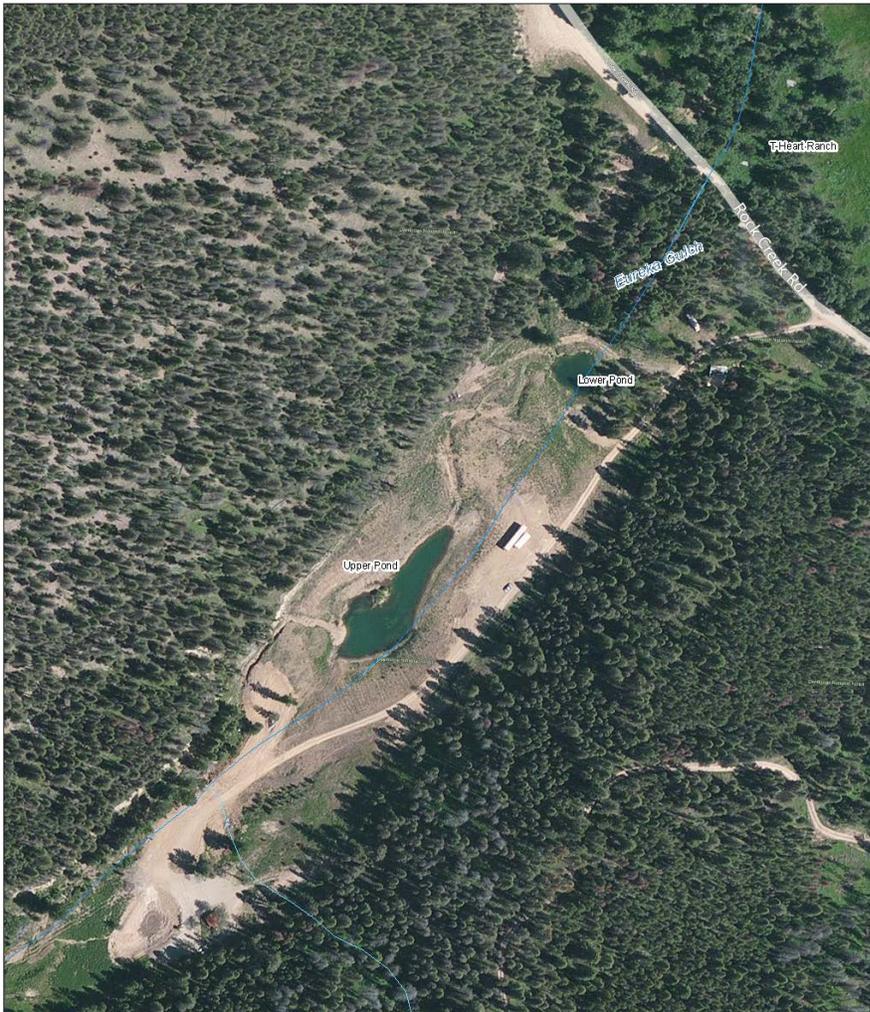
Figure 5-7. Aerial Photo of Eureka Gulch

In 2011, DEQ requested access to perform a sediment and habitat assessment on Eureka Gulch, but was denied access. Therefore, observations from previous assessments and aerial photos (**Figure 5-7**) will be used to evaluate the stream.

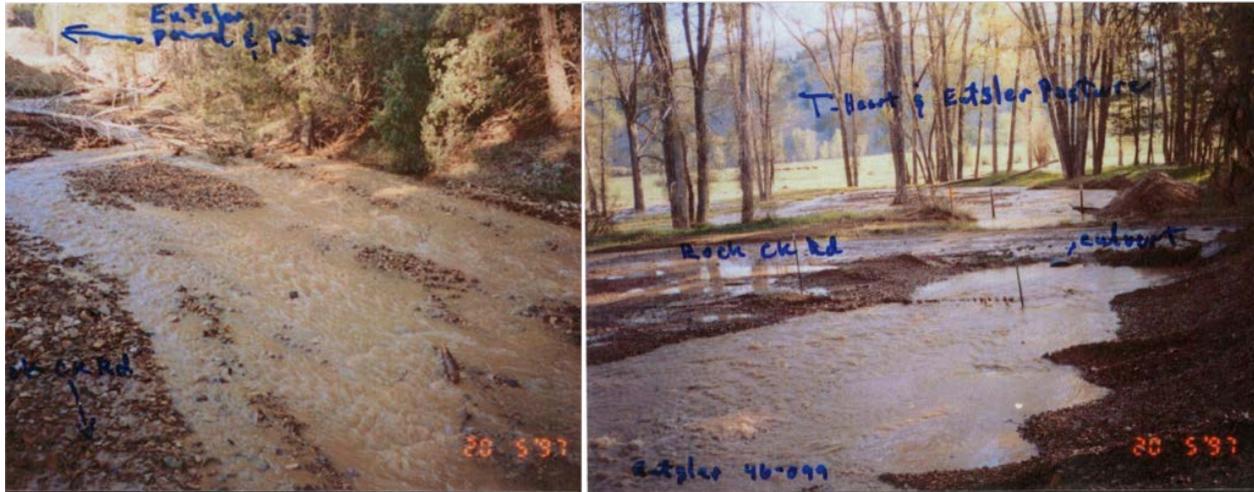
In 1996 and 1997, DEQ visited the Small Miners Exclusion Operation located on Eureka Gulch during high flows in April. The entire gulch bottom was disturbed from the mining operations. According to field notes, water was flowing like chocolate milk (see **Figure 5-8**). An extremely turbid plume of sediment was observed in the receiving waterbody on the T-Heart Ranch, which went from clear to opaque below Eureka Gulch. The lower settling pond was completely full and overflowing in the channel. The upper pond was full of turbid water, but not overflowing. The channel was extremely unstable and cutting vertically, where a diversion existed. Above the mine pit there was a very large amount of aggradation occurring with multiple channels cutting through the recently deposited substrate material. It appeared the material may have washed down from Quartz or Basin gulches.

Figure 5-8. Eureka Gulch in high flows 1997 – both leaving the pond and crossing Rock Creek Rd.

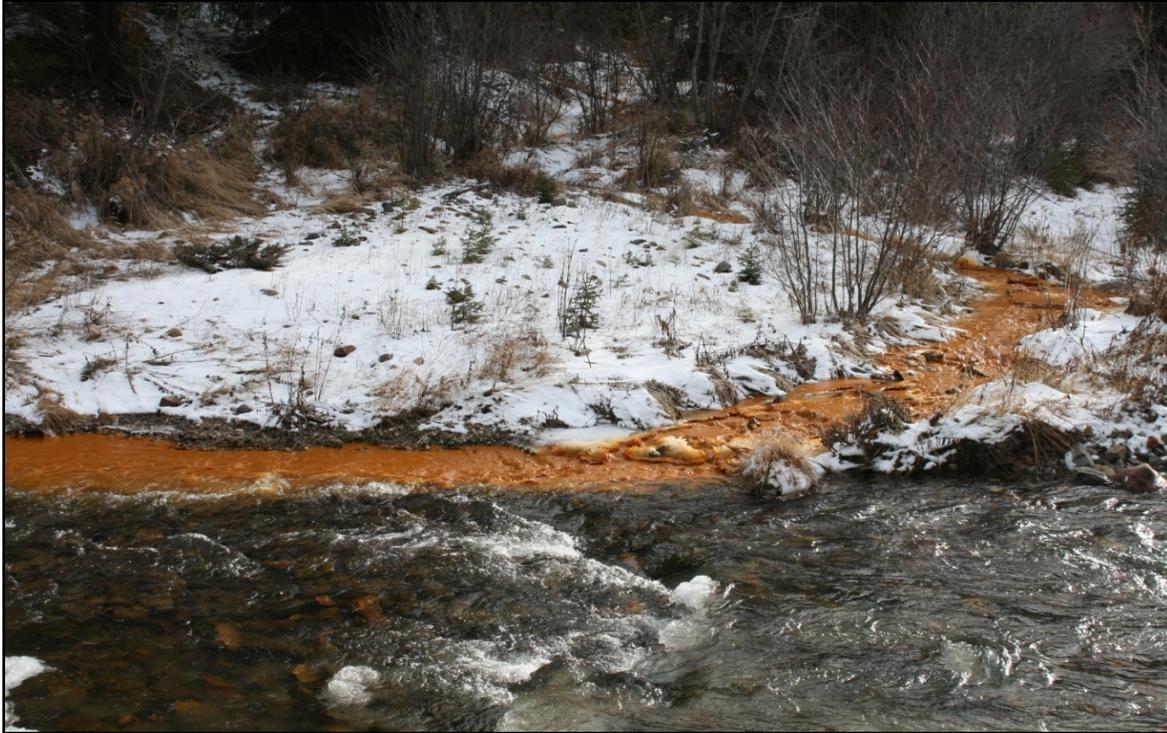
Figure 8-1. The iron oxide precipitation effects of acid rock drainage (ARD)

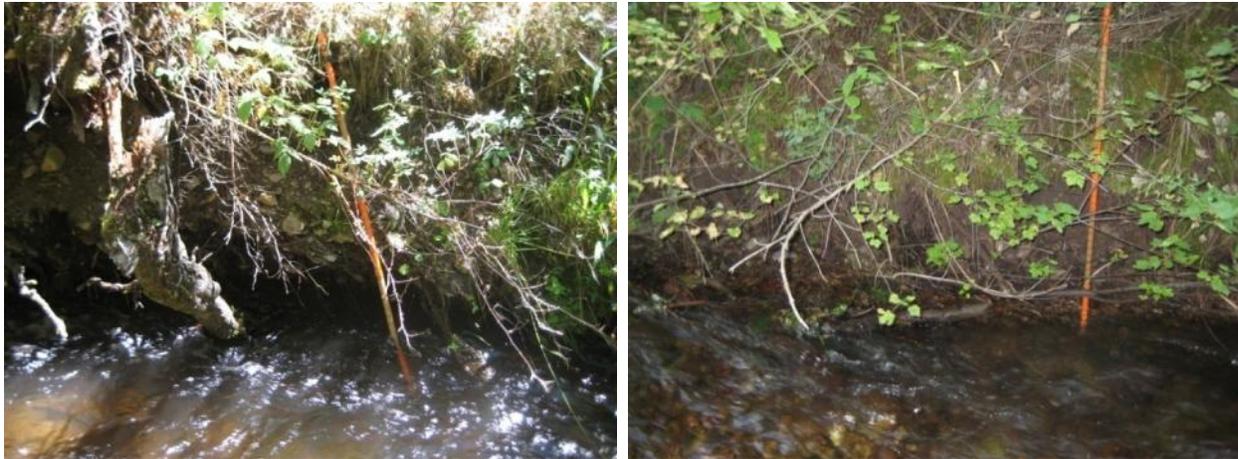
Figure C4-3. Typical eroding streambank conditions in Brewster Creek Reach 05-01.

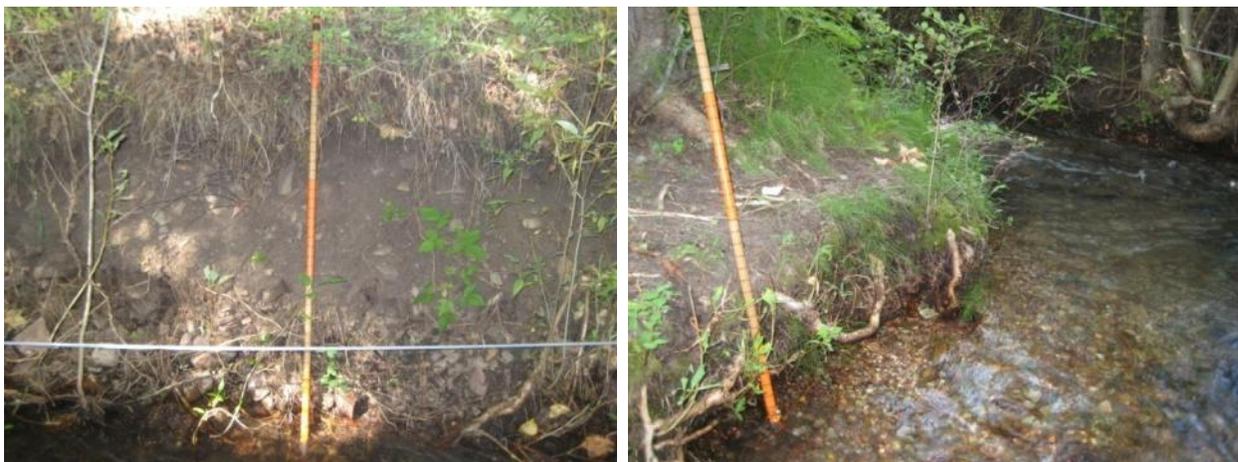
Figure C4-4. Typical eroding streambank conditions in Brewster Creek Reach 06-01.

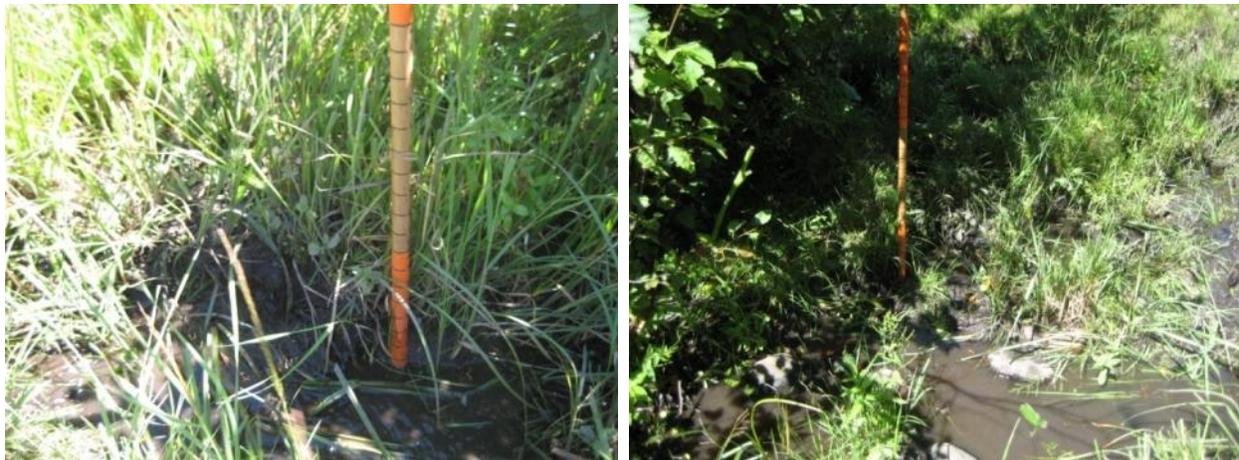
Figure C4-7. Typical eroding streambank conditions in Flat Gulch Reach 12-01.

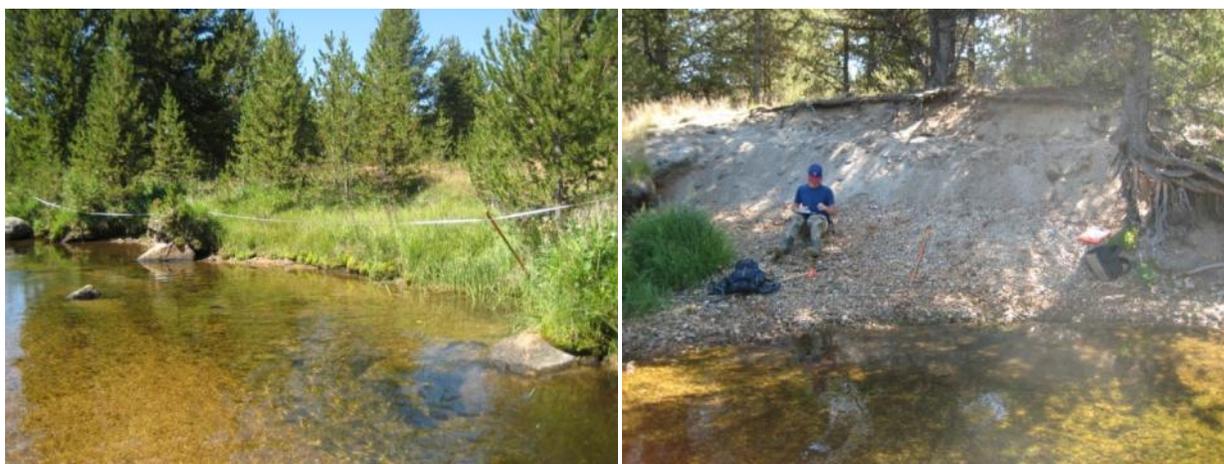
Figure C4-20. Typical eroding streambank conditions in West Fork Rock Creek 14-03.
